SALVAGING OLD PAVEMENTS BY RESURFACING

N. A. Billingsley, Jr.
Sr. Laboratory Engineer
District Eight

Special Study No. SS-4.0

July 1966

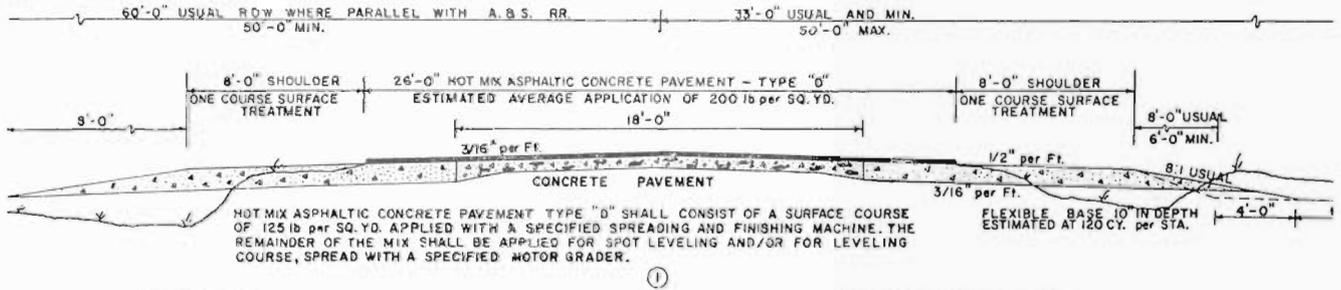
TYPICAL SECTION CONCRETE PAVEMENT WIDENED WITH FLEXIBLE BASE

- (1) Design number (1) consisted of 3200 feet of concrete pavement originally 18 feet wide. It was widened 8 feet on each side with ten inches of flexible base and overlaid with two inches of Type "D" Hot Mix Asphaltic Concrete. See Typical section (1).

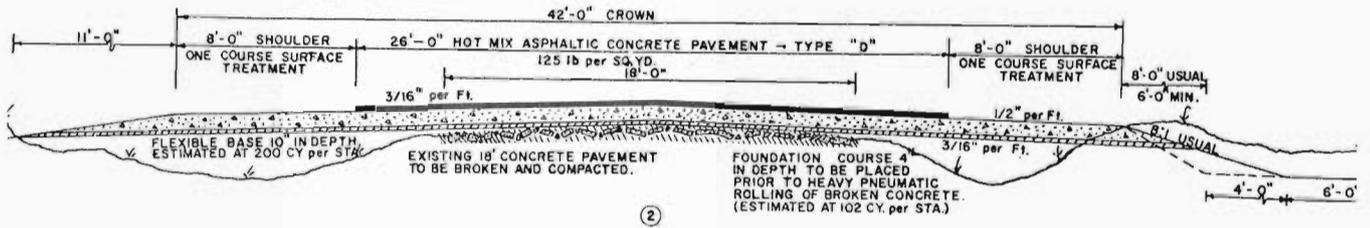
TYPICAL SECTION CONCRETE PAVEMENT BROKEN AND COMPACTED

- (2) Design number (2) consisted of 4500 feet of concrete pavement broken up and overlaid with four inches of foundation course, ten inches of flexible base. It was surfaced with one and one quarter inches of Type "D" Hot Mix Asphaltic Concrete. See typical section number (2).

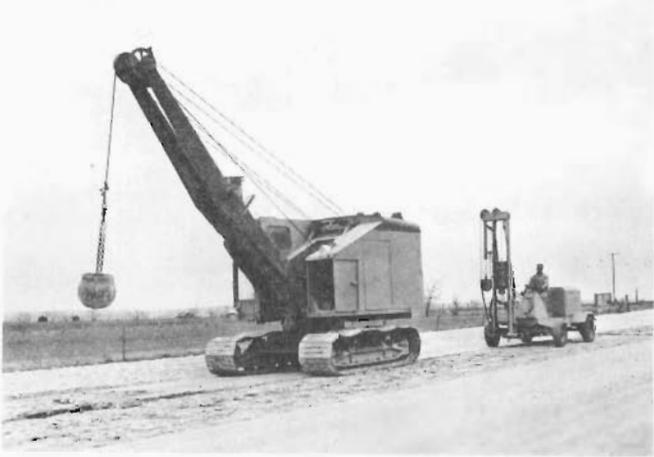
PHOTOGRAPH (5)

The contractor used two types of machinery for breaking up the old concrete as shown in Photograph (5).

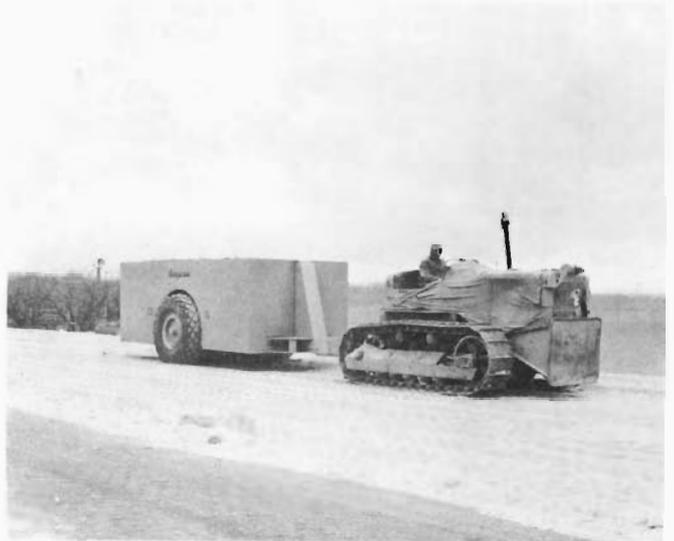
PHOTOGRAPH (6)

These broken-up chunks of concrete were then seated into the underlying soils by use of heavy rollers in accordance with the following special item. See Photograph (6).

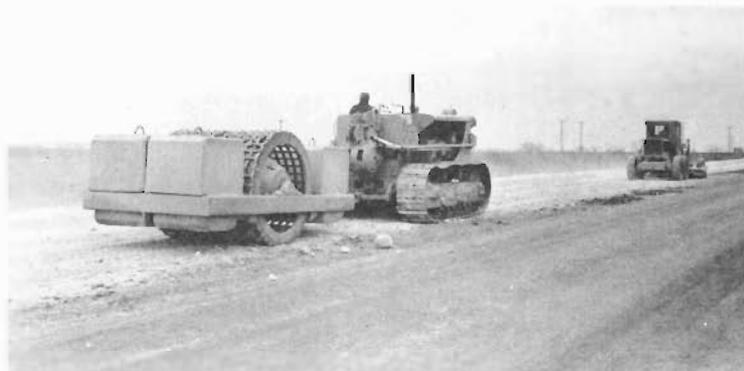
Photograph (7)

Foundation course material was placed on the broken concrete pavement prior to heavy pneumatic rolling. The foundation course material was pit run and contained large chunks of loosely cemented material. These were broken up by use of heavy grid roller. Only 35% was retained on a 40 mesh sieve as shown in Table I below. Thus, the chunks of broken concrete were easily surrounded. This operation is shown in Photograph (7).

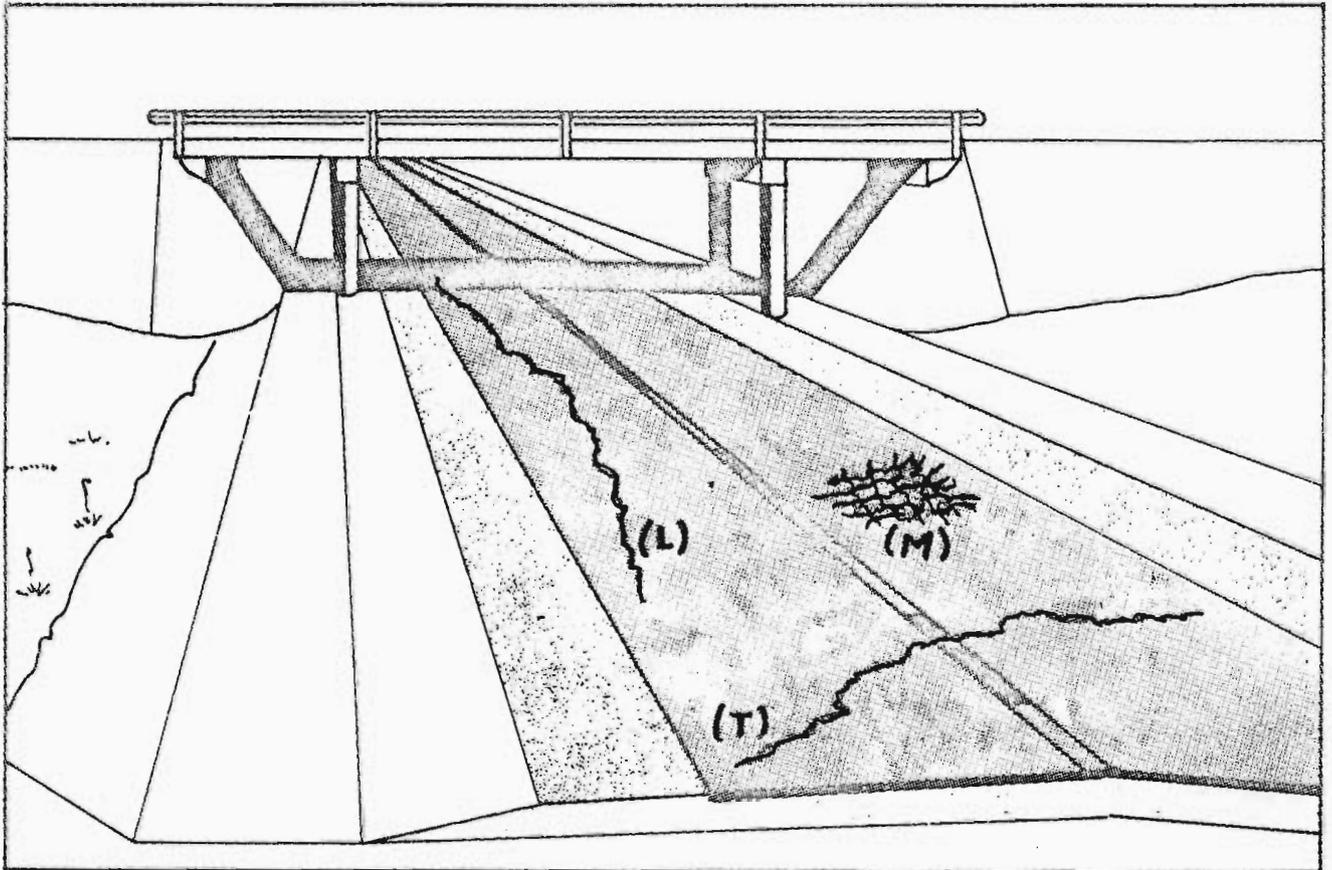
Asphaltic - Concrete
Pavement Failure Patterns

L₁, L₂, L₃ Longitudinal Cracking Pattern
T₁, T₂, T₃ Transverse cracking Pattern
M₁, M₂, M₃ Map Cracking Pattern

(NOTE: 1, 2, or 3 DENOTES VARYING DEGREE OF DISTRESS)

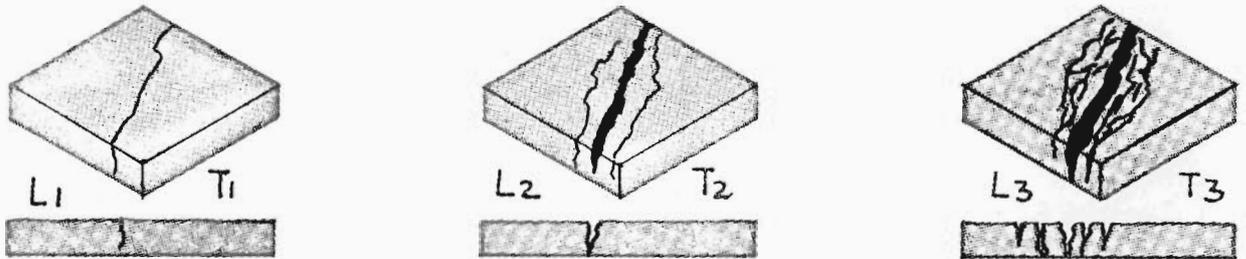
Longitudinal & Transverse Cracking Pattern

L1, T1	Slight	Hairline Cracks
L2, T2	Moderate	Cracks beginning to Spall
L3, T3	Severe	Disintegration of Material

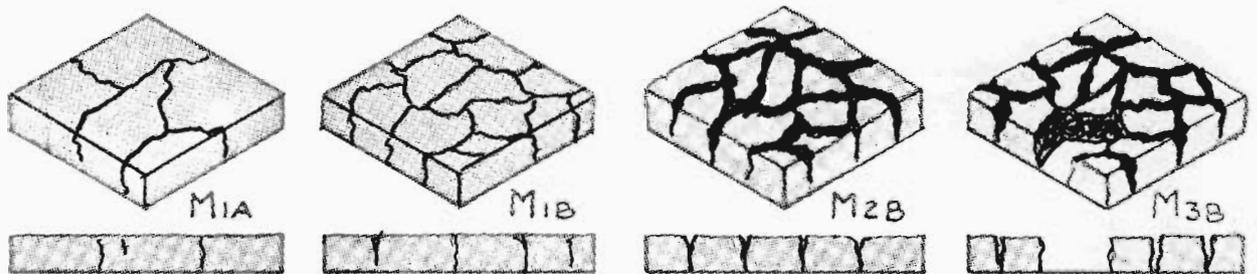
Map Cracking Pattern

M1A	Very Slight	Hairline cracks not visibly connected
M1B	Slight	Hairline cracks visibly connected
M2A	Slight to Moderate	Cracks beginning to spall at intersections
M2B	Moderate	Cracks with considerable spalling
M3A	Severe	Chunks of A-C loose but held in place
M3B	Very Severe	Chunks of A-C disintegrating & Crumbling away.
