PERFORMANCE OF
METAL REINFORCED
BITUMINOUS OVERLAYS
IN TEXAS

TEXAS HIGHWAY DEPARTMENT

TEXAS HIGHWAY DEPARTMENT
JUNE 1971

Supplement for District 2 - Fort Worth

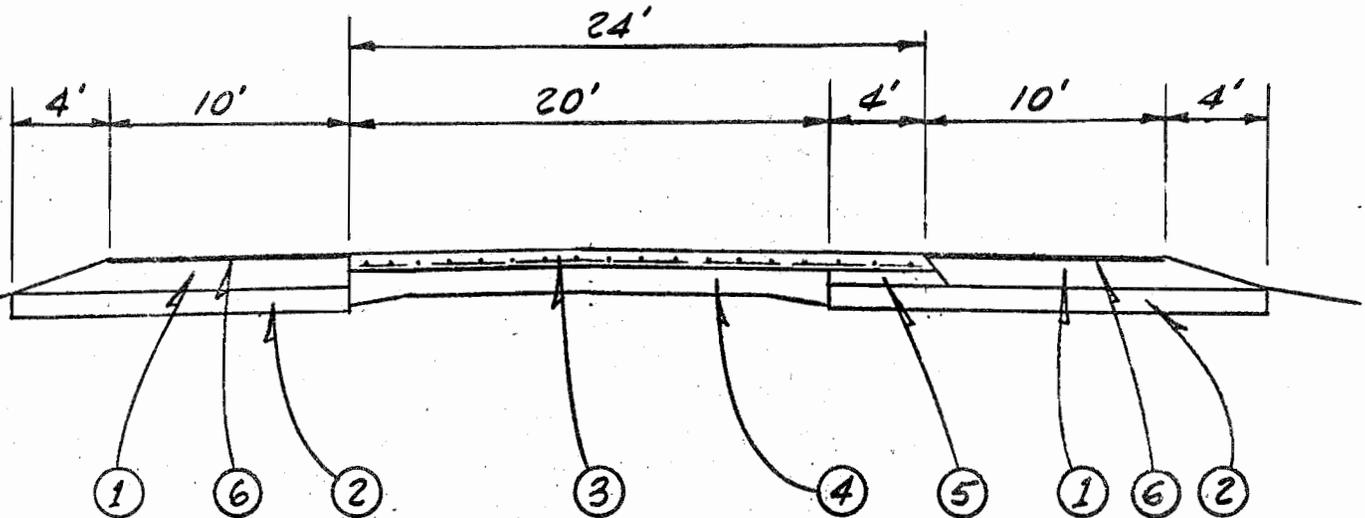
TYPICAL SECTION
 (WITH WIRE)

- (1) Flexible Base
- (2) Lime Treated Subgrade
- (3) 550 #/S.Y. Asph. Conc. Pvmt. w/3''x6''x # 10 Wire Fabric Reinf.
- (4) Exist. Concrete Pavement
- (5) 440 #/S.Y. Asph. Conc. Pvmt., Type "A"
- (6) Two Course Surface Treatment

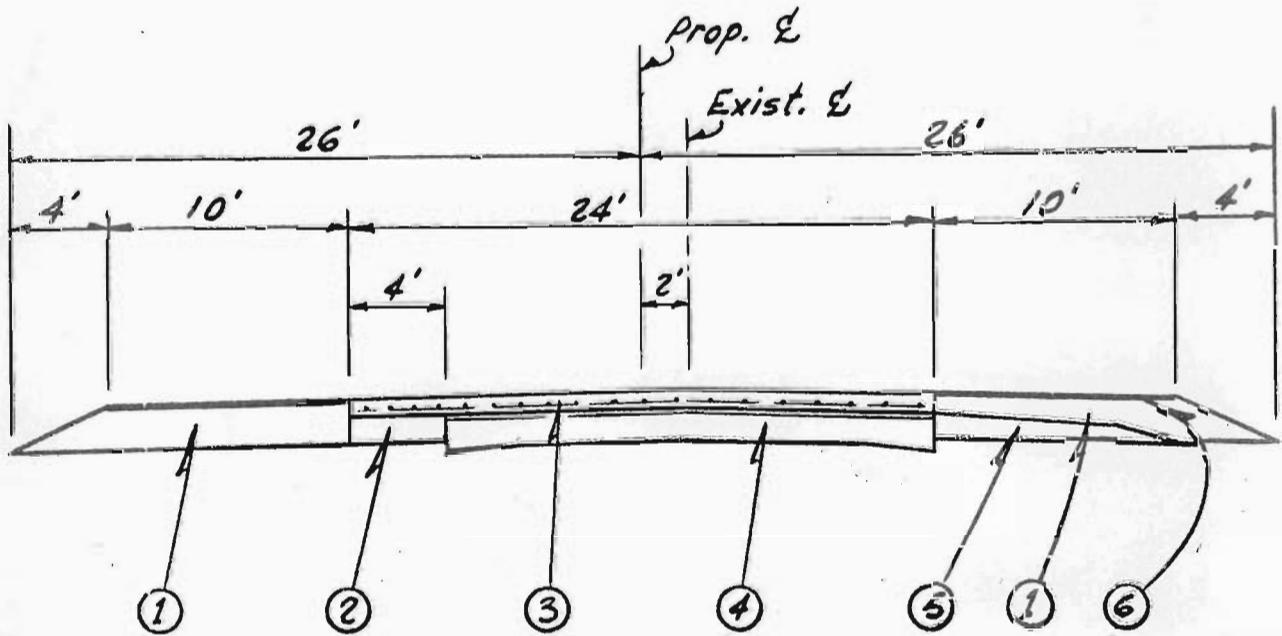
TYPICAL SECTION
 (WITH WIRE)

- (1) Flexible Base
- (2) 8" Class "A" Conc. (Reinf.)
- (3) 450#/S.Y. Asph. Conc. Pvm. w/3"x6"x # 10 Wire Fabric Reinf.
- (4) Exist. Conc. Pvm. & Asph. Overlay
- (5) Exist. Base
- (6) Two Course Surface Treatment & Prime

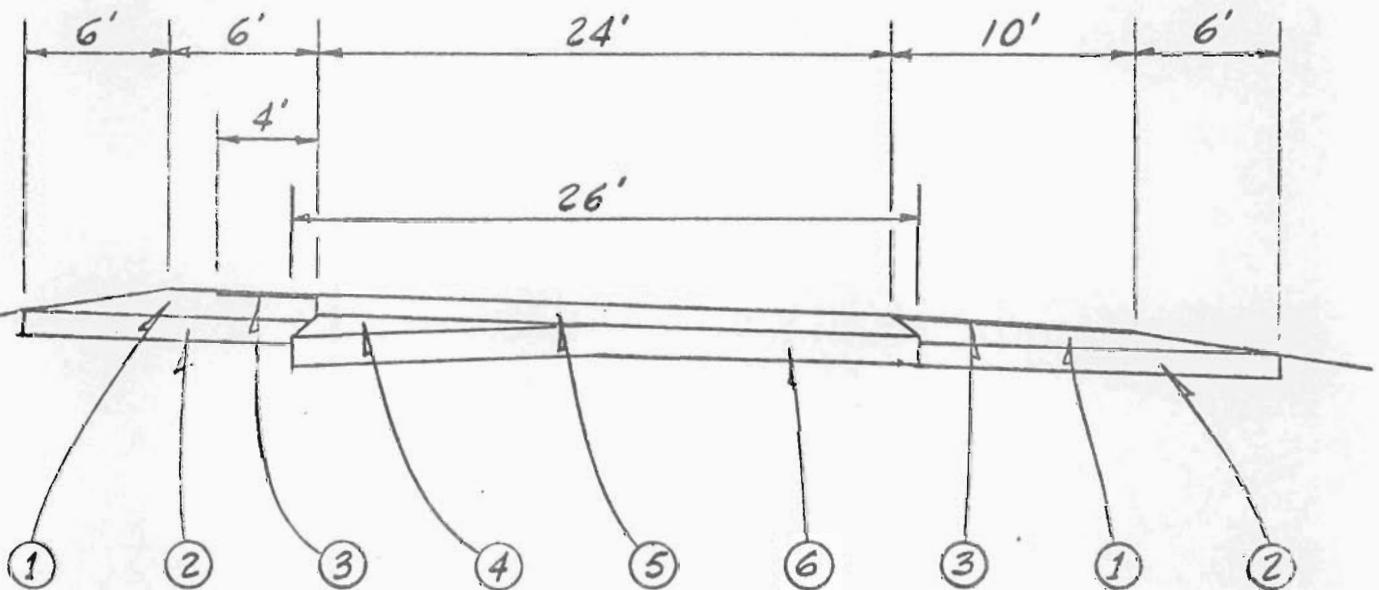
TYPICAL SECTION
 (WITH WIRE)

- (1) Flexible Base
- (2) Lime Stabilized Subgrade
- (3) Two Course Surface Treatment
- (4) ACP Level Up
- (5) 550 #/S.Y. Asph. Conc. Pmnt. w/3"x6"x # 10 Wire Fabric Reinf.
- (6) Exist. Concrete Pavement

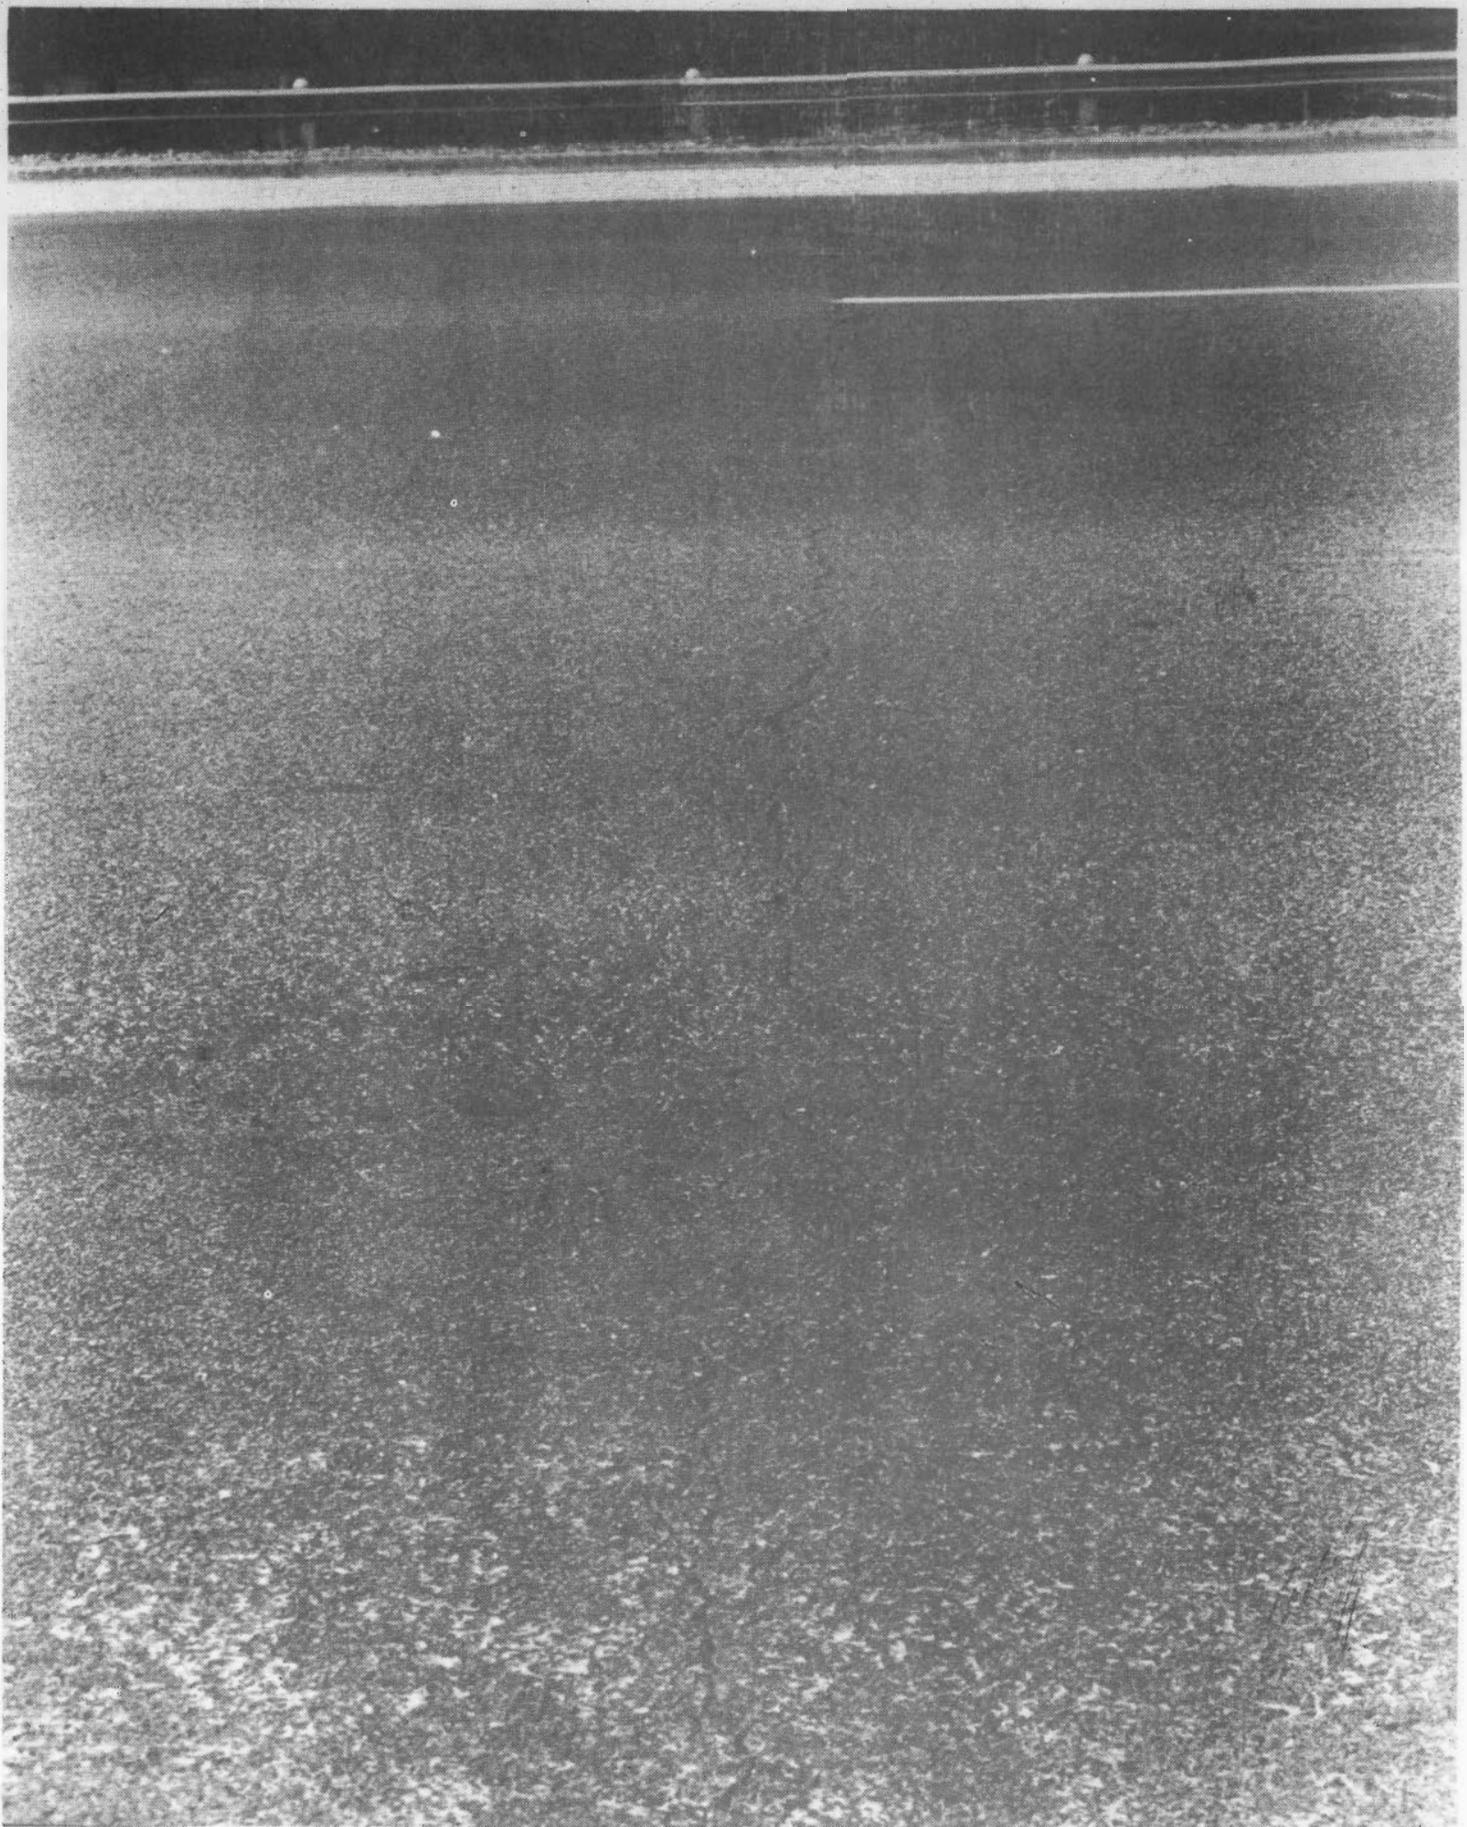
IH 45: NORTH OF FUQUA ON SOUTHBOUND LANES

- No. 6 & 7 Note slight transverse joint opening at 1" board joint. Knife is at median curb joint line. Longitudinal joints did not come through.

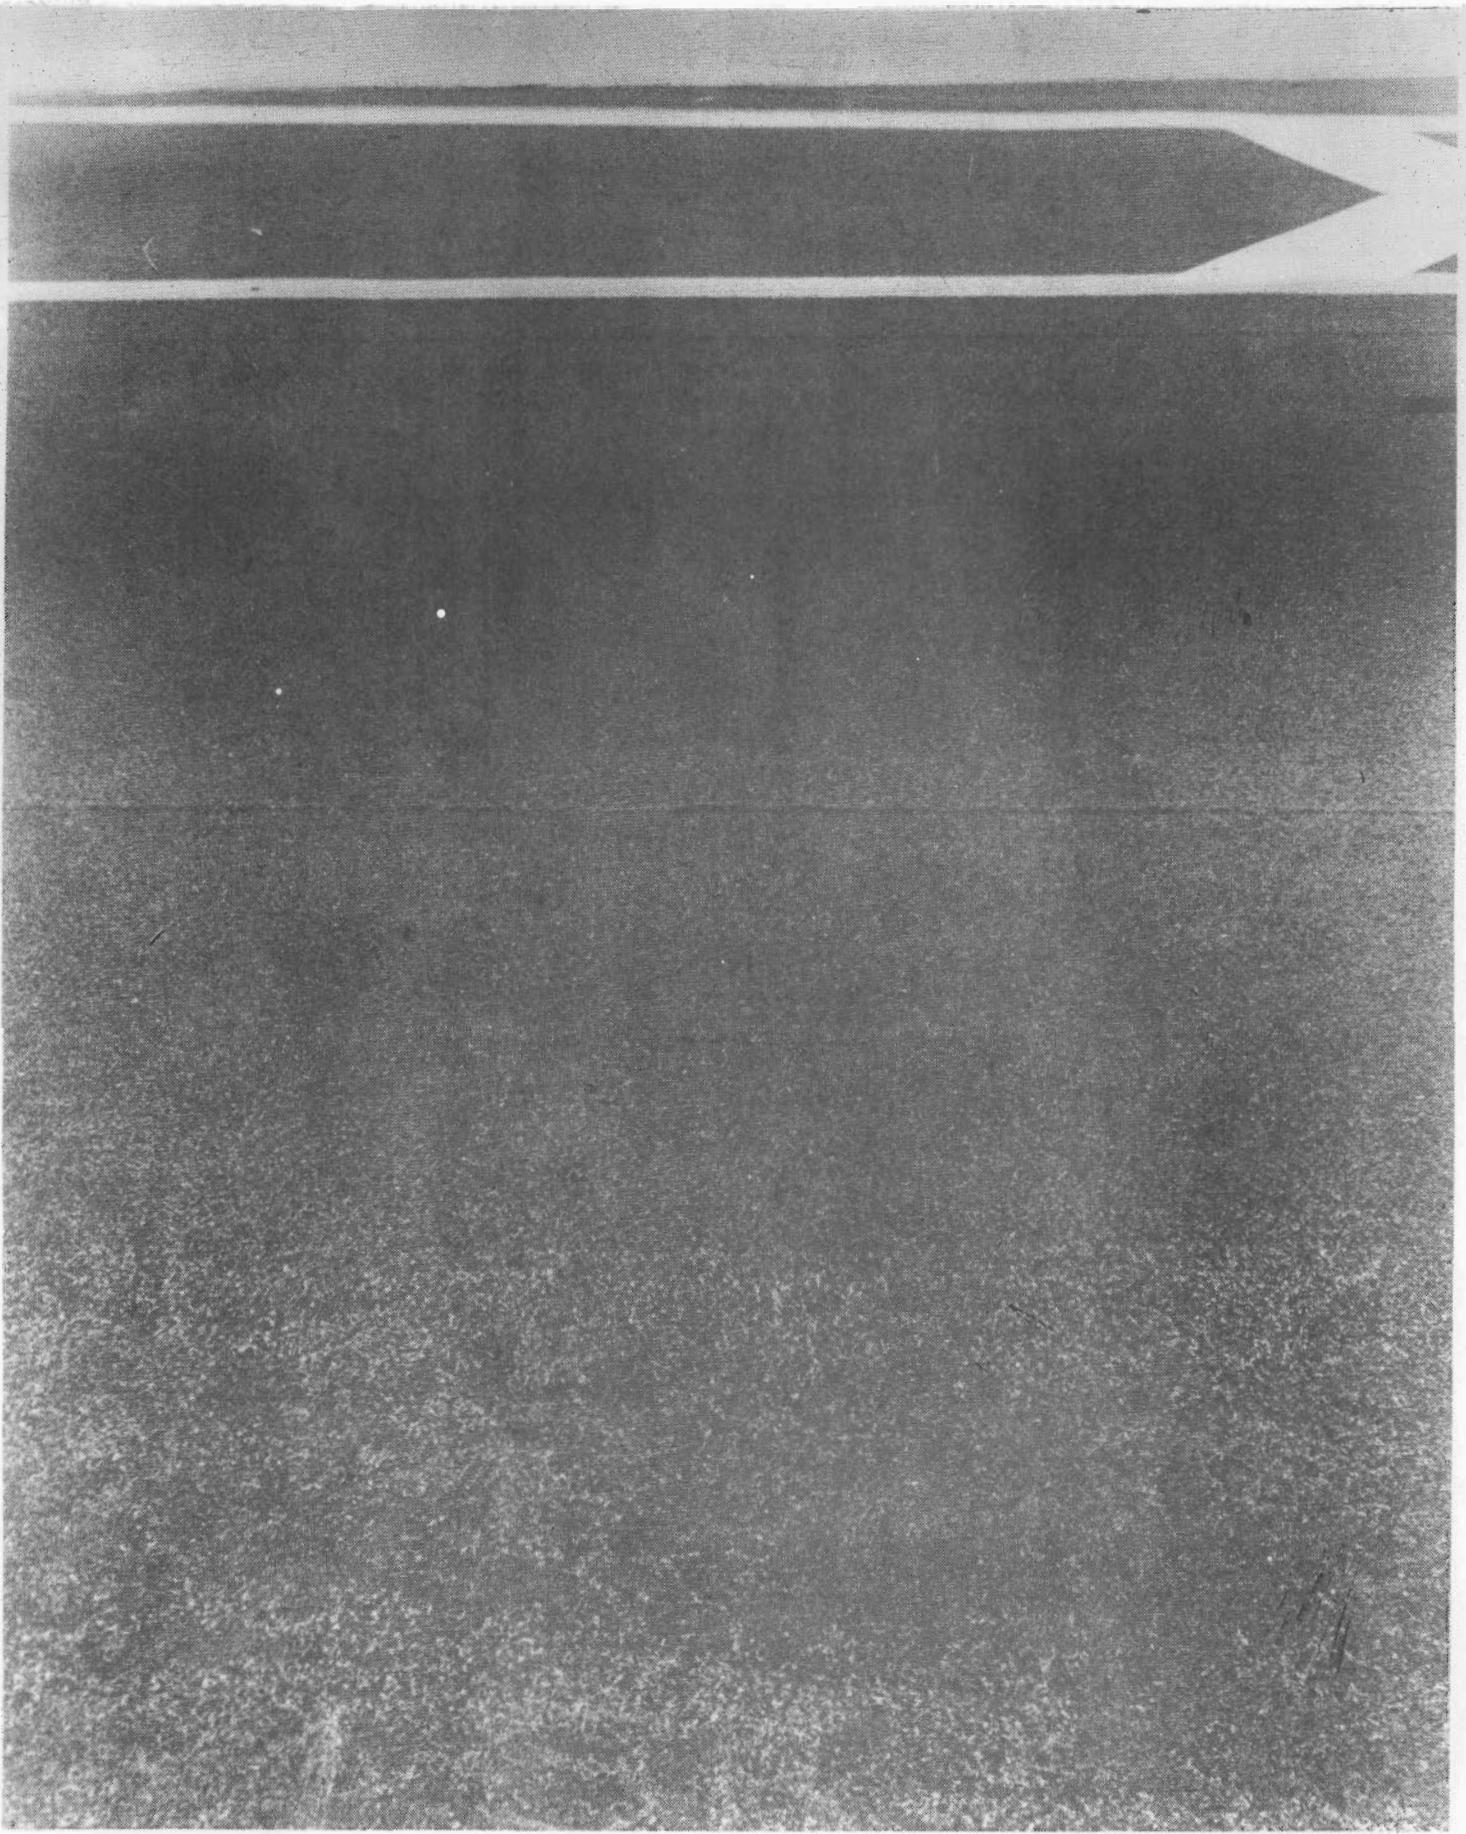
IH 45: BETWEEN CLEAR CREEK AND FM 518 No. 12

- No. 9: Southbound lane looking north. Compare with photo 10 which was taken opposite this picture. (with wire)
- No. 10: Northbound lane looking north, compare with photo 9 which was taken opposite this picture. Note crack pattern which reflects all concrete joints. (without wire)
- No. 11: Northbound lane showing reflection of expansion joint taken opposite photo 12. (without wire)
- No. 12: Southbound lane taken opposite 11. (with wire)
- No. 13: Northbound lane showing reflection of expansion joint. Taken opposite photo 14. (without wire)
- No. 14: Southbound lane taken opposite photo 13. (with wire)
- No. 15: Southbound lane showing reflection of expansion joint in section with wire.
