PERFORMANCE OF
METAL REINFORCED BITUMINOUS OVERLAYS IN TEXAS

Special Study 9.0

Conducted by
Texas Highway Department
Highway Design Division

August 1968

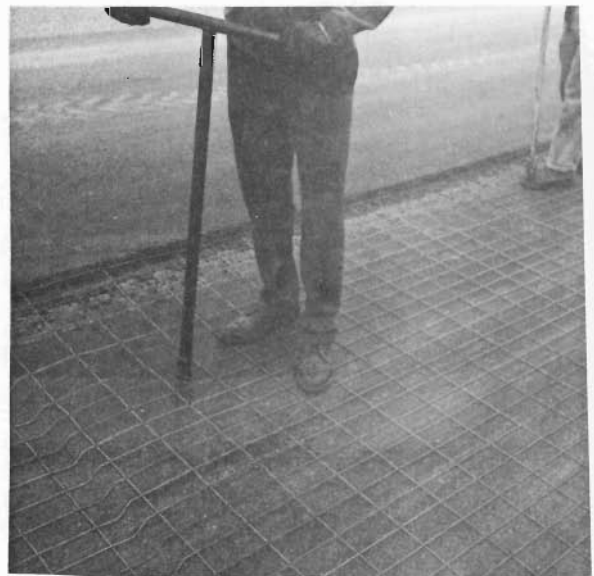
8

On the first day of this operation, the Contractor tried laying the wire mesh with very little and sometimes no crimping of the longitudinal wires. Considerable buckling of the mesh occurred and the Contractor became convinced that more crimping of the wire was needed in order to absorb the expansion and contracting of the wire caused by the extreme changes in temperature. The Contractor designed a mechanical crimper (Photographs 4, 5 and 6) which proved to be very helpful in accomplishing the crimping operation in a uniformly horizontal plane (Photograph 7) as well as accelerating the placement of the wire fabric. A few isolated slack areas in the fabric still had to be eliminated by hand crimping (Photograph 8).

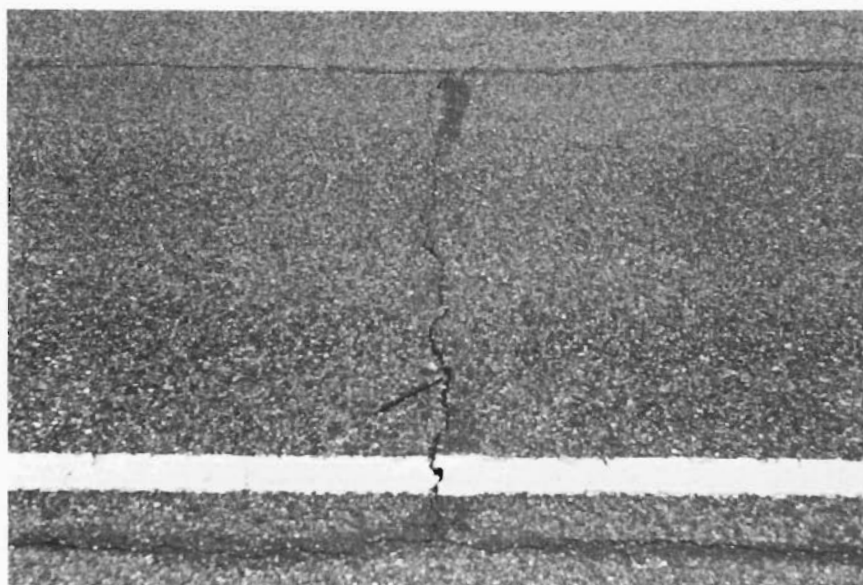
(Without Wire)

This is a close-up of the picture preceding which showed the view down the roadway.

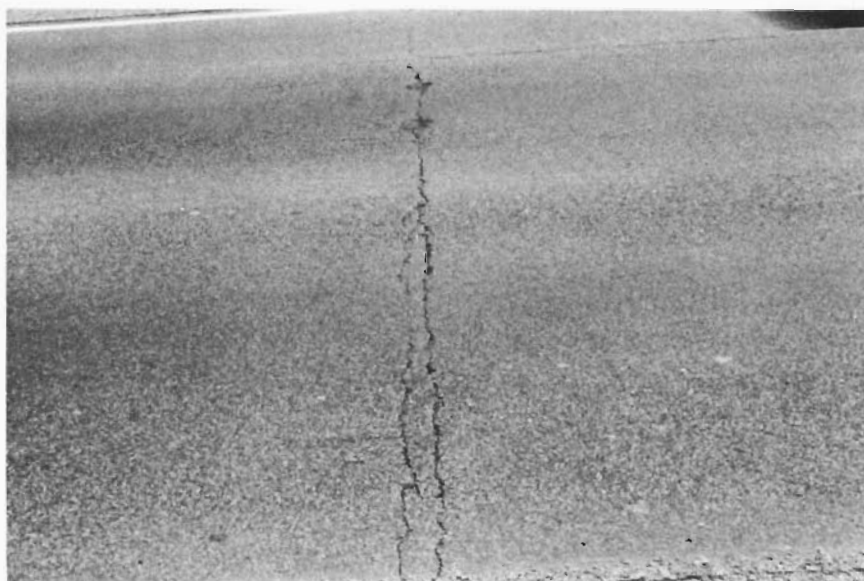
(Without Wire)

This is taken just north of the end of project I 45-1(64)031 and shows a light overlay without wire which was placed in the early 60's and appears to be about to ravel at this joint.

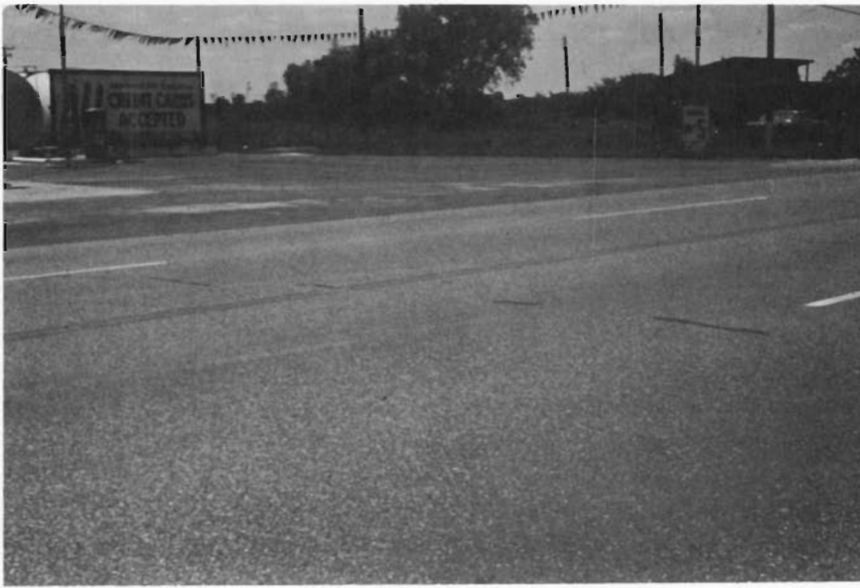
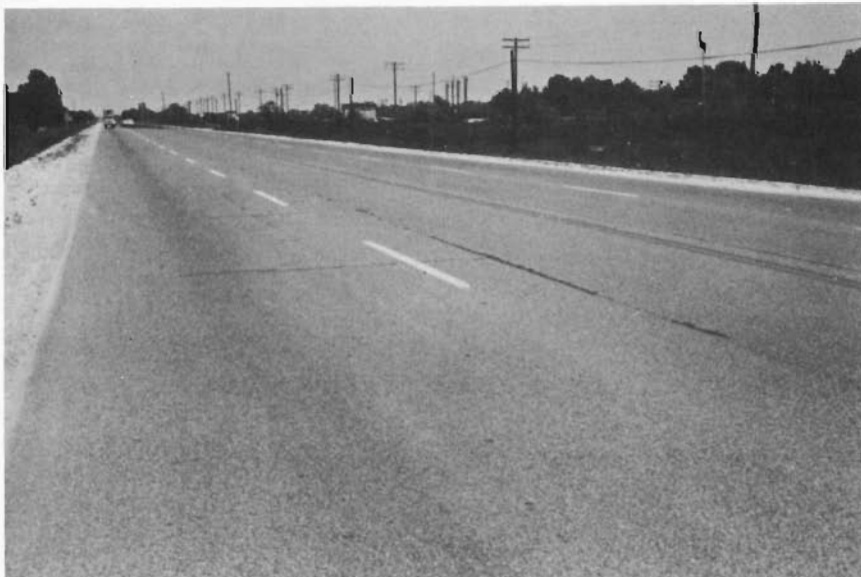
The above two pictures show the general pattern of cracking on S.H. 6. The cracks were generally hairline in size and the seals tended to exaggerate their size. One thing that these pictures do not show at this location that was evident when driving over the project is that the cracks over the flexible base were more frequent and wider than cracks over the wire reinforced sections.

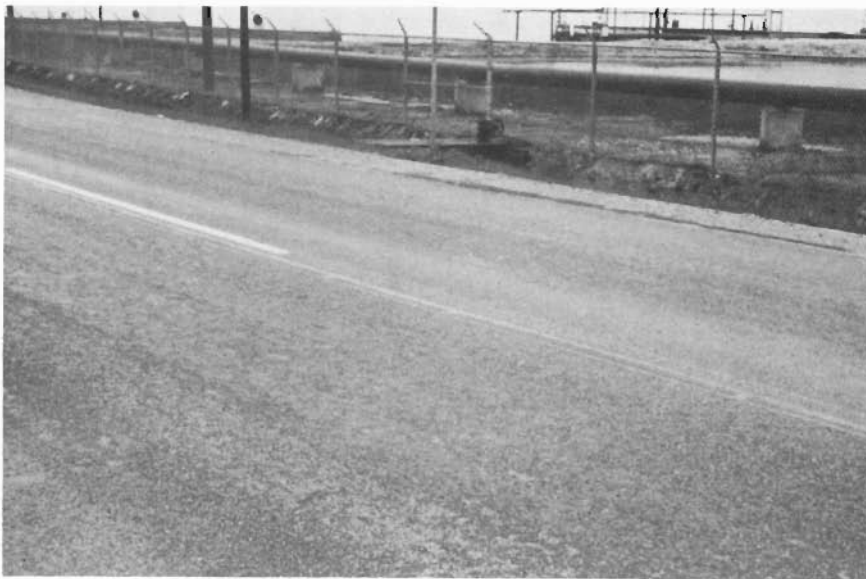
(WITH WIRE)

On the above rural section, there were no cracks.

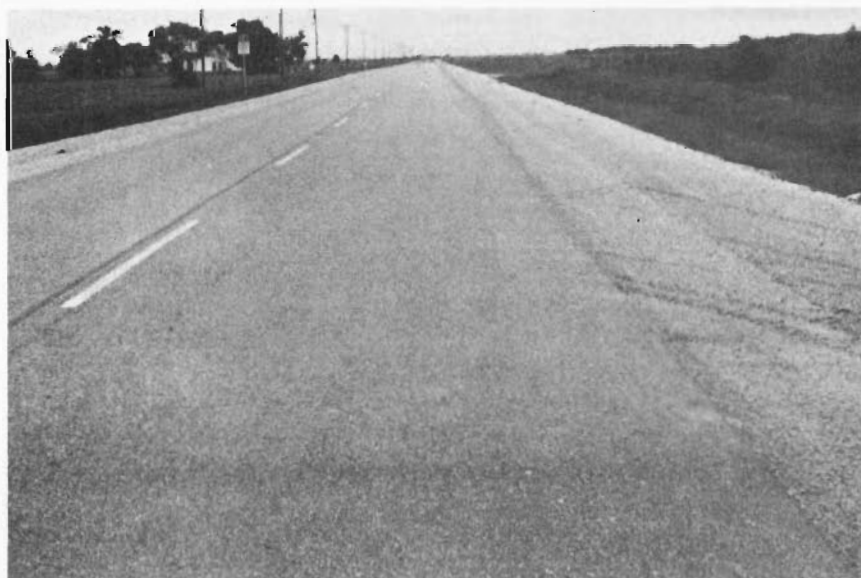
(WITH WIRE)

This picture was taken by turning around and looking south.
