SLICK PAVEMENTS

SLICK PAVEMENT

Prepared And Compiled By
District 15

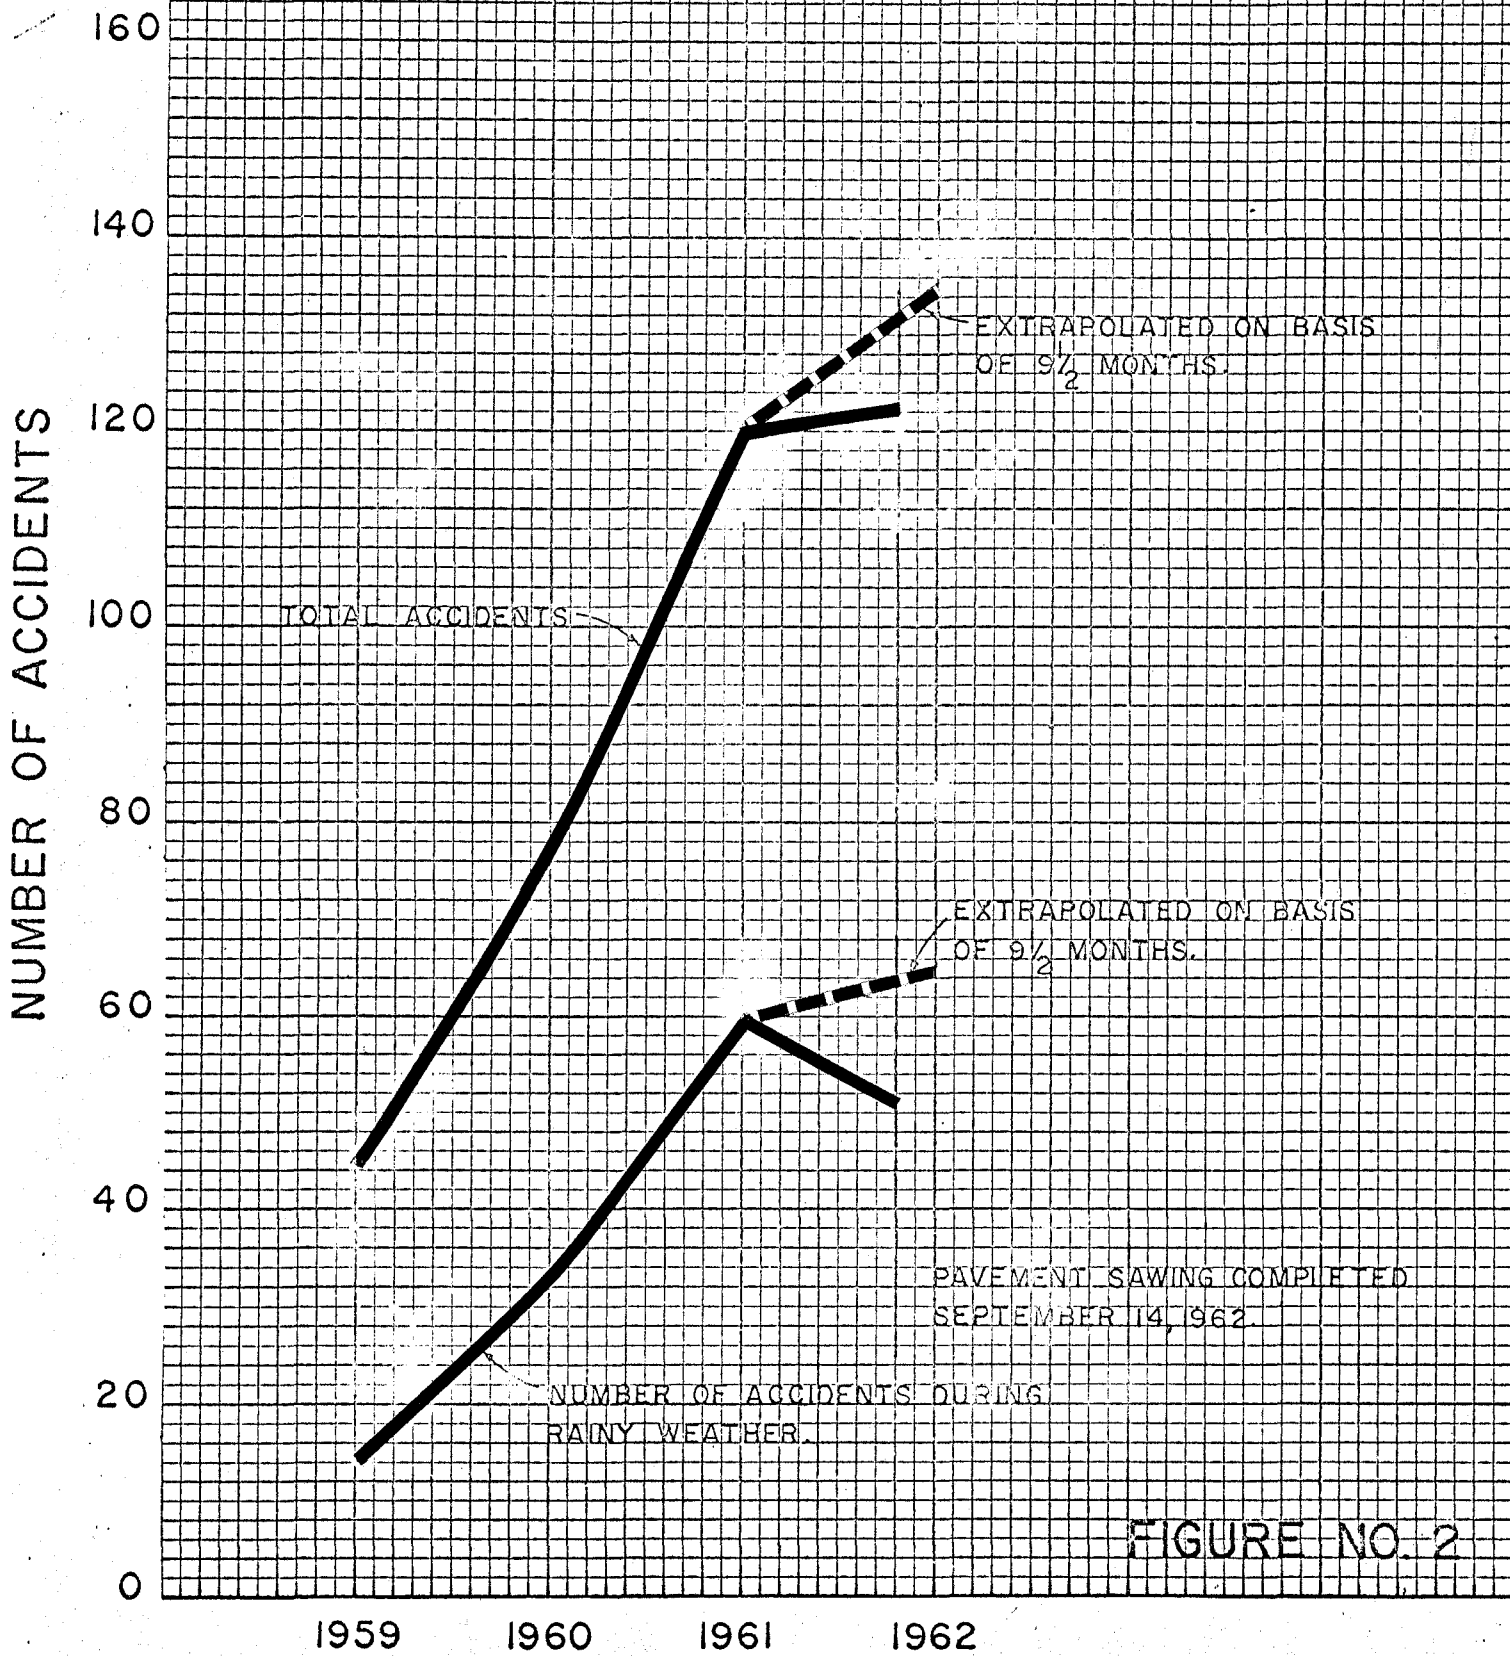
FIGURE NO. 2

The section of this highway between the N. Flores St. overpass and the Broadway overpass had reached a condition where corrective measures had to be taken in order to try to lower the accident rate. See Figure 2 for tabulation of accidents and Figure 3 for average daily traffic volumes. It will be noted that the accident rate is appreciably higher when the pavement surface is wet.

TOTAL ACCIDENT RATE
 INTERSTATE HIGHWAY NO. 35
 BEXAR COUNTY
 FROM N. FLORES ST. OVERPASS TO BROADWAY OVERPASS
