TESTING AND EVALUATION OF WORK ZONE

TRAFFIC CONTROL DEVICES

PROVIDED BY FLASHER EQUIPMENT COMPANY

Project No. 71770

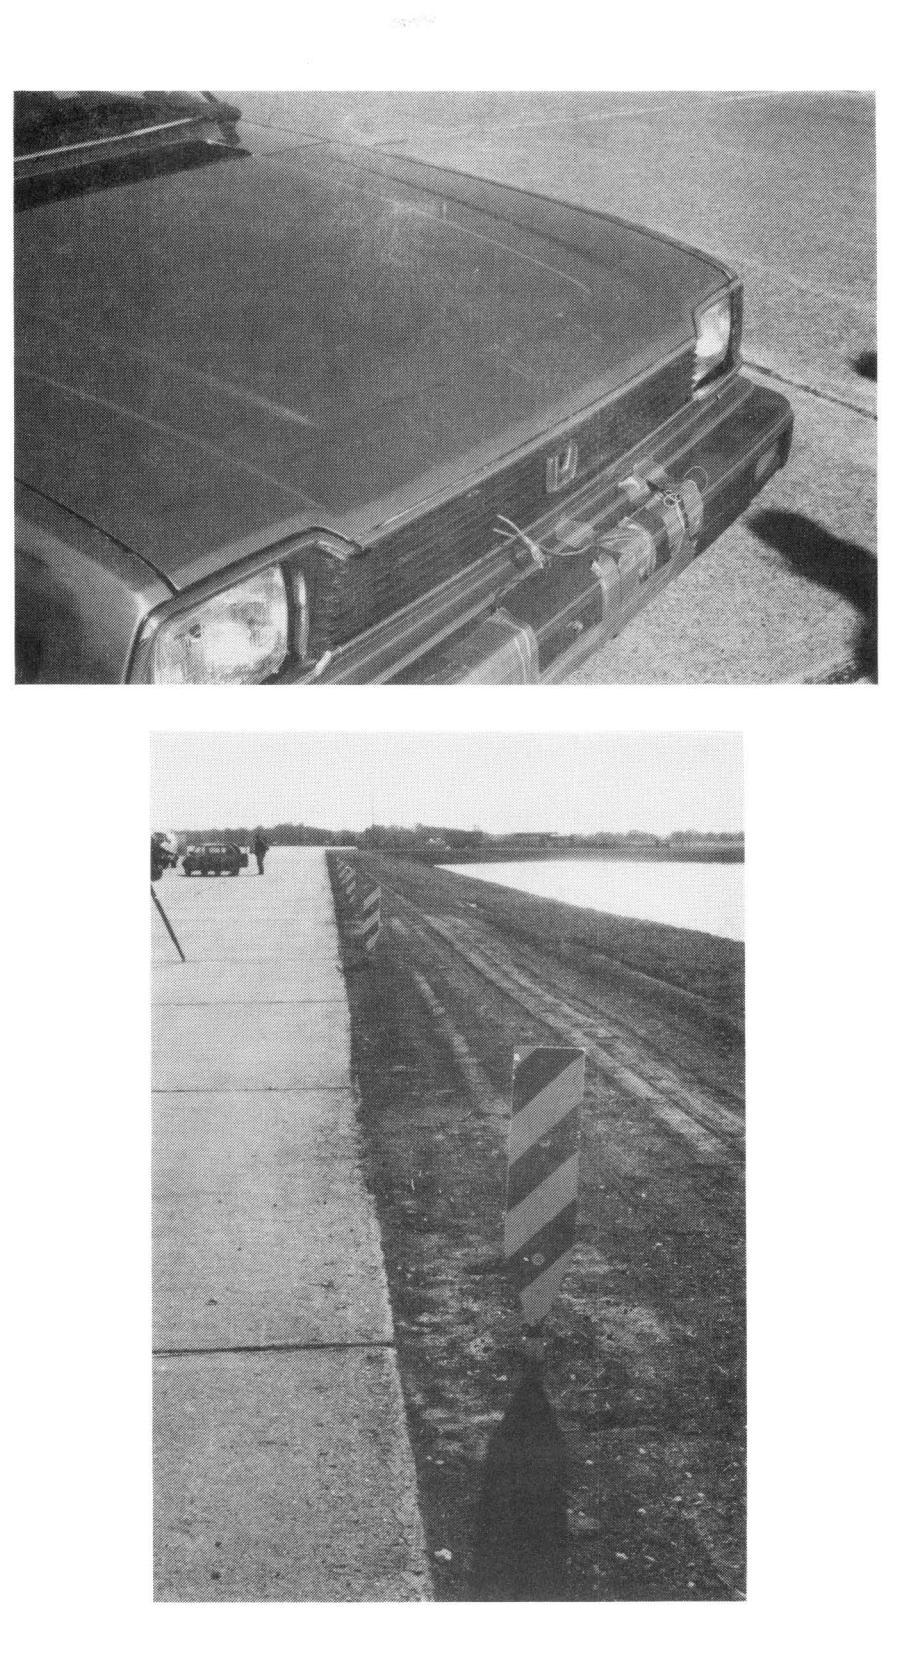
Figure 4. Vehicle and test site after test 7177-1.

The test vehicle was travelling at a speed of 43.9 mi/h as it contacted the first device. The impact point was the right quarter point of the vehicle bumper. The driver had to make a slight steering correction after the vehicle impacted the second device. This was probably the result of the cross slope on the soil surface and not caused by the impact with the single vertical panel assemblies. The vehicle traversed over all four single vertical panel assemblies smoothly and in a stable manner. All four vertical panels sprang up to their pre-impact positions after the vehicle went over them. The panels were scraped and slightly bent and the bolt on the top connection of the fourth panel broke off. The vehicle sustained minor scrapes to the hood which were polished out before the next test. Damage to the traffic control devices and the vehicle are shown in Figures 4 through 8.

The vehicle received cosmetic damages only and there was no penetration or intrusion of the occupant compartment of the vehicle. The vehicle remained on a relatively straight, smooth path through the test site with no intrusion into

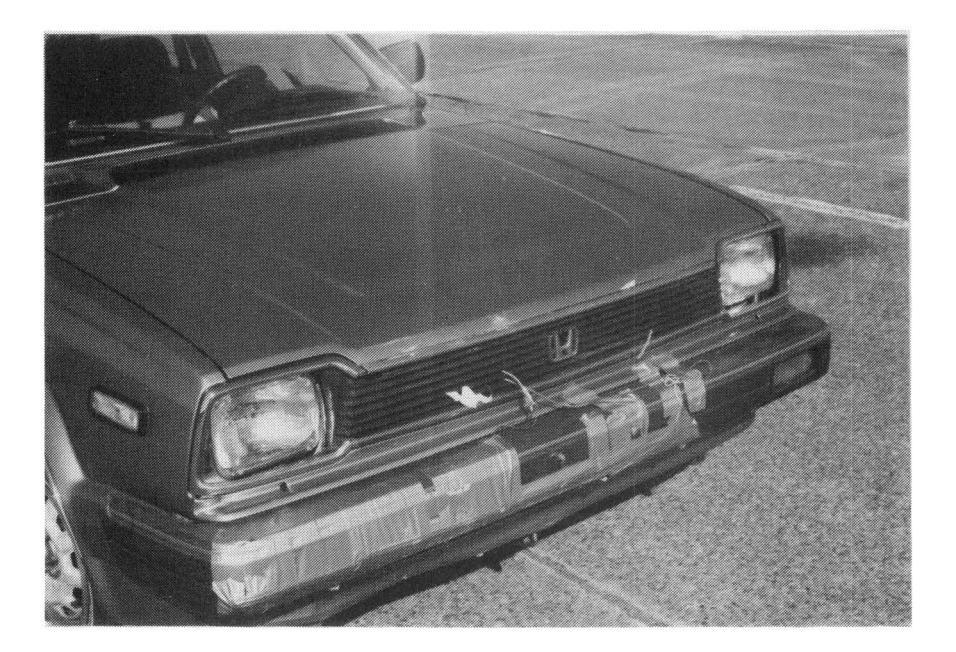
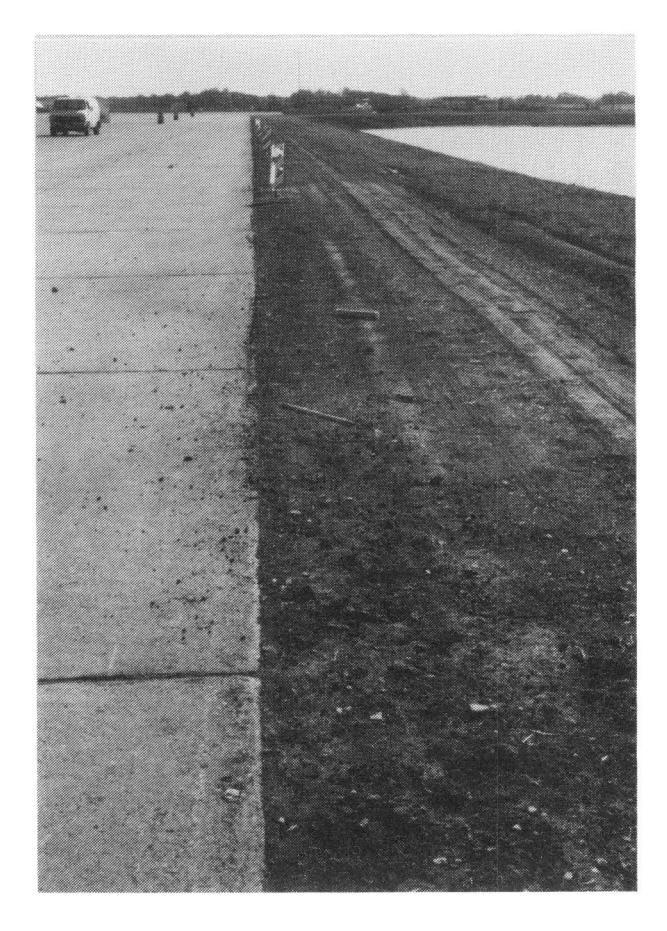
Figure 12. Vehicle and test site after test 7177-2.

The test vehicle impacted the first device with the right quarter point of the vehicle bumper, travelling at a speed of 60.0 mi/h. As the vehicle traversed over the first device, the whole assembly was pulled out of the ground and came to rest 105 feet down and 6 feet to the left of the impact point. One of the two battery packs separated from the post and came to rest 22 feet down from the impact point. There was no driver input as the vehicle rode smoothly over the following three devices which sprang up after the vehicle cleared them. All three panels were scraped and bent and the fastening bolts broke in the top connection of the third and fourth devices. The vehicle again received only minor scrapes to the hood which were quickly repaired before the next test. Damage to the traffic control devices and the vehicle are shown in Figures 12 through 16.

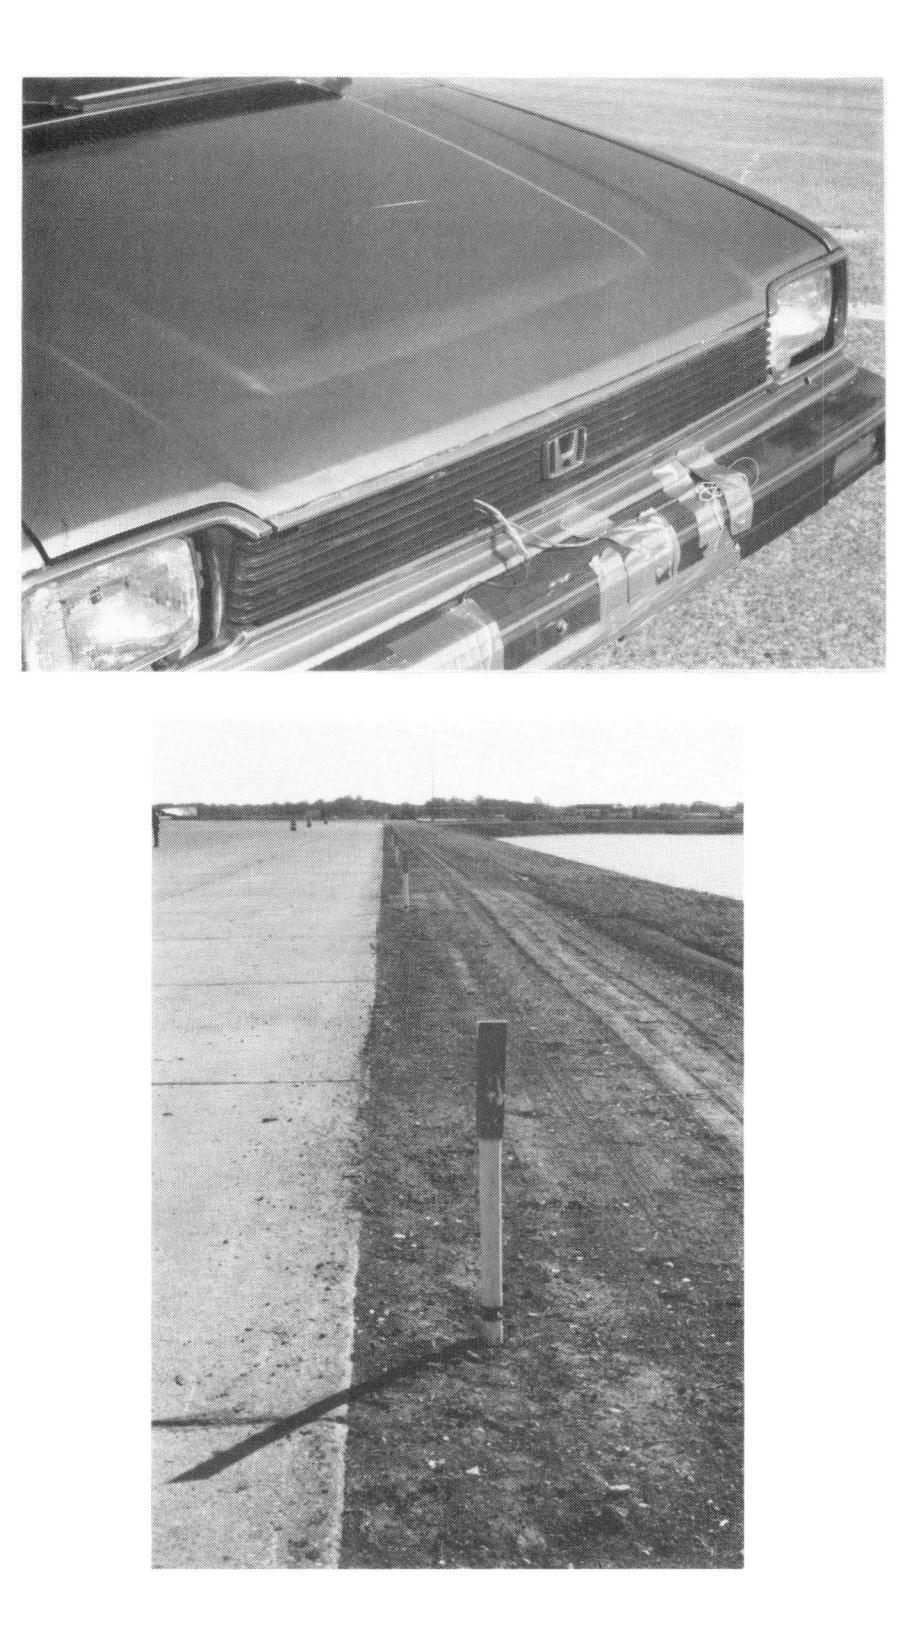
Figure 19. Vehicle and test site after test 7177-3.

The test vehicle was travelling at a speed of 58.2 mi/h as it contacted the first device with the right quarter point of the vehicle bumper. The driver again had to make a slight steering correction after the vehicle impacted with the third device due to the cross slope on the soil surface. Nevertheless, the vehicle traversed over all four devices smoothly and in a stable manner. All four delineator posts were bent and the reflective surface scraped, but the vehicle did not sustain any damage at all. Photographs of the delineators and the vehicle after the test are shown in Figures 19 through 23.

The vehicle received no damage during the test and there was no penetration or intrusion of the occupant compartment of the vehicle. The vehicle remained on a relatively straight, smooth path through the test site with no intrusion

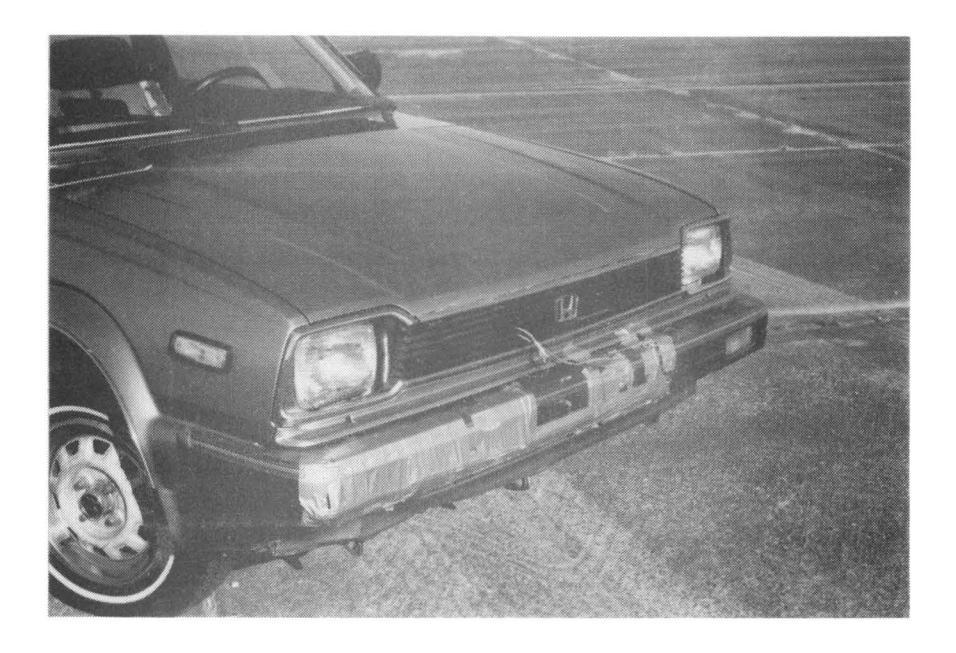
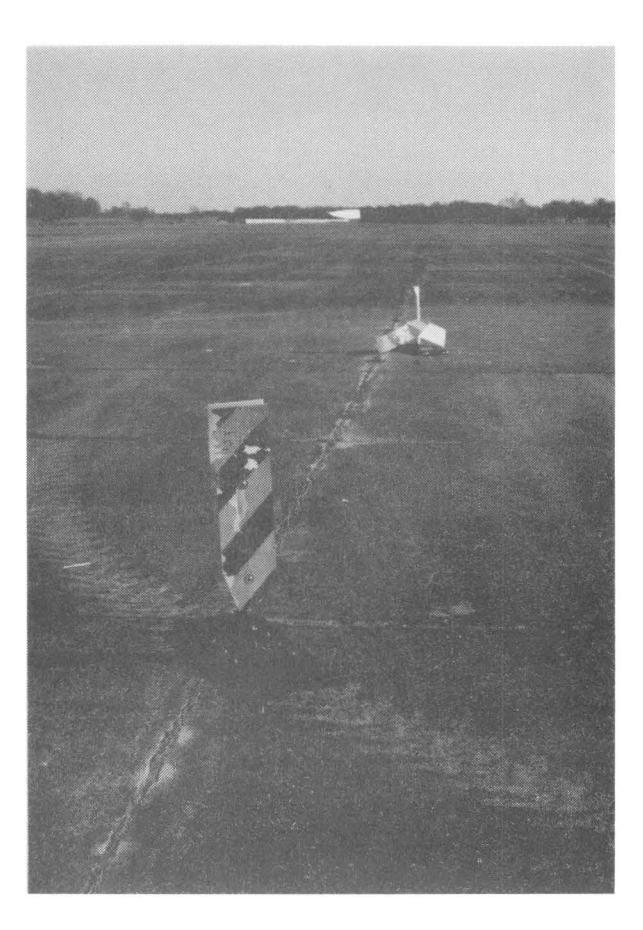
Figure 30. Vehicle and test site after test 7177-5.

came loose and the vertical panels were partially detached from the posts. Also, a 1-in x 1-in x 6-in lead insert broke loose from the portable base. As the vehicle traversed the second device, the rear wheel rode over the device, moving it 5.1 feet down and 2.0 feet to the left. The vehicle sustained no damage as shown in Figure 30. After-test photographs of the devices are shown in Figures 30 and 31.

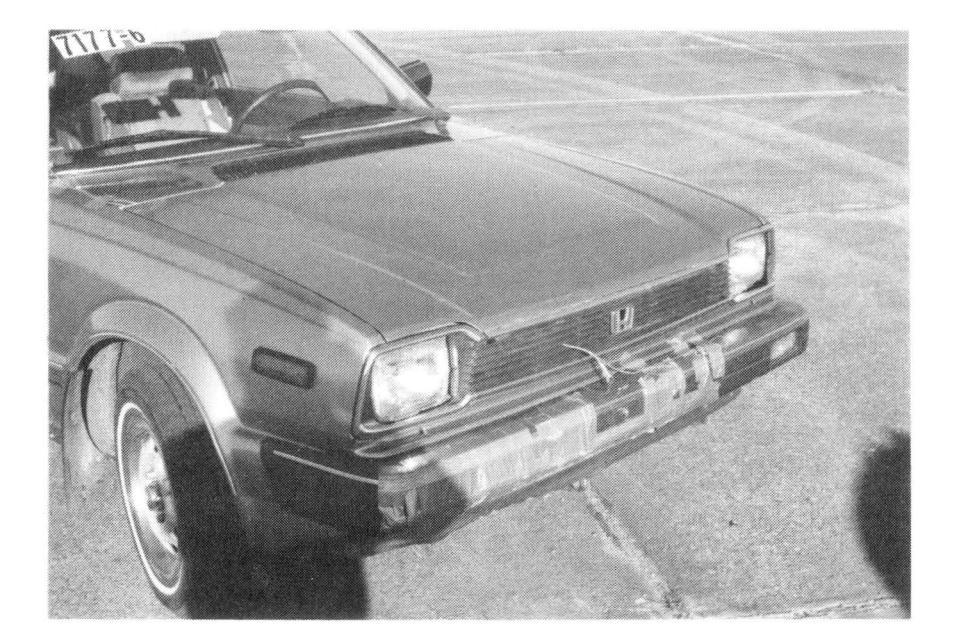
Figure 36. Vehicle after test 7177-6.

devices as shown in Figures 34 and 35. The vehicle received a scraped grill and is shown in Figure 36.

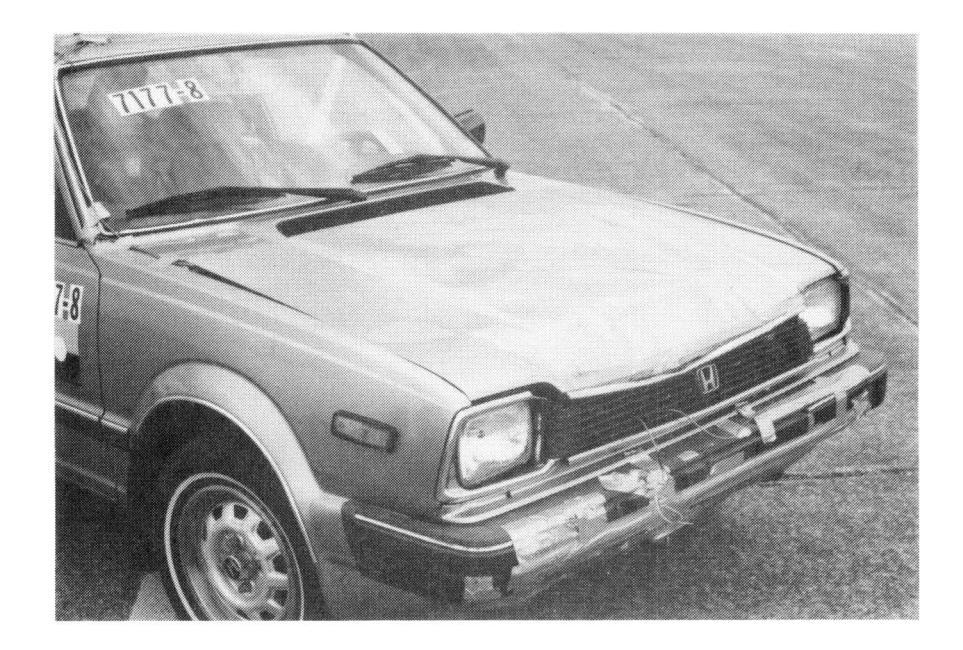
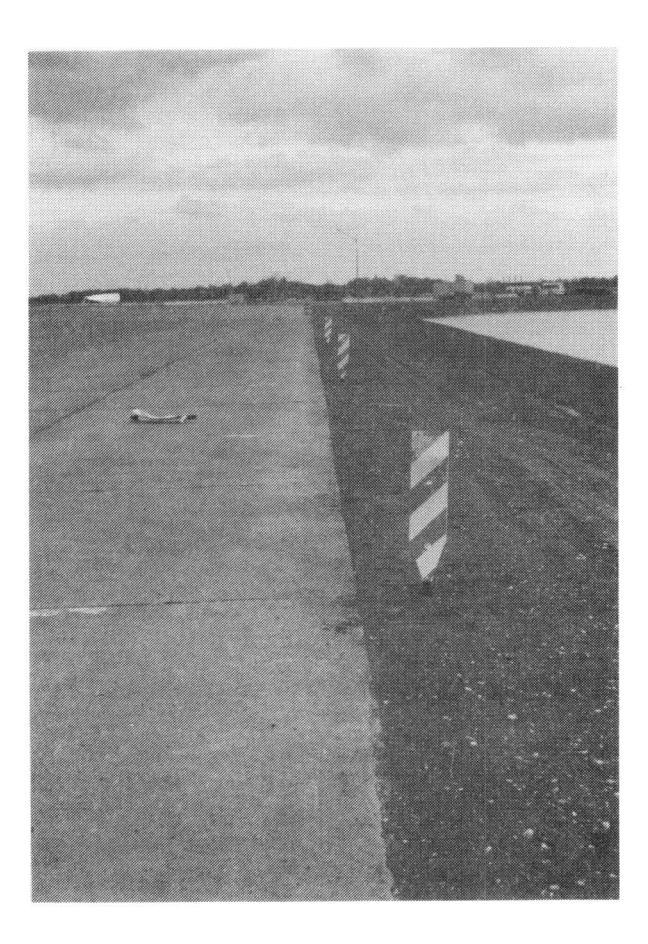
Figure 43. Vehicle and test site after test 7177-8.

The vehicle was travelling at a speed of 57.9 mi/h as it impacted the first device with the right quarter point of the vehicle bumper. As the vehicle travelled over the first device, a weld connecting the post and panel unit to the base broke, allowing the post and panel unit to become detached from the base and came to rest 96.0 ft down and 8.0 ft to the left from the point of impact. The lens of the flashing light unit attached to the top of the post was also broken. The vehicle rode smoothly over the three remaining devices, resulting in only slight bending and scraping to the vertical panels. Damages to the devices and the vehicle (cosmetic in nature) are shown in Figures 43 through 47.

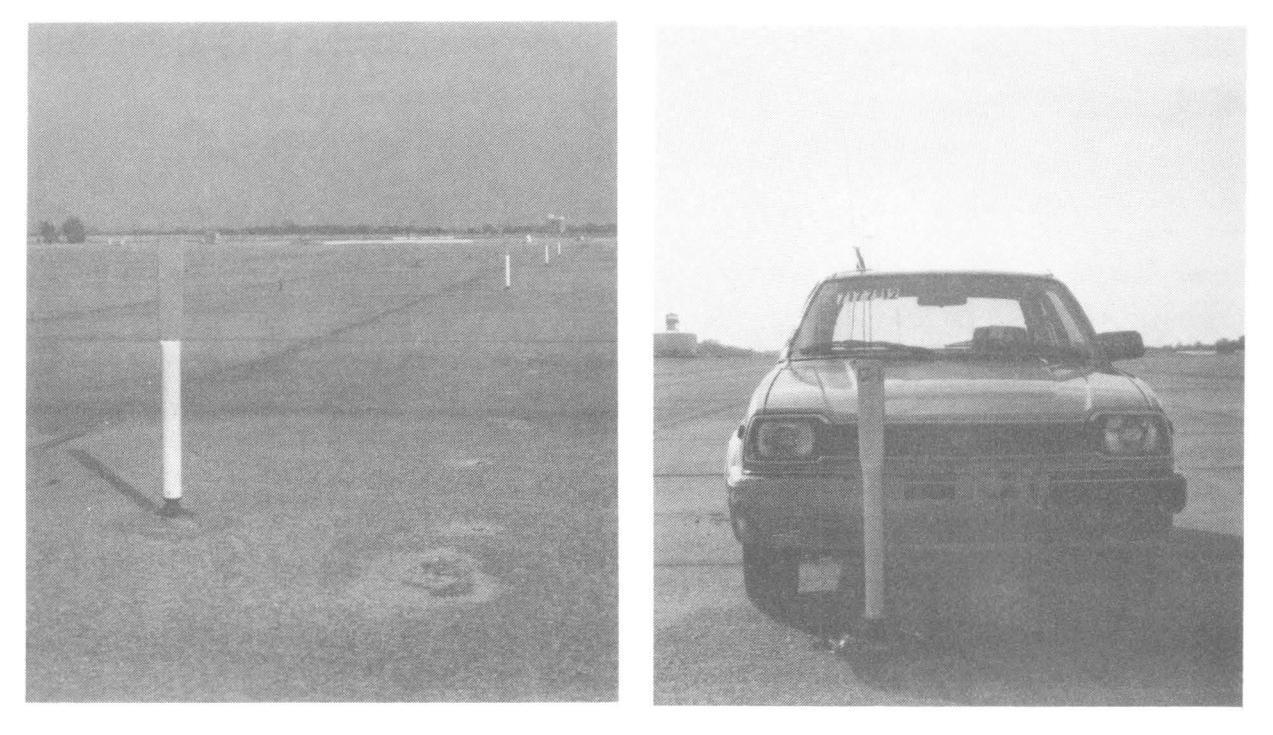
Figure 67 . Installation and vehicle before test 7177-12.

This test installation (shown in Figures 66 and 67) consisted of four (4) fixed delineator posts (Model No. 200-WEFA-101RO) spaced 60 feet apart for a nominal impact speed of 60 mi/h. The first two bases were attached to the pavement with an epoxy material while the last two bases were secured with a bituminous material.

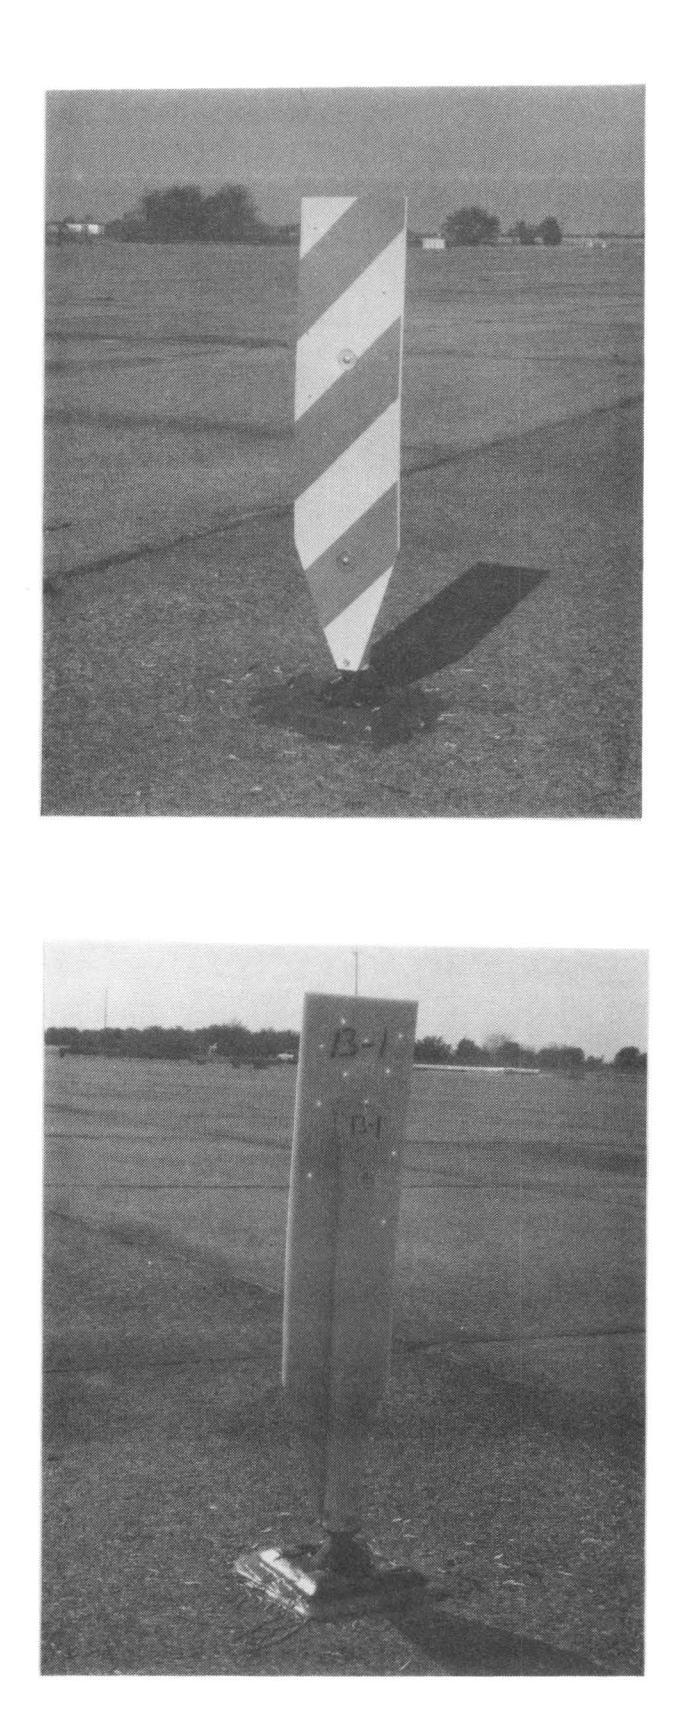
Figure 72. Typical device used for test 7177-13.

the pavement with an epoxy material while the last two bases were secured with a bituminous material. Photographs of the device are shown in Figure 72.

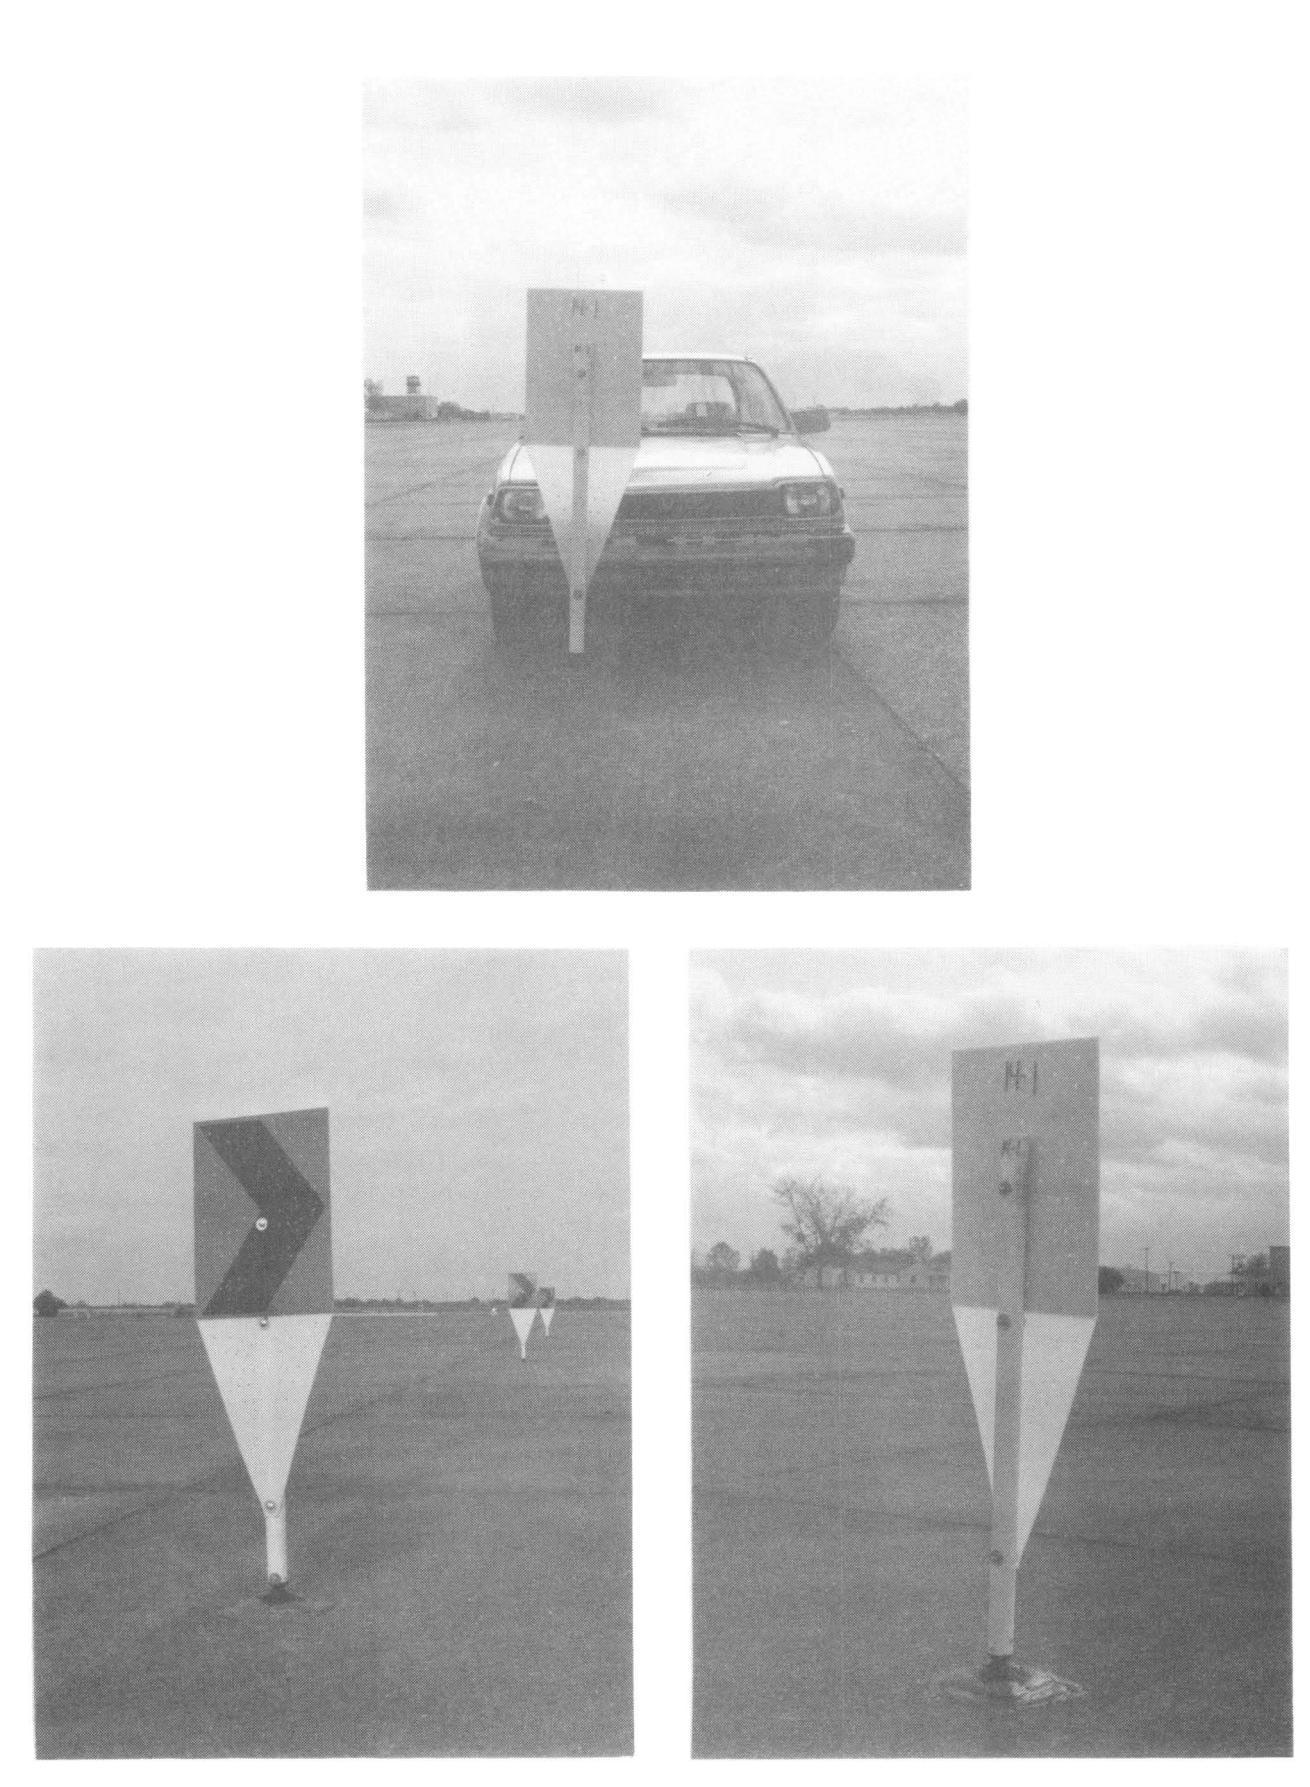
Figure 77. Installation and vehicle used for test 7177-14.

This test installation was identical to that of Test 10, i.e., three (3) fixed chevron sign assemblies (Model No. 405-WHL-101BO) arranged in a straight line, except for the spacing between the devices which was increased to 60 feet to account for the higher nominal impact speed of 60 mi/h. The bases were all secured to the pavement with an epoxy material. Photographs of the installation are shown in Figure 77.

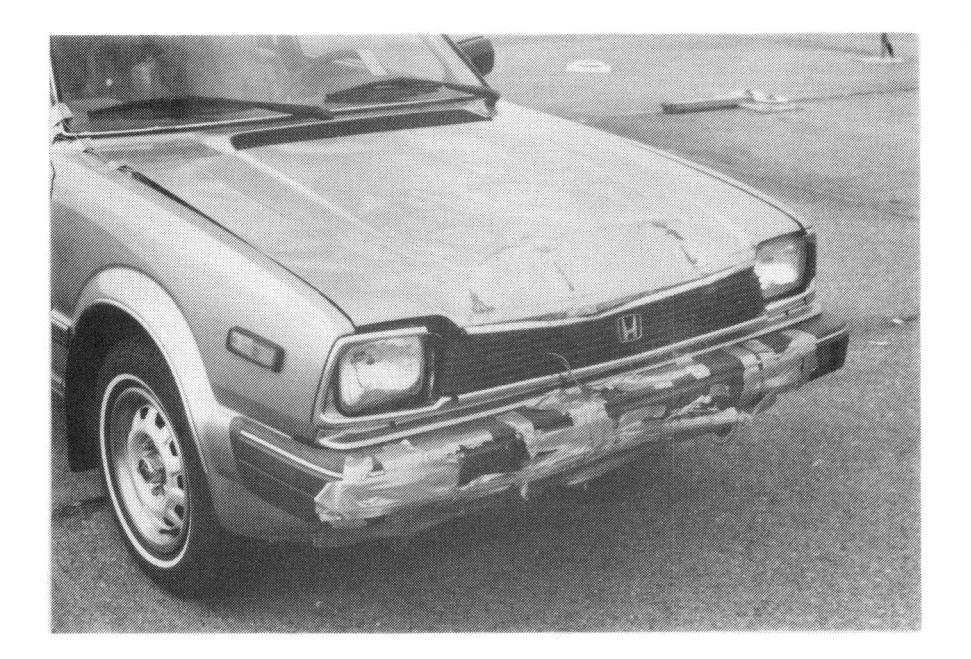
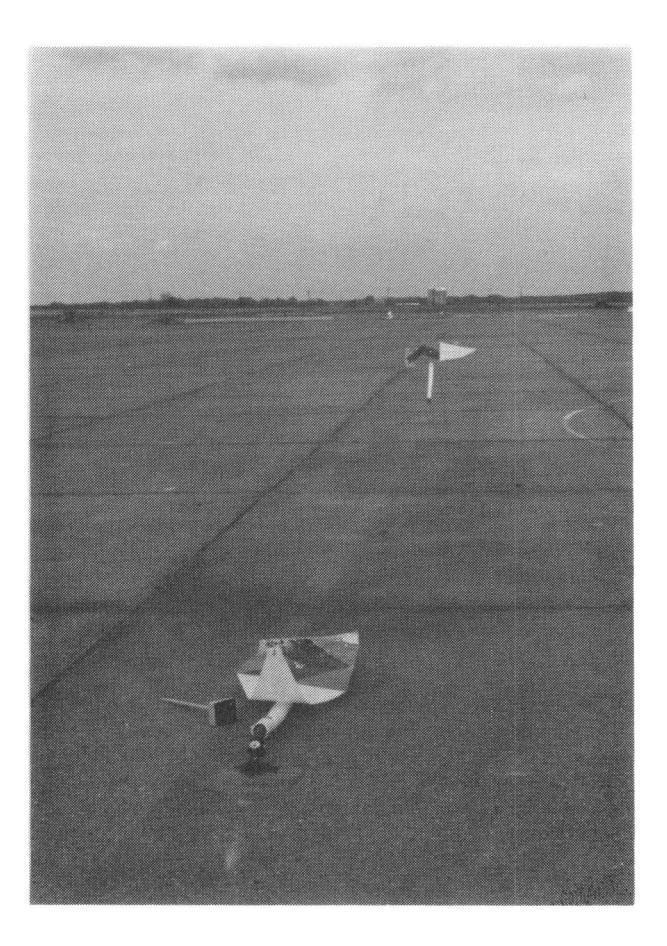
Figure 78. Vehicle and test site after test 7177-14.

The vehicle was travelling at a speed of 61.5 mi/h as it impacted the first device with the right quarter point of the vehicle bumper. As the vehicle struck each chevron sign assembly, the sign panel wrapped around the grill of the vehicle. All three sign assemblies were damaged substantially. The post and panel units remained bent and did not fully return to their pre-impact positions. The epoxy compound around the base of the first sign assembly was cracked. The vehicle sustained minor dents to the hood and scrapes to the grill. Damage to the vehicle and devices is shown in Figures 78 through 81.

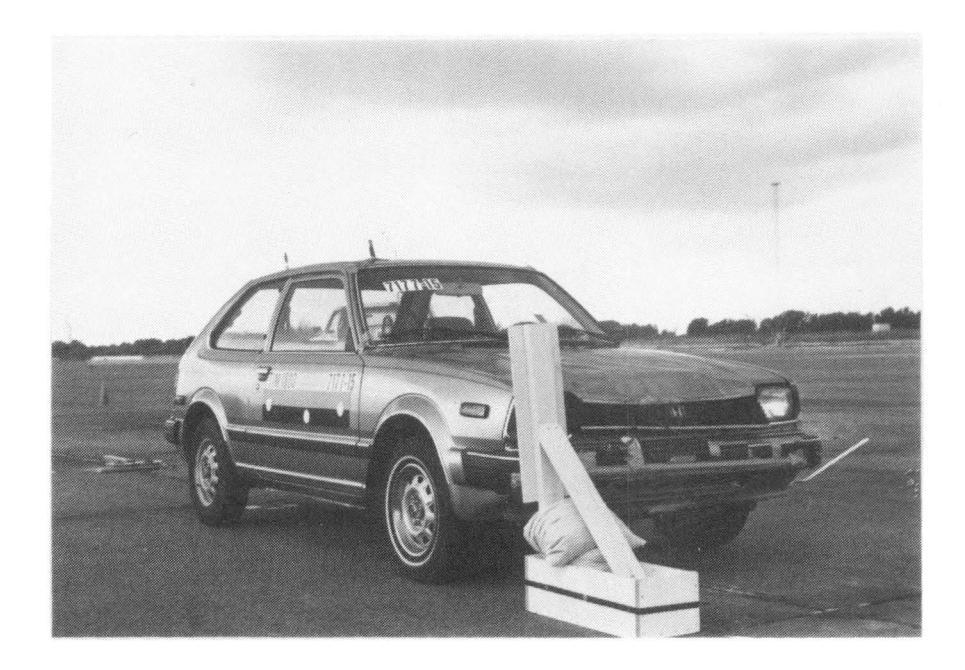
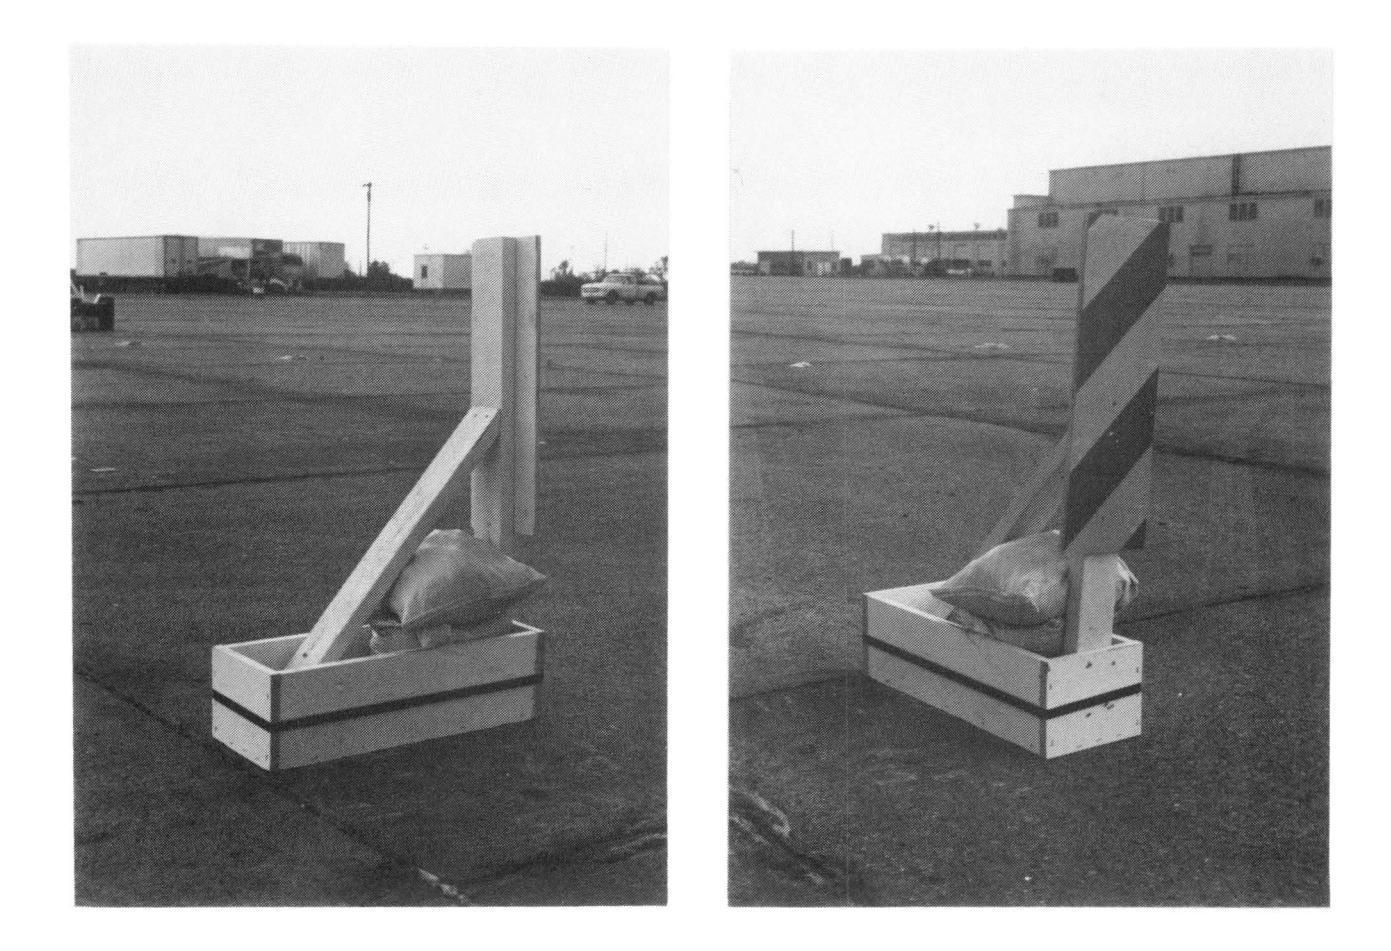
Figure 82. Device and vehicle prior to test 7177-15.

A vertical panel mounted on a wooden box weighted with sandbags, as shown in Figure 82, was used in this test. This vertical panel assembly is typical of those currently used in work zones in San Antonio, Texas. The purpose of this test was to provide some baseline of comparison for assessment of the impact performance of the various work zone traffic control devices crash tested in this study.

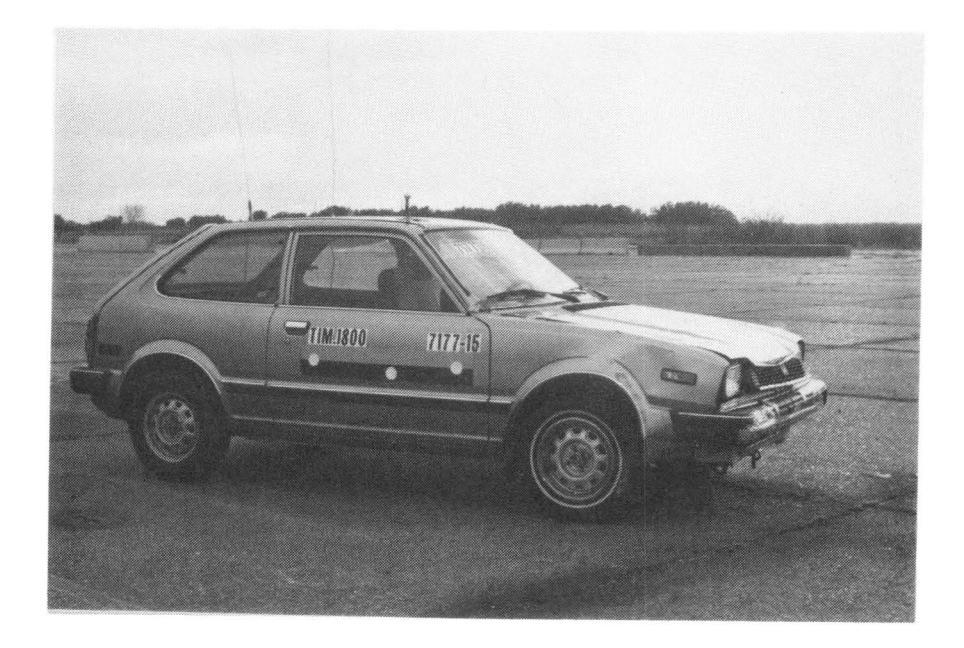
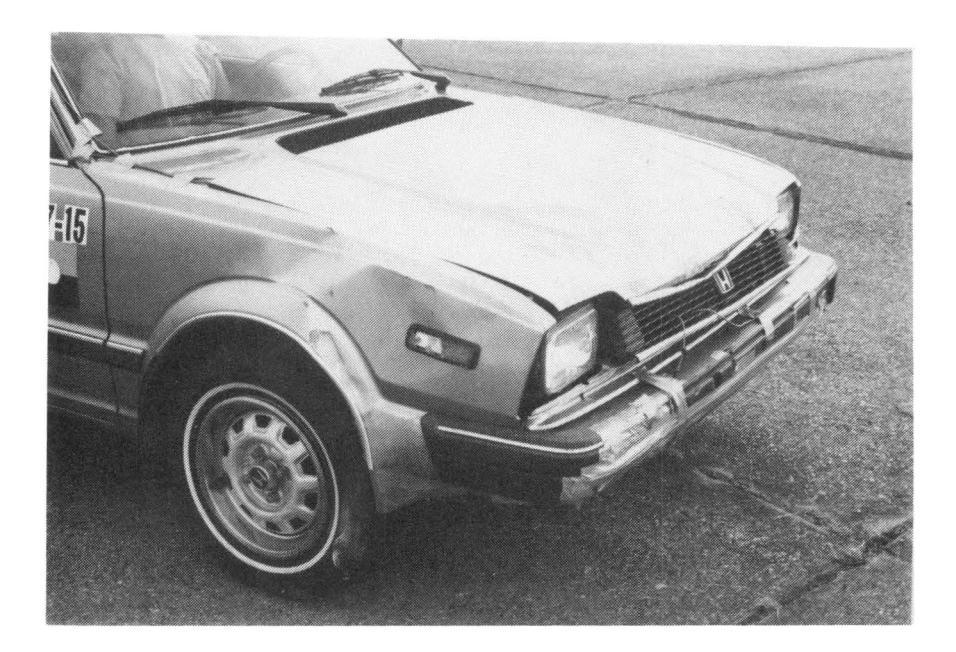
Figure 83. Vehicle after test 7177-15.

The vehicle was travelling at a speed of 62.6 mi/h as it contacted the device. As the vehicle rode over the device, the wooden box came apart from the impact force. Sand and debris, some of which were of considerable size, were strewn along the vehicle path over a relatively wide area. The device was totally destroyed and the vehicle received damage to the lower front spoiler and the right front quarter panel. Damage to the device and the vehicle are shown in Figures 83 and 84.

The vehicle sustained minor damage to the right side but there was no penetration or intrusion of the occupant compartment of the vehicle. The vehicle remained on a relatively straight, smooth path through the test site with minimal intrusion into adjacent traffic lanes. The vehicle remained relatively stable

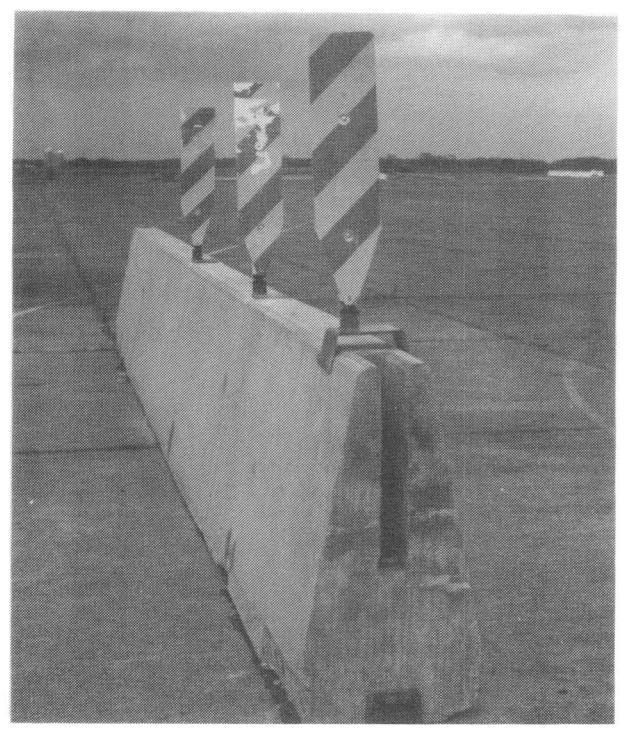
Figure 85. Installation used in tests 7177-16 and 17.

Tests 16 and 17 involved testing of vertical panel assemblies designed for mounting on top of concrete safety shaped barriers. Three (3) vertical panel assemblies (Model No. 300-WHRRN-104RO) were mounted on top of a segment of safety shaped concrete median barrier as shown in Figure 85. The first assembly used a conventional saddle mount while the second and third assemblies used a plate base mount designed by Flasher Equipment Company.

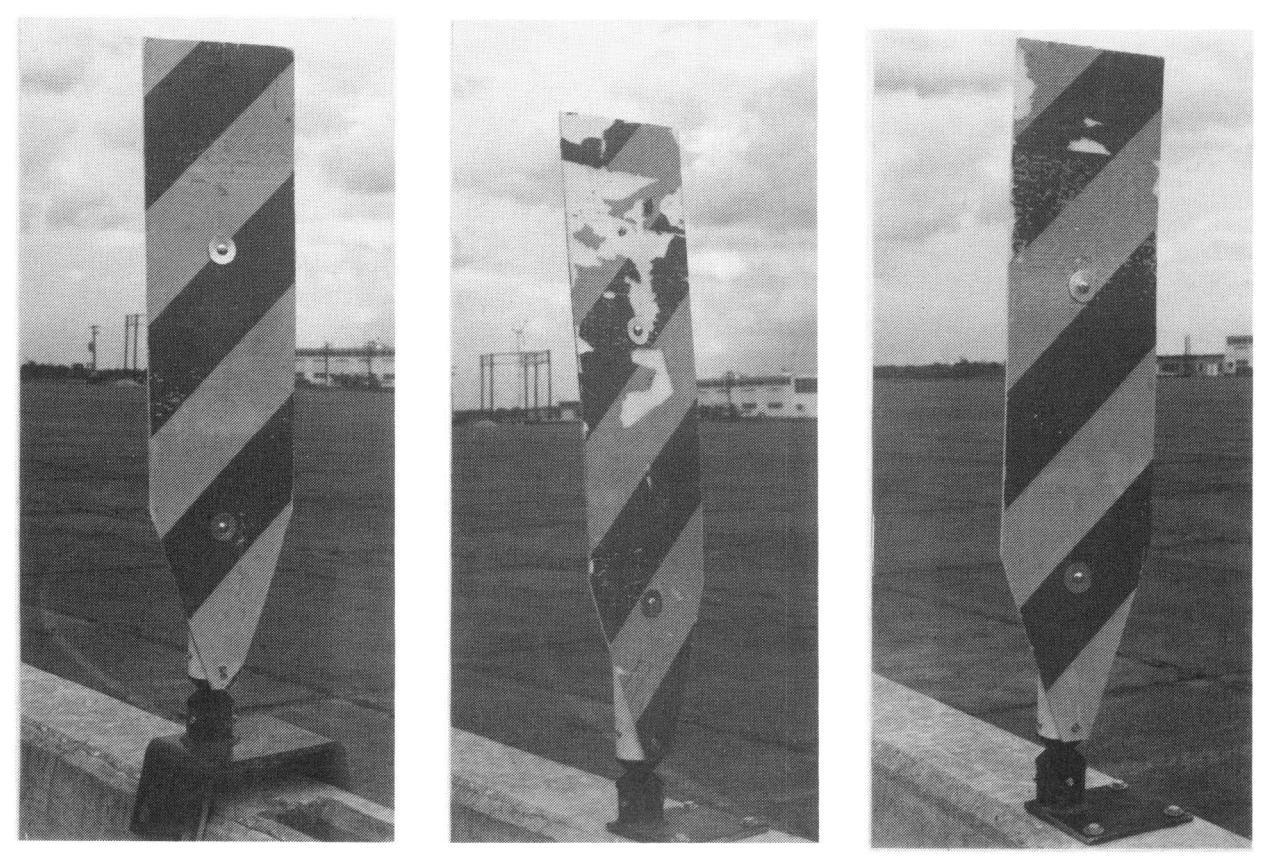
Figure 86. Devices after test 7177-16.

The truck was travelling at an approximate speed of 45 mi/h as it impacted the three vertical panel assemblies in test 16. No damage was sustained by the vertical panel assemblies except for minor scrapes on the panels, as shown in Figure 86.

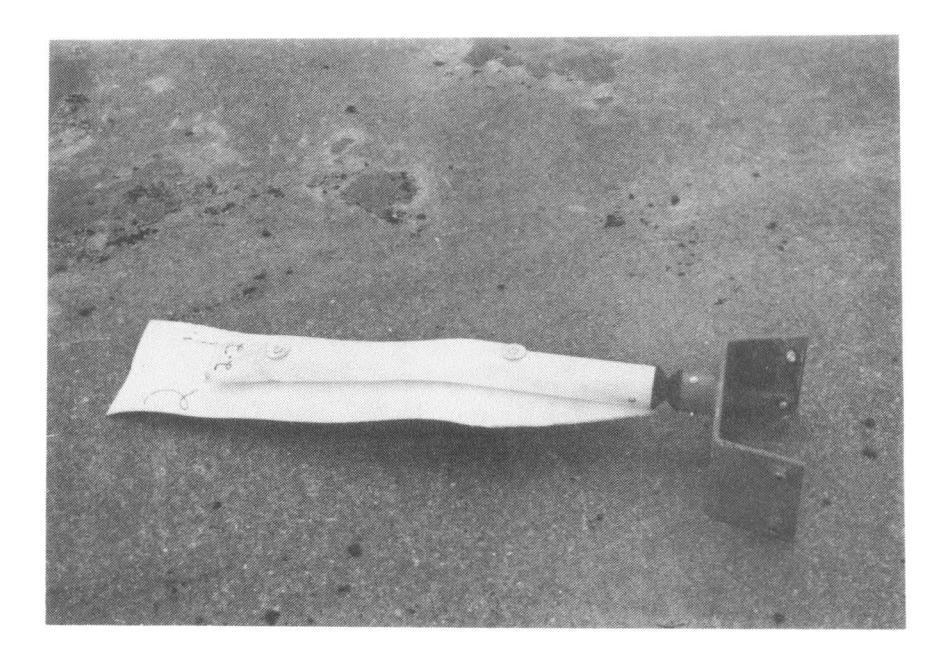
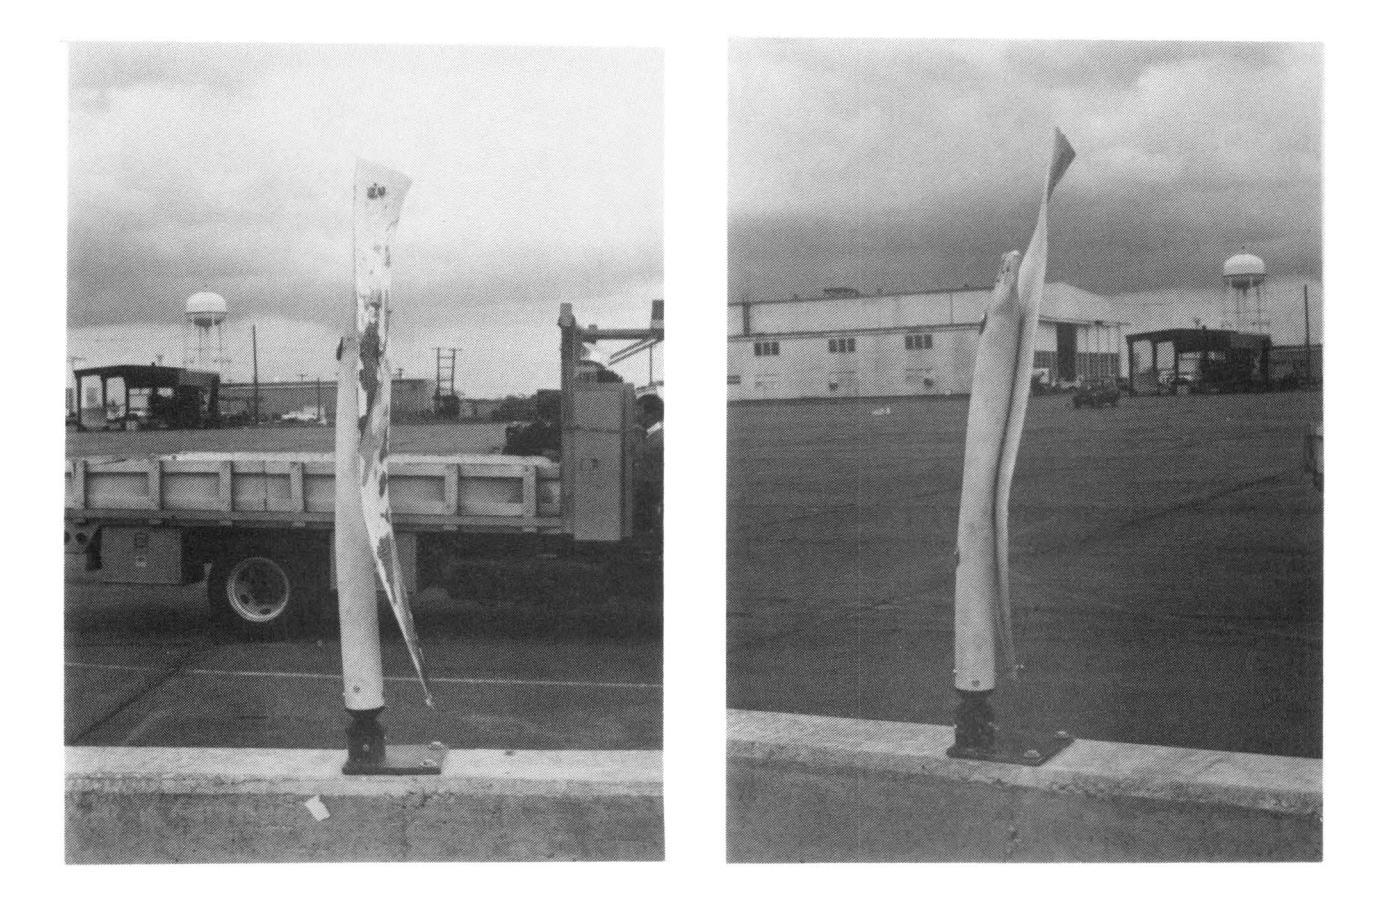
Figure 87. Devices after test 7177-17.

In test 17, the speed of the truck as it impacted the vertical panel assemblies was increased to approximately 60 mi/h. The saddle mount on the first vertical panel assembly became detached from the barrier as the pipe struck the vertical panel and the vertical panel assembly was thrown a short distance from the barrier. The remaining two vertical panel assemblies sustained minor damage, including bending of the posts and panels and scrapes to the reflective sheeting as shown in Figure 87. It should be noted that the saddle mount used to attach the first vertical panel assembly to the top of the concrete barrier was designed for barriers constructed to Texas specifications. The concrete barrier segment used in the test was constructed to Oklahoma specifications and the saddle mount was a little too narrow for a proper fit. This probably accounted for the failure of the saddle mount and the detachment of the first vertical panel assembly.
