A SURVEY OF EARTH SLOPE FAILURES
AND REMEDIAL MEASURES IN TEXAS

Research Report Number 161-1

Stability of Earth Slopes
Research Project 3-8-71-161

CENTER FOR HIGHWAY RESEARCH
THE UNIVERSITY OF TEXAS AT AUSTIN

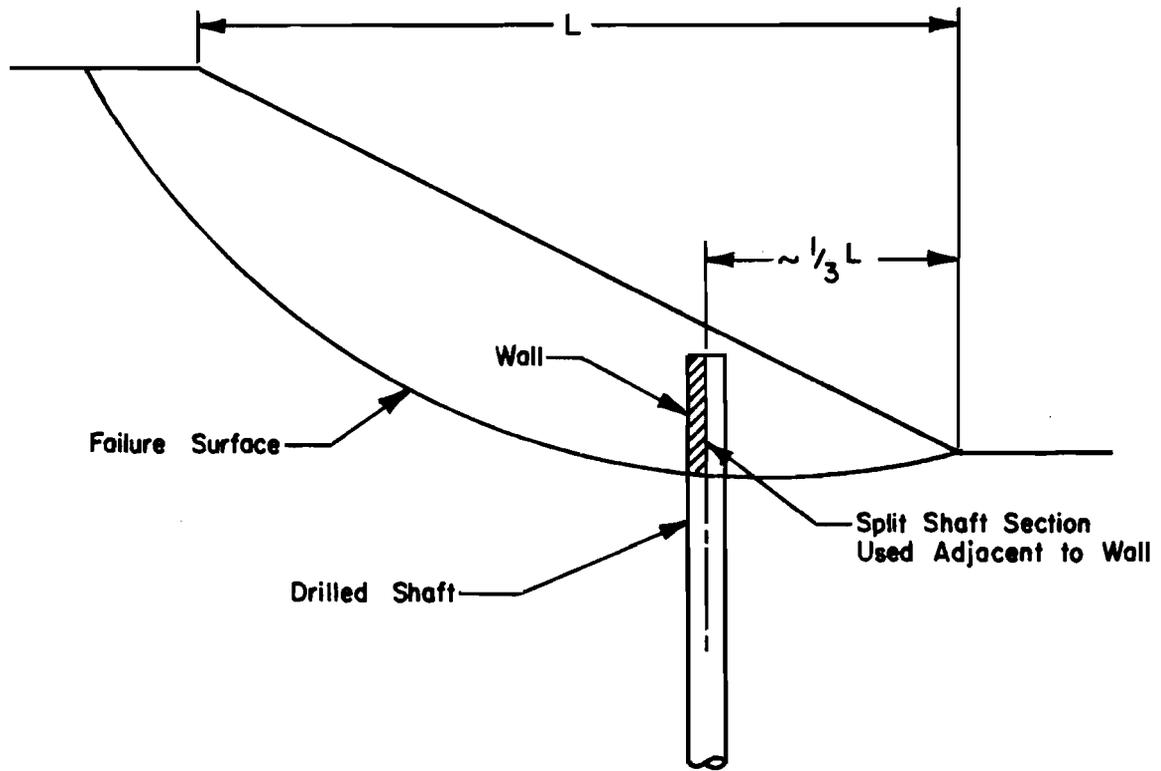
The correction of a number of slope failures in Texas has been accomplished by the use of concrete retaining walls located entirely within the original slope grade, as illustrated in Fig. 5.1. These structural restraint systems, locally referred to as slide suppressor walls, are generally founded on drilled shafts located approximately one-third the distance up the slope with the wall being placed so as to intersect the known or estimated failure surface. Once the slide suppressor wall has been placed, a drainage trench is excavated immediately behind the wall and backfilled with filter material. The slope is then regraded to its original grade.

Fig. 5.1. Slope stabilized with slide suppressor wall.

surface, as shown in Fig. 5.1. The use of the charts for this purpose can be illustrated by considering as an example the previously discussed slide which occurred on I.H. 35 beneath the Moore Street crossover bridge. A slide suppressor wall was used at this site to correct the failure which occurred in the 23-foot-high, 2 1/2:1 slope as shown in Fig. 5.16. The average unit weight of the soil at this site was approximately 122 pcf. In this instance an assumption of a circular failure surface appeared to be reasonable, and the maximum depth of this surface, measured normal to the slope face, was estimated to be between 6 and 7 feet.
