1. Report No. <i>TX-95-1948-1F</i>		2. Government Accession No.		3. Recipient's Catalog No.	
4. Title and Subtitle <i>REPAIR OF FIRE-DAMAGED CONCRETE PAVEMENT ON IH-45 NEAR ANGUS, TEXAS</i>				5. Report Date <i>January 1995</i>

**REPAIR OF FIRE-DAMAGED
CONCRETE PAVEMENT
ON IH-45 NEAR ANGUS, TEXAS**

Research Report Number 1948-1F

Repair of Fire-Damaged Concrete Pavement on I-45 (Evaluation Near Corsicana, Texas)

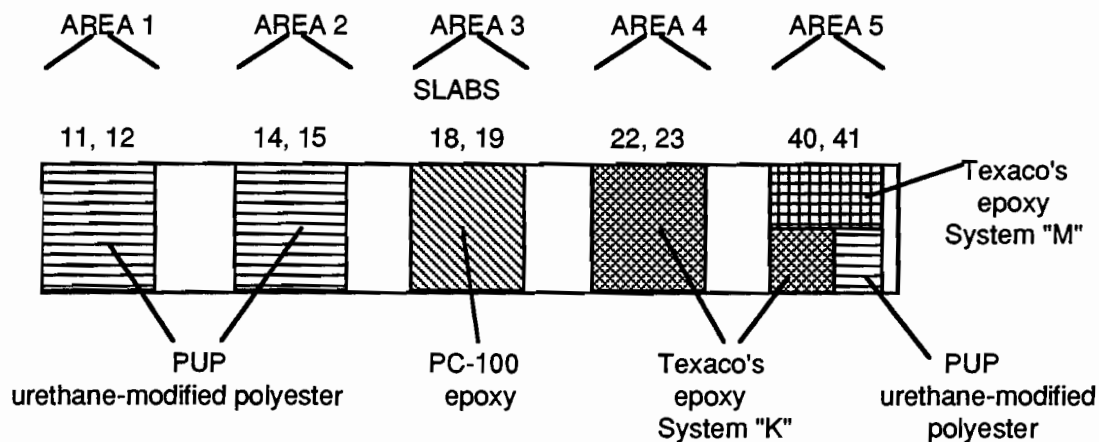
The final repair materials were chosen for their workability, their rapid cure times, and their durability in repairs to portland cement concrete specimens during the laboratory evaluations. The following is a brief description of each of the materials used in this project. Figure 1 schematically shows the slab locations on IH-45 where each of the repair materials was placed.

Figure 1. Repair materials were assigned to five large repair areas.

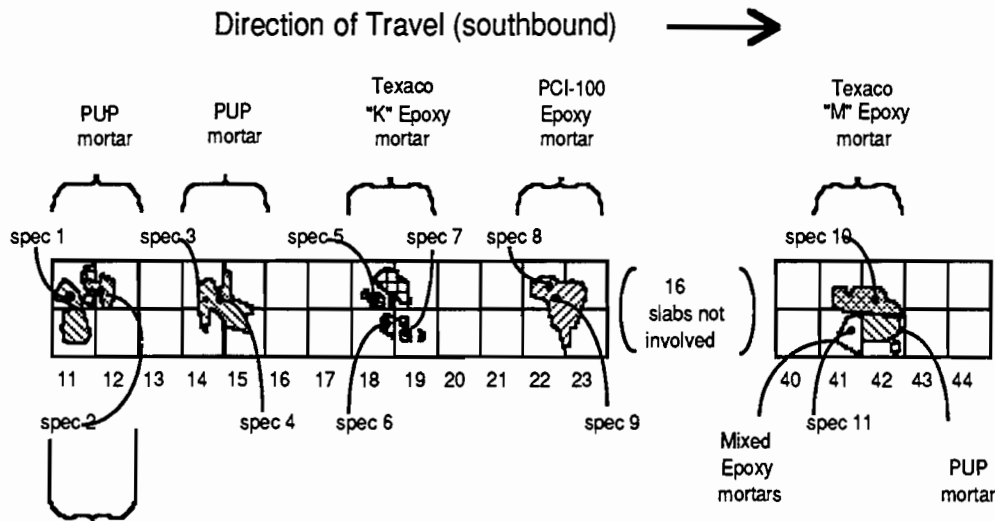
Bond tests were performed according to the ACI 503R method described in the American Concrete Institute's *Manual of Concrete Practice*.⁵ An exception to the test used a 4-inch-diameter core instead of the normally specified 2-inch-diameter core. Figure 1 diagrams the approximate locations where bond strengths were evaluated. Results from the tests are detailed in Table 1.

*Slabs no. 11 and no. 12 were repaired first with Transpo's T230 (Acrylic) Patching Mortar, but the mortar did not cure. The spalls were cleaned out and refilled with PUP. After the first six months several major PUP failures occurred and were patched with an MMA - based UT user-formulated system.

Figure 17. Diagram of the relative locations of repairs and tests on IH-45 near Angus, Texas.
