1. Report No. FHWA/TX-86/06+353-3F		2. Government Accession No.	
4. Title and Subtitle AN EXAMINATION OF EARTH SLOPE FAILURES IN TEXAS		5. Report Date November 1984

AN EXAMINATION OF EARTH SLOPE
FAILURES IN TEXAS

Research Report 353-3F

Stability Evaluation for Earth Slopes
Research Project 3-8-83-353

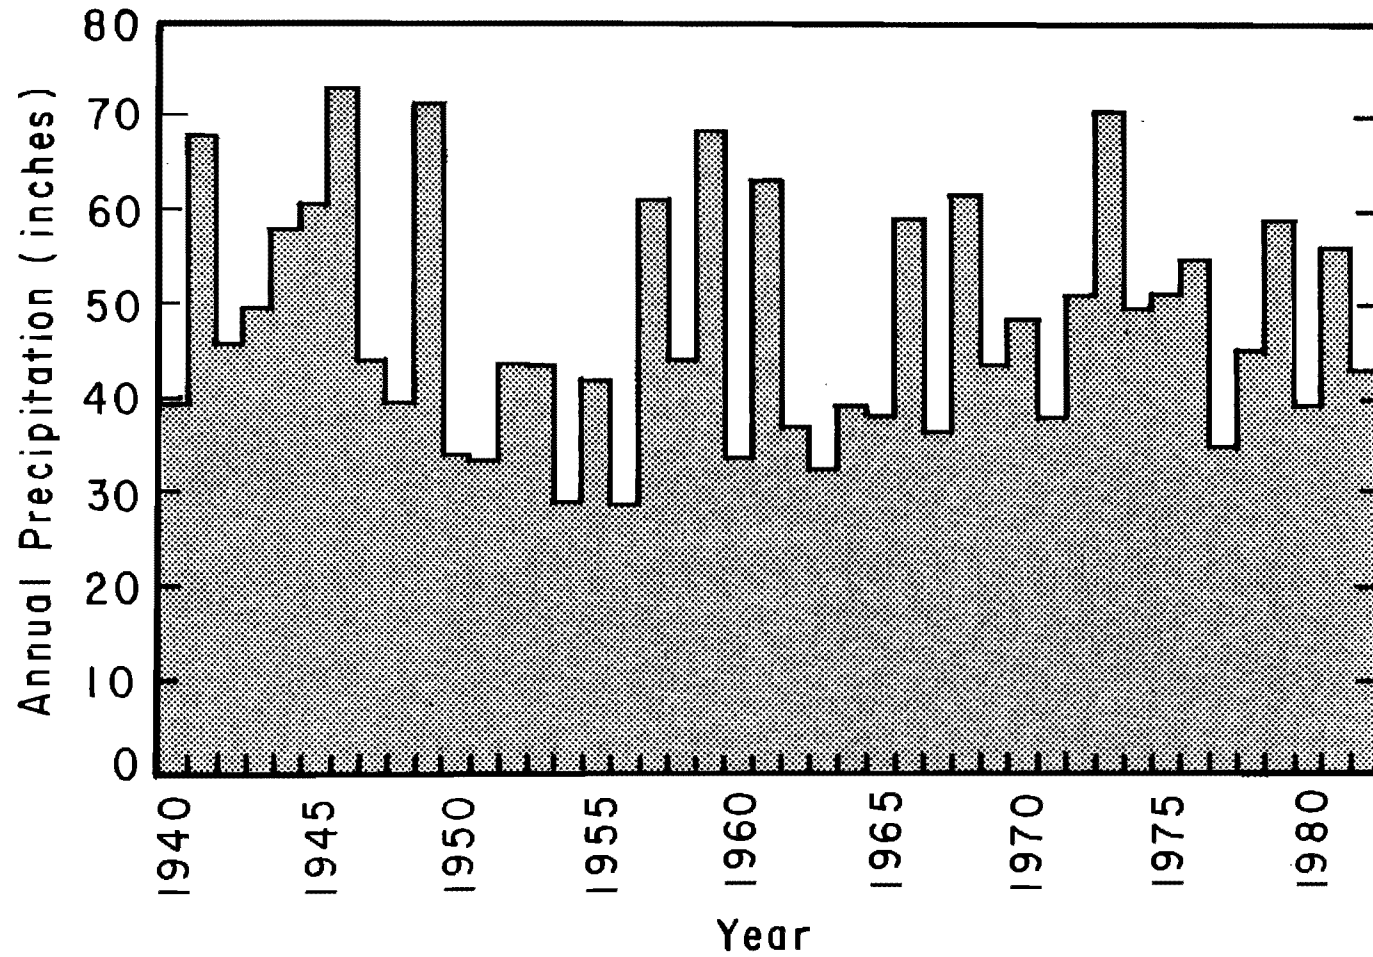
The annual precipitation in Houston for the years 1940 to 1982 is shown on a bar graph in Fig. 2.4. The annual precipitation appears to be generally increasing from about the year 1954 to 1982; however, there do not appear to be any years from 1974 to 1982 where the precipitation was exceptionally high, nor is there a sustained high annual precipitation over these recent years. Thus, annual precipitation records for Houston do not appear to correlate with the recent occurrence of numerous embankment slides in the Houston area.

Fig. 2.4. Annual precipitation in Houston for the years 1940 to 1982 (from Gale Research Company, 1981 and National Oceanic and Atmospheric Administration, 1979 to 1982).

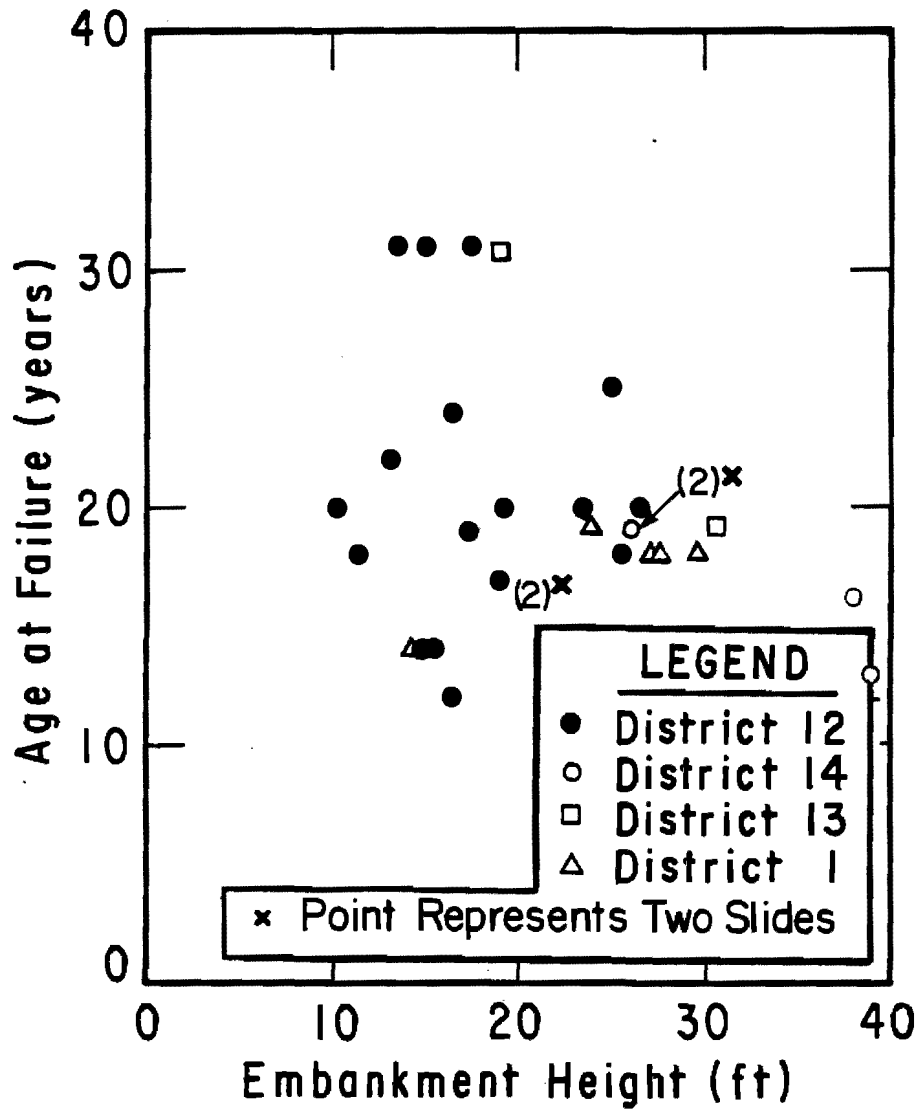
The age at failure is plotted versus the embankment height in Fig. 2.6. Examining the data shown in Fig. 2.6, there does not appear to be any relationship between the age at failure and the embankment height, i.e., embankment slope failures do not tend to occur on higher embankments before or after they occur on lower embankments.

Fig. 2.6. Variation of age at failure with embankment height for embankments which failed in Districts 1, 12, 13, and 14.

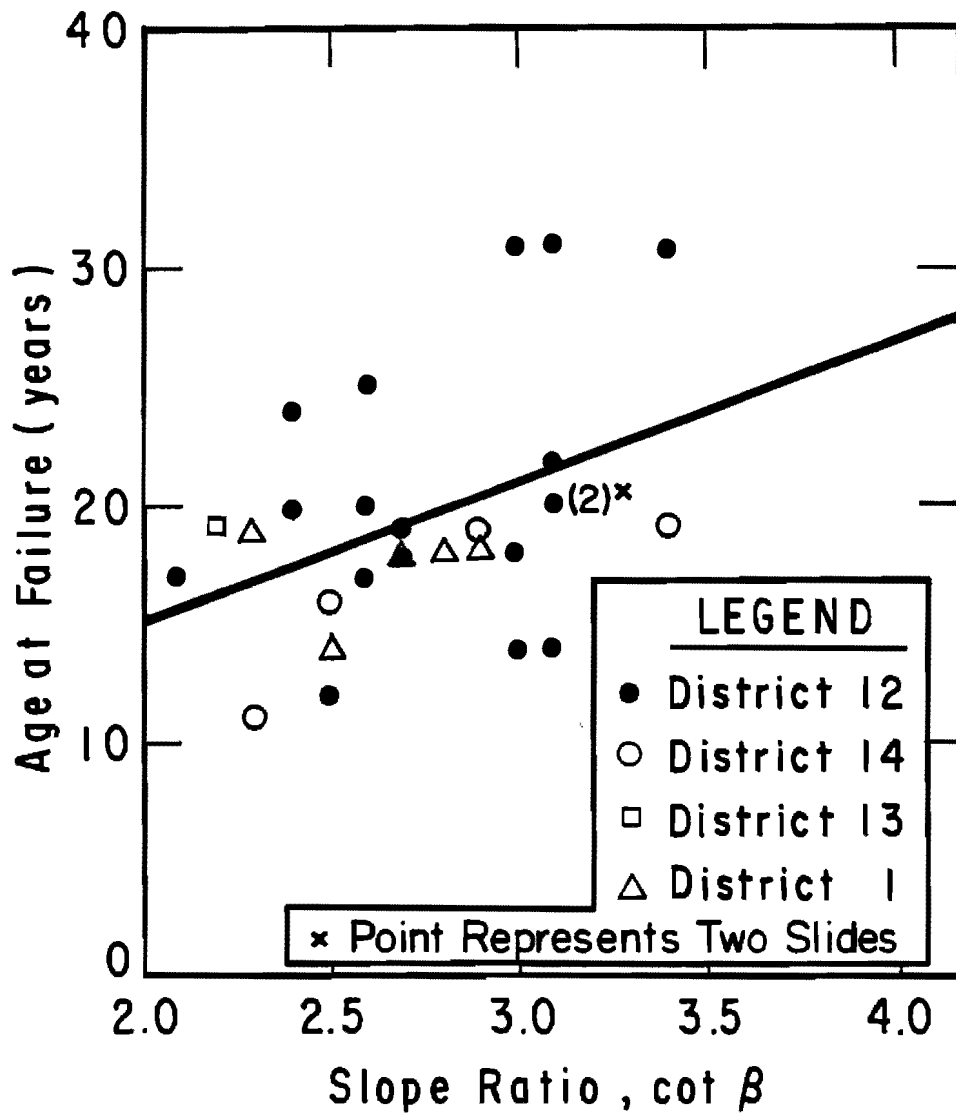
The age at failure is plotted versus the slope ratio ($\cot\beta$) in Fig. 2.7. The straight line shown on Fig. 2.7 represents the best fit line, which was calculated by the method of least squares. Examining the data shown in Fig. 2.7, it appears that embankment slope failures generally tend to occur on steeper slopes before they occur on flatter slopes.

Fig. 2.7. Variation of age at failure with slope ratio ($\cot \beta$) for embankments which failed in Districts 1, 12, 13, and 14.

This trend would be expected, especially if the soil is swelling and gradually losing strength with time.

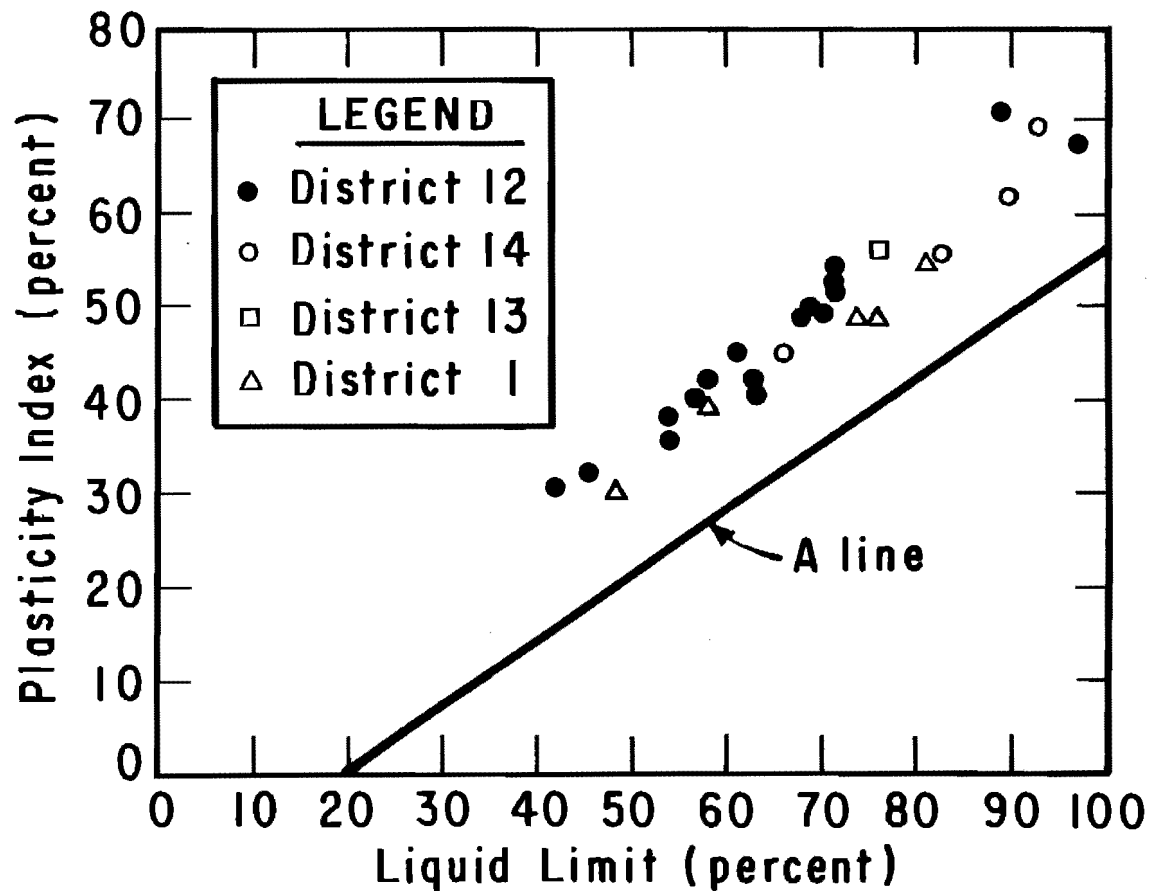
ted on a plasticity chart in Fig. 4.1. The liquid limits for these soils ranged from 42 to 97 percent, and the plasticity indices ranged from 30 to 71 percent. All but three of the soils represented in Fig. 4.1 are classified as highly plastic clays, CH, under the Unified Soil Classification System. The other three soils have liquid limits less than 50 percent and would be classified as clays with low to medium plasticity, CL.

An examination of Fig. 4.1 reveals no distinct grouping of soils from any given District. It should also be pointed out that although efforts were made to sample the "problem" soil at each site, it is certainly possible that the problem soil, the soil primarily responsible for failure, was not always sampled.

Fig. 4.1. Plasticity chart with Atterberg limits for soils from embankments which failed in Districts 1, 12, 13, and 14.

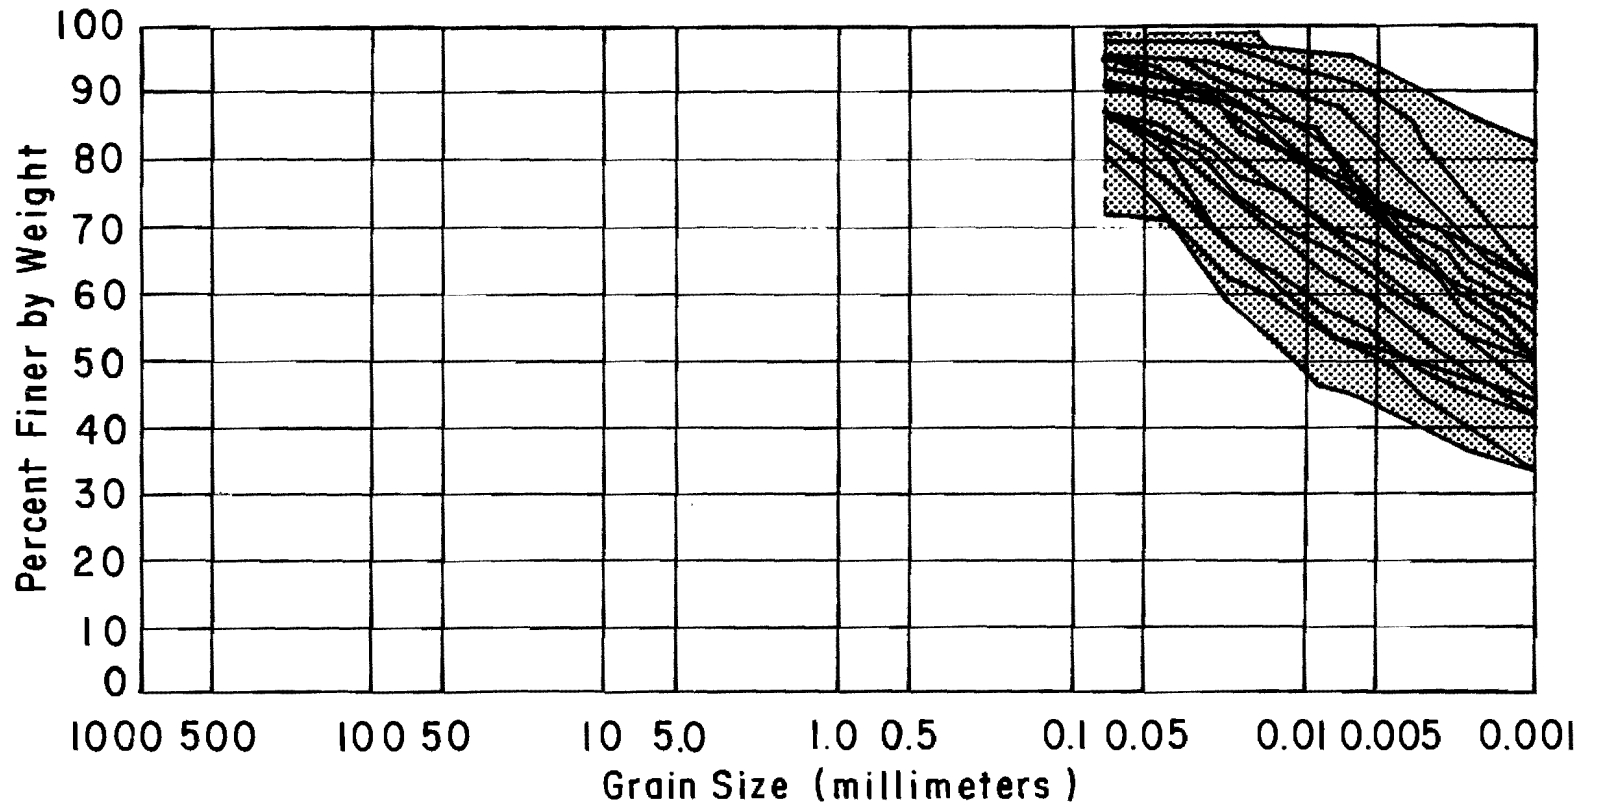
Fig. 4.3. Grain size distribution curves for problem soils from embankment slope failures in District 12.

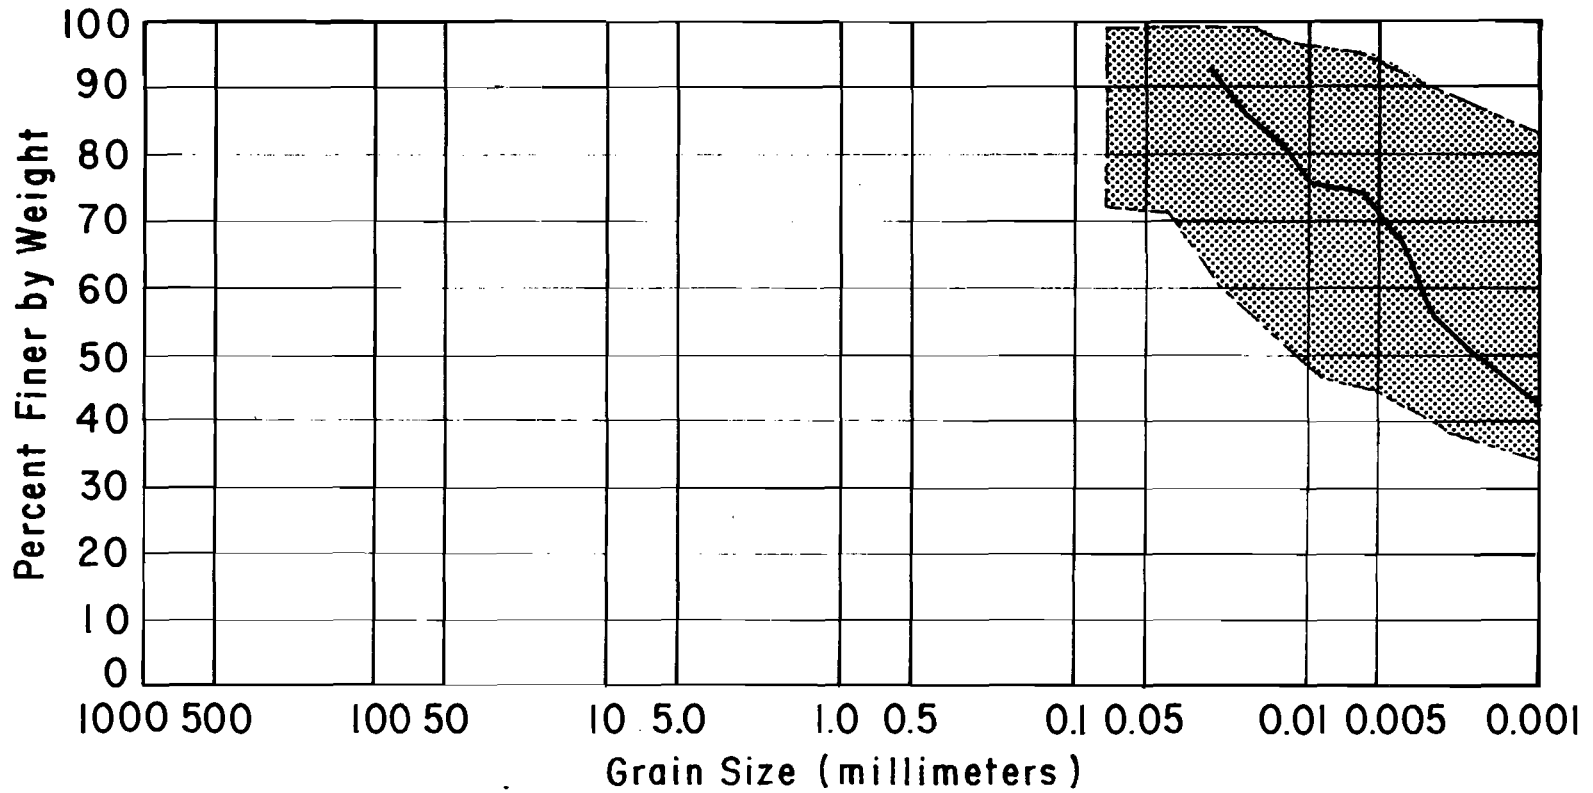
Fig. 4.7. Grain size distribution curve for worst soil from the stable slope near U.S. 79 and Carlos G. Parker Blvd. in District 14.

The grain size distribution curve for the worst soil from the stable slope at U.S. Highway 79 and Carlos G. Parker Boulevard in District 14 is shown in Fig. 4.7. This curve plots about in the middle of the shaded region.

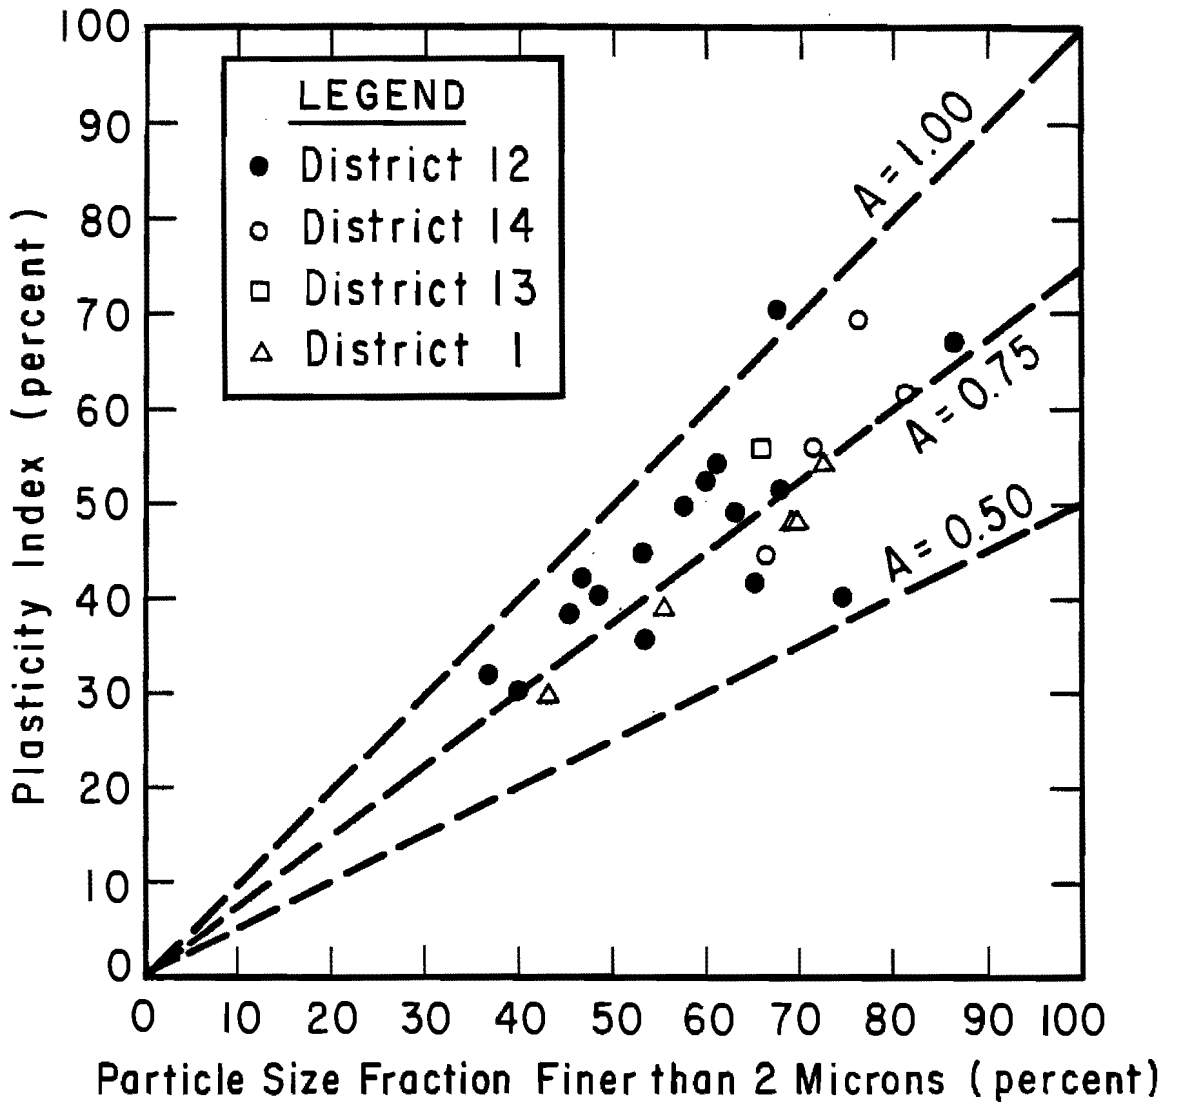
In Fig. 4.8, the plasticity index is plotted versus the clay fraction (percent by weight finer than 2 microns) for the problem soils from each of the embankment slides. By plotting the plasticity index against the clay fraction, soils with similar activities will fall on straight lines radiating from the origin. The dashed lines on Fig. 4.8 represent the locus of points for activities equal to 0.50, 0.75, and 1.00. Activities for the problem soils shown in Fig. 4.8 range from 0.54 to 1.05, the mean value is 0.79 and the standard deviation is 0.10. While there is a wide range in both the plasticity index and the clay fraction, the activities do not vary significantly. The problem soils from District 12 have slightly higher activities (the mean value is 0.81) while the problem soils from District 1 have slightly lower activities (the mean value is 0.71). The activity for the problem soil from District 13 was 0.85. Problem soils from District 14 have high plasticity indices and high clay fractions. Thus, the data for problem soils from District

Fig. 4.8. Variation of plasticity index with particle size fraction finer than 2 microns for soils from embankments which failed in Districts 1, 12, 13, and 14.

14 plot in the upper region of Fig. 4.8; however, the mean value for the activities of these soils is 0.79, which is identical to the overall mean value for all of the problem soils. For the soils examined and presented in Fig. 4.8 there does not appear to be any significant grouping or variation from one District to the next.

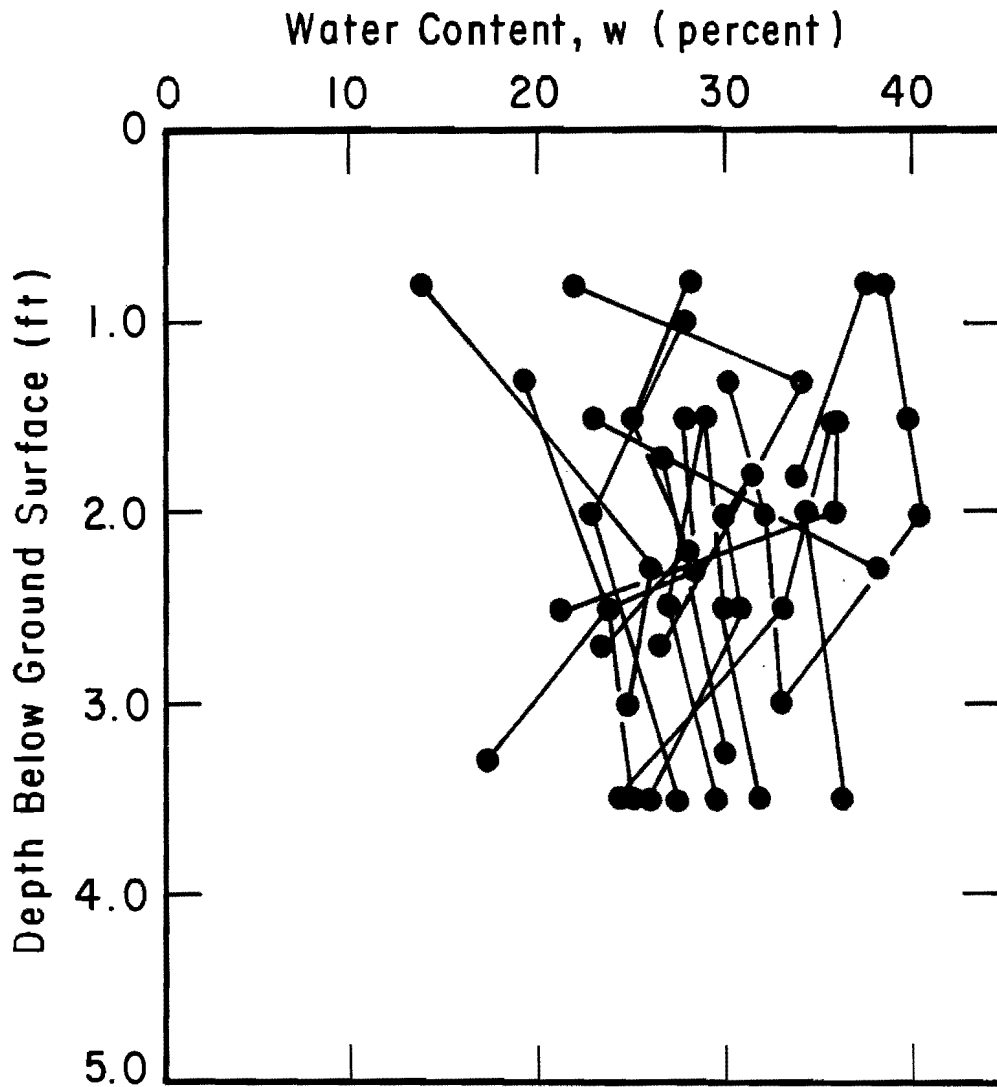
Fig. 4.9. Variation in water content with depth obtained for samples from borings in the slide mass.

The variation in water content with depth determined from samples obtained from hand auger borings within the area of the slide mass are shown in Fig. 4.9. The data points from each boring are connected by straight lines. There does not appear to be any consistent variation of water content with depth. Most of the water contents fall within the range of from 20 to 40 percent. It is not known if the water contents shown in Fig. 4.9 are representative of the values which existed at the time of failure. Changes in the topography of the slide area following the occurrence of the failure, combined with environmental factors, may affect the degree to which the measured water contents, shown in Fig. 4.9, represent conditions which existed at the time of failure.

The considerable variation in water content with depth which is illustrated in Figs. 4.9 and 4.10 may be due to the combination of environmental factors and variations in the soil type over the relatively shallow depths explored (0 to about 3.5 feet). Environmental factors will have a greater effect on the water content of soils near the slope surface than on soils at depth. The depth to which environmental fluctuations will influence water contents is not known and is perhaps itself dependant on numerous factors. Undisturbed Shelby tube samples have recently been obtained from the IH 610 and Scott Street site in District

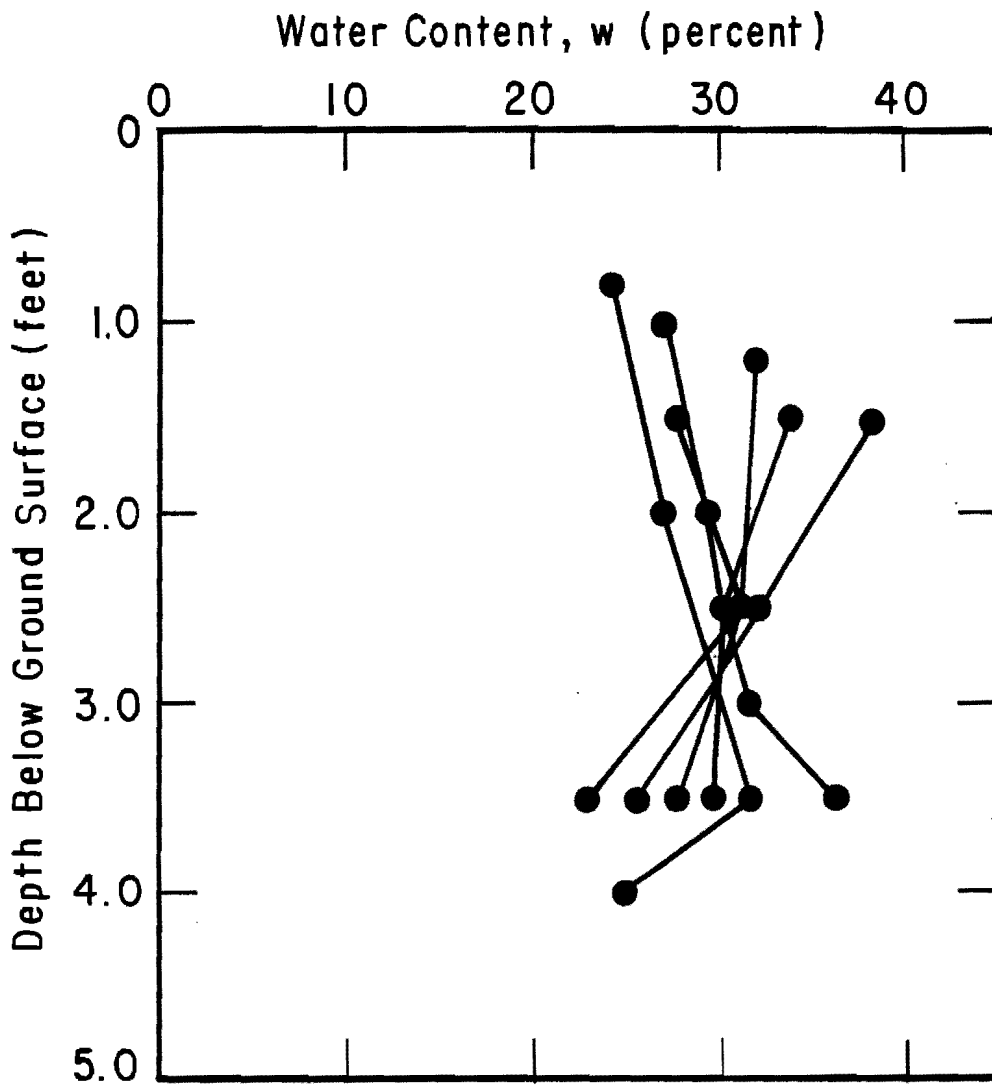
Fig. 4.10. Variation in water content with depth obtained for samples from borings adjacent to embankment slide.

The variation in water content with depth determined from samples obtained from hand auger borings outside the slide area are illustrated on Fig. 4.10. Once again, there does not appear to be any consistent variation of water content with depth. Most of the water contents fall within the range of from 25 to 35 percent.

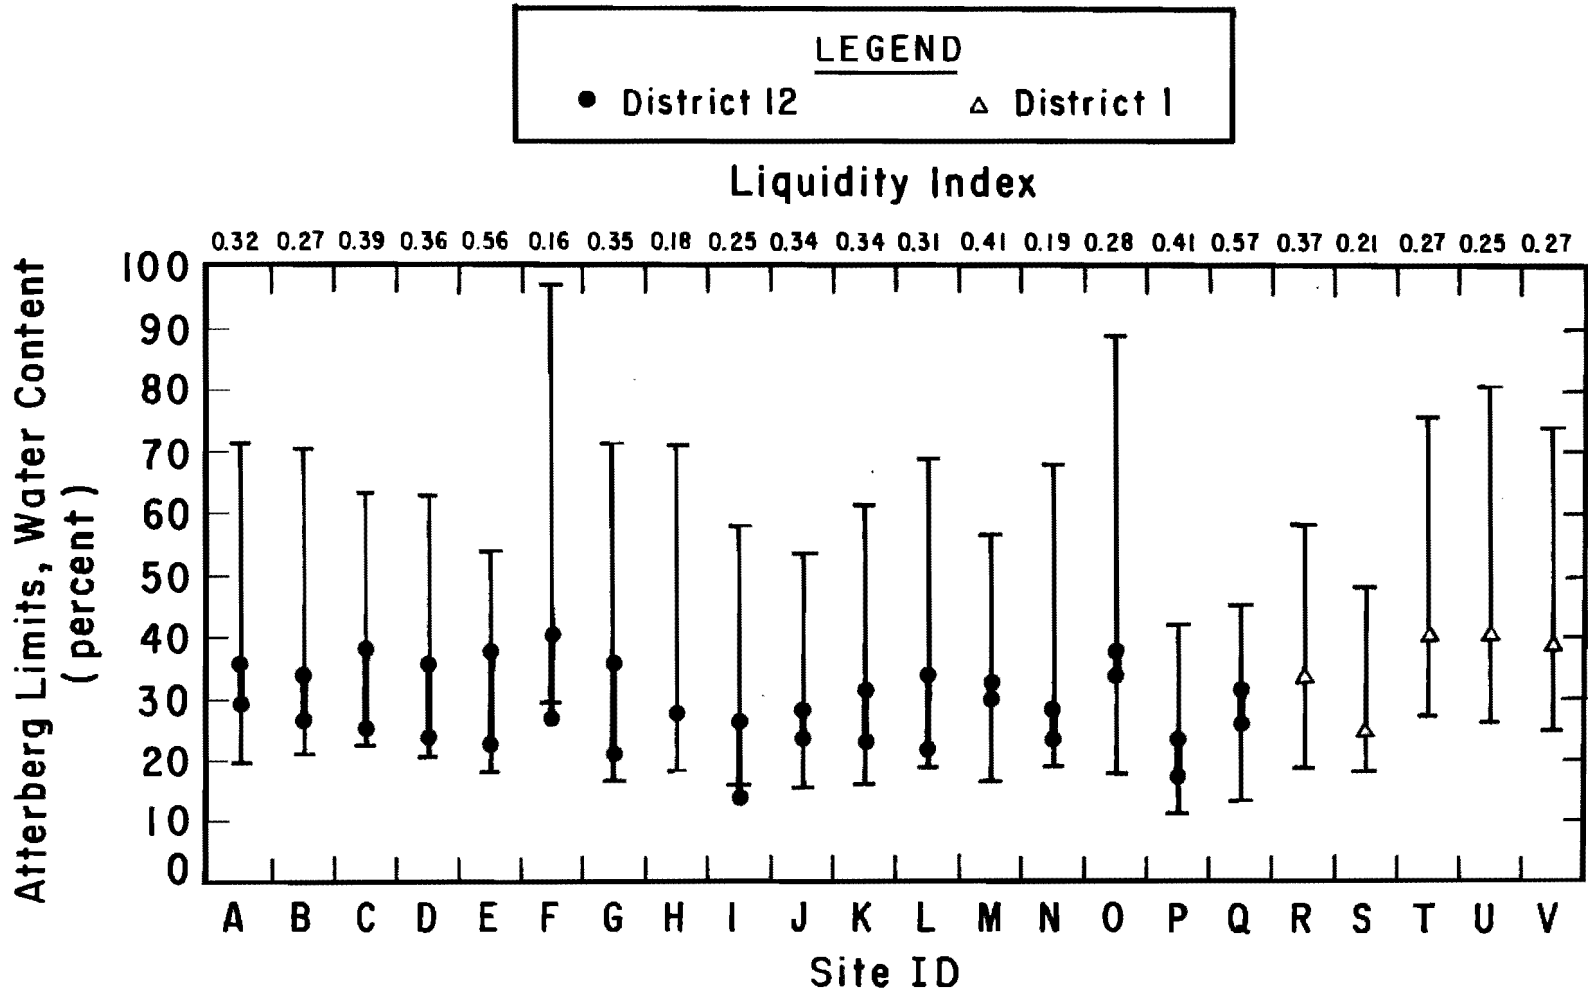
Fig. 4.11. Summary of Atterberg limits, water contents and liquidity indices for soils from embankments which failed in Districts 1 and 12.

where w_n is the natural water content, w_{PL} is the plastic limit, and w_{LL} is the liquid limit. The liquidity indices calculated are summarized in Fig. 4.11, along with the corresponding water contents and Atterberg limit values used to compute the liquidity indices. The site ID corresponds to the slope location as shown in Table 4.2. In Fig. 4.11, the upper and lower horizontal bars represent the liquid and plastic limits, respectively, while the length of the vertical line connecting these marks represents the plasticity index for the problem soil. The symbols represent water contents. Where a range of water contents was measured at a site, this range is shown by a heavy vertical line connecting a pair of symbols. The liquidity index shown at the top of Fig. 4.11 was determined using the highest water content measured at each site. The highest water content measured was not always measured for the sample which was

Values of the liquidity index range from 0.16 to 0.57. The mean value is 0.32, and the standard deviation is 0.11. Sowers (1979) states that, based on limited data, little swell will occur after a soil reaches a liquidity index of about 0.25. Based on this, the majority of the soils shown in Fig. 4.11 would appear to be in the vicinity of their fully swelled condition.

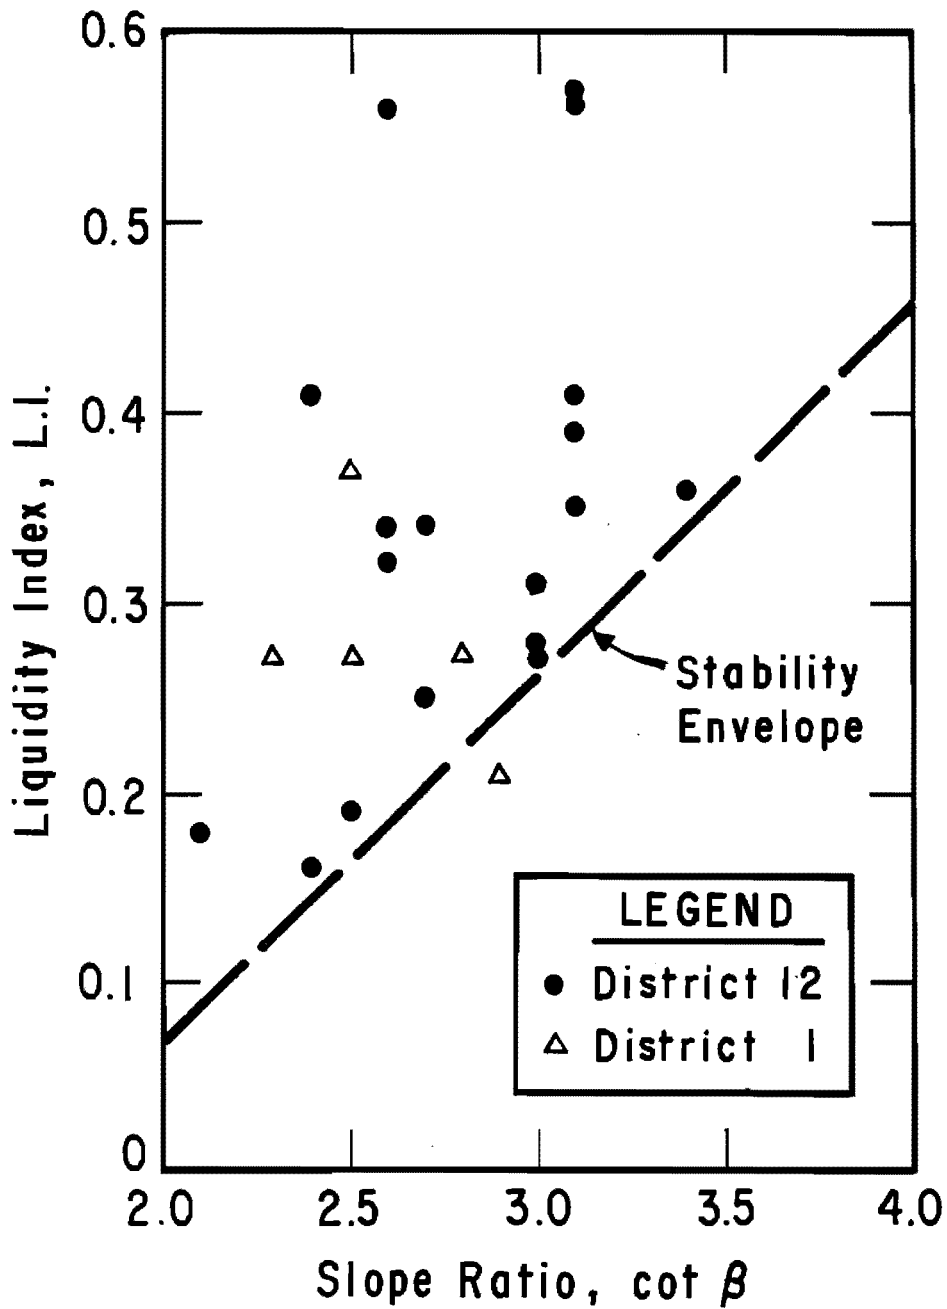
Fig. 4.12. Variation of liquidity index with slope ratio ($\cot \beta$) for soils from embankments which failed in Districts 1 and 12.

The liquidity index is plotted versus the slope ratio for embankment slides in Districts 12 and 1 in Fig. 4.12. Examining the data shown in Fig. 4.12, it appears that failure generally occurred on steeper slopes at lower liquidity indices and on flatter slopes at higher liquidity indices. Thus, failure may have occurred on some of the steeper slopes prior to their reaching a fully swelled, "long-term" condition. It appears that the data in Fig. 4.12 define a stability "envelope" shown approximately by the dashed line in Fig. 4.12. Most slopes with liquidity indices and slope ratios which plot below the line defining this envelope would be expected to remain stable while slopes which would plot above this line may fail. The scatter of points above the stability envelope line shown in Fig. 4.12 may be due to nonhomogenities within the embankment slopes. The presence of stronger materials within the slopes might restrict failure, whereas, if the embankment slopes were homogeneous, consisting of the problem soil, they would have failed at lower liquidity indices.

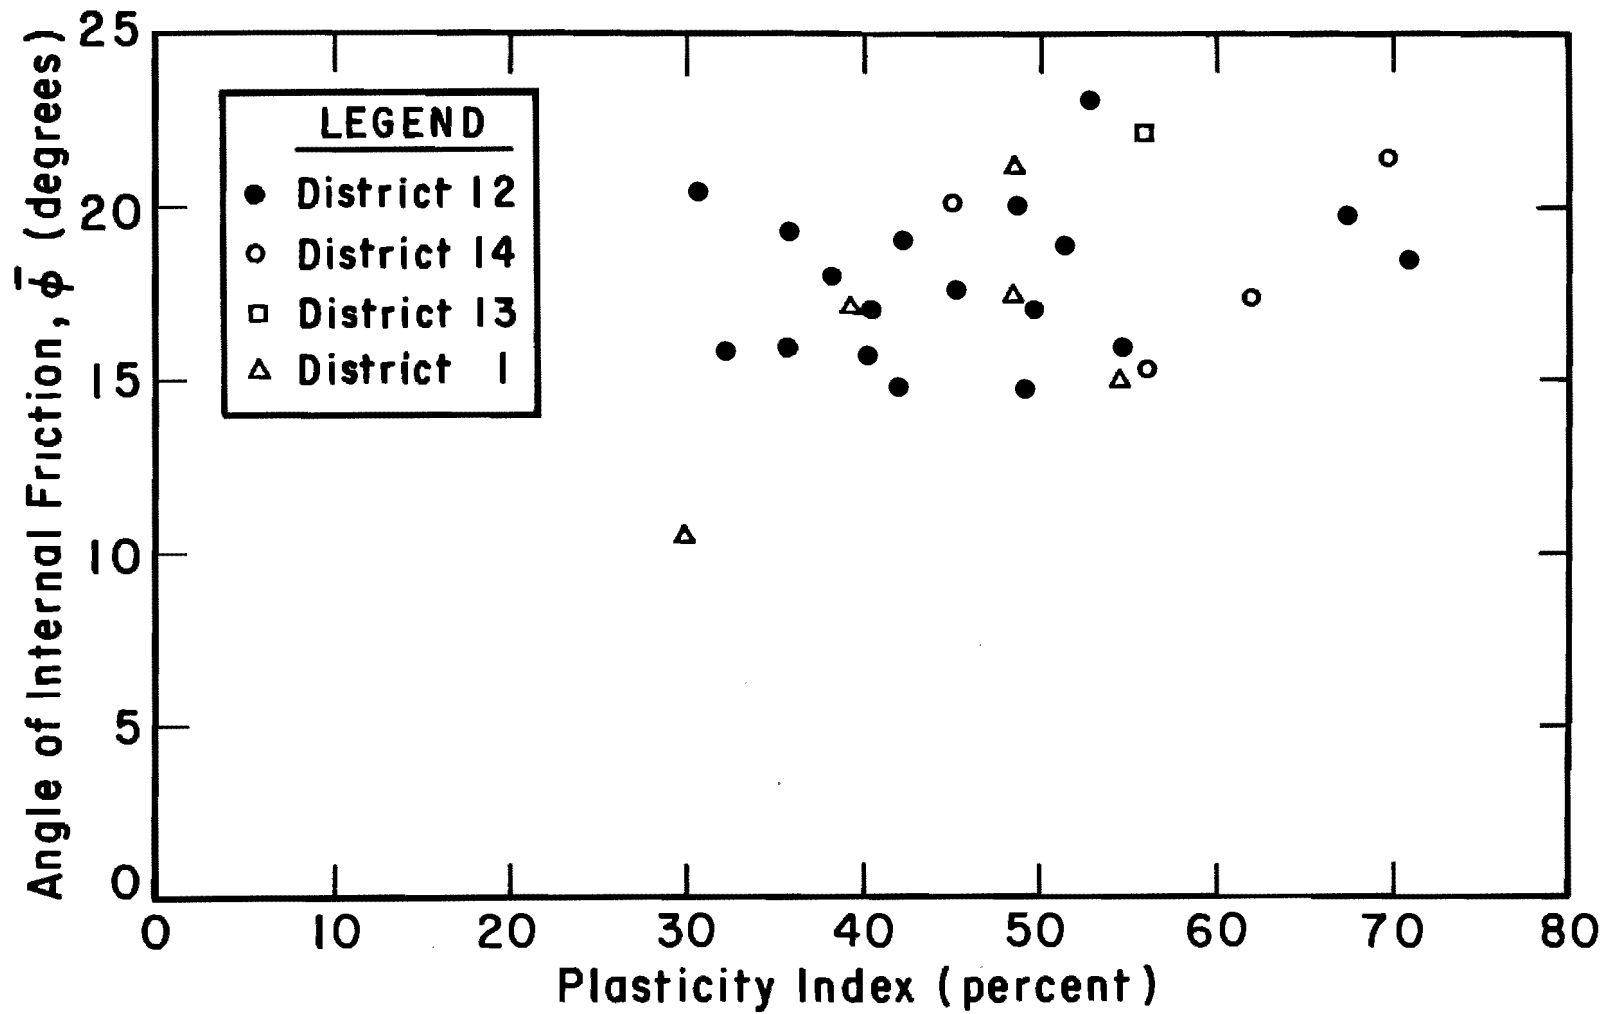
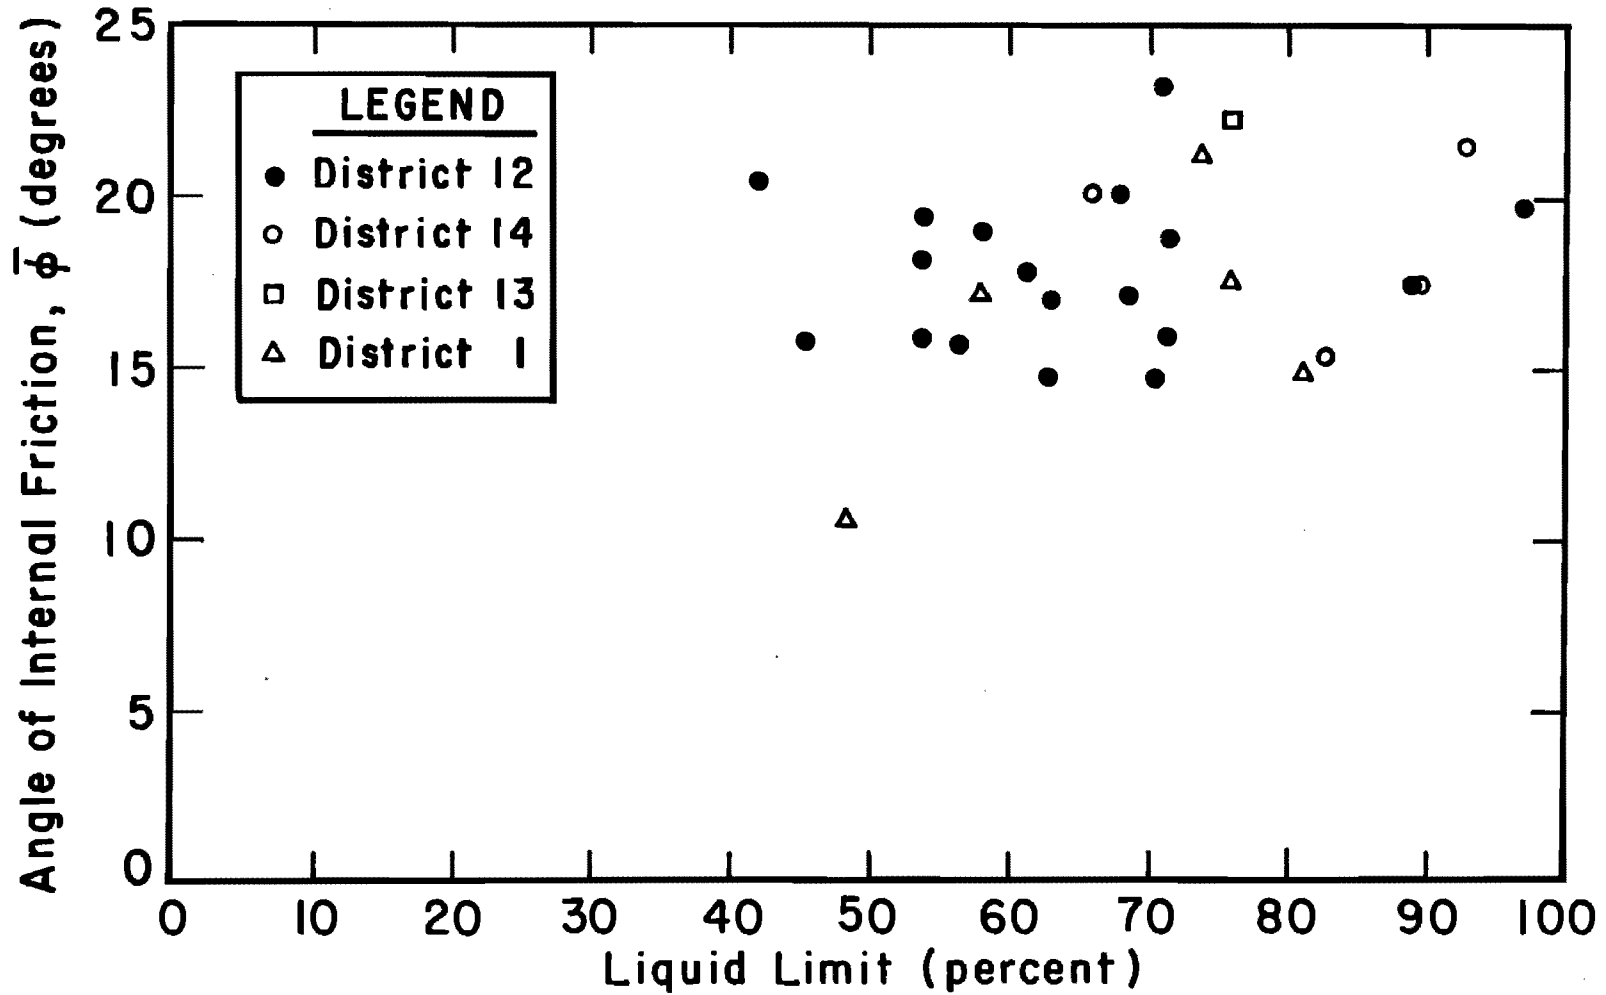
Correlation with Atterberg Limits: The back-calculated angles of internal friction based on zero pore water pressures are plotted versus the plasticity index of the problem soils in Fig. 4.13 for each embankment slide. A similar plot of the back-calculated angle of internal friction versus liquid limit is shown in Fig. 4.14. The two plots do not show significantly different features since there is generally a direct relationship between the plasticity index and the liquid limit for these soils. Soils with high plasticity indices generally have high liquid limits, and soils with low plasticity indices generally have low liquid limits.

The data in Figs. 4.13 and 4.14 show no distinct relationship between the friction angle and either the plasticity index or the liquid limit. Other researchers have found a general trend of decreasing effective stress angle of internal friction with increasing plasticity index, as shown in Fig. 4.15, which illustrates some of the relationships which have been developed for various soils. The trends shown in Fig. 4.15 are not observed for the data shown in Figs. 4.13 and 4.14.

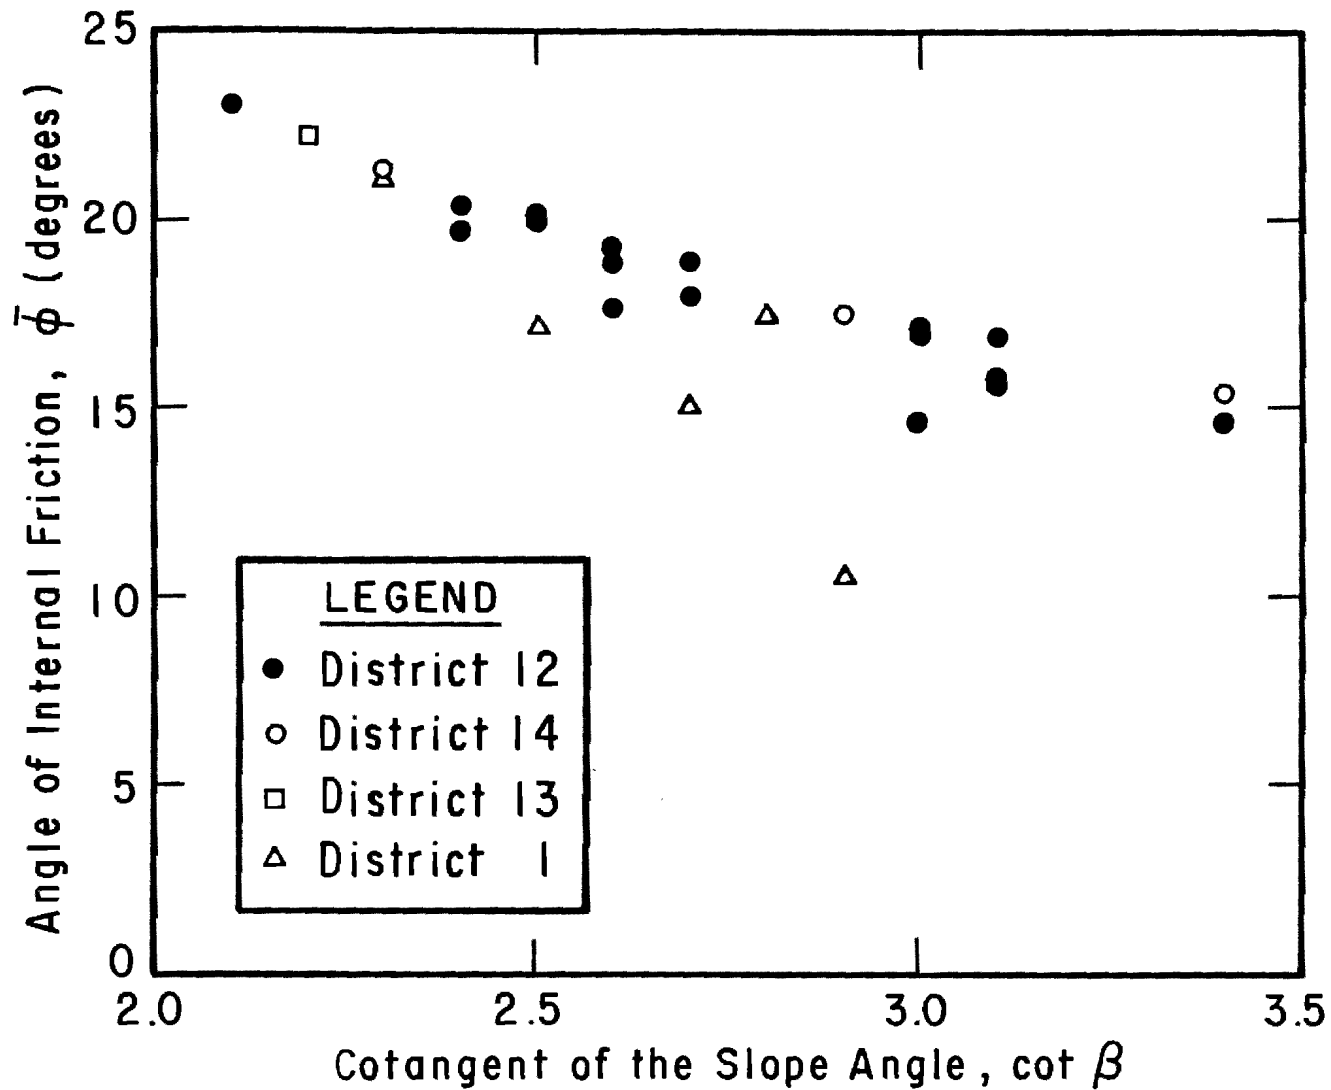
Fig. 4.16. Variation of back-calculated angle of internal friction ($\bar{\phi}$) with the cotangent of the slope angle ($\cot \beta$).

Influence of the Embankment Slope Angle: The back-calculated angles of internal friction based on zero pore water pressures are plotted versus the cotangent of the slope angle in Fig. 4.16. The variation of the angle of internal friction is found to be related to the slope angle for these failures. Steeper slopes, with smaller values of $\cot\beta$, have higher back-calculated friction angles, whereas the flatter slopes have lower back-calculated friction angles.

The lowest value of the back-calculated friction angle shown in Fig. 4.16, 10.5 degrees, corresponds to a very deep failure which occurred in District 1. The depth ratio for this slide is 0.53, the highest value of any of the slides examined. The highest values for the friction angles shown in Fig. 4.16 correspond to failures which occurred near the abutment and were therefore generally the steepest slopes. The mean value of the back-calculated friction angle for failures near the abutment was 21.7 degrees, and the standard deviation, 1.1 degrees. The mean value of the back-calculated friction angle for failures on side slopes was 17.0 degrees, and the standard deviation, 2.2 degrees.
