1. Report No. FHWA/TX-86/06+353-3F		2. Government Accession No.	
4. Title and Subtitle AN EXAMINATION OF EARTH SLOPE FAILURES IN TEXAS		5. Report Date November 1984

AN EXAMINATION OF EARTH SLOPE
FAILURES IN TEXAS

Research Report 353-3F

Stability Evaluation for Earth Slopes
Research Project 3-8-83-353

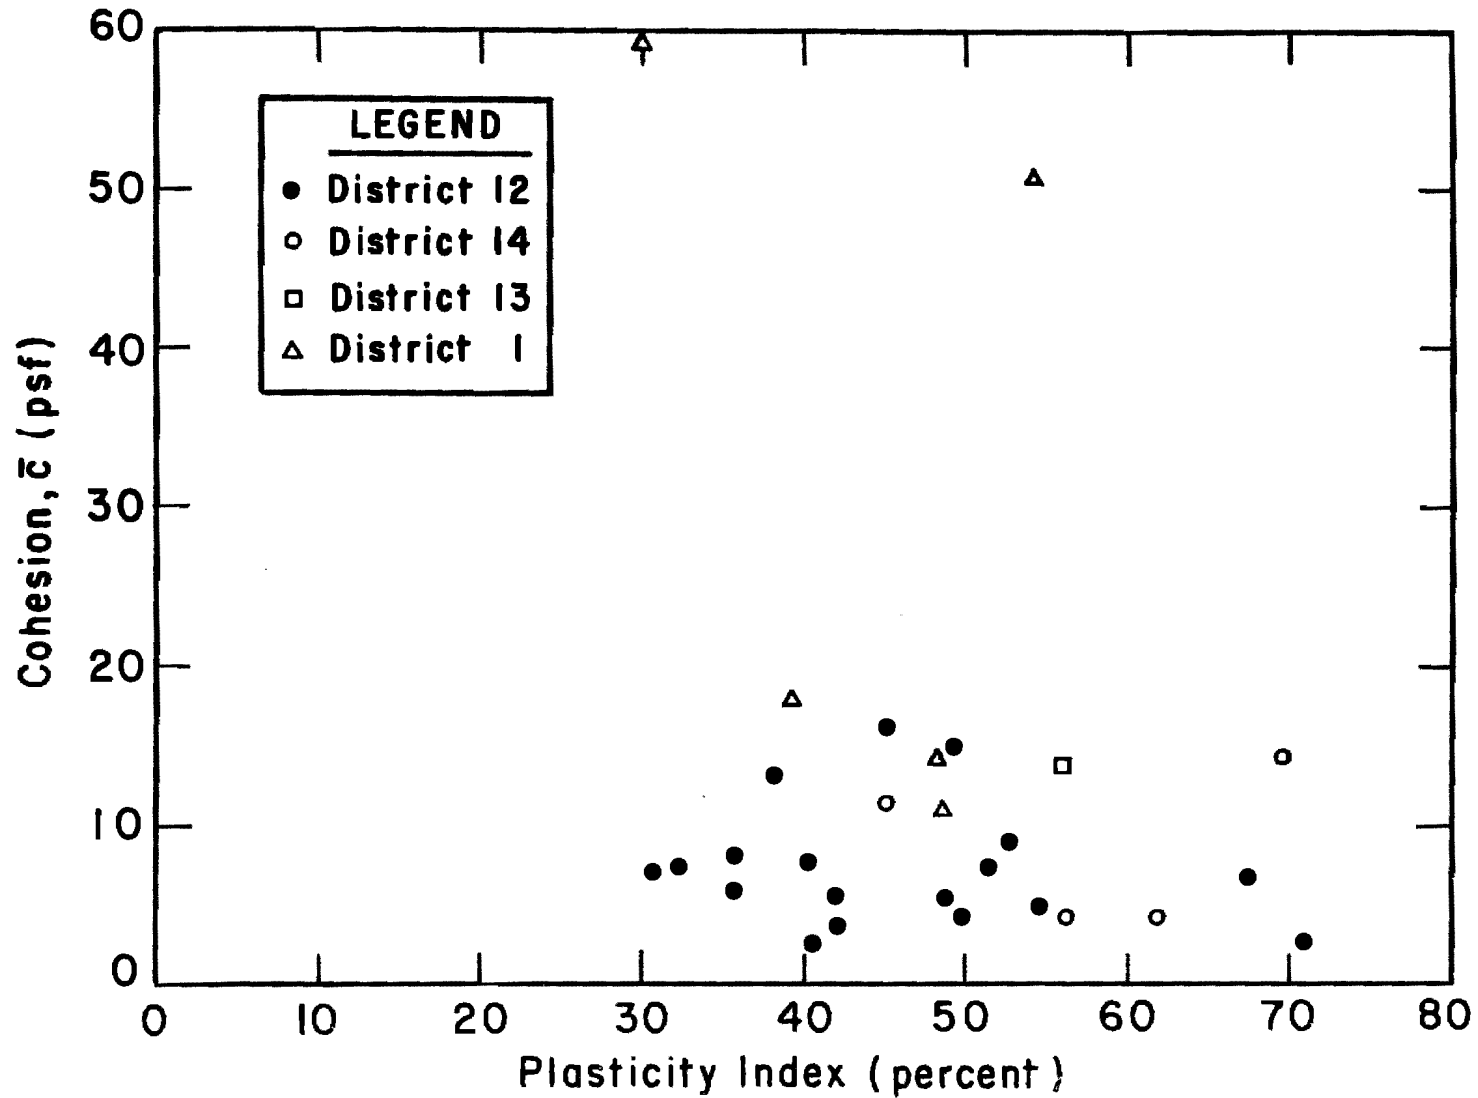
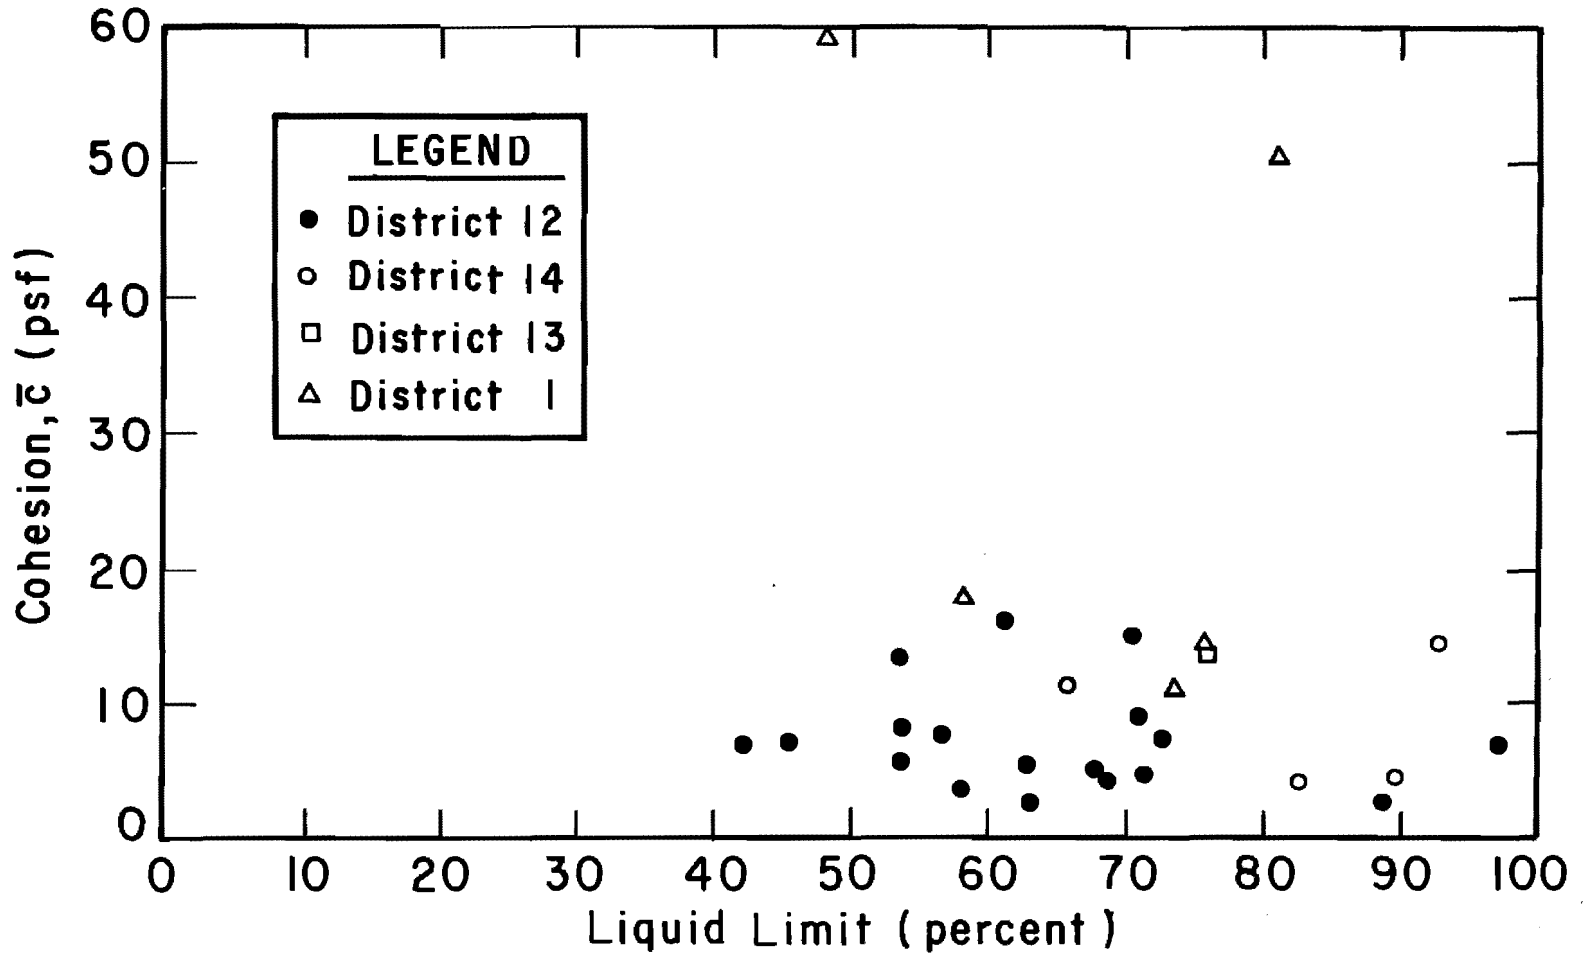
The back-calculated cohesion values based on zero pore water pressures are plotted against the plasticity index for the problem soil from each embankment slide in Fig. 4.17. A similar plot of the back-calculated cohesion values versus the liquid limit is shown in Fig. 4.18. The two plots do not show significantly different features.

The data in Figs. 4.17 and 4.18 show no distinct relationship between the cohesion and either the plasticity index or the liquid limit. In addition, the cohesion does not appear to be related to the slope angle as was the case for the back-calculated friction angle. It was found, instead, that any variation in the back-calculated cohesion was more closely related to variations in the slide depth ratio. The highest values of cohesion (assuming zero pore water pressure) were 50.6 and 59.4 psf for two slides which occurred in District 1. These two slides had the largest depth ratios of all slides examined. Conversely, the lowest values of the back-calculated cohesion generally correspond to the slides with the smallest depth ratios.

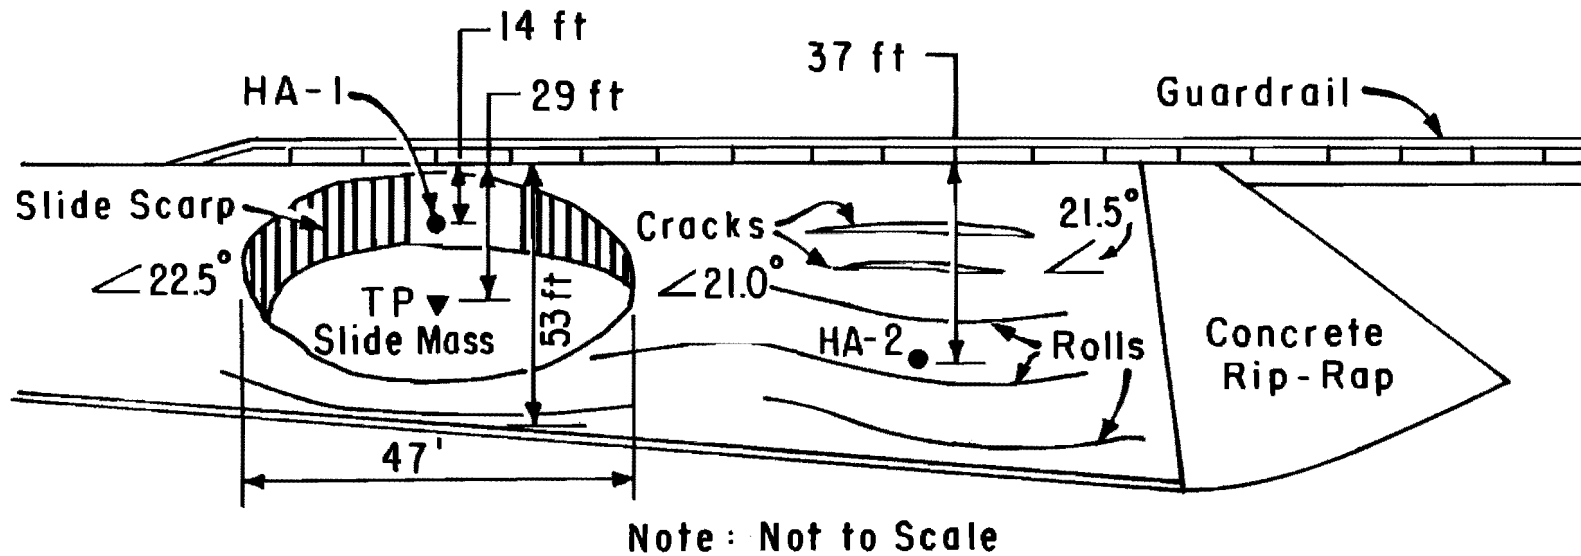
Fig. 5.2. Sketch of embankment at IH 610 and Scott Street (NE quadrant) showing extent of slope movement and sampling locations (redrawn from field sketch, 15 March 1983).

The face of the slope along the north side of the east embankment is shown on a sketch in Fig. 5.2. The portion of the slope which had failed was approximately 100 feet east of the west end of the embankment. Some additional slope movement was observed between the slide and the

Soil sampling at the IH 610 and Scott Street site during the initial field inspection (March 15, 1983) consisted of excavation of two hand auger borings and one test pit. The approximate locations of the borings and test pit are shown on the sketch in Fig. 5.2. Water content samples were taken from the two hand auger borings. Water content and soil profiles for these borings are shown in Fig. 5.4. There do not appear to be any consistent trends in the water content profiles. However, the average water content of those samples obtained from the boring located in the main slide scarp (HA-1) was about 35 percent, which is several percent higher than the average water content of 31 percent for samples taken from the adjacent section of the slope which was showing some slope movement (HA-2).

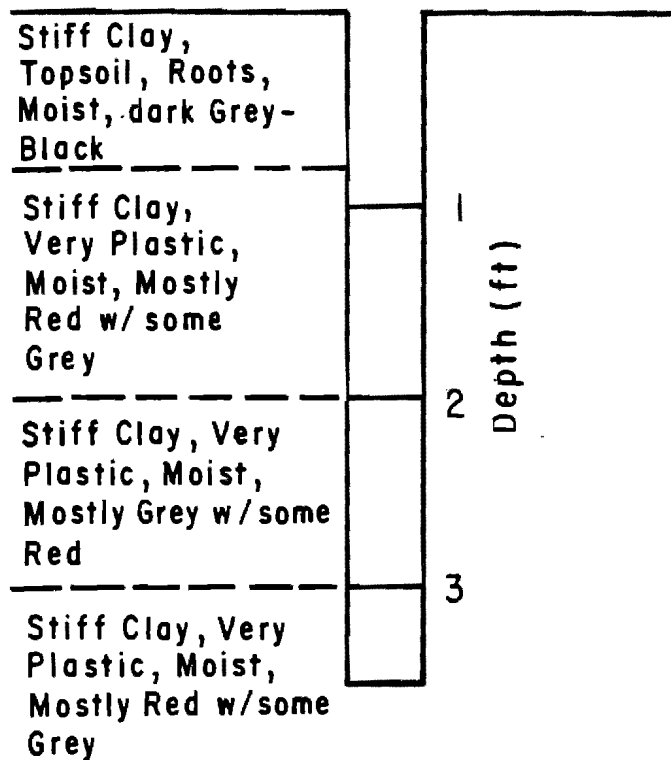
Fig. 5.6. Soil profile for the test pit at IH 610 and Scott Street (NE quadrant).

The test pit was excavated in the slide mass at the approximate location shown in Fig. 5.2 in order to obtain soil for the laboratory testing program. A cross-section through the slide showing the location of hand auger boring HA-1 and the test pit is presented in Fig. 5.5. The depth of the test pit was approximately 3.5 feet and does not appear to have been sufficient to penetrate the estimated location of the failure surface. The soil profile determined from the test pit is shown in Fig. 5.6. Two distinctly different clays were recognized during excavation of the test pit: a red Beaumont clay, and a grey Beaumont clay. Subsequent measurement of index properties showed that the red clay was more highly plastic and finer grained than the grey clay. The red clay was

therefore identified as the "problem" soil at this site. Consolidated-undrained (CU) triaxial compression tests with pore water pressure measurements were performed on both of these soils and are described in detail in the report by Gourlay and Wright (1984).

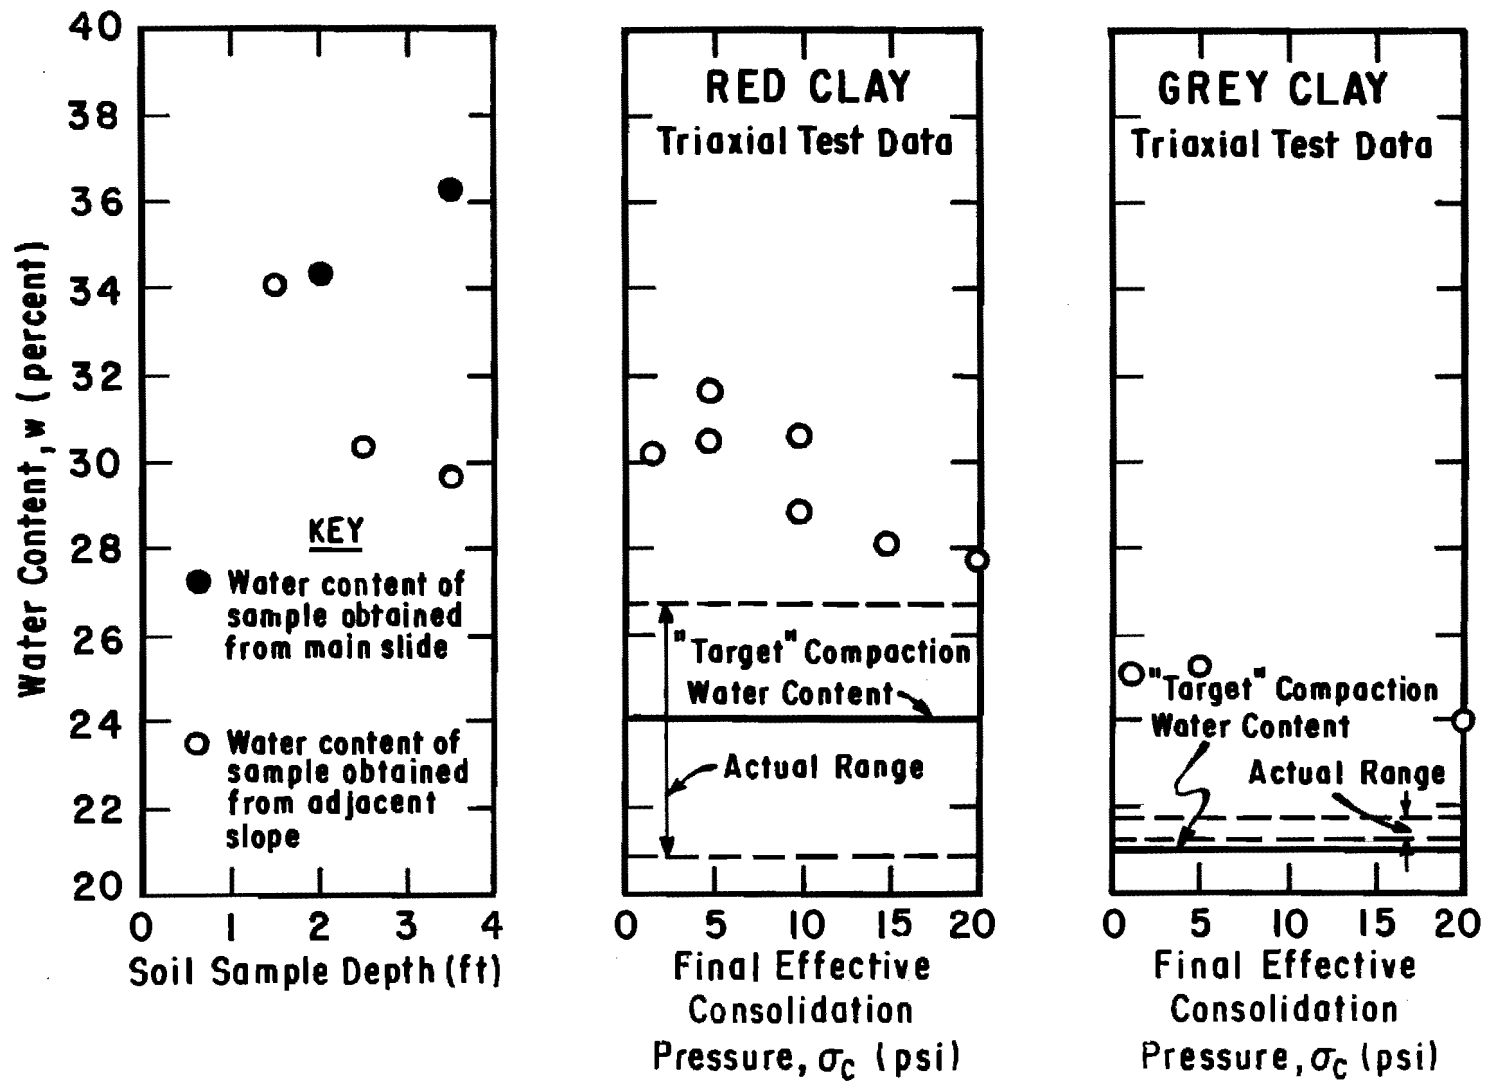
Fig. 5.9. Comparison of water contents from field samples with water contents of triaxial specimens for the IH 610 and Scott Street embankment.

The water content diagrams shown in Figs. 5.7 and 5.8 have been reproduced in Fig. 5.9 along with the water contents measured from the field samples. The water contents from the field samples are plotted versus the corresponding depth of the sample. It is found that the field water contents are near, or a few percentage points greater than, the final water contents of the laboratory specimens of red clay at low effective consolidation pressures. It would be expected that the two sets of water contents (field and laboratory at low consolidation pressures) would be similar since the field samples were taken from relatively shallow depths (1.5 to 3.5 feet) which correspond to low effective confining pressures, and since the majority of the samples obtained at this site consisted predominantly of the red clay. However, it is not known why some of the field water contents are greater than the final water contents of laboratory compacted specimens of the red clay with low consolidation pressures.

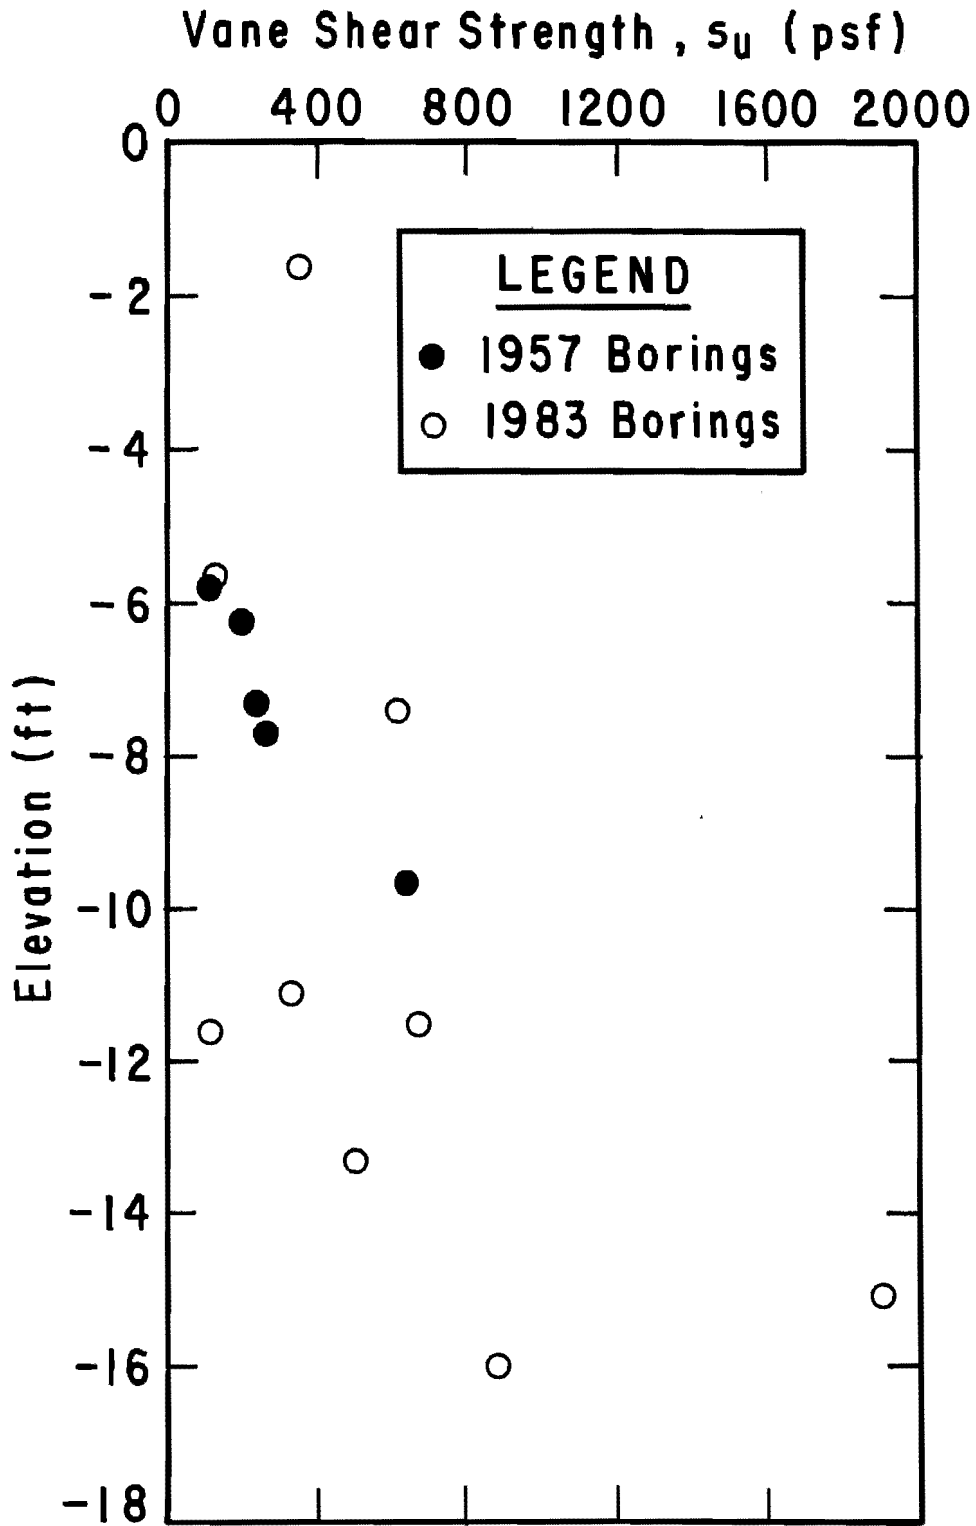
Fig. 7.2. Variation in the in-situ vane shear strength with elevation.

indices greater than about 20 percent, which probably applies to the soft clay muck. The vane shear strengths are plotted versus the elevation at the depth tested in Fig. 7.2 and versus the estimated effective vertical overburden stress at the depth tested in Fig. 7.3. Examining the data shown in Figs. 7.2 and 7.3, there appears to be a general increase in strength with depth; however, there are no consistent trends observed in either of these plots. In addition, it appears that the vane shear strengths summarized in Table 7.1 do not vary in any consistent manner in the horizontal direction.

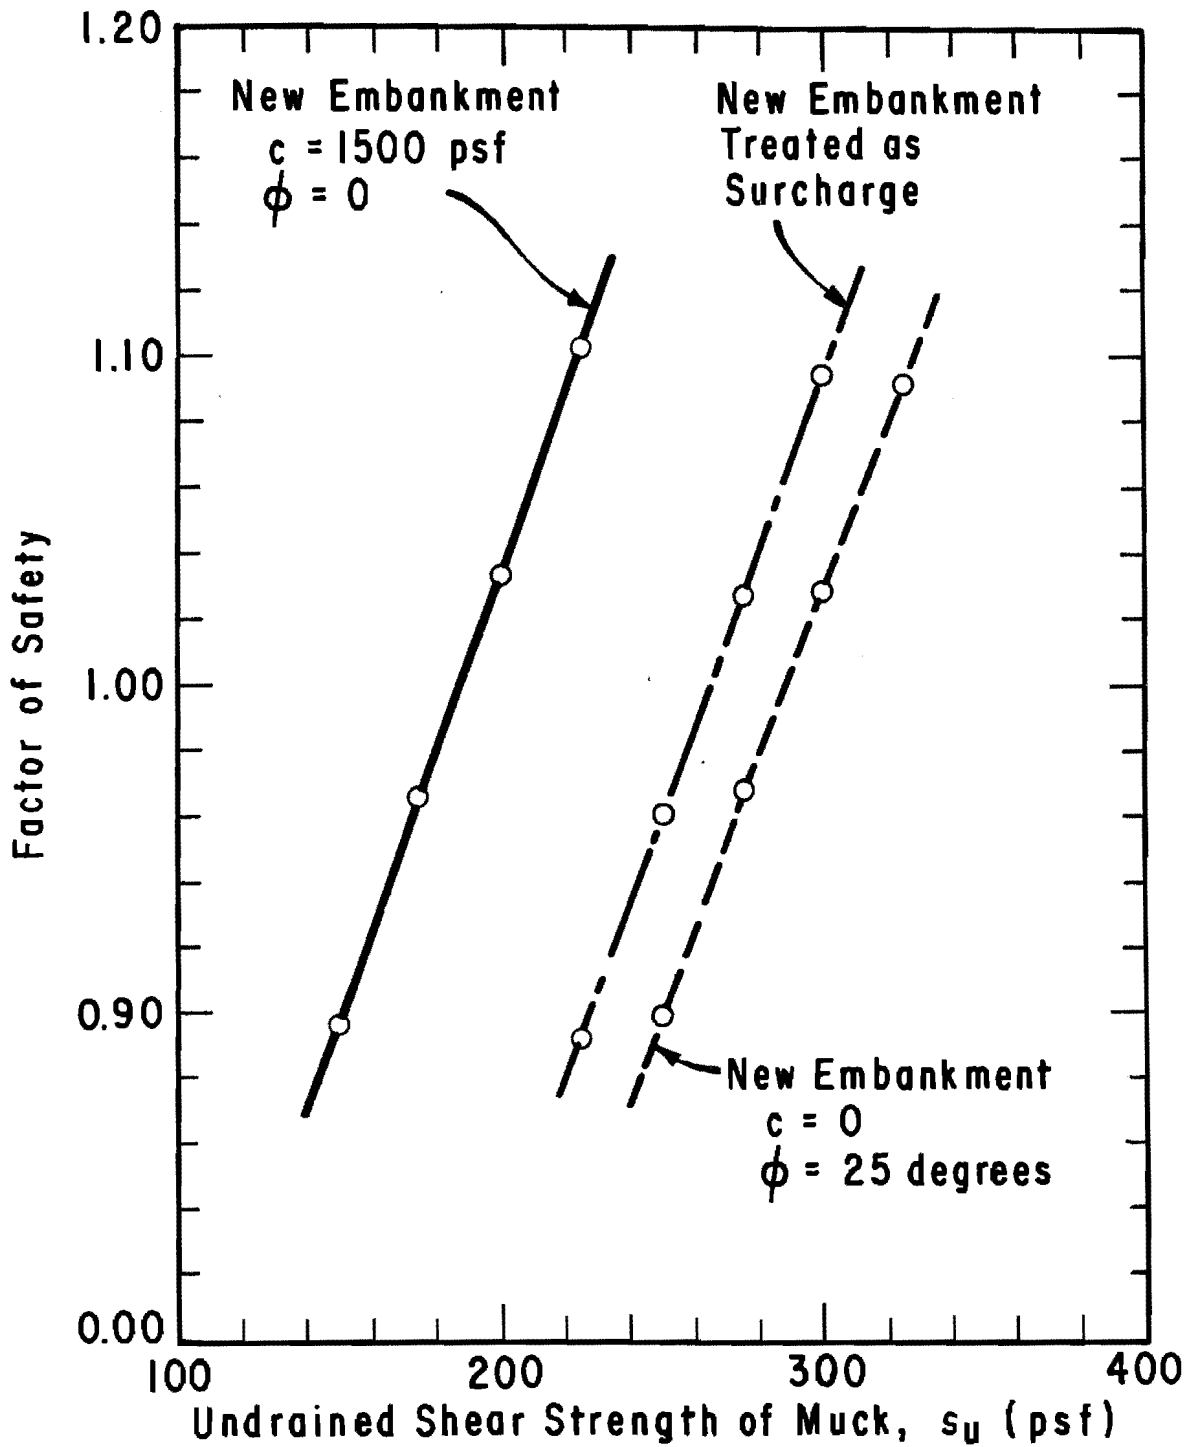
Fig. 7.4. Variation in the factor of safety with the assumed undrained shear strength of the "muck" for three characterizations of the new embankment fill.

The soft muck was assumed to be saturated and, accordingly, ϕ was assumed to be zero. The cohesion value (undrained shear strength) for the muck was varied from 150 to 325 psf, and the factor of safety was calculated for each of the three characterizations of the new embankment, as described above. The factor of safety is plotted versus the assumed undrained shear strength of the muck for the three embankment characterizations in Fig. 7.4. The shear strength of the muck corresponding to a factor of safety of unity for each of the embankment characterizations was read from this figure.

For the first new embankment characterization ($c = 1500$ psf and $\phi = 0$), the back-calculated shear strength for the muck is 188 pcf. The critical circular shear surface located for this case is shown in Fig. 7.5. For the second new embankment characterization ($c = 0$ and $\phi = 25$ degrees), the back-calculated shear strength for the muck is 288 psf. The critical circular shear surface located for the second case is shown in Fig. 7.6. Finally, when the new embankment is treated as a surcharge, the back-calculated shear strength for the muck is 265 psf. The critical circular shear surface located with the new embankment treated as a surcharge is shown on Fig. 7.7. Additional stability calculations were per-

Based on the results of the stability calculations, the shear strength of the muck appears to be in the range of about 200 to 300 psf. The critical shear surfaces located for the second and third new embankment characterizations, as shown in Figs. 7.6 and 7.7, are similar and are closest to the position of the observed failure (the approximate location of the actual slide scarp is shown in Fig. 7.1). The critical circular shear surface for the first embankment characterization, as shown in Fig. 7.5, does not intersect the new embankment fill and does not resemble the observed failure surface. The shear strengths (288 and 265 psf) which were back-calculated using the second and third characterizations of the new embankment are in good agreement and compare well with the vane shear strengths measured in the field and summarized in Table 7.1. The shear strength (188 psf) which was back-calculated based on the first characterization of the new embankment fill is significantly lower and is near the low end of the range of the vane shear strengths measured in the field.

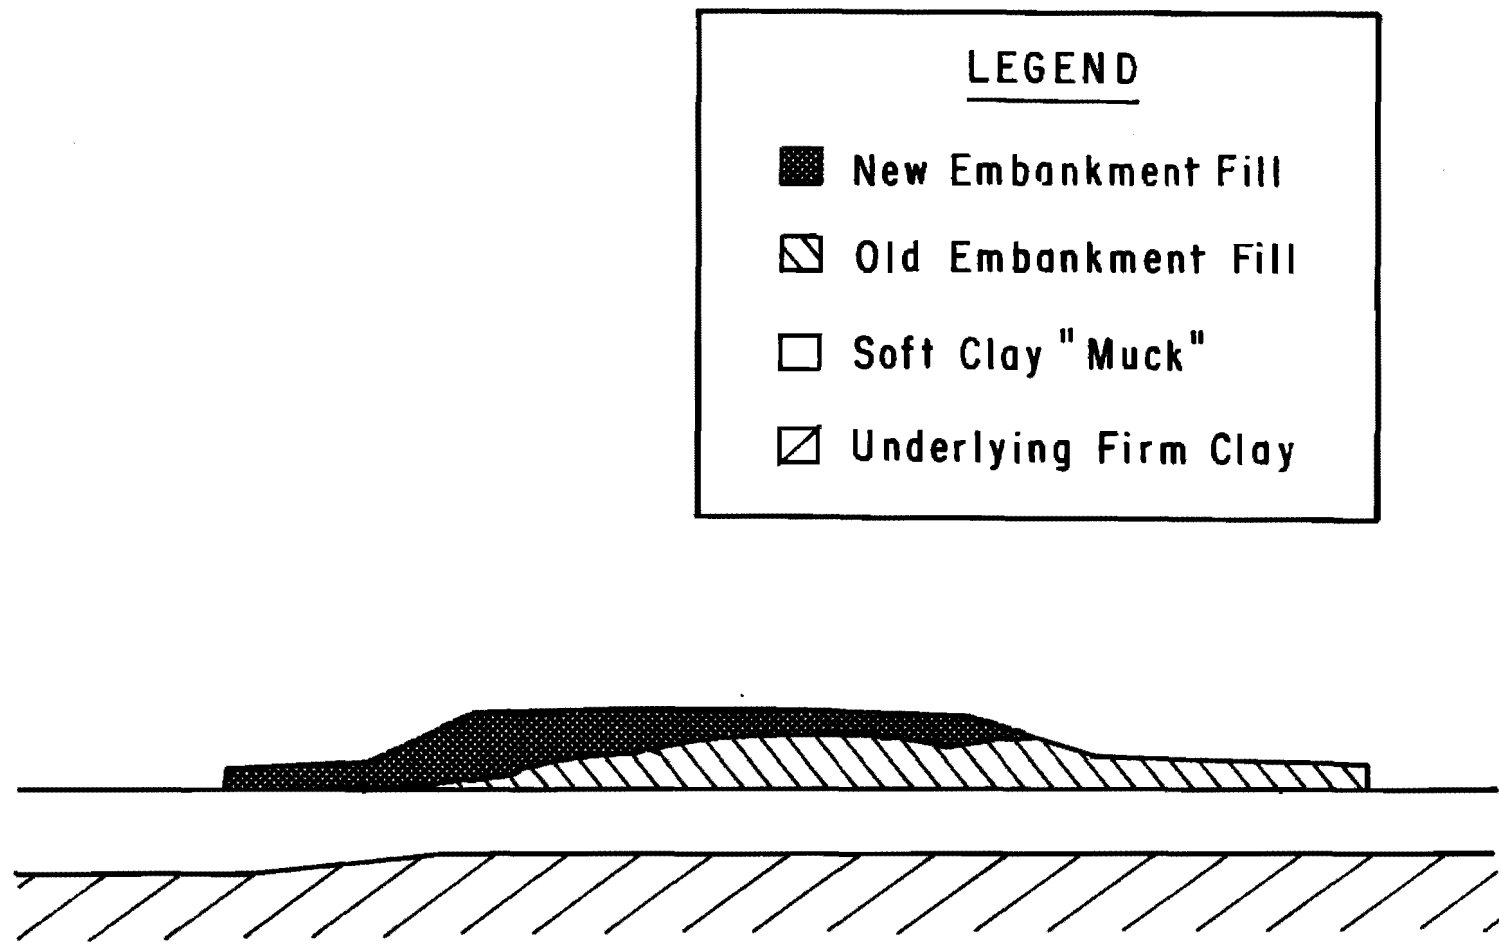
Fig. 7.8. Planned cross-section of completed Oso Bay embankment.

The first set of stability calculations for the completed embankment were performed assuming that the embankment was constructed as originally planned, with the cross-section shown in Fig. 7.8. The slope geometry shown in Fig. 7.8 is the same as the design geometry shown by the broken line in Fig. 7.1. The critical circular shear surface which was located is shown in Fig. 7.9. The factor of safety corresponding to this surface is 0.94. This value of the factor of safety for the "completed" embankment without repair seems reasonable; the slope geometry of the "completed" embankment in the vicinity of the failure is not significantly different from the geometry of the embankment which existed when failure occurred. Hence, the minimum factor of safety for this case is near unity.
