# INVESTIGATION OF CONCRETE COATING PROBLEMS

**Research Report 451-1F**

Research Project 3-9-86-451  
Concrete Coating Problems

Texas State Department of Highways  
and Public Transportation

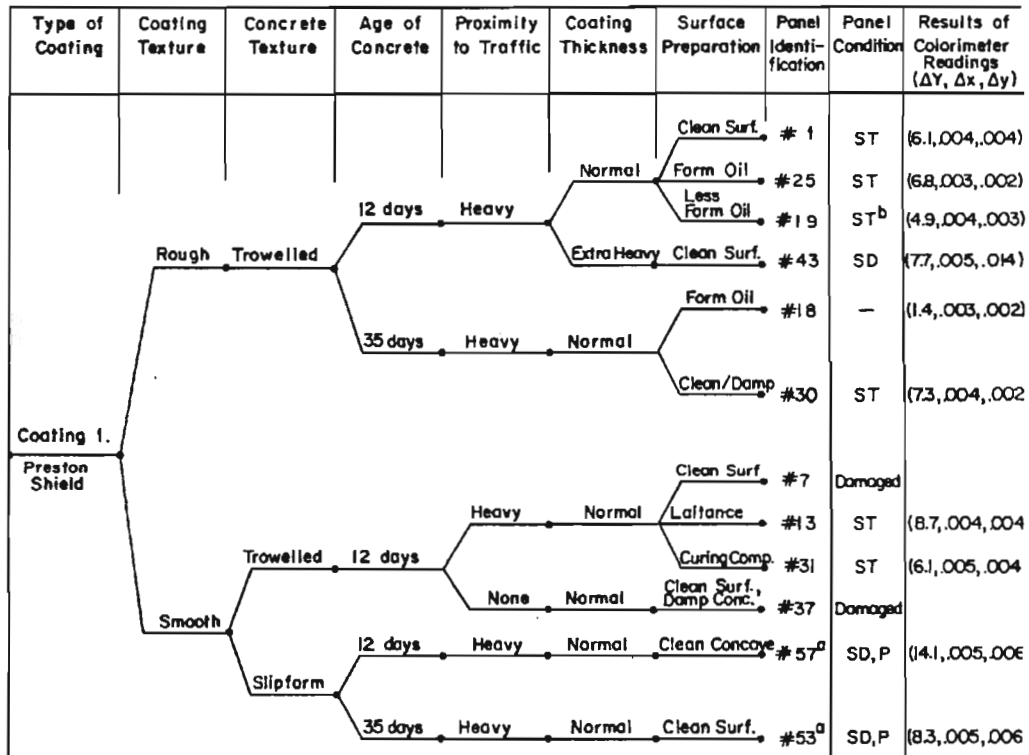
**Fig 5.1. The results of the exposure test on test panels coated with Prestonshield® (legend for panel conditions given in section 5.2).**

Figure 5.1 indicates the darkening effect due to coating thickness is evident primarily in those panels coated with Prestonsshield®. Panel No. 43, which had an extra-heavy thickness, showed significant darkening when compared with panels No. 1, No. 25, and No. 19, all of which had normal thicknesses of coating.

Almost all panels which have a concave surface shape have exhibited more darkening than those which are in the same group, have the same combinations of test variables, and have flat surfaces. This is shown in Fig. 5.1 by comparing the colorimeter readings of panel No. 57 ( $\Delta Y = 14.1$ ,  $\Delta x = .005$ ,  $\Delta y = .006$ ) with those of panel No. 53 ( $\Delta Y = 8.3$ ,  $\Delta x = .005$ ,  $\Delta y = .006$ ), both coated with Prestonsshield®. Even though both panels exhibited significant darkening, the  $\Delta Y$  of panel No. 57 by far exceeded that of panel No. 53. Similarly, panels No. 58 and No. 54, coated with Thoro-coat®, exhibited the same phenomenon, with the concave surface in panel No. 58 showing significant darkening com-

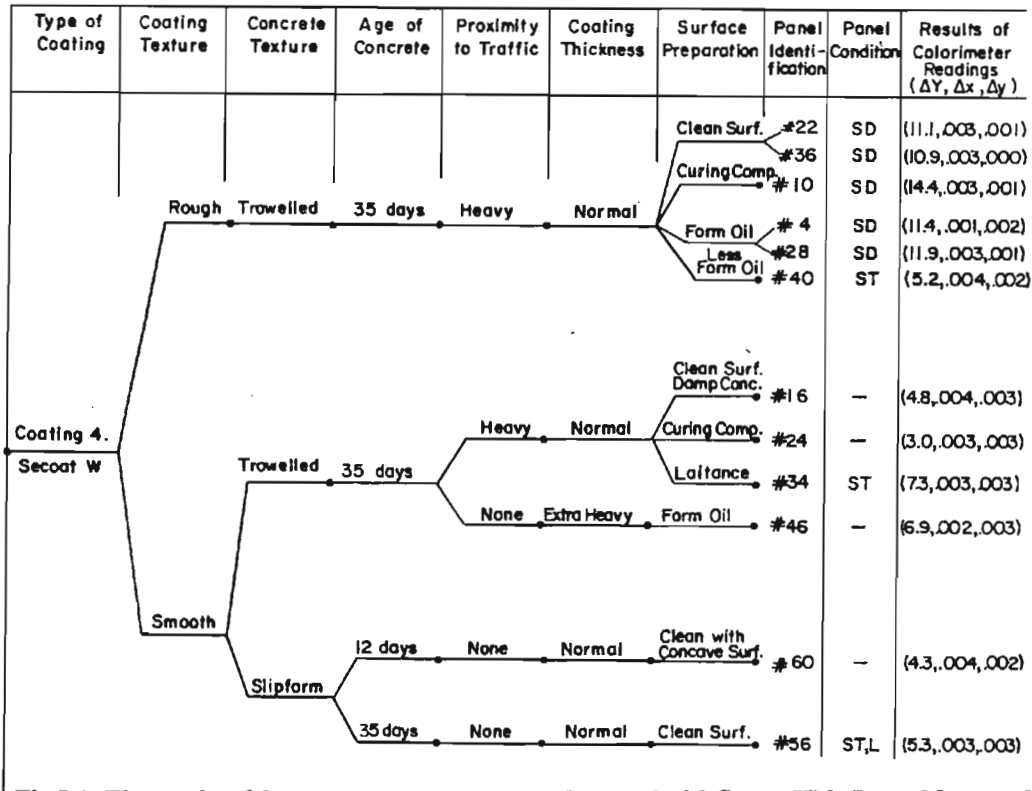
Fig 5.4. The results of the exposure test on test panels coated with Secoat W® (legend for panel conditions given in section 5.2).

The finding from the field survey that a rough surface collected contaminants and exhaust emissions more easily than a smooth one is verified by an analysis of panels coated with Secoat W®. From Fig 5.4, all Secoat W® panels with a rough coating texture showed significant darkening. On the other hand, only 30 percent of those with a smooth coating texture, not including the control panels, showed trends towards darkening. However, this effect was not as pronounced in the other coatings. For instance, the effect of a rough coating texture was not observed in those panels coated with Prestonshield® or Thorocoat®. As can be seen in Figs

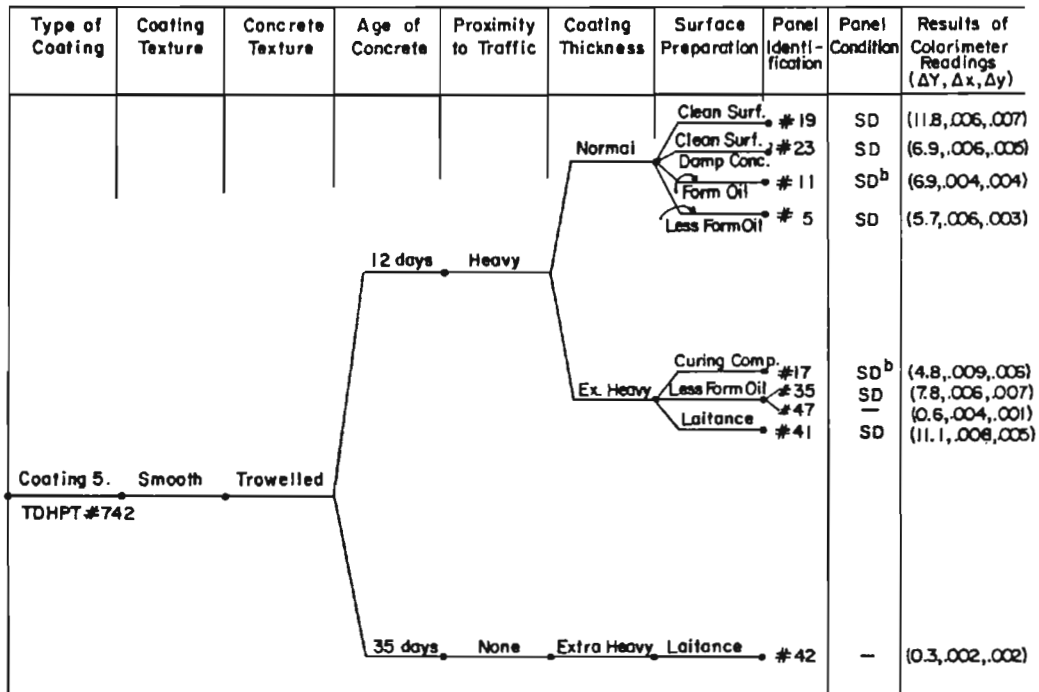
Fig 5.5. The results of the exposure test on test panels coated with TDHPT #742 (legend for panel conditions given in section 5.2).

As shown in Fig 5.5, all panels coated with Highway Department #742 coating had smooth surfaces, but there was still significant darkening in 85 percent of the panels. This may be due to #742's being whiter than the other coatings and that it is in its nature to darken slightly.

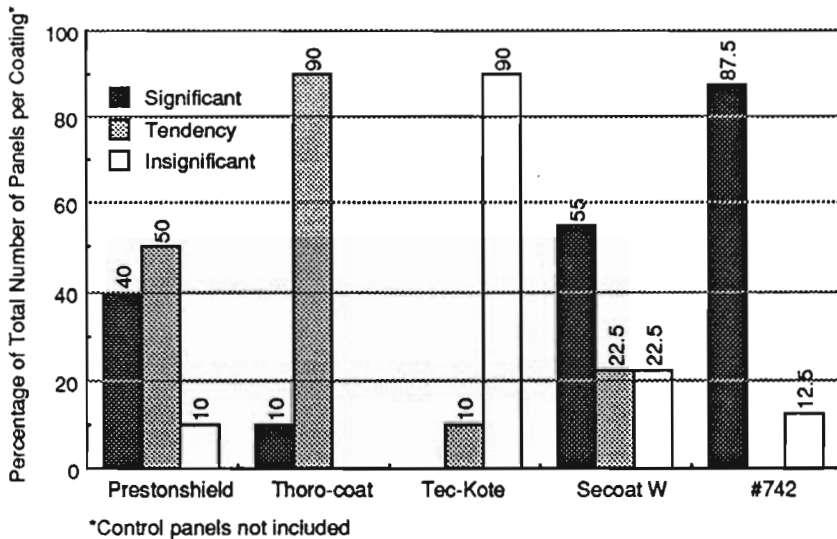
Next in order were Thorocoat®, Prestonshield, Secoat W®, and Highway Department #742. This is shown in Fig 5.7. However, it should be mentioned that the coating type alone is not necessarily the only variable affecting the change in color. For example, a rough coating texture could possibly be factor contributing the most to the darkening of Secoat W®. Figure 5.8 shows photographs of darkened panels which had rough Secoat W® texture, and Fig 5.9 shows photographs of panels which had smooth Secoat W® texture and had no serious darkening problems.

Fig 5.7 Darkening performance of the different coatings used.
