EFFECTS OF TEMPERATURE CHANGE ON PLASTIC CRASH CUSHIONS

Research Report Number 514-1F

Research Project 3-10-76-514

CENTER FOR HIGHWAY RESEARCH
THE UNIVERSITY OF TEXAS AT AUSTIN

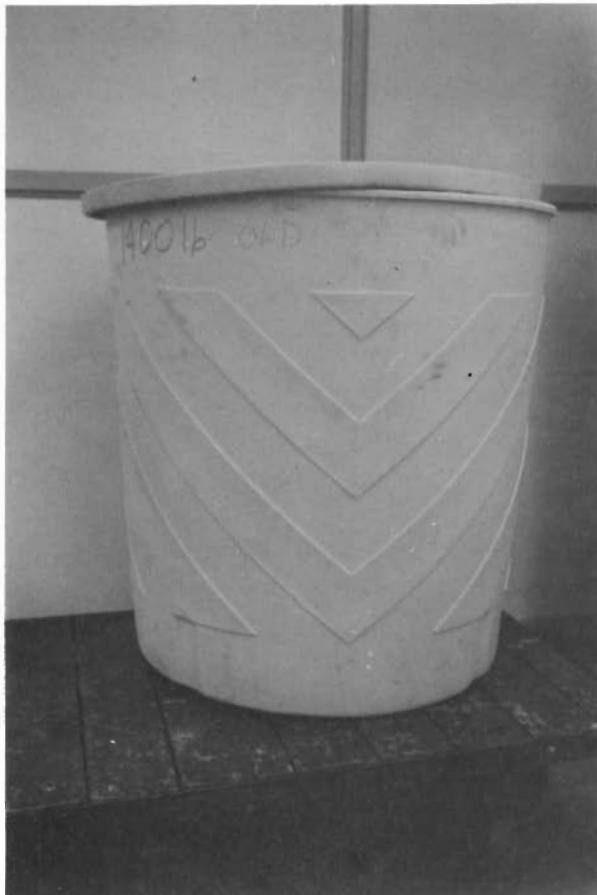
Fig 1a.

Both Energite units were received fully assembled (Figs 1a and 1b). One Fitch unit (F-1) was received partly assembled; the other was completely disassembled (Fig 2). While assembly of the new Fitch model was simple (Fig 3), some difficulty was experienced with the "pop rivets" that were supplied. The rivet kit did not contain enough washers for the entire assembly, but had an excessive number of rivets. Additionally, some of the rivets failed to "pop," which resulted in the rivet head being pulled completely through the expandable sleeve and washer. In at least four instances, a second rivet application was required. This minor difficulty might have been due to faulty operator technique, however.

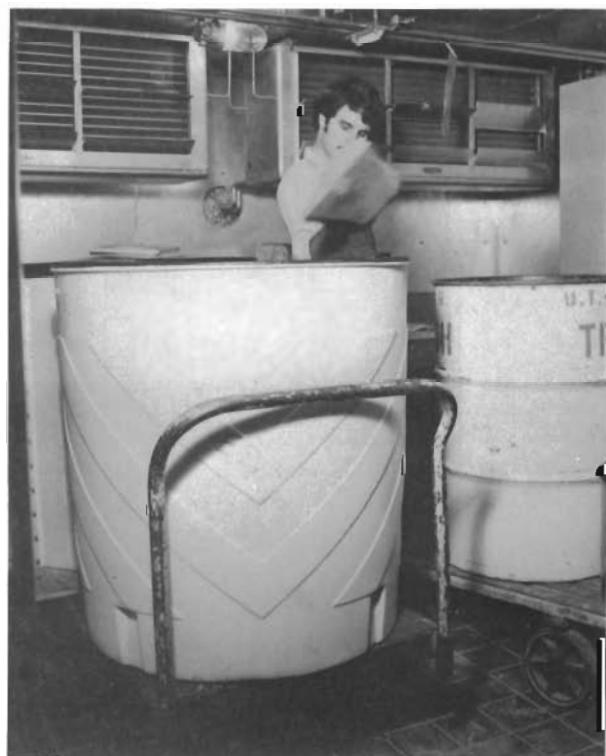
Fig 4.

The crash cushions, after assembly, were placed, two per vehicle, on four-wheeled carts and filled with sand (Fig 4). Cushions E-1 and F-1, which were paired on the same cart, contained sand with an average moisture content of 2 percent while E-2 and F-2 were filled with sand having a moisture content of 5 percent. The two Energite models each accepted the full 1,400 pounds of sand, as specified. The Fitch models, even with light tamping and screeding, would hold only 1,350 pounds of sand. The washed sand which was used in this study was obtained locally and is the type that is normally used for making concrete in the Austin area.

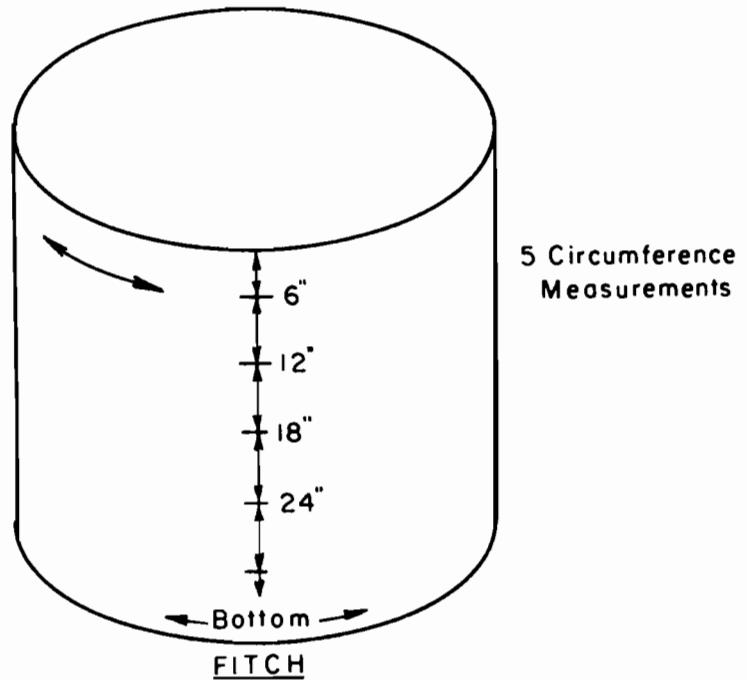
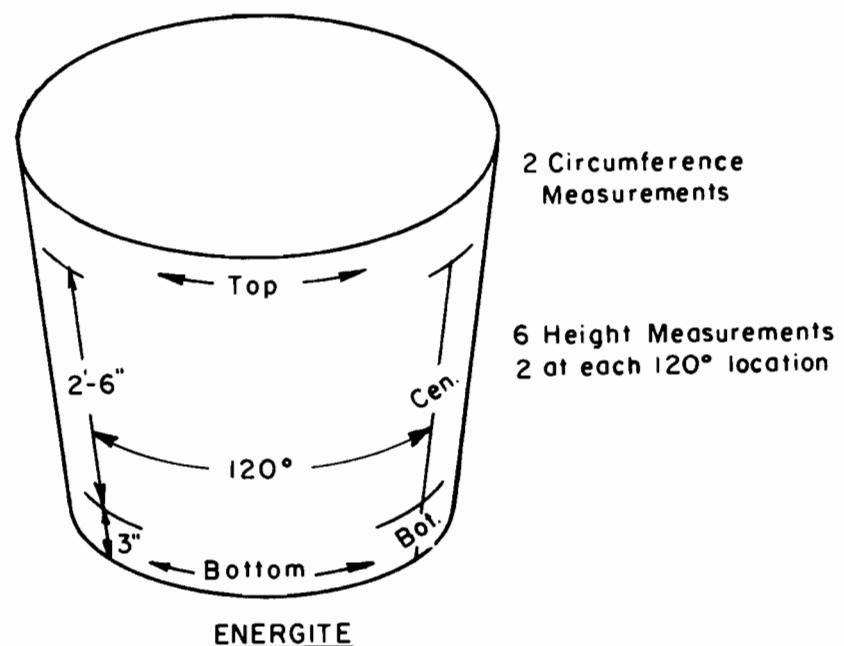
tapered sides, were each referenced for two circumference measurements and for six height measurements at 120-degree locations around the outside of each unit (Fig 5).

Fig 5. Dimensional measurement references.

As shown in Fig 5, a variety of dimensional measurements were made on all test units. These measurements were taken at the end of every cold and every hot cycle. Conditions under which the measurements were made were kept reasonably consistent and generally the measurements were concluded within a 15-minute period when the units were located in the 130° F chamber. Based on the consistency of data obtained, the measurement techniques appeared to be relatively free of significant errors.

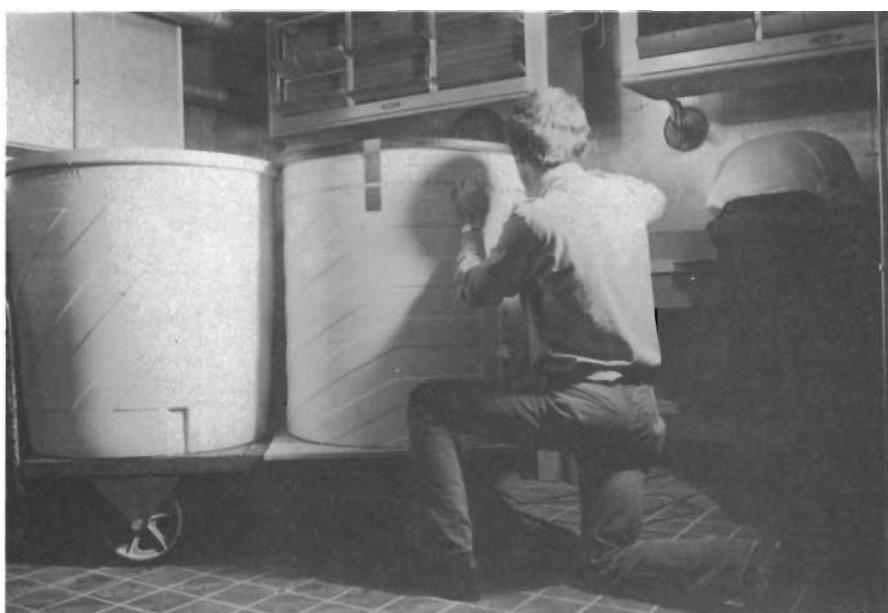
Fig 7.

Routinely all dimensional measurements were made immediately after the test units were moved from the 0° F chamber into the 130° F chamber (Fig 7). Sand and chamber air temperature readings (Fig 8) were made on an 18 to 24-hour basis. At the end of each temperature cycle all test units received a close physical inspection for evidence of cracking or distortion.

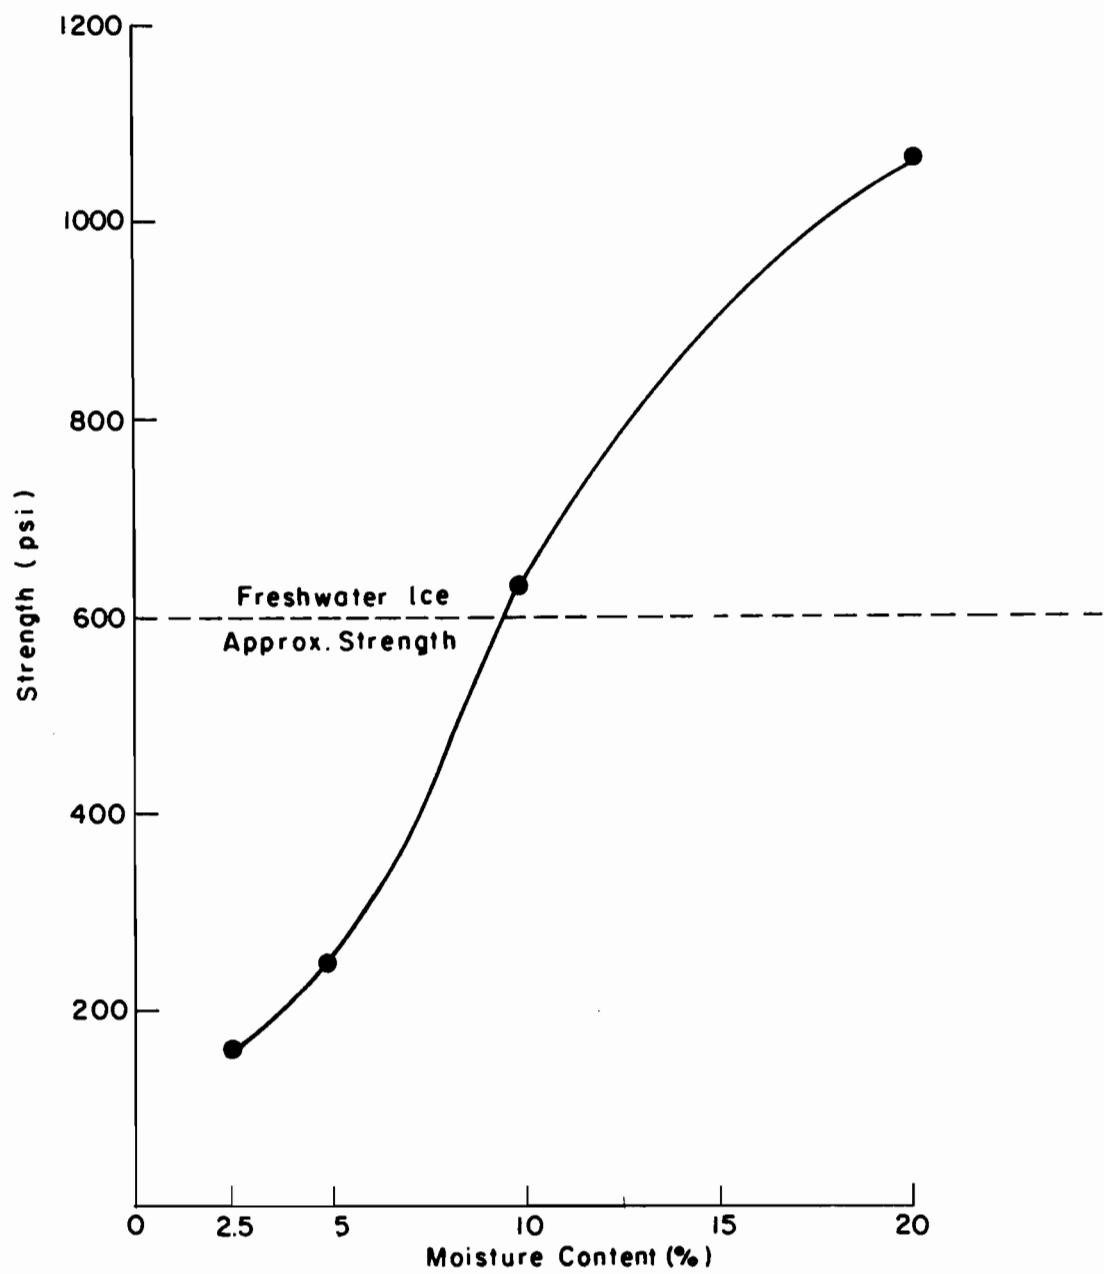
An area of particular interest was the effect of freezing temperatures on the strength of sand with varying moisture contents. Four sand specimens were prepared in 2-inch diameter by 4-inch high split molds, at moisture contents of 2-1/2, 5, 10, and 20 percent by weight of sand. All specimens were subjected to 0° F temperature for 30 hours, released from the molds, and immediately tested at room temperature (approximately 74° F). Despite the slight "melting" which occurred at the top and bottom loading surfaces during the unconfined compression test, which was conducted at about 0.05 inch per minute loading rate, each specimen exhibited significant ultimate compressive strengths as follows:

<u>Specimen/Moisture Content, %</u>	<u>Ultimate Compressive Strength, psi</u>
20	1,060
10	640
5	250
2.5	160

Additionally, and for comparison, two freshwater specimens were prepared in plastic molds and subjected to 0° F temperature for 72 hours. After release from the molds these ice specimens were compression tested in a 0° F chamber and yielded an ultimate compressive strength of approximately 600 psi (Fig 9). Three more sand specimens were prepared with a 2 percent moisture content for indirect tensile (splitting cylinder) testing. These specimens had a 2-inch diameter and a height of 1.2 inches, and yielded tensile strengths ranging from 25 to 29 psi based on elastic theory.

Fig 9. Effect of moisture content on ultimate compressive strength of frozen sand.

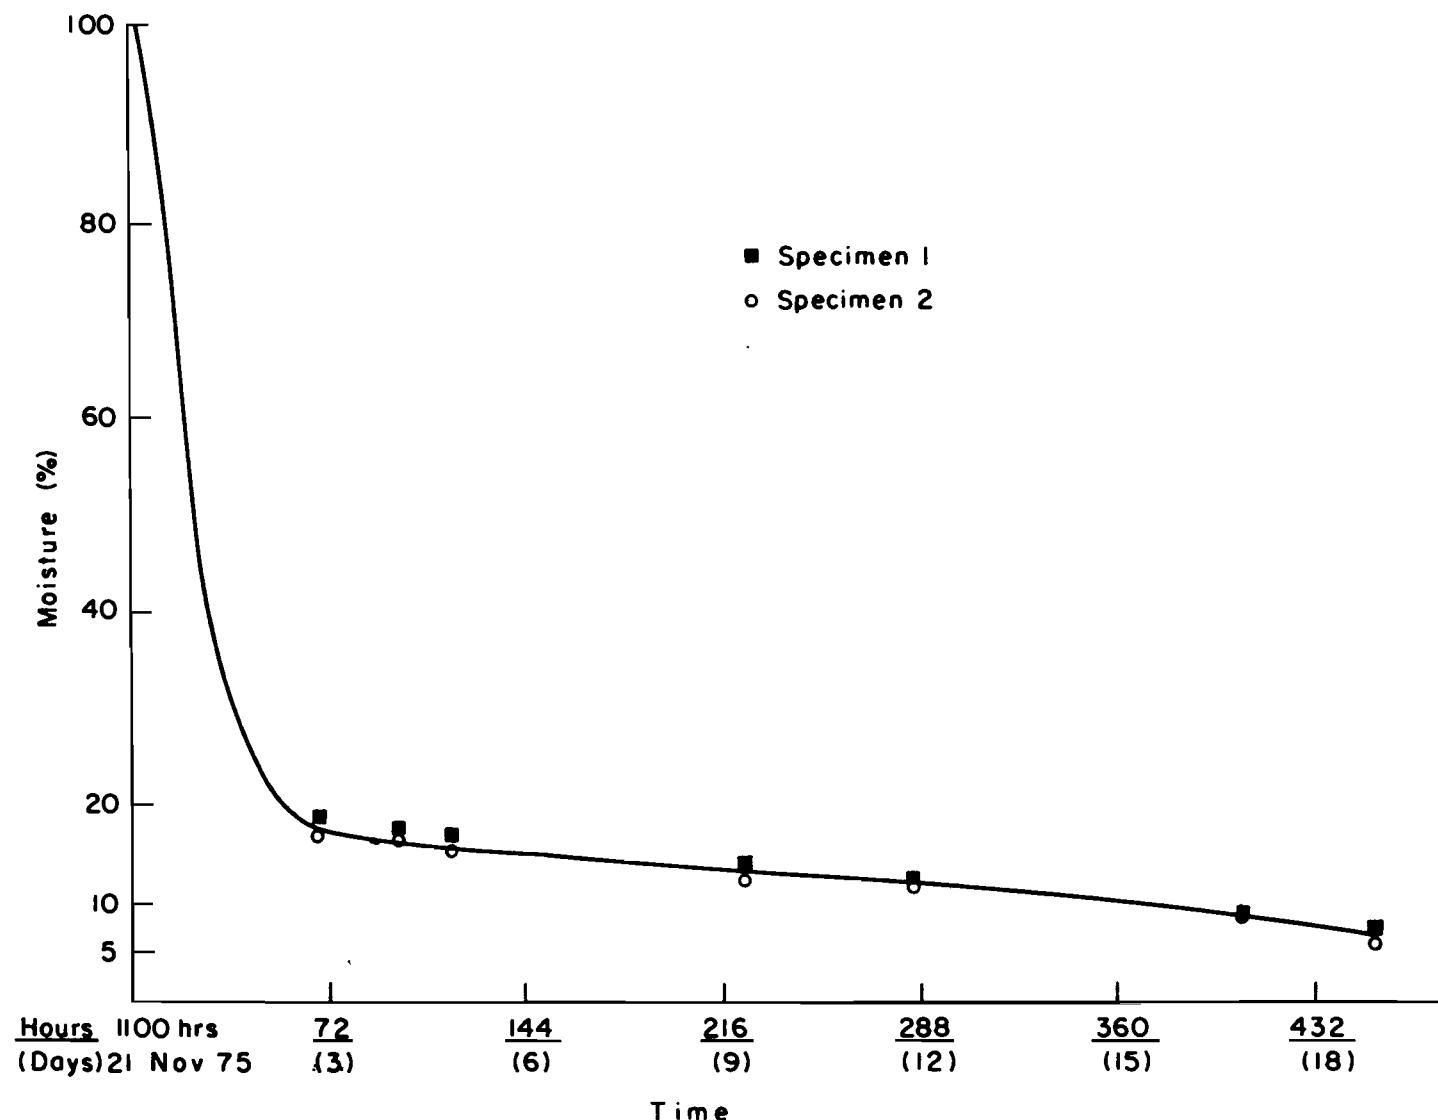
Another experiment dealt with the drainage of free water from a saturated sand specimen. Two half-pint wax-paper cups with numerous small perforations in the bottom were filled with 400 grams of oven-dried sand. The sand was slowly covered with water, which permitted drainage through the bottom holes. After the top of each container was covered with aluminum foil, they were stored in a nominal environment of 75° F and 50 percent relative humidity. During the first 72 hours of drainage, the specimens lost more than 80 percent of the added moisture. Thereafter, the moisture loss slowed radically, and at the end of 18 days of drainage the specimens contained about 8 percent moisture (Fig 10).

Fig 10. Water saturated sand drainage experiment
(percent moisture content with time).

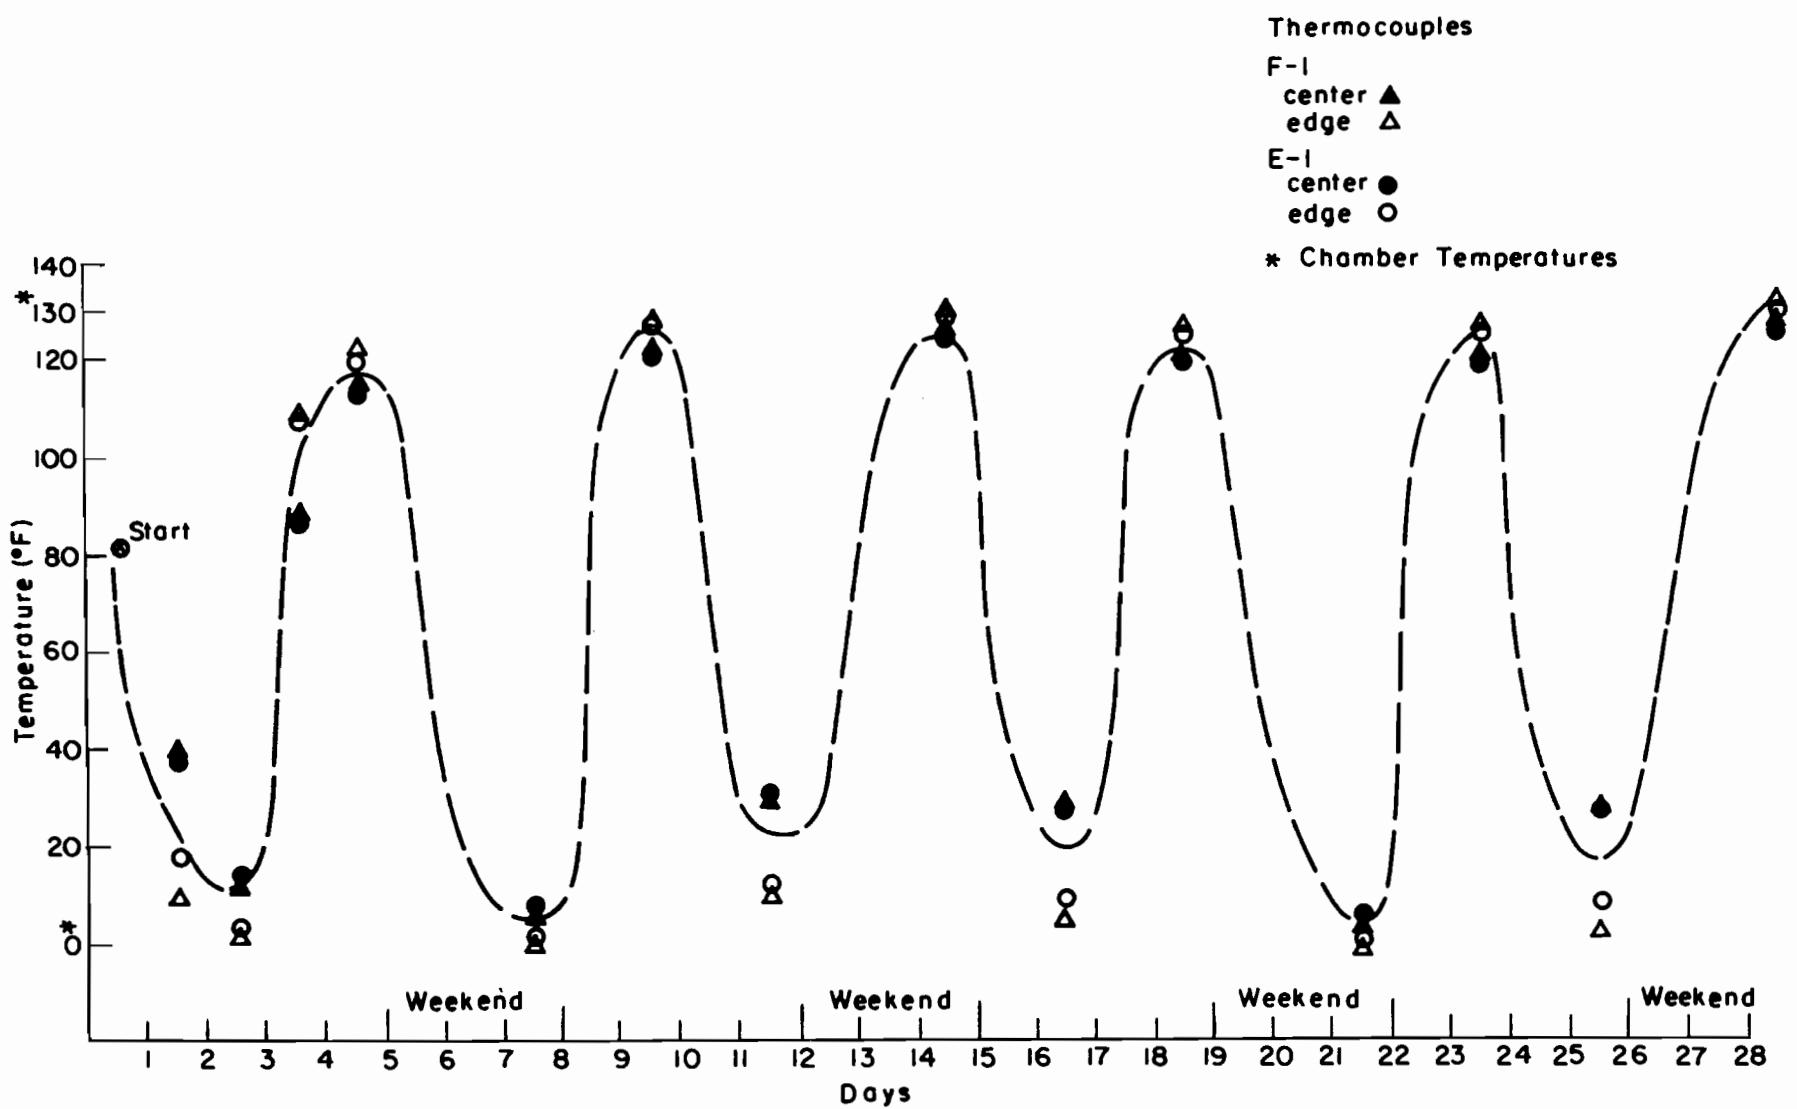
Actual testing of the plastic crash cushions started on October 27, 1975, when the four sand-filled units were moved from a stable temperature of 80° F into a 0° F temperature chamber. The preliminary plan called for cycling the test units between 0° F and 130° F every 24 hours. At the end of the first 24-hour period, the temperature in the sand mass center had fallen to only 38° F in both the Fitch and the Energite units, as indicated in Fig 13. Obviously more time was required; therefore, it was decided to extend the temperature cycle time to a minimum of 48 hours. This scheme was followed throughout the remainder of the test except for weekend periods, which were 72 hours long. As indicated in Fig 13, center sand temperatures seldom exactly equalled chamber temperatures. All observed sand temperatures were, however, within about 10° F of the 130° F air temperature in the hot chamber, and the sand temperatures were below 32° F before the specimens were moved from the cold chamber in every case. Figure 13 also shows that, for the most part, the

Fig 13. Temperature data.

Energite unit did not quite match the temperatures reached by the Fitch. It may be assumed that the air space inside the Energite functioned as an insulator and accounted for this characteristic.

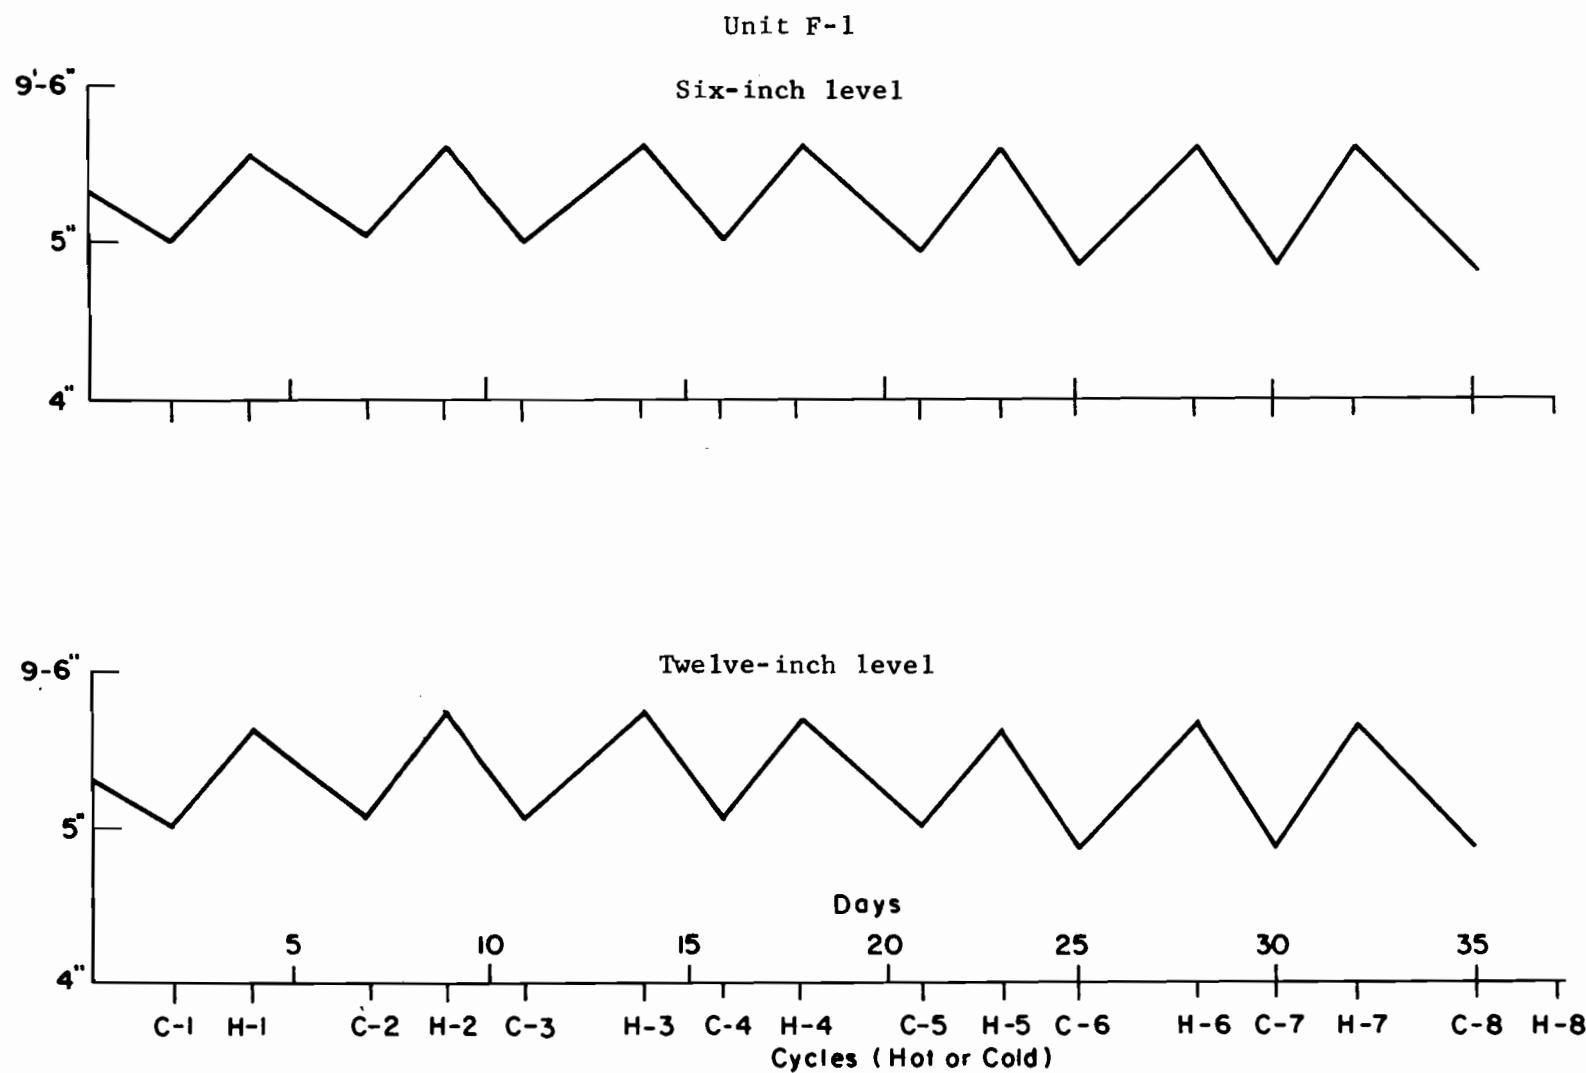
Figures 14 and 15 show the dimensional changes which occurred with time and temperature changes in the two Fitch units. As reflected in Fig 14, the total circumferential expansion-contraction movement of F-1 increased with time from an initial 1/2 inch to about 3/4 inch for each cycle and then stabilized. The F-2 unit, as shown in Fig 15, experienced a relatively uniform and consistent expansion-contraction movement throughout the test period. Neither unit exhibited any significant permanent deformation.

Fig 14. Circumference measurements with time and temperature.

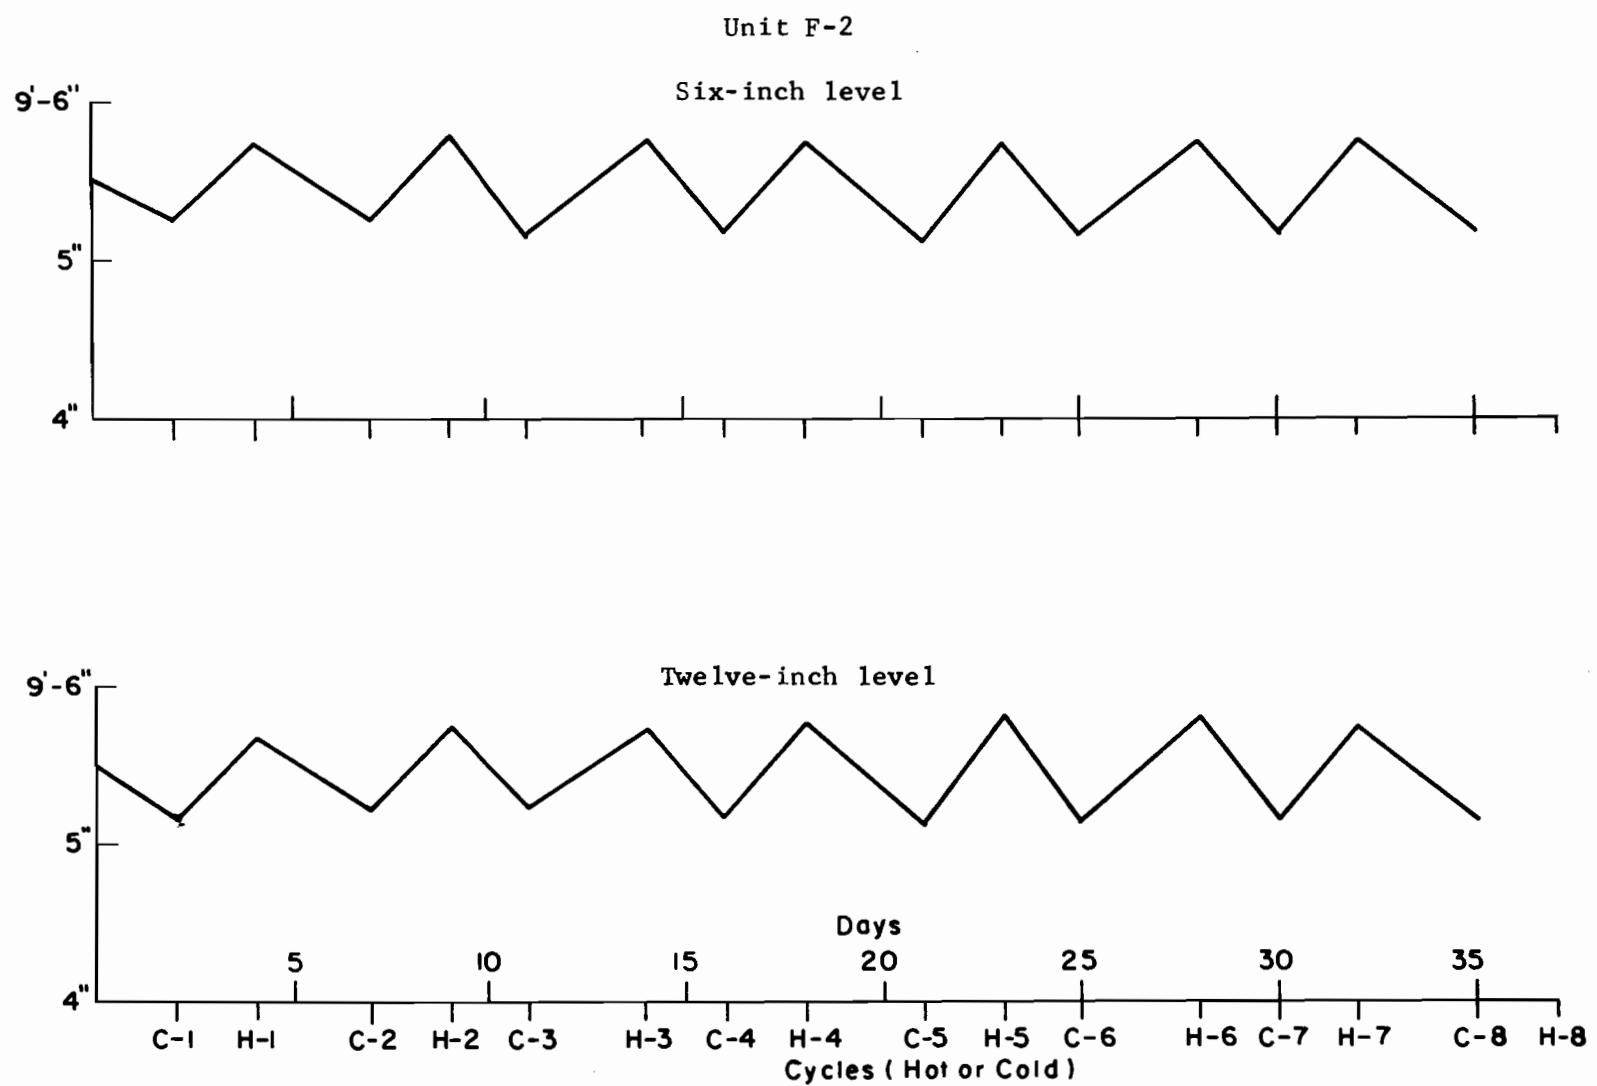
Fig 15. Circumference measurements with time and temperature.

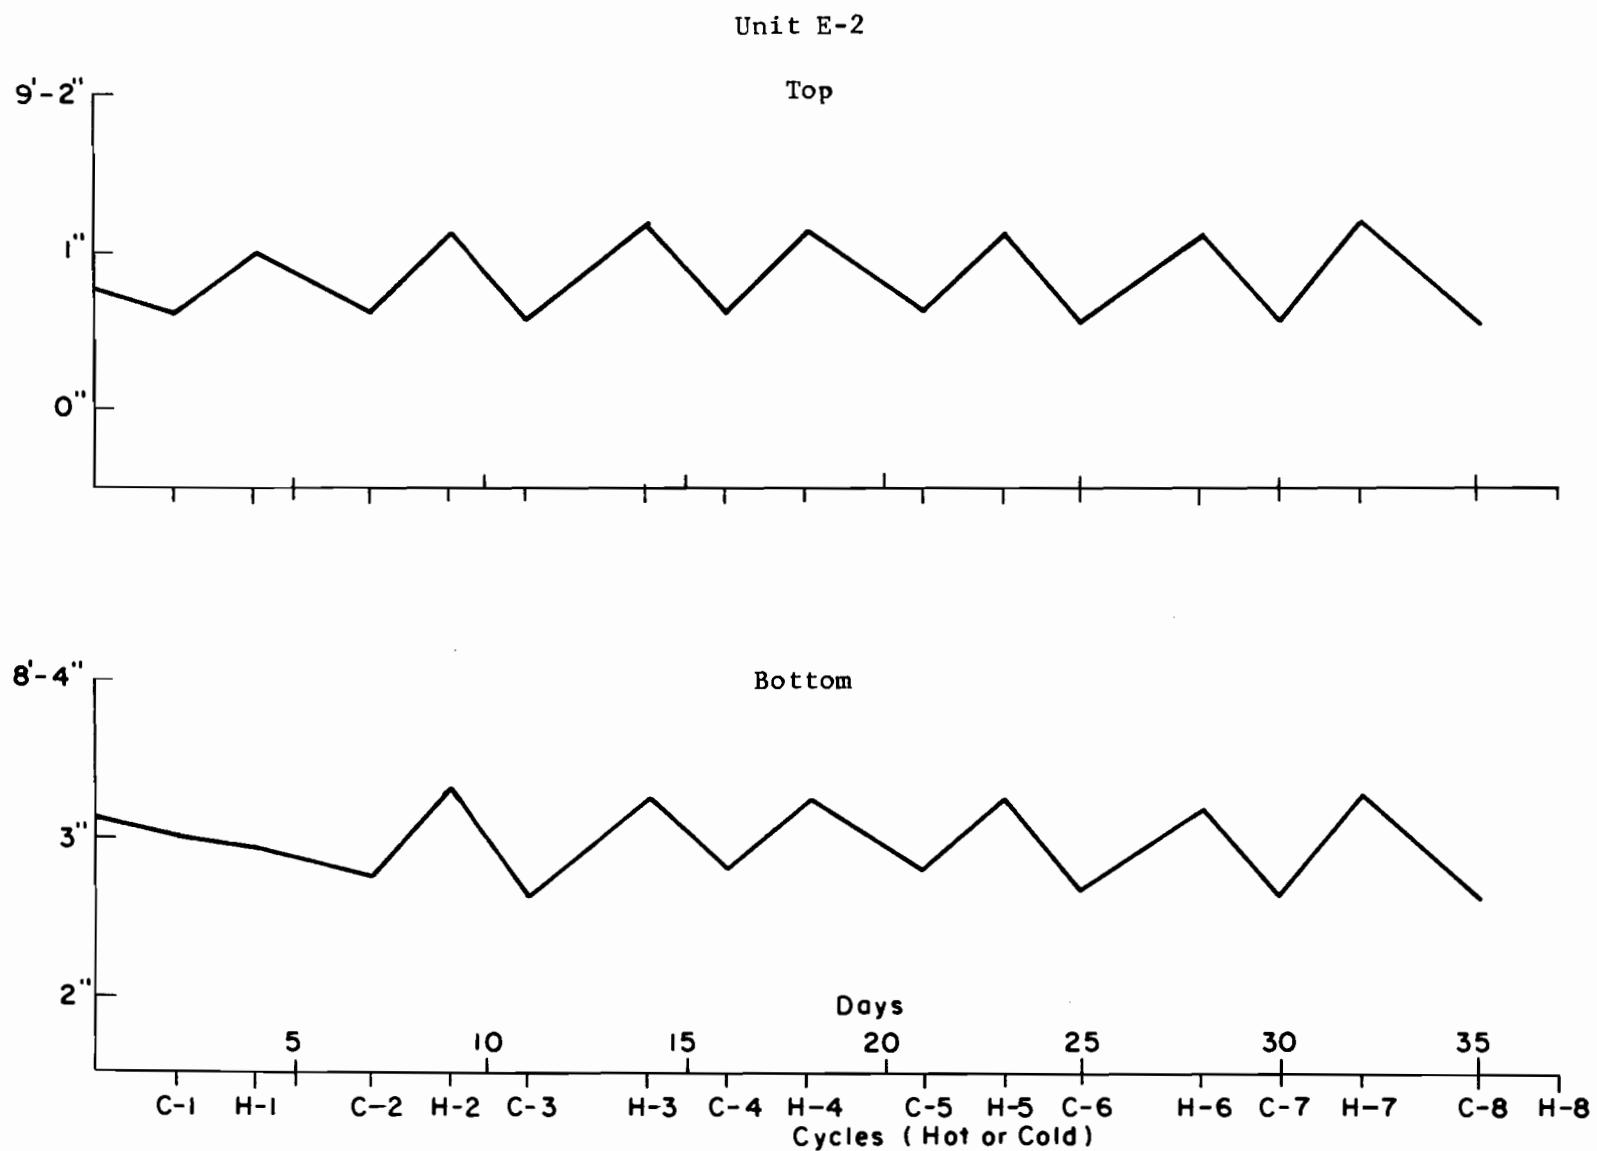
Circumference changes with time and temperature changes for the Energite units are depicted in Figs 16 and 17. The E-2 measurements shown in Fig 17, except for an unexplained lack of cyclic initial movement at the bottom, experienced no unusual circumference changes. The E-1 unit, Fig 16, however, began reacting quite early in the test. As the plot indicates, a very definite circumference increase occurred at the top both initially and throughout the test period. By the end of the test, the top circumference had enlarged more than an inch. At the conclusion of the second cold cycle a visible deformation had occurred at the unit's bottom, as shown in Fig 18. Also noted at this time was the unit's partially sagging lid, Fig 19.

Fig 17. Circumference measurements with time and temperature.

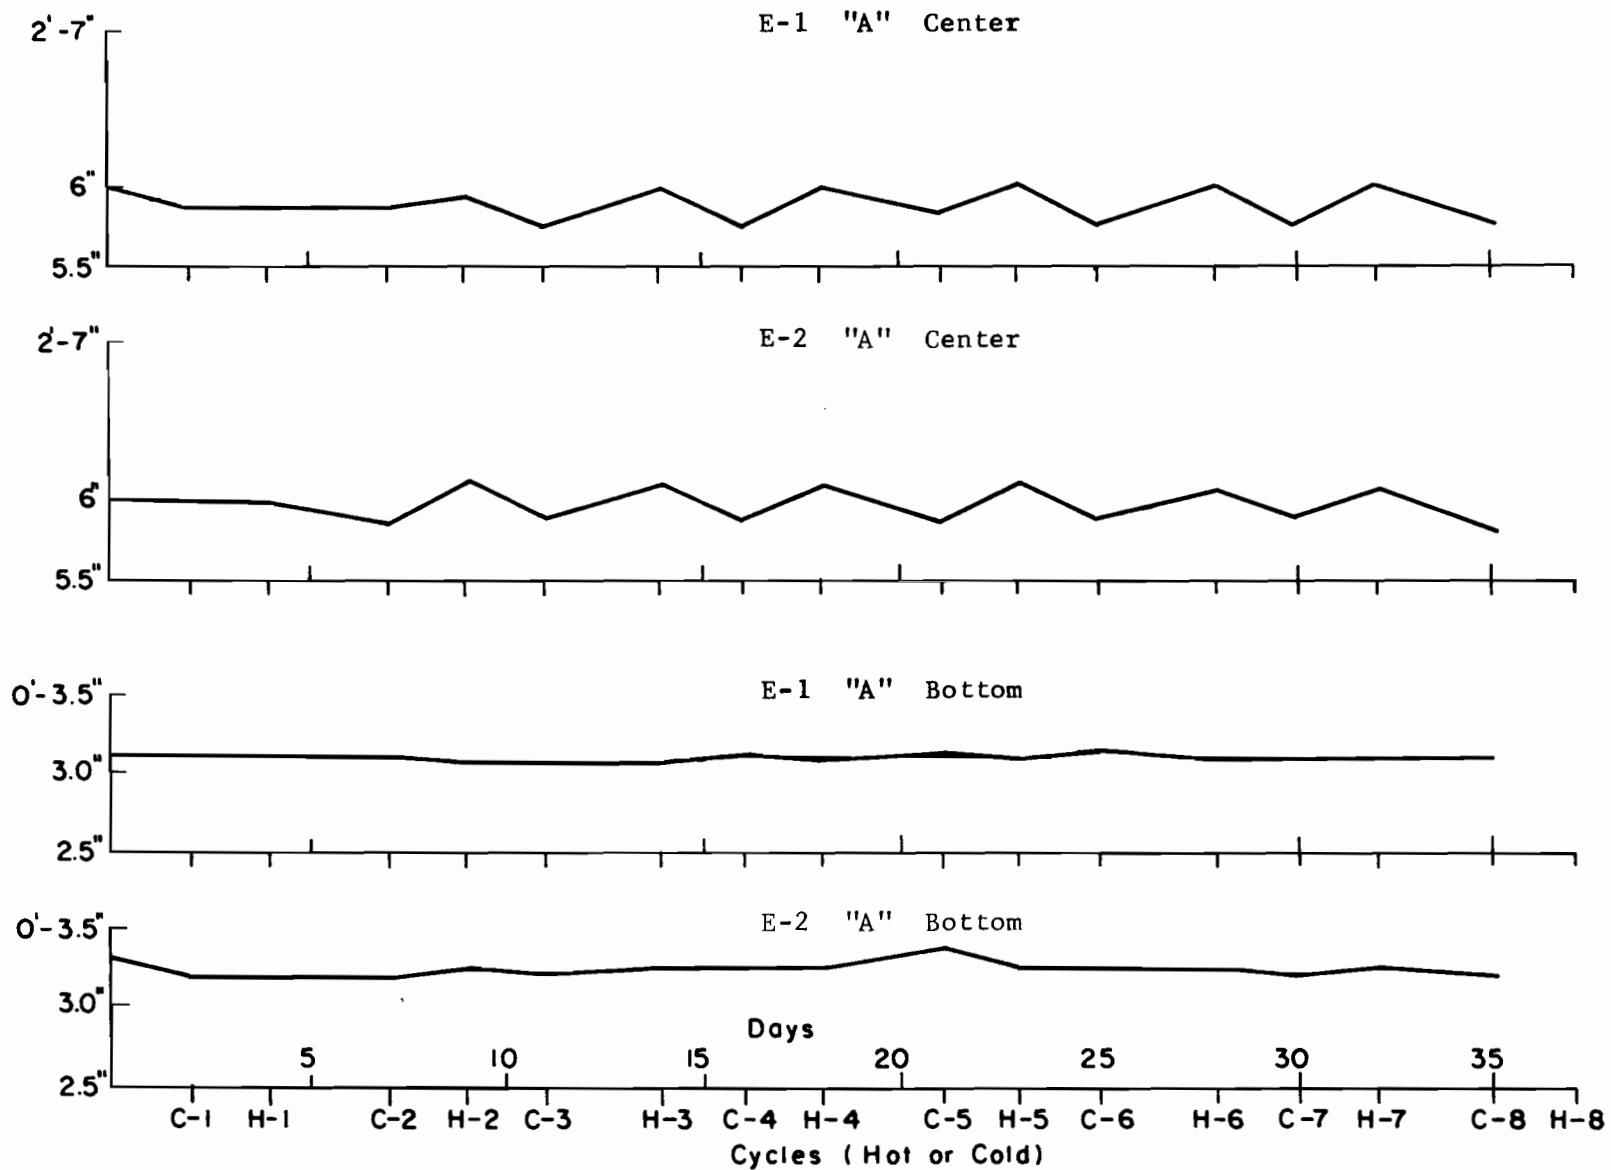
Figure 20 is a plot of the changes in height of the two Energite units with time and temperature changes. Except for the obviously greater actual expansion-contraction movements which occurred over the 2-ft 6-in. gage length at the center height of the units, there is no evidence of unusual height change.

Fig 20. Average height measurements with time and temperature.
