Bridge Repairs Project
El Paso County

Bridge Deck Repairs

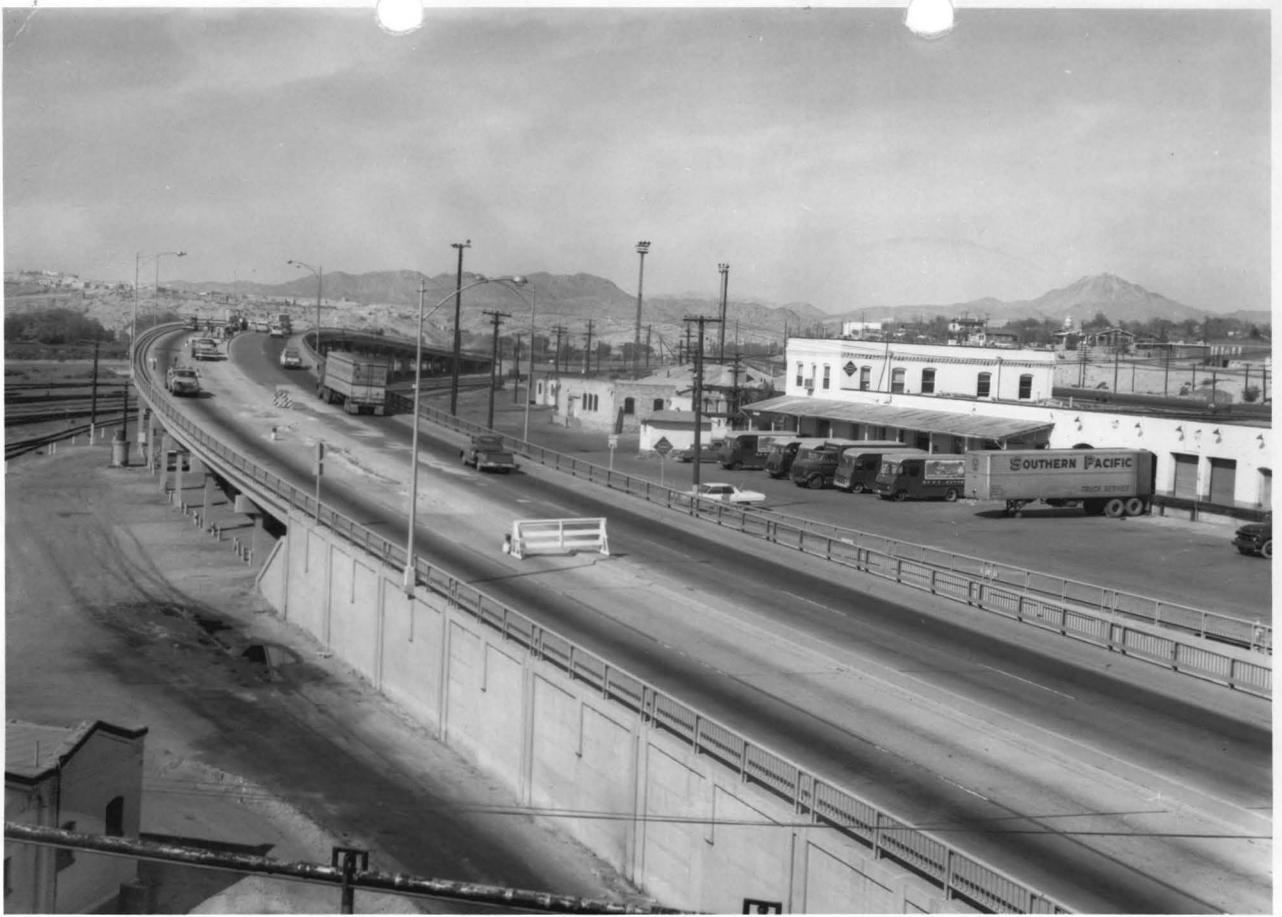
General View of P & SF Overpass Structure

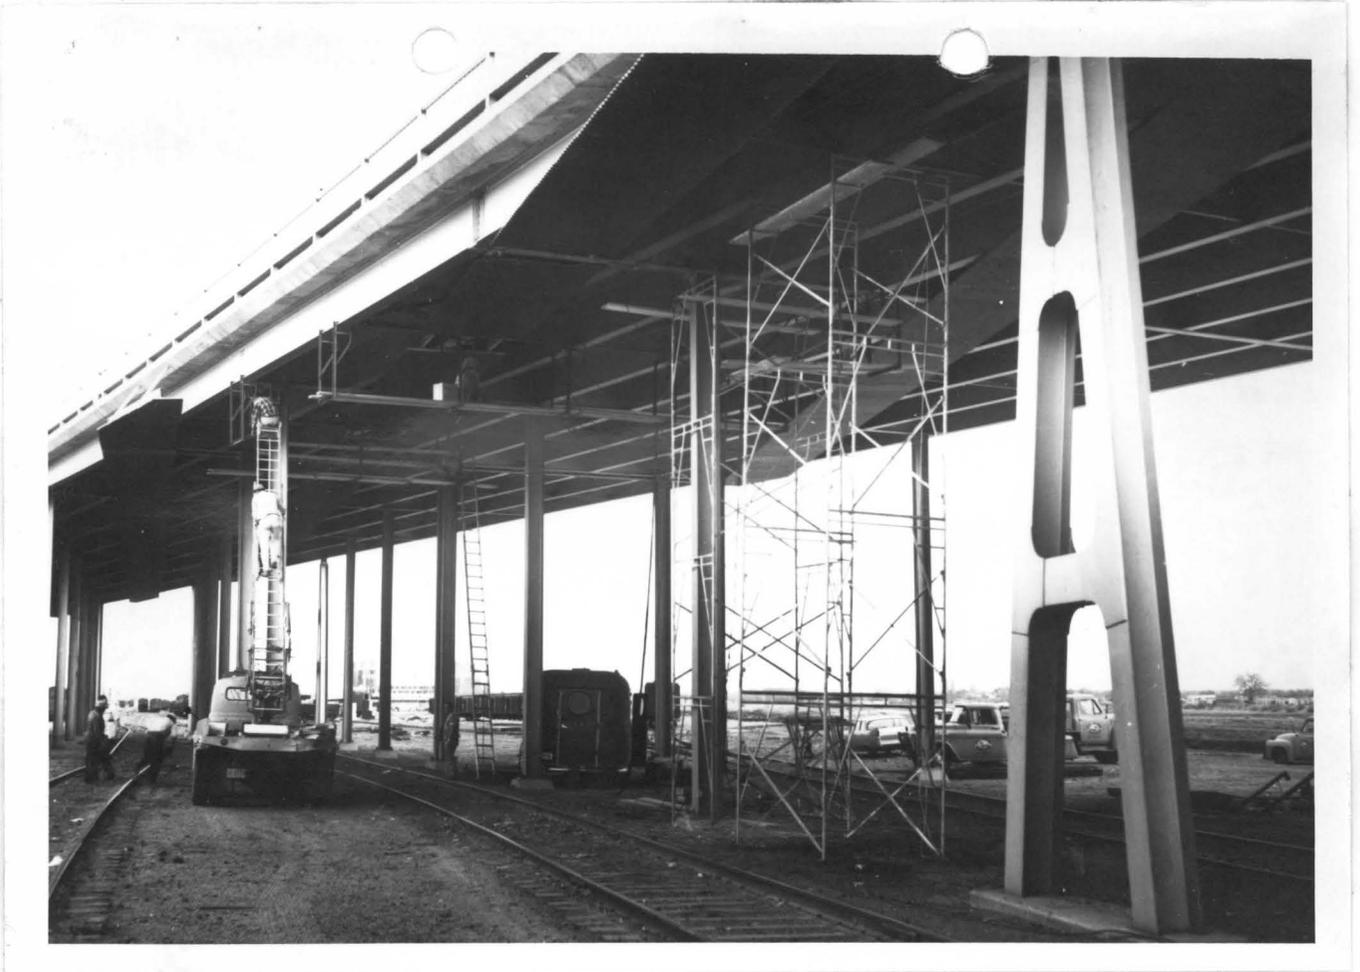
Strain and deflection gauges being placed. Bureau of Public Roads instrument trailer in center. Old Mexico on right.

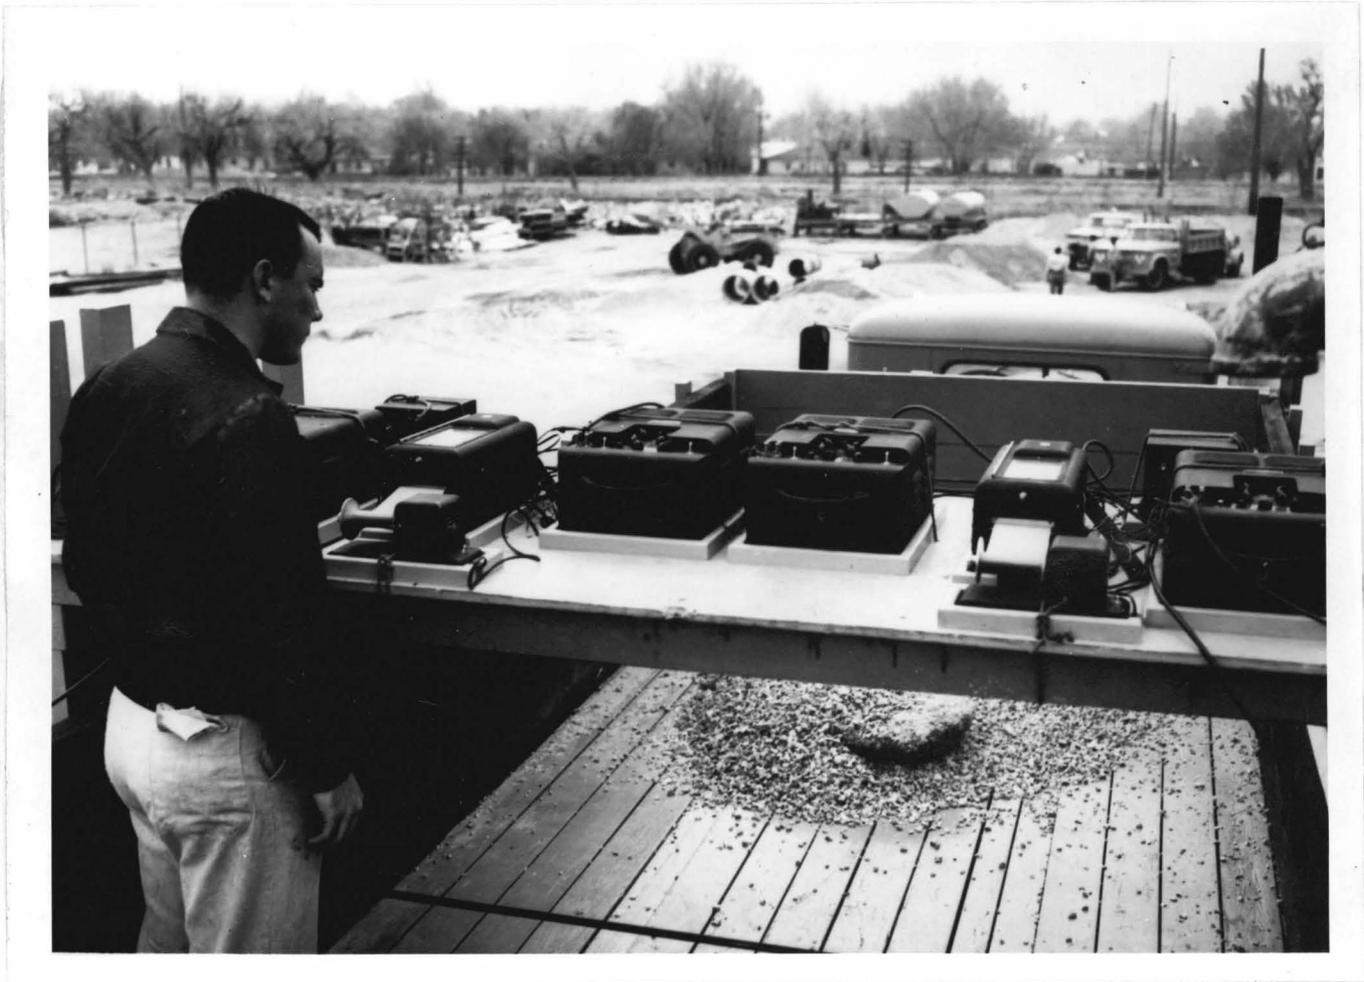
Ed Payne of District Bridge Division calibrates truck mounted instruments as Bureau of Public Roads' test truck is loaded.

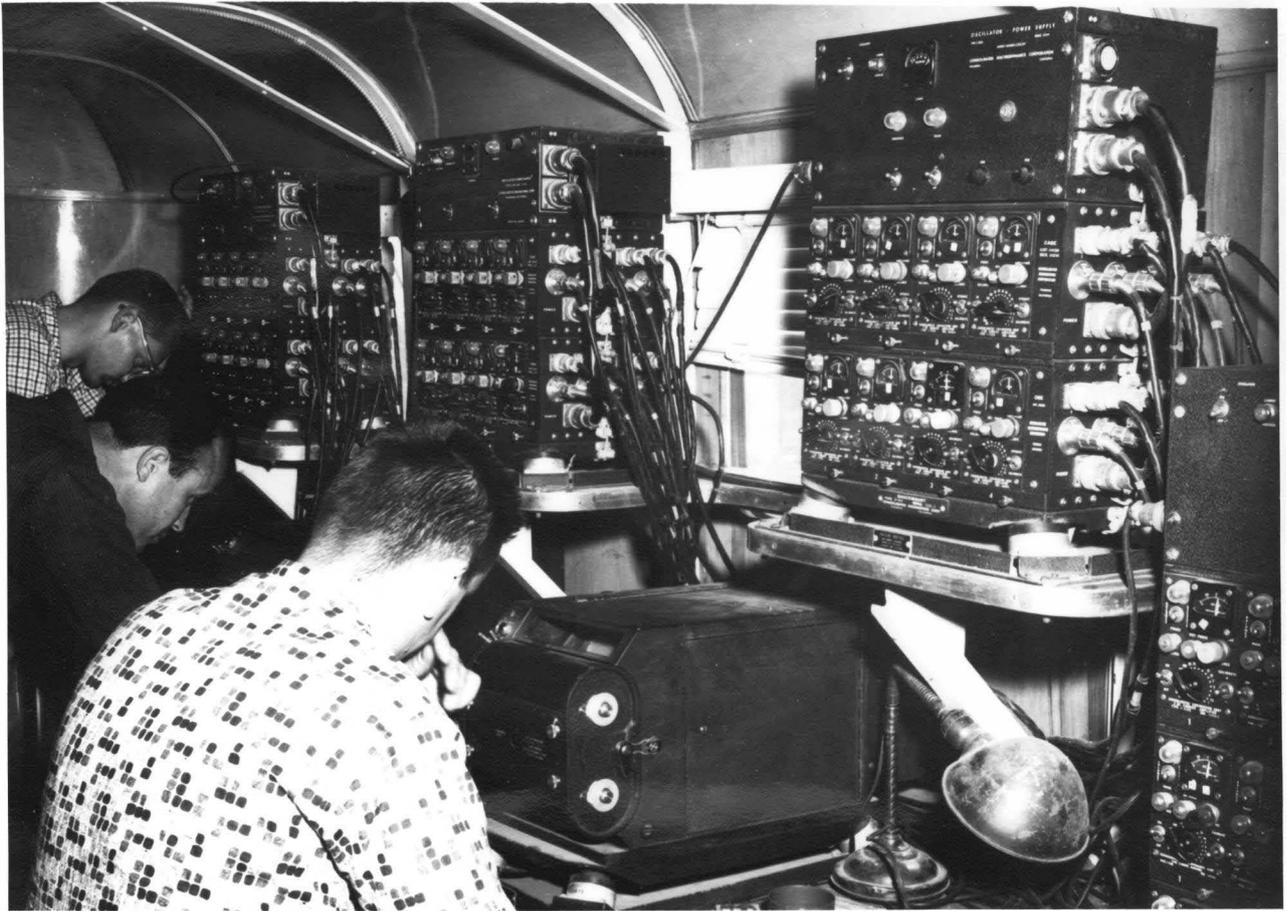
Interior view of Bureau of Public Roads lab trailer showing amplifiers and recorders. Paradee and Ybanez from District Bridge Section assist Christopher of Bureau in recording data.

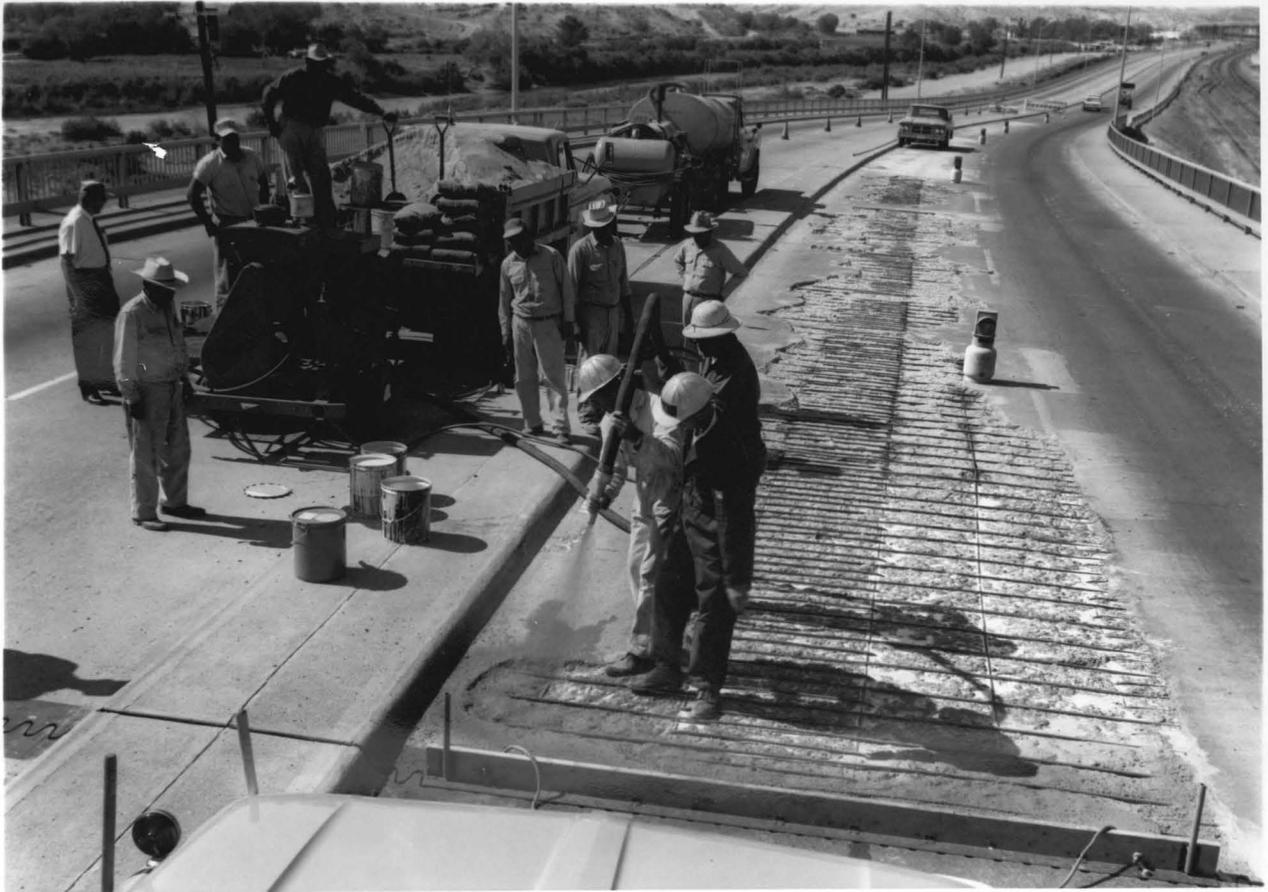
Gordon Vernon and Robert Barton of True Gun at the nozzle. Samaniego back up on the line. Medina and Moreno loading machine. Ferrari of D-18 is inspecting equipment. Velasco, Hernandez, Correo and Ramirez stand by to assist.

An alternate method of repair, using air emplaced concrete (Gunitite), was demonstrated by True Gun All Co. The deck was prepared in the manner outlined above. "Albitol" was used to glue the new concrete to the old in the same manner as epoxy. The patch was "gunned" with a mixture of one part cement Type III to four parts sand. A mixture of water and Albitol was added to the cement-sand mixture in the drum and wet concrete at a minimum slump was gunned on the deck. An auxiliary air ring at the nozzle gave the concrete an added push.

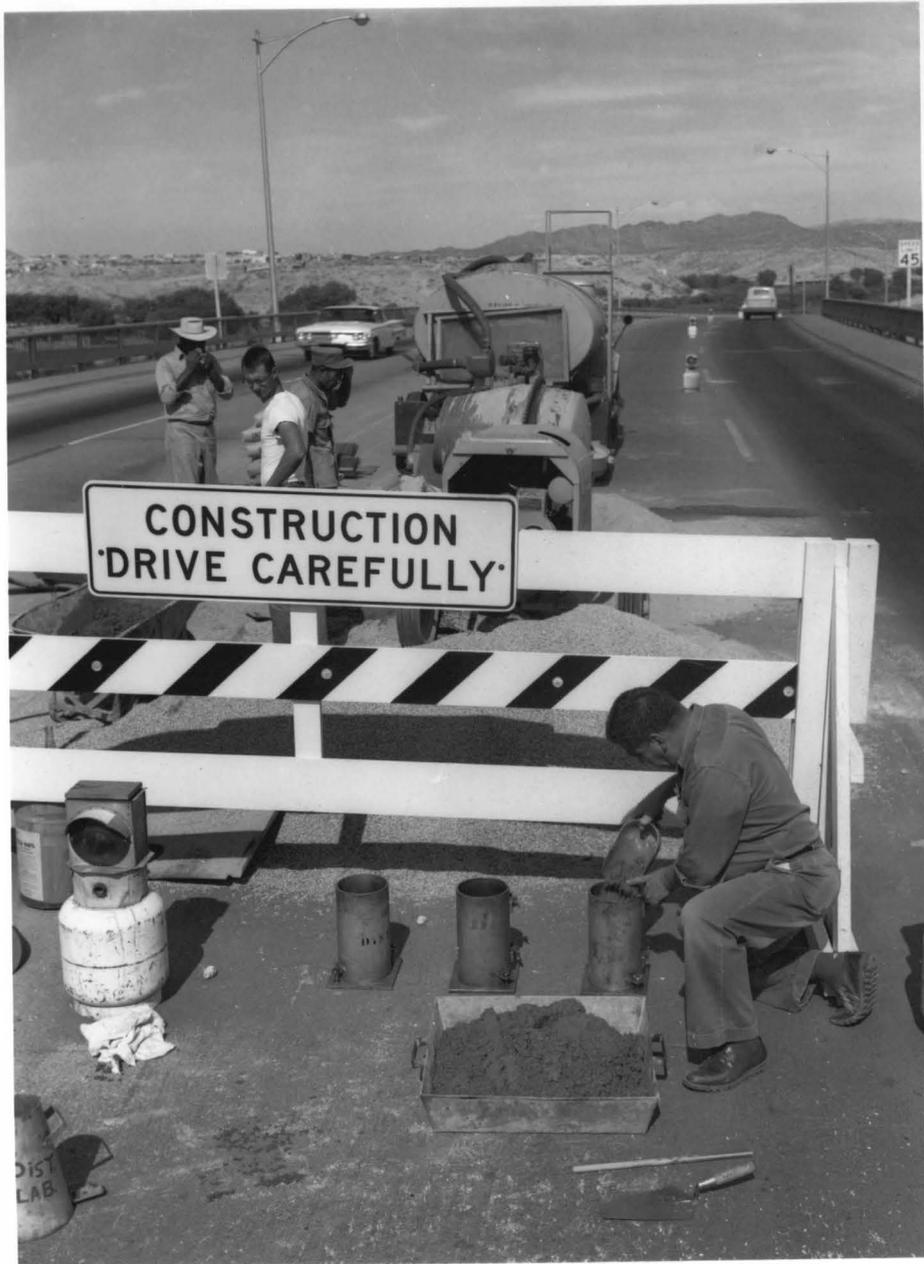
Mixer in operation on top of bridge. Holguin from the lab makes cylinders. Vejil operates the mixer. Jackson is operating a wheel barrow and "Shorty" Velasco runs the operation.

During the months of August and September, 1963, concrete patches were poured in the early morning hours to prevent curing cracks in the concrete. Concrete was mixed on the job because of the relatively small volumes needed. A 1-2-3 mix was used with maximum aggregate size of one-half inch and a minimum of water. (The slump averaged about one-fourth inch.) Just prior to pouring concrete the area was painted with epoxy. Curing was accomplished by wet sand for approximately seven days.

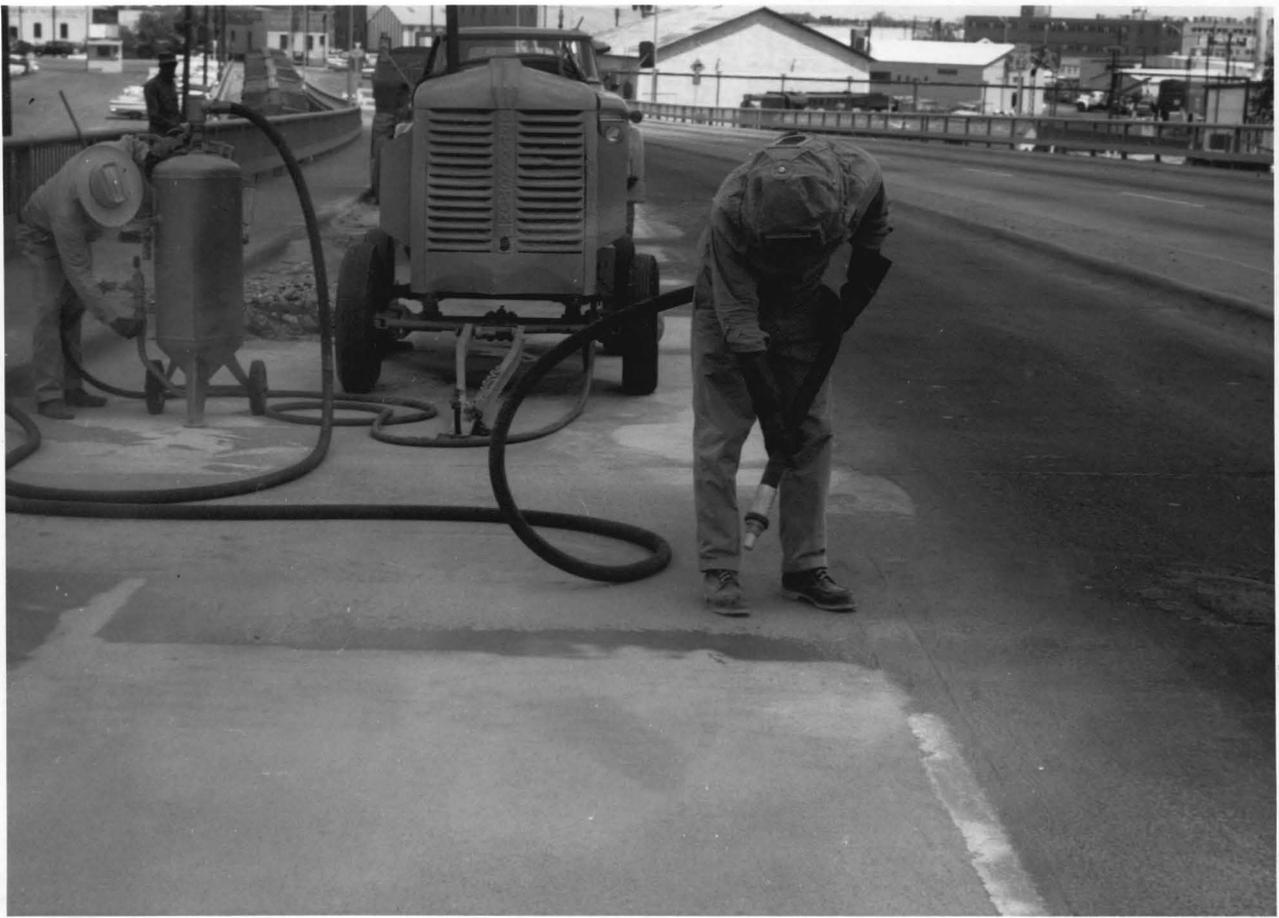
Velasco turns on the air and Aguirre operates the nozzle preparing the deck to receive a Guardkote epoxy seal.

The Maintenance Division set up a special job to repair this structure using Highway Department formula epoxy bonding agent, Class A concrete to patch the holes, and commercially produced Guard Kote epoxy for a deck sealer.
