TEXAS
TRANSPORTATION
INSTITUTE

**CRASH TESTS AND EVALUATION
OF SINGLE POST
HIGHWAY SIGNS**

**RESEARCH REPORT 146-11
STUDY 2-10-68-146
ADAPTATION OF ATTENUATION SYSTEMS**

August, 1973

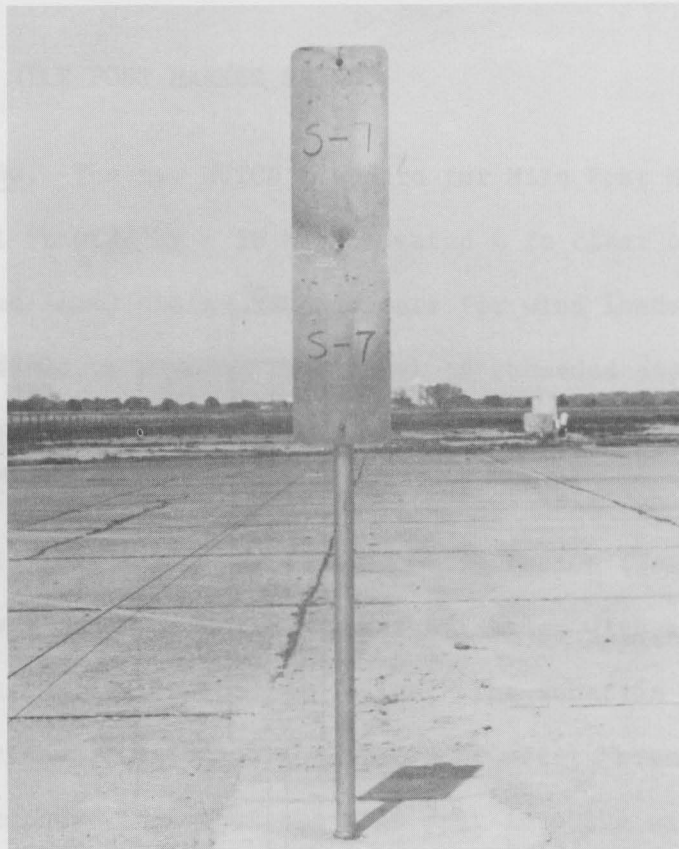
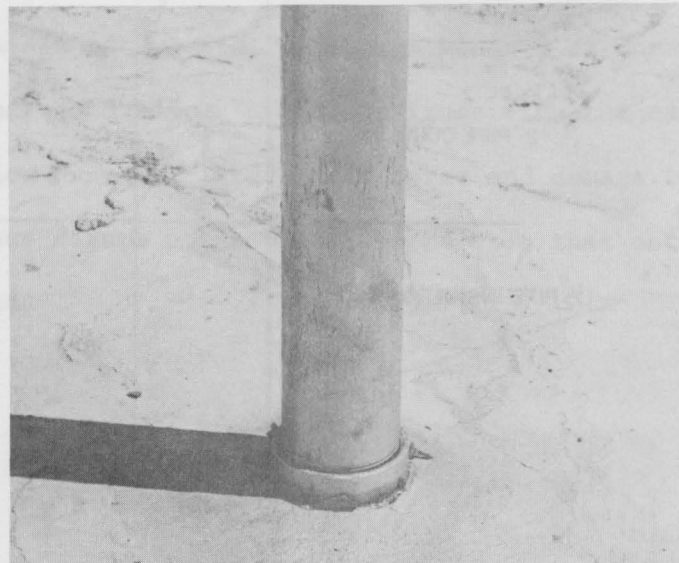
Figures 2 and 3 show a similar Mile Post Marker design with a 1.5 in. diam. pipe insert placed inside the 2 in. pipe. The function of the pipe insert was to delay the rotation of the sign post after "breakaway" on impact to avoid a secondary impact of the sign post into the windshield area. The 3970 lb vehicle impacted the sign head-on at 47.5 mph and sustained a speed change of 2.6 mph. The sign behaved as intended. The pipe hooked on the car hood after "breakaway" rode with the car and no secondary collision occurred. The impact force and damage to the vehicle front end (see Figure 5) was more severe than that obtained from other designs tested.

Figure 3. Mile Post Marker on 2" pipe post in threaded coupling with 1 1/2" pipe insert, Test S-7.

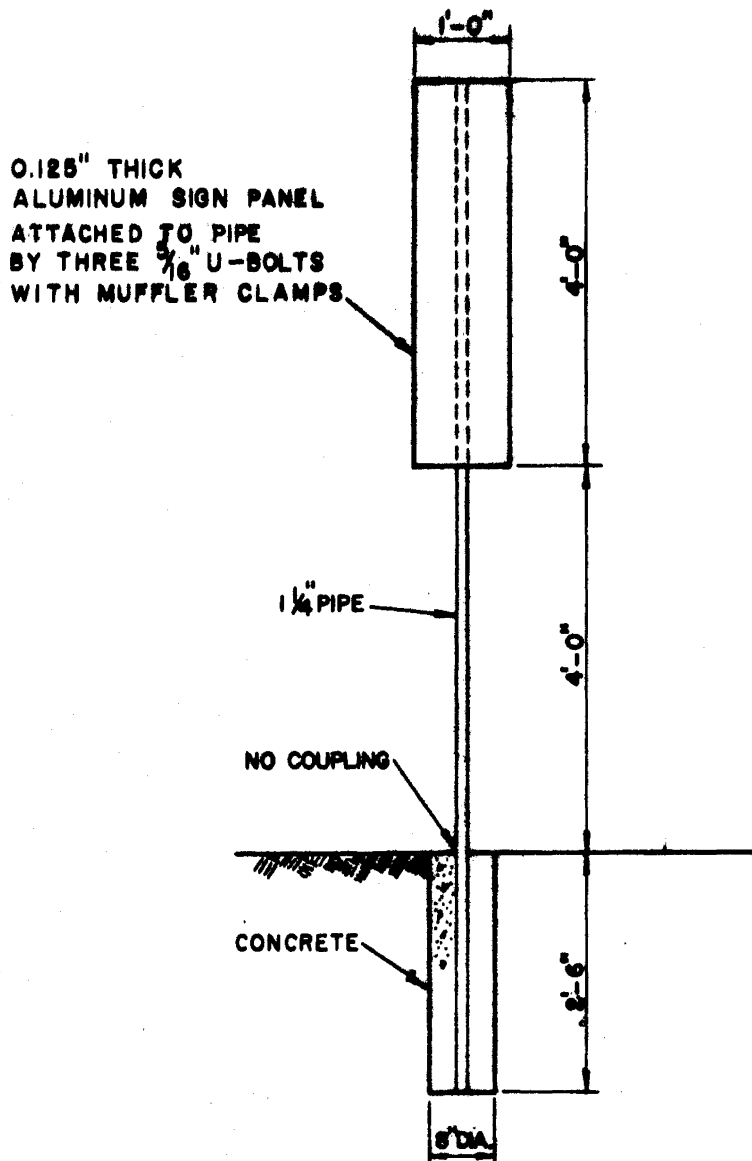
In Test S-12, the sign was impacted head-on at 56.9 mph. The post bent down as intended, however, the sign panel came off the post and hit the windshield of the vehicle (see Figures 9 and 10). The velocity change of the vehicle was 0.9 mph and it sustained a cracked windshield.

The U-bolts holding the 0.125 in. thick aluminum sign panel to the 1.25 in. diam. post slipped off the end of the pipe during impact. A threaded pipe cap on top of the post, a spot weld, a cross bolt or some other obstruction on the top of the pipe could have prevented the sign panel from slipping off the post.

Figure 6. Mile Post Marker in concrete footing.
Tests S-2 and S-12.

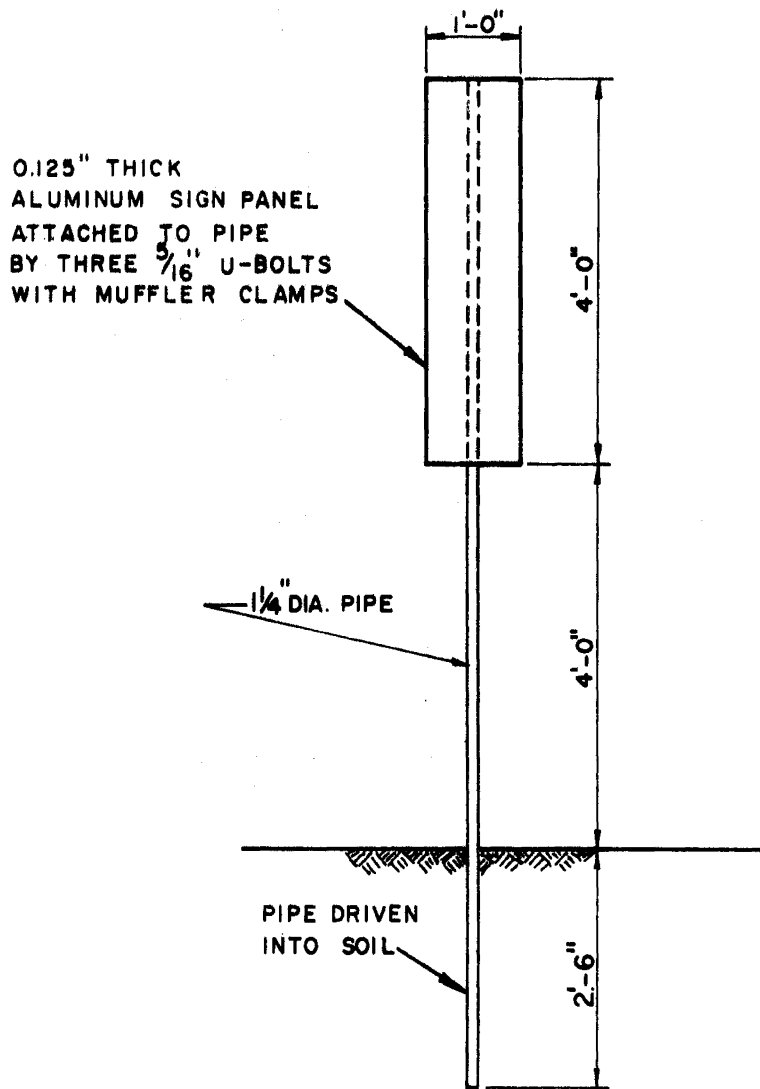
1.25" PIPE DRIVEN INTO SOIL. Figure 11 shows an alternative Mile Post Marker sign mounted on a 1.25 in. diam. pipe driven 2 ft - 6 in. into the soil. This is considered to be an economical design which exhibited excellent behavior during vehicle impact.

Figure 11. Mile Post Marker driven into soil.
Tests S-3, S-4, and S-5.

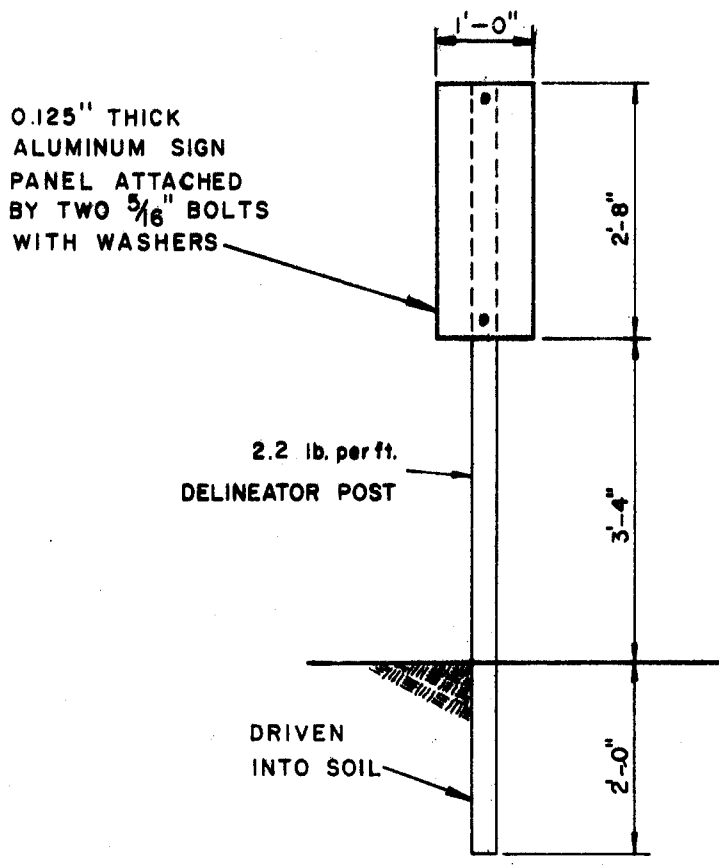
2.2 lb per ft DELINEATOR POST DRIVEN INTO SOIL. The standard Texas Mile Post Marker sign now installed on Interstate Highways in Texas consists of a 1 ft wide by 2 ft - 8 in. high panel mounted on a 6 ft high 2.2 lb per ft delineator post driven 2 ft into the soil (see Figure 18).

Figure 18. Texas Mile Post Marker mounted on delineator post driven into soil. Tests S-6, S-9, and S-15.

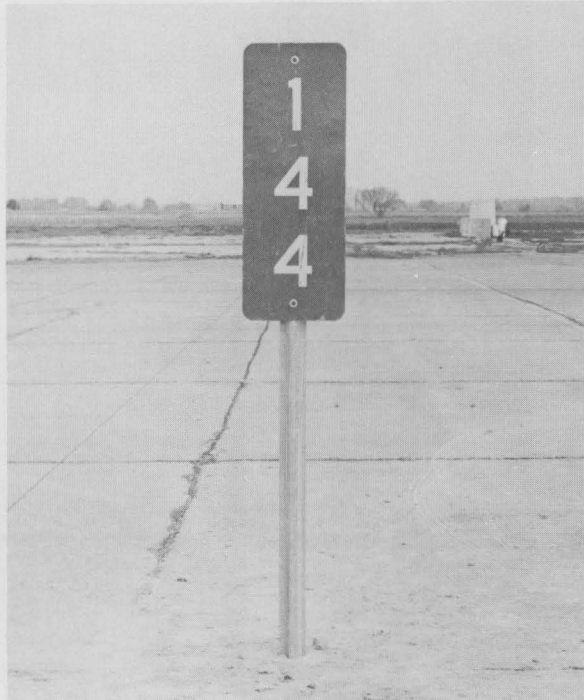
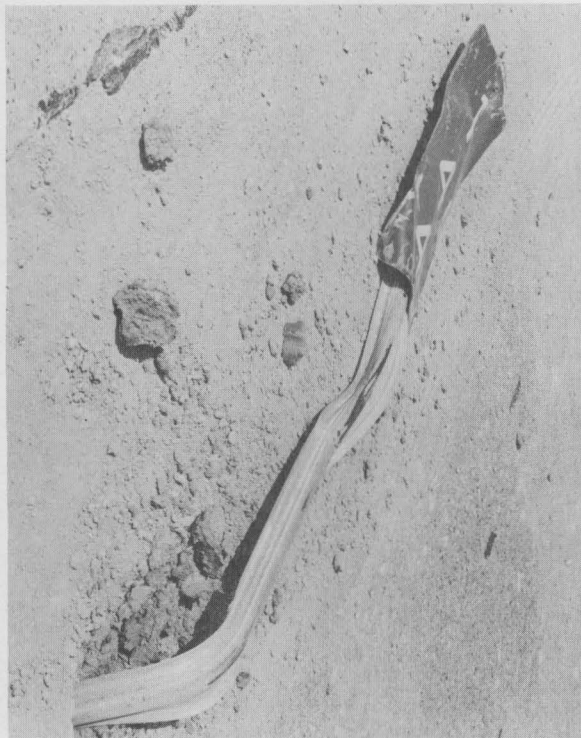
In Test S-9 the vehicle impacted the sign at 45.2 mph and again the sign bent down (see Figure 20). The speed change of the vehicle was 0.9 mph.

Figure 20. "Before" and "After" photographs of Texas Mile Marker mounted on delineator post driven into soil. Test S-9, 45.2 mph, $\Delta V = 0.9$ mph.

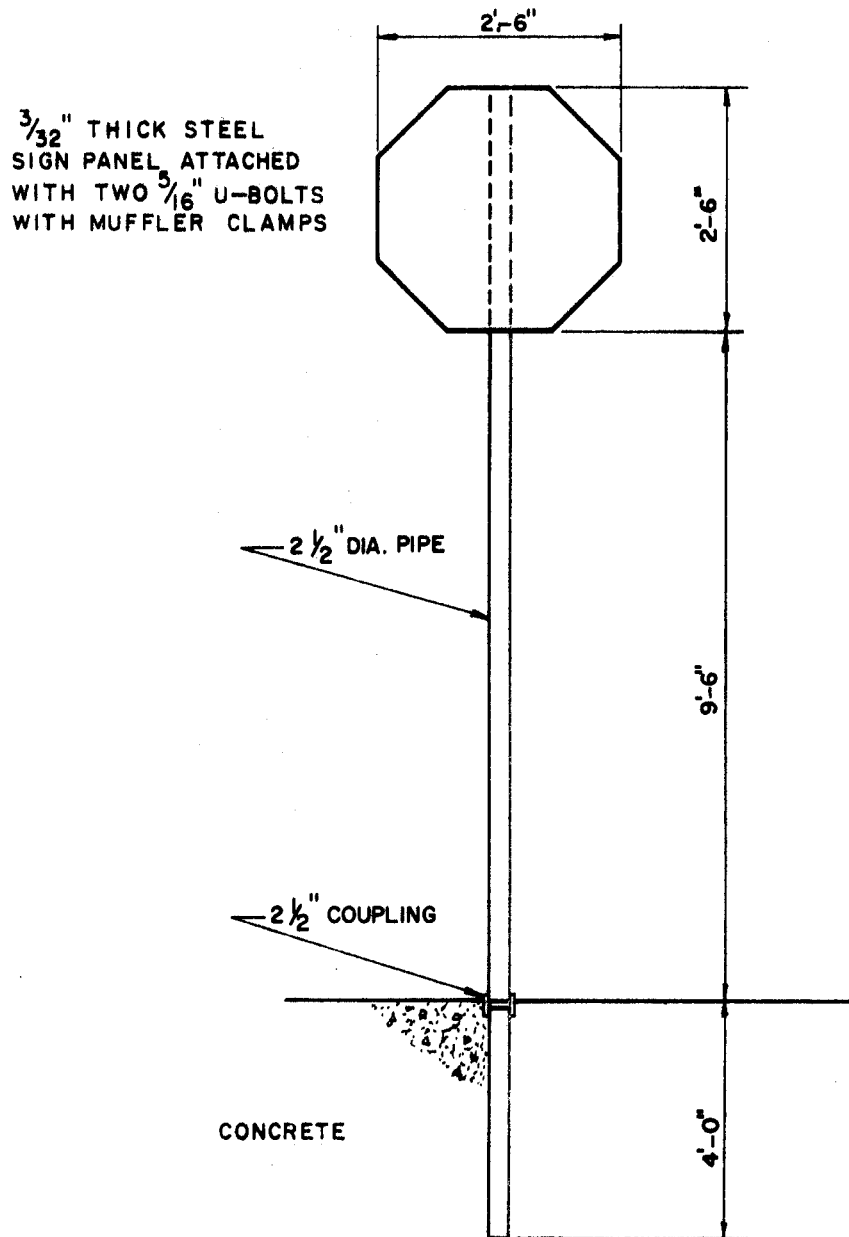
The standard Texas Highway Department Stop Sign is mounted on a 2.5 in. diam. pipe with a threaded coupling at the base as a break-away feature (see Figure 23). In Test S-10 the sign was impacted head-on at 45.5 mph. The pipe pulled out of the coupling (as intended), rotated and struck the rear roof of the car. The sign panel came off the post as it hit the ground (see Figure 24). The change in vehicle speed was 1.7 mph. The behavior of this sign is considered satisfactory, since the height and geometry of the sign is such that the secondary impact of the pole will be in the roof area of a standard passenger car.

Figure 23. Step Sign.
 Test S-10, 45.5 mph, $\Delta V = 1.7$ mph.

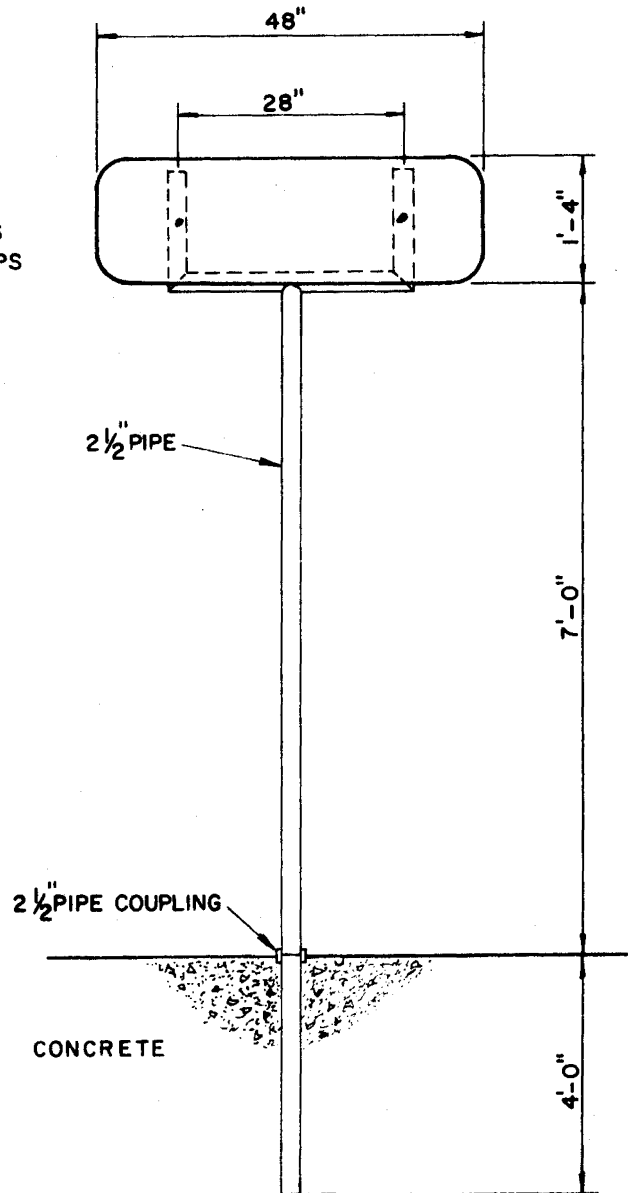
Figure 25. One Way Sign.
Tests S-13, S-14, and S-16.

As a result of these three tests, it is apparent that the connection of the sign panel to the pipe support needs strengthening. The two 5/16 in. U-bolts should be increased to four. In addition, threaded caps or some other stop device should be placed on top of the pipe to prevent the U-bolts from slipping off. Overall the One Way Sign behaved in an adequate manner.

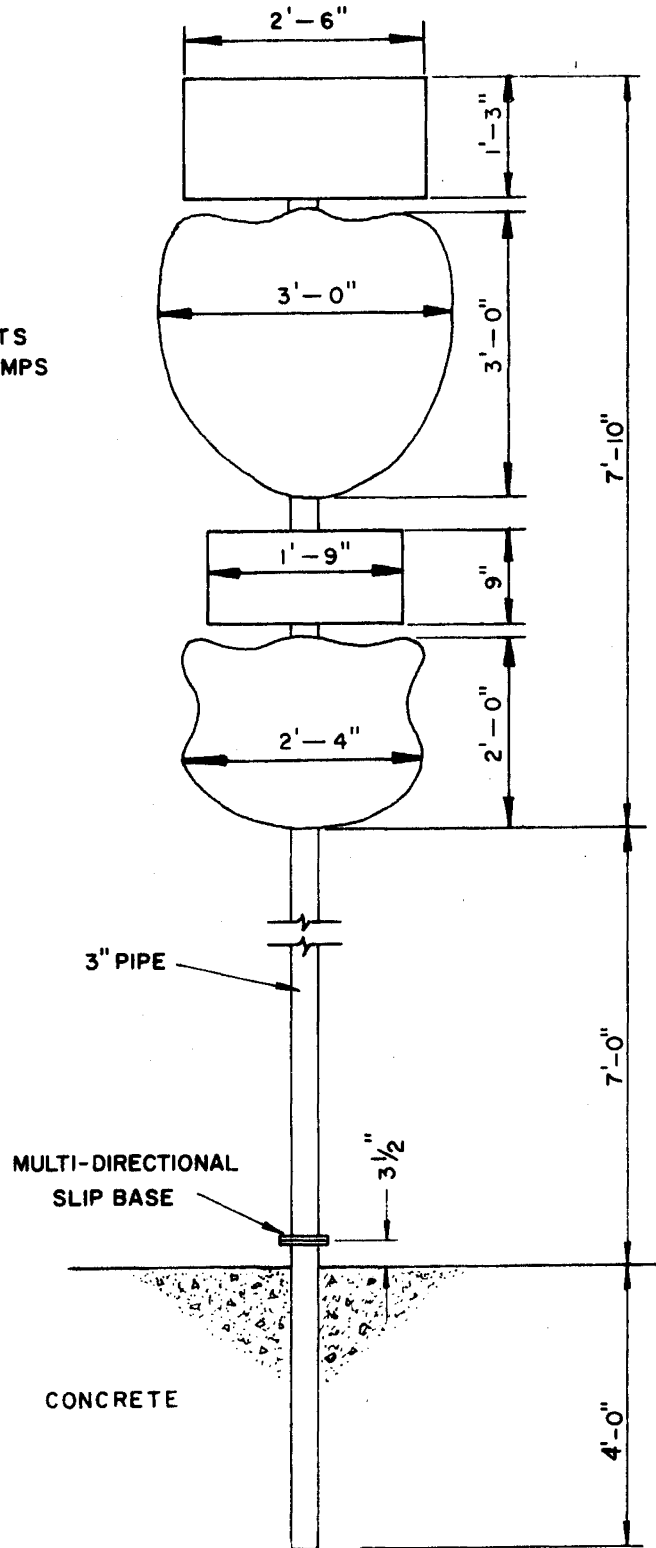
The Route Marker sign shown in Figures 32 and 33 is typically used on main lanes and frontage roads of Interstate Highways in Texas. The 3 in. diam. pipe mount is used to support a 36 in. Interstate Route Marker with a 24 in. Route Marker. For pipe supports 3 in. in diam. or larger, the multi-directional slip base is used (see Appendix A for details).

Figure 32. Route Marker with multi-direction slip base.
 Tests S-8 and S-18.

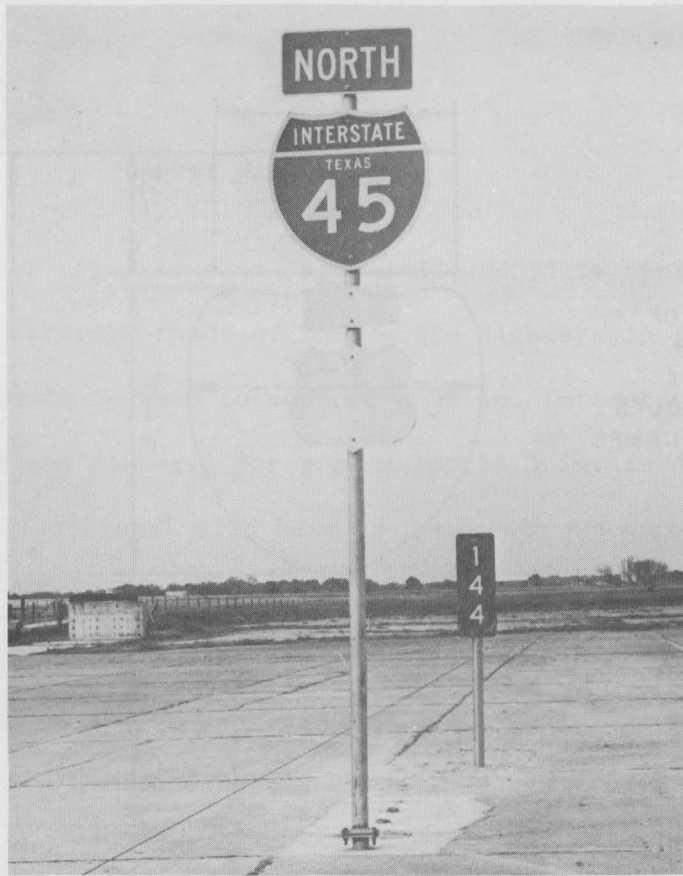
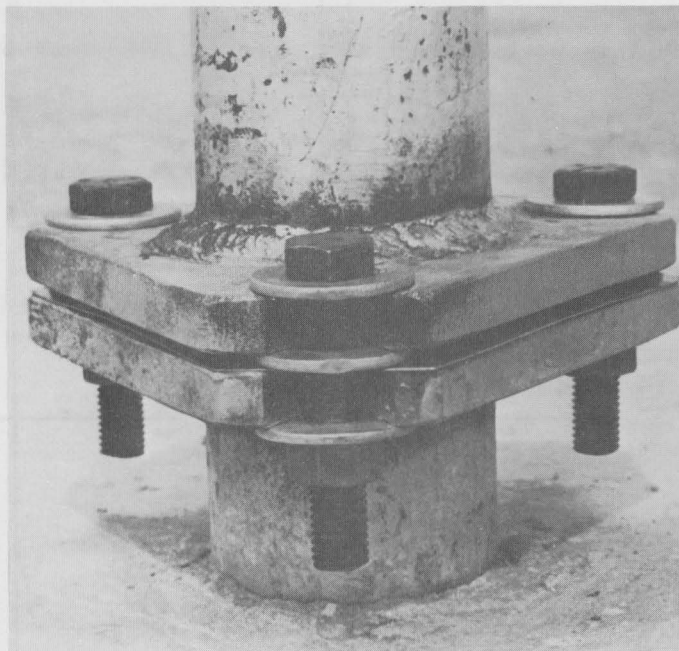
Figure 33. Route Marker supported on 3 in. pipe with multi-directional slip base.
Test S-8 and Test S-18.

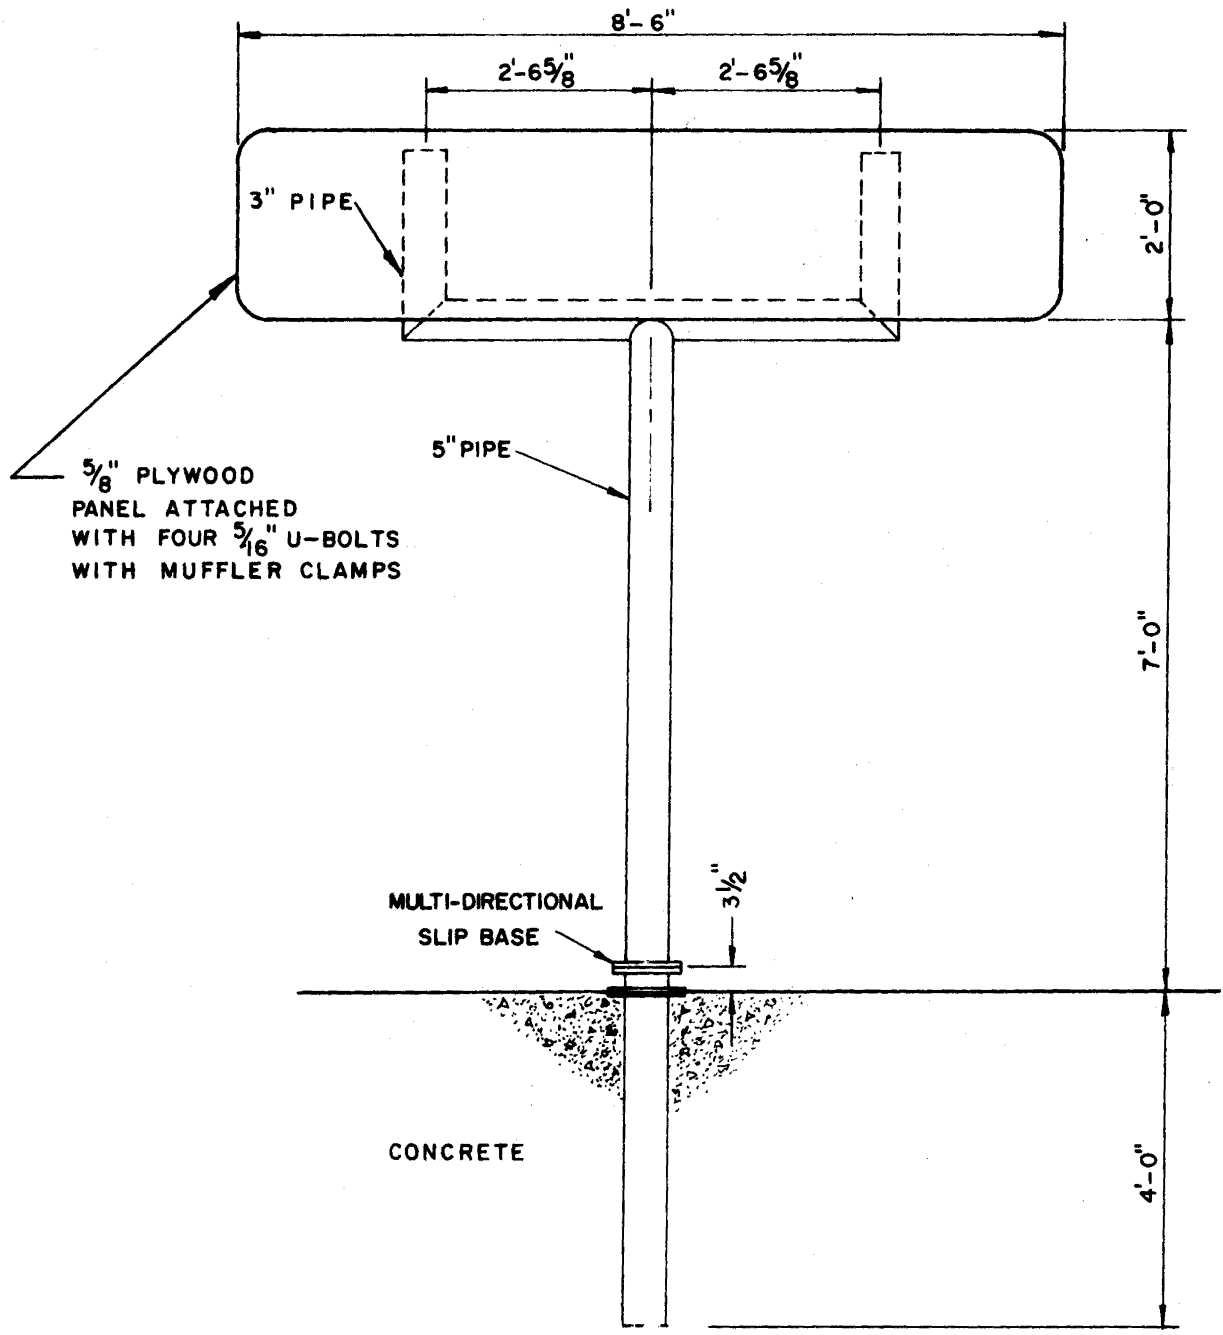
In Test S-11 the sign was impacted head-on at a speed of 44.5 mph and the change in speed of the vehicle was 1.4 mph. The slip base activated and the sign rotated about 110° and struck the roof of the vehicle rather hard over the front passenger compartment. Damage to the front of the vehicle was significant as shown by Figure 40. Figure 39 shows the final position of the sign structure.

Figure 37. Destination Sign with multi-directional slip base.
Test S-11 and S-17.

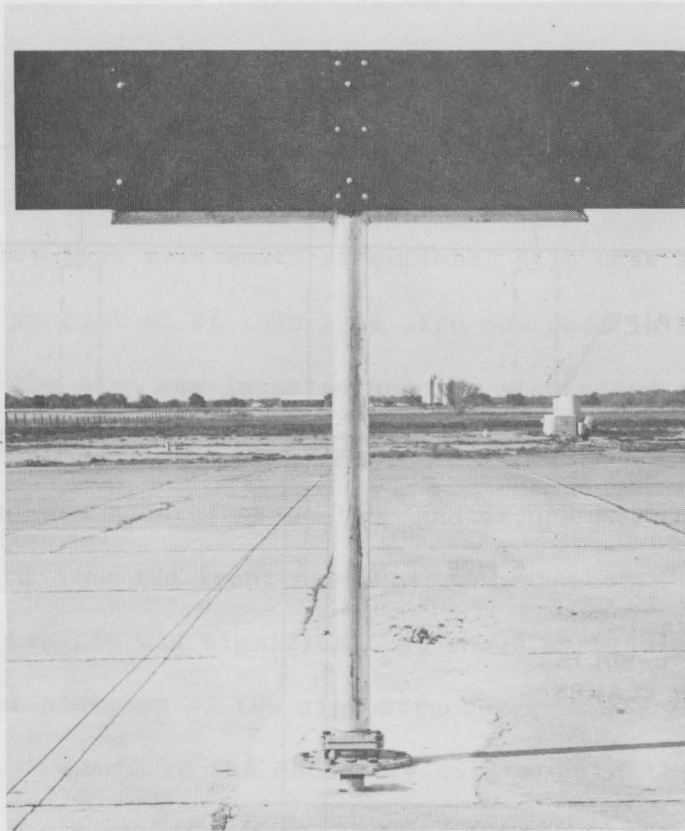
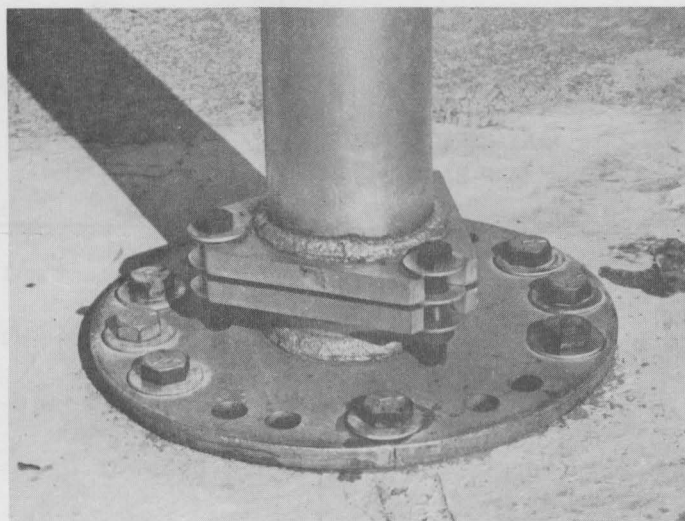
Figure 38. Destination Sign mounted on 5" pipe with multi-directional slip base. Test S-11. 44.5 mph, $\Delta V = 1.4$ mph.

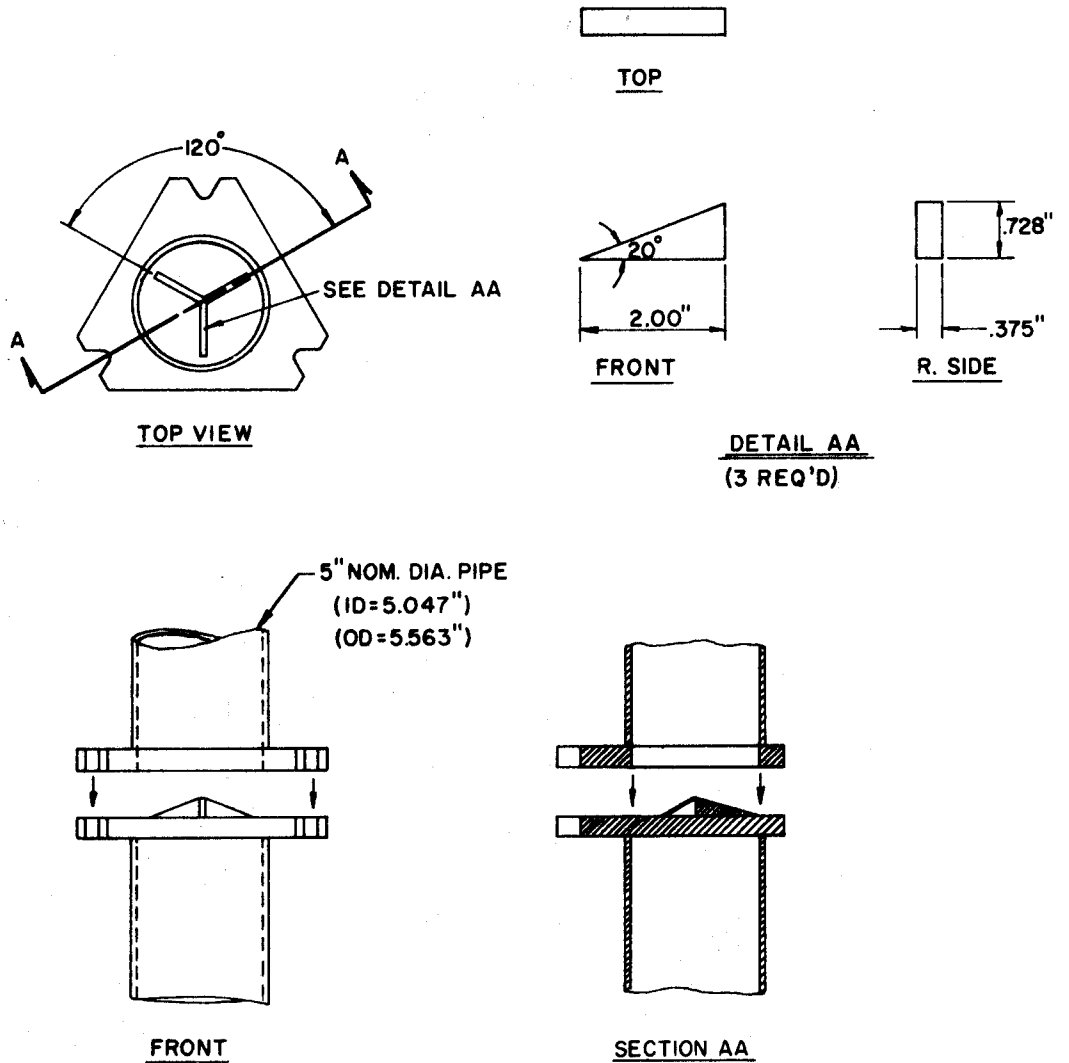
In an attempt to minimize the secondary collision of the sign with the roof of the car, the multi-directional slip base was modified to include riser plates as shown in Figure 42. The function of the riser plates is to impart an upward velocity to the sign post on vehicle impact. This upward velocity should raise the sign higher into the air and allow the vehicle to pass underneath and avoid a secondary collision with the roof of the car.

In Test S-17 the sign was impacted head-on at a speed of 45.5 mph and the change in speed of the vehicle was 1.7 mph. The slip base activated and the sign rotated about 120° and struck the roof of the vehicle over the rear passenger compartment. The sign raised about 2 ft higher into the air than in Test S-11, however, the secondary collision still occurred. Figures 43 and 44 show the sign and vehicle, respectively, after the test.

Figure 42. Multi-directional slip base with riser modification for 5" pipe support. Test S-17.

The modified slip base with riser shown in Figure 43 was considered partially successful. The recommended slip base with riser shown in Figure 45 is believed to be a better design which will impart a higher upward velocity to the sign post.

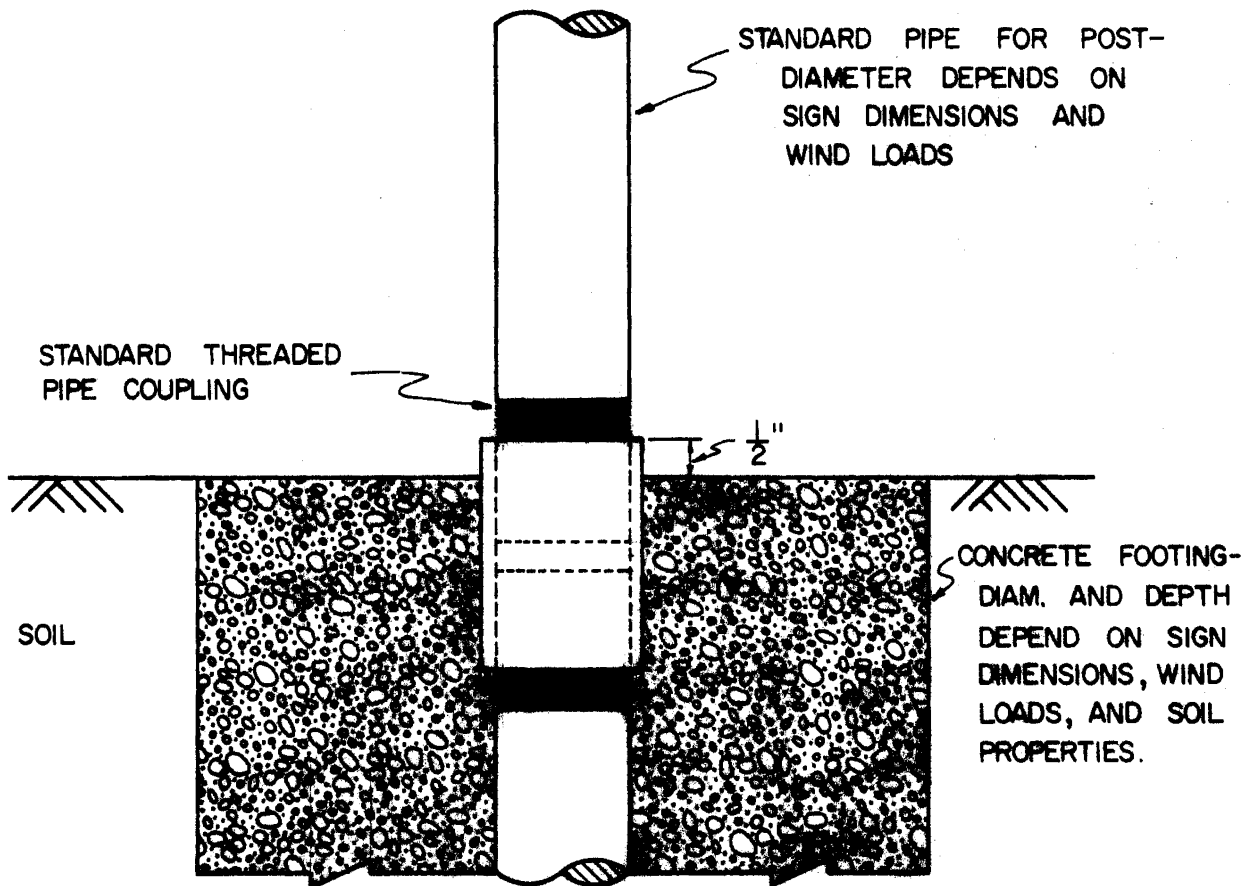
WHEN VEHICLE IMPACTS PIPE THREADS
WILL PULL OUT OF COUPLING CAST IN
CONCRETE. IF COUPLING THREADS ARE
DAMAGED, COUPLING CAN BE UNSCREWED
FROM LOWER PIPE AND REPLACED.

FIGURE A2 . THREADED COUPLING BREAKAWAY FEATURE

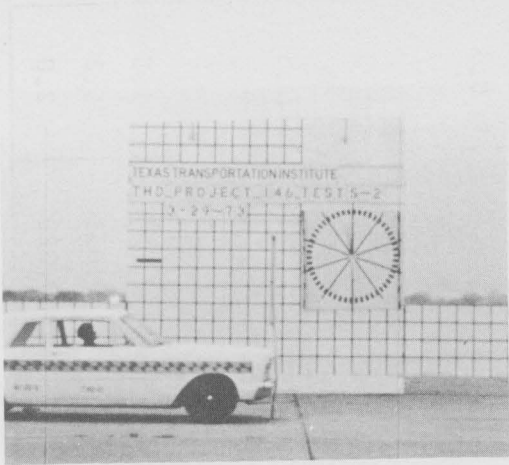
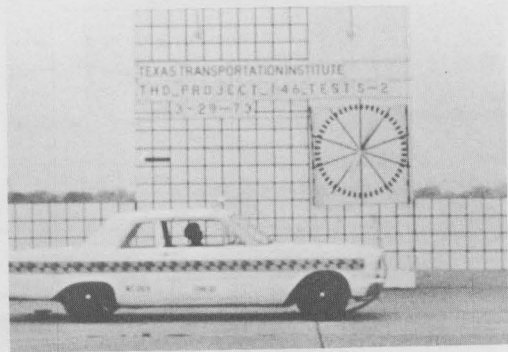
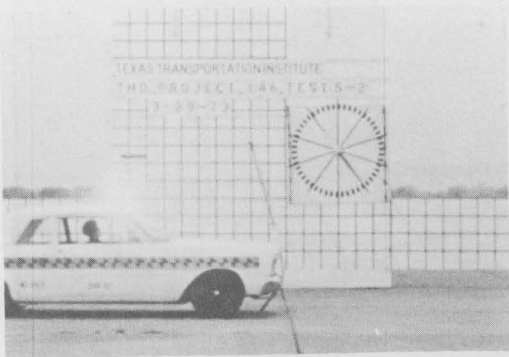
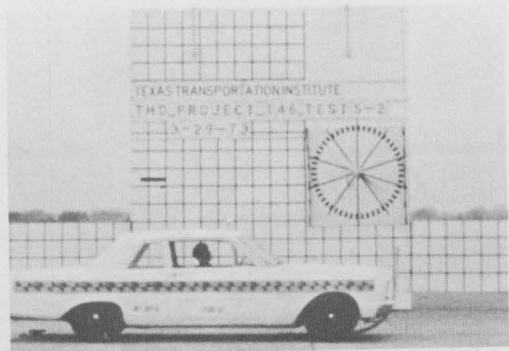
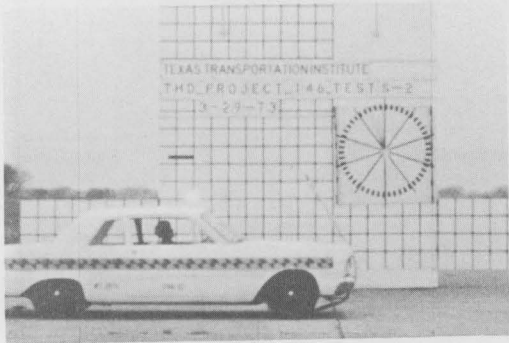
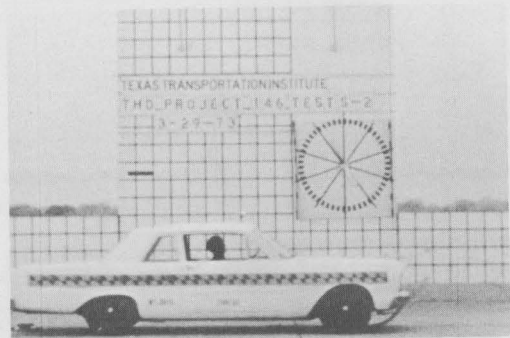
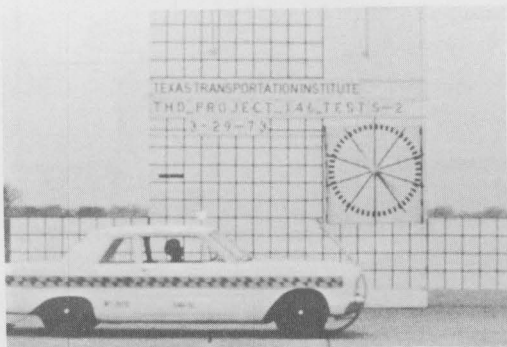
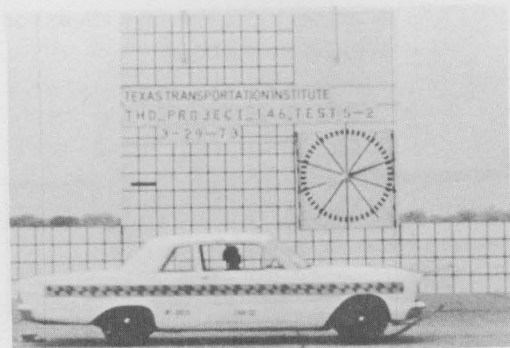
Figure C1. Sequential Photographs.
 Test S-2, 38.2 mph, $\Delta V = 1.3$ mph.
 -68-

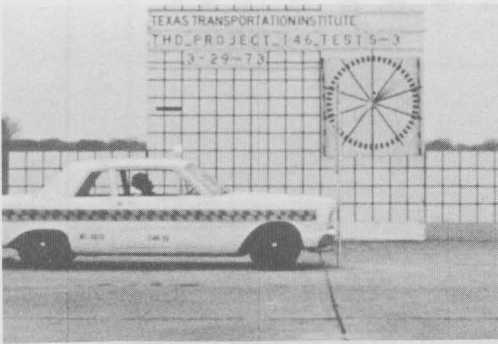
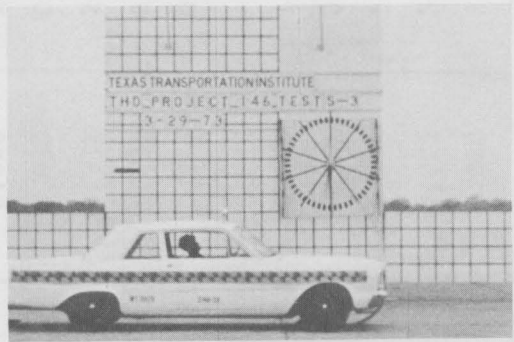
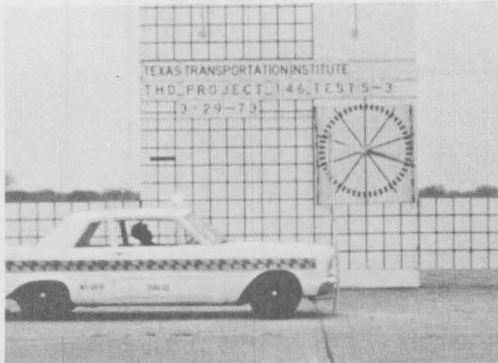
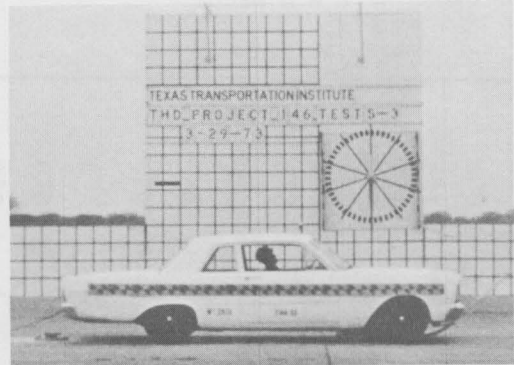
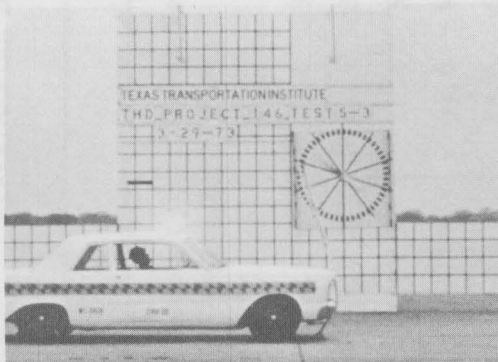
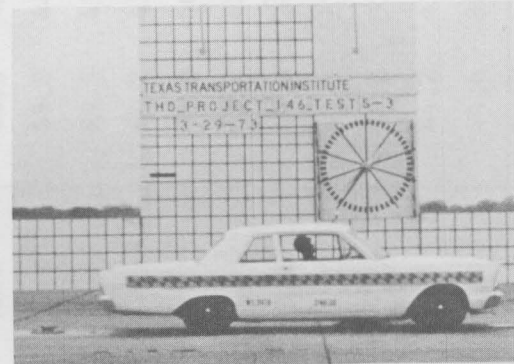
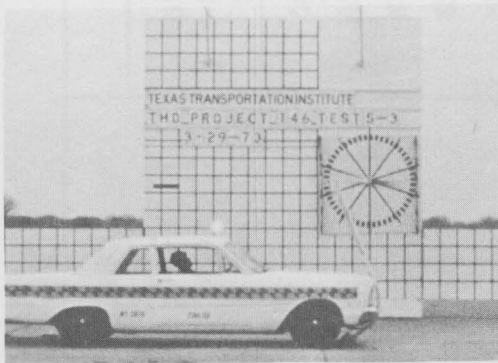
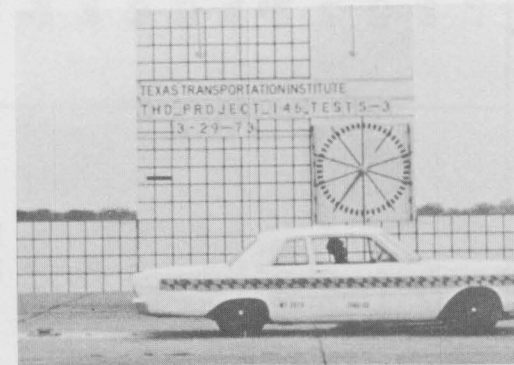
Figure C2. Sequential Photographs.
Test S-3, 31 mph, $\Delta V = 1.4$ mph.
-69-

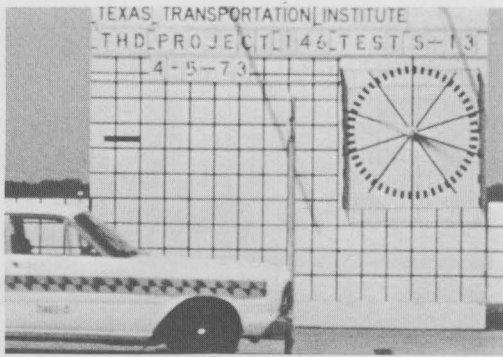
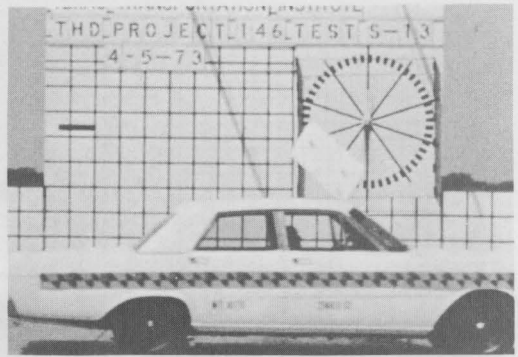
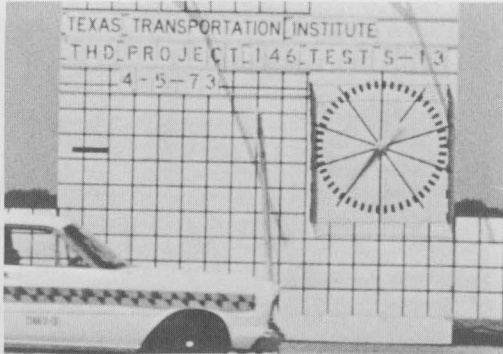
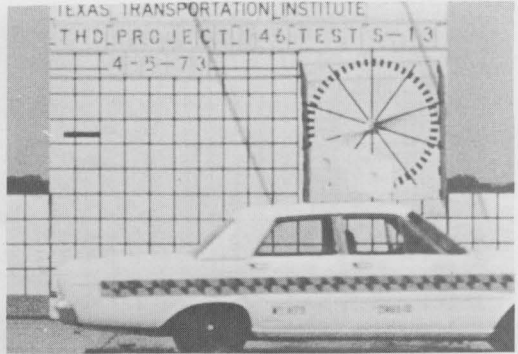
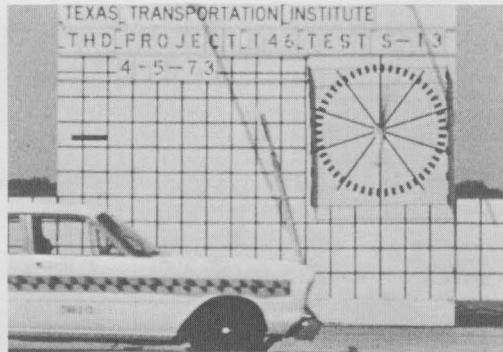
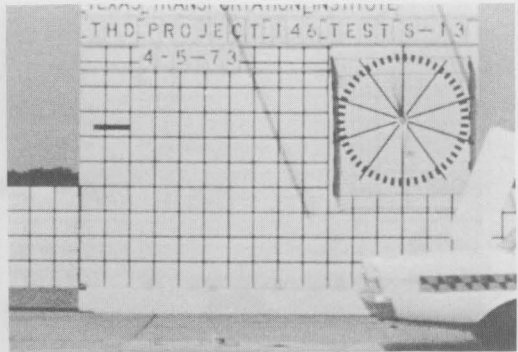
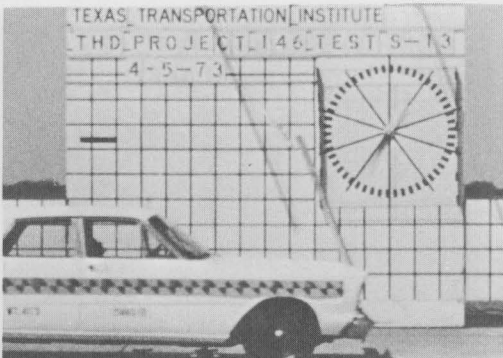
Figure C12. Sequential Photographs.
 Test S-13, 44.2 mph, $\Delta V = 1.5$ mph.

In Test S-13 the sign was impacted head-on at 44.2 mph and the vehicle change in speed was 1.5 mph. The post pulled out of the coupling and hooked over the hood. The sign panel came off during impact and passed over and lightly struck the roof of the car (see Figures 28 and 29). Damage to the vehicle was slight.

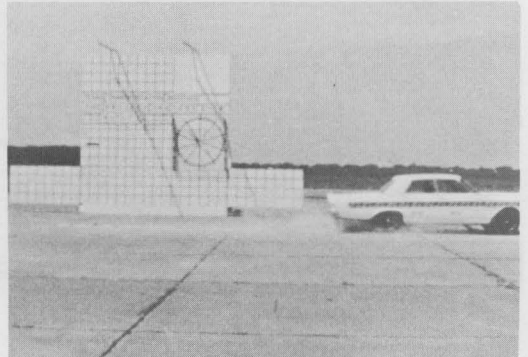
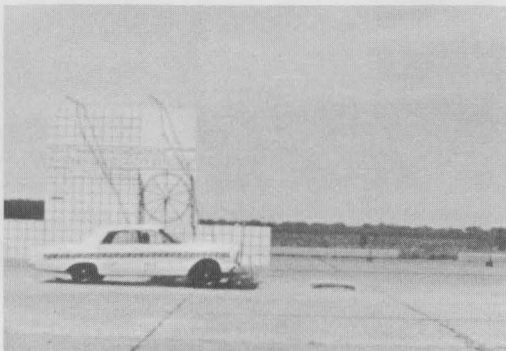
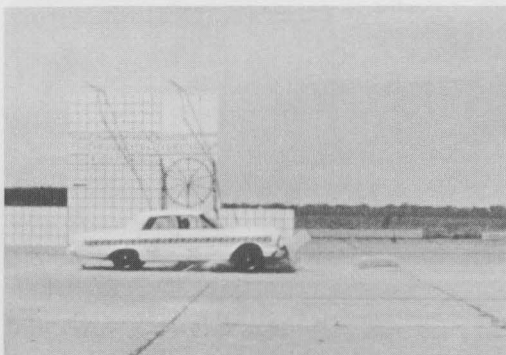
Figure C14. Sequential Photographs.
Test S-15, 28.1 mph, $\Delta V = 0.5$ mph.

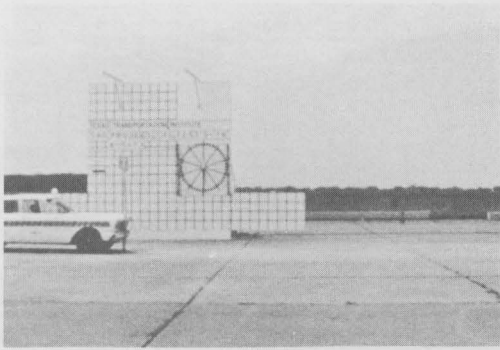
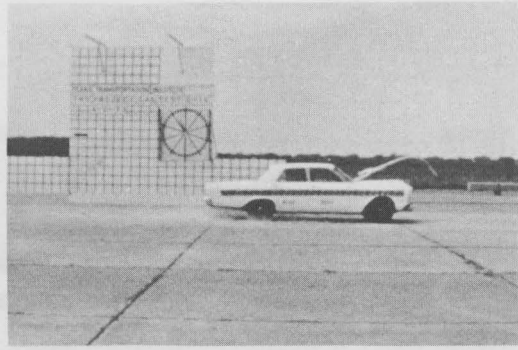
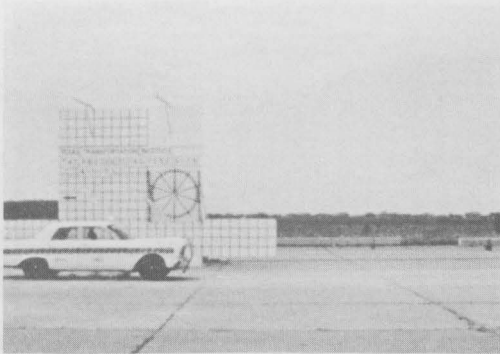
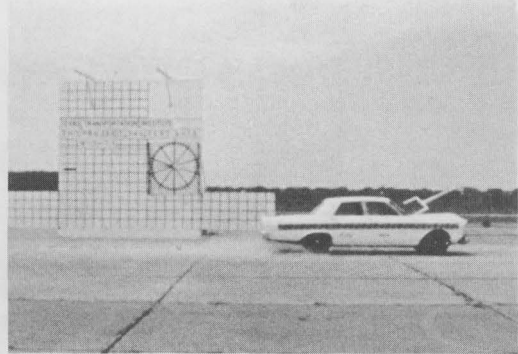
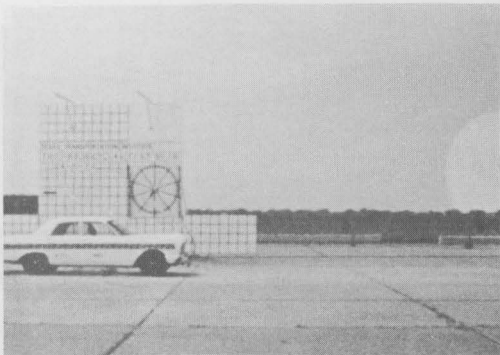
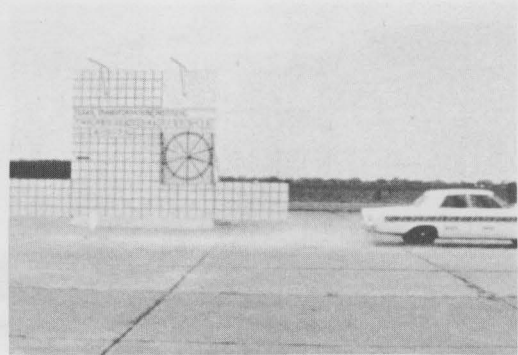
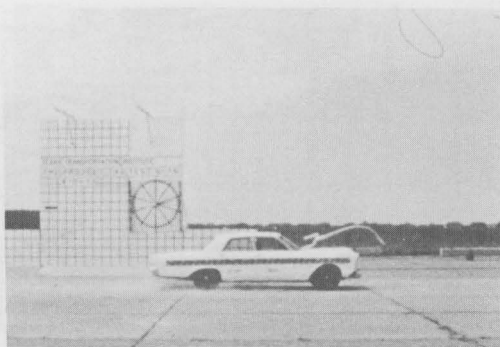
Figure C15. Sequential Photographs.
Test S-16, 58.4 mph, $\Delta V = 1.3$ mph.

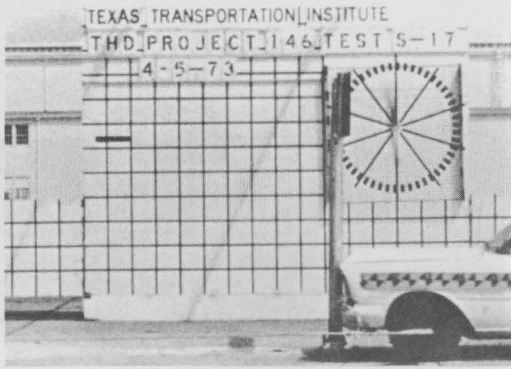
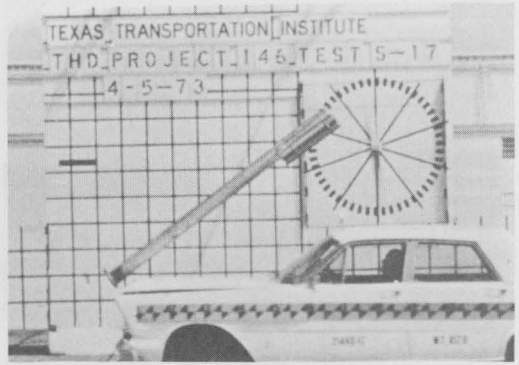
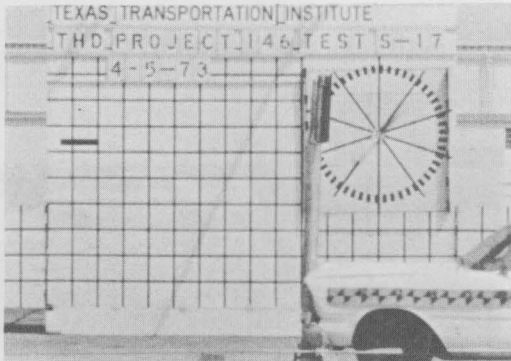
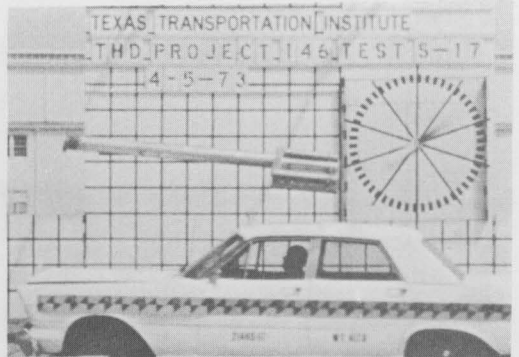
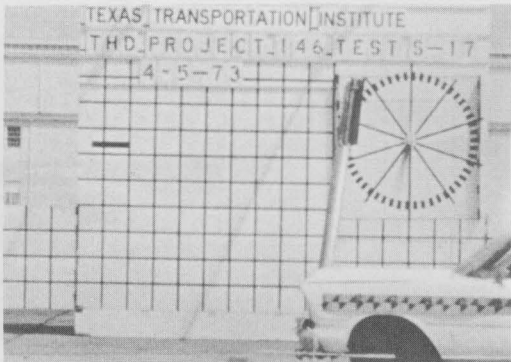
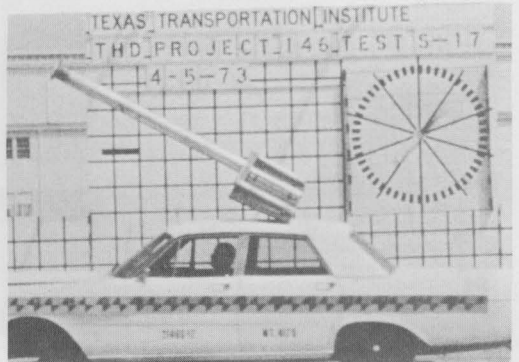
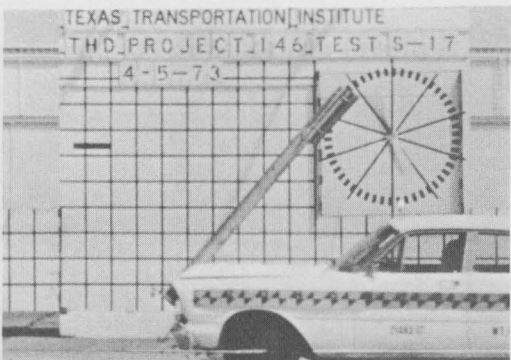
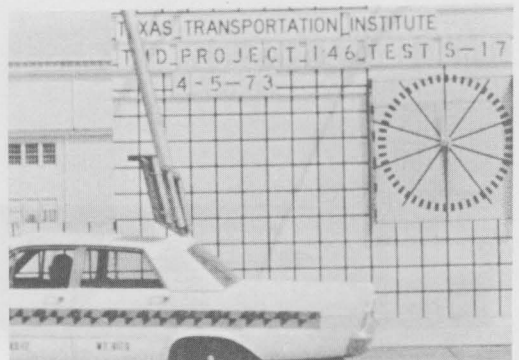
Figure C16. Sequential Photographs.
 Test S-17, 45.5 mph, $\Delta V = 1.7$ mph.
