TEXAS
TRANSPORTATION
INSTITUTE

**CRASH TESTS AND EVALUATION
OF SINGLE POST
HIGHWAY SIGNS**

**RESEARCH REPORT 146-11
STUDY 2-10-68-146
ADAPTATION OF ATTENUATION SYSTEMS**

August, 1973

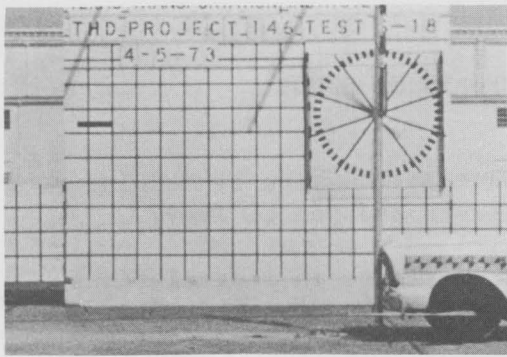
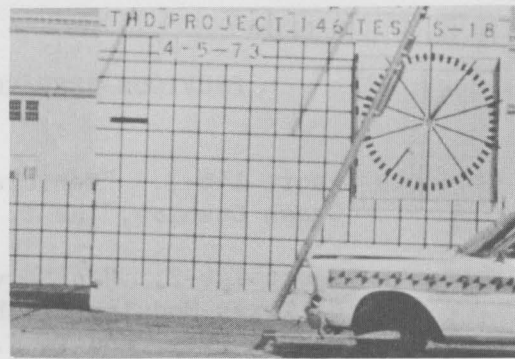
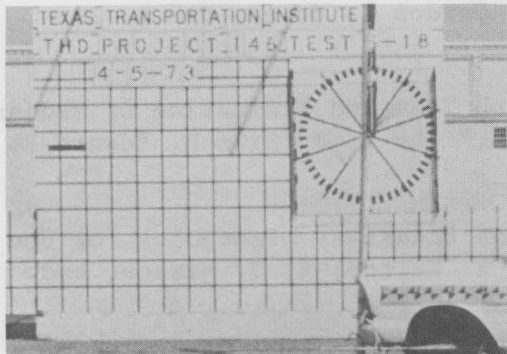
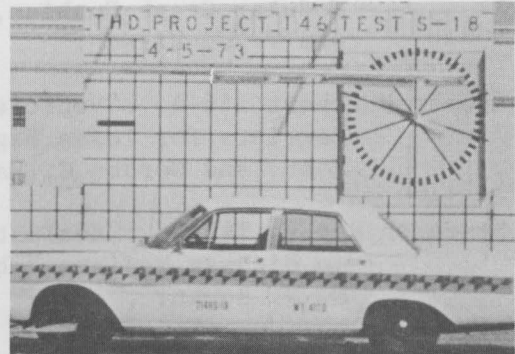
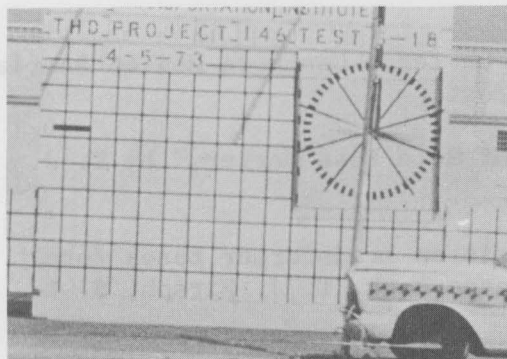
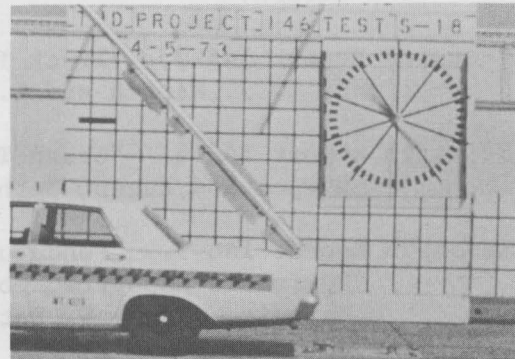
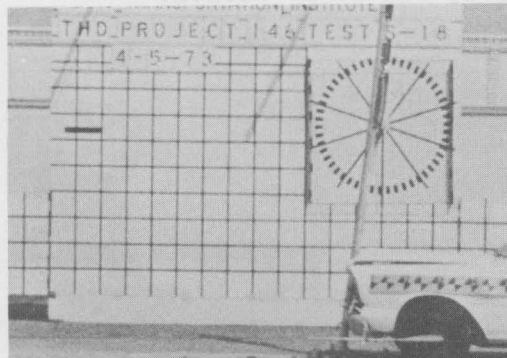
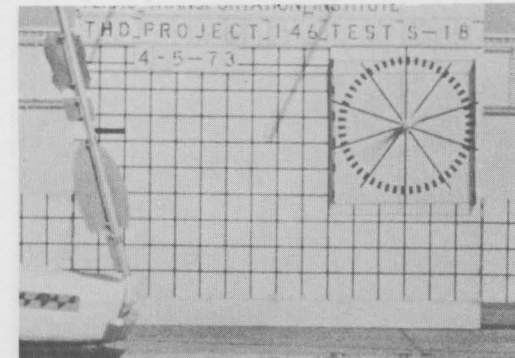
Figure C17. Sequential Photographs.
Test S-18, 31.3 mph, $\Delta V = 0.9$ mph.
-84-
