EVALUATION OF SURFACE - SEALING SYSTEMS UTILIZING SEAL COATS AND POLY-FAB UNDERSEAL

Report Number: 606-4

Initial Report
for
Evaluation of Experimental
Construction Project

Interstate Highway 40
Oldham and Potter Counties
Texas

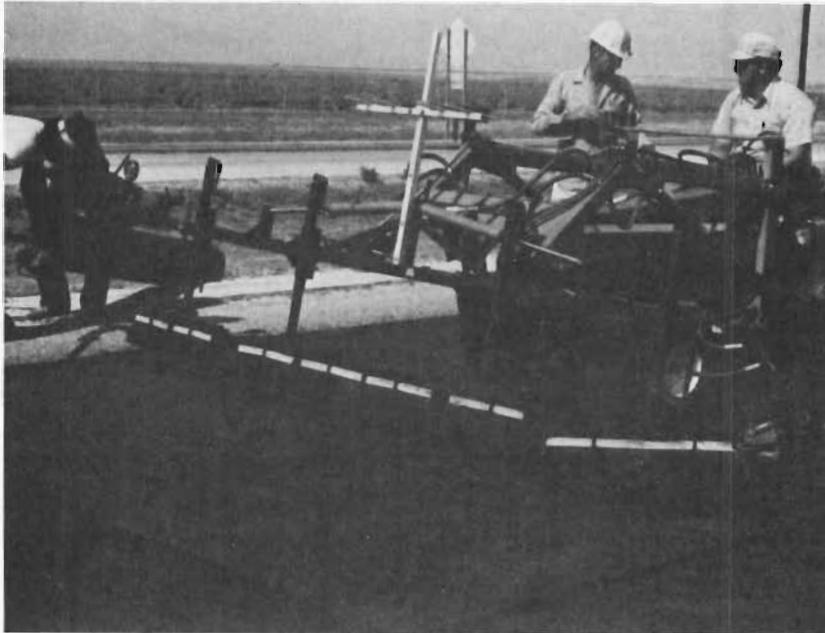
Picture 5

Phillips Fiber Corporation furnished a machine and operator to aid in placing of the Petromat. This machine was especially designed for the placing of this fabric (See Picture 5). The machine was a converted small front-end loader adapted as a placement vehicle for the Petromat. The overall performance of the machine was satisfactory.
