**FOURTH YEAR PROGRESS
REPORT
ON EXPERIMENTAL C R C P
IN WALKER COUNTY**

by
M. D. Shelby
and
B. F. Mc Cullough
**RETURN TO FILE D-10
TEXAS HIGHWAY DEPT.**

TEXAS HIGHWAY DEPARTMENT

March, 1965

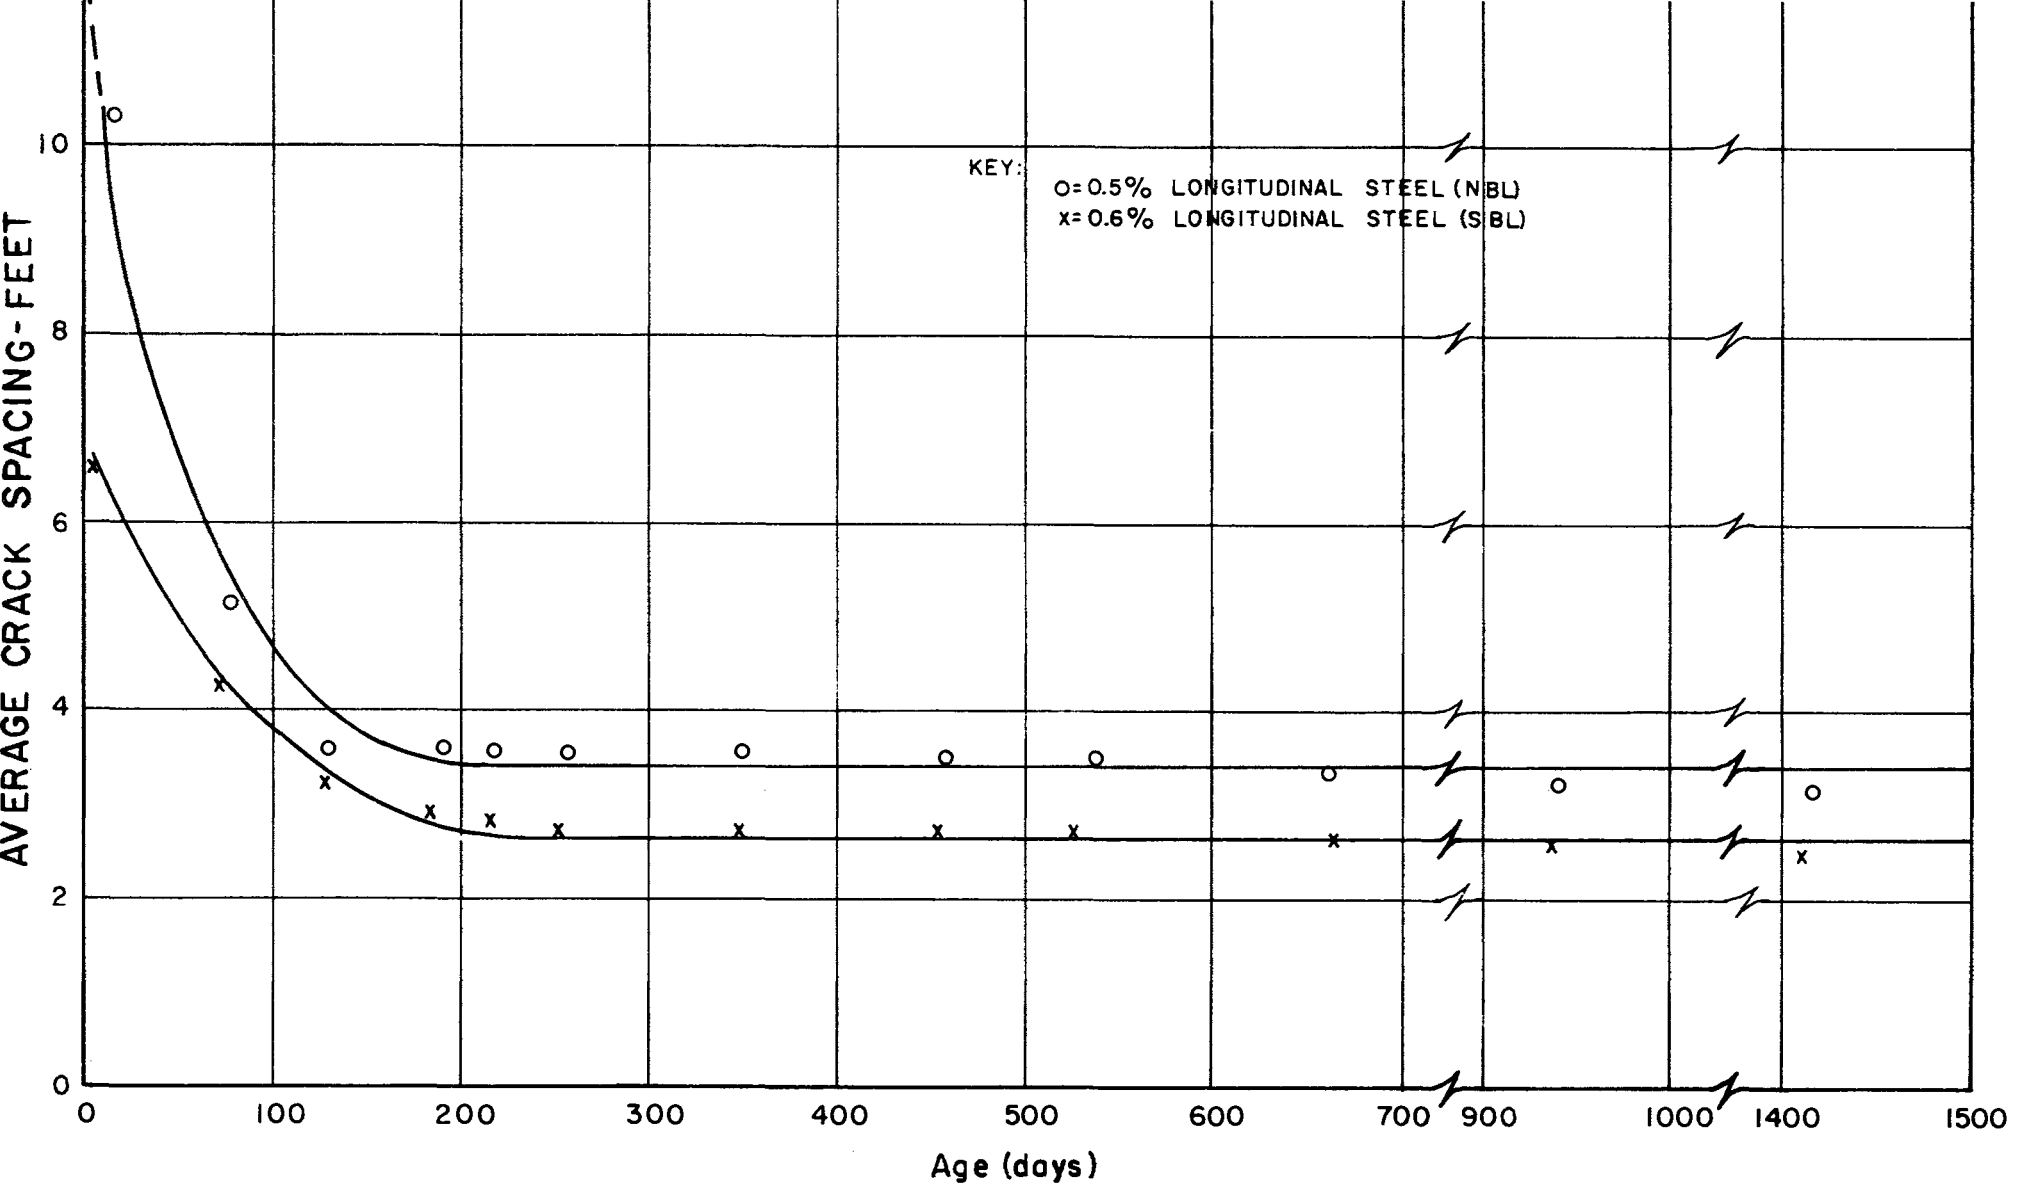
2,000 feet each were selected and periodic crack surveys have been conducted since the construction of the project. Figure 1 shows the age-crack spacing relationship for these two test sections. The data shows that there was a rapid initial decrease in the average crack spacing, but no noticeable change has occurred for either percent steel since an age of 200 days. The present age is a little more than four years. The average crack spacing for the 0.5 percent steel is 3.3 feet and 2.6 feet for the 0.6 percent steel. Therefore, from the standpoint of average crack spacing, both percentages of steel are performing equally well. In the original design concept for CRCP, it was felt that the average crack spacing should not exceed eight feet.⁶

RELATIONSHIP BETWEEN AGE AND THE AVERAGE CRACK SPACING ON THE TEST SECTIONS

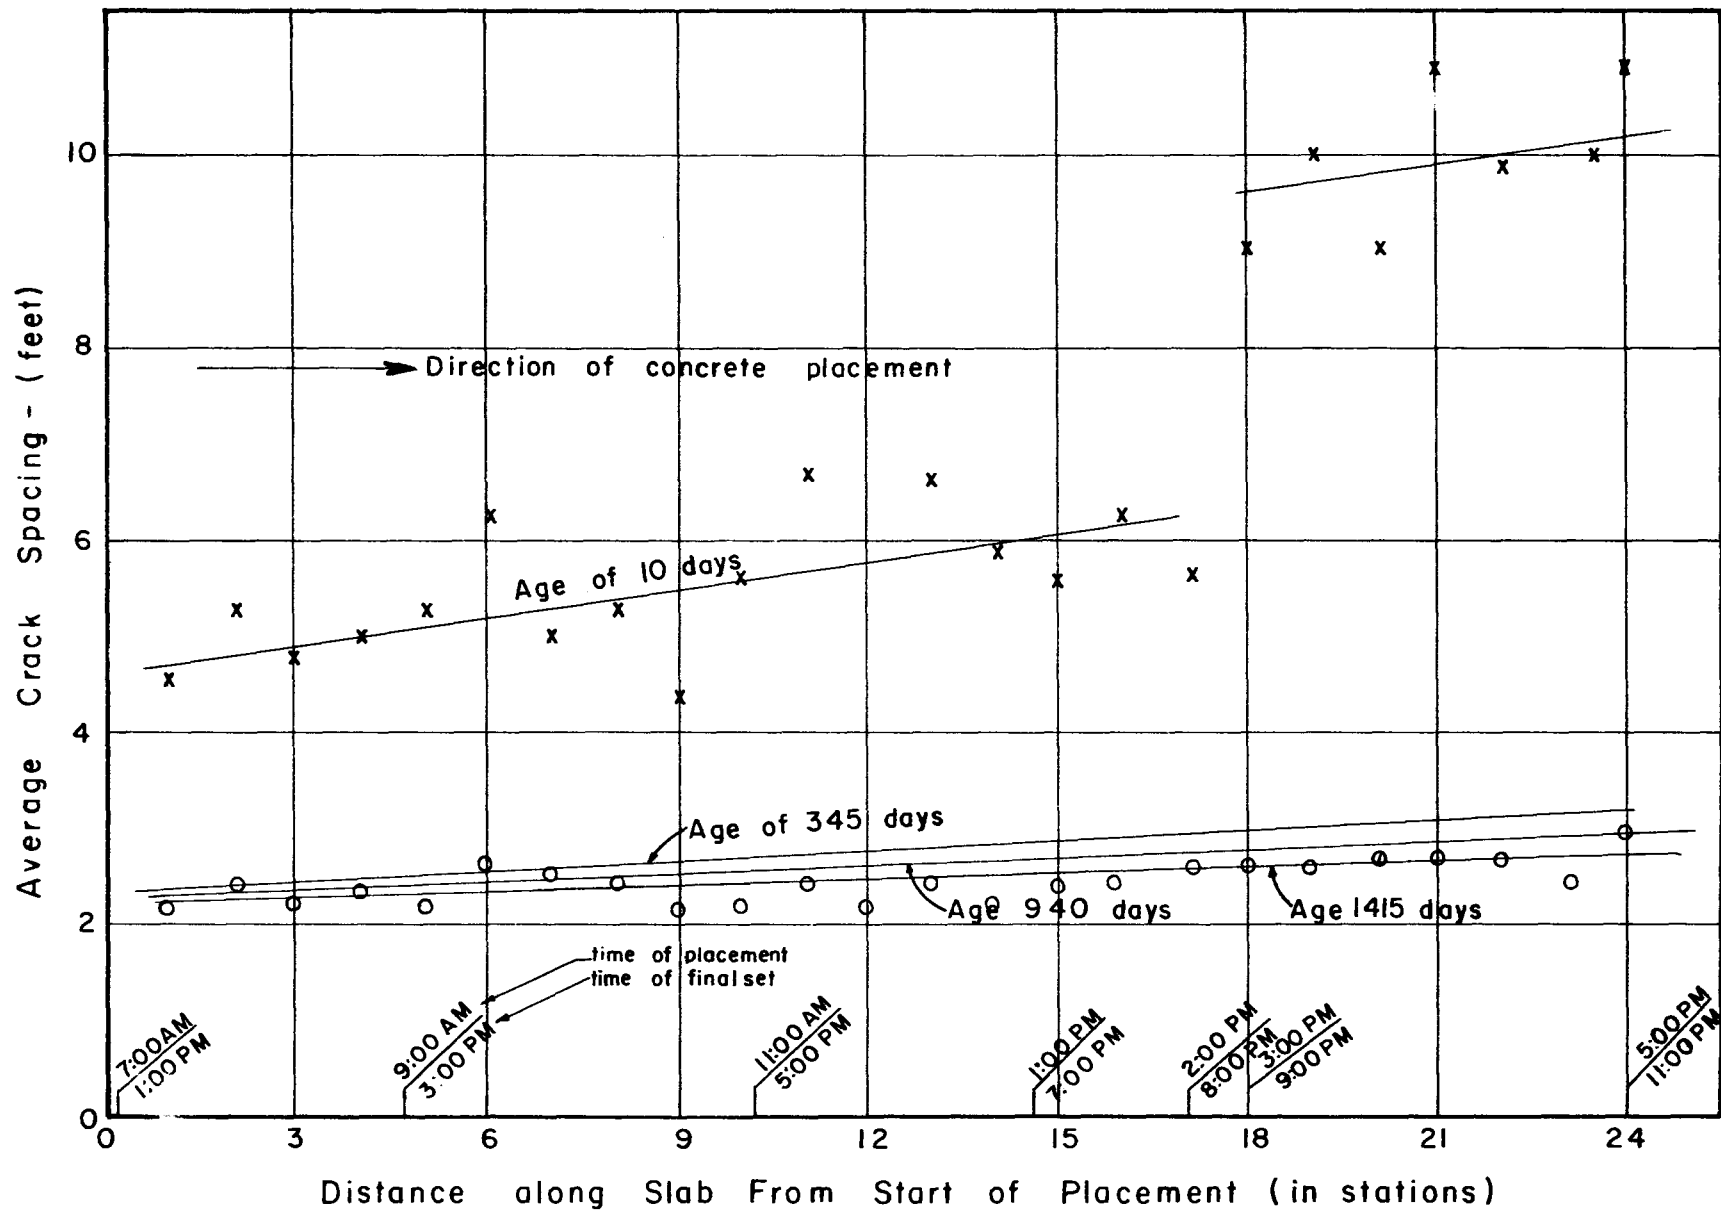
Earlier studies had indicated that the relative position within a slab had an effect on the average crack spacing. The data indicated that for any given day's placement the average crack spacing increased in the direction of concrete placement or paving. Figure 2 shows this relation for four different time periods. It is apparent that time is nullifying the effect of relative position since the trend line is approaching a horizontal position with increasing age.

Distance along Slab From Start of Placement (in stations)
**EFFECT OF RELATIVE POSITION WITHIN A SLAB
 ON THE AVERAGE CRACK SPACING - SBL (0.6%)**

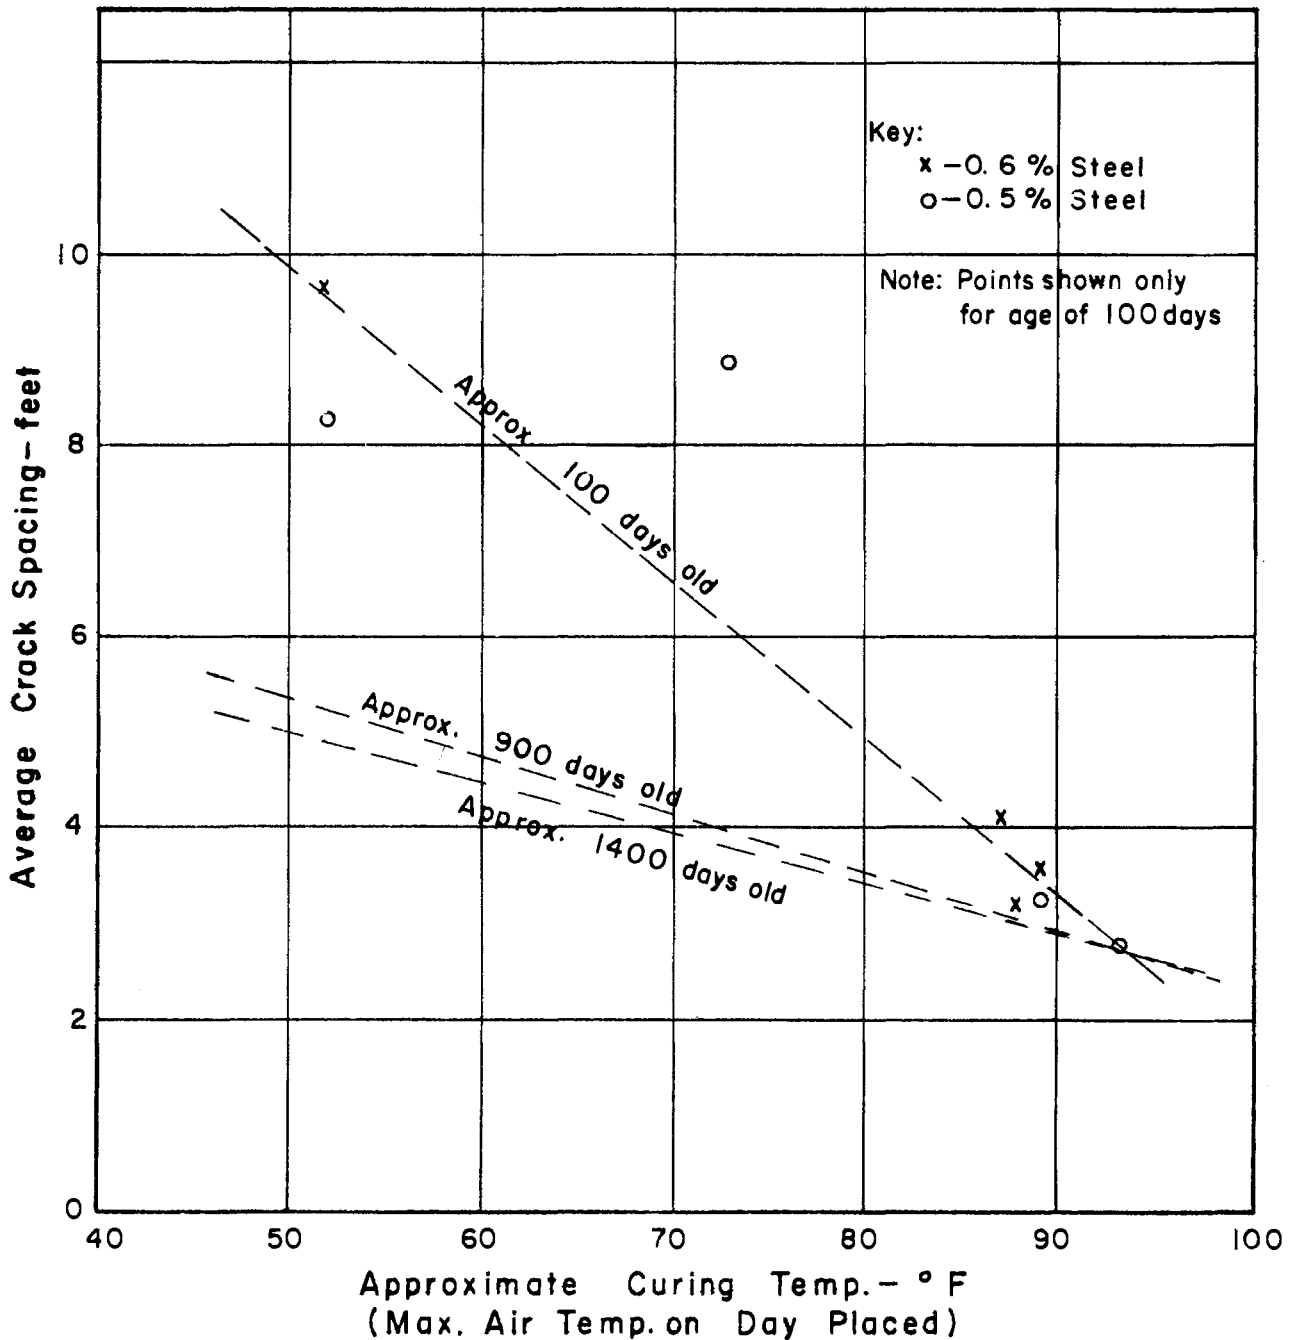
Figure 3 shows the relation between average crack spacing and approximate curing temperature for eight study sections located at various positions over the project. As was the case previously, age is tending to nullify the inverse relationship in that the trend line is approaching a horizontal.

AVERAGE CRACK SPACING VERSUS APPROXIMATE CURING TEMPERATURE FOR STUDY SECTIONS

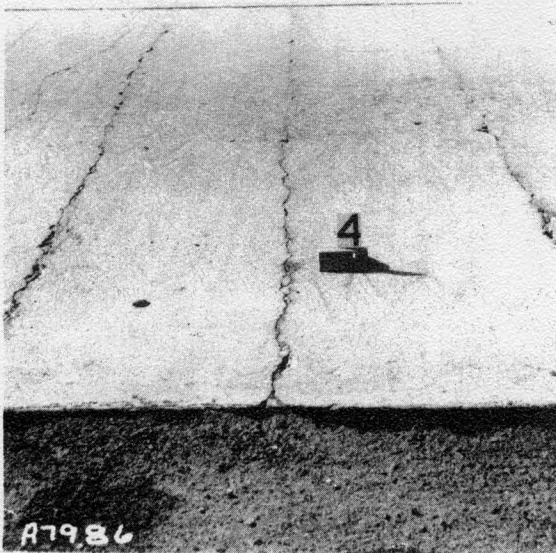
FIGURE B-1

The purpose of this report is to describe the observations made during the repairs of a failure in the experimental continuously reinforced concrete pavement on IH 45 South of Huntsville. The repairs were made adjacent to a construction joint in the northbound lane at Station 188. Figures B-1 and B-2 show the area prior to the beginning of repairs. A section 8 to 10 feet wide in the outside lane was removed on this date. An investigation of the slab removed and of the base materials revealed several interesting observations.

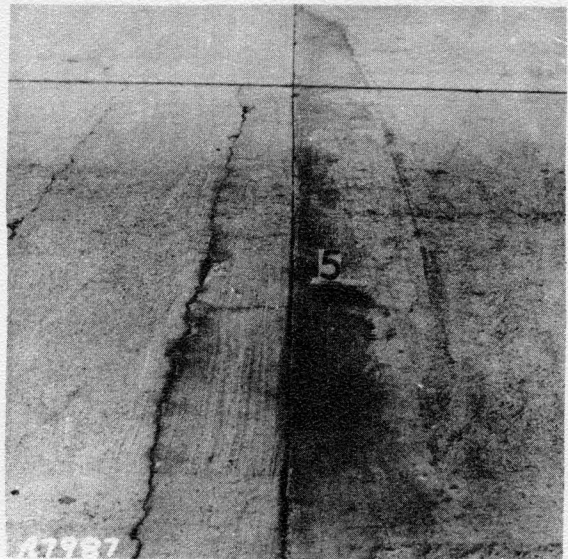
FIGURE B-2

Area Removed for Repairs
