TEXAS TECH UNIVERSITY

Project Level Performance Database for Rigid Pavements in Texas, II

Sung Woo Ryu, Sureel Saraf, Moon C. Won

Report #: 0-6274-1
www.techmrt.ttu.edu/reports.php

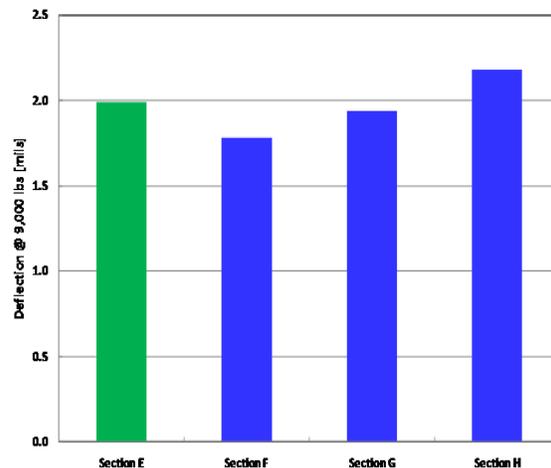
Figure 2.4 Average Mid-Crack Deflections of Each Section

Figure 2.4 shows that Section F has the lowest deflections, and Section H has the largest. Section F has the lowest steel percentage and Section H has the highest. It was anticipated that Section H would have the lowest deflections, since a larger amount of steel will keep the cracks tighter and reduce deflections even at the mid-point between two transverse cracks. The testing results do not support this idea. Figure 2.5 shows crack spacing and deflection relations for the four sections. Deflections here are those at mid-point between two transverse cracks. It shows that deflections at four locations on Section H (largest steel percentage) are particularly high, which led to the highest average deflections as shown in Figure 2.4. Without those four points, deflections could be fairly comparable in all sections. There is no clear trend between crack spacing and deflections, even though it appears that deflections decrease somewhat with increased crack spacing. Considering the precision of FWD deflections and the variability in slab thickness and subbase support, the effect of crack spacing on deflections is negligible.

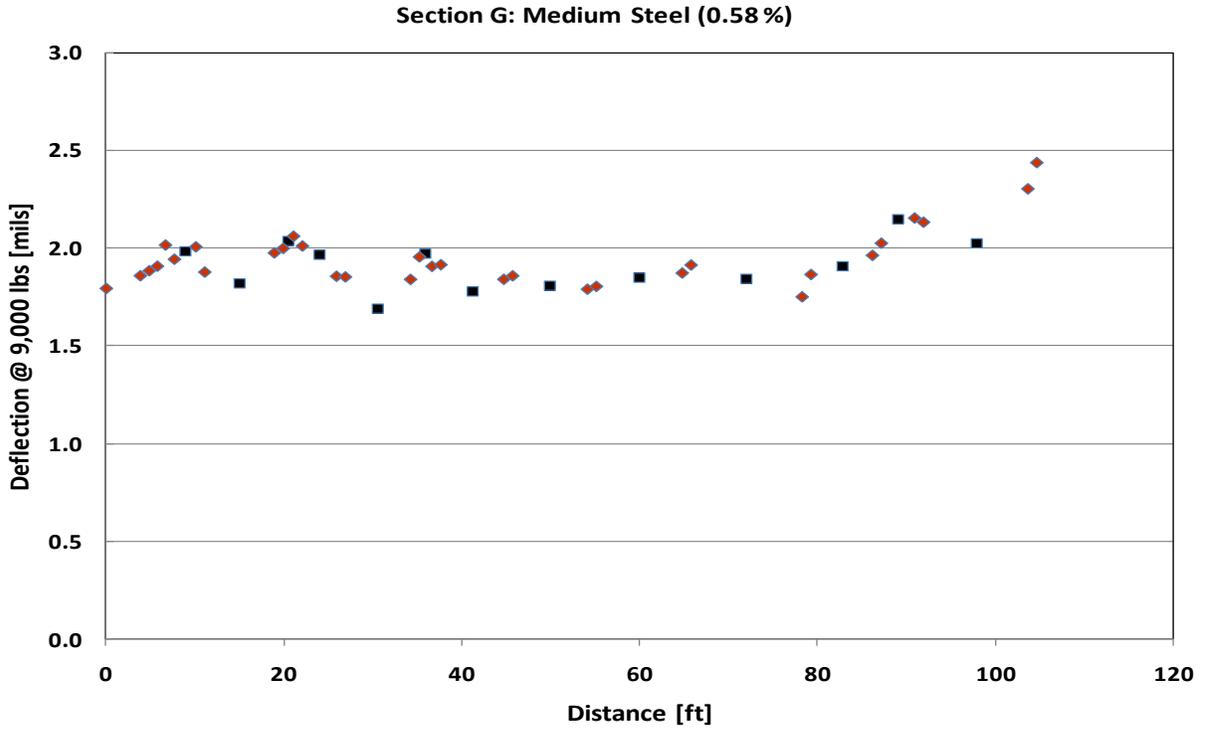
Figure 2.6 Deflections at Section G

Figures 2.6 and 2.7 show deflections in Sections G and H, respectively. Black squares represent deflections at the mid-point between cracks, and red diamonds represent deflections at upstream and downstream of cracks. Figure 2.6 shows that deflections at mid-point between cracks are

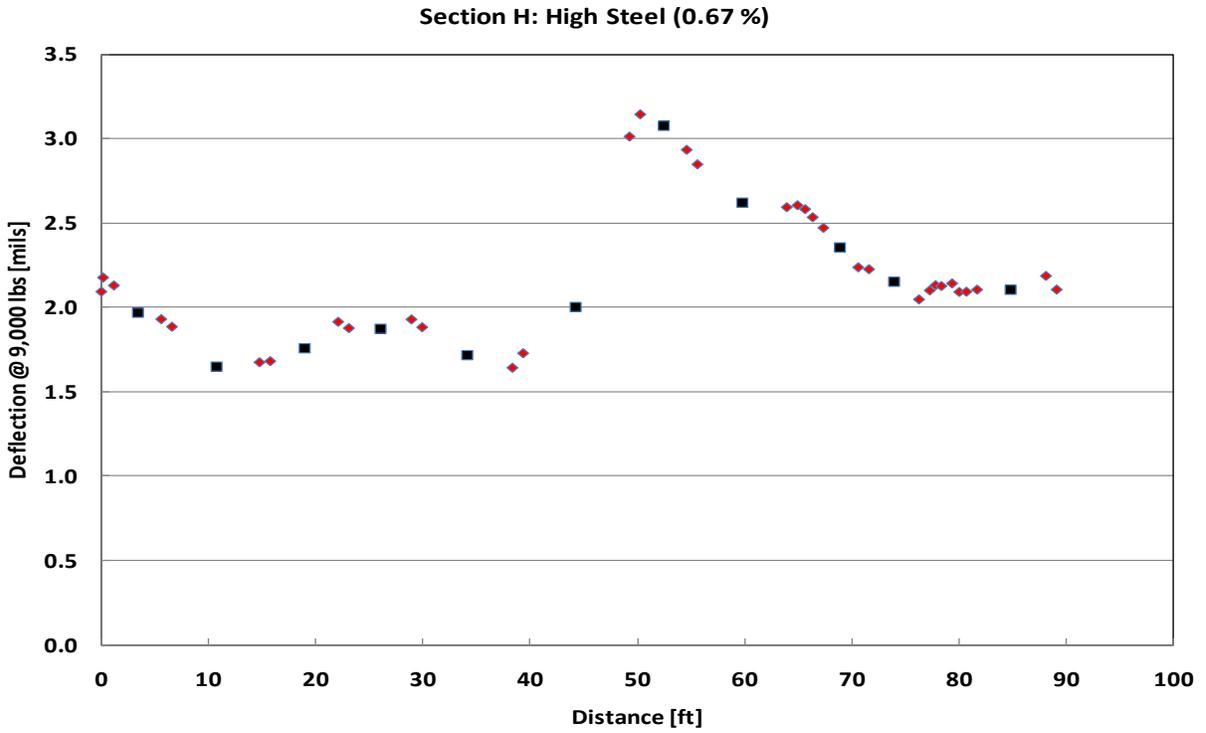
Figure 2.7 Deflections at Section H

lower than those at nearby cracks. On the other hand, Figure 2.7 shows that deflections at the mid-point between cracks register in between the deflections at nearby cracks. This might indicate that the support condition or slab thickness in Section H is not uniform. According to Westergaard equations, slab thickness has a substantial effect on slab deflections, and unless slabs are constructed with quite uniform thickness, the effects of steel percentages on slab deflections would be quite difficult to evaluate, as shown here.

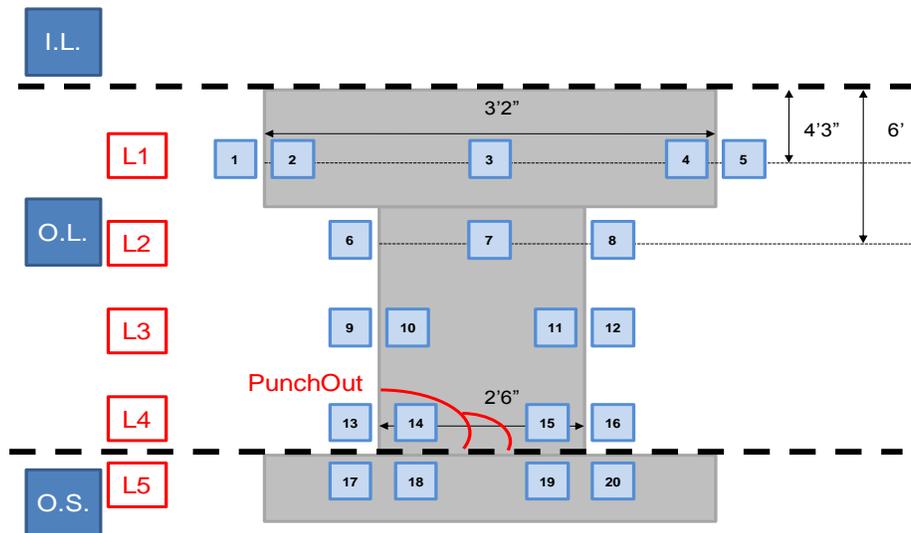
Figure 3.2 FWD Testing Location

Distresses were observed in several locations and the area office staff repaired the distresses. The distress shown in Figure 3.1 was repaired on May 4, 2010. Repair work was performed by the area office staff and forensic evaluations were conducted during the repair. Before the repair work began, deflection testing using falling weight deflectometer (FWD) was conducted. Figure 3.2 shows the locations of FWD testing. IL stands for inside lane, OL for outside lane and OS for outside shoulder. L1 through L5 indicate longitudinal line number for FWD testing. Most of the testing was done in the outside lane, with four locations in the outside shoulder.

It's quite interesting to note that even though the deflection at loading location #16 was quite high, that at loading location #15 was much smaller. As will be discussed later, both longitudinal and transverse steel were broken. The large difference between deflections in loading locations #15 and #16 indicates that there was a void under the slab at loading location #16, while no void existed under loading location #15. The direction of traffic is from left to right in Figure 3.2. In jointed plain concrete pavement (JCP), at transverse contraction joints with faulting, leave ends of the slabs are always depressed and approach ends of the slabs are always lifted. Figure 3.5 shows a typical faulting. When a vehicle is approaching a joint and there is water in the subbase material, it pushes materials under the slab in the approach side of the joint into and under the slab at the other side of the joint. When a vehicle passes the joint, it pushes the materials under the slab back to the other side of the joint, causing voids under the leave side of the slab at the joint. It appears that the same mechanism was at work at a transverse crack between load locations #15 and #16 in Figure 3.2.

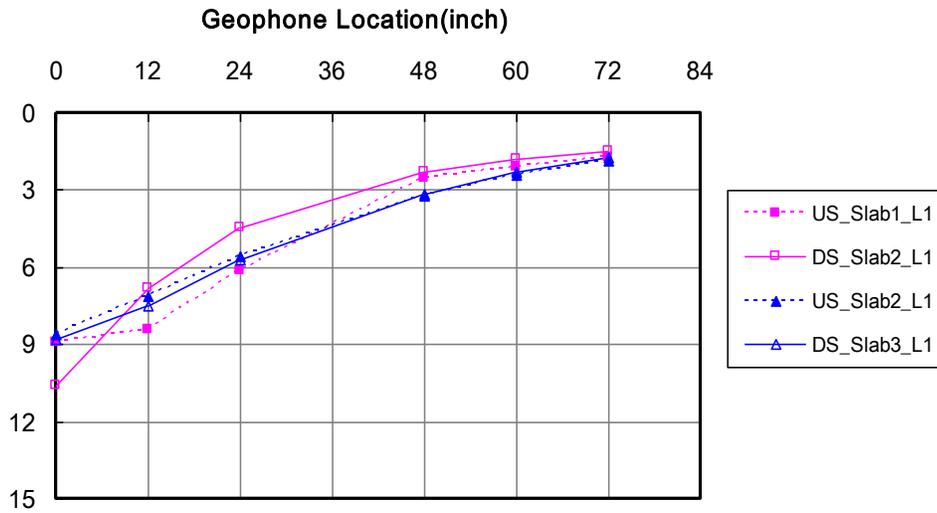
Figure 3.3 Deflections along L1

The deflections along L1 are shown in Figure 3.3. Deflection bowls are illustrated at four locations: upstream at transverse crack between loading locations #1 and #2 in Figure 3.2 (loading location #1), downstream at the same crack (loading location #2), upstream at transverse crack between loading locations #4 and #5 (loading location #4), and downstream at the same crack (loading location #5). The notation for slab is that Slab 1 is the CRCP on the left side of the left transverse crack with asphalt sealing in Figure 3.1, Slab 2 is the portion of concrete within two closely spaced transverse cracks, which includes punchouts, and Slab 3 is the CRCP on the right side of the right transverse crack with asphalt sealing. There were asphalt patches in this area, and efforts were made to place the loading plate and all sensors away from asphalt patches. Figure 3.3 shows that the deflections at 9,000 lb are about 9 mils. The deflections are quite large, considering the average deflection for 9-in. CRCP sections in Texas (according to the rigid pavement database) is about 3 mils. This large deflection is an indication of ruptures of either longitudinal steel or tie bars. In this testing, sensor #4 was placed on the other side of the loading plate for LTE evaluations. LTE at both transverse cracks were over 90 percent, even though there was a distress. As will be discussed later, high LTE values at transverse cracks that are undergoing punchout distress question the value of LTE in CRCP evaluations. Maximum deflections with respect to the statewide average deflections for the same slab thickness might be a better indicator of the structural condition of CRCP.

Comparisons of Figures 3.3 (distressed area) and 3.13 indicate that poor subbase support condition in the distressed area is responsible for the distress. It appears that there was a rather large variability in the support conditions in this project, and distresses occur where support conditions are poor.

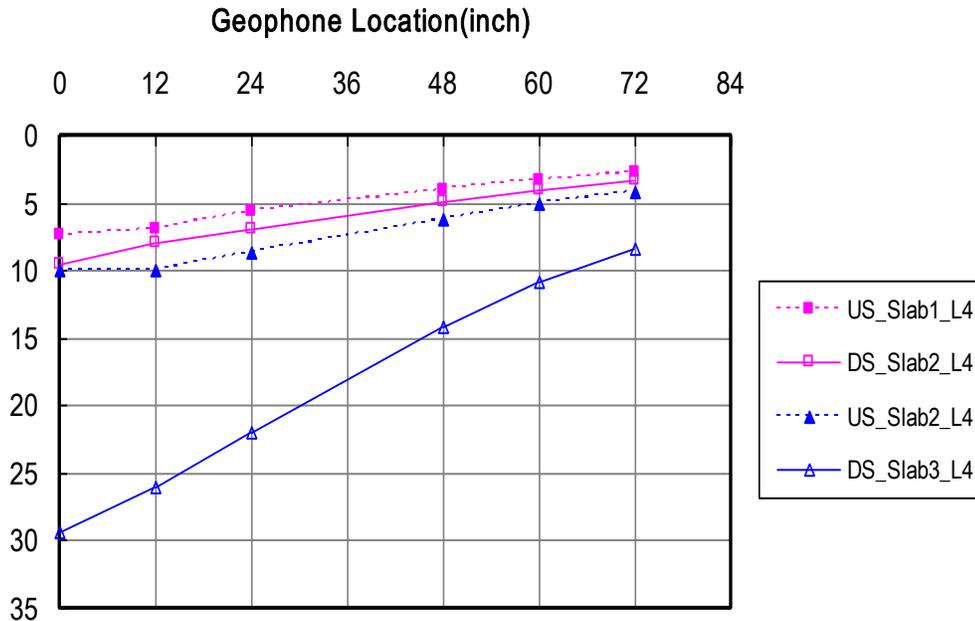
Figure 3.4 Deflections along L4

Figure 3.4 illustrates deflections along L4, which is at the longitudinal warping joint. Large deflection of about 30 mils is shown in the loading location #16 (see Figure 3.2). This large deflection is possible only if there is a steel rupture, whether it's longitudinal steel and transverse steel, and voids or weak subbase are present under the slab. The deflection at loading location #14 (DS_Slab2_L4 in Figure 3.4) is comparable to those of loading locations #13 and #15, even though the loading was applied on the slab segment isolated by cracks (Figure 3.1). This indicates that cracks themselves in CRCP, whether they are longitudinal or transverse, do not necessarily cause large deflections or distresses.

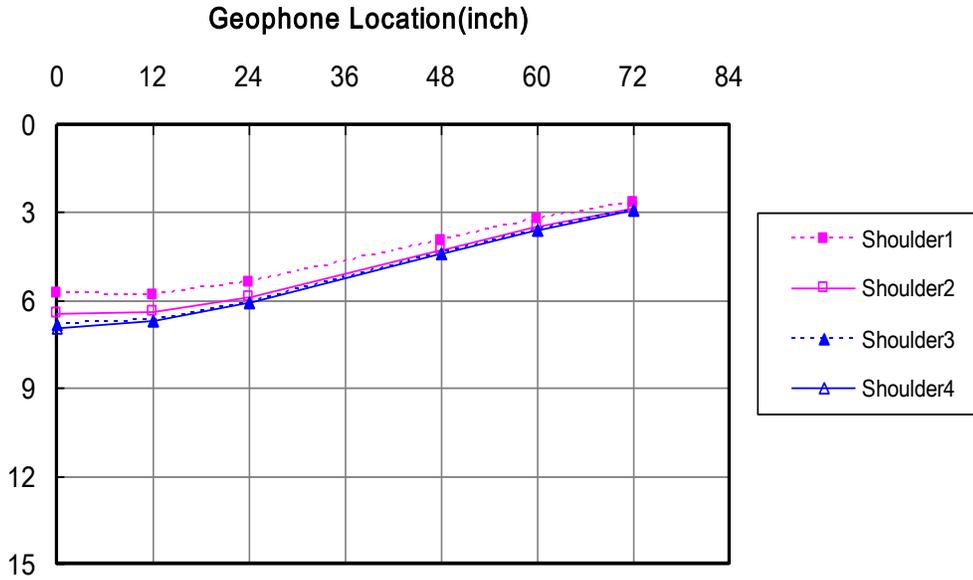
Figure 3.9 Deflections along L5

FWD testing was also conducted along L5, near the longitudinal warping joint in the outside shoulder (Figure 3.2). Figure 3.9 shows the deflection bowls at four locations (loading locations #17, #18, #19 and #20) (Figure 3.2). It shows that the deflections are not excessive. It is interesting to note that the maximum deflection at “Shoulder 4,” which is at loading location #20 and next to loading location #16, is about 7 mils. The continuity of longitudinal steel itself doesn’t explain this low deflection value. Recall that Westergaard equation shows 10.5 mils of deflections if it is in edge condition, with 300 psi/in modulus of subgrade reaction. The maximum deflection of 7 mils indicates that modulus of subgrade reaction is larger than 300 psi/in. Even when there is a void under the slab near a longitudinal joint, it was observed on US 75 in Sherman in the Paris District that the subbase condition on the other side of the joint is in good condition. It is believe that the same phenomenon occurred here.

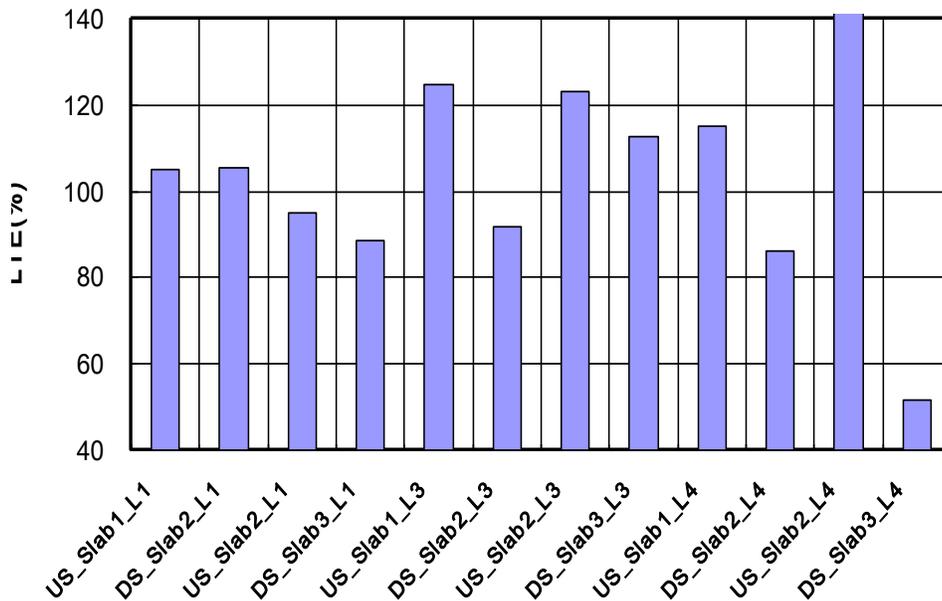
Figure 3.10 Load Transfer Efficiency at Transverse Cracks

- 1) Even though a punchout distress was in progress in the two transverse cracks, LTEs are maintained at a high level except at one location.
- 2) In general, LTE values at upstream were higher than those at downstream. It could be because of voids or weakened subbase support in the downstream side, as discussed above. In the upstream loading, sensor #4 deflection was relatively small compared to sensor #2 due to inadequate slab support in sensor #2 area, making the LTE at upstream larger. In the downstream loading, sensor #2 deflection was relatively high due to inadequate slab support and sensor #4 deflection was relatively low, resulting in smaller LTE at the downstream. This trend was not observed in the testing done in the rigid pavement database project. If subbase support condition at both sides of a crack is comparable, the LTEs at upstream and downstream should be similar.

- 3) There is a large difference in LTE values at loading locations #15 and #16 (US_Slab2_L4 and DS_Slab_3_L4). The deflection information in Figure 3.4, and the descriptions in above 2) explain the large difference in LTE.

- 4) Average LTE values at each location are all above 90 percent, even though there is non-uniform subbase support and the cracks are undergoing punchout distress. The current way of computing crack LTE may not be a good indicator of pavement condition. The ratio of upstream and downstream LTE, along with deflection of sensor #1, might be a better indicator.

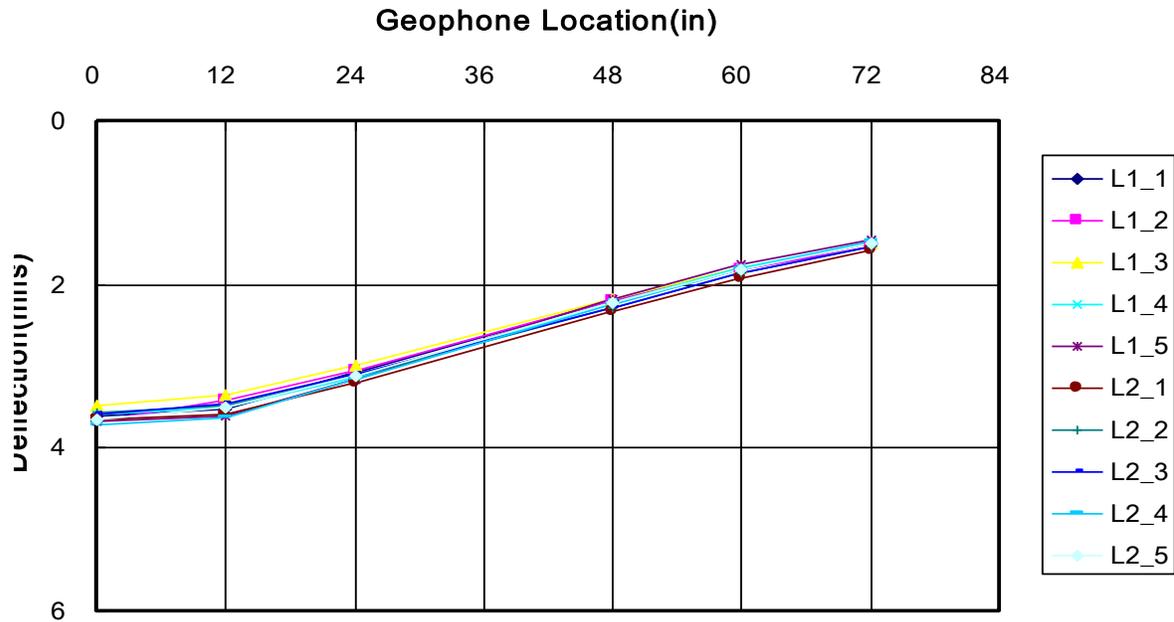
Figure 3.13 Deflections at Slabs with Large Crack Spacing at Both Locations

- 1) Maximum deflections were about 3.5 mils, which is much smaller than the values in the distressed area. This value is still a little larger than the statewide average for 9-in. CRCP.
- 2) Deflections were quite consistent, regardless of whether they were at cracks or the middle of the slab.
- 3) There was little difference in deflections between upstream and downstream locations.

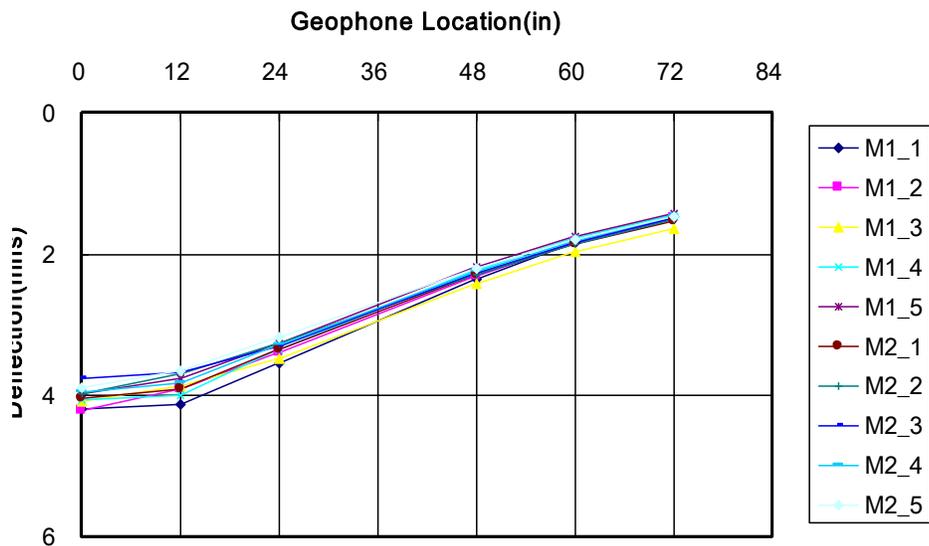
Figure 3.14 Deflections at Slabs with Medium Crack Spacing at Both Locations

Figure 3.14 illustrates the deflections obtained at Locations #1 and #2 for medium crack spacing. The findings can be summarized as follows:

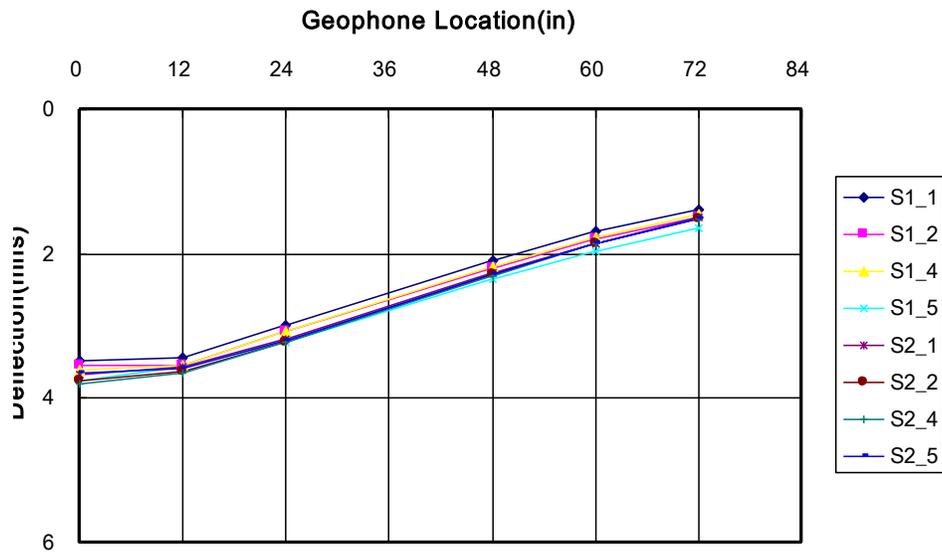
Figure 3.15 Deflections at Slabs with Small Crack Spacing at Both Locations

Figure 3.15 shows the deflections obtained at Locations #1 and #2 for small crack spacing. The deflections were quite similar to those for large crack spacing. Also, the maximum average deflection was smaller than that for medium crack spacing. In other words, there was no trend between crack spacing and maximum deflections. This is important because it confirms the findings from the rigid pavement database project that transverse crack spacing does not have an effect on deflections and LTEs. The fact that there was little difference in deflections between cracks and mid-slab indicates that cracks in CRCP are not necessarily weak elements in the pavement. They are there to relieve environmental stresses due to temperature and moisture variations. Also, this finding justifies the use of Westergaard's interior condition for stress and deflection analysis if the deflections are measured sufficiently away from longitudinal joints. One assumption needed for back-calculations of modulus values in pavement layers is the continuity of the concrete slab in both transverse and longitudinal directions, and CRCP will meet the assumption, as long as steel is not ruptured at transverse cracks.

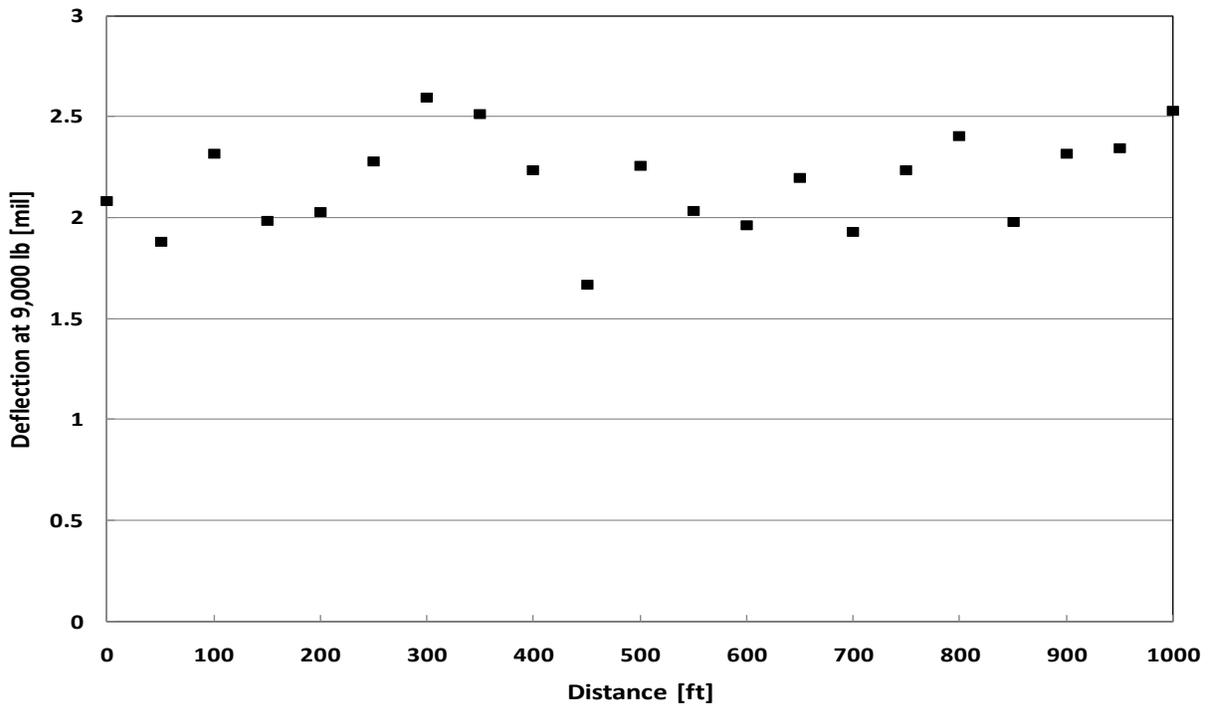
Figure 4.5 Deflection at 50-ft. Intervals at 12-US 290-1 Section in Houston

Figure 4.5 shows deflection data in the 12-US290-1 section in the Houston district. This section has a 10-in. slab and was built in 1992. The average deflection is 2.18 mils. There was a rather large variability in deflections. In this project, it was confirmed that the repeatability of well-calibrated FWD is excellent, and the variability in this section could be due to the non-uniformity in the slab support. In Chapter 3, it was shown that in CRCP, Westergaard's interior condition equation can be used to estimate subgrade modulus. Figure 4.6 shows deflections at the interior condition as affected by modulus of subgrade reaction (k). It shows that the k value varies from about 400 psi/in at the 300-ft. location to 900 psi/in at the 450-ft. location, with the average of about 650 psi/in. Even though there was no punchout distress in this section, eventually

punchouts will develop and it could be at the 300-ft. to 350-ft. location. This shows the need for better quality control during construction for slab support. Development and implementation of intelligent compaction could help achieve more uniform slab support.

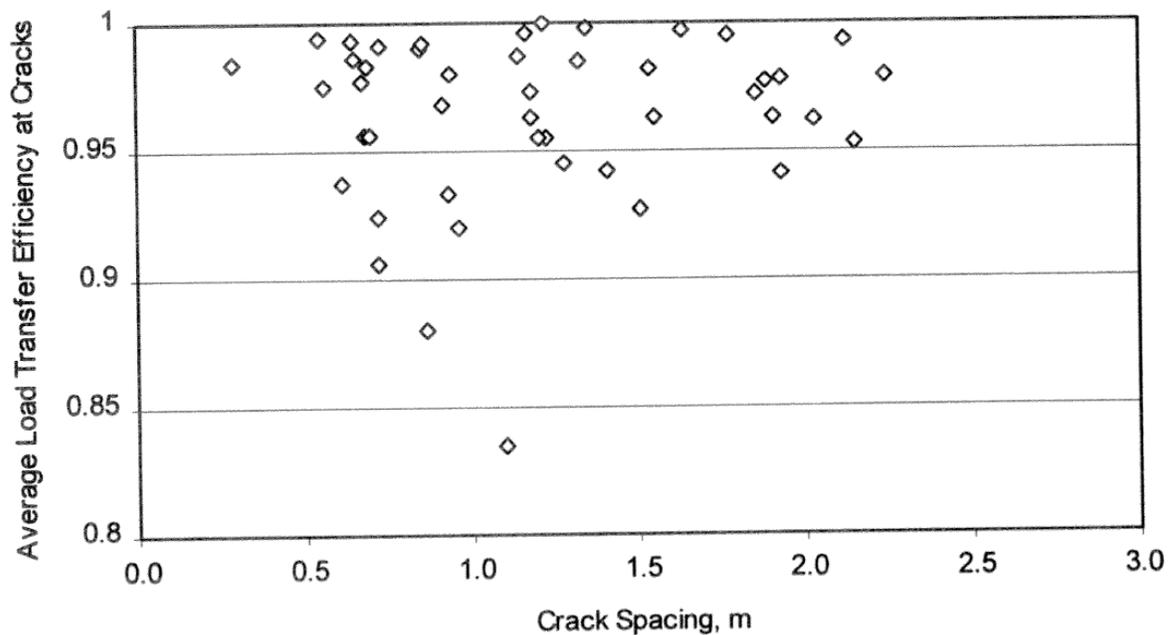
Figure 4.7 Effect of Crack Spacing on LTE from LTPP

It has been reported that LTE is an important structural response that has a significant effect on CRCP performance (ERES, 2004). It also has been reported that crack spacing should not be large, since large crack spacing will lead to large crack width and lower LTE (ERES, 2004). A hypothesis was made in the development of MEPDG for CRCP under NCHRP 1-37(A) that there is a good correlation between crack spacing and crack width, and between crack spacing and LTE. It was decided at the beginning of this research study that, based on the assumptions made in MEPDG, LTEs will be evaluated at three different transverse crack spacings. A primary objective was to evaluate the effect of crack spacing on LTE and to collect information on overall LTE values in CRCP in Texas. At each Level I section, 12 cracks were selected; 4 each for small, medium, and large crack spacing. Data collected so far could not validate the hypothesis in MEPDG. In other words, there was no good correlation between crack spacing and LTE. Figure 4.7 shows the correlation between crack spacing and LTE from the LTPP database (FHWA, 1999). No correlations were observed. It was also noted that more than 96 percent of the cracks had LTE values higher than 90 percent, and the other 4 percent (2 cracks) had more than 80 percent LTE. LTE values obtained in the TxDOT database project also confirm the findings from LTPP. There is no correlation between crack spacing and LTE.

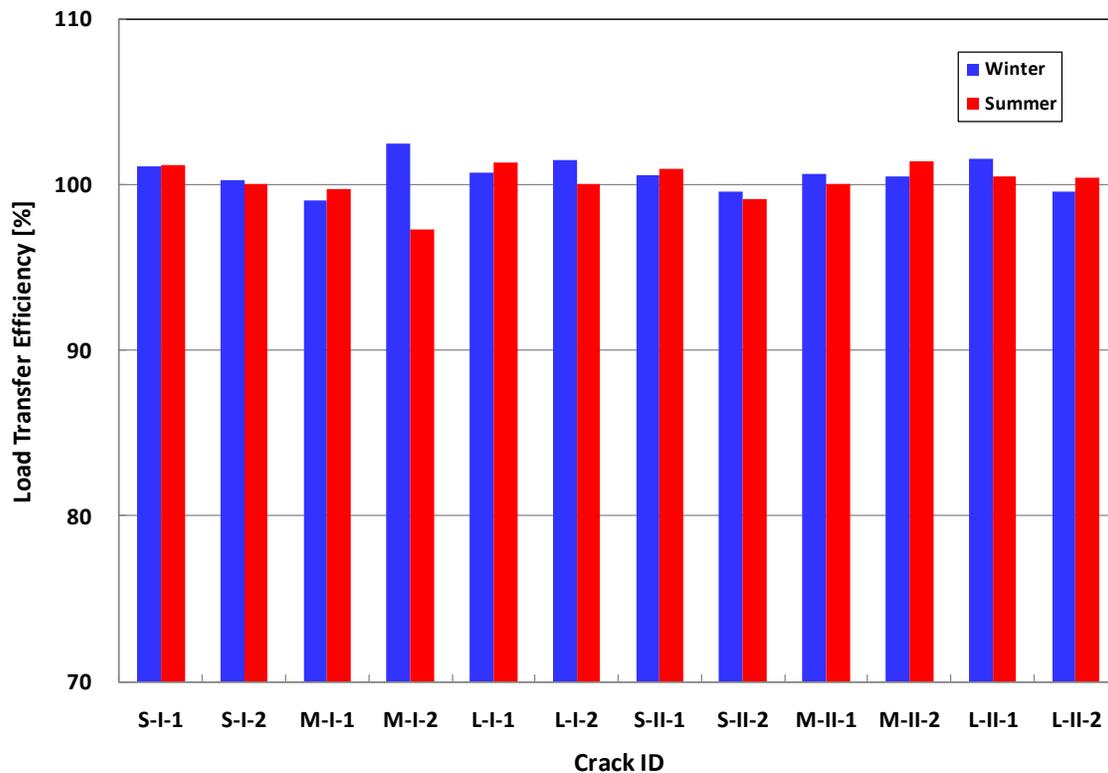
Figure 4.8 LTE Values from 24-I 10-4 in El Paso District

Figure 4.8 shows the LTE values obtained in FY10 at the El Paso Section (24-I10-4). S stands for “short” crack spacing, M for “medium” crack spacing, and L for “large” crack spacing. Blue bars indicate LTE values in the winter and red in the summer. In this project, LTE testing was conducted in the summer and in the winter. The objective of the testing in two seasons was to evaluate the temperature effect on LTE. Figure 4.8 shows that LTEs are all quite high, and there was no practical difference between winter and summer testing. The testing results obtained so

far show no temperature effect. Also, no correlations were observed between crack spacing and LTE. This trend has been consistent from the beginning of the project and in all test sections.

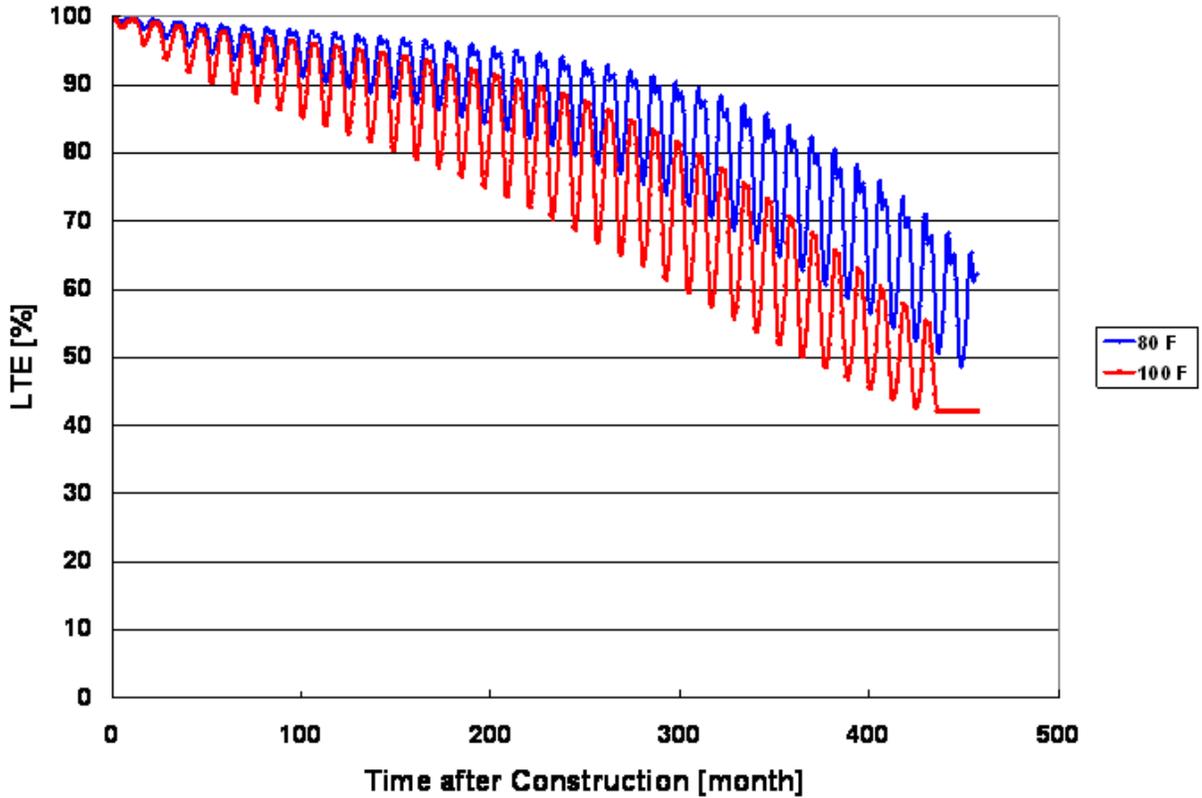
Figure 4.9 LTE Variations over Time from MEPDG

Figure 4.9 shows the LTE output from MEPDG. It shows that LTE was high in the summer and low in the winter. This is because MEPDG assumes that crack width varies with temperature. In the summer, concrete volume expands and crack width becomes smaller, which leads to higher LTE. On the other hand, in the winter, concrete volume contracts and crack width becomes larger, leading to lower LTE. Figure 4.9 also shows that LTE decreased to as low as 40 to 50 percent at the end of design life. It appears that the crack width and LTE models in MEPDG over-estimate the effect of temperature and crack spacing. Extensive deflection testing conducted in this project over the years produced a consistent trend – crack spacing and temperature do not have any effect on LTE. LTPP also confirms no effect of crack spacing on LTE.

As discussed in Chapter 3, it appears that LTE is not a good indicator of CRCP performance. LTE is an important variable if the punchout mechanism involves widening of crack, and resulting decrease in LTE. Evaluations of punchouts in Texas do not support this punchout mechanism. Punchouts occur when there is deficient slab support, either by voids or degradation of subbase materials. As long as there is adequate slab support, LTE values are maintained quite high. All the LTE information collected in this study shows that almost all the cracks have LTE values higher than 90 percent regardless of crack spacing, slab thickness, age of the pavement or season of testing. LTE variations shown in Figure 4.8 could not be found.

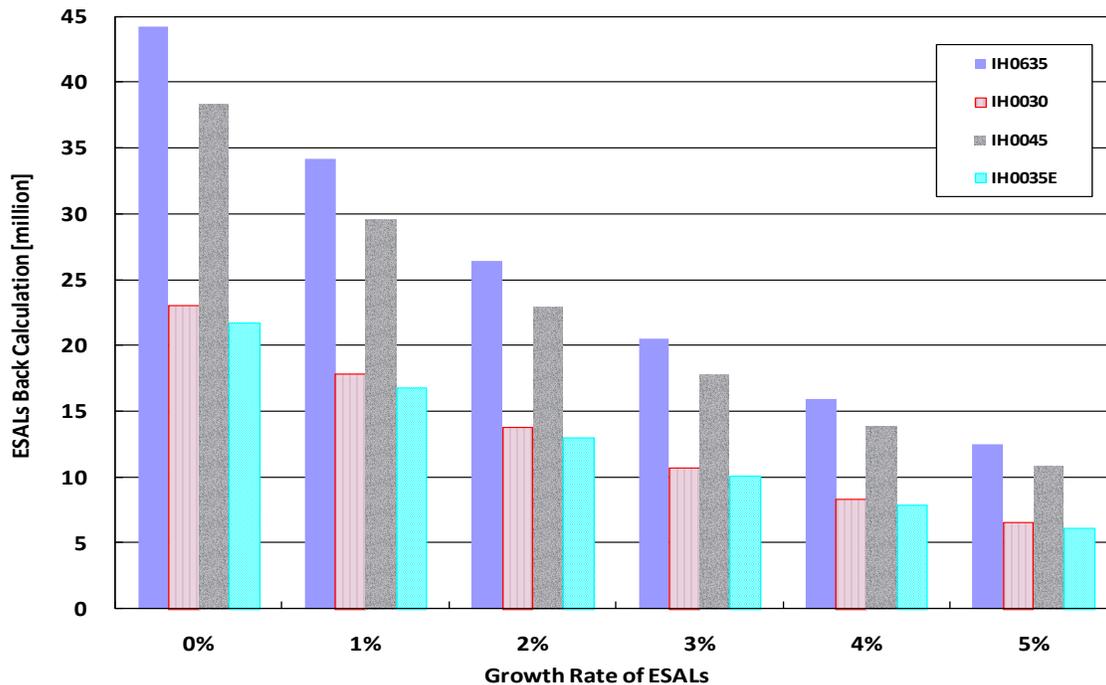
Figure 5.1 Estimated Accumulated ESALs for Various Growth Rates

The selection of 4 % was arbitrary. Unfortunately, traffic growth rate has a substantial effect on traffic data. Figure 5.1 illustrates the effect of traffic growth rate on estimated accumulated ESALs.

In the development of Figure 5.1, 20-year ESALs were obtained from PMIS and the procedure described above was followed. It shows a substantial effect on the past ESALs. For example, for IH 635, with 0 percent growth assumed in the future and in the past, the accumulated traffic from the construction of the pavement is about 44 million ESALs. On the other hand, with a three percent growth rate, the value becomes less than half of the value with a 0 percent growth rate. Similar trends were observed in other highways as well. In other words, arbitrarily selecting traffic growth rate could result in over-estimation or under-estimation of past ESALs. This could be a problem when developing a transfer function. Unless there is a reasonable traffic growth rate available, traffic back-calculation from PMIS should not be used. For a transfer function to be reasonably accurate, all three elements – punchout rate, traffic, and estimated damage in pavement – must be reasonably accurate. Out of these three, the estimates for punchout rate and estimated damage in pavement can be made with certain accuracy. Pavement engineers and researchers have some control on those two variables. On the other hand, obtaining reasonably

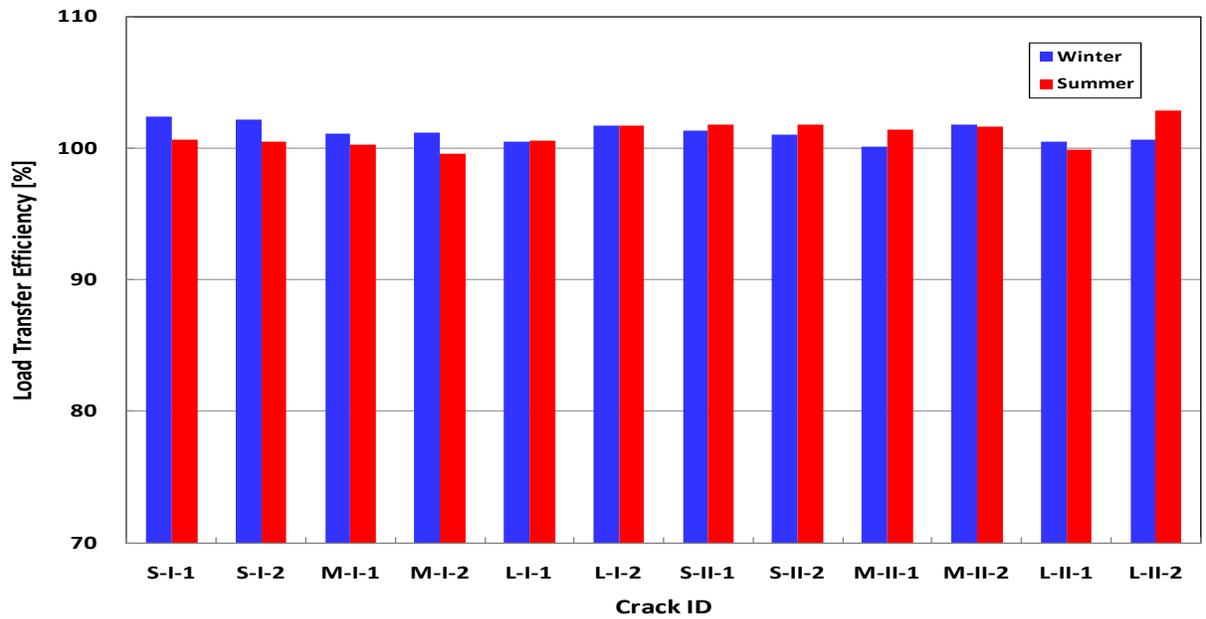
Figure E.14 LTE Evaluations in FY10 [25-I40-2]

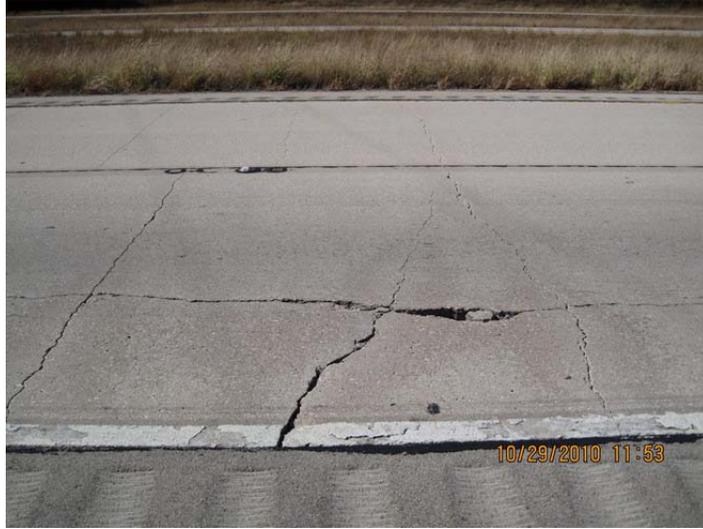
E-PCH (US81 Wichita Falls)

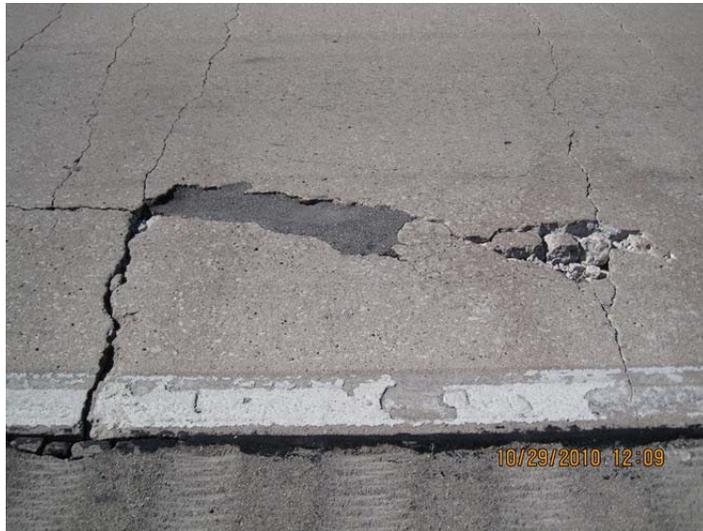
E-PCH (US81 Wichita Falls)

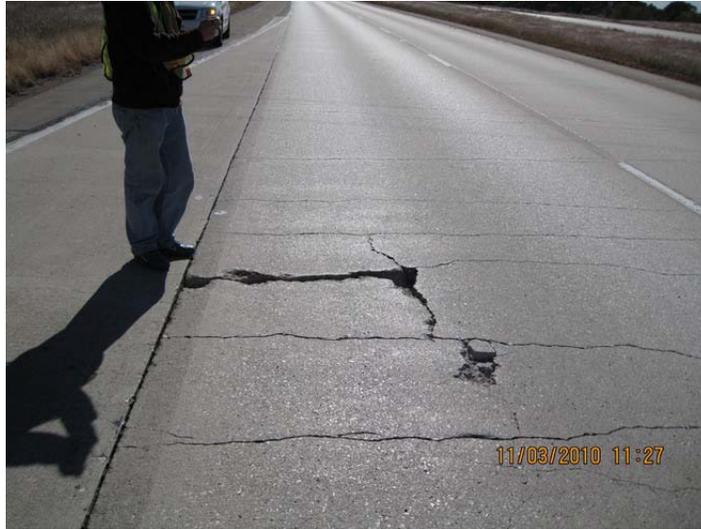
E-PCH (US81 Wichita Falls)

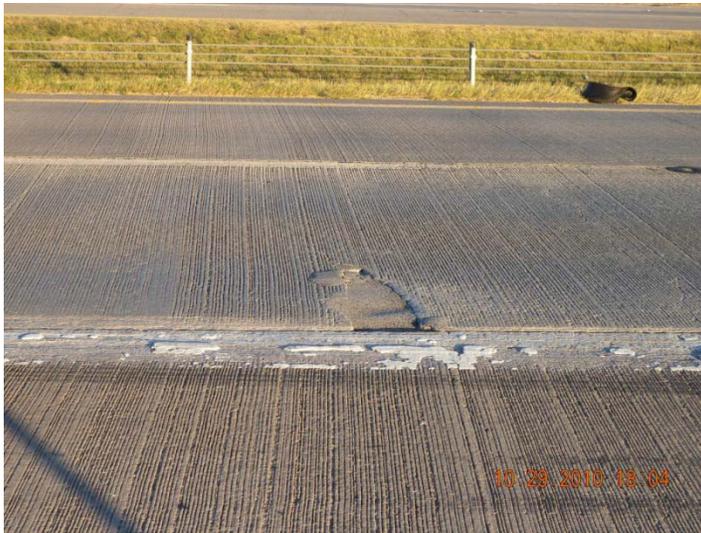
E-PCH-PTB (IH35-Wichita Falls)

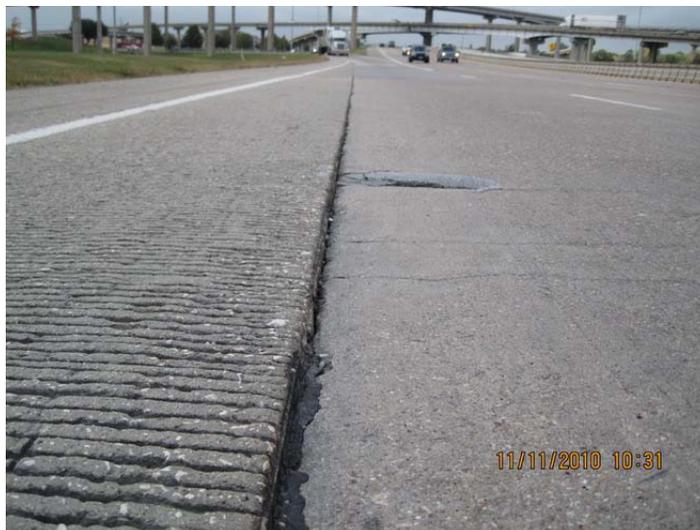
E-PCH-PTB (IH30-Dallas)

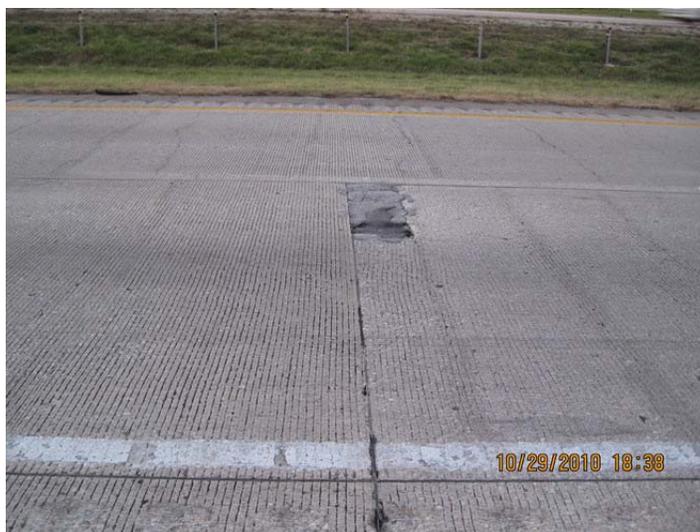
PCH-CJ (IH35-Wichita Falls)

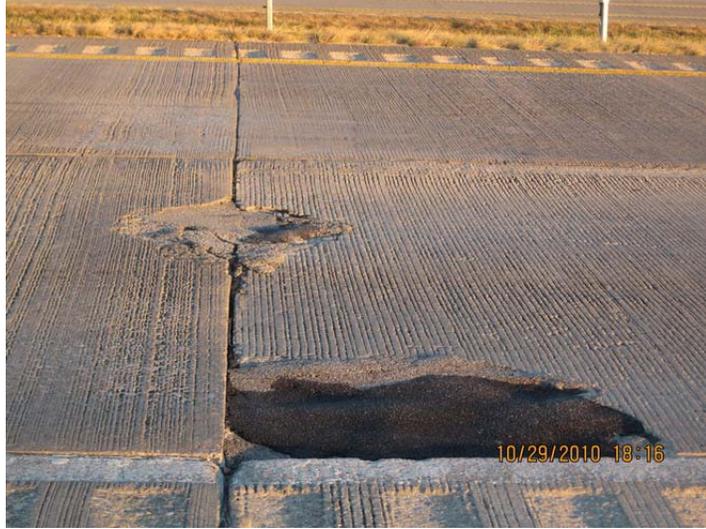
PCH-CJ (IH35-Wichita Falls)

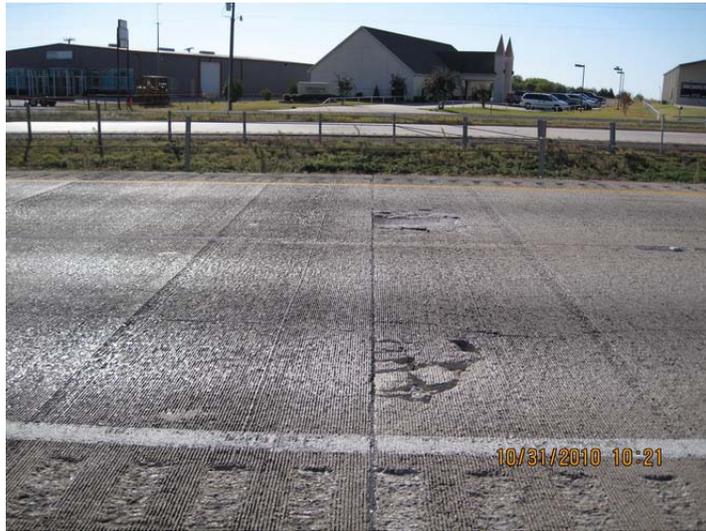
PCH-CJ

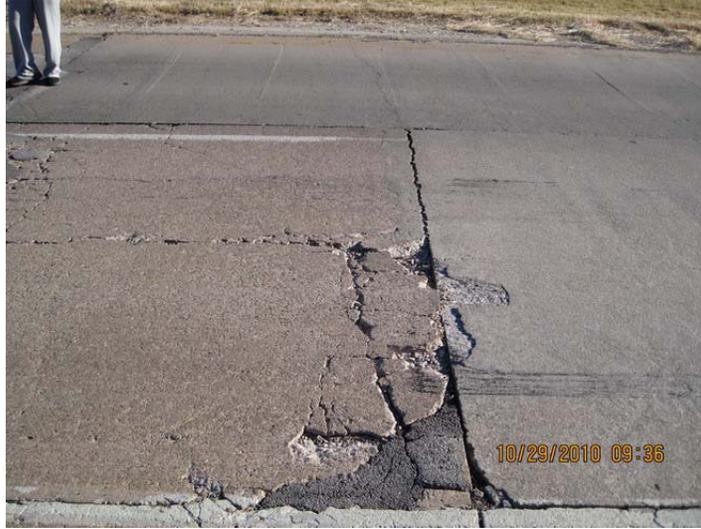
PCH-RJ

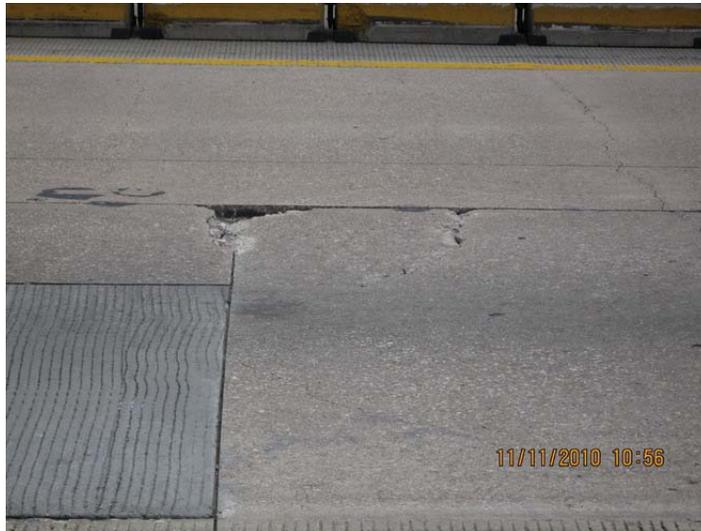
PCH-RJ (IH30 Dallas)

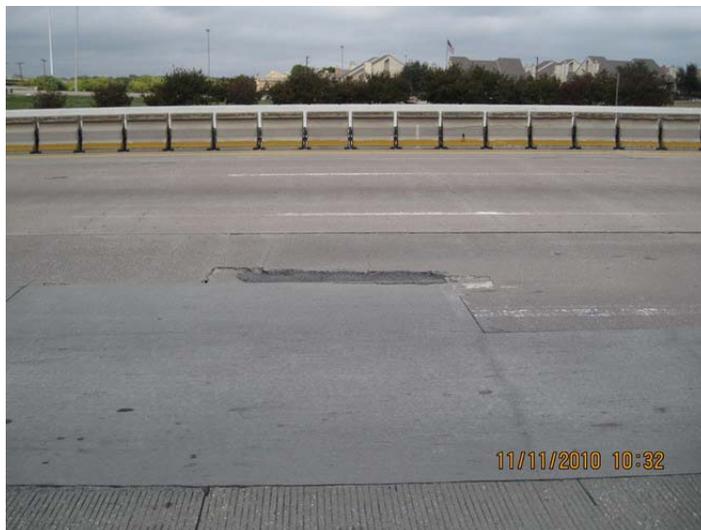
PCH-RJ (IH30-Dallas)

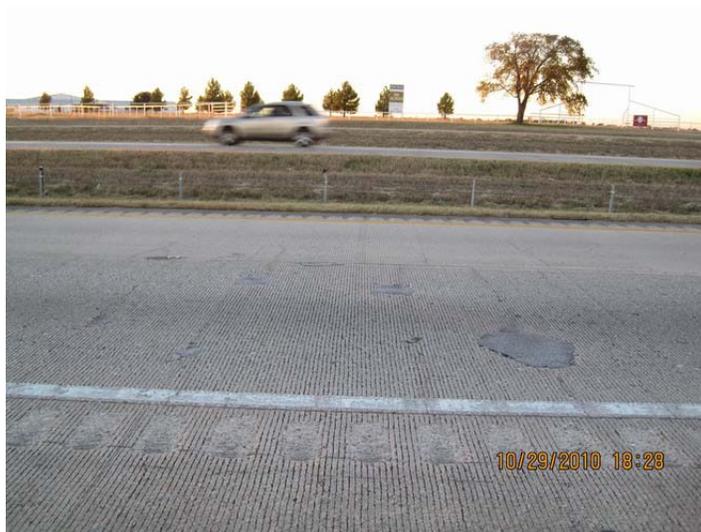
BS-PCW (IH35-Wichita Falls)

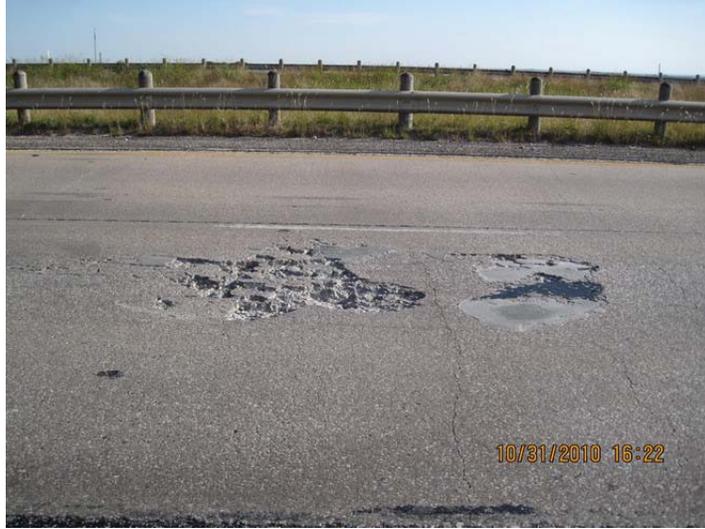
BS-PCW (SH114-Dallas)

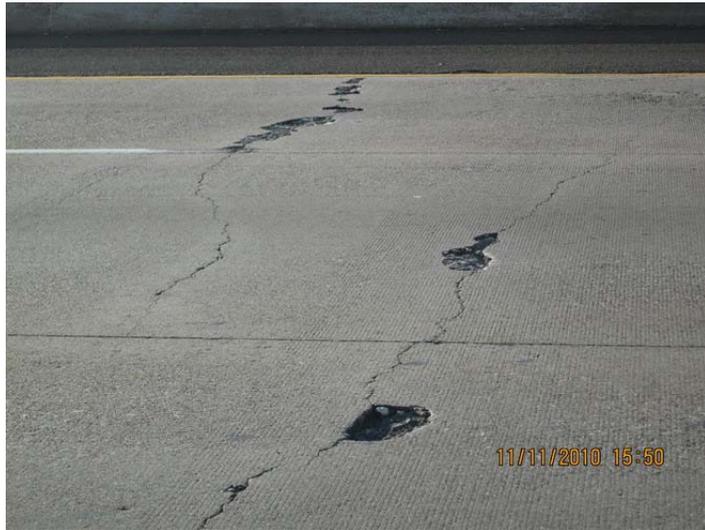
BS-PCW (SH360-Fort Worth)
