TEXAS TECH UNIVERSITY

Improvements of Full Depth Repair Practices for CRCP Distresses

Report #: 0-6611-1
www.techmrt.ttu.edu/reports.php

September 2013

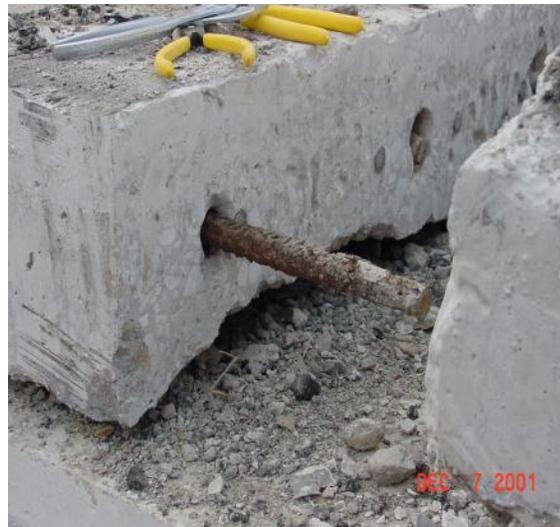
The effectiveness of this method also varied. A substantial portion of the repairs done with this method resulted in further distresses and needed further repairs within a few years. Figure 1.2-(a) shows the distress of the repairs done in this method. Figure 1.2-(b) shows a gap between Tie bars used for previous repairs and surrounding concrete. Since the full-depth cut face of concrete at repair boundaries is smooth, the load transfer efficiency (LTE) at repair joints is achieved primarily by Tie bars and base support. If bonding between Tie bar and surrounding concrete is not fully achieved, the Tie bar might become loose and shear mode failure or reduction in load transfer could occur due to repetitive traffic and environmental loading. Accordingly, it is imperative that Tie bars are fully bonded to existing concrete.

Figure 1.2- (b) Gap between tie bar and surrounding concrete

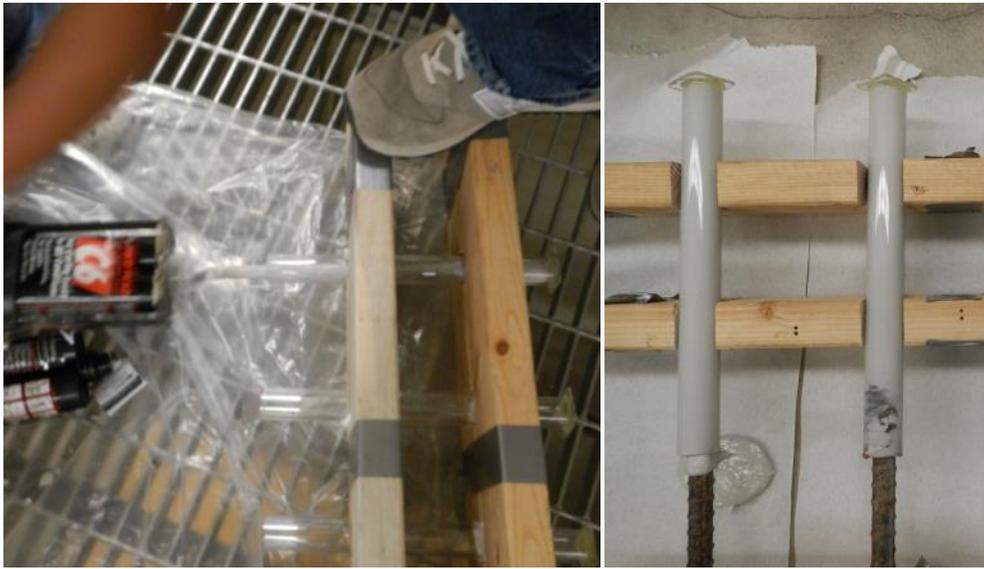
even in the non-compliance method of epoxy injection, tie bars were coated with a large quantity of epoxy – enough to fill the voids between tie bars and concrete. Also, in every non-compliance method, it was observed that there was excess epoxy draining down from the holes. To further investigate the mechanism for the low bond strength of the “Non-compliance” method, experiments were conducted, where epoxy was injected into 12-in long and 7/8-in diameter transparent plastic tubes using both methods. Figure 3.3-(g) shows the simulated condition of the epoxy inside a hole when epoxy is injected by the method specified in Item 361. It shows that the hole is filled with epoxy. Figure 3.3-(h) shows the simulated condition of the epoxy inside a hole when epoxy is injected by the non-compliance method. The figure clearly shows voids inside the hole, which could explain the low bond strength shown in Figure 3.3-(f). It should be noted that, in this experiment, a tie bar was coated with more epoxy than needed to fill the voids between the tie bar and the tube wall. During the testing, it was noticed that a large amount of epoxy was flowing out of the tube, similar to what was observed in the field when epoxy was injected by the non-compliance method. The voids shown in Figure 3.3-(h) are not due to a deficient amount of epoxy coated in a tie bar; instead, it appears that air inside the tube was compressed while a tie bar coated with epoxy was being inserted, pushing the epoxy toward the outside of the tube. This mechanism might explain the large drain downs of epoxy in the field when epoxy is applied with the non-compliance method, as well as the low bond strength and poor performance of FDR. On the other hand, when epoxy is applied as specified in Item 361, a tie bar pushes the epoxy towards the entrance of the hole, pushing air out of the hole and filling the hole with epoxy with no void, as shown in Figure 3.3-(g), explaining a good bond strength and FDR performance.

Figure 3.3- (g) “simulated” epoxy injection by the method specified in Item 361

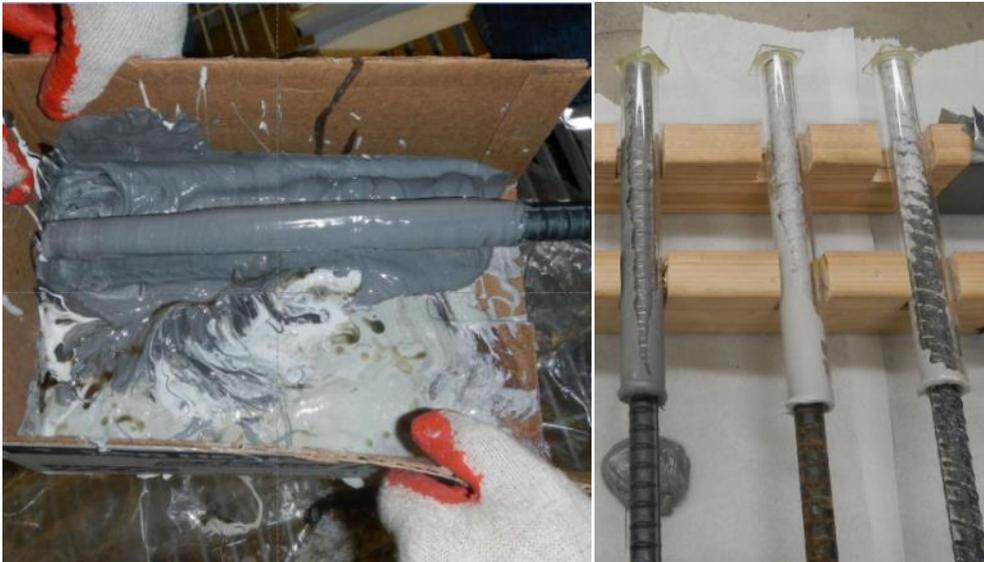
Figure 3.3- (h) “simulated” epoxy injection by “Non-compliance” method

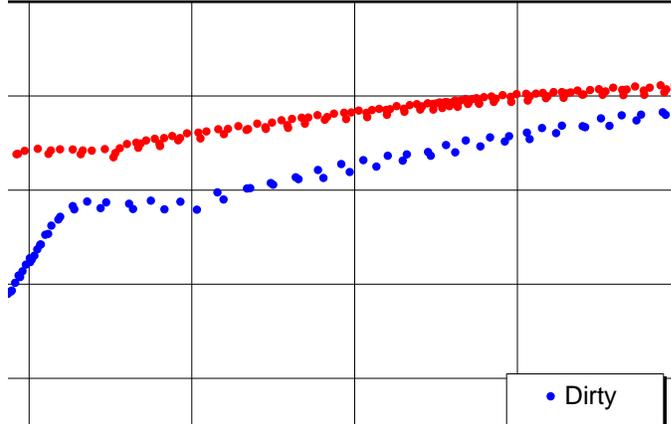
Figure 3.7- (b) Pullout test result for the cleanliness of drilled hole

Current Item 361 does not require hole cleaning before epoxy injection. Drilling operations generate large quantities of dust and, unless cleaned out, this dust will stay inside the holes and might reduce the bond strength. Figure 3.7-(a) shows the condition of drilled holes that were cleaned (left) and not cleaned (right) observed after pull-out testing. The effect of cleanness of the holes on the bond strength was evaluated, and Figure 3.7-(b) shows that, even though leaving dust in the holes before epoxy injection does not appear to adversely affect ultimate bond strength, the pull-out displacements are larger compared with those in clean holes due to larger shear strains at the interface between epoxy and dust. Epoxy injection without cleaning holes might result in widening of repair joint widths, reducing load transfer efficiency and leading to poor performance.

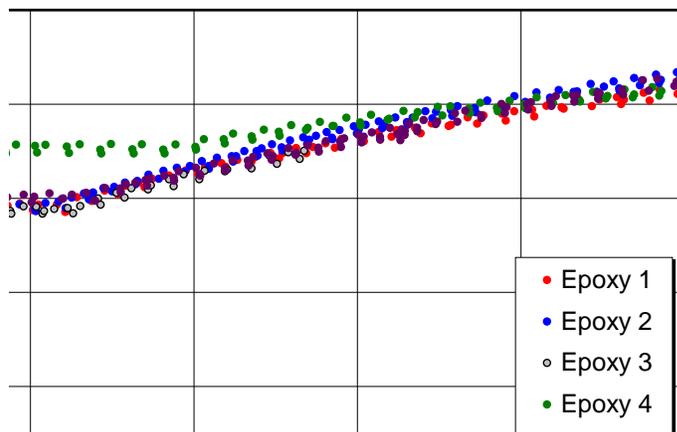
Figure 3.8- (b) Pullout test result for different epoxies

The materials requirements for Type III, Classes A and C appear to be inadequate in ensuring good performance of FDR, and materials that meet those requirements might not provide optimum FDR performance. Five epoxies were randomly selected from the list of TxDOT's approved list for Type III, Class C epoxy, and bond strength was evaluated ⁽¹⁰⁾. Figure 3.8-(a) shows five epoxies selected for the test. Figure 3.8-(b) illustrates that all five epoxies produced similar bond strength performance. This does not necessarily indicate the adequacy of the current requirements for Type III, Classes A and C epoxies in DMS 6100.

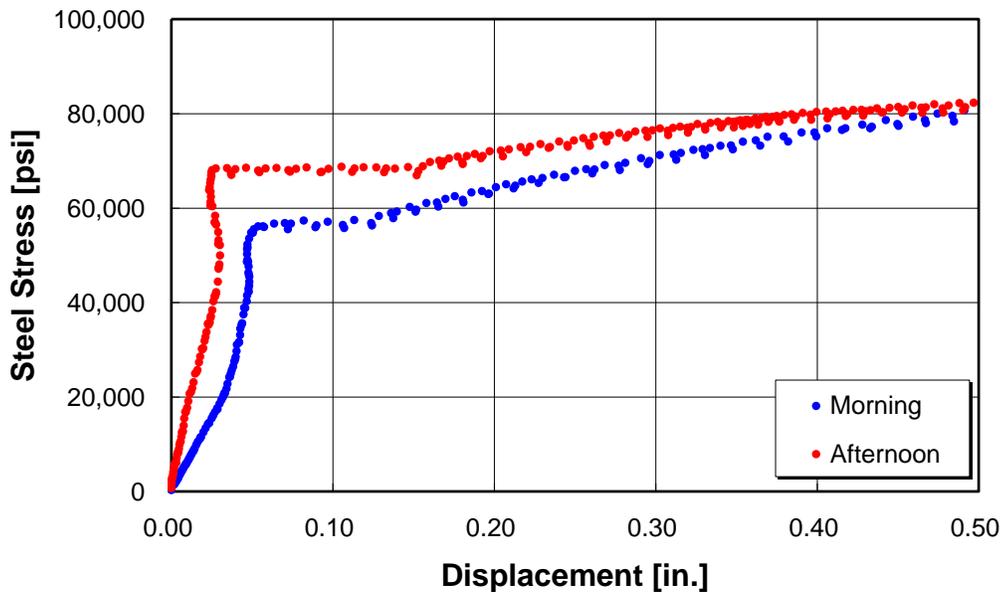
Figure 3. 9 Pullout test result for curing temperature

Since the chemical reactions between two parts of the epoxy are responsible for strength gain, the rate of strength gain of epoxy should depend on the curing temperature. Curing temperature effect was evaluated by injecting epoxy in the morning when the air temperature was about 50 °F, and in the afternoon when the air temperature was about 75 °F. Figure 3.9 shows testing results. A difference observed in the bond strength should be due to the different yield strengths of the tie bars used in the testing program. From a practical standpoint, there was no difference in bond strength or pull-out displacement. As long as air temperature during FDR is above 50 °F, the temperature effect should be minimal.

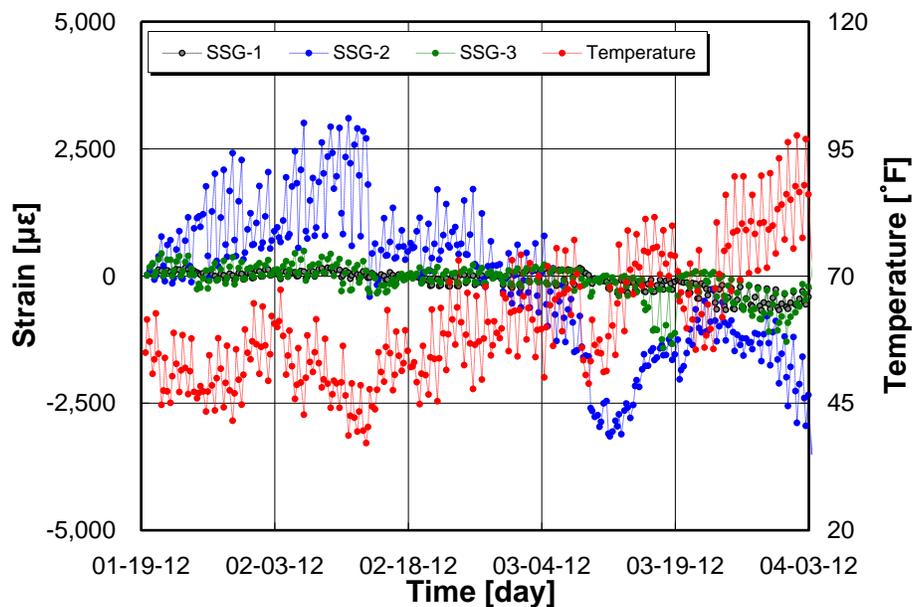
Figure 3.13- (a) Behavior of steel strain gages on tie bars

Figure 3.13-(a) shows the variations in steel strains for 2.5 months. Temperature was measured by thermocouples in concrete installed at the tie bar depth, which is the mid-depth of the 7-in concrete slab and 5.5-in from the new pavement surface. Little variations are observed in steel strains in SSG-1 and SSG-3. It appears that the holes were not completely filled with epoxy, and there was a debonding between tie bars and concrete. On the other hand, large variations are observed in strain gage SSG-2, which indicates that in this hole, epoxy was properly applied and adequate bonding achieved between tie bar and surrounding concrete. It is observed that the steel strain exceeded a yield point when the concrete temperature dropped in the middle of February. This high strain and stress in the tie bar #2 could be the result of a reduced number of tie bars and some tie bars not functioning properly due to poor bond between tie bars and concrete in the holes. Low subbase friction between concrete and natural subgrade could have contributed to the high strain in the tie bar as well. Later on, as concrete temperature went up, tensile strain in the tie bar decreased. Eventually, as concrete temperature further increased, steel strain became in compression. It is noted that from March 10 through March 14, 2012, concrete temperature dropped substantially. It is expected that tensile strain in the tie bar will increase due to the decrease in concrete temperature. However, tensile strain in the tie bar during that time period actually decreased substantially, resulting in a compression state due to a one-inch rain and

subsequent swelling of concrete on March 10, 2012. Figure 3.13(a) also shows that concrete temperature increased from March 15, 2012; however, strains in the tie bar moved in the tensile direction, which is contrary to what is expected. This is probably due to the shrinkage of concrete due to continued drying after the rain. After March 23, 2012, concrete temperature went up and so did the strains in the tie bar.

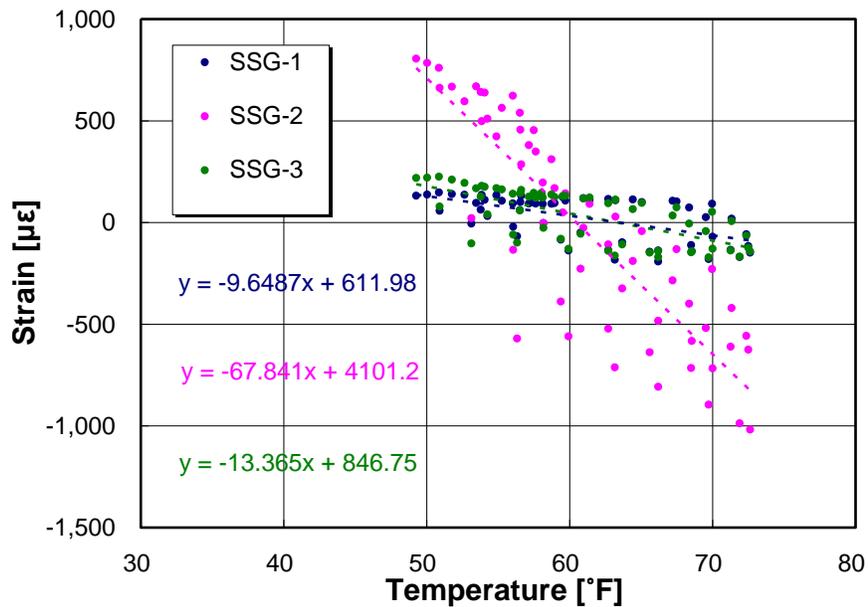
Figure 3.13- (b) Strain vs. temperature

Figure 3.13-(b) shows steel strain versus temperature from the 2nd to 4th of March, 2012. The rate of steel strain variations over temperature of SSG-2 was about five or seven times larger than those of SSG-1 and SSG-3, as expected. Poor bonding condition of SSG-1 and SSG-3 resulted in smaller variations of steel strain, compared with those of SSG-2.

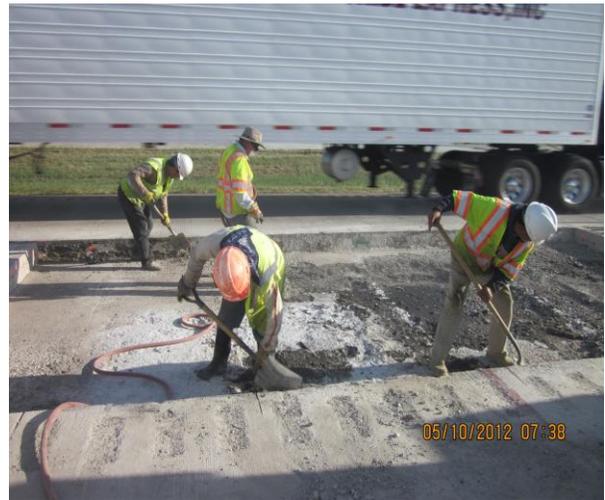
Figure 3.15- (b) Removal of loose base

The repair slab was 26.4 ft long and 12.6 ft wide and the repair was done in May, 2012. Holes were made with hammer drill, and the repair operations went smoothly. Figure 3.15-(a) shows the condition of the asphalt base after the slab was removed. The asphalt base in some areas was quite loose, indicating potential moisture damage and resulting CRCP distress. Figure 3.15-(b)

shows the operations of loose base material removal in accordance with the Item 361 requirement.

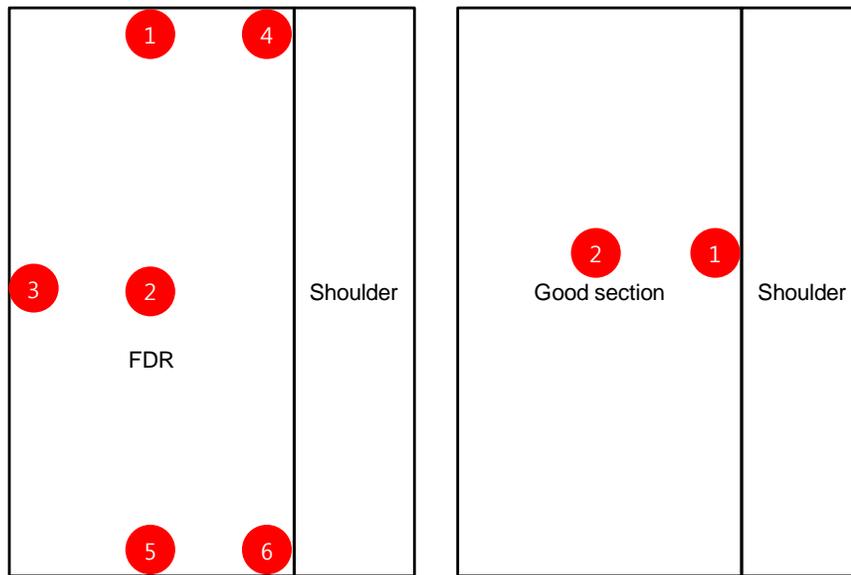
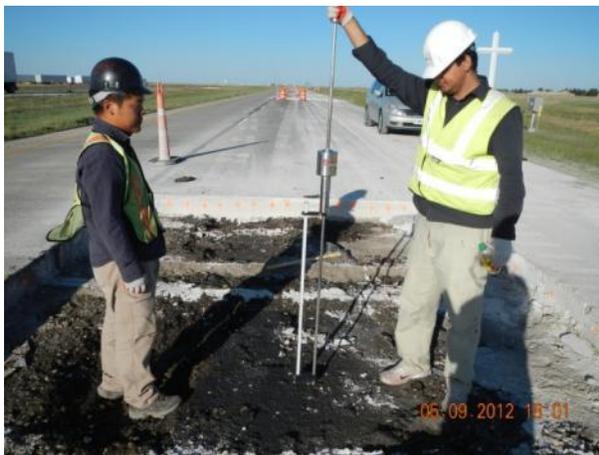
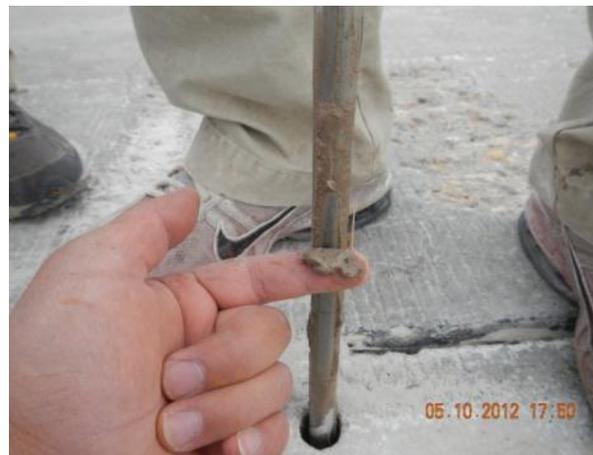
Since loose materials in the base course were observed in the distressed areas, further investigation was conducted to evaluate the base condition of the CRCP section in this area. A CRCP section in good condition was selected, and dynamic cone penetrometer (DCP) testing was conducted in the FDR area as well as in the CRCP section in good condition. Figure 3.16-(a) shows the DCP testing locations in the FDR area and CRCP section in good condition. Figure 3.17 shows resilient modulus values in each layer at both the FDR and CRCP section in good condition. In general, there was no significant difference in modulus values between two sections, and the modulus values were quite low. During the DCP test, it was confirmed that soil was saturated at both the FDR and CRCP section in good condition as shown in Figure 3.16-(c). It appears that moisture in the soil degraded soil stiffness and strength, and potentially caused stripping of asphalt base material, which resulted in larger deflections and subsequent distresses.

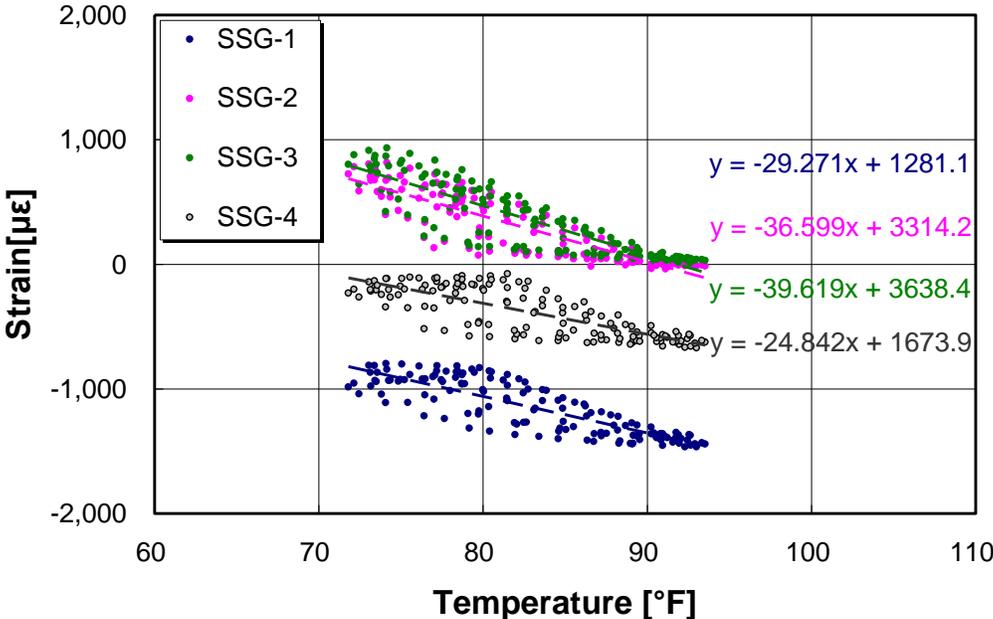
Figure 3.19- (a) Behavior of steel strain gages on tie bars

Figure 3.19-(a) shows steel strain rate vs. temperature measured from the 24th to 29th day of May, 2012. The steel strain rates ranged from -25 to -40 $\mu\epsilon/^\circ\text{F}$. Variations in the steel strain rates per temperature among the four tie bars in the Amarillo section were much smaller than those in the Wichita Falls section, which had the maximum and minimum rates of -68 $\mu\epsilon/^\circ\text{F}$ and -10 $\mu\epsilon/^\circ\text{F}$, respectively. It is presumed that the adequate bonding condition achieved in the Amarillo section by the proper method of epoxy application resulted in decreased variability in the steel strain rates per temperature. Also, the steel strains and stresses in the Amarillo section were much lower than those of the tie bar properly installed at the Wichita Falls section. Three factors – quality epoxy injection, adequate amount of tie bars, and reasonable base friction in the Amarillo section – apparently contributed to the lower values of strains and stresses as well as rate of steel strain rate per temperature in tie bars in the Amarillo section.

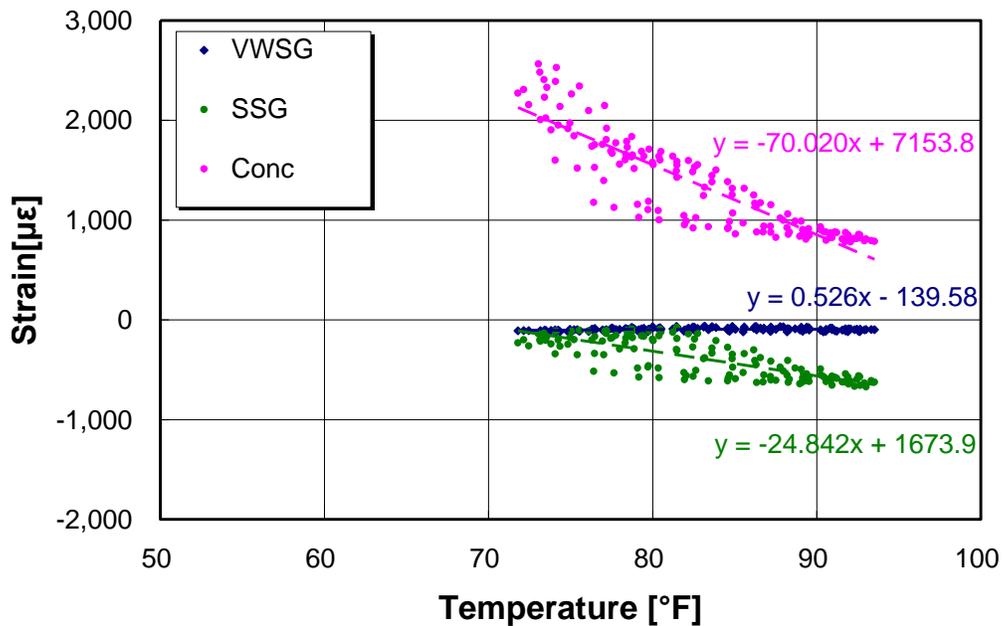
Figure 3.19- (b) Strain vs. temperature of each gage at SSG 4 location

Figure 3.19-(b) illustrates the rate of strain changes of various gages with respect to temperature variations at the repair joint during the 24th to 29th day of May, 2012. Here, “Conc” represents electrical concrete strain gage. Figure 3.19-(b) shows that the slope of the electrical concrete strain gage data is the largest and negative, which implies that there was no full-bond between old and new concrete. It should be noted that one half of the electrical concrete strain gage was embedded into the existing concrete and the other half in the repaired concrete. Figure 3.19-(b) also indicates a positive yet quite small slope of the VWSG data, which indicates that the repaired concrete is effectively restrained by tie bars. When the concrete temperature goes up, both repaired concrete and existing concrete expands, resulting in tensile direction of concrete strain in the VWSGs and compressive direction of strain in the electrical concrete strain gage. This dataset provides valuable information on the behavior of concrete and steel at a repair joint, which can be summarized by this statement:

“Full-bond between existing concrete and repair concrete at repair joints is not likely. Most of the load transfer will be achieved by tie bars and base support.”

The above summary signifies the importance of providing adequate bond strength between tie bars and concrete and of restoring good base support. Without both, the performance of FDR will be significantly compromised.

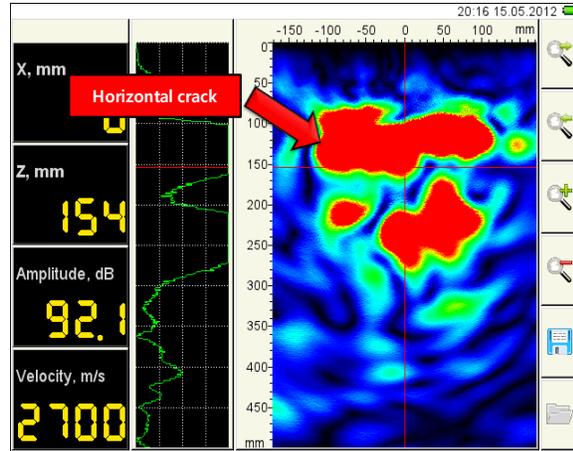
Figure 4.4-(b) MIRA result at section 1

cracking were identified and selected for testing. Figure 4.4-(a) shows two cracks – the one on the top is a natural CRCP crack, while the one in the middle is due to horizontal cracking. Figure 4.4-(b) shows the MIRA analysis and image, illustrating the existence of horizontal cracking. The red color illustrates voids or gap in the concrete. To confirm MIRA analysis results, coring was made and horizontal cracking was observed, as shown in Figure 4.4-(c) and (d).

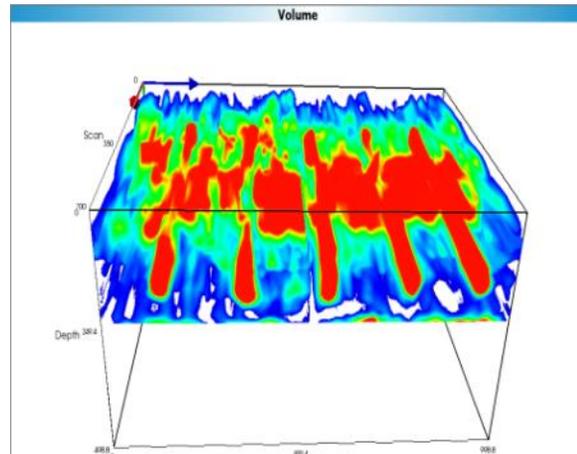
Figure 4.5-(b) 3D result by MIRA

concrete inside the pavement was evaluated with MIRA. Figure 4.5-(b) illustrates 3-D analysis result from MIRA testing. Horizontal crack was detected at mid-depth, along with longitudinal steel. Figure 4.5-(c) shows the plan view of the MIRA analysis results. The extent of horizontal cracking and longitudinal steel is illustrated.

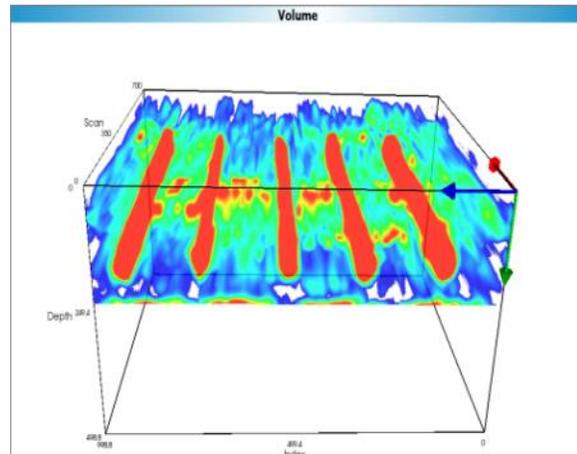
Figure 4.6-(b) 3D result by MIRA

Figure 4.6-(a) shows another CRCP location, where the evidence of horizontal cracking does not exist. This section was evaluated with MIRA. Figure 4.6-(b) illustrates the 3-D image analysis result with MIRA. MIRA detected rebars at mid-depth, but there was no horizontal crack at mid-depth. Figure 4.6-(c) shows the plan view of MIRA analysis result, illustrating that there was no

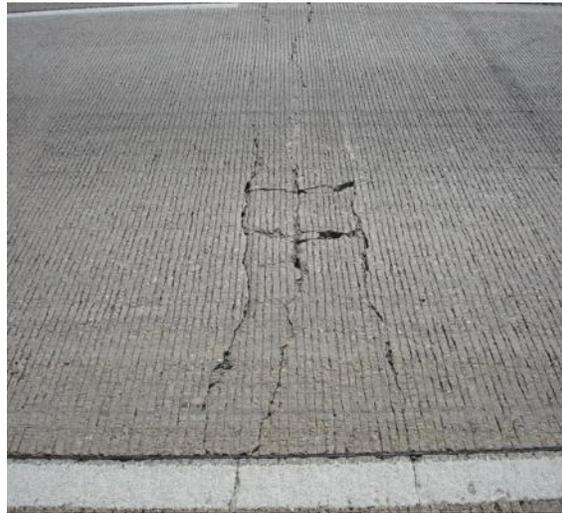
Figure 4 – Partial depth distress under wheel path

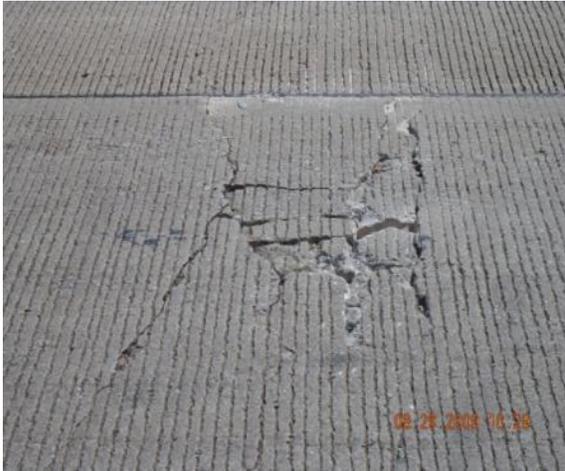
Figure 7 – Partial depth distress under wheel path

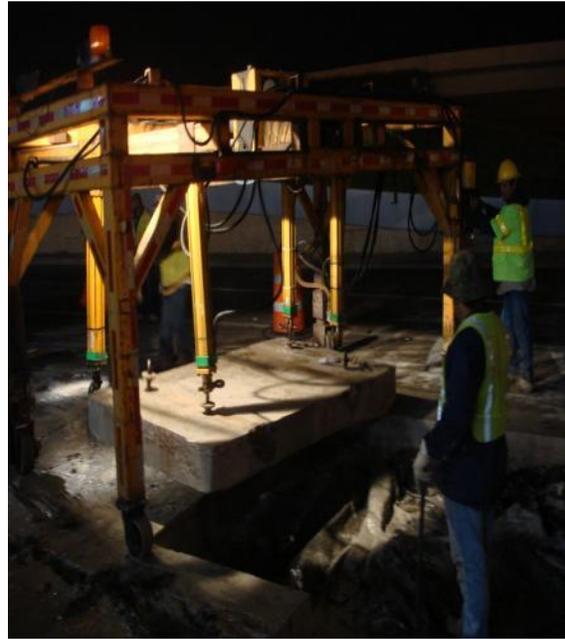
Figure 10 – Removal of slab

Repair boundaries are saw cut full-depth. Once saw cut is completed, the concrete should be removed within 7 days. There are several different ways to remove the concrete slab. Slab removal operations should not cause damage to the base. Figure 10 illustrates one of the most desirable ways of removing the slab. This method causes the least damage to the base during the slab removal.

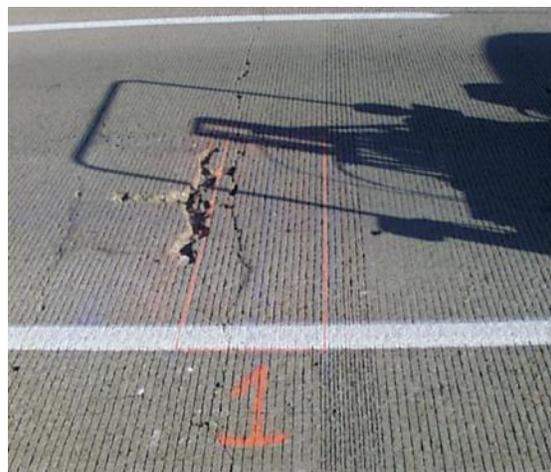
Figure 6 – Partial depth distress under wheel path

crack from the right. This material is calcium carbonate and it is observed at PDD quite often. Figure 6 also shows no faulting at longitudinal warping joint and several longitudinal cracks.

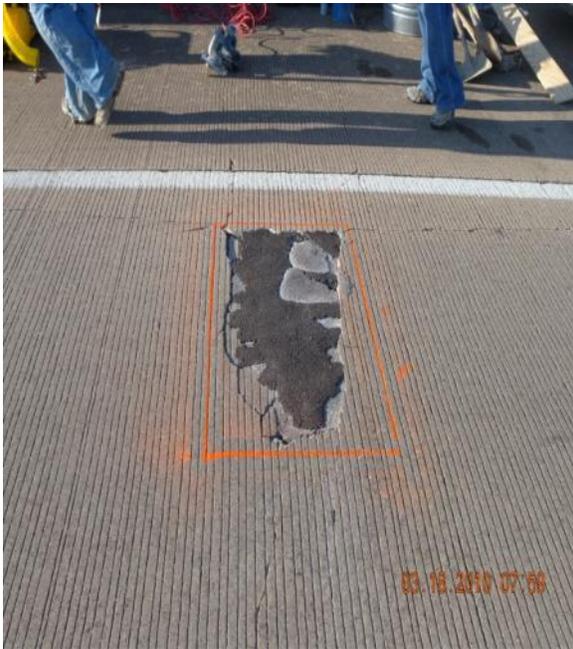
Figure 7 – Boundary of PDR straight and clearly marked

Once the distress has been determined as a PDD, the boundary of the repair area has to be established. Unlike full depth distress, PDD is normally confined longitudinally by transverse cracks. Transversely, the boundary should contain all longitudinal cracks or fractured concrete. Accordingly, about 2 to 3 inches outside of the transverse cracks that confine the distress area can be the limit of PDR in the longitudinal direction. Repair limits for transverse direction has to be beyond the distress area. Taking 1-in diameter cores can provide more definite information on the repair limits in transverse direction. In addition, repair areas shall not be closer than 6-in to any other transverse crack or joint. The minimum size of the repair area should be 1-ft in both longitudinal and transverse directions. The boundaries thus determined are clearly marked for saw cutting operation as shown in Figures 6 and 7. The repair boundaries should be straight for the ease of saw cutting.

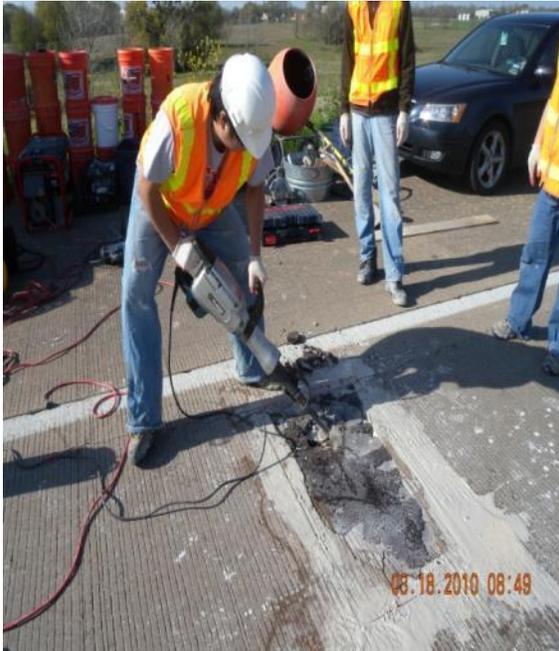
Figure 9 – Removing concrete using a jackhammer

Once saw-cut is completed, remove the concrete using jackhammers with a maximum weight of 37.5 lbs. Start the removal of concrete at the center portion of the repair area and proceed toward the repair boundaries as shown in Figure 9. If the removal of concrete is difficult, additional saw cutting the distressed concrete into smaller pieces can facilitate the removal operation. In addition to using jackhammers, small hammers with spade bits can be useful for removing concrete near repair boundaries. Experience shows that careful removal of the concrete pieces using jackhammers with a maximum weight of 37.5 lbs and small hammers with spade bits won't damage the surrounding concrete. After the removal of the concrete, inspect the repair boundaries to ensure that the repair boundaries include all the distressed concrete. If delaminations are observed beyond the repair boundaries, conduct sound testing to determine new repair boundaries, and saw cut the new boundaries. If the distress is extended below the mid-depth or the longitudinal steel depth, remove the distressed concrete using small jack hammers.

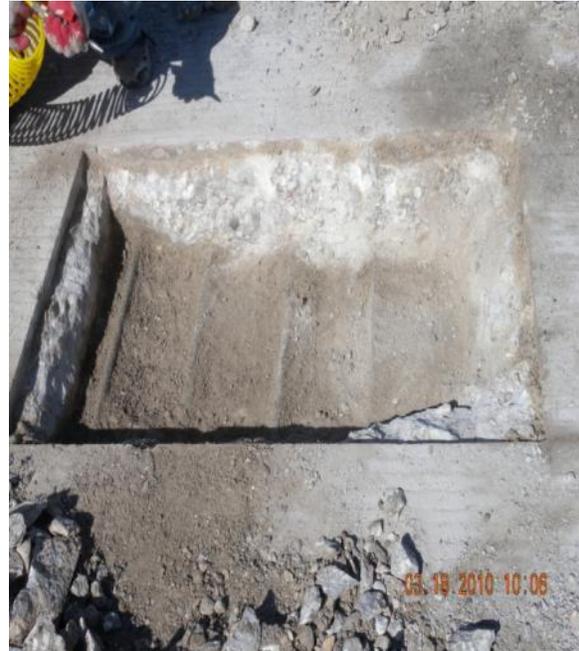
Figure 10 – Large amount of fine materials at the bottom of the PDD

Once the concrete removal is completed, the surfaces of the repair area, both vertical faces and the bottom area, should be thoroughly cleaned. Due to the nature of the distress and concrete removal operations, there will be a large amount of fine materials within the PDD area that were generated by the abrasion actions of concrete pieces under traffic wheel loading as shown in Figure 10. These fine materials must be completely removed to provide a good bonding between the repair materials and existing concrete. Experience shows that good bonding between repair materials and existing concrete surface is essential to the good performance of PDR. If a good bonding is not achieved, the effectiveness of PDR will be limited and further distress will result.

remaining fine materials and fractured pieces on the repair surface. In many cases, reinforcing steel will be exposed as shown in Figure 10. Use sandblasting to remove any cement paste from reinforcing steel. Finally, clean the repair area and exposed reinforcing steel using compressed air.
