TEXAS TECH UNIVERSITY

Testing of Alternative Supporting Materials for Portable Roll-Up Signs Used for Maintenance Work Zones

Research Project #: 0-6639
Research Report #: 0-6639-1
www.techmrt.ttu.edu/reports.php

May 2014

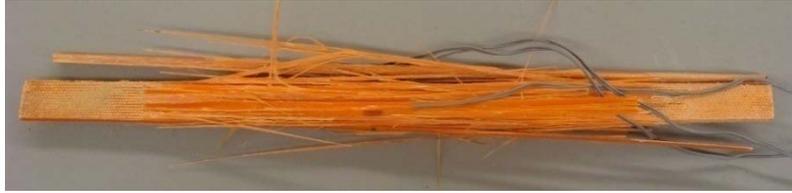
Figure 3.9 Failed Specimen after Tensile Failure.

The material properties determined from the tension tests include tensile strength, ultimate strain, Young's modulus, and Poisson's ratio. The stress-strain relationships were created using the longitudinal strain gauges and the load recorded from the load cell on the MTS machine. The stress-strain relationship for the 5/16-in. thick specimen (Type 2) is illustrated in Figure 3.8 while Table 3.2 summarizes the material properties determined from the tension test. The failure mode appeared to be due to the rupture of fibers at various locations. A typical failure for the tension tests conducted is depicted in Figure 3.9.

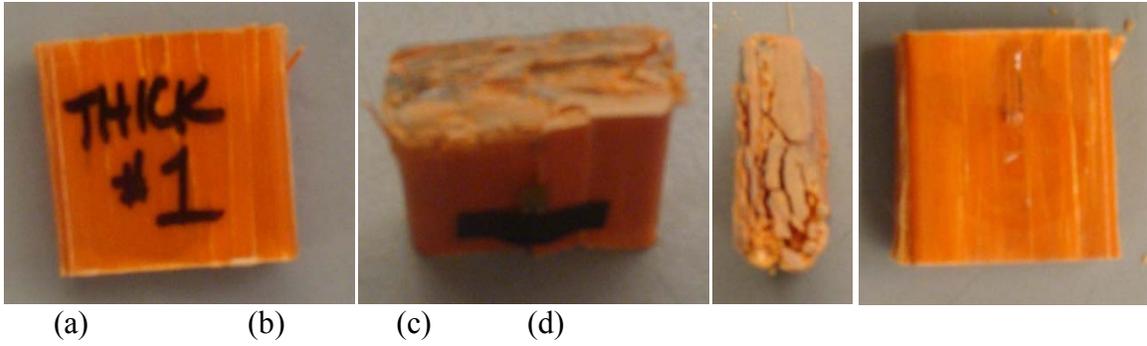
Figure 3.11 Failed Specimens as a Result of Compressive Failures

The stress-strain relationships obtained from the tests on Type 2 specimens (5/16-in. thick) is shown in Figure 3.10 while Table 3.3 summarizes the material properties determined from the compressive tests. Matrix (resin) failure was observed in the compression test specimens. Matrix failure caused the longitudinal fibers to lose the continuous lateral support needed to sustain the load. The fibers ultimately begin to buckle as the matrix damage progresses. The matrix-type failure is illustrated in Figure 3.11. The matrix damage is not localized in one location, but is through the entire member. This can be seen in Figures 3.11(a) and 3.11(d) in the form of

vertical striations. A better view of the matrix damage can be seen in Figures 3.11(b) and 3.11(c). The buckling of the fibers, however, is localized at the top and bottom of the specimens.

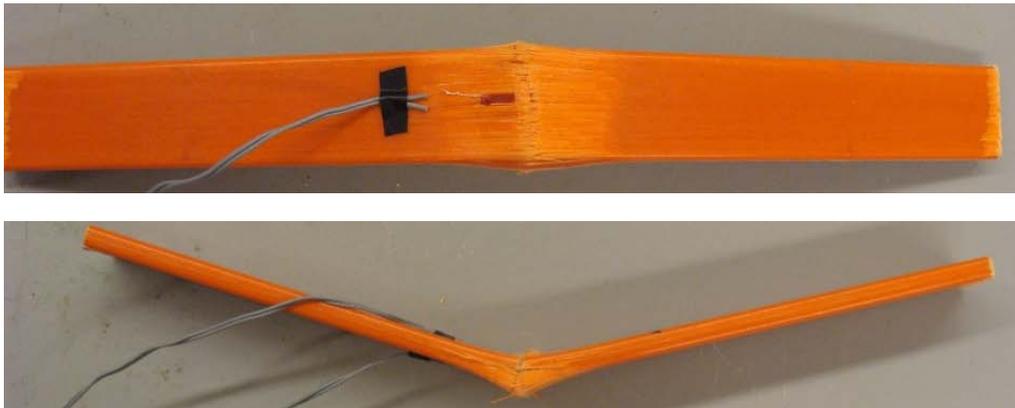
Figure 3.13 Failed Specimen - Bending Failures

The moment-deflection relationships for Type 2 specimens (5/16-in. thick specimens) are presented in Figure 3.12 while Table 3.4 summarizes the flexural properties of the materials obtained from the bending tests. The failure mode of the bending specimens was fiber rupture of the outermost fibers of the specimen as shown in Figure 3.13.

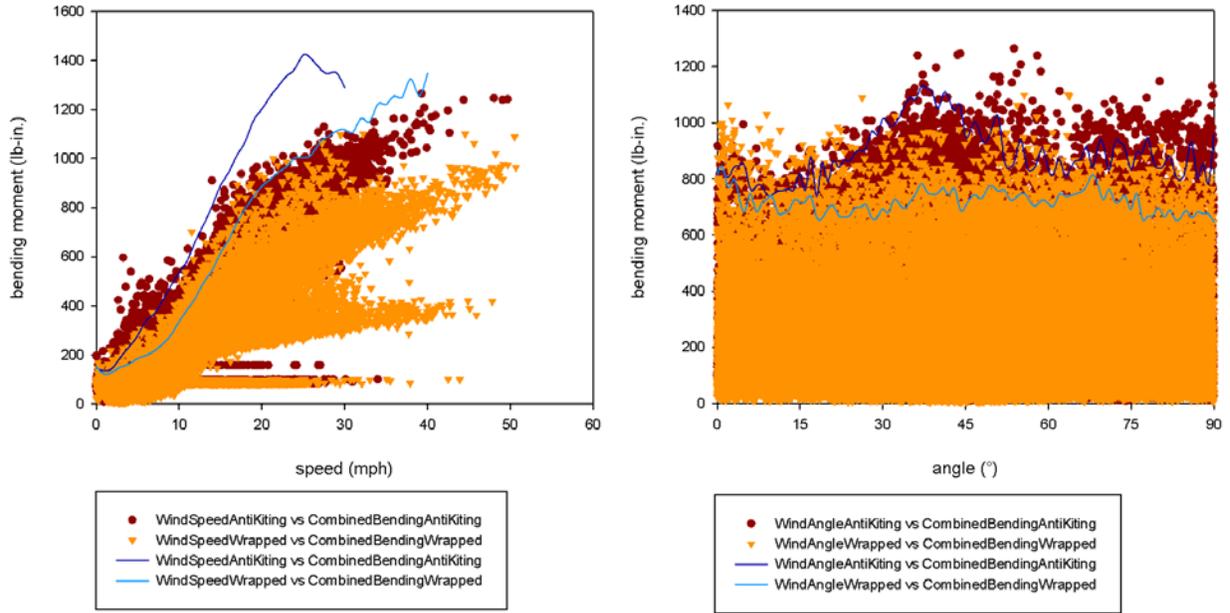
Figure 3.24 Combined Bending vs. Wind Speed and Angle Relationship

The combined bending (i.e. vector sum of the strong axis bending moment and the weak axis bending moment) case appears to be similar to the weak axis bending case, as shown in Figure 3.24. The moment is directly dependent on the wind speed; while for a given wind speed, the anti-kiting case appears to generate 40-50% more load than the wrapped case. The wind angle does not appear to have nearly the same significance.

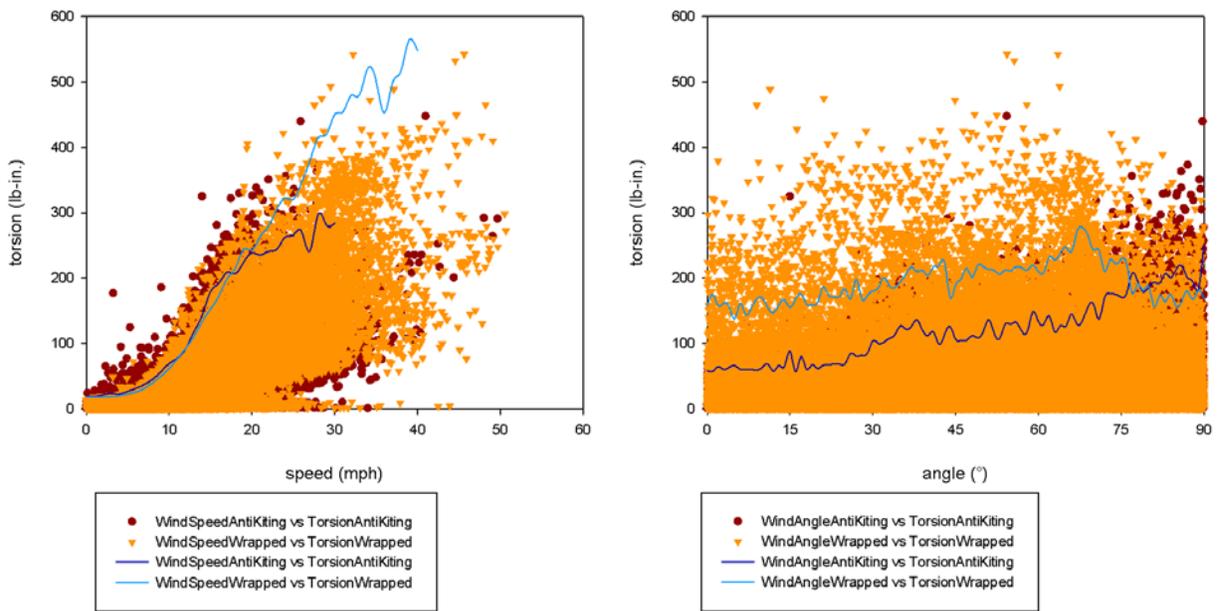
Figure 3.25 Torsion vs. Wind Speed and Angle Relationship

Torsion appears to be proportional to wind speed as shown in Figure 3.25(a). However, there appears to be no discernible difference between anti-kiting and wrapped cases in relation to wind speed. There does appear to be a correlation between wind angle and torsion which suggests that more oblique wind angles produce higher torsion as shown Figure 3.25(b).

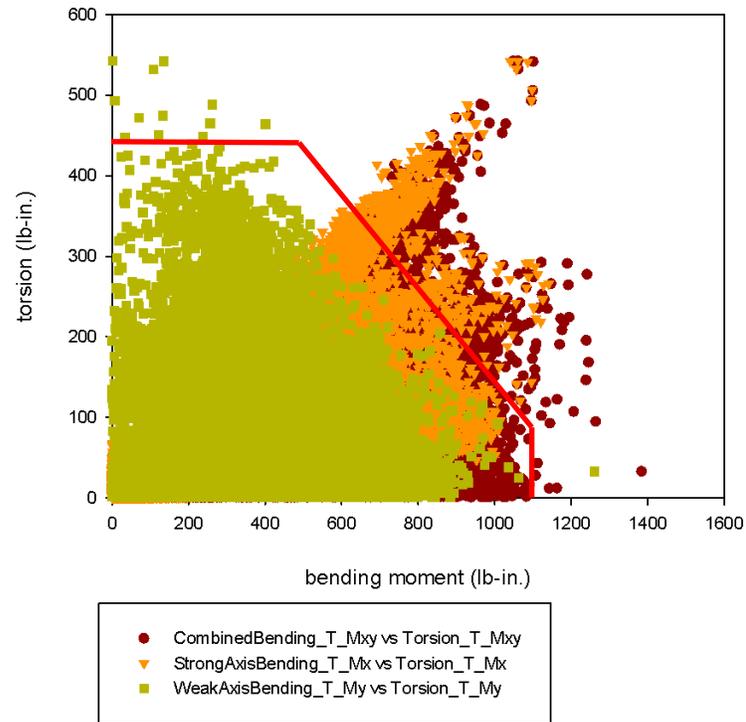
Figure 3.26 Relationship between Torsion and Bending Moment

The signs provided by TxDOT as well as the two signs which failed at the field site indicate that the probable failure is a combination of bending and torsion. Figure 3.26 shows the various bending moments plotted against torsion. The most critical condition is the weak axis bending vs torsion shown in green on the plot. This provides a definable moment-torsion interaction curve. Any replacement material needs to have a moment-torsion strength which falls outside this curve.

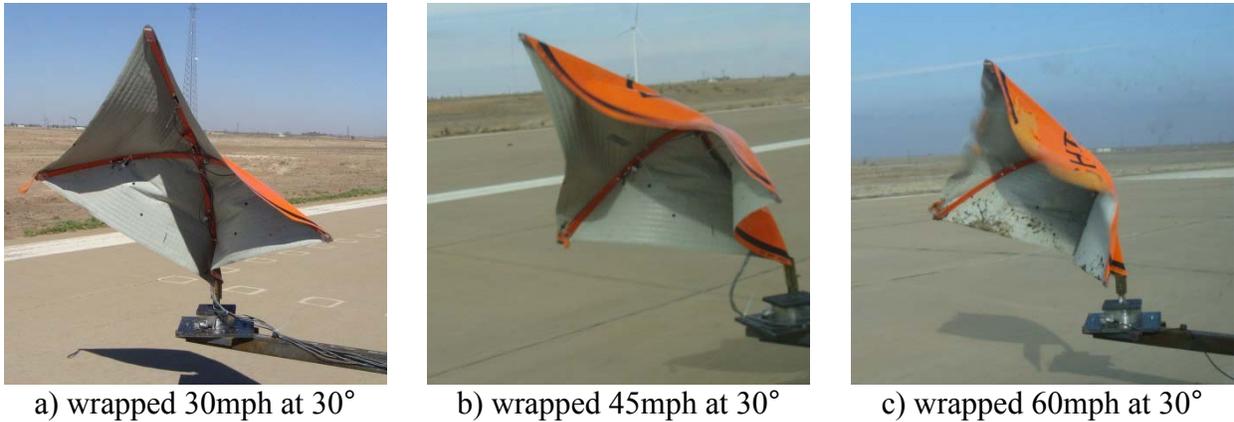
Figure 3.28 Bending vs. Wind Speed Relationship

Several observations were made visually during the testing. The first observation is that the bending in the sign is dependent and proportional to the wind speed as shown in Figure 3.28. Another observation is that the sign flapped more violently at higher speeds as shown in Figure 3.28. At 60mph, the flapping caused delamination of the sign face along the top edges. Another key observation is that the sign always twisted into the wind. The result was such that the observed torsional displacement was much higher for oblique wind directions. Also interesting is that the degree of bending did not appear to depend strongly on wind angle. This can be seen also in Figure 3.29.

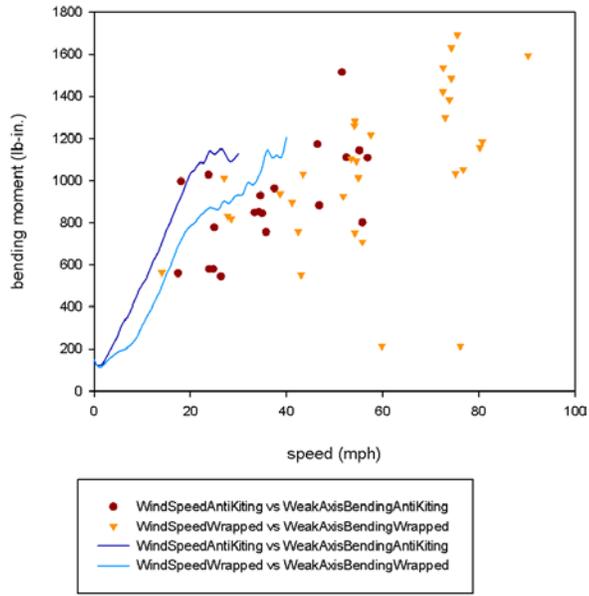
Figure 3.31 Correlation between the Data obtained from the Continuous Field Data and Truck-Generated Wind Tests - Weak Axis Bending

the field data. Figure 3.31 shows the truck-generated wind test data as points while the blue lines represent the field data. The truck generated data seems reasonably correlated with the field data upper bounds.

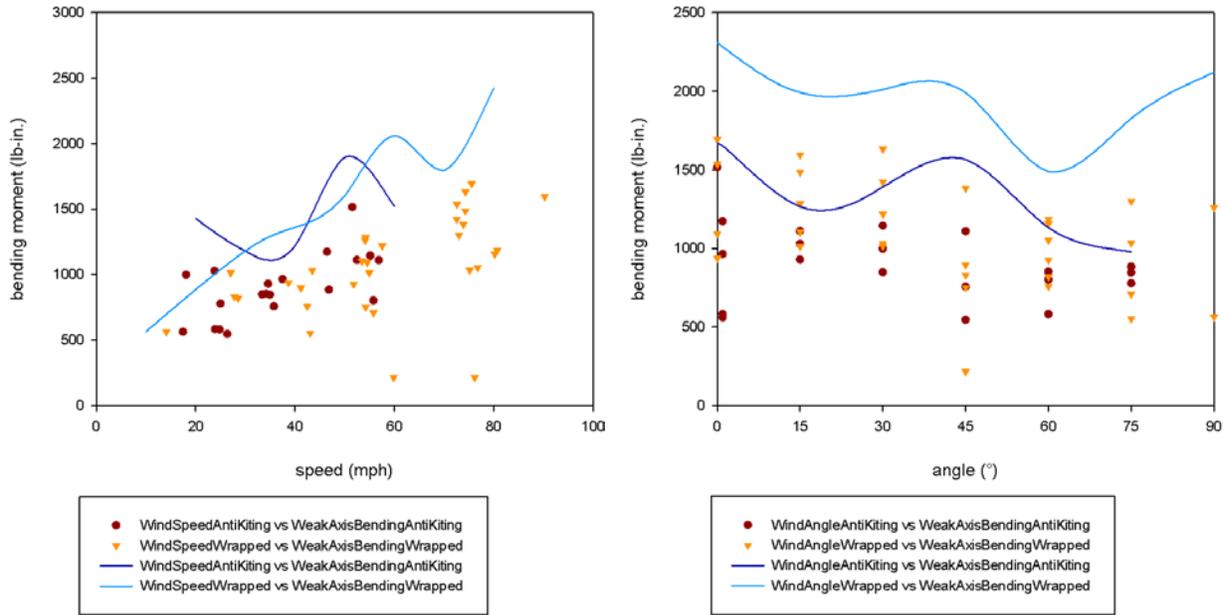
Figure 3.32 Weak Axis Bending vs. Wind Speed and Wind Angle

Figure 3.32 show the data with roughly calculated upper bounds. Clearly, the weak axis bending is dependent on wind speed. There appears to be some correlation with respect to wind angle, though the worst case weak axis bending loads appear to occur at lower attack. There does not appear to be a clear difference between the anti-kiting and wrapped case with respect to wind speed.

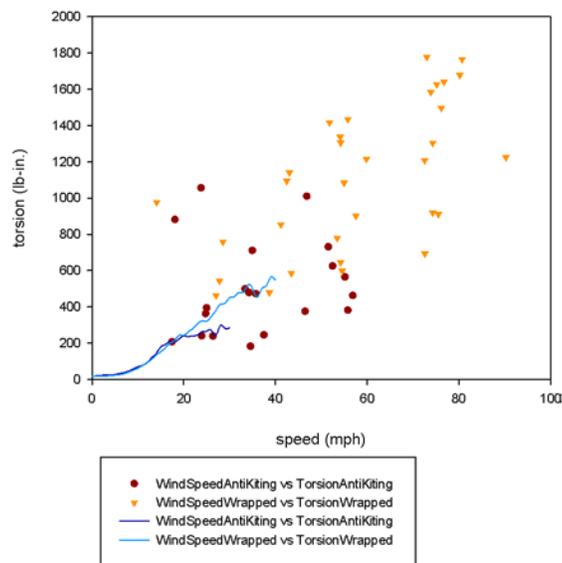
Figure 3.37 Correlation between the Data Obtained from the Continuous Field Data and Truck-Generated Wind Tests - Torsion

Torsion is the first variable which does not closely correlate with the field data as shown in Figure 3.37. This may be due to the prolonged nature of the torsion with added gusts to create torsion in the continuous field data. Nevertheless, the truck-generated wind data seemed to be conservative.

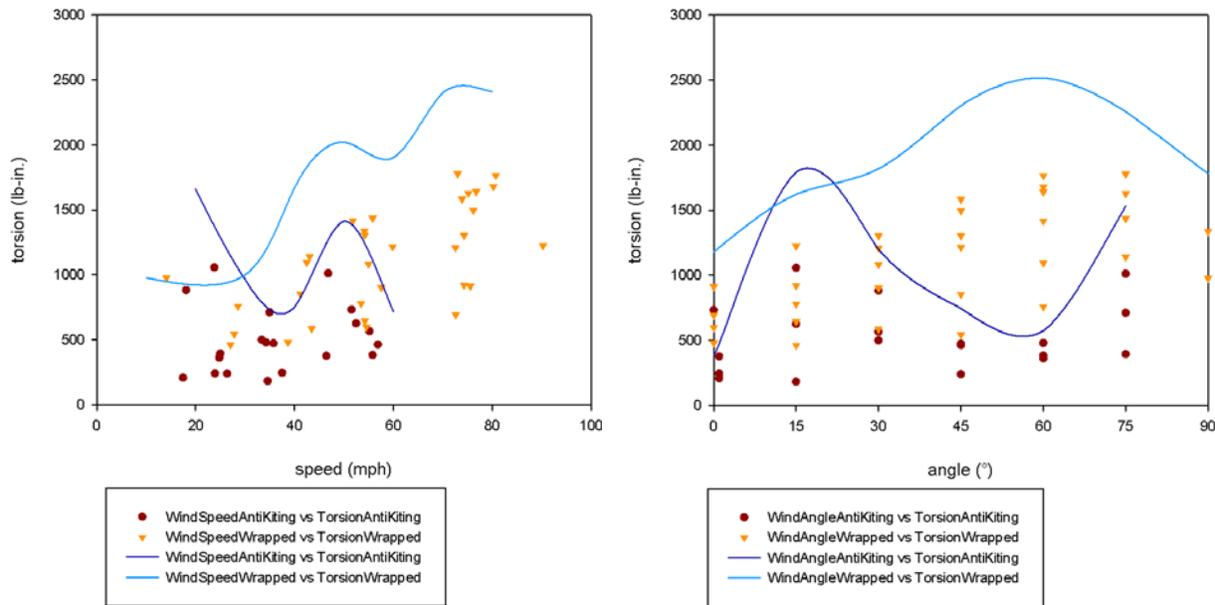
Figure 3.38 Torsion vs. Wind Speed and Wind Angle

In this case, torsion again appears proportional to wind speed, particularly for the wrapped case as shown in Figure 3.38. For some reason, it appears that there is less torsion produced by the anti-kiting case as shown in Figure 3.38. The wrapped case also shows a distinctive relationship between wind speed and wind angle indicating that 60° and 75° attack angles may produce the worst torsion.

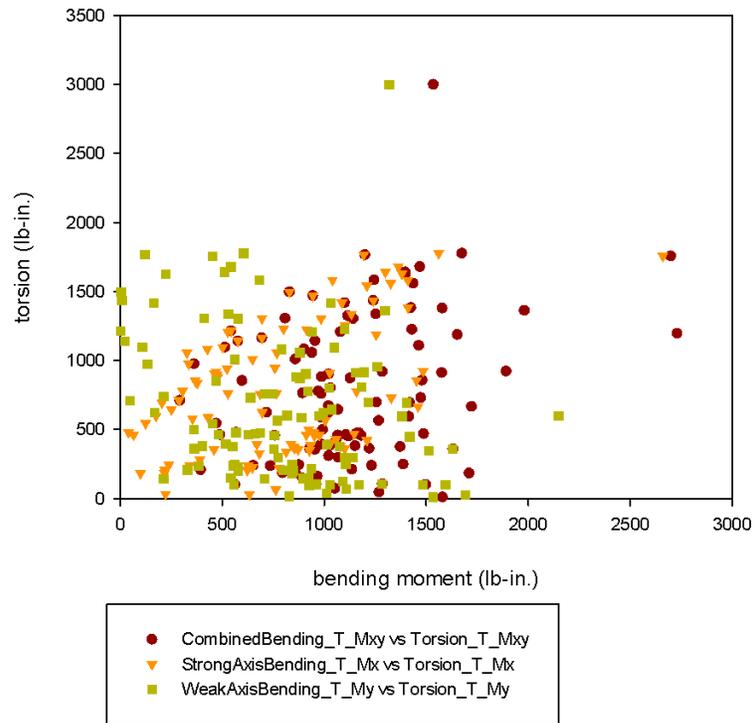
Figure 3.39 Interaction between Torsion and Moment

Figure 3.39 shows the interaction between torsion and bending moment. The critical case is the weak axis bending vs. torsion shown in green. This shows a similar shape to the field data but with naturally much larger magnitudes. Again this can be used to generate a torsion moment curve that must be resisted by any replacement materials.

The magnitude of the loads is also a major finding. The truck test allowed for much high wind loads, but the loads, particularly the torsion loads appear to be considerably larger than the loads

shown in the field test. The difficulty is that two signs were broken at the field site at far smaller loads than those required to break a sign on the truck. This suggests that the failure of the signs may be a progressive rather than sudden and catastrophic. Therefore, a replacement sign support needs torsional strength with a measure of fatigue resistance.

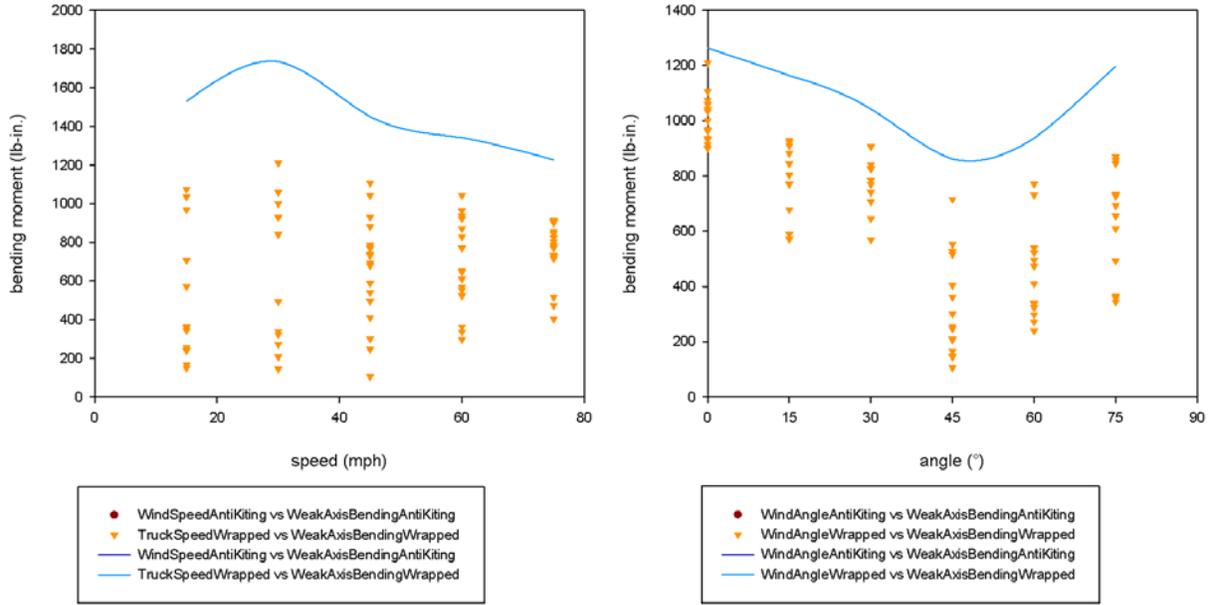
Figure 3.41 Weak Axis Bending vs. Wind Speed and Wind Angle

In terms of weak axis bending, the results were not as expected based on the visual observations. Specifically, the truck speed did not appear to directly increase the degree of bending moment as shown in Figure 3.41. The wind angle also seems odd, because the visual observations showed more deformation at more oblique angles. Apparently the portion that caused weak axis bending was actually maximized when the sign face was perpendicular to the direction of travel. It is worth noting that the weak axis bending induced by the truck is on the same order of magnitude as the weak axis bending moments recorded during field testing.

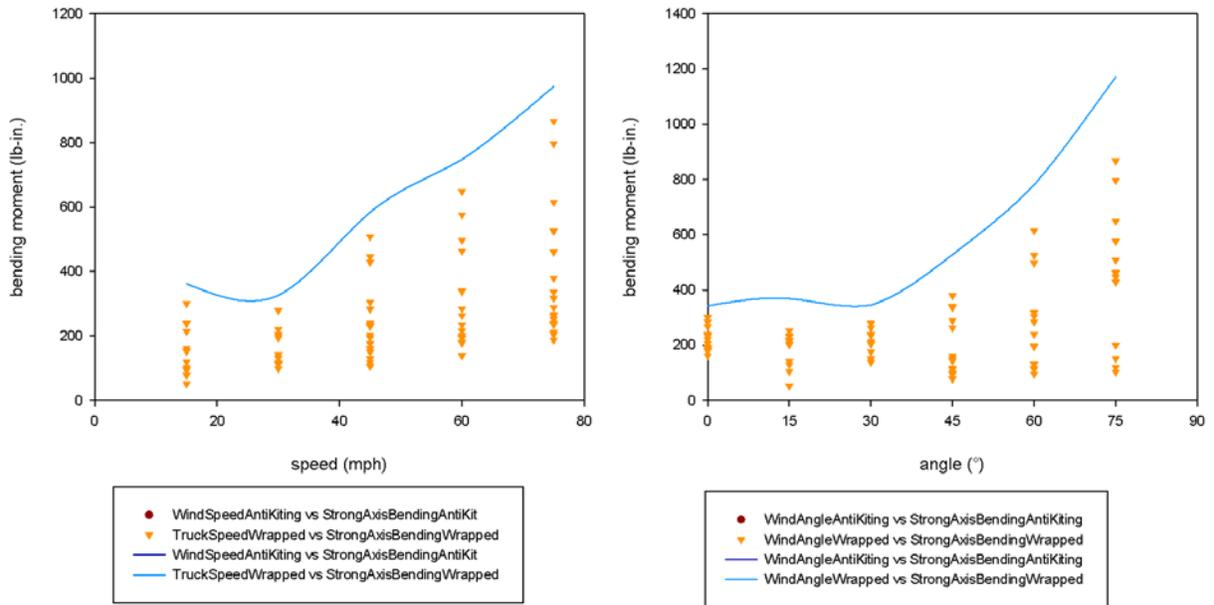
Figure 3.42 Strong Axis Bending vs. Wind Speed and Wind Angle

Strong axis bending on the other hand shows a strong correlation with truck speed as shown in Figure 3.42. Additionally, it agrees with the visual interpretation that more energy is imparted as the sign face is rotated toward parallel with the road. Again, the order of magnitude is similar to the field site tests.

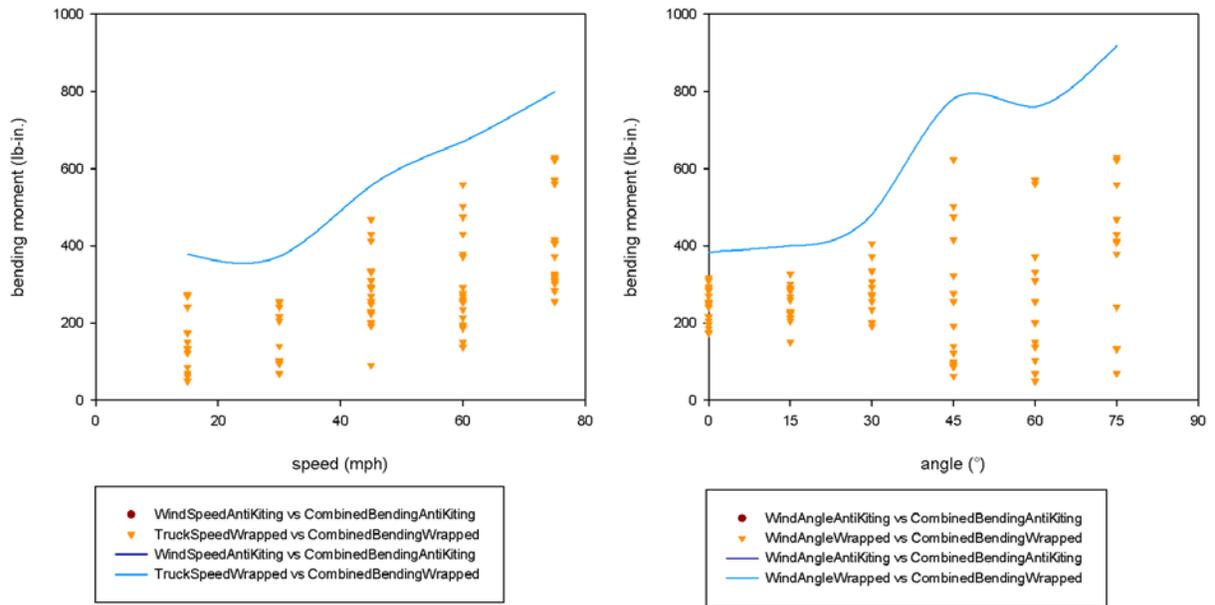
Figure 3.43 Combined Bending vs. Wind Speed and Wind Angle

The combined bending shares the majority of its trends with the strong axis bending as shown in Figure 3.43; it is directly proportional to both truck speed and angle.

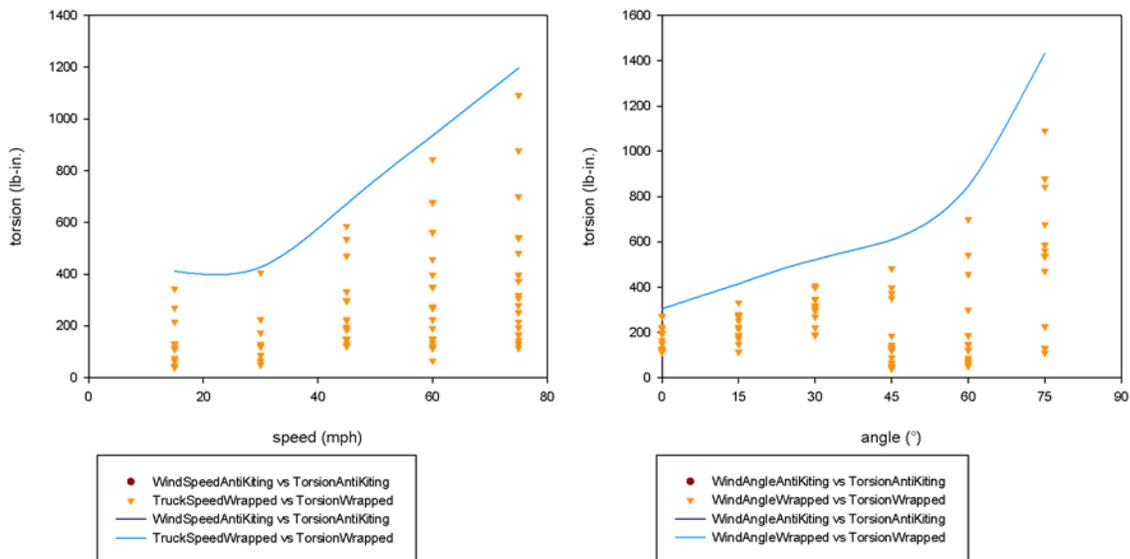
Figure 3.44 Torsion vs. Wind Speed and Wind Angle

Figure 3.44 shows the relationship between torsion and wind speed and angles. The torsional load on the sign is both directly proportional to both truck speed and angle. The torsional load maximizes at the top speed and 75° off perpendicular. This torsional moment is significantly larger than any torsional moment measured at the field site.

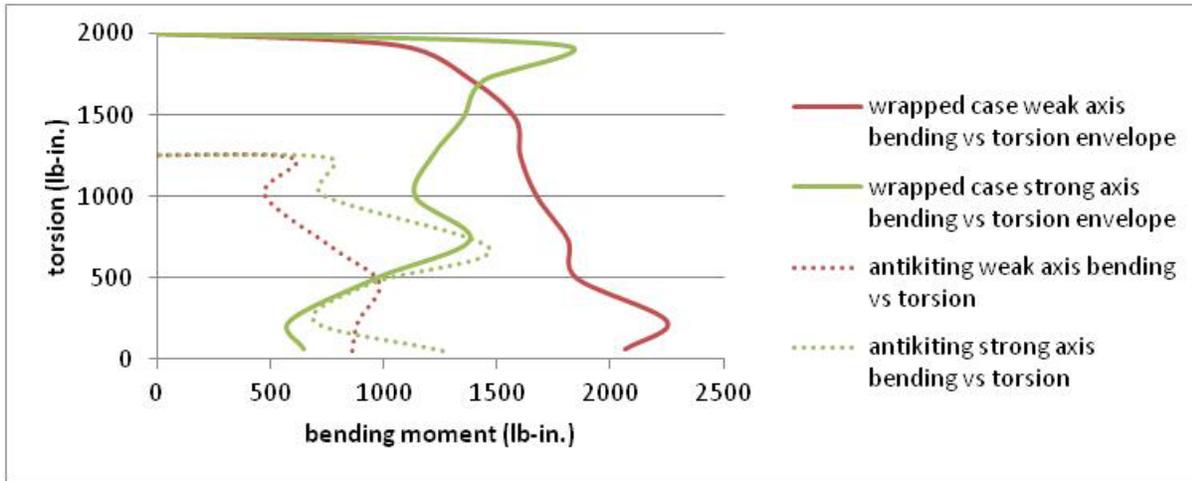
Figure 4.9 Torsion-Bending Moment Interaction of Fiberglass Frame Signs

The torsion and bending moments at the bottom of vertical members induced by wind loads changes as the stiffness of both vertical and horizontal frames changes. Figures 4.9 and 4.10 show the torsion and bending moments for the fiberglass frame signs and steel frame signs. As shown in the figures, the torsion and bending moments increased as the stiffness of frames increased. However, it should be noted that the torsional moment increase was not as large as the increase in bending moment. Thus, increased torsional stiffness is recommended to avoid cracking in the fiber direction. The vertical member must be able to resist at least the torsion of 2,000 lb-in measured from the fiberglass frame signs, but without increasing the bending stiffness.

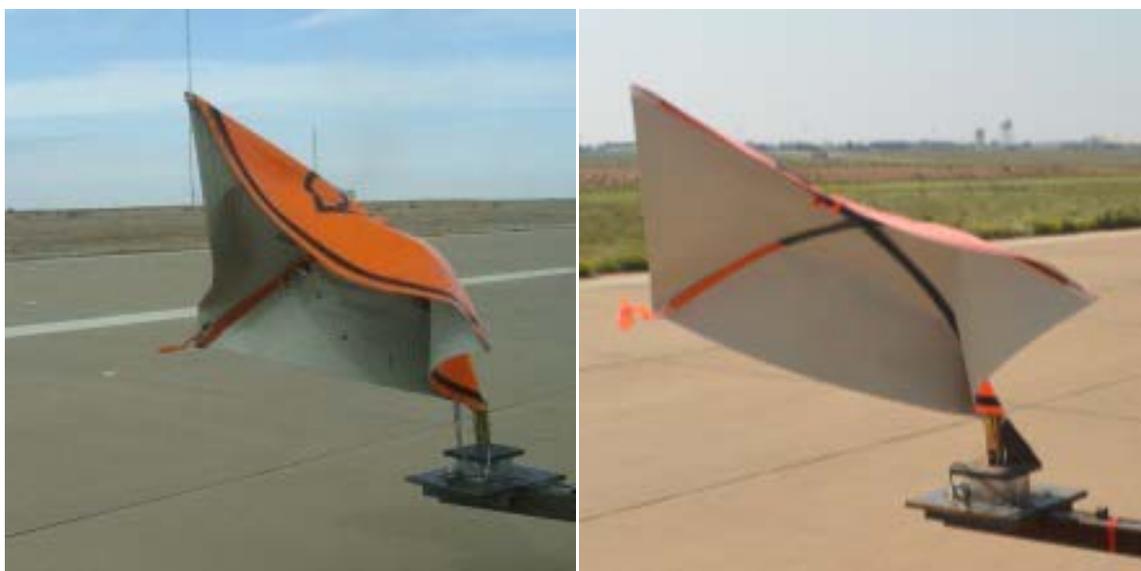
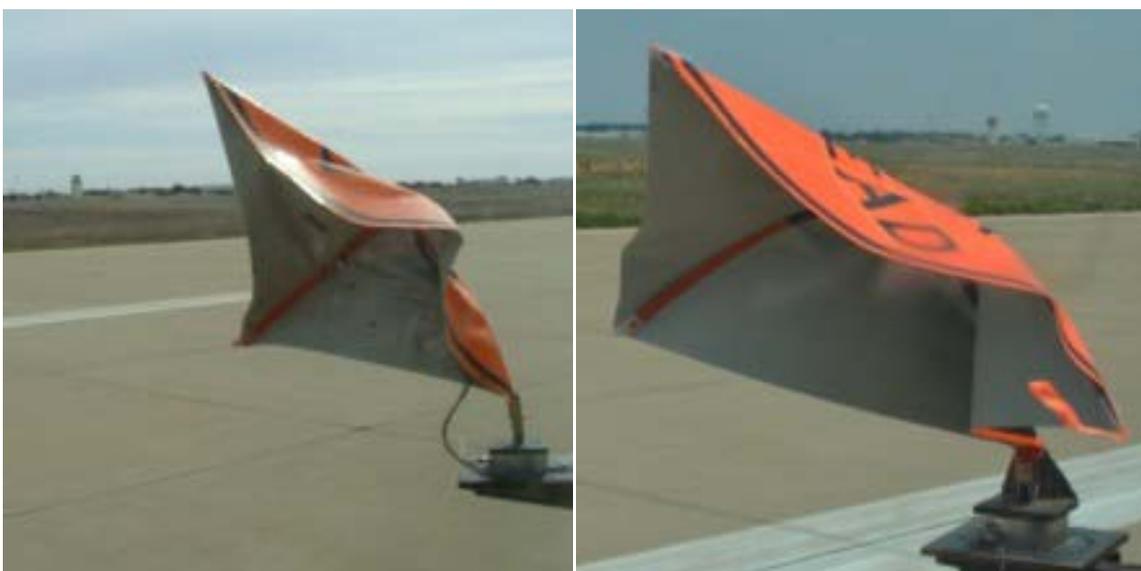
Figure 6.3 Comparison of Modified (right) and Un-modified Design (left)

The modified sign performed much better than the unmodified sign as shown in Figure 6.3. Serviceability was reasonable through 45mph as shown in Tables 6.1 and 6.2. Around 50-60mph, the serviceability began to degrade as the sign rotated away from perpendicular under oblique wind loads. The increased bending stiffness in horizontal member successfully resisted the wind loads. However, the increase horizontal stiffness also resulted in greater bending in the vertical member. The wrapped case performed much better than the anti-kiting case. In the anti-kiting case, the sign pockets slipped off the horizontal member, but this happened at a higher wind speed than in the unmodified sign.

The most amazing improvement was the increase in elastic response provided by the carbon fiber. At the higher speeds, several times, the vertical members were thought to be broken, but when the wind loads were removed, the member fully recovered.

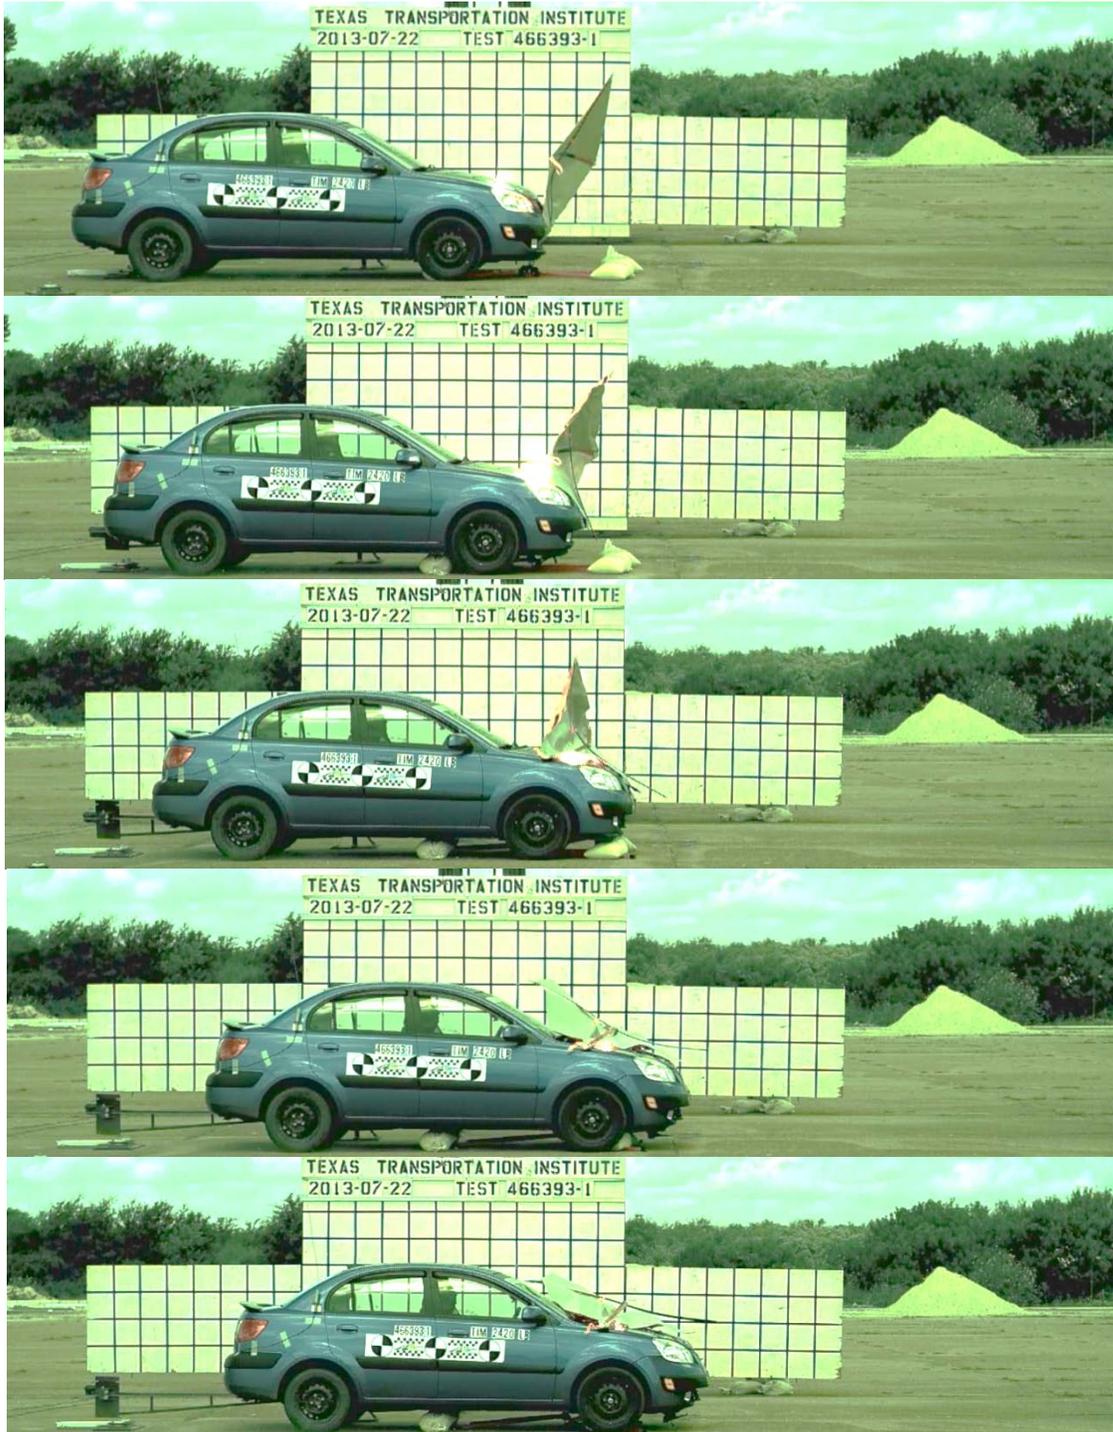
Figure 6.17 Photos at Impact for Test 1

Figure 6.17 shows a series of photos at the time of impact during Test 1. As shown in the figure, the vertical member was released from the plastic pocket at the bottom and the top end of the vertical member hit the windshield. The windshield damage was very severe, leaving a penetration hole in it, as shown in Figure 6.18. The spring loaded bracket could hold the plastic pocket but failed to secure the vertical member at the impact as shown in Figure 6.19. Therefore, Test 1 did not pass the MASH requirements, because of the hole in the windshield caused by the impact of the vertical member.

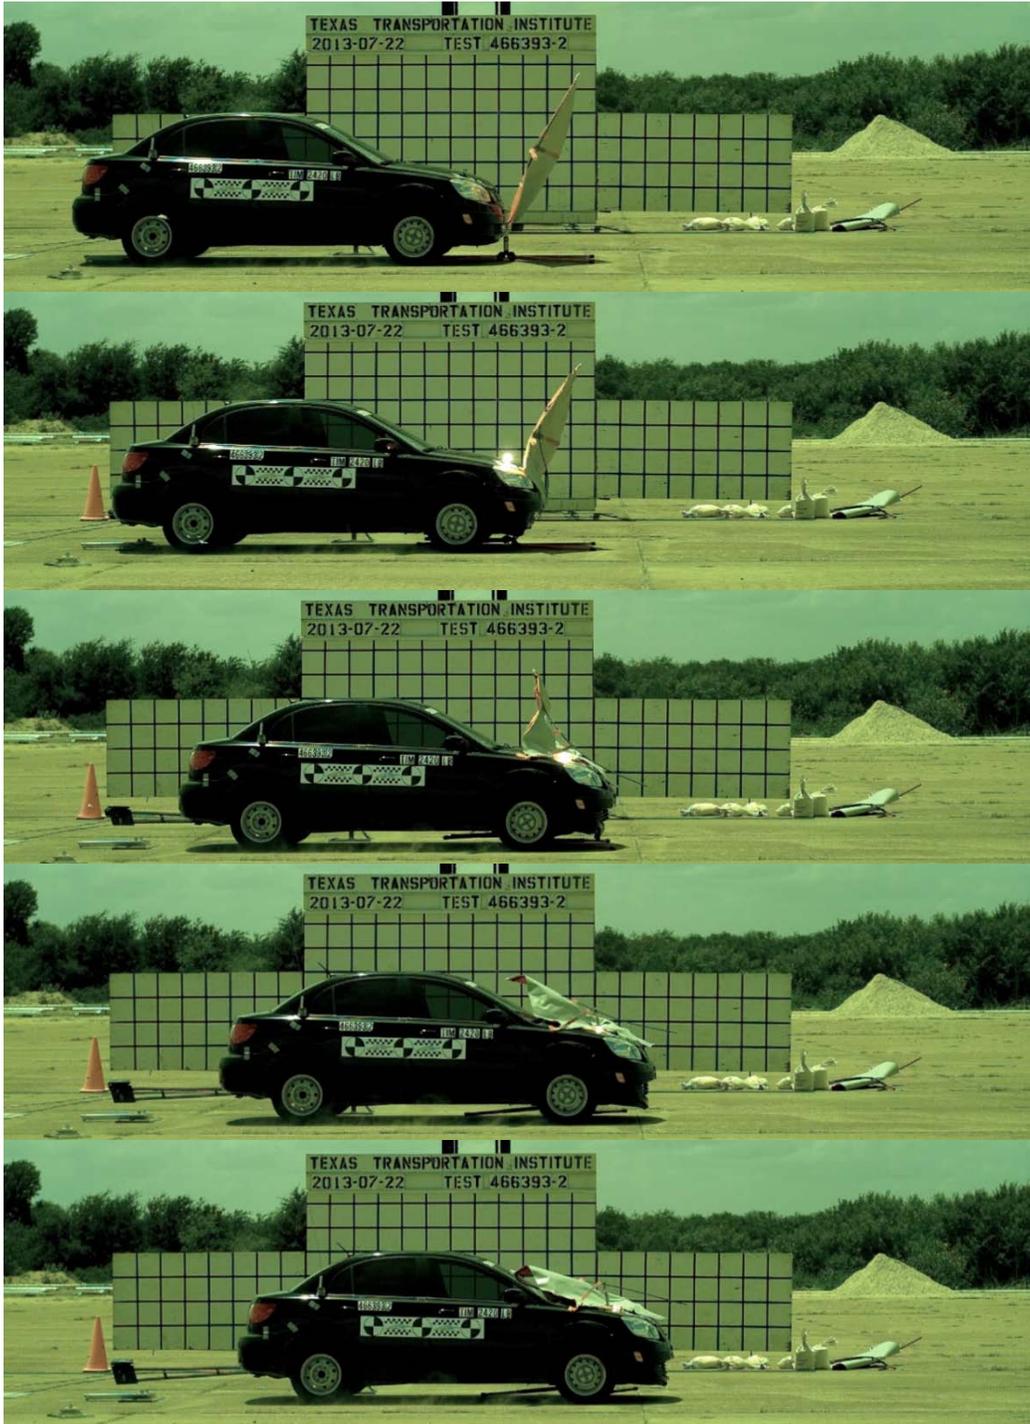
Figure 6.20 Photos at Impact for Test 2

Figure 6.20 shows a series of photos at the time of impact during Test 2. As shown in the figure, the vertical member was released from the plastic pocket at the bottom and the top end of the vertical member hit the windshield just like Test 1. The windshield damage was also very severe, leaving a penetration hole in it, as shown in Figure 6.21. The spring loaded bracket performed exactly the same way as in Test 1 and could not secure the vertical member at the impact. Therefore, Test 2 did not pass the MASH requirements, because of the hole in the windshield caused by the impact of the vertical member. .

Considering the fact that Test 1 and Test 2 Test Signs behaved almost same way, the sandbags did not affect the damage level of windshield.

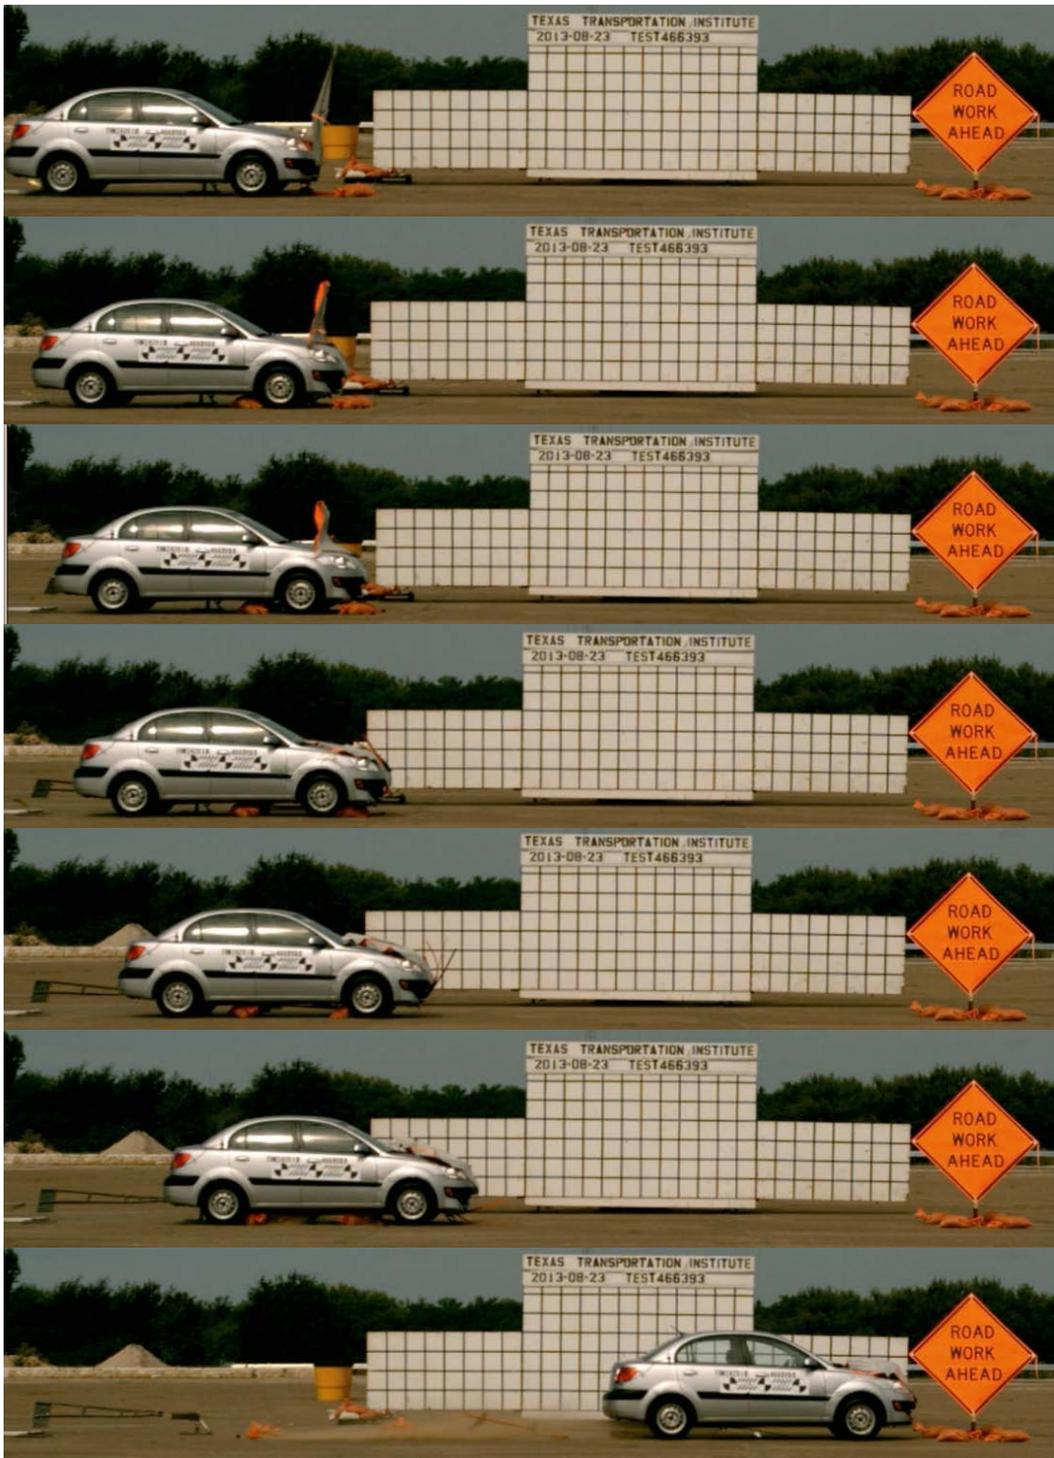
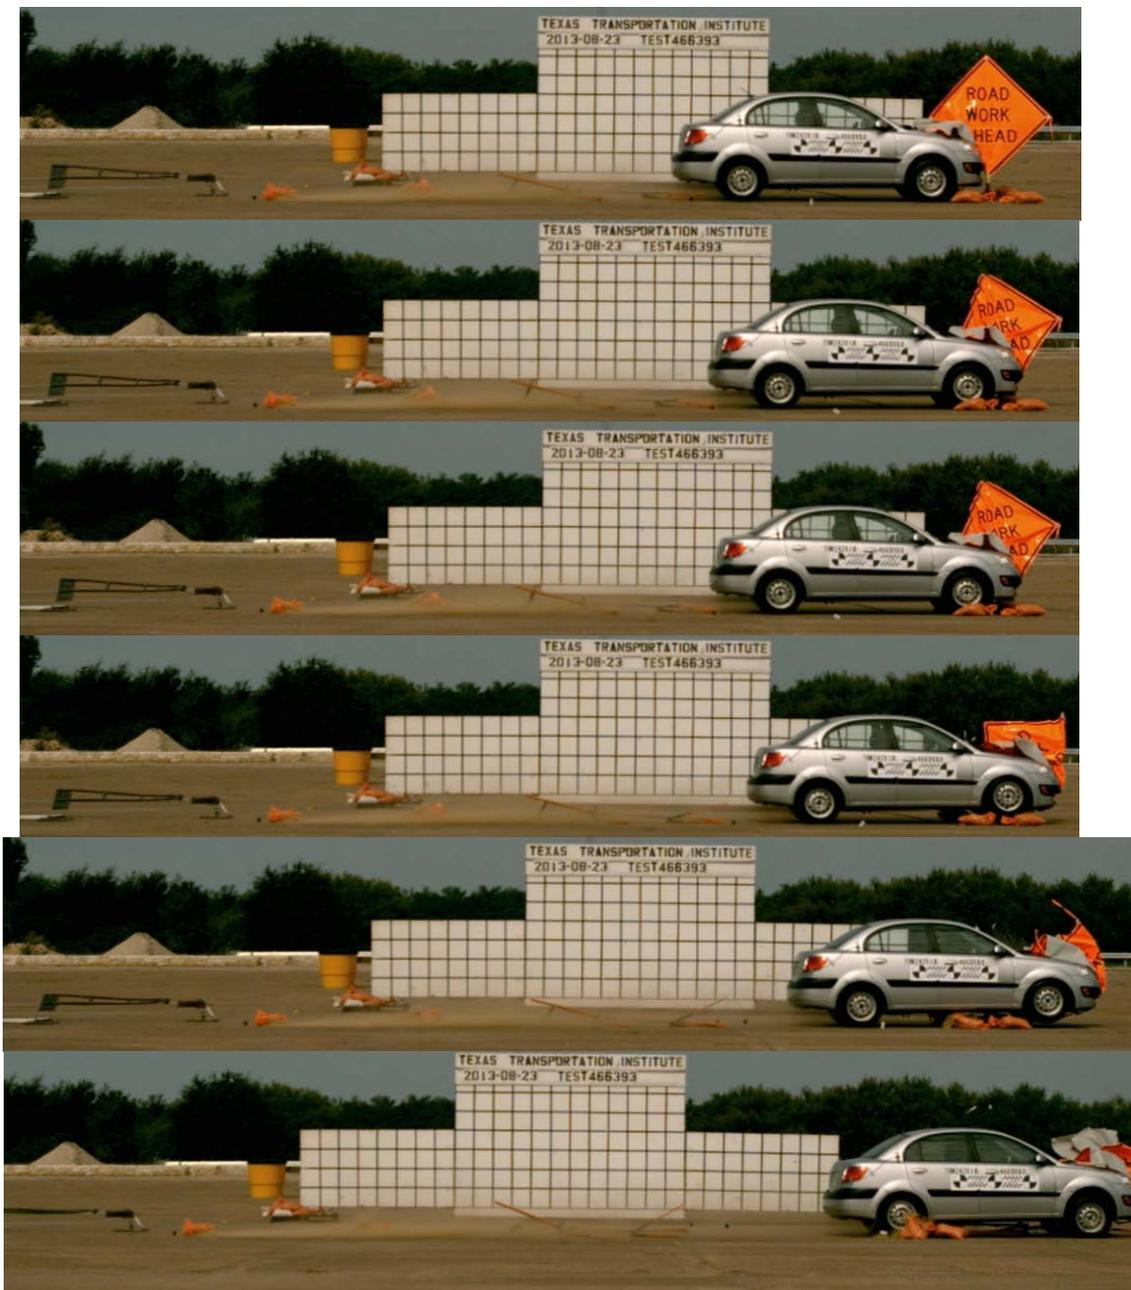
Figure 6.22 Photos at Impact for Test 3 (Continues on the Next Page)

Figure 6.22 shows a series of photos at the time of impact during Test 3. Unlike Tests 1 and 2, the vertical member was not released from the plastic pocket at the bottom as shown in Figure 6.22. As a result, the windshield damage was not as severe as those observed in Tests 1 and 2. That is, penetration or intrusion of the parts of the Test Sign was not observed in Test 3, as shown in Figures 6.23 through 6.24. The through bolt bracket could hold the plastic pocket and the vertical frame member at the impact as shown in Figure 6.25. Therefore, Test 3 satisfied the MASH requirements. However, it should be noted that the broken pieces of the plastic pocket at the top of vertical member flew into the windshield as shown in Figure 6.24 and the windshield damage shown in Figure 6.24 was due to the impact of the broken plastic pocket parts, not due to the direct impact of vertical member.

Test 3 (through-bolt bracket and sandbags) passed the crashworthiness requirements specified in MASH. Therefore, it is recommended that the proposed sign design be used with the sign base that has a through bolt bracket.

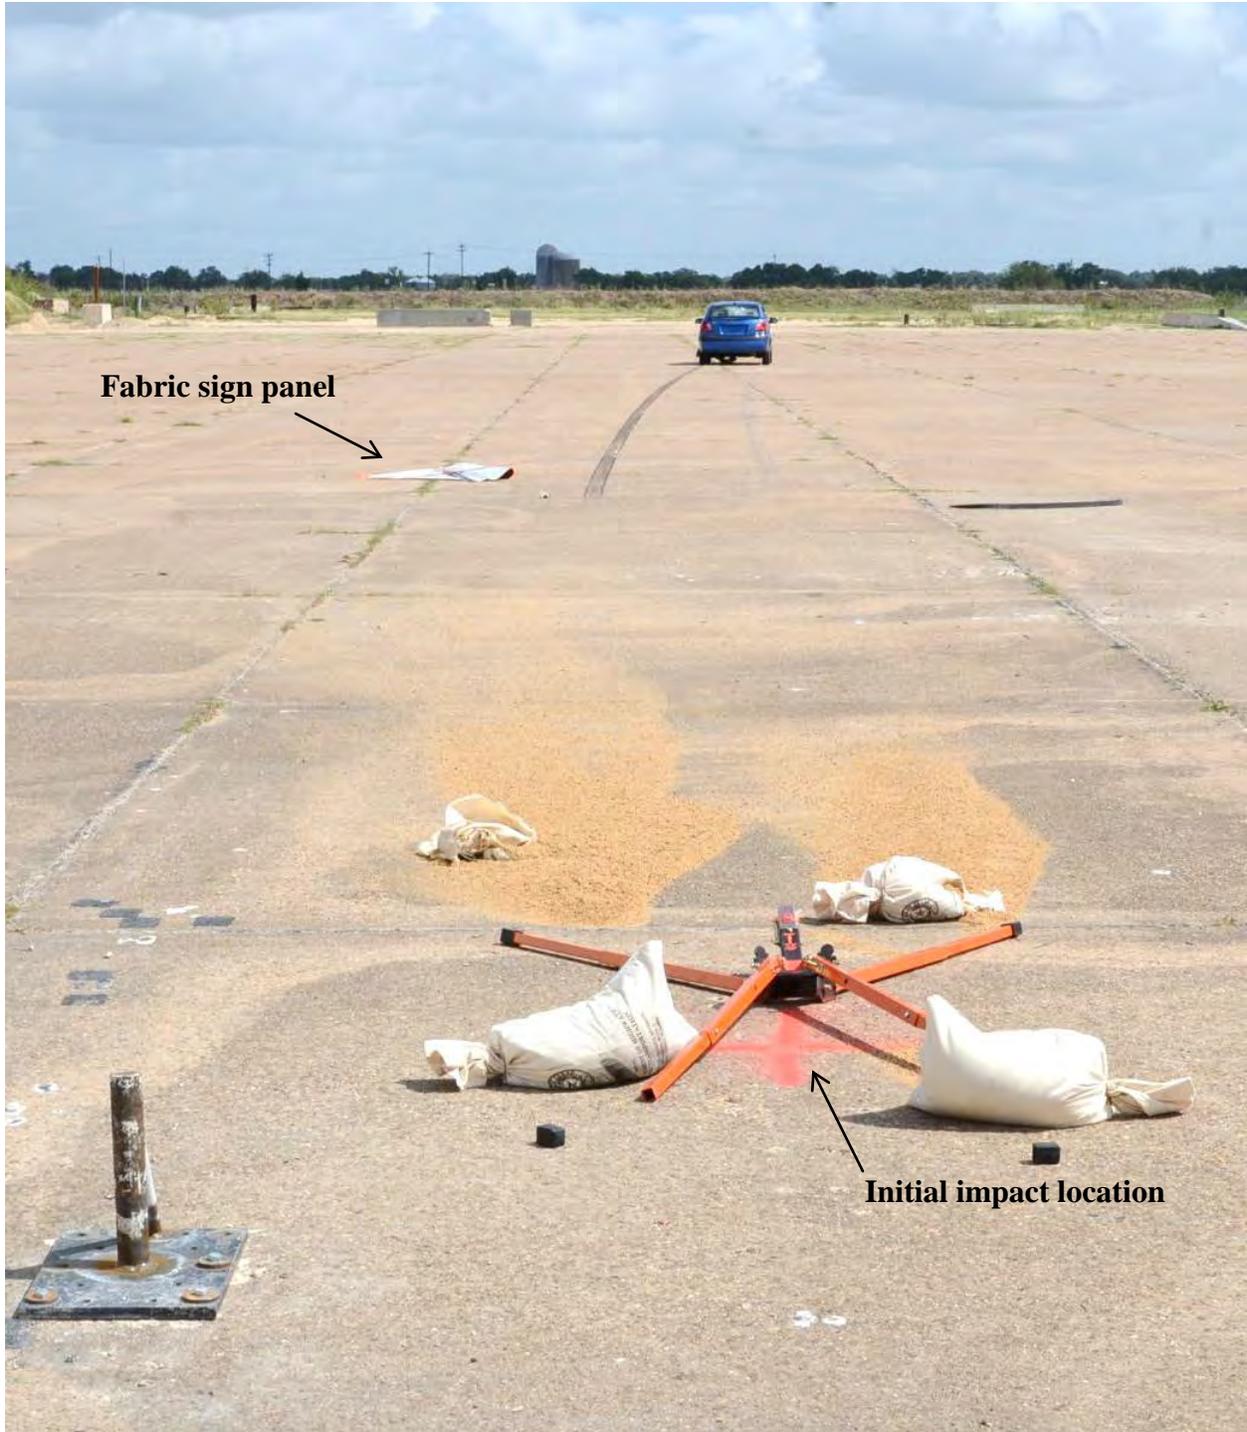
Figure 5.3. After Impact Locations for Test No. 466393-1.

Figures 5.3 and 5.4 show damage to the work zone traffic control device. The fabric sign panel and stays separated from the lower base, contacted and penetrated the windshield, rode up and over the vehicle, and came to rest 75 ft downstream of impact. The base of the temporary sign support came to rest 1.4 ft downstream of impact. Two of the sandbags remained intact, one was torn open and emptied of sand, and the fourth was torn and partially emptied.
