TEXAS TECH UNIVERSITY

Testing of Alternative Supporting Materials for Portable Roll-Up Signs Used for Maintenance Work Zones

Research Project #: 0-6639
Research Report #: 0-6639-1
www.techmrt.ttu.edu/reports.php

May 2014

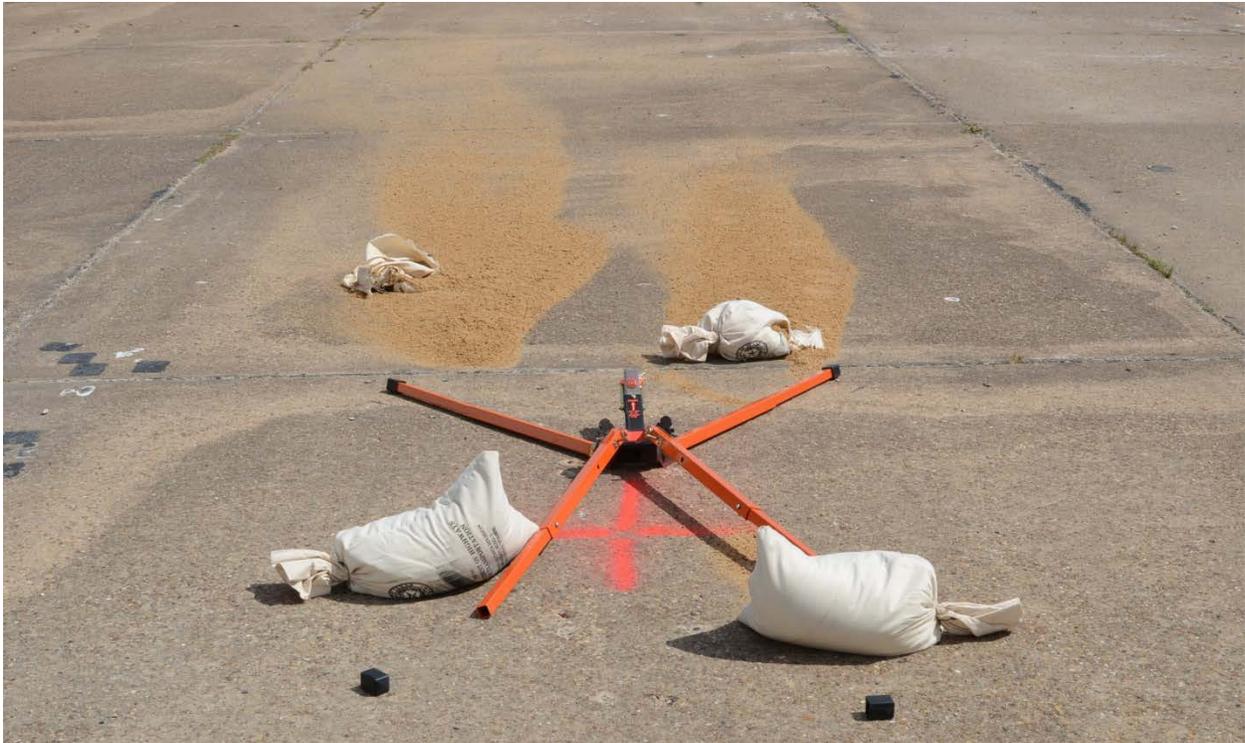
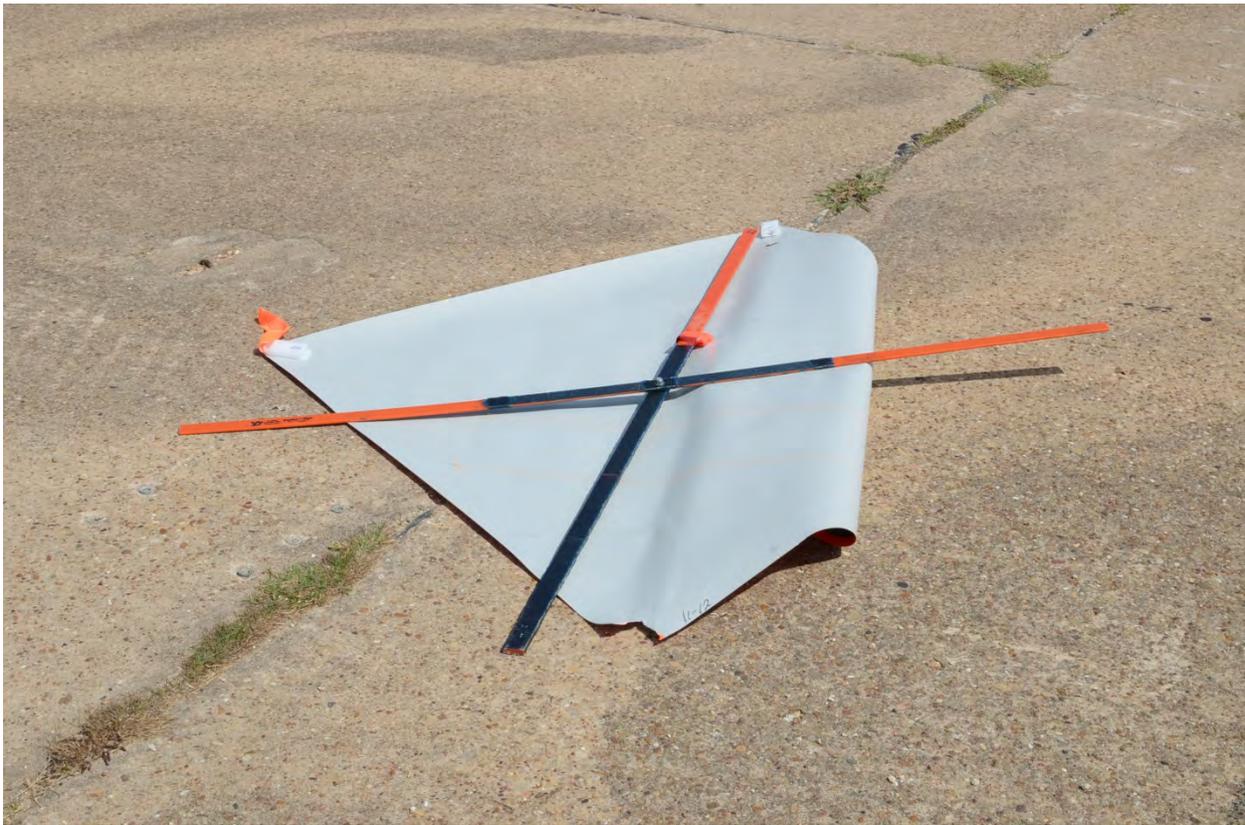
Figure 5.4. Installation after Test No. 466393-1.

Figures 5.3 and 5.4 show damage to the work zone traffic control device. The fabric sign panel and stays separated from the lower base, contacted and penetrated the windshield, rode up and over the vehicle, and came to rest 75 ft downstream of impact. The base of the temporary sign support came to rest 1.4 ft downstream of impact. Two of the sandbags remained intact, one was torn open and emptied of sand, and the fourth was torn and partially emptied.

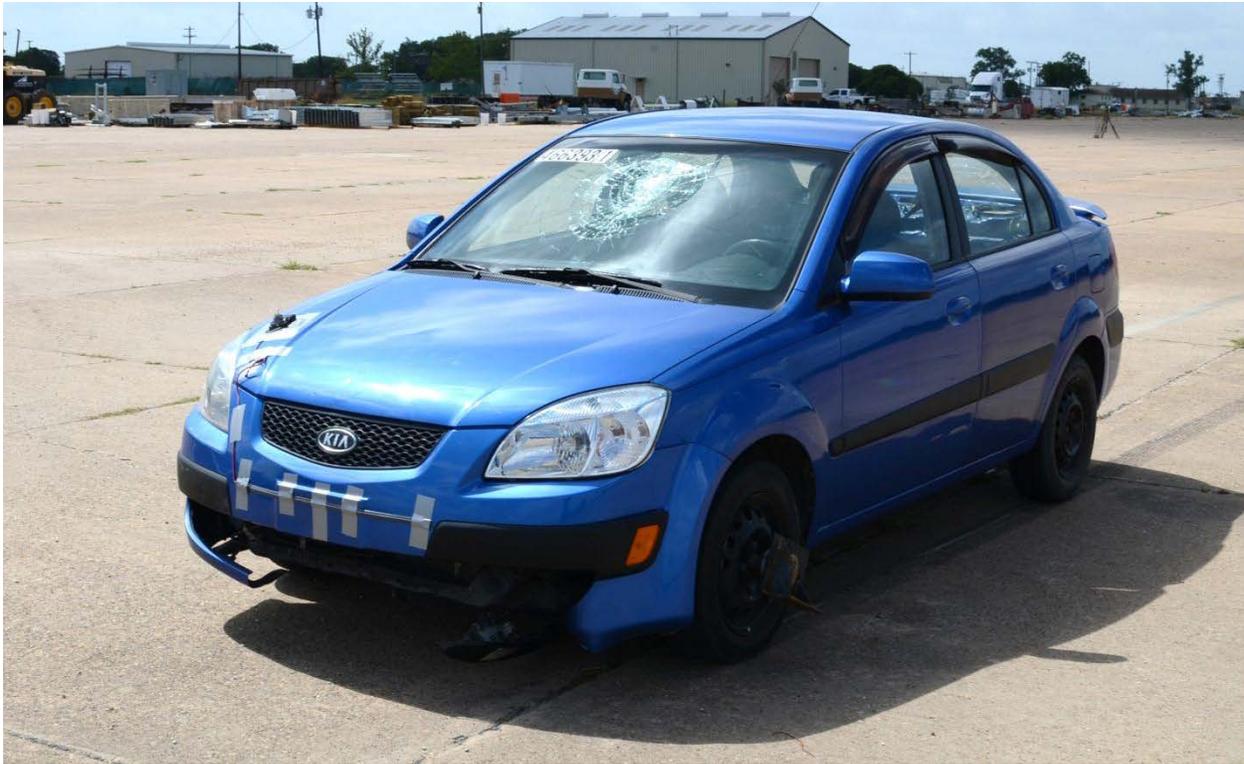
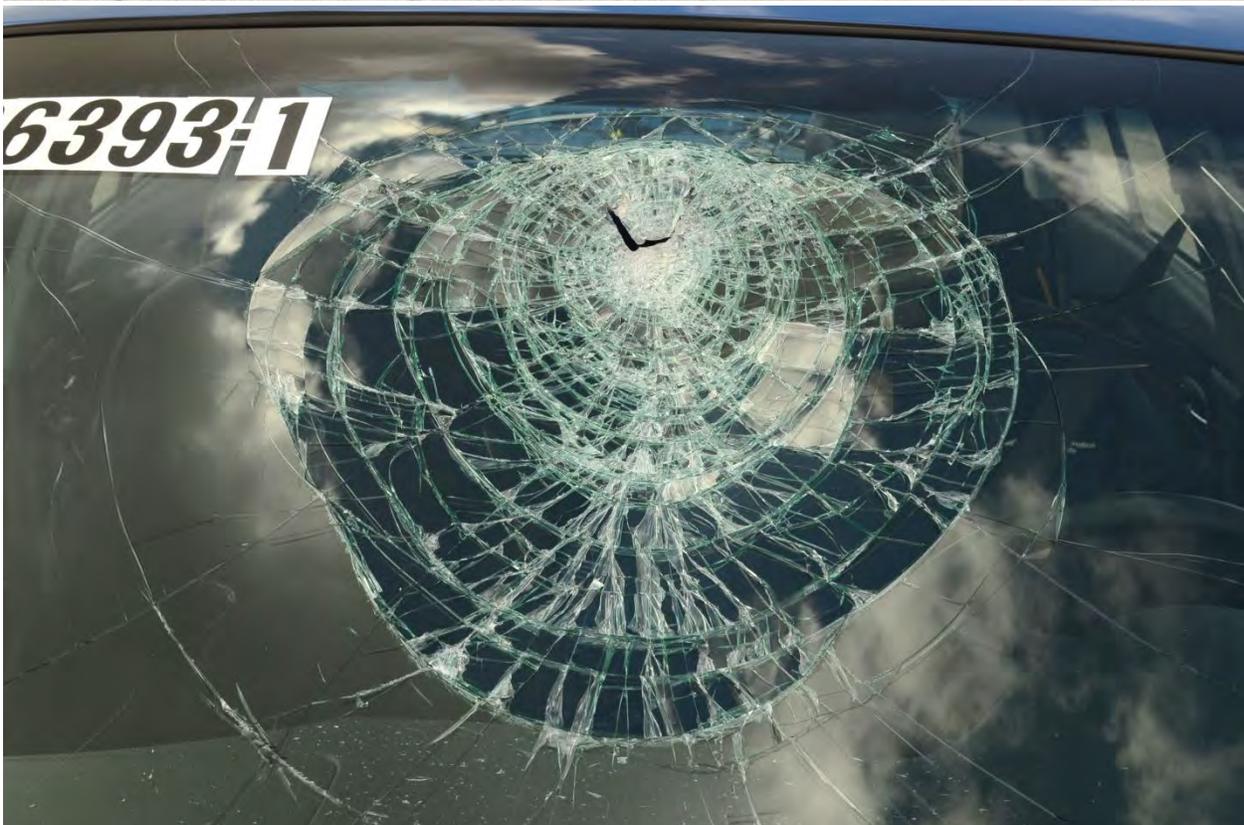
Figure 5.5. Vehicle after Test No. 466393-1.

Figure 5.5 shows damage to the 1100C vehicle. The bottom of the front bumper cover was fractured, and the hood sustained scuff marks. No measureable deformation was noted to the exterior hood or bumper. The windshield was punctured/cut by the top corner of the sign panel, leaving a 2-inch \times 1.5-inch hole. The area around the puncture was depressed into the occupant compartment 1.5 inches, and the total area shattered measured 20 inches \times 17.25 inches. Figure 5.6 shows the windshield damage from inside the occupant compartment. Table D2 and D3 in Appendix D provides exterior crush and occupant compartment measurements.

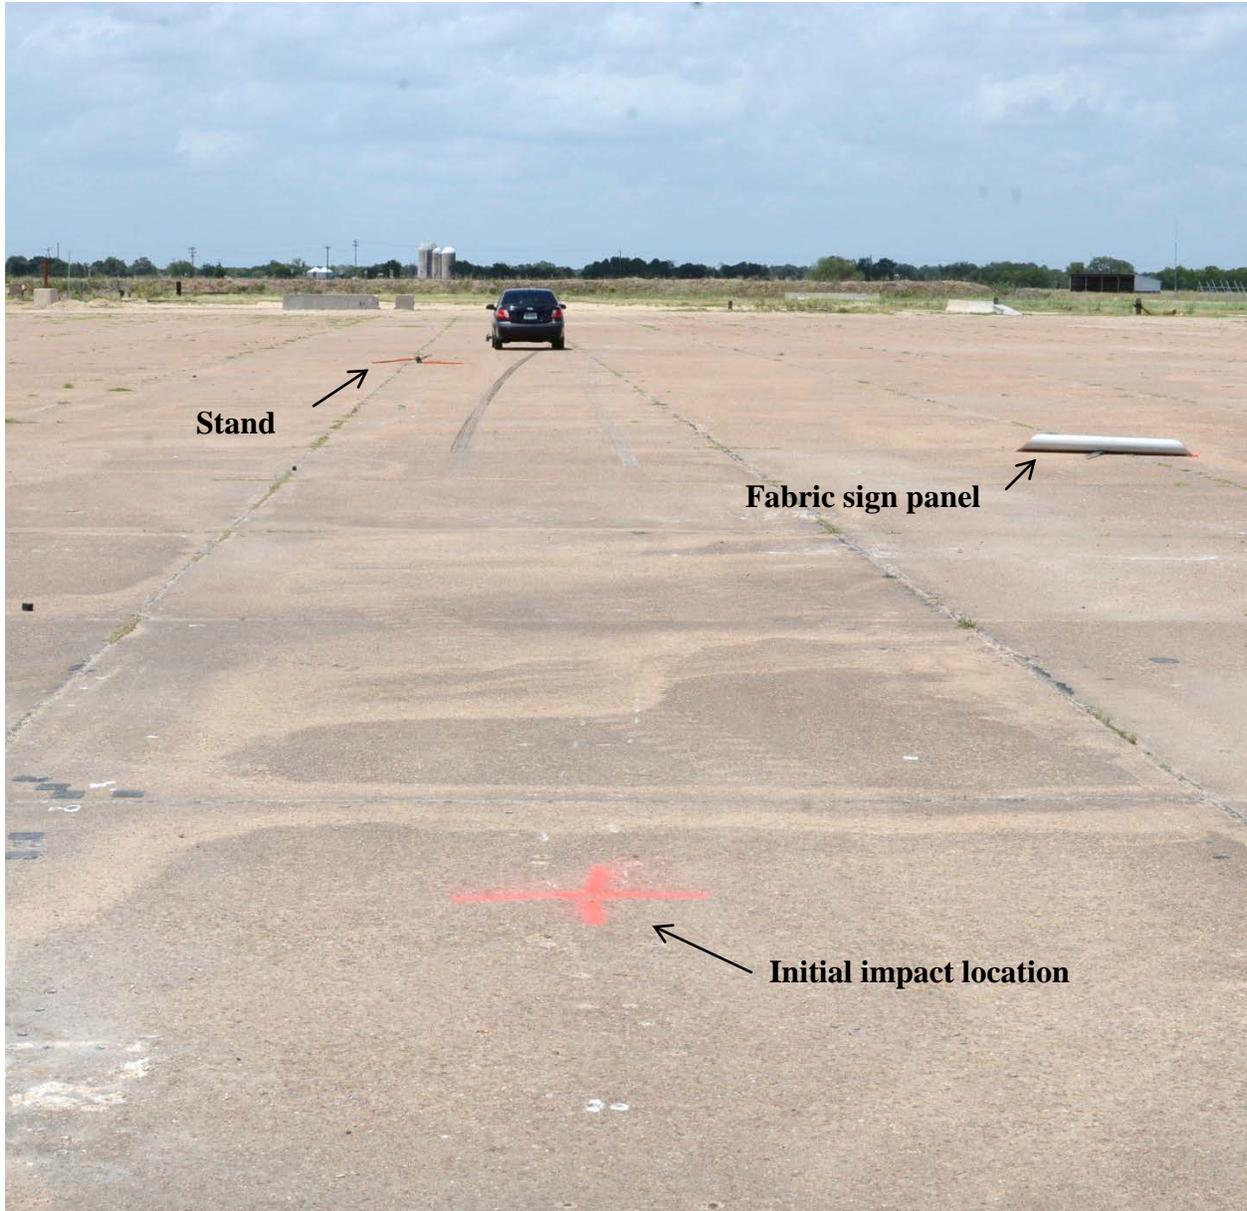
Figure 5.10. After Impact Locations for Test No. 466393-2.

Figures 5.10 and 5.11 show damage to the roll-up sign stand. The fabric sign panel and stays separated from the lower base, contacted and penetrated the windshield, rode up and over the vehicle and came to rest 65 ft downstream of impact. The base of the sign came to rest 158 ft downstream of impact.

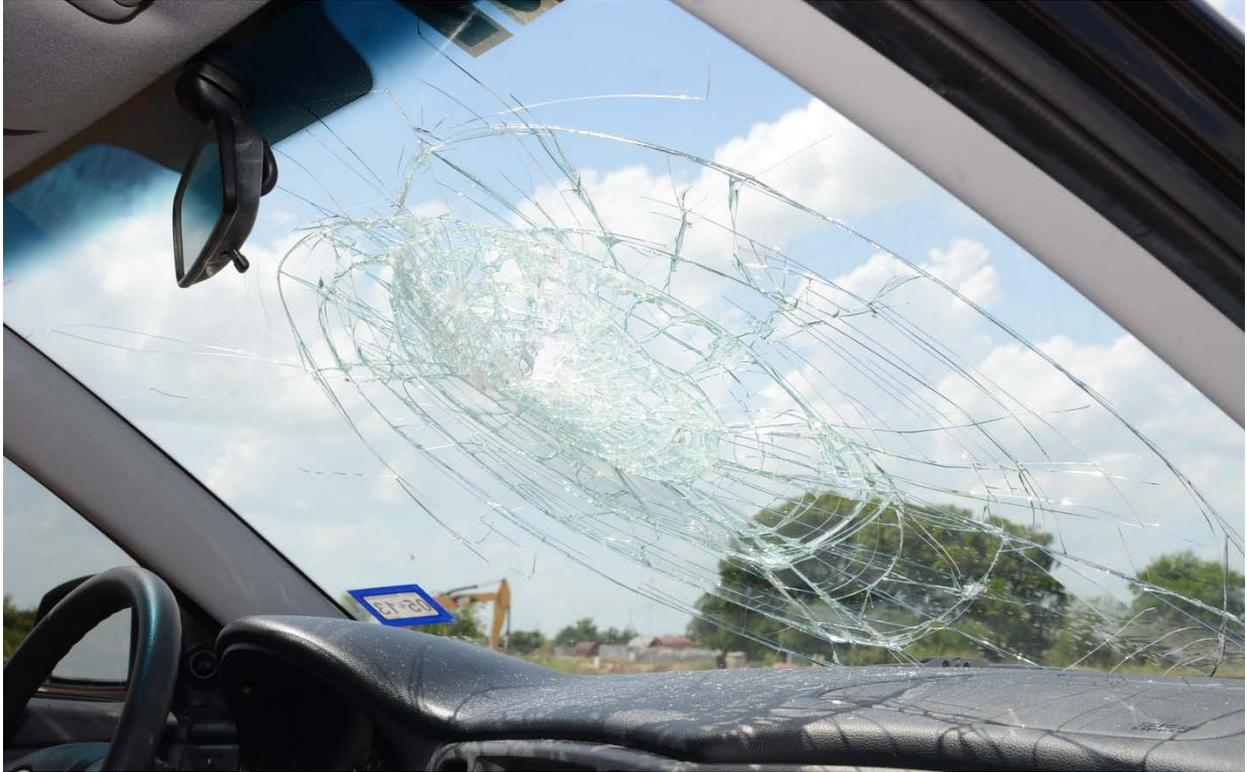
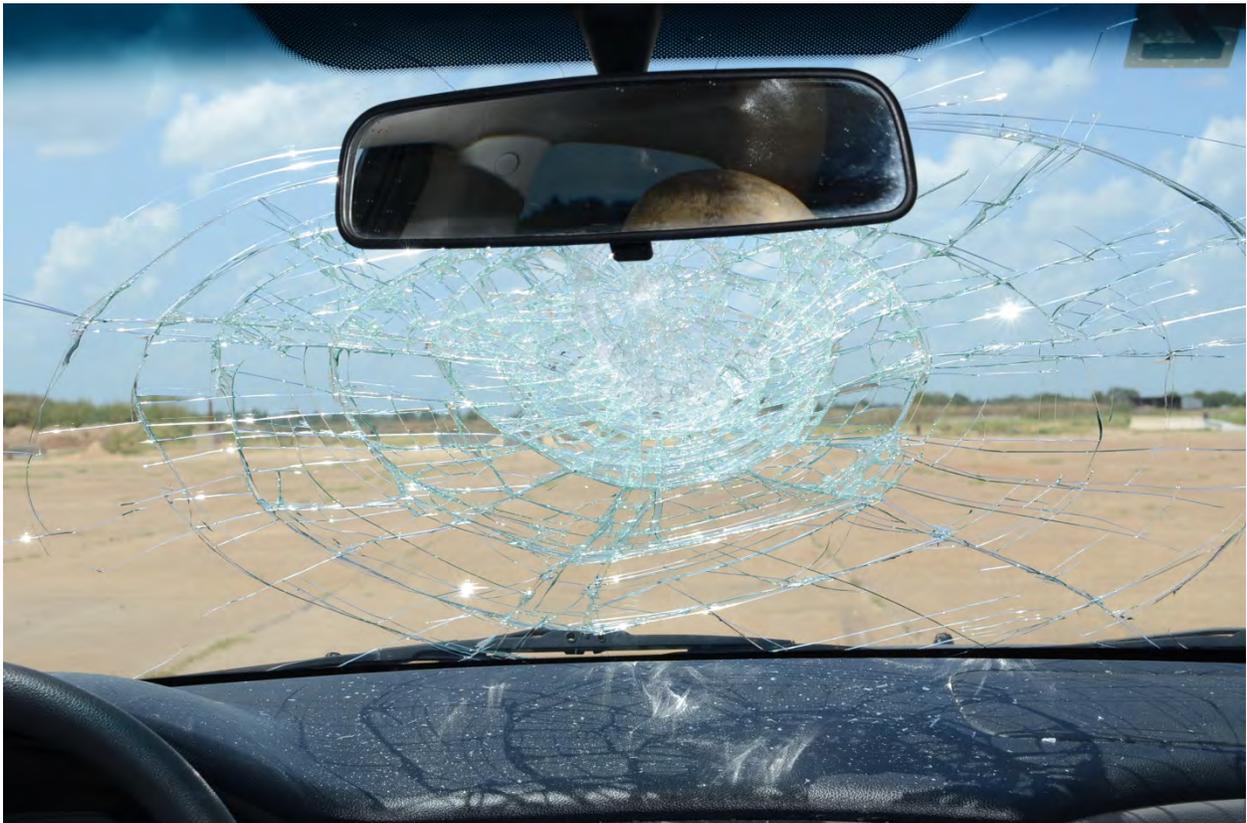
Figure 5.12. Vehicle after Test No. 466393-2.

Figure 5.12 shows damage to the 1100C vehicle. The hood sustained scuff marks. No measurable deformation was noted to the exterior hood or bumper. The windshield had a 4-inch \times 1.5-inch hole. The area around the hole was depressed into the occupant compartment 1.5 inches, and the total shattered area on the windshield measured 15 inches \times 13 inches. Figure 5.13 shows the windshield damage from inside the occupant compartment. Table D5 and D6 in Appendix D provides exterior crush and occupant compartment measurements.

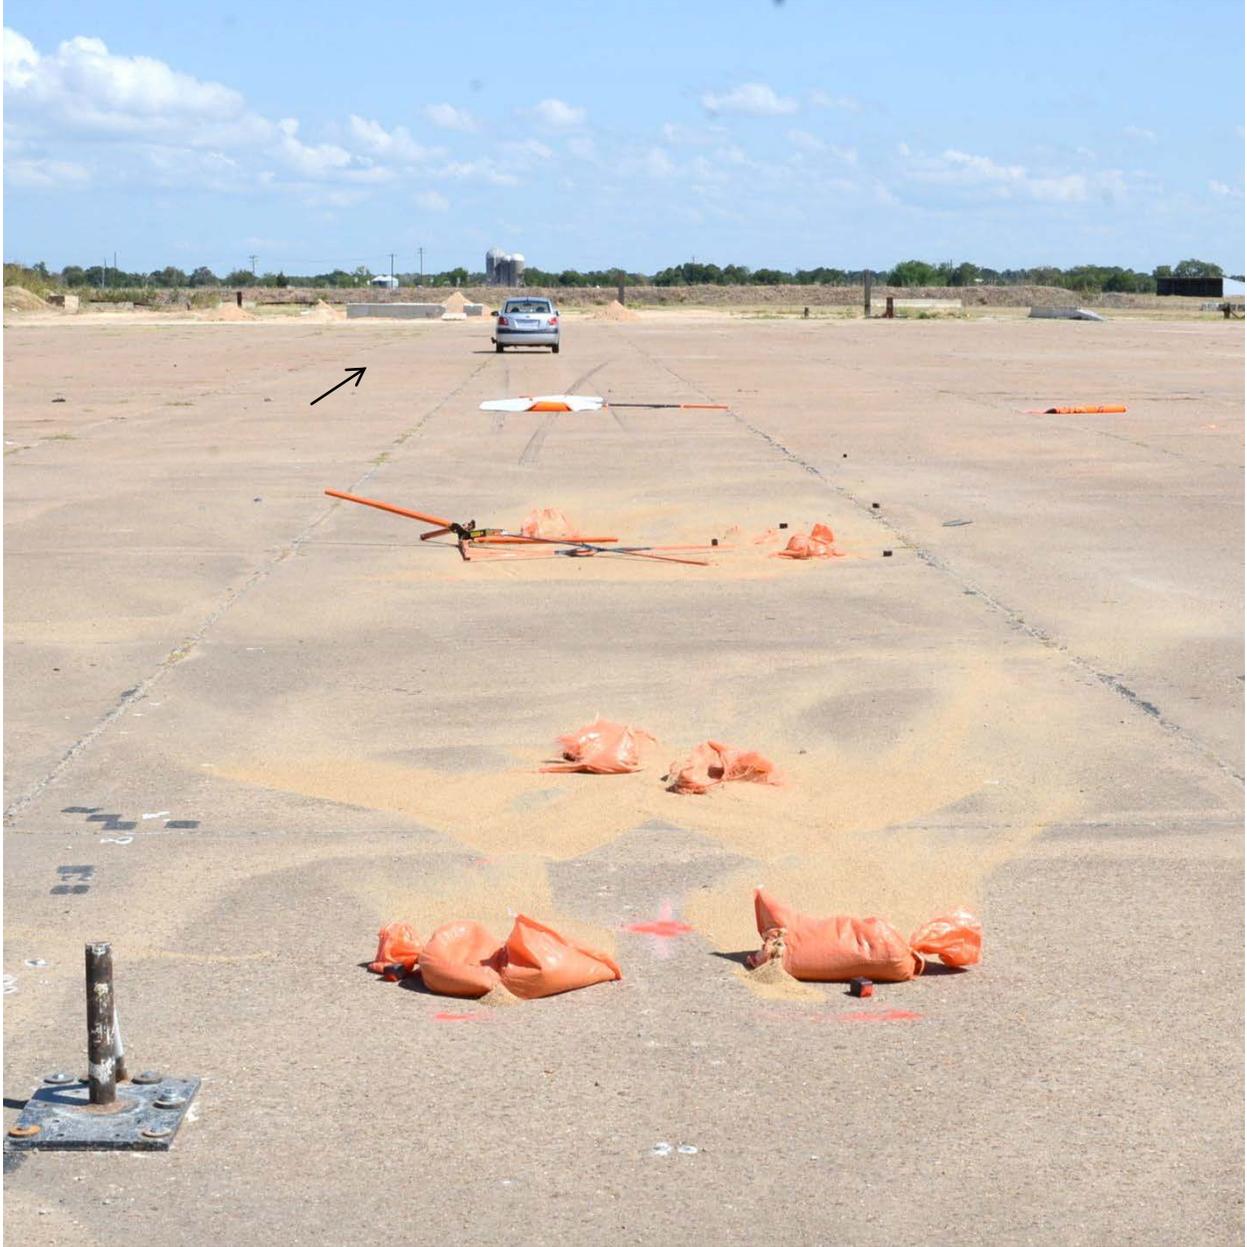
Figure 5.18. After Impact Locations for Test No. 466393-3.

Figures 5.18 and 5.19 show damage to the work zone traffic control device. The fabric sign panels separated from each of the lower bases. The plastic corner pocket at the top corner of the sign panel released from the fabric sign and struck the middle of the windshield. The fabric sign panels then rode up and over the vehicle. The base of the first work zone traffic control device came to rest 35 ft downstream of impact, and the second base came to rest 75 ft downstream of impact.

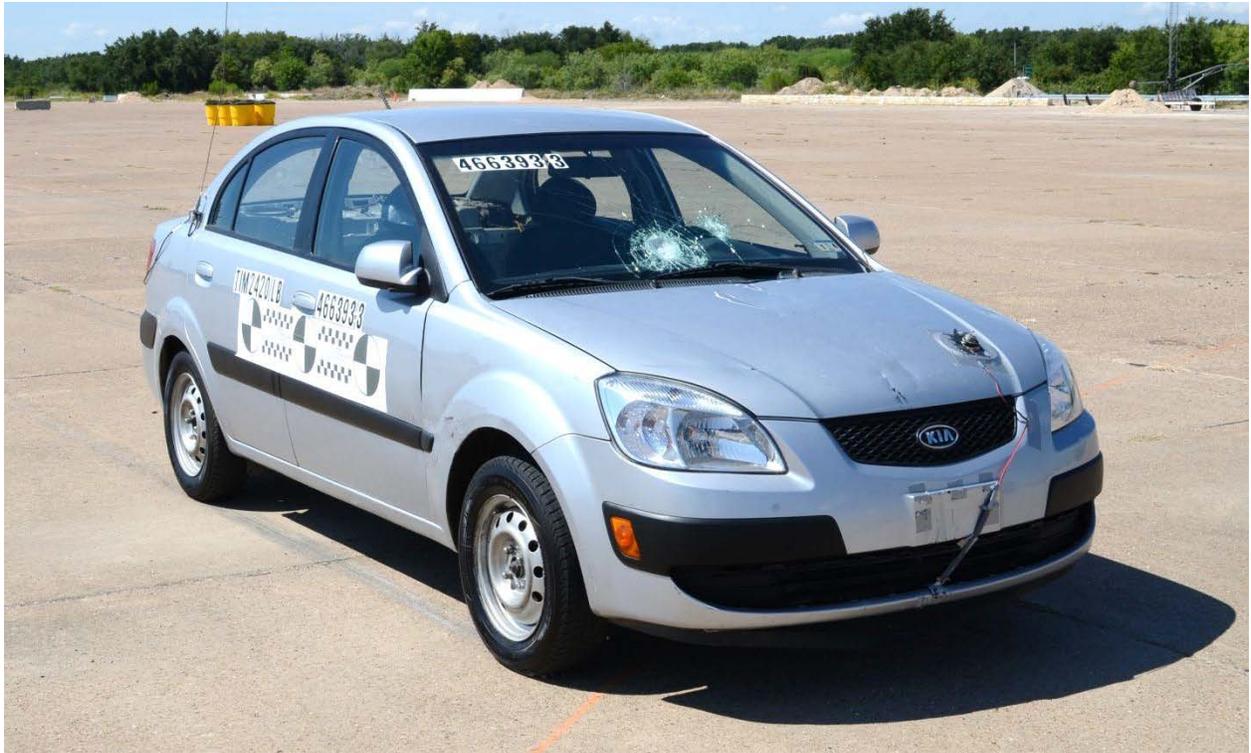
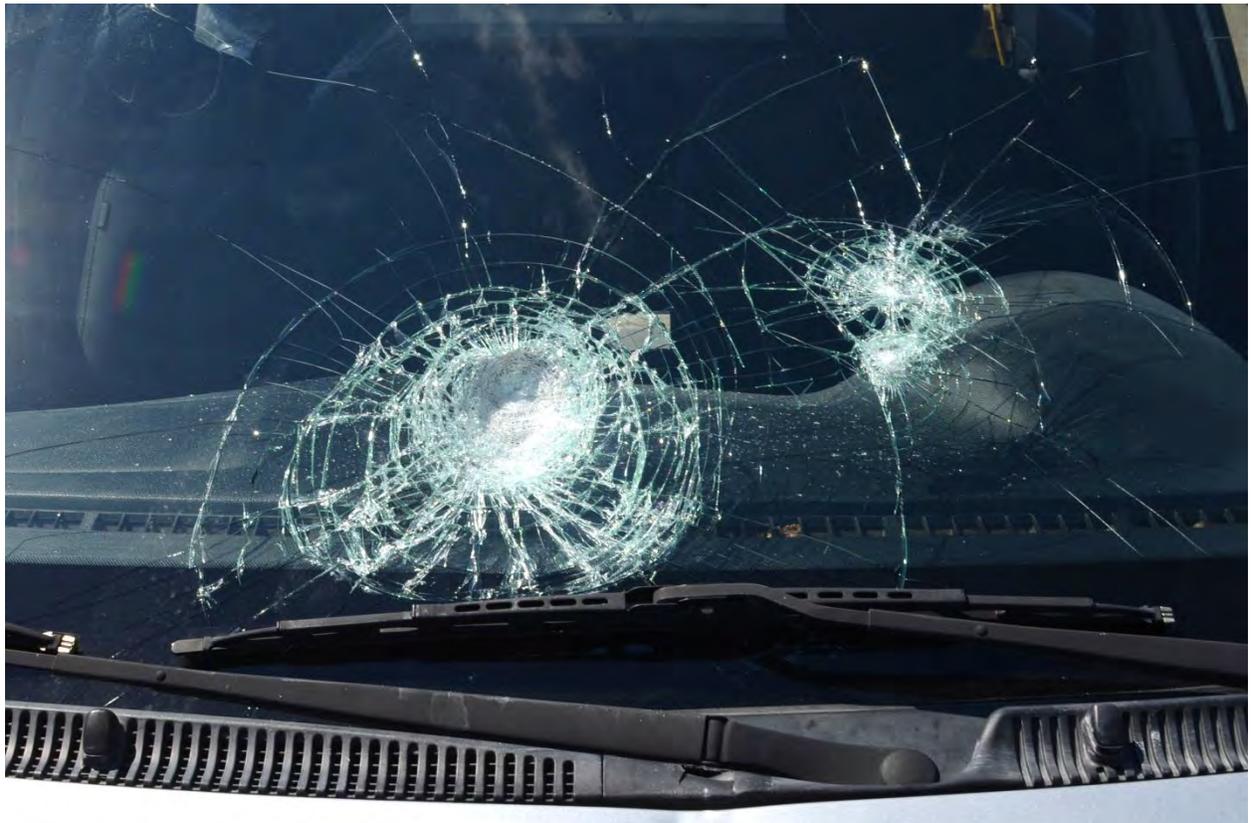
Figure 5.20. Vehicle after Test No. 466393-3.

Figure 5.20 shows damage to the 1100C vehicle. The hood sustained scuff marks. No measureable deformation was noted to the exterior hood or bumper. Contact with the top corner of the first fabric roll-up sign panel caused the windshield to shatter over an area measuring 3 inches \times 3.5 inches. This area was deformed toward the occupant compartment 0.75 inches, but there was no penetration or tear of the plastic liner. Contact of the plastic corner pocket from the second roll-up sign caused cracking of the windshield in two other small areas measuring 2.5-inch \times 2-inch and 1.5-inch \times 1-inch. There was no deformation of these areas into the occupant compartment. The gas tank had a puncture measuring 1.85 inches \times 0.26 inch. Figure 5.21 shows the damage to the gas tank. Table D8 and D9 in Appendix D provides exterior crush and occupant compartment measurements.

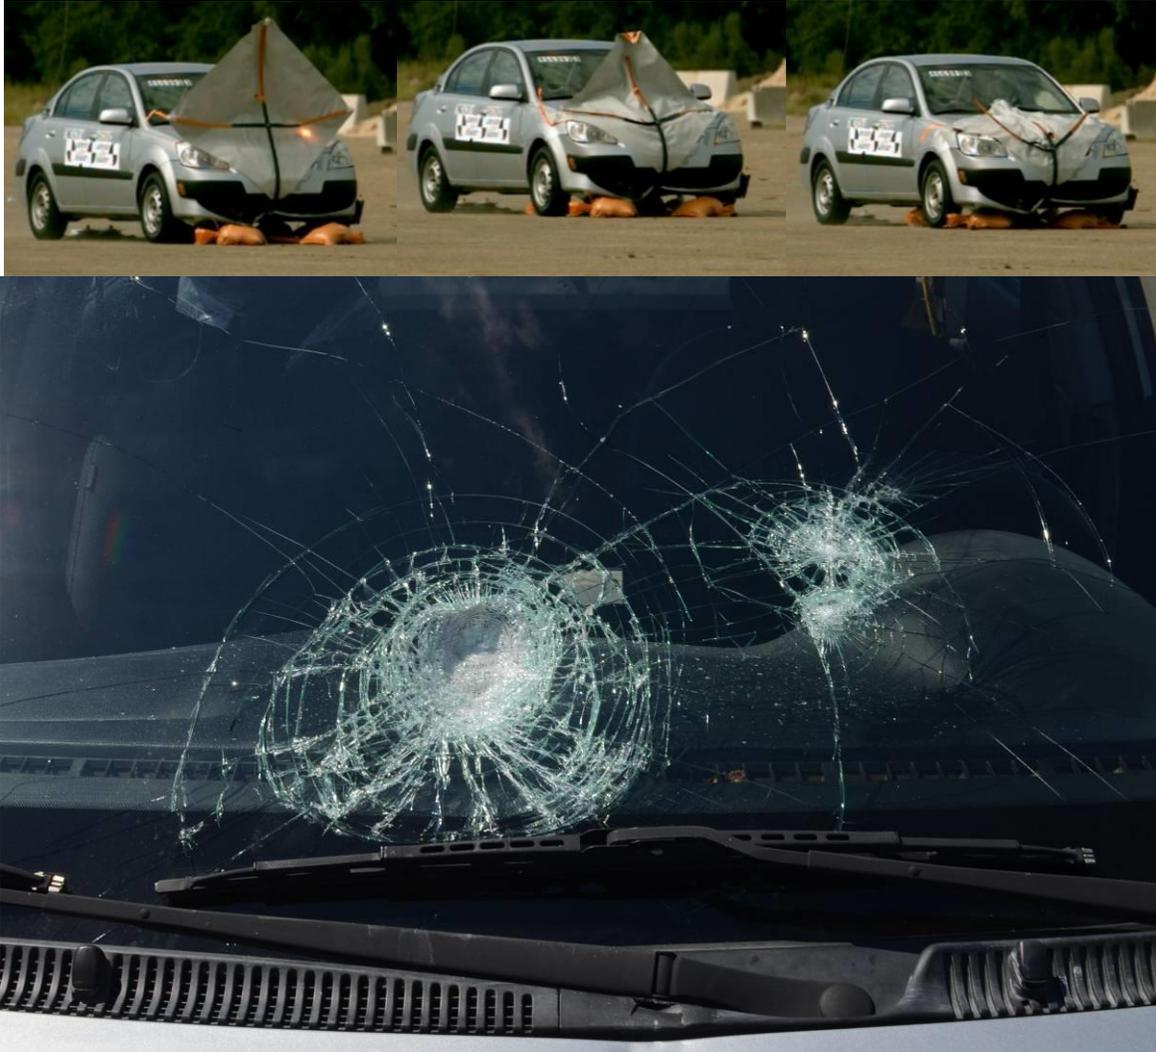
From the observation on the crashworthiness test results, it was found that the prototype through-bolt connection could be an effective way to protect the windshield from penetration by the vertical batten. With the through-bolt connection, the vertical batten was not pulled out from the bracket at the impact and did not hit the windshield as shown in Figure 4. On the other hand, when the spring-loaded universal, snap-in, pocket-type roll-up sign receiver bracket were used, the vertical batten slipped out from the bracket at the impact and the top end of the vertical batten hit the windshield, tearing the plastic liner (i.e., making a punch hole in the windshield), which caused a failure to meet the MASH requirements, as shown in Figure 5.

Figure 4. Photos of the crashworthiness test on the proposed roll-up sign design with the prototype through-bolt connection.

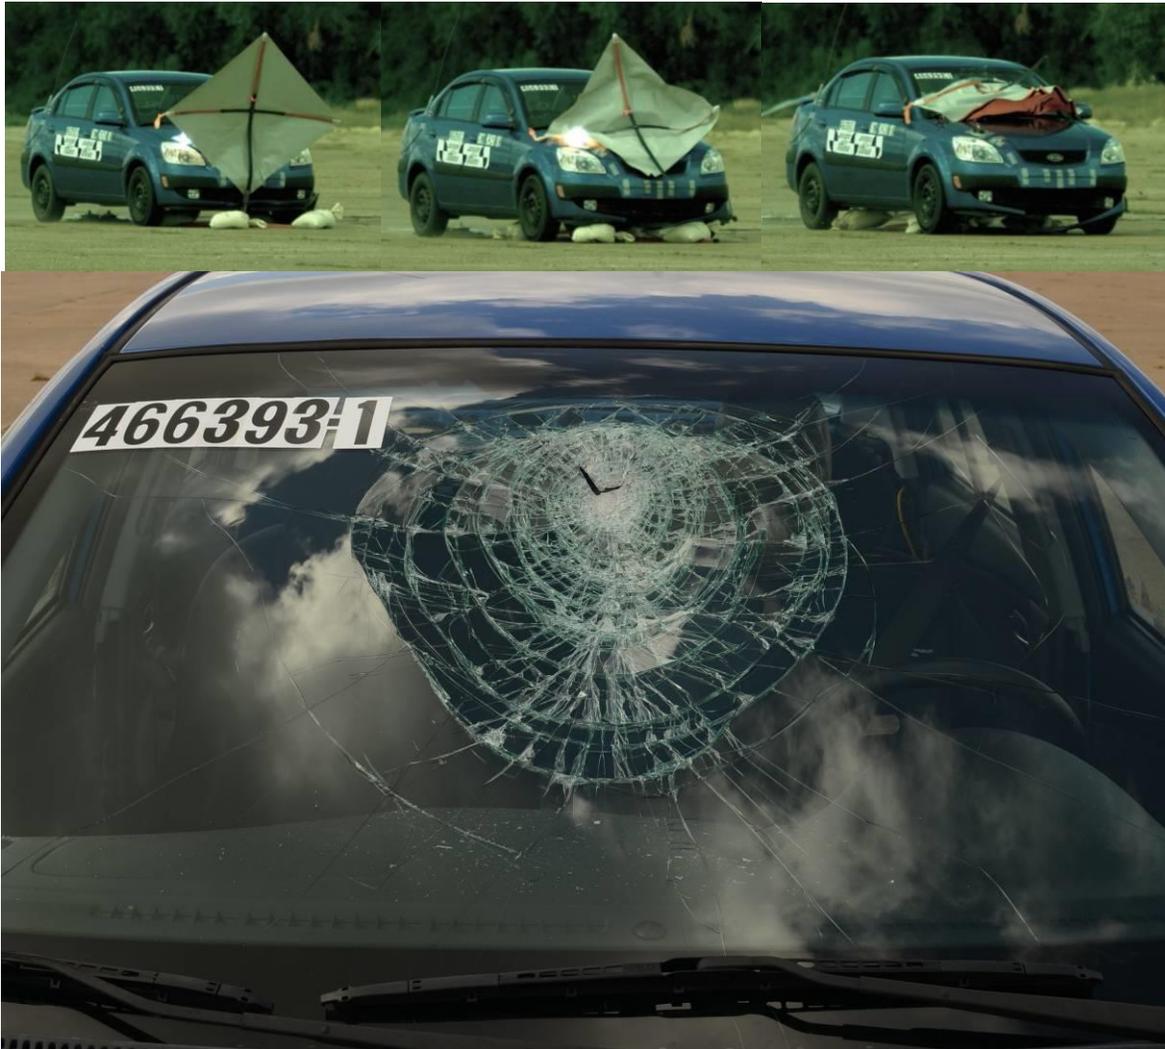
Figure 5. Photos of the crashworthiness test on the proposed roll-up sign design with spring-loaded universal, snap-in, pocket-type roll-up sign receiver bracket.
