Minimize Premature Distresses in Continuously Reinforced Concrete Pavement

Sureel Saraf, Pangil Choi, Sungwoo Ryu,
Tewodros Ghebrab, Moon C. Won

Texas Department of Transportation

Research Project #: 0-6687
Research Report #: 0-6687-1
www.techmrt.ttu.edu/reports.php

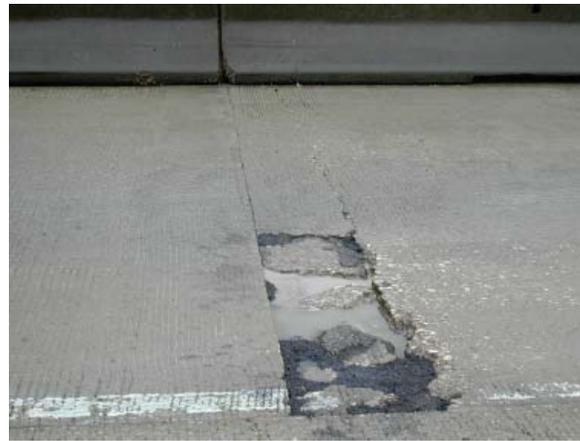
Figure 2. 3 Distress at TCJ

As shown in Table 2.1, about 40 percent of the total punchouts surveyed were at the transverse construction joint (TCJ) or repair joint. Figures 2.2 and 2.3 illustrate the distresses observed at TCJs. These types of distresses were not only observed at TCJs in new construction projects, but also where new CRCP was connected to old CRCP as shown in Figure 2.4 or at repair TCJs as shown in Figure 2.5.

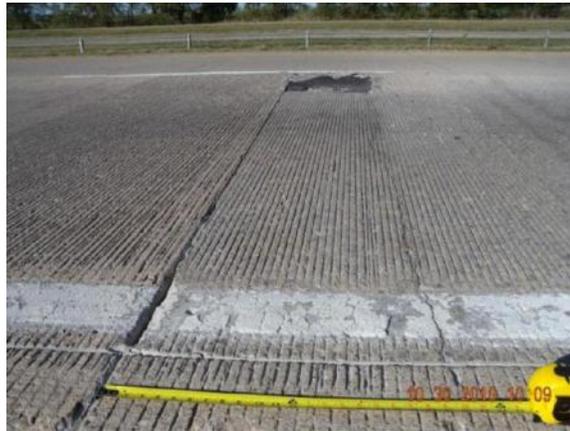
Figure 2. 6 Distress at 2 ft. from TCJ

As illustrated in Figure 2.6, the distresses at TCJ are usually observed at a distance of two feet from the TCJ. Currently, 50% additional longitudinal steel is placed at the TCJs in the form of 50-in. long tie-bars. In Texas, CRCP design standards dating back as early as 1961 provide details of the use of tie-bars at TCJs as shown in Figure 2.7.

Although no documented evidence exists on the rationale behind the introduction of additional steel at the TCJs, the reasoning could have been that if the longitudinal steel amount is deficient, stresses at longitudinal steel at TCJs can be elevated above an allowable level. In early CRCP construction in Texas, longitudinal reinforcement was in the range of 0.47% to 0.52% which is lower than the values in use currently. In 1969, a new design standard was published and 0.6% longitudinal steel was provided as an option of two longitudinal steel percentages (0.5% and 0.6%). It is possible that at a low longitudinal steel amount, steel stress could increase above an allowable level at TCJs. In such situations, the widths of TCJs could be larger, with water getting

into the joint and resulting in corrosion of steel. However, the presence of distresses in the area where the additional steel ends, i.e. two feet from the TCJ, implies that the presence of additional steel at the TCJ plays a role in the occurrence of distresses near the TCJ.

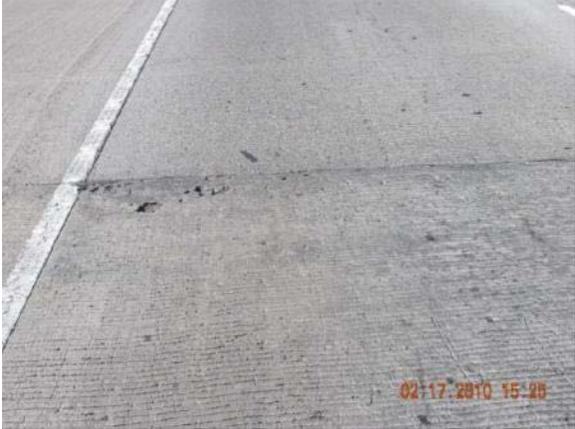
Figure 2. 12 Surface Voids at TCJ

As shown in Figure 2.12 and Figure 2.13, surface distresses in the form of voids are observed at the TCJs. The cause of such distresses could be the quality of in-place concrete in these areas. The concrete used on either side of the TCJ is usually the first or the last batch of the concrete for

that particular day of construction. The quality of the concrete at the TCJ may vary slightly from the concrete quality in the rest of the slab. Also, concrete placement and consolidation at the TCJ is carried out manually since the slip-form paver cannot start or end the paving process right at the TCJ.

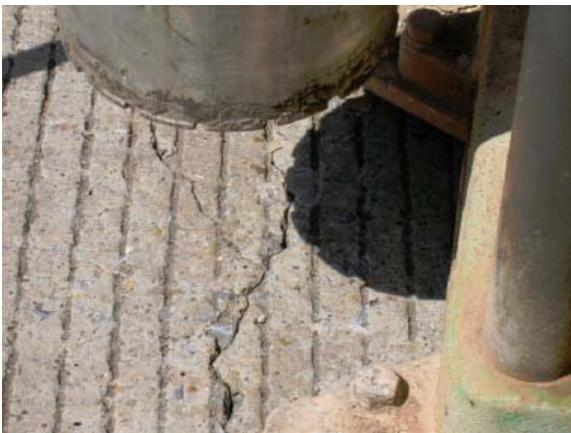
Figure 2. 20 Coring at Y-Crack Location

Figure 2.20 shows a Y-crack and Figure 2.21 illustrates the core taken at the Y-crack location. As shown in Figure 2.21, the core contains two horizontal cracks which may induce premature distresses in the form of partial-depth punchouts. The basic principle of CRCP design is based on the assumption of solid concrete that is bonded with longitudinal steel. Once this assumption is violated, the life of CRCP is reduced and premature distresses might develop.

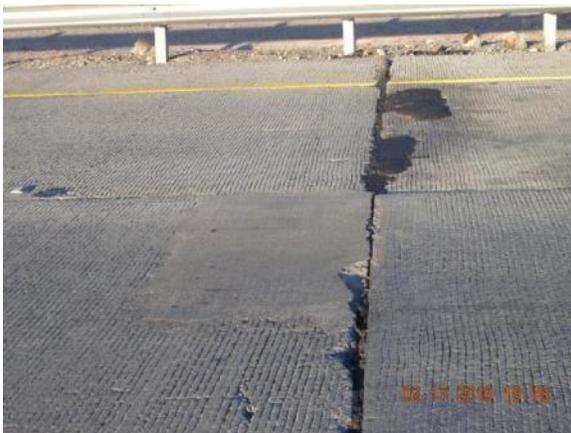
Figure 2. 24 Distress at TCJ on IH 10 in the El Paso District

Figures 2.24 through 2.27 represent TCJ on IH 10 in the El Paso District. This section was constructed in 1995. The slab thickness is 13 in. and 4-in. Type B asphalt concrete pavement was used as subbase. The TCJ width in this section is around 2-in. Considerable movement of the slabs near the TCJ has resulted in the occurrence of distresses in both the lanes.

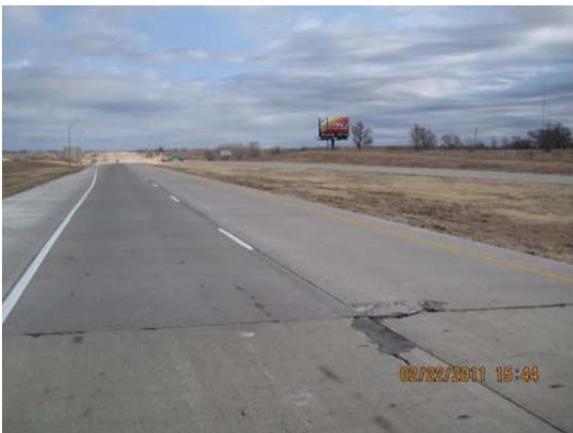
Figure 2. 28 Distress at TCJ on IH 40 in the Childress District

Figures 2.28 through 2.31 illustrate a section on IH 40 in the Childress District. This section exhibits distresses near the TCJ. The width of the TCJ at this section was measured in the morning and evening on November 2, 2012. The TCJ width decreased from 1/2 in. in the morning to 3/8 in. in the evening. The maximum and minimum temperature at this location on November 2, 2012 was 82 °F and 53 °F respectively. A zoomed-in view of the TCJ at this location provides evidence of steel slipping away from the concrete or occurrence of debonding between the steel and concrete. This provides evidence of debonding, and the resulting increase in TCJ width causing occurrence of distresses at the TCJ. CRCP segments in this area were removed and replaced due to expansion of subgrade soil containing gypsum due to lime stabilization. It appears that the restoration of the continuity of longitudinal reinforcement was not properly made.

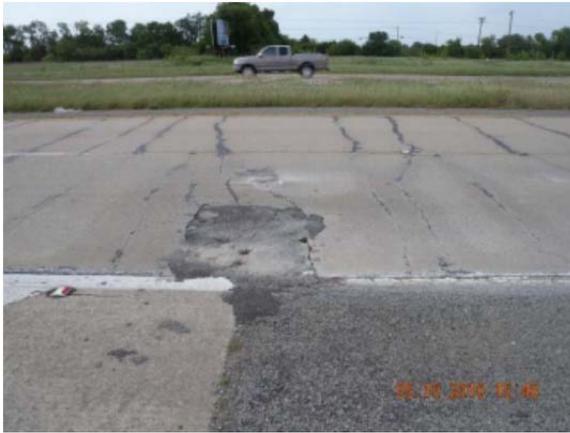
Figure 2. 32 Distress at Gore Area Due to Different Edge Support Conditions

Distresses are observed at gore areas where asphalt shoulder is used. Figure 2.32 shows distresses in the outside lane at the end of the concrete gore. When a CRCP section has two different shoulder types next to each other as shown in Figure 2.32, the edge of the CRCP slab at the transition between tied concrete and asphalt shoulders changes from Westergaard's so-called interior condition to an edge condition. The difference in slab deflections between the interior and edge conditions due to wheel load applications is considerable. Figure 2.33 shows deflection testing conducted on IH 35 in Denton County in the Dallas district.

This large difference in deflection between the two loading conditions as wheel load is applied in this area will cause high local differential deflections (from 4.3 mils to 12.6 mils), which could lead to distresses. Since TxDOT started building CRCP with tied concrete shoulder, the frequency of this distress type will decrease significantly.

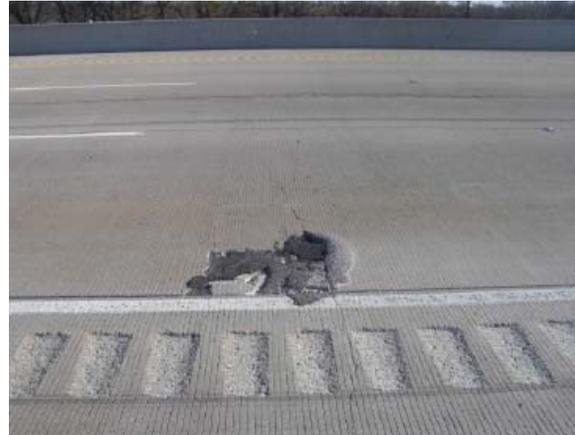
Figure 2. 38 Distresses Near LWJ

Distresses at longitudinal construction joint (LCJs) or longitudinal warping joints (LWJs) are frequently observed. Figures 2.37 and 2.38 illustrate distresses observed at LCJ and LWJ, respectively. Until now, the distress shown in Figure 2.37 was classified as a punchout that resulted from short transverse crack spacing. Assuming that larger crack spacing would prevent this distress type, efforts were made in the past to minimize the occurrence of short crack spacing. However, there are many cracks with short spacing that do not develop into this type of distress. Field evaluations of this type of distress reveal that horizontal cracking is observed at the depth of the longitudinal steel. The distress shown in Figure 2.38 was investigated and horizontal cracking was observed at the depth of the longitudinal steel. Even though part of the distresses shown in Figures 2.37 and 2.38 are under the wheel path and when loading positively contributed to the progression of this distress, the longitudinal joint appears to play a role in the development of this distress type. Since this type of distress is rarely observed in CRCP with crushed limestone as a coarse aggregate in concrete, it is postulated that concrete volume change potential and possibly concrete modulus of elasticity plays a major role in development of this

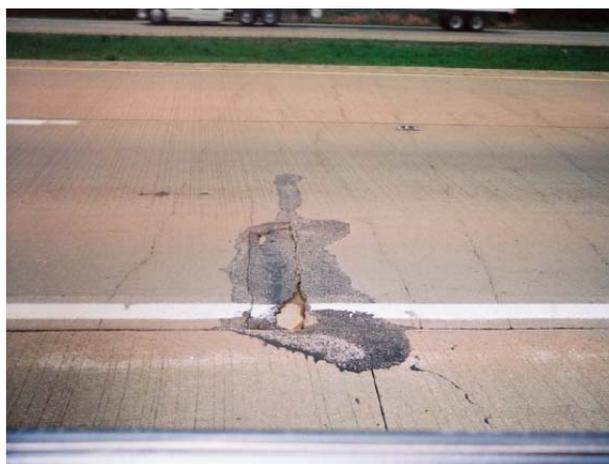
Figure 2. 40 Distress at CRCP/CPCD
(Photo courtesy of M. Plei)

David Lippert, P.E. of Illinois DOT states that the distresses occurred about five years after construction. Interestingly, this project had a 5-year warranty. Mr. Lippert also stated that no comprehensive investigation was conducted and the exact mechanism was not identified. He also mentioned that in Illinois, they use tied CPCD as a shoulder for CRCP, and this type of distress is not common. It appears that large slab movements near the transverse warping joints in CPCD shoulder could cause distresses in CRCP, when certain conditions are met, such as larger movements of CPCD due to insufficient base friction.

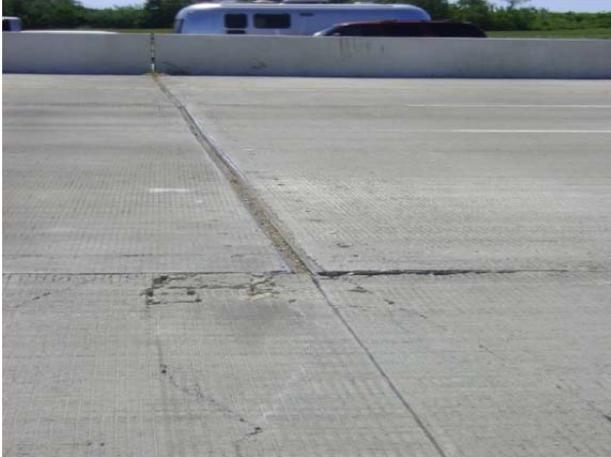
Figure 2. 41 Distress in CRCP Next to CIP-PCP on IH 35 in Hillsboro

A similar type of distress occurred in Texas. Figure 2.41 shows a distress in CRCP tied to cast-in-place pre-stressed concrete pavement (CIP-PCP) on IH 35 in Hillsboro. Distress occurred in CRCP tied to CIP-PCP. In CIP-PCP, two layers of polyethylene sheets were placed under the concrete slab to reduce sub-base friction and pre-stress loss. Due to the reduced sub-base friction, CIP-PCP slab will move almost freely, resulting in large slab movement near the armor joint area. On the other hand, CRCP slab movements are quite limited due to the sub-base friction and the continuity of the longitudinal steel. Due to the differential slab movements of the two slabs that are tied together at the longitudinal joint by tie bars, distresses occurred.

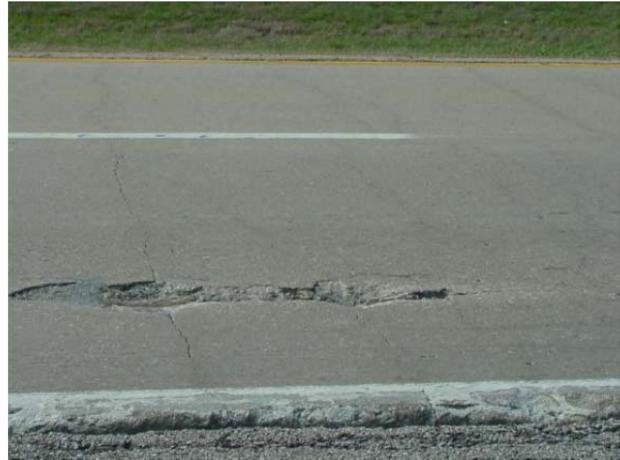
Figure 2. 44 Distress Associated With Steel Placed Too High

might not have had enough concrete cover for the #8 bar size. Placing longitudinal steel near the surface could have other consequences, as shown in Figure 2.44. Concrete spalled out at the location of the steel, exposing longitudinal steel. Since only #6 bars are used for tie bars in Texas, this issue was not investigated in this study.

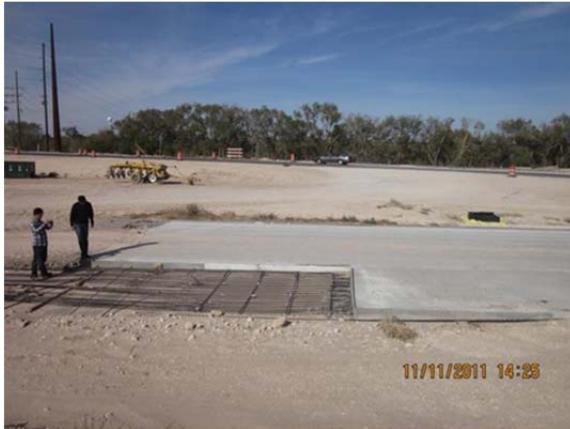
Figure 3. 4 Existing Slab at LBB-I Test Section

Figure 3.4 illustrates the condition of the existing pavement side of LBB-I test section. As shown in Figure 3.5, a header was placed at the end of construction on November 15, 2010. However, the longitudinal steel in this region was not extended to be spliced with longitudinal steel on the other side of the joint that would be constructed in the future. Also, 50% additional multi-piece tie-bars were installed during the construction of the transverse construction joint at the existing pavement. Female tie-bars were installed at the TCJ during construction and the header was placed at the end of construction.

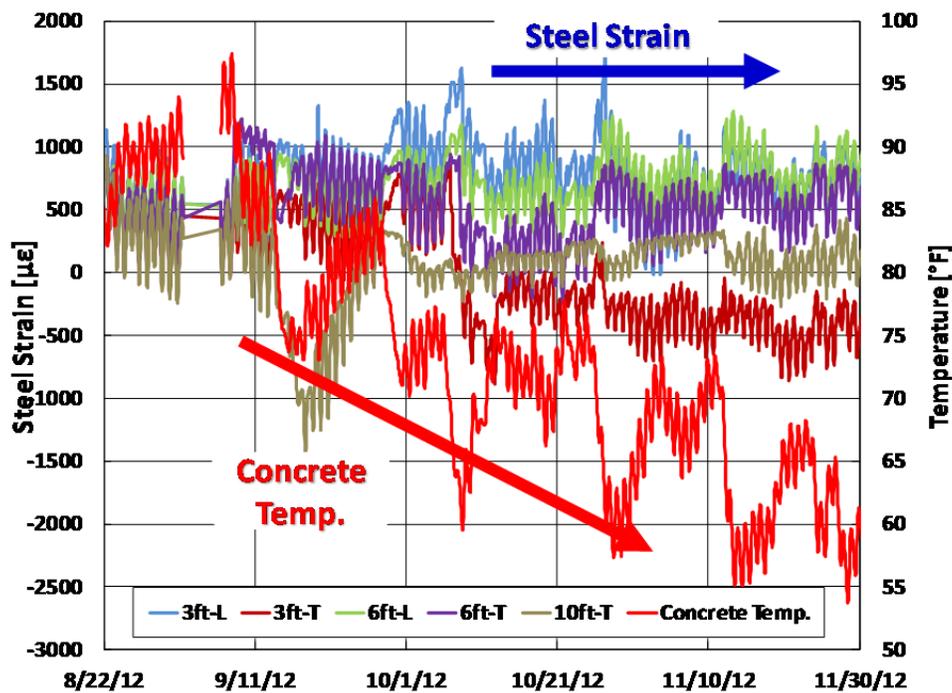
Figure 3. 37 Early Age Steel Strain at BWD-I Test Section

Figures 3.37 and 3.38 illustrate the early and later age behavior of steel strain at BWD-I. As can be seen in Figure 3.37, concrete temperature dropped from 70 °F to 55 °F from October 1, 2012 to November 30, 2012. However, the steel strains in the longitudinal as well as additional tie-bars remained relatively steady, while experiencing daily variations due to daily temperature variations, as observed in the Lubbock test section. As shown in Figure 3.38, the steel strains in the longitudinal steel at 3 ft. and 6 ft. from the LCJ remained steady at around 1,000 micro strains and 500 micro strains in tension, respectively. However, after the temperature increase from March 7, 2012, steel strains in the tie-bar at 6 ft. moved towards compression, as those at the tie-bars at 3 ft. and 10 ft.

On the other hand, strains in the longitudinal steel remained in tension, which indicates that the behavior of longitudinal steel and additional tie bars is quite different. The primary reason for this discrepancy in the behavior is the continuity condition of the bars. When the concrete temperature increases, the volumes of both concrete and steel bars try to increase as well. In general, there is a good bond between longitudinal steel and surrounding concrete, and the concrete and longitudinal steel behaves as a composite material. On the other hand, additional tie bars are not continuous, and there is a discontinuity at the end of the tie bar. When the concrete temperature volume expands due to temperature increase, concrete could push tie bars

longitudinally towards TCJs, causing tie bars in compression and, if excessive, tensile stress in the vertical direction in the concrete near the tie bars, potentially resulting in horizontal cracks at the depth of tie bars. This mechanism of horizontal cracking in concrete slabs has been observed at transverse contraction joints in jointed concrete slabs where dowels cause vertical tensile stresses in concrete when temperature increase is excessive. Based on the available CRCP design standards, TxDOT has been using additional tie bars as early as 1960, and it is difficult to form a logical or technical justification for the use of additional tie bars at TCJs. It could be that an assumption was made at that time that additional tie bars would behave the same way as longitudinal steel and thus complement longitudinal steel at TCJs, reducing the stress level in longitudinal steel at TCJs and improving overall performance. The data from field experimentation indicates that is not the case.

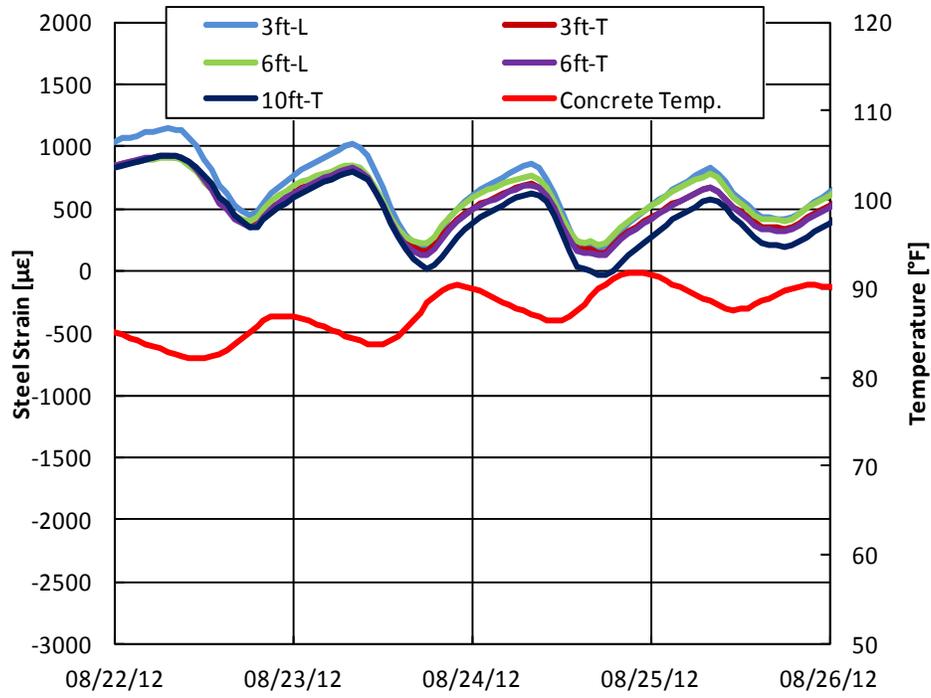
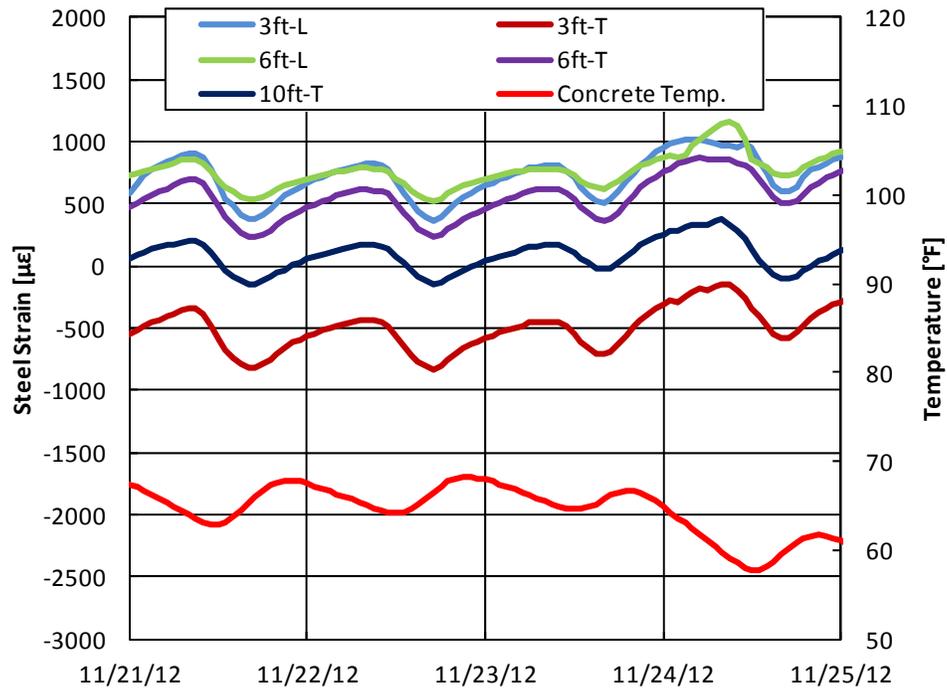
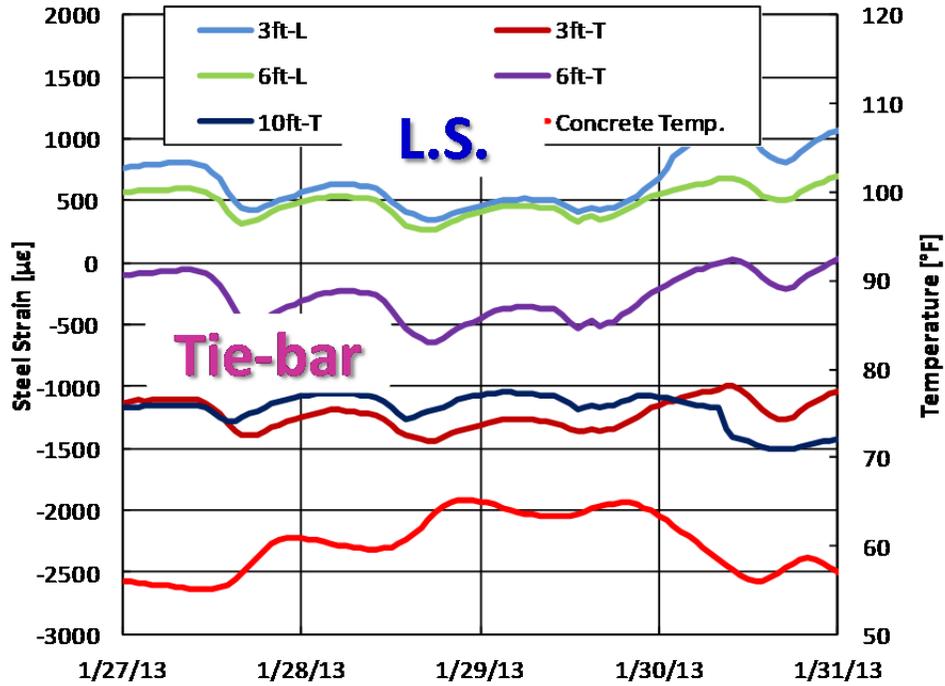
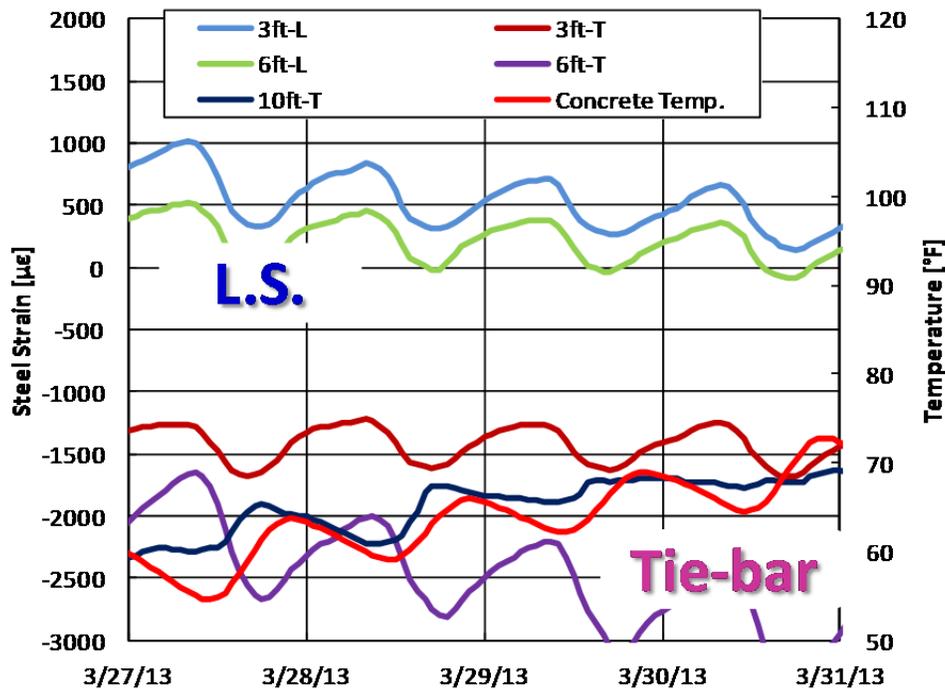
Figures 3.39 through 3.42 provide a more exhaustive display of the steel strains at BWD-I test section from the early age until seven months after construction. They show that the variations in steel strains in longitudinal steel at 3 ft. and 6 ft. from the pavement edge remained relatively small and in tension, whereas the steel strains in tie-bars gradually moved towards compression. This disparity in steel strains between longitudinal steel and additional tie bars provides valuable technical information which should be considered for improved design of TCJs in CRCP.

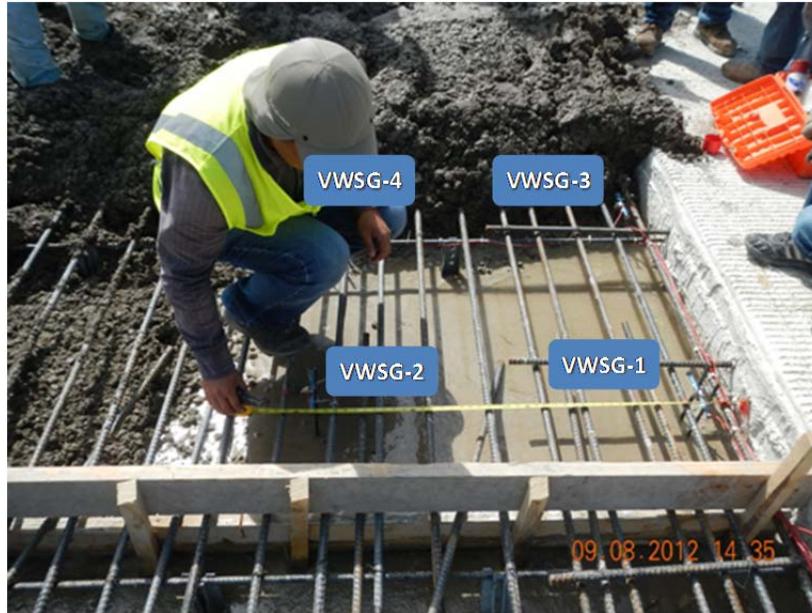
Figure 3. 44 VWSG Installation at BWD-II Evening Test Section

As shown in Figure 3.44, additional tie-bars from both the TCJ and LCJ in addition to the longitudinal steel can be seen near the installation of VWSG-1. At VWSG-3, tie-bars from the LCJ and longitudinal steel were present. At VWSG-2 tie-bars from the TCJ and longitudinal steel can be observed. At VWSG-4 only longitudinal steel is present due to the location being 4 ft. from the TCJ as well as LCJ. Thus, the highest concentration of restraint in the form of additional and longitudinal steel can be seen at the location of VWSG-1.

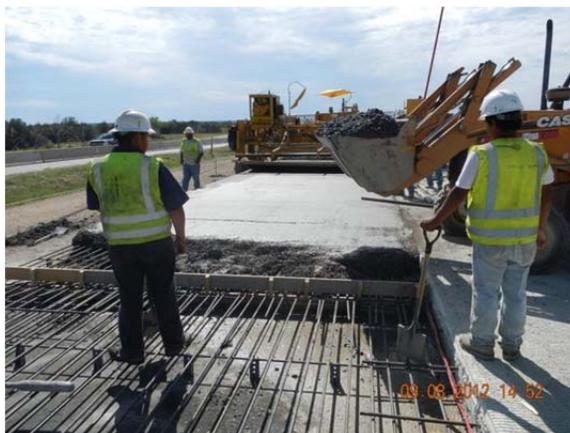
Figure 3. 45 Concrete Placement at BWD-II Evening Section

Figures 3.45 and 3.46 show the construction process at the BWD-II evening placement side. The construction near the TCJ is carried out manually since the paver cannot pass over the headers placed to construct the TCJ at the end of the day’s paving. The concrete used for paving near the evening section at TCJ is usually the last batch of concrete and its quality may vary from the concrete used in the rest of the pavement. Also, compaction near the TCJ is carried out using hand-held vibrators which may affect the overall consolidation of concrete in this area.

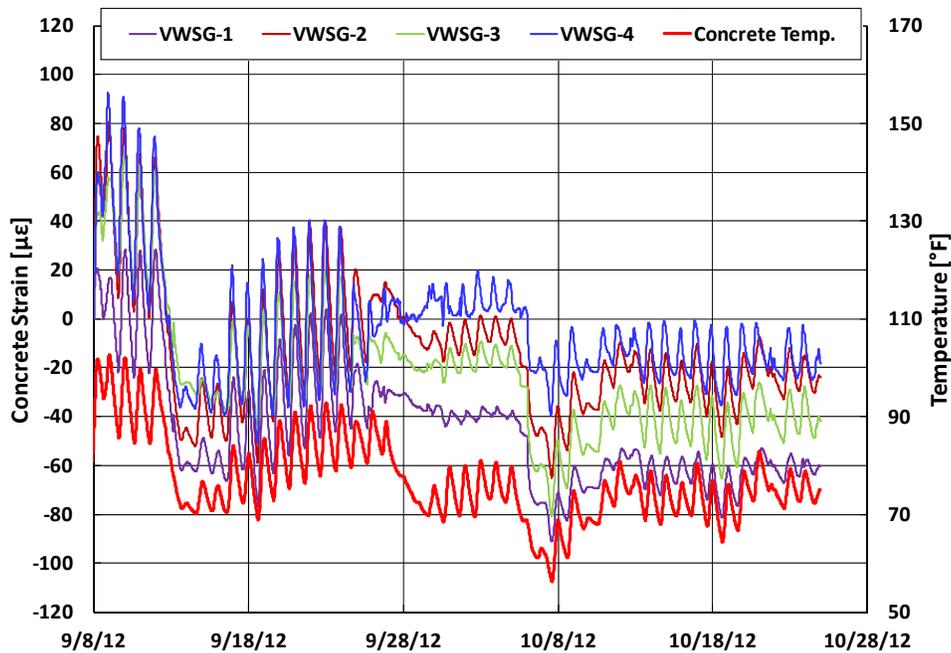
Figure 3. 51 Concrete Strain Variation at BWD-II Test Section

Figure 3.51 shows the daily concrete strain variation with temperature at the BWD-II section. The evening side of the TCJ was placed on September 8, 2012 and the morning side on September 24, 2012. The concrete strain varies with daily temperature variation at all four

VWSG locations. However, after September 24, 2012, there is a clear distinction between the concrete strains at the four locations. The highest concrete strain can be seen at the VWSG-4 location, which is at 4 ft. from the LCJ and TCJ and the lowest concrete strain is observed at VWSG-1, which is closest to the LCJ and TCJ at a distance of 0.5 ft. from the LCJ and 1 ft. from the TCJ.

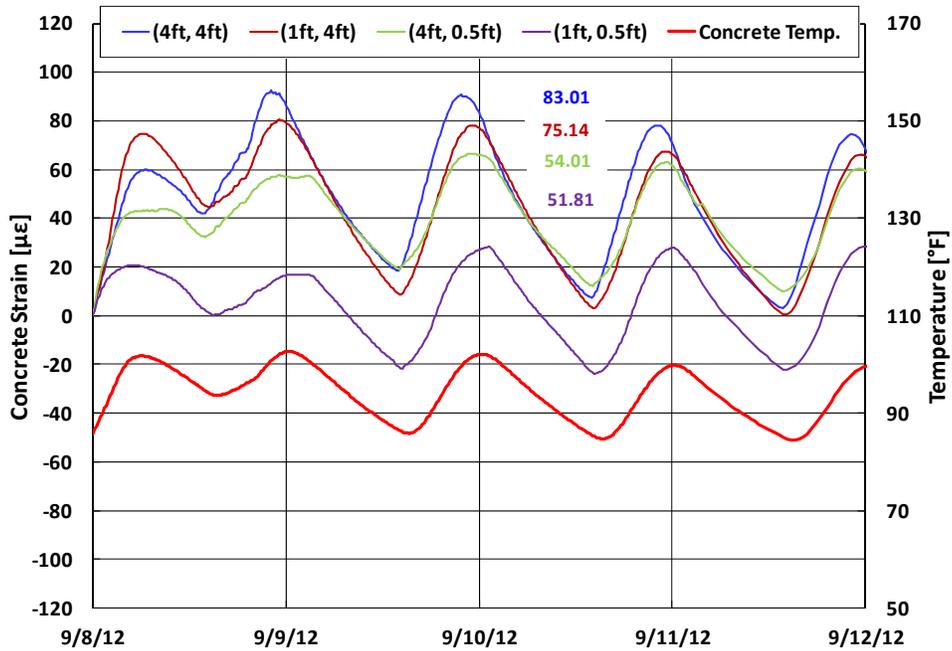
Figure 3. 52 BWD-II Concrete Strain Comparison Before Morning Side Placement

Figures 3.52 and 3.53 represent the concrete strain variation at the four VWSG locations at BWD-II for 4-day intervals, before and after placement of the concrete on the morning side of the TCJ. As shown in Figure 3.52, on September 10, 2012, the daily concrete temperature varied from 85°F to 100 °F. As the temperature varied by 15 °F, the total concrete strain variation at VWSG-1, VWSG-2, VWSG-3 and VWSG-4 was 51.81 με, 54.01 με, 75.14 με and 83.01με respectively. Thus, the highest daily strain variation was experienced at the VWSG-4 location and the lowest at the VWSG-1 location. This can be explained by the presence of additional tie-bars at the junction of TCJ and LCJ where the VWSG-1 is located, leading to high restraint towards movement of concrete and thus exhibiting the lowest daily concrete strain variation. However, VWSG-4 is at a distance of 4 ft. from the LCJ and TCJ. At this location concrete is only restrained by longitudinal steel and hence experiences less restraint and higher total daily

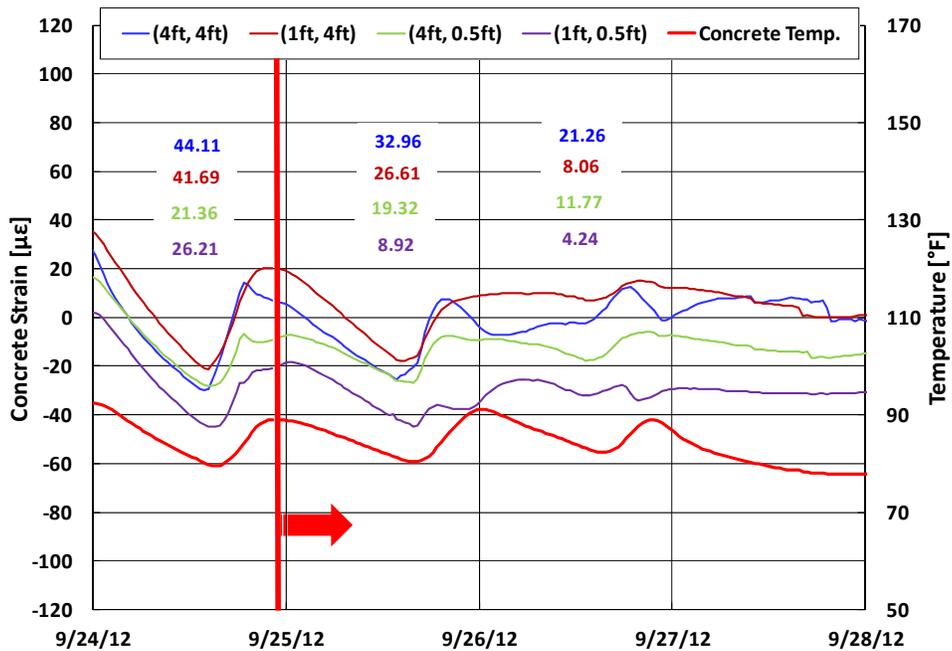
Figure 3. 53 BWD-II Concrete Strain Comparison After Morning Side Placement

strain variation. Figure 3.53 presents the concrete strain variation from September 24, 2012 to September 27, 2012. As can be seen, the daily total concrete strain variation decreased a lot after concrete was placed on the evening side of the TCJ on September 24, 2012.

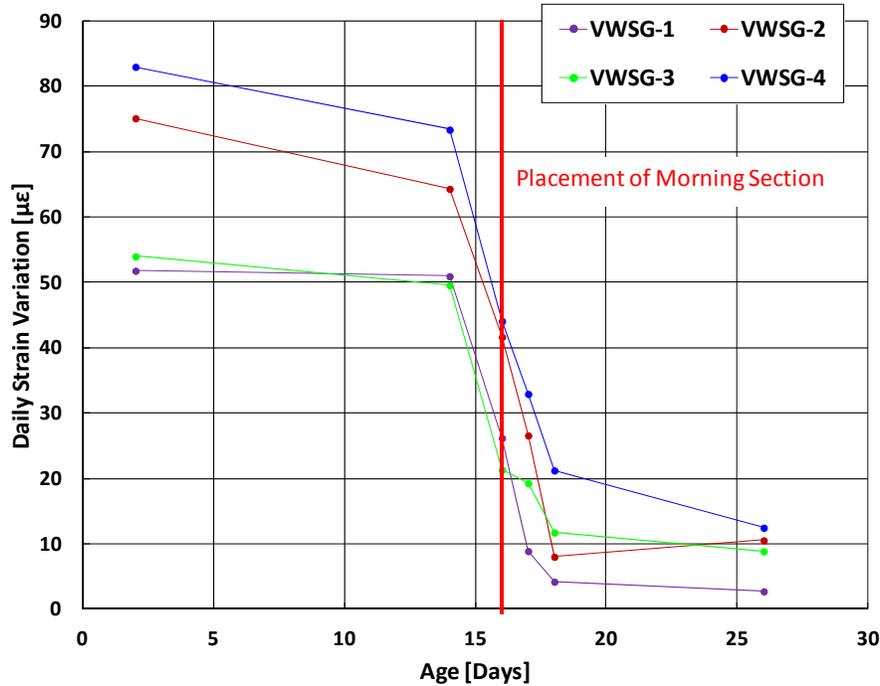
Figure 3. 54 Daily Strain Variation Near and Away From the Longitudinal Construction Joint at BWD-II Test Section

As shown in Figure 3.54, the daily strain variation before the construction of the morning side at the TCJ are highest at VWSG-4, followed by VWSG-2. Both these locations are at a distance of 4 ft. from the LCJ. At 0.5 ft. from the LCJ, VWSG-1 and WSG-3 locations show similar daily strain variation characteristics. On Day 16, after the construction of the morning side, the daily strain variations at all VWSGs dropped drastically. However, the highest drop in daily concrete strain variation can be seen at the VWSG-1 location, where the daily strain variation dropped by 70% from 26 micro strains to 8.9 micro strains on Day 17. Further daily strain variation monitoring revealed that at the end of 26 days since construction of the evening section, the lowest daily concrete strain variation was observed at VWSG-1 and the highest at VWSG-4.

Thus, before the evening side placement at BWD-II, the concrete strain near the junction of the TCJ and LCJ experienced the lowest strain. After construction of the evening side, the concrete strain variation near the junction dropped drastically. As a result, the concrete stress at the junction of the TCJ and LCJ would be higher than the rest of the pavement when the adjacent lane is already constructed and the TCJ is not continuous along the two lanes. Also, when the evening side at such a TCJ is constructed after a delay of more than two weeks, a sudden drop in daily strain variation and a resulting increase in concrete stress is experienced by the concrete closest to the TCJ and LCJ.

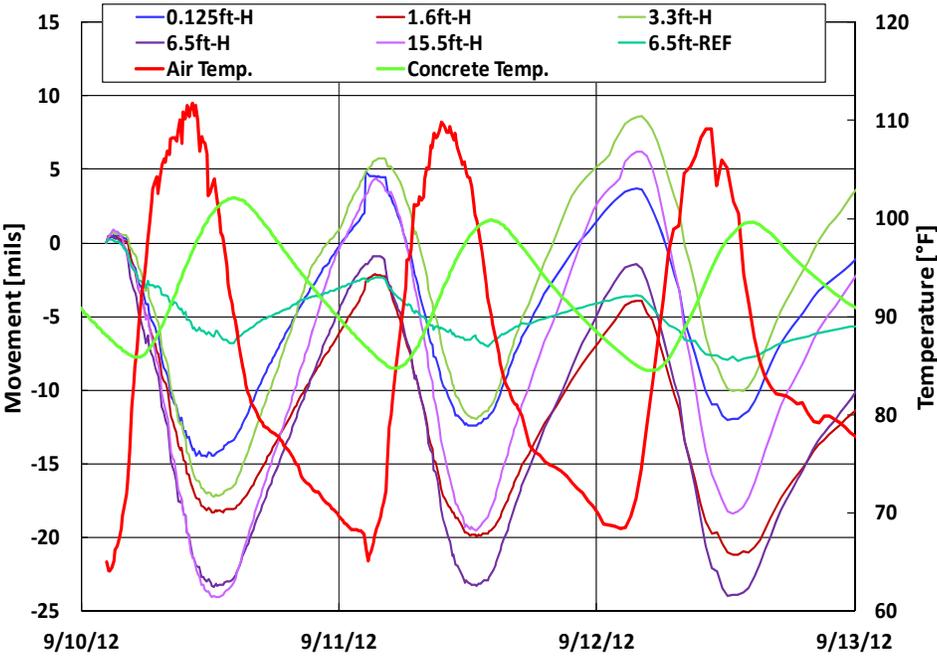
Figure 3. 55 Daily Slab Movement Along the Transverse Construction Joint at BWD-II

Figure 3.55 illustrates the daily longitudinal movement of the slab at different distances from the LCJ measured using the crackmeters. As the daily air temperature and consecutively the concrete temperature increases, the crackmeter movement goes into compression. This means that as the temperature increases and the slab expands at the face of the TCJ, the crackmeter goes into compression. Inversely, as the air and temperature decreases, the slab contracts and the crackmeter's movement exhibits tension.

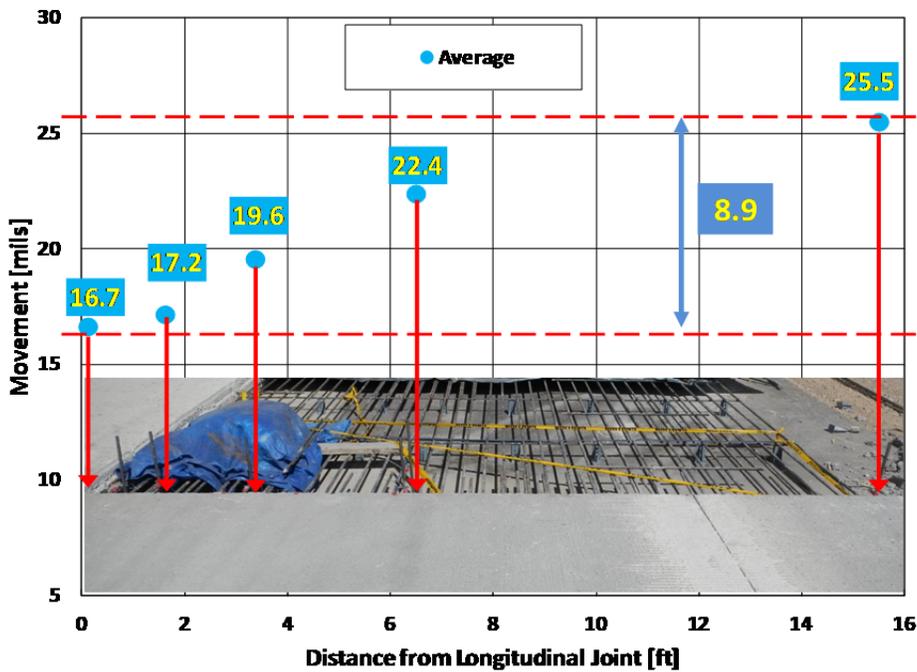
Figure 3. 56 Average Longitudinal Movement of the Slab Along the Transverse Construction Joint

The average longitudinal movement of the slab over five days is illustrated in Figure 3.56. The displacement at the location closest to the LCJ at 0.125 ft. is 16.7 mils and the displacement at the free edge of the slab, 15.5 in. from the LCJ is 25.5 mils. This difference quantifies into a difference of 8.9 mils between the two terminals of the slab along its width. Thus, when concrete is not placed on the morning side of a TCJ, the slab exhibits large movement as we move away from the longitudinal construction joint.

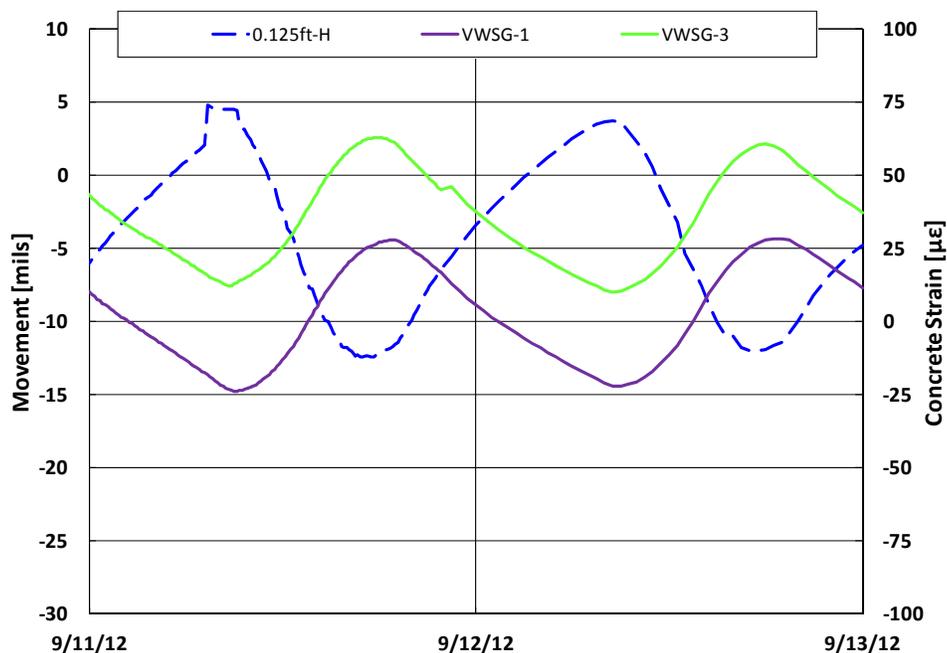
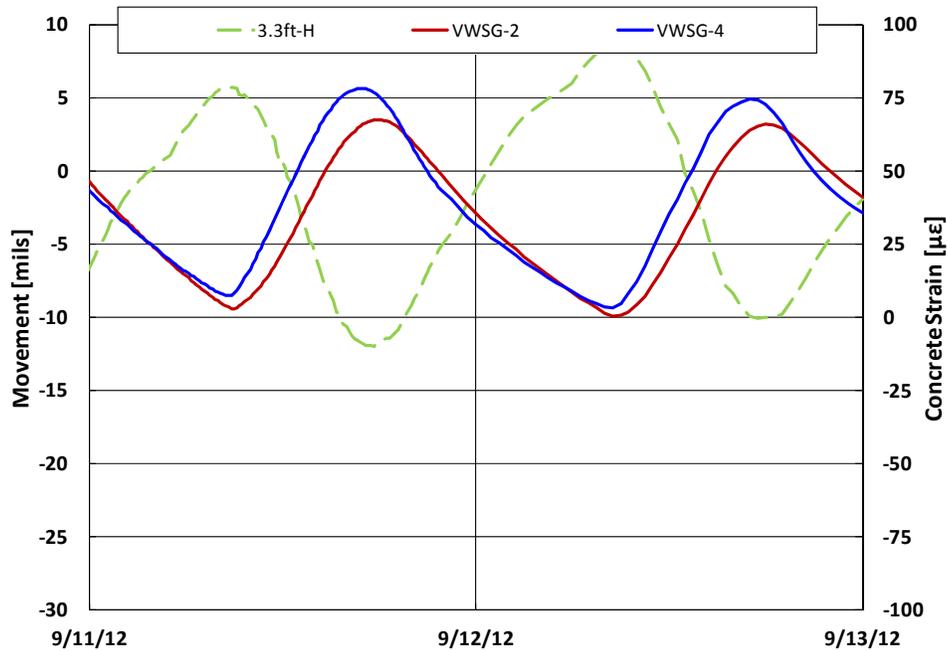
Since VWSGs had been installed inside the concrete in the evening side of the slab where crackmeters were installed at the face of the TCJ at BWD-II test section, a good relationship between the longitudinal movement of the concrete slab near the TCJ and the concrete strains evaluated using the VWSGs can be determined. Figure 3.57 presents the longitudinal movement of the slab at a distance of 0.125 ft. from the LCJ and the concrete strain movement at VWSG-1 and VWSG-3 locations that are at a distance of 0.5 ft. from the LCJ and 1 ft. and 4ft. from the TCJ respectively. On September 11, 2012, as the temperature dropped during the night, the slab contracted, the crackmeter was in tension whereas the concrete strain was in compression. As temperature increases during the day and the slab expands, the crackmeter moves from 5 mils in tension to 12 mils in compression and the VWSG-1 moves from 25 microstrain in compression to 25 microstrain in tension. Figure 3.58 shows the relationship between crackmeter movement at 3.3 ft. from the LCJ and concrete strain variation at VWSG-2 and VWSG-4. Similar behavior of crackmeter movement and daily variation in concrete strain can be observed at this location.

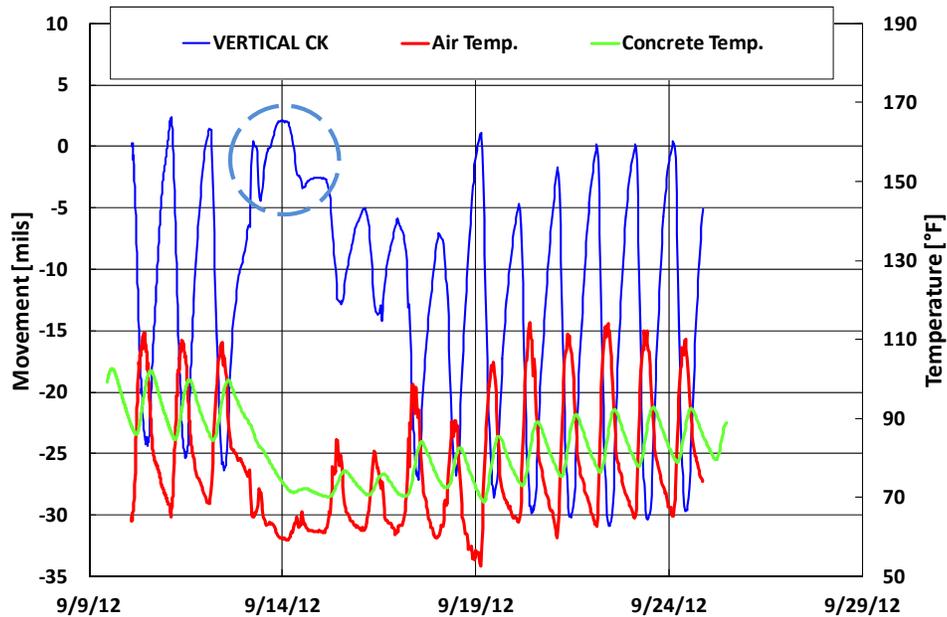
Figure 3. 59 Vertical Slab Movement at the Free Edge of the Slab

A vertical crackmeter was installed at the free edge of the BWD-II test section before concrete was placed on the evening side to determine the vertical movement of the slab with temperature variations in concrete. Figure 3.59 illustrates the vertical movement at 15.5 ft. from the longitudinal construction joint, at the free edge of the slab. The air temperature and concrete temperature during the period of monitoring from September 10, 2012 to September 29, 2012 are also represented in Figure 3.59. As the concrete temperature increases, the vertical movement goes into compression; that is, the slab curls down and with the decrease in concrete temperature, the vertical movement goes into tension, causing the slab to curl up. During the period between September 10, 2012 and September 12, 2012 when the concrete temperature varied between 84 F and 98 F, the vertical movement experienced by the slab was 26 mils. Also, when it rained on September 13, 2012 and the concrete temperature kept going down overnight on September 14, 2012, the crackmeter movement experienced compression. From September 19, 2012 to September 24, 2012 as the concrete temperature started increasing from 83 F to 93 F, a vertical movement of 30 mils was recorded.

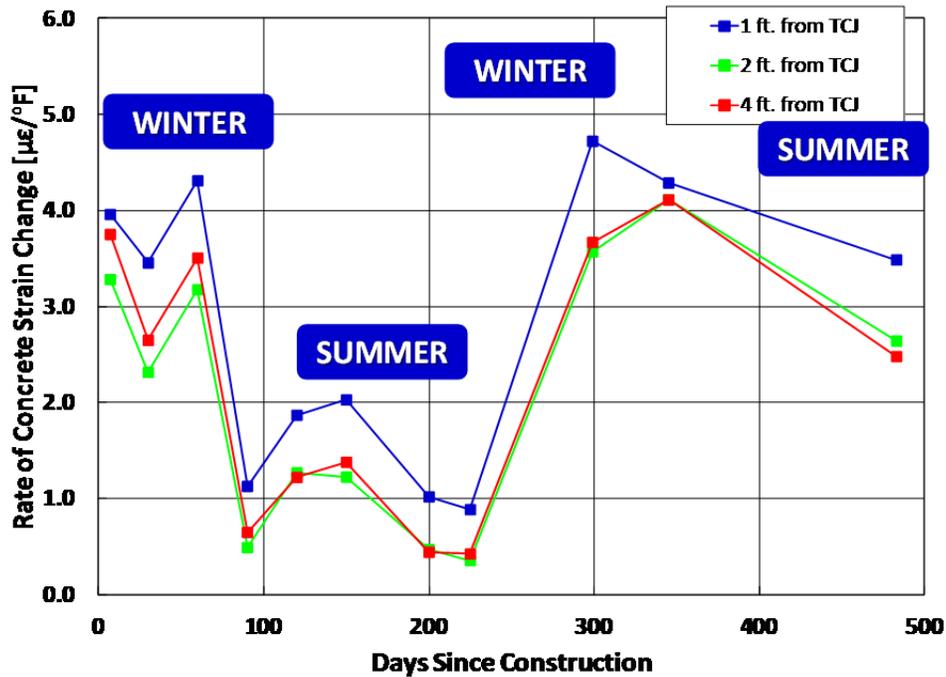
Figure 3. 60 Rate of Concrete Strain Change at TCJ – LBB-I Test Section

Behavior of concrete strain variation derived from VWSGs installed in LBB-I test section is shown in Figure 3.60. Figure 3.60 illustrates the rate of concrete strain variations with temperature until 500 days from the day of construction at LBB I section. Right after construction, during the winter season, the rate of concrete strain change was between $3.5 \mu\epsilon/^\circ\text{F}$ and $4.0 \mu\epsilon/^\circ\text{F}$. As the concrete temperature increased during summer, the rate of strain change dropped to between $1.5 \mu\epsilon/^\circ\text{F}$ and $2.0 \mu\epsilon/^\circ\text{F}$. In the following winter, rate of concrete strain change increased again to between $4.0 \mu\epsilon/^\circ\text{F}$ and $5.0 \mu\epsilon/^\circ\text{F}$. With increase in temperature during the summer, more than 400 days after construction, the rate of concrete strain change again start drops. LBB I section was constructed in the winter, when the rate of concrete strain variations are high; as temperature increases in summer, the rate of concrete strain changes reduced substantially. The rate increased again in the winter season in the following year and it seems to follow the same pattern of reduction in strain changes as the summer sets in the following cycle. This pattern of reduction in the rate of concrete strain changes during summer can be explained by insufficient space for concrete to expand at the TCJ, for TCJs placed during the winter.

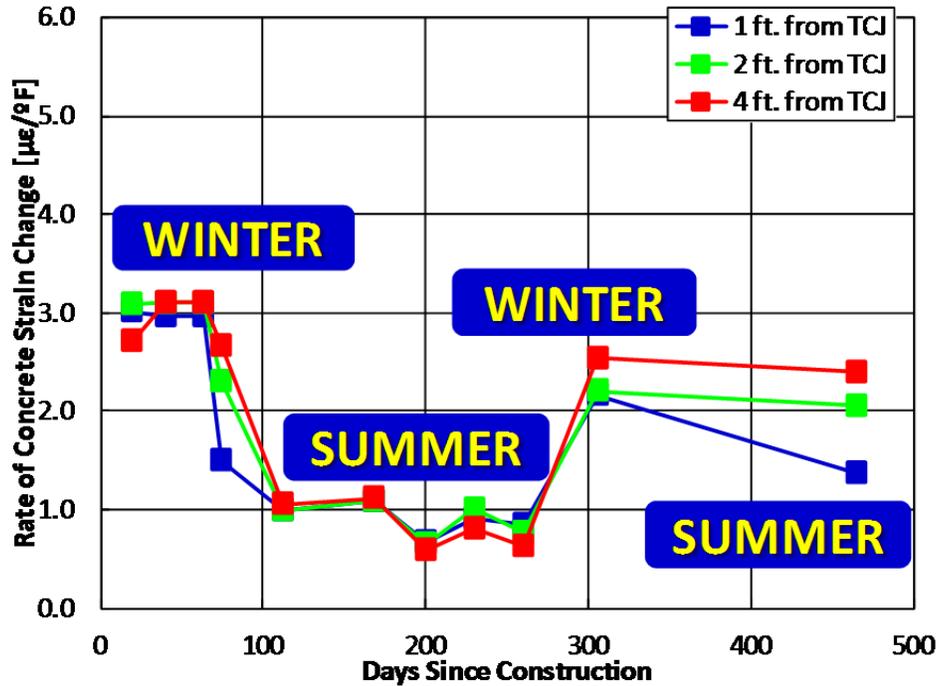
Figure 3. 61 Rate of Concrete Strain Change at LBB II TCJ - Winter Construction

Figures 3.61 and 3.62 display the variations in the rate of concrete strain overtime at TCJs constructed in the winter (LBB II) and summer (BWD I) respectively. Figure 3.61 shows that the rate of concrete strain change at 1 ft, 2 ft and 4 ft from the TCJ was high in winter and low in summer. The initial rate of concrete strain change during the winter season was between 2.7 $\mu\epsilon/^\circ\text{F}$. Once temperature increased during the summer, the rate dropped to 0.5 $\mu\epsilon/^\circ\text{F}$. Again, as temperature dropped during the following winter, the rate increased to 2.5 $\mu\epsilon/^\circ\text{F}$.

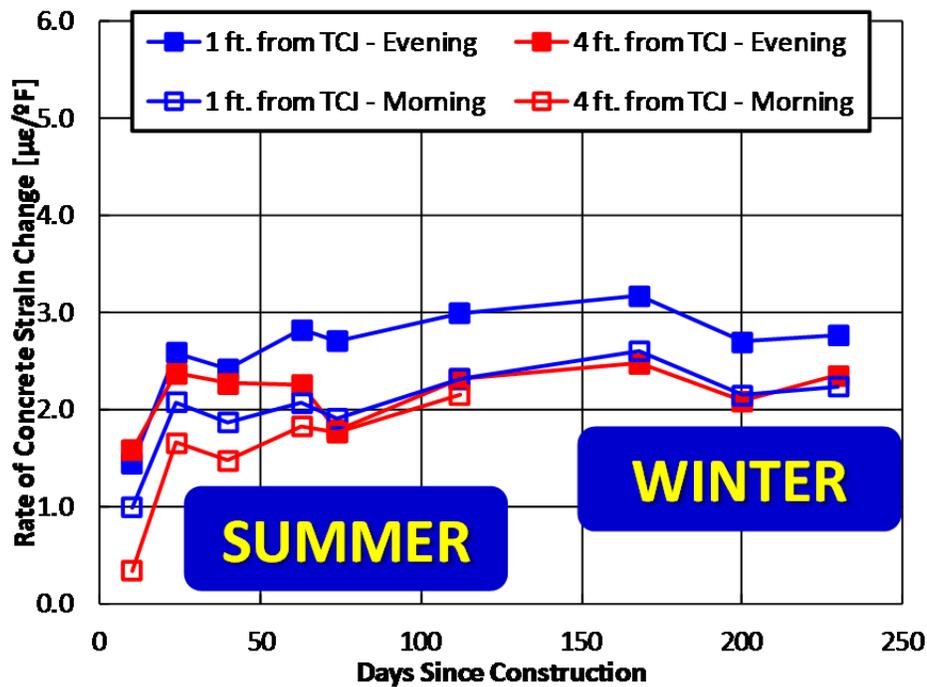
Figure 3. 62 Rate of Concrete Strain Change at BWD I TCJ - Summer Construction

In the summer construction section at BWD I, the data available until now, shown in Figure 3.62, shows a similar pattern of low concrete strain change rate initially in the summer but the rate increased as winter approached. These concrete strain rate changes were at a distance of 1 ft. and 4 ft from the TCJ in the evening and morning sections at BWD-I. The rate of concrete strain change right after construction of the BWD-I test section in summer 2012, was between 0.3 $\mu\epsilon/^\circ\text{F}$ and 1.5 $\mu\epsilon/^\circ\text{F}$. As the temperature dropped in winter, around 100 days after construction, the rate of strain change increased to between 2.0 $\mu\epsilon/^\circ\text{F}$ and 3.0 $\mu\epsilon/^\circ\text{F}$.

It is postulated that when the concrete is placed at the TCJ during winter construction, the concrete setting temperature is low, and as the concrete temperature increases in the summer,

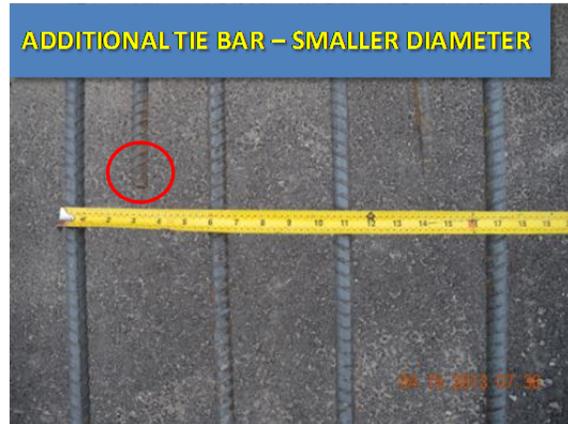
Figure 3.66 shows the SSG installation at the WAC test section. As can be seen in Figure 3.66, SSGs were installed on top of additional and longitudinal steel right at the face of the TCJ. Also, it was noticed that the additional tie-bar diameter was smaller than the longitudinal steel diameter at this test section, as illustrated in Figure 3.67. Since the center two lanes were paved first, the SSG lead wires had to be run through the outside two lanes into the datalogger. Hence, the SSGs lead wires were run through PVC pipes and embedded into the asphalt base in the outside lanes, as shown in Figures 3.68 and 3.69.

Figure 3.67 Tie-Bar Diameter Smaller than Longitudinal Steel

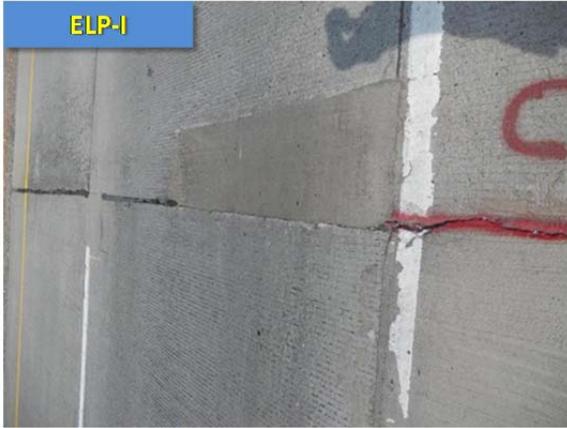
Field conditions of ELP-I and ELP-II transverse construction joints were not similar, although being successively located. As shown in Figure 4.3, at ELP-I distress had occurred at the TCJ and had been repaired by Portland cement concrete (PCP) patching. The joint width at the ELP-I TCJ was around 2 in. as shown in Figure 4.4. Contrastingly, at the ELP-II section the pavement near the TCJ was in good condition without sign of any distresses as shown in Figure 4.5. Also, the joint width at ELP-II was around 3/8 in. as illustrated in Figure 4.6.

Figure 4. 3 Distresses at ELP-I Test Section
