Minimize Premature Distresses in Continuously Reinforced Concrete Pavement

Sureel Saraf, Pangil Choi, Sungwoo Ryu,
Tewodros Ghebrab, Moon C. Won

Texas Department of Transportation

Research Project #: 0-6687
Research Report #: 0-6687-1
www.techmrt.ttu.edu/reports.php

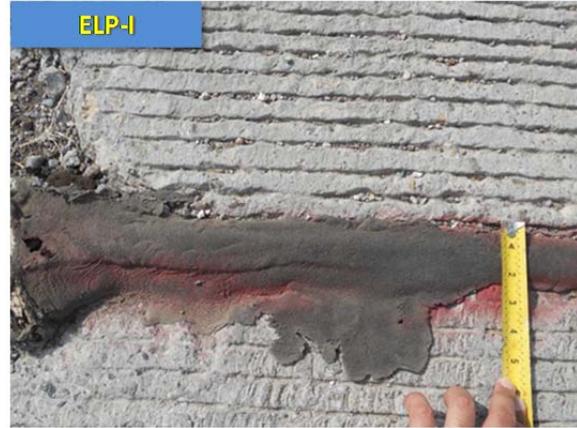
Field conditions of ELP-I and ELP-II transverse construction joints were not similar, although being successively located. As shown in Figure 4.3, at ELP-I distress had occurred at the TCJ and had been repaired by Portland cement concrete (PCP) patching. The joint width at the ELP-I TCJ was around 2 in. as shown in Figure 4.4. Contrastingly, at the ELP-II section the pavement near the TCJ was in good condition without sign of any distresses as shown in Figure 4.5. Also, the joint width at ELP-II was around 3/8 in. as illustrated in Figure 4.6.

Figure 4. 4 Wide Transverse Construction Joint Width at ELP-I Test Section

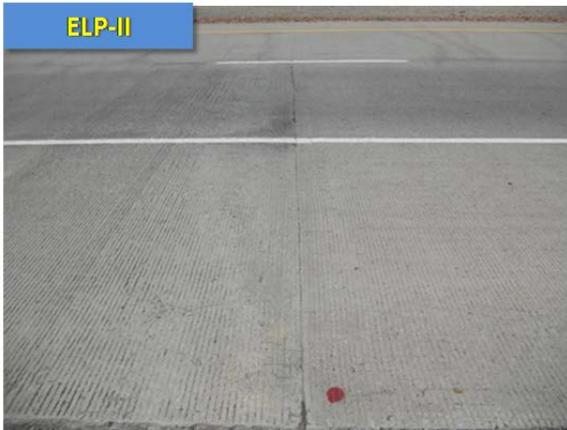
Figure 4. 5 Transverse Construction Joint Condition at ELP-II Test Section

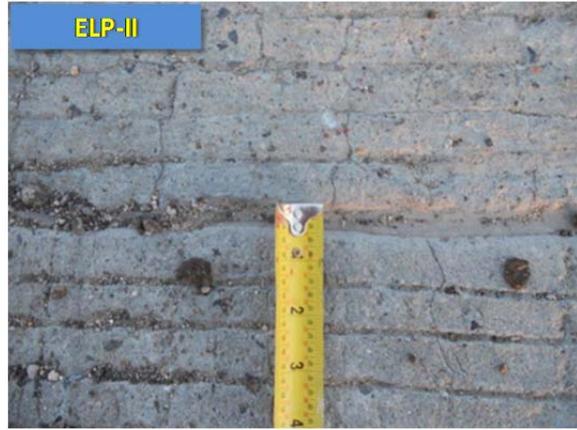
Figure 4. 6 Narrow Transverse Construction Joint Width at ELP-II Test Section

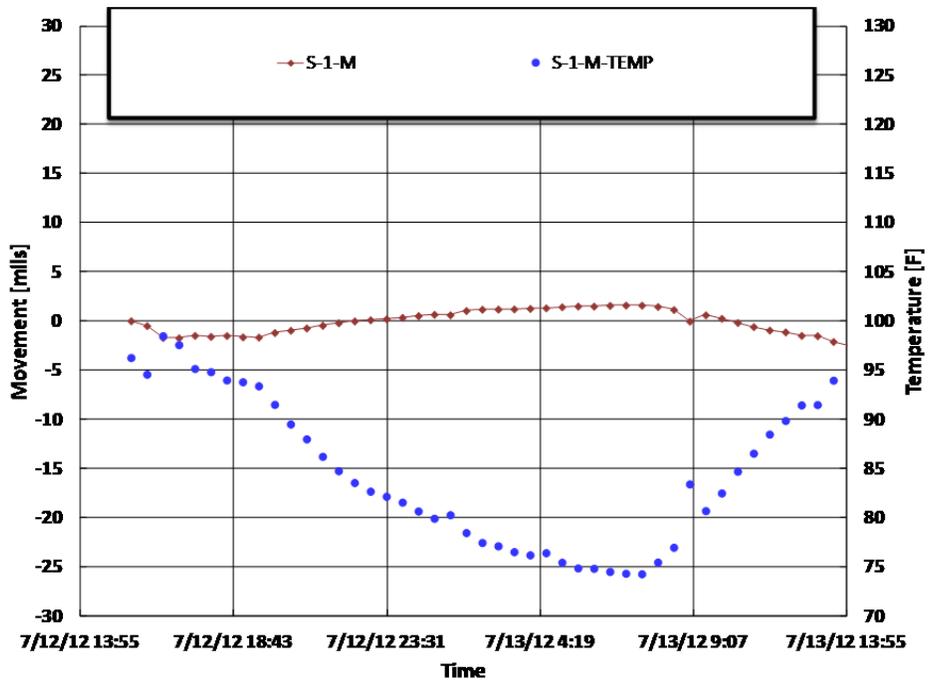
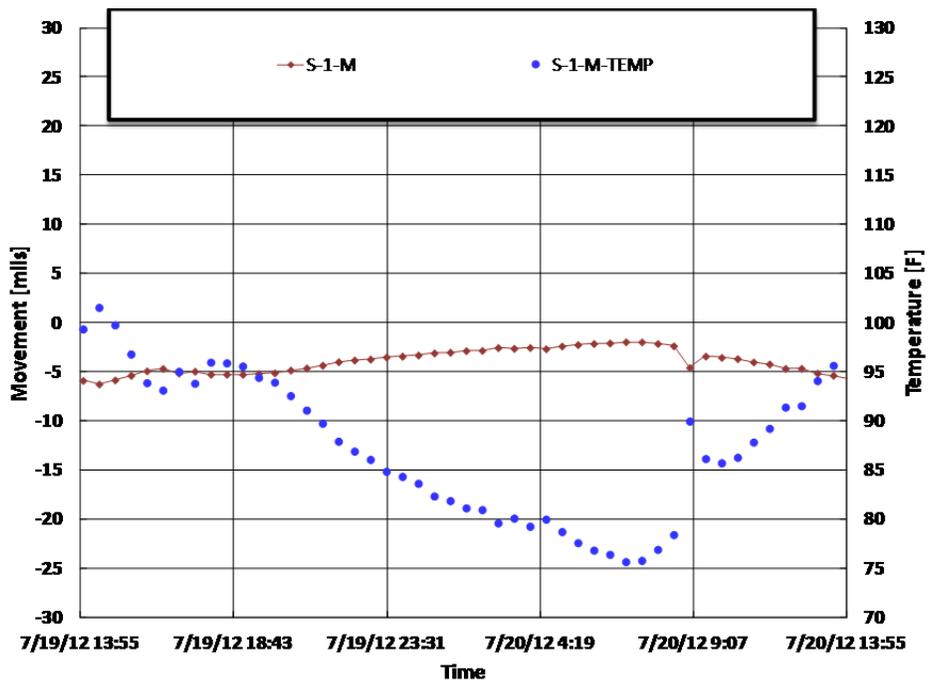
ELP-II without distresses and narrow joint width is depicted in Figures 4.11 and 4.12. According to the data available, the average joint movement at the ELP-II location is 0.075 mils per °F.

Figure 4. 11 Movement of Good Transverse Construction Joint on IH 10 in El Paso – Day 1

Figure 4. 12 Movement of Good Transverse Construction Joint on IH 10 in El Paso – Day 7

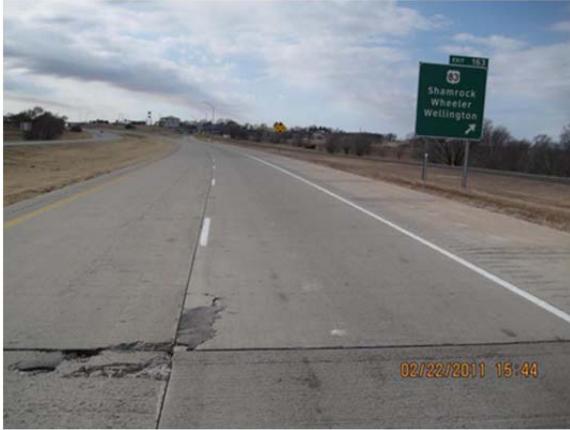
The test section on IH 40 in the Childress district exhibits severe distresses near the transverse construction joints, as shown in Figures 4.15 and 4.16. As discussed earlier, CRCP segments in this area were removed due to the expansion of lime-stabilization of gypsum bearing soil. The distresses observed seem to be more concentrated at the junction of the transverse and longitudinal joint in both the inside and outside lanes. Also, both the lanes seem to be constructed at the same time since the transverse construction joint runs through both the lanes at the same location.

Figure 4. 15 Distresses Near Transverse and Longitudinal Construction Joint Intersection at Childress Test Section

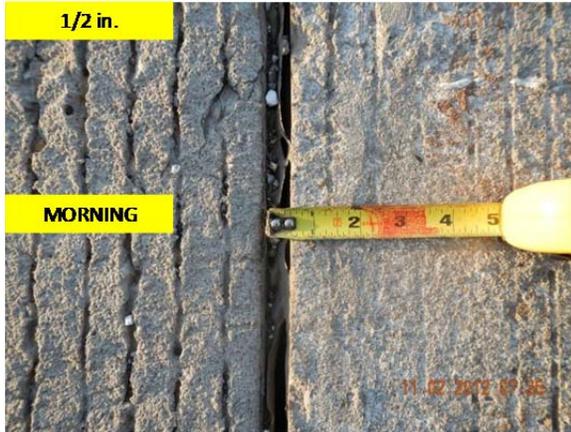
The crack spacing at the transverse construction joint were measured at this location in the morning and evening on November 2, 2012, as shown in Figures 4.17 and 4.18. In the morning the joint width was $\frac{1}{2}$ in. and in the evening the joint width decreased to $\frac{3}{8}$ in. This implies that during the day when ambient temperature, and consequently the concrete temperature, increased, the slabs on both the sides of the TCJ expanded, resulting in reduced joint width. With decrease in temperature during the night, the joint width again increased to $\frac{1}{2}$ in. for the same temperature variation. Also, the joint spacing at this TCJ was noted in February 2011 as 1 in. and again in March 2013 as $\frac{7}{8}$ in., as shown in Figures 4.19 and 4.20, respectively. This considerable variation in longitudinal movement of individual slabs at the TCJ needed to be investigated.

Figure 4.17 Transverse Construction Joint Width in the Morning at Childress Test Section

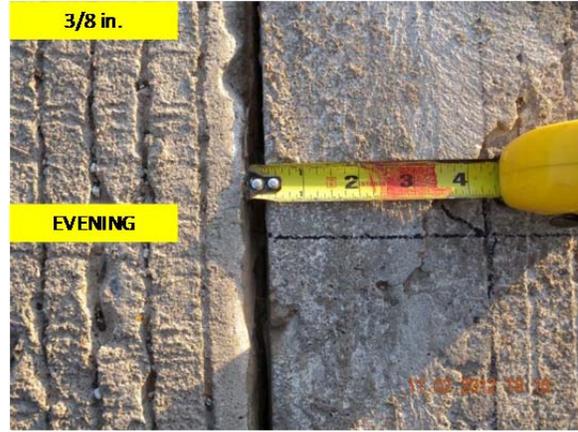
Figure 4.18 Transverse Construction Joint Width in the Evening at Childress Test Section

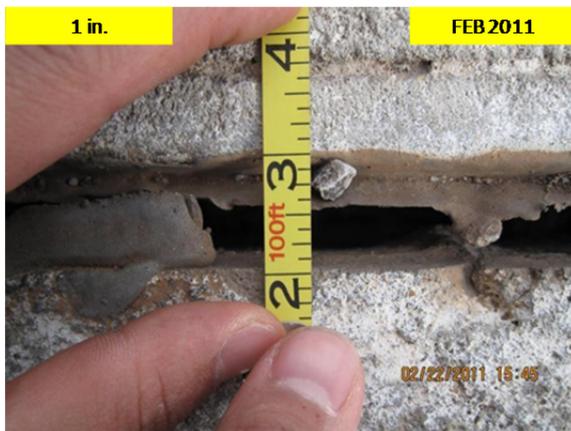
Figure 4.19 Transverse Construction Joint Width at Childress Test Section in February 2011

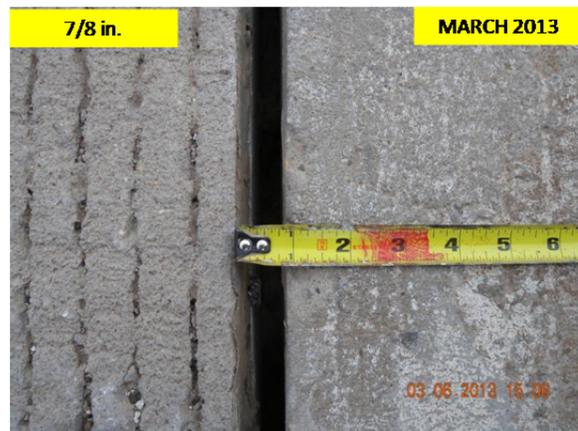
Figure 4.20 Transverse Construction Joint Width at Childress Test Section in March 2013

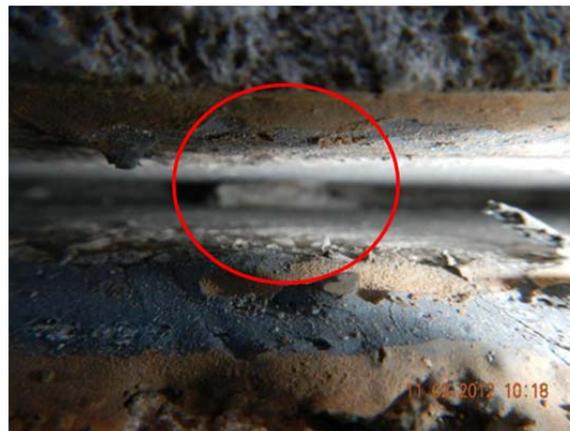
Also, while closely observing the longitudinal and additional steel through the depth of the transverse construction joint, concrete was found to be protruding from the face of the slab at the transverse construction joint as shown in Figure 4.23.

Figure 4. 23 Steel Slipping Out of Concrete at Transverse Construction Joint

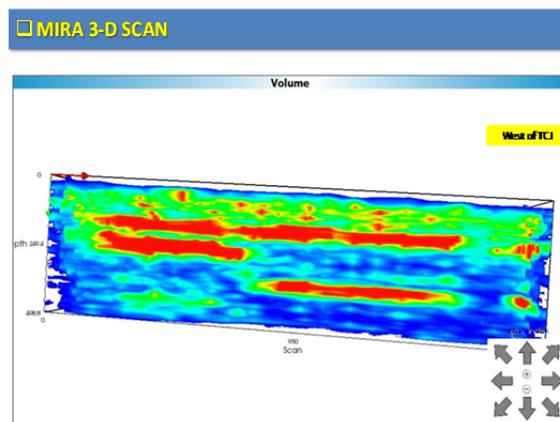
MIRA 3-D scanning was conducted at this location as depicted in Figure 4.26, which revealed delamination under the longitudinal steel. However, this delamination was observed only near the transverse construction joint and did not extend longitudinally through the entire length of the pavement, as shown in Figure 4.27.

Figure 4. 27 Delamination Near Transverse Construction Joint on IH 40 in Childress

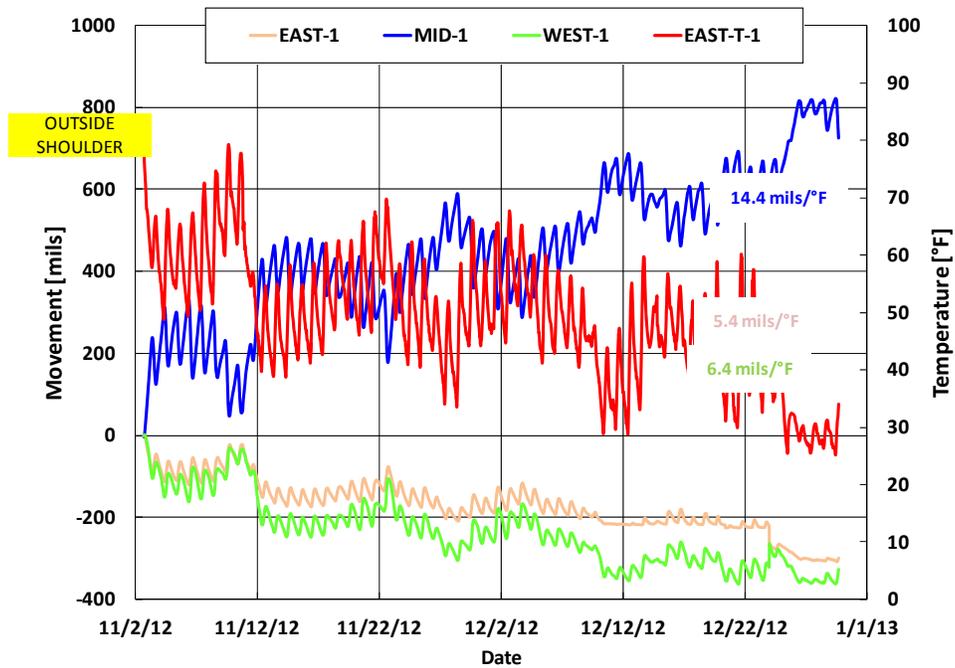
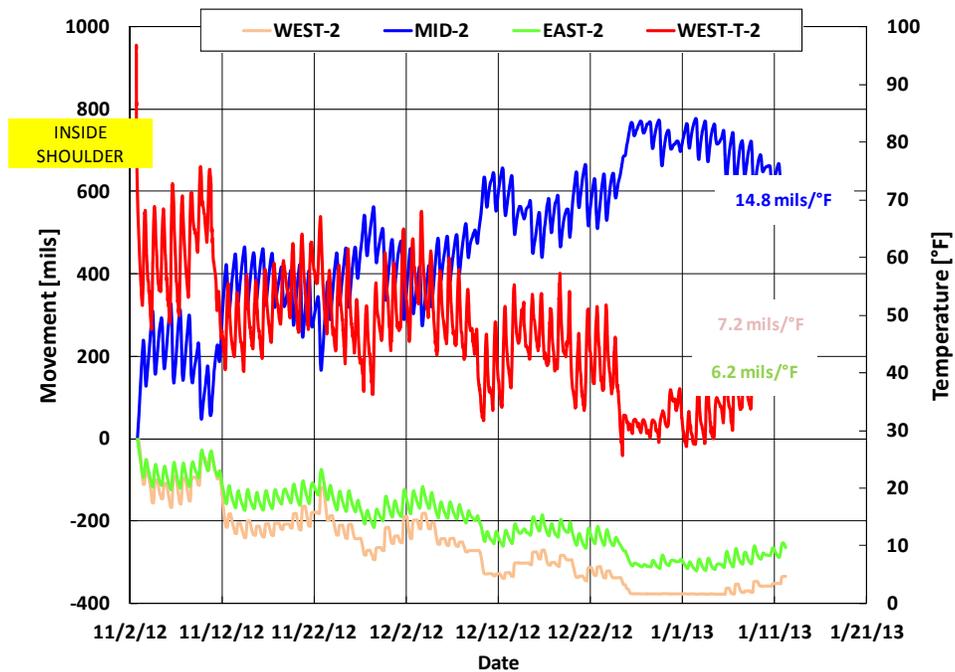
The crackmeter movement data discussed above provided good correlation between the individual longitudinal slab movements and movement across the transverse construction joint. The average joint movement at this location from the gages installed on the inside and outside shoulder can be computed as 14.6 mils per °F, which is quite high.

In the presence of such large longitudinal movement at the transverse construction, the occurrence of distresses near the longitudinal and transverse construction joint with relative movement of slab due to temperature variations is unavoidable.

Figure 4. 28 Slab and Joint Movement at Transverse Construction Joint on IH 40 in Childress – Outside Shoulder

Figure 4. 29 Slab and Joint Movement at Transverse Construction Joint on IH 40 in Childress – Inside Shoulder

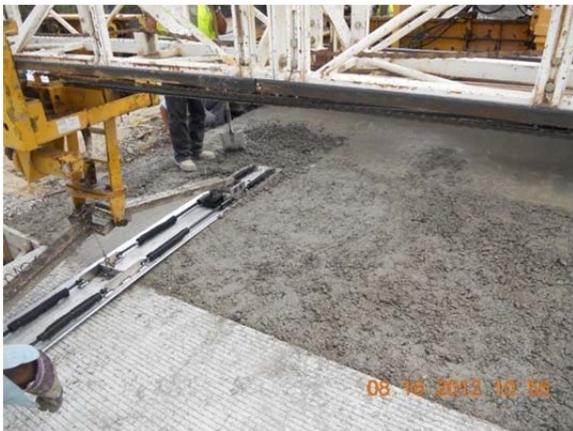
Figure 4. 32 Auto-Float Stuck in Concrete Due to Mis-alignment of Paver

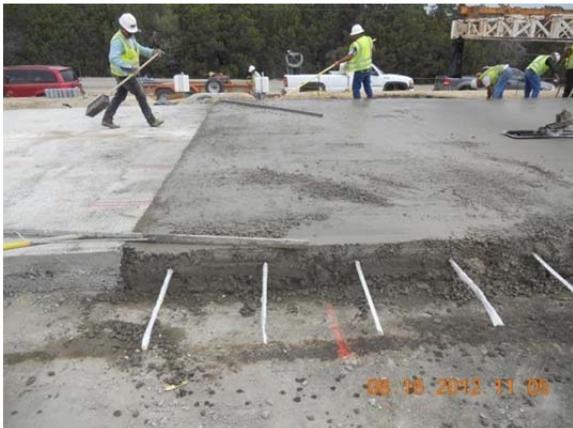
Figure 4. 34 Finishing Process Becomes Difficult as Concrete Hardens

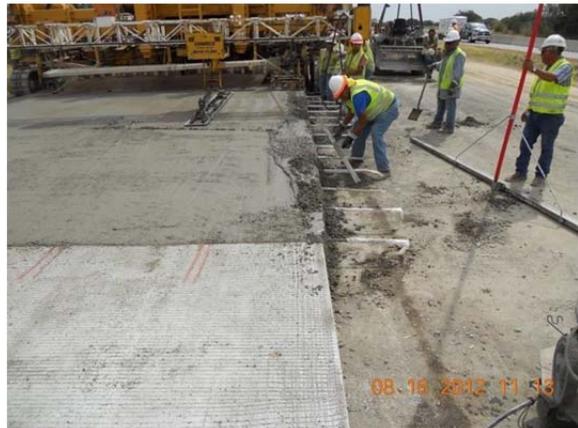
Figures 4.30 through 4.35 shows various stages of construction at the BWD-I transverse construction joint, in the morning section on IH 20 in the Brownwood district. As can be seen in the pictures, the first concrete truck arrived at 9. 30 a.m. on August 16, 2012. Concrete was placed using shovels in the area near TCJ, and a hand-held vibrator was used for compaction. How far the vibrator is effective in compaction in this area due to the presence of additional steel, cannot be stated. Construction in this area lasted more than one and a half hours, and the concrete started to harden; this hardening caused the auto-float used for finishing to get stuck in the concrete, as can be seen in Figure 4.32. Also, in the absence of any formwork on the sides, pavement on the inside edge looks uneven compared to the rest of the pavement.

Figure 4. 35 Uneven Slab Edge

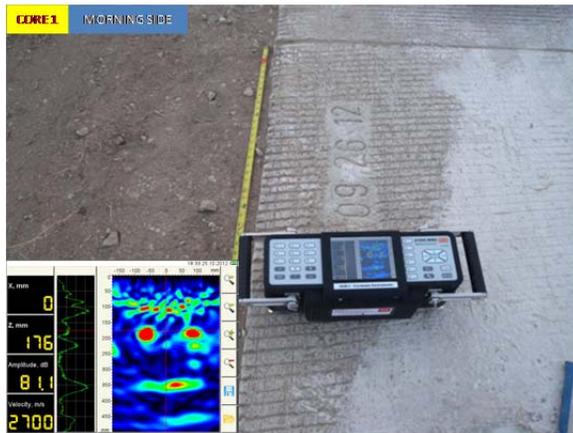
Figure 4. 37 BWD-II Coring Location 1 and MIRA Scan

Before coring, the MIRA Tomographer was used to estimate the location of the steel in concrete. Figure 4.37 presents the scan from the MIRA Tomographer at Location 1 on the morning construction side on IH 20 in Brownwood. This location is at 32 in. from the TCJ. In addition to the red areas representing the longitudinal steel, certain voids appear in the top 4 in. of the concrete slab at this location. Similarly, the MIRA Tomographer was used to scan the pavement at 29 in. from the TCJ in the evening construction section at BWD-II. Again, the presence of voids on the top 4 in. was observed at this location, as shown in Figure 4.38. MIRA Tomographer was used again at 35.5 ft. from the TCJ on the evening construction side of BWD-II. The MIRA scan is shown in Figure 4.39. The concrete appears to be free of any voids. Also, while coring at location 1 and 2 near the TCJ, the coring team was able to remove cores right off after coring to the base. However, at Location 3, as shown in Figure 4.39, after coring through the depth of the slab, the core had a good bond with the asphalt base below and hence had to be struck with a hammer to remove the core.

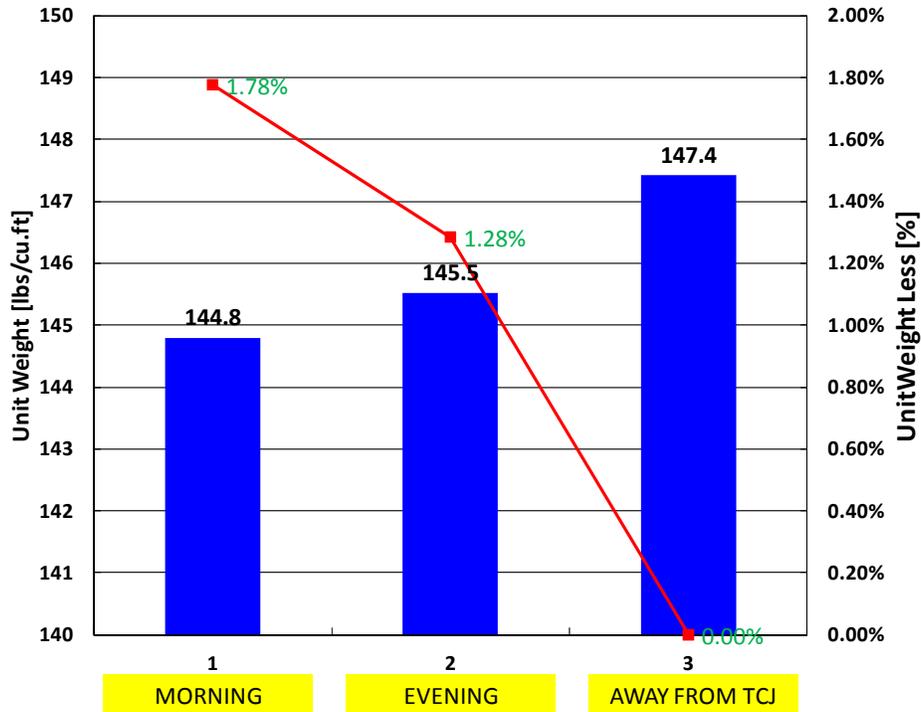
Figure 4.40 Unit Weight of Cores Taken at BWD-II Section

Coring was conducted at these three locations on October 26, 2012 and the unit weight of the cores was evaluated. The dynamic modulus of the cores was evaluated using Free-Free Resonance Core Tester. As can be seen in Figure 4.40, the unit weight of cores near the construction joint in both the evening and morning construction sections are lower by more than 1% compared to the core away from the TCJ. Figure 4.41 shows the Dynamic Young's Modulus of the three cores. The Dynamic Modulus of the core in the morning construction section is almost 9% less and of the evening construction section is around 5% less than the core taken away from the TCJ. It should be noted that there is a significant difference in the Dynamic Young's modulus of cores in the evening area near the TCJ and 35.5 ft. from the TCJ, even though concrete placement at both these locations took place on the same day.

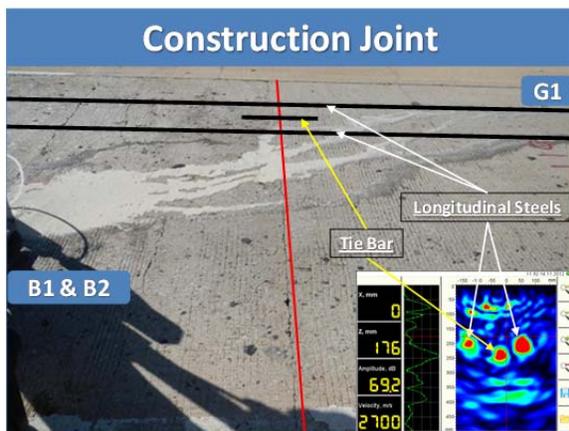
Figure 4.42 Surface Condition of Coring Location on US 287 in Wichita Falls

As shown in Figure 4.42, coring was conducted at three locations on US 287 in the Wichita Falls district on November 14, 2012. A number of voids were observed on the concrete pavement surface. Figures 4.43 through 4.45 represent the MIRA Tomographic scans and the cores taken from two bad sections and one good section at this location. Voids that appear in the MIRA Tomographic scans as red areas can also be seen in the cores as represented for the sections B1 and B2 in Figures 4.43 and 4.44, respectively. Figure 4.45 represents the MIRA scan and core taken at the location with no voids.

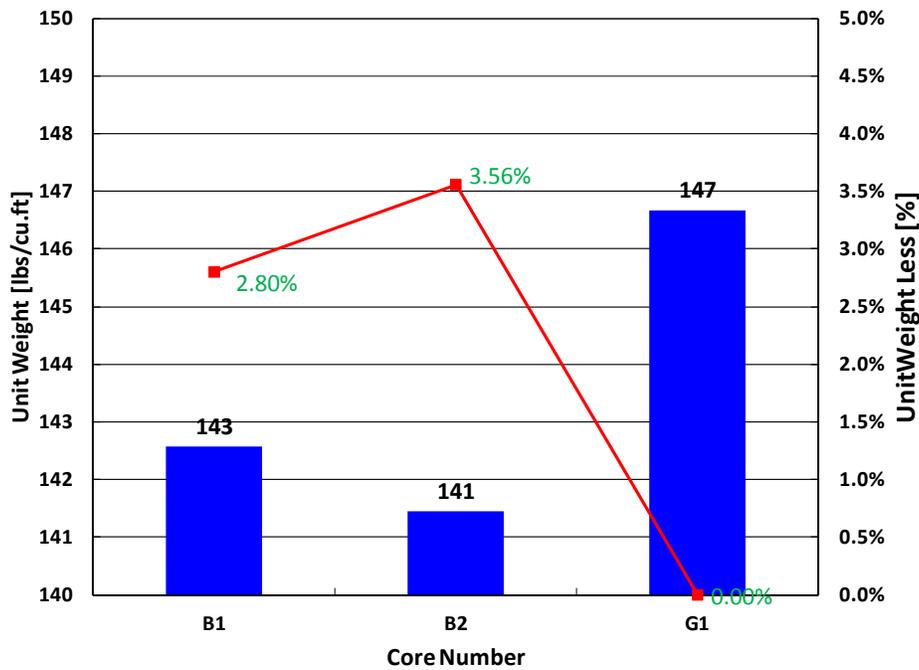
Figure 4. 46 Unit Weight of Cores Taken on US 287 in Wichita Falls

The results for Unit Weight and Young’s Modulus testing carried out at the three locations on US 287 in Wichita Falls district are presented in Figures 4.46 and 4.47 respectively. As shown in Figure 4.46, the unit weights of cores at B1, B2 and G1 location are 143 lbs./cu. ft., 141 lbs./cu. ft. and 147 lbs./cu. ft. respectively. The unit weight of core B1 is 2.80% lower and of B2 is 3.56% lower than the core from the good location G1 with no voids. The difference in Dynamic Young’s Modulus of Elasticity between the locations with and without voids in the cores is significant, as shown in Figure 4.47. The Dynamic Young’s Modulus of cores B1, B2 and G1 are 5.2 million psi, 3.08 million psi and 5.4 million psi respectively. The Dynamic Young’s modulus of the core B2 with voids is 43.75 lower than that of the core G1, which had no voids.

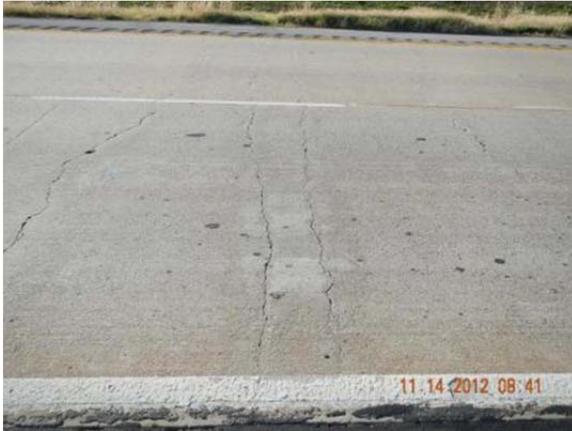
Figure 4. 52 Narrow Cracks on US 287 in the Wichita Falls District

Figures 4.52 and 4.53 represent narrowly spaced transverse cracks on US 287 in the Wichita Falls district. The cracks appear to be later age. There is no evidence of distresses due to the narrowly spaced cracks in this section.

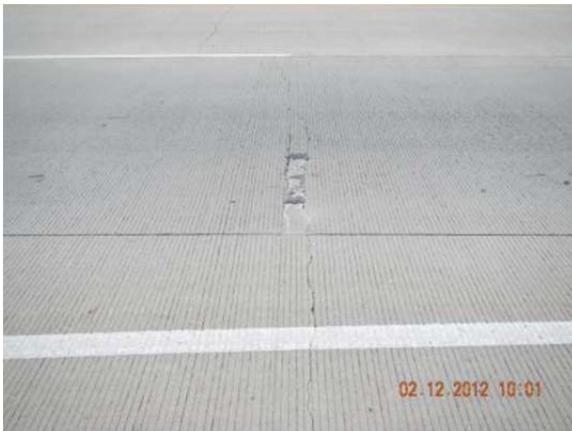
Figures 4.54 and 4.55 represent narrowly spaced cracks on IH 45 in the Dallas district. This section was built in 1975. The pavement thickness is 10-in. The subbase and subgrade for this section comprise of 6-in. cement stabilized base and 6-in. lime treated subgrade respectively.

Figure 4. 54 Distress Due to Narrow Cracks on IH 45 in the Dallas District

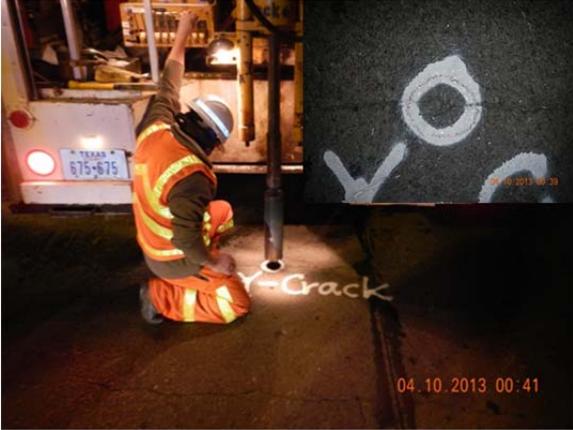
Y-cracks were also identified on IH 10 near mile post 20 in El Paso district at two locations identified as Location-1 and Location -2 henceforth. As shown in Figure 4.56, on the surface the Y-crack width at Location-1 looked tight although there was evidence of small spalling right where the y-crack is formed as can be seen in the inserted picture in Figure 4.56. Coring was conducted at this section. The core shown in Figure 4.57 revealed that the Y-crack extended throughout the depth of the slab. Also, the Y-crack width at the top appeared wider than at the bottom of the core. The formation of the Y-crack as can be seen in Figure 4.57 was at the intersection of the longitudinal and transverse steel.

Figure 4. 56 Coring Conducted at Y-crack Location on IH 10 in El Paso District – Location 1

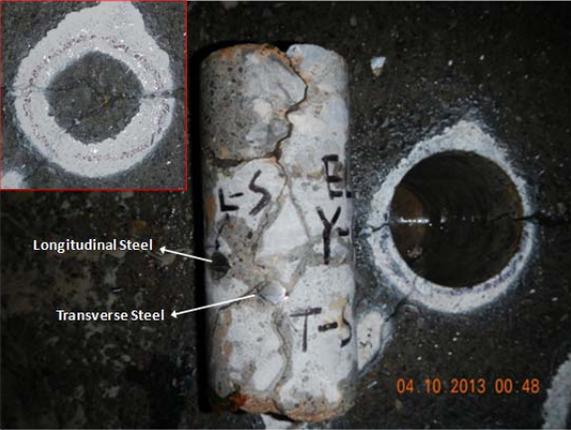
Figure 4. 57 Y-crack at the Intersection of Longitudinal and Transverse Steel on IH 10 in El Paso District – Location 1

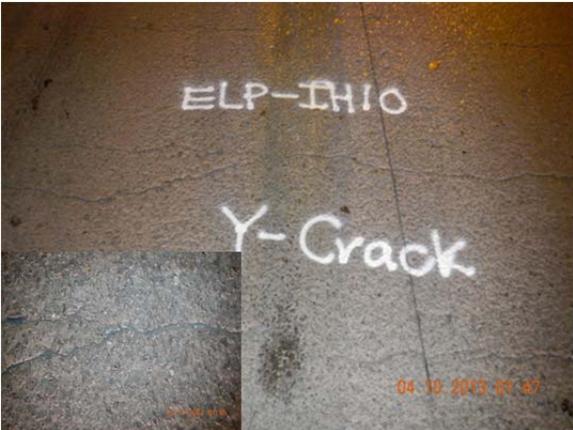
The Y-crack detected at Location-2 on IH 10 in El Paso district showed no distress formation or signs of spalling on the surface as shown in Figure 4.58. Again, after conducting coring at the Y-crack Location-2, the Y-crack was found to be formed at the intersection of longitudinal and transverse steel as shown in Figure 4.59.

Figure 4. 58 Y-Crack on IH 10 in El Paso District – Location 2

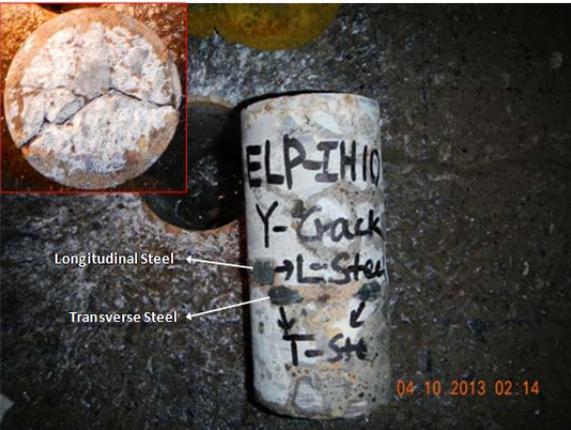
Figure 4. 59 Core Taken at Y-crack Location 2 on IH 10 in El Paso District – Location 2

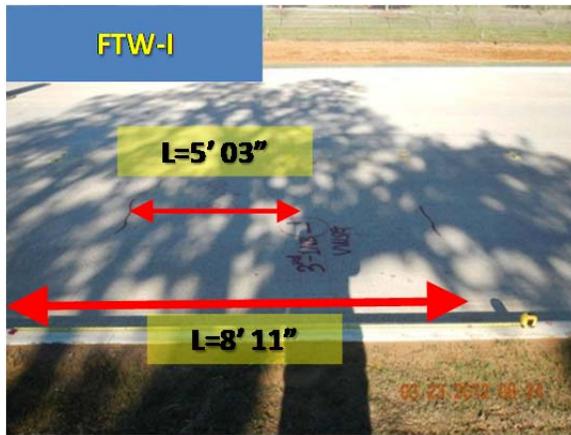
Figure 4. 62 Crack Location at FTW-I Test Section

Figures 4.62 and 4.63 show the transverse crack pattern near the VWSGs installed at FTW-I and FTW-II test section. At FTW-I, transverse cracks were observed at 5 ft. 3in. from the location of the VWSGs. At FTW-II, the transverse crack nearest to the VWSGs was at a distance of 2 ft. and 10 in.

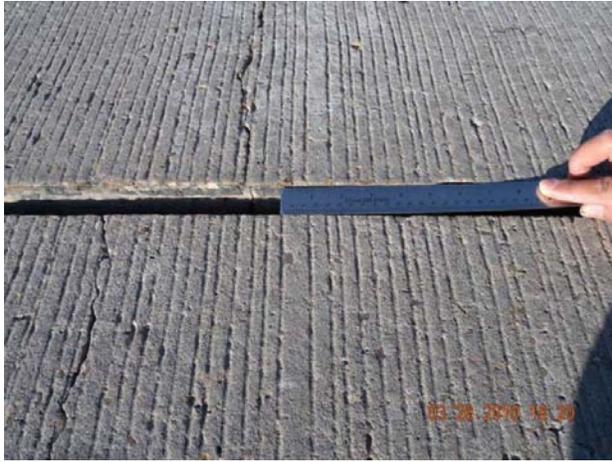
a. Joint Separation of LWJ and Relative Movement Between Slabs

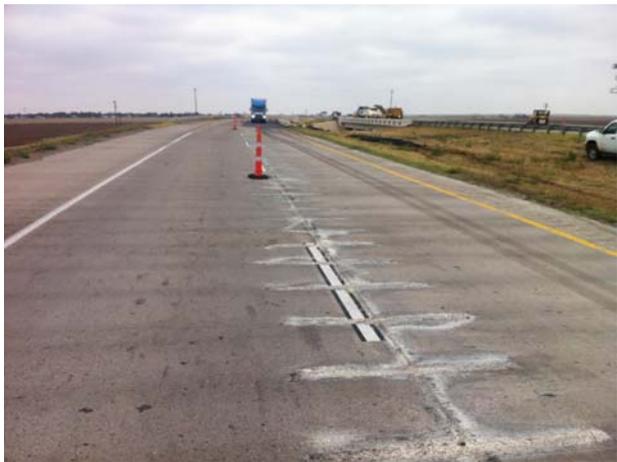
b. Slot Stitching

One of the premature distresses observed in Texas is distress near longitudinal construction joints (LCJs) or longitudinal warping joints (LWJs). To identify mechanisms of the distresses related to LCJs, 4 CRCP sections that experience distresses at LCJs and LWJs were identified. Figure 4.72 (a) illustrates distresses at LCJ on IH 27 in the Lubbock District before repair. According to TxDOT 2010 PMIS, these distresses were recorded as punchout. However these are not real punchouts but these distresses may have been caused by relative lane movement between inside and outside lane. Figure 4.72 (b) shows the picture after repair. As can be seen in Figure 4.73 (a), the relative movement between inside lane and outside lane was observed and the relative movement was almost 1 in. as can be seen from the tining spacing at LWJ. Longitudinal joint separation was also observed in this section. Figure 4.73 (b) illustrates the faulting at longitudinal joint. This section was overlaid with asphalt concrete as shown in Figure 4.74 (a). Figure 4.74 (b) shows the stitched longitudinal joint before asphalt overlay.
