Implementing the Ultra-High Pressure Water Cutter for Roadway Maintenance Applications: Final Report

Sanjaya P. Senadheera, Roderick B. Henderson,
James G. Surles, William D. Lawson

Texas Department of Transportation

Research Project 5-5230-01
Research Report 5-5230-01-2
www.techmrt.ttu.edu/reports.php

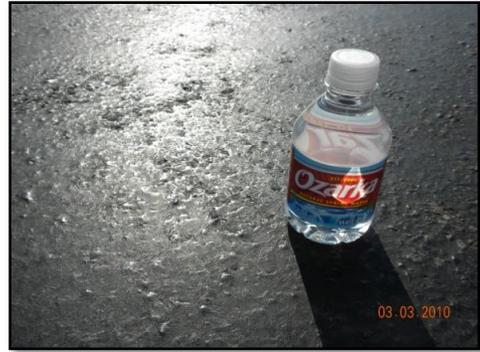
As can be seen in Figure 1.3, the section of FM 2562 selected for treatment was very heavily flushed. The contractor made five passes with the UHP water cutter, varying the rate of advance to accomplish different degrees of asphalt removal. One finding of the demonstration was that Rampart's technology was actually superior, or more advanced, than the New Zealand/Australia technology previously identified by the research team. Rampart's UHP water cutter truck uses a *fixed* deck blaster rather than an umbilical-mounted deck blaster, eliminating the need to have a person walk behind the truck and operate the unit. Further, Rampart's truck relies on a hydrodynamic transmission to better control the rate of advance of the water cutter unit. The result is improved control of the asphalt surface treatment, and a safer maintenance process.

(b) Heavily flushed seal coat, pre-treatment

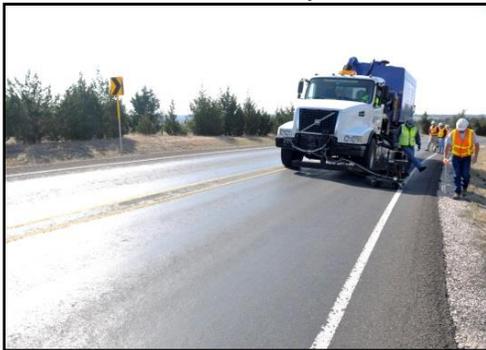
(c) Initial pass, UHP water cutter

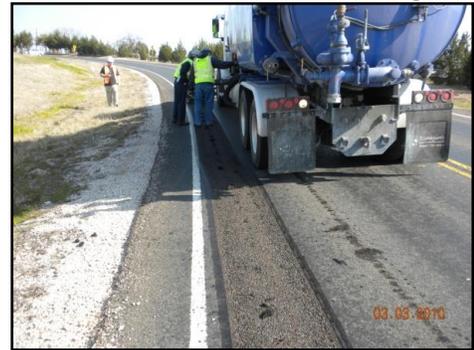
(f) Results from first treatment pass

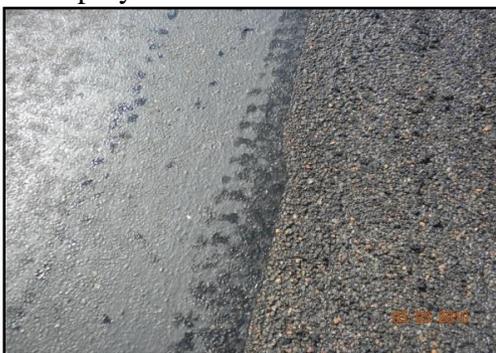
(g) Comparison of pre- vs. post-treatment

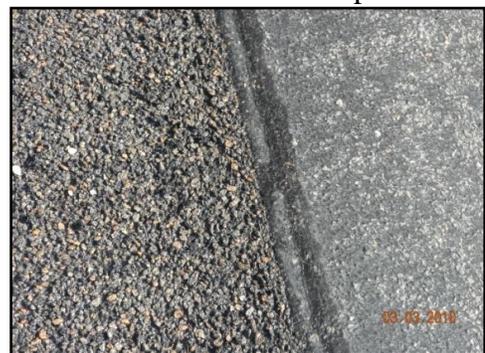
(h) Close-up of treated road surface

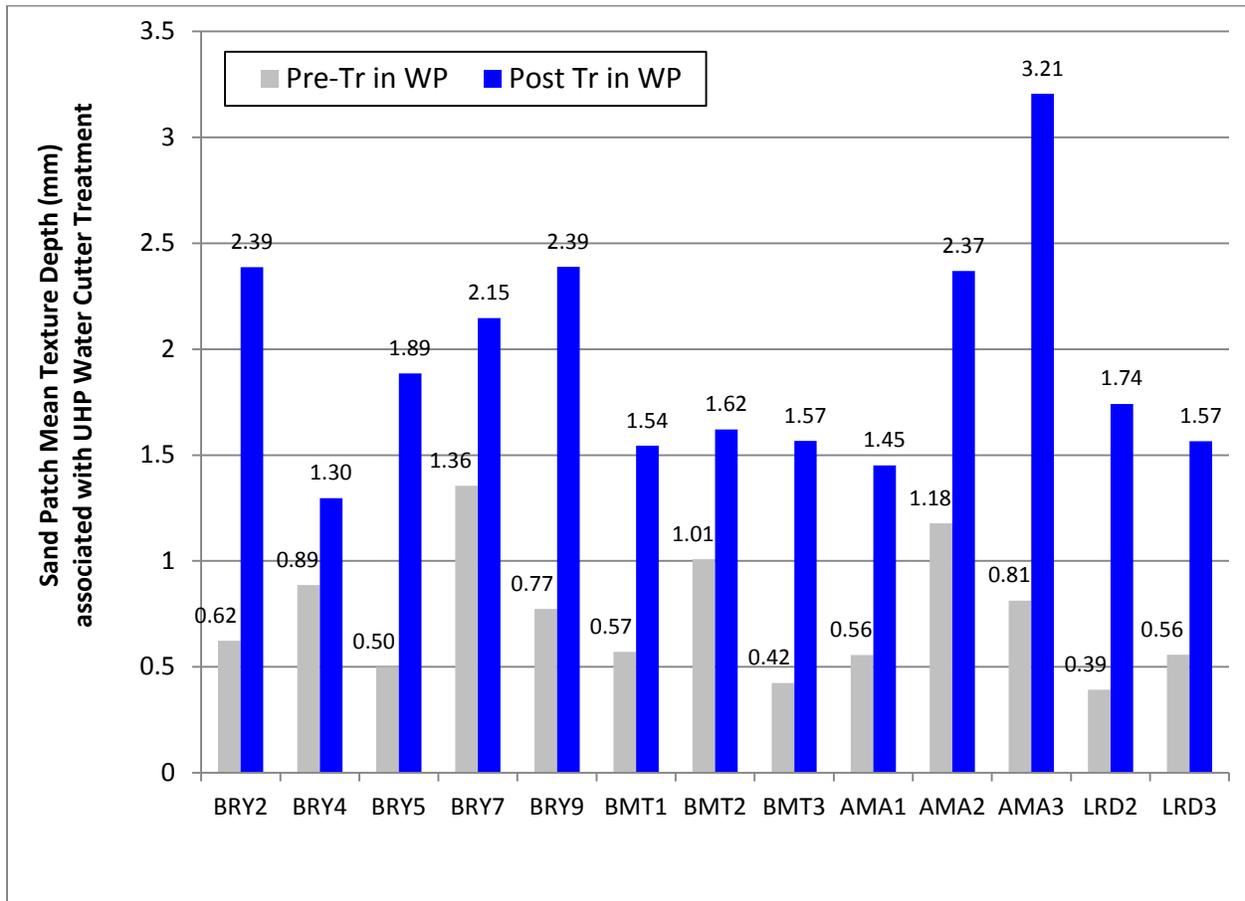
Texture data include the Sand Patch test and the CTM test. Figure 3.1 shows the Sand Patch mean texture depth for all 13 test sites both before and immediately after the water cutter treatment. These results show that water cutter treatment resulted in remarkable improvement in the sand patch mean texture depth. Research suggests average texture depths of approximately 0.8mm to 1mm are desirable for satisfactory wet weather skid resistance. The literature does not clearly indicate specific acceptable values for average texture depth, but this range was established by this research team based on the guidance established for seal coats by Transit New Zealand (2002) and the NITRR South Africa as reported by Estakhri and Gonzales (1988). The

sand patch mean texture depth prior to the treatment showed three of the 13 sites with macrotexture values equal to or greater than 1mm, with the range of values being 0.4 to 1.2mm. After the treatment, the mean texture depths ranged from 1.3 to 3.2mm.

FIGURE 3.1. Sand Patch Mean Texture Depth for All Test Sites Before and Immediately After UHP Treatment

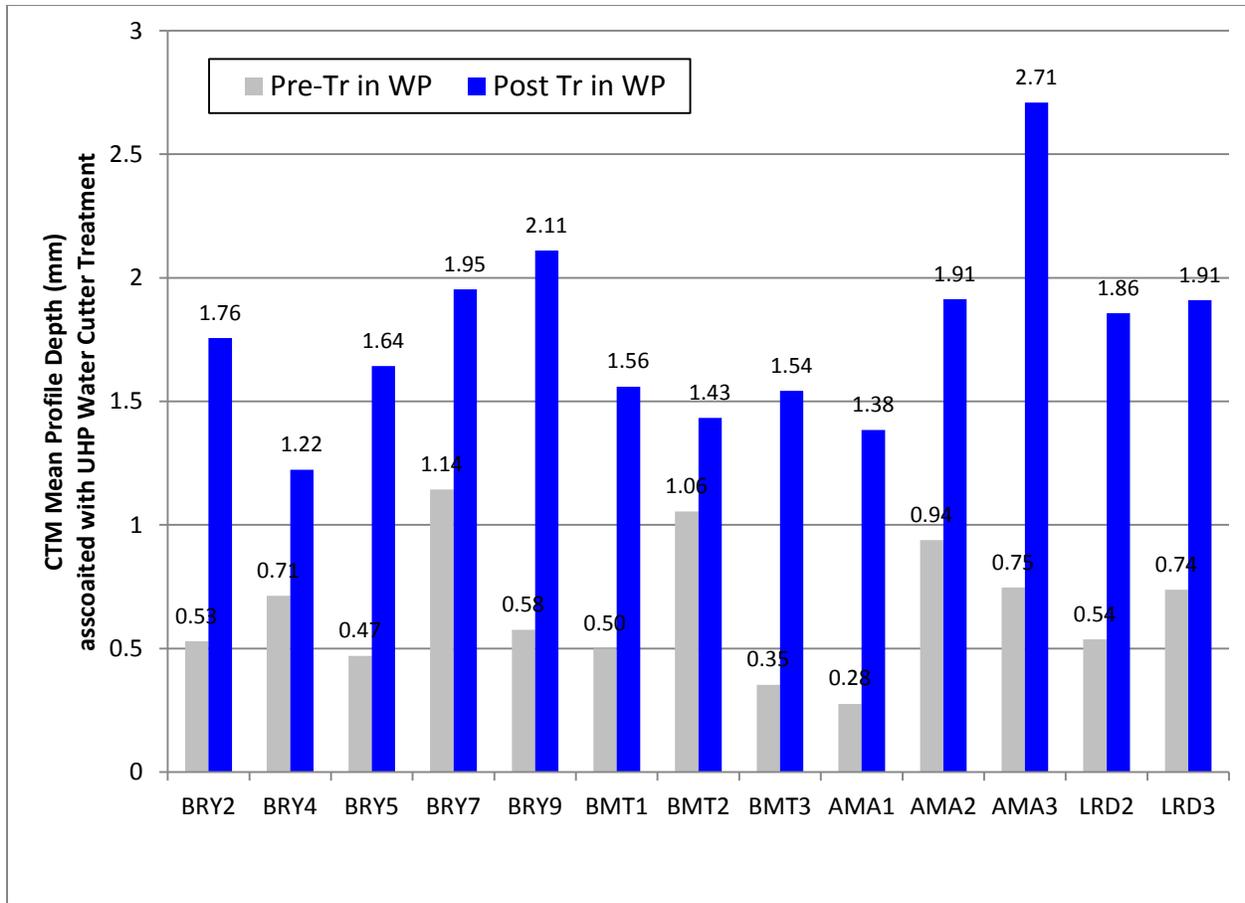
Similar observations can also be made from Figure 3.2, which shows the pavement texture represented by the CTM mean profile depth. The range of CTM mean profile depth values before treatment was 0.3mm to 1.3mm, which increased to 1.2mm to 2.7mm after treatment.

FIGURE 3.2. CTM Mean Profile Depth for All Test Sites Before and Immediately After UHP Treatment

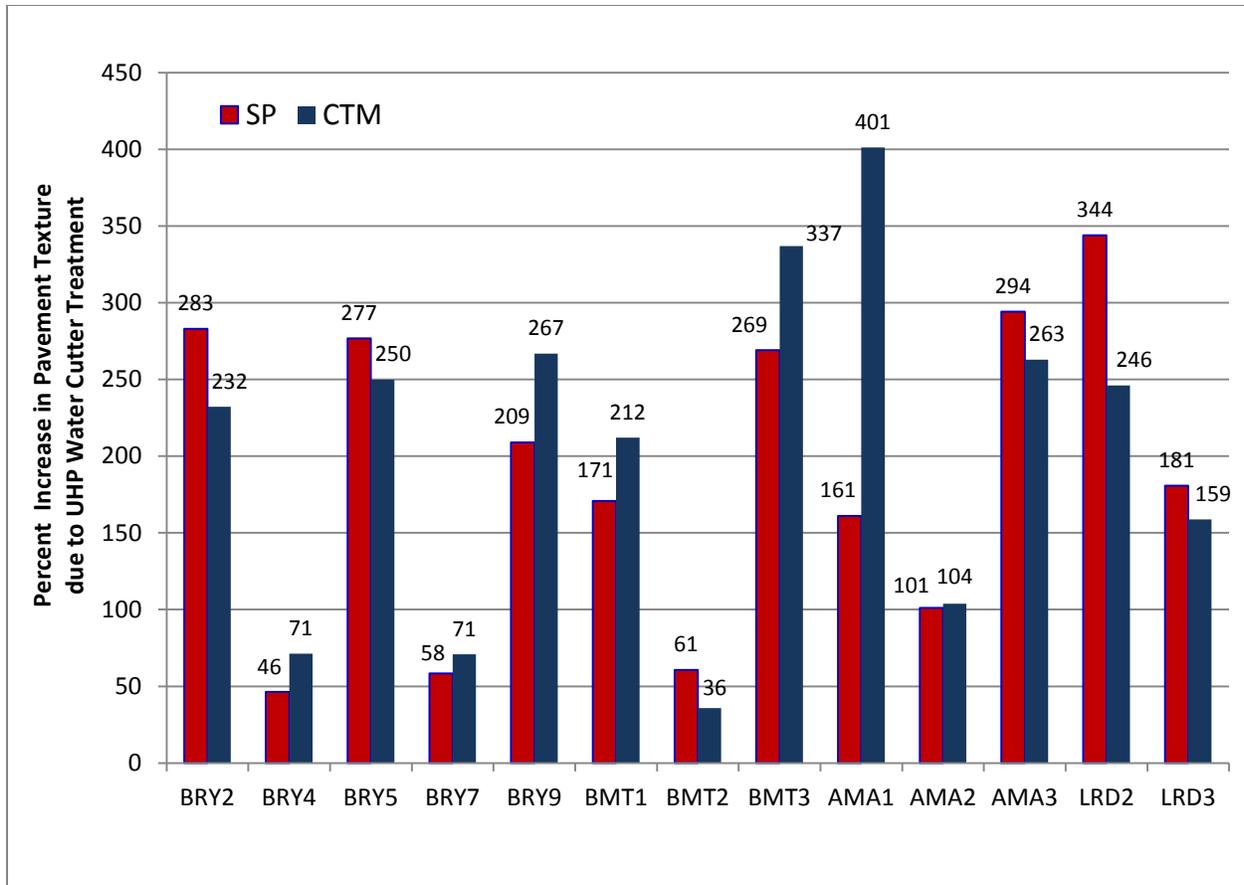
Figure 3.3 shows the percent improvement in sand patch mean texture depth and CTM mean profile depth as a result of water cutter treatment. The results show remarkable improvement in patch mean texture depths, with increases from 46 percent to 344 percent, averaging 189 percent across all sites. Ten of the 13 projects showed improvements of 100 percent or more. The three sites with around 50 percent increase in macrotexture were all sites with non-uniform flushing levels along the section.

Similar results exist for CTM mean profile depths, with increases from 36 percent to 401 percent, average 204 percent across all sites. Again, ten of the 13 projects showed improvements of 100 percent or more.

FIGURE 3.3. Percent Increase in Sand Patch Mean Texture Depth and CTM Mean Profile Depth for All Test Sites from Pre-Treatment to Post-Treatment

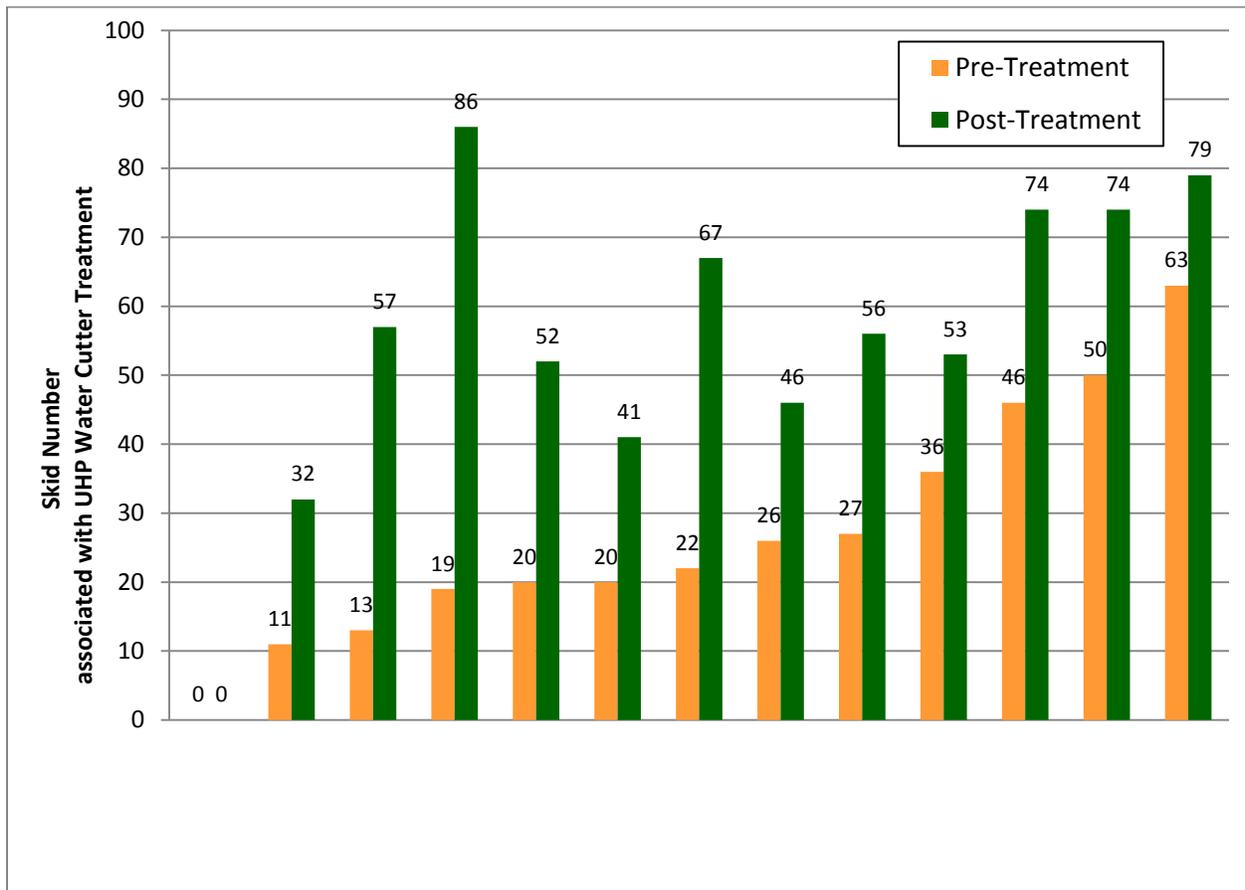
Results presented in Figure 3.4 show very high increases in the skid number, indicating the success of this treatment method to improve pavement skid resistance. Prior to the treatment, four of the 13 sections had a skid number greater than 35, five between 20 and 35, three below 20, and one site was not tested. According to the TxDOT project director for this research, a

skid number of 20 is generally considered to be the threshold to initiate further investigation of pavement conditions for any type of pavement for a test speed of 50 miles per hour using the smooth tire [Goehl, 2012]. After the treatment, eleven of the 13 sections had skid numbers over 40, which is well above the generally-considered threshold minimum of 35 for high-traffic pavements. The remaining section showed a skid number of 32.

Three of the thirteen test sites showed skid number increase in excess of 40, one showed an increase between 30 and 39, seven showed increases between 20 and 29, and one site had an increase less than 20. The site with the lowest change in the skid number after the treatment exhibited non-uniform and sporadic flushing, so the skid truck likely was not able to test the same location before and after the treatment. Two of the sections with the lower increases in the skid number used low microtexture, low-friction siliceous gravel aggregate. The lowest post-treatment skid numbers may be due to the type of limestone used in these two sites and other factors. The skid number and the DFT friction number are both functions of the macrotexture as well as microtexture. Therefore, the aggregate used in the surface has a significant influence in the final value of the friction parameter value.

FIGURE 3.4. Skid Number Values in Wheel Path for All Test Sites Before and Immediately After UHP Treatment

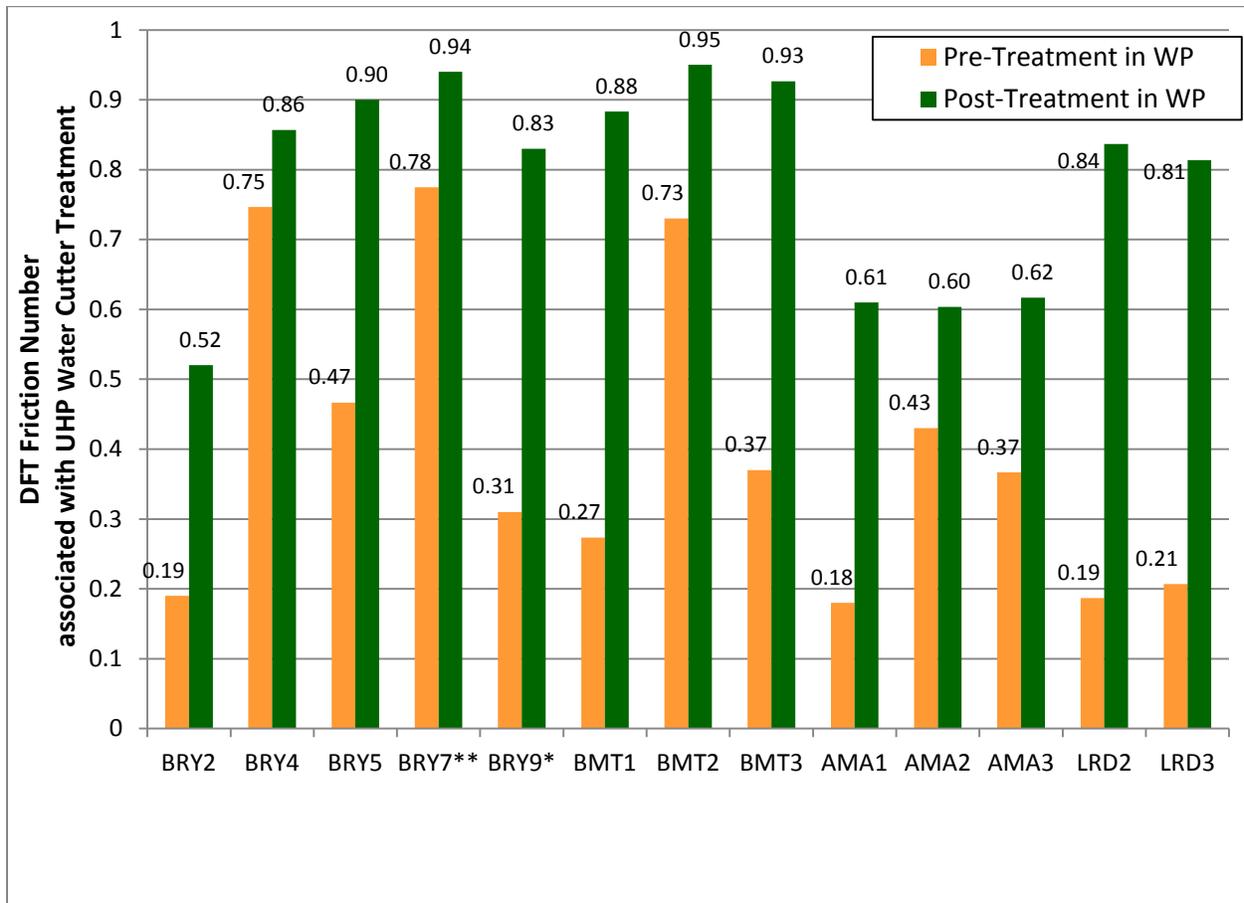
The DFT friction numbers showed trends similar to those of the skid number (Figure 3.5). Prior to treatment, seven of the 13 section had DFT friction numbers over 0.35 and six were below.

After the treatment, all thirteen sections had DFT friction numbers above 0.35. In Figure 3.5, the results from the DFT show mostly similar trends in friction values compared to the skid numbers. All sections showed remarkably high increases in the DFT friction value with the lowest increases in the siliceous gravel sections. It is interesting to note that the two sections LRD2 and LRD3, which used the weak limestone, had high post-treatment friction values and also three-fold increases. There appears to be a general correlation between the skid truck and DFT results.

FIGURE 3.5. DFT Friction Number Values for All Test Sites Before and Immediately After UHP Treatment

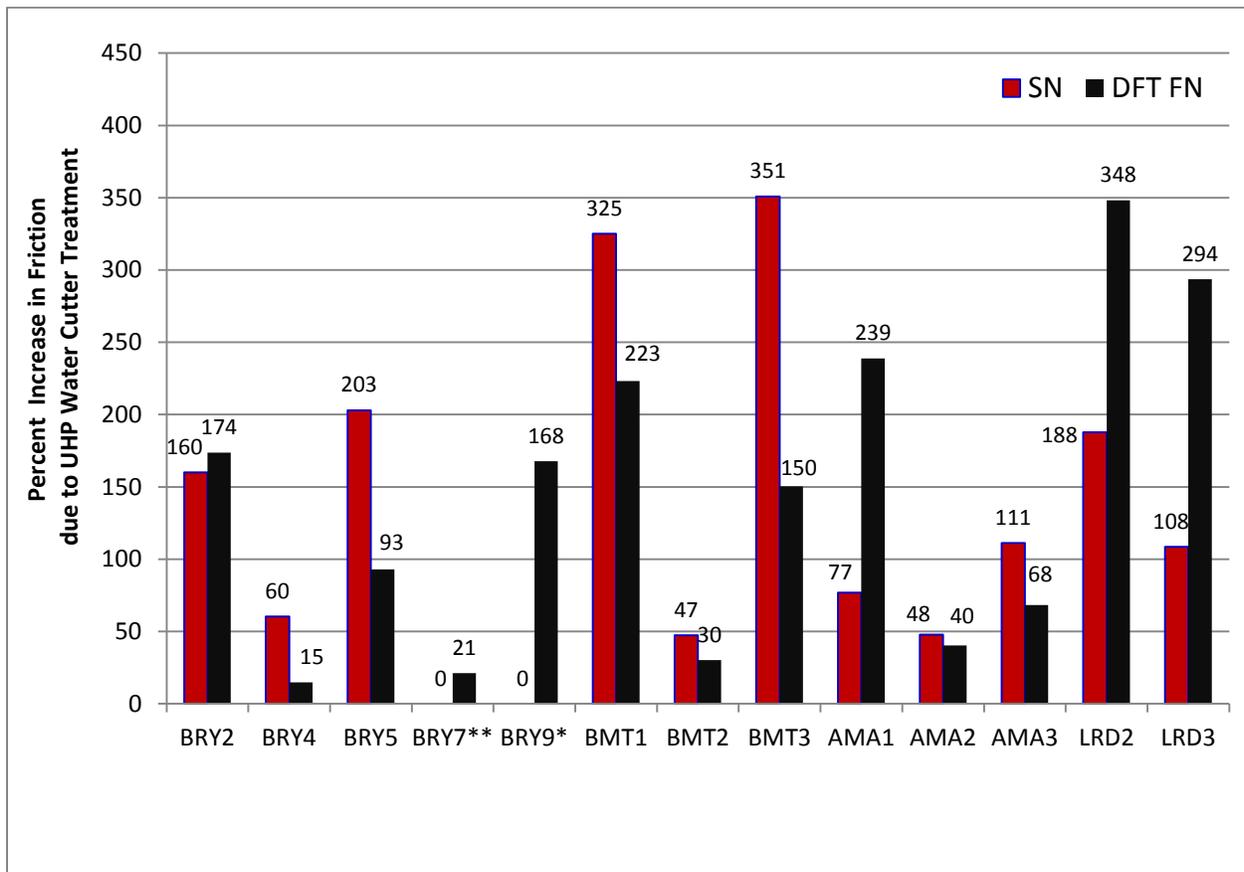
Figure 3.6 shows the percent increase in friction due to the water cutter treatment measured using the skid truck and the DFT. The overall results for skid number values show increases from 0 percent to 351 percent, averaging 129 percent across all sites. Seven of the thirteen sites showed at least a 100 percent increase in the skid number.

Similar results exist for the DFT friction number, with increased from 15 percent to 348 percent, averaging 143 percent across all sites. Seven sites showed at least a 100 percent increase in the DFT friction number.

FIGURE 3.6. Percent Increase in Skid Number in Inside Wheel Path for All Test Sites From Pre-Treatment To Post-Treatment

A few sites showed unexpectedly low increases. This may be attributable to factors not related to the general effectiveness of the treatment. The sites that showed low increases either used low friction siliceous gravel aggregate (AMA1, AMA2 and AMA3) or had uneven flushing along the length of the highway section (in BRY4 and BRY7). The trends were similar for both the skid number and DFT friction number values.

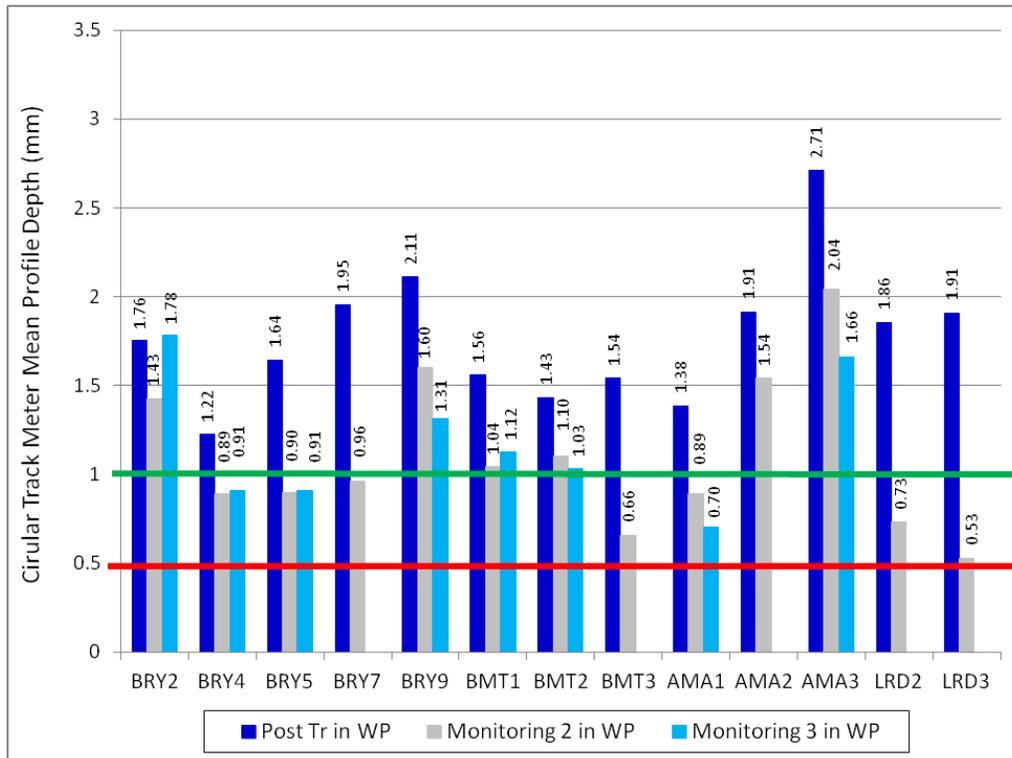
Figures 4.1 and 4.2 present the survivability results associated with the pavement texture data. Figure 4.1 shows that pavement texture, as measured by the CTM at completion of monitoring, for six of the 13 sites was at or above the desired threshold (mean profile depth of 1.0 mm).

Pavement texture at completion of monitoring for all thirteen sites was at or above the maintenance threshold (Mean Profile Depth of 0.5mm). Mean profile depths at last monitoring, as measured by the CTM, varied from 0.53mm to 1.78mm, averaging 1.07mm.

FIGURE 4.1. Treatment Survivability as Measured by Whether Pavement Texture (CTM Mean Profile Depth) Survived to Completion of Monitoring At or Above Specified Performance Threshold Values

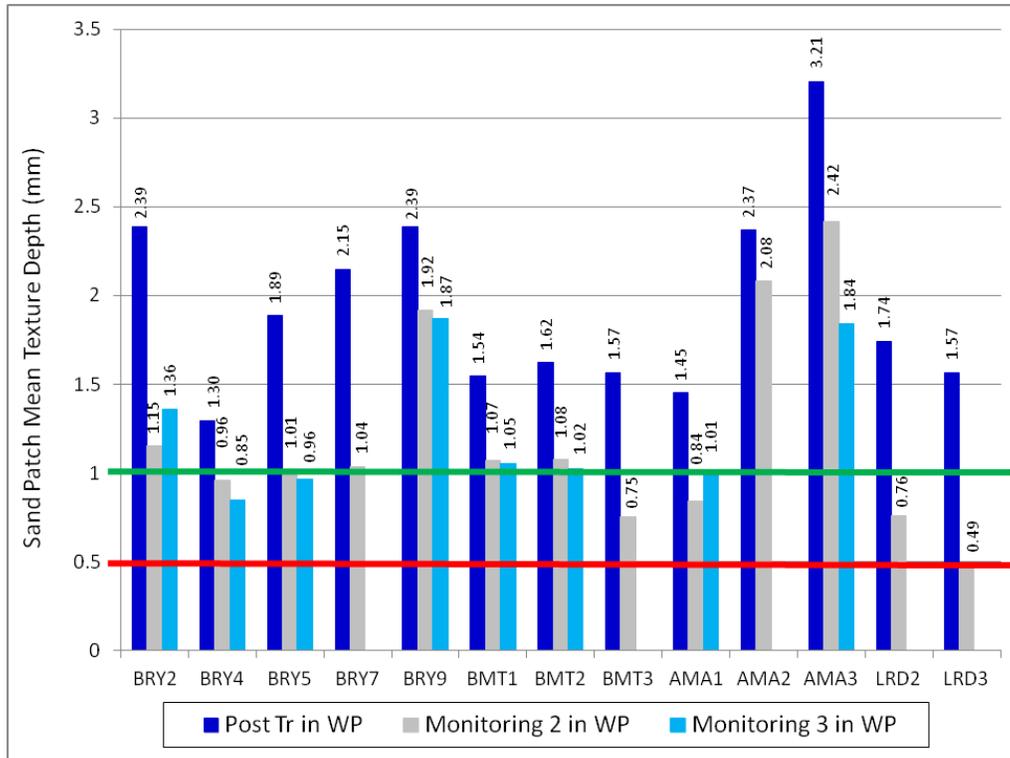
Figure 4.2 shows that pavement texture, as measured by the SP test at completion of monitoring, for eight of the 13 sites was at or above the desired threshold (mean texture depth of 1.0 mm). Pavement texture at completion of monitoring for 12 of 13 sites was at or above the maintenance threshold (Mean Texture Depth of 0.5mm). Mean texture depths at last monitoring, as measured by the SP test, varied from 0.49mm to 2.08mm, averaging 1.15mm.

FIGURE 4.2. Treatment Survivability as Measured by Whether Pavement Texture (SP Mean Texture Depth) Survived to Completion of Monitoring At or Above Specified Performance Threshold Values

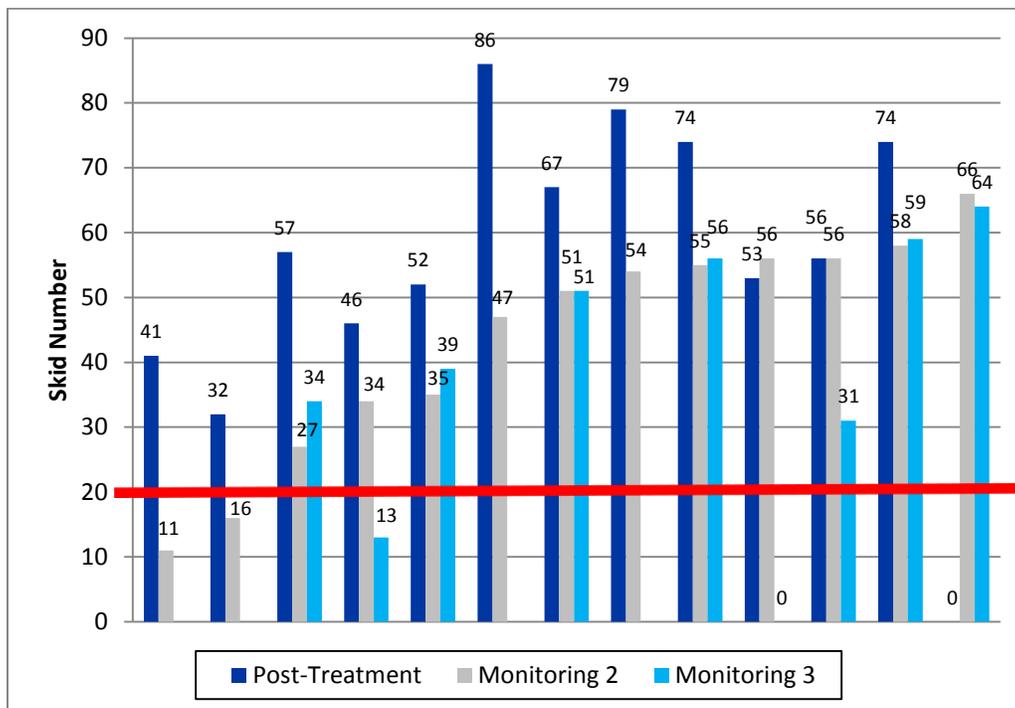
Figures 4.3 and 4.4 present the survivability data associated with the pavement friction data. Figure 4.3 shows that pavement friction, as measured by the SN at completion of monitoring, for ten of the 13 sites was at or above the maintenance threshold (SN = 20). Skid numbers at last monitoring varied from 11 to 64, averaging 40.

FIGURE 4.3. Treatment Survivability as Measured by Whether Pavement Friction (SN) Survived to Completion of Monitoring At or Above Specified Performance Threshold Value.

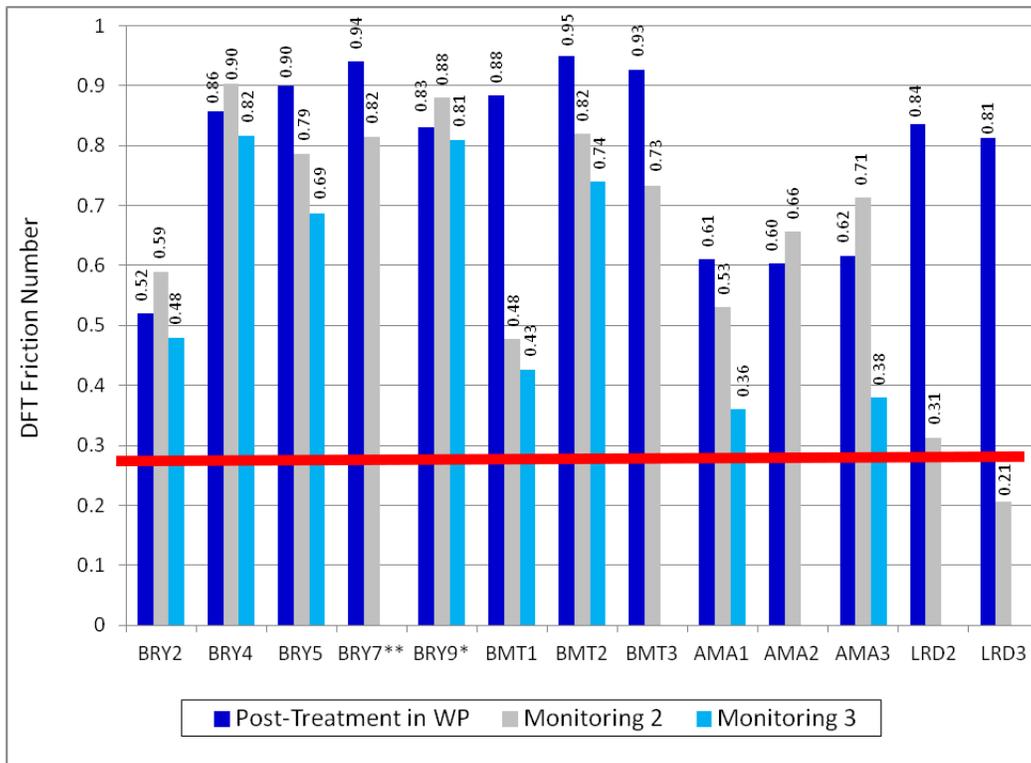
Figure 4.4 shows that pavement friction, as measured by the DFT FN at completion of monitoring, for 12 of the 13 sites was at or above the maintenance threshold (DFT FN = 0.27). DFT FN values at last monitoring varied from 0.21 to 0.82, averaging 0.57.

FIGURE 4.4. Treatment Survivability as Measured by Whether Pavement Friction (DFT FN) Survived to Completion of Monitoring At or Above Specified Performance Threshold Value

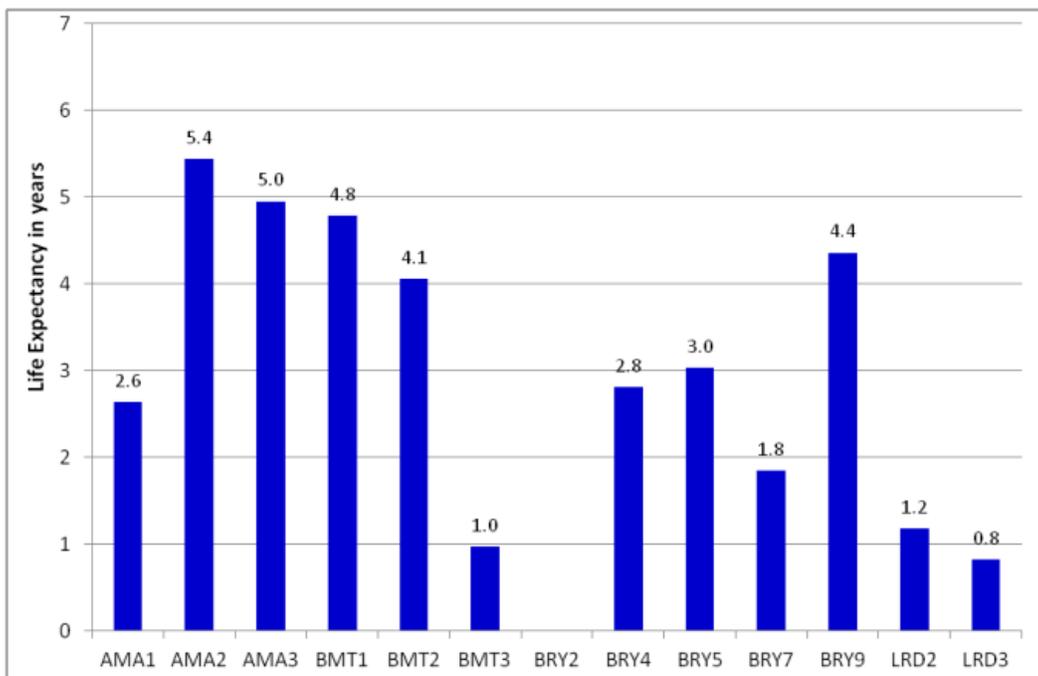
Figure 4.6 presents the life expectancy charts associated with the CTM data. Review of Figure 4.6 shows that CTM mean profile depth data for one site are not available (BRY2). For the twelve sites with CTM life expectancy data, Figure 4.6 indicates that the pavement texture, as measured by the CTM, at 11 of these sites is predicted to last one or more years. Similarly, the

texture at eight sites is predicted to last two or more years, the texture at six sites is predicted to last three or more years, and the texture at five sites is predicted to last four or more years. Again, these life expectancy predictions are based on CTM decay models.

FIGURE 4.6. Treatment Life Expectancy, In Years, Predicted Based On Pavement Texture Estimated From CTM Mean Profile Depth Data

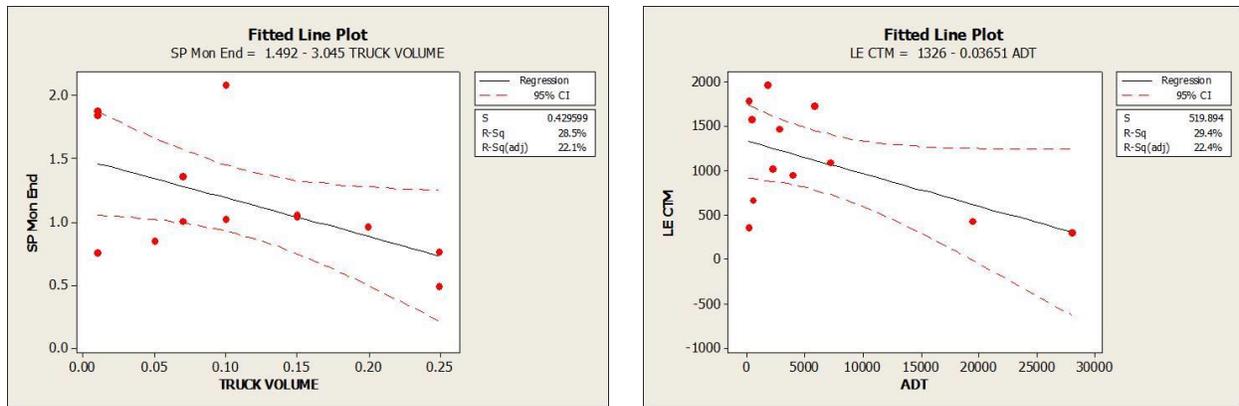
The results from these analyses suggest that durability parameters are most strongly influenced by average daily traffic volume and by the percentage of trucks (Figure 4.10) as would be expected:

- Traffic volume (ADT): higher traffic volume reduces treatment survivability and life expectancy.
- Truck volume: more truck traffic reduces treatment survivability and life expectancy.

FIGURE 4.10. Factors That Influence UHP Treatment Durability as Determined by Statistical Analyses of the Survivability and Life Expectancy Data

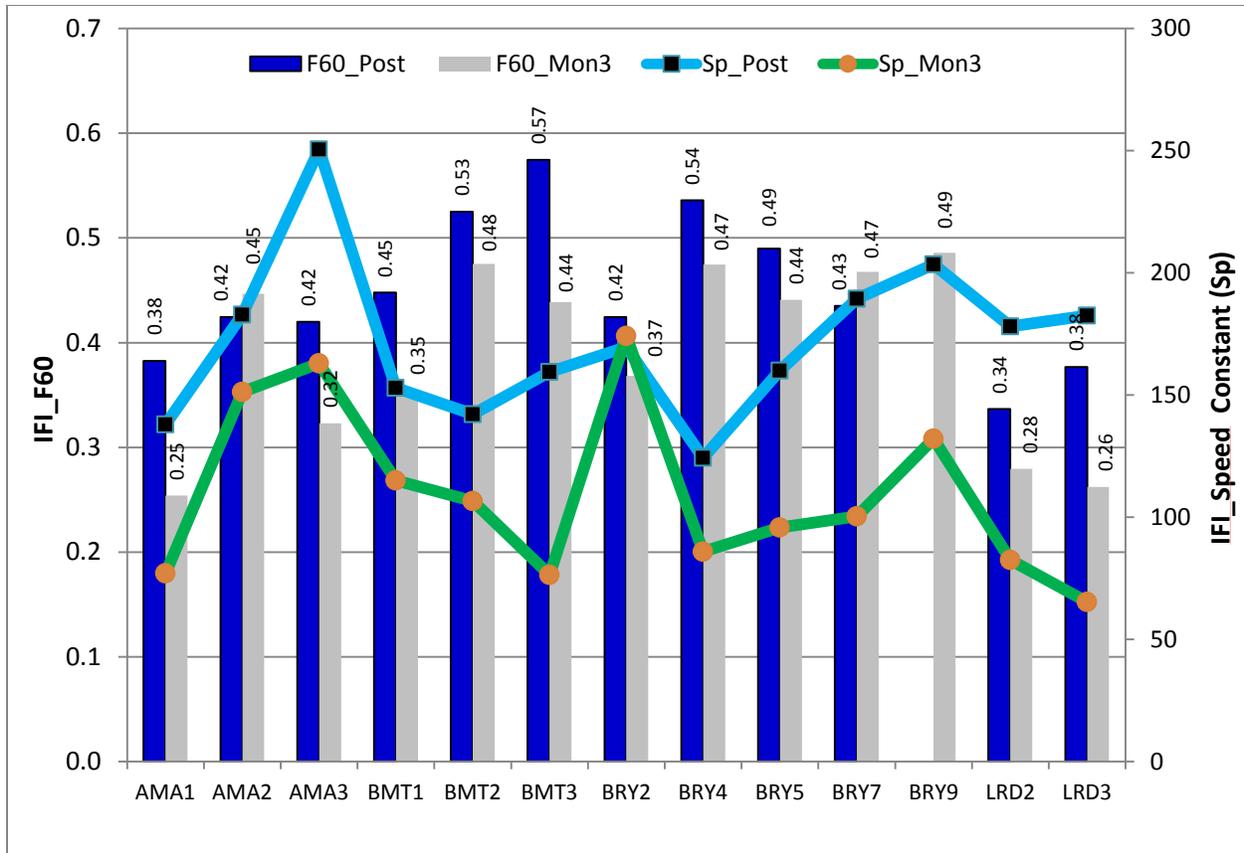
FIGURE 4.11. International Friction Index (IFI) Calibrated Friction Number, F60, and Speed Constant (Sp) for Test Sites

Review of the IFI data indicates that both the F60 and the Sp values decreased over time. F60 values decreased for ten of 12 sites, with variations ranging from +9 percent to -34 percent, averaging -15 percent. Sp values decreased for 12 of 13 sites, with variations ranging from +3 percent to -64 percent, averaging -36 percent.

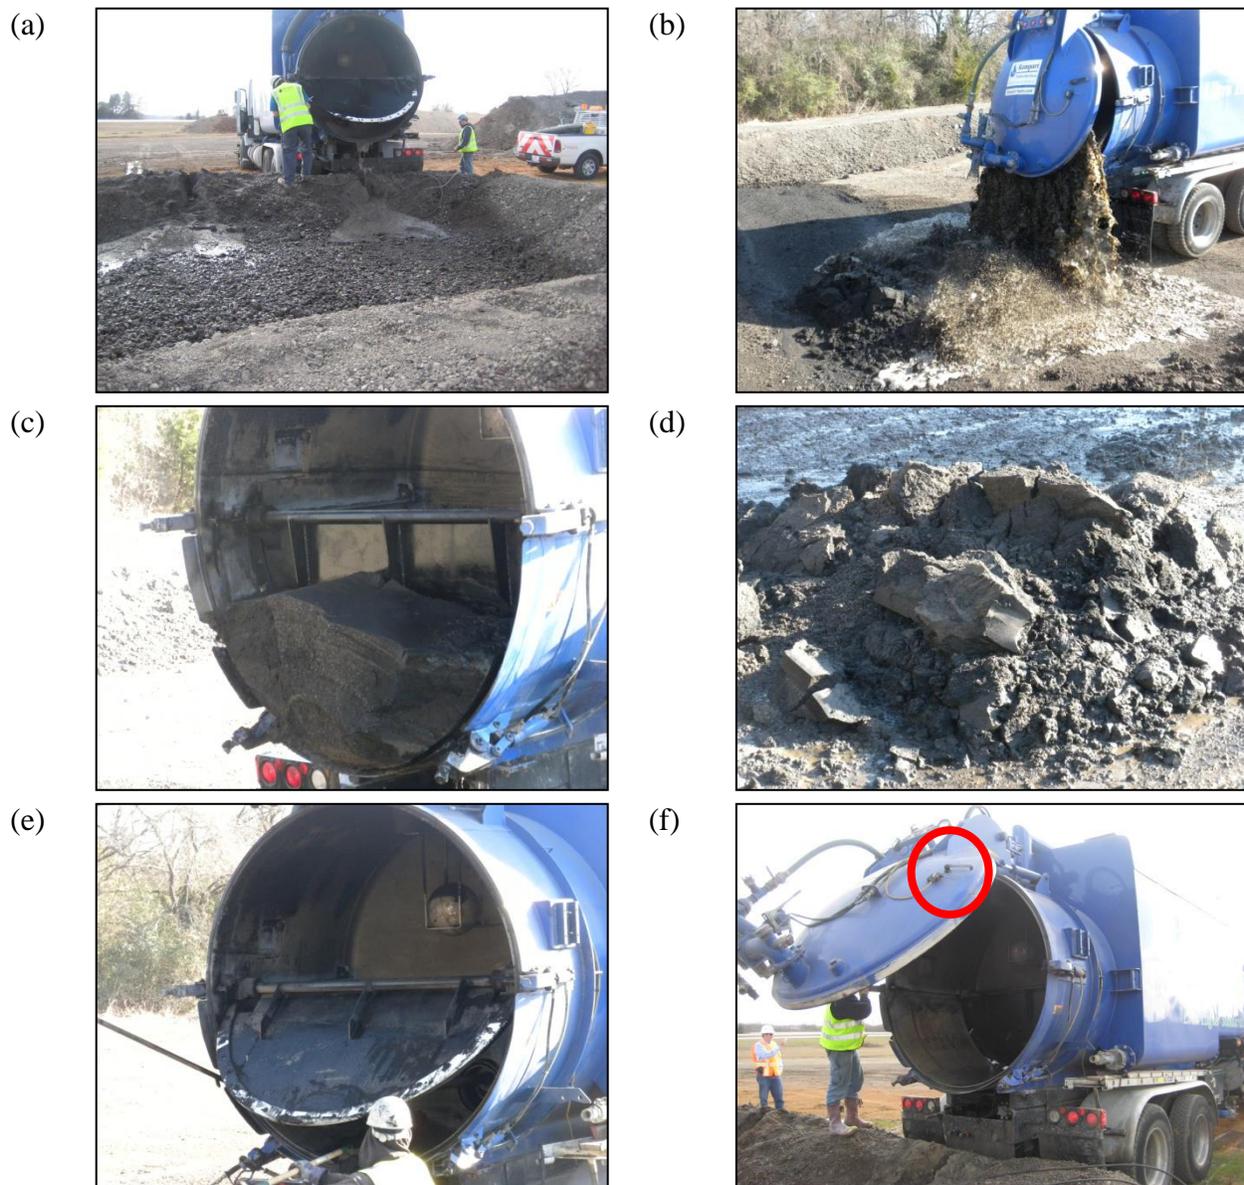
Because the debris tank has only 1,000 gallon capacity and the water supply tank has 4,000 gallon capacity, the location of an approved dump site will significantly impact the rate of production. Figure 5.3 illustrates the key steps involved in the waste disposal process. The back gate of the truck has a gage that indicates the material level in the waste tank [see the circled area in Figure 5.3(f)]. The truck is able to directly back into the disposal area and open the rear gate as shown. This operation requires that the disposal area is firm enough to carry the laden truck that is at least partially filled with water. Once the gate is opened, water spills out of the truck, but the solid material must be pushed out using a hydraulic ram inside the waste tank.

FIGURE 5.3. Disposal of excess flushed asphalt removed by the treatment; (a) A bermed area chosen by the TxDOT maintenance yard used to dispose the material without run-off; (b) Opening of rear gate spills out the water among the waste; (c) lump of asphalt and sand waste pushed out using hydraulic system; (d) lump of asphalt and sand waste on the ground; (e) cleaning of waste tank using high-pressure water jet; (f) cleaning of waste tank solid material – the circle highlights the gage on the rear gate that indicates the material level in the waste tank.

The maintenance supervisor must ensure that the waste material is disposed according to guidelines stipulated by the TxDOT Environmental Division. The waste material consists of ground asphalt, sand, and water. When the temperature of the pavement is relatively high, evidence of some emulsification of the asphalt could be observed. Ideally, the disposal area is to be bermed around to prevent immediate run-off of the material.

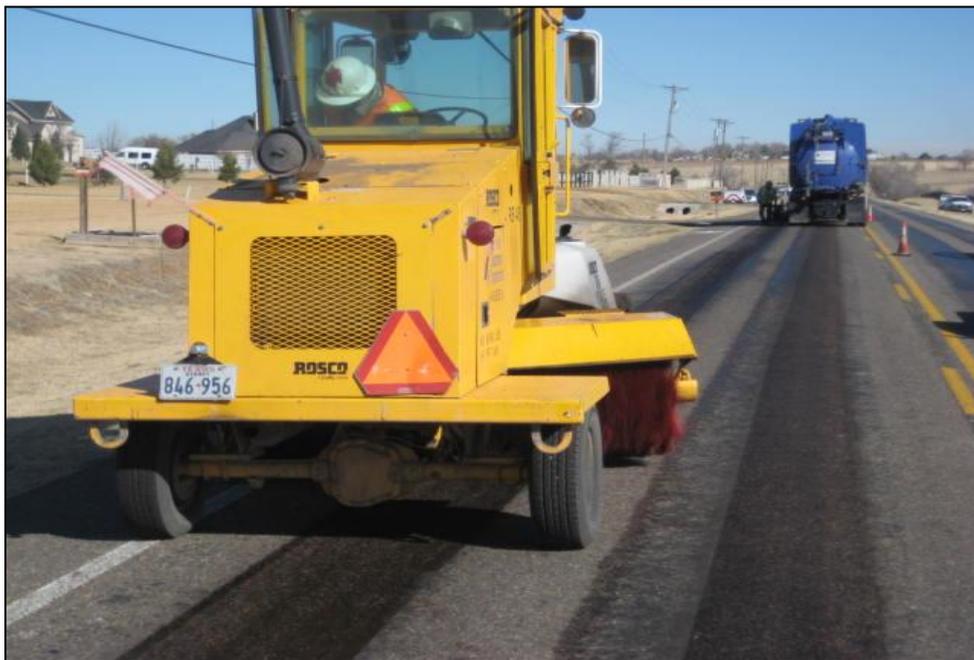
FIGURE 5.7. Power Broom Used to Sweep Remaining Asphalt Left After Treatment Head Vacuum System

Figures 5.5 through 5.9 illustrate some situations we observed during the treatment process. The UHP water cutter removes a significant amount of excess asphalt material from the pavement surface. The actual quantity removed will depend on the travel speed, rotational speed of the spray bar, the nozzle configuration in the bar, extent of flushing on the road and the asphalt and aggregate material characteristics. Figure 5.5 shows the removed asphalt left on the road when the vacuum system is not operating. Under conditions that can be labeled as "typical," the vacuum system in the machine is capable of sucking up all the material. Typical conditions would mean desirably cool temperatures and modified binders. However, there can be situations where the vacuum system is unable to remove all the cut asphalt as shown in Figure 5.6. Figure 5.7 shows a power broom following the water cutter to ensure that all material is removed from the roadway before traffic is allowed back.

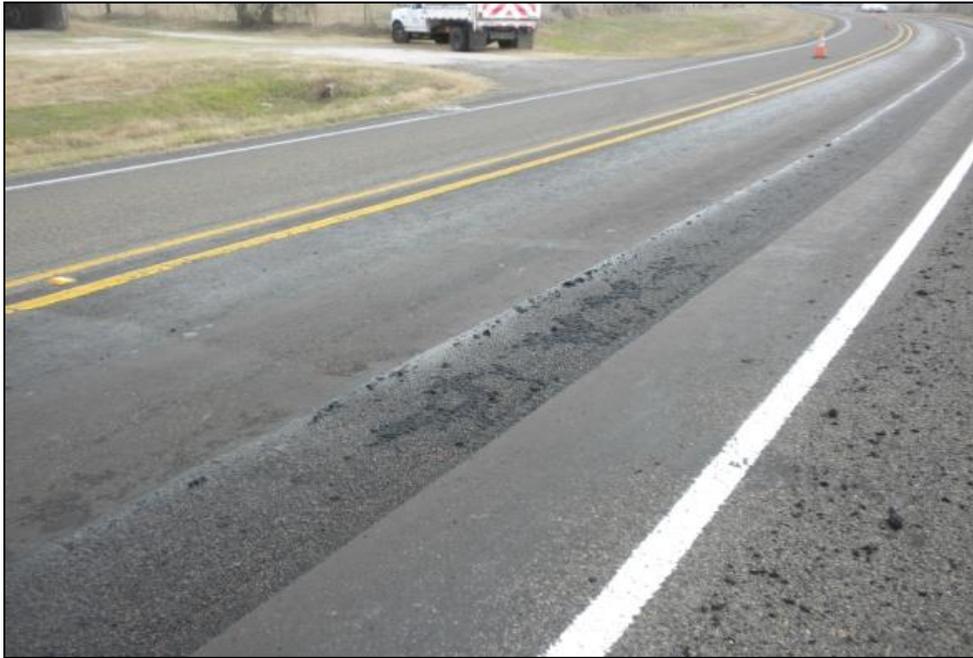
Figure 5.8 also illustrates a phenomenon where the treatment process may leave a sharp shallow drop along the edge of the treated strip. This drop is not deep enough to cause traffic to lose control if caught on the edge. This issue can be alleviated by changing the nozzle configuration to gradually taper-off the treatment depth towards the outside of the treated strip. Another outcome that is influenced by the nozzle configuration is not having sufficient nozzle coverage in a certain part of the treatment trip.

FIGURE 5.8. Treated Wheel Patch Showing Small Amounts of Asphalt Not Vacuumed and Then Pressed Back Into Lane By Tires of Water Cutter Truck. Picture Also Shows Sharp Edge Sometimes Left by Treatment at Edge Of Strip

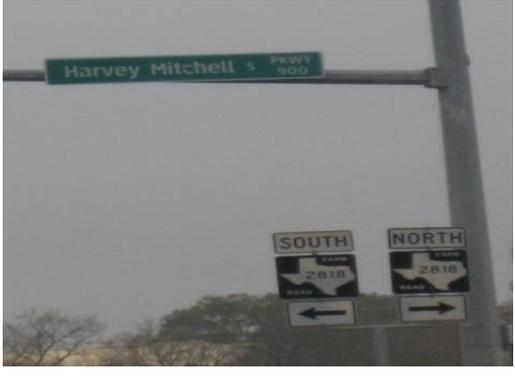
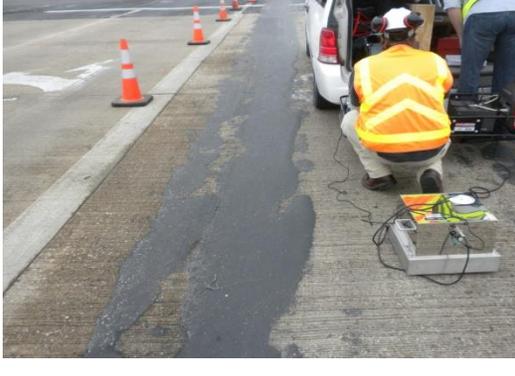
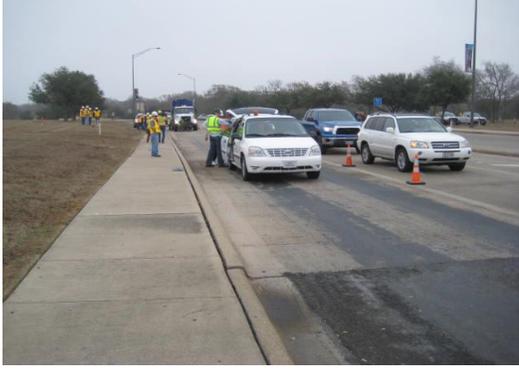
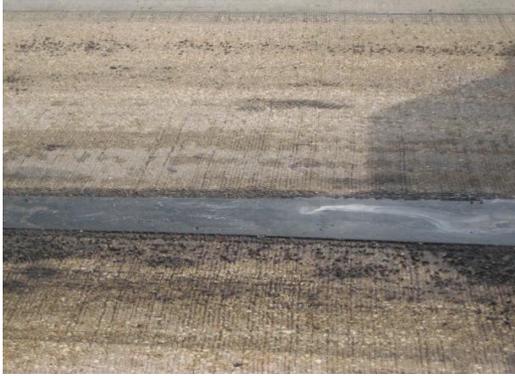
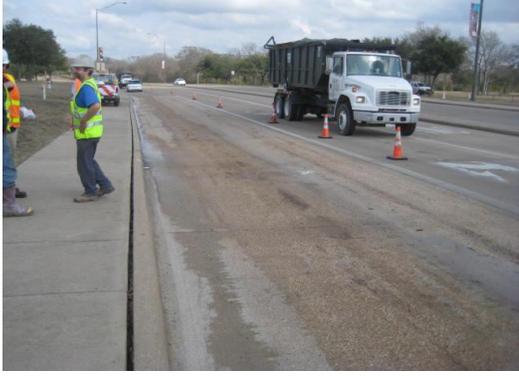
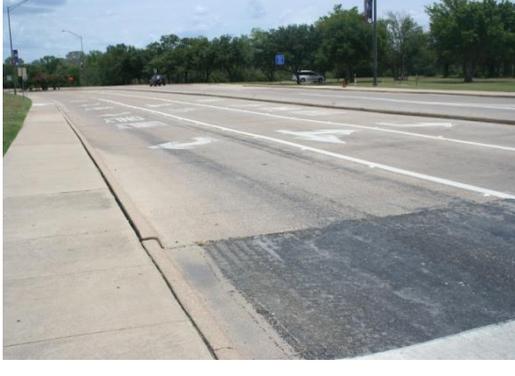
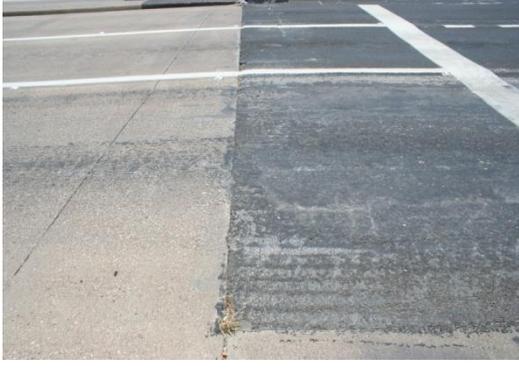
<p>Figure XX. BRY1 Pictures (a) highway and location; (b) roadway surface before treatment; (c) close-up spilt asphalt; (d) roadway surface after treatment; (e) close-up of flushed surface immediately after treatment; (f) close-up of surface at third follow-up ; (g) roadway surface at third follow-up</p>	
(b)

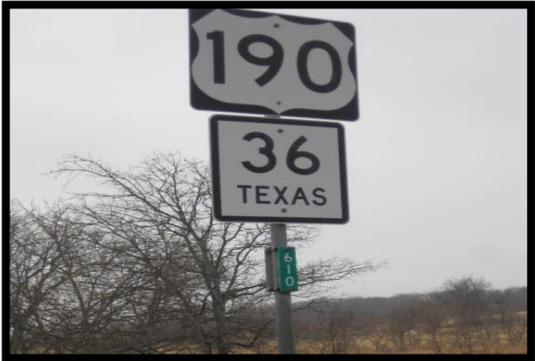
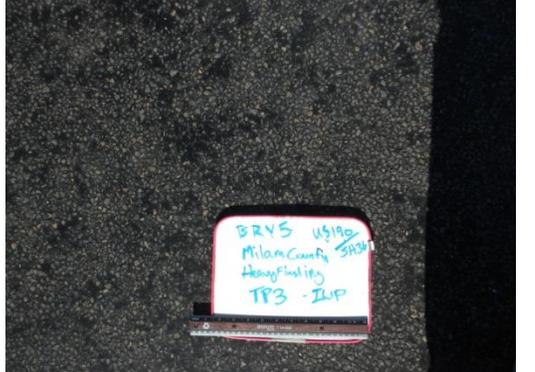
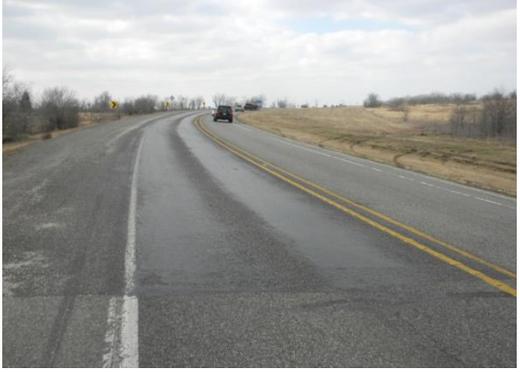
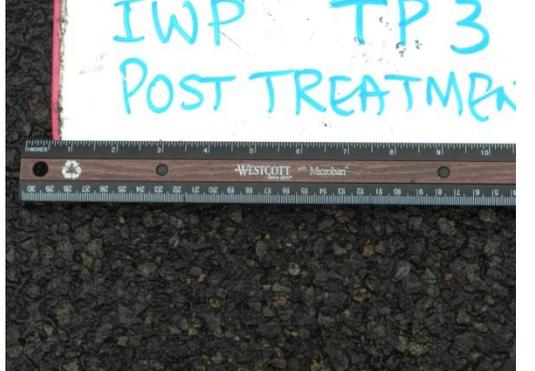
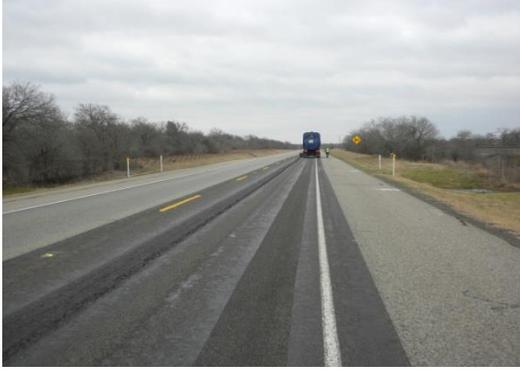
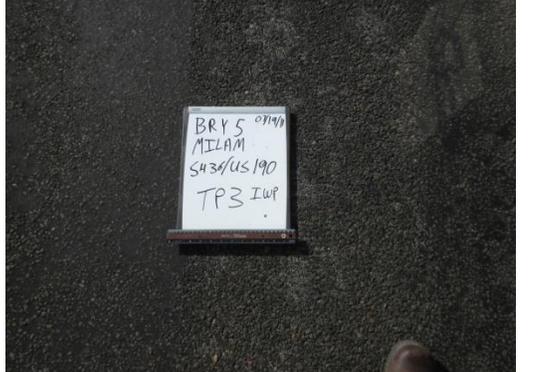
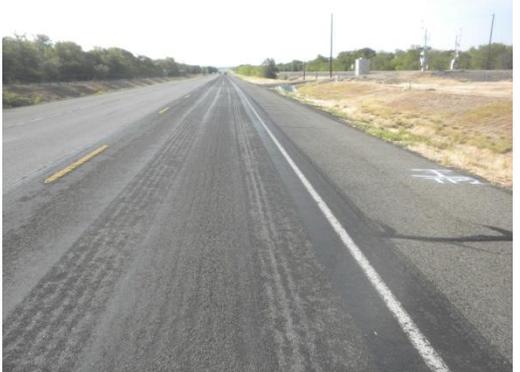
Site Photographs

<p>Figure XX. BMT3 Pictures (a) highway and location; (b) close-up of flushed surface before treatment; (c) roadway surface before treatment; (d) close-up of flushed surface immediately after treatment; (e) roadway surface after treatment; (f) close-up of surface at first follow-up ; (g) roadway surface at first follow-up , (h) roadway surface at second follow-up ; (i) close-up of surface at second follow-up , (j) close-up of surface at third follow-up ; (k) roadway surface at third follow-up</p>	
(b)
