Implementing the Ultra-High Pressure Water Cutter for Roadway Maintenance Applications: Final Report

Sanjaya P. Senadheera, Roderick B. Henderson,
James G. Surles, William D. Lawson

Texas Department of Transportation

Research Project 5-5230-01
Research Report 5-5230-01-2
www.techmrt.ttu.edu/reports.php

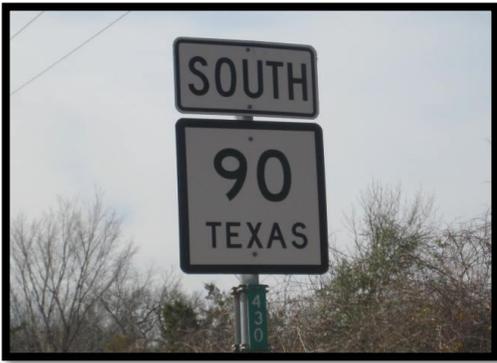
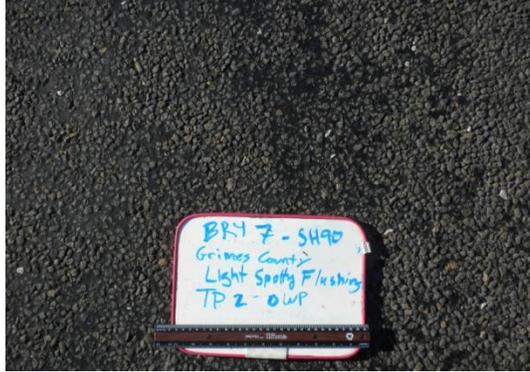
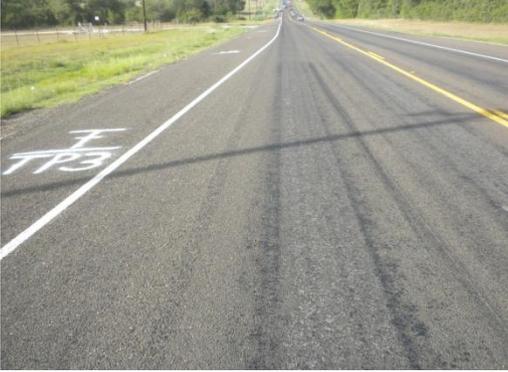
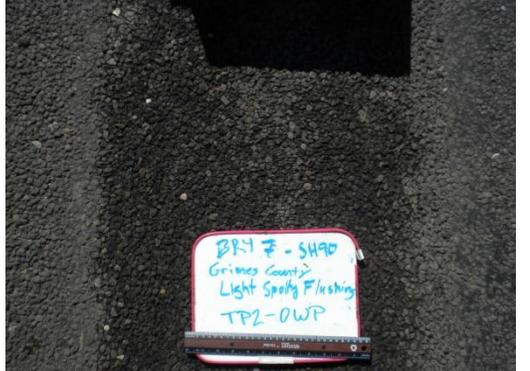
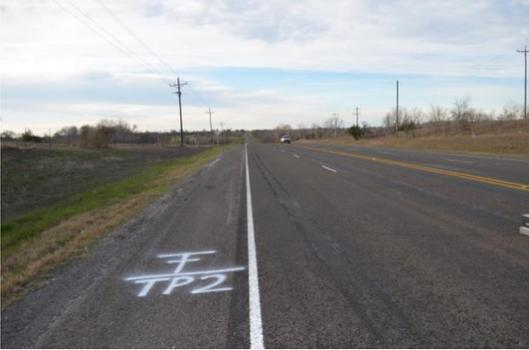
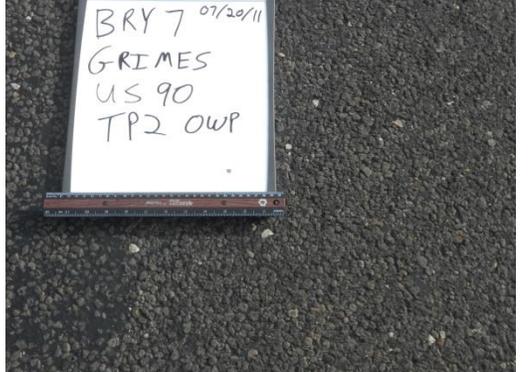
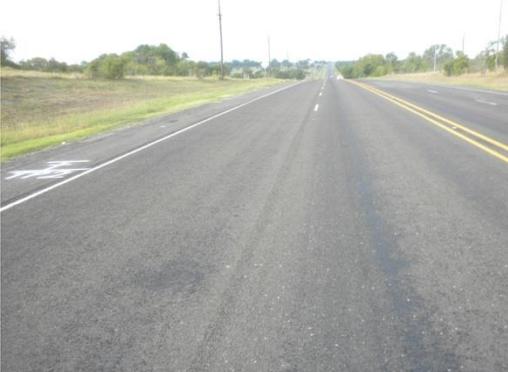
(b) Figure XX. BMT3 Pictures (a) highway and location; (b) close-up of flushed surface before treatment; (c) roadway surface before treatment; (d) close-up of flushed surface immediately after treatment; (e) roadway surface after treatment; (f) close-up of surface at first follow-up ; (g) roadway surface at first follow-up , (h) roadway surface at second follow-up ; (i) close-up of surface at second follow-up .	
(b)

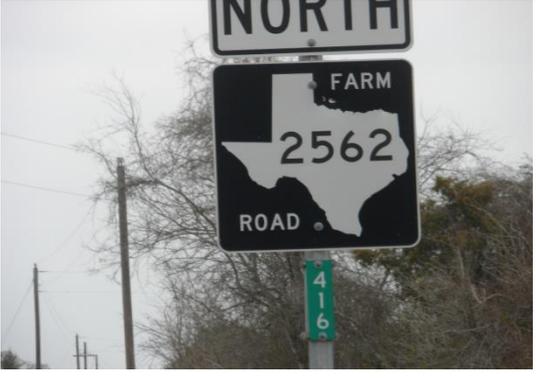
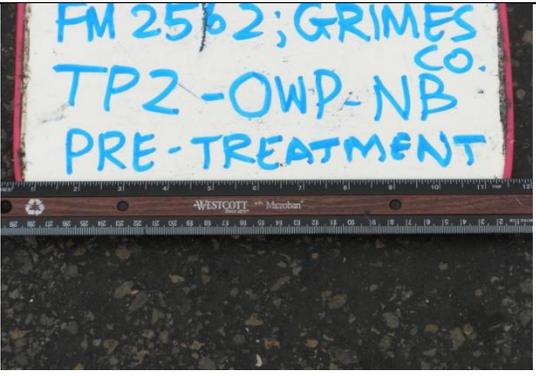
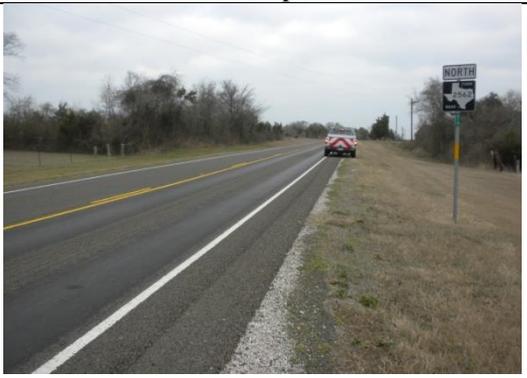
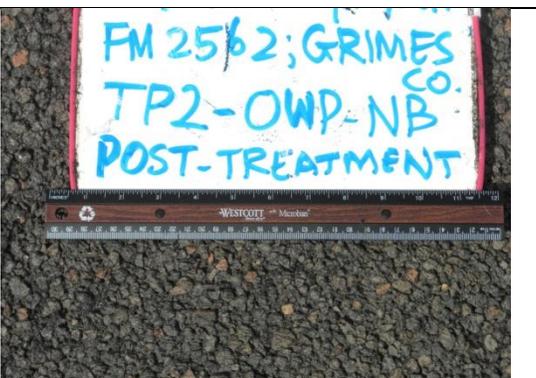
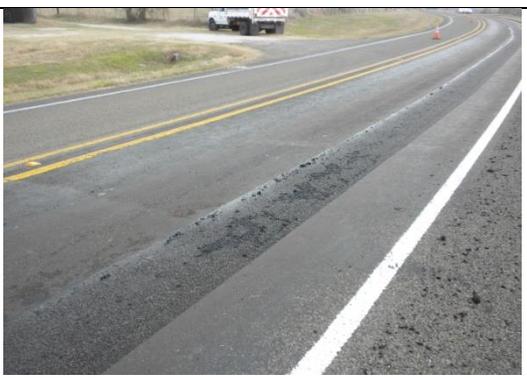
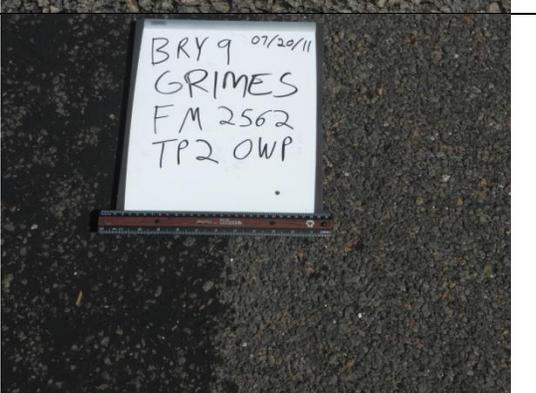
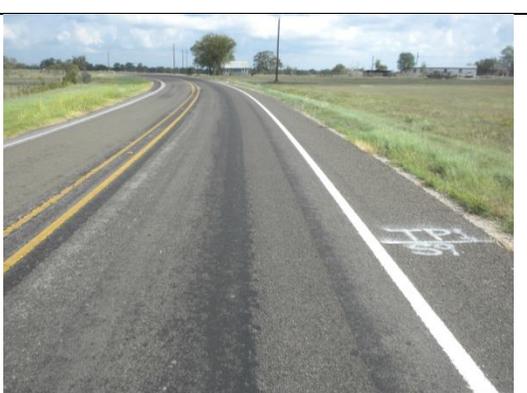
Figure XX. BMT3 Pictures (a) highway and location; (b) close-up of flushed surface before treatment; (c) roadway surface before treatment; (d) close-up of flushed surface immediately after treatment; (e) roadway surface after treatment; (f) close-up of surface at first follow-up ; (g) roadway surface at first follow-up , (h) roadway surface at second follow-up ; (i) close-up of surface at second follow-up , (j) close-up of surface at third follow-up ; (k) roadway surface at third follow-up
(b)

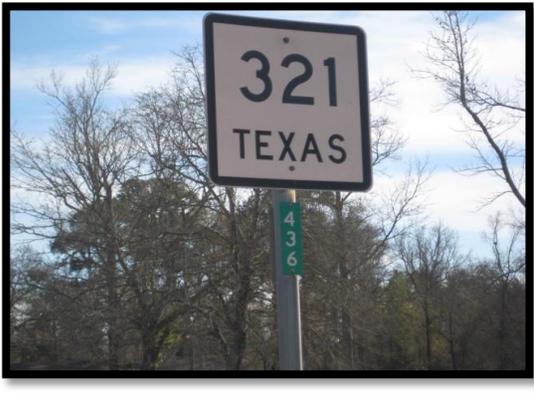
<p>Figure XX. BMT3 Pictures (a) highway and location; (b) close-up of flushed surface before treatment; (c) roadway surface before treatment; (d) close-up of flushed surface immediately after treatment; (e) roadway surface after treatment; (f) close-up of surface at first follow-up ; (g) roadway surface at first follow-up , (h) roadway surface at second follow-up ; (i) close-up of surface at second follow-up , (j) close-up of surface at third follow-up ; (k) roadway surface at third follow-up</p>
(b)

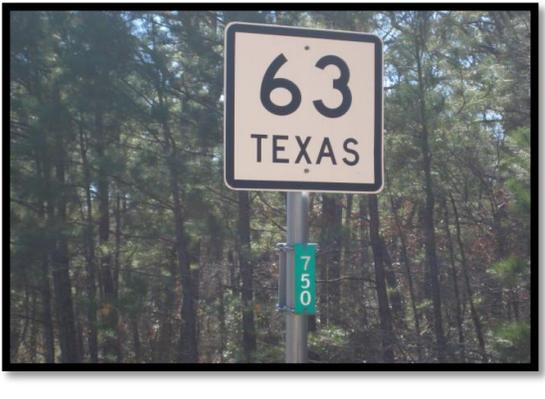
<p>Figure XX. BMT3 Pictures (a) highway and location; (b) close-up of flushed surface before treatment; (c) roadway surface before treatment; (d) close-up of flushed surface immediately after treatment; (e) roadway surface after treatment; (f) close-up of surface at first follow-up ; (g) roadway surface at first follow-up , (h) roadway surface at second follow-up ; (i) close-up of surface at second follow-up , (j) close-up of surface at third follow-up ; (k) roadway surface at third follow-up</p>	
(b)

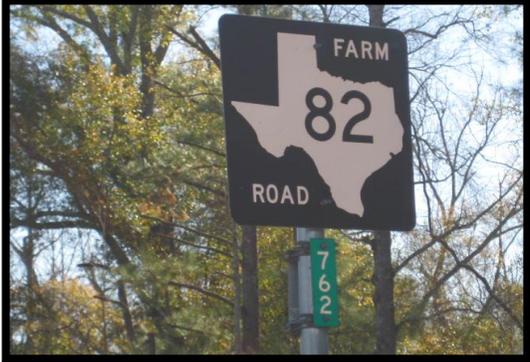
Figure XX. BMT3 Pictures (a) highway and location; (b) close-up of flushed surface before treatment; (c) roadway surface before treatment; (d) close-up of flushed surface immediately after treatment; (e) roadway surface after treatment; (f) close-up of surface at first follow-up ; (g) roadway surface at first follow-up , (h) roadway surface at second follow-up ; (i) close-up of surface at second follow-up .
(b)

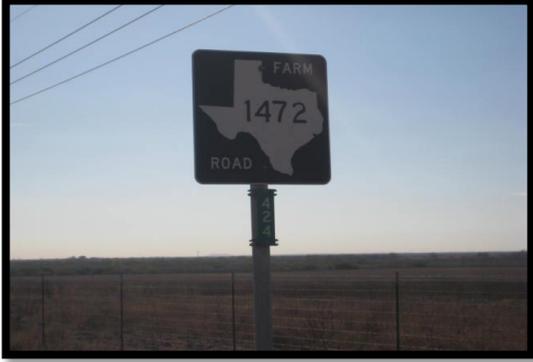
<p>Figure XX. BMT3 Pictures (a) highway and location; (b) close-up of flushed surface before treatment; (c) roadway surface before treatment; (d) close-up of flushed surface immediately after treatment; (e) roadway surface after treatment; (f) close-up of surface at first follow-up ; (g) roadway surface at first follow-up , (h) roadway surface at second follow-up ; (i) close-up of surface at second follow-up , (j) close-up of surface at third follow-up ; (k) roadway surface at third follow-up</p>
(b)

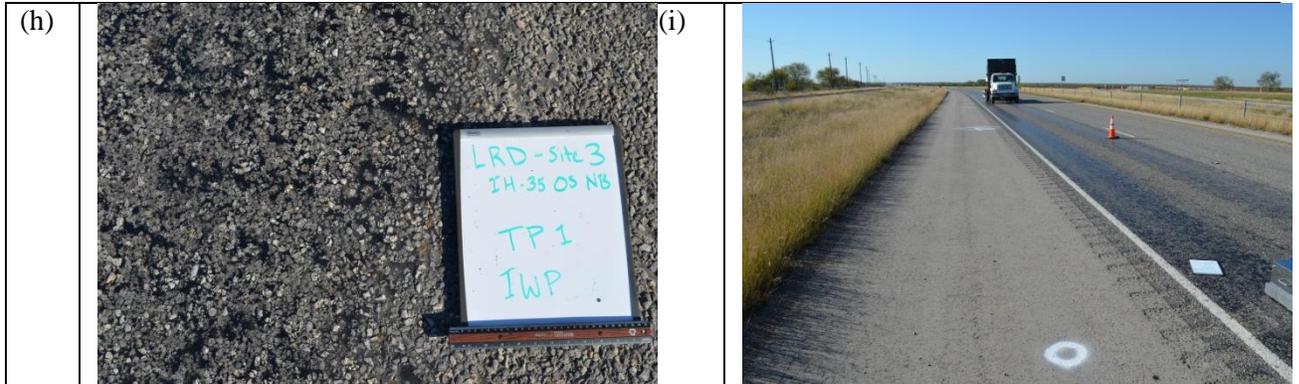
(a)		<p>Figure XX. BMT3 Pictures (a) highway and location; (b) close-up of flushed surface before treatment; (c) roadway surface before treatment; (d) close-up of flushed surface immediately after treatment; (e) roadway surface after treatment; (f) close-up of surface at first follow-up ; (g) roadway surface at first follow-up , (h) roadway surface at second follow-up ; (i) close-up of surface at second follow-up.</p>	
(b)		(c)	
(d)		(e)	
(f)		(g)

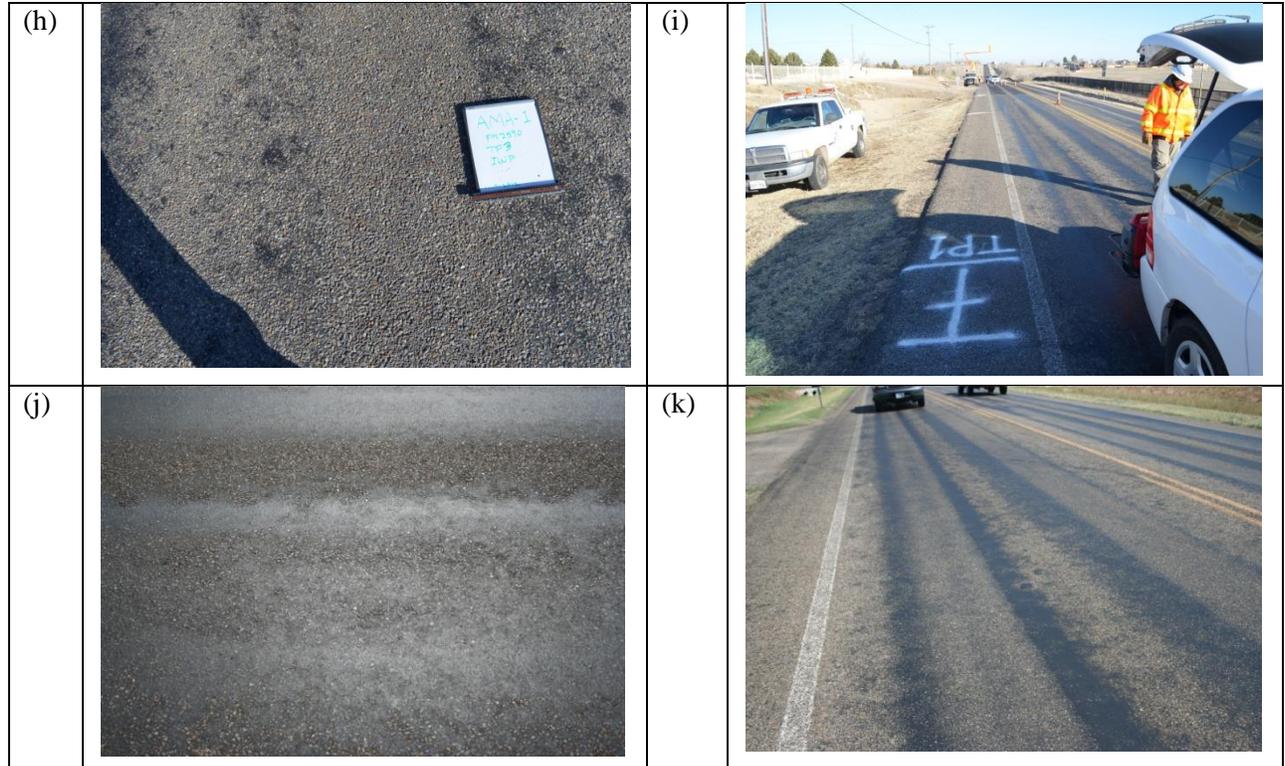
(a)		<p>Figure XX. BMT3 Pictures (a) highway and location; (b) close-up of flushed surface before treatment; (c) roadway surface before treatment; (d) close-up of flushed surface immediately after treatment; (e) roadway surface after treatment; (f) close-up of surface at first follow-up ; (g) roadway surface at first follow-up , (h) roadway surface at second follow-up ; (i) close-up of surface at second follow-up , (j) close-up of surface at third follow-up ; (k) roadway surface at third follow-up</p>	
(b)		(c)	
(d)		(e)	
(f)		(g)

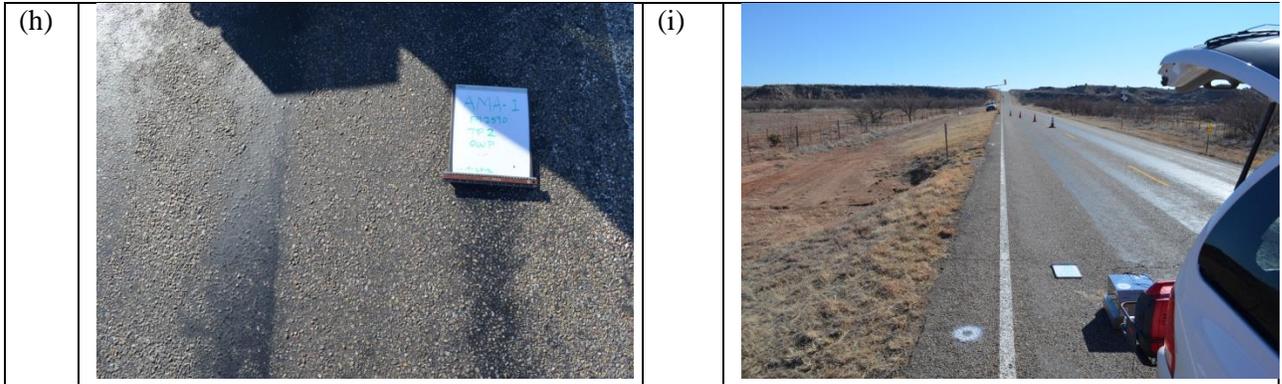
Figure XX. BMT3 Pictures (a) highway and location; (b) close-up of flushed surface before treatment; (c) roadway surface before treatment; (d) close-up of flushed surface immediately after treatment; (e) roadway surface after treatment; (f) close-up of surface at first follow-up ; (g) roadway surface at first follow-up , (h) roadway surface at second follow-up ; (i) close-up of surface at second follow-up.

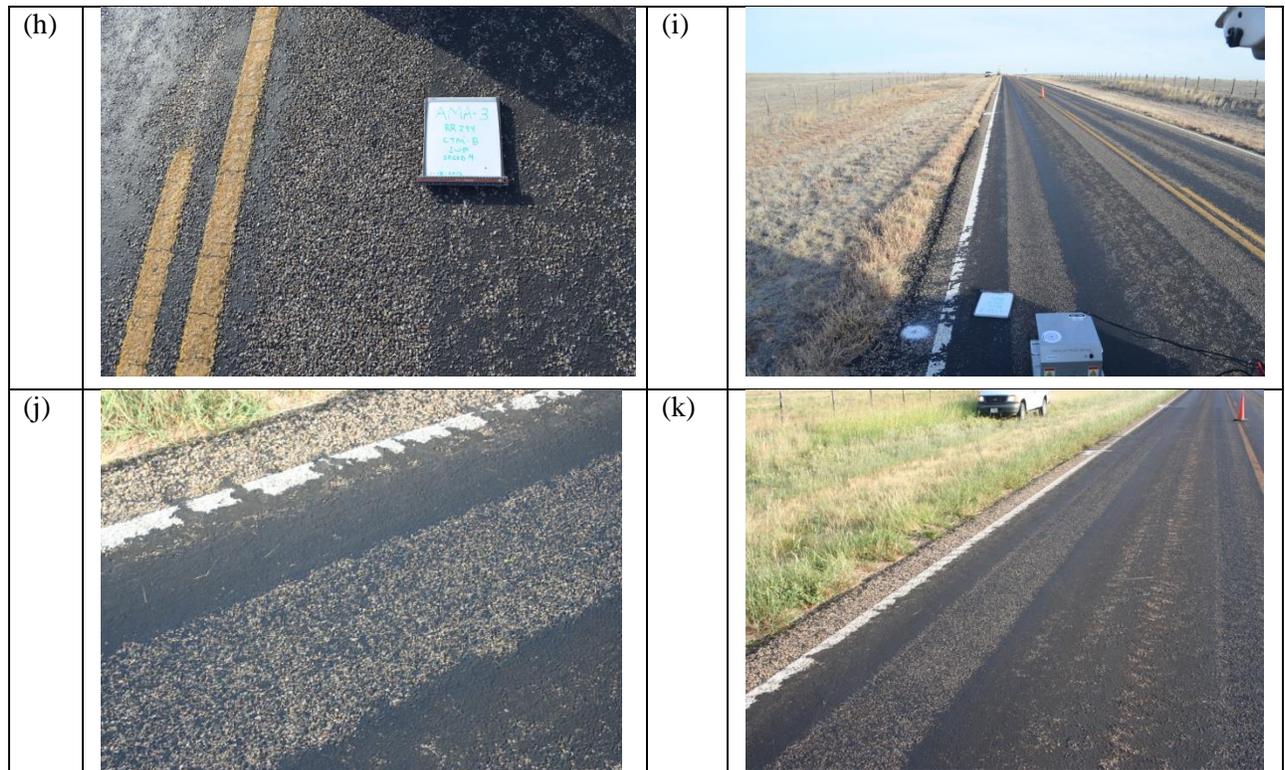
Site Photographs

(a)		<p>Figure XX. BMT3 Pictures (a) highway and location; (b) close-up of flushed surface before treatment; (c) roadway surface before treatment; (d) close-up of flushed surface immediately after treatment; (e) roadway surface after treatment; (f) close-up of surface at first follow-up ; (g) roadway surface at first follow-up , (h) roadway surface at second follow-up ; (i) close-up of surface at second follow-up , (j) close-up of surface at third follow-up ; (k) roadway surface at third follow-up</p>	
(b)		(c)	
(d)		(e)	
(f)		(g)
