Texas Tech University

# Implementation of Concrete Overlay Evaluation and Design

Research Project 5-6910-01  
Research Report 5-6910-01 R1  
<http://www.techmrt.ttu.edu/reports.php>

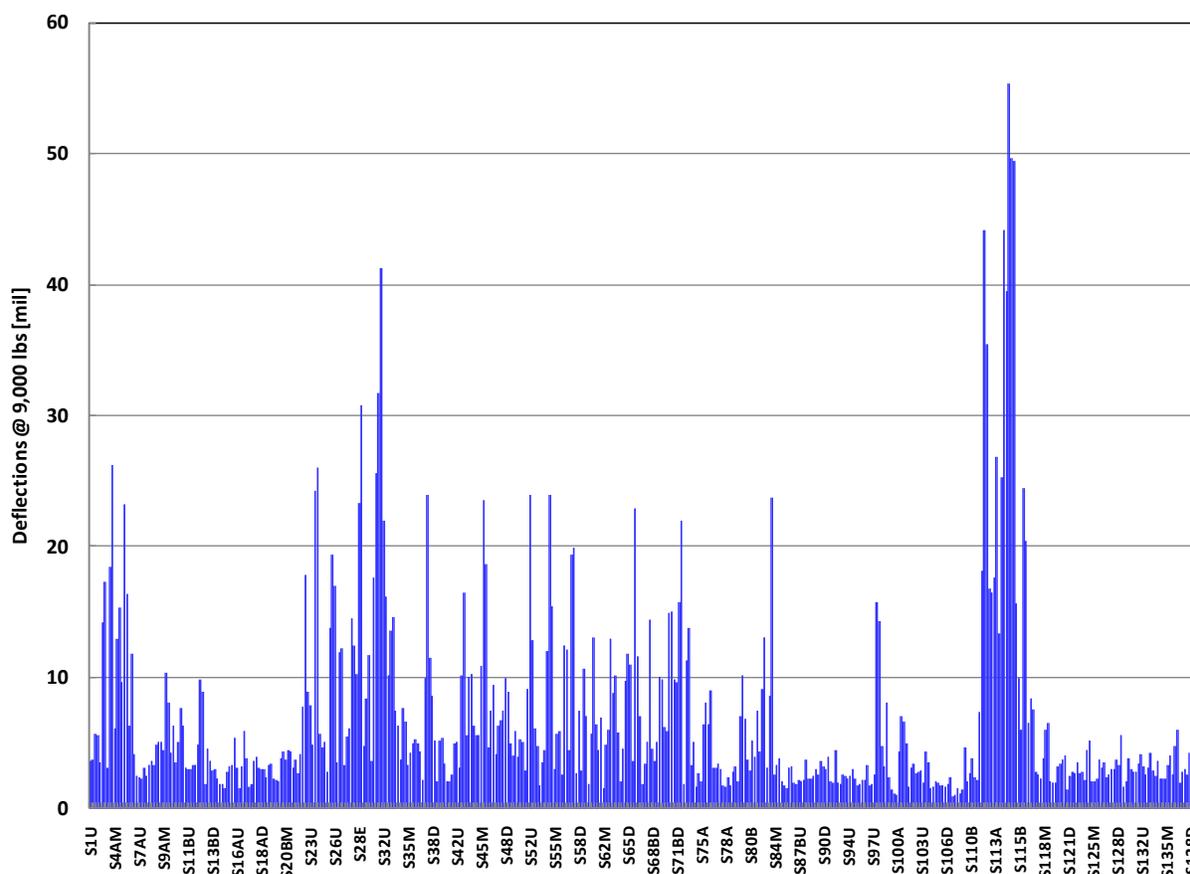
**Figure 2 Deflections measured using FWD machine in US 75 in Sherman**

For the rehabilitation of CPCD in US 75 in Sherman, detailed evaluations of the existing condition of the CPCD were made with FWD. The deflections obtained are shown in [Figure 2](#). It illustrates quite poor structural conditions at some joints and cracks. It is to be noted that in this project, dowels were used at transverse contraction joints, which quite possibly keeps deflections low and load transfer efficiency (LTE) over 70 %. Even though most large deflections were at transverse repair joints and cracks, some were at transverse contraction joints, indicating poor slab support. There were two major issues in this pavement section: one is poor drainage and the other poor materials in the flex base. The PI values of the base materials in this section were quite high, and the combination of high PI and poor drainage (high moisture content) was a primary cause for distress and a poor condition of the CPCD. In CPCD sections in US 75 managed by the Sherman Area Office, this section was in the worst condition, and was selected for the 7-in CRCP BCO. The thought was that, if 7-in CRCP BCO could provide good performance in this section, the same overlay design could be applied to the rest of the CPCD sections managed by the Sherman Area Office. However, large deflections at contraction joints/repair joints/cracks were a major concern for CRCP bonded overlay, especially a potential for reflection cracking. No information was available regarding whether reflection cracking in CRCP might compromise the performance of CRCP overlay. To address this uncertainty concerning a potential problem with reflection cracking, it was decided that 2-ft wide non-woven fabric be placed on transverse contraction joints and repair joints. This decision was based on neither past experience nor theoretical analyses. This decision was solely based on the engineering judgement of the pavement designer. The placement of this fabric is not without potential problems. It will actually cause debonding between old and new concrete, increasing slab deflections and potential distresses. As of the writing of this report, there are 30 repairs done in the outside lane, but none in the inside lane. In other words, the difference in the performance for more than 13 years between inside and outside lanes is significant.

Since the truck traffic is mostly in the outside lane, it could be construed that the truck traffic was the primary cause for the difference. On the other hand, there were a number of issues during the construction of the outside lane, while the inside lane construction went smoothly with no issues. Accordingly, construction quality might explain the difference. Or it could be the combination of both – i.e., truck traffic and construction quality caused a big difference in the performance of inside and outside lanes. The use of fabric does not explain the difference in the performance of the two lanes since fabric was placed in both lanes. However, the performance of the repairs of distresses in the outside lane, which consisted of removing deteriorated concrete in the overlay and non-woven fabric, followed by cleaning the surface of CPCD and placing new concrete, has been excellent, indicating that the use of fabric was not needed to prevent or retard reflection cracking. The tentative conclusion from the US 75 experimental project is that (1) bonded CRCP overlay on CPCD could be a good rehabilitation option, (2) construction quality is an important factor for the good performance of bonded CRCP overlay on CPCD, and (3) the use of non-woven fabric is not needed. Encouraged by the satisfactory performance of this 7-in CRCP bonded overlay on CPCD under heavy truck traffic, the Paris District identified a section of Loop

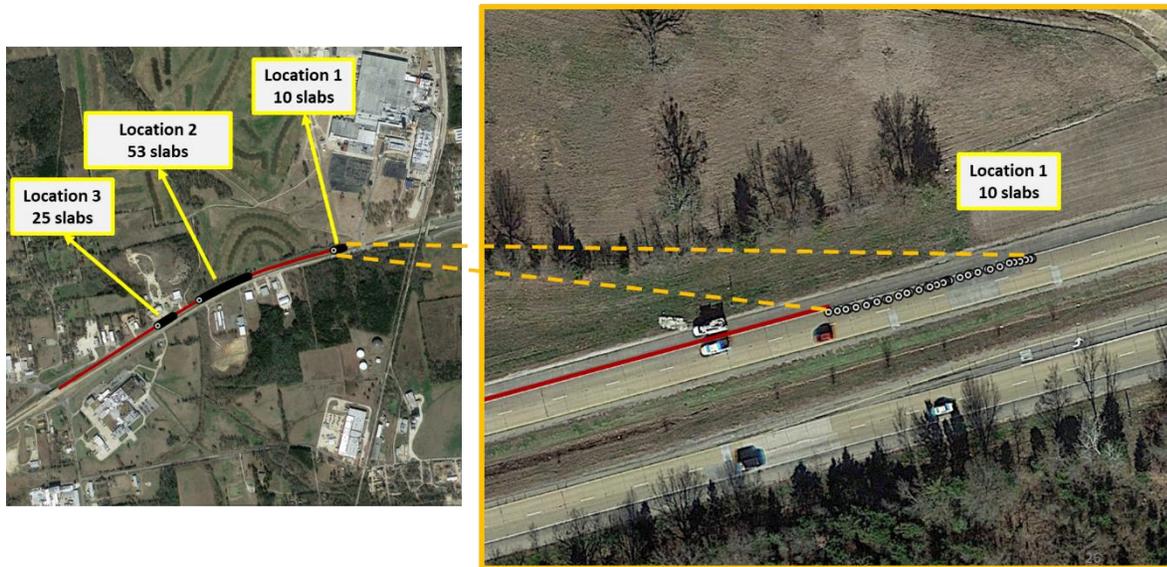
**Figure 10 FWD drops in location 1**

In Location 1 as shown in Figure 10, the deflection of 37 points were measured. Figure 11 shows the measured deflections in Location 1 segment. It is observed that 2 larger deflections are between 2 smaller deflections. The 2 larger deflections are those evaluated at a joint, and the other 2 smaller deflections are at mid-slabs. Most of the mid-slab deflections are about 4 mils, while the joint deflections vary from 4 to 8 mils. The variations at transverse contraction joints or repair joints may be attributed to various conditions of joints – some may be locked, and some may be fully separated. It can be recalled in the specifications that the dowels shall be coated or smooth. This is to prevent bonding of the dowel bar and concrete. However, when the dowel bars are bonded to the concrete at both sides of joints, joint movements are restrained, forcing slabs on both side of the joint behave like a continuous slab (“locked joints”). With this, some joints in Location 1 are potentially locked, resulting deflections comparable to those mid-slabs. Such

behavior suggests potential issues with dowel installation. It was also noticed that the LTE values obtained at those suspected locked joints were relatively high.

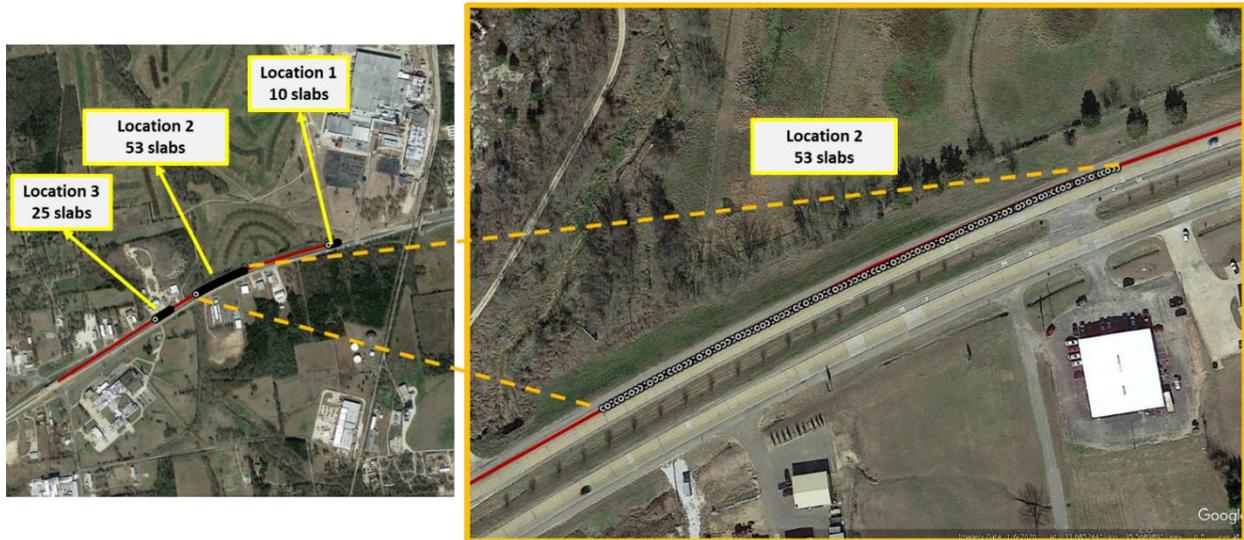
**Figure 12 FWD drops in Location 2**

The Location 2 segment, shown in [Figure 12](#), had a total of 180 points covering 53 slabs. [Figure 13](#) shows the measured deflections across the entire segment. It can be observed that the first 300

feet of the segment have high deflections. The deflection recorded went up to 20 mils. Pavement condition information shows that these areas are repaired slabs, which indicates that the repairs were not done properly. Meanwhile, the deflections mid-slabs recorded after the first 300 feet of the segment were relatively consistent which ranges from 4 to 4.5 mils.

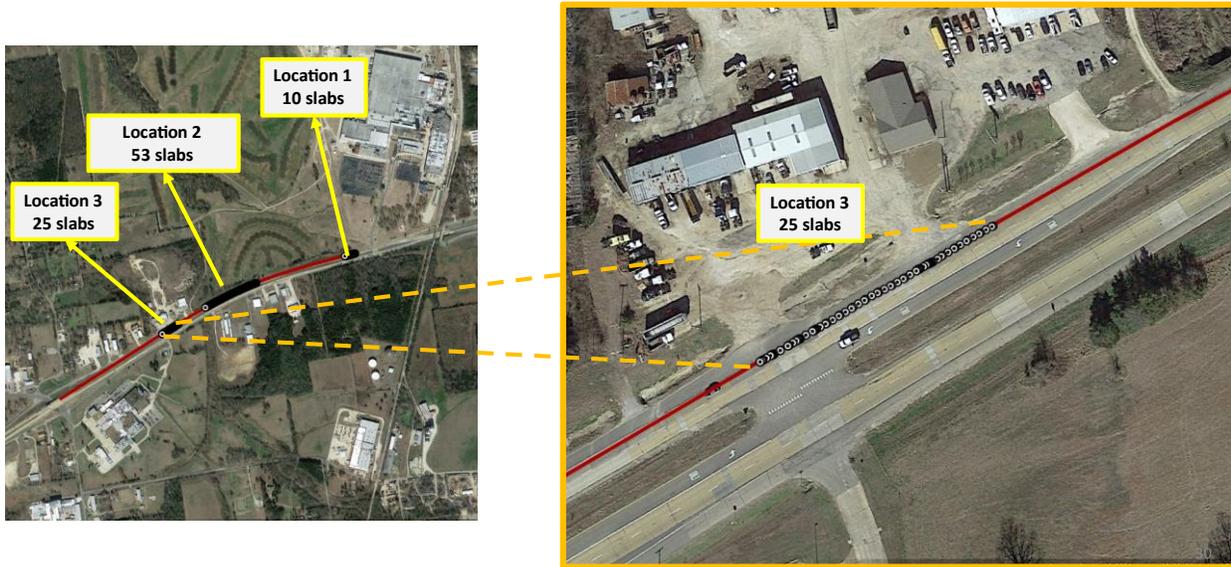
**Figure 14 FWD drops in Location 3**

The Location 3 segment, shown in [Figure 14](#), had a total of 74 points covering 25 slabs. [Figure 15](#) shows the measured deflections in the entire segment. It was also observed that the large deflections were measured on the repaired slabs. The highest deflection in the segment was recorded to be 17.3 mils whereas the lowest deflection was 3.9 mils.

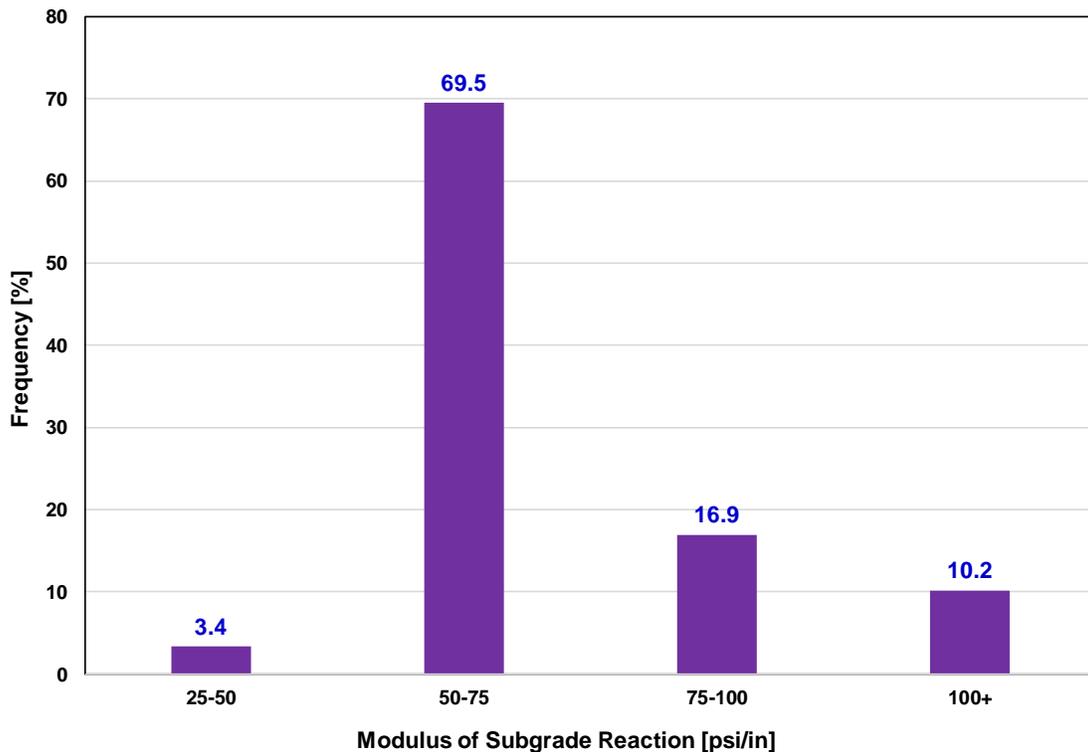
**Figure 16 Modulus of subgrade reaction**

From the FWD data, the modulus of subgrade reaction and LTE were calculated. The average value of LTE was about 83% with standard deviation of 10.6%. Meanwhile, the average value of modulus of subgrade reaction estimated from the AREA method was about 72 psi/in. The distribution of the calculated values is shown in [Figure 16](#).

It can be observed that most of the modulus of subgrade reaction values fall within 50-75 psi/in accounting for 70% of the data points evaluated and about 17% are within the 75-100 psi/in range. A typical value assumed for new CRCP design is 300 psi/in; however, it can be observed that only about 10% of the data points are above 100 psi/in. This indicates that the slab support in this project is inferior to the slab support provided by the current 2 base structures, which justifies the implementation of concrete overlay.

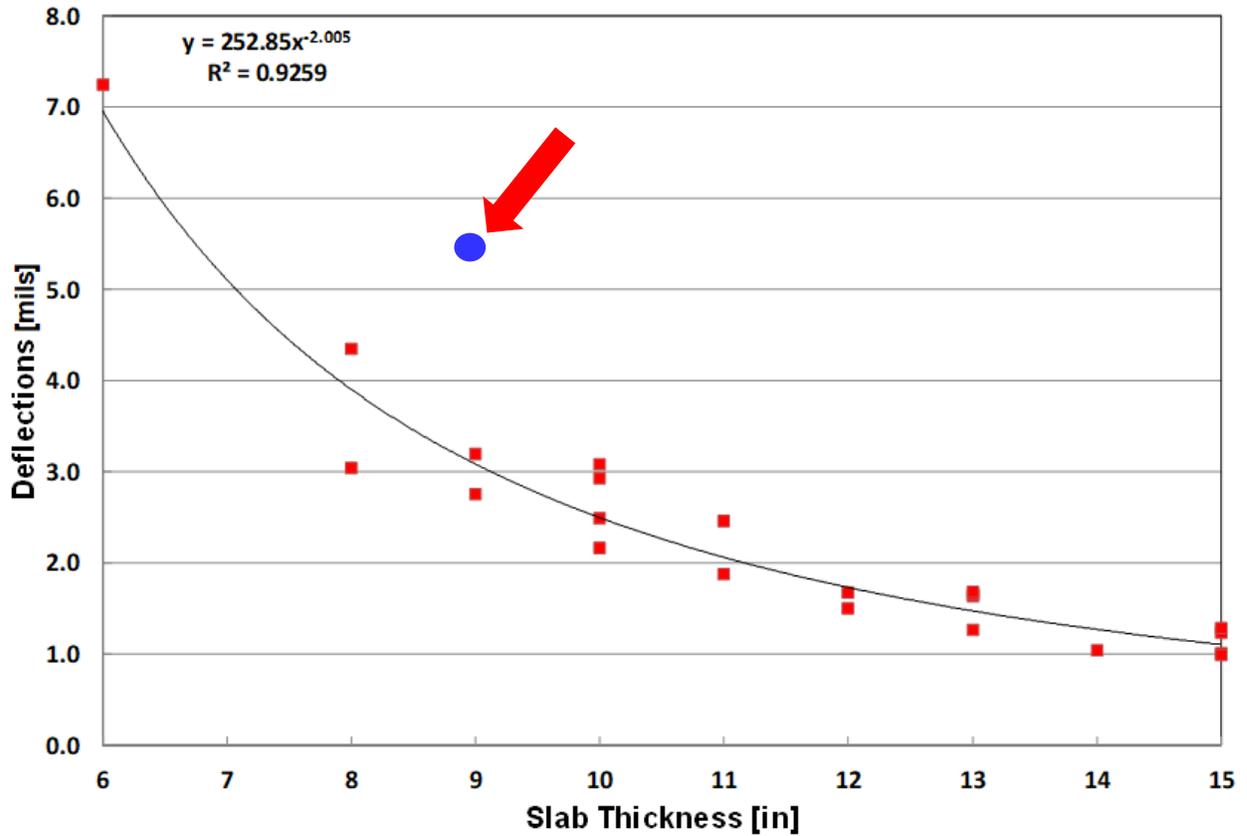
**Figure 17 Relationship between slab thickness and deflections from the database project**

To identify the effects of the lower subgrade support in the measured deflections, the average mid-slab deflection was compared to the statewide average deflections in CRCP obtained from the dataset collected in the previous rigid pavement database projects. It can be seen in [Figure 17](#) that the average mid-slab deflection of this 9-in CPCD section at 5.4 mils, represented in blue

round marker, is higher than the deflection of a typical 9-inch CRCP. The “equivalent” CRCP slab thickness is about 6.5-in. In other words, the structural capacity of the existing CPCD here is, even though the slab is 9-in thick, it is structurally equivalent to 6.5-in CRCP with one of the current 2 base types. Again, this justifies a concrete overlay as a logical rehabilitation option.

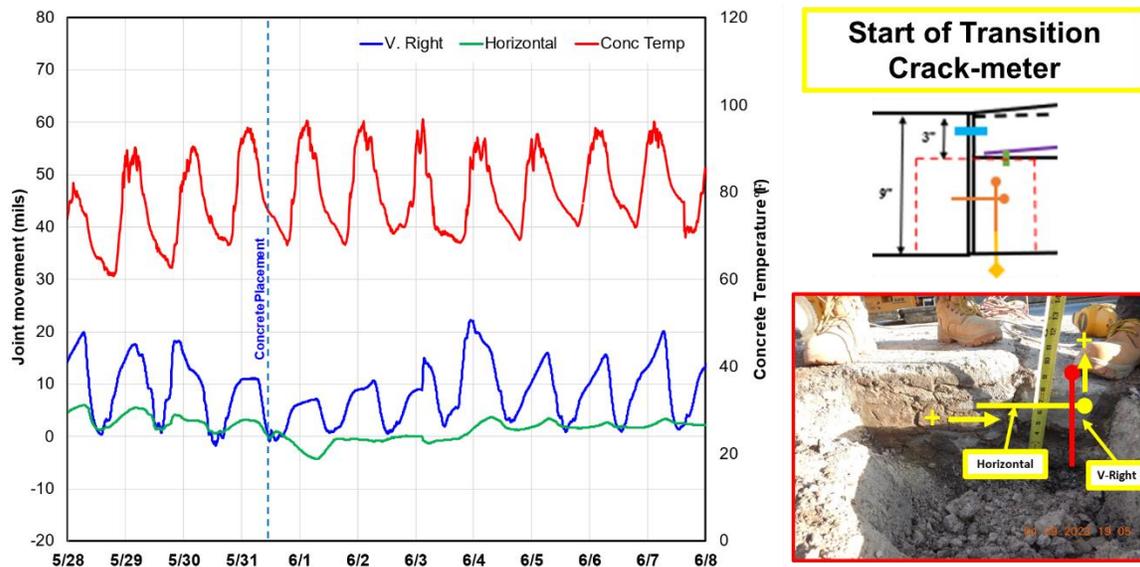
**Figure 56 Crackmeter data analysis at section 1**

As shown in [Figure 56](#), two crackmeters were installed in Section 1. One crackmeter was installed horizontally and the other vertically on the milled section, where the slab thickness of the CPCD is 6 inches. The round markers in yellow and red in the illustration indicate where movements of the slab were measured, either horizontally or vertically. As for the signage for slab movements, when the horizontal crack meter moves towards the right direction, the value will be positive (+), indicating that the slab is moving away from the transition joint, increasing joint width. As for the vertical crack meter, the positive (+) values indicate that the slab is moving in the upward direction.

The recorded data from Section 1 (start of the transition) is presented in [Figure 56](#). Here, the primary y-axis is joint movement measured in mils. The secondary y-axis provides information on concrete temperature at a depth of 3-inch from the milled section where the horizontal crackmeter is installed. The x-axis provides the date and time it was recorded. It can be observed that there was minimal horizontal movement recorded before and after concrete placement. The same is true with the vertical movement of the slab. There was no significant effect that resulted from the concrete overlay. At this location, the thickness of the overlay was 3 inches, equal to the depth of the milling since this is the beginning of the transition. However, as will be discussed later, the horizontal movements at this joint are quite small. If the dowels were properly installed, they are not supposed to restrain slab movements in the longitudinal direction. The daily joint movement in the longitudinal direction at this joint should be in the range of 9 mils to 14 mils. This range was estimated with the assumption that the subbase friction will reduce the free slab movements by 20 % to 50 %, as well as the thermal coefficient of concrete at 5 microstrains/°F. Prior to the overlay placement, the maximum joint movement was 4 mils, which suggests that dowels restrained concrete movements, and this joint was locked. On the other hand, vertical movements are not small, indicating that locking joints still experience warping movements, even though their magnitudes are much smaller than those at joints with working dowels, which will be discussed later.

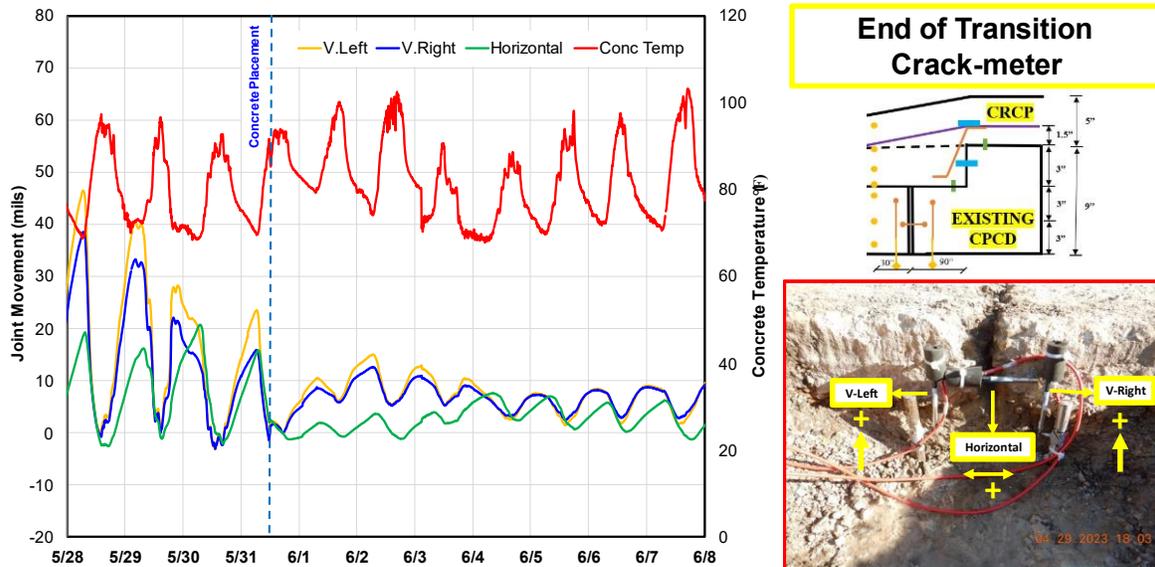
**Figure 57 Crackmeter data analysis at section 2**

As shown in Figure 57, three crackmeters were installed in Section 2. Section 2 is a joint located 120 feet from the start of transition and 7 feet before the end of transition. This section has 6 inches of existing CPCD and 7.7 inches of CRCP overlay thickness above the joint. The horizontal joint movement is measured 3 inches from the milled surface of the existing CPCD, while the vertical joint movements were measured 2 inches from the milled surface of the existing CPCD and 2 inches away from the joint. The positive (increasing) values of the horizontal displacement indicate that the sensor is expanding and thus the joint width is expanding. Meanwhile, the positive (increasing) values of the vertical displacement indicate that the sensor is moving upward, i.e., the slabs are curling up.

It is observed that, compared with the slab movements after the overlay concrete placement, the slab movements before the concrete overlay placement were significantly larger, as much as up to 20 mils for longitudinal movements and 40 mils for vertical movements, while those after the overlay concrete placement were about 8 mils for both movements. Temperature insulation effects and the restraints provided by the longitudinal steel in CRCP overlay on concrete volume changes in the existing CPCD are considered to be responsible for this substantial reduction in slab movements. This manifests the benefits of longitudinal steel in concrete pavement in reducing slab movements from temperature and moisture variations. Compared with the slab movements observed in Section 1, those in this Section are much larger, especially before the placement of overlay concrete. It appears that dowels are not locked in this joint. Another observation is that substantial reduction in vertical movements were recorded in this joint after overlay placement, while not much difference was observed in Section 1. It is recalled that in Section 1, longitudinal steel was not continuous through the joint; rather, it was terminated at the

joint. This indicates the role of longitudinal steel in restraining concrete volume changes. The last observation is a rather small difference between data from 2 gages, which indicates a good quality of gage installation practice.

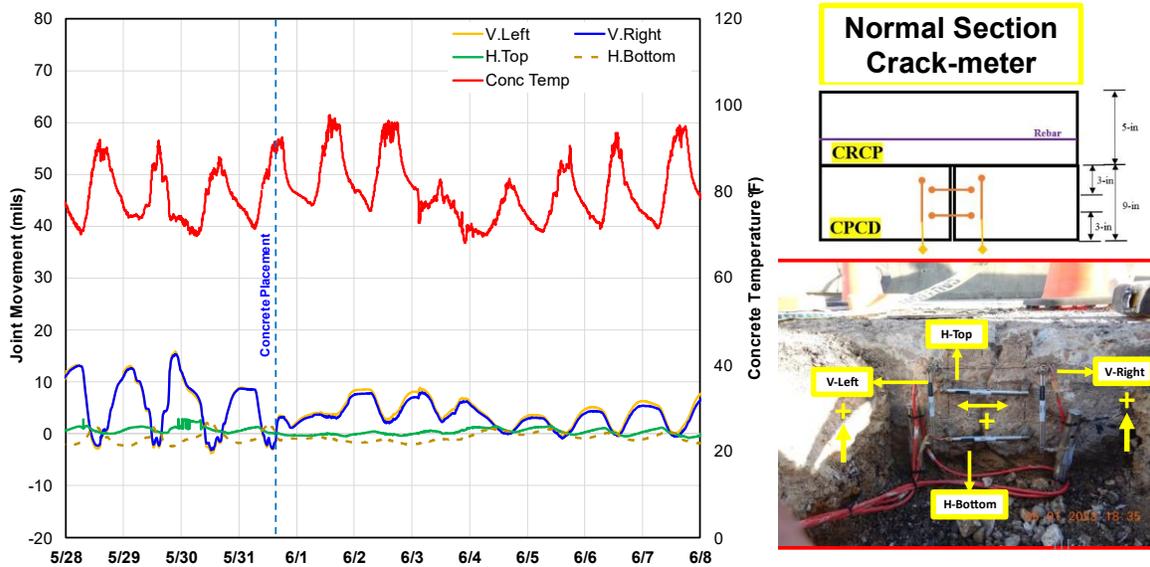
**Figure 58 Crackmeter data analysis at section 3**

Figure 58 shows slab movements data as well as the installation of four crackmeters at Section 3, which is located 500 feet from the start of the transition in the outside lane, and it is a representative of a regular overlay section where the thickness of the existing CPCD is 9 inches and the CRCP overlay thickness is 5 inches. Two crack meters measured the horizontal joint movements: one at 3 inches from the surface of the CPCD layer (H.Top) and the other at 3 inches from the bottom of the CPCD layer (H.Bottom). The other two crack meters measured the vertical movement of the CPCD on the left (V.Left) and on the right (V.Right) side of the joint.

Compared to Section 1 and Section 2, this section recorded the least horizontal movements, even smaller than those in Section 1, where the joint was suspected of being locked. It appears that this joint was also locked. The vertical movements prior to overlay concrete placement are comparable to those for Section 1. However, after overlay concrete placement, they were reduced substantially in the beginning, followed by increased vertical slab movements, which could be due to the formation of a transverse crack in CRCP overlay on top of this joint. However, their magnitude is much smaller, about 1/3 of those observed in Section 1, which again manifests the effects of continuous longitudinal steel above this joint. On more observation is that, prior to the overlay concrete placement, vertical movements at this joint were not small, indicating that locked joints restrain longitudinal concrete movements more effectively than vertical movements. In other words, even when the joint is locked, the joint experiences some level of warping and curling, which reduces warping and curling stresses in concrete slabs. This explains

why very few transverse cracks have been observed in CPCD in Texas, even when some joints are locked. Another evidence of warping and curling being allowed in the locked joint is that the longitudinal movements observed in the two gages in Figure 58 shows warping and curling behavior. For example, in the morning of May 29, while the temperature increases, the longitudinal slab movements recorded were contraction in the top gage and expansion at the bottom gage.

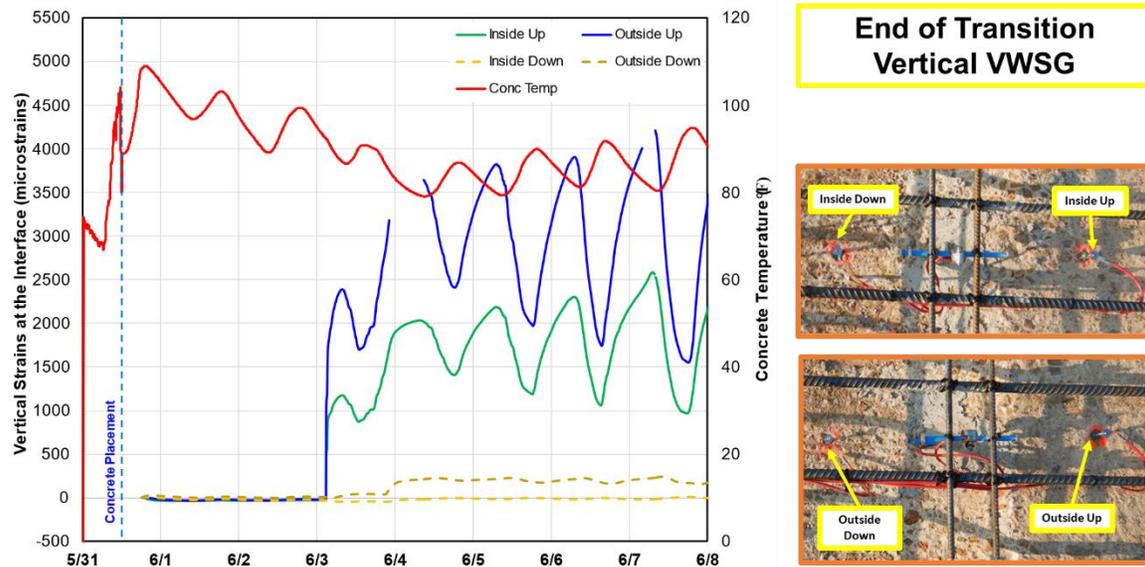
**Figure 61 Vertical VWSG data analysis at section 2**

Figure 61 depicts the standard setup and data analysis for both vertical VWSG and longitudinal VWSG in Section 2. Notably, all four vertical VWSGs registered negligible strain from the concrete placement on May 31, 2023, until June 3. It's worth recalling our earlier discussion in Section 4.1 (Figure 51), where a significant 1-inch rainfall event occurred on June 3, contributing to a sustained reduction in concrete temperature.

The abrupt vertical movement at the overlay interface, potentially triggered by the plummeting slab temperature and other factors, resulted in a rapid increase in vertical strain. At 6 inches after the end of the transition segment, the outer sensor indicated approximately 2500 microstrains, while the inner sensor recorded about 1200 microstrains. These substantial strain values strongly suggest debonding at the interface after the transition segment.

Meanwhile, at 6 inches before the end of the transition segment, vertical strains displayed minimal increases, emphasizing that significant vertical movement at the interface occurred primarily at the area after the transition segment. However, it's noteworthy that the "Outer-Down" sensor exhibited a strain increase of 250 microstrains on June 4, coinciding with a further surge in vertical strains of up to 3500 microstrains at the locations after the transition segment ("Outside-Up" and "Inside-Up" sensors).

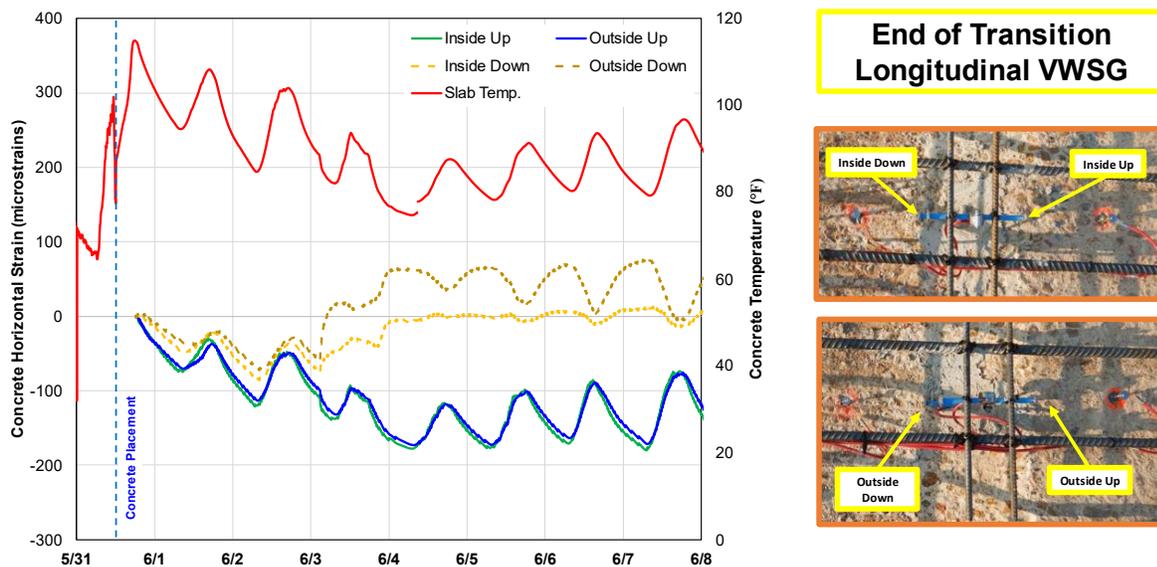
**Figure 63 Longitudinal VWSG data analysis at Section 2**

Figure 63 illustrates the longitudinal concrete strain behaviors at the termination of the transition segment, with two "Up" sensors installed at the mid-depth of the concrete overlay and another two "Down" sensors, where half of their length is embedded in the existing CPCD, and the remaining half in the CRCP overlay, as depicted in Figure 64. This dual-sensor arrangement provides insights into the interface behavior at the transition's conclusion.

From the time of concrete overlay placement until June 3, all four longitudinal VWSGs recorded compressive strains, characteristic of concrete undergoing the hydration process. However, a notable shift occurred on June 3, simultaneous with the vertical strain surge to 2500 microstrains. The two longitudinal VWSGs situated at the interface recorded an escalating tensile strain. The outer longitudinal sensor exhibited a higher tensile strain of approximately 80 microstrains compared to the inner longitudinal sensor, which showed about 0 microstrains. While these values do not clearly indicate debonding, they suggest tensile behavior in the interface, likely resulting from debonding beyond the end of the transition segment.

Conversely, the longitudinal sensors at the mid-depth of the overlay continued to record compressive strains, indicating an absence of cracks traversing the sensor locations in the overlay layer. This phenomenon, distinct from observations in US 75 in Sherman, raises the idea of significant drying shrinkage in the concrete overlay as the underlying cause.

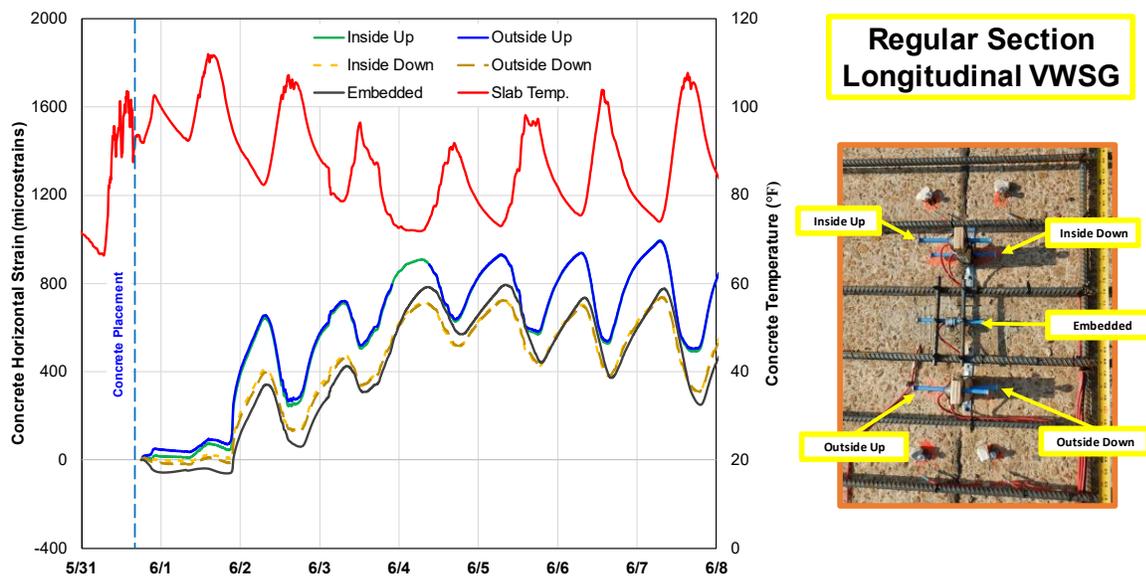
**Figure 66 Longitudinal VWSG data analysis at Section 3**

Figure 66 shows the longitudinal strain behaviors at various depths in the CRCP overlay. It can be observed that the strain near the surface of the overlay (Inside Up and Outside Up) have higher strains compared to the strain behaviors at the bottom of the overlay layer (Inside Down and Outside Down). The difference in strain behaviors at the top and bottom of the CRCP overlay is indicative of the curling and warping behavior that exists in the overlay layer.

Another observation is the strain behavior at the top of the existing CPCD layer (Embedded). The strain magnitudes between the top of the CPCD layer and bottom of the CRCP overlay layer are close but there is a slight difference. It is presumed that when the interface is properly bonded, the strain close to the interface will be similar or very close in magnitude and trends. One may also argue that the locked joint condition which was identified earlier may have influenced the difference in strain behaviors. Nevertheless, this data implies that the interface is not behaving under as a fully bonded condition.

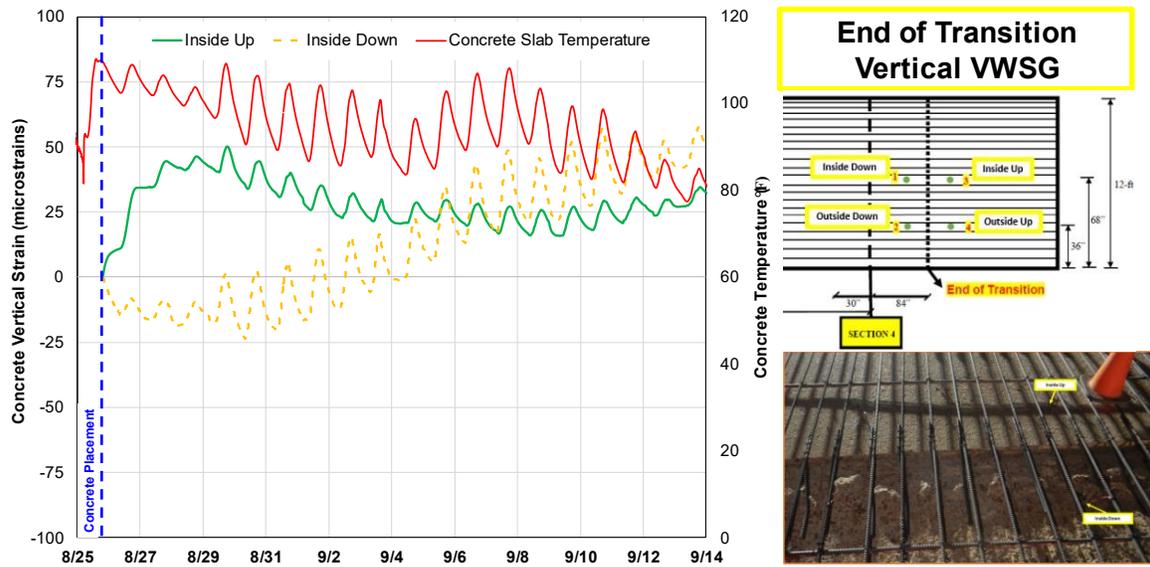
**Figure 67 Vertical VWSG data analysis at Section 4**

Figure 67 illustrates the standard setup and data analysis for the VWSG at Section 4, located at the end of the transition. On August 25, 2023, during the concrete placement, only two of the VWSGs remained functional. Consequently, the data from the other two gauges, which were situated in the outside up and outside down positions, is not included in this report. The VWSGs installed in the 'inside up' and 'inside down' locations exhibited relatively low vertical strains from the outset. The strain values fluctuated between zero microstrains and a range of -25 microstrains to +50 microstrains during the first 21 days following concrete placement. Given the minimal magnitude of these recorded microstrains, it may imply that there was no significant vertical movement at the overlay interface which will indicate that there was no sign of debonding which was observed at the same location on the outside lane. This finding is validated by the absence of cracks in this area.

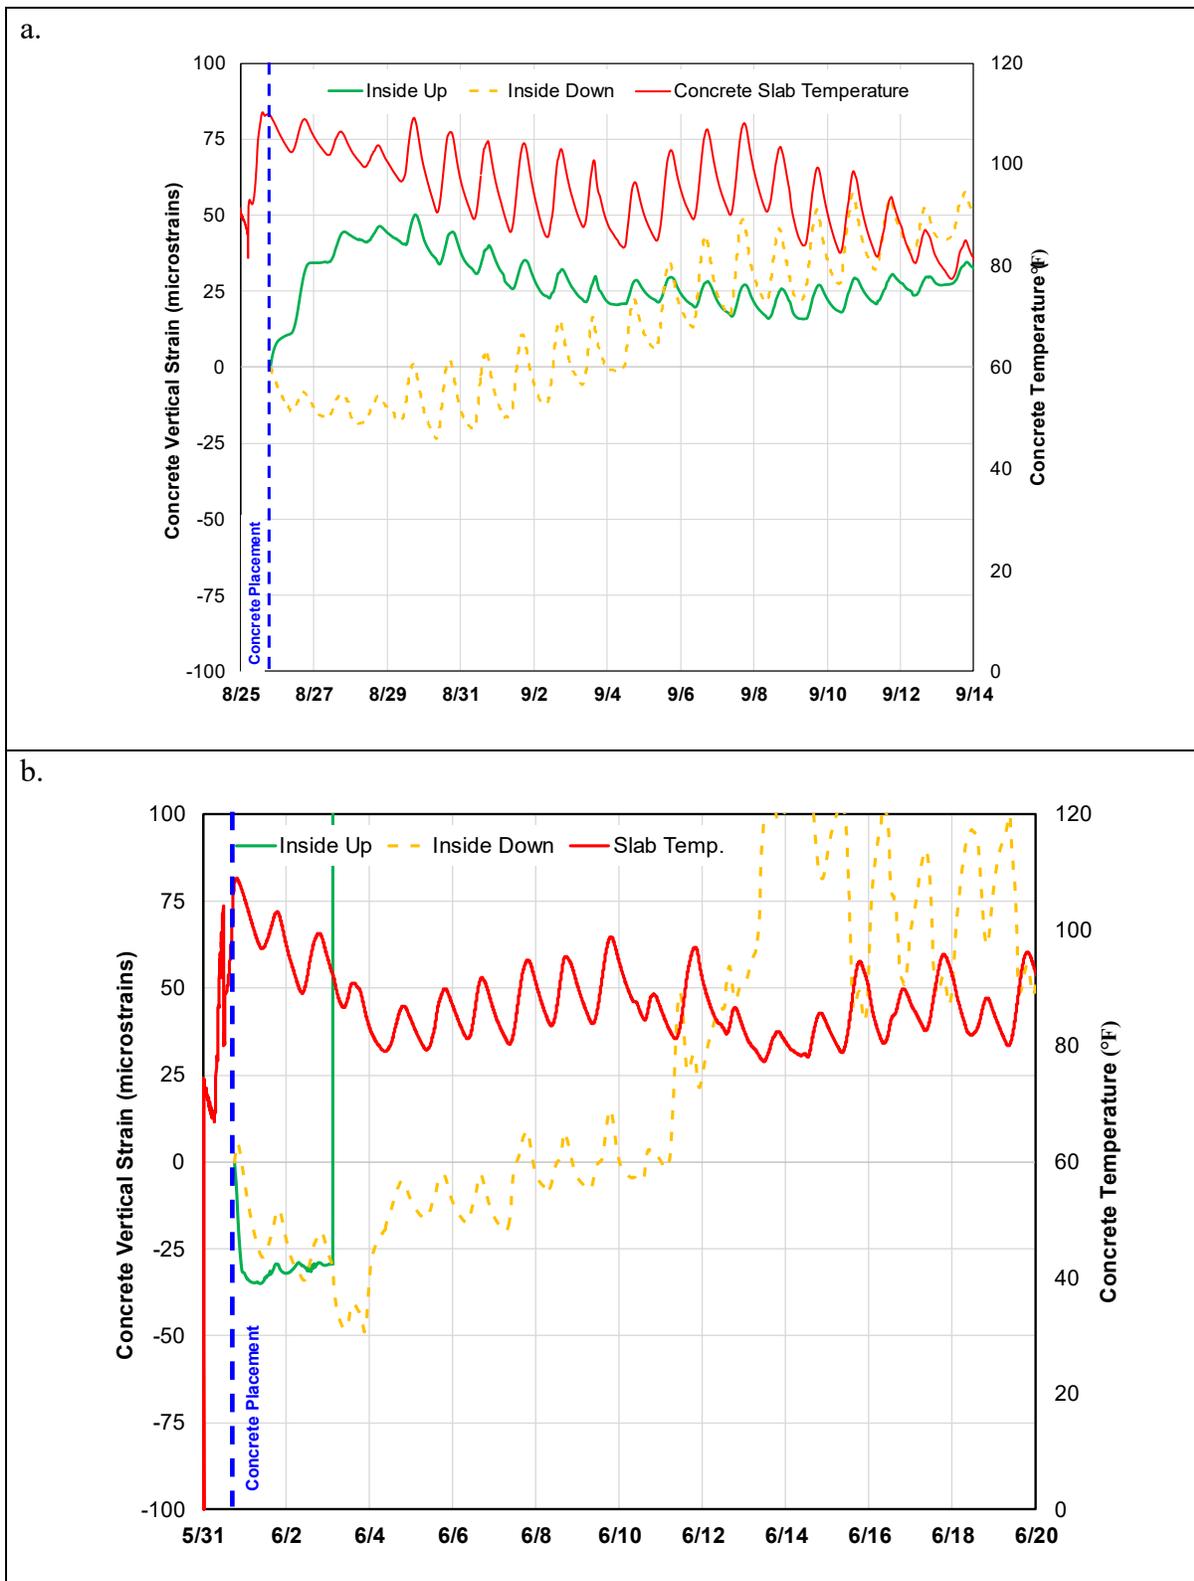
**Figure 68 Comparison of vertical strains in Section 2 and Section 4**

The installation of VWSGs in Section 4 during the construction of the inside lane primarily aimed to detect any discrepancies in the results compared to those observed in Section 2. Since both sections represented the end of a transition, a thorough understanding of their behavior was deemed essential. [Figure 68-\(a\)](#) presents an analysis of Section 2 and [Figure 68-\(b\)](#) Section 4 for the first 21 days following concrete placement. To facilitate a clear comparison, data from only two VWSGs, specifically 'inside up' and 'inside down,' are considered.

The analysis clearly shows that Section 4 exhibited relatively higher deformation compared to Section 2. This difference, as previously discussed in Section 4.4.2, is attributed to the crack observed adjacent to Section 2. Notably, the 'inside down' VWSG readings for both sections demonstrated very similar trends, with an initial recording of -25 microstrain. This comparative analysis leads to an important conclusion: in the absence of cracks, the end of a transition, such as Section 4, is expected to behave in a manner similar to this section.

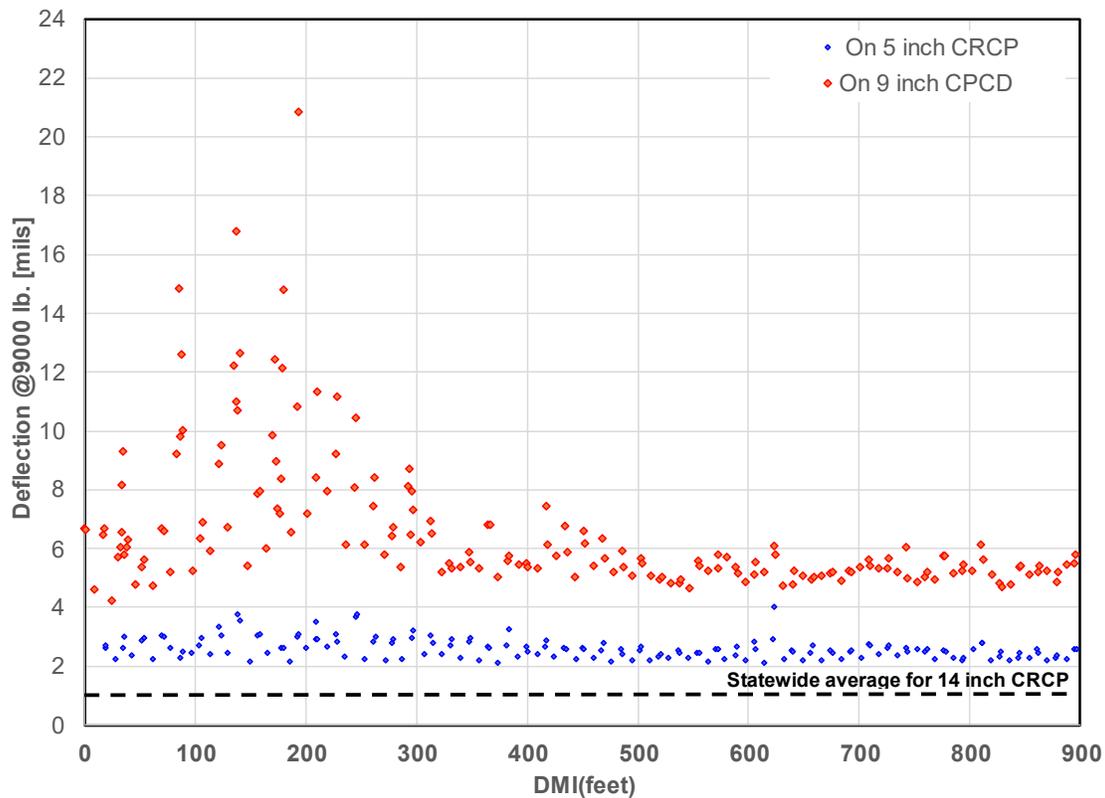
**Figure 69 Comparison of FWD deflection between 9-inch CPCD and after placing 4-inch CRCP in location 2**

Figure 69 shows the FWD deflections on newly overlaid 5-inch CRCP at Location 2. Comparing it with FWD deflections on 9-inch CPCD, FWD results showed improved uniformity even at the locations where there are large deflections recorded on the CPCD. The blue dots, which represent FWD drops on CRCP overlay ranged between 2 mils to 4 mils. It can be observed that, regardless of the variability in deflections on the CPCD layer, the deflections measured on the CRCP overlay are relatively consistent. For instance, if we compare the deflections of the segment between DMI 0 to 300 and between DMI 300 to 900 after the overlay, there is minimal difference in the measured deflections on CRCP overlay, even though there was a large difference in deflections on CPCD between the two segments. This indicates the capability of bonded CRCP overlay on improving the structural condition of CPCD.

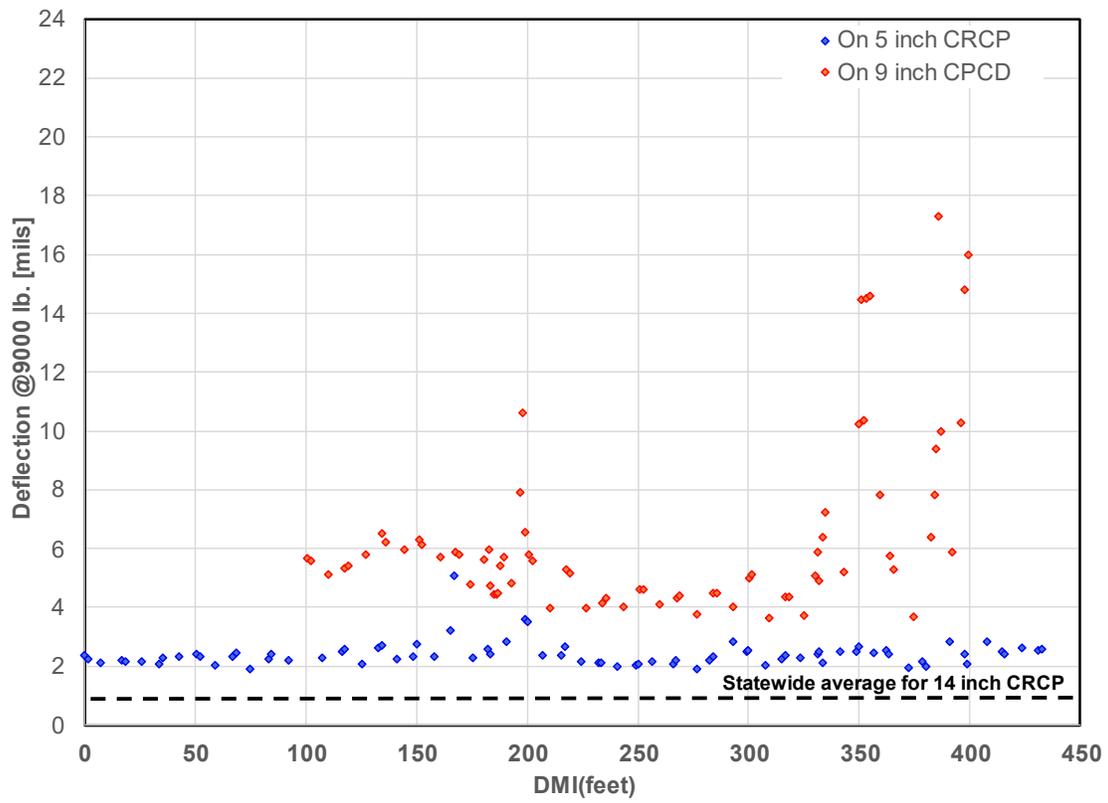
**Figure 70 Comparison of FWD deflection between 9-inch CPCD and after placing 5-inch CRCP in location 3**

Figure 70 shows the FWD deflections on CPCD and 5-inch CRCP at Location 3. As was observed in Location 2, 5-in CRCP overlay reduced not only the deflections themselves, but the variability in slab deflections. This improvement in the deflection characteristics implies better long-term performance of the overlaid CRCP. Although the average deflection on the CRCP overlay is larger than the statewide average of 1.25 mils for a 14-inch CRCP, the reduction in deflection compared to the existing CPCD is notably significant. The significant reduction in deflection by the placement of CRCP overlay was also observed in previous BCO projects in US 281 Wichita Falls and Loop 610 South in Houston.

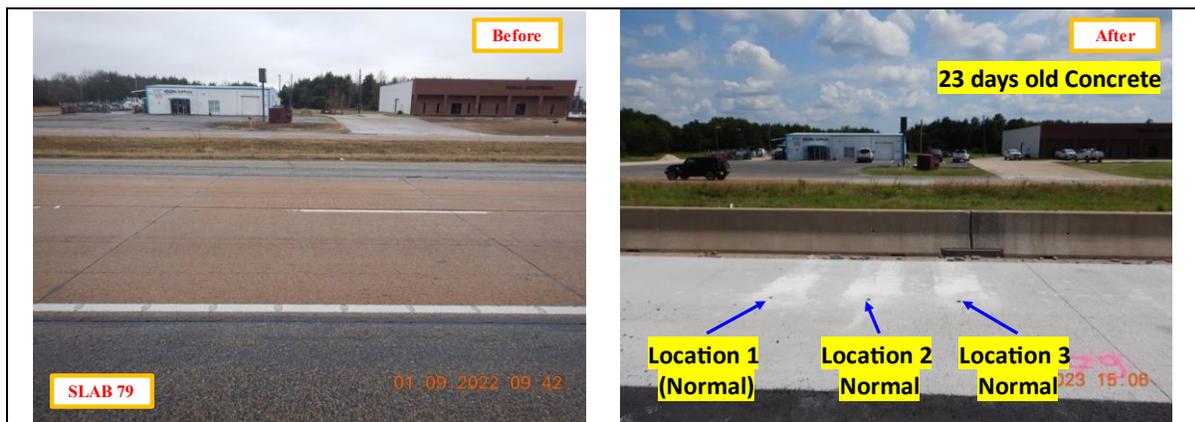
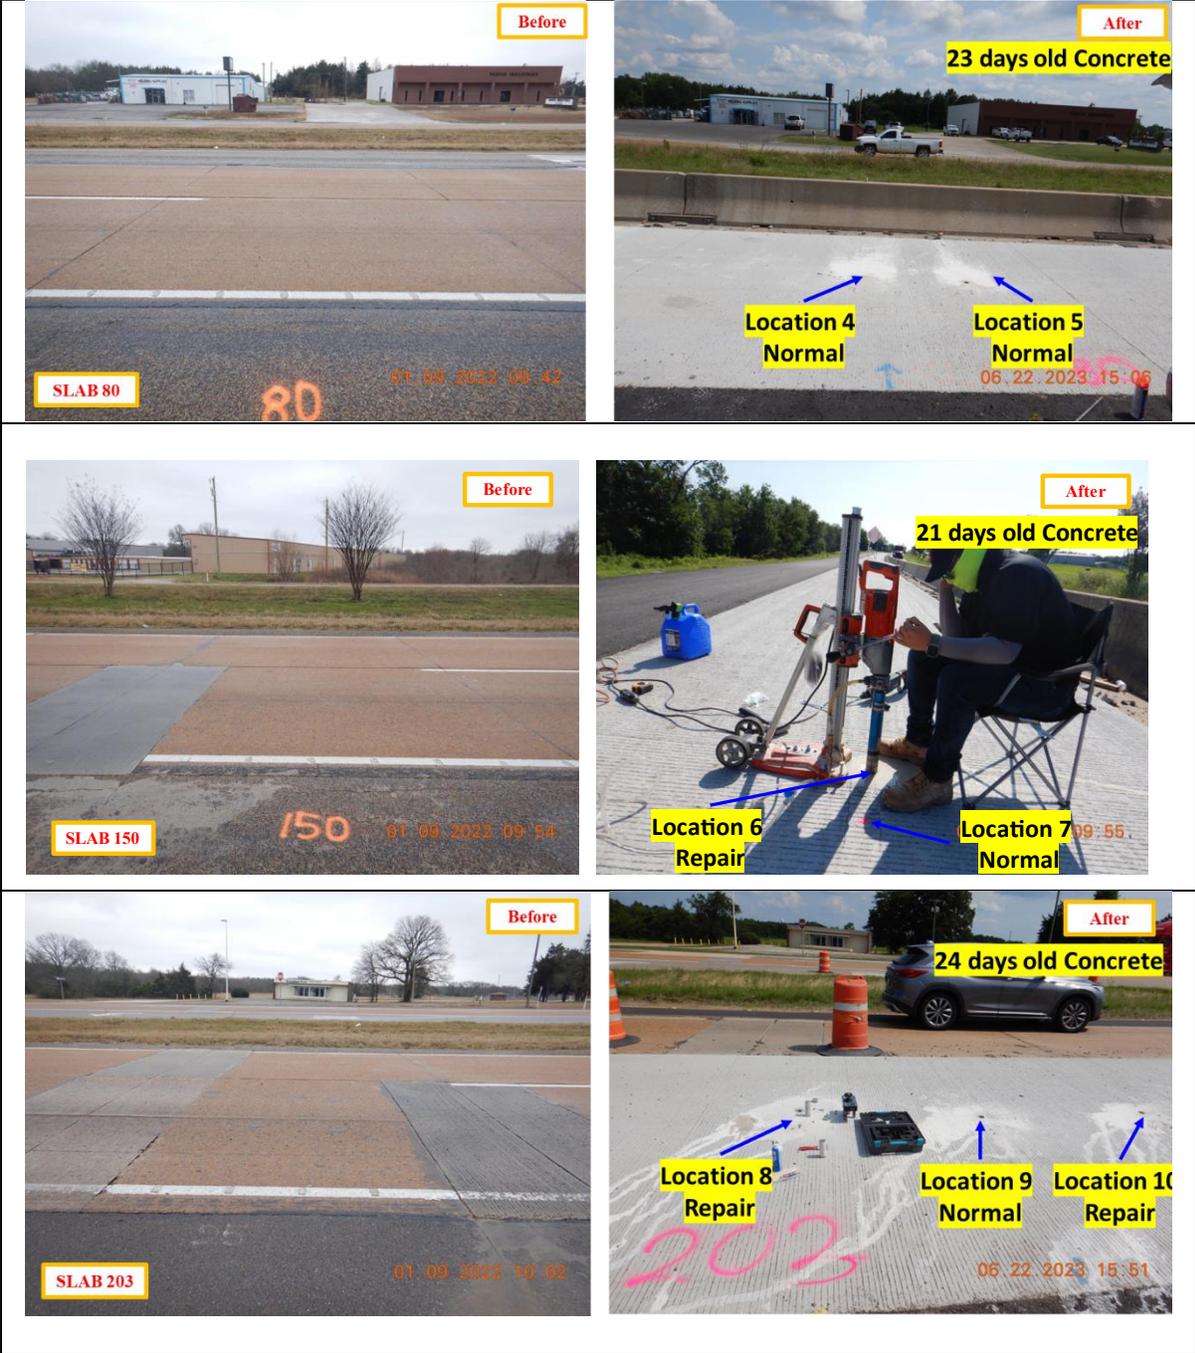
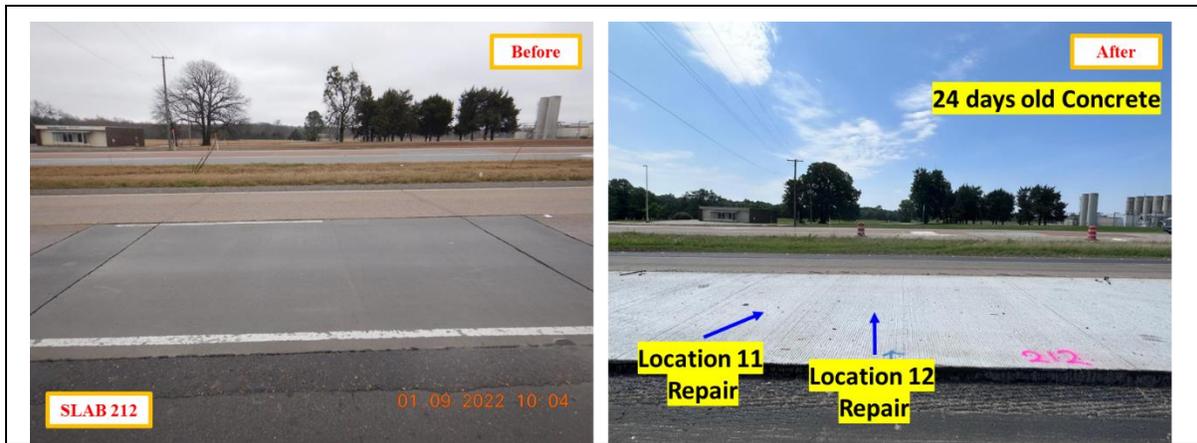
**Figure 74 Coring Location for Bond Test on outside lane**

Table 7 presents a summary of the bond tests conducted on the outside lane. A total of five slabs were identified based on visual survey conducted in November 2019. 12 coring locations were selected in those 5 slabs. Of these, 5 coring locations were on repaired areas, labeled as 'Repair' in the summary. The remaining 7 locations were on existing CPCD without distresses, marked as 'Normal' in the summary. Figure 74 Coring Location for Bond Test on outside lane illustrates the coring locations for each slab, both before and after concrete placement. Notably, all bond

tests resulted in failure, occurring at the interface between the existing CPCD and the new CRCP overlay.

One of the potential reasons for the failure in conducting the bond test is the condition of the existing CPCD. It was observed during coring operation that the concrete in CPCD layer is quite solid, and it took a long time to be able to core the existing concrete even by a quarter of an inch. It might be that the phase of coring for existing CPCD concrete induced bending on the 5-in concrete core, causing debonding at the interface. This needs to be further verified.
