Texas Tech University

# Implementation of Concrete Overlay Evaluation and Design

Research Project 5-6910-01  
Research Report 5-6910-01 R1  
<http://www.techmrt.ttu.edu/reports.php>

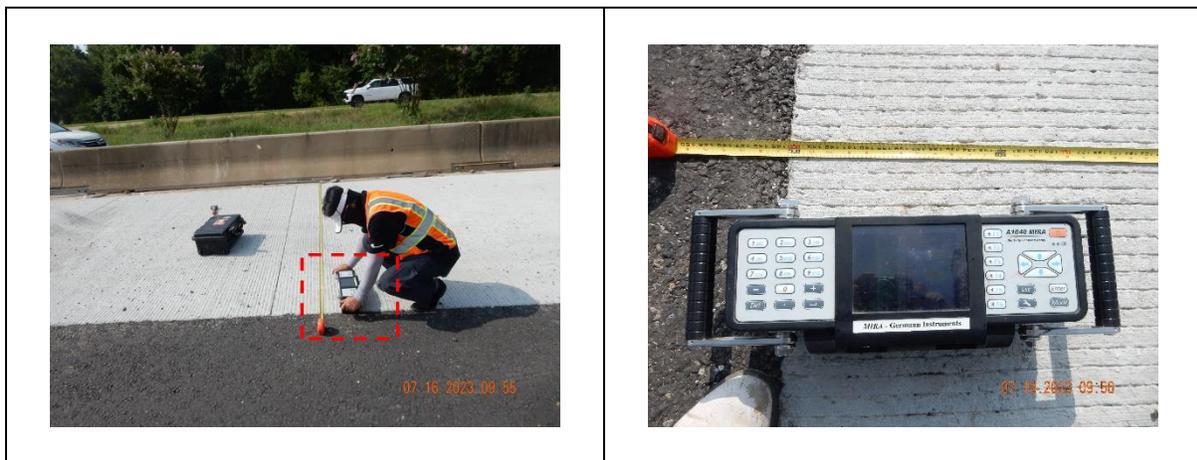
**Figure 75 MIRA scanning performed in a selected slab.**

As discussed earlier, an issue of debonding in the outside lane was identified. To investigate potential debonding, a specific slab section in the outside lane was selected, and MIRA testing was performed. Figure 75 illustrates the MIRA testing on the selected slab.

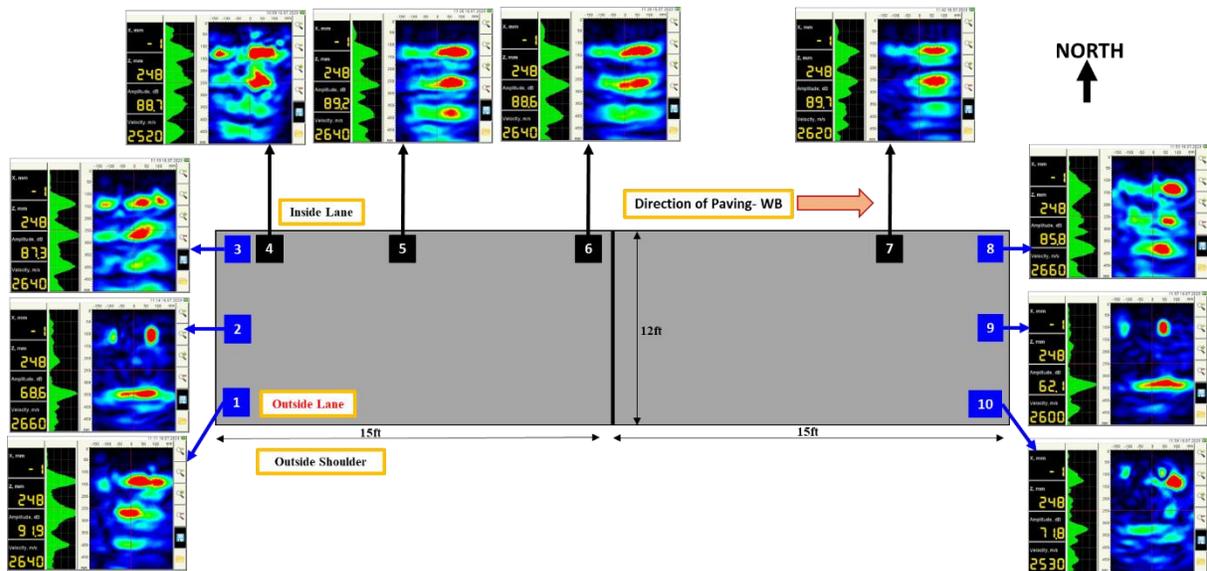
**Figure 76 MIRA image of selected slab on outside lane**

Figure 76 presents the MIRA testing results. The images, specifically numbers 1, 3, 4, 5, 7, and 8, indicate, in general, debonding occurred at slab corners and along the longitudinal edges. However, at the middle of the transverse contraction joints, debonding was not observed.

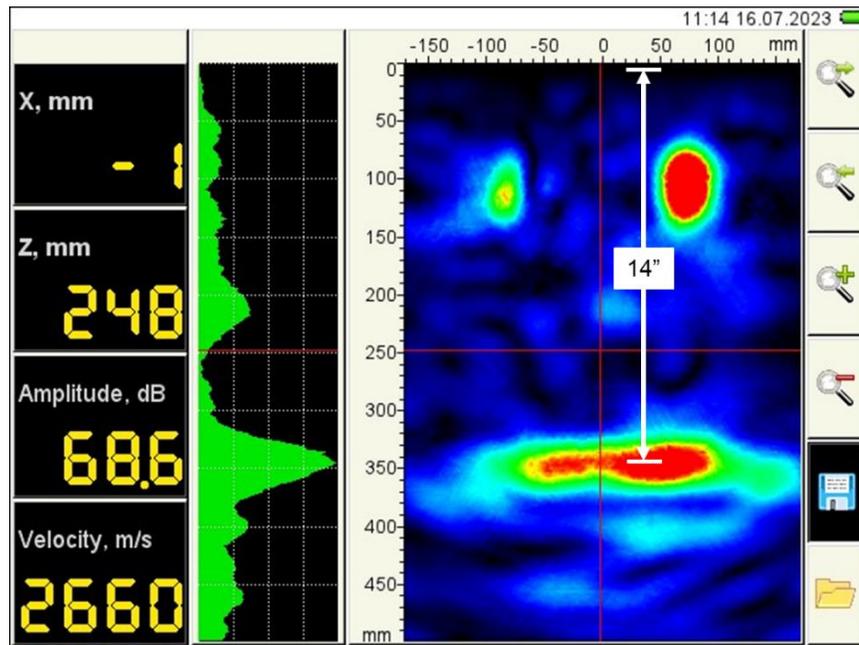
**Figure 77 MIRA image with no debonding**

In MIRA images, areas in blue represent solid concrete with no large voids. On the other hand, red areas represent void or materials quite different from concrete, such as steel. [Figure 77](#) is the image taken at Location 2, showing two longitudinal steels placed at 4-in deep and a total slab thickness of 14-in (350 mm), which is the combined slab thickness of 9-in CPCD and 5-in CRCP. And no void or debonding is observed at the interface (100 mm down from the surface).. This is evident in MIRA images numbered 9 and 10 as well.

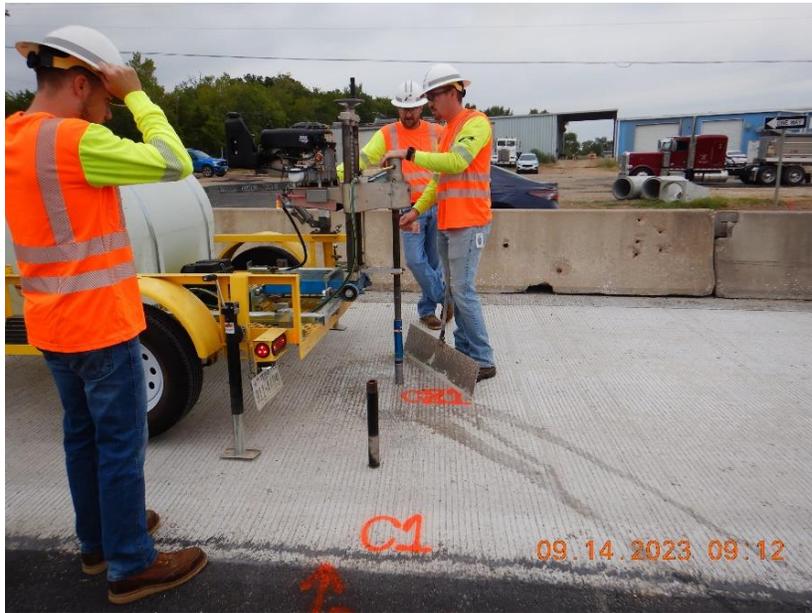
Figure 79 Trailer mounted coring machine used for Inside lane

Based on the experience of bond test conducted in the outside lane, the research team opted for a trailer mounted coring machine to perform the test in the inside lane as shown in [Figure 79](#). The primary objective of this approach was to determine if a trailer-mounted coring machine could minimize eccentricity of the drilling to prevent premature shear failure at the overlay interface or

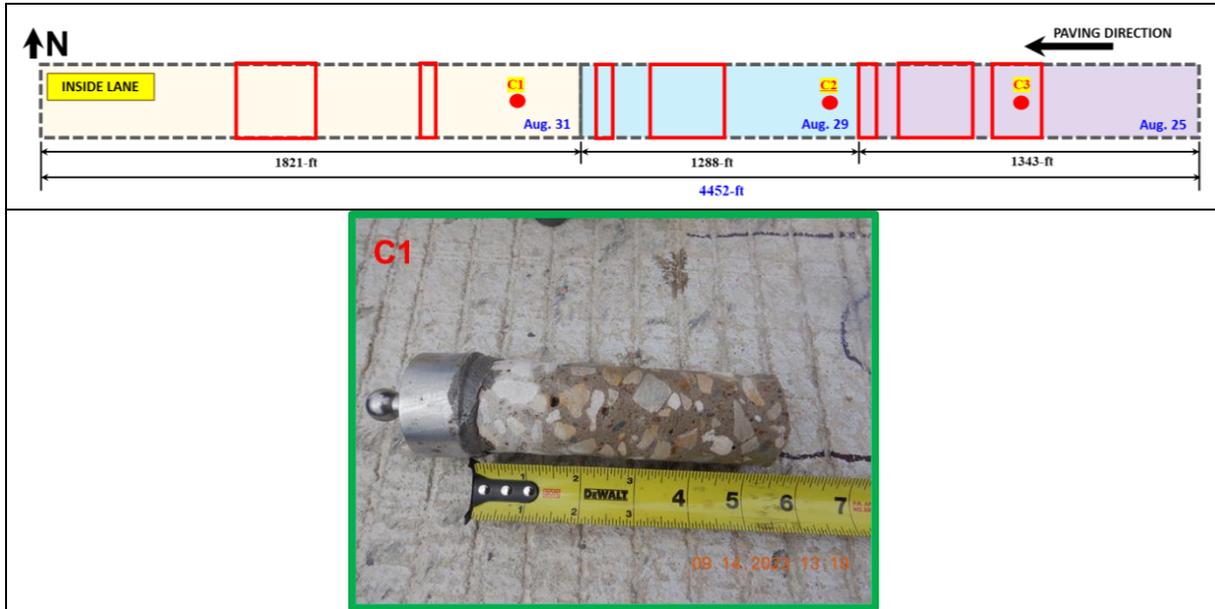
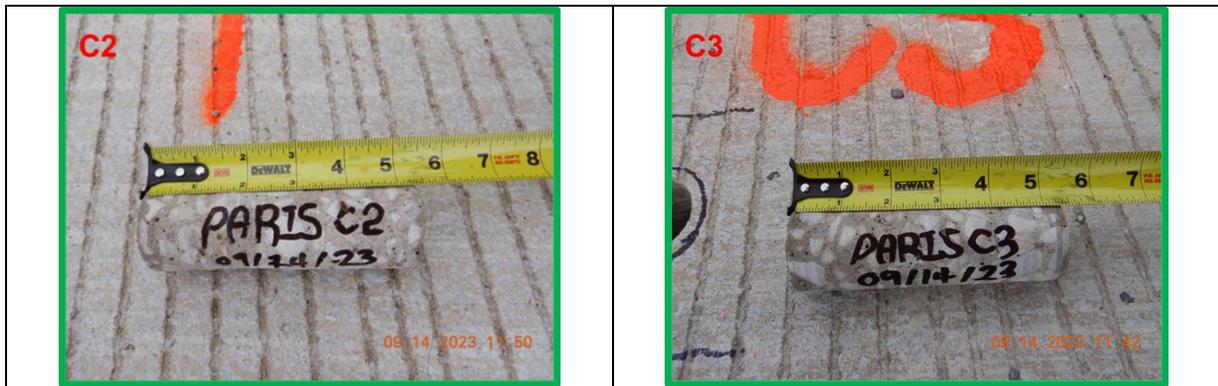
Figure 80 Coring location and bond test for Inside lane

to minimize damage to the concrete interface. To this end, three locations were selected for coring tests, as shown in [Figure 80](#). [Table 9](#) provides a summary of these tests in the inside lane.

Of the three coring locations, locations C2 and C3 encountered failures during the coring operation, while location C1 did not fail. The bond test at coring location C1 revealed a bond strength of 109 psi. Concrete in this location was placed on August 31, 2023, making it relatively new concrete at only 15 days old. In contrast, coring locations 2 and 3, constructed on August 29 and August 25, 2023, respectively were 17 and 21 days old, respectively, yet they failed during the coring operation. This observation led to the hypothesis that the failures were not attributable to shear failure at the interface caused by the coring method.

An alternative explanation for the shear failures at the interface between the existing and overlay slabs could be linked to construction methods, as suggested by the distresses observed in the inside lane. These findings and their correlation with the bond test results in both the inside and outside lanes are further discussed in the following sections.

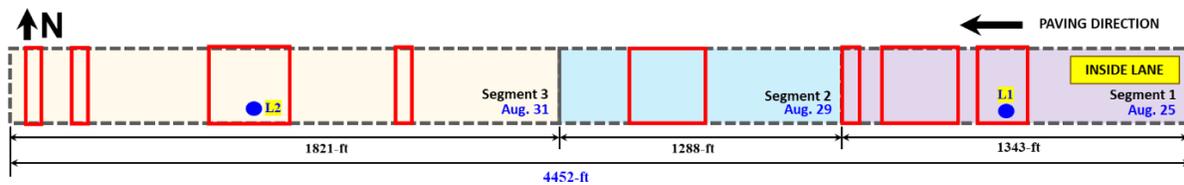
Figure 81 Location of longitudinal crack in inside lane

Upon completion of the inside lane construction, longitudinal cracks were observed. Figure 81 shows the location of a longitudinal crack observed in the field. Table 10 provides a detailed summary of these longitudinal cracks as observed in the field.

Longitudinal cracks were notably aligned directly above the longitudinal steel, indicating that these are settlement cracks. This correlation suggests a direct link to the construction process. During construction, it was noted that the slump of the delivered concrete was higher than the required 4 inches. This observation is supported by the job control testing results as shown in [Table 11](#). This data implies a correlation between higher slump and the occurrence of settlement cracks in the inside lane.
