# DEVELOPING GUIDELINES FOR REPAIRING SEVERE EDGE FAILURES: TECHNICAL REPORT

### Report 0-6271-2-1 Project 0-6271 Project Title: Developing Guidelines for Repairing Severe Edge Failures

Published: April 2014

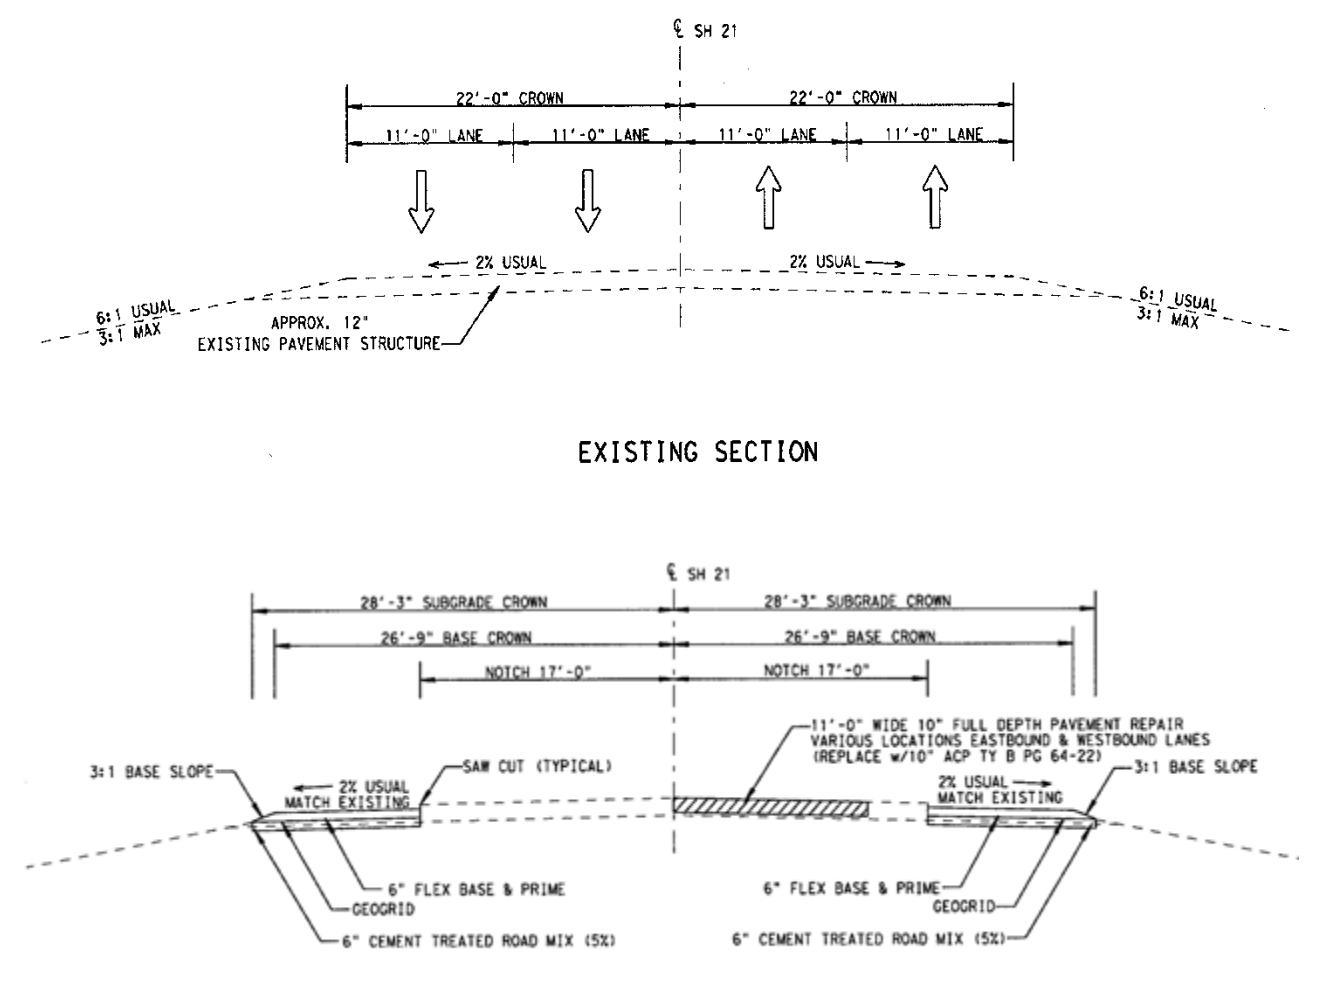
Figure 3. Existing and Proposed Sections on SH 21 from US 290 to FM 2440.

Figure 3 presents the existing and proposed typical sections from the Austin District project on SH 21 from US 290 to FM 2440. Key elements from the plans included:

- Use of road-mixed cement treatment with a geogrid on top of the cement-treated layer.
- Placement of a flexible base course over the geogrid to provide additional protection from reflection cracks.
- Treatment of distress in the inside lines with full-depth pavement repair replacing with Type B mix.

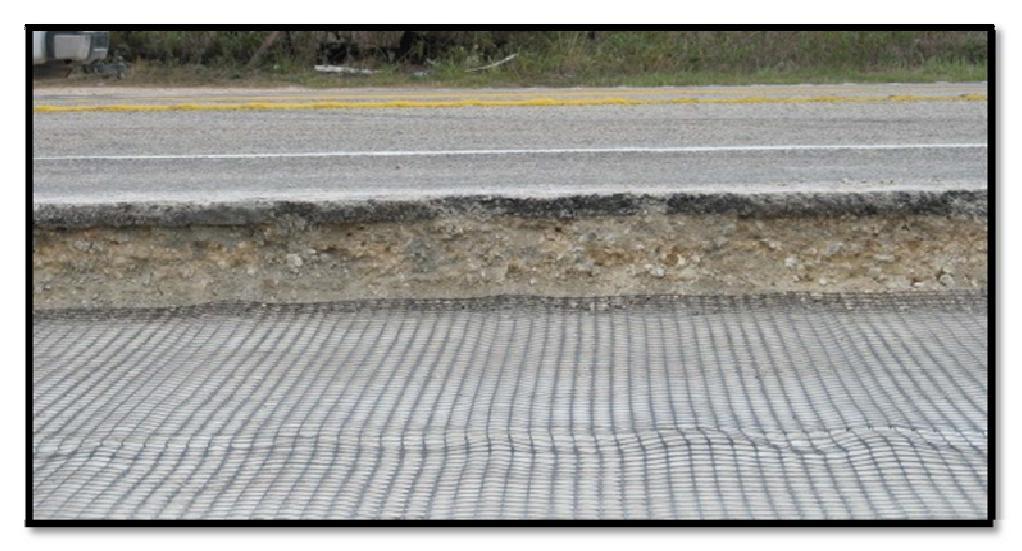
**Figure 4. Geogrid Placement on SH 21.** *Image Courtesy of Mike Arellano.*

These sections have been constructed. Figure 4 shows the geogrid placement on SH 21.

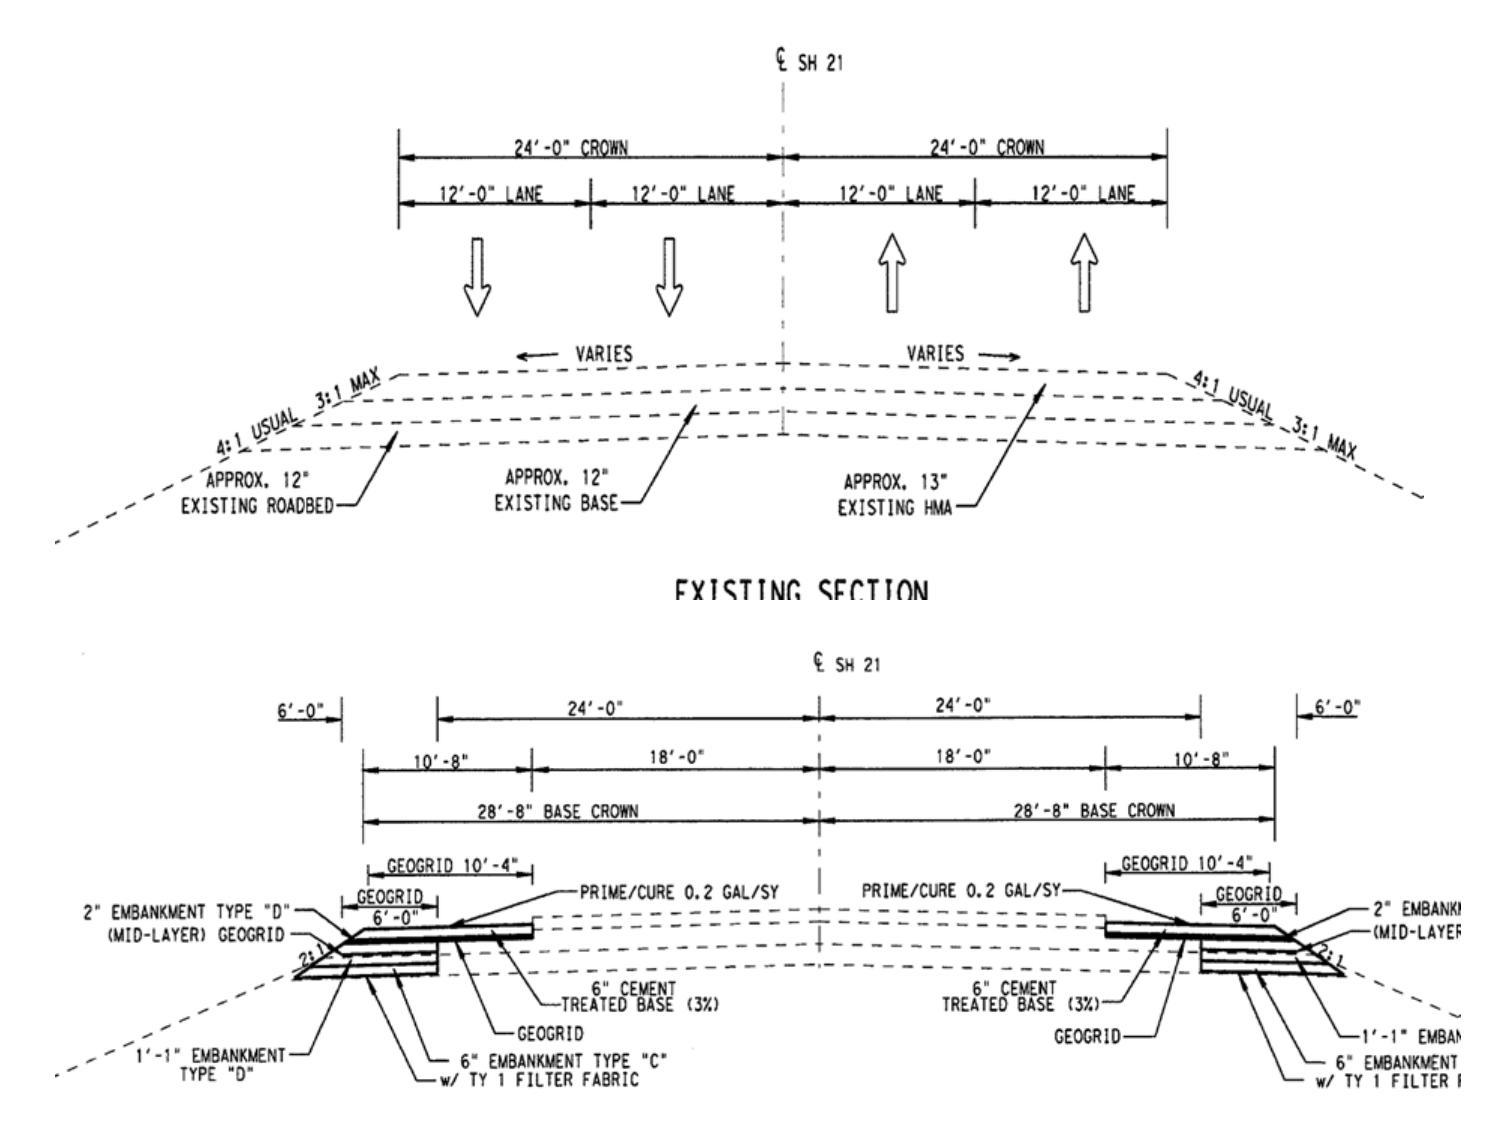
PROPOSED SUBBASE/BASE SECTION Figure 6. Existing and Proposed Double Geogrid Sections on SH 21.

Figure 6 presents the typical existing section and the proposed double-geogrid section. Key elements from the plans included:

- The pavement would gain a 4 ft shoulder and the subgrade would be cut to a depth exceeding the depth of the weak zone observed in the DCP profiles.
- The widened pavement embankment included a mid-level geogrid.
- The cement treated base would be over a second geogrid; the plans also called for microcracking the cement treated base.
- The final surfacing would be a thin overlay mix designed using both the Hamburg and Overlay Test.

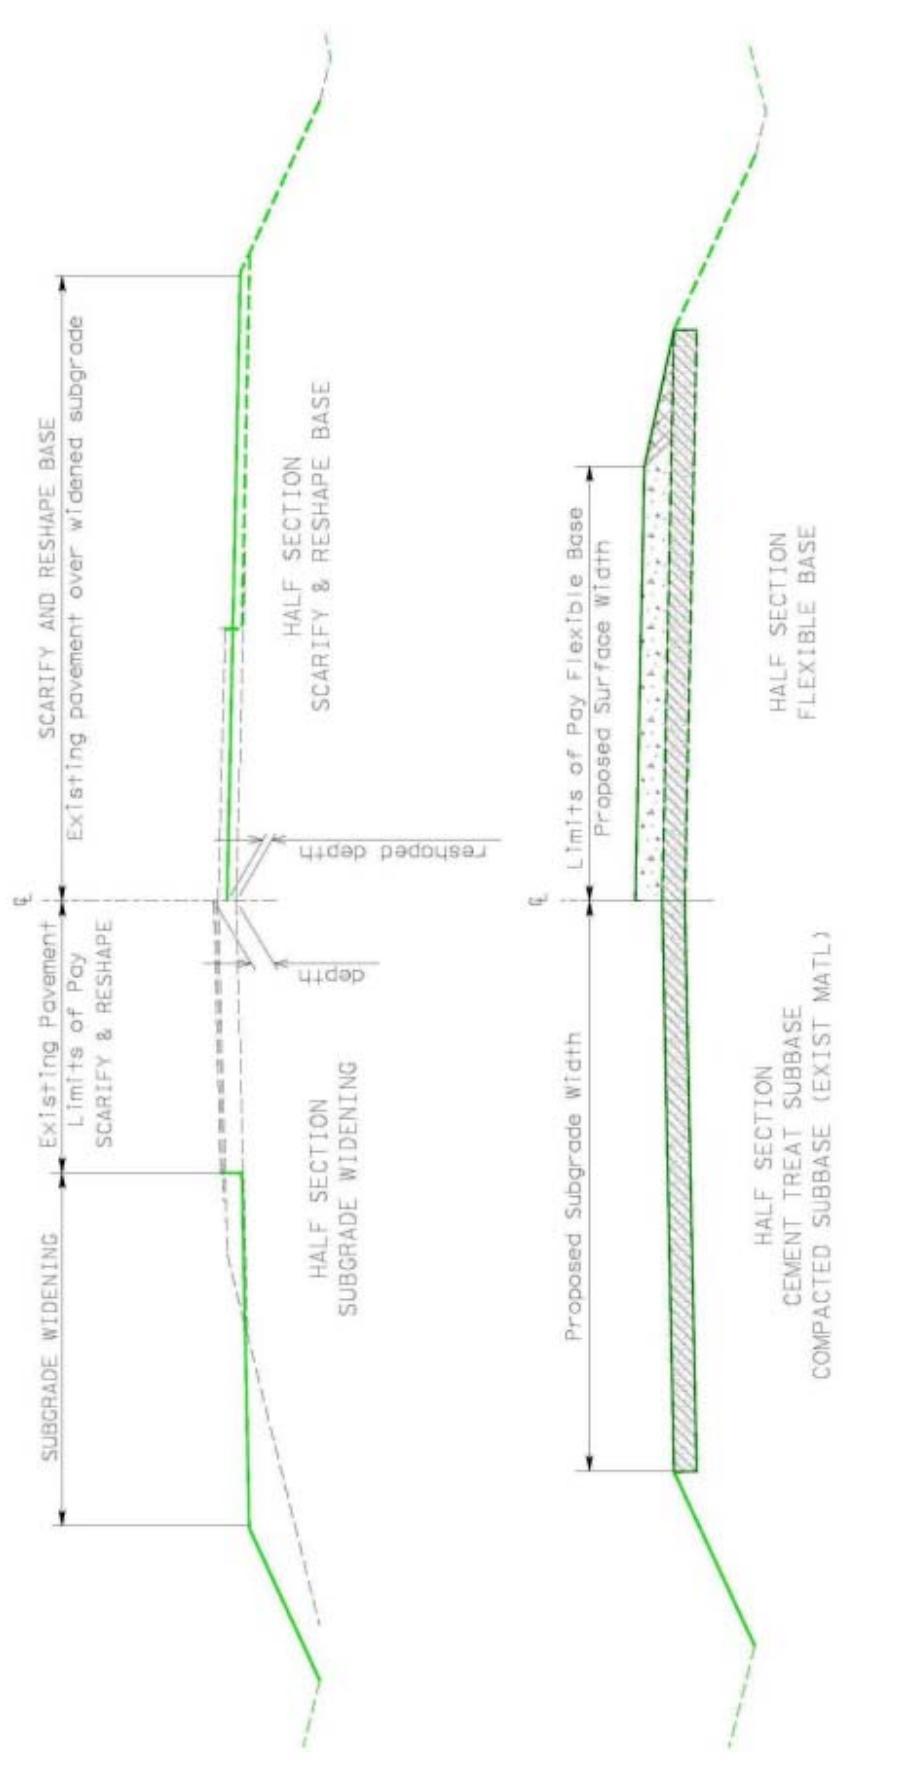
# Figure 7. Typical Section for Low-Volume Roadway Repair in the Bryan District.

Figure 7 illustrates a typical cross section for low volume roadway repair in the Bryan District. Based upon the soils tests, historical problem areas, and zones of weak subgrade detected in the FWD, the district will select limits of where to use geogrid reinforcement. The purpose of the geogrid is to minimize reflective cracking from the subgrade up through the pavement structure.

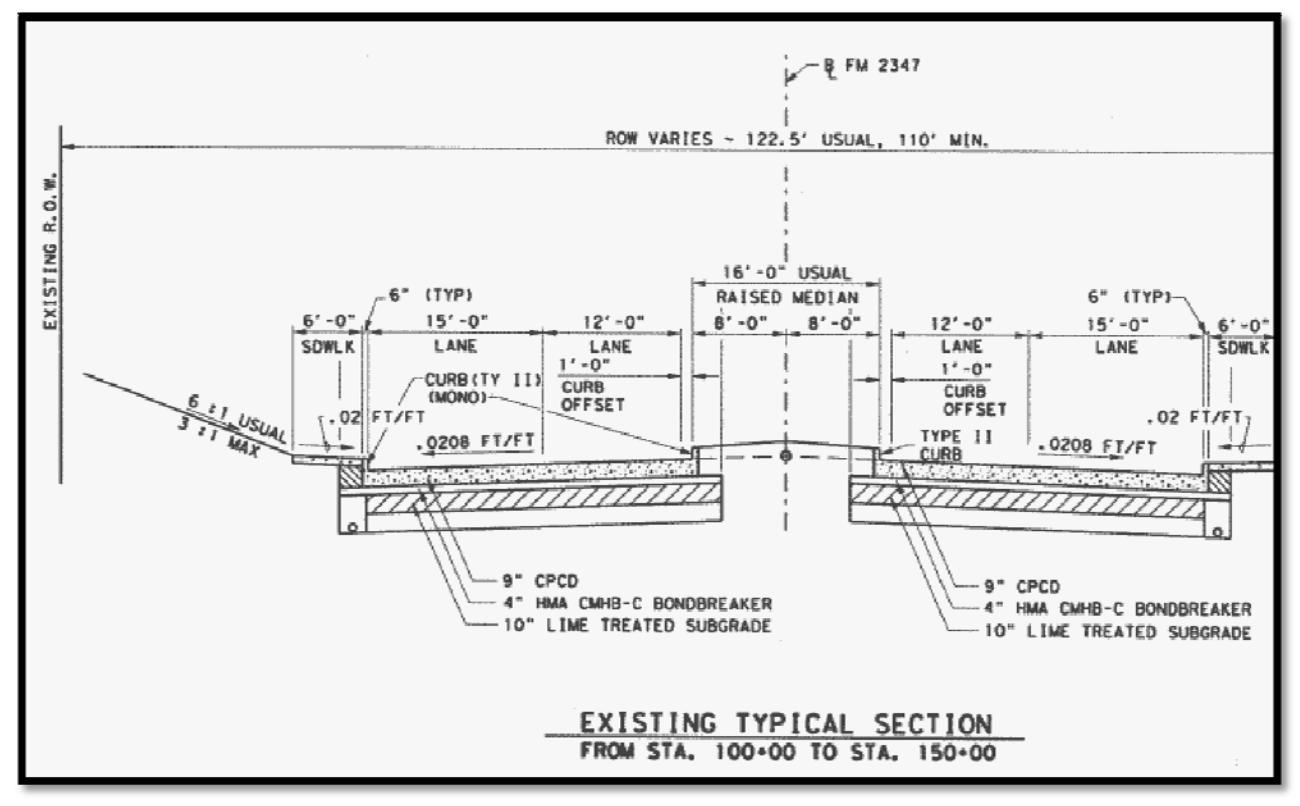
Figure 10. Typical Existing CPCD Section.

The Bryan District also has one of the few well documented cases of edge repair of concrete pavement. The distress shown in Figure 9 occurred shortly after construction. The subgrade plasticity index ranged from 14 to 49. Figure 10 presents the typical existing section. Figure 11 presents the repair details, which used a continuously reinforced concrete pavement (CRCP) repair tied to the existing concrete pavement contraction design (CPCD). As Figure 12 illustrates, although the crack did recur, the crack severity is much less than before.

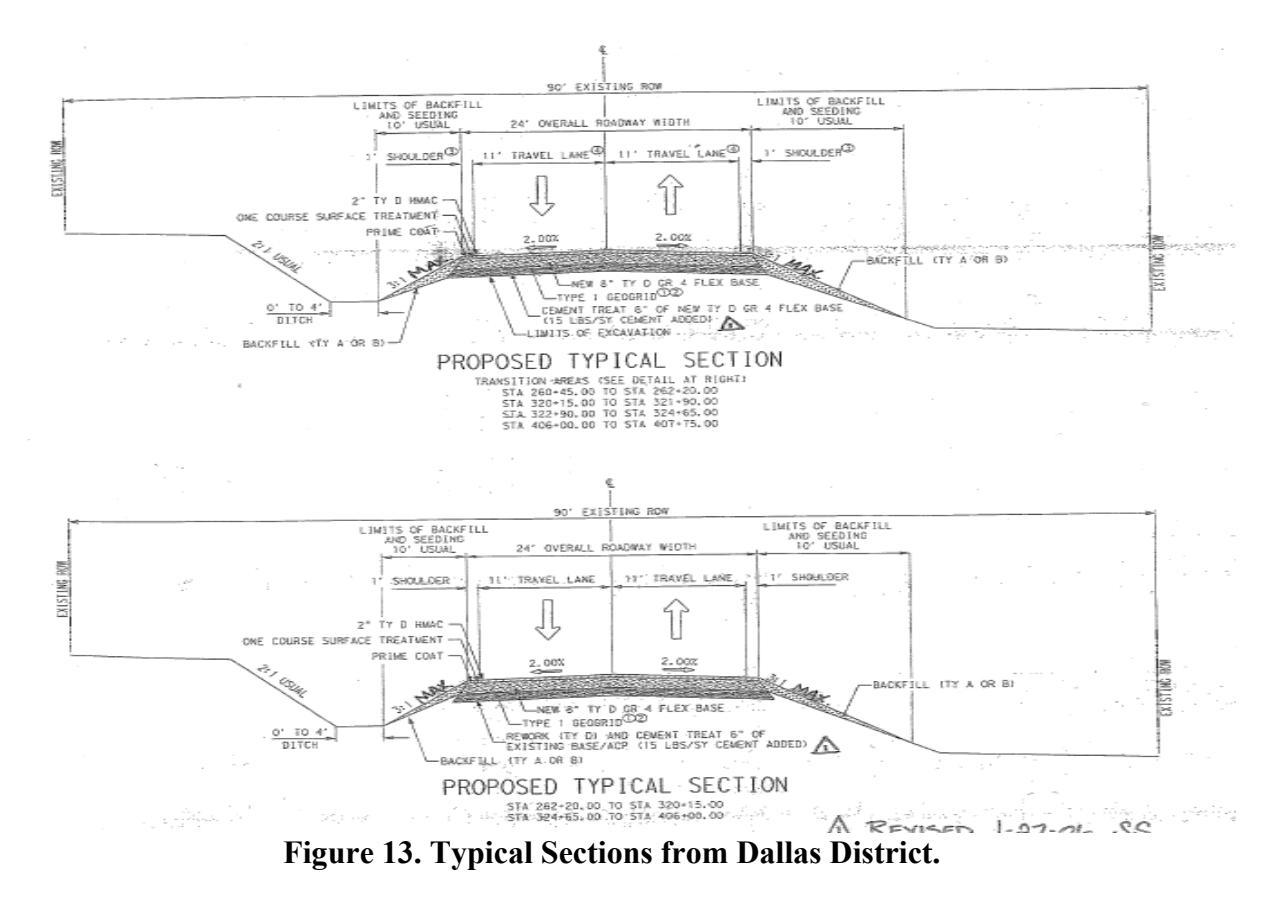
Figure 13 presents a typical cross section for projects in the Dallas District. Over the past years, the district has performed repairs on the following pavements:

- FM 549, FM 1827, FM 550, FM 148: FDR with geogrid and flex base overlay.
- FM 548, FM 740, FM 429: FDR with cement/emulsion and geogrid reinforcement.

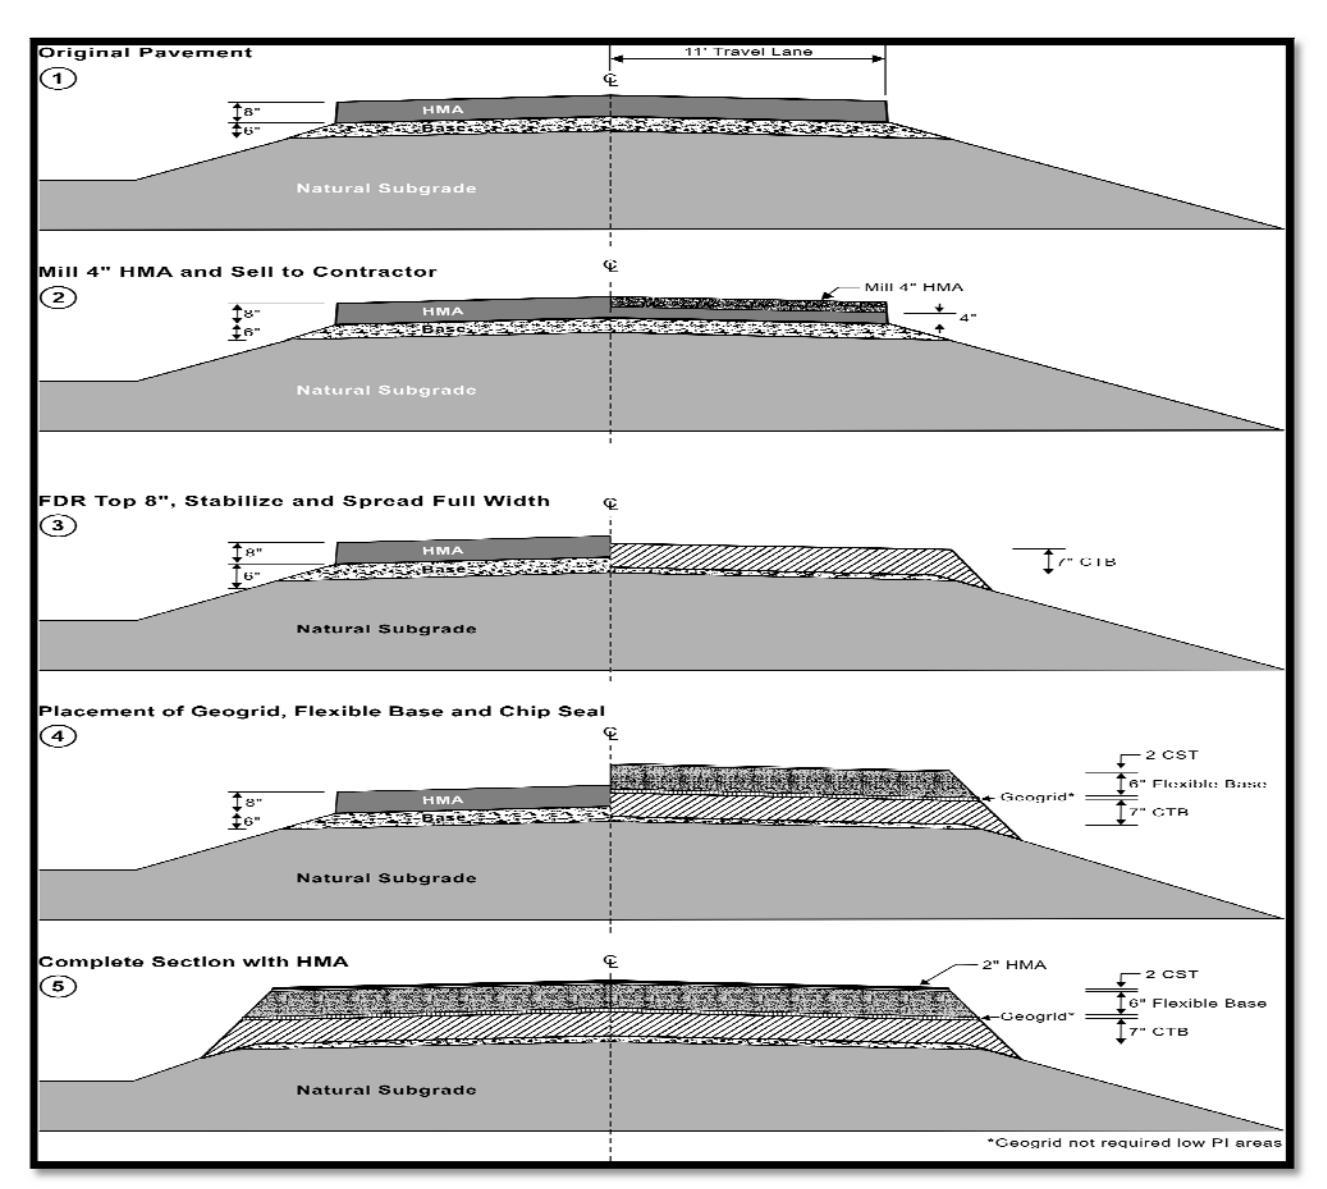
Figure 15. Repair Sequence for FM 148.

FM 550 and FM 148 both employed similar repair strategies. Figure 15 presents the repair sequence proposed for FM 148. Constructed in 2010, Figure 16 illustrates the constructed section tested met the structural design expectations.

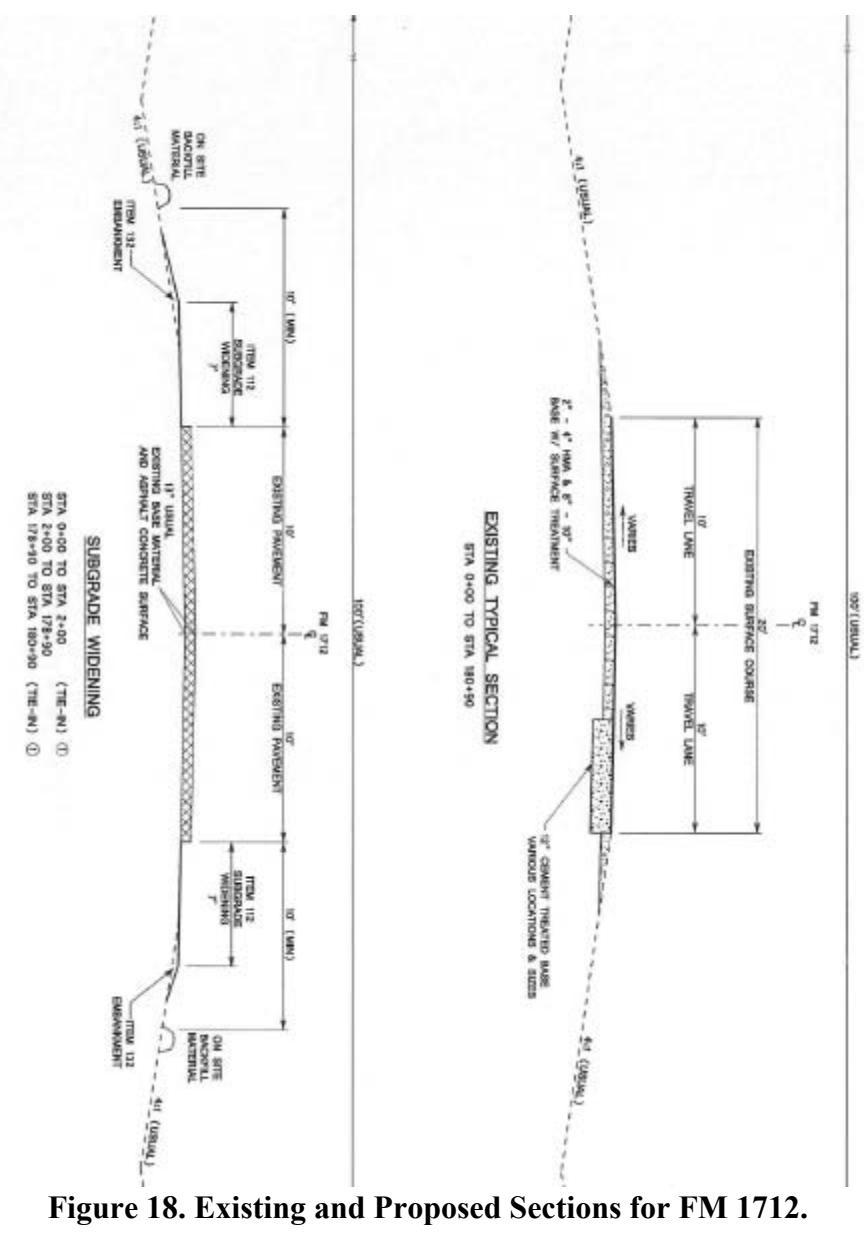
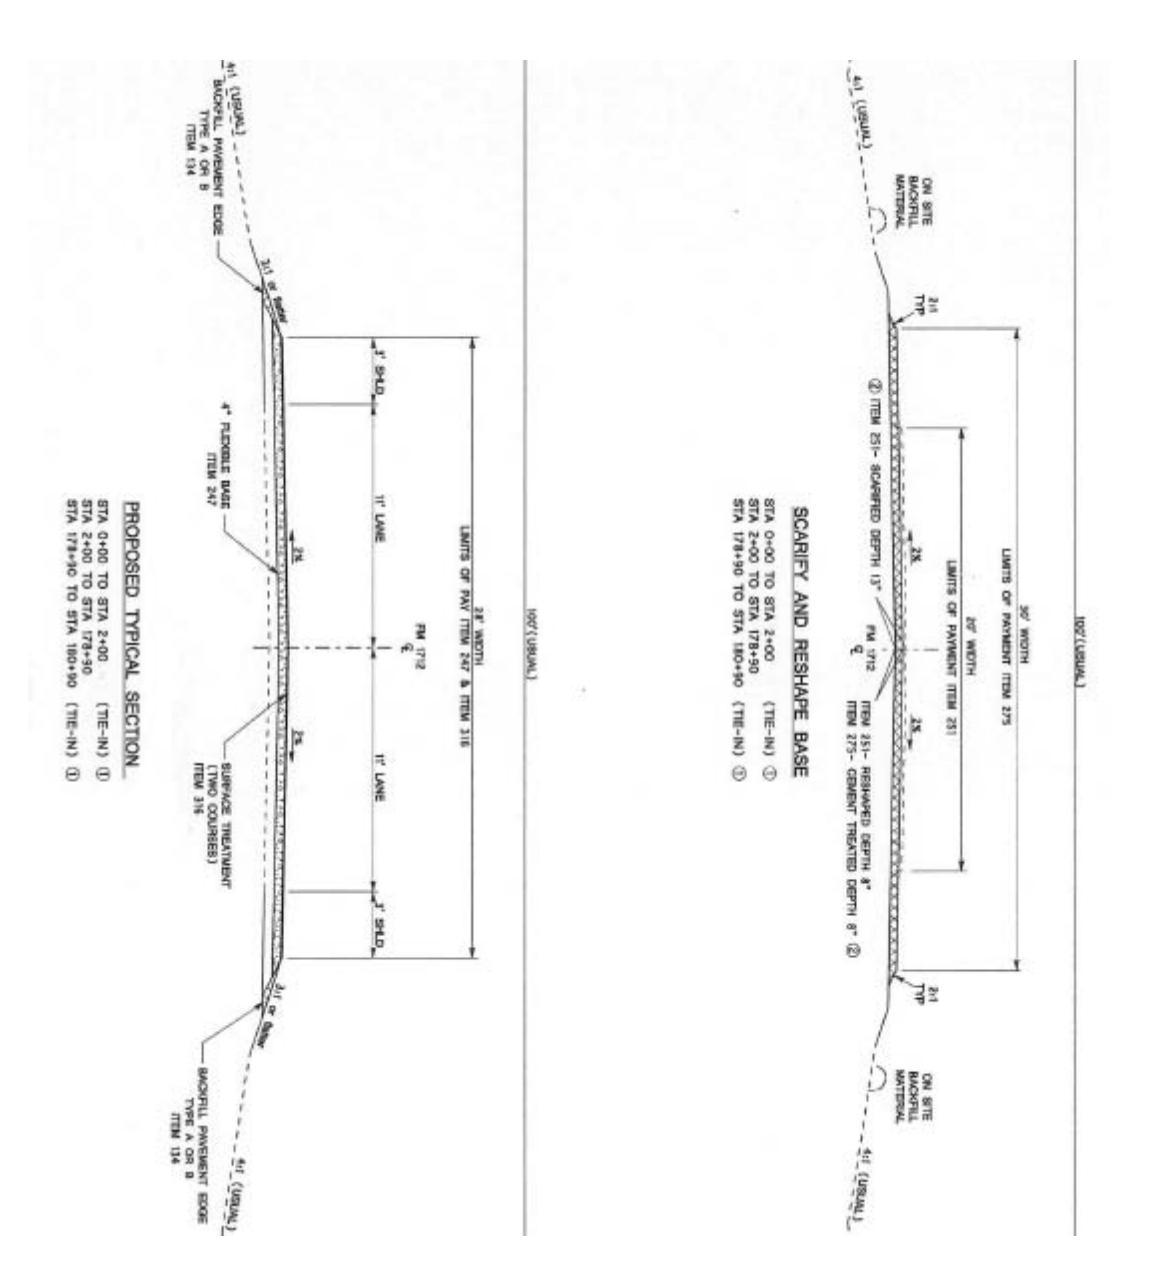
Figure 18. Existing and Proposed Sections for FM 1712 (Cont.).

Figure 18 presents the existing and proposed typical sections for FM 1712 from reference marker 406+1.604 to FM 487. The edge problems on this pavement were addressed by subgrade widening, scarifying, and reshaping the existing material followed by cement treatment to a depth of 8 inches, and then a 4 inch flexible base layer surfaced with a two course surface treatment. The Bryan District used Type D, Grade 2 flexible base for the new flexible base layer. Figure 19 shows representative images of the pavement's present condition. No distresses were observed.

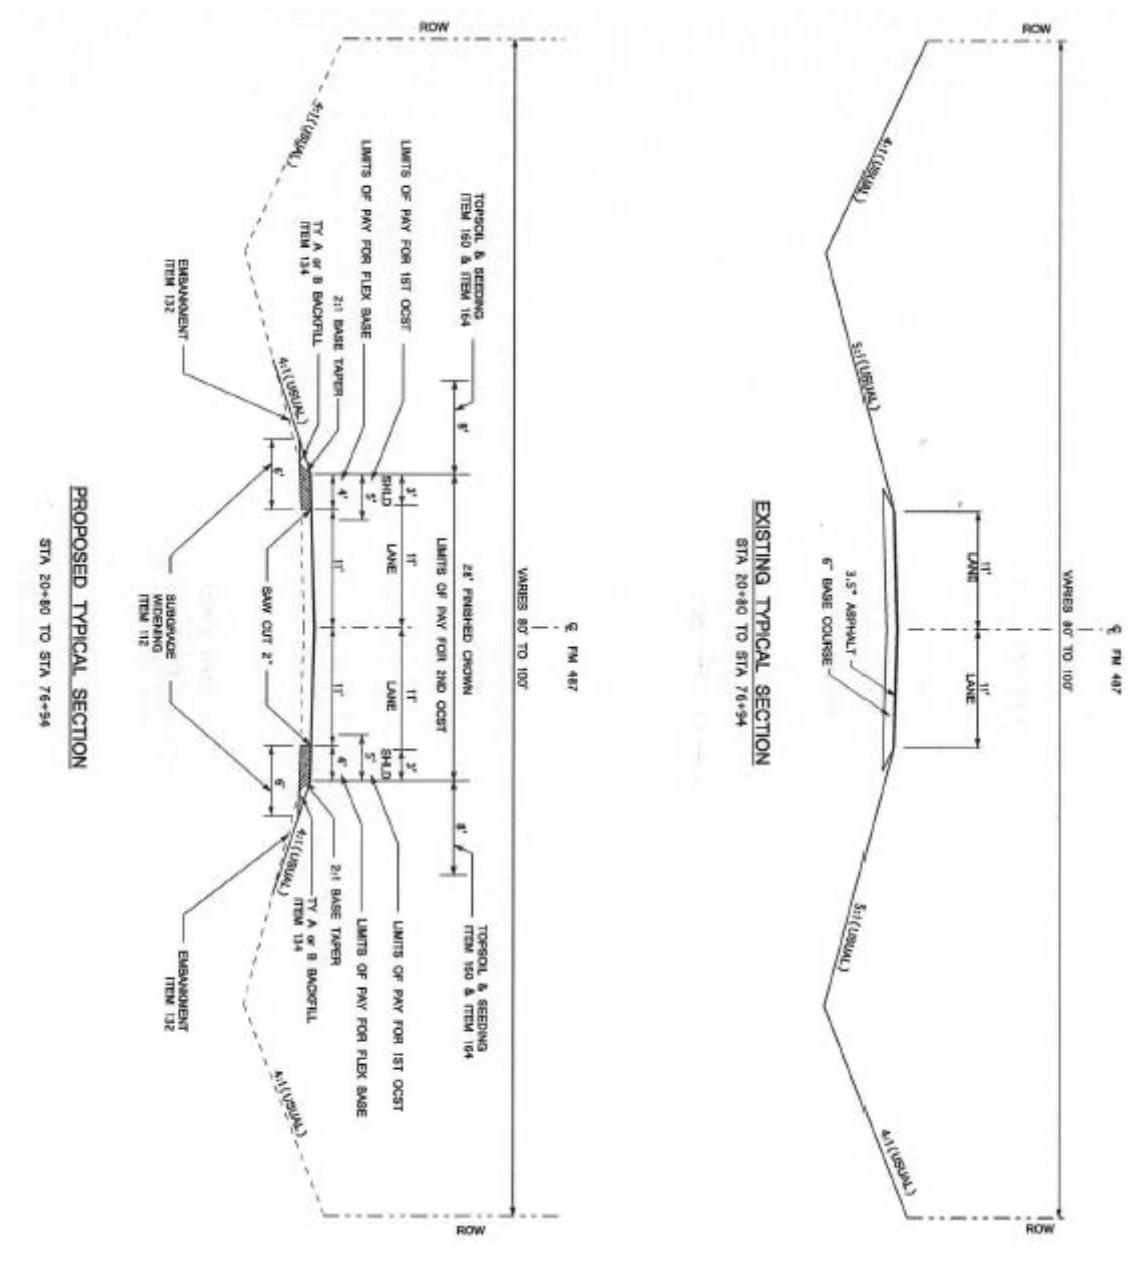
Figure 20. Existing and Proposed Sections for FM 487.

Figure 20 presents the existing and proposed typical sections for FM 487 from FM 1712 to reference marker 590+0.016. FM 487 was widened by adding shoulders alongside the existing pavement. The shoulders were constructed with Type D Grade 2 flexible base.

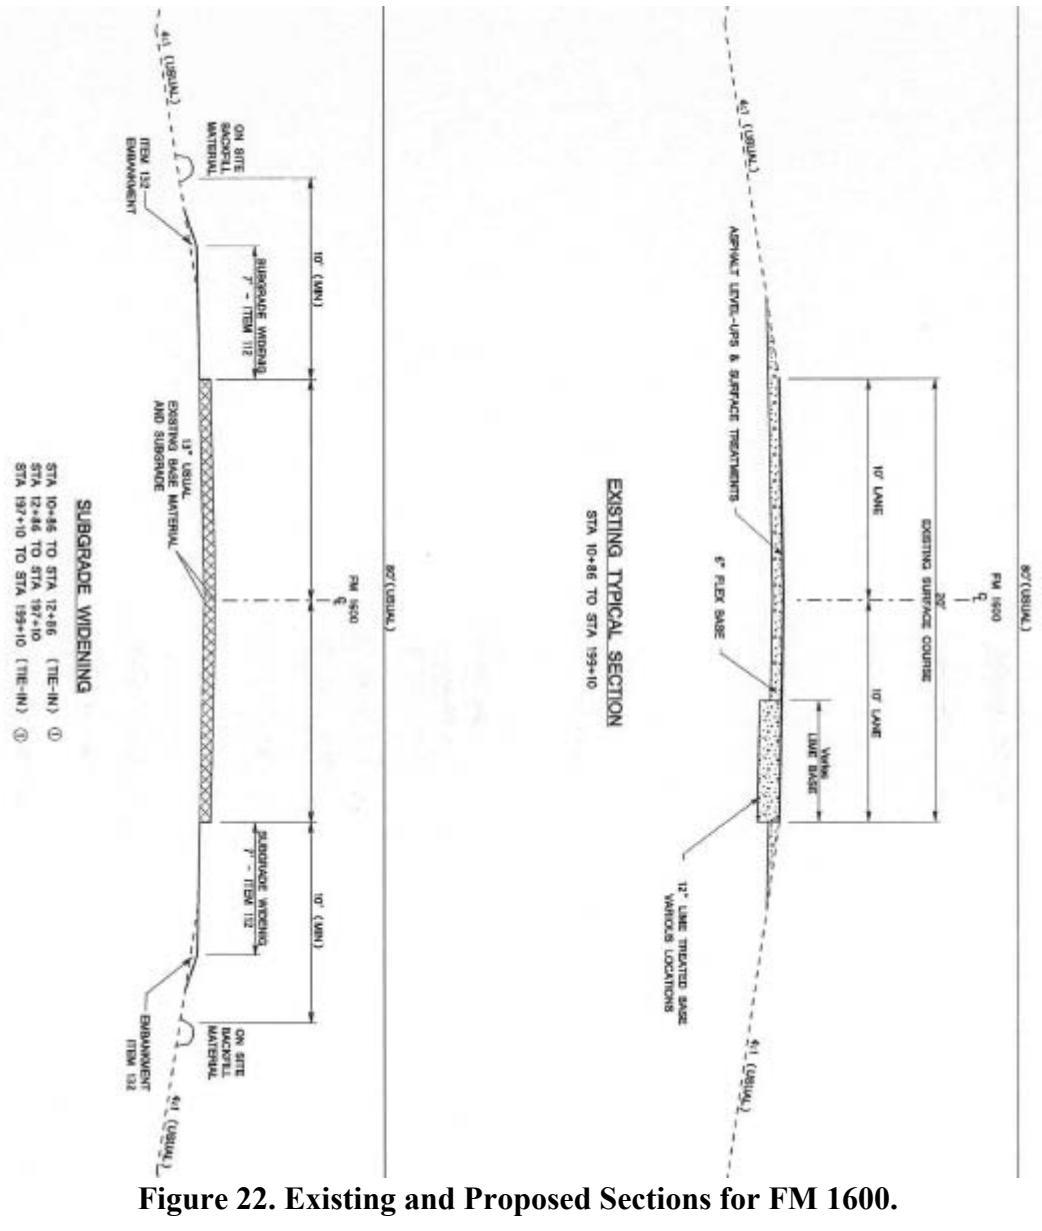
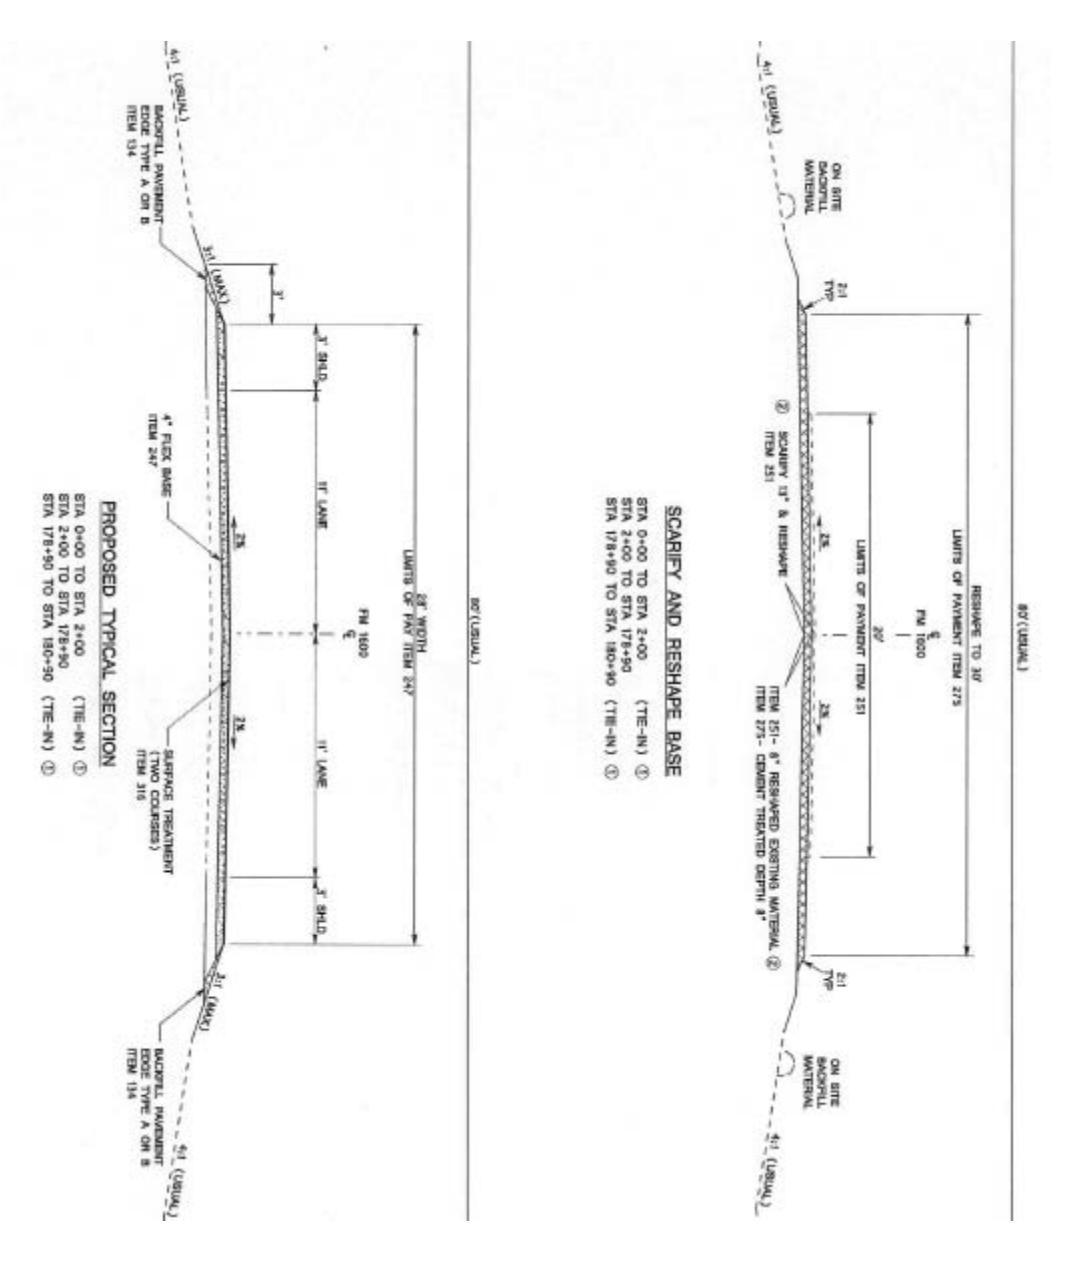
Figure 22. Existing and Proposed Sections for FM 1600 (Cont.).

Figure 22 presents the existing and proposed typical sections for FM 1600 from reference marker 400+1.700 to reference marker 404+1.205. This section was widened by full depth recycling of the existing pavement and placement of new flexible base. Type D Grade 2 flexible base was used for the new 4 inch flexible base layer. Cement stabilization of the existing roadbed was performed to an 8 inch depth.

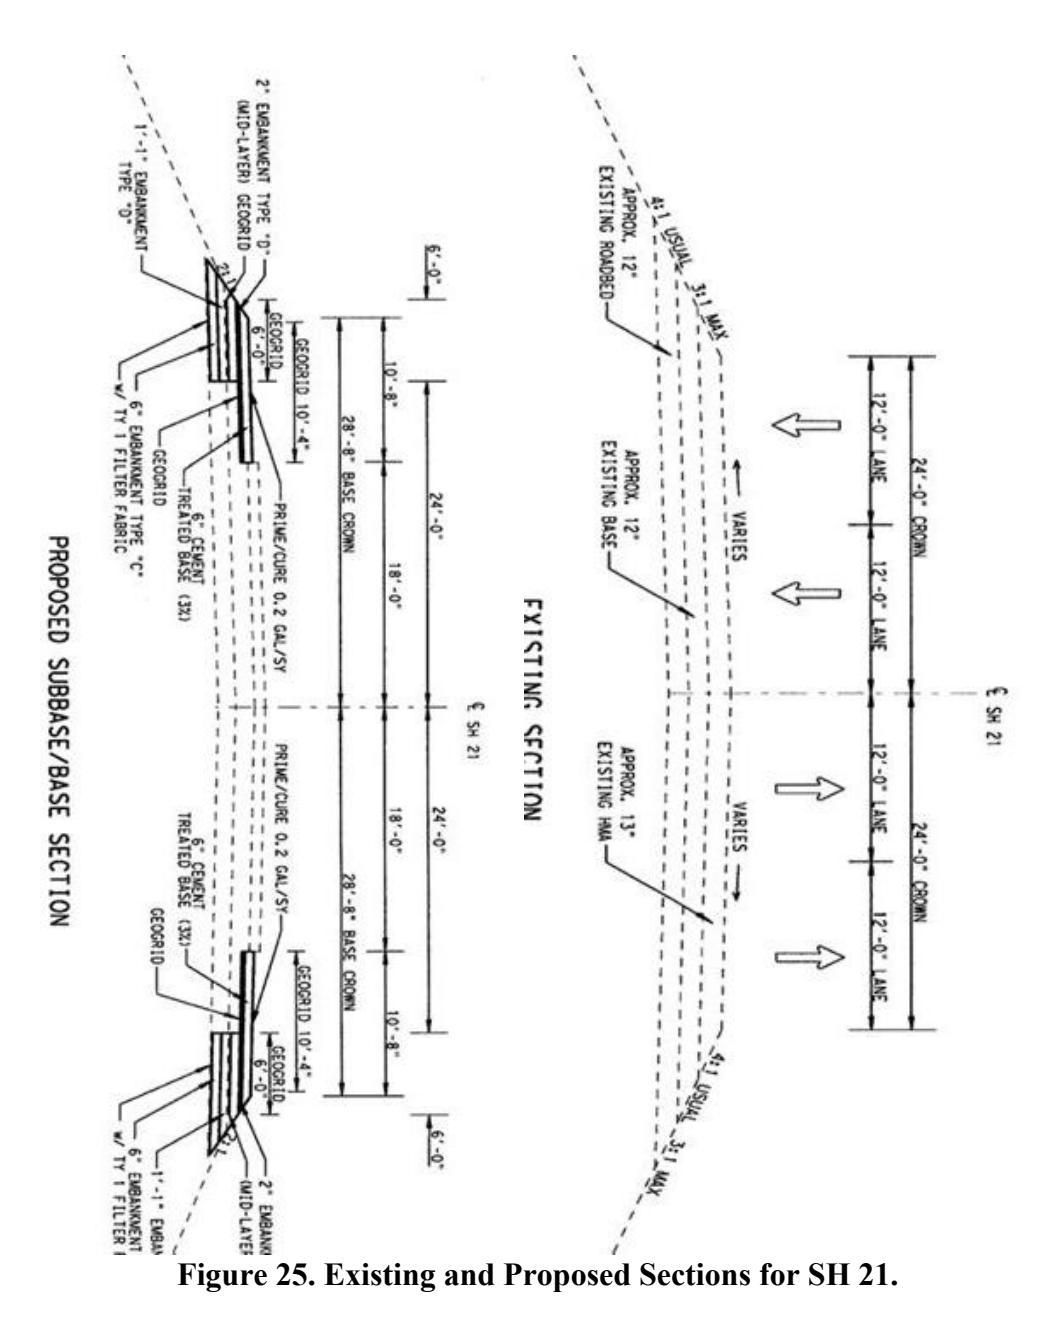
Figure 25 presents the existing and proposed typical sections for SH 21 from US 290 to 0.8 mi. east of FM 1441. This pavement exhibited steep front slopes, poor ride, and indications of slope failures. The proposed section included two layers of geogrid reinforcement, and the cement-treated layer included microcracking and the Austin District's Item 275/276 notes. The Appendix presents those notes.

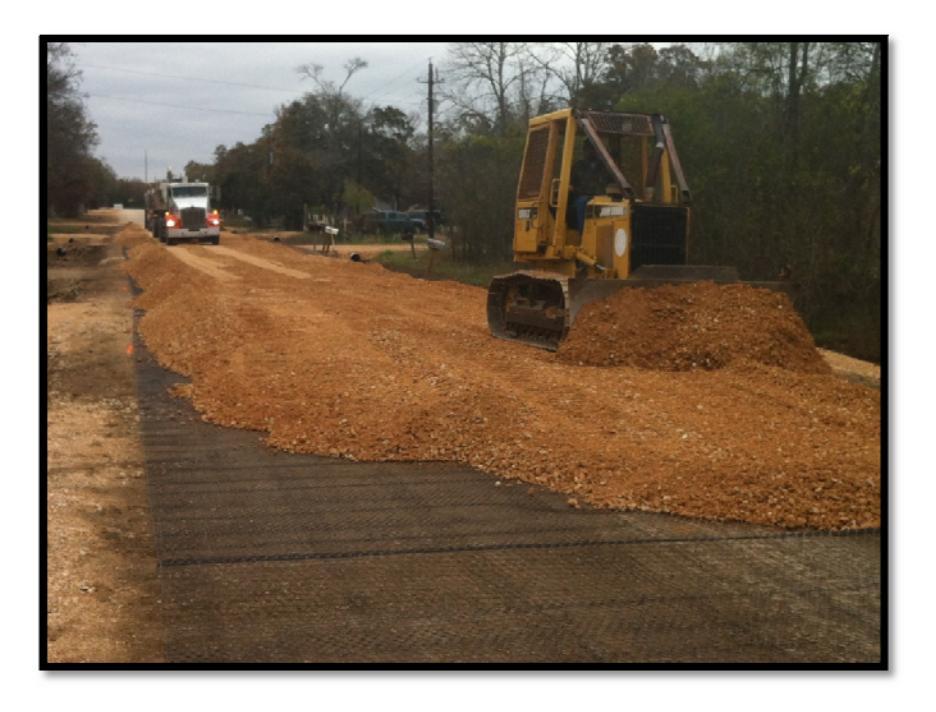
Figure 27. Construction of Geogrid Section on Benchley Dr.

Brazos County officials recently embarked on trying geogrid reinforcement on problem county roads near Benchley, TX. Figure 27 shows construction of the geogrid section on Benchley Dr. in 2013. Figure 28 shows extensive cracking currently exists in the section without geogrid, while Figure 29 and Figure 30 show that the section with grid reinforcement has improved performance but is not totally crack free. The geogrid sections were constructed with a lime treated subgrade, geogrid, 6 inches of Grade 1 flex base, and then a two course surface treatment.

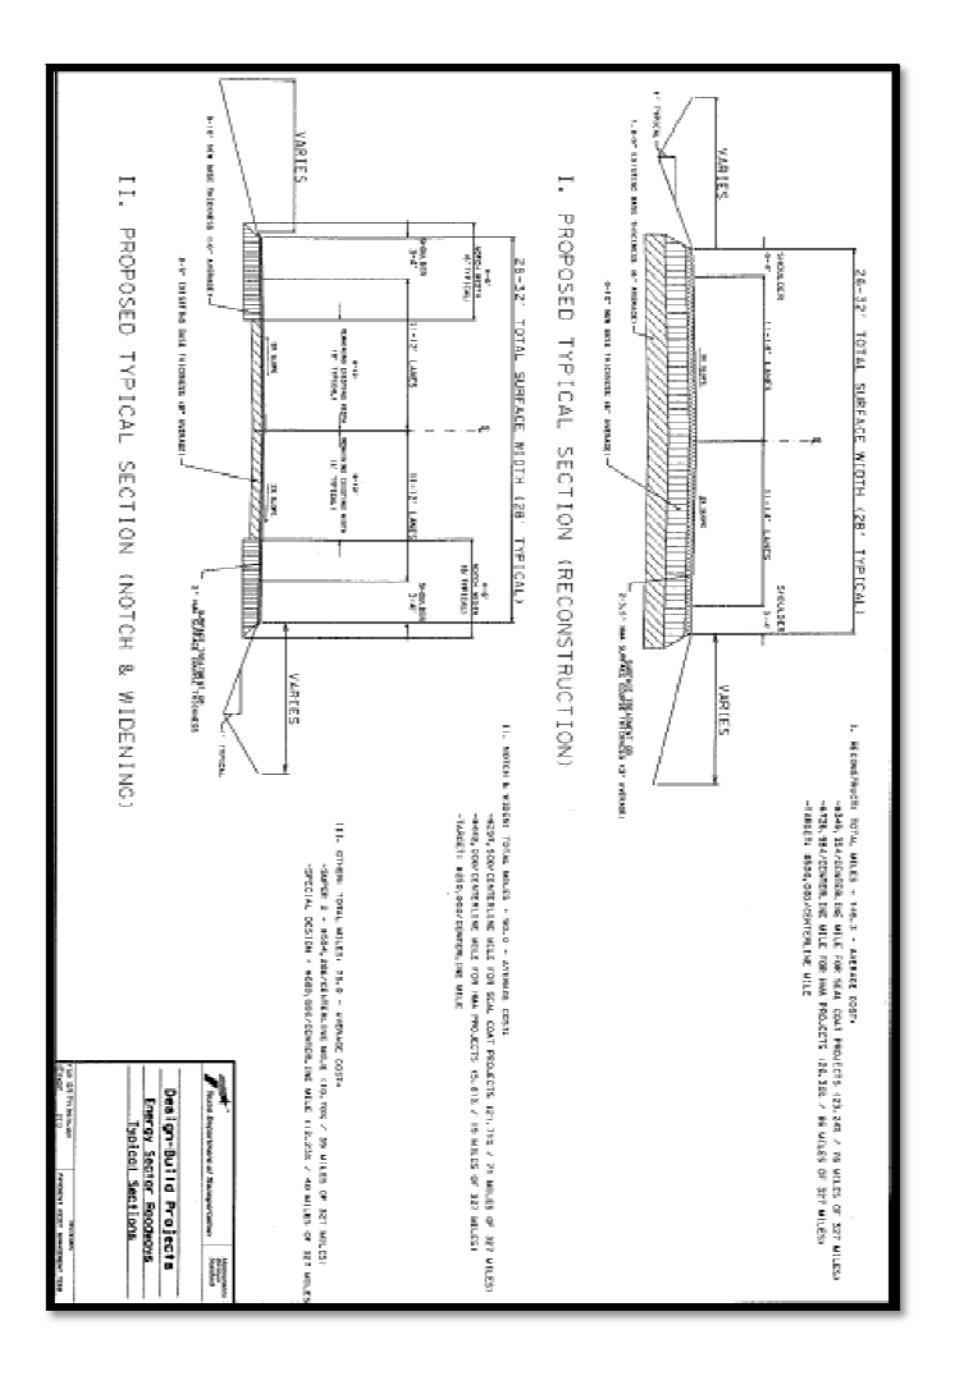
Figure 32. Statewide Summary of Rehabilitation versus Notch and Widening Costs.

Visits to the Bryan District discussing treatment of edge failures revealed that pavement sections could be scarified and reshaped to achieve a uniform cross section for very similar costs as just notching and repairing or widening the edge. Figure 32 presents average costs that suggest that as long as surface treatments are the wearing surface, reconstruction is quite cost competitive. Based on results in the Bryan District, the field performance of sections suggests scarifying/reshaping/reconstructing the pavement to achieve a uniform section achieves better performance than notching and widening. These findings match observations in project 0-6748 (6), which stated:

The findings suggest that, especially if costs are competitive, full rehabilitation should be preferred over simply notching and repairing the edge.

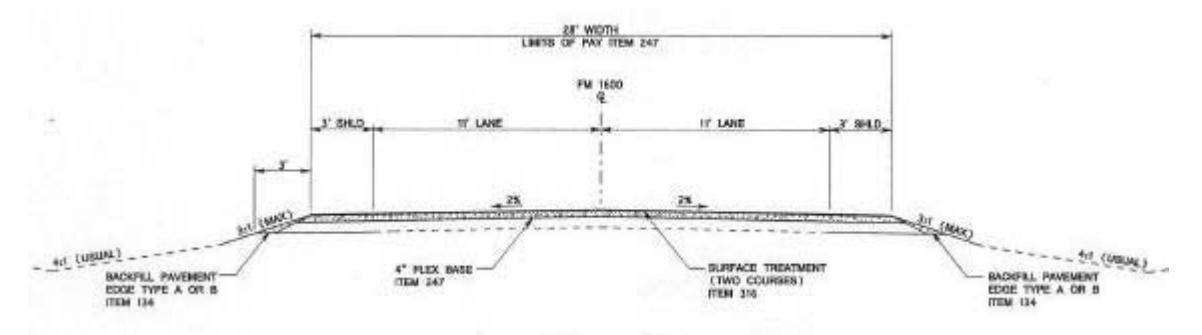
Figure 33. Typical Section Not Including Geogrid.

Figure 33 shows a typical section not including geogrid, while Figure 34 presents a typical section including geogrid.
