Strengthening of Existing Inverted-T Bent Caps— Volume 2: Experimental Test Program

Technical Report 0-6893-R1-Vol2

TEXAS A&M TRANSPORTATION INSTITUTE
COLLEGE STATION, TEXAS

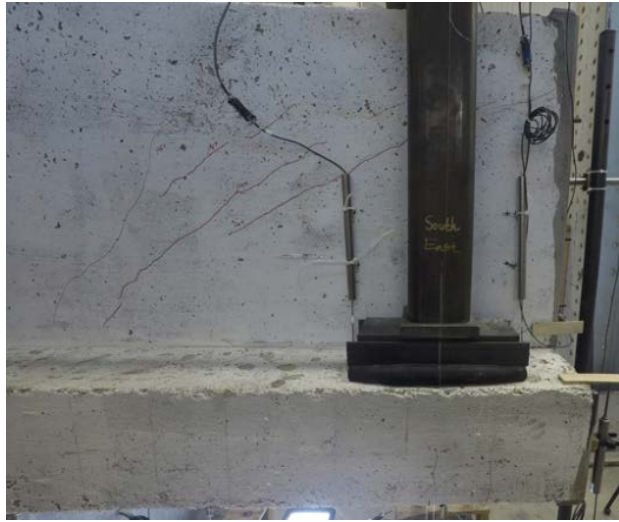
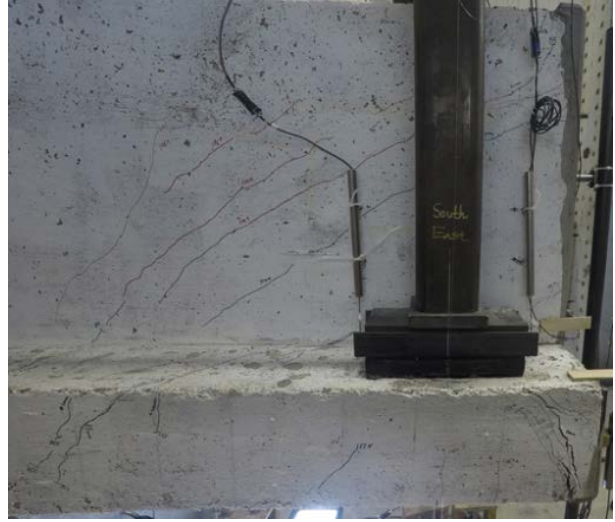
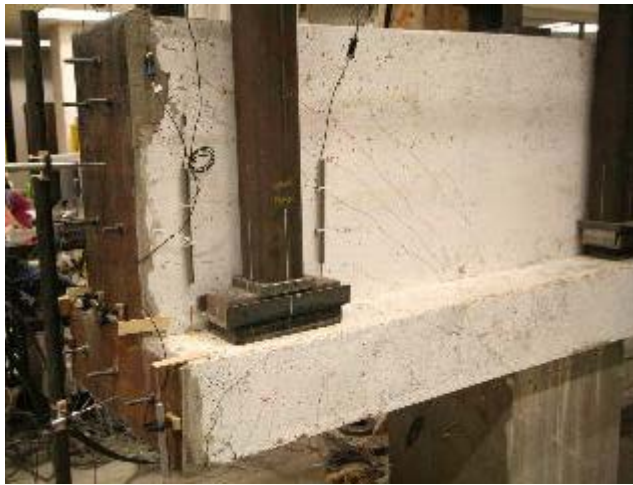
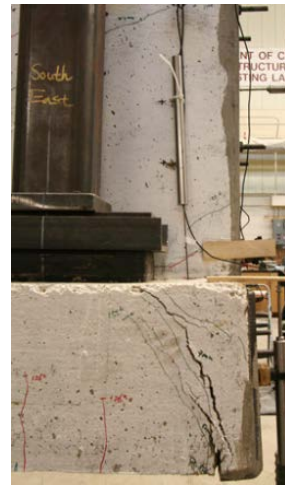
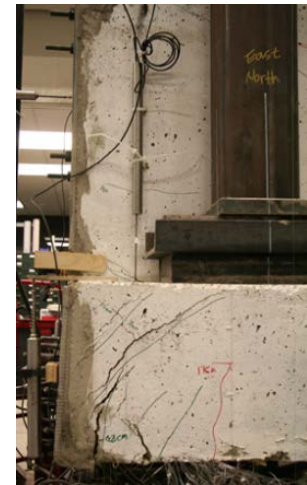
Figure 3.13. Observed Damage for T2E1 at Final Load Levels.

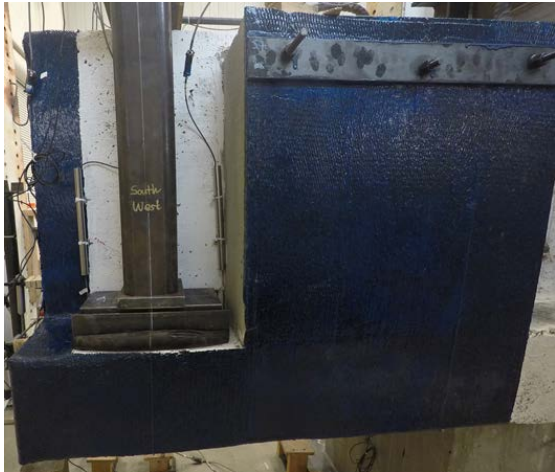
(a) North side at ULS

At the ULS of 68 kips, cracks formed at the interface between the concrete block and the ledge beside the south side bearing pad. Figure 3.19(a) shows the observed damage on the north side ledge at current load level. Web shear cracks were detected on both sides of the web at the east side of the concrete block. More cracks were observed on the web as the load increased. Horizontal cracks on the flange of the end face started forming at 78.5 kips. Interface cracks between the north side concrete block and the ledge were detected at 81.5 kips.

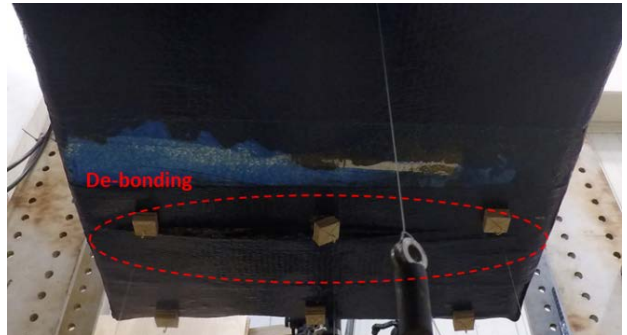
(b) Bottom at measured ultimate load

At the measured ultimate load of 92 kips, the bottom tip of the web FRP de-bonded, as shown in Figure 3.19(b). On the south side concrete block, vertical cracks formed on the FRP wrap. Shear-cracking-induced debonding of the FRP was observed near the center of the south side concrete block. No notable damage was detected on the end face.

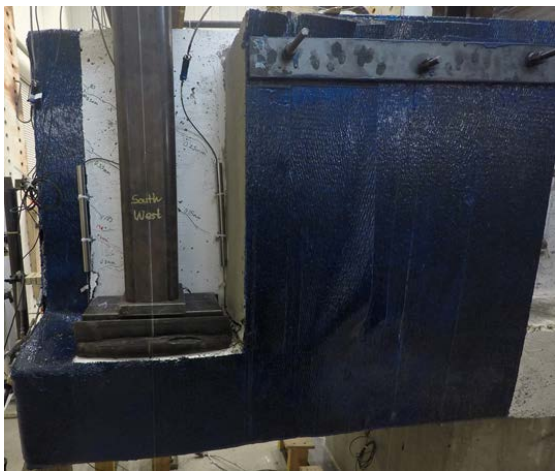
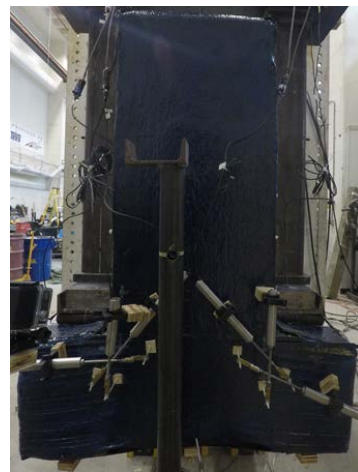
The specimen was further loaded after documenting the damage at the measured ultimate load. The applied load was sustained at 90 kips for about two minutes and then dropped to 80 kips. Figure 3.19(e) and (f) show the observed damage at the final load level. Additional cracks formed, and the FRP wrap de-bonded at the top of the south side concrete block. Vertical- and shear-crack-induced FRP debonding was also detected on the north side. FRP separation was observed at the web-ledge interface near the end of the bent cap. The damage increased significantly while the load was sustained at 80 kips for approximately three minutes. The test was ended when the load dropped to 65 kips which was 30 percent lower than the measured ultimate load.

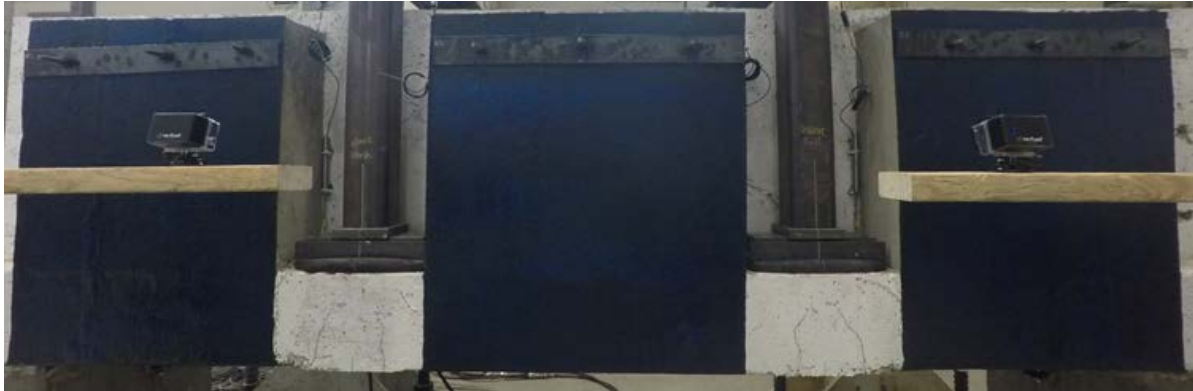
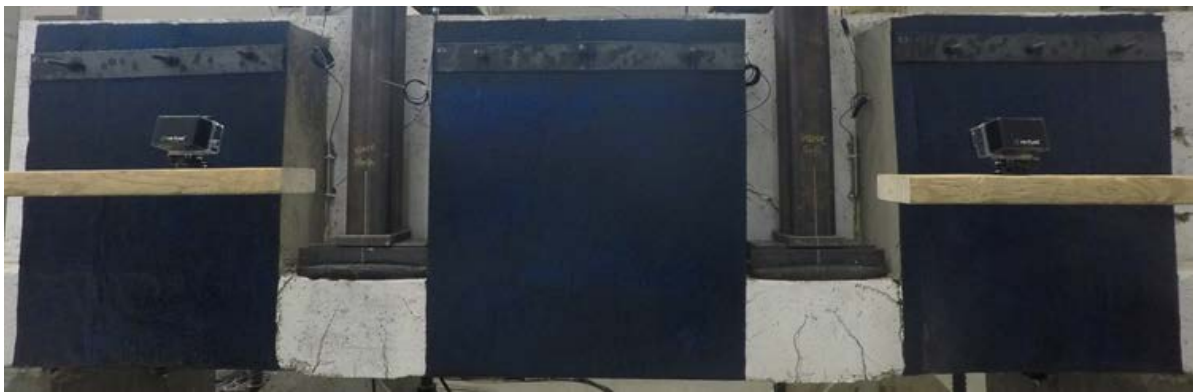
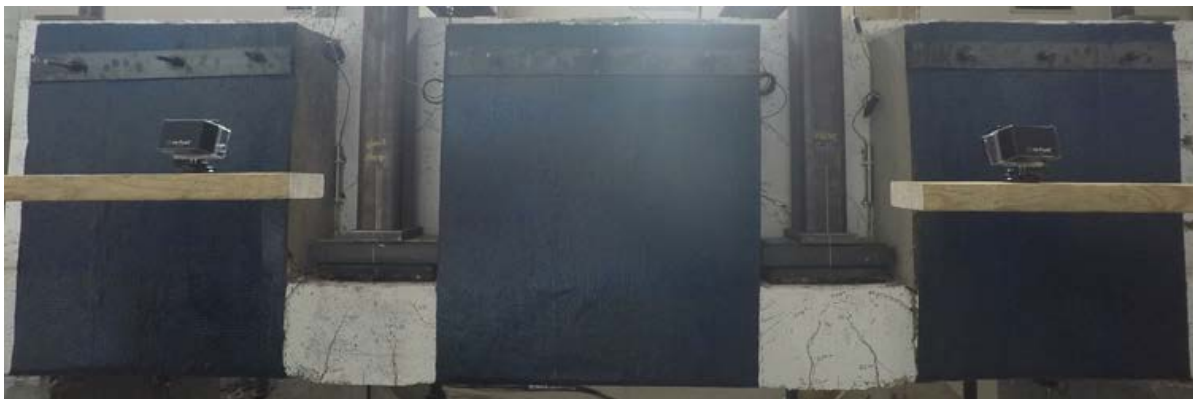
Figure 3.25. Observed Damage for Test T2I2 at Different Load Levels.

The measured ultimate load of 111 kips was 63 percent larger than the estimated capacity of 68 kips and 23 percent larger than the interior hanger-deficient reference capacity. The test was ended after documenting damage at the measured ultimate load. Figure 3.25 shows the observed damage at different load levels. The bent cap experienced a combined hanger and ledge failure.

At the SLS of 49 kips, no new cracks formed. At a load of 74 kips, diagonal cracks formed on the side face of the ledge under the bearing pads. At the ULS of 78.5 kips, the cracks formed at the interface of the concrete blocks and the ledge. Flexure cracks were also detected on the bottom along the interface of the FRP strip and the bent cap. Crack extensions and new crack formations were observed as load increased. More diagonal shear cracks formed on the web behind the loading points. Near the top of the bent cap, the cracks on the web propagated horizontally.

End interfacial debonding of FRP was detected at the east end of the southwest concrete block at 109 kips. At the measured ultimate load of 111 kips, intermediate shear-crack-induced interfacial debonding of the FRP was observed at all inner ends of the concrete blocks.

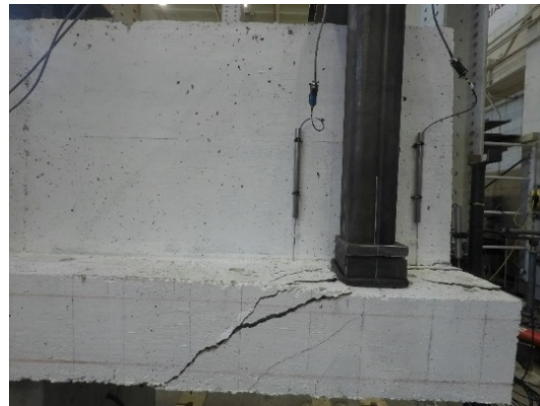
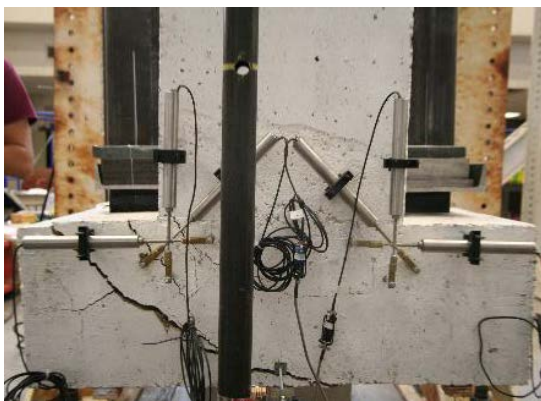
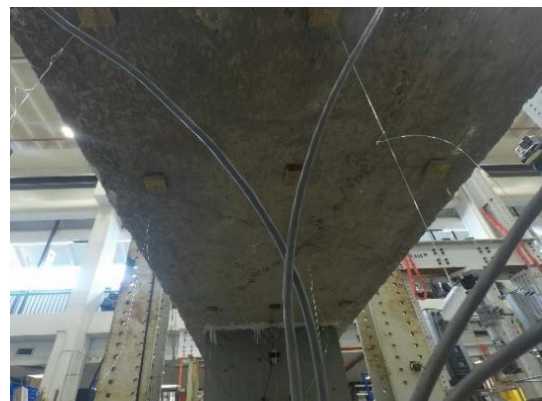
Figure 3.29. Observed Damage for T3W1 at Final Load Level.

The measured ultimate load (70 kips) was 37 percent larger than the estimated capacity (51 kips). The test was ended when the applied load dropped to about 70 percent of the measured ultimate load. Figure 3.29 shows the observed damage for test T3W1 at the final load level. The specimen showed a punching shear failure, evidenced by the concrete cone punched out from the ledge, as shown in Figure 3.29(a).

At approximately the service load, a 3 in. long diagonal crack formed at the north reentrant corner of the end face. At SLS (45 kips), a new crack formed at the web-ledge interface behind the bearing pad and propagated to the end of the specimen. The cracks were progressively extended until ULS.

At ULS (68 kips), a new crack formed on the top of the ledge 16 in. from the inner side of the bearing pad. Right after ULS, the concrete cone cracks began to form on the side of the ledge. A change of slope in the load-deflection curve was observed. As the loading increased, new cracks formed primarily from the edge of the bearing pad on top of the ledge and extending diagonally to the vertical surface of the ledge and the end surface of the bent cap. The measured ultimate load of 70 kips was observed within 60 seconds after the initiation of the cone cracks. The formation of the main concrete cone was clearly visible before the failure took place. The maximum width of the cone crack was 2 mm at the measured ultimate load.

The specimen was loaded further after the measured peak, and significant damage progression was observed. The test was stopped when the load dropped to 52 kips. Final failure of the ledge was obtained as the cracks reached the bottom surface of the ledge either on the side surface of the ledge or the end surface of the bent cap. The maximum width of the cone crack was 7 mm at the final load level. The average angle of the main concrete cone was 32.5 degrees, which was shallower than the expected angle of 45 degrees.

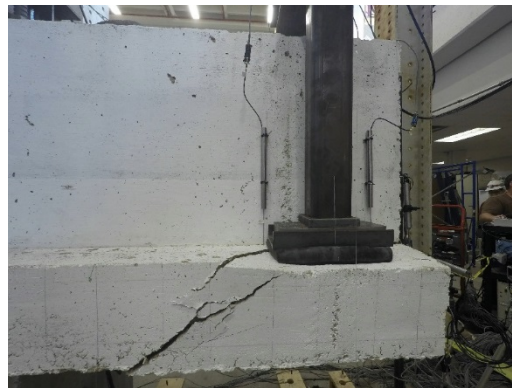
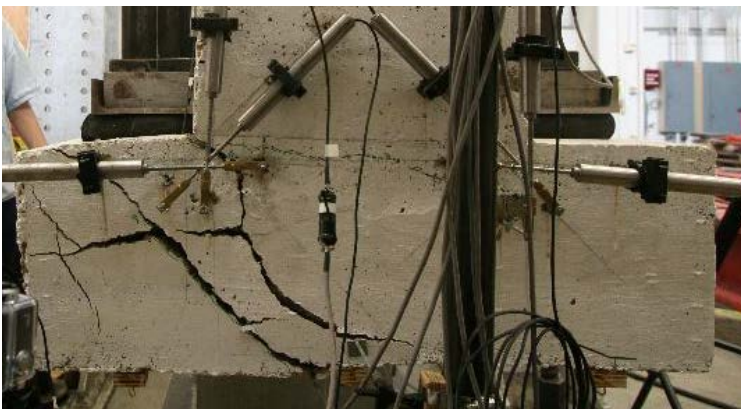
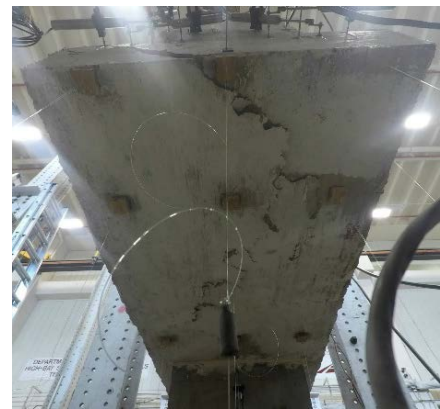
Figure 3.31. Observed Damage for T3E1 at Final Load Level.

The measured ultimate load (80 kips) was 31 percent larger than the estimated capacity of 61 kips and 14 percent larger than the measured ultimate load capacity of the exterior punching shear test with the small bearing pad. The test was ended when the applied load dropped to about 50 percent of the measured ultimate load. Figure 3.31 shows the observed damage for T3E1 at the final load level. The bent cap failed in punching shear when a clear concrete cone formed under the loading point.

The damage progression was similar to that observed for T3W1. The initial crack was observed at the SLS of 45 kips. A diagonal crack formed at the south reentrant corner of the end surface of the bent cap with a length of 4 in. This crack also extended toward the inner side of the bent cap along the web-ledge interface about 6 in. and progressively extended as the loading increased.

At the ULS of 68 kips, a new crack was found on the end surface that formed from the south reentrant corner and extended almost horizontally about 14 in. Another diagonal crack on the end surface that connected to the outside edge of the bearing pad and on the top surface of the ledge that also initiated from the inner edge of the bearing pad was also detected. Extensive cracks began to form as the load increased above ULS. Similar crack patterns as T3W1 were observed, and most of the cracks formed from the edge of the bearing pad and diagonally extended to the side of the ledge. The main concrete cone crack initiated at a load of 78 kips, accompanied by a slope change in the load-deflection curve. The crack quickly extended to the bottom of the bent cap. The measured ultimate load of 80 kips was observed shortly after the cone crack took place. The maximum width of the cone crack at the measured peak was 2 mm.

The specimen was loaded further after the measured peak. More cracks formed and the width of the cone cracks were increased significantly. The test was ended when the load dropped to 43 kips. The width of the cone crack on the side of the ledge was 10 mm at the final load level. An average angle of 32.5 degrees was observed for T3E1, which was the same as T3W1.

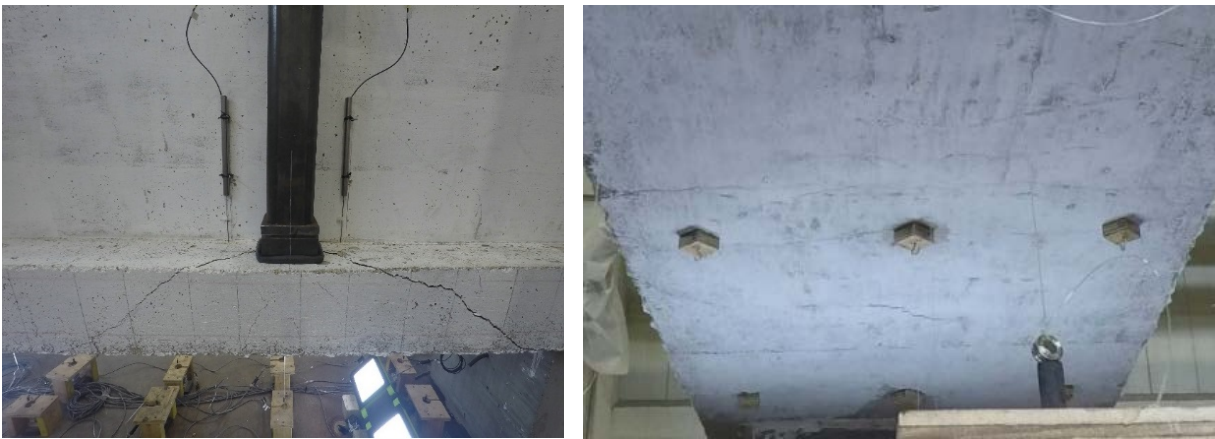
Figure 3.33. Observed Damage for T3I1 at Final Load Level.

The measured ultimate load (104 kips) was 89 percent larger than the estimated capacity of 55 kips. The test was ended when the applied load dropped to about 90 percent of the measured ultimate load. Figure 3.33 shows the damage for test T3I1 at the final load level. A clear punching shear failure was observed in which a truncated concrete pyramid punched out from the ledge.

The first cracks were observed at the service load. A crack began to form at the corner of the bent cap behind the bearing pad and extended 11 in. away from the pad. This crack extended to the side surface of the ledge as the loading reached the ultimate state. At the ultimate loading, different crack patterns formed compared to the previous tests. An almost vertical crack formed on the side surface of the stem that was 6 in. away from the south side of the bearing pad, and one more vertical crack formed on the other side surface of the stem. Moreover, cracks formed right underneath the bearing pad on the side surface of the ledge, extended to the bottom of the ledge, and went all the way through the flange of the bent cap on the bottom surface. The main concrete cone began to form at 92 percent of the failure load, and more cracks formed on the side surface of the stem. A notable difference in the crack pattern for test T3I1 was that the cracks on the stem and on the bottom went through the flange of the bent cap. The ledge failed as the main concrete cone cracks reached the bottom of the ledge. The formation of the concrete cone was obvious on the side surface of the ledge. However, there was no punching action on the bottom surface of the bent cap. Crack angles were 30 degrees on the west side and 35 degrees on the east side.

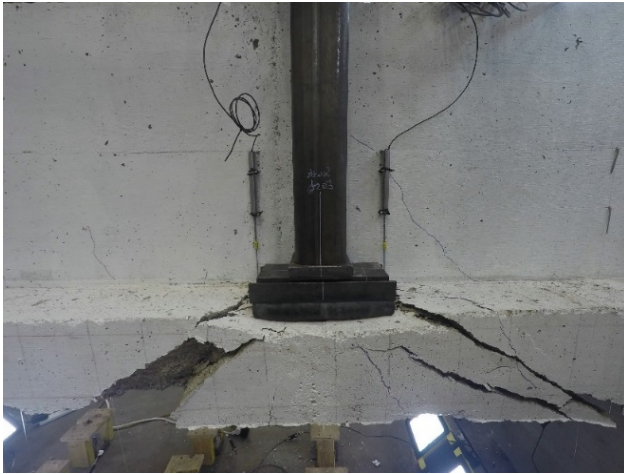
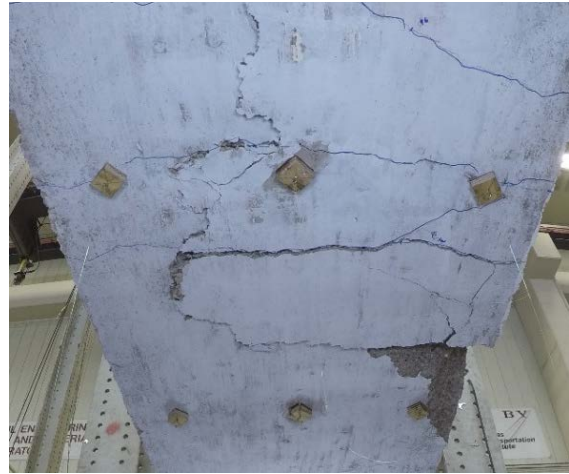
(a) T3I2

The measured ultimate load for T3I2 and T3I3 (94 kips) was 25 percent larger than the estimated capacity of 75 kips but 10 percent smaller than the measured ultimate load capacity of the interior punching shear test with the small-size bearing pad. The test was ended when the applied load dropped to about 75 percent of the measured ultimate load. Figure 3.36 shows the observed damage for T3I2 and T3I3 at final load level. Both the tested regions experienced punching shear failure with truncated pyramid-shaped failure surfaces forming under the loading points.

The observed crack patterns and failure shapes for both tests were similar to the interior punching shear test with the small-size bearing pad. No cracks were found at SLS. Right after SLS, a crack formed in a similar way from the corner behind the bearing pad and extended diagonally about 11 in. away from the pad. The crack extended to the side surface of the ledge as the loading increased to the ultimate loading state. A small diagonal crack formed on the stem at the ultimate loading. Significant cracks formed when the load increased to 90 kips. A long 45-degree shear crack formed on the stem, and the main concrete cone also began to form at this loading stage. Similar crack patterns were formed on the bottom surface for test T3I2 as well.

The ledge failed as the concrete cone completely formed but with a relatively lower strength of 94 kips, even though it was loaded with the large bearing pad. Therefore, to have one more set of the data, T3I3 was conducted right beside the T3I2 location and loaded up to failure without stopping the load. A similar pattern was observed, and the ledge failed at the same load as T3I2 (94 kips), even though there were preexisting cracks at the location of T3I3 that were caused from T3I1. Moreover, the concrete cones from T3I2 and T3I3 intersected since the loading points were located closer to each other. The set of average crack angles for the concrete cone was 30 to 35 degrees and 40 to 45 degrees for T3I2 and T3I3, respectively.

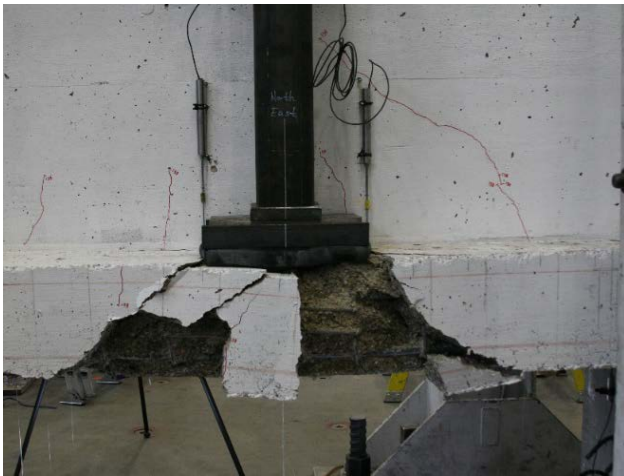
Figure 3.36. Observed Damage for T3I2 and T3I3 at Final Load Level.

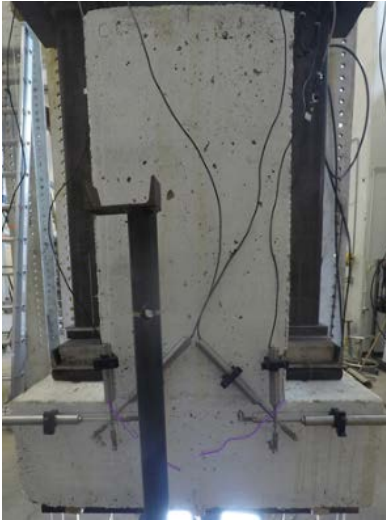
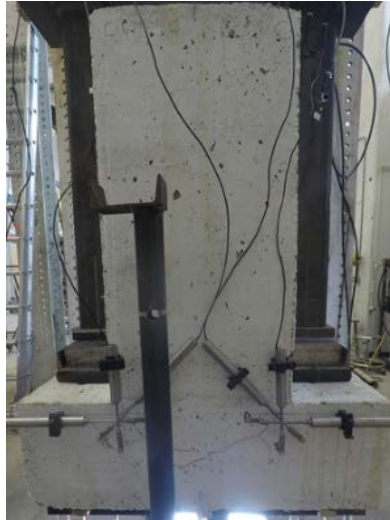
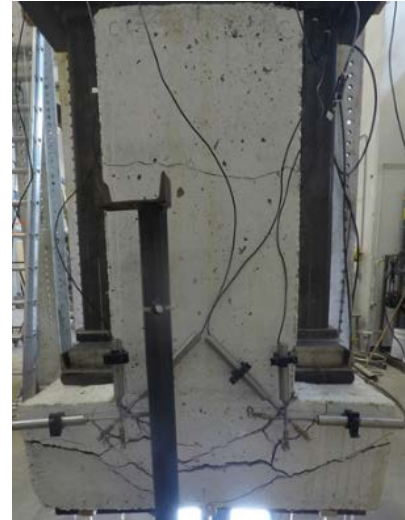
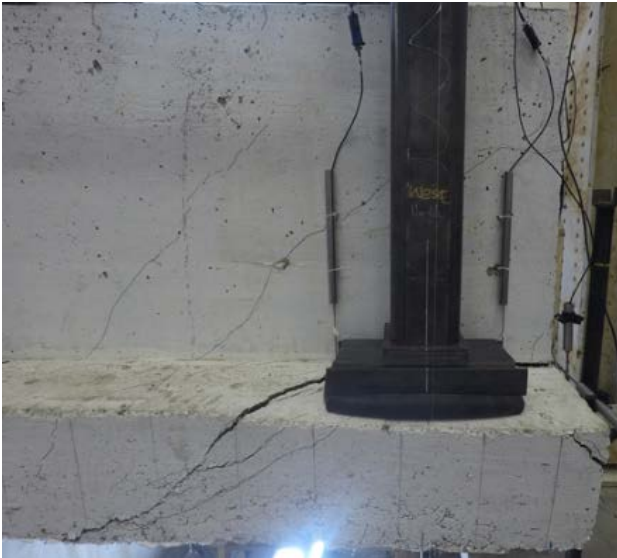
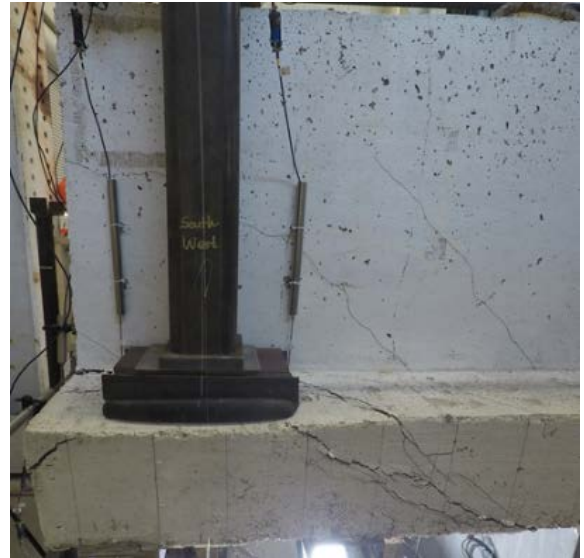
Figure 3.40. Observed Damage for Test T4W1 at Final Load Levels.

The measured ultimate load (90 kips) was 14 percent larger than the estimated capacity (79 kips) and 36 percent larger than the exterior ledge-deficient reference capacity. The test was ended when the applied load dropped to about 80 percent of the measured ultimate load. Figure 3.40 shows the observed damage at the final load level. The specimen experienced a combined ledge flexure and punching shear failure, with more extensive damage occurring on the south side.

The initial crack formed at SLS (45 kips) at the web-ledge interface behind the south side bearing pad. It propagated to the end of the specimen along the web-ledge interface. On the end face, the crack extended diagonally at an approximate angle of 30 degrees.

Under the ULS demand of 68 kips, crack extensions and new crack formations were observed. The cracks at the web-ledge interface propagated toward the column. On the top of the ledge, the cracks at the web-ledge interface extended diagonally to the side face of the ledge. Diagonal shear cracks were also detected on both sides of the web. On the end face, another diagonal crack formed at the north corner. The two diagonal cracks on the end face started at the reentrant corner, propagated horizontally, and connected. A hanger crack formed on the end face 26 in. above the bottom of the bent cap.

Significant extension of existing cracks and new crack formations on the entire tested region were observed as the load went higher than ULS. More diagonal cracks formed on the top of the ledge and further extended to the side face. On the web, new diagonal shear cracks were also presented. New cracks were only formed on the ledge part of the bent cap on the end face. The cracks at the web-ledge interface behind the south bearing pad had a maximum crack width of 8 mm. The maximum crack width observed on the end face was 7 mm. The deflection of the outside channel under the bent cap was visible to the naked eye at the measured ultimate load.

After marking the cracks at the measured ultimate load, the bent cap was loaded further. Crack widths increased except on the hanger crack, with wider cracks on the south side ledge. The bent cap lost its load carrying capacity gradually. The test was ended when the load dropped to 71 kips, which was 20 percent lower than the measured ultimate load.

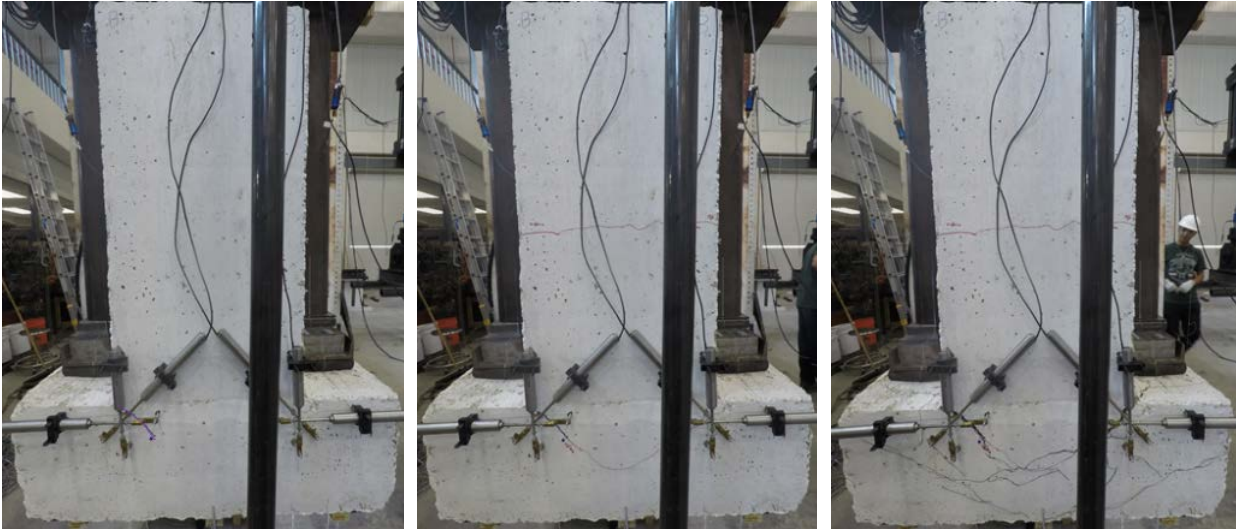
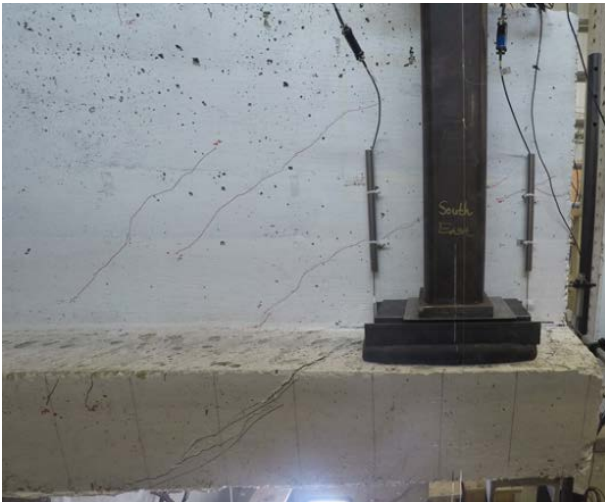
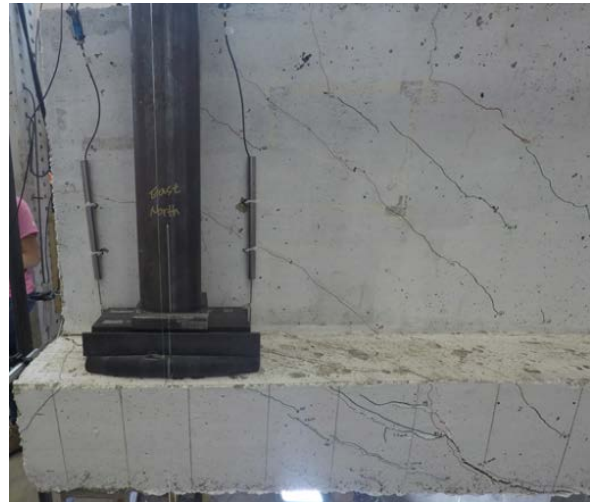
Figure 3.43. Observed Damage for Test T4E1 at Different Load Levels.

The measured ultimate load (80 kips) was about 27 percent larger than the estimated capacity (63 kips) and 21 percent larger than the interior ledge-deficient specimen reference capacity. The test was ended when the applied load dropped to about 90 percent of the measured ultimate load. Figure 3.43 shows the observed damage at final load level. A combined ledge and punching shear failure occurred, with greater damage on the north side.

The initial cracks formed at 40 kips at the web-ledge interface behind the south bearing pad. Negative flexure cracks were detected on the north side of the web. At the SLS of 45 kips, interface cracks behind the bearing pads were found at both sides of the ledge. On the end face, cracks propagated diagonally at an angle of 32° toward the center of the bent cap.

At a load of 57 kips, initiation of diagonal shear cracks was observed on both sides of the web. A hanger crack formed 24.5 in. above the bottom of the bent cap on the end face. At the ULS of 68 kips, more web cracks appeared. On the top of the ledge, the cracks behind the bearing pad extended diagonally, starting at the inner edge of the bearing pad and going to the side face of the ledge. More ledge cracks formed near the web-ledge interface on the end face. The maximum width of the ledge cracks on the end face was 0.9 mm, and the width of the hanger crack was 0.5 mm.

As the load exceeded ULS, the bent cap showed significant crack length and width extensions and new cracks formed. Most of the new cracks formed on the ledge. More cracks formed on the north side of the ledge than on the south side. At the measured ultimate load of 80 kips, diagonal cracks formed on the top of the ledge on both sides. On the side of the ledge, new cracks mainly formed on the north side ledge, with a maximum width of 4.5 mm. One more web shear crack formed on the north side, while no new crack formations were observed on the south side of the web. The negative cracks on the north side of the web extended farther. On the end face, new ledge cracks were detected. As shown in Figure 3.43(d) and (e), more cracks formed on the north part. The maximum crack width on the end face was 6 mm. The width of the hanger cracks remained the same.

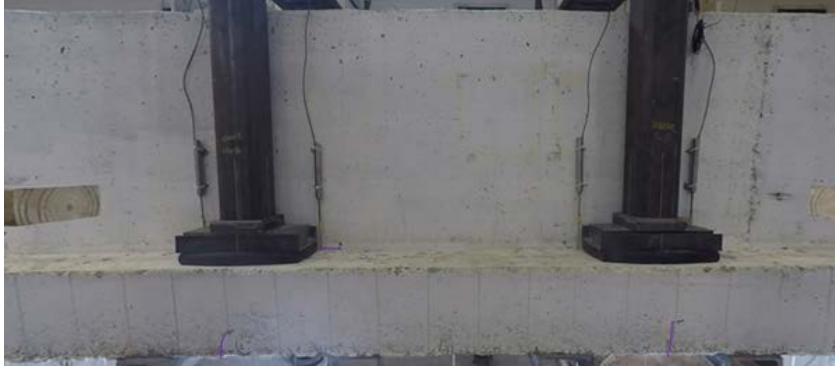
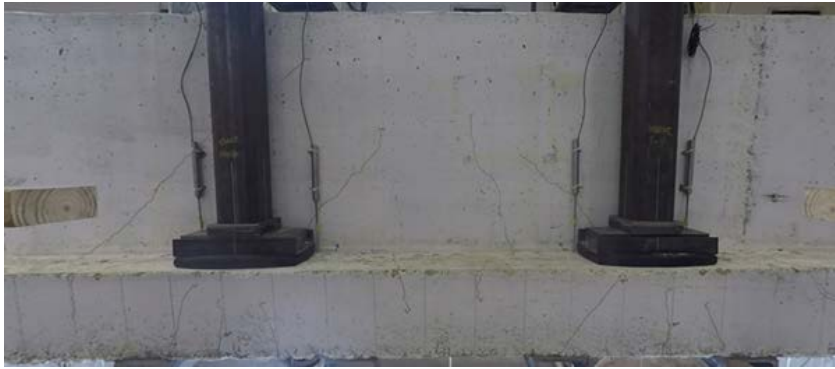
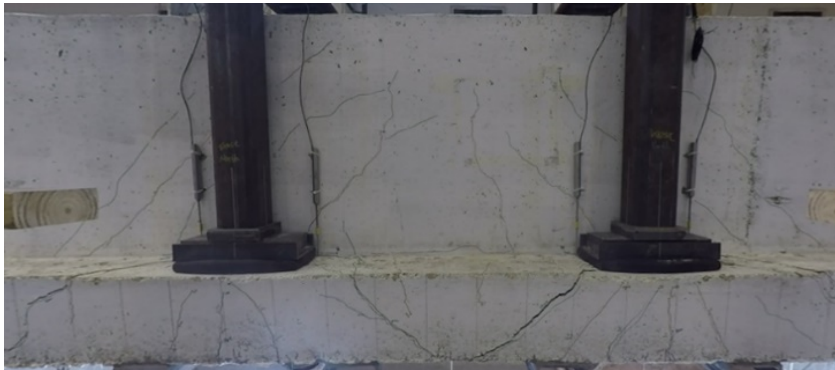
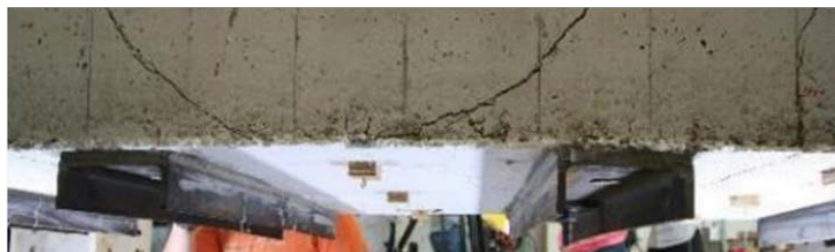
Figure 3.46. Observed Damage for Test T4I1 at Different Load Levels.

The measured ultimate load (99 kips) was 6 percent smaller than the estimated capacity of 105 kips and 16 percent larger than the interior ledge-deficient reference test measured ultimate load. The test was ended after documenting the damages at the measured ultimate load. Figure 3.46 shows the observed damage. The bent cap failed in a combined ledge flexure and punching shear.

The initial cracks were found at the SLS of 49 kips at the web-ledge interface behind the bearing pads. The cracks at the interface propagated about 10 in. toward both sides of the bearing pad, and diagonally extended to the top of the ledge. Flexure cracks were detected on the bottom of the bent cap under the loading points.

At the ULS of 78.5 kips, more diagonal shear cracks were formed on both sides of the web. The shear cracks close to the center of the bent cap had steeper angles than the cracks near the columns. More diagonal cracks formed at the top of the ledge. Diagonal cracks were detected on the side face of the ledge at the outside of the bearing pads with the exception of the northwest bearing pad. Cracks formed on the inside as well as around the northwest bearing pad. The maximum crack width of the diagonal cracks on the side face of the ledge was 2 mm. On the bottom of the bent cap, two more flexure cracks were detected.

A significant crack width increase of ledge cracks was observed as the load was increased above the ULS demand. New crack formations were observed on the entire test region. At the measured ultimate load of 99 kips, the deflection of the two outside channels was visible. Diagonal cracks on the side face of the ledge had a maximum width of 5 mm. A clear pyramid-shaped cone formed under all the bearing pads. The outside diagonal cracks on the ledge were wider than the inside cracks.

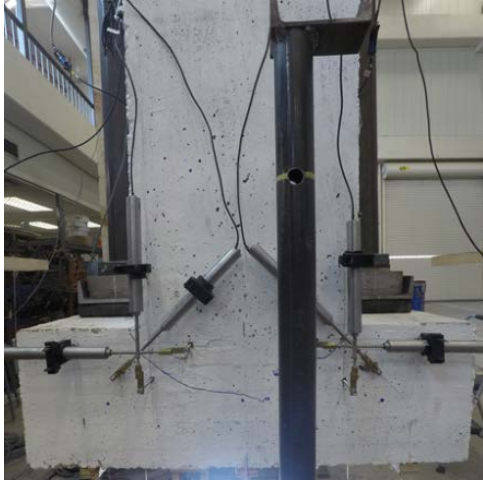
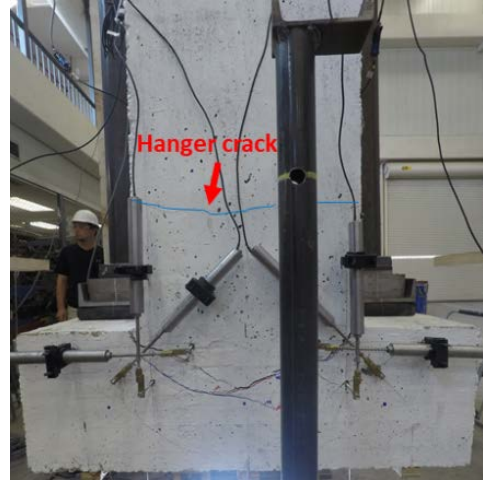
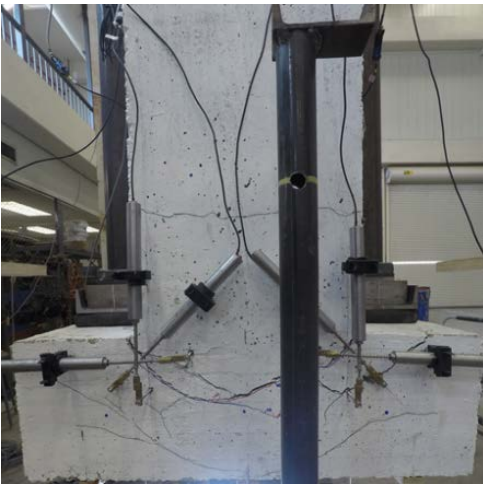
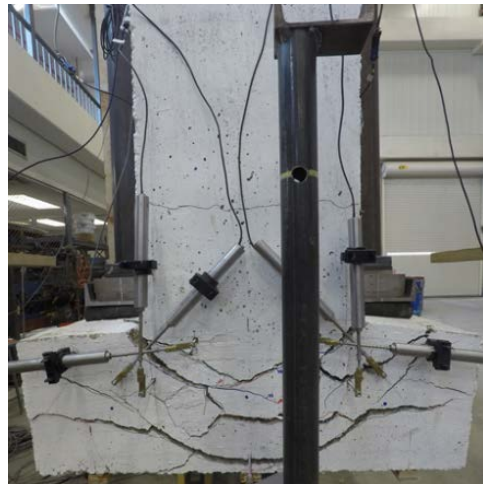
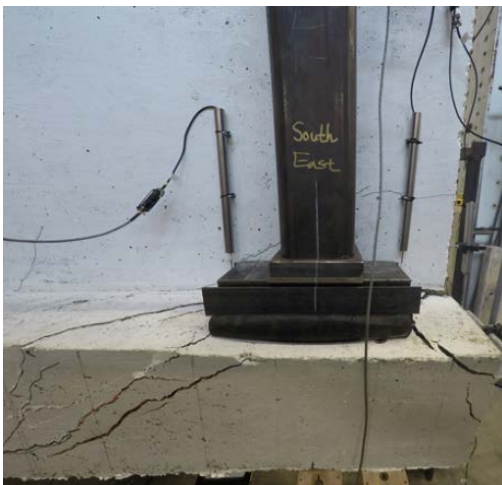
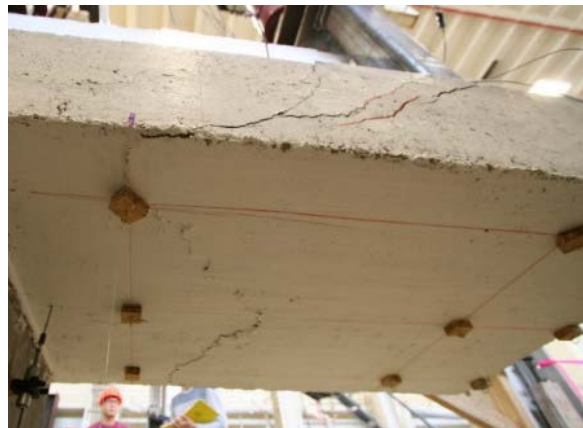
Figure 3.49. Observed Damage for T5E1 at Different Load Levels.

The measured ultimate load (66 kips) was 37 percent larger than the estimated capacity (48 kips). Loading continued after the measured ultimate load until the applied load dropped to about 45 percent of the measured peak load. Figure 3.49 shows the observed damage for test T5E1 at different load levels. The failure started as a ledge flexure failure and finally formed a combined ledge flexure and punching shear failure.

The initial crack formed at 41 kips at the web-ledge interface behind the south bearing pad. At SLS, similar cracks formed behind the northern bearing pad. The cracks behind the bearing pad propagated along the web-ledge interface to the end face. On the end face, cracks extended diagonally at an angle of approximately 30 degrees, as shown in Figure 3.49(a). On the top of the ledge, the cracks behind the bearing pad extended diagonally, starting at the inner edge of the bearing pad and going to the side face of the ledge. The cracks that formed at SLS were all hairline cracks.

After marking cracks at the measured ultimate load, the specimen was further loaded by adding the same amount of pressure to the actuator. The load was then increased to 62.5 kips and then dropped to 37.5 kips. Crack length and width growth of existing cracks except the hanger crack was observed. The maximum width of the ledge cracks on the end face increased to 4 mm, while the width of the hanger cracks remained the same. New crack formations on the side and bottom of the ledge were also detected. The cracks on the side of both ledges extended to form a cone shape. The cone started from each side of the ledge and connected on the bottom of the bent cap, as shown in Figure 3.49(f). The load was sustained at about 32 kips while it was loaded again and then dropped to 23 kips at the final stage.

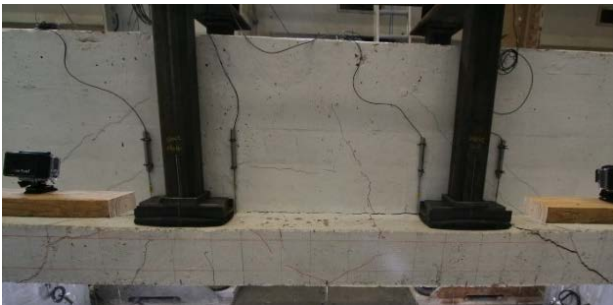
(c) Measured ultimate load—north side

Under the measured ultimate load, width extension of existing cracks and new crack formations around the northwest bearing pad were detected. Figure 3.51(c) shows the observed damage on the north side. It is evident in the figures that more damage occurred on the north side than on the south side. New cracks mainly formed on the side face of the ledge. The width of the diagonal ledge shear crack on the outside of the northwest bearing pad was 3.5 mm. Web-ledge interface cracks on the north side increased to 3.5 mm.

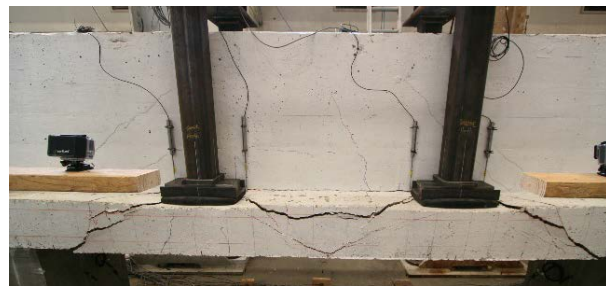
(d) After peak—north side

The bent cap was further loaded after the measured ultimate load by pumping the same amount of pressure to both actuators. The east and west actuator loads were sustained at around 73 kips and 75 kips, respectively. Figure 3.51(d) shows the extent of damage at a post-failure load of 45 kips, when the cracks further opened and the north side ledge region deformed outward and downward from the web.

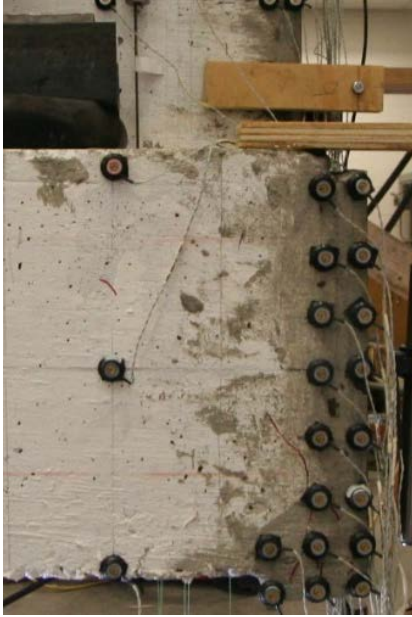
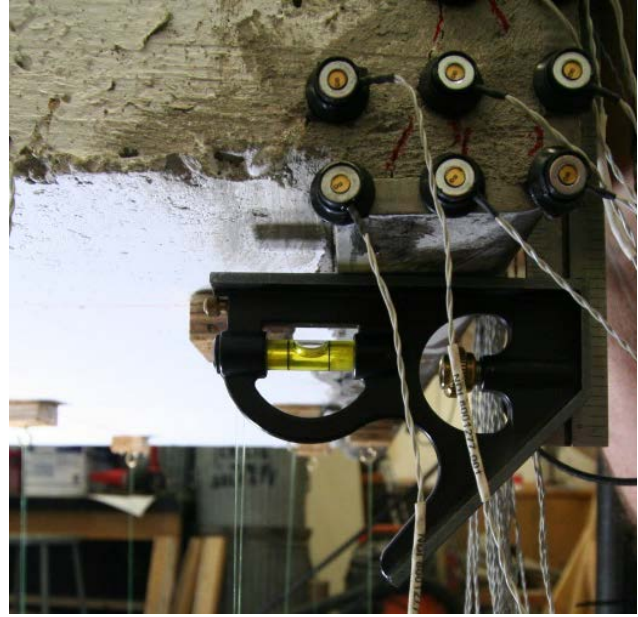
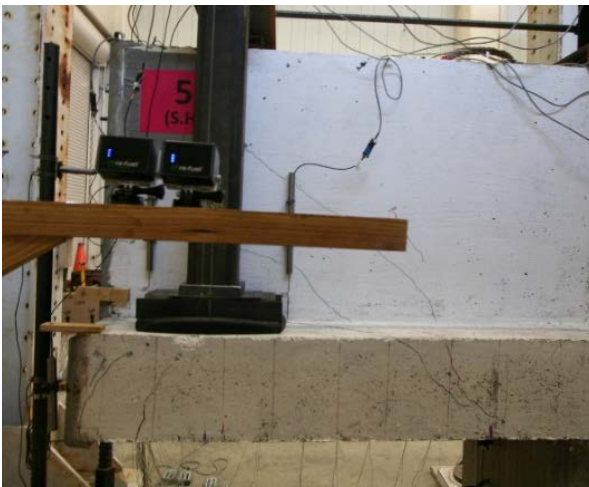
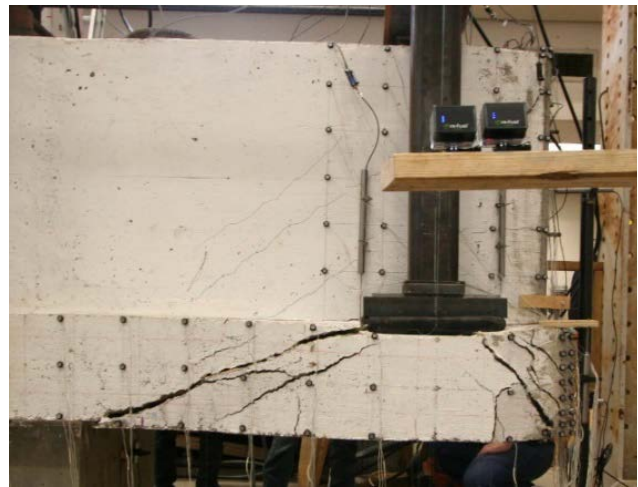
Figure 3.54. Observed Damage for T5W1 at Final Load Level.

Under the ULS of 68 kips, new cracks formed on the web and on the top and side face of the ledge. Diagonal ledge cracks were observed around the bottom corner of the ledge side face. Diagonal web cracks were also detected on the web.

During loading to the measured ultimate load, crack extensions and new crack formations were observed on both the web and ledge. The grout cracks between the end plate and the bent cap formed at 80 kips. Under the measured ultimate load of 86 kips, the bottom tip of the end plate deformed outward, as shown in Figure 3.54(b). More damage occurred on the north side than on the south side. Significant extensions of existing cracks and new crack formations on the north side ledge are seen in Figure 3.54(d). A hanger crack was detected near the neutral axis of the bent cap. There were fewer cracks at the inside of the bearing pad compared to the reference test, which may have been due to the restraint provided by the end plate. The diagonal cracks outside of the bearing pad showed a steeper angle than the inside cracks. The bottom of the end plate deformed outward and downward about 0.5 in. at the end of the test.

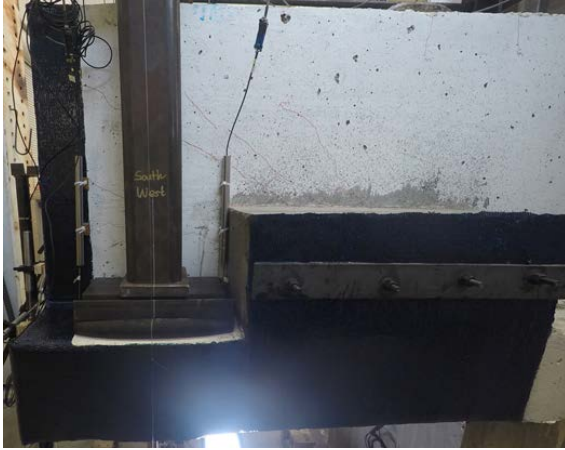
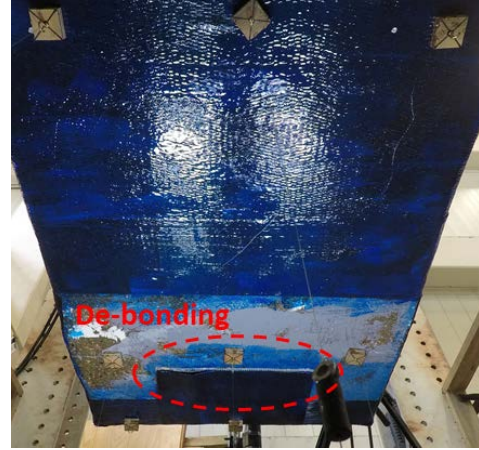
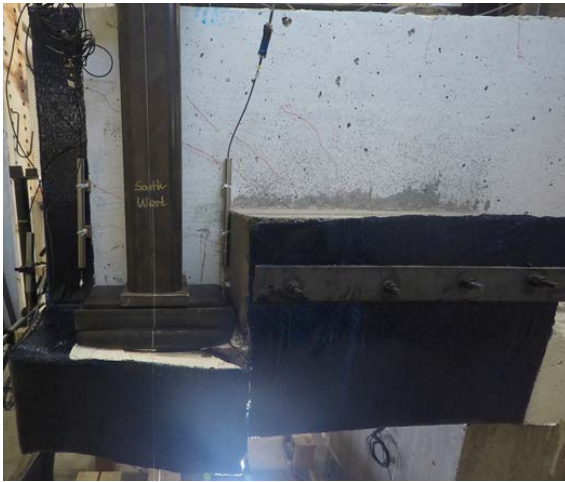
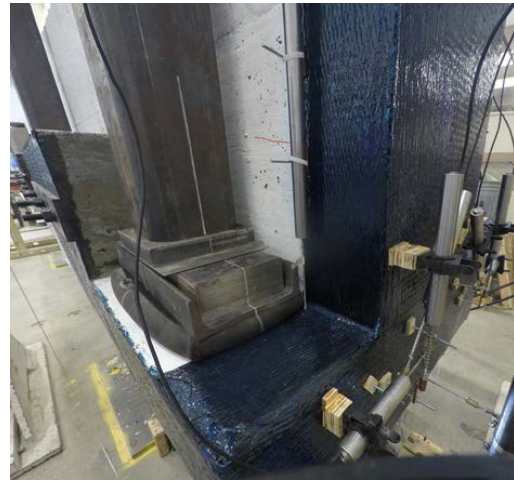
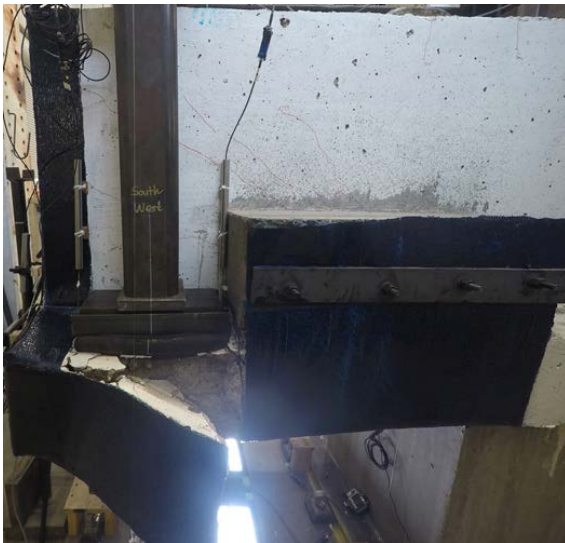
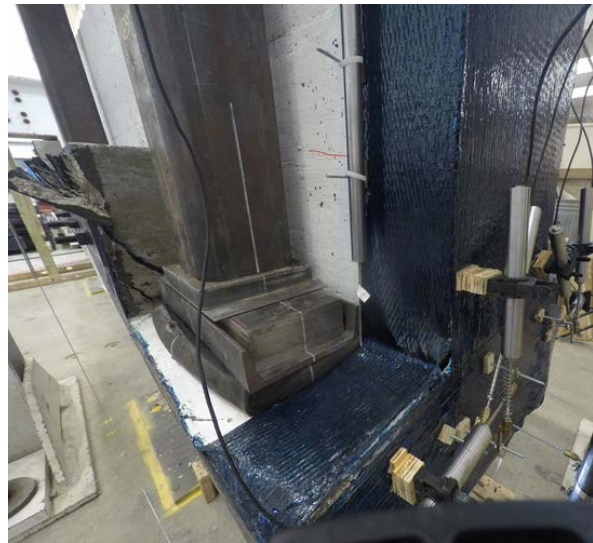
(a) South side at measured ultimate load

(b) Bottom at measured ultimate load

(c) South side at post-peak 75 kips

(d) North corner at post-peak 75 kips

(e) South side at final load level

(f) North corner at final load level

Figure 3.58. Observed Damage for Test T6W1 at Different Load Levels.
