Strengthening of Existing Inverted-T Bent Caps— Volume 2: Experimental Test Program

Technical Report 0-6893-R1-Vol2

TEXAS A&M TRANSPORTATION INSTITUTE
COLLEGE STATION, TEXAS

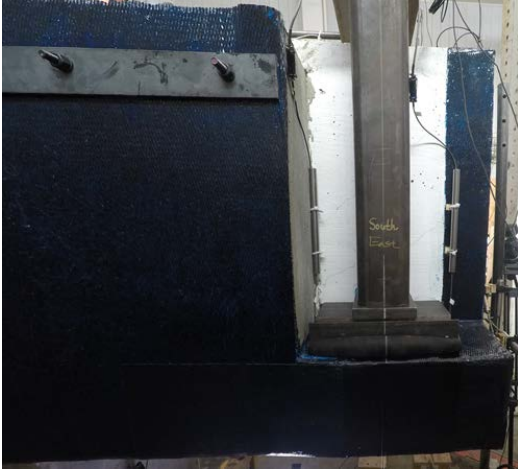
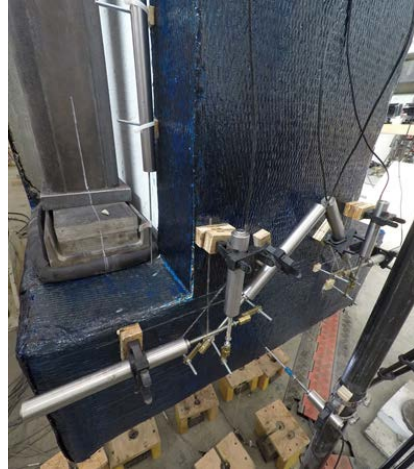
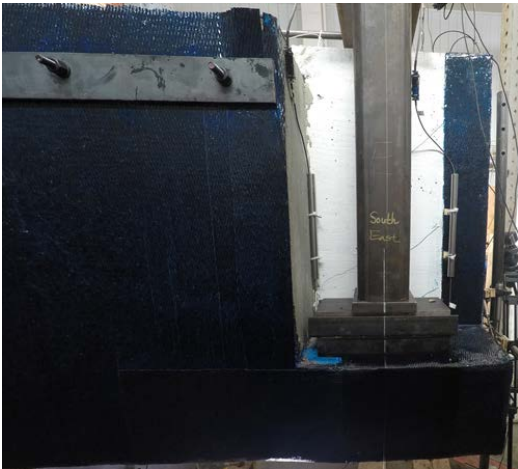
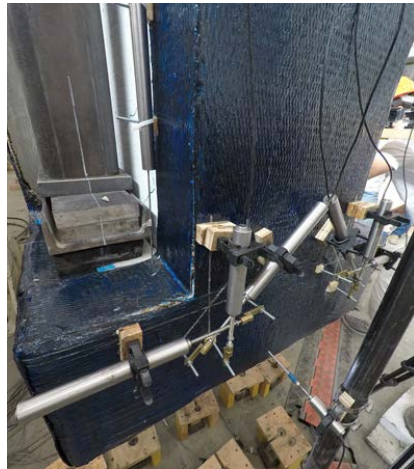
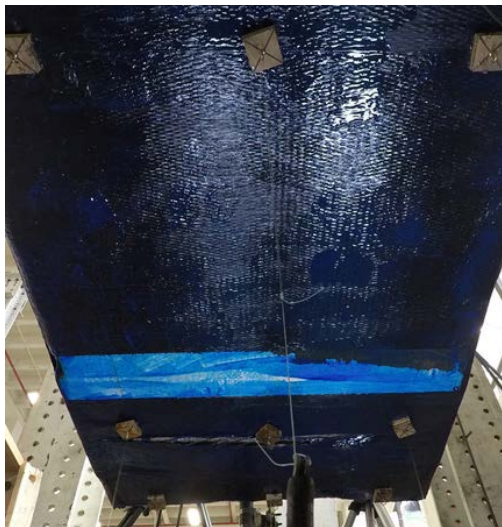
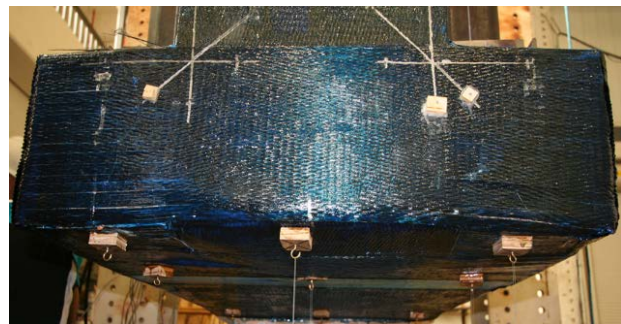
The measured ultimate load (120 kips) was 69 percent larger than the estimated capacity (71 kips) and 82 percent larger than the exterior ledge-deficient reference capacity. The test was ended when the applied load dropped to about 75 percent of the measured ultimate load. Figure 3.61 shows the observed damage. The specimen at final load level showed a combined ledge flexure and punching shear failure.

No damage was visible until the ULS demand of 68 kips. At ULS, cracks formed at the interface between the concrete block and the ledge beside the south side bearing pad. A web shear crack was detected on the south side web at the inner side of the concrete block. Negative flexure cracks formed on the north side of the web.

More cracks on the web were observed as the load increased. A hanger crack formed at 88 kips. At a load of 102.5 kips, horizontal cracks started to form on the flange at the end face. Intermediate shear-crack-induced debonding of the FRP occurred at the end of the concrete block on the bearing pad side. More separations of the FRP strip were observed at the end of the concrete block as the load went higher. At a load of 112.5 kips, a separation of the FRP was observed at the web-ledge interface near the end of the bent cap. At the measured ultimate load of 120 kips, end interfacial debonding of the FRP was observed at the end of the south side concrete block. The load dropped to 100 kips, accompanied by a loud sound, due to shear rupture of the FRP at the end region of the concrete block.

(a) North side at measured ultimate load

(b) North corner at measured ultimate load

(c) North side at final load level

(d) North corner at final load level

(e) Bottom at final load level

(f) Ledge after removal of load

Figure 3.61. Observed Damage for Test T6E1 at Different Load Levels.

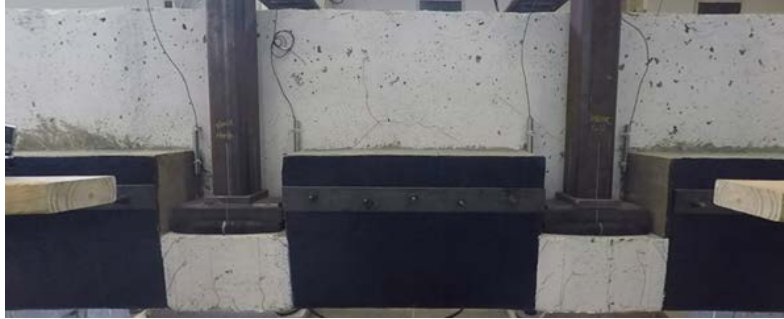
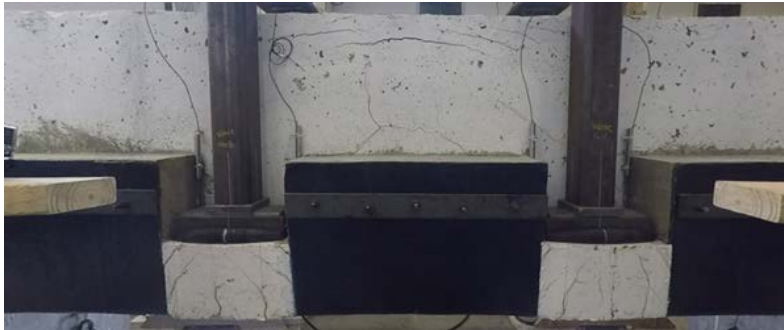
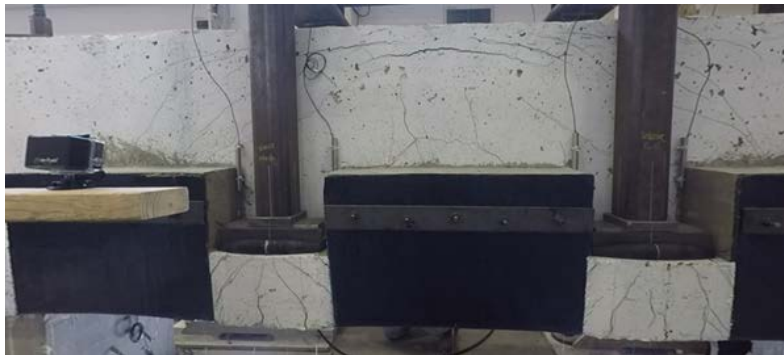
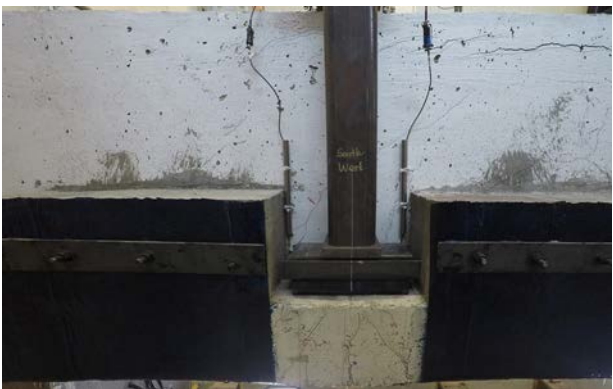
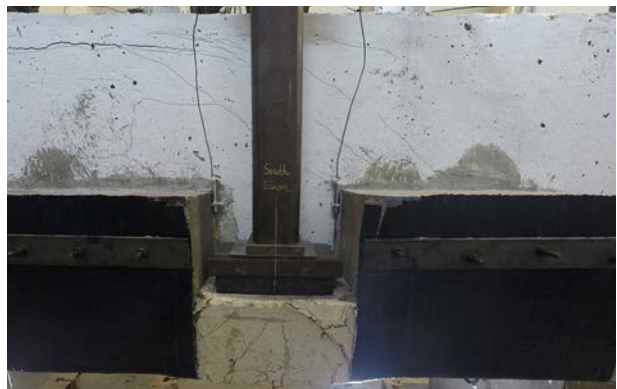
The measured ultimate load (103 kips) was 6 percent larger than the estimated capacity (97 kips) and 21 percent larger than the interior ledge-deficient reference capacity. The test was ended when the applied load dropped to about 90 percent of the measured ultimate load. Figure 3.64 shows the observed damage at the final load level. The specimen at the final load level showed a combined hanger and punching shear failure.

At the SLS of 49 kips, the initial cracks formed at the interface of the northwest concrete block and the ledge. Flexure cracks were detected on the bottom along the interface of the FRP strip and the bent cap. More cracks formed on the side face of the north side ledge at the interface of the FRP strip and bent cap. At a load of 75 kips, the first diagonal shear cracks were detected on the web behind the southwest load point.

At the ULS of 78.5 kips, more cracks had formed at the interface between the FRP and bent cap. Diagonal shear cracks were detected on both sides of the web. On the side face of the ledge, diagonal cracks formed under the bearing pad between the concrete blocks. Crack extensions and new crack formations were observed as the load increased.

End interfacial debonding of the FRP was detected at the east end of the southwest concrete block at 84 kips. More cracks formed on the web. As the load increased, the web shear crack angles appeared to decrease, tending more toward horizontal angles between the loading points. More end interfacial debonding of the FRP occurred at the end of the concrete blocks. At a load of 99 kips, intermediate shear-crack-induced interfacial debonding was observed at the end of the southeast concrete block. The web shear cracks from the outside of the bearing pads connected horizontally near the top of the bent cap formed interior hanger cracks. At the measured ultimate load of 103 kips, intermediate shear-crack-induced interfacial debonding of the FRP was observed at all inner ends of the concrete blocks. The maximum crack width of the interior hanger cracks was 5.5 mm.

(a) North side at ULS

(b) North side at measured ultimate

(c) North side at final load level

(d) Southwest at final load level

(e) Southeast at final load level

Figure 3.64. Observed Damage for Test T6I1.

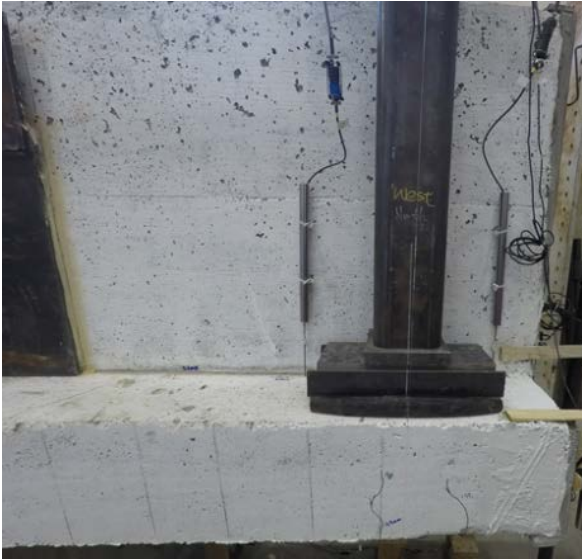
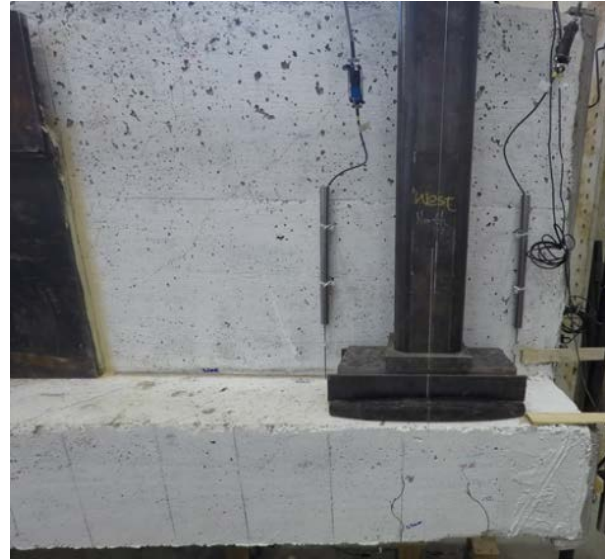
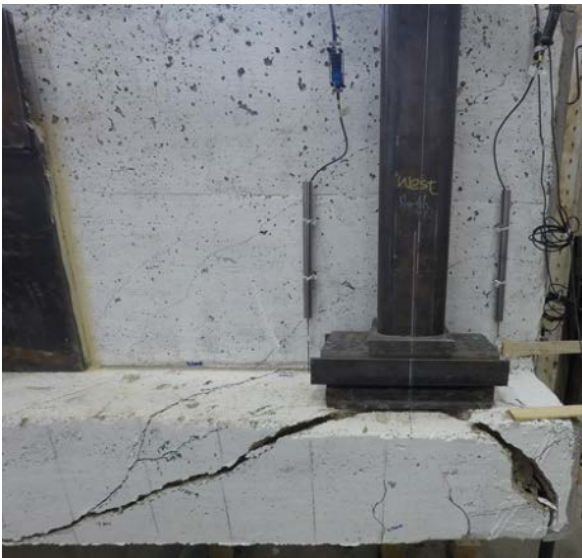
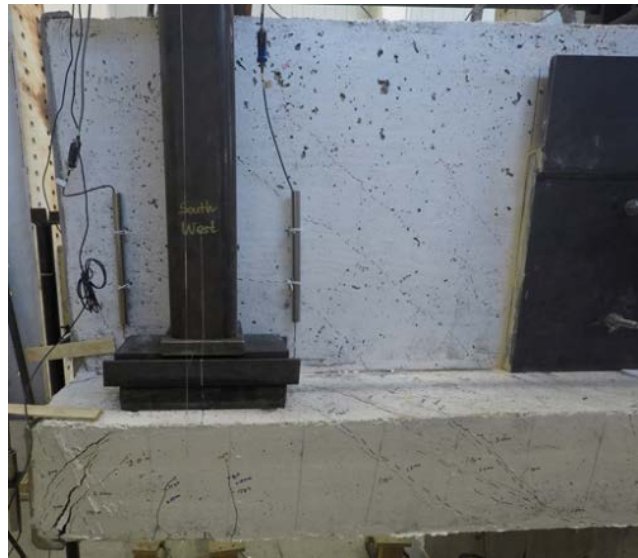
The measured ultimate load (88 kips) was 63 percent larger than the estimated capacity of 54 kips and 33 percent larger than the ultimate load capacity of the exterior ledge-deficient reference capacity. The test was ended when the applied load dropped to about 60 percent of the measured ultimate load. Figure 3.75 shows the observed damage at the final load level. The bent cap experienced a punching shear failure on the north side. Damage was more extensive on the north side of the bent cap.

Under the ULS of 68 kips, diagonal shear cracks on both sides of the web were detected. The web-ledge interface cracks extended diagonally to the top of the ledge. More diagonal cracks formed on the side face of the ledge on both sides. A negative flexure crack was detected on the north side web.

During loading to the measured ultimate load, crack extensions and new crack formations were observed on both the web and ledge. The bottom corner of the end plate started to open as the load reached 77 kips. At a load of 82.5 kips, vertical cracks formed on both sides of the web at the top of the end plate. At the measured ultimate load of 88 kips, more cracks were observed on both sides of the web and ledge. The north side of the ledge had more severe damage than the south side. A clear pyramid-shaped cone formed under the north side bearing pad.

(a) North side at SLS

(b) North side at ULS

(c) North side at final load level

(d) South side at final load level

Figure 3.75. Observed Damage for Test T7W2 at Different Load Levels.

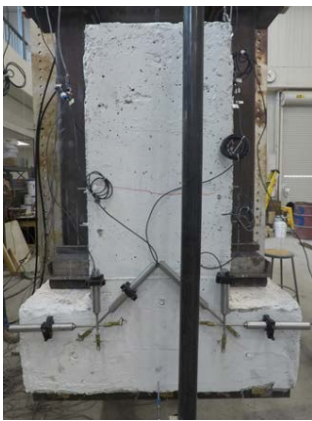
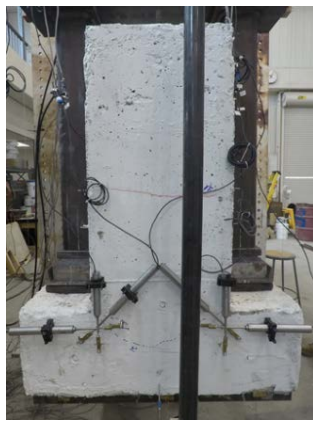
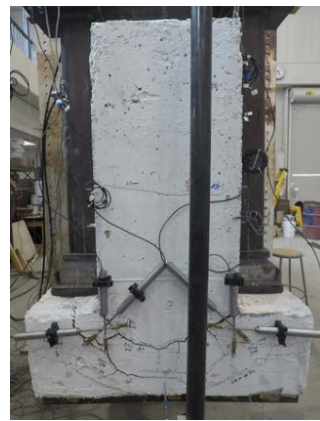
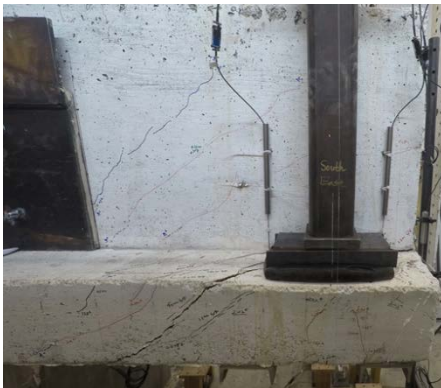
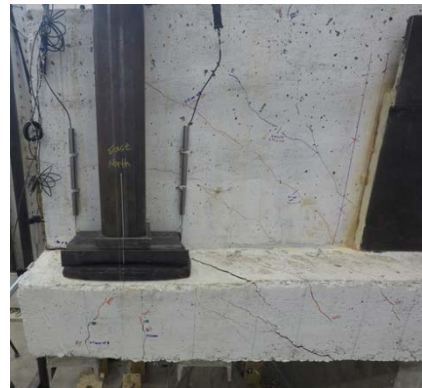
At the ULS of 68 kips, more diagonal cracks formed on the end face. A flexure crack was detected on the north side web. The width of the old hanger crack on the end increased to 0.4 mm, and the width of the new hanger crack that formed at SLS near the web-ledge interface was 0.5 mm at ULS.

Crack extensions and new crack formations were observed as the load went above ULS. A pyramid-shaped cone started to form under the bearing pad on both sides of the specimen when the load exceeded 90 kips, accompanied by a slope change in load-deflection curve. Significant damage progression was observed after 90 kips. The measured ultimate load of 101 kips was observed in 90 seconds. The width of the cone cracks on the side ledge, and of the hanger crack near the web-ledge interface on the end face, increased extensively during this stage. The width of the old hanger crack on the end face above the neutral axis did not increase. The maximum width of the cone cracks and hanger crack at the measured ultimate load were both 2.5 mm. The test was stopped when the load dropped to 93 kips. More damage on the south side than the north side was observed after the measured ultimate load. The maximum widths of the cone cracks on the south side and north side were 4 mm and 2.5 mm at the final load level, respectively. The widths of the new and old hanger cracks on the end face were 3.5 mm and 0.5 mm at the final load level, respectively.

(a) End face before test

(b) End face at SLS

(c) End face at final load level

(d) South side at final load level

(e) North side at final load level

Figure 3.77. Observed Damage for Test T7E2 at Different Load Levels.

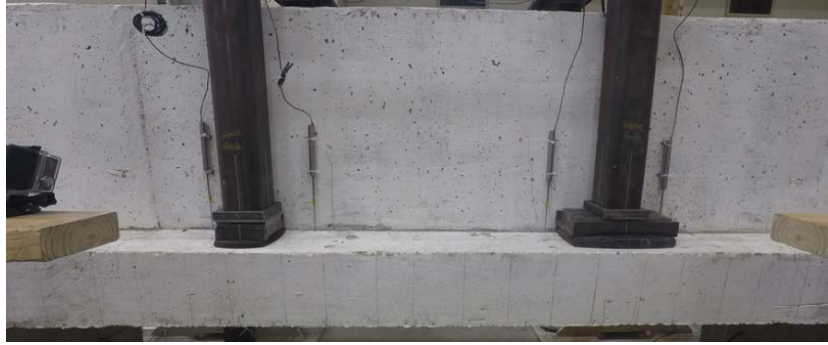
(a) North side at ULS (loaded simultaneously)

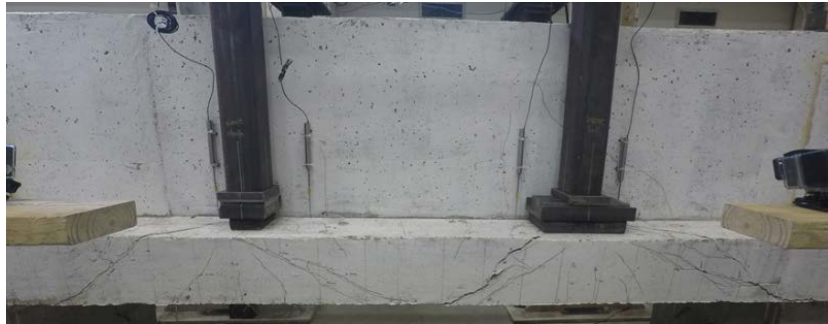
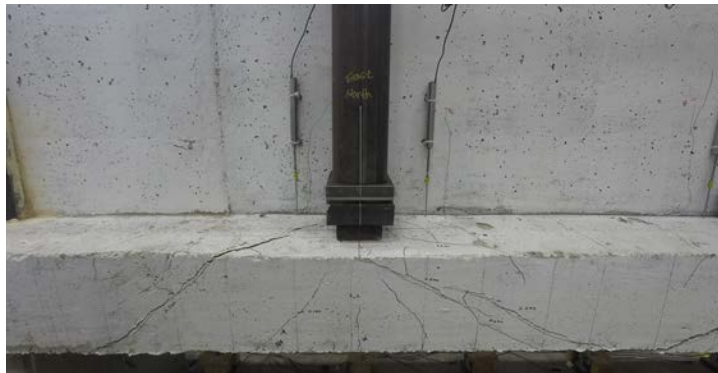
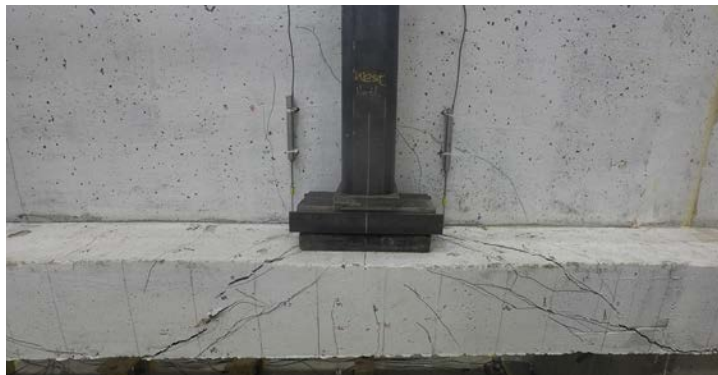
(b) North side at final load level

(c) T7I1 at final load level

(d) T7I2 at final load level

Figure 3.80. Observed Damage for Test T7I1 and T7I2 at Different Load Levels.

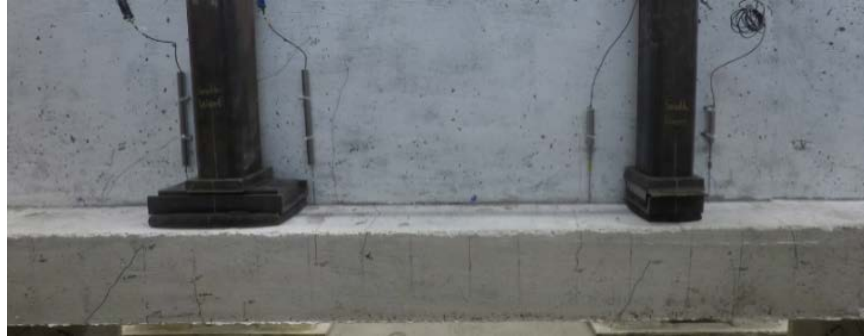
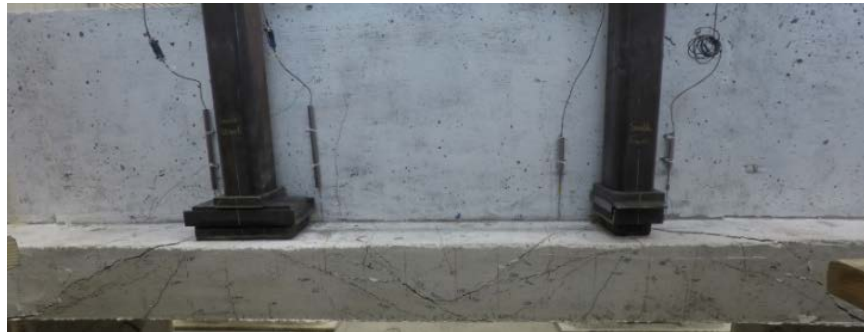
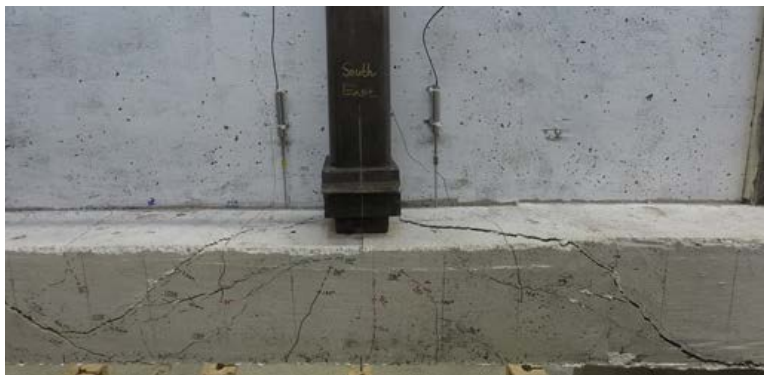
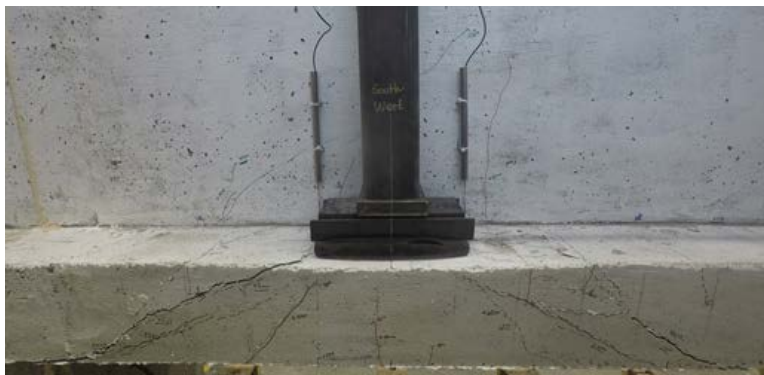
The measured ultimate load for test T7I3 was 112 kips, which was 75 percent larger than the estimated capacity (64 kips). The measured ultimate load for test T7I4 was 113 kips, which was 30 percent larger than the estimated capacity (87 kips) and 1 percent larger than the measured ultimate capacity of T7I3. Tests T7I3 and T7I4 were stopped when the applied load dropped to about 70 percent and 85 percent of the corresponding measured ultimate load, respectively. Figure 3.83 shows the observed damage for tests T7I3 and T7I4. Both tested regions experienced punching shear failure.

All the existing cracks were hairline cracks before the test. At the dead load, no new cracks had formed. The load for T7I4 was then increased to ultimate failure, while for T7I3, it was held at the dead load level. At the SLS of 49 kips, the width of the existing cracks increased a bit and a new crack formed at the web-ledge interface between the two bearing pads. The interface crack was the widest crack at SLS, with a width of 0.2 mm.

At the ULS of 78.5 kips, a new crack formed on top of the ledge near the center of the specimen. More new crack formations and extension of the existing cracks were observed as the load increased upon ULS. A diagonal crack propagated diagonally from the northwest corner of the bearing pad to the side of the ledge at 90 kips. The formation of the main cone cracks initiated at 100 kips. The west side of the cone crack formed first at 100 kips, accompanied by a slope change of the load-deflection curve. The east side of the cone crack formed at 108 kips. The measured ultimate load of 113 kips was observed within 60 seconds after both sides of the main cone cracks formed. The widths of the west and east side of the cone cracks were 1.5 mm and 1 mm at the measured ultimate load, respectively. The starting point of the west side cone crack on the side of the ledge was 4 in. away from the west tip of the bearing pad, whereas the east side

started at the east tip of the bearing pad. More diagonal cracks were detected on the top and side of the ledge. The load dropped gradually after the peak, and the test was ended when the load dropped to 95 kips. The widths of the west and east side of the cone cracks were increased to 2.5 mm and 2 mm at the final load level, respectively.

The load for T7I3 increased to ultimate failure after the load for T7I4 was retracted to the dead load level. Extension of the existing cracks was observed at the SLS of 49 kips. At the ULS of 78.5 kips, new diagonal cracks formed on top of the ledge. The diagonal cracks on the side of the ledge beneath the bearing pad extended about 2 in. The main cone cracks started to form at 105 kips. The east side of the cone crack formed first, resulting in a slope change in the load-deflection curve. The west side of the cone formed at 112 kips. The applied load reached the measured ultimate load (113 kips) shortly after both sides of the cone crack formed. The widths of the west and east sides of the cone cracks were 1.5 mm and 2 mm, respectively, at the measured ultimate load. The starting points for the west and east side of the cone cracks on the side of the ledge were 12 in. and 14 in. away from the west and east tip of the bearing pad, respectively. More diagonal cracks on the side of the ledge that had shallower angles than the main cone cracks were formed at the measured ultimate load. These cracks started at the tip of the bearing pads and connected to the main cone cracks at about half the depth of the ledge on both sides. More cracks formed on top of the ledge, and the cracks on the web extended. The load dropped gradually after reaching the measured ultimate load. The test was stopped when the applied load dropped to 80 kips. The widths of the west and east side of the cone cracks were 3.5 mm and 4 mm at the final load level, respectively.

The west side of the failure plane for T7I3 intersected with the one for T7I4 that was conducted before T7I3 (Figure 3.83[b]).

(a) South side at dead load (loaded simultaneously)

(b) South side at final load level

(c) T7I3 at final load level

(d) T7I4 at final load level

Figure 3.83. Observed Damage for Test T7I3 and T7I4 at Different Load Levels.

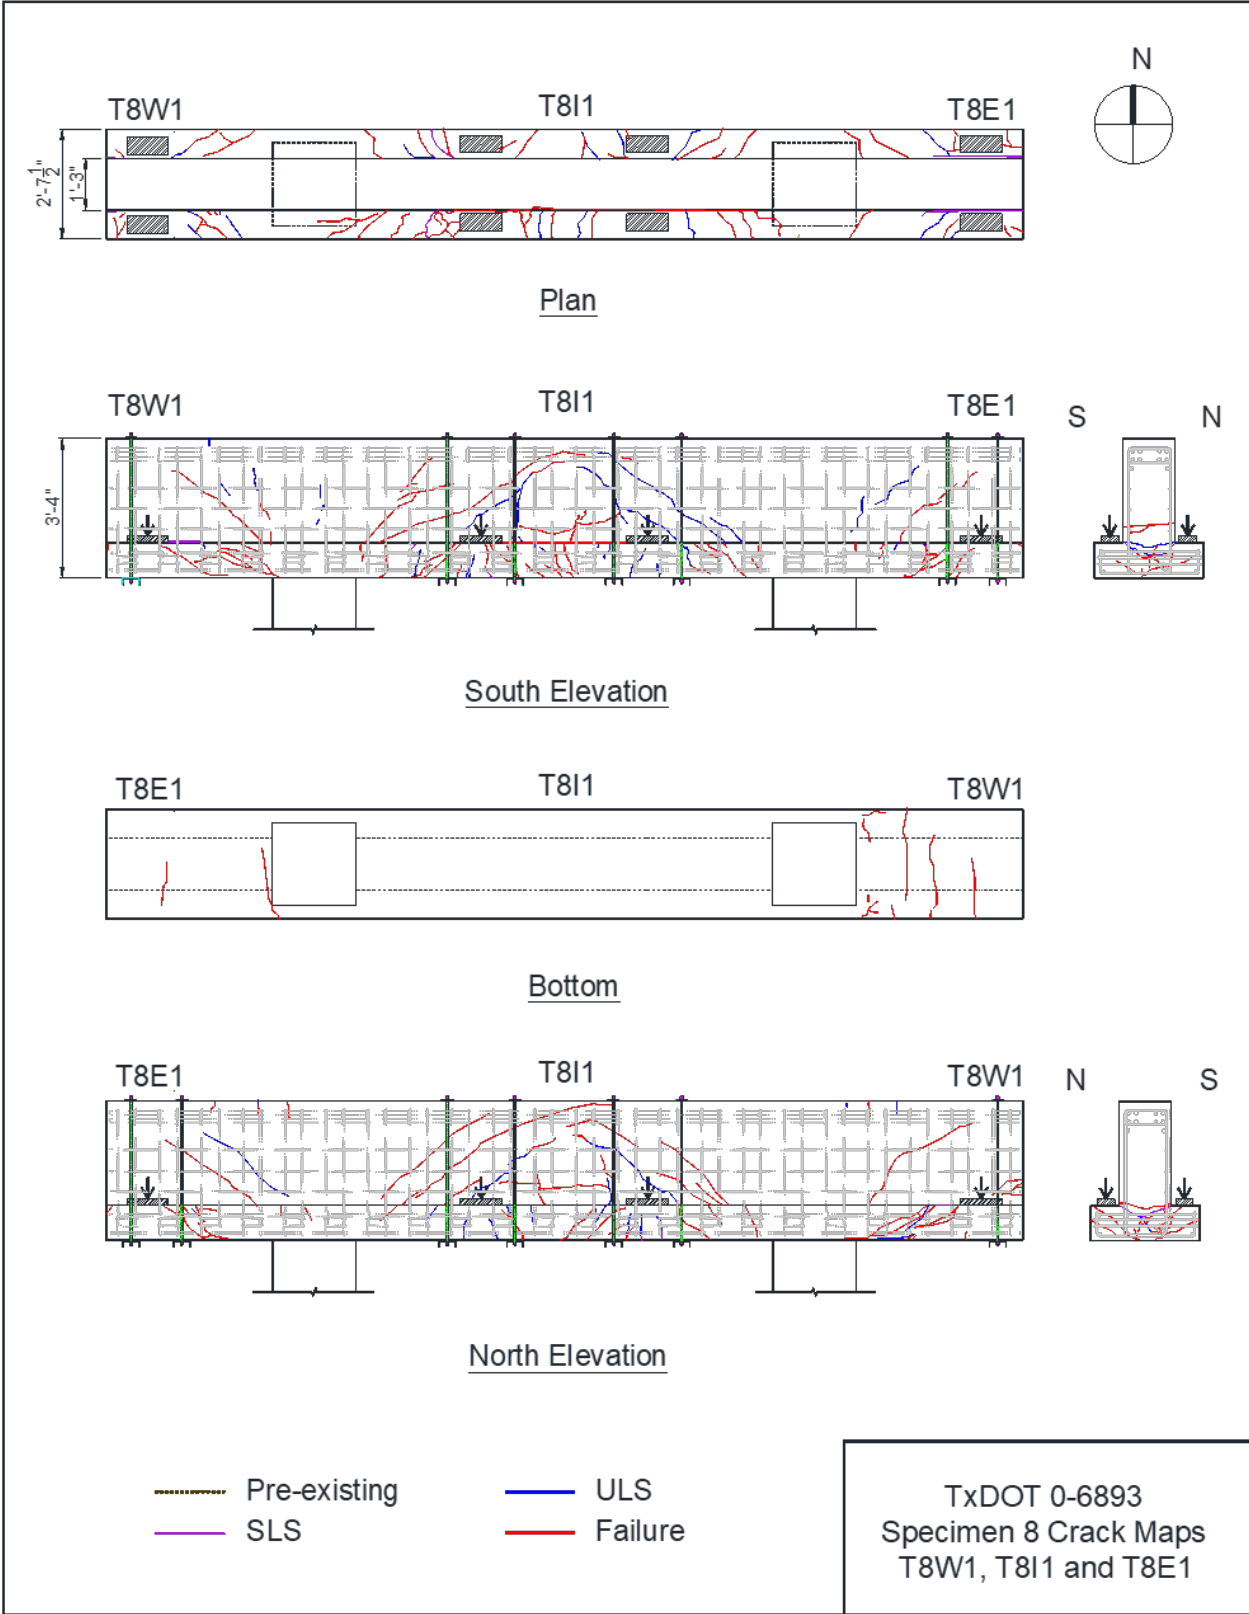
Figure 3.84. Crack Maps for Tests T8W1, T8I1, and T8E1.

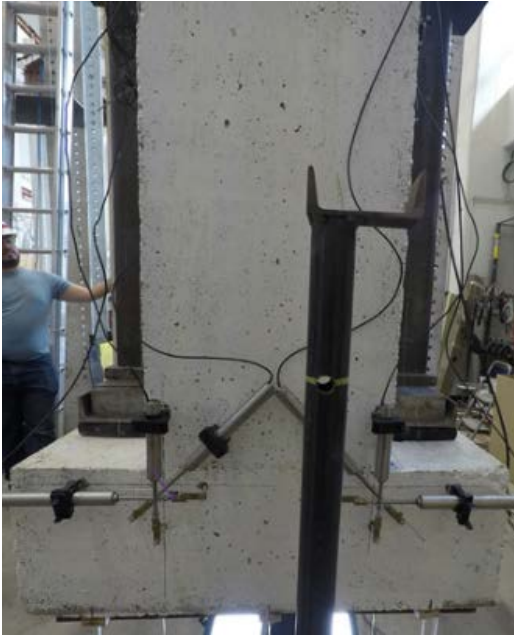
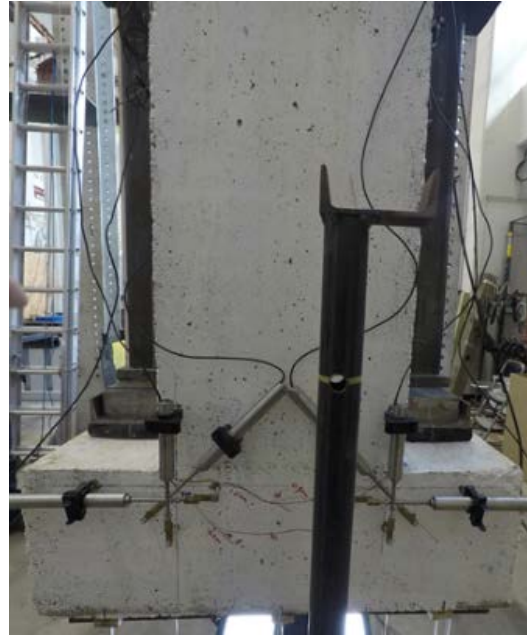
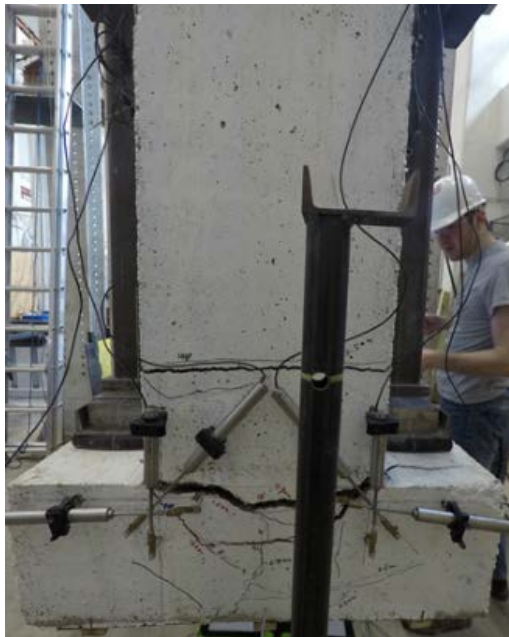
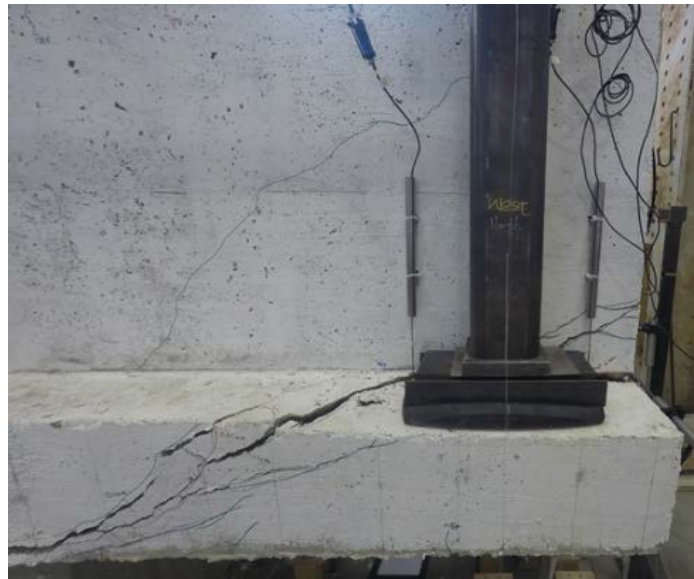
The measured ultimate load (88 kips) was 37 percent larger than the estimated capacity (64 kips) and 33 percent larger than the exterior hanger-deficient reference capacity. The test was ended when the applied load dropped to about 70 percent of the measured ultimate load. Figure 3.87 shows the observed damage at the final load level. The bent cap experienced a hanger failure.

The initial crack, observed at the SLS of 45 kips, formed at the web-ledge interface behind the bearing pad on both sides of the ledge, extending to the end of the specimen. On the end face, the crack extended diagonally at an approximate angle of 32 degrees. The two diagonal cracks on the end face started at the reentrant corner, propagated horizontally, and connected at a load of 60 kips.

Under the ULS of 68 kips, crack extensions and new crack formations were observed. The cracks at the web-ledge interface propagated toward the column of the bent cap. On the top of the ledge, the cracks at the web-ledge interface extended diagonally to the side face of the ledge. Diagonal shear cracks were detected on the south side of the web. Negative flexure cracks were detected on the north side of the web. The crack near the web-ledge interface on the end face had a maximum crack width of 0.9 mm.

Significant extensions of existing cracks and new crack formations on the entire tested region were observed as the load went higher than ULS. Web shear cracks formed on the north side at 73 kips. More diagonal cracks formed on the top of the ledge and further extended to the side face. A hanger crack formed on the end face near the neutral axis of the bent cap at 82 kips. The hanger cracks were propagated to the web at 84 kips.

At the measured ultimate load of 88 kips, new ledge shear cracks had formed on the end face. The horizontal crack on the end face near the web-ledge interface opened up to 7 mm. The second hanger formed near the neutral axis and had a width of 5 mm. More diagonal cracks were detected on the side face of the ledge with a maximum width of 11 mm. The deflection of the outside channel under the bent cap was visible at the measured ultimate load.

(a) End face at SLS

(b) End face at ULS

(c) End face at final load level

(d) End face at SLS

Figure 3.87. Observed Damage of Test T8W1 at Different Load Levels.

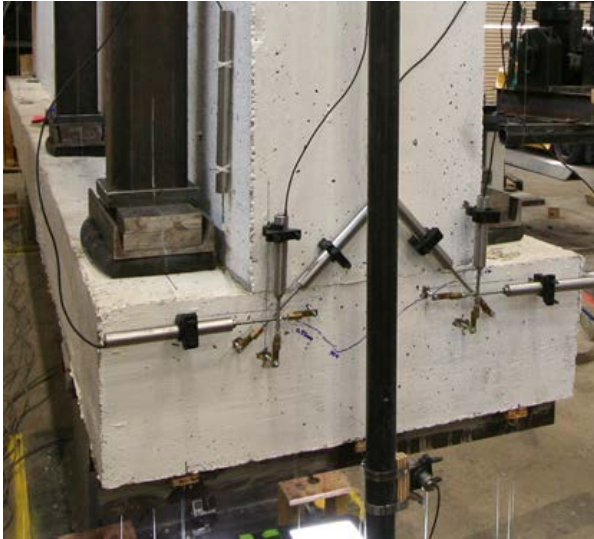
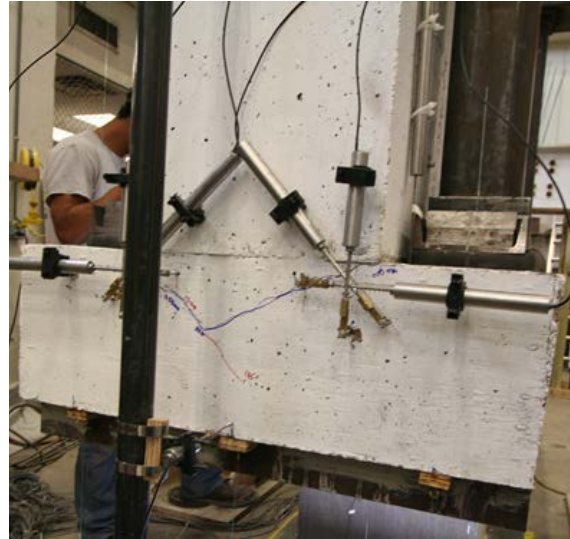
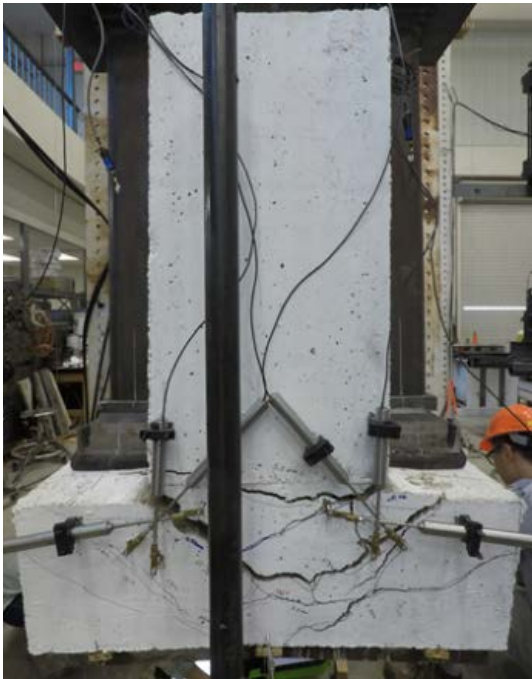
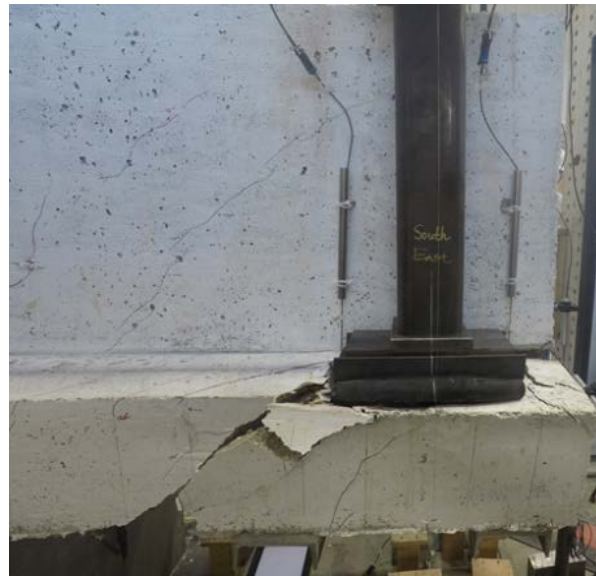
The measured ultimate load (98 kips) was 19 percent larger than the estimated capacity (82 kips) and 48 percent larger than the exterior hanger-deficient reference capacity. The test was ended when the applied load dropped to about 90 percent of the measured ultimate load. Figure 3.90 shows the observed damage. The damage was more extensive on the south side.

Cracks formed before SLS and the retrofit solution installation was completed by stressing the threadbars. The cracks formed at the web-ledge interface behind the bearing pad. The bent cap was loaded again to SLS. No new crack formation was observed. The existing cracks remained as hairline cracks.

At the ULS of 68 kips, shear cracks were detected on both sides of the web. The diagonal cracks that started at the two reentrant corners on the end face were propagated horizontally and connected to each other. The width of the crack was 1 mm. At the top of the ledge, the cracks behind the bearing pad extended diagonally, starting at the inner edge of the bearing pad and going to the side face of the ledge.

As the load exceeded ULS, the bent cap showed significant crack length and width extensions with the formation of new cracks. Most of the new cracks formed on the ledge. At a load of 75 kips, a hanger crack formed on the end face near the neutral axis of the bent cap. At the measured ultimate load of 98 kips, more diagonal cracks had formed on the top and side face of the ledge on both sides. New shear cracks were also detected on both sides of the web. On the end face, new ledge cracks were detected. The width of the crack near the web-ledge interface on the end face increased to 5.5 mm.

(a) End face at SLS (after fastened threadbars)

(b) End face at ULS

(c) End face at final

(d) South side at final

Figure 3.90. Observed Damage for Test T8E1 at Different Load Levels.

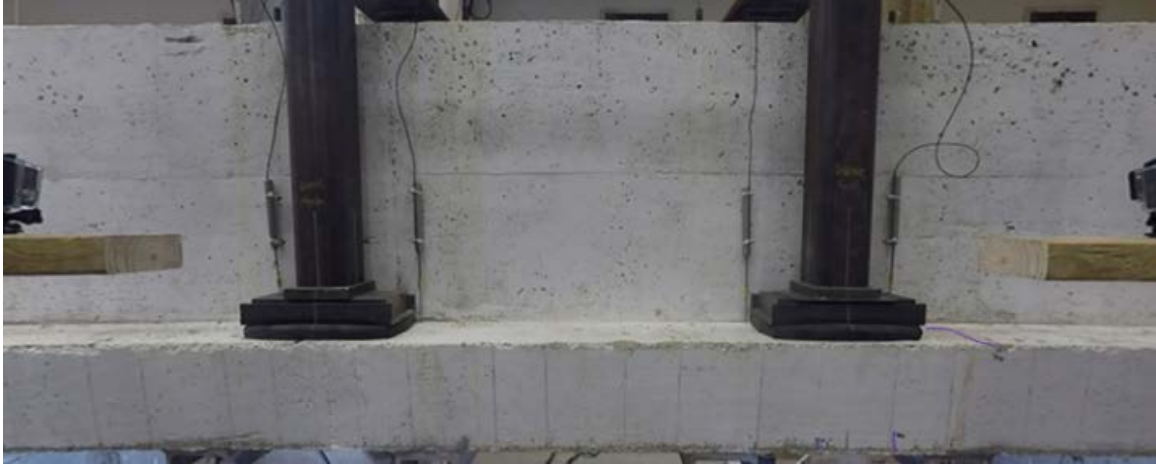
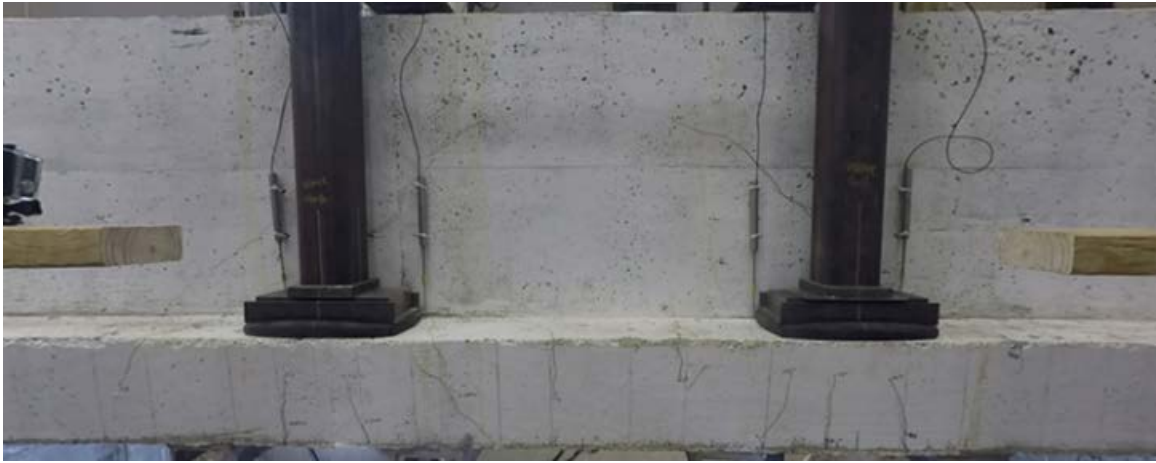
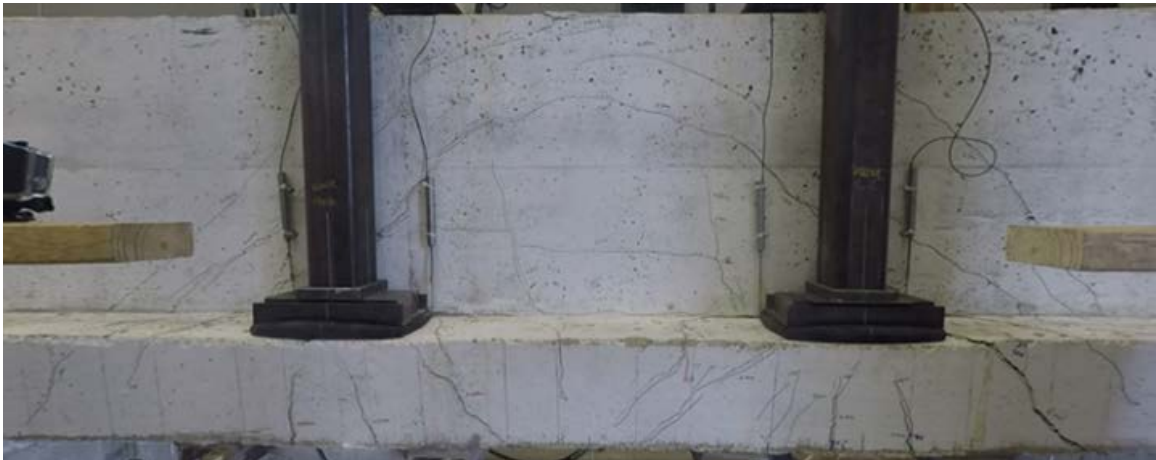
The measured ultimate load (109 kips) was 30 percent larger than the estimated capacity (84 kips) and 21 percent larger than the interior hanger-deficient reference test measured ultimate load. The test was ended when the applied load dropped to about 90 percent of the measured ultimate load. Figure 3.93 shows the observed damage. The specimen failed in hanger.

The initial cracks were found at the SLS of 49 kips at the web-ledge interface behind the bearing pads. The cracks at the interface propagated toward both sides of the bearing pad and diagonally extended to the top of the ledge on the outside of the bearing pad. Flexure cracks were detected on the bottom of the bent cap right under the loading points. Crack extensions and new cracks were observed as the load increased.

At the ULS of 78.5 kips, diagonal shear cracks were formed on both sides of the web. The web shear cracks at this state were formed on the outside of the bearing pads, going toward the center of the bent cap. More diagonal cracks were formed on top of the ledge. Diagonal cracks were also detected on the side face of the ledge near the bearing pads. The maximum crack widths of the diagonal cracks on the side face of the ledge and the web shear cracks were 1 mm and 0.3 mm, respectively.

New cracks formed throughout the specimen, and ledge crack widths increased significantly. At the measured ultimate load of 109 kips, deflections of the two outside channels were visible. More diagonal shear cracks formed on both sides of the web. The angles of the shear cracks decreased as they propagated toward the center of the bent cap. The maximum width of the web shear cracks was 0.9 mm.

(a) North side at SLS

(b) North side at ULS

(c) North side at final load level

Figure 3.93. Observed Damage for Test T8I1 at Different Load Levels.

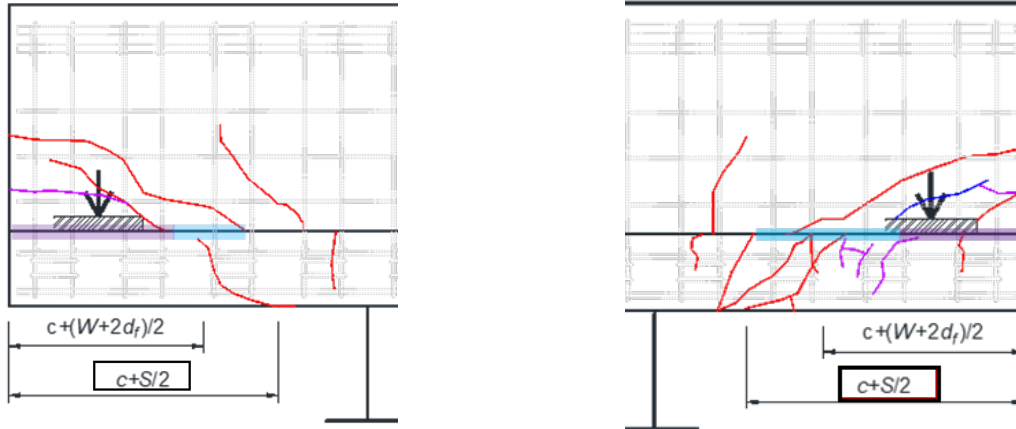
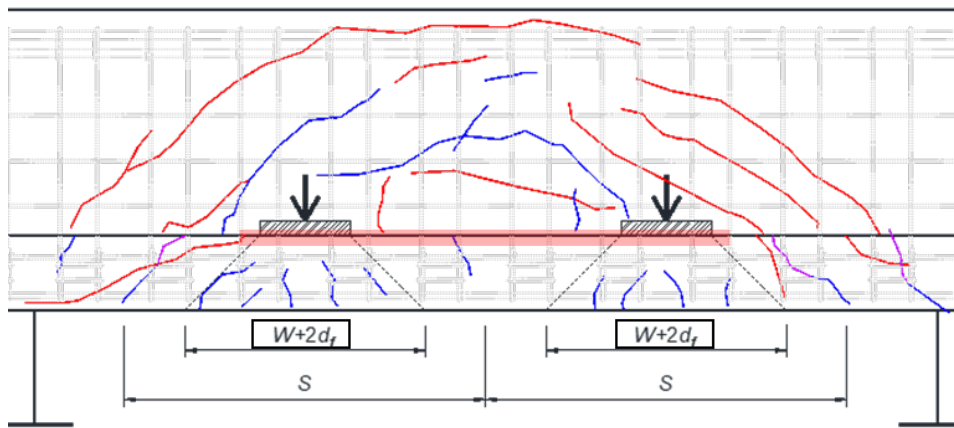
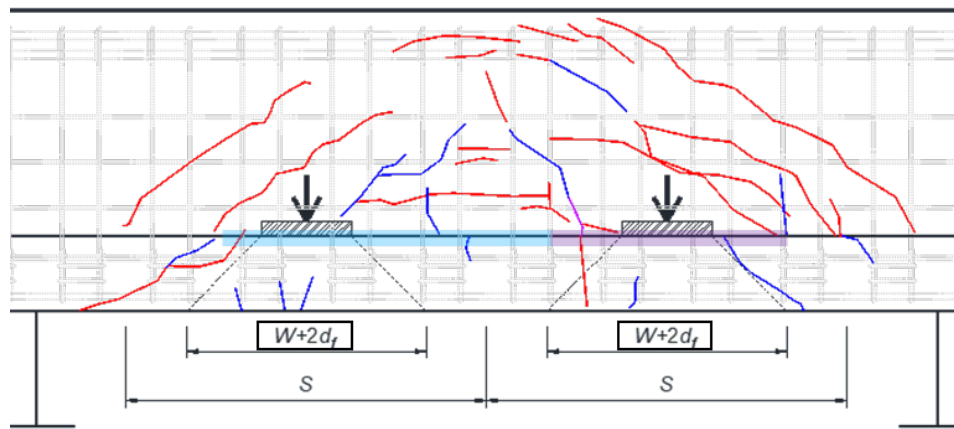
To understand the large discrepancy between estimated and observed capacities, and to assess if AASHTO design equations are appropriate, the progression of damage throughout the tests should be evaluated. To support this, Figure 4.3 shows the observed damage and the distribution widths used for calculation of the estimated capacity; the boxed distribution width indicates that which controls the capacity calculation.

(a) South side of T1W1

(b) North side of T1W1

(c) South side of T1I1

(d) North side of T1I1

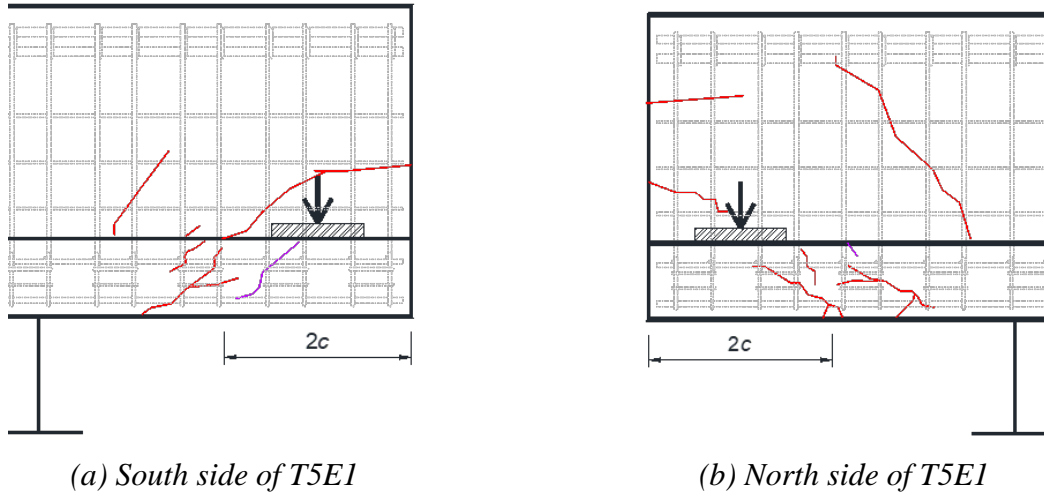
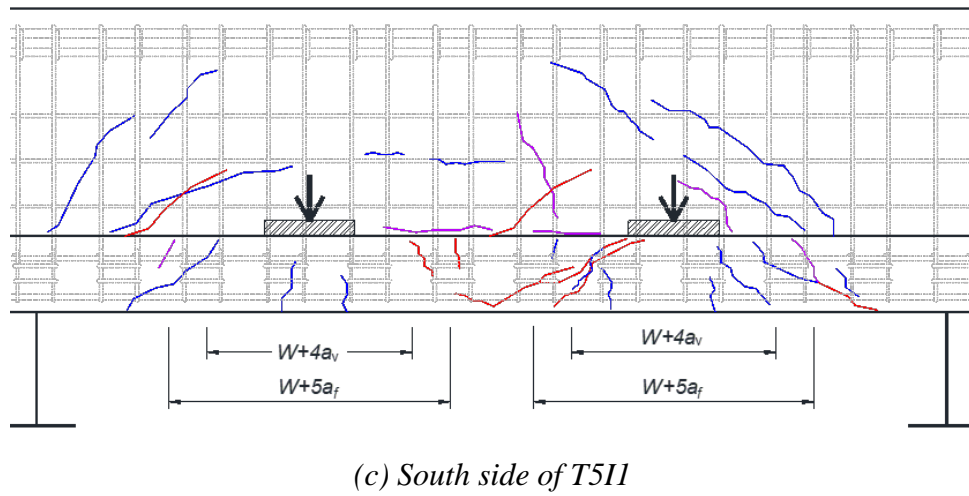
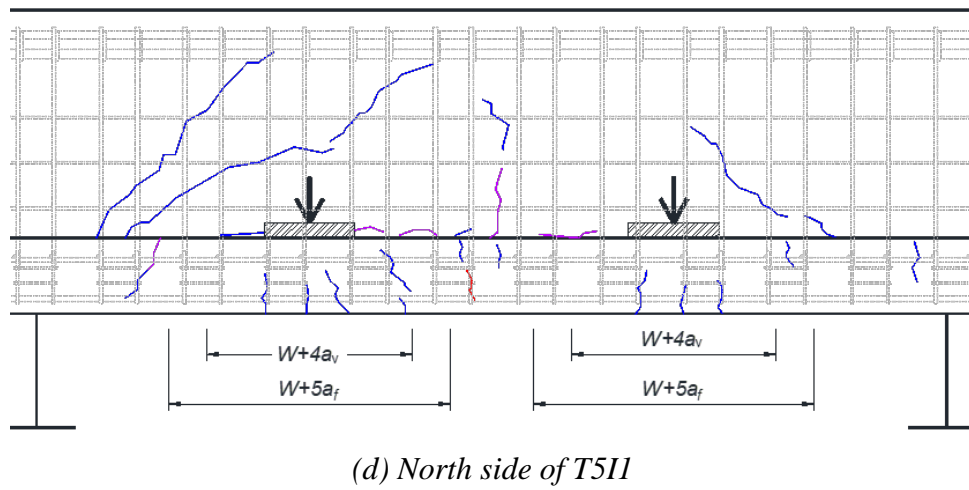
To assess if AASHTO design equations are appropriate, Figure 4.5 shows the observed damage and the distribution widths used for calculation of the estimated capacity. For the exterior ledge, the distribution width ($2c$) is considerably smaller than the width of the observed damage. For the interior ledges, the distribution width is similar to the width of the observed damage. Thus, to provide a better estimation of exterior ledge capacities for in-service bent caps, a rational modification of the distribution width for both ledge flexure and shear friction is described in the following subsection.

Figure 4.5. Observed Cracks and AASHTO Distribution Widths for Ledge-Deficient Reference Tests.
