# Riprap Filters and Stability of Riprap-Covered Slopes: Technical Report

Technical Report 0-7091-R1

TEXAS A&M TRANSPORTATION INSTITUTE  
COLLEGE STATION, TEXAS

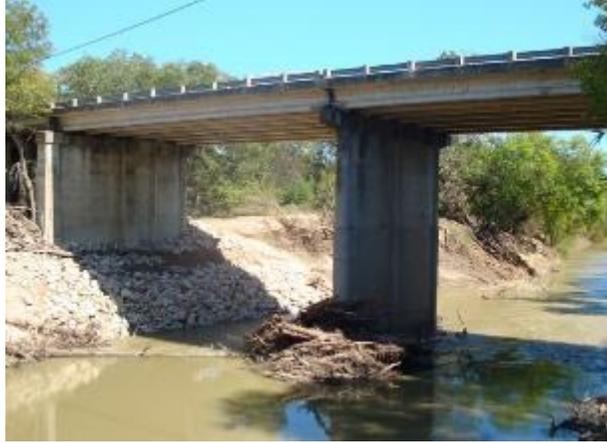
**Figure 66. Site Picture (Briaud et al., 2010).**

The riprap failure occurred in 2010. Now, the northern and southern banks of the main channel downstream of the bridge are experiencing problems due to meandering of the river. The pier in the center of the river shows large accumulations of debris lodged at its upstream nose. Figure 66 and Figure 67 show the riprap failure that was investigated.

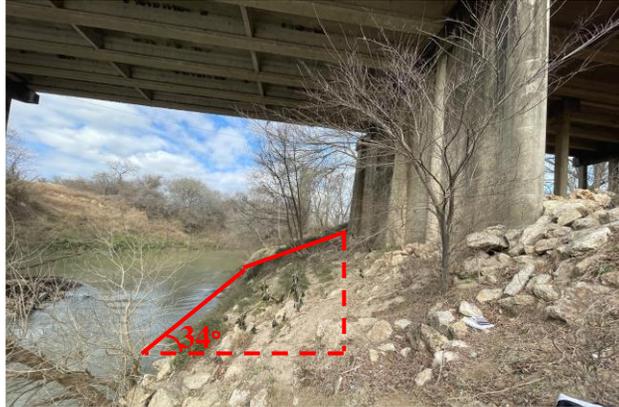
**Figure 68. Riprap-Covered Slope with Two Angles.**

Figure 68 and Figure 69 show a global picture of the site taken on the day of the site visit. Two testing locations were chosen near the top of the slope and slightly downstream of the pier. It was also noticed that a lot of debris had accumulated around the center pier, thus accelerating the flow next to the slope of the main channel. The slope where the riprap was placed had a nonuniform cross section that was steeper at the bottom of the slope and flatter at the top, which seemed to indicate scour at the bottom of the slope. The slope studied was the steeper slope, which had an angle of 34 degrees from horizontal.

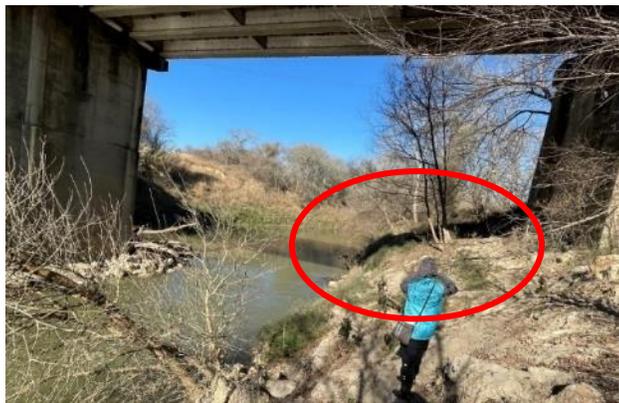
**Figure 69. Riprap-Covered Slope between Main Channel and Flood Plain.**

Considering that the underlying soil is classified as being of high to medium erodibility, the most probable event causing the failure is that abutment scour started to develop at the toe of the slope, which led to a steeper slope angle in the bottom half of the slope. The slope angle may have reached a value that became too steep for the riprap to resist. From previous slope stability analyses, it has been found that the steepest slope to safely place riprap on would be a 2:1 slope. However, the slope angle in this case is 1.4:1, which is not recommended based on previous analysis.

It can be concluded that the failure in this case is due to abutment scour that modified the angle at the bottom of the slope and induced failure of the riprap-covered slope.

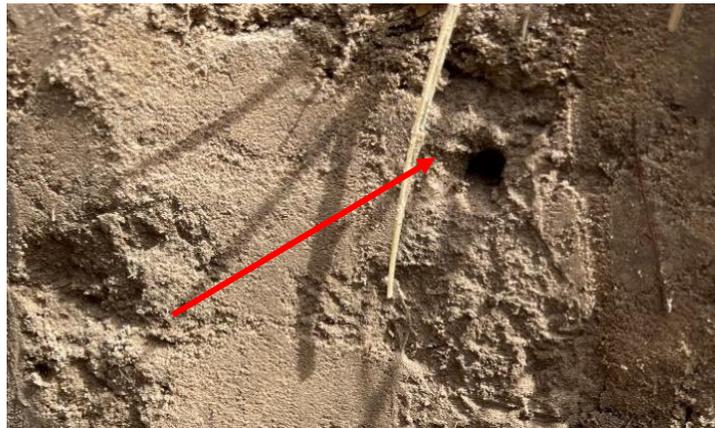
**Figure 72. Pocket Erodrometer Test.**

The PET is a quick in-situ test that helps to quantify the erodibility of the soil being tested by repeated jetting and measurement of the depth of the hole generated (Briaud et al., 2012). Two tests were performed with the PET (Table 15). Figure 72 shows the penetration hole after the PET. A penetration depth of 24.5 mm indicated that the soil is highly erodible.

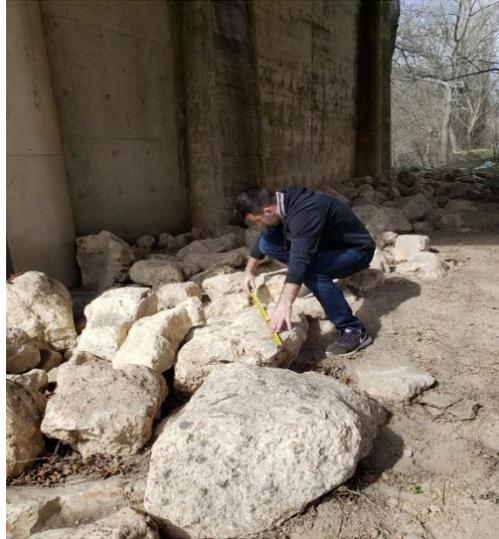
**Figure 73. Riprap Size Measurement.**

Table 16 shows some properties also estimated at the site, including the riprap  $d_{50}$  (Figure 73).

Figure 74 can be used to investigate what velocity is required to start eroding a geomaterial given its  $d_{50}$ —in other words, finding the critical velocity given the  $d_{50}$ . Using Table 16 and Figure 74, it can be seen that the 0.45 m  $d_{50}$  leads to a critical velocity of 5 m/s. This value is very high for river flows, which means that the riprap washing away is not the issue in this case, unless the critical velocity tends to decrease when the riprap is placed on a slope.

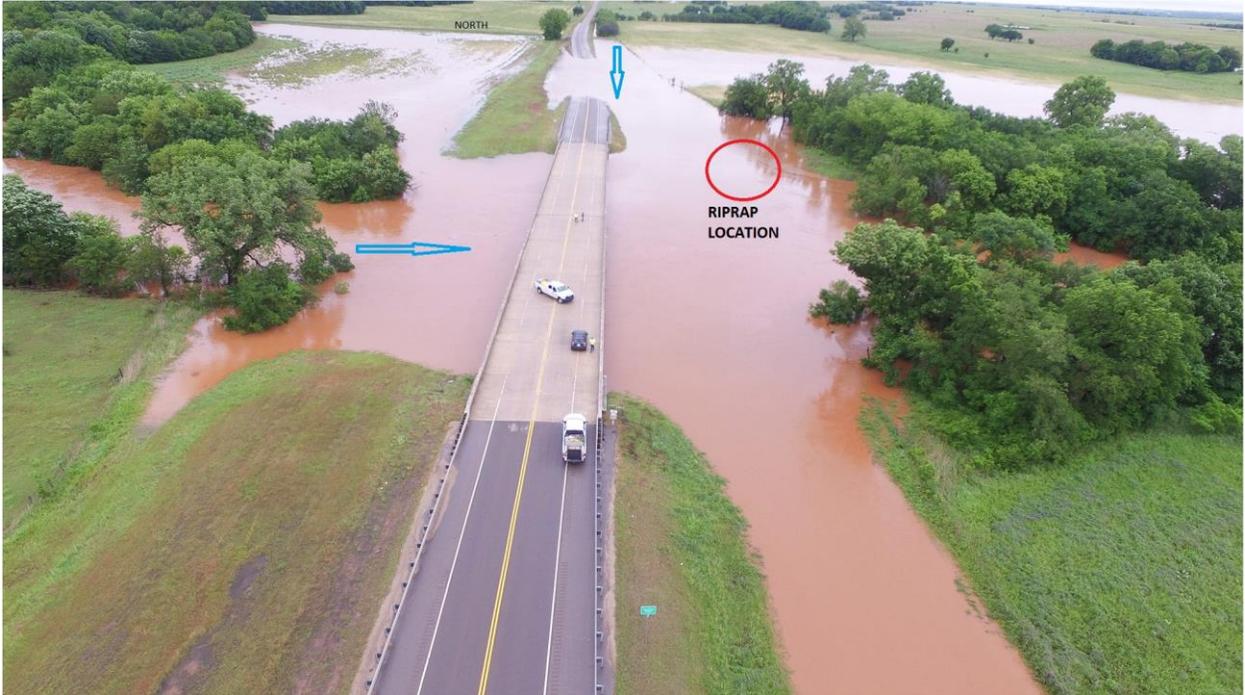
**Figure 84. Flood during 2019 (Courtesy of Oklahoma DOT).**

This case history was obtained from the Oklahoma DOT as part of the distributed survey. During a bridge construction on SH 74 over Skeleton Creek, Oklahoma (7.4 mi north of Crescent, Oklahoma), riprap was placed in order to line the termini of a USGS blue-lined unnamed channel running south into Skeleton Creek. Design plans show riprap thickness to be 0.45 m, with a  $d_{50}$  equal to 12 inches. The riprap was to be installed on top of a 6-inch granular filter. Construction was still underway in May 2015 when heavy rainfall occurred, and the riprap washed away. A site investigation took place after this failure, and it was concluded that the slope was too steep for this high-velocity channel, and this factor caused failure of the riprap (Figure 84 and Figure 85). Therefore, the concerned entity decided to use an alternative solution instead of riprap and lined the embankment with sod and Armormax B2 erosion Control Mat (Figure 86). Monitoring of this solution was regular, and it displayed great performance. In 2019, an extreme flood event took place in Oklahoma, and the countermeasure held well during this event, which corresponded approximately to a 100-year event.

Given that the  $d_{50}$  of the riprap was equal to 12 inches, the critical velocity would be around 4.5 m/s, according to Figure 74 this factor should have been sufficient. However, it may be that the critical velocity of the riprap on that steep slope was not as high as given by Figure 74 for a flat surface. This result indicates that a relationship might exist between the slope angle and the critical velocity of riprap stones for a given  $d_{50}$ . This case history appears to not be a slope stability failure but rather that the riprap on the slope was displaced by high flow velocities.

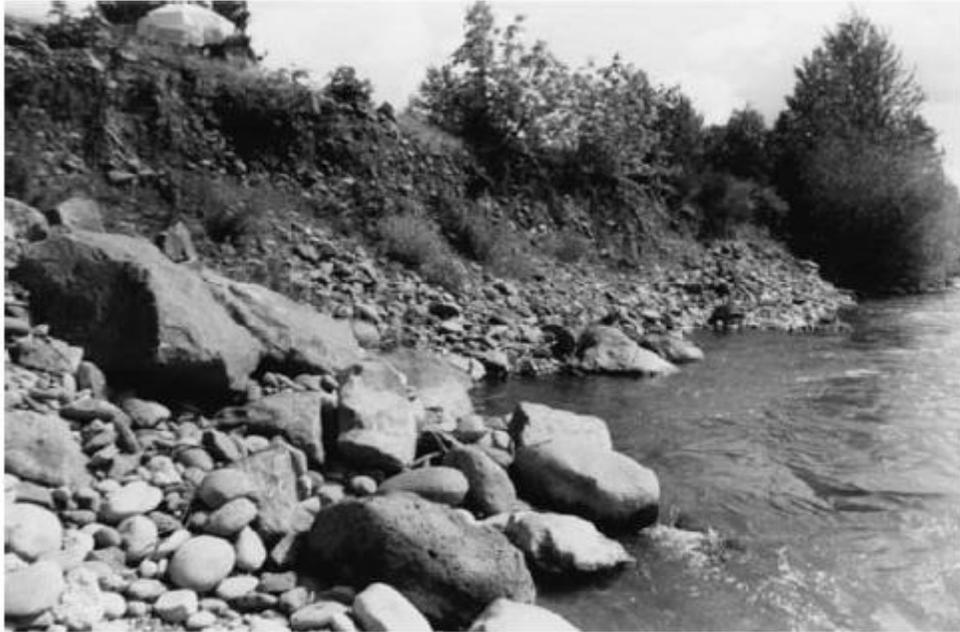
**Figure 94. Willamette Highway over Salmon Creek Riprap Failure (Lagasse et al., 2006).**

This case history was obtained from *Riprap Design Criteria, Recommended Specifications, and Quality Control* (Lagasse et al., 2006). The location is Salmon Creek on the Willamette highway (Route 58), Lane County, Oregon. The riprap failure was attributed to impinging flow that caused undermining at the toe of the slope (Figure 94). The riprap was designed by the USACE Portland District following EM 1110 guidelines. One of the assumptions made during the design was that parallel flow conditions would be occurring. Post-failure analysis showed that the main causes of failure were a combination of the steepness of the slope, the riprap stones being rounded (which reduces the global frictional resistance), and no filter layer being present. Again, the common issue of the steepness of the slope was mentioned in this case history. Moreover, it was mentioned that the failure occurred during turbulent flow conditions, which are not typically taken into consideration in design. Finally, friction is a major contributor to riprap movement resistance, and using rounded stones lowers this resistance because rounded rocks have smaller global friction than angular rocks; indeed, rounded stones do not provide interlocking resistance during shearing.

View upstream of west bank just upstream of Route 58 bridge  
(photographed May 1992)

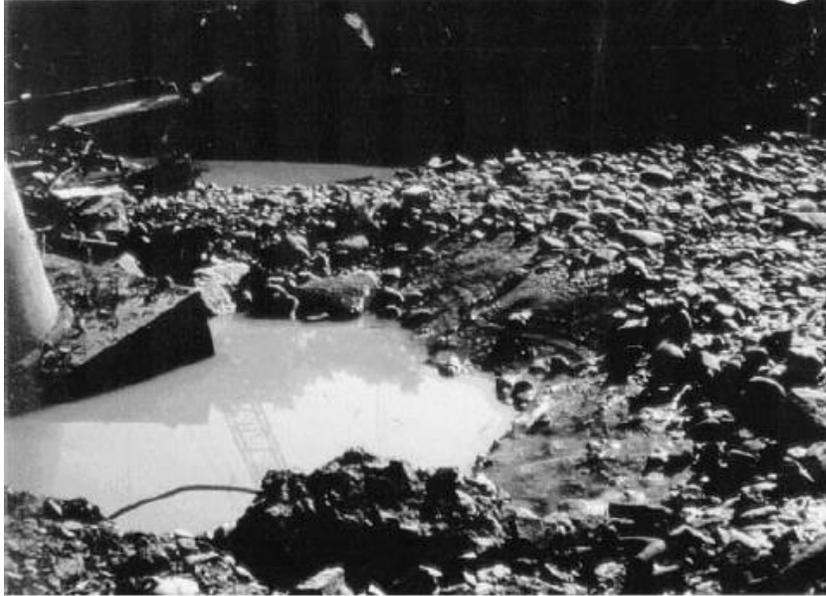
**Figure 96. I-90 Bridge over Schoharie Creek (Lagasse et al., 2006).**

This case history was obtained from *Riprap Design Criteria, Recommended Specifications, and Quality Control* (Lagasse et al., 2006). A major bridge failure occurred in 1987 on the I-90 bridge over Schoharie Creek near Albany, New York, costing 10 lives. The reason of failure was scour at the bridge piers due to riprap failure (Figure 96). The peak flow was  $1,838 \text{ m}^3/\text{s}$ , with a 70- to 100-year return period. The footings were set 1.5 m into the stream bed in glacial till, which was assumed during the design stage to be non-erodible. However, flume studies of samples of the stratified drift showed that some material does erode at a velocity of 1.5 m/s. At a velocity of 2.4 m/s, the erosion rates were high, which called for the need of riprap as a countermeasure. From 1953 to 1987, high-velocity flows were able to displace some of the riprap, which led to rapid erosion of the native soil in 1987. During an inspection in 1979, it was documented that a good portion of the riprap around the pier was missing; however, during another inspection in 1985, absence of the riprap was not detected and led to continuous erosion and failure of the piers. It can be concluded from this case history that another critical variable in the performance of riprap is proper inspection; inspectors must be trained to recognize when riprap has washed away, especially underwater, because this is a critical stage of the failure mobilization, not only in regard to the failure of the riprap but also in regard to the failure of the structure, which could lead to fatalities.

Pier 2 in the foreground with Pier 3 in the background.

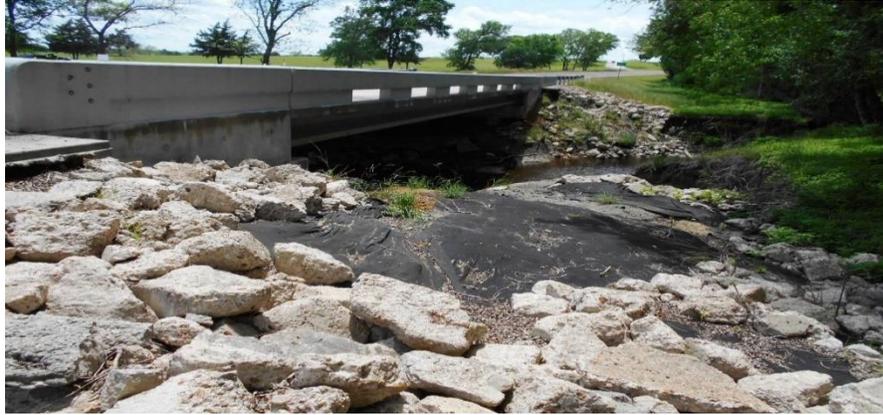
**Figure 98. Geotextile underneath the Riprap (Courtesy of TxDOT).**

This case history was obtained from TxDOT. It occurred in Washington County beside the bridge on FM 1155 over Little Sandy Creek. Riprap was installed on a 3:1 slope (Figure 97) as a scour countermeasure, but then it washed away along the stream. A geotextile blanket was present (Figure 98). One possible reason failure occurred is that the riprap stones used on the site were smaller than the size indicated in the design. When it was replaced by grouted riprap, it worked well. Riprap stone sizing is a crucial parameter for the resistance of the riprap against hydraulic stresses caused by the flow.

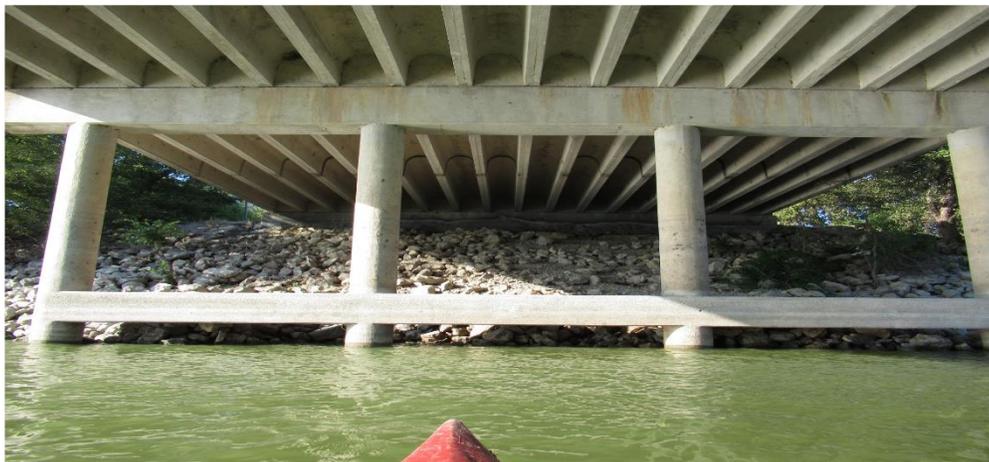
**Figure 99. SH 78 over Price Creek Riprap-Covered Slope (Courtesy of TxDOT).**

This case history was obtained from TxDOT. It occurred in Dallas District and deals with the bridge built in 1972 on SH 78 over Price Creek. The riprap was placed on a 2:1 slope (Figure 99). Failure of riprap occurred when the limestone rock riprap moved downhill (Figure 100) and ended up resting on the interior bents, becoming piled higher around each column as time went on. The recommended action was to reconstruct the north and south banks with large (300 to 500 lb) concrete rubble, or with gabions. The last time it was inspected was September 12, 2019.

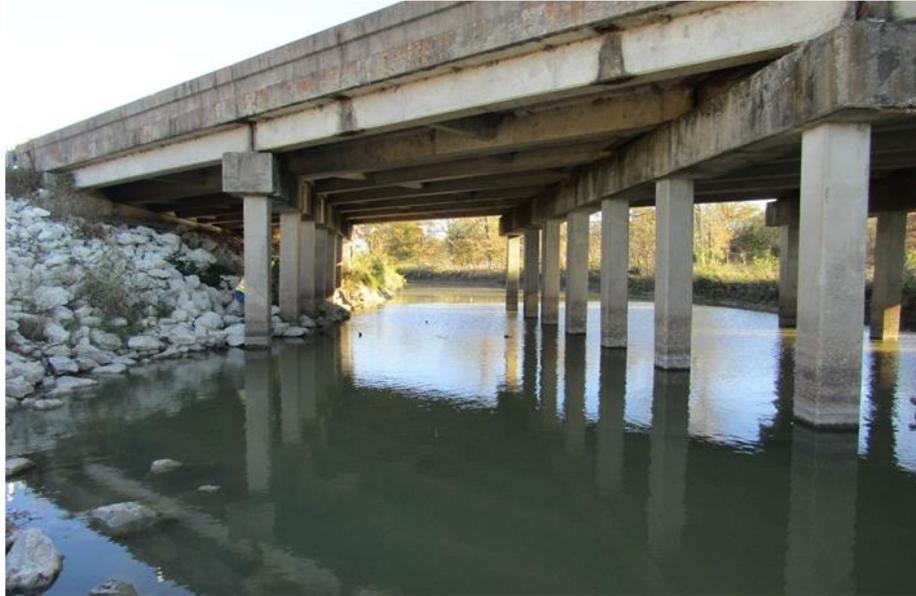
**Figure 105. FM 218 over Cowhouse Creek Riprap-Covered Slope (Courtesy of TxDOT).**

This case history was obtained from TxDOT. It is located in the Waco District and relates to the bridge built on FM 218 over Cowhouse Creek. A concrete cover was installed on the 3:1 slope. This countermeasure was undermined, and the concrete riprap failed in 2007. It was replaced by stone riprap in the form of crushed rock up to 6 inches in size that was used to fill all the voids caused by scour (Figure 105). This stone riprap also failed, and it was repaired by re-installing stone riprap. The exact failure mechanism is not known, but a 3:1 slope does not typically lead to slope stability problems; however, undersized riprap stones might be a potential issue triggering the failure of the riprap when subject to water flow.

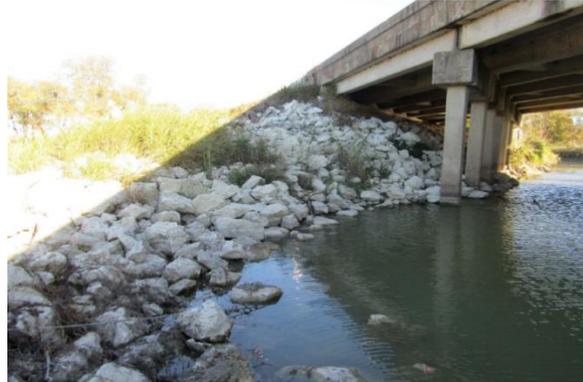
**Figure 107. US 84 over Navasota River E Relief Riprap-Covered Slope (Courtesy of TxDOT).**

This case history was obtained from TxDOT. It occurred in the Waco District and relates to the bridge built on US 84 at Navasota River. Concrete riprap was installed on a 2:1 slope. The concrete riprap failed and was replaced by stone riprap (Figure 107). However, the riprap stones were too small and did not stay in place.

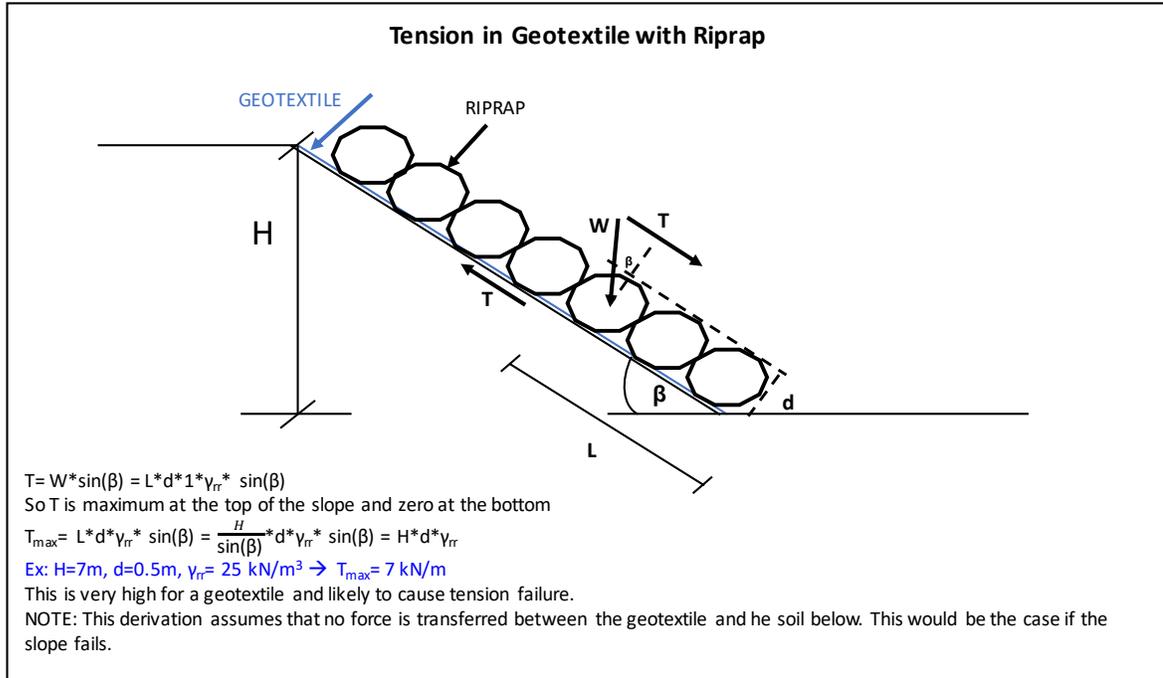
**Figure 108 Geotextile Tension Failure Derivation**

First, when the geotextile is loaded with riprap, tension forces will develop in the geotextile, especially when the geotextile is anchored. Figure 28 shows how these tension forces are generated and how to estimate their magnitude.

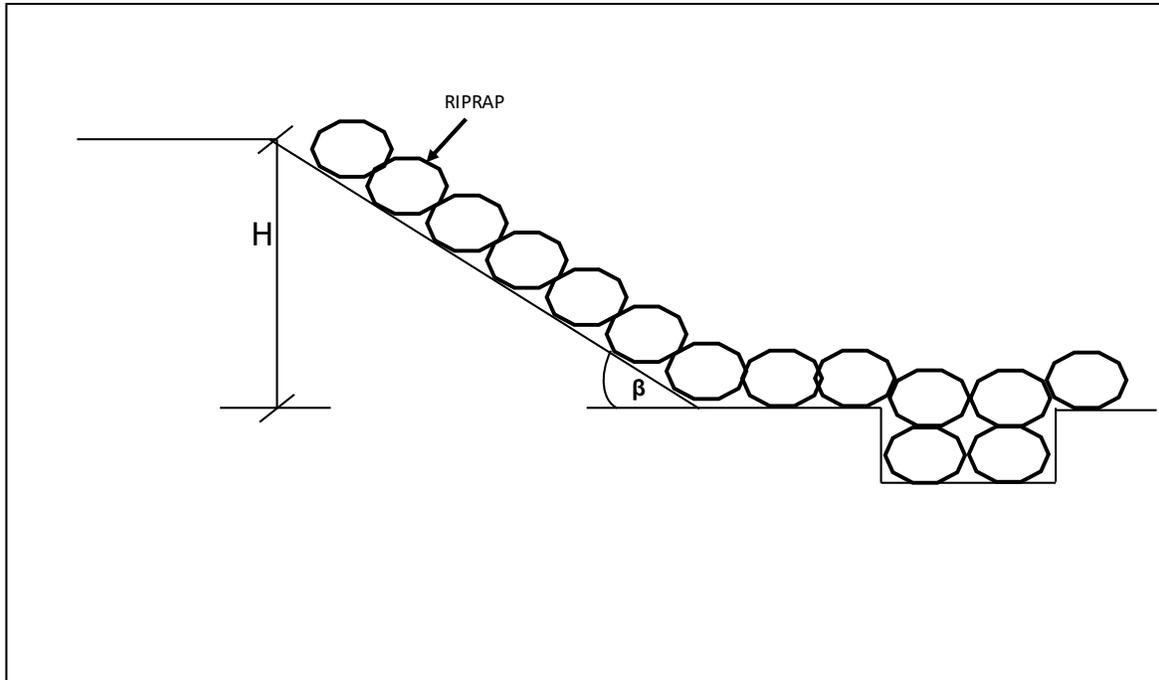
**Figure 109 Riprap Sliding Stability Countermeasure**

Second, the riprap stones can slide along the geotextile or the geotextile can slide over the soil of the embankment fill ; this was also mentioned by some survey responders as one of the drawbacks of using geosynthetic filters instead of granular filters. There are two interfaces: the riprap to geotextile interface and the geotextile to embankment soil interface. Both interface friction forces would have to be checked to ensure that a proper factor of safety is satisfied. One problem is that the friction coefficient for both interfaces is not well known and tests have to be conducted to ensure reasonable values. Figure 109 shows a possible solution to minimize such a failure mechanism.

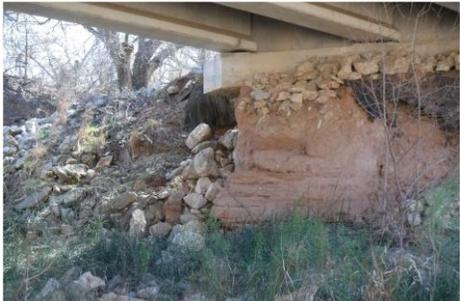
43	TxDOT	FM 667 Cobb Hollow - Wichita Falls	Riprap Washed away
