Evaluating Candidate Projects for Seal Coat Stability

Technical Report 0-7106-R1

TEXAS A&M TRANSPORTATION INSTITUTE
COLLEGE STATION, TEXAS

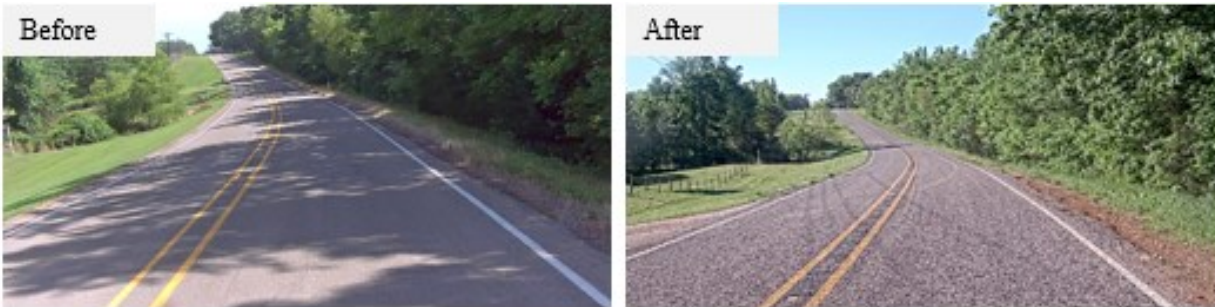
Figure 35. Site 6 Before and After Seal Coat Construction.

Description	Results
ADT (veh/day)	954
Trucks (%)	19
Precipitation (inches/year)	49
Climate zone	East Texas
Estimated date of first frost	12/1
Binder application rate (gal/yd ²): AC20-5TR	0.5
Aggregate application rate (yd ² /yd ³): PB ¹ grade 3	110
Construction date	6/26/2023
Texture (mils): 5/15/2023	53.6
Texture after seal coat (mils): 7/6/2023	127.9
Second texture after seal coat (mils): 5/9/2024	106.6
Observations	Seal coat was applied at a good rate with no excessive flushing or rock loss.

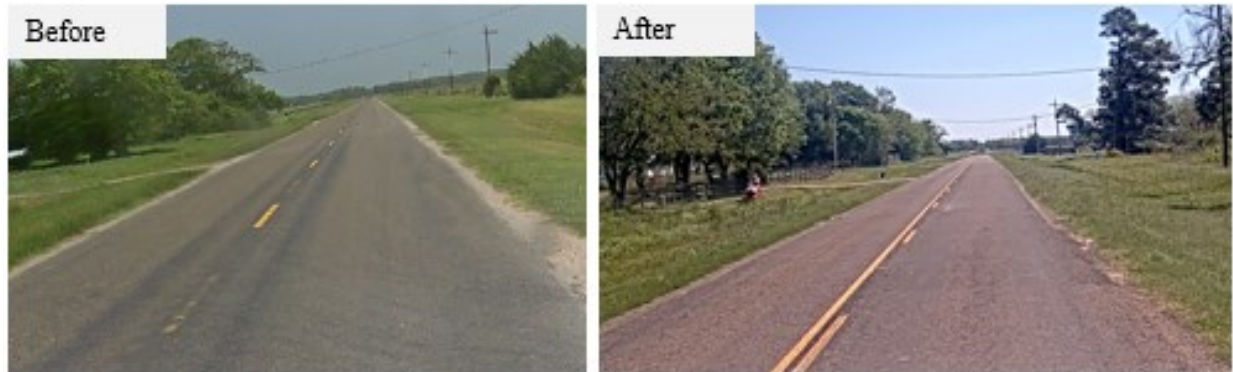
Figure 37. Site 7 Before and After Seal Coat Construction.

Description	Results
ADT (veh/day)	364
Trucks (%)	10.2
Precipitation (inches/year)	56
Climate zone	Upper Coast
Estimated date of first frost	1/3
Binder application rate (gal/yd ²): AC20-5TR	0.35
Aggregate application rate (yd ² /yd ³): PL ¹ grade 4	146
Construction date	5/4/2023
Texture (mils): 3/15/2023	37.2
Texture after seal coat (mils): 5/15/2023	90.4
Second texture after seal coat (mils): 5/13/2024	61.5
Observations	Seal coat was applied at a good rate with no excessive flushing or rock loss.

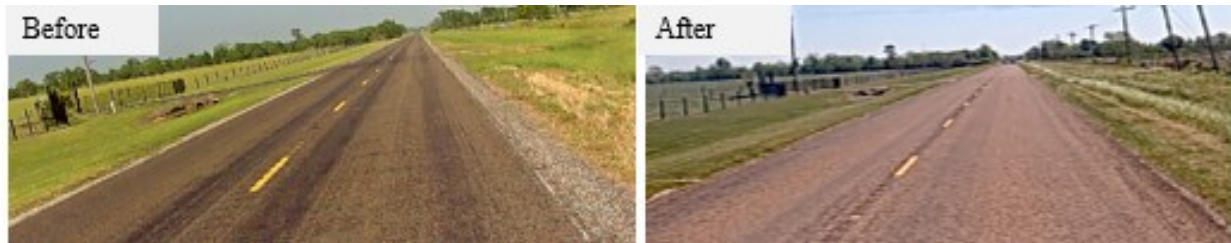
Figure 39. Site 9 Before and After Seal Coat Construction.

Description	Results
ADT (veh/day)	452
Trucks (%)	4.6
Precipitation (inches/year)	56
Climate zone	Upper Coast
Estimated date of first frost	1/3
Binder application rate (gal/yd ²): AC20-5TR	0.34
Aggregate application rate (yd ² /yd ³): PL ¹ grade 4	133
Construction date	5/4/2023
Texture (mils): 3/16/2023	36.3
Texture after seal coat (mils): 5/16/2023	88.1
Second texture after seal coat (mils): 5/9/2024	57.7
Observations	Existing flushing affected the new seal coat. Otherwise, the seal coat was applied at a good rate with no excessive flushing or rock loss.

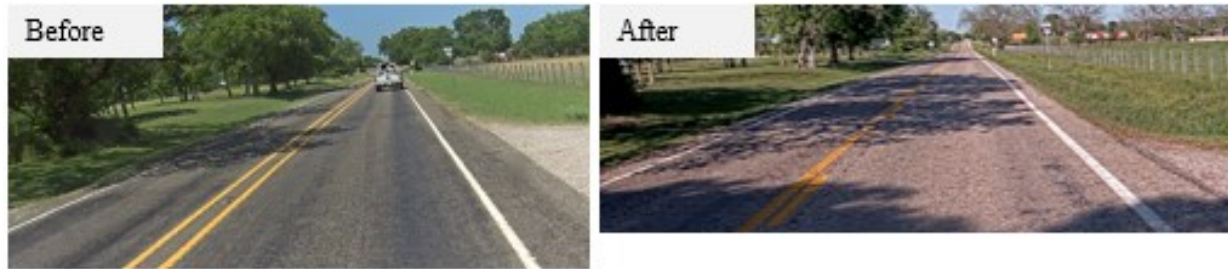
Figure 43. Site 14 Before and After Seal Coat Construction.

Description	Results
ADT (veh/day)	754
Trucks (%)	15.5
Precipitation (inches/year)	39
Climate zone	South Central
Estimated date of first frost	12/12
Binder application rate (gal/yd ²): AC20-5TR	0.38
Aggregate application rate (yd ² /yd ³): PL ¹ grade 4	114
Construction date	5/11/2023
Texture (mils): 5/1/2023	45.4
Texture after seal coat (mils): 6/12/2023	98.4
Second texture after seal coat (mils): 5/9/2024	80.3
Observations	Seal coat was applied at a good rate with no excessive flushing or rock loss.

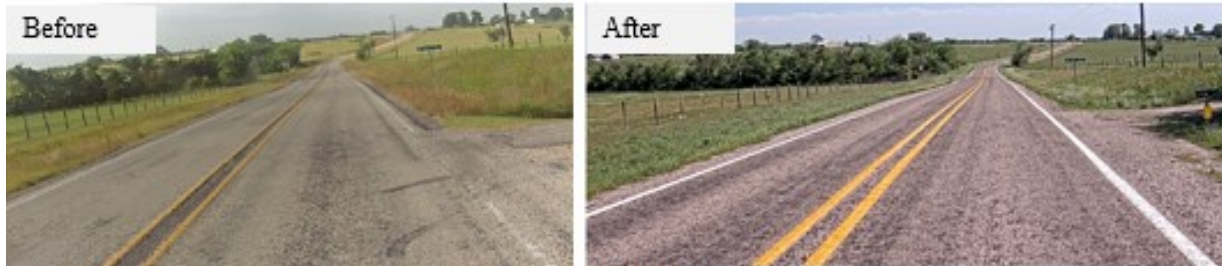
Figure 44. Site 15 Before and After Seal Coat Construction.

Description	Results
ADT (veh/day)	297
Trucks (%)	31.6
Precipitation (inches/year)	41
Climate zone	South Central
Estimated date of first frost	12/12
Binder application rate (gal/yd ²): AC20-5TR	0.4
Aggregate application rate (yd ² /yd ³): PL ¹ grade 3	117
Construction date	5/17/2023
Texture (mils): 5/1/2023	54.5
Texture after seal coat (mils): 6/12/2023	97.4
Second texture after seal coat (mils): 5/9/2024	76.2
Observations	Seal coat was applied at a good rate with no excessive flushing or rock loss.

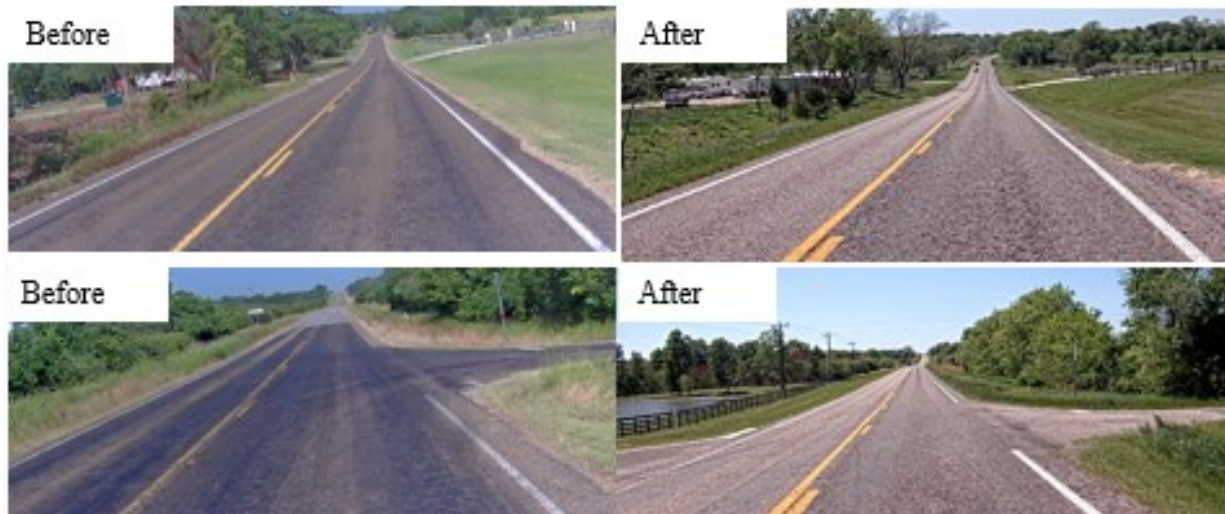
Figure 45. Site 16 Before and After Seal Coat Construction.

Description	Results
ADT (veh/day)	414
Trucks (%)	26.1
Precipitation (inches/year)	41
Climate zone	South Central
Estimated date of first frost	12/12
Binder application rate (gal/yd ²): AC20-5TR	0.39
Aggregate application rate (yd ² /yd ³): PL ¹ grade 3	97
Construction date	5/17/2023
Texture (mils): 4/25/2023	40.3
Texture after seal coat (mils): 6/12/2023	94.2
Second texture after seal coat (mils): 5/9/2024	74.4
Observations	Seal coat was applied at a good rate with no excessive flushing or rock loss.

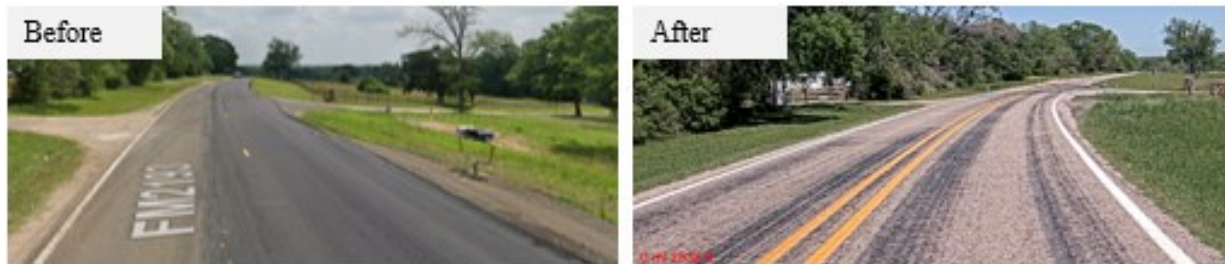
**Figure 46. Site 17 Before [10] and After Seal Coat Construction.**

Description	Results
ADT (veh/day)	789
Trucks (%)	2.5
Precipitation (inches/year)	41
Climate zone	South Central
Estimated date of first frost	12/12
Binder application rate (gal/yd ²): AC20-5TR	0.36
Aggregate application rate (yd ² /yd ³): PL ¹ grade 4	122
Construction date	5/17/2023
Texture (mils): 4/25/2023	36.7
Texture after seal coat (mils): 6/12/2023	61.9
Second texture after seal coat (mils): 5/9/2024	44.3
Observations	Preparatory work affected the seal coat. The seal coat application rate led to flushing in the wheel paths; however, no rock loss was observed between the wheel paths.

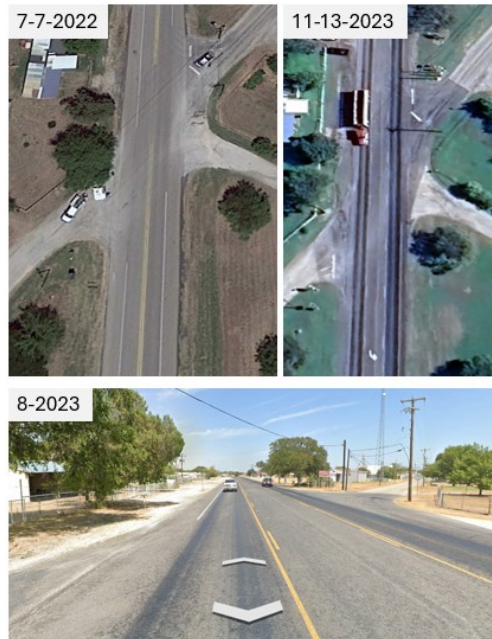
Figure 47. Site 18 Before and After Seal Coat Construction [11].

Description	Results
ADT (veh/day)	1,266
Trucks (%)	35.5
Precipitation (inches/year)	31
Climate zone	North Central
Estimated date of first frost	12/1
Binder application rate (gal/yd ²): AC20-5TR	0.36
Aggregate application rate (yd ² /yd ³): PB ¹ grade 4	137
Construction date	6/2/2023
Texture (mils): n/a	n/a
Texture after seal coat (mils): 7/24/2023	70.5
Second texture after seal coat (mils): 5/9/2024	36
Observations	Flushing was observed in the wheel paths. Seal coat application rate was high.

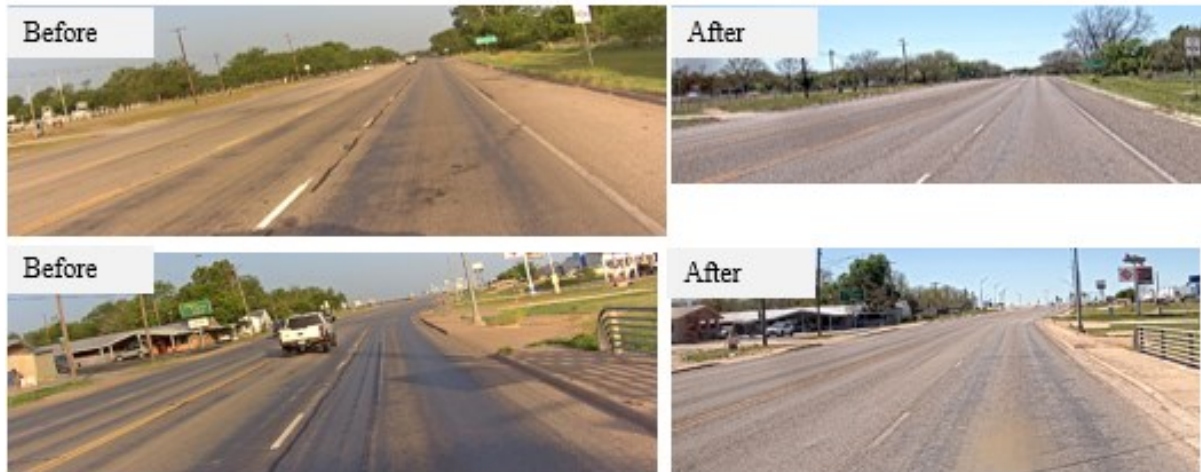
Figure 48. Site 19 Before and After Seal Coat Construction.

Description	Results
ADT (veh/day)	1,109
Trucks (%)	23.5
Precipitation (inches/year)	31
Climate zone	North Central
Estimated date of first frost	12/1
Binder application rate (gal/yd ²): AC20-5TR	0.28
Aggregate application rate (yd ² /yd ³): PB ¹ grade 4	135
Construction date	6/20/2023
Texture (mils): 4/18/2023	36.9
Texture after seal coat (mils): 6/29/2023	67.8
Second texture after seal coat (mils): 5/9/2024	51.0
Observations	Existing flushing affected the seal coat. Minor rock loss was observed between the wheel paths.

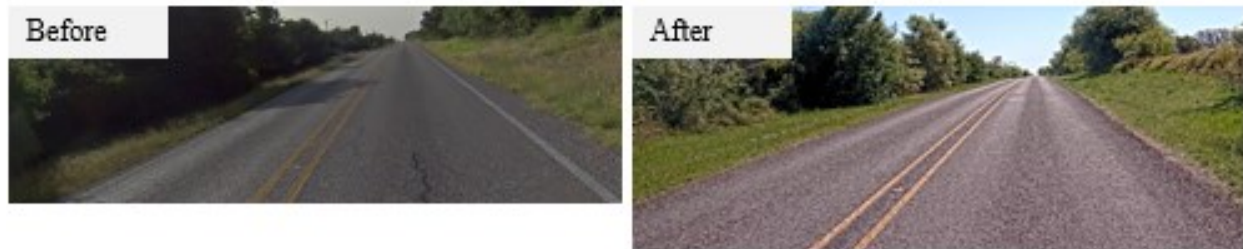
Figure 49. Site 20 Before and After Seal Coat Construction.

Description	Results
ADT (veh/day)	169
Trucks (%)	11.2
Precipitation (inches/year)	31
Climate zone	North Central
Estimated date of first frost	12/1
Binder application rate (gal/yd ²): AC20-5TR	0.36
Aggregate application rate (yd ² /yd ³): PB ¹ grade 4	137
Construction date	6/2/2023
Texture (mils): 4/18/2023	61.4
Texture after seal coat (mils): 6/29/2023	85.4
Second texture after seal coat (mils): 5/9/2024	72.3
Observations	Seal coat was applied at a good rate with no excessive flushing or rock loss.

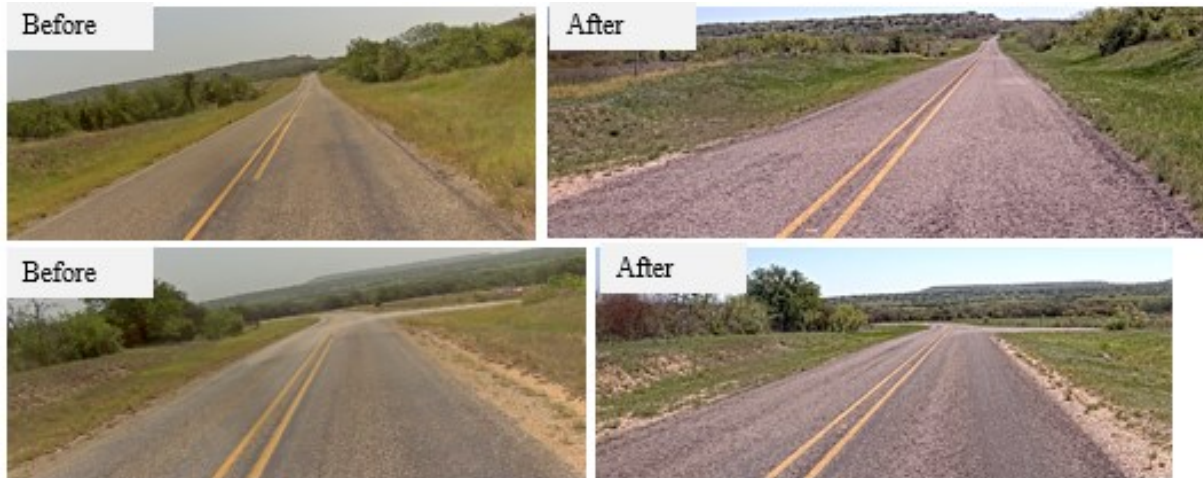
Figure 50. Site 21 Before and After Seal Coat Construction.

Description	Results
ADT (veh/day)	116
Trucks (%)	8.4
Precipitation (inches/year)	31
Climate zone	North Central
Estimated date of first frost	12/1
Binder application rate (gal/yd ²): AC20-5TR	0.37
Aggregate application rate (yd ² /yd ³): PB ¹ grade 4	137
Construction date	6/1/2023
Texture (mils): 4/21/2023	54.1
Texture after seal coat (mils): 6/29/2023	103.7
Second texture after seal coat (mils): 5/9/2024	70.6
Observations	Seal coat was applied at a good rate with no excessive flushing or rock loss.
