COMPLIANCE TESTING OF AN END TREATMENT FOR THE LOW-PROFILE CONCRETE BARRIER

Report 1403-S
Research Study Number 0-1403
Research Study Title: Development of a High-Speed
Low-Profile Concrete Barrier

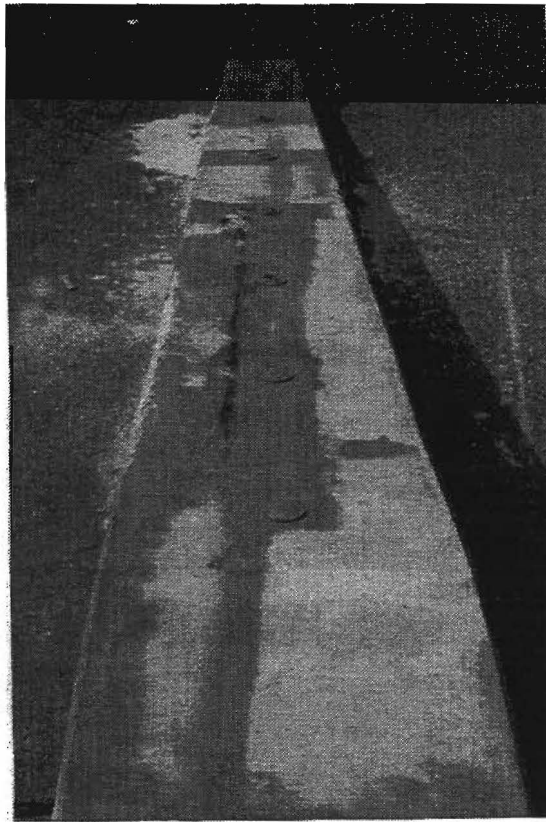
Figure 14. Low-Profile End Treatment After Test 1949A-3

As can be seen in Figure 14, the end treatment received minimal damage. There was cosmetic damage (i.e., tire marks) and the edges of the end treatment were chipped. A minor crack occurred around the location of the steel pin in the end treatment. There was no movement of the end treatment.

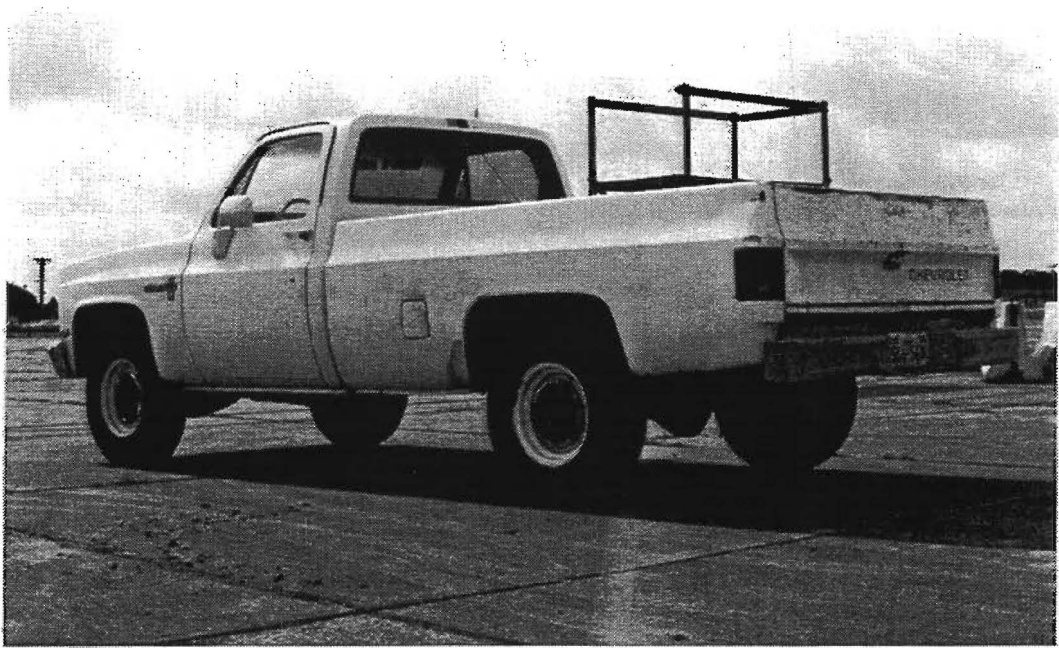
Figure 15. Vehicle After Test 1949A-3

As shown in Figures 15 and 16, the vehicle sustained damage to the undercarriage only. The cross member, lower A-arms and differential housing were scraped as the vehicle straddled the installation.

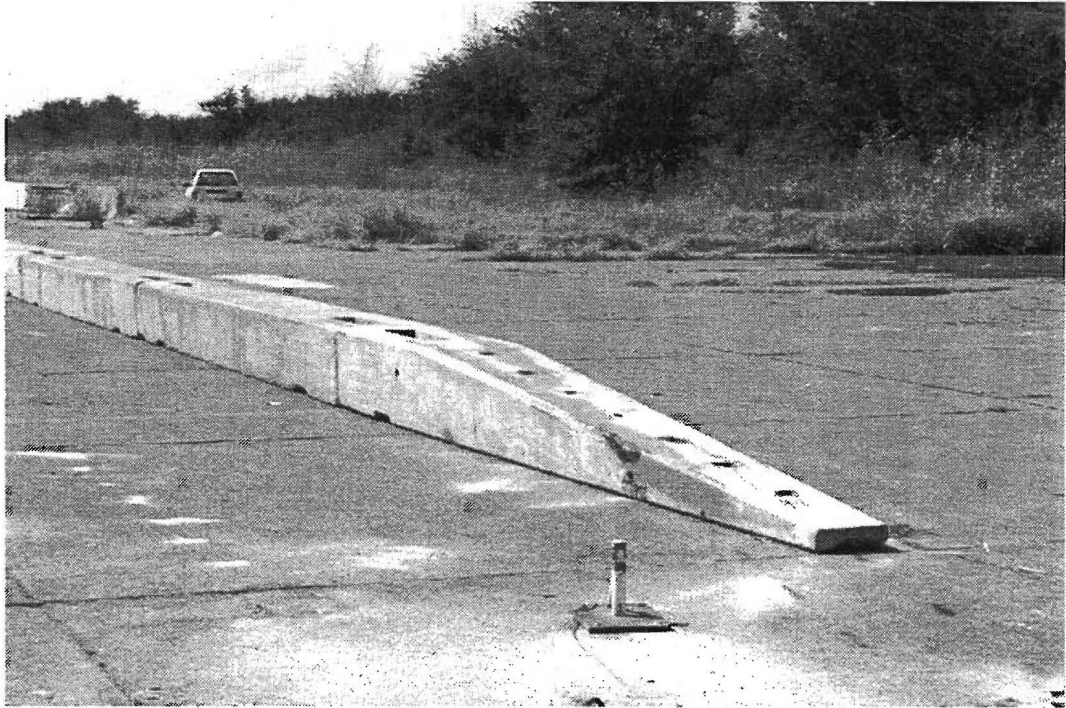
Figure 21. After Impact Trajectory for Test 414038-2

The end treatment was not damaged as shown in Figures 21 and 22. Tire marks were found on the top surface from 1.37 m from the end to 2.46 m. The undercarriage scraped the end treatment from 300 mm from the end to 1880 mm. There were tire marks on the pavement 15.2 m down from impact where the vehicle touched ground.

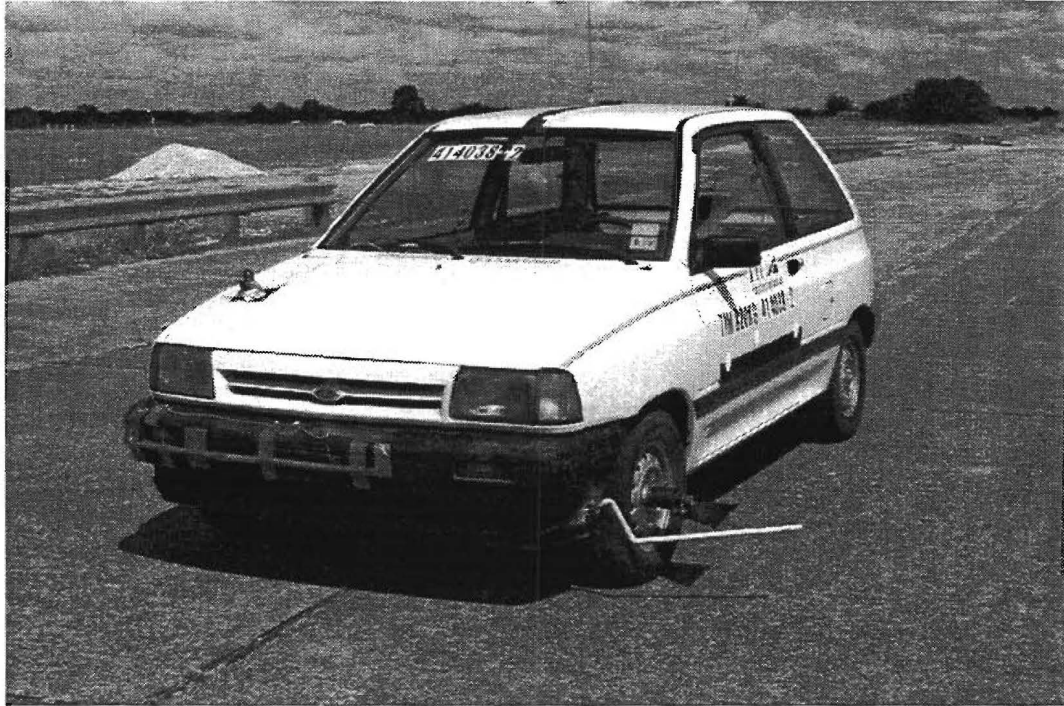
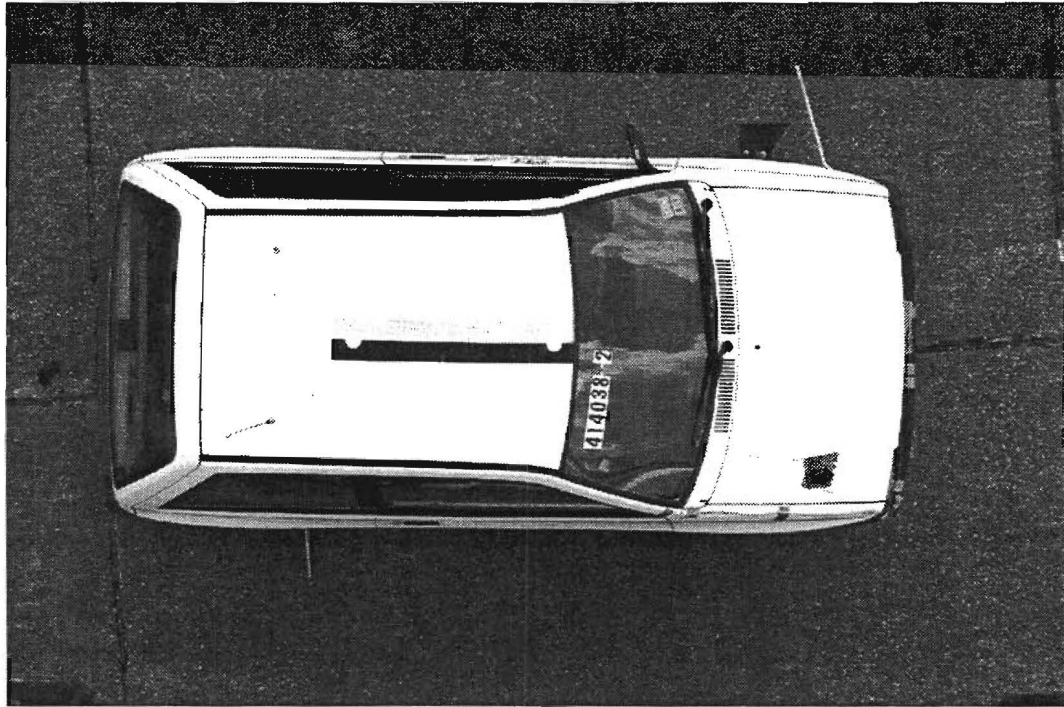
Figure 23. Vehicle After Test 414038-2

As shown in Figure 23, there was no body damage to the vehicle. The undercarriage was scraped only, with no other damage to the suspension or other components under the vehicle. No measurable crush to the exterior of the vehicle and no deformation of the occupant compartment occurred.

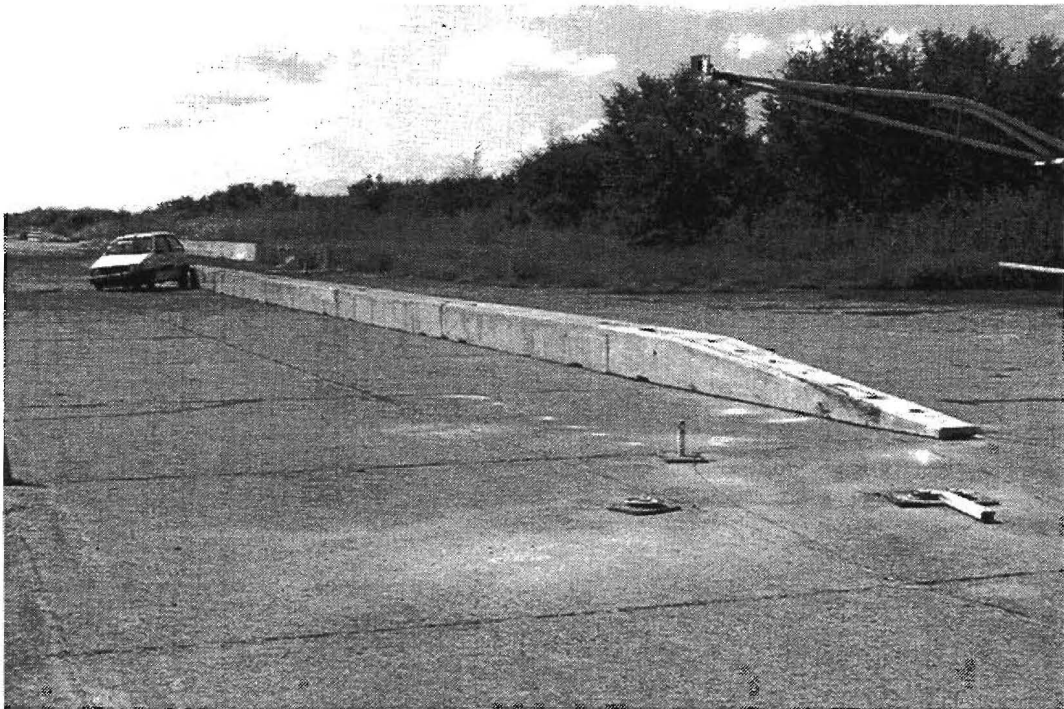
Figure 33. After Impact Trajectory for Test 414038-1

There was minimal damage to the end treatment as shown in Figures 33 and 34. The vehicle was in contact with the end treatment and low-profile barrier for 8.3 m during the first contact and 2.4 m during the second contact. There was no sign of movement in the end treatment or the barrier. The last joints crumbled when the vehicle came to rest at the end of the installation.

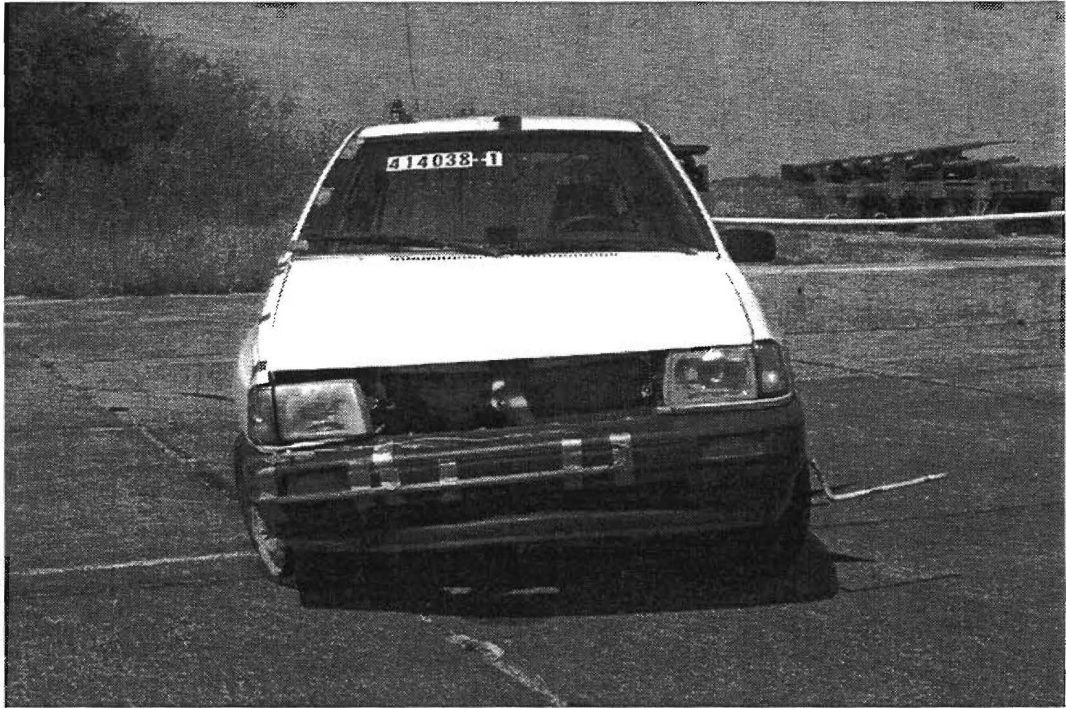
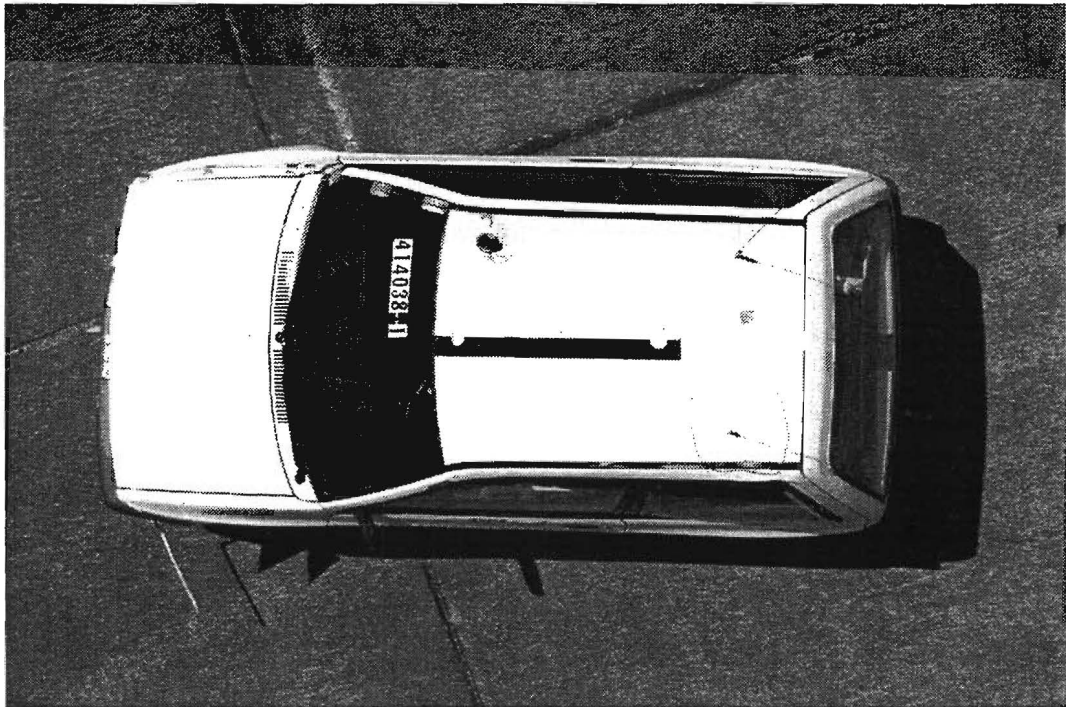
Figure 35. Vehicle After Test 414038-1

The vehicle received damage to the right front corner, as shown in Figure 35, with most of the damage to the undercarriage. The right strut, sway bar and right side axle were deformed. Also damaged were the front bumper, grill, both right side tire and wheel assembly, and the right door was jammed. There was no measurable exterior crush to the vehicle. Maximum deformation into the occupant compartment was 35 mm in the firewall/floorpan area.

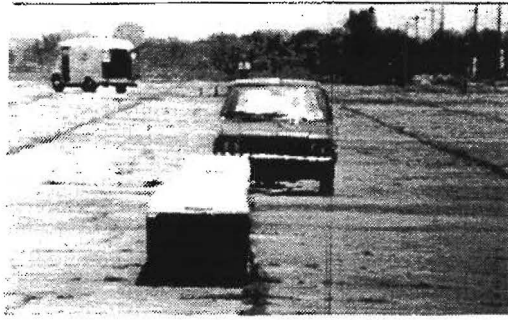
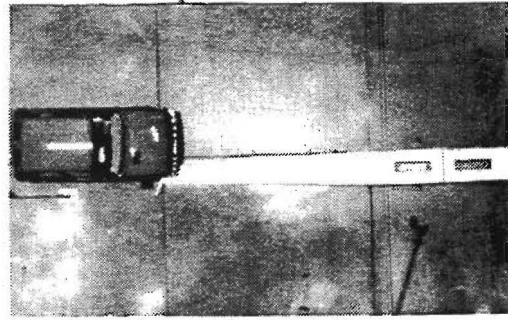
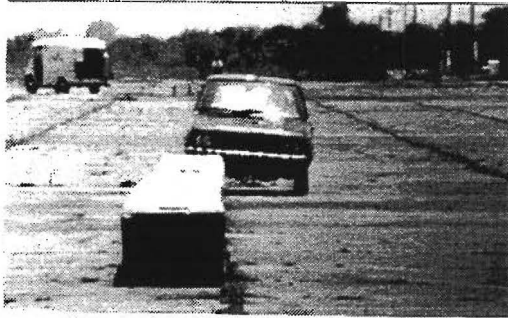
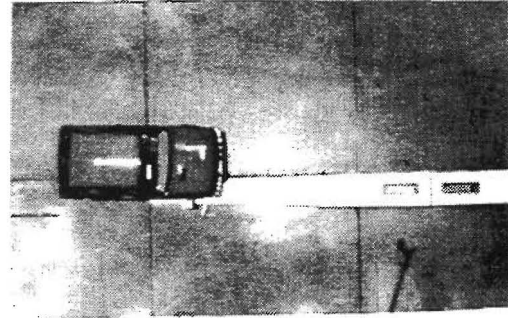
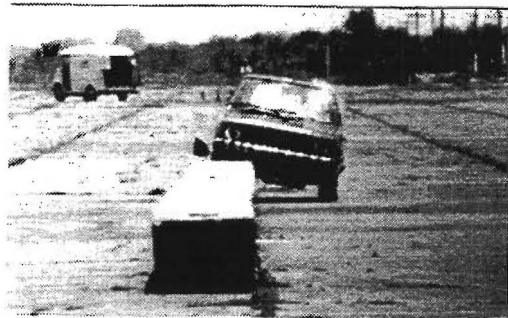
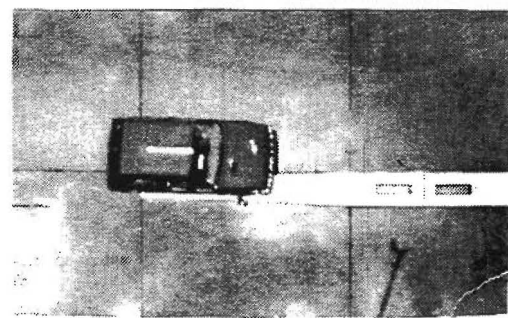
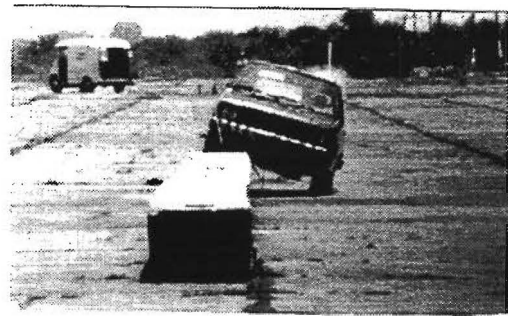
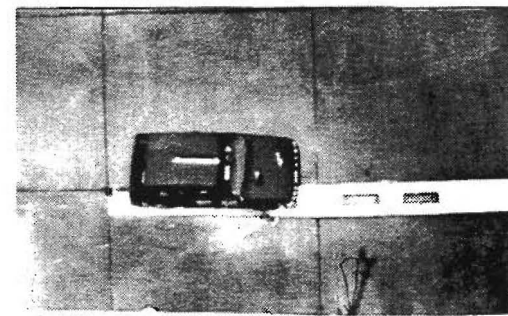
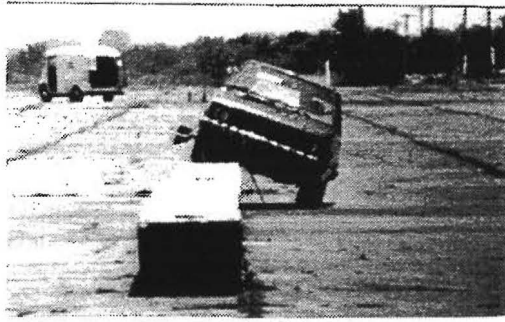
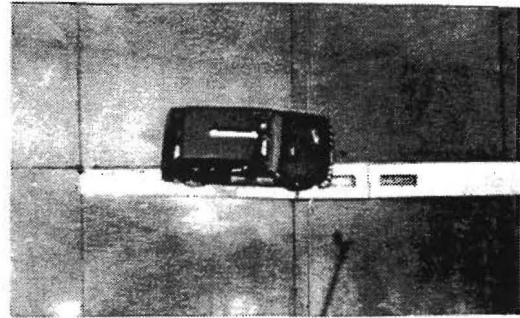
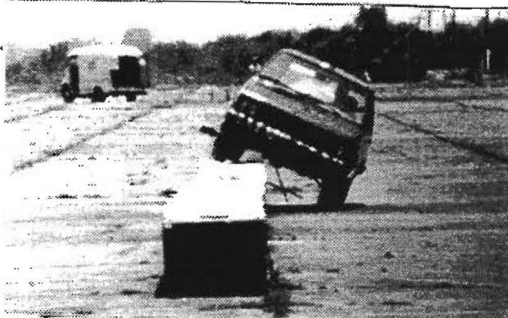
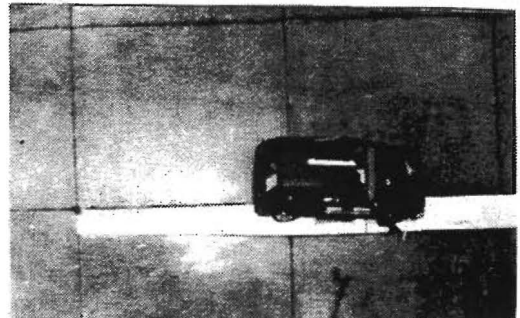
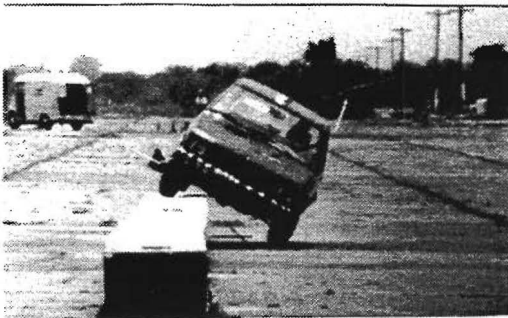
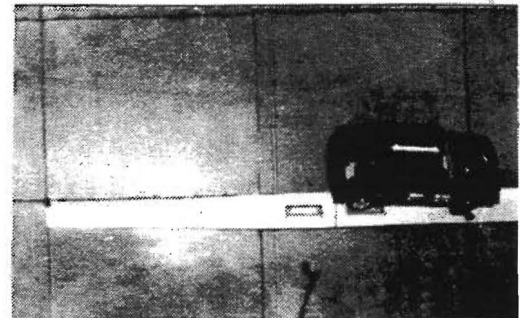
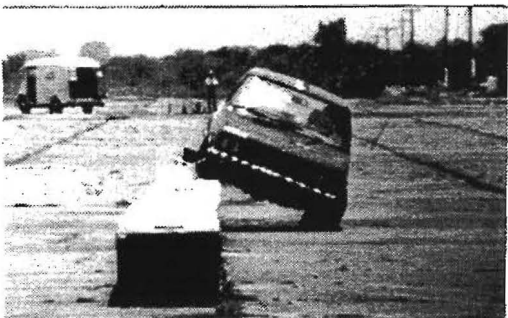
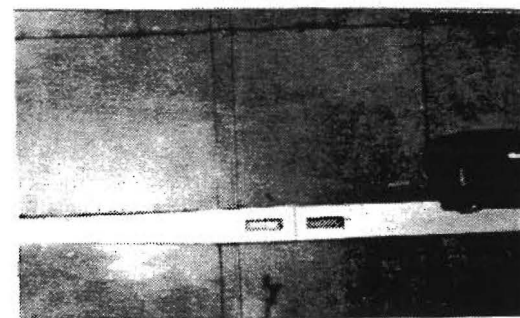
**Figure 38. Sequential Photographs for Test 1949A-2
(Overhead and Frontal Views)**

The vehicle impacted the end treatment end-on with the centerline of the right wheel aligned with the centerline of the end treatment. The vehicle impacted the end treatment with a speed of 72.6 km/h. The angle of impact was 0 degrees. As the vehicle rode up the barrier, it remained stable and continued on a straight path. The right rear tire mounted the end of the end treatment at 0.137 s. The tires on the right side of the vehicle lost contact with the end treatment at 0.341 s. At 0.428 s, the vehicle reached a maximum roll angle of approximately 28 degrees. The tires touched down on top of the barrier at 0.457 s and immediately thereafter passed over the connection of the end treatment to the main body of the low-profile PCB traveling at a speed of 71.1 km/h and a 0.3 degree angle. The right side of the vehicle continued riding along the top of the main body of the low-profile barrier until the right rear wheel dropped off the barrier at 0.823 s with the vehicle traveling at 65.3 km/h. The exit angle was 2.0 degrees. The brakes were applied at 0.833 s after impact, the vehicle yawed clockwise and came to rest facing the end treatment 54 m downstream from the initial impact. Sequential photographs of the impact are shown in Figures 38 and 39 of Appendix C.

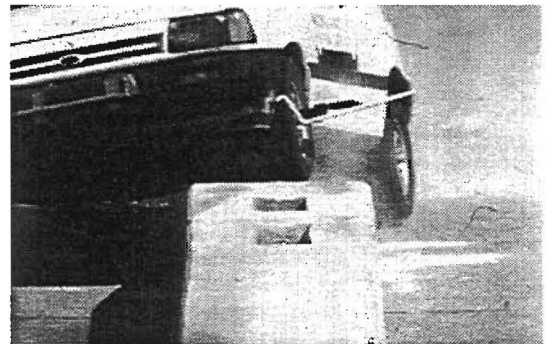
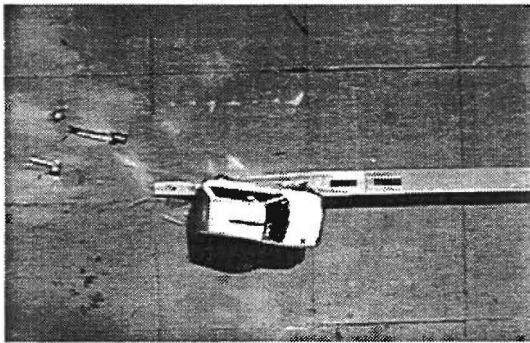
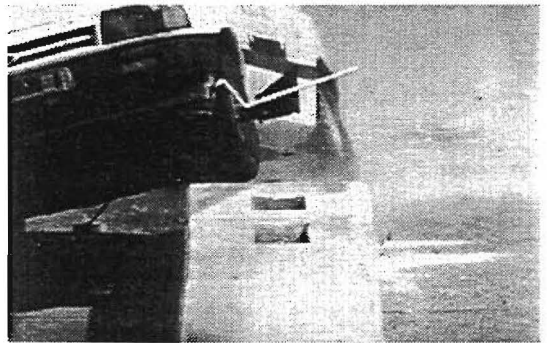
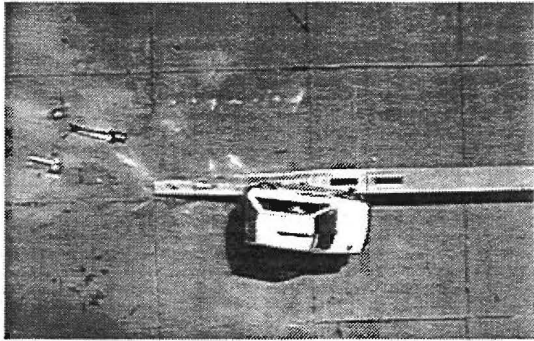
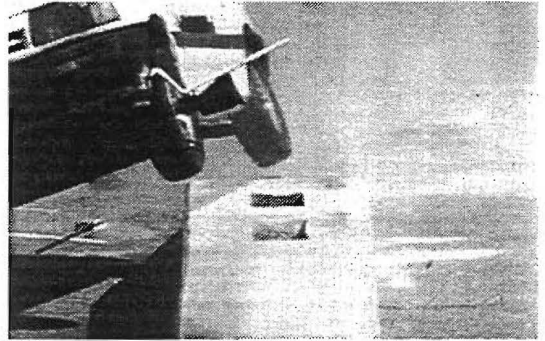
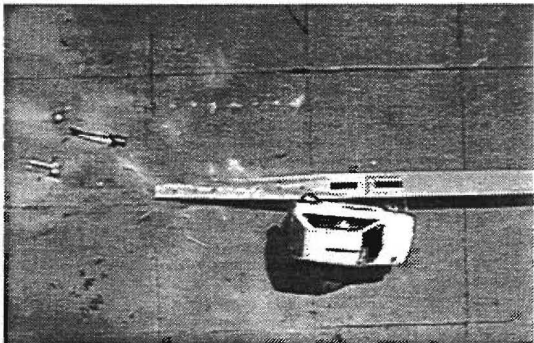
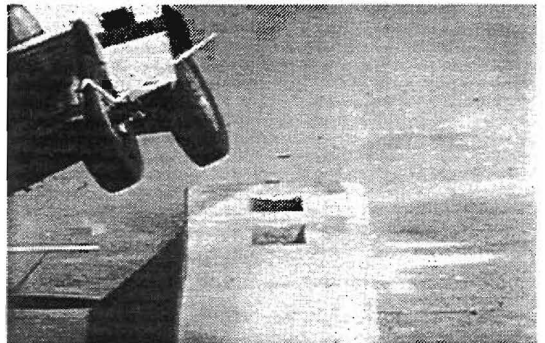
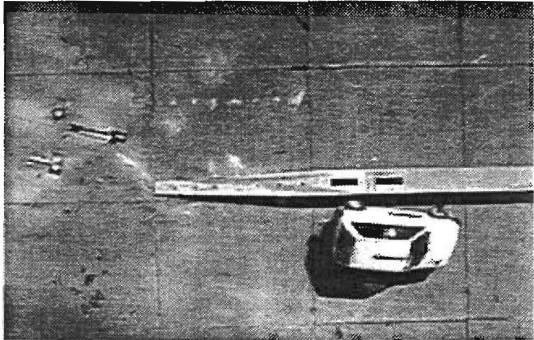
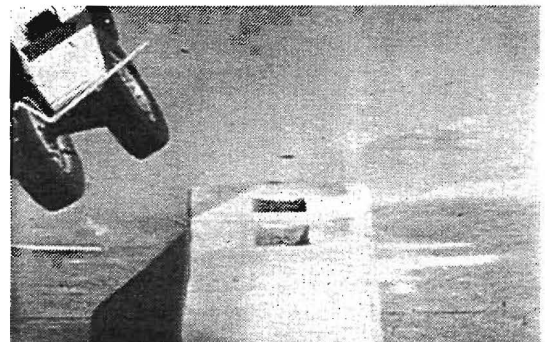
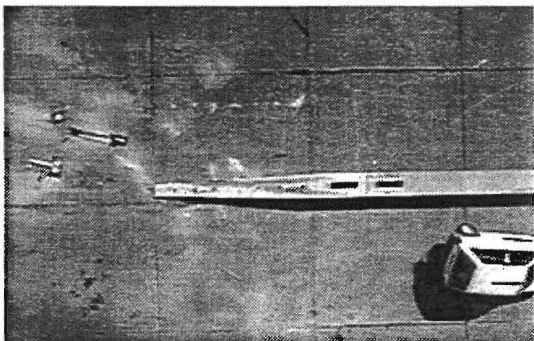
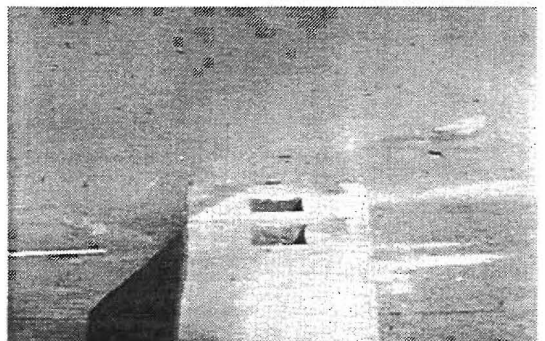
**Figure 42. Sequential Photographs for Test 414038-2
(Overhead and Frontal Views)**

The vehicle, traveling at 68.91 km/h, impacted the nose of the end treatment at 15.06 degrees with the right quarter point of the vehicle aligned with the centerline of the end treatment. As the left front vehicle tires began to roll up the end treatment at 0.032 s, the vehicle began to pitch upward. The vehicle continued up the end treatment and the left front tire rolled off the barrier and at 0.251 s the rear wheel lost contact with the barrier. The vehicle was traveling at 63.15 km/h and was exiting behind the barrier at 7.72 degrees. The vehicle continued behind the installation. Brakes on the vehicle were applied at 2.5 s and the vehicle subsequently came to rest 64.0 m down and 13.7 m behind the low-profile barrier. Sequential photographs of the test period are shown in Figures 42 and 43 of Appendix C.

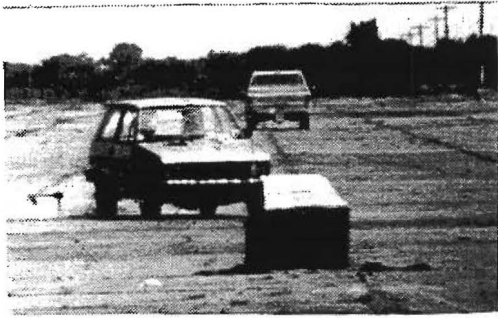
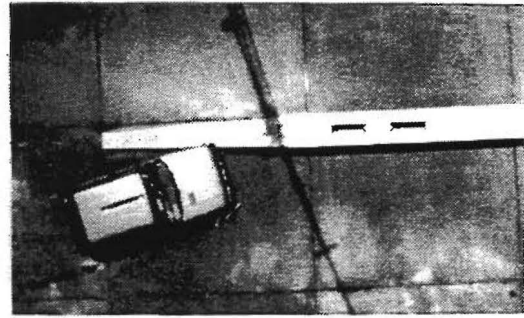
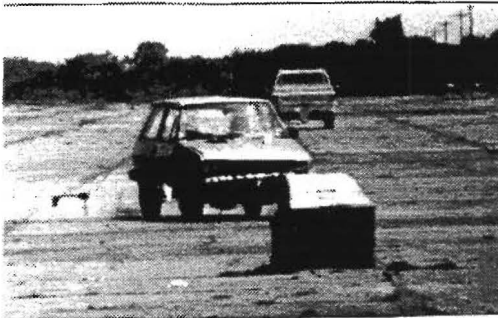
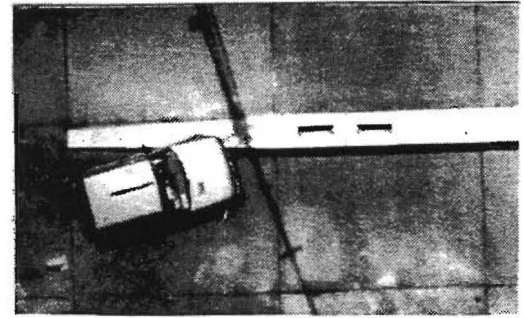
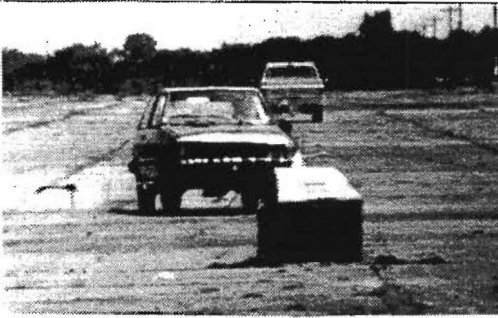
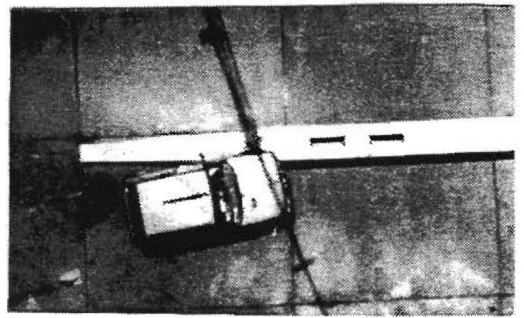
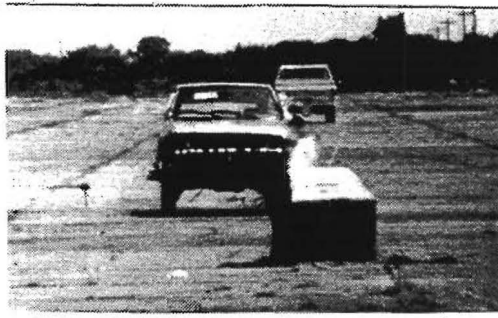
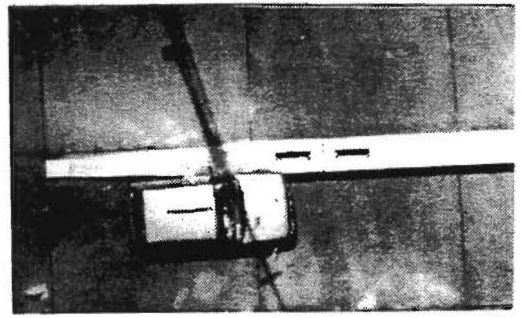
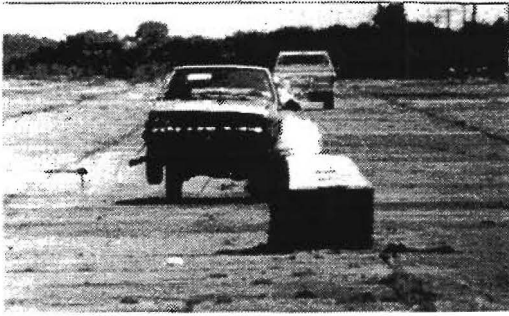
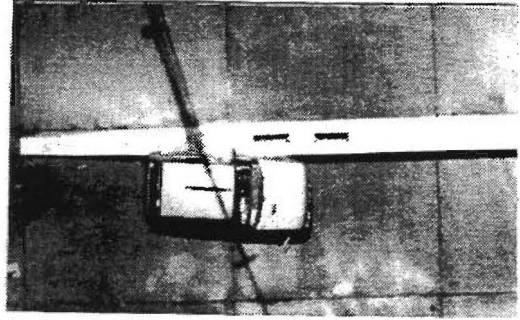
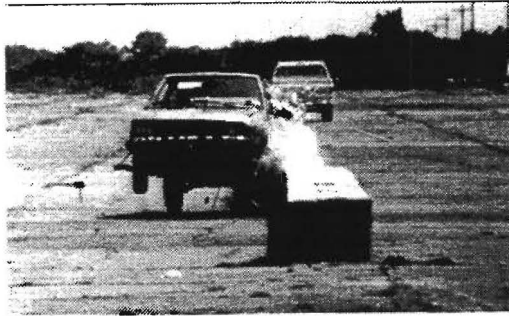
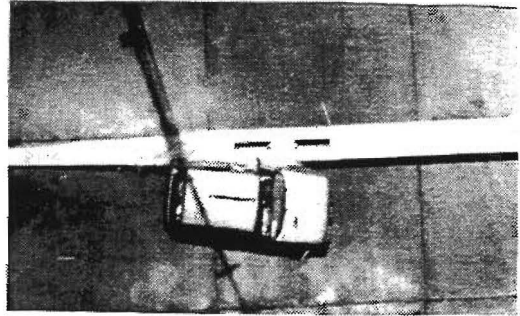
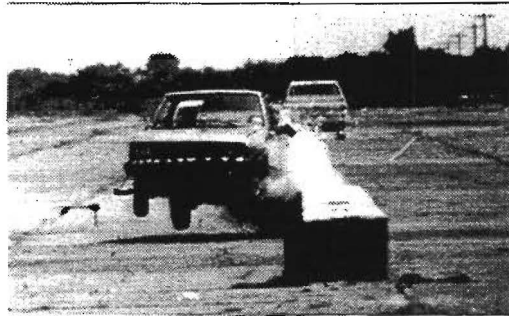
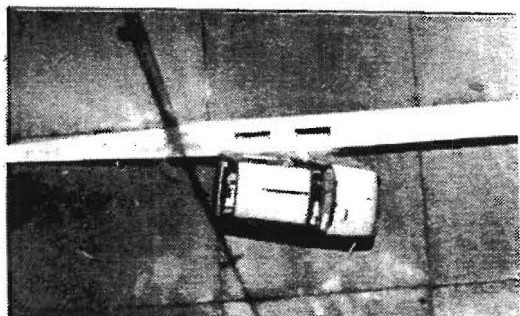
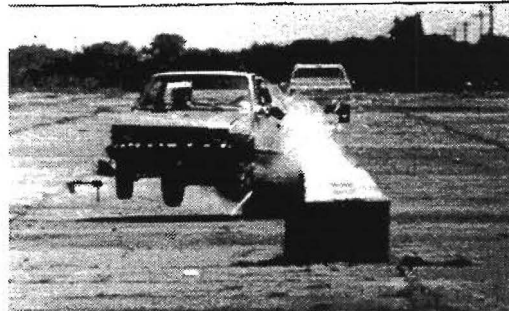
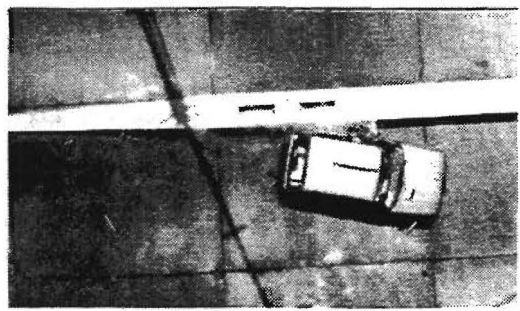
**Figure 44. Sequential Photographs for Test 1949A-1
(Overhead and Frontal Views)**

The vehicle impacted the end treatment 2.0 m from the end at a speed of 71.9 km/h. The angle of impact was 16.3 degrees. At 0.027 s after impact, the left wheel turned under and at 0.032 s the roof began to deform just over the door post location. The vehicle began to redirect at 0.050 s after impact and at 0.084 s, the dummy shattered the driver's side window. By 0.161 s, the vehicle was traveling parallel to the end treatment at a speed of 62.3 km/h, and at 0.188 s the rear of the vehicle impacted the end treatment. The vehicle became airborne at 0.253 s and remained airborne as the vehicle lost contact with the end treatment at 0.389 s traveling at a speed of 60.2 km/h and with an exit angle of 6.1 degrees. The brakes were applied at 2.5 s after impact, the vehicle yawed counterclockwise and came to rest facing the installation 39 m downstream of the point of impact. Sequential photographs for this test are shown in Figures 44 and 45 in Appendix C.
