FLEXBEAM REDIRECTIONAL SYSTEM FOR THE
MODULAR CRASH CUSHION

Research Report Number 146-3
Studies of Field Adaptation
of Impact Attenuation Systems
Research Study Number 2-8-68-146

TEXAS TRANSPORTATION INSTITUTE

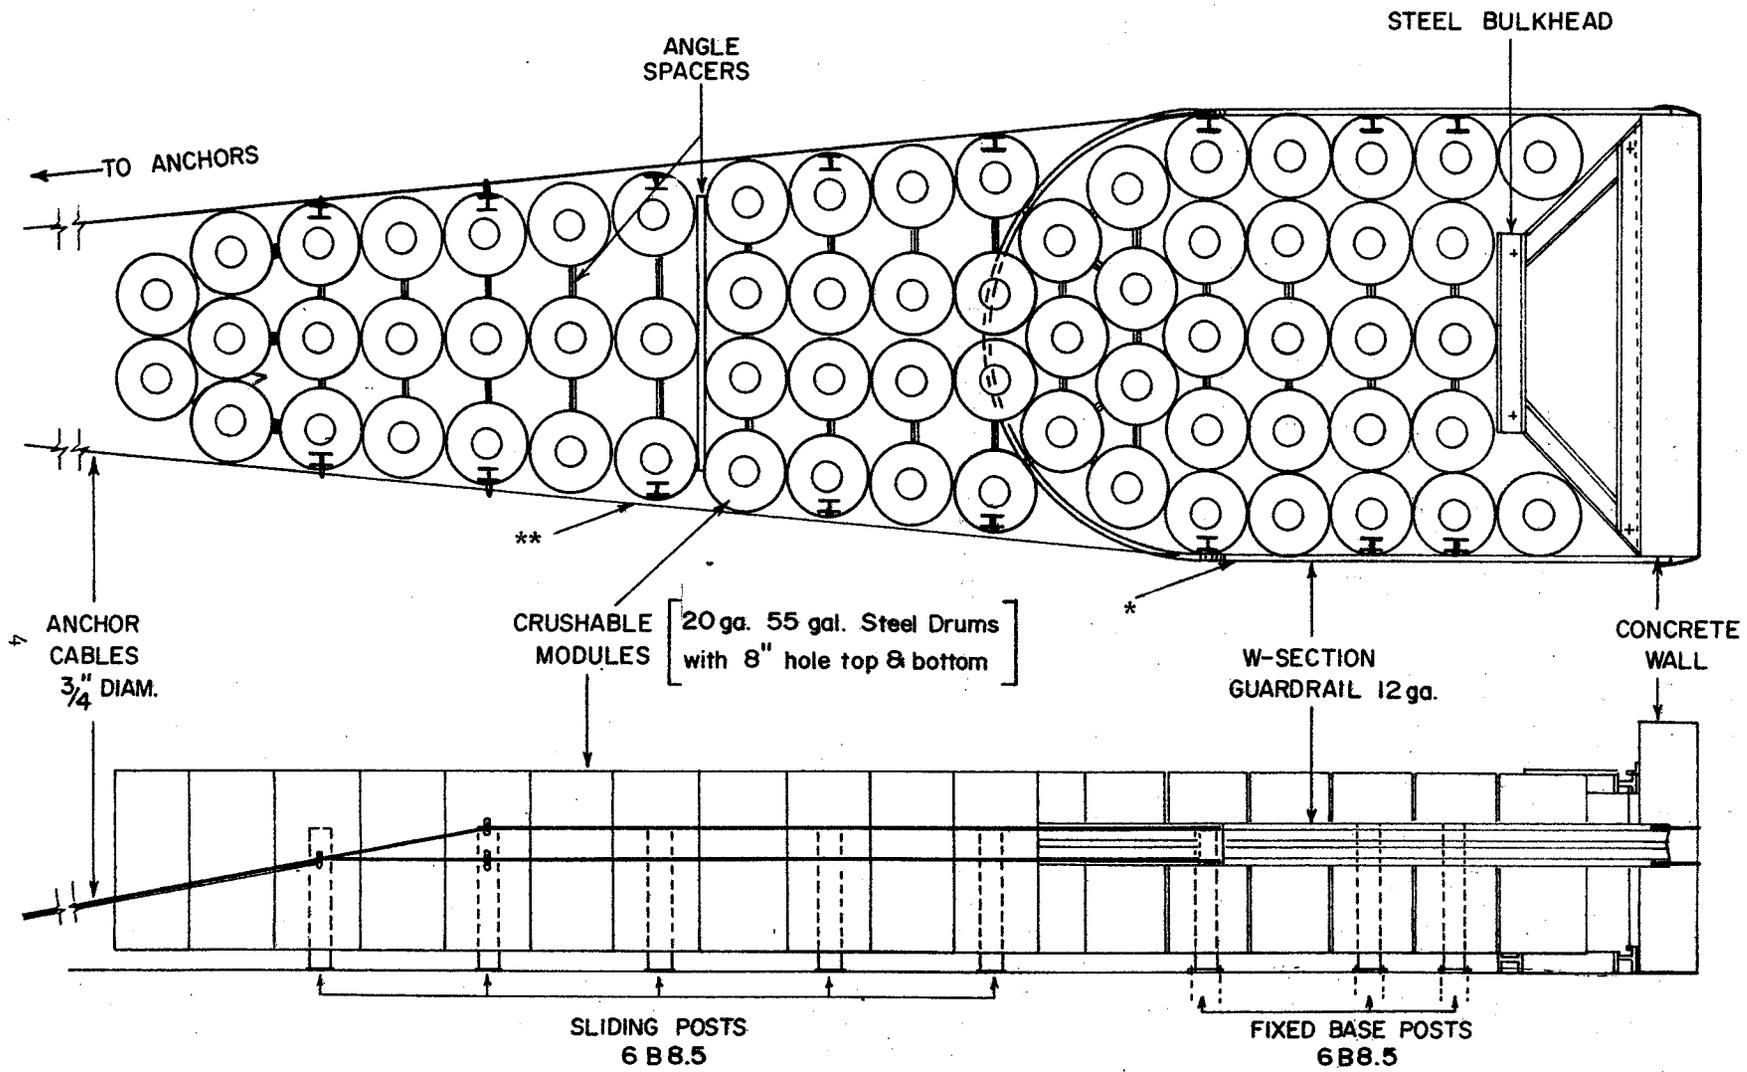
FIGURE 1, DRAWING OF MODIFIED MODULAR CRASH CUSHION

* IMPACT POINT, TEST 1146-6

** IMPACT POINT, TEST 1146-7

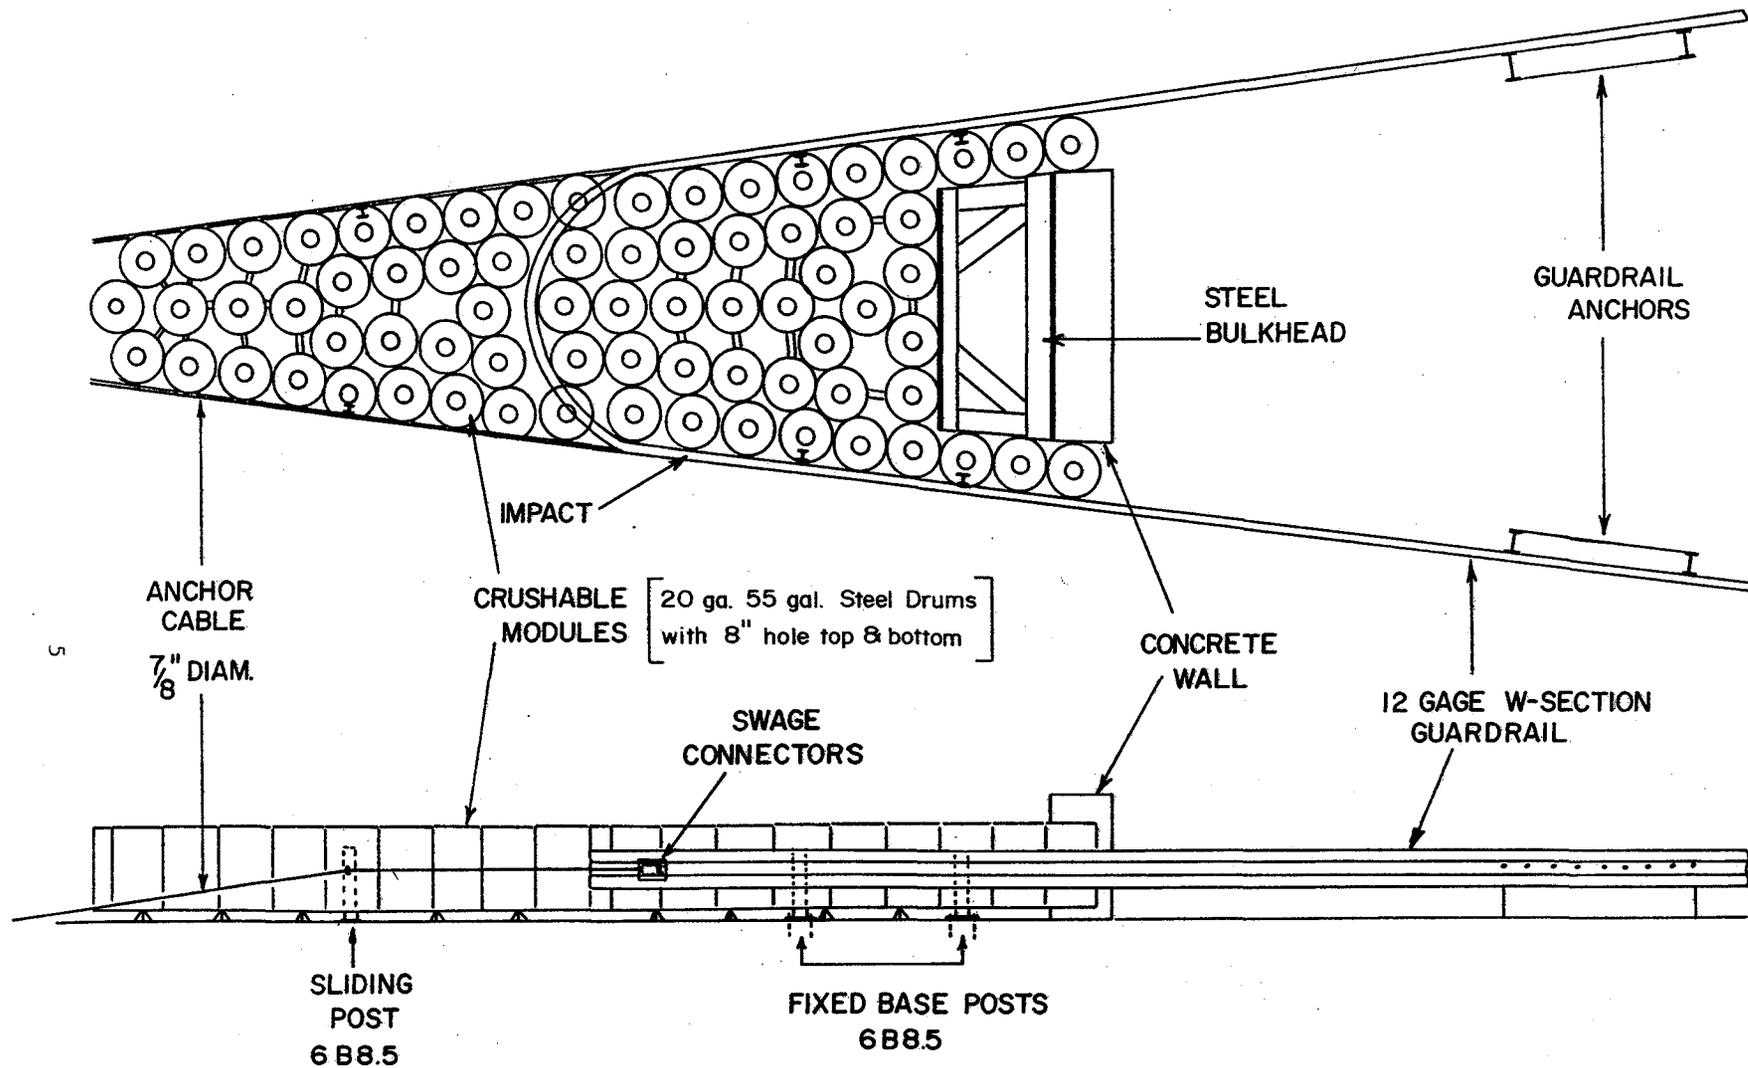
FIGURE 1A, MODULAR CRASH CUSHION CONFIGURATION - TEST 1146-8

Impact at 20° with center line of cushion on W-section guardrail, 15.5 feet in front of the rigid wall. See Figure 1A.

Several modifications were made to the cushion before this test was run. These included extending the W-section guardrail 22 feet beyond the rigid wall, adding more drums to the system and enclosing more drums with the W-section guardrail, relocating and removing some of the 6 B 8.5 support posts, and using a single 7/8" diameter anchor cable (with swage connectors) on each side. A 1963 Oldsmobile impacted the guardrail section at the same point as in Test 1146-6. The vehicle did not redirect as intended and contacted the steel bulkhead after 0.148 sec, causing a high peak deceleration. The vehicle then rebounded slightly, rotated, and came to a stop as shown in Figure 20. The guardrail was damaged beyond repair, and some of the I-beams were ripped from their plates. Damage to the front end of the vehicle was severe as shown in Figure 16.

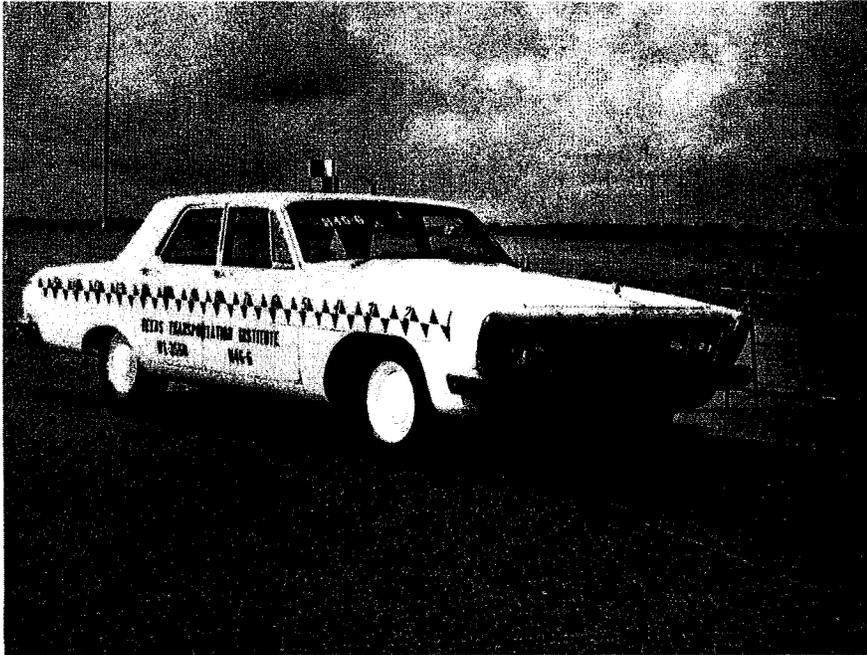
Figure 3, Vehicle Before Test 1146-6.

In this test, a 1963 Plymouth sedan (Figure 3) impacted the guard-rail portion at the rear of the cushion and was redirected. The vehicle traveled about 150 feet before striking a large piece of concrete (which was not associated with the test) and coming to rest (see Figure 4).

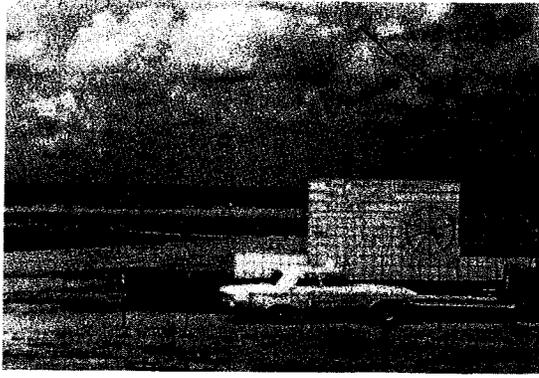
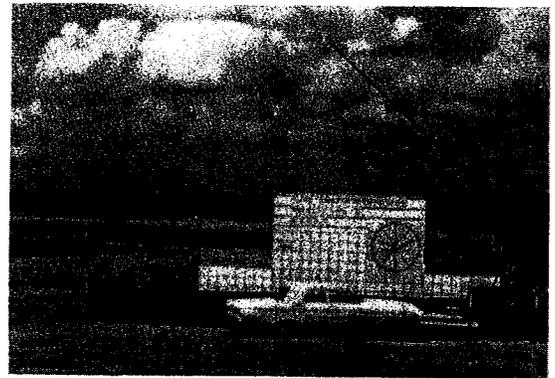
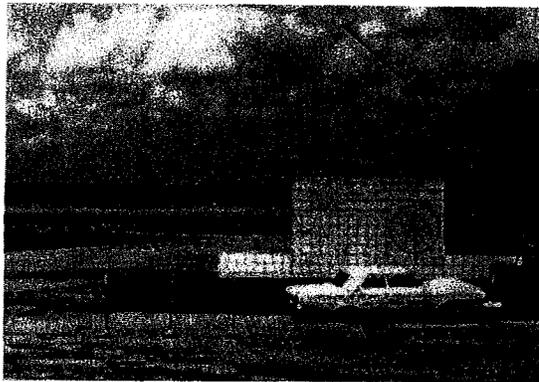
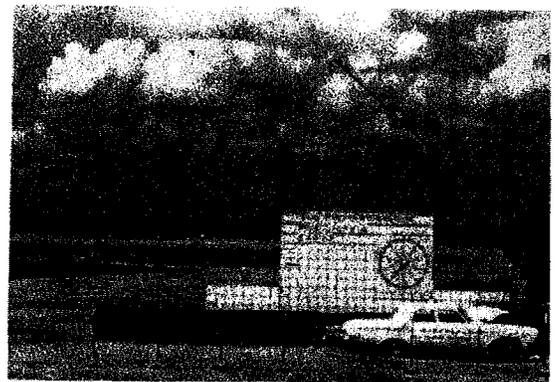
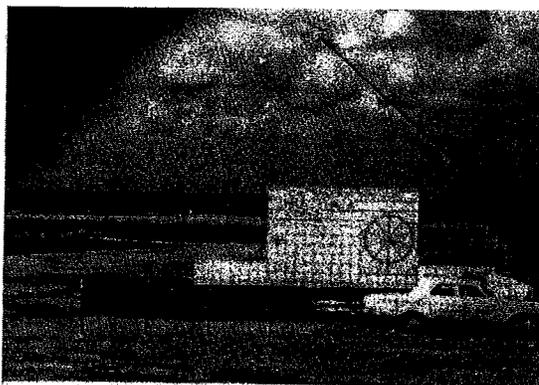
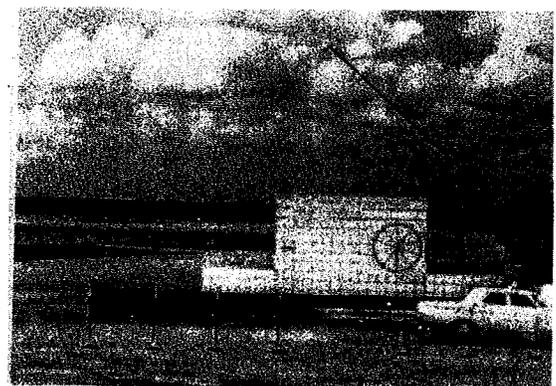
Figure 5, Sequential Photographs of Test 1146-6.

There was only minor damage to the crash cushion (Figures 6 and 7). The vehicle sustained considerable damage to the left front end. The amount of damage due to the collision with the concrete block was undetermined. The broken windshield resulted from the vehicle's hood breaking free during the primary impact (Figures 4 and 5).

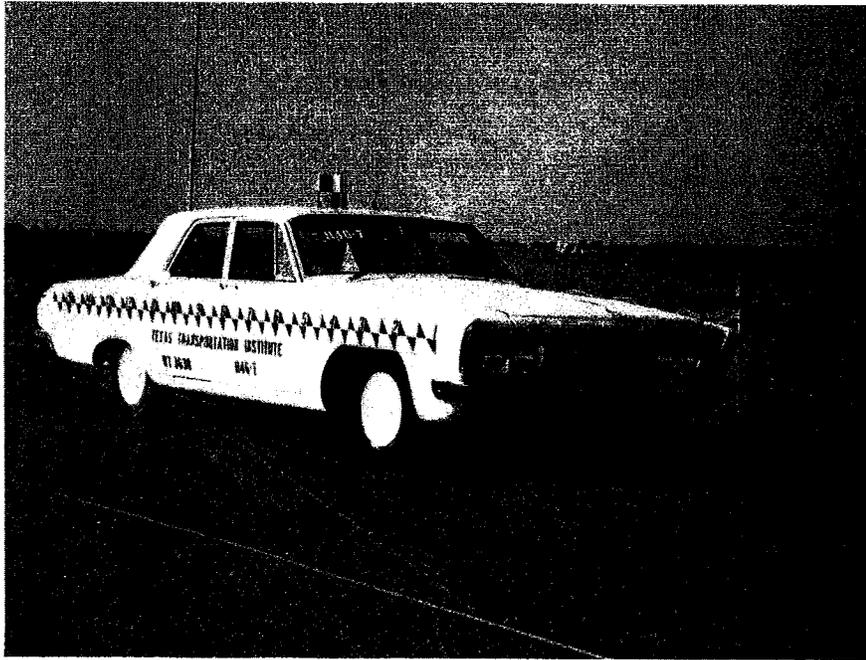
Figure 8, Vehicle Before Test 1146-7.

Again, a 1963 Plymouth sedan (Figure 8) was used. The crash cushion was restored to its original condition prior to the test (Figures 9 and 12). In this test, the vehicle was directed into the modules in front of the curved portion of the guardrail to determine the severity of the secondary collision with the rail.

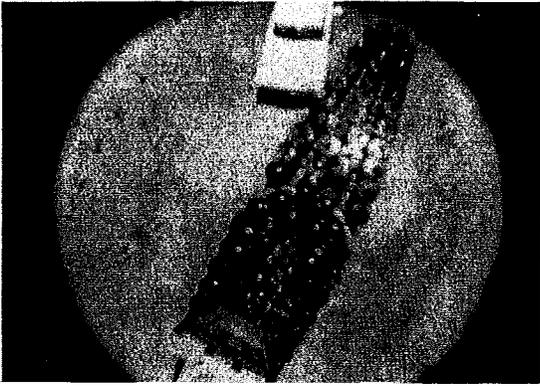
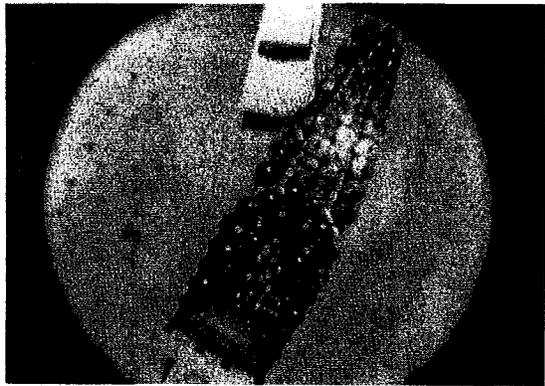
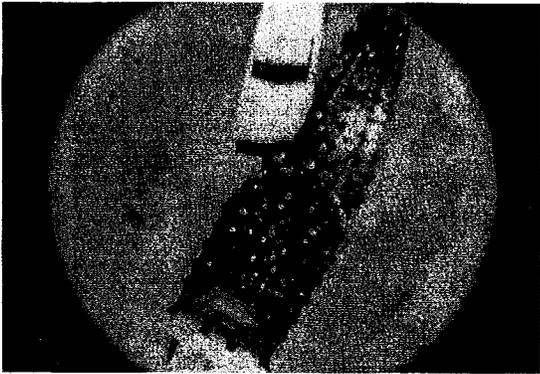
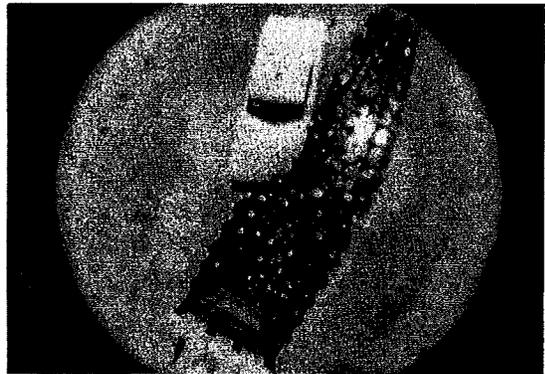
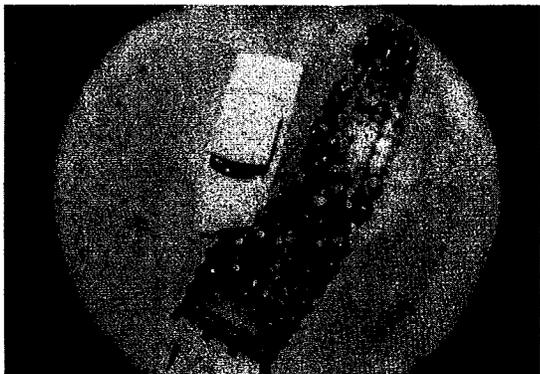
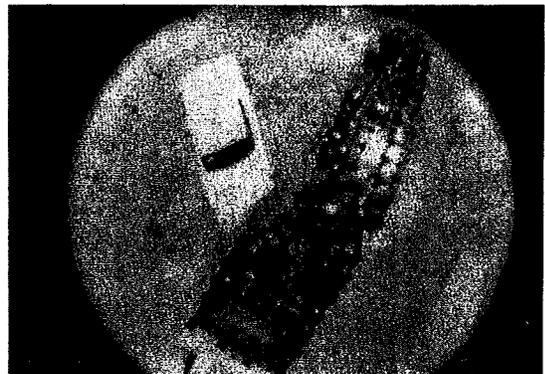
Figure 11, Overhead View of Test 1146-7.

The vehicle traveled about 9.5 feet from the point of initial contact with the modules to the point of initial contact with the guardrail. As the left front end of the vehicle was intercepted by the curved portion of the rail (Figures 13 and 14), the accompanying deceleration caused the vehicle to rotate about 35° and come to a stop. Some rebounding was observed (Figure 11). Again, the left front end was severely damaged, but the passenger compartment was not penetrated.

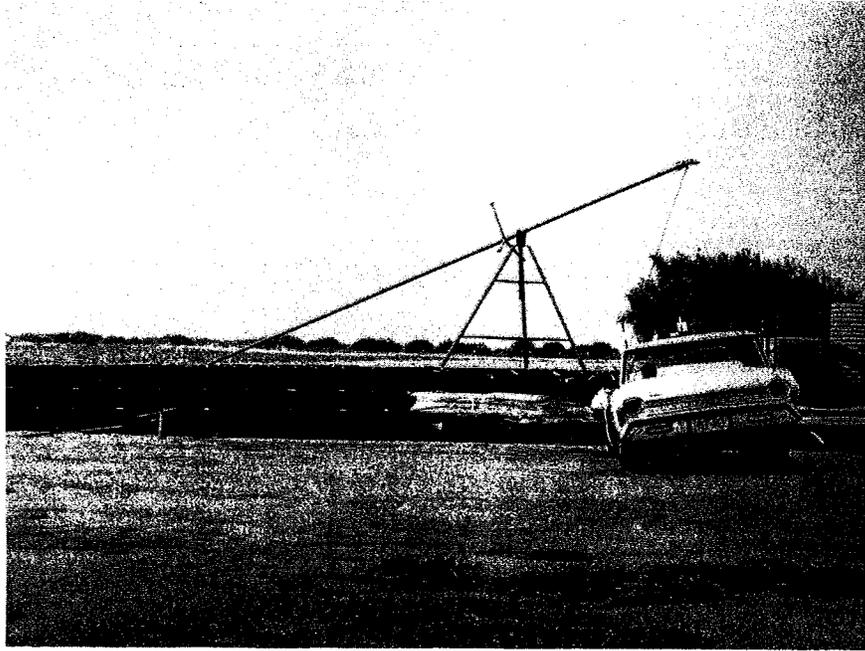
In this test, there was only one 6 B 8.5 fixed post at the impact point to support the guardrail. In the previous (successful) test, there were three fixed posts near the impact point to support the guardrail.

Figure 21, Impact Area After Test 1146-8.

It is evident that the longitudinal cables attached to the flexbeam form an integral part of the redirection system. These cables must provide lateral stability in angled impacts while producing negligible interference in head-on crashes. The third test reported here demonstrated the need for strong and rigid cable connectors, and several fixed posts supporting the guardrail as use in test 1146-6.
