1. Report No. FHWA/TX-01/1792-3	2. Government Accession No.	3. Recipient's Catalog No.	
4. Title and Subtitle TESTING AND EVALUATION OF A PEDESTAL BASE SIGN SUPPORT		5. Report Date January 2001

TESTING AND EVALUATION OF A PEDESTAL BASE SIGN SUPPORT

Report 1792-3
Project Number 0-1792
Research Project Title: Roadside Safety Hardware
for Traffic Control Devices

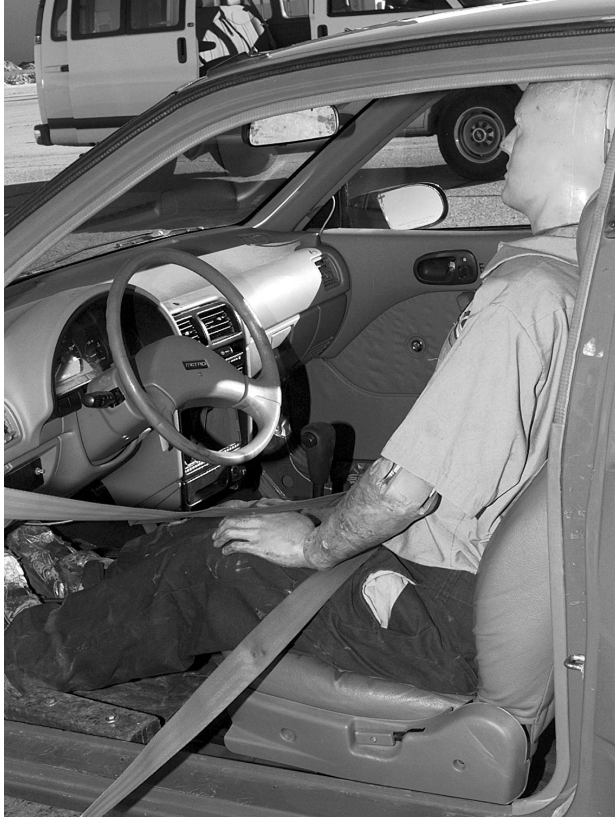
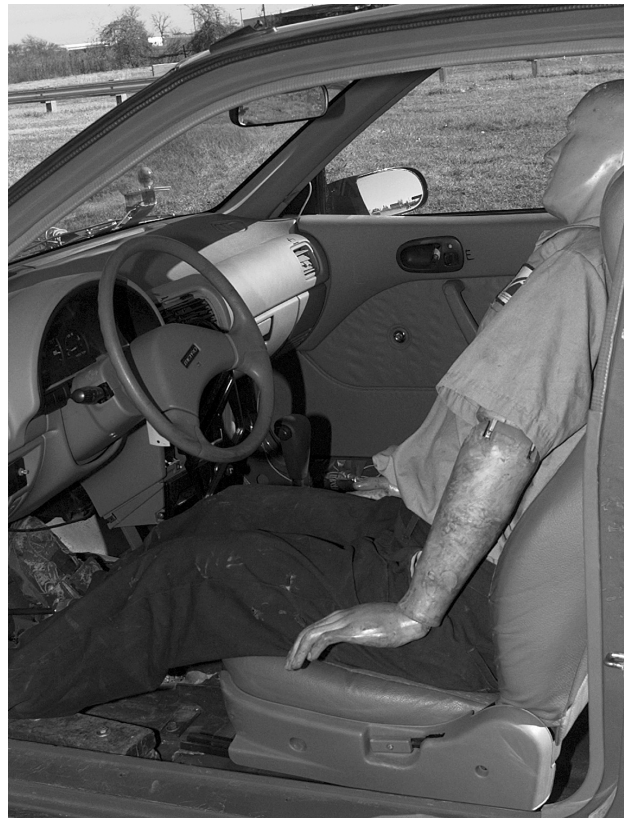
Figure 10. Interior of Vehicle for Test 417920-1.

As shown in [Figure 9](#), the vehicle sustained minimal damage to the bumper, hood, fan, radiator, and radiator support. Maximum exterior crush to the vehicle was 140 mm (5.5 inch) to the right front inner bumper at bumper height. Maximum deformation of the occupant compartment was 30 mm (1.2 inch) to the center of the roof. The interior of the vehicle is shown in [Figure 10](#). Exterior vehicle crush and occupant compartment measurements are shown in [Appendix B, Tables 3 and 4](#).

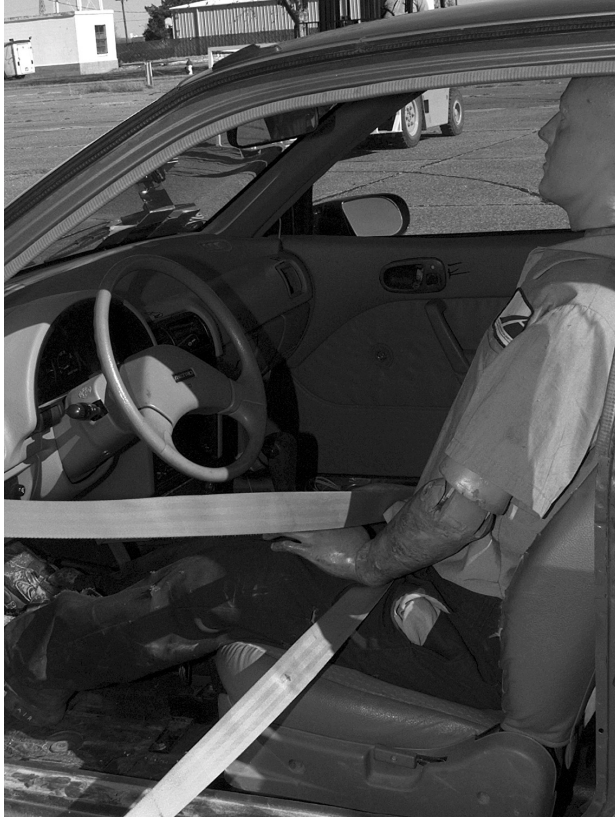
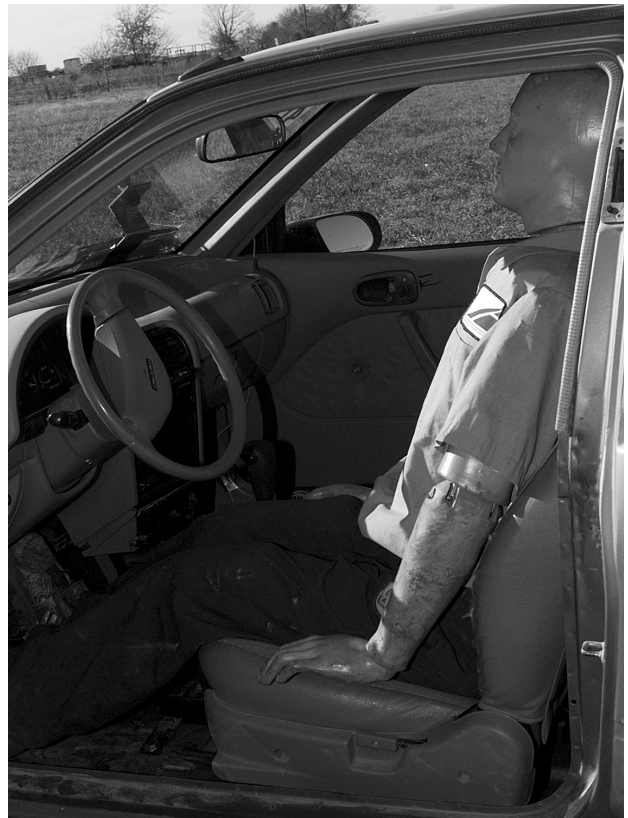
Figure 17. Interior of Vehicle for Test 417920-2.

As shown in [Figure 16](#), the vehicle sustained minimal damage to the bumper, hood, fan, radiator and radiator support. Maximum exterior crush to the vehicle was 200 mm (7.9 inch) to the left front inner bumper at bumper height. The interior of the vehicle is shown in [Figure 17](#). Exterior vehicle crush and occupant compartment measurements are shown in [Appendix B, Tables 5 and 6](#).

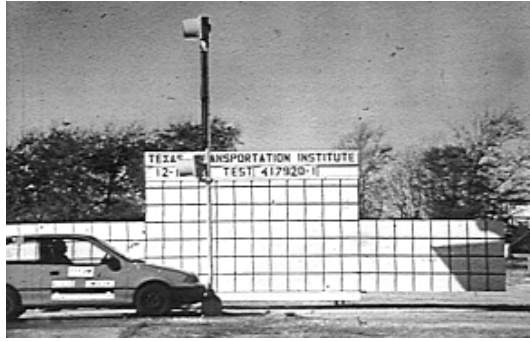
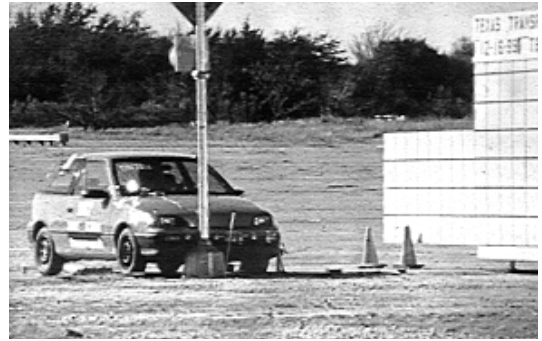
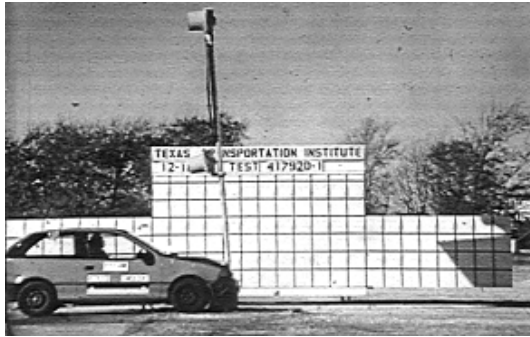
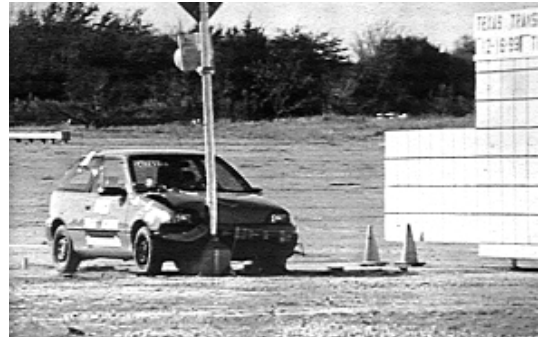
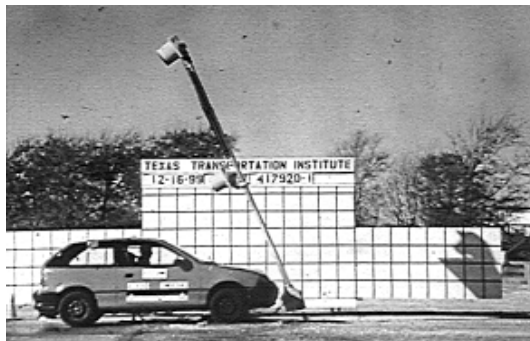
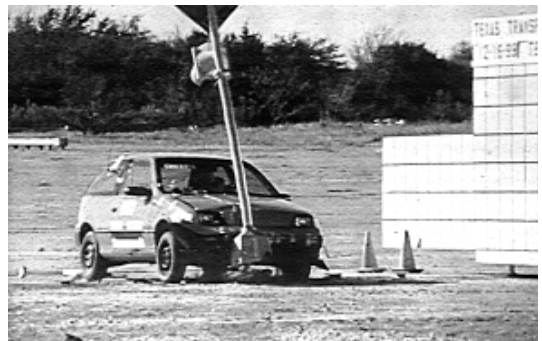
**Figure 21. Sequential Photographs for Test 417920-1
(Perpendicular and Oblique Views).**

The vehicle impacted the sign support head-on at a speed of 35.2 km/h (21.9 mi/h). At 0.002 s, the underside of the bumper of the vehicle contacted the pedestal base, and at 0.015 s, the pedestal base and pole moved. A crack on the field side of the pedestal base formed at 0.041 s. By 0.049 s, the pedestal base had fractured, and by 0.056 s, the pole bounced off the bumper of the vehicle. The vehicle lost contact with the pole at 0.126 s as the vehicle was traveling at a speed of 27.0 km/h (16.8 mi/h). At 0.481 s, the lower signal light contacted the vehicle at the top of the windshield near the roof, and at 0.507 s, the pole was parallel with the ground above the hood. The sign panel contacted the rear right corner of the roof of the vehicle at 0.569 s, and at 0.692 s, the pole lost contact with the rear window. By 0.719 s, the lower signal light lost contact with the roof of the vehicle as the vehicle was traveling at a speed of 26.6 km/h

(16.5 mi/h). By 0.811 s, the upper warning beacon contacted the ground surface. Brakes on the vehicle were applied as the vehicle exited the test site and the vehicle came to rest 32.0 m (105.0 ft) from the impact point. Sequential photographs of the test can be found in [Appendix C, Figure 21](#).
