1. Report No. FHWA/TX-04/4564-1		2. Government Accession No.		3. Recipient's Catalog No.	
4. Title and Subtitle EVALUATION OF GUARDRAIL TO CONCRETE BRIDGE RAIL TRANSITIONS				5. Report Date October 2003

EVALUATION OF GUARDRAIL TO CONCRETE BRIDGE RAIL TRANSITIONS

Report 4564-1
Project Number 0-4564
Research Project Title: Guardrail to Concrete Bridge Rail Transitions

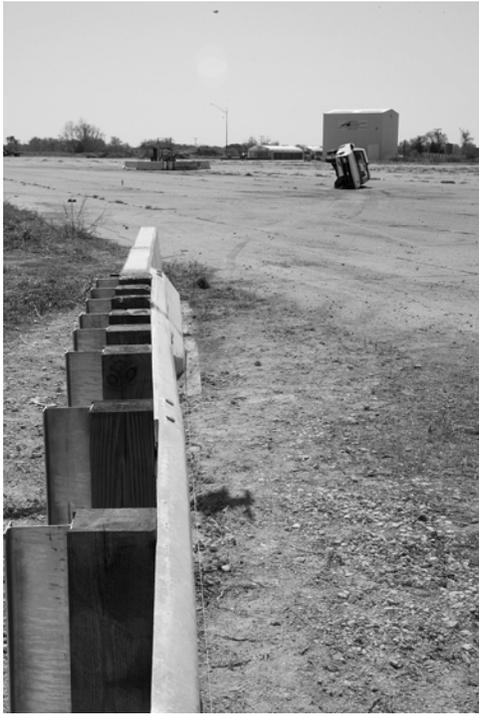
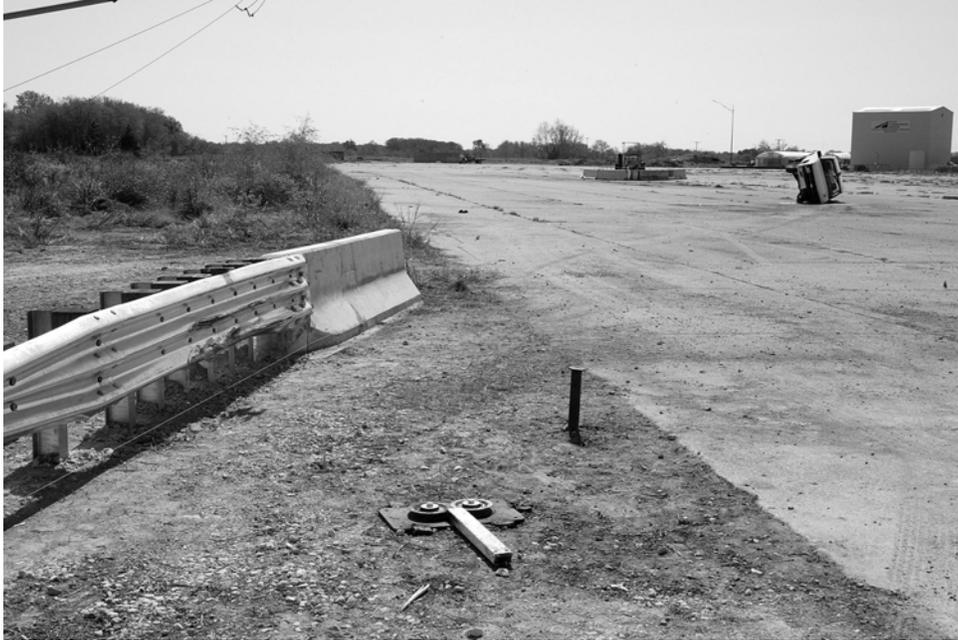
Figure 6. After Impact Trajectory Path for Test 445643-1.

Figures 6 and 7 show the transition sustained minimal damage. The lower edge of the thrie beam was folded under and flattened 2.4 in (60 mm) adjacent to the concrete parapet. Tire marks found on the end of the parapet extended 1.8 in (45 mm) from the traffic face, and compacted dirt extended another 1.8 in (45 mm) beyond the tire mark, for a total distance of 3.6 in (90 mm). The wood blockout at post 15 was split on the traffic face and the corners of the blockouts on posts 15 through 17 were shaved off approximately 1.6 in (40 mm). No tire marks were observed on the posts. Maximum dynamic deflection during the test was 4.1 inches (105 mm). Maximum residual deformation was 2.3 in (59 mm) between posts 15 and 16. Working width was 25 in (636 mm) and total length of contact of the vehicle with the transition was 135 in (3425 mm).

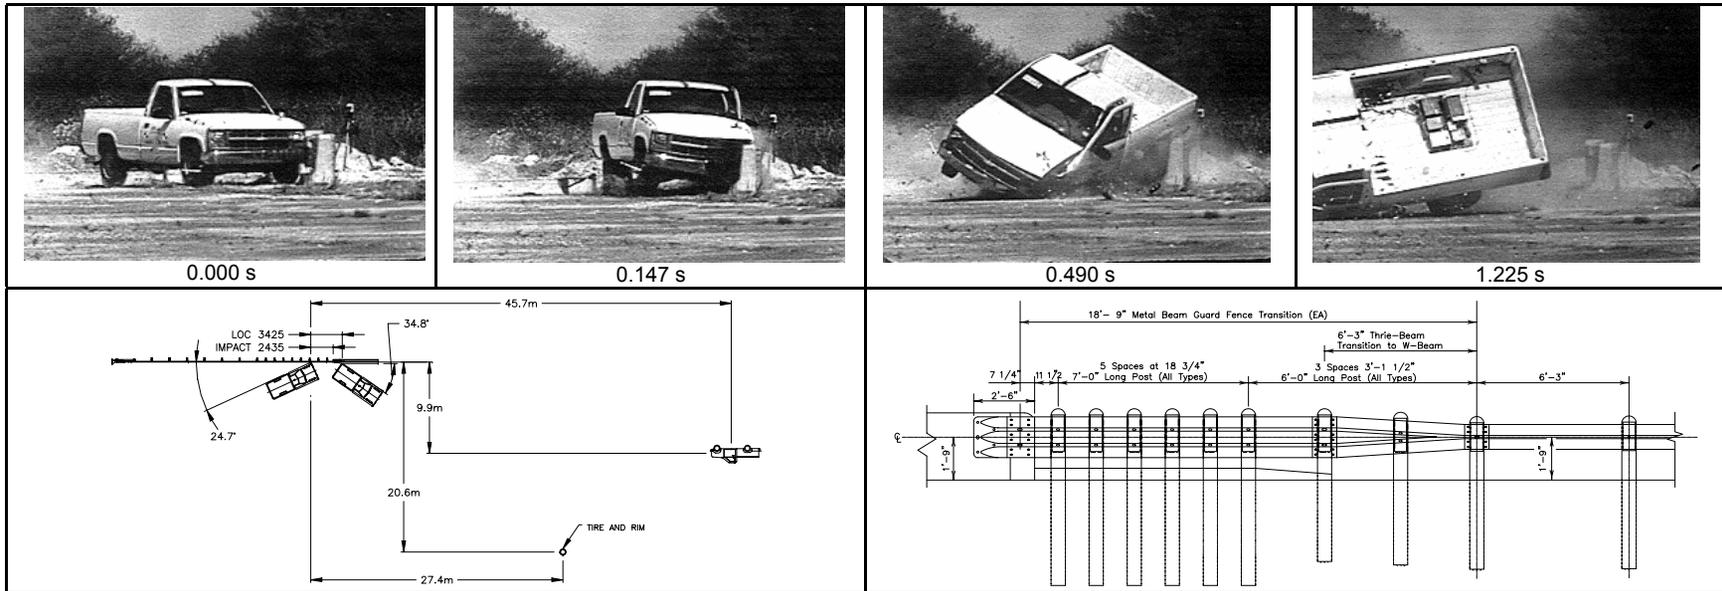
Results: No detached elements, fragments, or other debris were present to penetrate or to show potential for penetrating the occupant compartment, or to present undue hazard to others in the area. Maximum occupant compartment deformation was 6.8 in (172 mm) in the center floorpan area over the transmission tunnel. (*FAIL*)

Results: The vehicle remained upright during the collision; however, the vehicle rolled onto its left side after loss of contact with the rail. (*FAIL*)

Results: The vehicle came to rest on its left side 149.9 ft (45.7 m) downstream of impact and 32.5 ft (9.9 m) forward of the traffic face of the rail. (*FAIL*)

Results: Exit angle at loss of contact was 34.9 degrees, which was 141 percent of the impact angle. (*FAIL*)

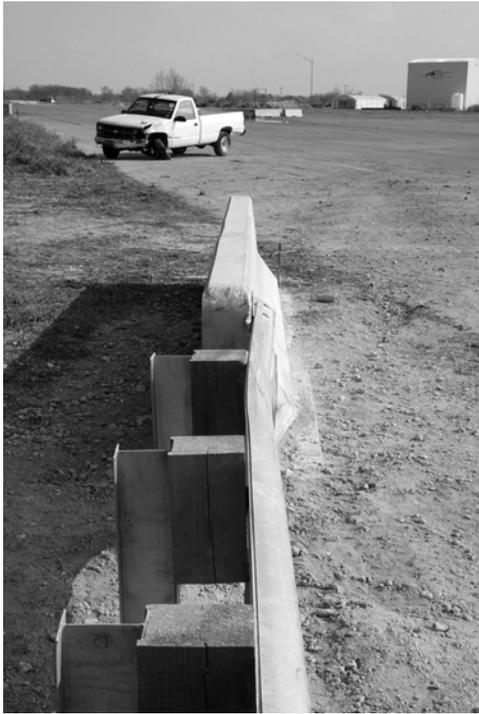
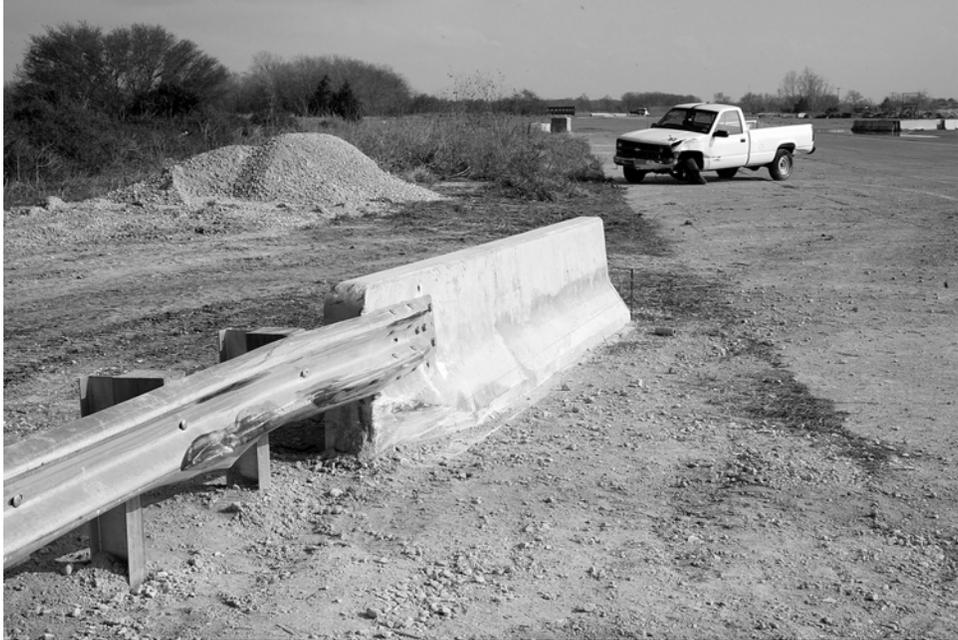
Figure 15. After Impact Trajectory Path for Test 445643-2.

As Figures 15 and 16 show, the transition sustained minimal damage. The lower corrugation of the W-beam was gouged and flattened in the immediate vicinity of impact. Tire marks were found on the end of the parapet extending 3.5 in (90 mm) from the traffic face. There were no tire marks observed on the posts. Maximum dynamic deflection of the transition during the test was 2.6 in (65 mm). Maximum residual deformation was 1.6 in (42 mm) near post 13. Working width was 17.6 inches (448 mm), and total length of contact of the vehicle with the transition was 106 inches (2704 mm).

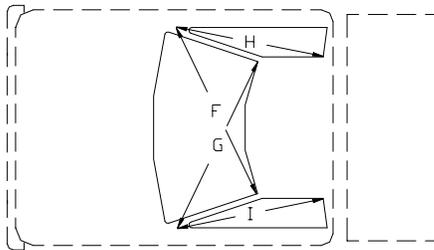
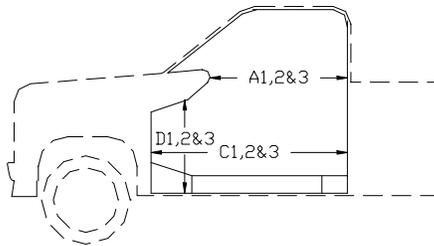
O c c u p a n t C o m p a r t m e n t D e f o r m a t i o n

BEFORE (mm)	AFTER (mm)
A1	872	852
A2	942	919
A3	915	913
B1	1082	1055
B2	1017	845
B3	1074	1066
C1	1373	1350
C2		
C3	1370	1374
D1	314	370
D2	159	110
D3	316	320
E1	1585	1563
E2	1592	1600
F	1465	1470
G	1465	1452
H	1250	1275
I	1243	1243
J*	1525	1440

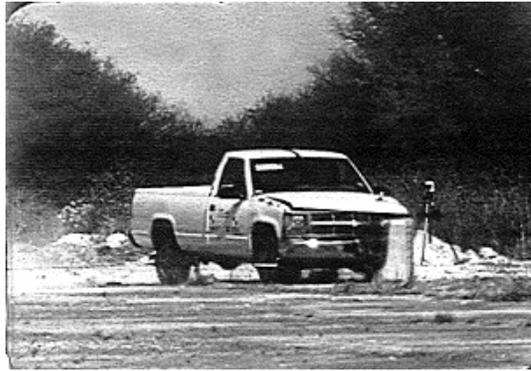
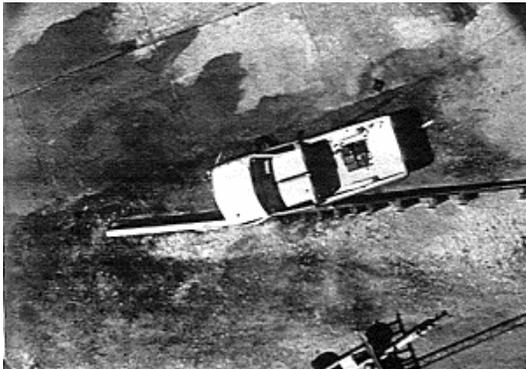
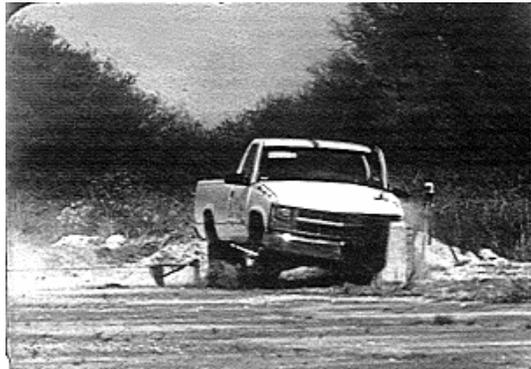
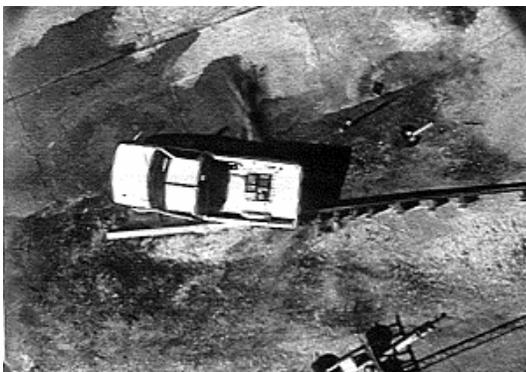
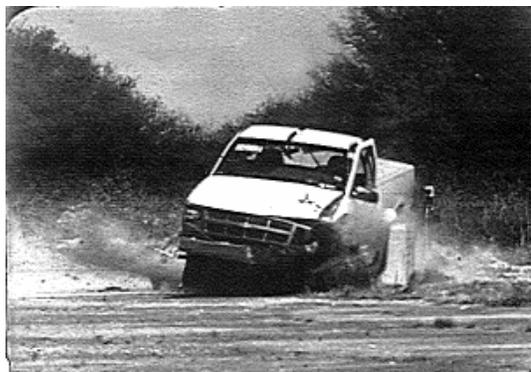
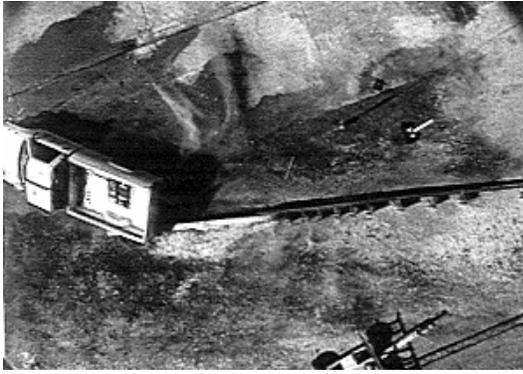
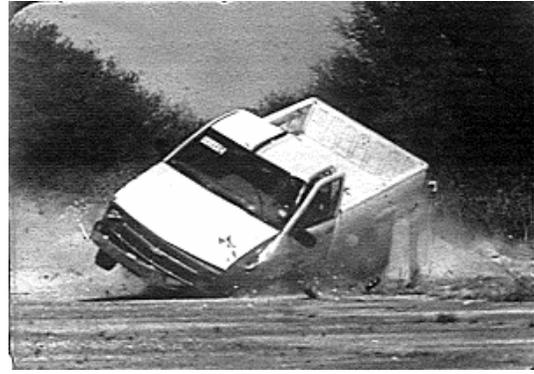
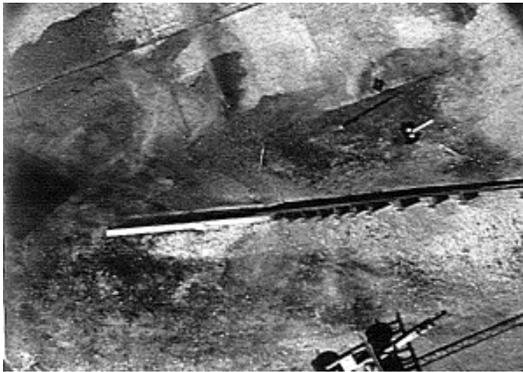
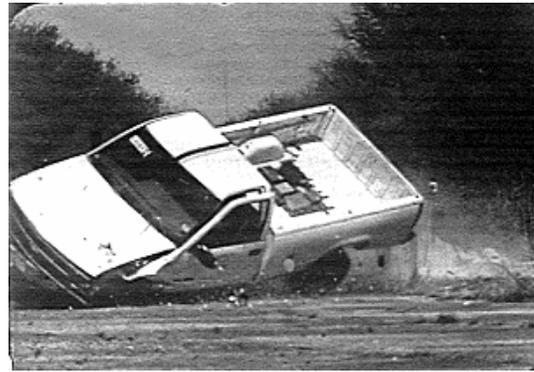
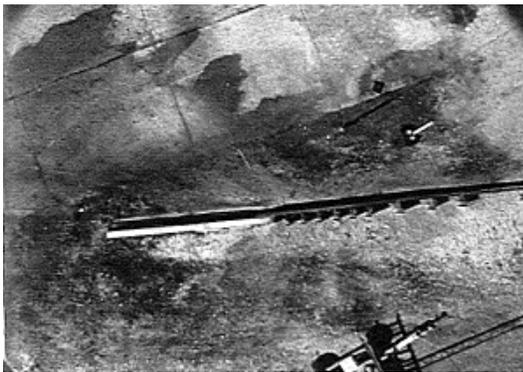
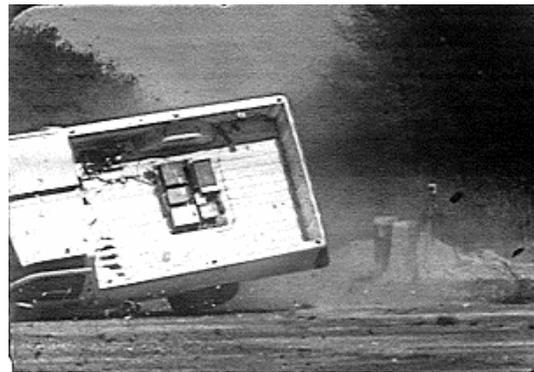
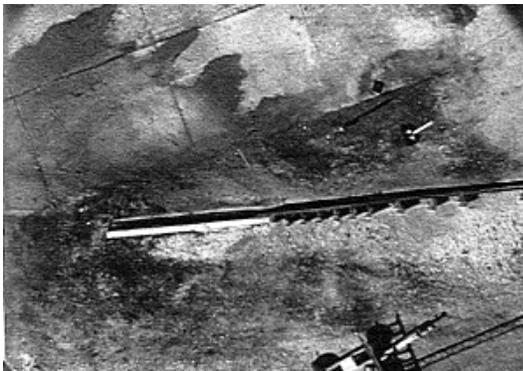
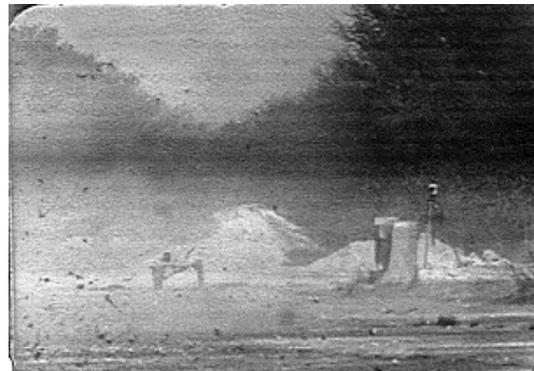
Figure 22. Sequential Photographs for Test 445643-1 (Overhead and Frontal Views).

The vehicle, traveling at a speed of 61.3 mi/h (98.7 km/h), impacted the transition 8.0 ft (2.435 m) upstream of the end of the concrete parapet at an impact angle of 24.7 degrees. Shortly after impact, posts 12 and 13 began to deflect toward the field side of the installation. At 0.010 seconds (s) after impact, post 14 began to deflect toward the field side, and at 0.015 s posts 15 and 11 deflected toward the field side. Post 16 deflected toward the field side at 0.107 s, and post 17 at 0.022 s. The vehicle began to redirect at 0.027 s. At 0.214 s, the vehicle became parallel with the rail and was traveling at a speed of 41.0 mi/h (65.9 km/h). The left rear of the vehicle contacted the rail at 0.244 s. At 0.572 s, the vehicle lost contact with the rail and was traveling at a speed of 40.2 mi/h (64.7 km/h) and an exit angle of 34.8 degrees. As the vehicle exited the test area, the right side wheels became airborne, and the vehicle began to roll counterclockwise and yaw clockwise. Brakes on the vehicle were not applied, and the vehicle subsequently came to rest on its left side 149.9 ft (45.7 m) downstream of impact and 32.5 ft (9.9 m) forward of the traffic face of the rail. Sequential photographs of the test period are shown in Appendix C, Figures 22 and 23.

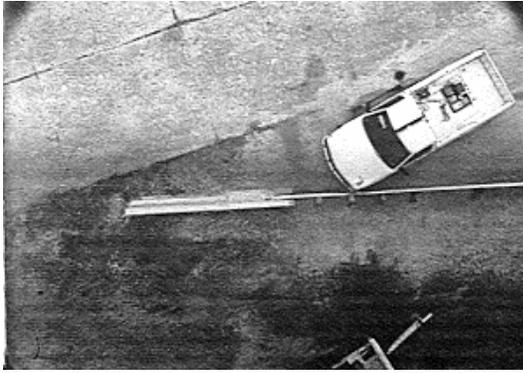
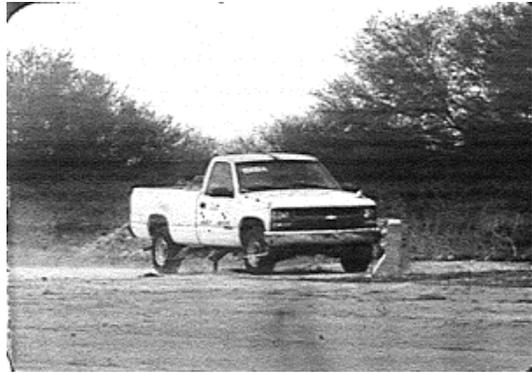
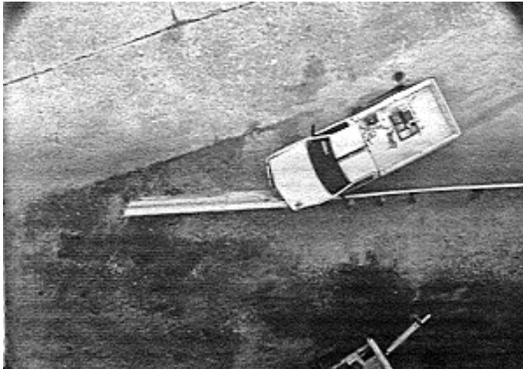
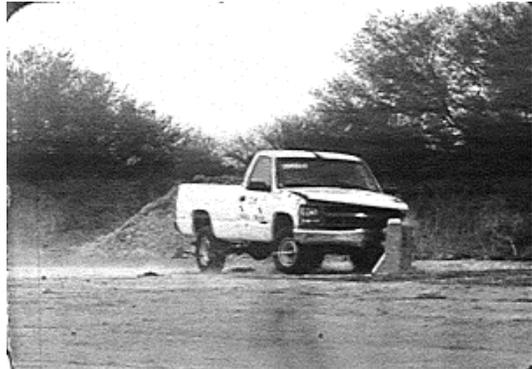
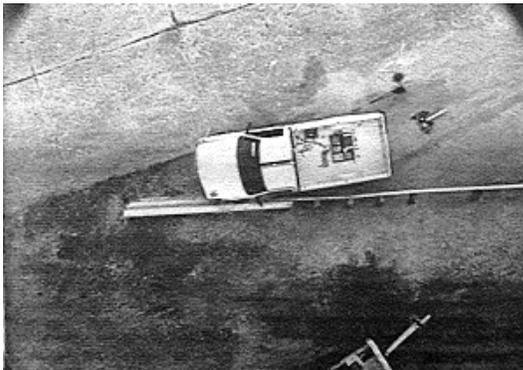
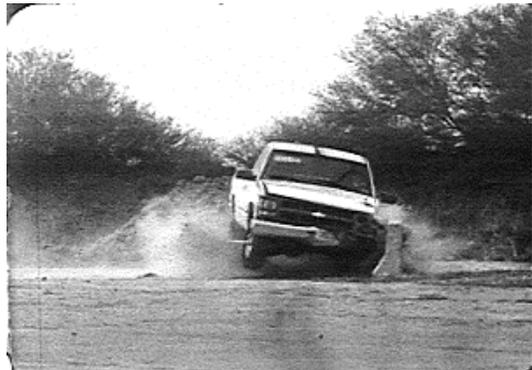
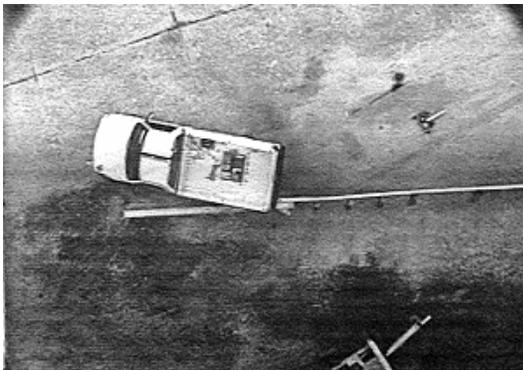
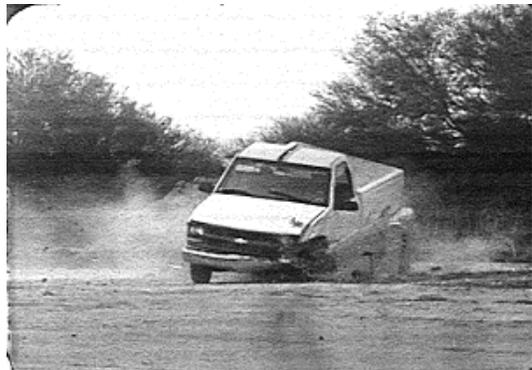
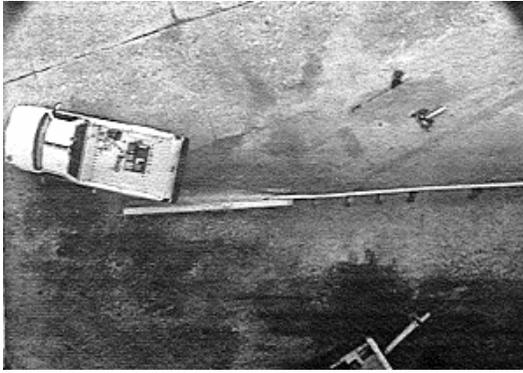
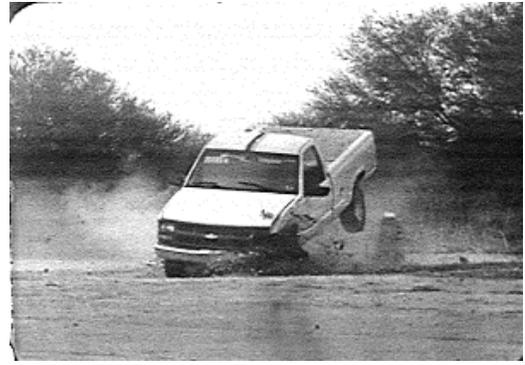
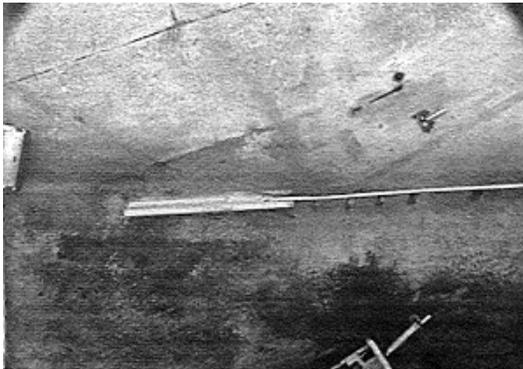
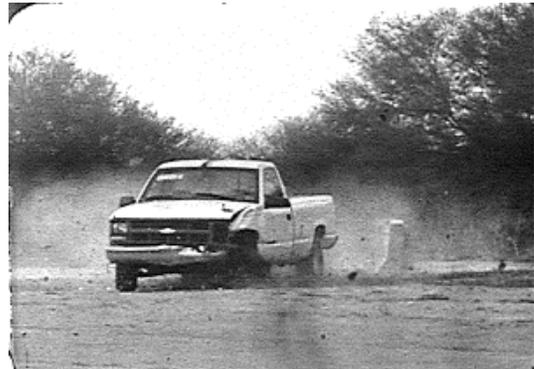
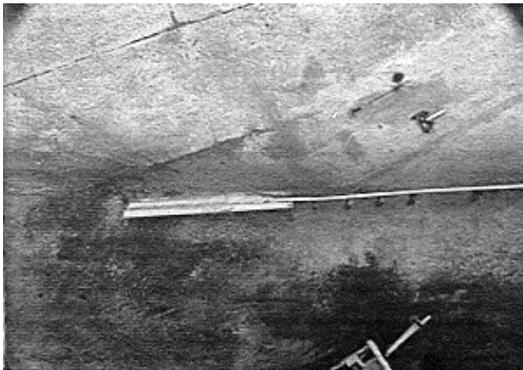
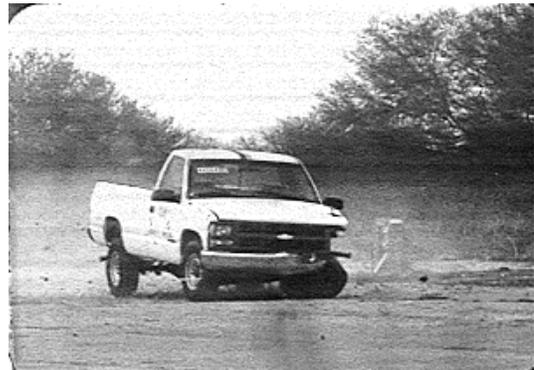
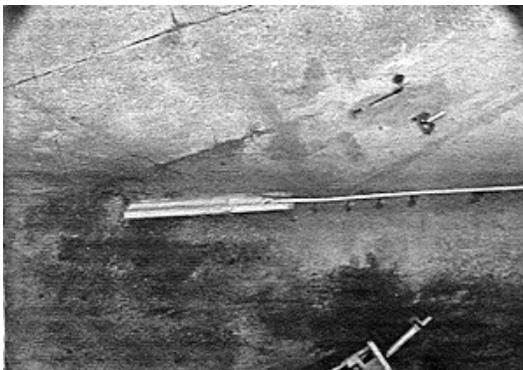
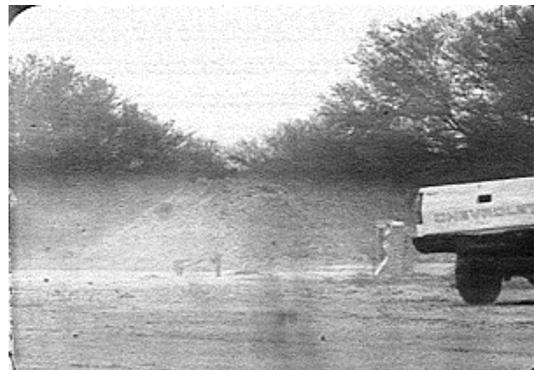
Figure 24. Sequential Photographs for Test 445643-2 (Overhead and Frontal Views).

deflated, and at 0.233 s, the vehicle lost contact with the rail element. At 0.287 s, the vehicle was traveling parallel with the transition at a speed of 29.8 mi/h (47.9 km/h). The rear of the vehicle contacted the transition at 0.365 s and then contacted the end of the parapet at 0.392 s. At 0.557 s, the vehicle lost contact with the transition and was traveling at a speed of 27.4 mi/h (44.1 km/h) and an exit angle of 15.7 degrees. Brakes on the vehicle were applied 1.9 s after impact, and the vehicle subsequently came to rest upright 90 ft (27.4 m) downstream of impact and with the rear of the vehicle aligned with the traffic face of the rail. Appendix C, Figures 24 and 25 shows sequential photographs of the test period.
