CRASH TEST AND EVALUATION OF THE TxDOT T224 BRIDGE RAIL

Test Report 9-1002-15-5

TEXAS A&M TRANSPORTATION INSTITUTE
COLLEGE STATION, TEXAS

TEXAS DEPARTMENT OF TRANSPORTATION

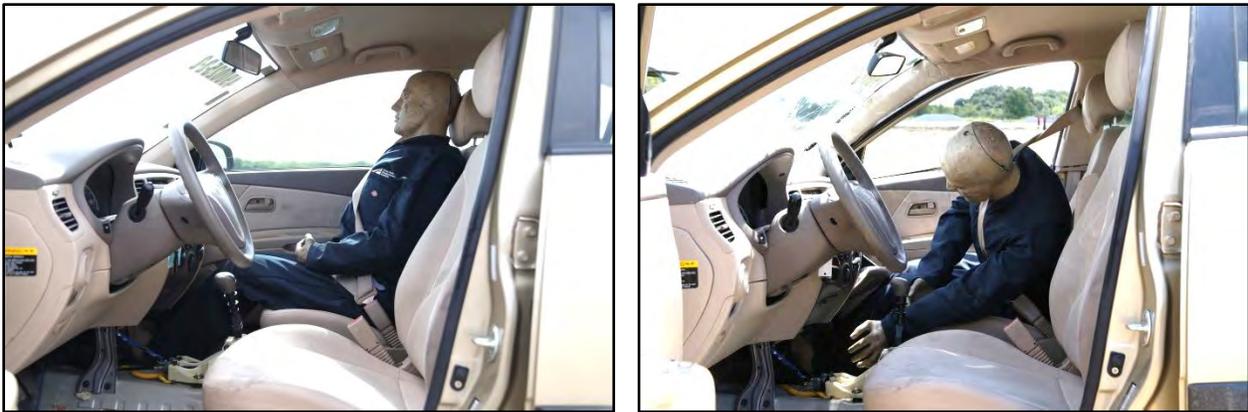
Figure 5.5. Interior of Test Vehicle for Test No. 490025-2-2.

Figure 5.5 shows the interior of the vehicle. Tables C.2 and C.3 in Appendix C.1 provides exterior crush and occupant compartment measurements.

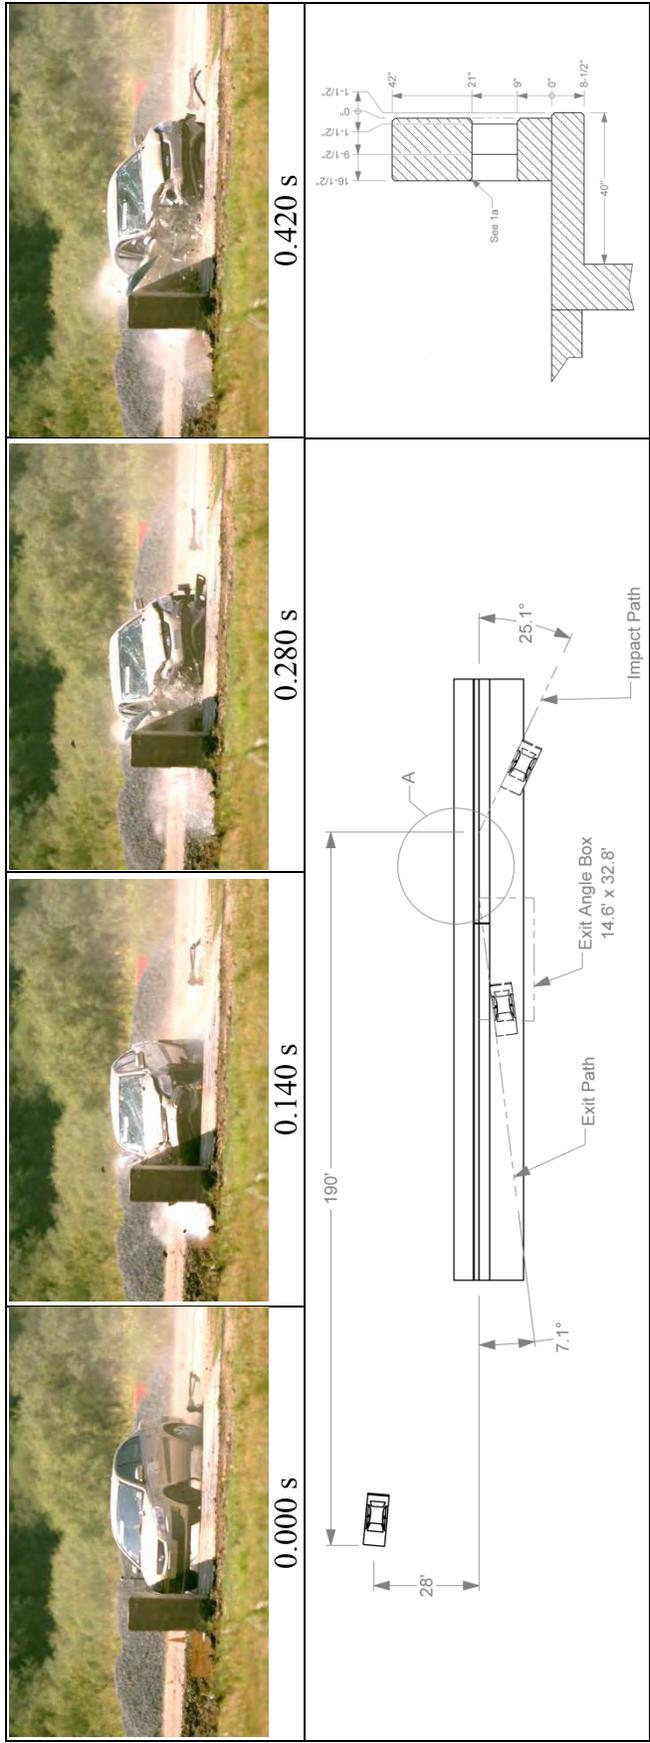
General Information	
Test Agency.....	Texas Transportation Institute (TTI)
Test Standard Test No.....	MASH Test 5-10
TTI Test No.....	490025-2-2
Test Date.....	2015-08-18
Test Article	
Type.....	Bridge Rail
Name.....	TxDOT T224 Bridge Rail
Installation Length.....	160 ft 2 inches
Material or Key Elements.....	42-inch high 16½ inch wide reinforced concrete rail with integral reinforced concrete posts every 15 ft with 10 ft clear window between adjacent posts
Soil Type and Condition	
Type/Designation.....	1100C
Make and Model.....	2009 Kia Rio
Curb.....	2448 lb
Test Inertial.....	2422 lb
Dummy.....	165 lb
Gross Static.....	2587 lb
Impact Conditions	
Speed.....	62.6 mi/h
Angle.....	25.1 degrees
Location/Orientation.....	4.2 ft upstream of post 4
Impact Severity	
Speed.....	57 kip-ft
Angle.....	41.7 mi/h
Exit Conditions	
Speed.....	7.1 degrees
Occupant Risk Values	
Longitudinal OIV.....	31.5 ft/s
Lateral OIV.....	30.2 ft/s

Longitudinal Ridedown.....	14.1 g
Lateral Ridedown.....	10.1 g
THV.....	47.8 km/h
PHD.....	15.5 g
ASI.....	2.68
Max. 0.050-s Average	
Longitudinal.....	-17.8 g
Lateral.....	-17.2 g
Vertical.....	-2.4 g
Post-Impact Trajectory	
Stopping Distance.....	190 ft downstrm
	28 twd field side
Vehicle Stability	
Maximum Yaw Angle.....	52 degrees
Maximum Pitch Angle.....	3 degrees
Maximum Roll Angle.....	7 degrees
Vehicle Snagging.....	No
Vehicle Pocketing.....	No
Test Article Deflections	
Dynamic.....	None measureable
Permanent.....	None
Working Width.....	16.5 inches
Vehicle Damage	
VDS.....	01RFQ5
CDC.....	01RFEW4
Max. Exterior Deformation.....	13.0 inches
OCDI.....	RF0014000
Max. Occupant Compartment Deformation.....	4.0 inches

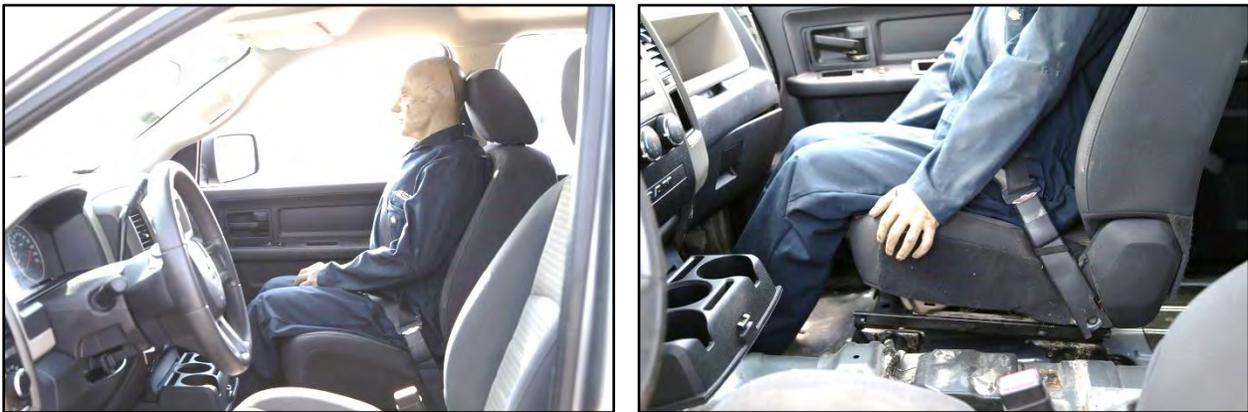
Figure 6.5. Interior of Test Vehicle for Test No. 490025-2-3.

Figure 6.4 shows the damage that the 2270P vehicle sustained. The right front rail, the right front upper and lower A-arms, and the right upper and lower ball joints were deformed. Also damaged were the front bumper, grill, hood, right front fender, right front tire and rim, right front door and door glass, right rear exterior bed, right rear tire and rim, and rear bumper. The A-pillar was deformed causing the windshield to fracture. Maximum exterior crush to the vehicle was 18.0 inches in the front plane at the right front corner at bumper height. Maximum occupant compartment deformation was 5.0 inches in the right firewall area. Figure 6.5 shows the interior

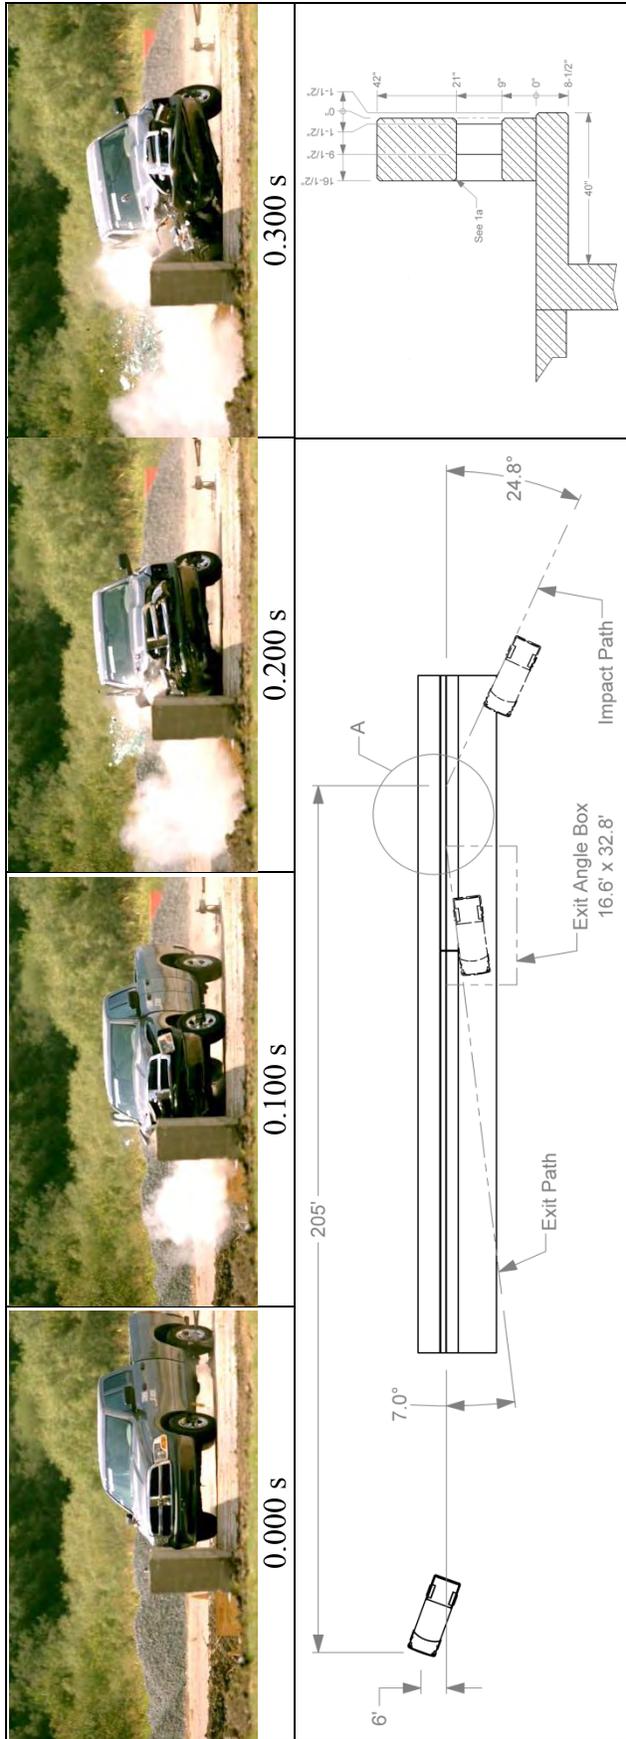
Speed 64.3 mi/h
 Angle 24.8 degrees
 Location/Orientation 3.9 ft downstirn of post 3
Impact Severity123 kip-ft
Exit Conditions
 Speed 41.2 mi/h
 Angle 7.0 degrees

Dynamic Negligible
 Permanent None
 Working Width 16.5 inches
Vehicle Damage
 VDS 01RFQ5
 CDC 01FREW5
 Max. Exterior Deformation 18.0 inches
 OCDI RF1032000
 Max. Occupant Compartment Deformation 5.0 inches

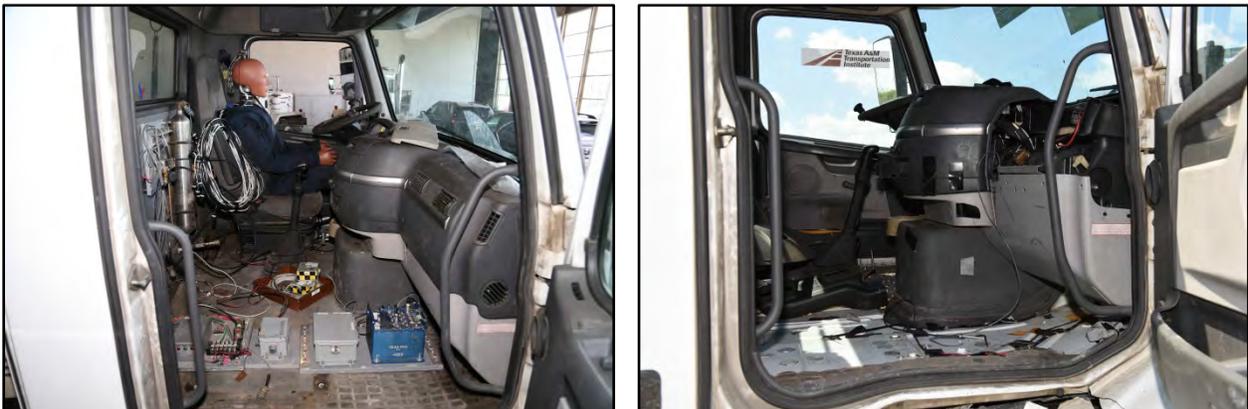
Figure 7.5. Interior of Test Vehicle for Test No. 490025-2-1.

Figure 7.4 shows the damage that the vehicle sustained. The front axle was pushed rearward 36 inches, and the right tie rod, right U-bolts, and right front shock and mount were deformed. Also damaged were the front bumper, hood, right front tire and rim, right front fender, right fuel tank, right side steps, and right rear outer tires and wheel rims of the tractor tandem. The right side lower edge of the trailer was also deformed and scraped. Maximum exterior crush to the vehicle was 12.0 inches in the front plane at the right front corner at bumper height. No occupant compartment deformation occurred. Figure 7.5 shows the interior of the vehicle.

No occupant compartment deformation occurred. (PASS)

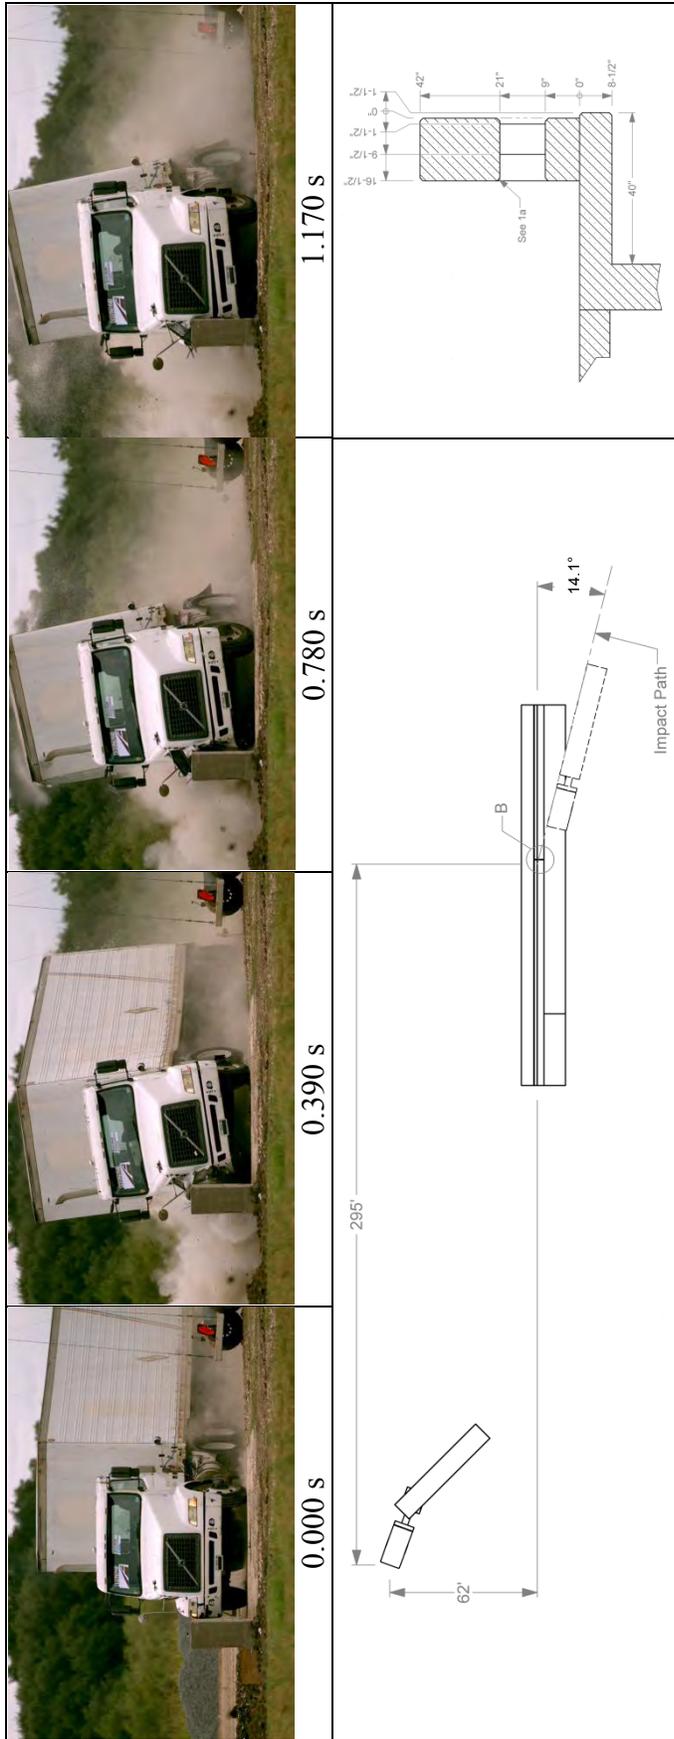
<p>General Information</p> <p>Test Agency Texas Transportation Institute (TTI) Test Standard Test No. MASH Test 5-12 TTI Test No. 490025-2-1 Test Date 2015-08-21</p> <p>Test Article</p> <p>Type Bridge Rail Name TxDOT T224 Bridge Rail Installation Length 160 ft 2 inches Material or Key Elements 42-inch high 16½ inch wide reinforced concrete rail with integral reinforced concrete posts every 15 ft with 10 ft clear window between adjacent posts Concrete Bridge Deck, Dry</p> <p>Soil Type and Condition</p> <p>Test Vehicle</p> <p>Type/Designation 36000V Make and Model 2003 Volvo VE w/1995 Dorsey Trailer Curb 30,240 lb Test Inertial 79,760 lb Dummy 185 lb Gross Static 79,945 lb</p>	<p>Impact Conditions</p> <p>Speed 50.5 mi/h Angle 14.1 degrees Location/Orientation 2.0 ft downstrm of joint</p> <p>Impact Severity 404 kip-ft</p> <p>Exit Conditions</p> <p>Speed 41.3 mi/h Angle 0.4 degree</p> <p>Occupant Risk Values</p> <p>Longitudinal OIV 4.3 ft/s Lateral OIV 14.8 ft/s Longitudinal Ridedown 8.9 g Lateral Ridedown 15.1 g THIV 17.7 km/h PHD 17.3 g ASI 0.58 Max. 0.050-s Average Longitudinal -3.3 g Lateral -6.2 g Vertical -4.7 g</p>	<p>Post-Impact Trajectory</p> <p>Stopping Distance 295 ft downstrm 62 ft twd field side</p> <p>Vehicle Stability</p> <p>Maximum Yaw Angle 34 degrees Maximum Pitch Angle 8 degrees Maximum Roll Angle 18 degrees Vehicle Snagging No Vehicle Pocketing No</p> <p>Test Article Deflections</p> <p>Dynamic 2.1 inches Permanent 1.2 inches Working Width 38.5 inches</p> <p>Vehicle Damage</p> <p>VDS NA CDC 01FREW3 Max. Exterior Deformation 12.0 inches Max. Occupant Compartment Deformation None</p>
