Texas Tech University

Proper Overlay Type and Designs for PCC Pavement

Research Report 0-6910-R1

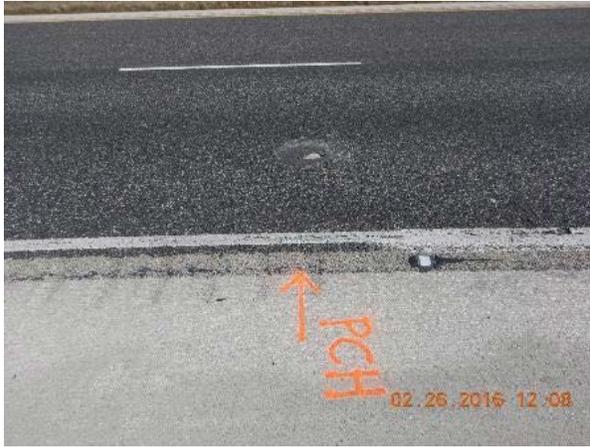
(a) Reflected distress from the existing punchout on 8-in. CRCP

Figure 3.2 Observed AC distresses

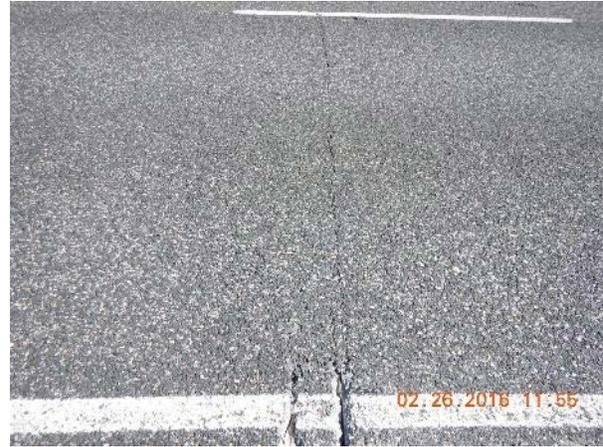
(b) Reflected distress at repair joint in BCO

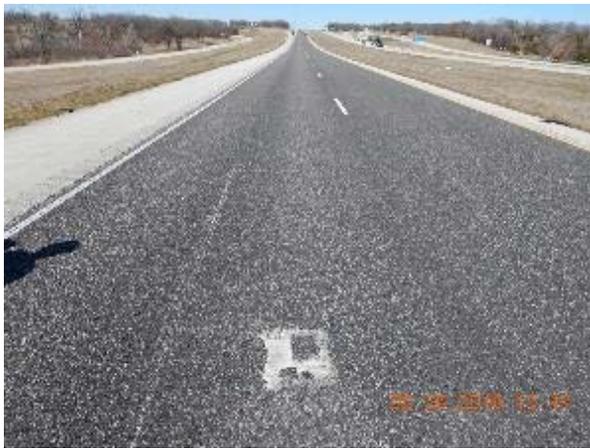
(c) Surface condition due to BCO distress #1

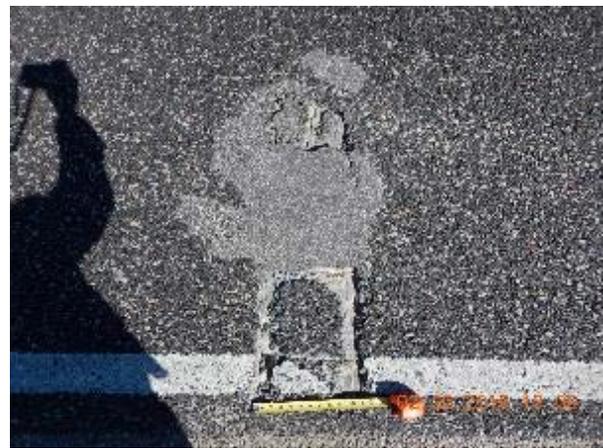
(d) Surface condition due to BCO distress #2

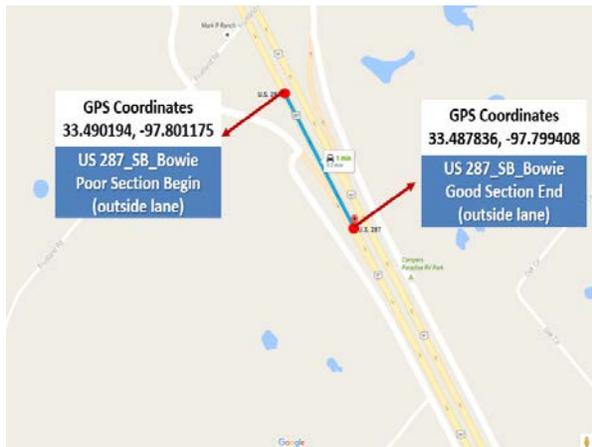
(a) With distresses (poor section)

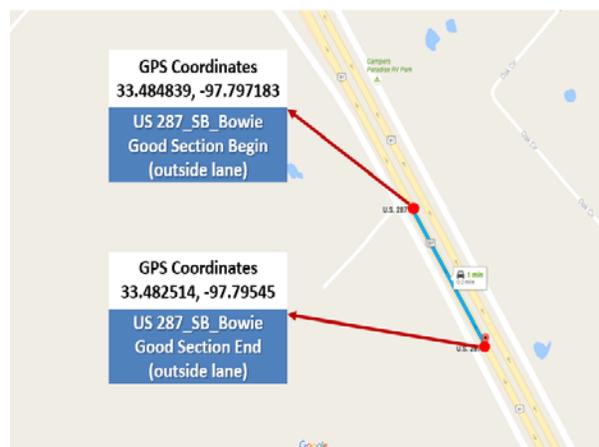
(b) Without distresses (good section)

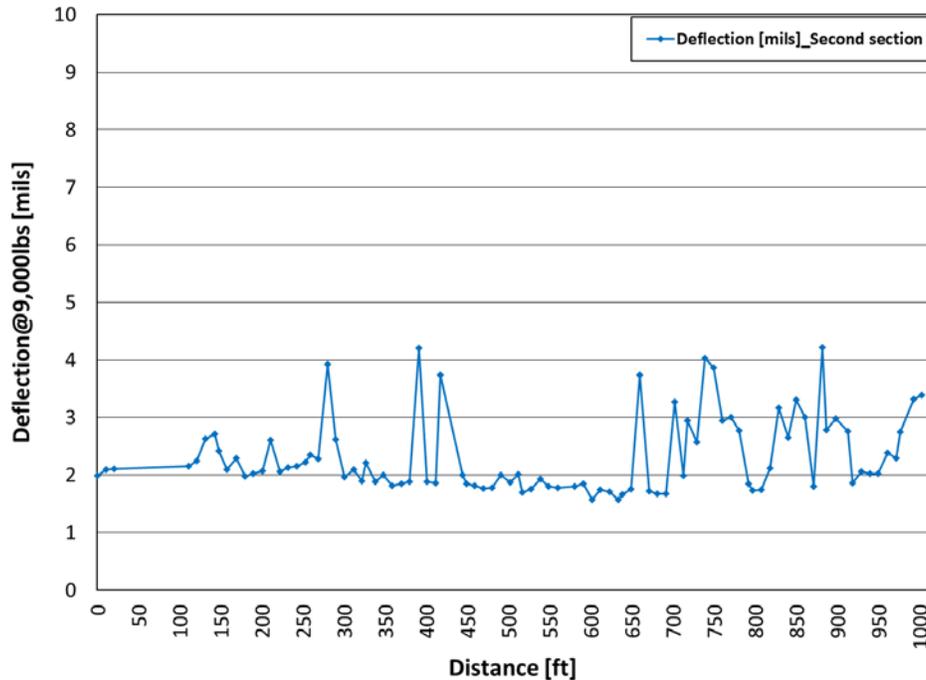
FWD testing was conducted at 10-ft intervals over approximately 1,000-ft for each section. **Figures 3.4 and 3.5** show deflections measured in poor and good sections, respectively. It is observed that overall deflections and their variability were larger in the poor section than in the good section. In the poor section, deflections greater than 7 mils were recorded at two locations, which coincided with PFC distress locations, whereas the deflections in the good section were smaller and more uniform. It appears that delamination or debonding at the poor section was also responsible for larger deflections. Field testing was conducted in 2010 on the existing 8-in. CRCP prior to the overlay, which included Total Pavement Acceptance Device (TPAD) testing, DCP testing, and deflection testing with FWD. Also, bond strength testing was conducted in November 2012, prior to the opening of the 4-in. BCO to traffic. Those field-testing results are discussed in Chapter 4.

Figure 3.5 FWD testing result at good section (without distresses)

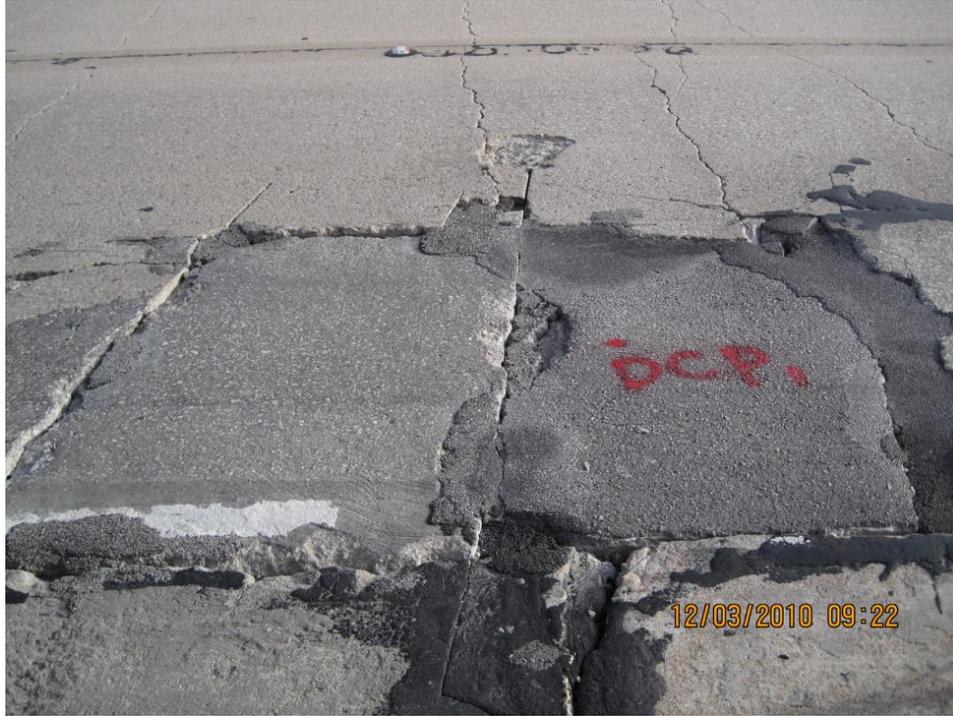
Figure 3.6 shows coring locations for P1 and P2. Two cores were taken upstream and downstream of a distress area. There was a punchout distress on 8-in. CRCP at this location as shown in Figure 3.7, and the personnel of TxDOT’s Wichita Falls District repaired this section by full-depth repair (FDR) method before the BCO construction. However, repaired punchout still reflected through the BCO and PFC overlay, which indicates that FDR in the existing CRCP was not able to completely restore the structural condition of the pavement. Quite often FDR just replaces distressed concrete with new concrete, without restoring slab support. The poor slab support must have caused the punchout distress in the first place. Table 3.3 illustrates the measured deflections on PFC overlay at each coring location. The average deflection at the poor section was 3.62 mils compared with 2.21 mils at the good section. Even without detailed statistical analysis, this difference clearly indicates the effects of overlaid slab deflections on the performance of BCO. Figure 3.8 shows the coring operation. As Figures 3.9 and 3.10 show, debonding failures occurred at all coring locations in the poor section. On the other hand, good bonding was observed at all coring locations in the good section, as shown in Figure 3.11. This strong correlation between bonding condition and the overlay pavement deflections and performance is interesting and

Figure 3.7 Punchout distress in the existing 8-in. CRCP (picture taken on December 3, 2010)

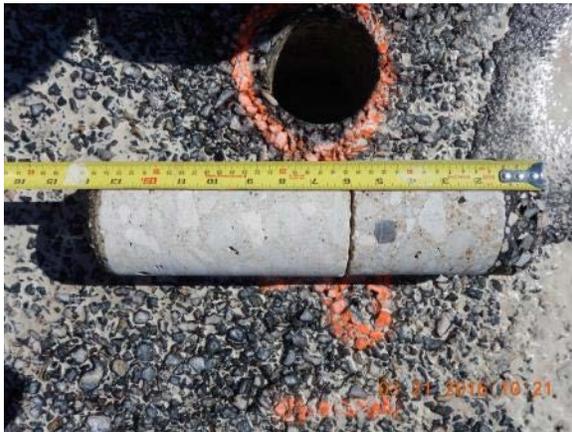
a. P1 core (debonding)

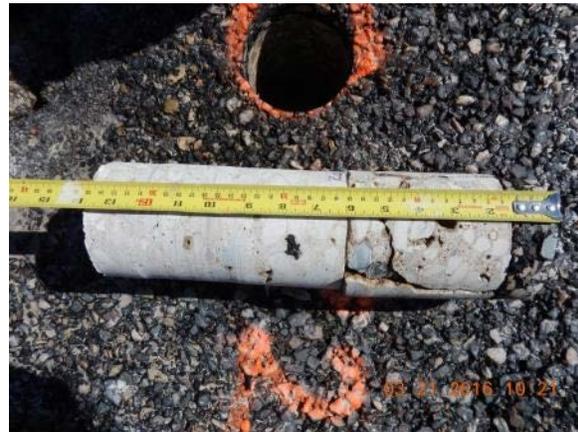
valuable information. First, it appears that debonding was caused by poor slab support or discontinuities along FDR boundaries and resulting large slab deflections, even after FDR. Small deflections in the good section appear to be due to adequate slab support, which is also responsible for good bonding. Figure 3.11-(e) shows a core taken at the good section. It shows a good bonding, even though the core was taken at a transverse crack in the existing 8-in. CRCP, which indicates that transverse cracks in CRCP do not necessarily cause debonding.

b. P2 core (debonding)

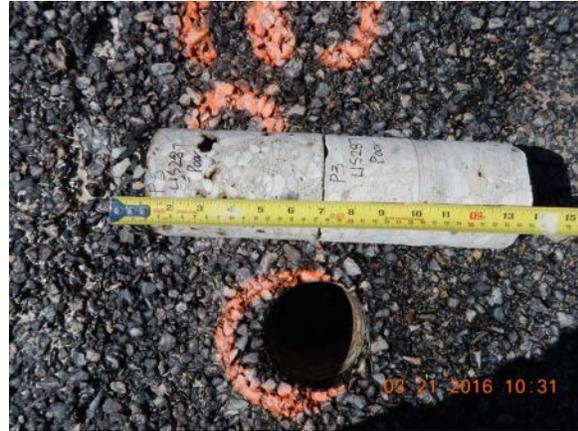
b. P3 core (debonding)

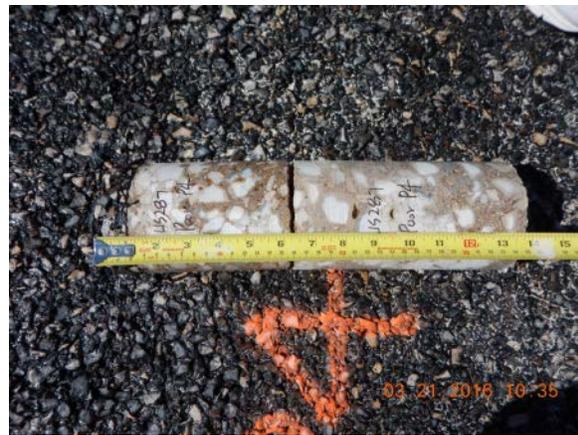
d. P4 core (debonding)

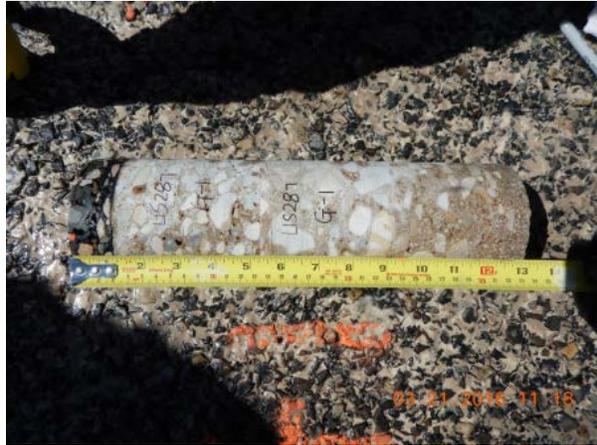
b. G1 core (good bonding)

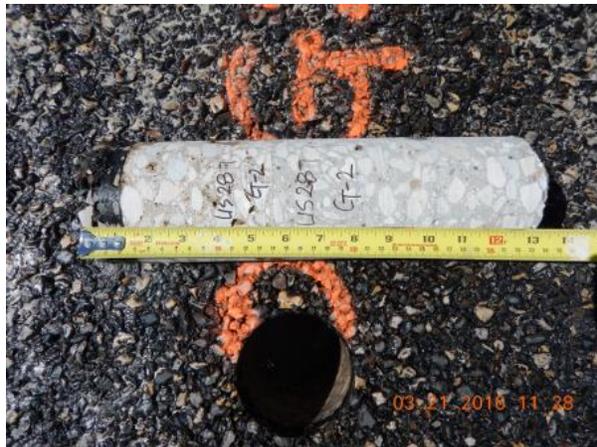
d. G2 core (good bonding)

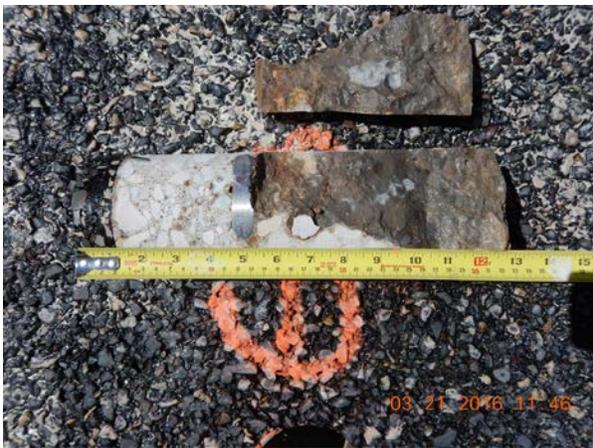
e. G3 core (good bonding)

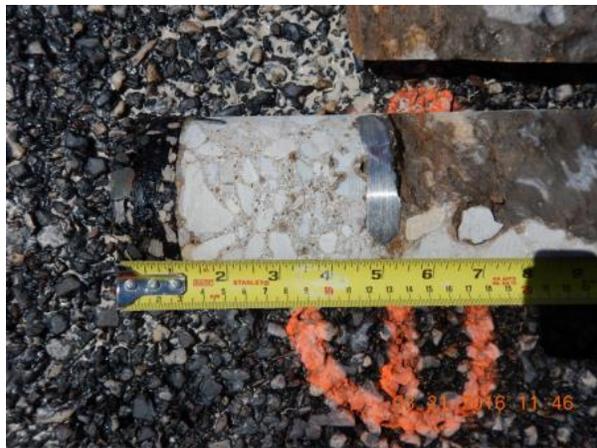
f. Close-up view of G3 core

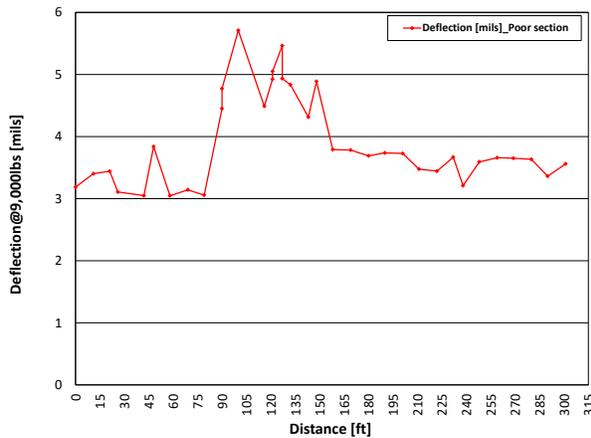
Figure 3.14 FWD deflection on US 281 (poor section)

good sections, respectively. Average deflections were measured at 3.2 mils at the good section and 3.9 mils at the poor section. Deflections near the TCJ (at about 105-ft) were larger than those further away from the TCJ. To identify the cause(s) for the large deflection at the TCJ, in-depth evaluations—including coring, DCP testing, and the MIRA testing—were conducted, which will be discussed later. It should be noted that the TCJ here is in the 4-in. BCO, and does not necessarily affect the TCJ in the existing 8-in. CRCP. It was quite difficult to determine whether the TCJ in BCO matched the TCJ in the existing CRCP. However, it is most likely that the TCJ in BCO was placed to facilitate the construction of BCO, not to match the existing TCJ in the existing CRCP. The distress observed near the TCJ was due to materials/construction-related issues during BCO construction.

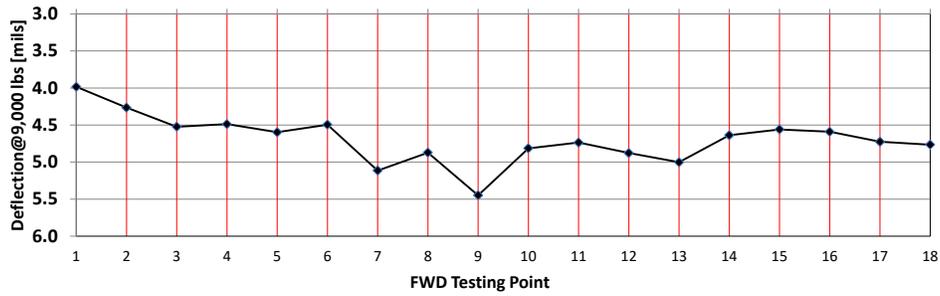
Figure 3.16 FWD deflection near the TCJ

FWD testing was conducted at 1-ft intervals from 8-ft away on one side of the TCJ and 10-ft away from the other side of the TCJ, and testing results are illustrated in [Figure 3.16](#). Deflection increases toward the TCJ (Testing Points 10 and 11) as clearly demonstrated in [Figure 3.16](#).

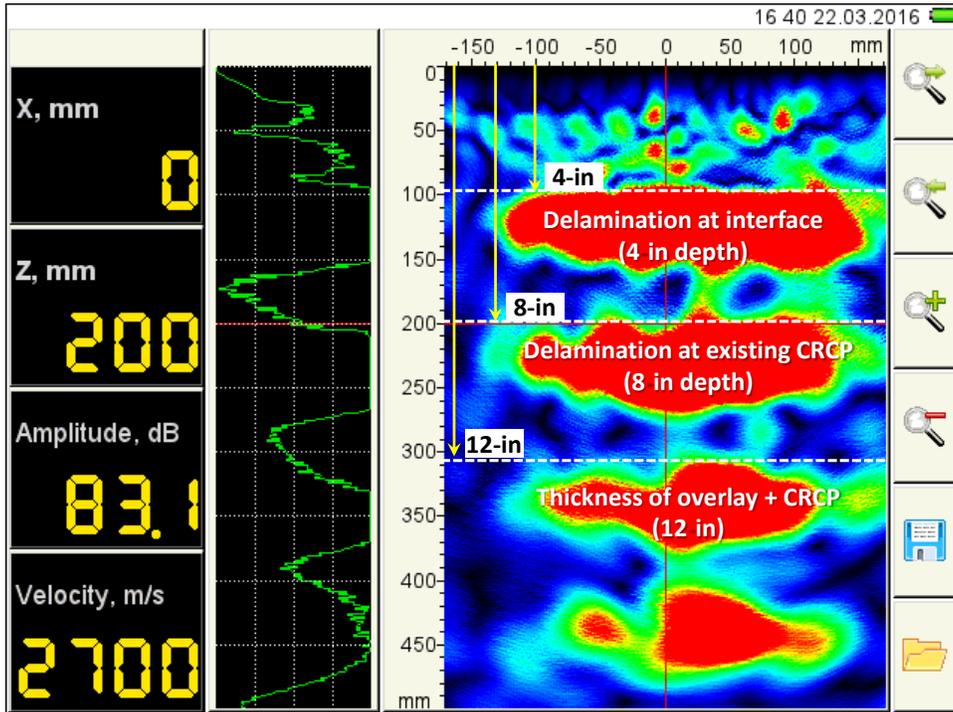
Figure 3.17 MIRA image near the TCJ

MIRA testing was also conducted at every FWD testing location, and delamination was detected near the TCJ at the overlay interface (4-in. depth from the top) and within the existing CRCP (8-in depth from the top) as shown in [Figure 3.17](#). This delamination indicates that there was an existing horizontal crack within the existing 8-in. CRCP. On the other hand, delamination and horizontal crack disappeared away from the TCJ, as shown in [Figure 3.18](#). [Figure 3.19](#) shows slabs removed at this location during FDRs, and horizontal cracks were observed. In Texas, horizontal cracks at the depth of longitudinal steel and resulting distresses such as slab segmentation are the primary distress type in CRCP. Punchout due to closely spaced transverse cracks and cantilever action is rarely observed.

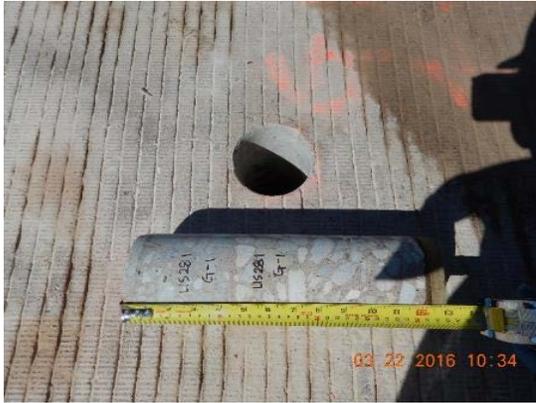
a. G-1: away from transverse crack
(deflection @ 9,000 lbs: 3.5 mils)

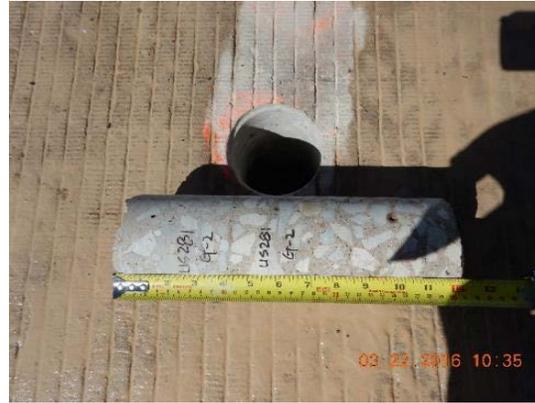
b. G-2: away from transverse crack
(deflection @ 9,000 lbs: 3.2 mils)

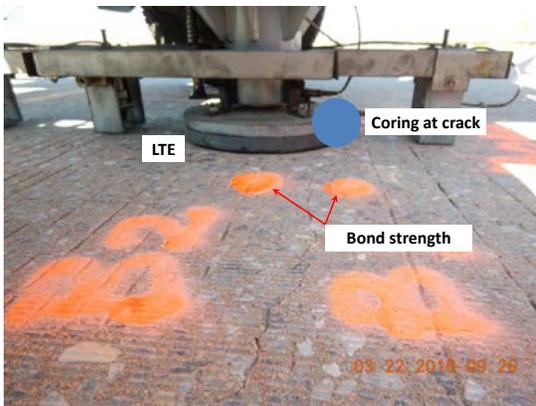
Figure 3.24 illustrates the condition of concrete cores at each location, along with deflection at 9,000 pounds measured from FWD testing. As shown in this figure, good bonding was observed at the interface both at the crack and away from the crack. **Figure 3.25** shows a close-up view of the core taken at the transverse crack. This figure illustrates that the transverse crack did not progress toward the pavement bottom, but rather stopped at the mid-depth in the BCO. It shows that the placement of longitudinal steel near the bottom of 4-in. BCO, along with the use of crushed limestone as coarse aggregate (which provides a low CoTE), adequately restrained concrete volume changes due to temperature and moisture variations.

c. G-3: at transverse crack
(deflection @ 9,000 lbs: 4.0 mils)

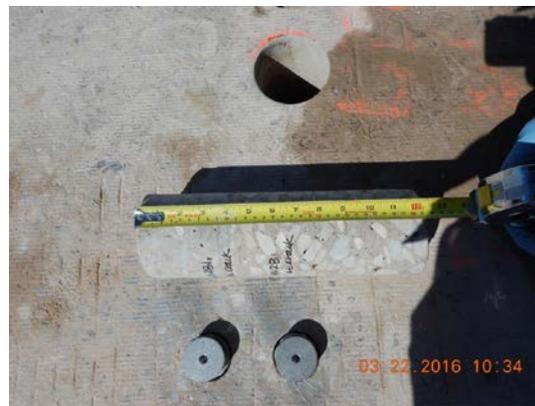
d. G-3 core at transverse crack

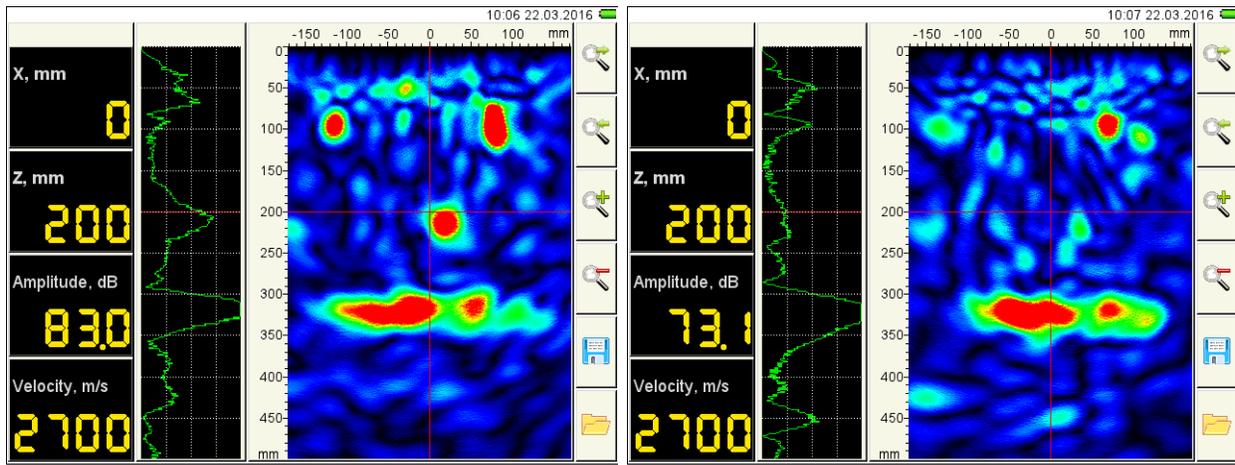
Locations for bond strength testing were selected on the basis of deflection, as well as whether transverse cracks existed. **Figure 3.27** shows bond strength testing results with a deflection value at each location. MIRA testing was also conducted before bond strength testing. C1 and C2 in **Figure 3.27** are located near a transverse crack in the overlay pavement. **Figures 3.28-(a) and (b)** show MIRA images at the locations C1 and C2. The reinforcements in the BCO and existing 8-in. CRCP are shown and no delamination observed at the interface between 4-in. BCO and 8-in. existing CRCP.

a. 2-D MIRA image at C1

b. 2-D MIRA image at C1

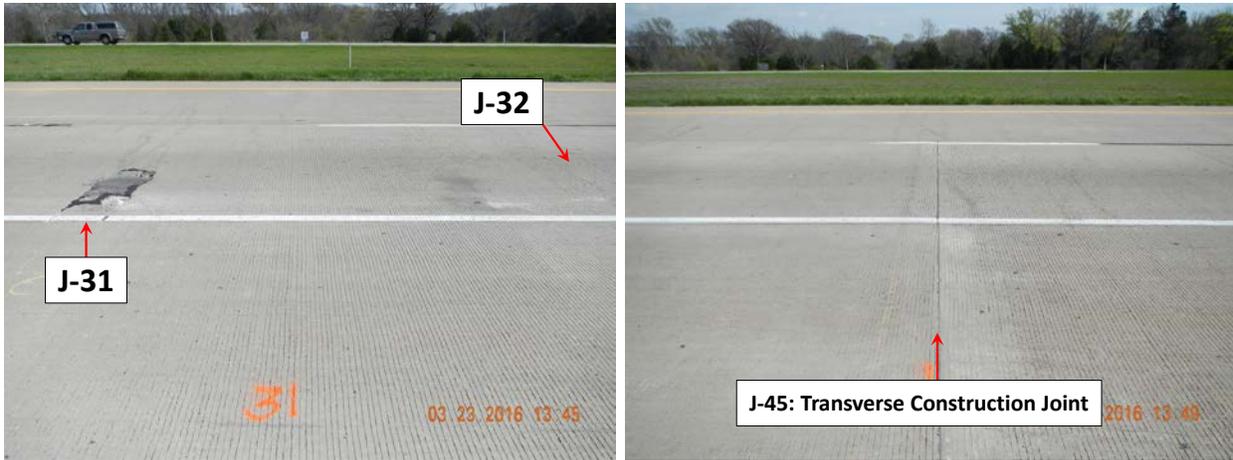
a. Distress at Joint #31 (J-31)

b. TCJ (J-45)

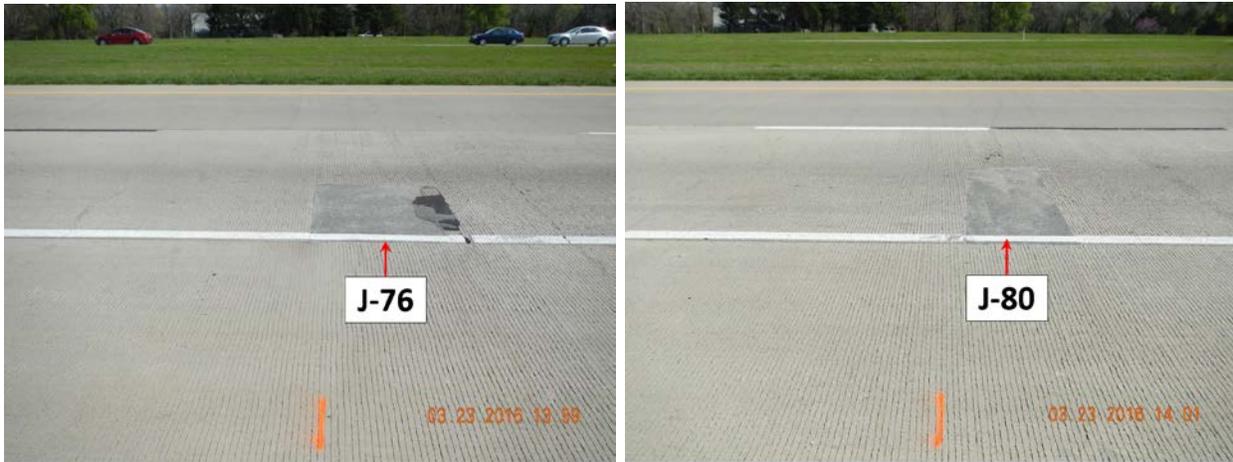
c. Distress at J-71

d. Distress at J-80

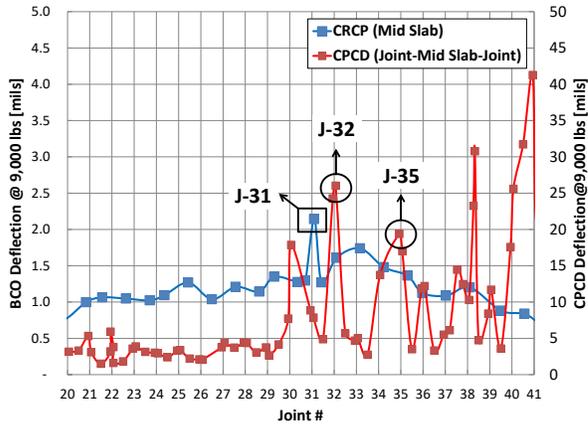
a. Deflection vs BCO distress (J-21 to J-40)

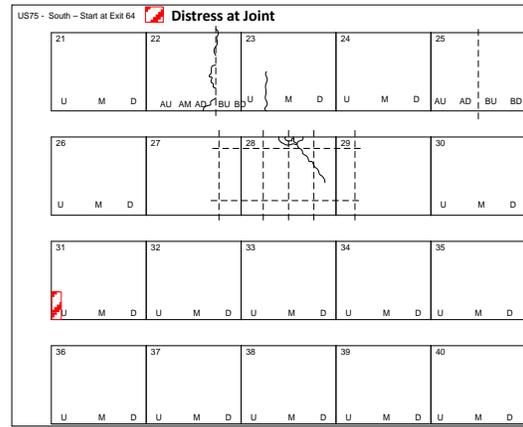
b. Distress map (J-21 to J-40)

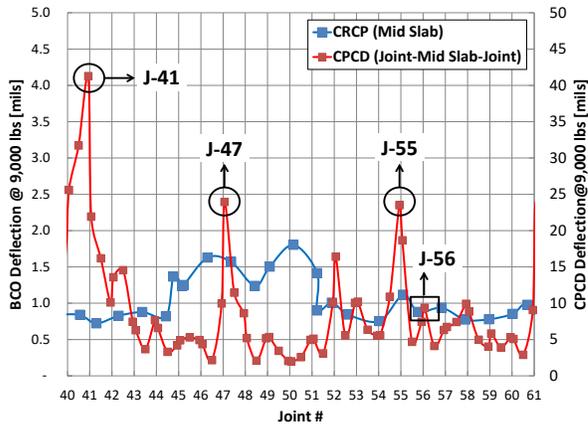
c. Deflection vs BCO distress (J-41 to J-60)

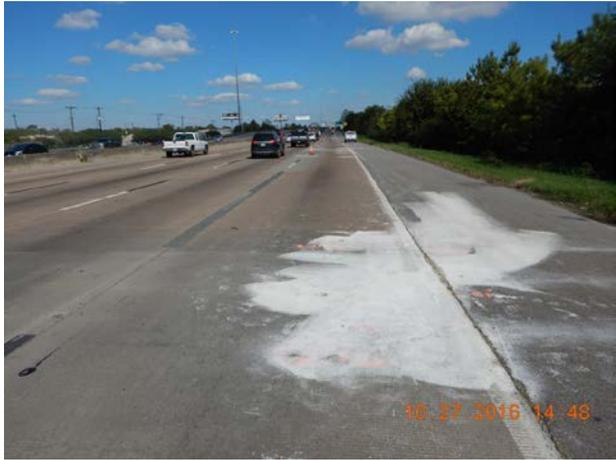
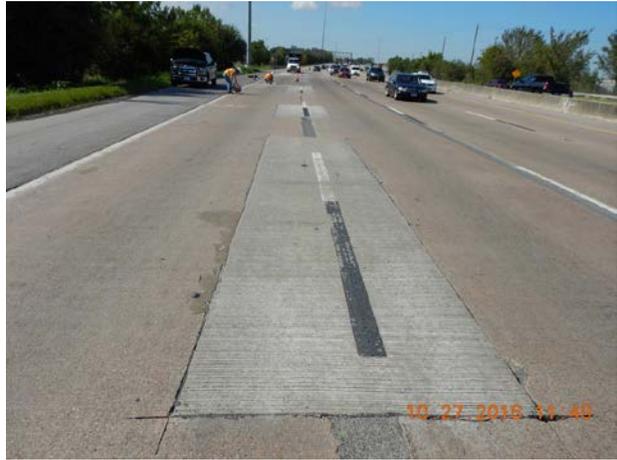
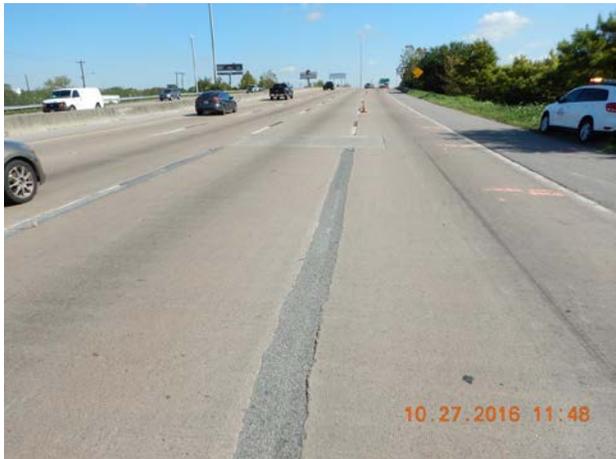
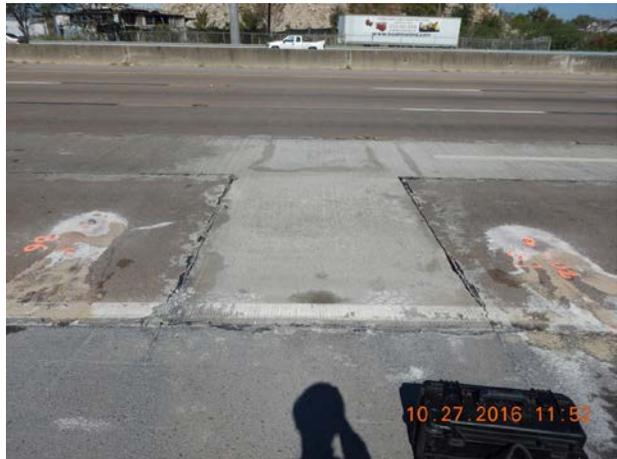
Figure 3.37 Pavement condition on Loop 610 South

Figure 3.37-(a) provides an overall view of the section. Several PCCPs were placed at the longitudinal joints (Figure 3.37-(b)), and a Fibrecrete patch was also observed, as shown in Figure 3.37-(c). PCCPs at the outside lane were also observed (Figure 3.37-(d)). Bond strength testing was conducted near the PCCP after FWD testing. A detailed distress map was developed, as shown in Figure 3.38.

b. PCCPs at longitudinal joint

c. Fibrecrete patch

d. PCCP at outside lane

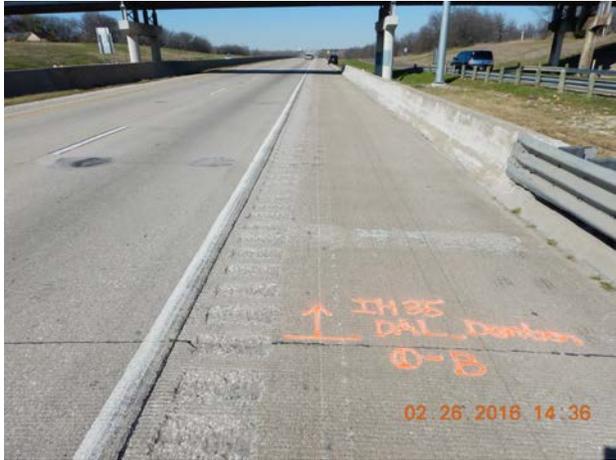
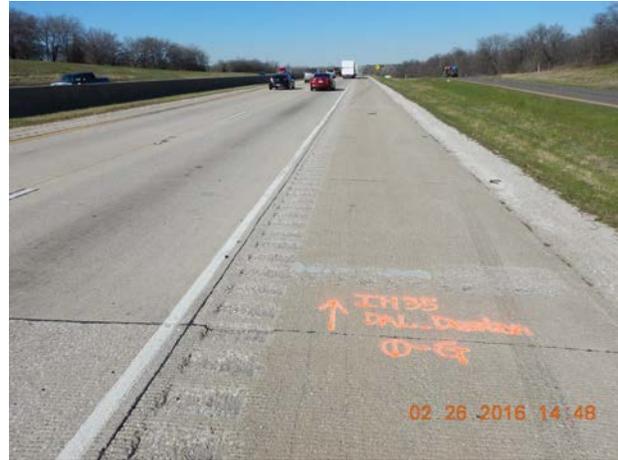
Figure 3.47 Pavement condition of poor and good sections

A visual survey was conducted on February 26, 2016, to select locations for field testing and evaluation. Based on the pavement condition, two sections were selected: one section with distresses (poor section) and the other without distresses (good section), as shown in [Figure 3.47](#). The only distress type observed in this UBCO project was an asphalt patch under the wheel path at transverse contraction joints, as shown in [Figure 3.47-\(a\)](#).

a. Poor section

b. Good section

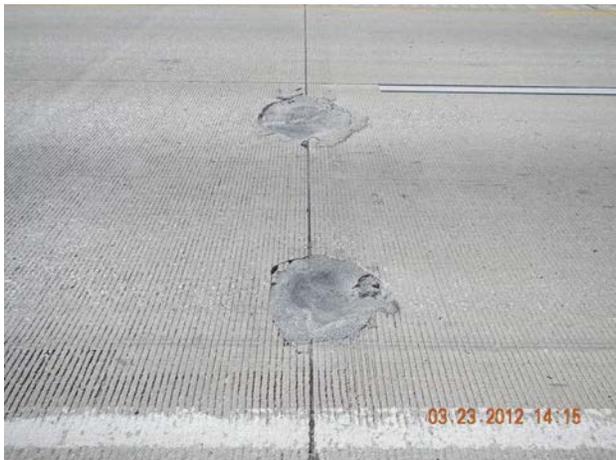
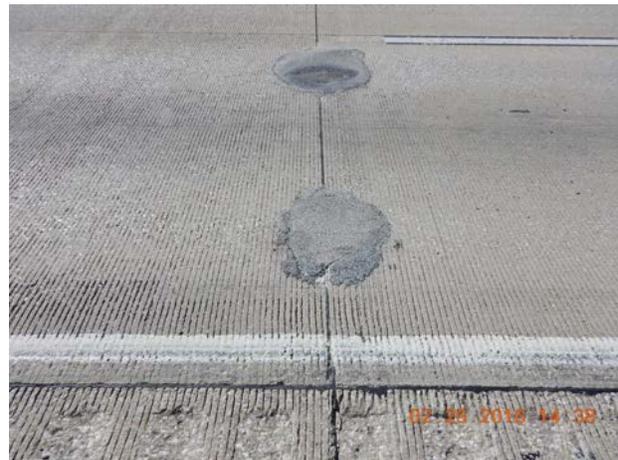
Figure 3.48 Distress comparisons between March 2012 and February 2016

The performance of this UBCO section was monitored under the TxDOT research project 0-6274 (rigid pavement database), and the condition of this distress was evaluated on March 23, 2012. [Figures 3.48-\(a\) and \(b\)](#) illustrate the comparisons of the distresses at the same joint. They show a minute progress in the distress over a 4-year timeframe, and additional asphalt patching material was placed.

a. Picture taken on March 23, 2012

b. Picture taken on February 26, 2016

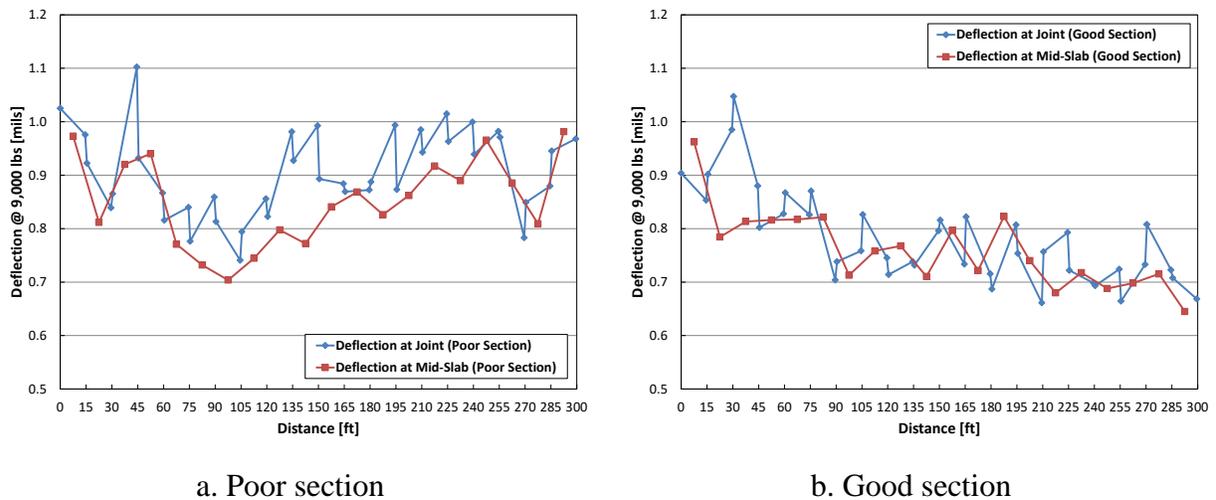
Figure 3.51 Deflection comparison between joint and mid-slab on IH 35 in Denton County

Figures 3.51-(a) and (b) illustrate deflection comparisons at transverse contraction joints and at mid-slab for the poor and the good sections. It is observed that the overall deflections are quite small, indicating that the structural capacity of this UBCO system is quite adequate. It is also observed that the mid-slab deflections were a little lower than those at the joints in the poor section, as shown in Figure 3.51-(a). The average deflections at the joint and mid-slab were 0.91 and 0.85, respectively. On the other hand, in the good section, there was no significant difference in deflections at joint and mid-slab. The average deflections at joint and mid-slab were 0.78 and 0.76, respectively. Also, the average deflection at the good section was slightly lower than that at the poor section. These results illustrate that joint behavior at the poor section was a little more active compared that in the good section. However, it should be recognized that the criterion used for the

selection of “good” and “poor” sections was asphalt patching, as shown in [Figure 3.48](#). It is not clear whether the increased deflections at joints in the poor section caused those distresses. It might have. However, there are CPCD sections in Texas with deflections at transverse contraction joints greater than the values obtained in the poor section, but with no distresses observed. Accordingly, it can be postulated that these distresses could have been due to materials/construction quality issues. [Figure 3.52](#) compares the LTE between the poor section and good sections; no significant difference was identified between the two sections. It is also observed that LTE values remained quite high after almost 30 years under heavy traffic.

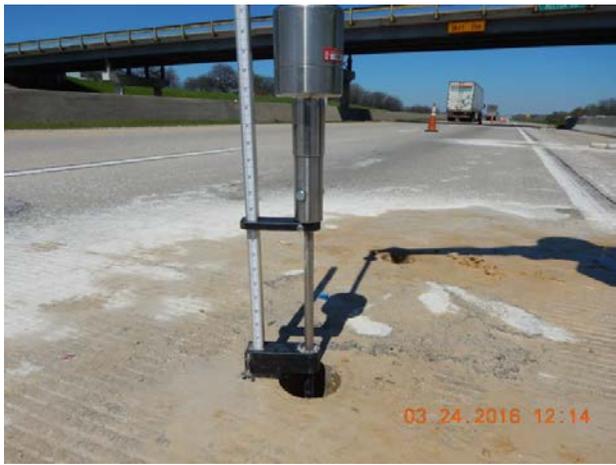
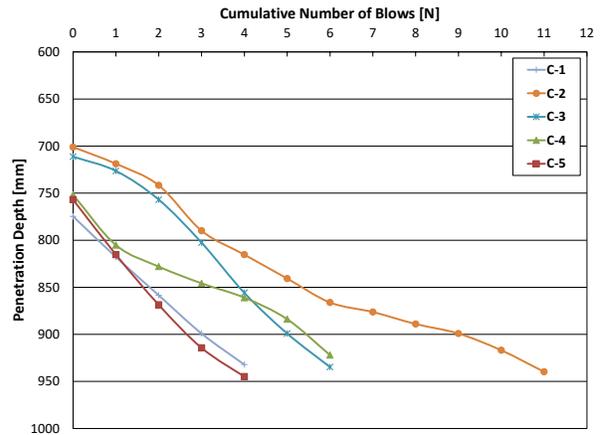
Figure 3.53 DCP testing on IH 35 in Denton County

DCP testing was conducted at good and poor sections to compare base support characteristics. [Figure 3.53-\(a\)](#) shows DCP testing operation near the distress at this location. [Figure 3.53-\(b\)](#)

presents DCP testing results. The testing was conducted up to 27-in. and 29-in. depths from the pavement surface, which is 4-in. or 6-in. underneath the existing 10-in. CPCD slab, respectively. As shown in the testing results, the condition of subgrade was quite poor, while the pavement provided good structural performance in terms of low deflections. Satisfactory structural performance of this pavement system in the presence of poor support conditions should not be interpreted as an indication that poor support condition is acceptable. Rather, the good structural capacity of this pavement system is thanks to the 23-in. pavement system (11-in. concrete, 2-in. AC layer, and 10-in. concrete slab). A very thick slab system could overcome the deficiencies in the slab support, even though the system will cost much more to build.

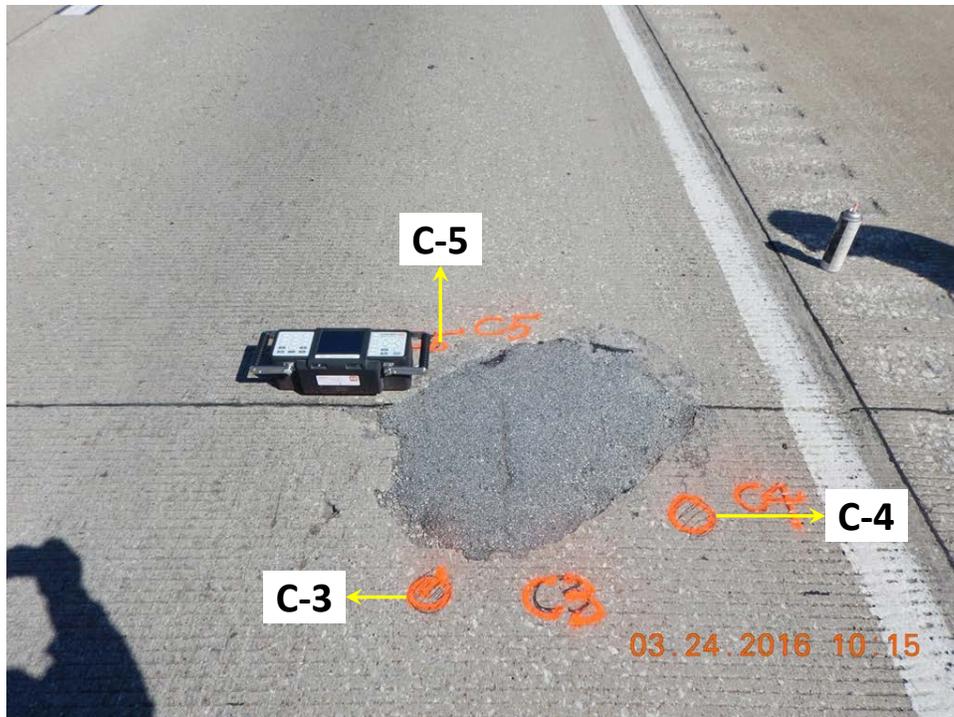
Figure 3.55 Coring locations for C-3, C-4, and C-5 around joint distress

and existing CPCD were in compliance with the design thicknesses. **Figure 3.55** illustrates coring locations for C-3, C-4, and C-5 for in-depth evaluation of distress at the transverse contraction joint. While coring operation was underway, it was observed that for all five cores, the AC interlayers came out in a fully-bonded condition to the overlaid CPCD; this is illustrated in **Figures 3.56 and 3.57**. The quality of asphalt material was quite solid without deterioration. This finding implies that the UBCO system behaves as a partially-bonded condition rather than a fully-unbonded condition, and should be considered for the UBCO thickness design.

Figure 3.57-(a) illustrates the MIRA testing result at Location C-4 (see **Figure 3.55**), showing a delamination at 3.5-in. depth from the pavement surface. The core taken at this location clearly shows that there is delamination at 3.5-in. depth as shown in **Figure 3.57-(b)**. It appears that delamination occurred first at transverse contraction joints and repeated wheel loading applications resulted in the distress observed. At this point, the exact mechanism of initial delamination at the joints is not known. On the other hand, at the same joint with distresses under wheel path, delamination was not detected by MIRA between wheel paths, which contravenes the assumption of delamination first, followed by the distress. Further investigations will be needed to accurately identify the mechanisms of the distress observed at this location.

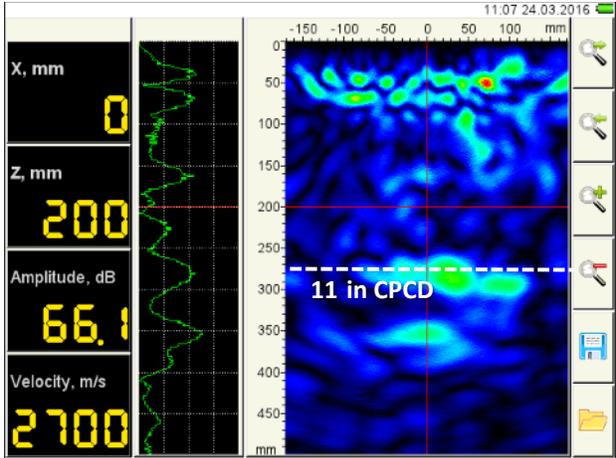
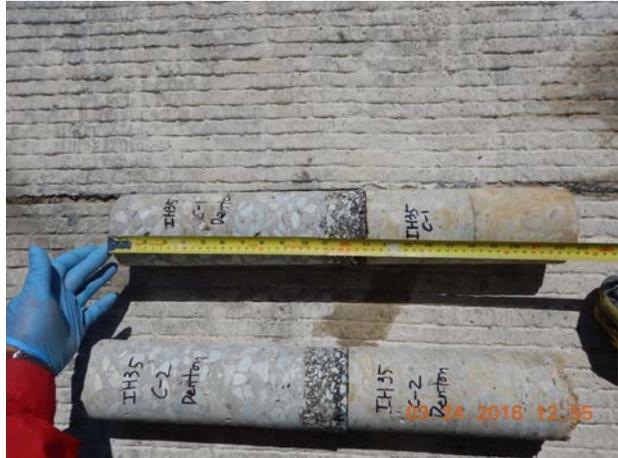
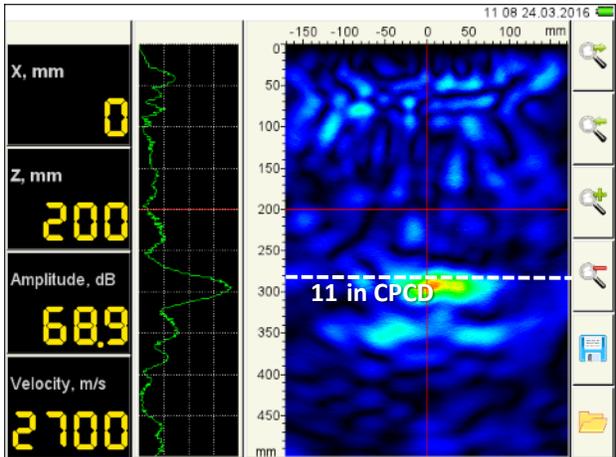
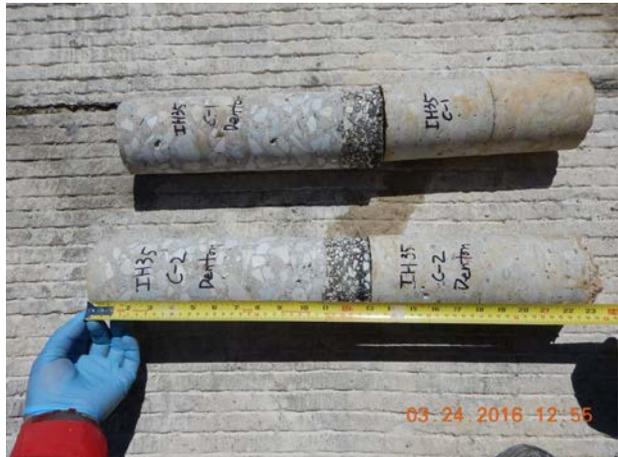
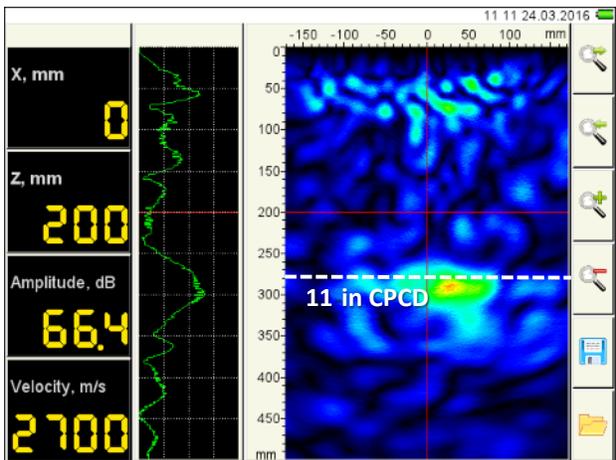
Figure 3.56 MIRA testing result and core condition of C-1, C-2, and C-3

a. MIRA image at C-1

b. C-1 core (1.0 mil@9,000 lbs)

c. MIRA image at C-2

d. C-2 core (0.9 mils@9,000 lbs)

e. MIRA image at C-3

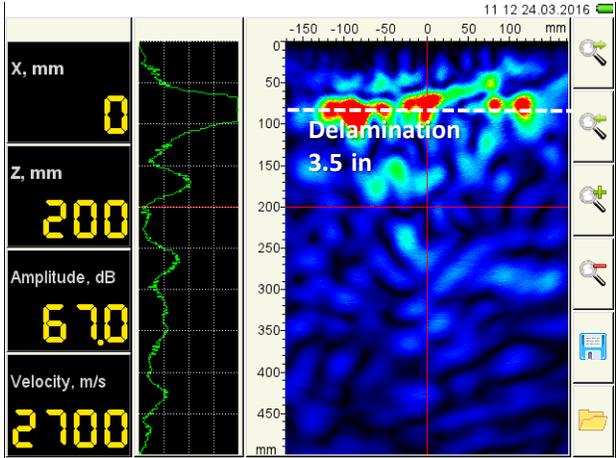
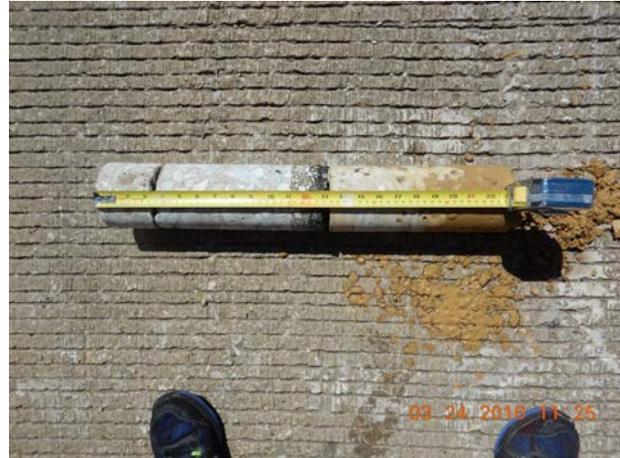
a. MIRA image at C-4

b. C-4 core (0.9 mils@9,000 lbs)

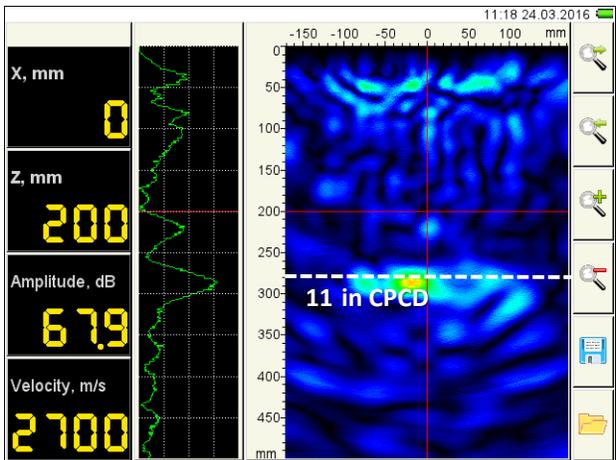
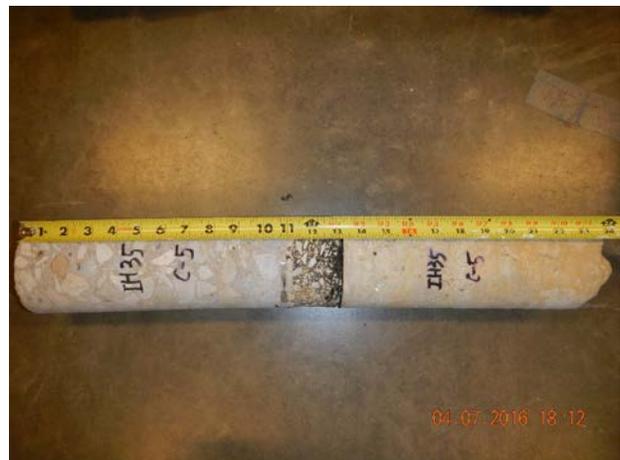
c. MIRA image at C-5

d. C-5 core (0.9 mils@9,000 lbs)

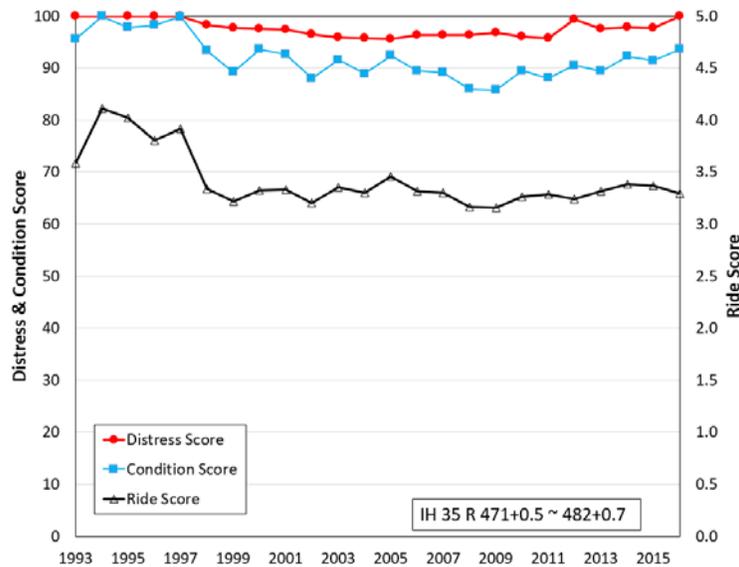
Figure 3.58 Pavement score history on IH 35

Figure 3.58 shows the pavement score history at this location. The distress and condition scores were greater than 90 in 2016, which means that the pavement condition can be classified as “very good,” but the 2016 ride score was 3.3, which indicates that the pavement condition is classified as “good.” During the pavement survey in the tested overlay section, a few asphalt patches were observed under the wheel path at the transverse contraction joint; otherwise there were no other distresses.

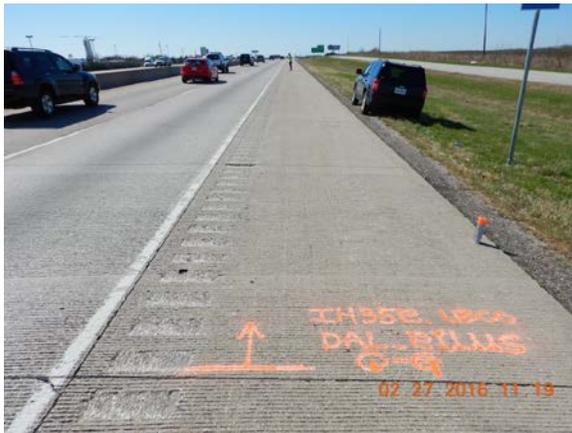
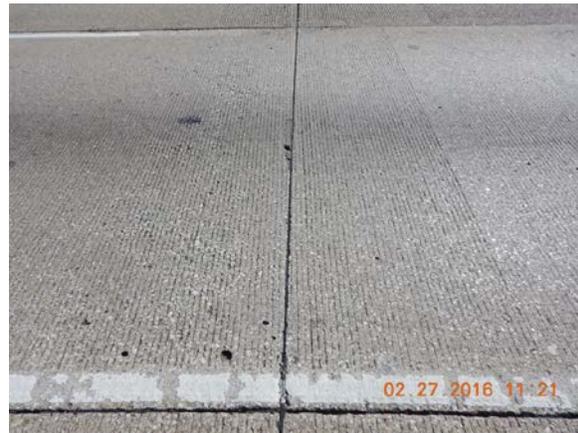
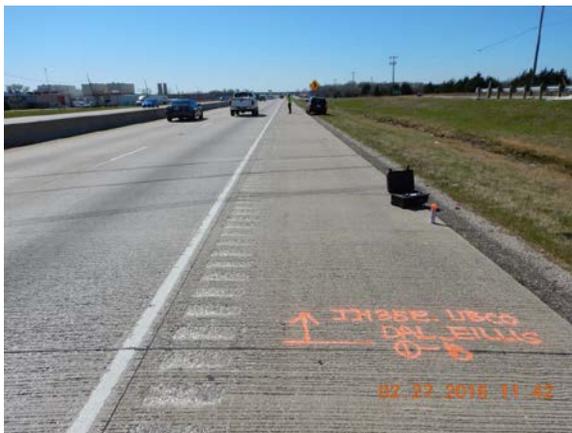
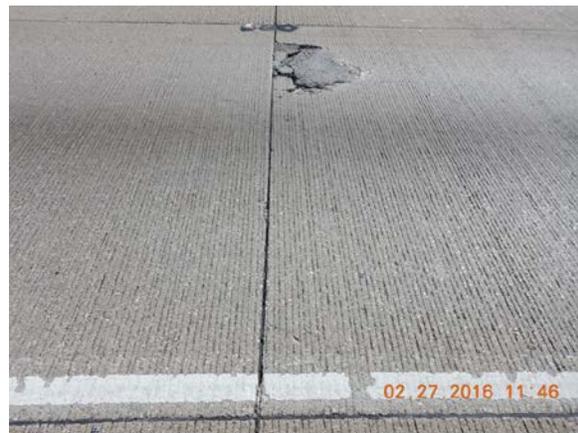
Figure 3.60 Condition of the pavement

Visual survey was conducted on February 27, 2016. Two sections (good and poor) were selected based on visual pavement condition evaluations. Even though the sections were divided into good and poor sections, distress level in the poor section was quite low. Field evaluations including FWD testing, MIRA testing, and DCP testing were conducted on March 29, 2016. Under a heavy traffic volume at this location, the overall pavement condition was quite satisfactory, with the exception of intermittently observed minor distresses at transverse contraction joints. **Figure 3.60** shows the pavement condition at good and poor sections. In the poor section, a distress resembling distresses in CRCP at TCJs is observed.

b. Distress at the good section

d. Distress in poor section

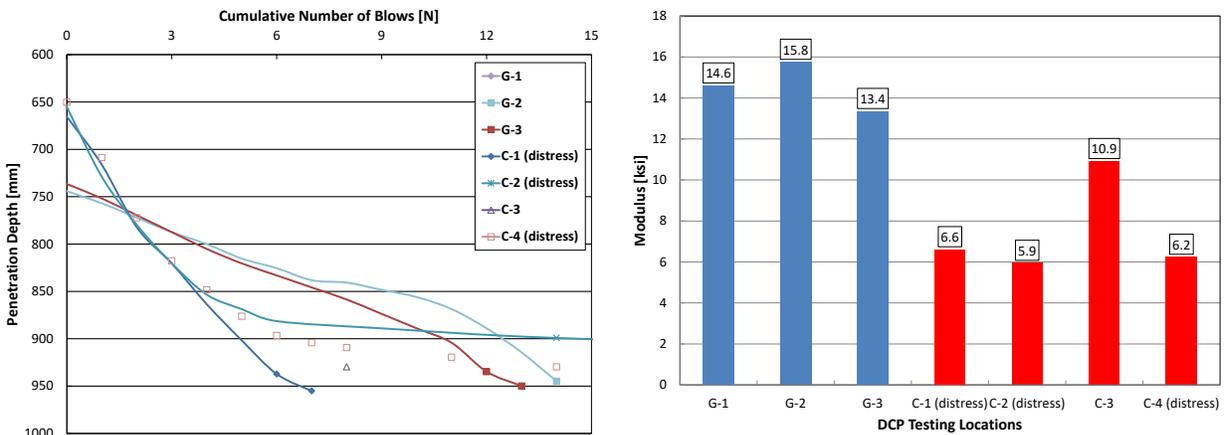
Figure 3.63 DCP testing results on IH 35E in Ellis County

Test results show that the modulus values of the layer under the old CPCD slab at the poor section are lower than those at the good section, as shown in Figure 3.63. However, deflection results showed the poor section had smaller deflections than did the good section, which is somewhat contradictory to the expected result.
