Texas Tech University

Proper Overlay Type and Designs for PCC Pavement

Research Report 0-6910-R1

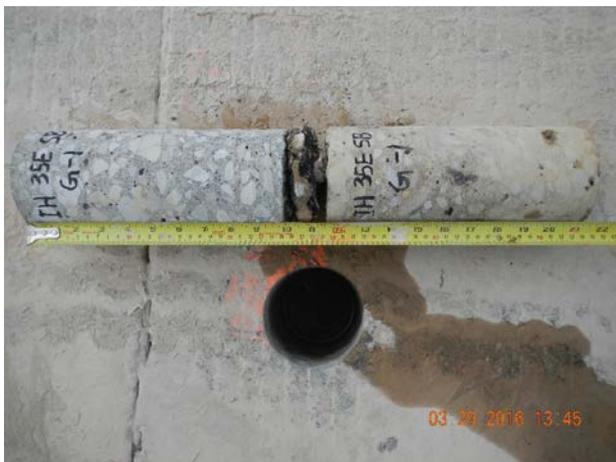
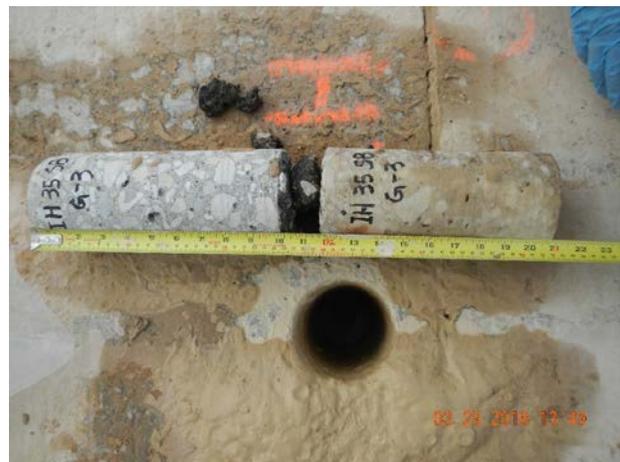
Figure 3.65 Cores taken on IH 35E in Ellis County

As shown in **Figures 3.65-(a) and (b)**, the asphalt interlayer was severely deteriorated, resulting in large deflections. In contrast, a small deflection was measured at the poor section because the asphalt interlayer was in good condition, as shown in **Figures 3.65-(c), (d), (e), and (f)**. Accordingly, it is determined that the main reason for the discrepancy between deflections and base modulus was the quality of the asphalt interlayer. In other words, larger deflections in the good section were due to deteriorated AC interlayer.

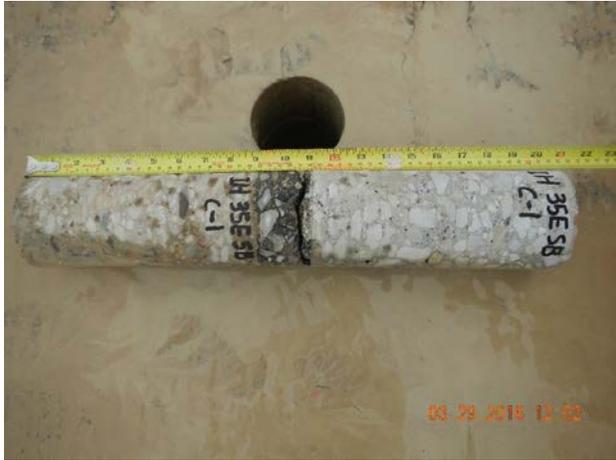
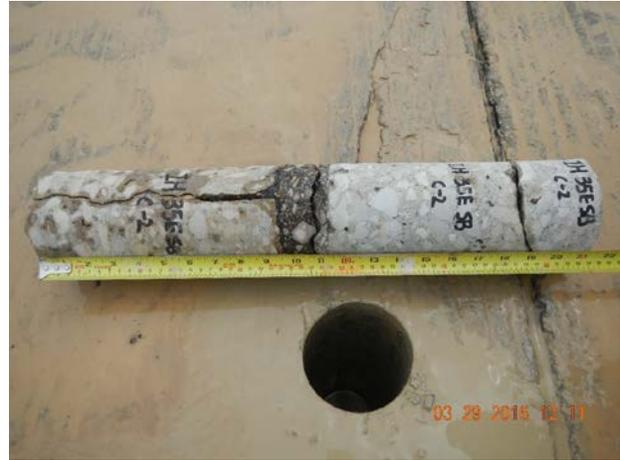
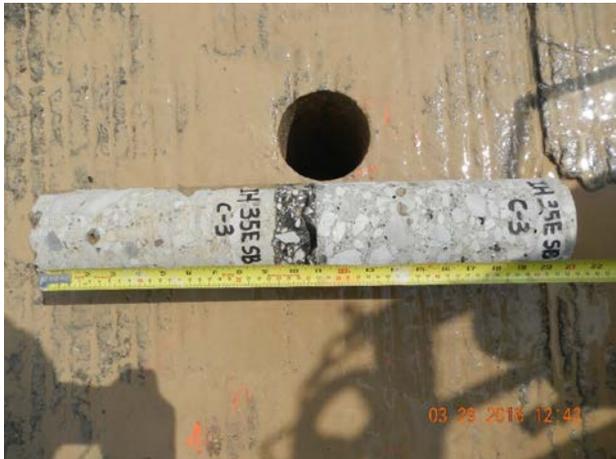
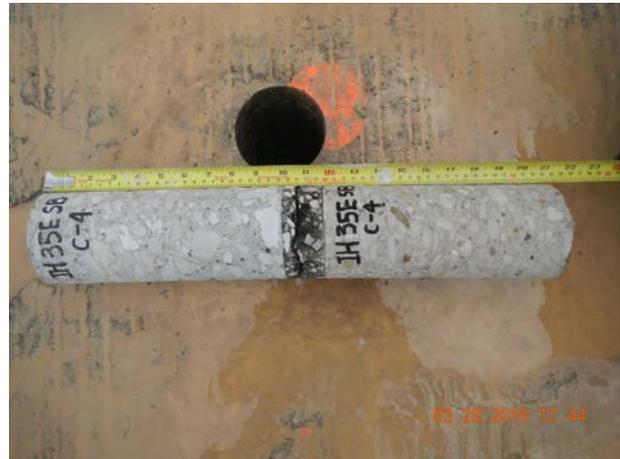
Figure 3.65-(d) shows the core taken directly on top of a crack at the outside wheel path of the outside lane, and illustrates that the transverse contraction joint in the overlaid CPCD was mismatched with the old CPCD joint along the crack. As shown in the picture, this distress also included delamination at 3.0-in. or 3.5-in. depth from the pavement surface. The distress here suggests that during UBCO construction of CPCD, matching new joint locations with those in old joints is important, unless joints are mismatched intentionally, which will be further discussed in the next chapter.

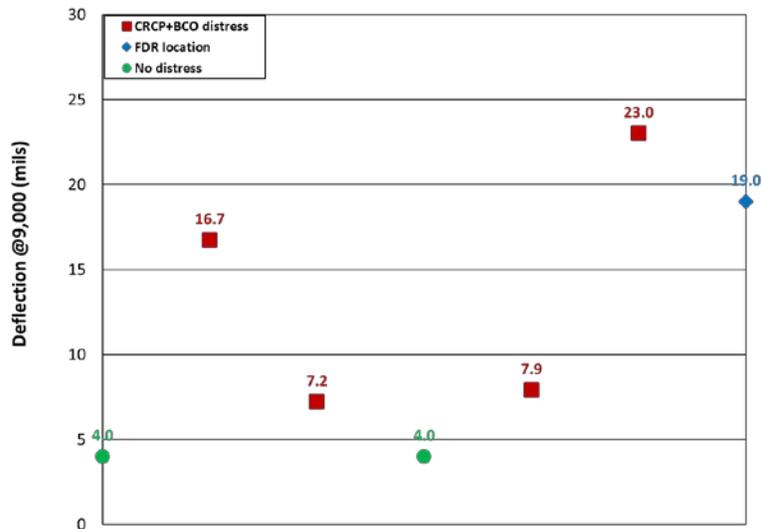
Figure 4.4 FWD deflection with distresses in old CRCP

Since the locations of distresses in the existing CRCP prior to BCO construction were accurately recorded with GPS, it was feasible to determine whether those distresses reflected through BCO and caused distresses in BCO. **Figure 4.4** shows the relationship between distresses in BCO and deflections in the existing CRCP. Red squares indicate distresses in BCO in the form of slab segmentation caused by delamination, while green dots indicate a lack of distresses in BCO. It shows a rather good correlation between deflections in the existing CRCP and distresses in BCO. This implies that FDRs done prior to BCO failed to restore the structural capacity of the existing CRCP, primarily because the distresses in the existing CRCP were due to deficient slab support—and the FDRs did not restore slab support. Instead, FDRs just replaced fragmented concrete with new concrete.

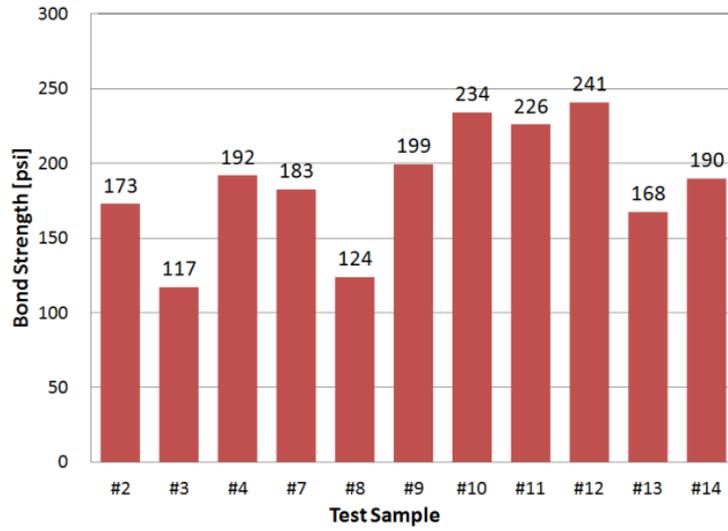
Figure 4.7 Bond strength test results for US 287 in Bowie

The importance of bond strength on BCO performance has been well demonstrated. To evaluate the effect of bond strength on BCO performance, bond strength testing was conducted on all BCO on CRCP projects. Figure 4.6 and Figure 4.7 show the locations of bond strength testing in US 287 in Bowie and bond strength testing results, respectively. More detailed discussions on bond strength testing results are presented later. Bond strength varied from 117 psi to 241 psi.

The table indicates that on US 287 in Bowie, all the failures or separations in the bond testing occurred at the interface, which implies poor surface preparation or other construction and materials issues. On US 281, there were no failures at the interface; more failures developed in the existing CRCP than in the overlaid concrete. On Loop 610 South, there was no interface failure, and an almost equal number of failures occurred in the existing CRCP and overlay. It should be noted that when the failures in the bond strength testing occur in the existing CRCP or within the overlay, the strength being measured is actually the direct tensile strength of the concrete in that layer. It is interesting to note that on US 281, tensile strengths of concrete in the existing CRCP were quite low, while those on Loop 610 South were quite high. Since no interface failures were observed on US 281 and Loop 610 South, surface preparation and BCO construction practices in those two projects appear to have been quite satisfactory, while those in US 287 appear to be of poor quality. This set of data presents quite valuable information, and further analysis and interpretations will be conducted. **Figure 4.11** shows the bond strength distributions at all three projects. As discussed earlier, the bond strength values at Loop 610 South in Houston (actually the concrete tensile strength) are much higher than those in the other two projects. Note that on Loop 610 South in Houston, plain concrete, reinforced concrete, and fibrous concrete are designated as NC, RC, and FC, respectively.

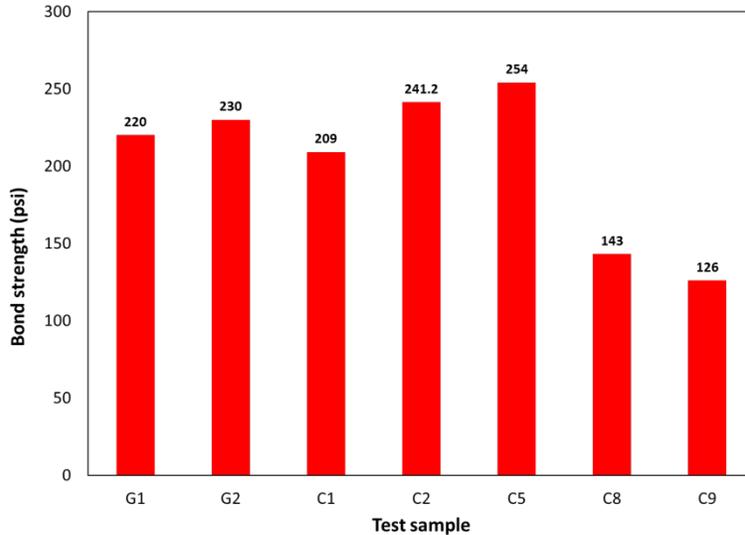
Figure 4.9 Bond strength test results for US 281 in Wichita Falls (2016)

Figure 4.8 shows bond strength testing in US 281 in Wichita Falls, and Figure 4.9 shows the testing results. Bond strength varied from 126 psi to 254 psi.

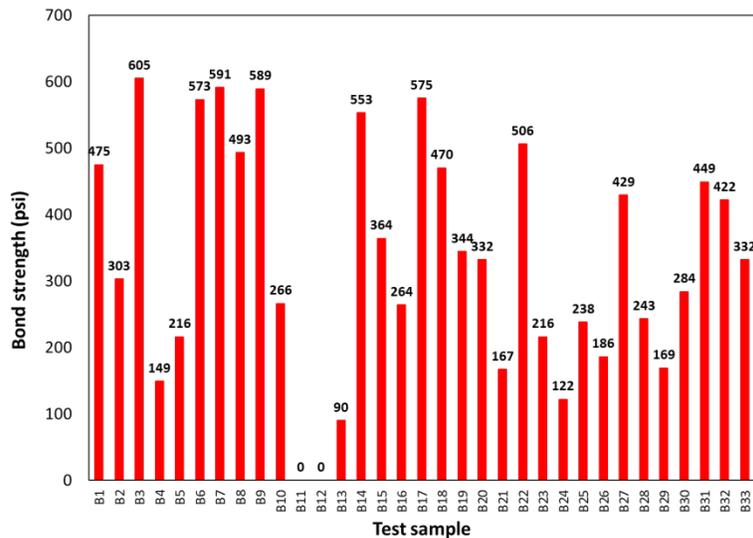
Figure 4.10 Bond strength test results for Loop 610 South in Houston (2016)

Figure 4.10 shows bond strength testing results from Loop 610 South in Houston. Five different slab thickness and reinforcement type combinations were used at this location: (1) 2-in. plain (B3 to B6); (2) 2-in. reinforced with welded wire fabric (B7 to B14); (3) 3-in. reinforced with welded wire fabric (B15 to B23); (4) 3-in. with fibers (B24 to B31); and (5) 2-in. with fibers (B32 to B33). B1 and B2 were at a transition zone. Also, issues arose with the coring operation at B11 and B12, and bond strength testing was not conducted at these two locations.

Table 4.1 summarizes the overall testing results from the three projects with failure mode. The average bond strength values were 186 psi in US 287, 197 psi in US 281, and 355 psi in Loop 610 South. It is noted that average bond strength on Loop 610 South was much greater than the

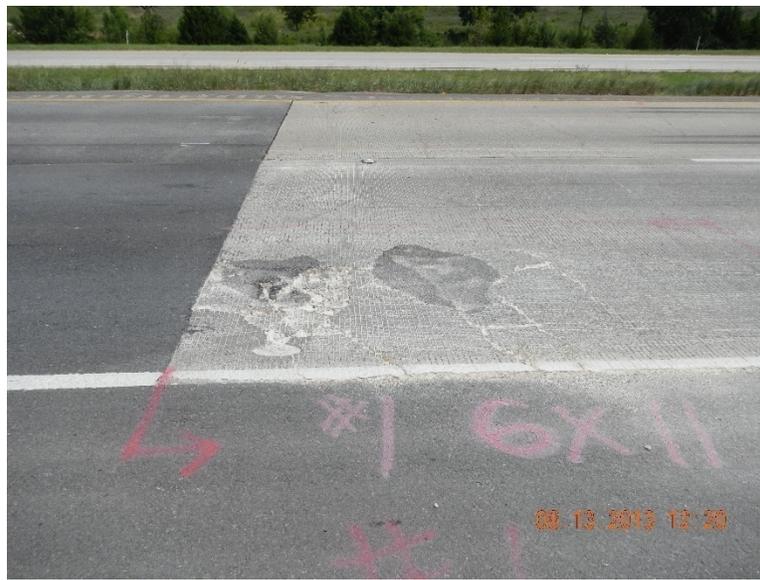
Figure 4.15 Transition area on BCO on US 287 in Bowie

During the field evaluations of BCO performance, it was observed that distresses were more prevalent in areas with discontinuities, such as transition areas between asphalt pavement and BCO, near the bridge expansion joints, or at longitudinal/transverse construction joints. **Figure 4.15** shows transition area conditions in the western end of the US-287 section in Bowie. This distress is confined to the outside lane, which implies that heavy truck wheel loading might have increased stress levels at the interface beyond the bond strength in this area. **Figure 4.16** shows distresses in a TCJ area on US 281 in Wichita Falls. As discussed in Chapter 3, severe delaminations were observed in this area. It appears that warping and curling of concrete caused initial delamination, which developed into fragmentation of overlay concrete. This indicates more stringent quality control or modifications in design may be needed at transverse or longitudinal construction joints, such as better curing.

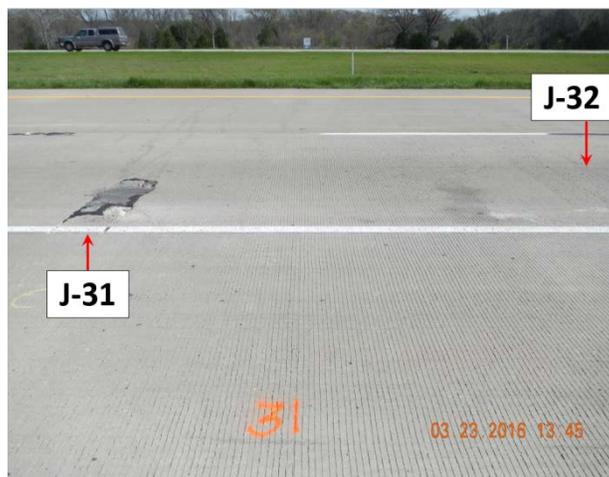
- 1) Most of the distresses on CRCP BCO were at transverse contraction joints in the existing CPCD.
- 2) In general, large deflections on CPCD at transverse contraction joints increased the potential for distresses in CRCP BCO.
- 3) However, in slabs with Joint No. 95 or above where the deflections on CPCD were small, the frequency of distresses on CRCP BCO was quite high. This appears to illustrate the construction quality issues.
- 4) Overall, joint deflections at 9,000 lbs loading of less than 8 mils on CPCD could be a good threshold value for the feasibility of CRCP BCO.

Figure 4.21 Distress on J-31

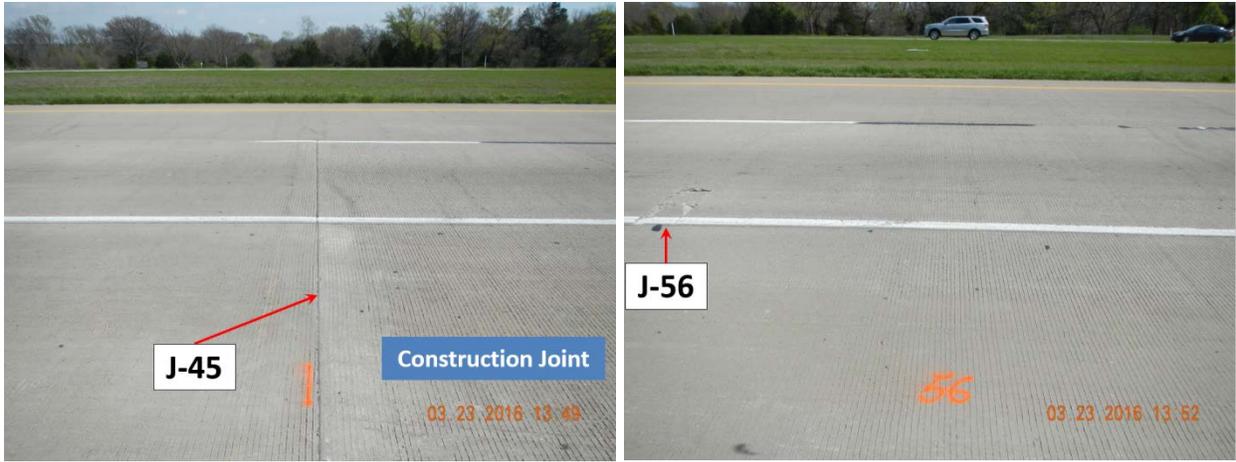
Figure 4.23 Construction joint at J-45 and distress on J-56

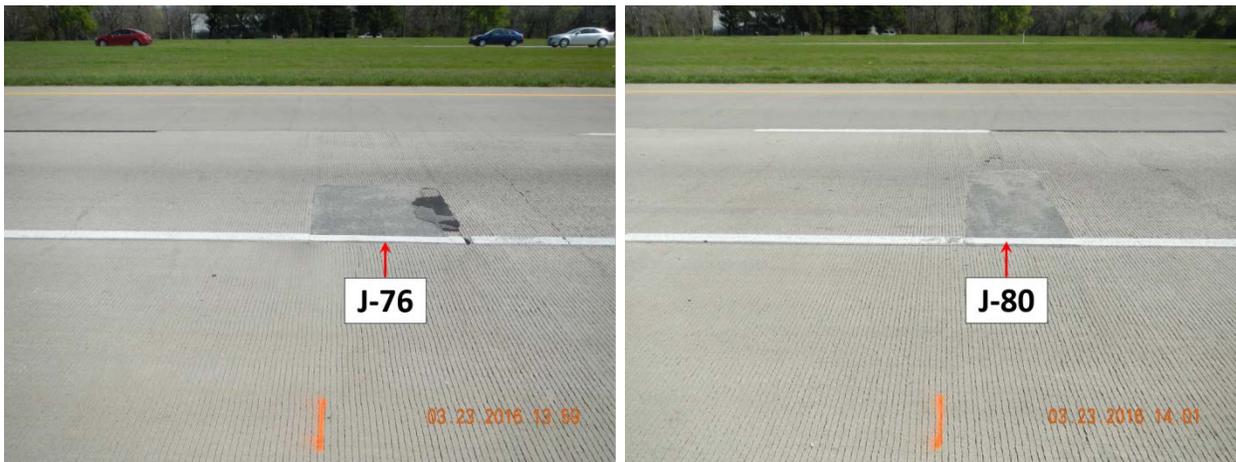
Figure 4.25 Distress on J-76 and J-80

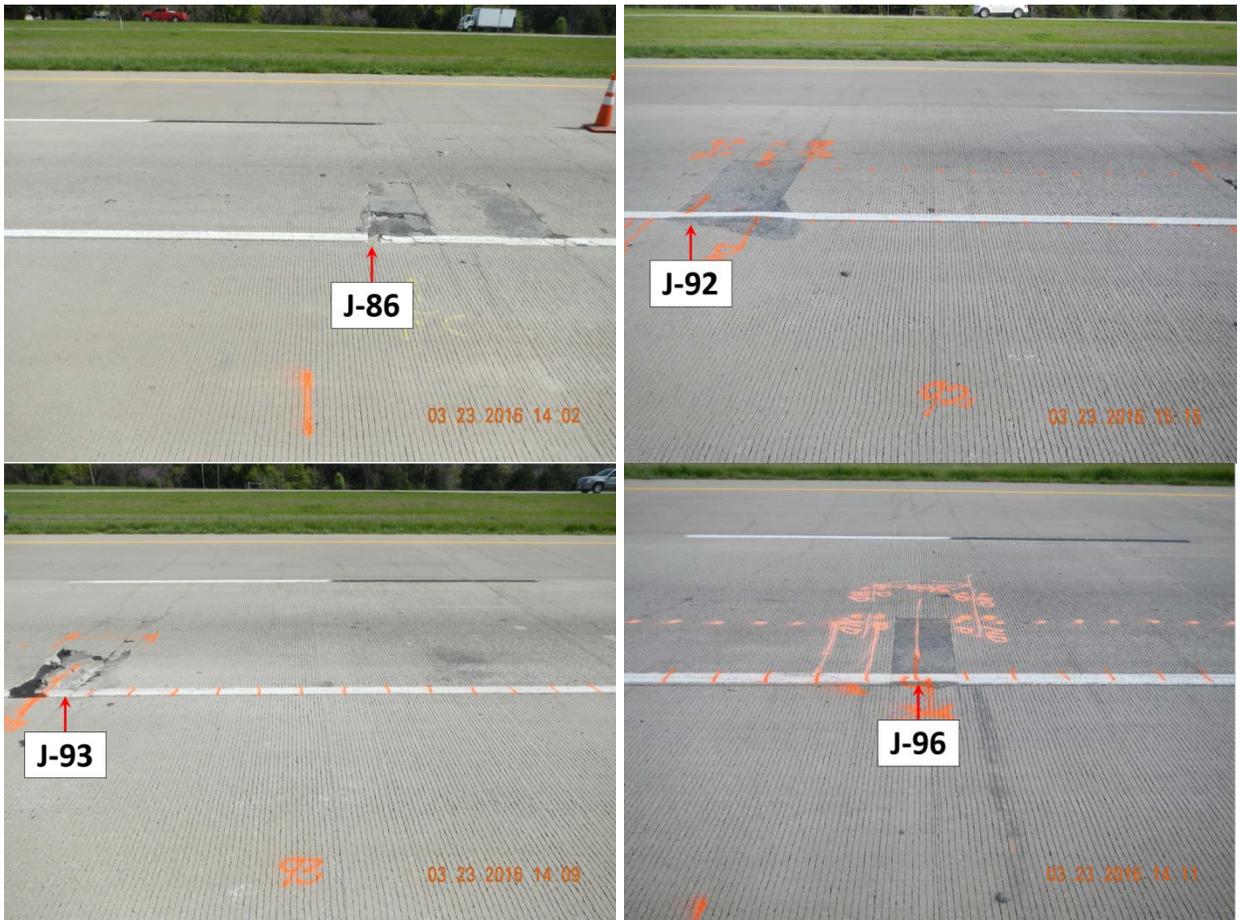
Figure 4.27 Distress on J-86, J-92, J-93, and J-96

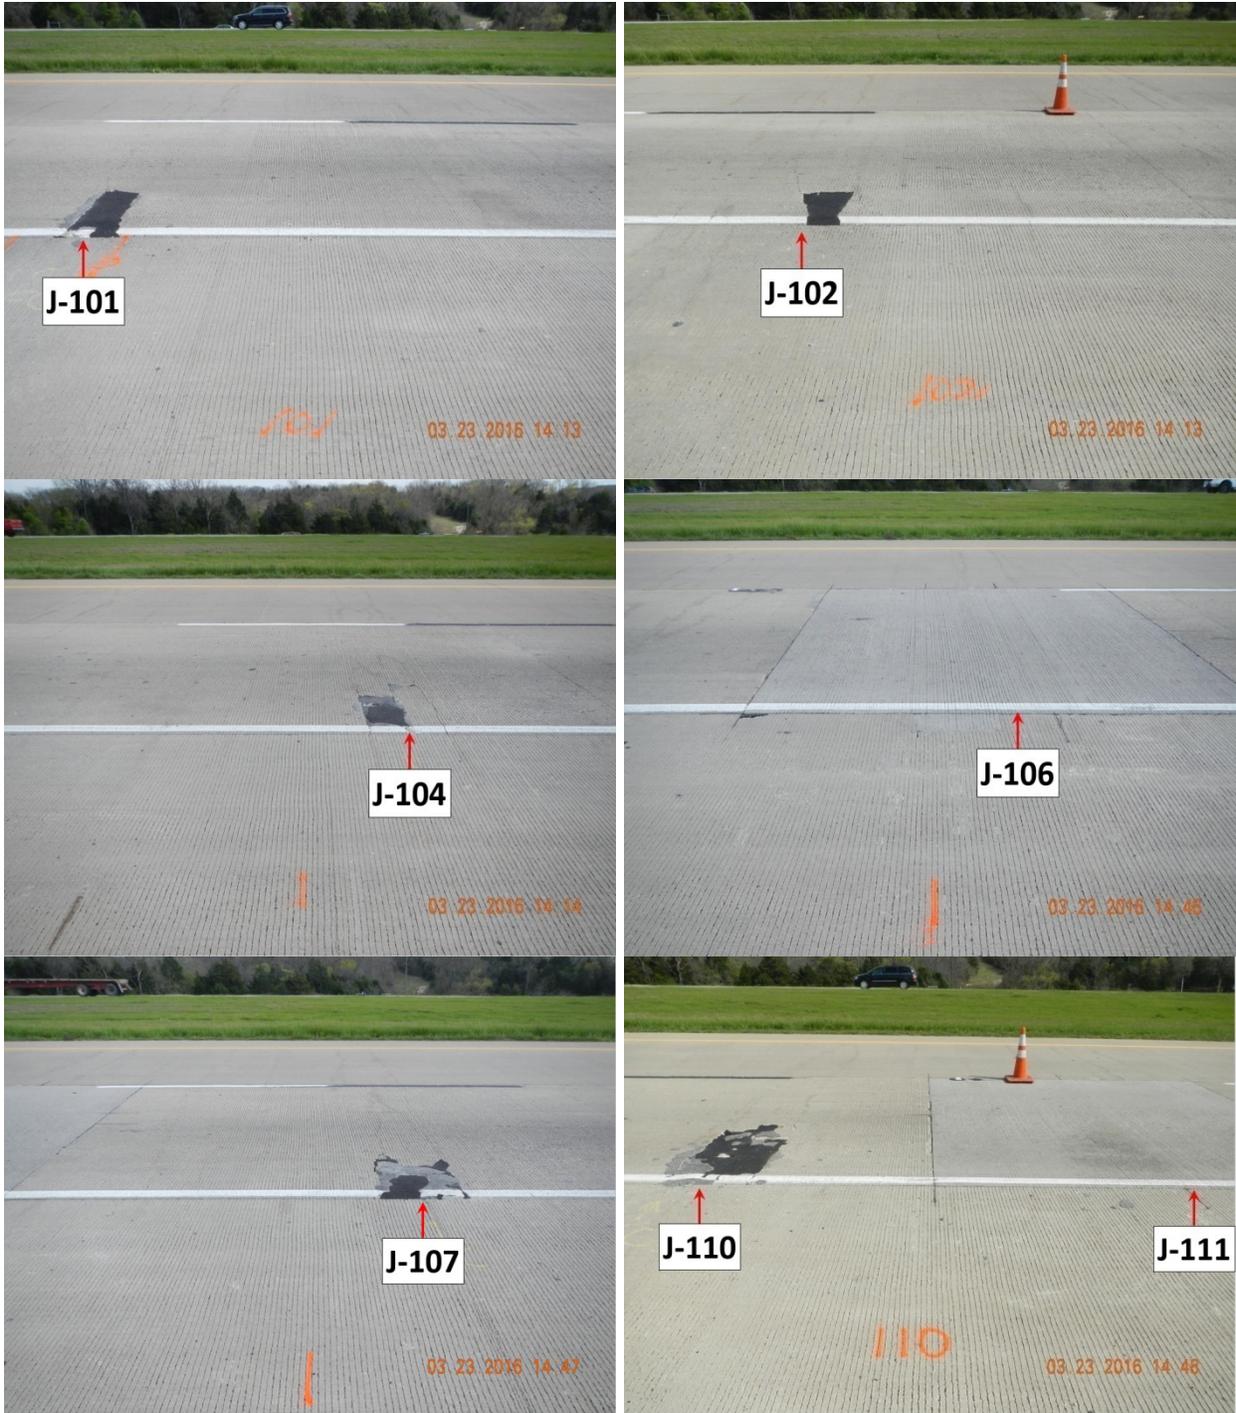
Figure 4.30 Distress on J-101, J-102, J-104, J-106, J-107, J-110, and J-111

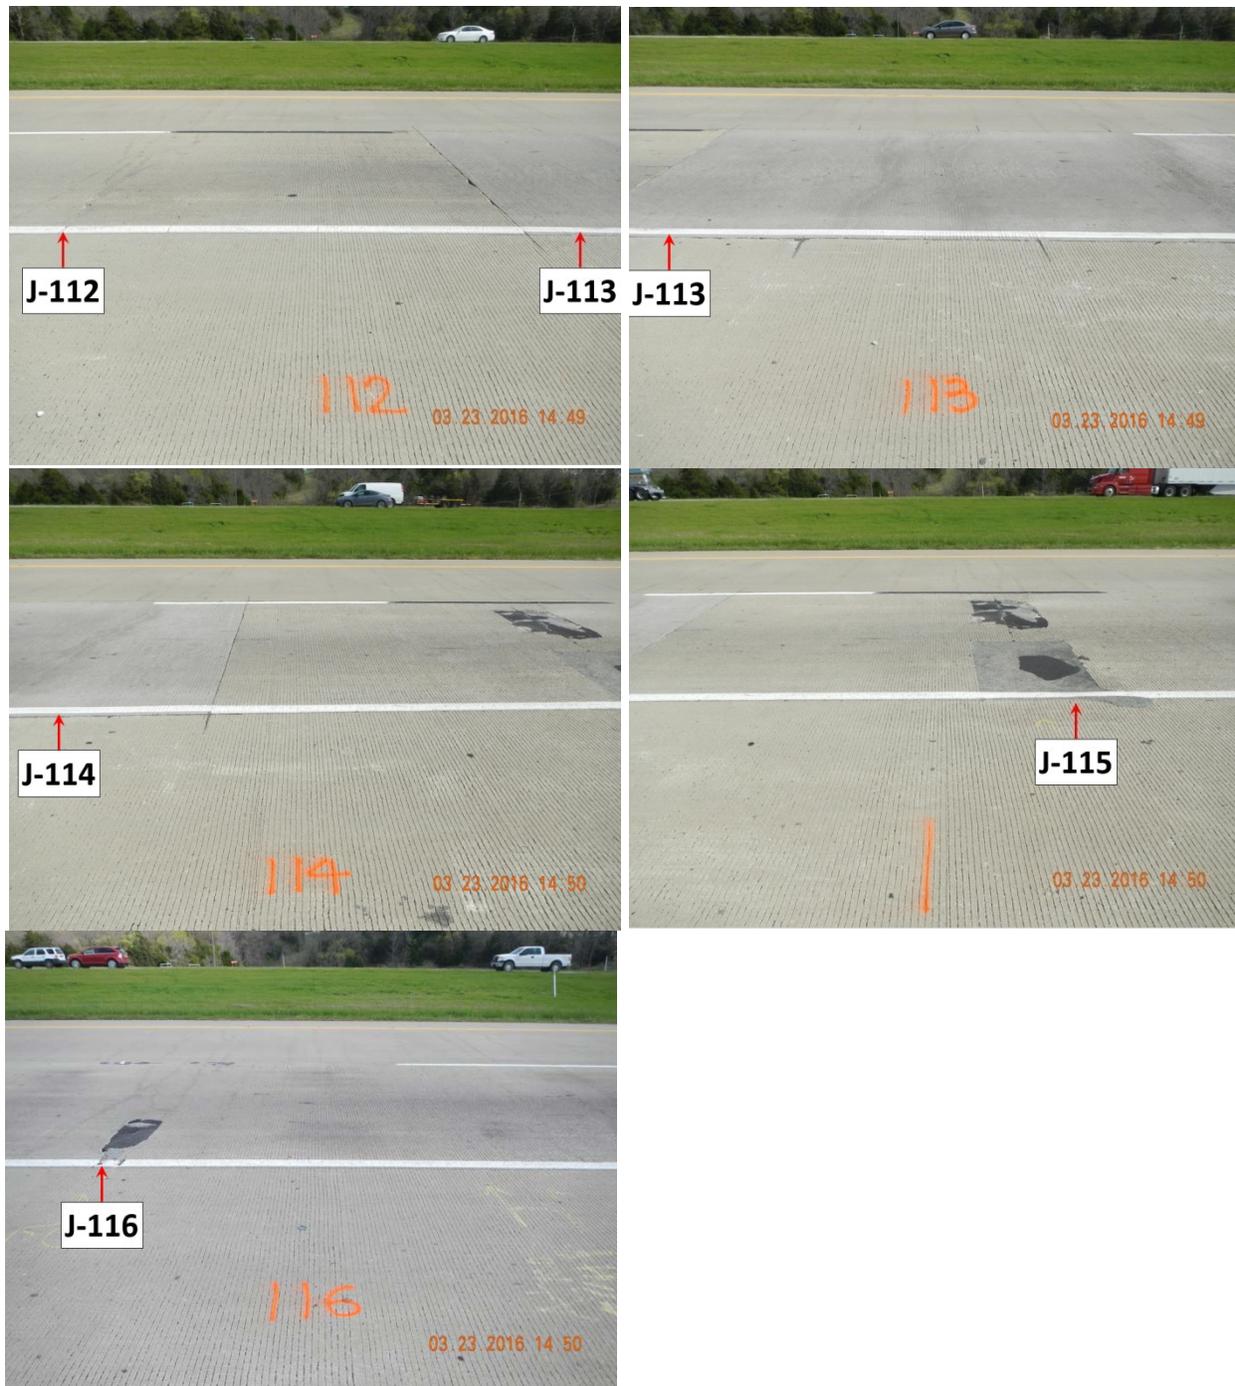
Figure 4.31 Distress on J-112, J-113, J-114, J-115, and J-115

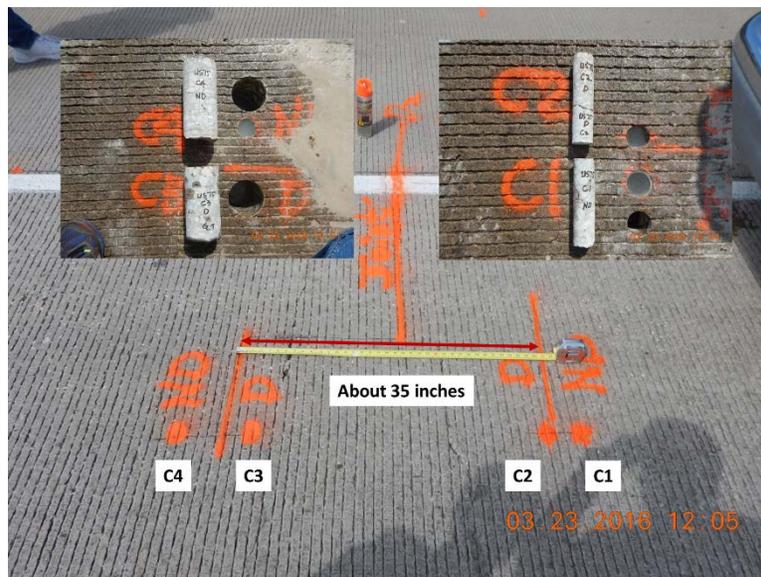
substantially beyond the fabric placement area. To evaluate the extent of debonding from the end of the non-woven fabric, MIRA testing was conducted. MIRA testing at one joint location showed that debonding extended by 6-in. beyond the end of non-woven fabric. To validate the MIRA evaluations, cores were taken at delaminated and non-delaminated areas evaluated by MIRA, as shown in Figure 4.32. MIRA evaluations were quite accurate. It is not known when the delamination actually occurred. Considering this section has been under heavy truck traffic for the last 6 years, this rate of delamination propagation is encouraging and could provide good technical evidence of the feasibility of CRCP BCO on CPCD. As discussed in Chapter 3, some early distresses were repaired as early as 2012 by removing both the concrete in the 7-in. BCO and non-woven fabric, followed by placing new concrete. These repairs performed very well, indicating that the use of non-woven fabric was not needed. Encouraged by this finding and the performance of this CRCP overlay on CPCD, TxDOT scheduled another CRCP BCO on CPCD on US 82 in Paris. Deflections on the existing CPCD were measured and almost all the deflections were less than 20 mils, with an average deflection of 6.4 mils. For this scheduled repair, non-woven fabric will not be used, and CRCP overlay will be placed directly on CPCD.

Figure 4.32 Delamination propagation

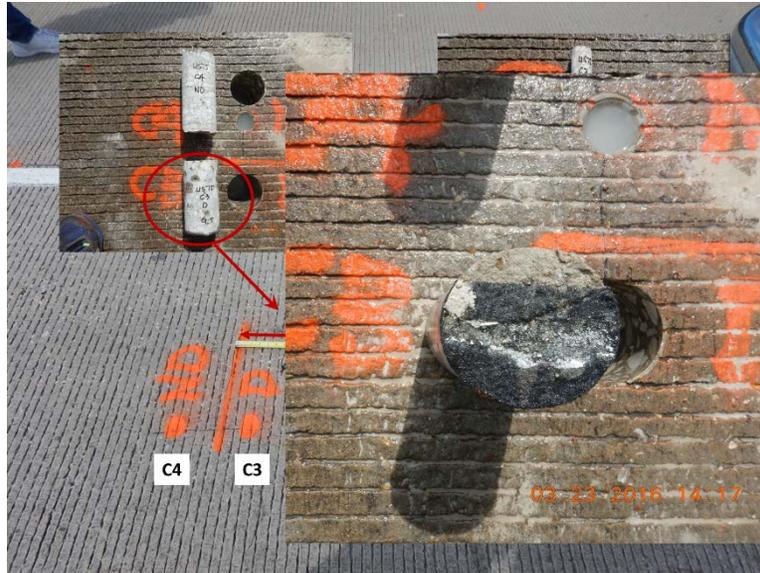
Figure 4.33 shows that fabric was attached to BCO concrete, which is expected since cement mortar from BCO concrete is absorbed into the fabric, creating mechanical bond. Accordingly, the debonding occurred between the fabric and the top of CPCD.

Figure 4.33 Core with an attached non-woven fabric

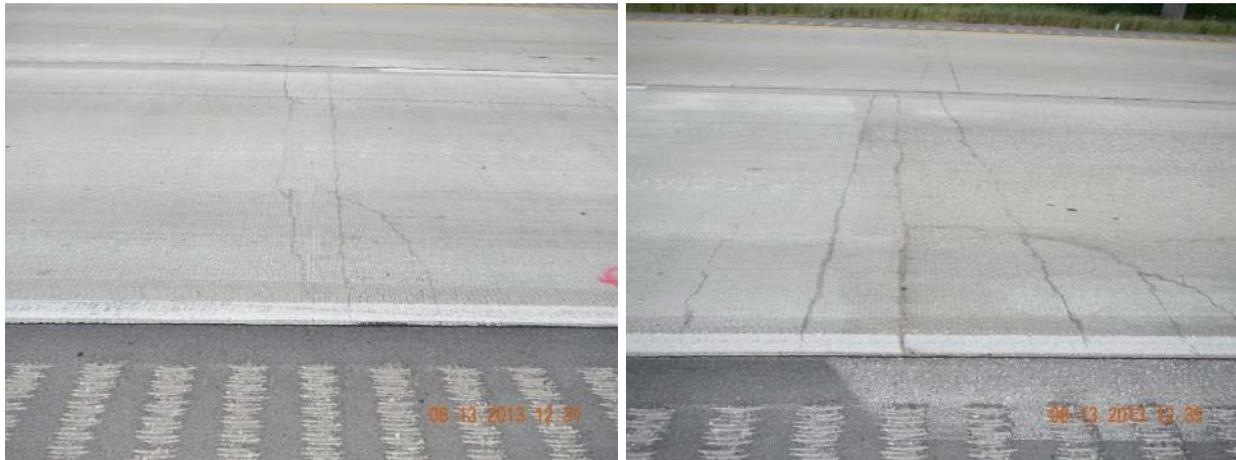
approach is to place BCO on an existing pavement with relatively low deflections, since such a BCO system will have smaller deflections, even with a thinner overlay slab. Thus, to determine whether existing PCC pavement is a good candidate for BCO or not, criteria on deflections of existing pavement should be developed. Figures 5.1 and 5.2 illustrate typical BCO distresses that occur following the distress mechanism described above.

Figure 5.1 Distress due to large deflection in existing CRCP (US 287 in Bowie)

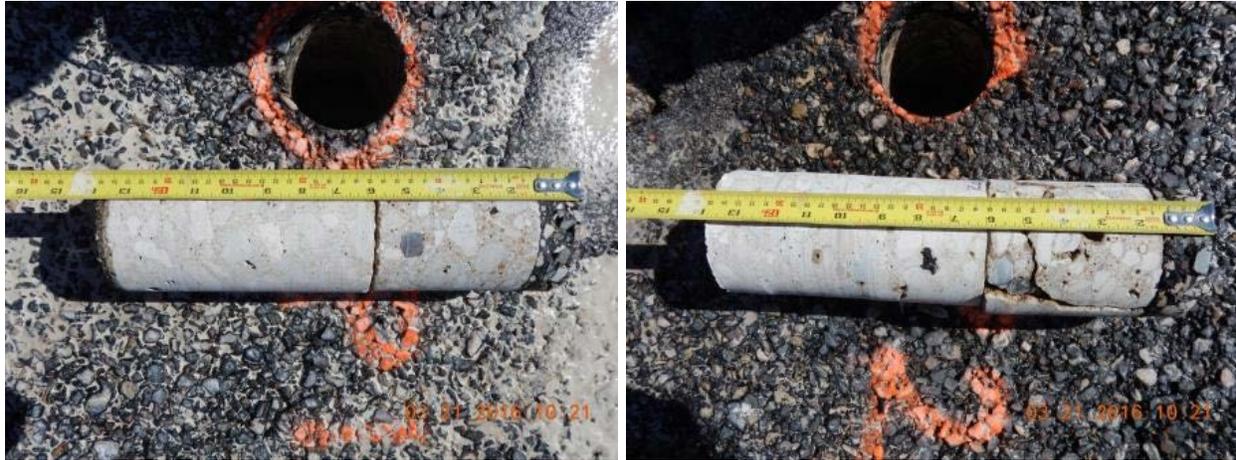
Figure 5.2 Delamination and BCO distress (US 287 in Bowie)

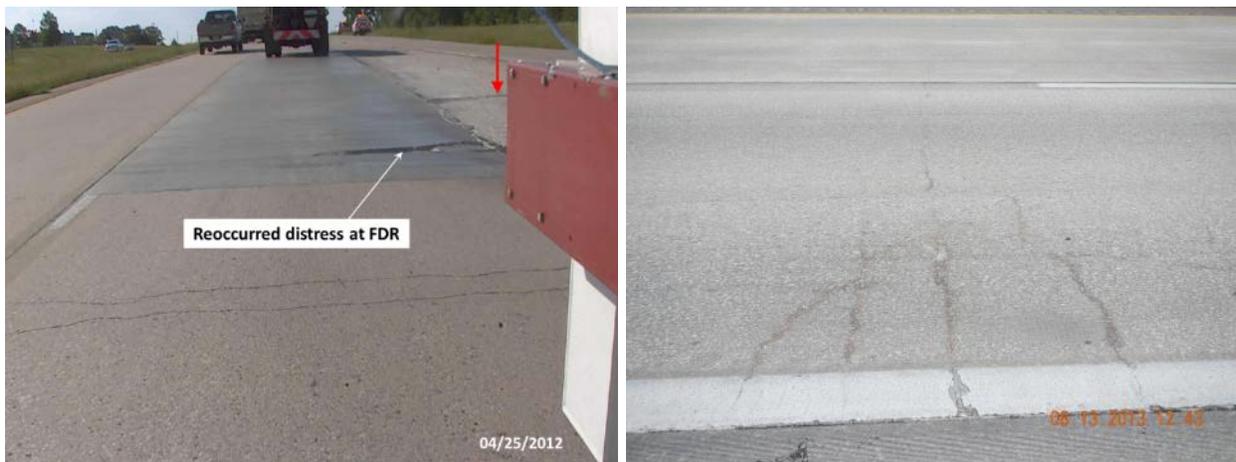
In the US-287 BCO project in Bowie, distresses were observed on BCO slabs along the repair boundaries in the existing CRCP. As shown in **Figure 5.3-(a)**, large deflections were measured at the FDR repair joints. In April 2012, deflection testing was conducted on existing CRCP with TPAD. Deflection profiles in **Figure 5.3-(a)** are from the TPAD testing. As a result, the secondary distress occurred again within the FDR slab before the BCO was placed, as illustrated in **Figure 5.3-(b)**. Eventually, the distresses in the FDR areas in the existing CRCP were reflected to the BCO as shown in **Figure 5.3-(c)**. This distress mechanism could be considered as a subset of the distress mechanism discussed earlier (larger deflections of BCO system potentially causing delamination and distress). In other words, large deflections in the existing PCC pavement slabs could be one of the primary distress development mechanisms in BCO.

(b) Distress within FDR slab

(c) BCO distress

Figure 5.3 Distress at FDR joint (US 287 in Bowie)

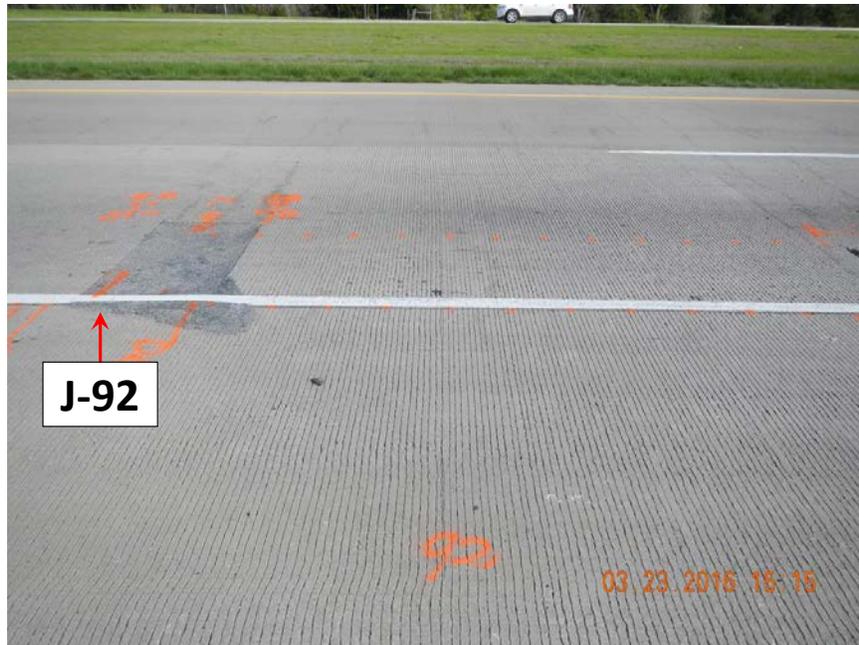
Figures 5.4 and 5.5 show typical distresses in CRCP BCO on CPCD on US 75. The distresses appear to be confined to the extent of the geotextile. It is not known what type of distresses could have occurred without the geotextile. However, if the deflections at transverse contraction joints in existing CPCD are less than a to-be-developed threshold value, a CRCP overlay without a geotextile could work.

Figure 5.5 Distress in CRCP BCO on CPCD (US 75 in Sherman #2)

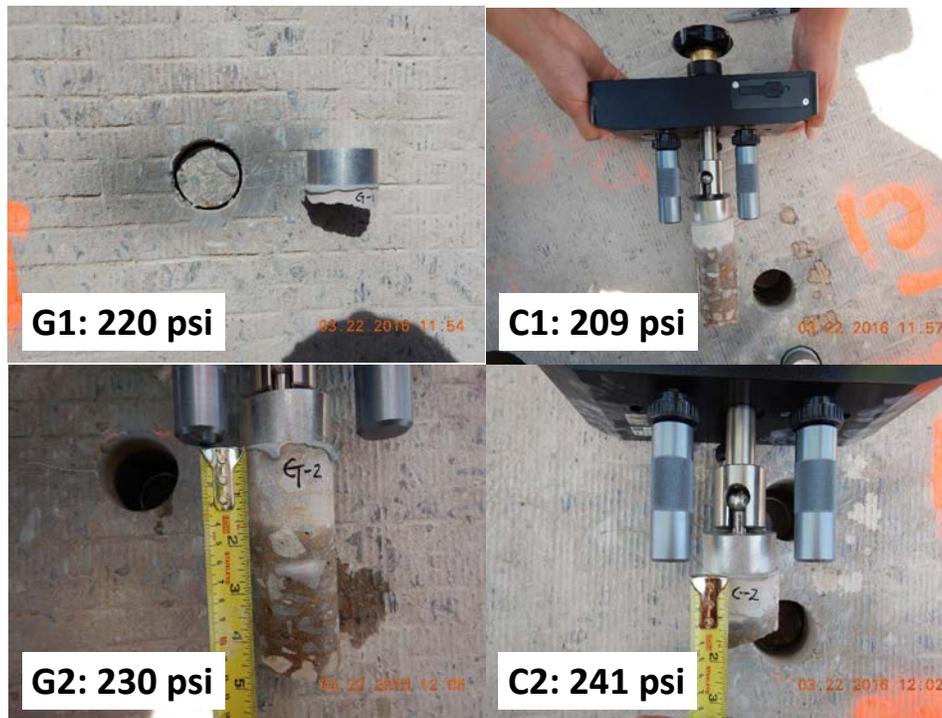
As discussed in the previous chapters, in all nine locations evaluated for bond strength at the US-281 site in Wichita Falls, failure planes in concrete were all either within the existing or overlaid slabs, but none at the interface. In other words, bond strengths at the interface were greater than the tensile strengths of concrete in the existing slab or overlaid slab in all those locations. The average bond strength obtained was 197 psi. This value is somewhat lower than the expected tensile strength of concrete in both the existing or overlaid slabs. However, this result indicates that the bond strength at this location was adequate to provide monolithic behavior of the overlaid

Figure 6.3 Bond strength testing and failure mode on US 281 in Wichita Falls

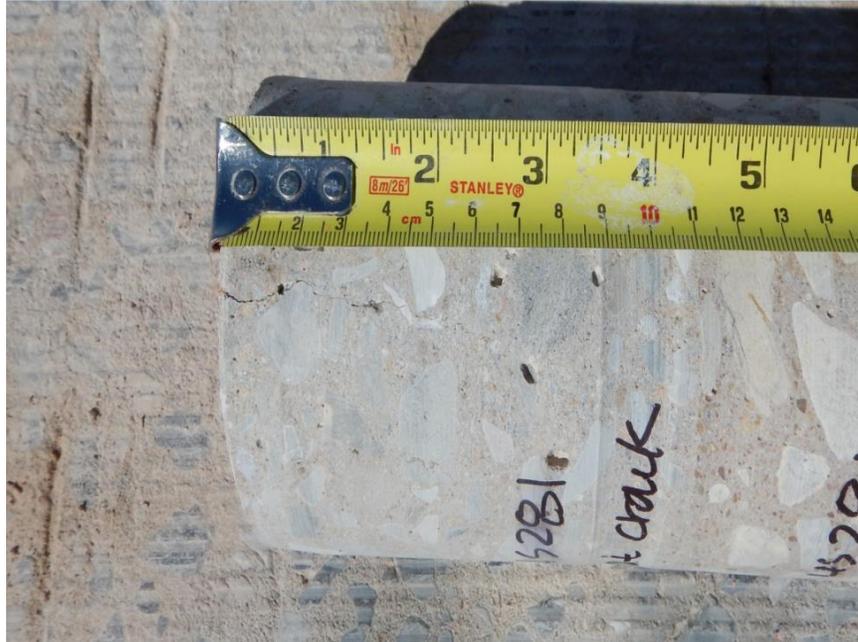
Figure 6.4 Close-up view of concrete core taken at transverse crack

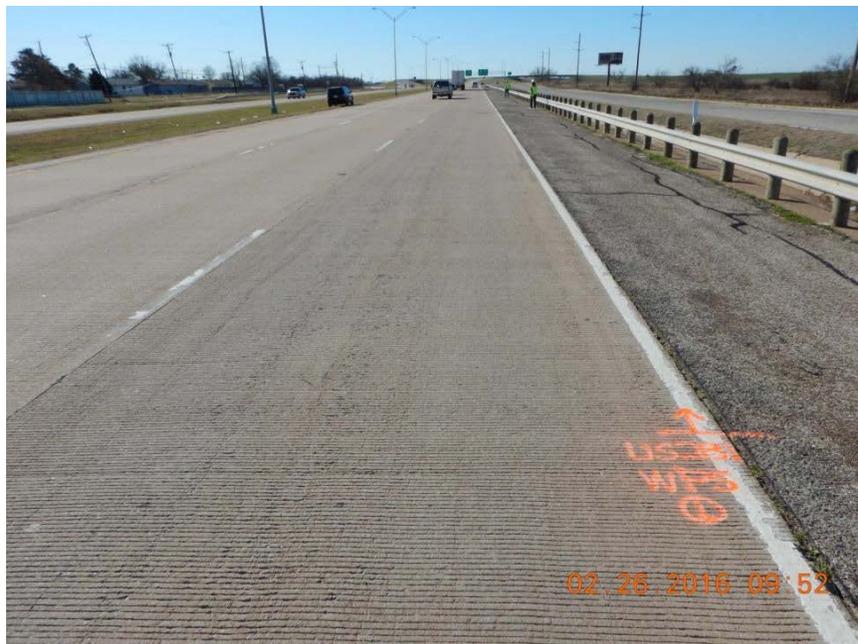
Figure 6.5 Overall BCO condition on US 281 in Wichita Falls

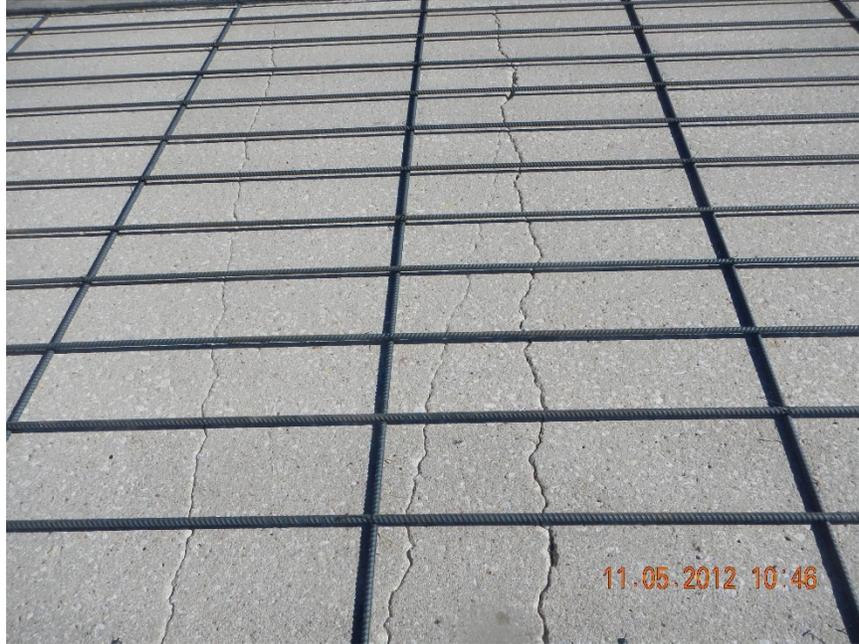
In the US-287 BCO project in Bowie, the surface of the existing CRCP was prepared by the same method applied to US 281 in Wichita Falls. **Figure 6.6** shows the surface texture after the shot blasting. Compared with the surface texture prepared in US 281 project, as shown in Figure 6.1-(b), the surface texture shown in Figure 6.6 appears to be not as rough. Unfortunately, measurements were not made on surface texture characteristics on both projects, and direct comparison of the surface textures in both projects is not possible. As discussed earlier, bond

strength in the US-287 project in Bowie was quite low and all the failures in bond testing were at the interface. More specifically, bond strength testing was conducted at 14 locations on November 15, 2012, 9 or 10 days after BCO placement. Bond testing showed that failures occurred at the interface at 11 locations, as illustrated in [Figure 6.6](#). At the other three locations, the concrete in overlaid layer became loose during coring, and pull-out bond testing was not even feasible. It appeared that almost no bonding existed at those three locations. Bond strength varied from 117 psi to 241 psi at the remaining 11 testing locations, with an average value of 186 psi. If the three locations where bonding did not exist are included, the average bond strength would be 146 psi, which is much lower than the value obtained in US 281 in Wichita Falls, even though the age of bond strength testing in US 287 in Bowie was only 9 or 10 days. It should be recalled that the bond strength of US 287 in Bowie was obtained prior to the opening of the pavement to the traffic, while the bond strength in US 281 in Wichita Falls was obtained after 14 years of traffic applications. It should also be recalled that the failure planes in US 281 in Wichita Falls were not at the interface, while those in US 287 in Bowie were all at the interface. Even though large deflections in the existing CRCP appear to be responsible for early-age distresses and poor performance of the BCO on US 287 in Bowie, what could have happened if the bonding at the interface had been good remains unknown. Considering the significant effect of good bonding on BCO performance, including bonding requirements, such as bond strength, in the specifications may be needed; the bond strength requirements were incorporated in the draft specifications developed in this study. However, the bond strength requirements might increase the BCO cost, since contractors see them as added uncertainty and raise the bid price. Since these bond strength requirements are new, providing a bonus for good bond strength might be a good incentive, until the PCC paving industry becomes knowledgeable on how to achieve good bond strength and comfortable with those requirements.

Figure 6.6 Close-up view of surface texture after shot-blasting, US 287 BCO in Bowie

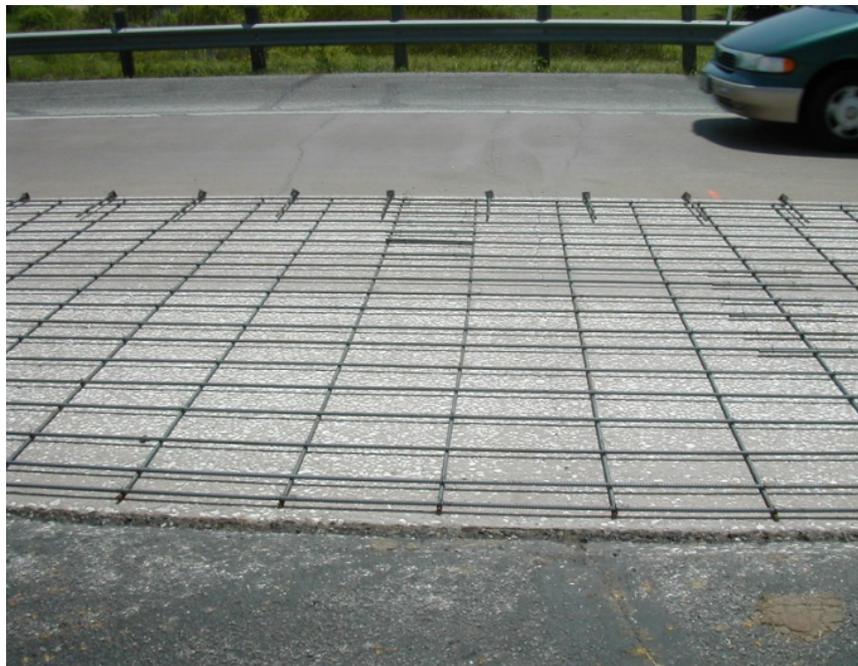
Figures 6.8 and 6.9 show steel placements in 4-in. BCO projects on US 281 in Wichita Falls and US 287 in Bowie, respectively. In both projects, longitudinal steel was placed on top of transverse steel, which was placed on top of the existing PCC pavement. The longitudinal steel was placed near the bottom of BCO layer because the concrete volume changes near the interface could be

minimized by longitudinal steel, which could improve bond strength. As discussed earlier, this steel placement worked well for US 281 in Wichita Falls, while bond strength and BCO performance were rather poor at US 287 in Bowie. However, it is believed that, when BCO thickness is 4-in., the placement of longitudinal steel near the bottom of BCO is a good practice. **Table 6.1** illustrates the recommended reinforcing steel percentage and steel depths in BCO in TxDOT Pavement Manual.

Figure 6.8 Longitudinal rebar placement on US 281 in Wichita Falls

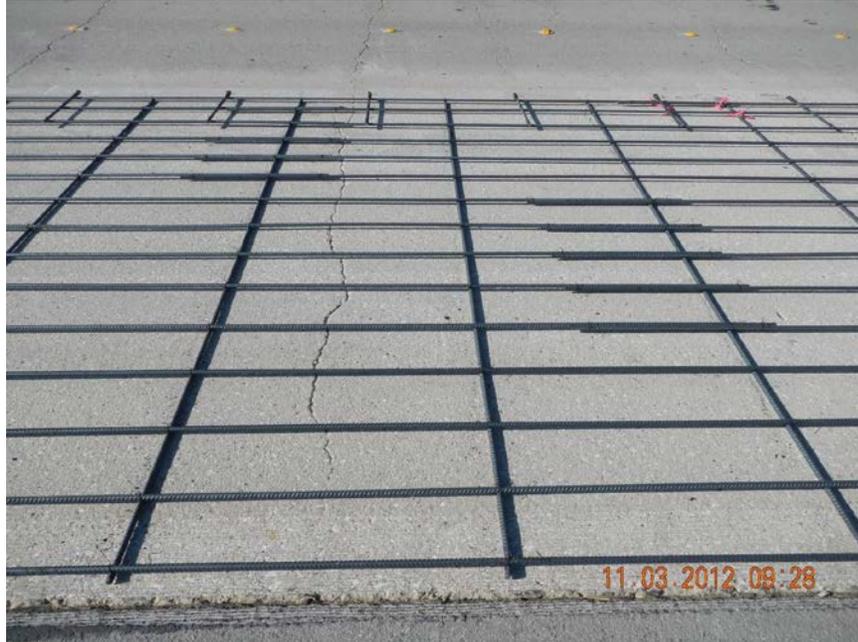
Figure 6.9 Longitudinal rebar placement on US 287 in Bowie

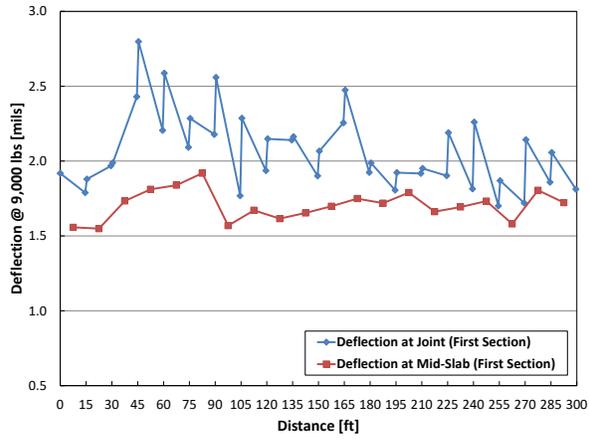
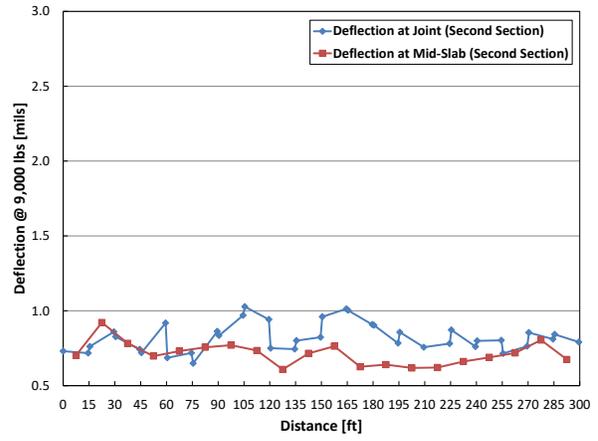
Figure 6.10 Deflection comparison between joint and mid-slab on IH 35E in Ellis County

As discussed in Chapters 3 and 4, at the IH 35E UBCO site in Waxahachie, the condition of UBCO was excellent, with quite small deflections and practically no distresses, except for a small crack near a transverse contraction joint, which will be discussed in the next section. For field evaluation purposes, the project was divided into two sections: good and poor. A section with the area containing a small crack was classified as a *poor* section, and the rest a *good* section. Deflections were measured at both sections and they were larger in the good section than in the poor section, as shown in [Figure 6.10](#). Coring was conducted in both sections to obtain concrete cores for material evaluations as well as the condition of the hot mix asphalt (HMA) interlayer. The HMA interlayer in the good section was deteriorated while that in the poor section was in a good condition, as shown in [Figure 6.11](#). It appears that the poor condition of the HMA interlayer in the good section resulted in larger deflections, while the good condition of the HMA interlayer in the poor section yielded smaller deflections. Even though the UBCO condition in both good and poor sections is quite excellent at this point, the long-term structural performance of the good section might be not as good as that of the poor section. This indicates that, for UBCO design and

construction, close attention should be paid to the materials selection and placement of the HMA interlayer.

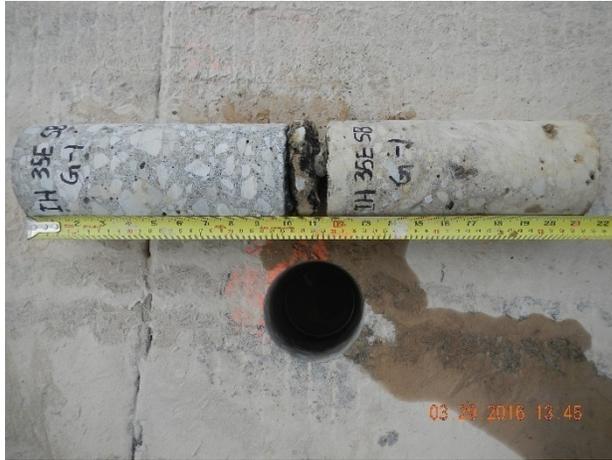
(a) Good section, G-1

Figure 6.11 Deteriorated AC interlayer in good and poor sections, IH 35E
