Performance and Improvement of Texas Poor Boy Continuous Bridge Deck Details: Final Report

Technical Report 0-7013-R1

TEXAS A&M TRANSPORTATION INSTITUTE COLLEGE STATION, TEXAS

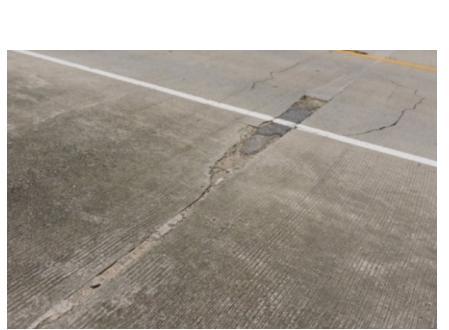
(a) Cracking and spalling on top of deck

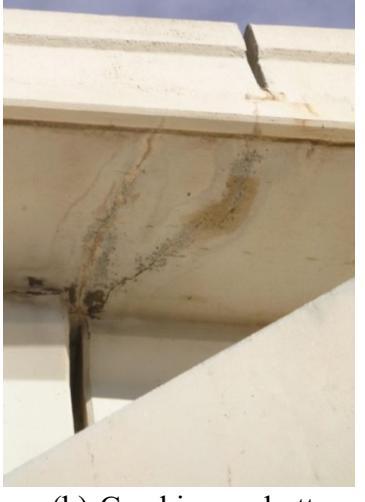
(b) Cracking on bottom of overhang

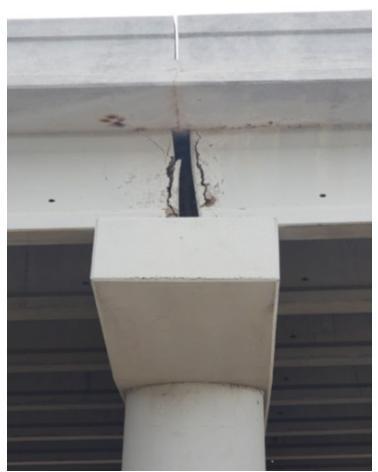
(c) Girder end damage

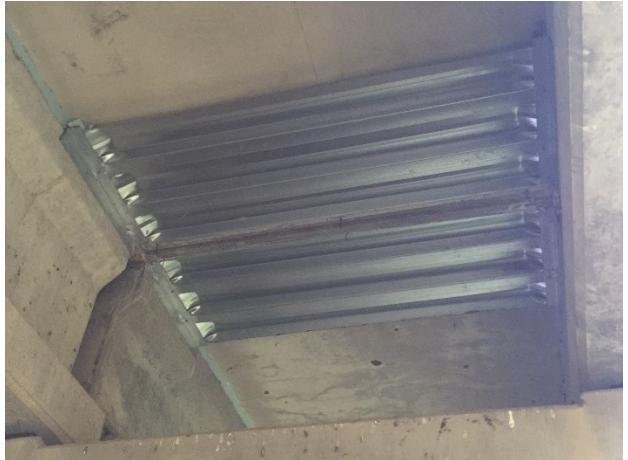
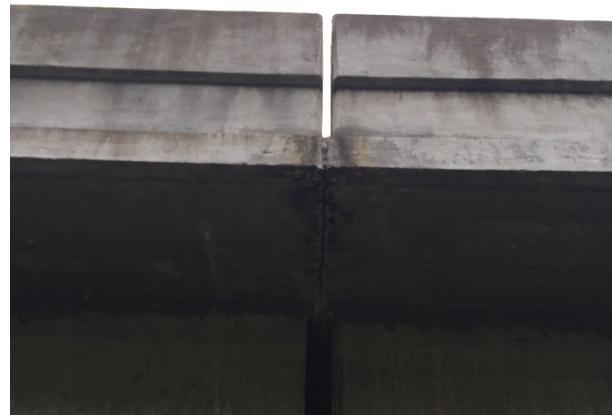
Visual inspection of the bridge confirmed the inspection report damage of minor spalling at the construction joint. The conditions of the continuous deck regions at Bent 2 and Bent 4 were similar. Figure 4.3 shows the condition of the link slab region at Bent 4 from below the deck and the top of the deck at Bent 2. The PMDF was in good condition, with no indication of rust or other damage. In the overhang, some minor spalling was observed at the PBJ crack, but no cracking was noted. Visual observations on the top side of the deck indicated that zip strips were used to form the main PBJ crack. The zip strip was still intact, but some minor spalling was observed at several locations along the length. Figure 4.3(c) shows the marked cracks in the NDE region. Secondary PBJ cracks were present at approximately the end of the portion of the deck where PMDFs were used. The secondary PBJ cracks were 0.014–0.016 in. wide in the NDE region. Hairline cracks were present in the link slab region and in the main deck, and they were primarily longitudinal, with an occasional transverse crack.

(a) PMDF at Bent 4

(b) Bottom of overhang at Bent 4

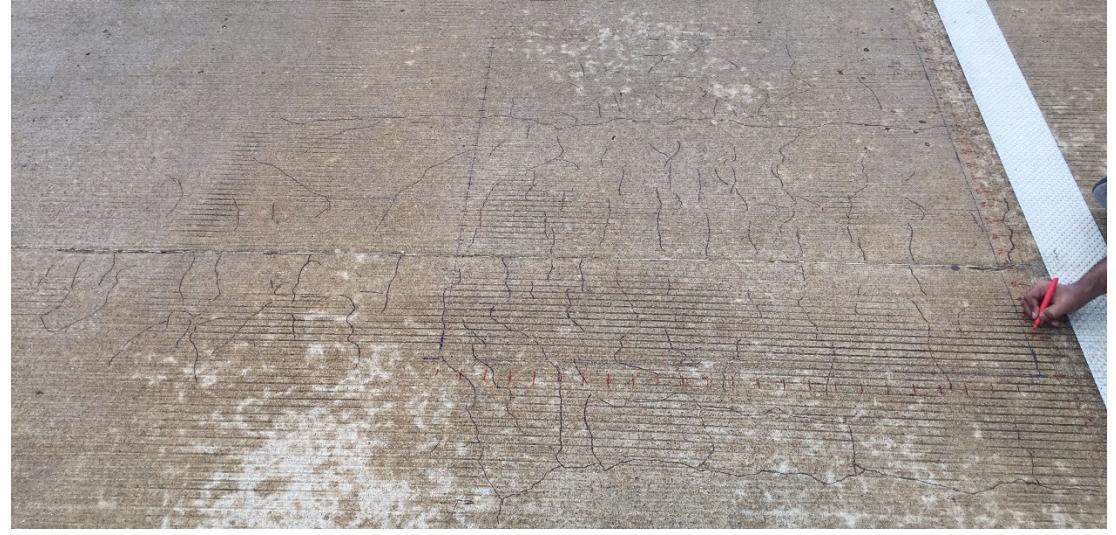
(c) Marked cracks in the NDE region at Bent 2 Figure 4.3. Link slab condition for Bridge ATL1 (FM 556 over Lilly Creek).

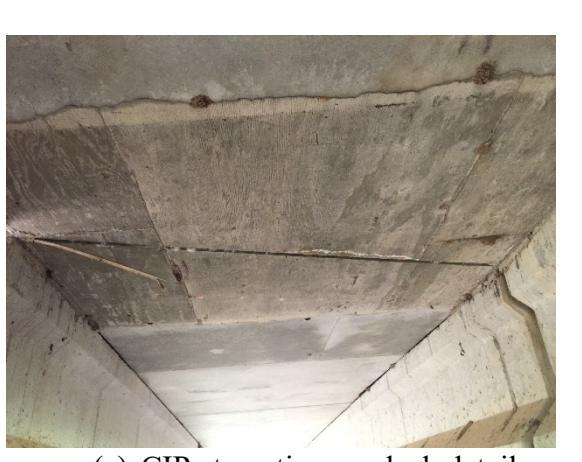
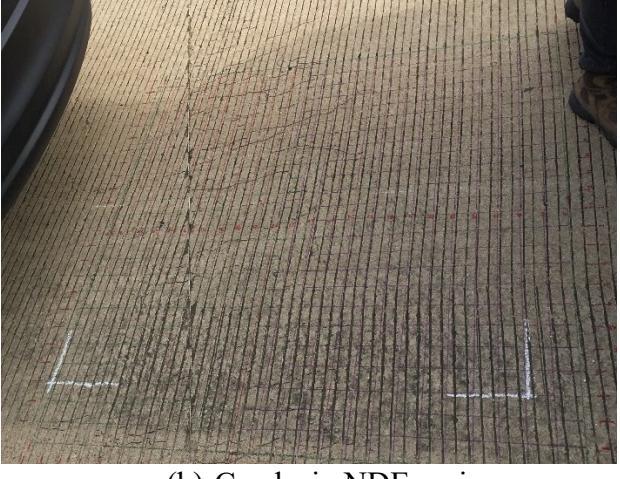
Visual inspection of the bridge confirmed the inspection report damage. The condition of all continuous deck regions was similar. Figure 4.11 shows representative conditions of the link slab regions. Visual observations on the top side indicated that zip strips were used to form the main PBJ crack. The zip strip was still intact, but some minor spalling was observed at several locations along the length. There were no distinct secondary PBJ cracks. Aside from the main PBJ crack, random cracks were present. The maximum cracks were 0.008 in. near the exterior side of the girder, but most cracks were 0.007 in. or less.

(a) CIP at continuous deck detail
 (b) Cracks in NDE region
 Figure 4.11. Typical link slab condition for Bridge ATL2 (FM 250 over Black Cypress Creek).

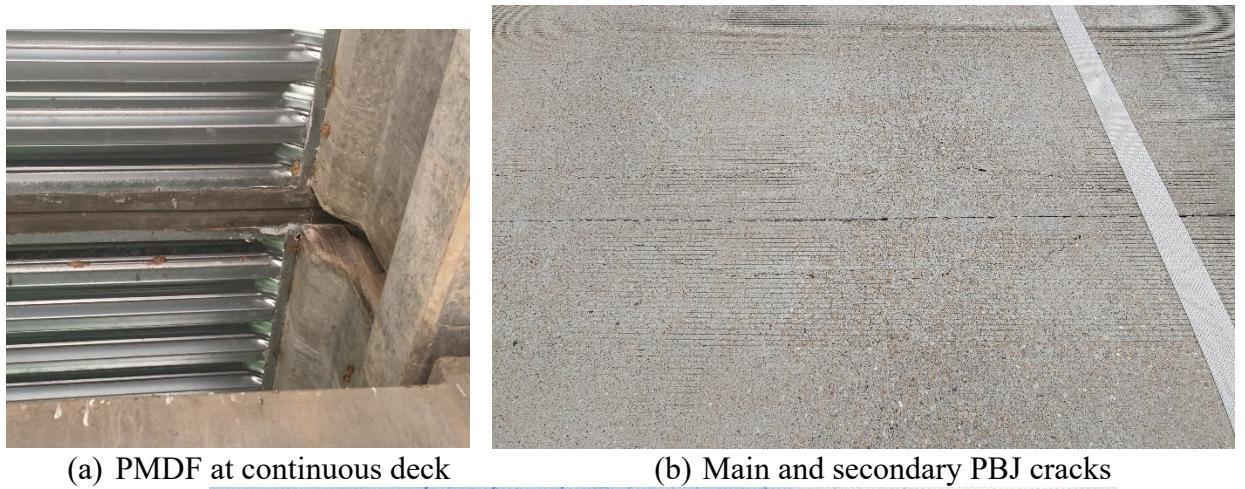
Visual inspection of the bridge confirmed the damage indicated in the inspection reports, with all PBJ regions having similar damage characteristics. Figure 4.18 shows the condition of the PMDF below the continuous deck and the pattern of cracking on the top of the deck. Efflorescence was observed at the ends of the girders, and small gaps in the PMDF were present below the location of the main PBJ crack. Otherwise, the PMDF was in good condition with no indication of rust.

Figure 4.18(b) shows the main and secondary PBJ cracks typical of all continuous deck joints. The main PBJ crack was formed with a zip strip that was still located in the deck. There was moderate spalling along the main crack, larger than observed in the other bridges inspected in the Atlanta District. The location of the secondary cracks relative to the main PBJ crack varied, occurring as close as 5 in. at the girders or as far as 11 in. between the girders. The width of the secondary cracks varied from 0.020–0.025 in. and was smallest over the girders. Similar crack patterns were observed in the overhang, but the widths were 0.014–0.016 in. Figure 4.18(c) shows the marked cracks in the NDE region. In addition to the main and secondary PBJ cracks, cracking was consistent with the rest of the deck, with most of the cracks being longitudinal cracks and measuring as hairline cracks.

(c) Cracks in NDE region Figure 4.18. Typical link slab condition for Bridge ATL3 (FM 154 over Little Cypress Bayou).

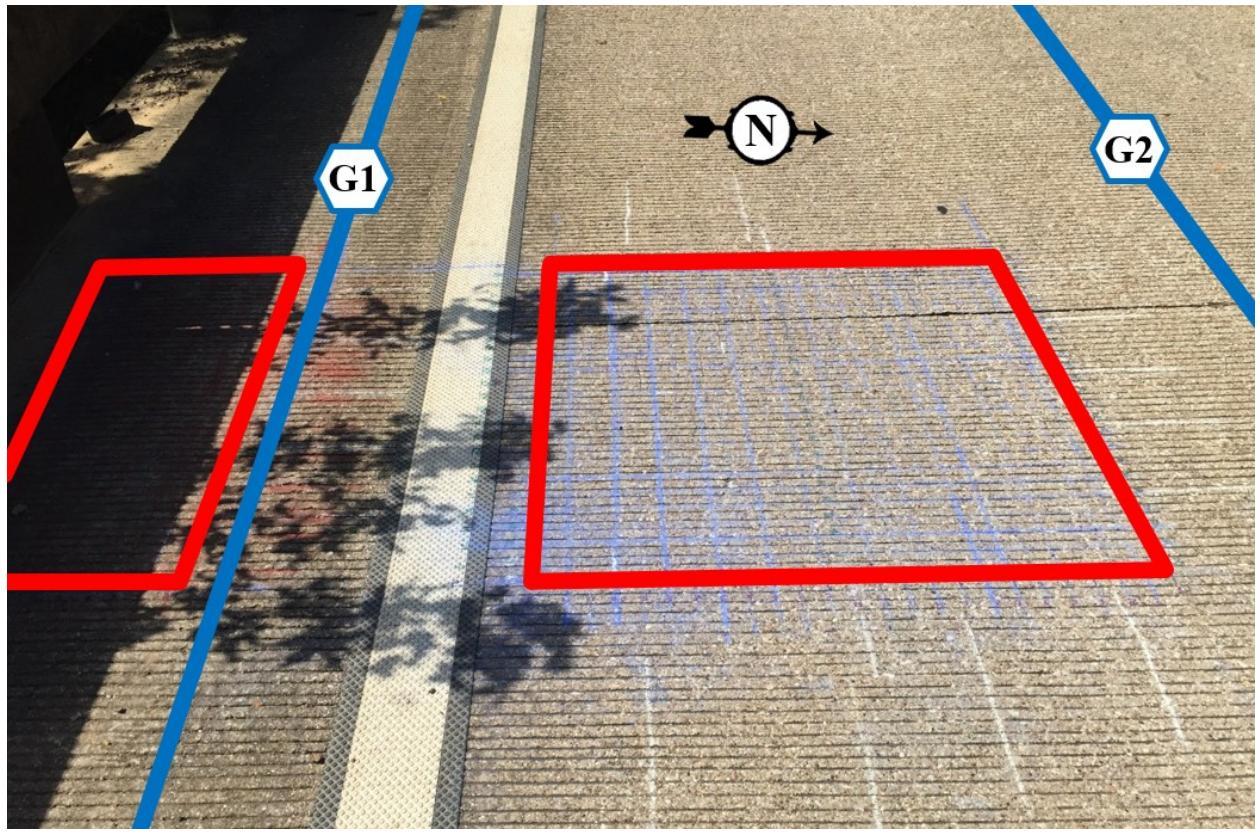
Figure 4.27. NDE region at Bent 3 for Bridge ATL4 (FM 968 over Clarks Creek).

The NDE regions are shown in Figure 4.27. The main NDE region was a 4-ft by 4-ft region at Bent 2, located in the northbound lane and between G1 and G2. The region was off center relative to the main PBJ crack to capture the reinforcement at the main crack plus an extension beyond the CIP region.

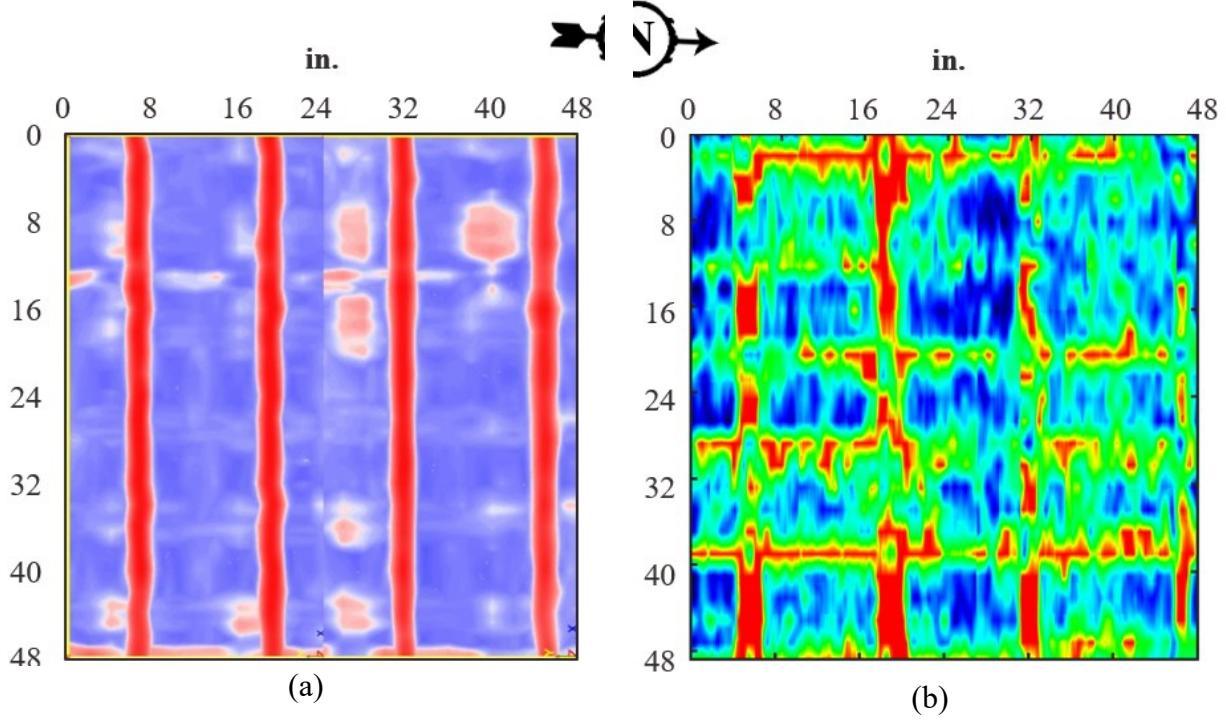
Figure 4.28. ATL4 results for (a) GPR and (b) UST of top longitudinal reinforcement between the girders at depth 4.95 in.

Figure 4.28 confirms the spacing of the top longitudinal reinforcement in the as-built drawings as 12 in. Figure 4.29, however, only shows transverse bars at 9.5 in. Transverse bent bars at 9.5-in. spacing were not found in GPR or UST images. Figure 4.30 and Figure 4.31 show that the reinforcement is deeper in the slab by approximately 1 in. at the PBJ than in the rest of the deck. A thickened CIP slab and a different depth of reinforcement at the PBJ are not specified in drawings or details. The spacing of the bottom longitudinal steel, seen in Figure 4.31(a), is approximately 7 in., which is a reasonable value given that bottom longitudinal steel is not shown on drawings as being placed over the girder lines and is instead clustered between the girder lines.

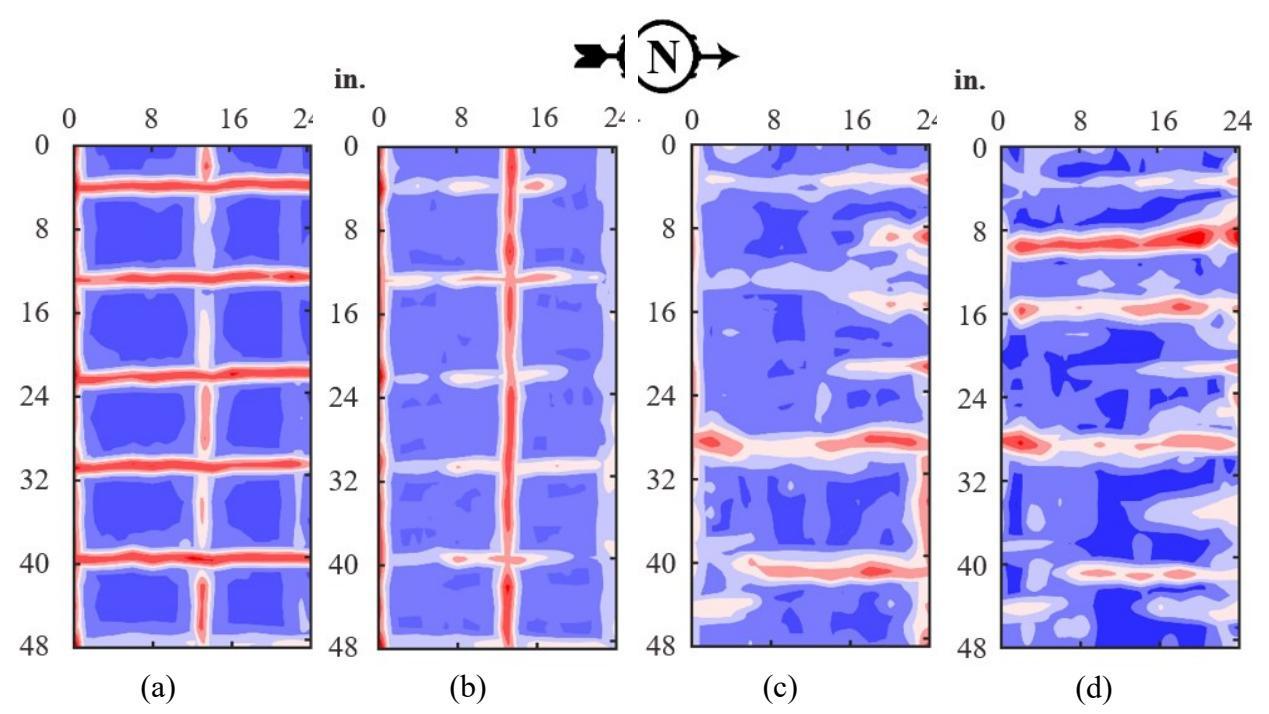
Figure 4.32. ATL4 GPR results in the overhang for (a) top transverse reinforcement at depth 4.23 in., (b) top longitudinal reinforcement at depth 4.98 in., (c) bottom reinforcement at 8.23 in., and (d) bottom reinforcement at 8.73 in.

Figure 4.32 shows GPR images of the reinforcement placement in the overhang NDE region. Figure 4.32(a) and (b) show similar top-layer reinforcement spacing as in the primary NDE region between the girders. Figure 4.32(c) and (d), however, are less conclusive for the bottom reinforcement but still show that bottom transverse reinforcement appears to be placed deeper in the PBJ region. No evidence of voids or delaminations was discovered using IR images.

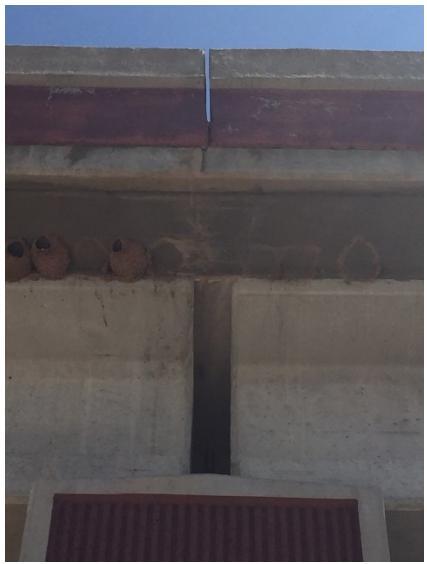
Visual inspection of the bridge confirmed the inspection report damage, and the condition of all continuous deck regions was similar. Figure 4.34 shows representative conditions of the link slab regions. Visual observations below the deck indicated confirmed cracking and efflorescence in the CIP overhangs. While the PCPs were in excellent condition, the gap between flush panels had some material hanging loss, and water stains were clearly present on the bent caps. On the top of the deck, the extensive cracking was confirmed. The main PBJ crack formed naturally (no zip strip). Between girders, the maximum width was 0.030 in. In the overhang, the maximum width was 0.025 in. Minor spalling was present in several locations along the main PBJ crack. Aside from the main PBJ crack, extensive cracks were present in the link slab region and the overall deck. Most cracks were no larger than 0.008 in., but one longitudinal crack was measured as 0.012 in. and several other longitudinal cracks as 0.010 in. While there were no distinct secondary PBJ cracks spanning the width of the bridge, NDE Area #3 contained a large transverse crack located 35.625 in. from the main PBJ crack with a width of 0.016–0.025 in.

(b) Cracking and efflorescence in overhang

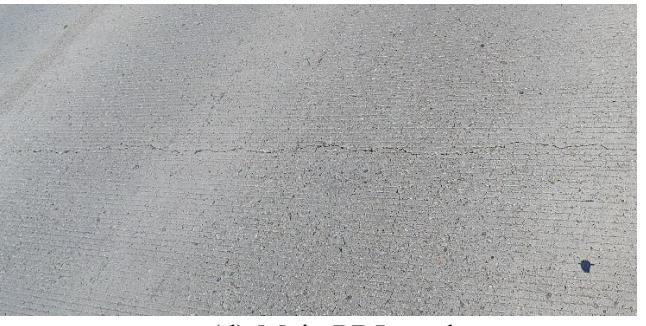
(d) Main PBJ crack

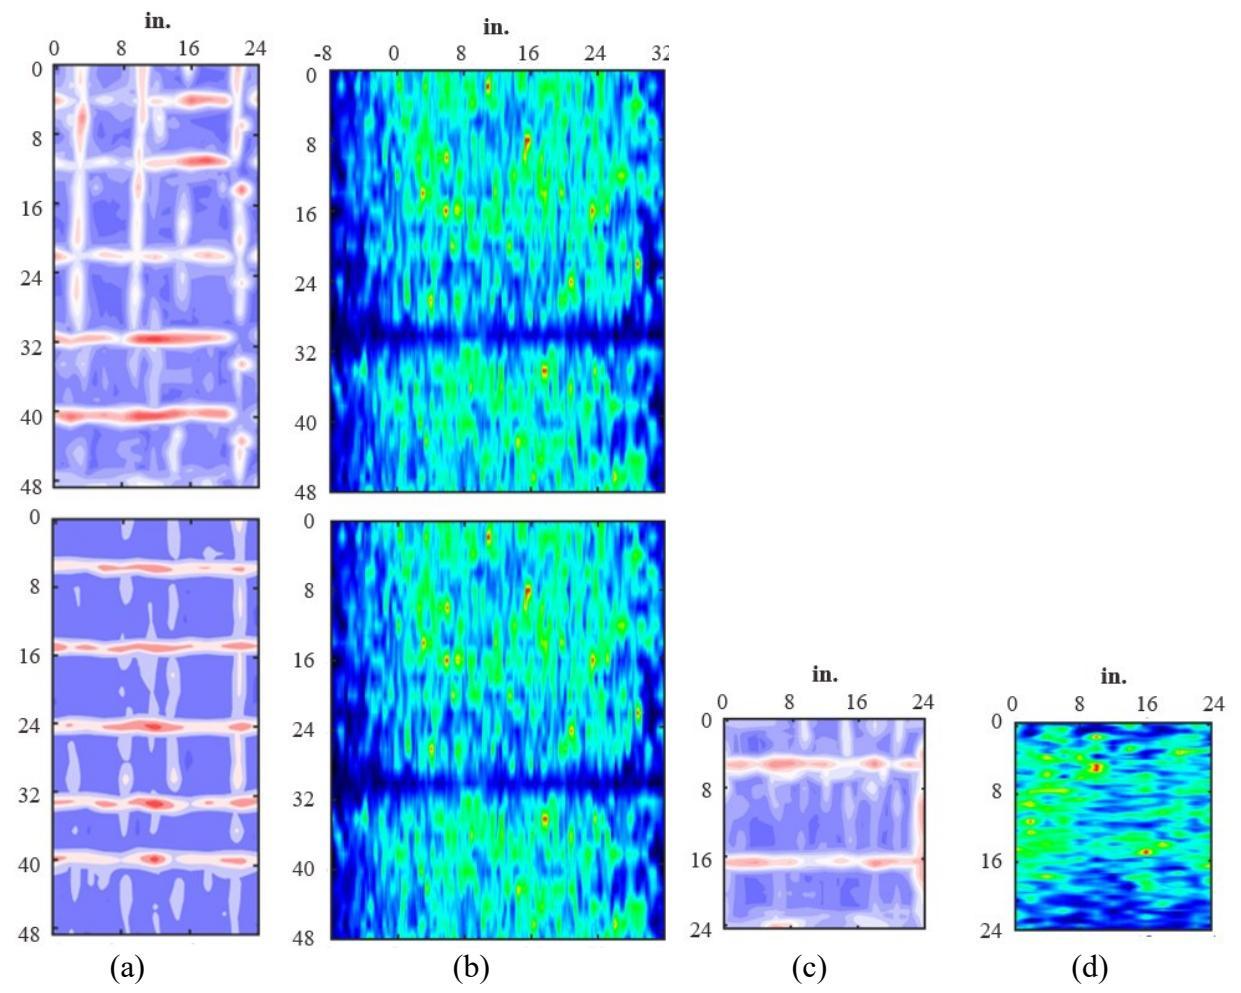
Figure 4.37. LUB1 results for top longitudinal reinforcement at depth 3.73 in. for (a) GPR in NDE Regions 1 and 2, (b) UST in Regions 1 and 2, (c) GPR in Region 3, and (d) UST in Region 3.

Figure 4.37 and Figure 4.38 confirm the spacing of the top longitudinal and transverse reinforcement in the as-built drawings as 9 in. and 6 in., respectively. Additionally, the dark horizontal areas in Figure 4.37(b), Figure 4.38(b), and Figure 4.39(b) at approximately 32 in. on the vertical axis appear to show a reflection caused by the edge of the girders. Figure 4.39 confirms that bottom longitudinal reinforcement is clustered between the girder lines, while bars are not placed directly over the girders, which is consistent with the design drawings. No evidence of voids or delaminations was discovered using IR images.

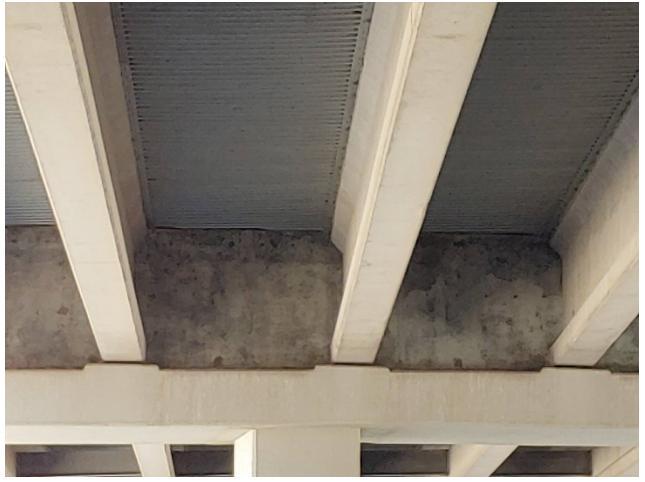
Access below the bridge for visual inspection was limited; however, photographs taken from the shoulder of I-27 show spalling at the tops of the stems (Figure 4.41a). The bridge was sloped down toward the eastbound lane. At the time of visual inspection, water had pooled against the rail over the bent. Visual inspection below the bridge revealed dusting of the PMDF around and adjacent to a drainpipe (Figure 4.41[b]). Figure 4.41(c) shows the cracking at the top of the deck. Significant spalling was present along the main PBJ crack. The main PBJ had been formed at the time of construction (wider than a zip strip) and was not measured. The secondary PBJs were 2 ft 6 in. apart, aligning with the edges of the inverted-T bent cap stem and measured 0.03 in. wide in a couple of locations within the NDE region but were mostly 0.01–0.014 in. wide. Other transverse cracks in the NDE region were no more than 0.006 in., and longitudinal cracks did not exceed 0.012 in. wide. Adjacent to the sidewalk, diagonal cracks formed as shown in Figure 4.41(d).

(a) Inverted-T bent cap and PMDF between girders

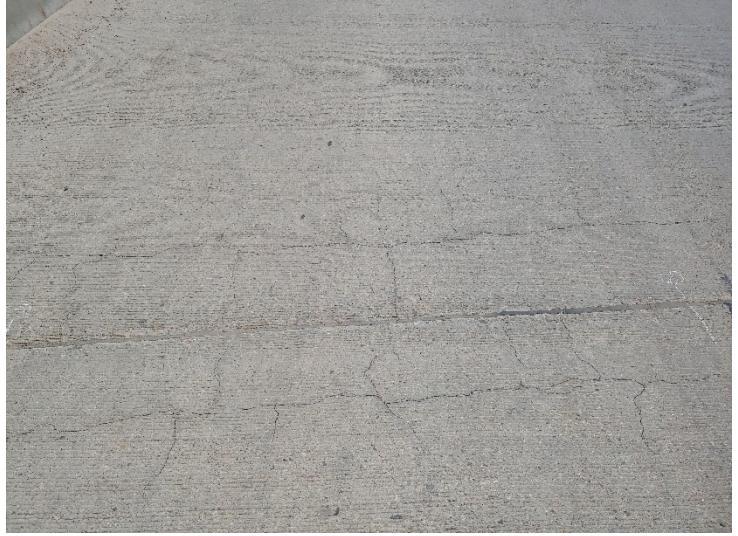
(c) Marked cracks in NDE area

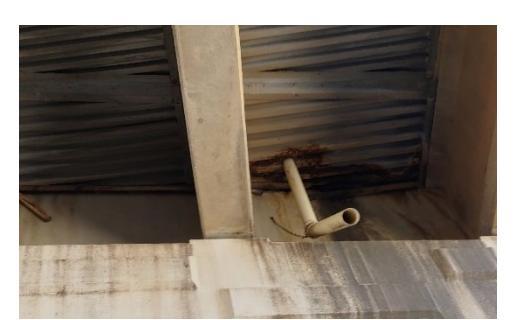
(b) Rusting PMDF on eastbound side

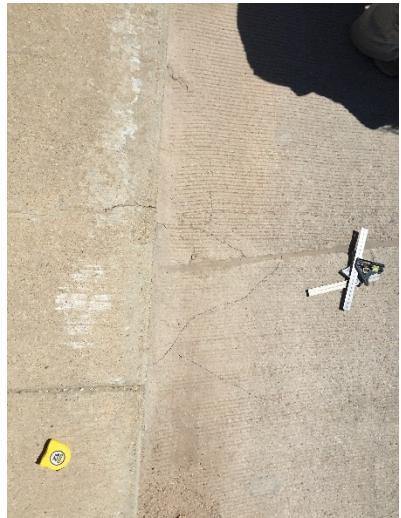
(d) Marked cracks adjacent to sidewalk

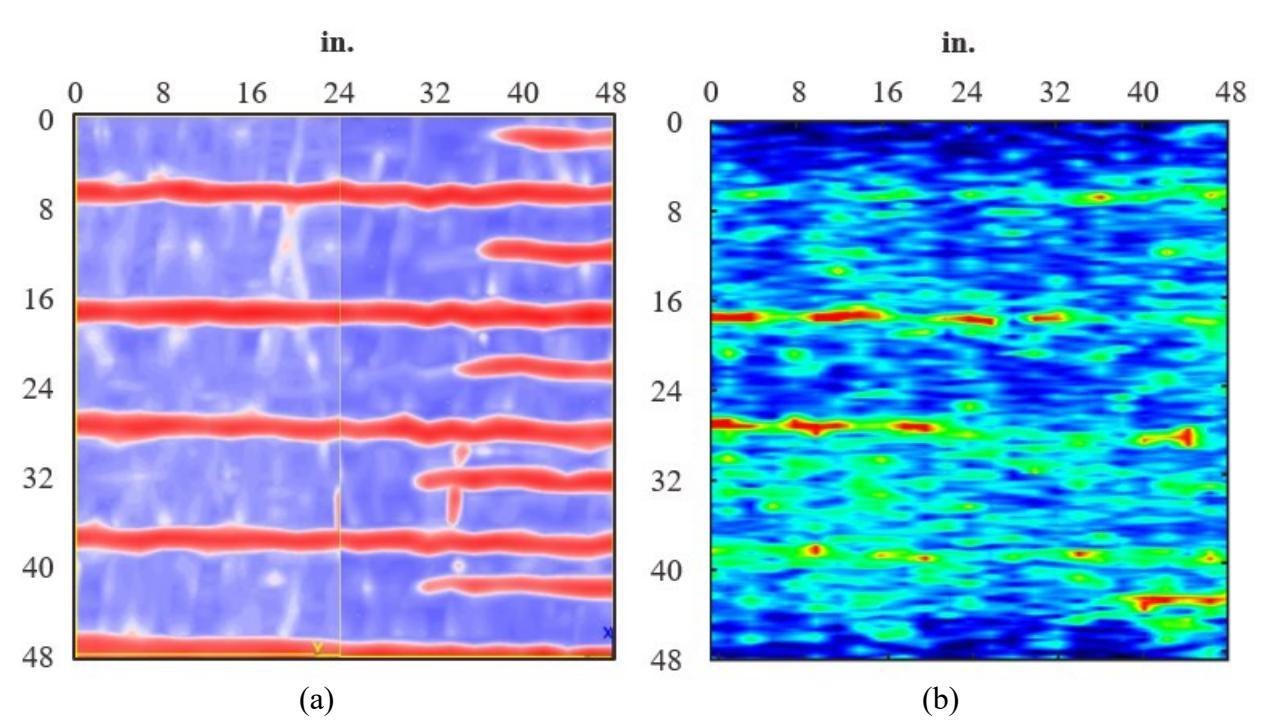
Figure 4.44. LUB2 results for (a) GPR and (b) UST of top transverse reinforcement at depth 2.73 in.

Figure 4.43 and Figure 4.44 confirm the specified top reinforcement spacing. The top end of the bent transverse bars can be seen on the right side of the GPR and UST images in Figure 4.44, spaced between the straight transverse bars. The bottom end of the same bent transverse bars can be seen on the left of the GPR image in Figure 4.45(a). The ribs of the PMDF are visible in the UST image in Figure 4.46(b). No evidence of voids or delaminations was not found on the deck.

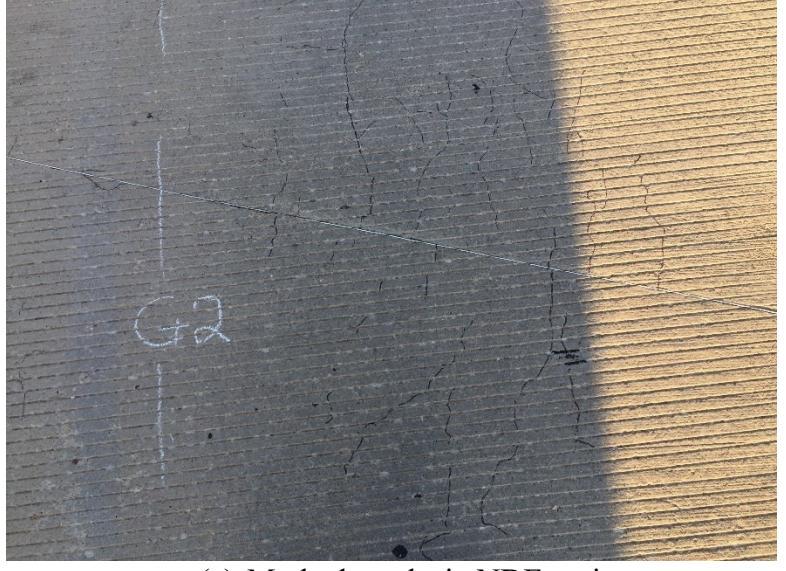
Visual inspection of the bridge confirmed the excellent condition. Some hairline cracks were present in the deck, consisting mainly of longitudinal cracks. Figure 4.48(c) shows the marked cracks in the NDE region. No spalling was observed along the main PBJ crack in the NDE region. The main PBJ crack measured 0.025 in. wide. Visual inspection from the ground beneath the bridge did not indicate any cracking or efflorescence in the overhang, and the panels and girder ends were all in excellent condition except for filler material between some panels hanging loose below the main PBJ crack.

(c) Marked cracks in NDE region Figure 4.48. Typical link slab condition for Bridge LUB3 (US 62 over Research Blvd.).

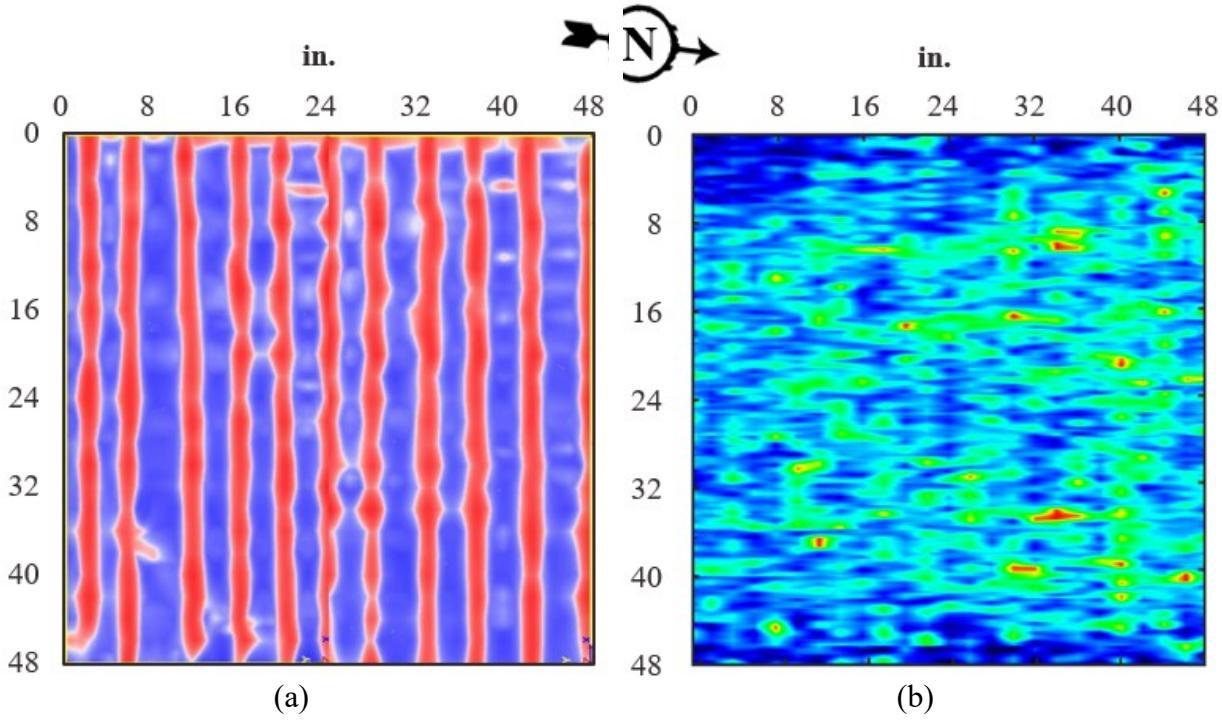
Figure 4.50. LUB3 results for (a) GPR and (b) UST of top longitudinal reinforcement at depth 4.73 in.

Figure 4.50 appears to show that the top longitudinal reinforcement was doubled in the PBJ region since the bars are spaced at approximately 4.5 in. Figure 4.51 confirms that the top transverse bars are spaced according to the design drawings. The diagonal gap between the PCPs can be faintly seen in Figure 4.52, crossing the image at approximately 16 in. on the left to 32 in. on the right on the vertical axis. Figure 4.49 shows the diagonal PBJ crack and longitudinal cracks extending from the PBJ. No evidence of voids or delaminations was found in the IR images.

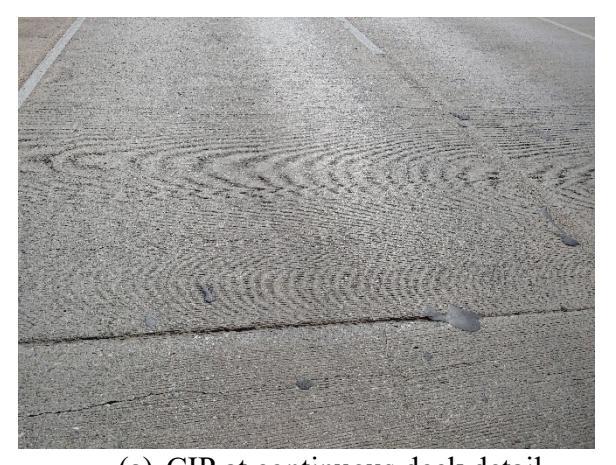
Visual inspection of the bridge confirmed the inspection report damage on the top of the deck; visual inspection below the bridge was not possible. The condition of all three continuous deck regions was similar. Figure 4.54 shows representative conditions of the link slab regions. The main PBJ crack had been formed as a construction joint, with the material no longer present. Considerable spalling was present along the main PBJ crack. Where measurable, the main crack was as wide at 0.030 in. Secondary PBJ cracks formed approximately 18 in. on either side of the main PBJ crack, measuring as wide as 0.025 in. in the NDE region. Outside the main NDE region, the secondary PBJ cracks were diagonal and joined with the main PBJ crack over the girder. Other cracks in the main NDE region measured no more than 0.01 in. except for one longitudinal crack outside the east secondary PBJ crack. Diagonal cracks were also present in the overhang, as shown in Figure 4.54(b).

(a) CIP at continuous deck detail
(b) Marked cracks in overhang
Figure 4.54. Typical link slab condition for Bridge LUB4 (WB Loop 289 over University Ave.).

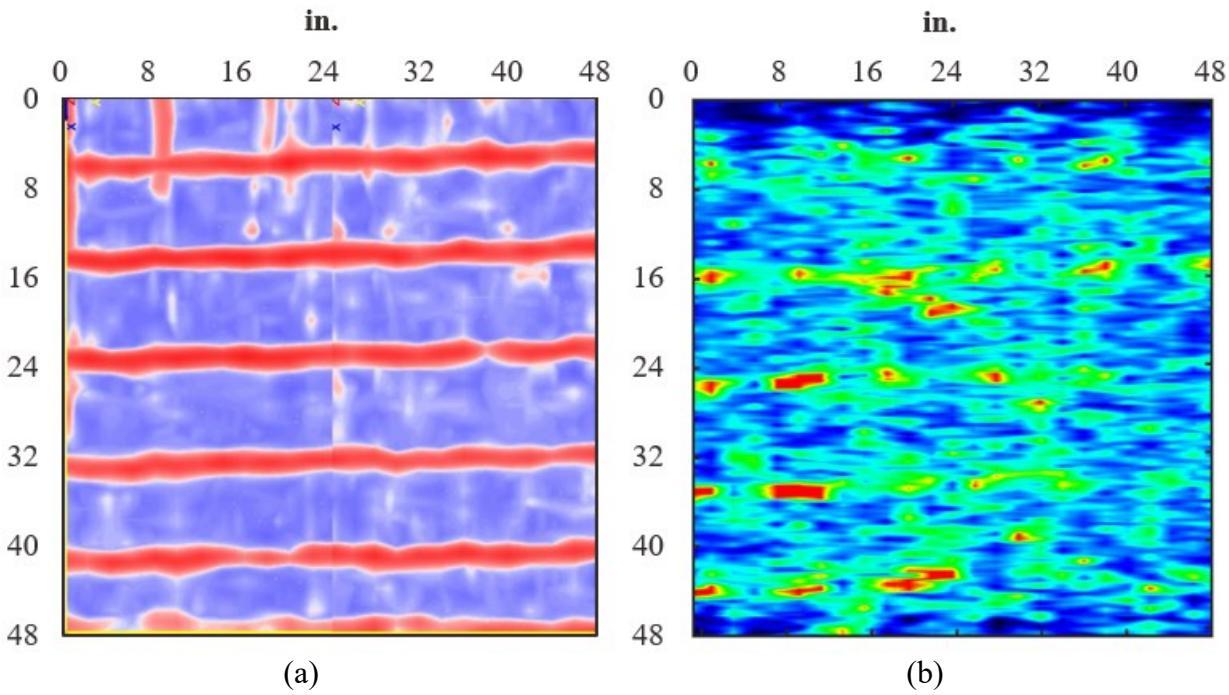
Figure 4.58, Figure 4.59, and Figure 4.60 show that the top and bottom longitudinal and transverse reinforcement appears to be spaced according to the design drawings. Figure 4.61 shows the PMDF at the bottom of the link slab. The longitudinal reinforcement spacing is consistent in the overhang, shown in Figure 4.62 and Figure 4.64. However, Figure 4.63 shows

Figure 4.59. LUB4 results for the primary NDE area for (a) GPR and (b) UST of top transverse reinforcement at depth 3.5 in.

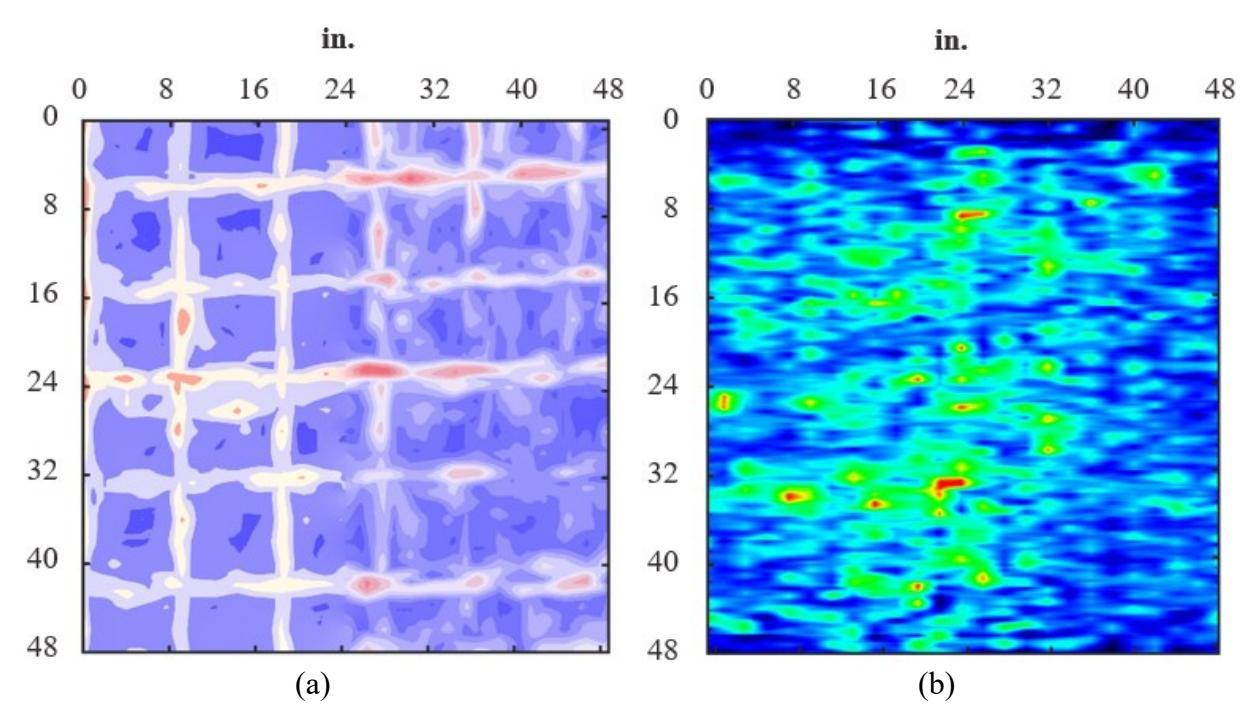
Figure 4.60. LUB4 results for the primary NDE area for (a) GPR and (b) UST of bottom reinforcement at depth 6.5 in.

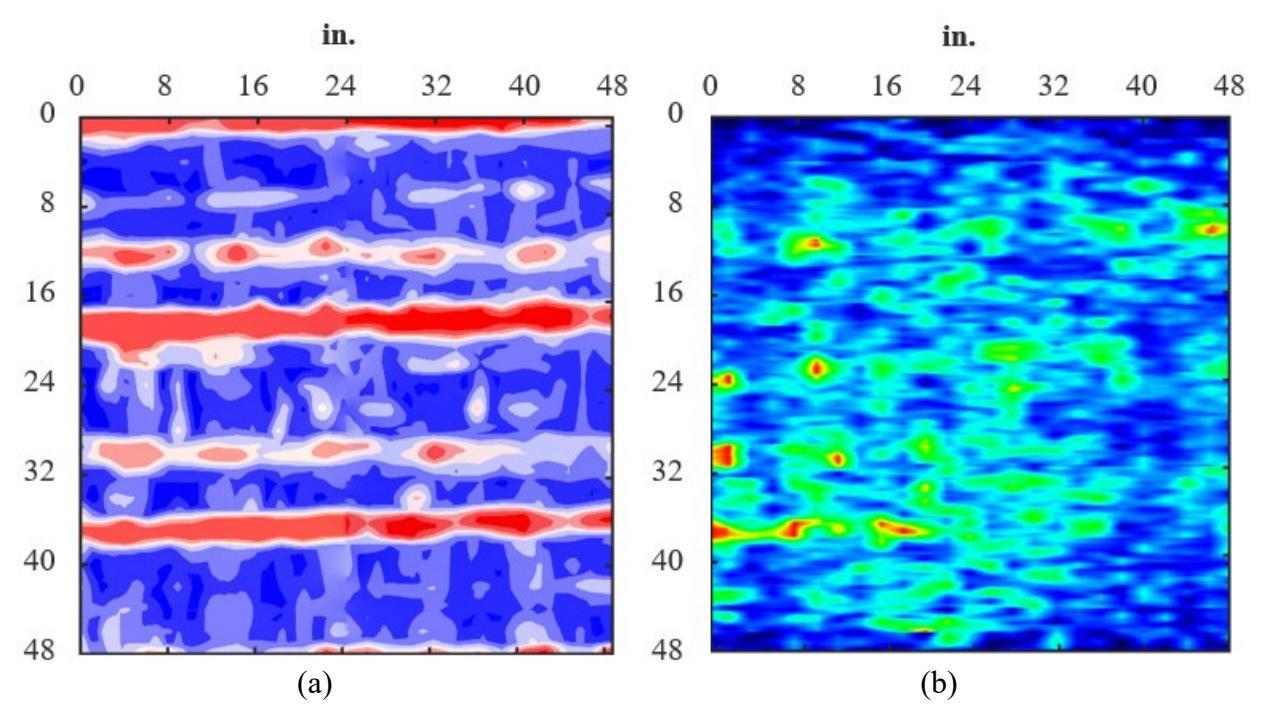
Figure 4.61. LUB4 results for the primary NDE area for (a) GPR and (b) UST of PMDF at depth 8.5 in.

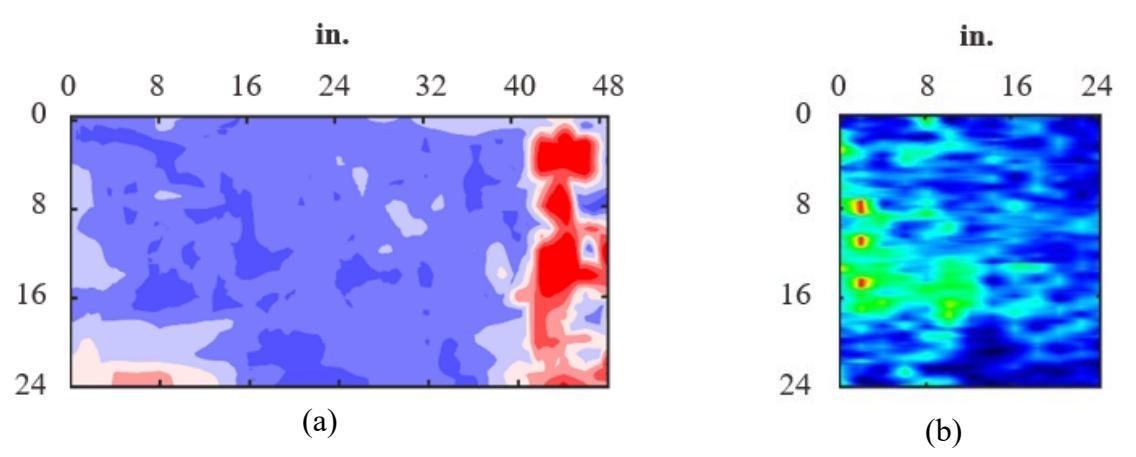
doubled transverse bars in the overhang, which is consistent with design drawings. The single rib of PMDF visible in Figure 4.65 indicates that the PMDF section directly below the PBJ is at a slightly different depth. No evidence of delaminations or voids was found in the IR images.

Figure 4.65. LUB4 results for the secondary NDE area for (a) GPR and (b) UST of the PMDF in the overhang at depth 8.5 in.

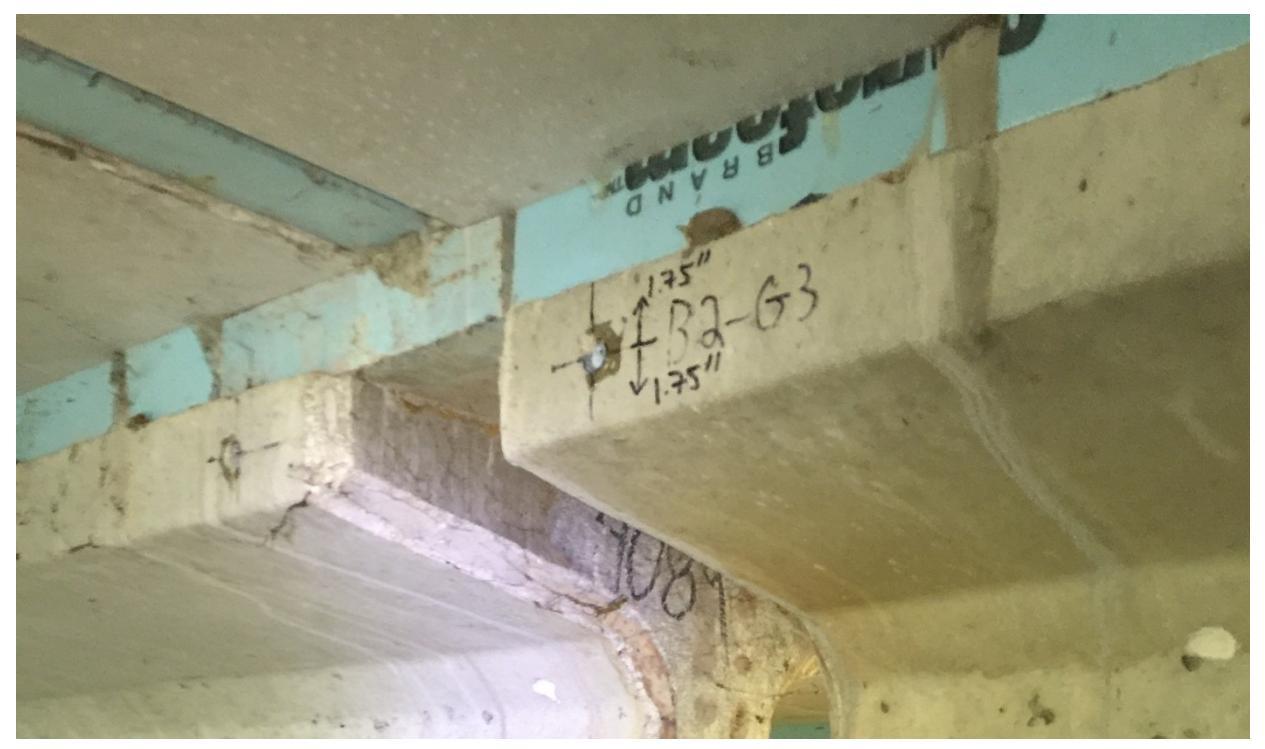
The current flush panel detail (Figure 6.1[a]) utilizes a ³/₄-in. redwood board, chamfered at the top to act as a crack former, between the panels from either span of the girder line. During field visits for BRY3 and BRY4, flush panel details were observed to have been constructed differently than in the current standards, utilizing bedding strip foam for the gap between the panels (Figure 6.2). It is not clear what the design drawings or approved change orders were for these bridges, only that the constructed detail is different than the current standard.

Figure 6.2. Observed flush panel detail for BRY4.

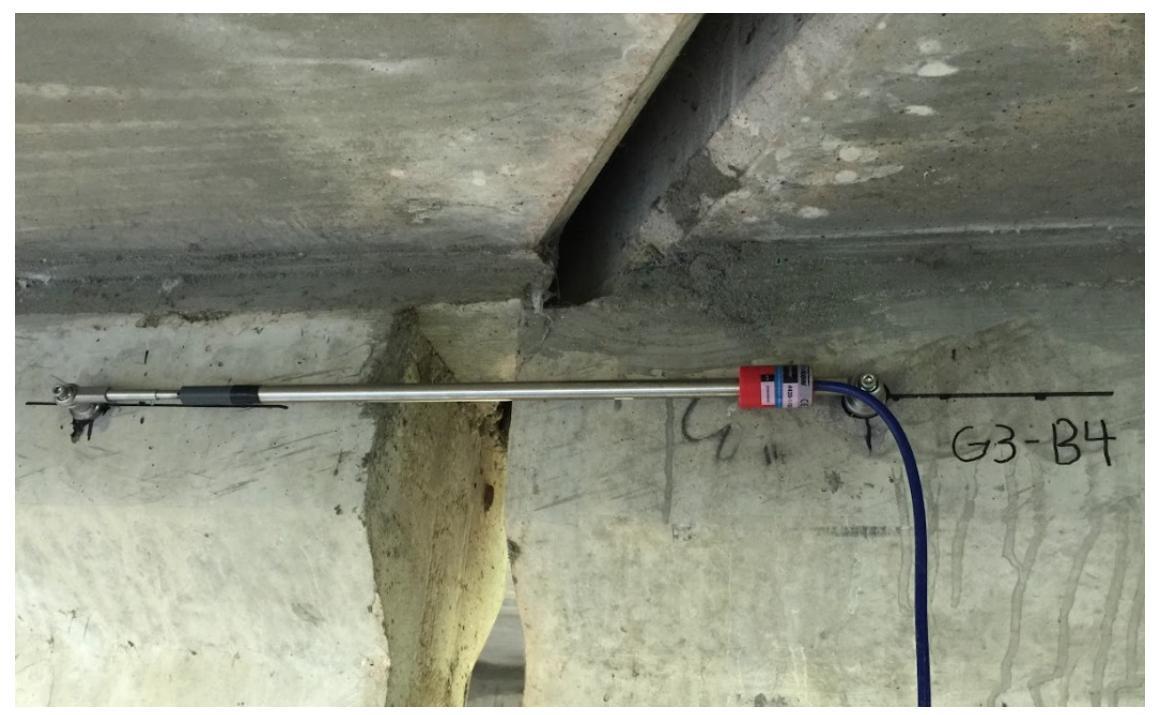
Figure 6.11. Contact between girder end and the deck of the adjacent span at an expansion joint on Old River Bridge.

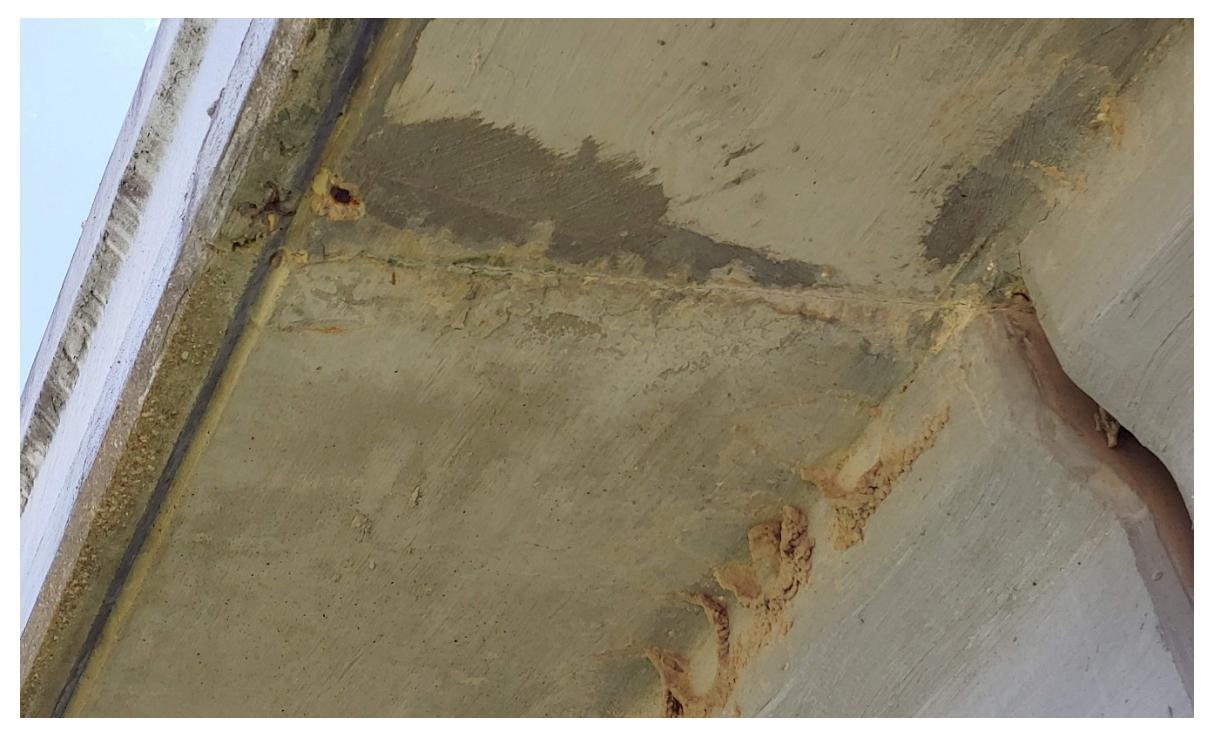
Figure 6.12. Cracking in the deck above the girder ends at skewed supports on Peach Creek Bridge.

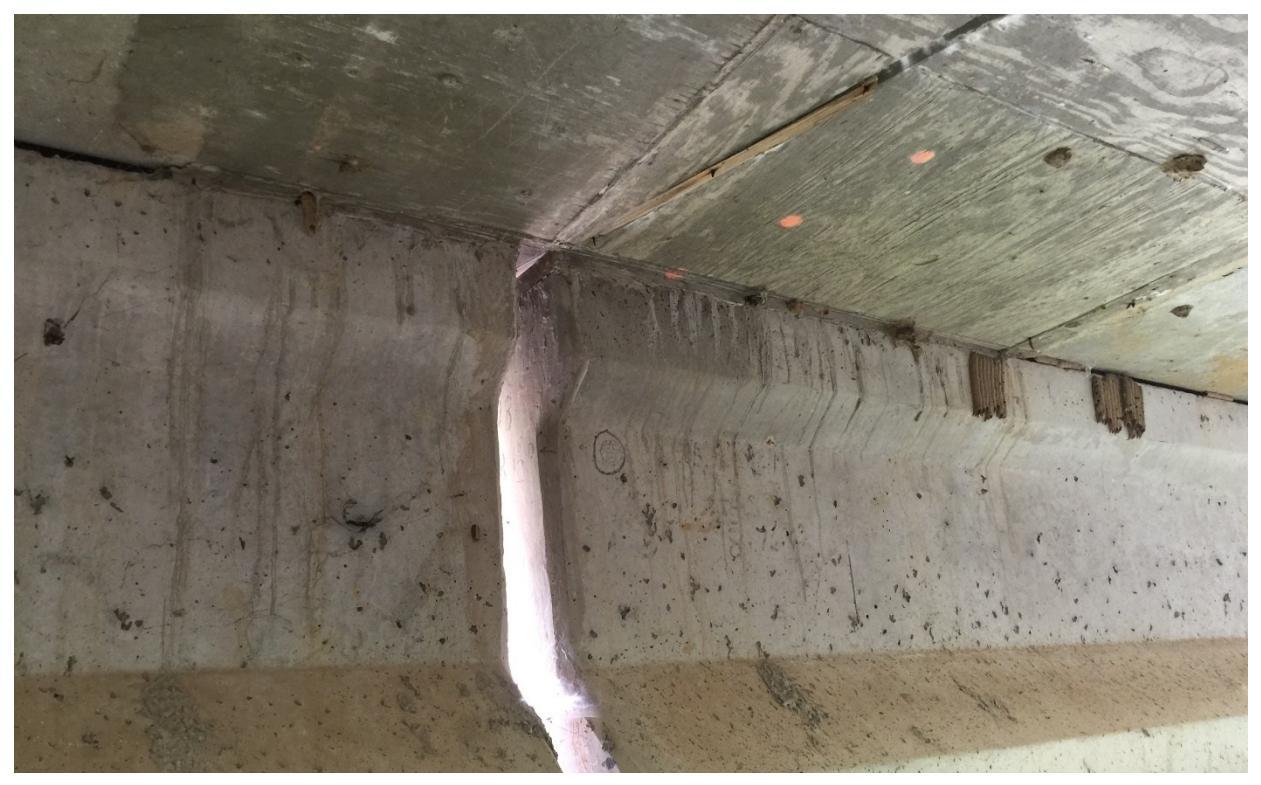
Figure 6.13. Atlanta District bridge without a foam insert or skewed girder end detail.

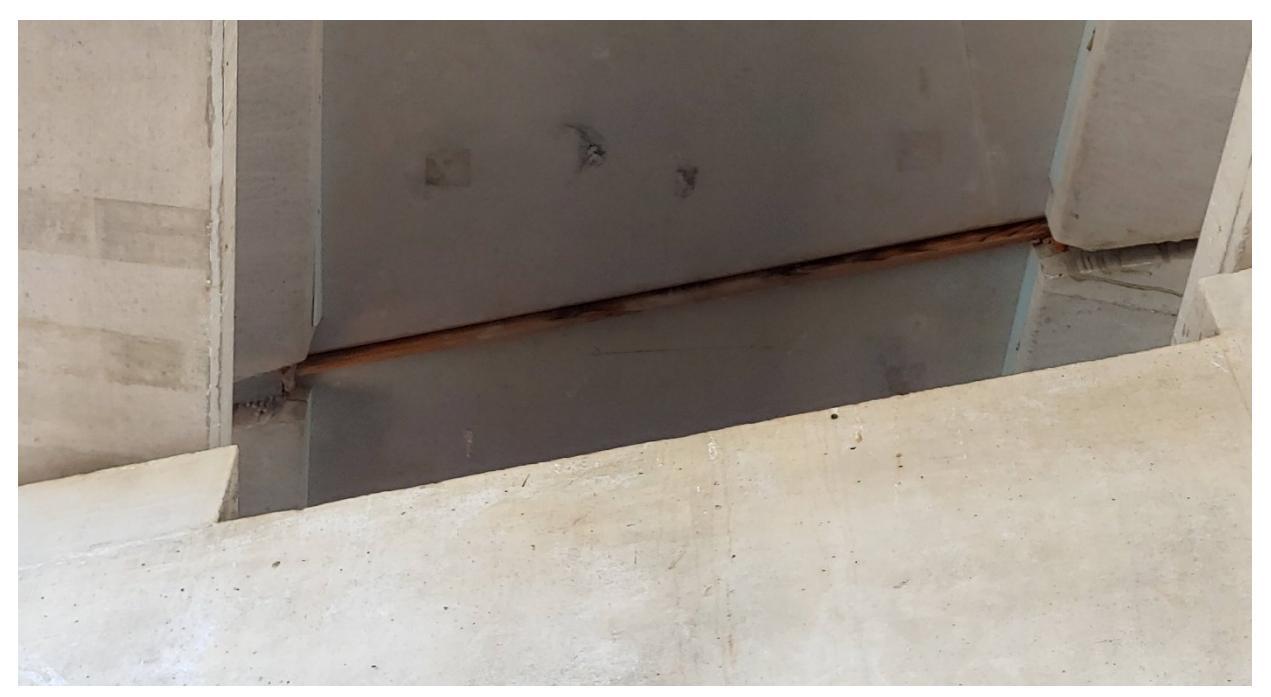
An as-built example of a skewed girder end detail is shown in Figure 6.14 on a bridge in the Lubbock District on Highway 62 (Bridge ID 5-152-00380-01-236). This bridge has a 19-degree skew. Of the four skewed bridges with visible details that the project team assessed as part of Task 3, only one had a visible skewed end detail. The application of these details appears to be inconsistent.

Figure 6.14. Lubbock District bridge with skewed girder end details.
