Performance and Improvement of Texas Poor Boy Continuous Bridge Deck Details: Final Report

Technical Report 0-7013-R1

TEXAS A&M TRANSPORTATION INSTITUTE COLLEGE STATION, TEXAS

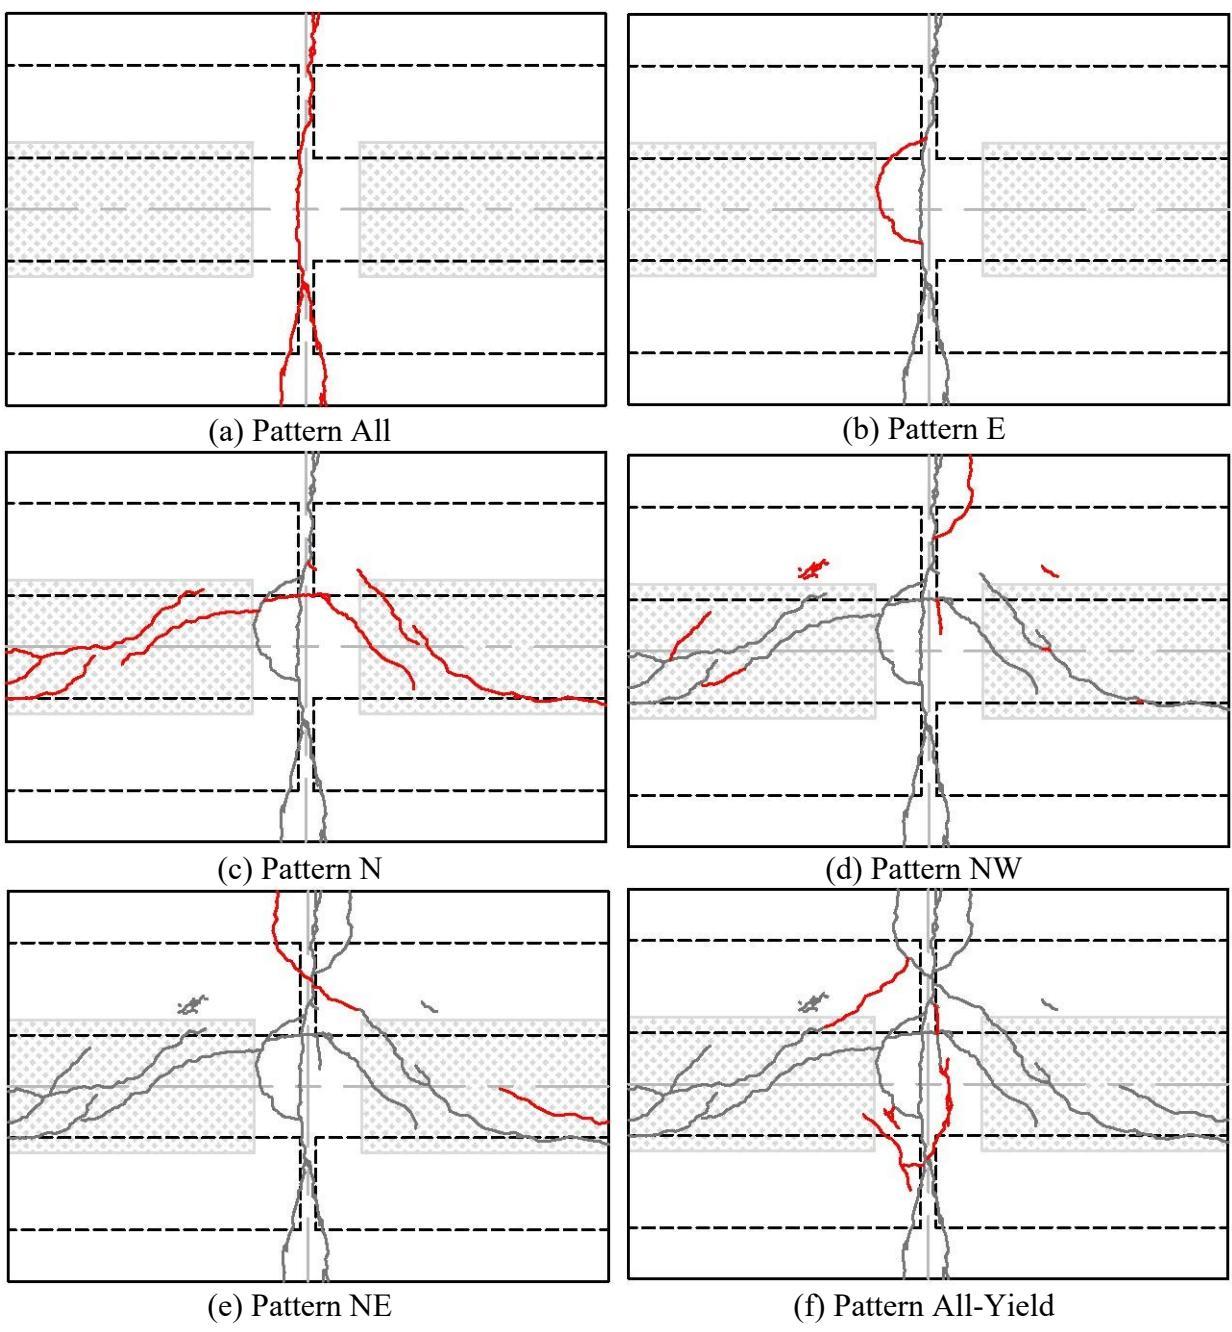
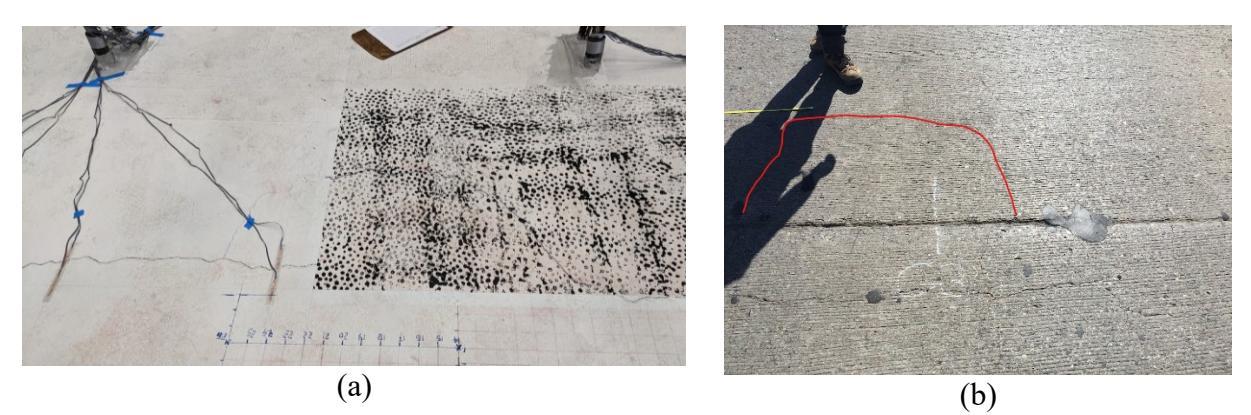
During the initial asymmetric patterns, only one new crack formed. In Pattern E-1, a D-shaped crack formed on the west side of the link slab center (Figure 9.50). The D was not centered transversely, with the north leg over the girder flange and the south leg slightly north of the south girder edge. The transverse portion of the D was located over the edge of the panel. The crack was hairline at formation and fully closed after unloading. This was the first such damage observed in the experimental test but was similar to damage that was seen on one bridge in field evaluations.

Figure 9.50. PBJ-OP1 D-shaped crack: (a) formed during Pattern E-1 and (b) similar damage observed in LUB4.

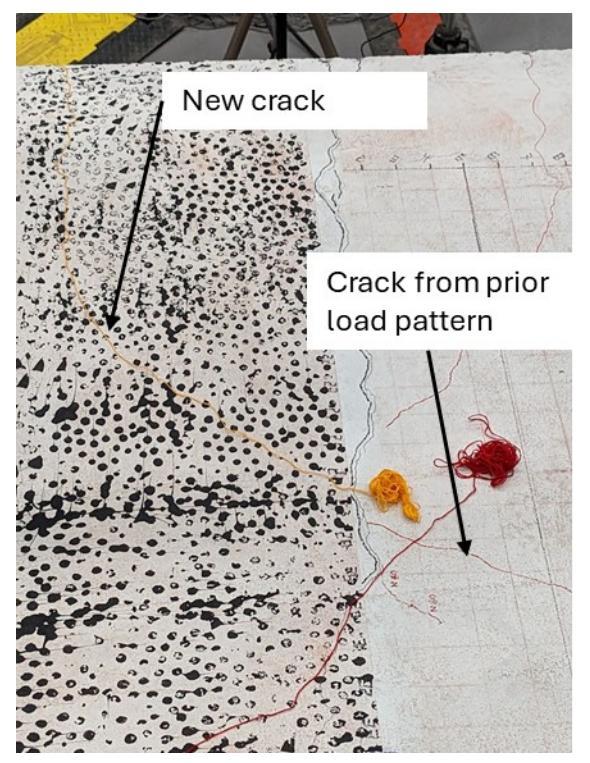
Figure 9.51. PBJ-OP1: North overhang cracks formed during Pattern NW-1 (red sharpie) and Pattern NE-1 (gold string) (right edge of speckled region is center of link slab).

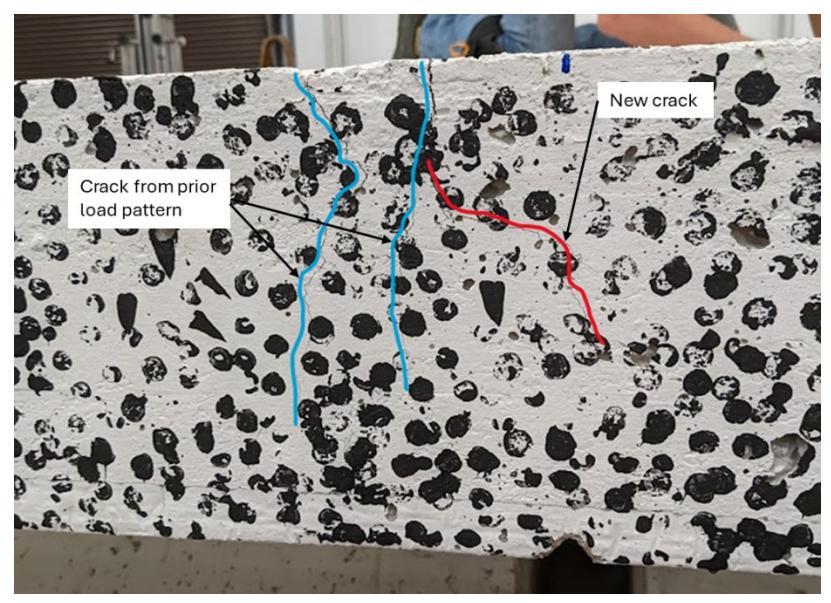
During Pattern All-Yield, new cracks formed and significant widths were measured for existing cracks. The first new crack to form was an offset crack between the girder lines, located approximately 6 in. east of the center, which was farther back than the west offset crack. The crack angled toward the center near the girders, ending near the center of the girders where it converged with existing cracks. The crack was not visible at the beginning of the pause but had appeared by the time crack widths had been documented. At loads of 360 kips and higher, some additional new cracks formed near the end of the southwest girder; these cracks did not match any of the typical crack damage documented in the field. Loading was terminated at 430 kips because one of the strain gages had a large spike; the gage was located near the location of the offset crack (formed during the initial load pattern), which had grown to 2 mm (0.0787 in.) in width. On the north edge of the deck, the east offset crack branched into a longitudinal crack at the depth of the top reinforcement for approximately 1 in. before continuing as a vertical crack (Figure 9.52). After unloading, the 2 mm (0.0787 in.) wide crack had closed significantly.

Figure 9.52. PBJ-OP1: East offset crack on north edge of deck at 430 kips in Pattern All-Yield (cracks at prior load steps shown in blue, new crack shown in red).

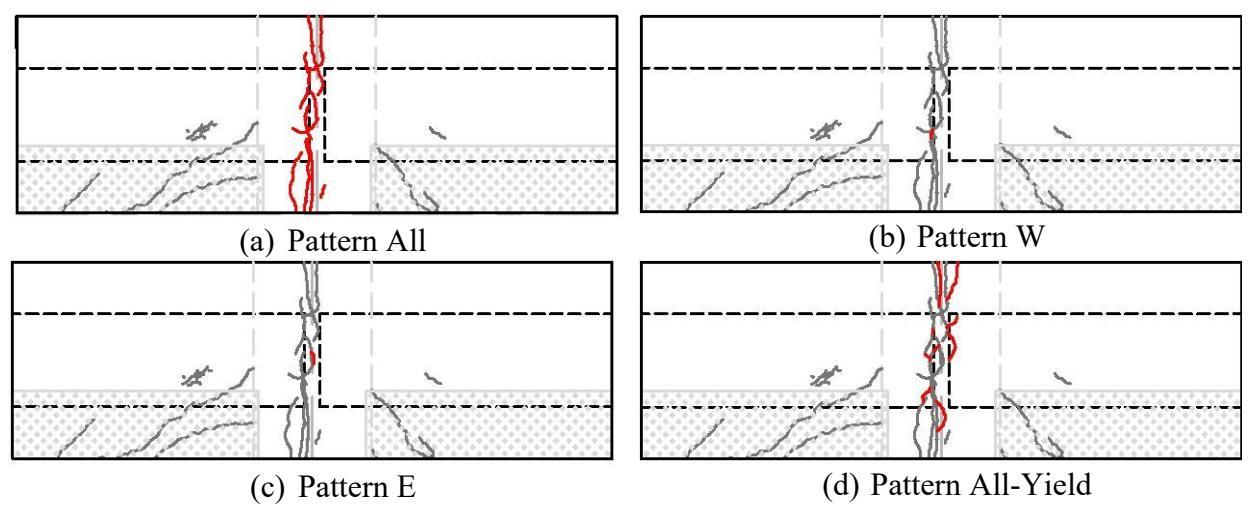
Figure 9.53shows the cracks for all load pattens applied to PBJ-OP1R. Existing cracks, including those in the south half of the deck, are shown in gray.

Figure 9.53. PBJ-OP1R: Cracks for all tests, with hatched region not tested (gray cracks are from prior test [PBJ-OP1]).

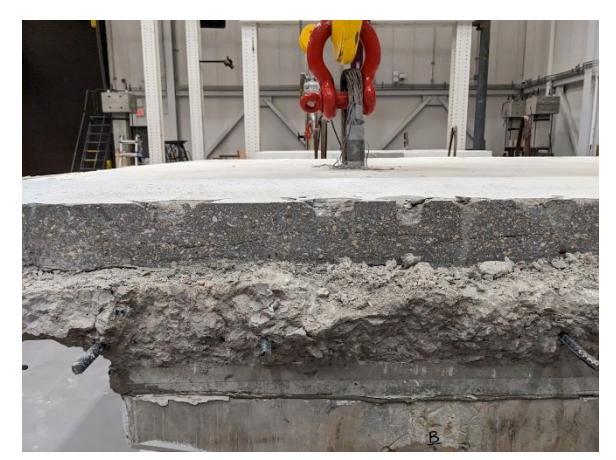
Following testing, the girders were separated for removal from the lab. A partial-depth saw cut was made on both sides of the center. The HPC concrete was sufficiently debonded from the bottom of the deck so that the section of HPC between the saw cuts could be removed by prying with a crowbar. The remaining concrete was removed with a jackhammer, which caused sufficient damage. A post-demo autopsy could not provide useful information on the damage in areas not visible during the testing. One area that was useful to examine post-demo was the cross-section of the east girder, shown in Figure 9.55. A horizontal crack was seen mid-depth of the HPC.

Figure 9.55. PBJ-OP1R: Post-test demolition view of concrete over east girder showing horizontal crack at mid-depth.

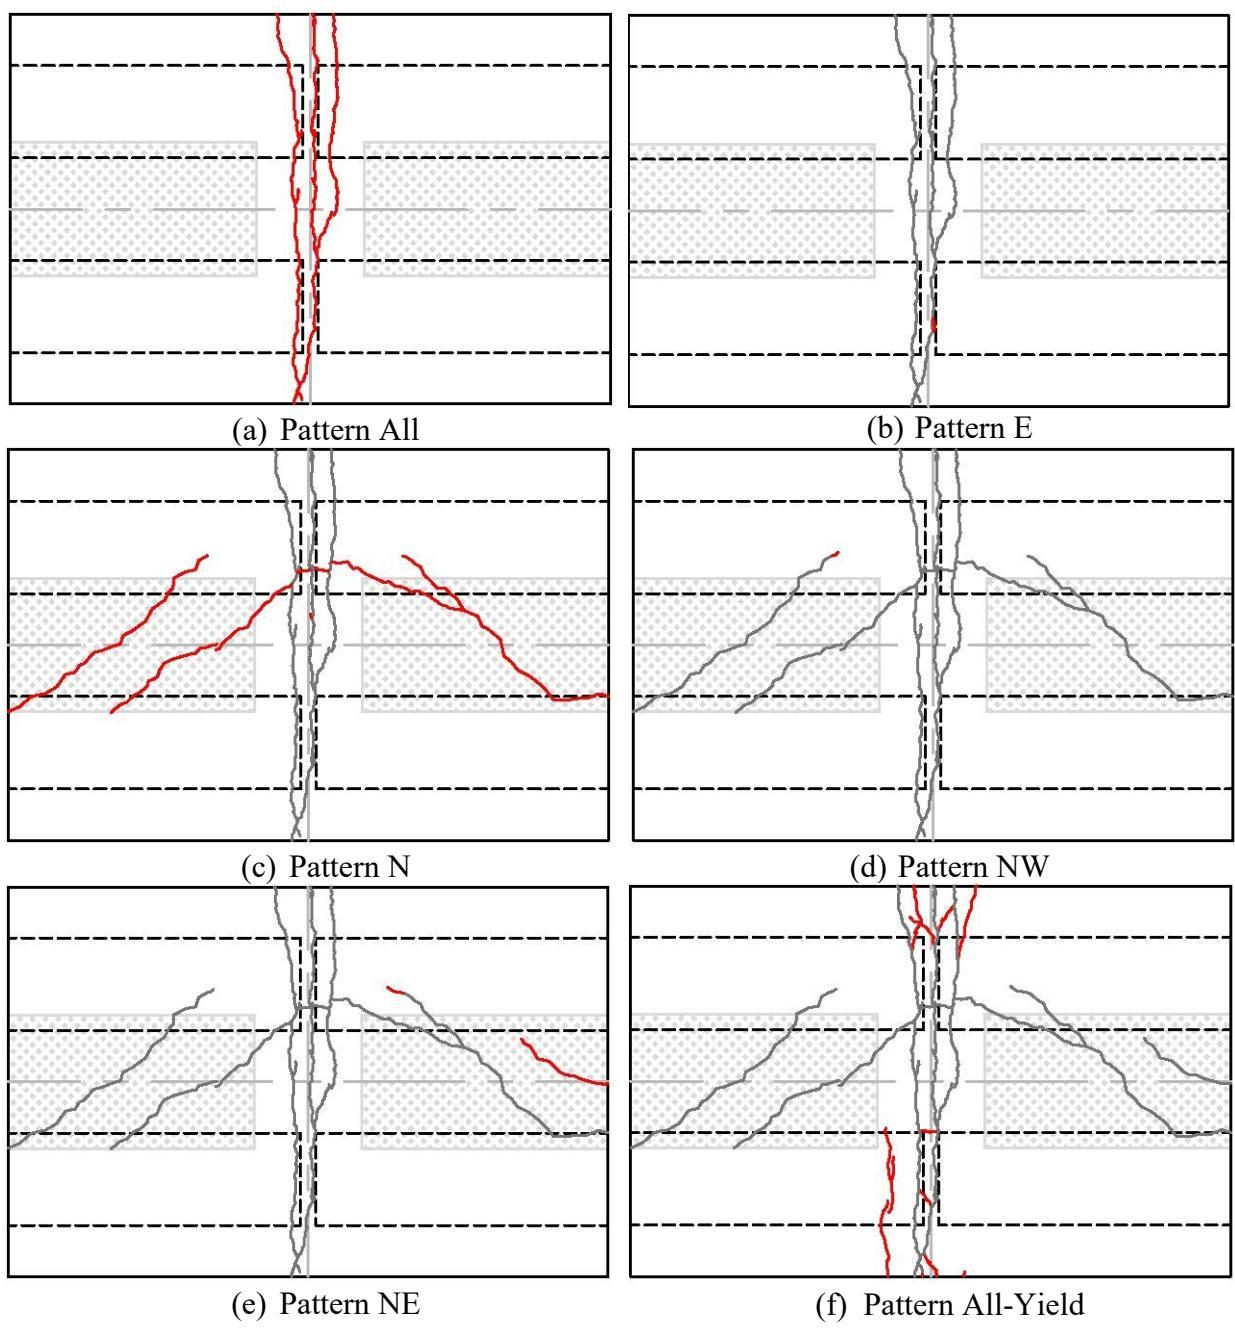
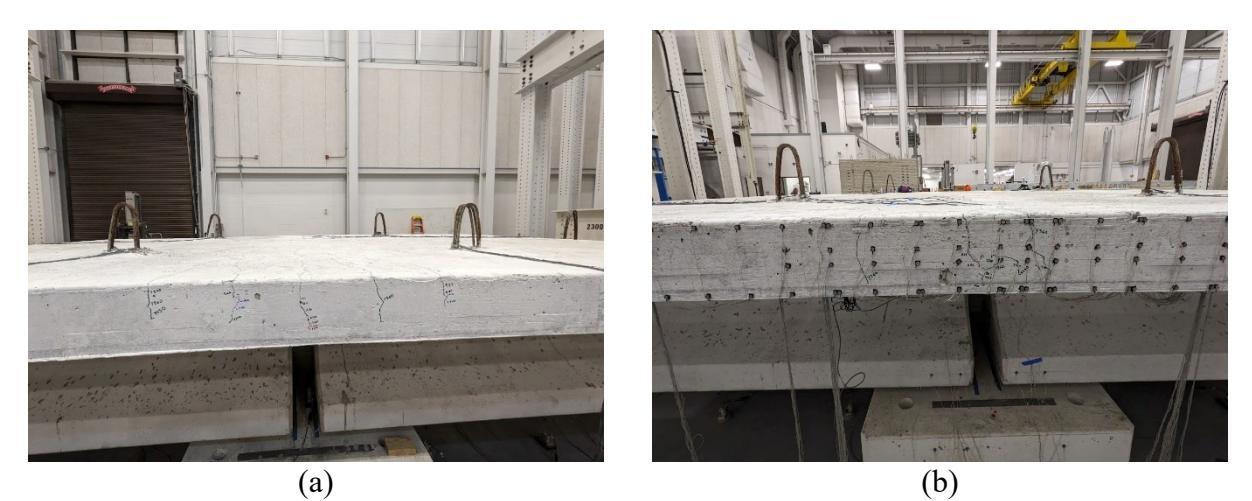
Cracks on the edges of the deck are shown in Figure 9.57. During the asymmetric patterns, cracks extended slightly toward the bottom on the north edge but did not extend on the south edge, although the overall depth was greater on the south edge following Patterns All-1, W, and E. During Pattern All-Yield, minor increases in depth occurred on the north main crack (to 2 in. from bottom of deck), with larger extensions on the north secondary/tertiary cracks (up to middepth). No extensions were seen on the south edge during Pattern All-Yield; however, after Pattern E-Yield, the crack became full depth. The load at which this occurred was not known; however, it provides evidence that full-depth crack occurrence may be caused by asymmetric span loading.

Figure 9.57. PBJ-OP2: Deck edge cracks following Pattern All-Yield on (a) north half of deck and (b) south half of deck.
