Evaluation of Corrosion Prevention and Mitigation Approaches Used on Texas Bridges—Volume 2: Reinforced Concrete Bridges

Technical Report 0-7040-R1-Vol2

TEXAS A&M TRANSPORTATION INSTITUTE COLLEGE STATION, TEXAS

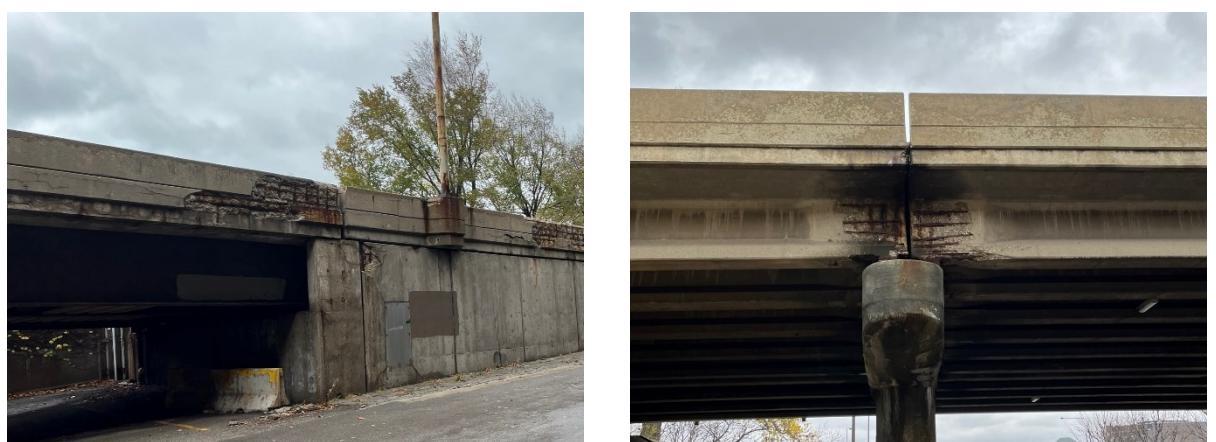
(a) Spalling at Rail Due to Corrosion (b) Spalling at Girder End Due to Corrosion **Figure 2.2. Deterioration of Reinforced Concrete Structures Caused by Steel Corrosion.**

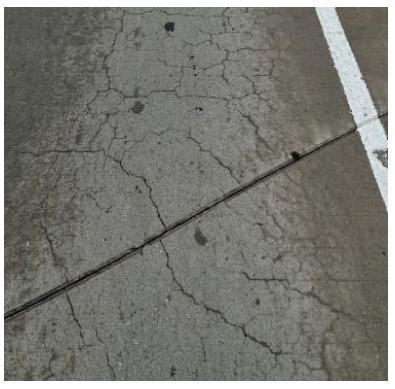
(a) Cracks at Deck Joint

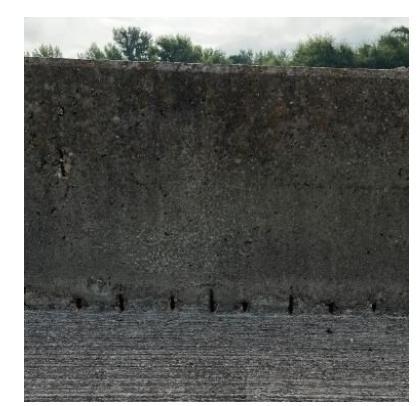
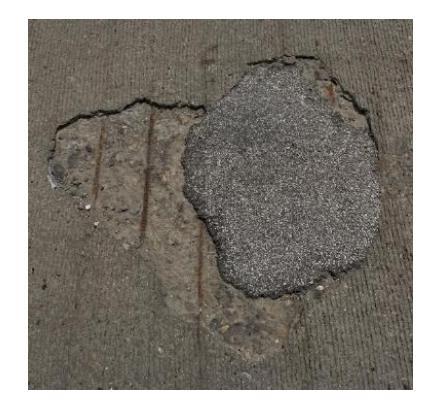
(b) Exposed Rebar on Deck due to Delamination

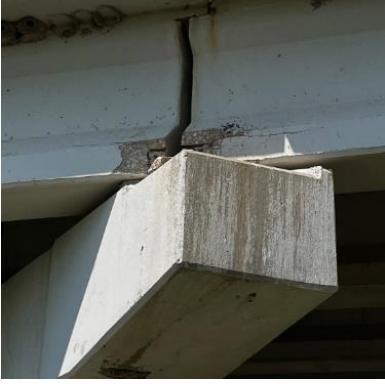
(c) Exposed Rebar on Concrete Rail (d) Spalling at a Girder End Figure 3.5. Types of Deterioration.

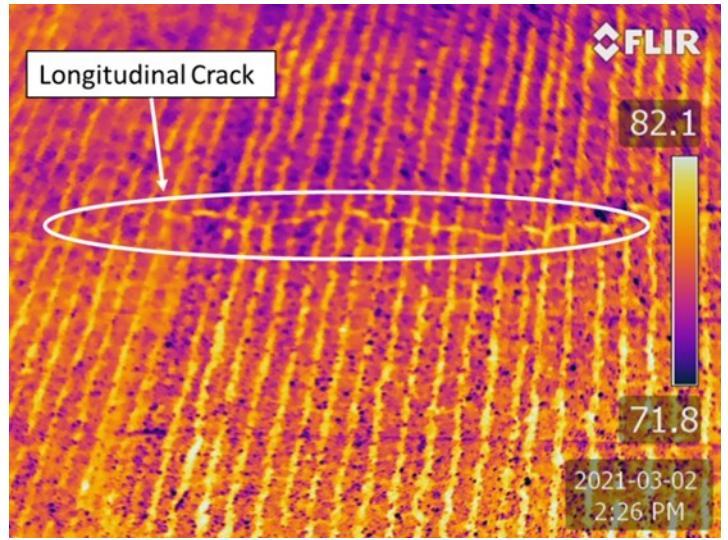
IRT was used for detecting any surface damage on concrete structures. During and after the visual inspection, infrared pictures were taken at the grids and at places where severe deteriorations were visible. Figure 3.7 shows longitudinal surface cracking that was visible in thermal imaging. The thermal imaging results are documented in the appendix.

Figure 3.7. Infrared Picture of a Deck Showing a Transverse Crack.

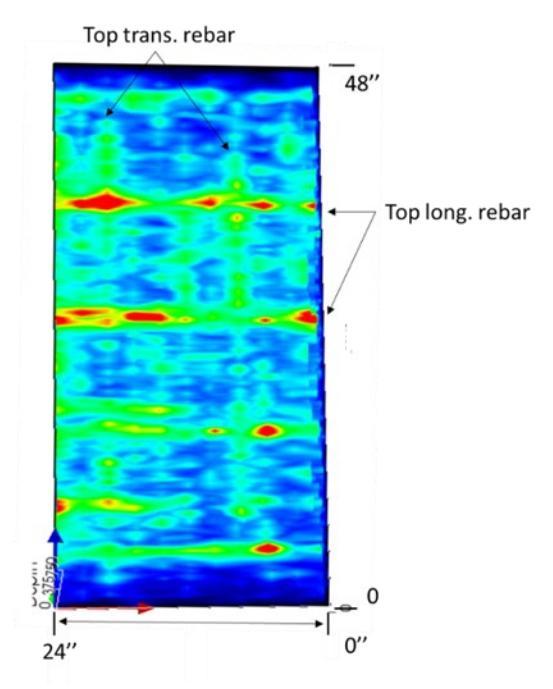
Figure 3.9 shows an example of the UST results conducted on concrete decks. As shown in this figure, large reflection occurs at the rebar locations because of impedance differences. Through further analysis of the results, smaller reflections were identified, and it was possible to identify some deterioration such as cracks and voids in concrete.

Figure 3.9. Results of UST.

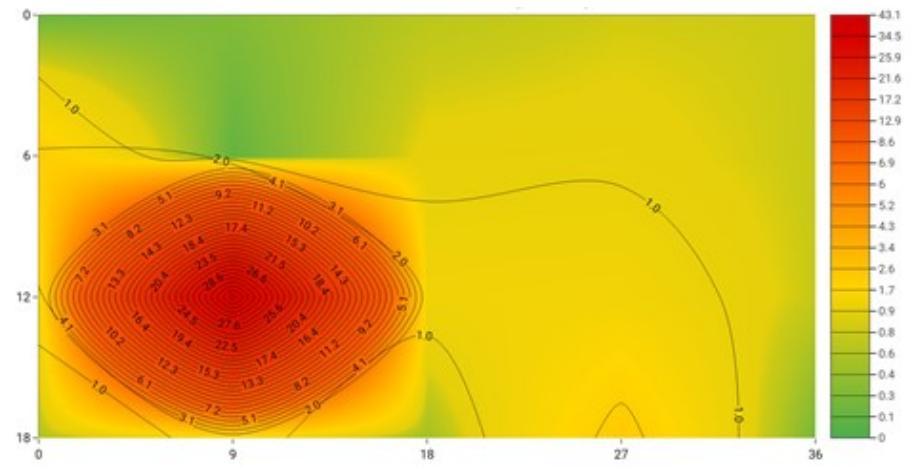
Figure 3.10. Result of AMA–RC–10 Bridge Corrosion Rate Mapping, Corrosion Current Density (µA/cm²).

iCOR was used to measure the instantaneous corrosion rate of the rebar and in-situ resistivity. The device measured the corrosion rate without making a direct connection with the rebar, which made this process an advantage during scanning of the concrete decks. The iCOR readings from intersections of rebars identified from the GPR scanning were documented for further analysis and to develop corrosion rate mapping and evaluate the in-situ resistivity of concrete. Figure 3.10 shows a typical corrosion rate mapping developed for AMA–RC–10.

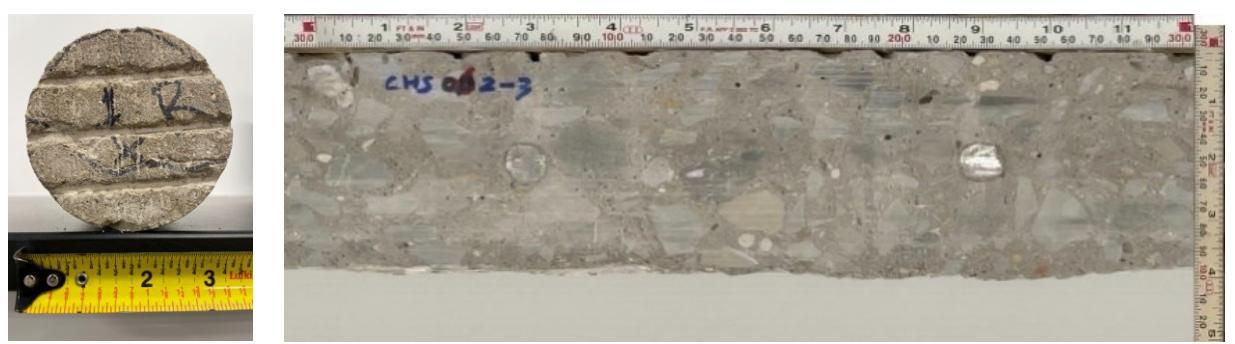
(b) Side View Figure 3.11. Pictures of an Extracted Core.

If it was feasible, the cores were drilled deep enough to extract a portion of the precast panel. Figure 3.11 provides an example of a core sample with rebar, and Figure 3.12 illustrates the distribution of core locations within a grid. Following the extraction of core samples, the holes were patched using Quikrete Fastset DOT Mix Cement and gravel, following the guidelines outlined in the *Concrete Repair Manual* (TxDOT, 2021).

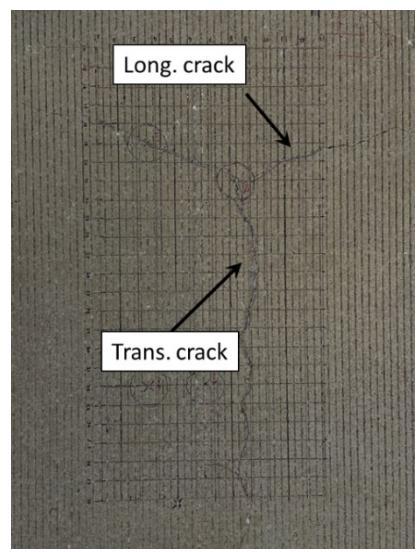
(a) Transverse and Longitudinal Cracks at PCP Joints (ATL-RC-05)

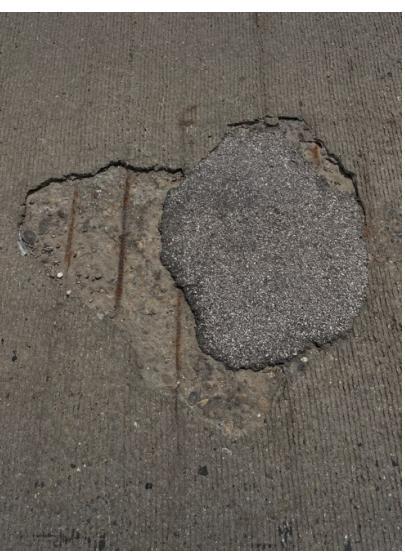
Apart from cracking, the extent of damage to the decks was generally minimal. On some bridges, minor spalling was observed along the cracks at poor boy joints or at the edges of sealed expansion joints. Occasionally, there were small areas of spalling on some bridges. Exposed steel reinforcement was found on one bridge deck (LBB–RC–04). This specific region, measuring approximately 8 in² in the main lane, is depicted in Figure 3.13(b) and indicated a lack of sufficient overlay cover.

(b) Exposed Rebar on Deck (LBB-RC-04)

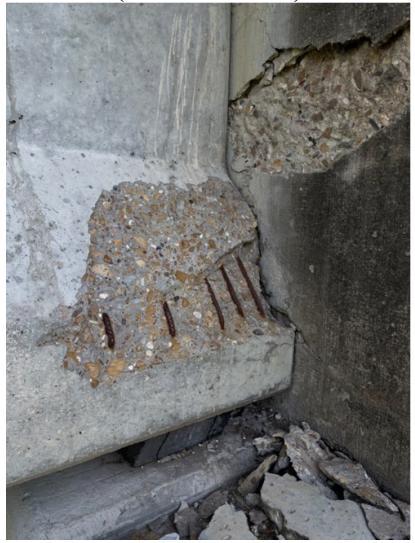
Abutment damage was documented in many bridges and typically consisted of horizontal and vertical cracks on the backwalls on the outside of the girders. These cracks were measurable widths for most bridges. The horizontal cracks often extended between the girders, as shown in Figure 3.13(c). Damage was observed in the backwall, where girder expansion led to the ends bearing against the backwall, as shown in Figure 3.13(c).

Cracks that appeared on the girders of the most inspected bridges were limited to hairline cracks. In addition, horizontal cracks were frequently observed to form at the interface of girder webs and flanges. Spalling was also observed at the ends of girders in some bridges, which caused corrosion damage to mild steel and prestressing strands. One potential reason for the concrete spalling was because of thermal expansion and settlement of the abutment, which resulted in bearing of the girder against the backwall, as shown in Figure 3.13(d). Concrete spalling of the girders was observed in the Amarillo and Lubbock Districts.

(c) Cracks and Efflorescence on Abutment(d) Exposed Rebar on the Girder(LBB-RC-06)(LBB-RC-06)Figure 3.13. Common Damages in Concrete Bridges.

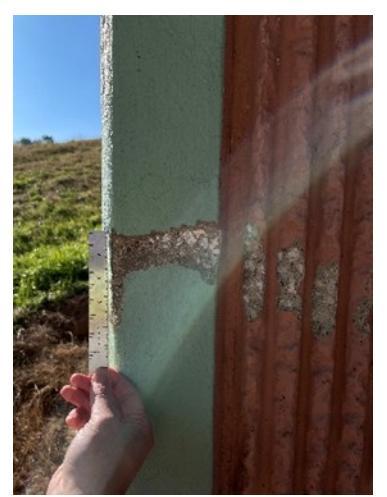
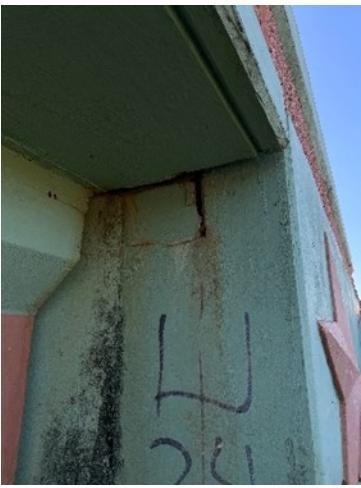
(a) Spalling at abutment wall (TYL–RC–03) (b) Crack at abutment wall (TYL–RC–03) Figure 3.14. Deterioration of Bridges in Region 2.

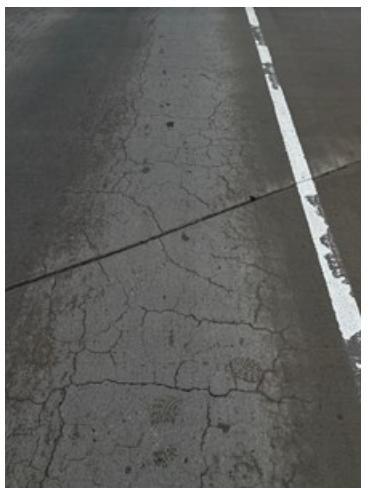
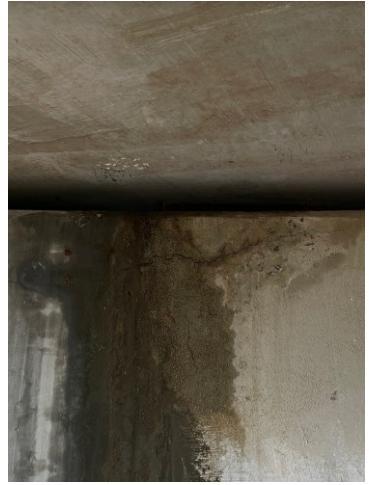
(a) Map cracks propagating from a joint (ELP-RC-01)
 (b) Water leakage from crack at abutment (ELP-RC-01)
 (ELP-RC-01)
 Figure 3.15. Deterioration of Bridges in Region 3.

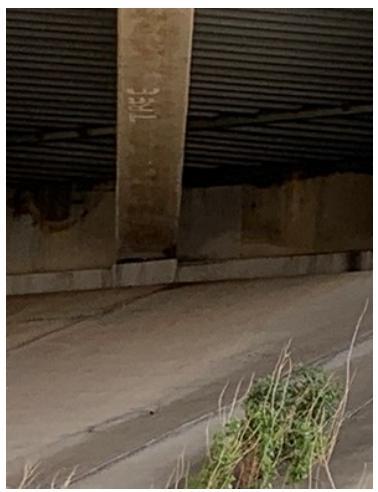
(c) Corrosion at metal deck from an abutment (ELP-RC-06)

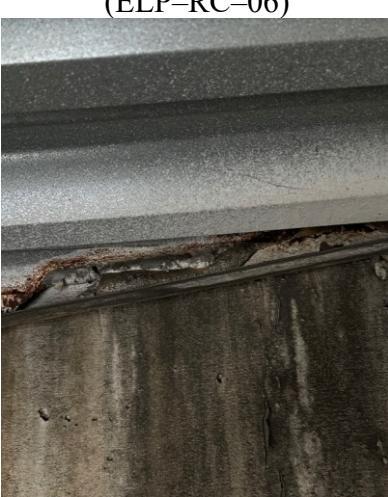
Figure 3.15(d) shows corrosion near the bearing pad on FTW–RC–03. Figure 3.15(e) illustrates the corroded metal deck form near the abutment joint on FTW–RC–04. Figure 3.15(f) displays cracks and efflorescence on the abutment backwall on FTW–RC–05, and Figure 3.15(g) shows exposed and corroded rebar on the abutment due to spalling of concrete on TYL–RC–02. Spalling of concrete frequently leads to exposure of rebar, which is prone to corrosion. Consequently, it is necessary to address spalling, implement appropriate maintenance, and repair strategies to prevent corrosion. Figure 3.16 shows exposed and corroded rebar on the concrete rail on ATL–RC–01 in Region 4. The rebar corroded due to concrete spalling, as well.

(e) Corrosion detected at deck (FTW–RC–04)

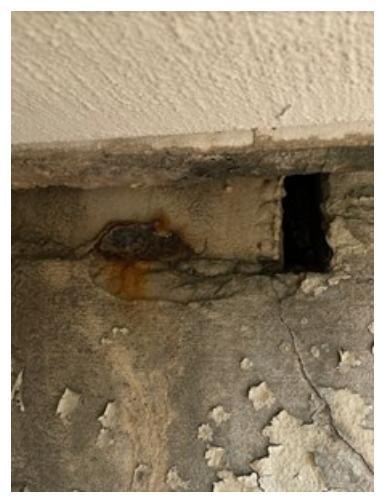
(d) Corrosion near bearing pad (FTW-RC-03)

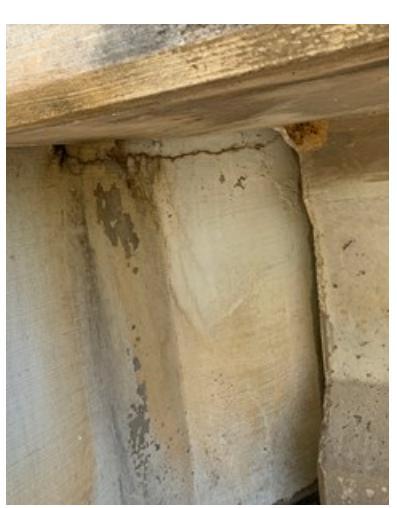
(f) Crack and efflorescence at abutment backwall (FTW–RC–05)

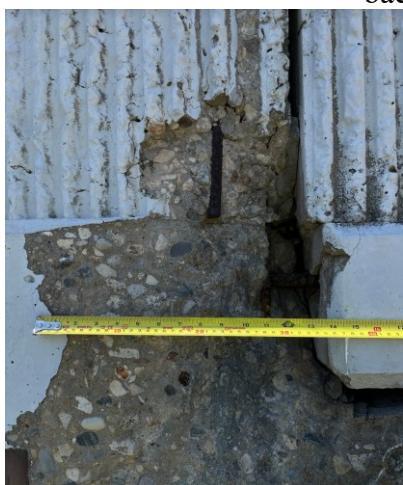
(g) Exposed and corroded rebar at abutment (TYL-RC-02) Figure 3.15. Deterioration of Bridges in Region 3 (Cont.).

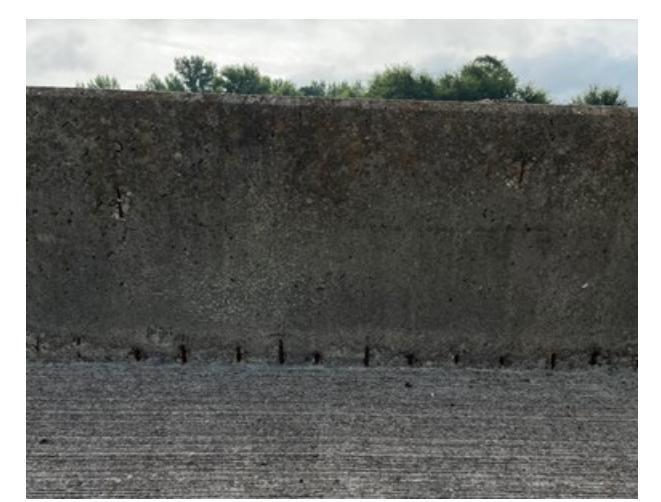
Figure 3.16. Exposed and Corroded Rebar at Concrete Rail at ATL-RC-01 in Region 4.

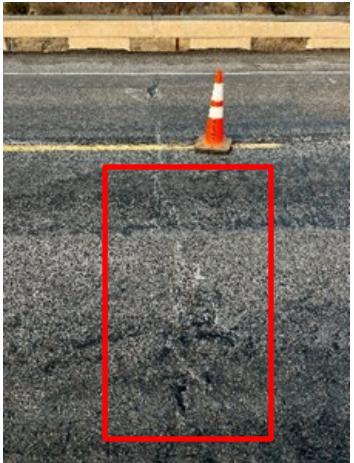
Figure 3.17 illustrates the deterioration of bridges in Region 5. Figure 3.17(a) shows cracks and delamination of the asphalt overlay. Cracks and delamination allow moisture to penetrate the asphalt overlay and reach the concrete underneath, which can cause further corrosion of reinforcement steel in bridge decks. Figure 3.17(b) depicts cracks on the bottom surface of the deck. Figure 3.17(c) shows cracks and rust on the abutment backwall on CHS-RC-06. This type of cracking was probably caused by settlement of the abutment and often leads to corrosion of rebar. Figure 3.17(d) shows exposed and corroded rebar at the concrete rail in the WFS-RC-03 bridge, which may be due to spalling of concrete from corrosion formation on the rebar surface. Figure 3.17(e) also shows a similar crack to the one in Figure 3.17(c), but it perhaps developed as a result of water leakage on the abutment backwall on WFS-RC-03. Cracks on the abutment wall are common types of concrete cracking due to settlement. Figure 3.17(f) displays a corroded metal deck form near a joint on WFS-RC-04 that was generally visible on bridges with a permanent metal deck form (PMDF) at joints due to water leakage from the joints. Figure 3.17(g) illustrates horizontal cracks and efflorescence on the abutment backwall on WFS-RC-05, while Figure 3.17(h) shows a hole that formed within the pavement and extended into the deck. Severe pitting corrosion and metal loss of the reinforcement steel as a result of the hole are evident in Figure 3.17(i).

(a) Cracks and delamination of asphalt overlay (CHS-RC-05)

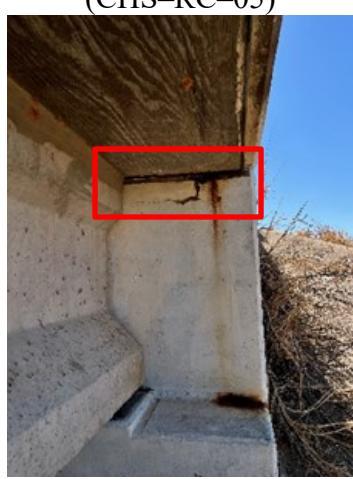
(c) Cracks at abutment backwall (CHS-RC-06)

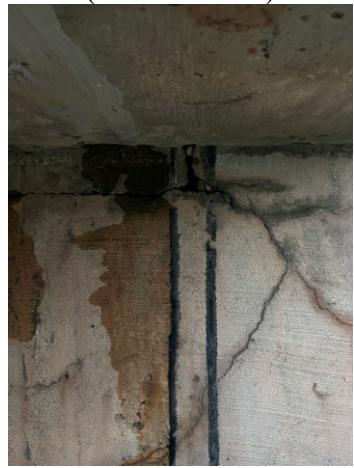
(e) Crack at abutment backwall (WFS-RC-03)

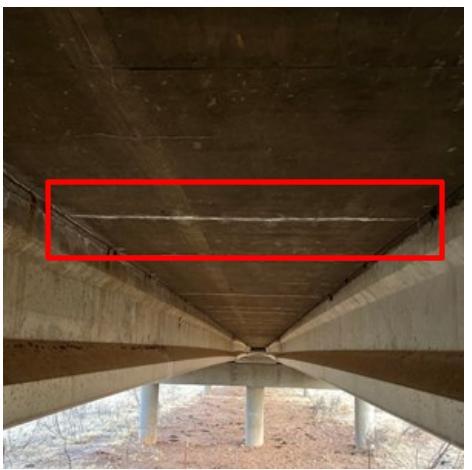
(b) Moderate cracks on bottom surface of deck (CHS-RC-05)

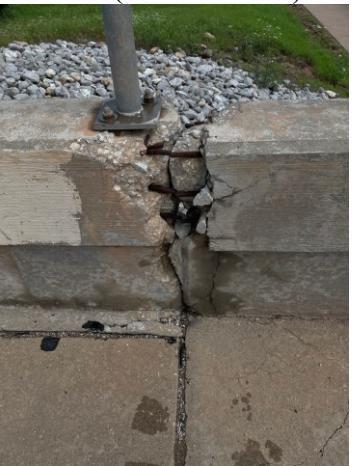
(d) Exposed and corroded rebar at concrete rail (WFS-RC-03)

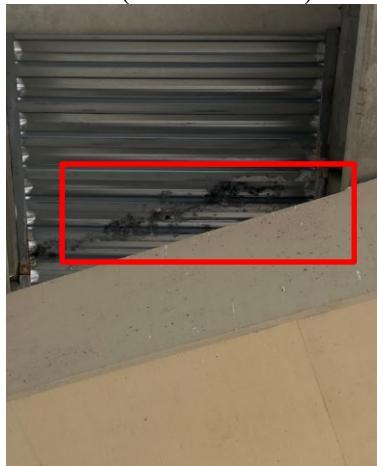
(f) Corroded metal deck form near joint (WFS-RC-04) Figure 3.17. Deterioration of Bridges in Region 5.

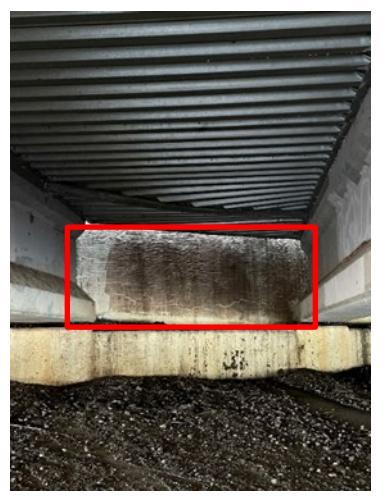
(g) Horizontal cracks and efflorescence at abutment backwall (WFS-RC-05)

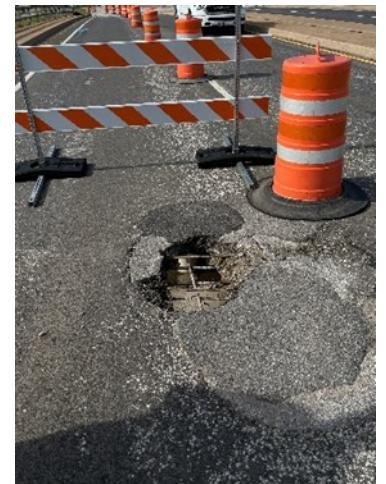
(h) Development of a hole on deck (WFS-RC-07)

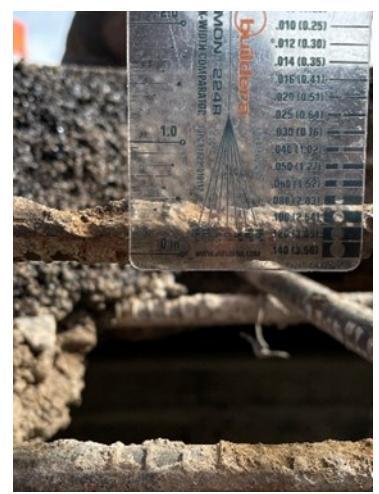
(i) Pitting corrosion where the hole was (WFS-RC-07) **Figure 3.17. Deterioration of Bridges in Region 5 (Cont.).**

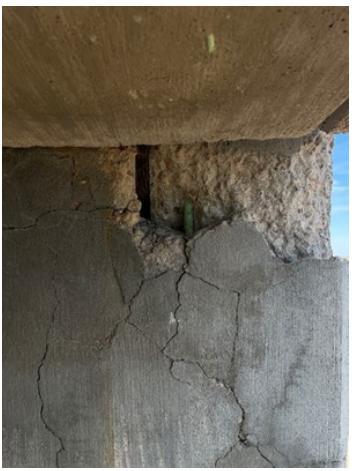
Figure 3.18 shows deterioration of bridges in Region 6. Figure 3.18(a) shows exposed and corroded ECR due to settlement on AMA–RC–02. As the abutment wall fell off, the ECR was exposed to air, thus damaging the coating and potentially causing corrosion of the rebar. Rust propagated and caused further spalling on the abutment wall. Figure 3.18(b) displays rust on the concrete rail on AMA–RC–04. Rebar was not exposed to air, but water penetration within cracked spaces still remains possible. Figure 3.18(c) shows typical corrosion on the PMDF near a joint on AMA–RC–04 that was also observed on WFS–RC–04.

(a) Exposed and corroded ECR due to spalling at abutment (AMA–RC–02)

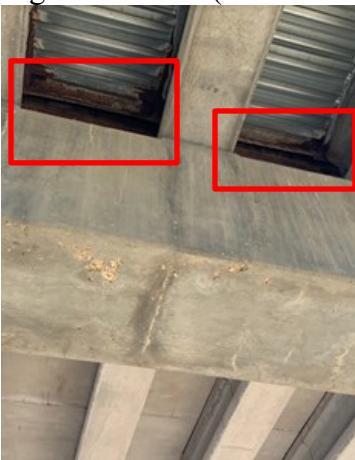
(c) Corrosion on the metal deck form near a joint (AMA-RC-04)

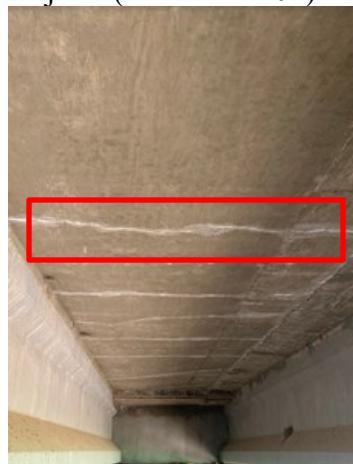
efflorescence on the bottom surface of the deck on AMA–RC–08 that can potentially lead to the corrosion of either black rebar or ECR, particularly if the coating has been damaged.

(e) Cracks and efflorescence on bottom surface of deck (AMA-RC-08)

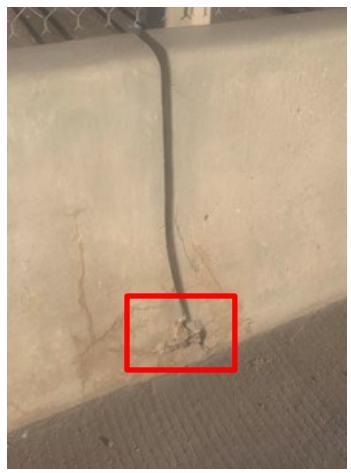
(b) Rust at rail bottom (AMA-RC-04)

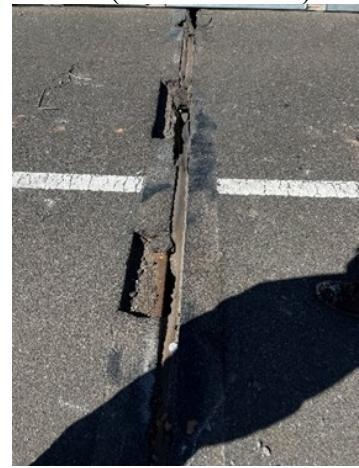
(f) Spalling of overlay at joint (CHS-RC-01)

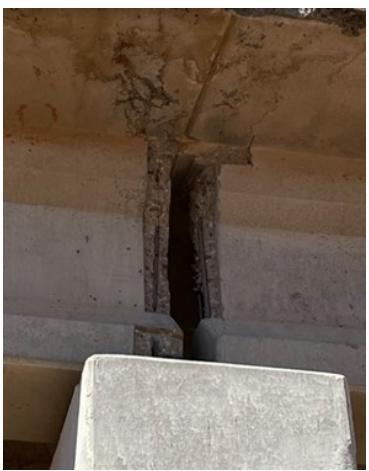
(g) Spalling and exposed rebar at girder ends (CHS-RC-01)

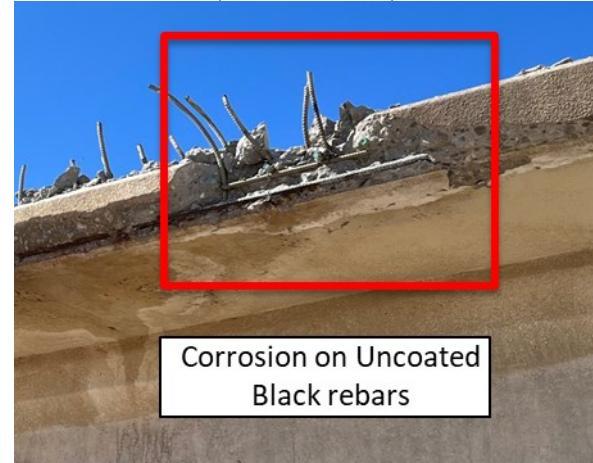
(i) Location of the corroded uncoated black rebar (CHS-RC-01)

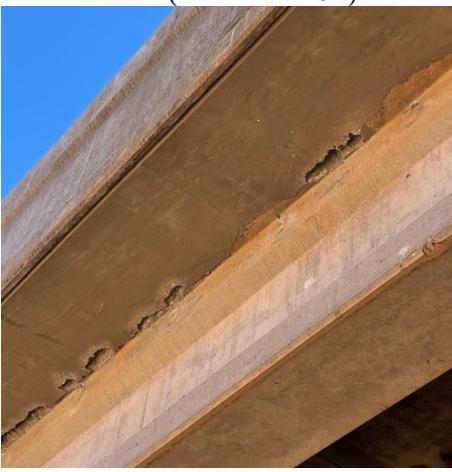
(k) Concrete fall-off at intersection of replaced overhang (CHS–RC–01) (l) Transverse and longitudinal cracks on deck surface (CHS–RC–02) Figure 3.18. Deterioration of Bridges in Region 6 (Cont.).

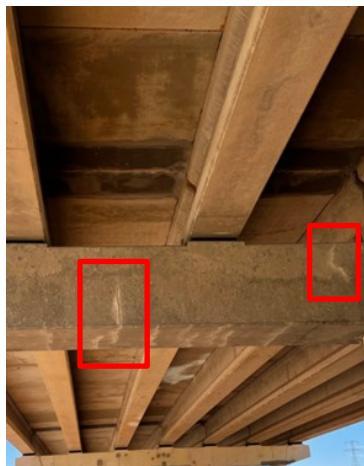
(h) sealed cracks on a bent cap (CHS-RC-01)

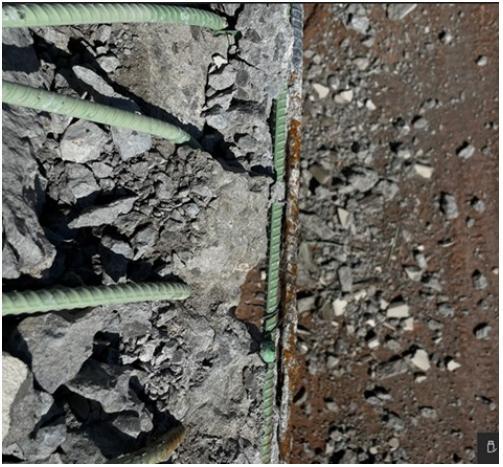
(j) Corrosion on uncoated black rebar at the bottom mesh near overhang (CHS–RC–01)

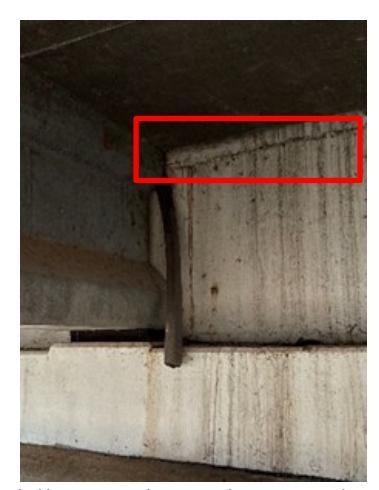
(m) Hairline cracks at abutment back wall (CHS-RC-04) Figure 3.18. Deterioration of Bridges in Region 6 (Cont.).

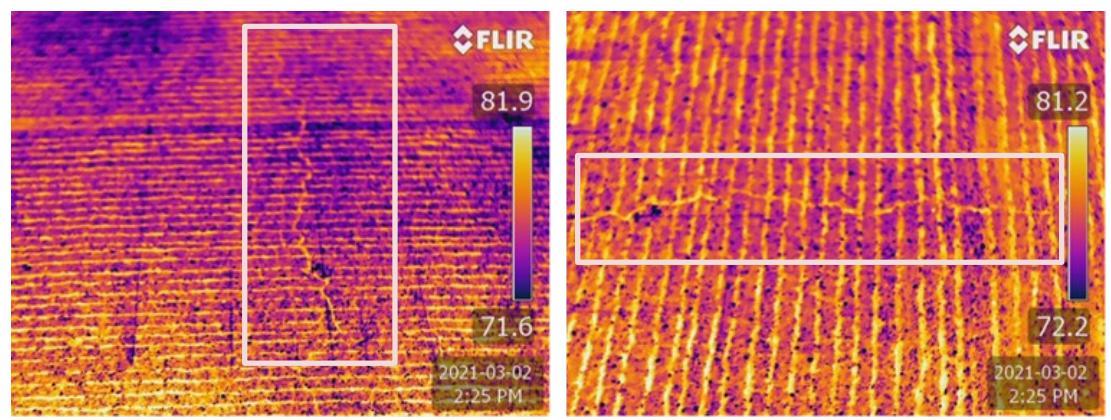
Figure 3.19. Thermal Imaging of CRP-RC-02 Showing Cracks.

Thermal images taken from bridge structures were used to analyze surface cracking on concrete elements. Figure 3.19 shows longitudinal cracks that are visible from the IRT photos. As shown in Figure 3.19, thermal imaging enables quick and efficient assessment of cracks. It can detect superficial defects on the bridge decks, including cracks that may not be easily visible to the unaided eye. IRT detects temperature differences caused by cracks, enabling precise identification and mapping of surface cracking.

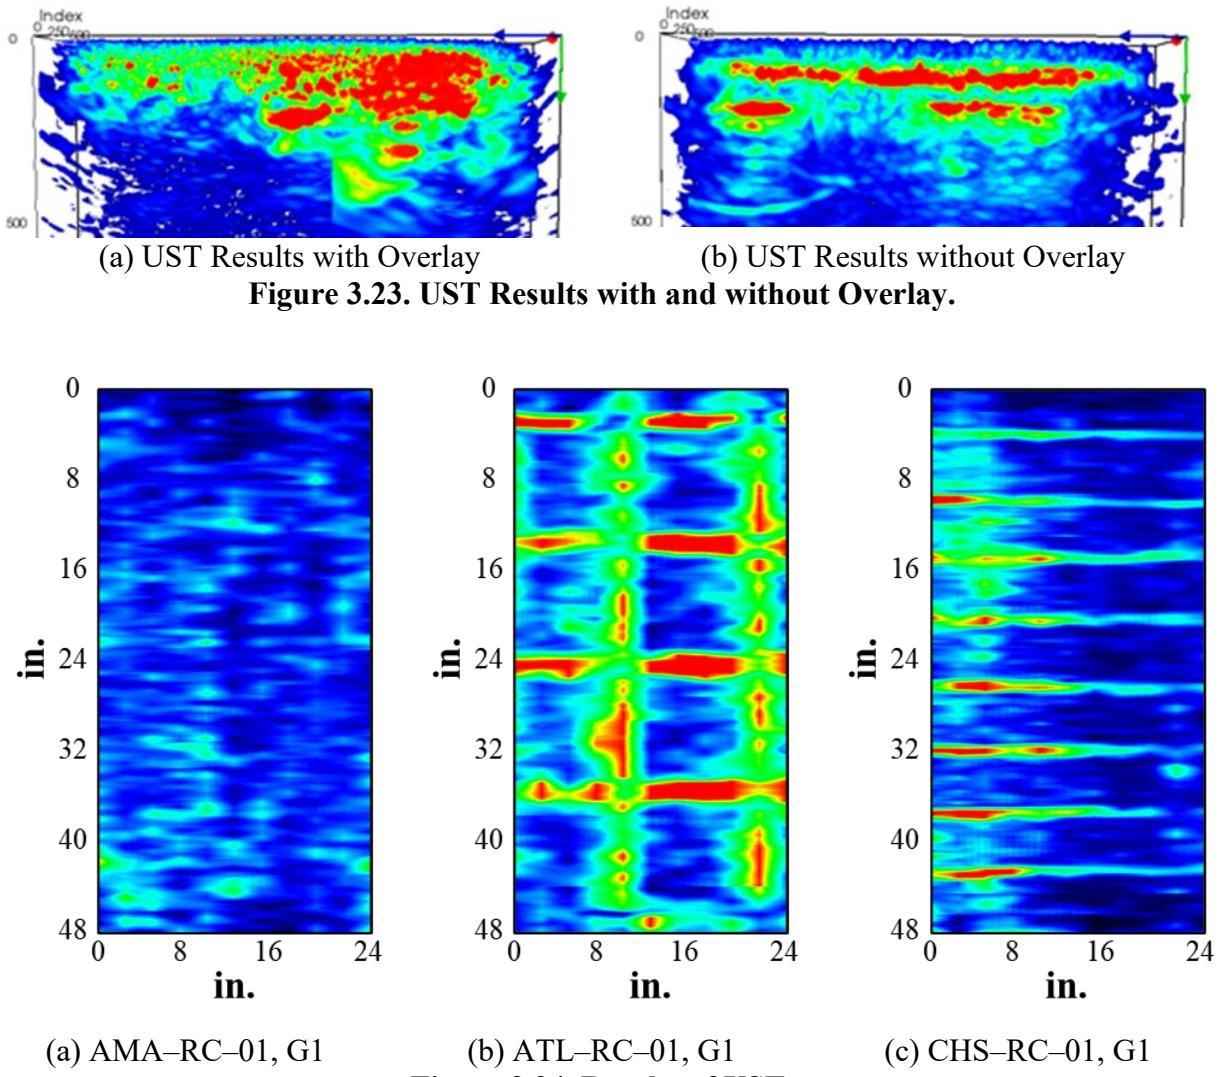
Figure 3.24. Results of UST.

Figure 3.22 shows UST results that can be used to locate the rebar inside and on the bottom of the concrete deck. Note that any defects that were smaller than rebar were difficult to find due to reflections. It is hard to determine whether the reflection is due to a defect or is just noise. If there were overlays such as asphalt, then it would be even more difficult to find the rebars because of noises around the asphalt surface (Figure 3.23[a]). However, if a bridge does not have an overlay, UST scanning can be useful to locate rebar and identify potential areas of deterioration (Figure 3.23[b]). To reduce the noise, the results needed to be normalized and validated by comparing the UST results with the actual cores. After normalization and validation, deteriorations such as voids and corrosion could be found by analyzing the UST results. The appendix contains all the UST scanning results, while Figure 3.24 supplies examples of a few concrete decks.

The resolution of the results obtained from UST was sometimes poor. A possible reason is that UST was only performed in one direction, mainly due to time constraints during the field investigation. As a result, the propagated wave in the concrete was polarized, making it difficult and challenging to interpret the resulting data and accurately match rebar to produce an image of rebar. Additionally, the presence of grooves on the concrete surface may have also caused dispersion of sound waves. Therefore, some of the results provided by UST did not lead to desirable outcomes.

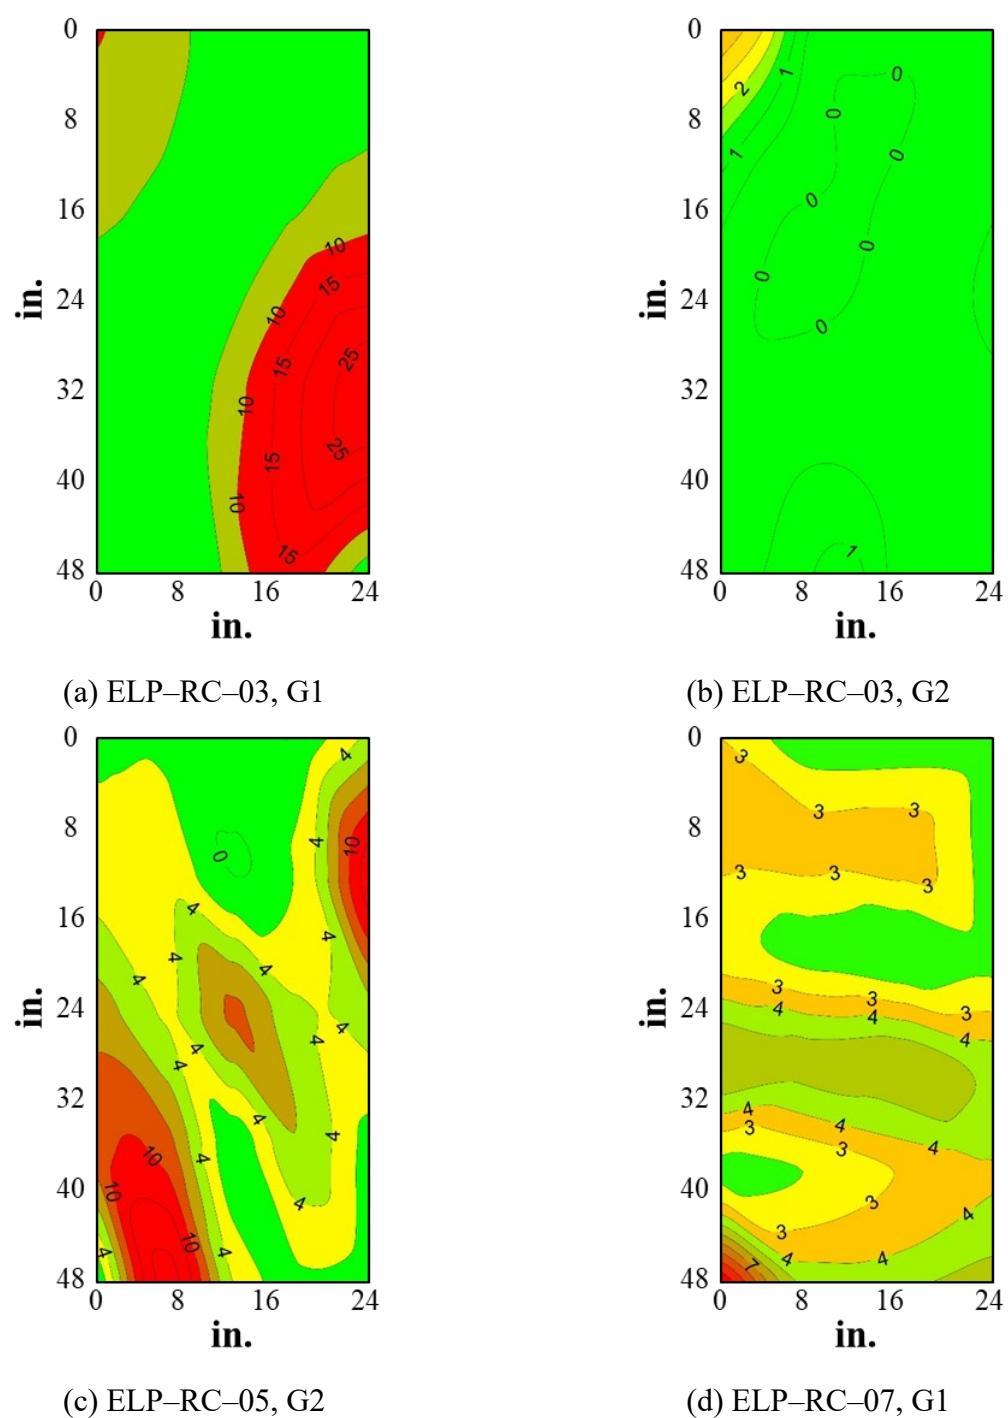
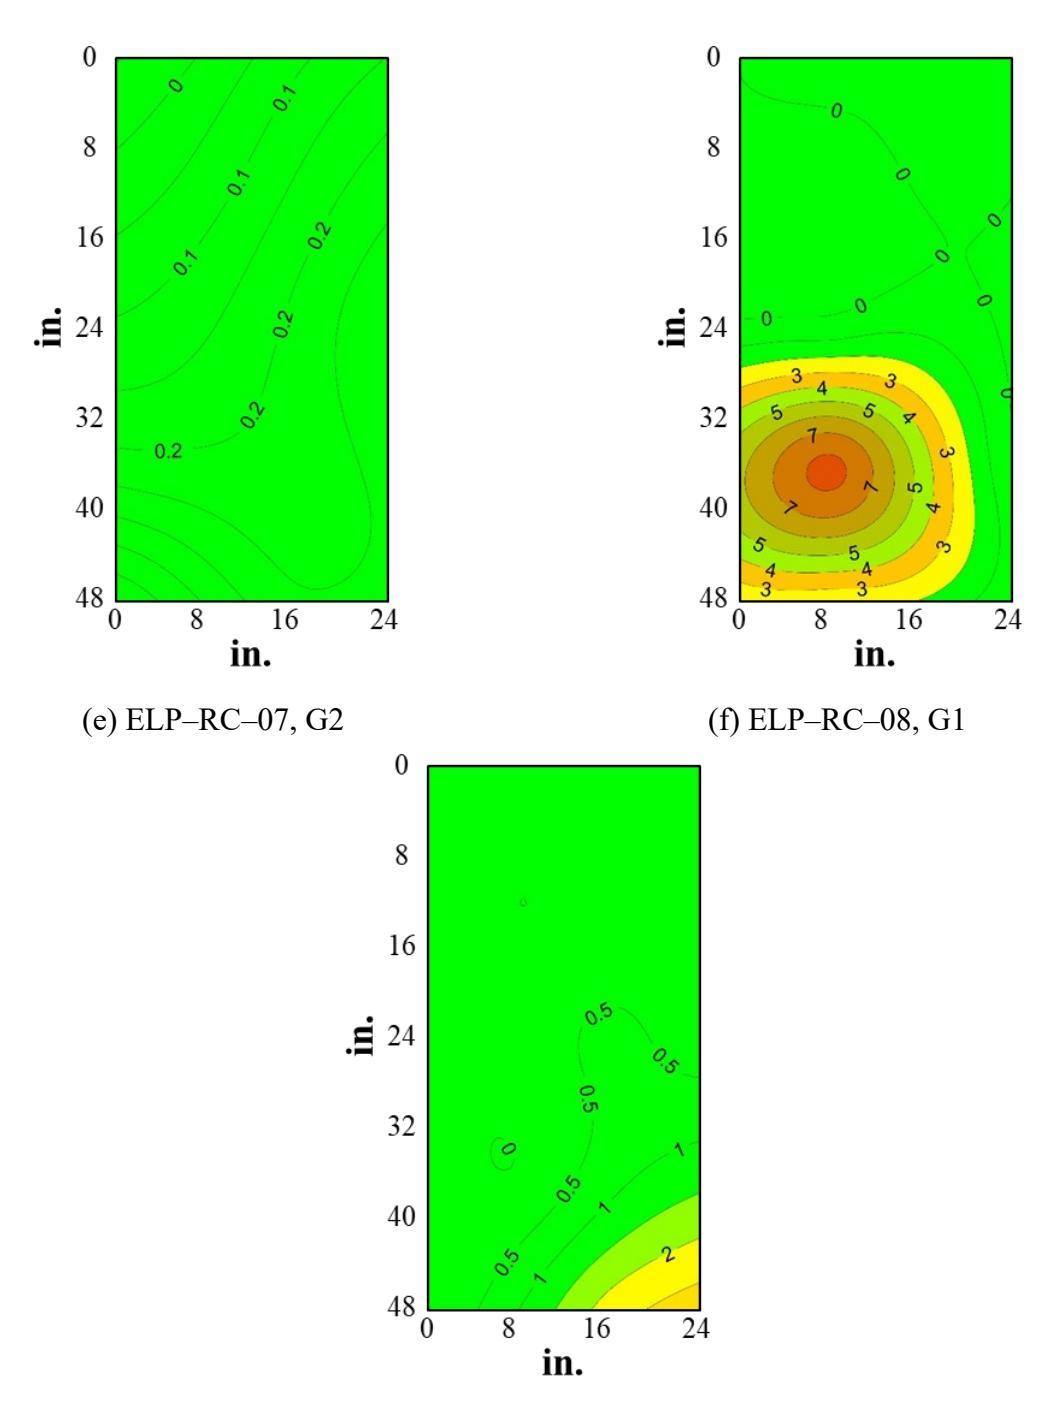
Figure 3.25 shows results of corrosion rate mapping of bridges in Region 3, including ELP–RC–03, ELP–RC–05, ELP–RC–07, and ELP–RC–08. Among the bridges, ELP–RC–03 G2, ELP–RC–07, and ELP–RC–08 were classified as being in moderate condition in terms of corrosion rate. These bridges exhibited corrosion damage within the range of 10 to 15 years according to the corrosion rate mapping. On the other hand, ELP–RC–03 G1 and ELP–RC–05 had a high corrosion rate and were expected to have some corrosion damage within the range of 2 to 10 years; particularly, ELP–RC–08 and ELP–RC–05 had corrosion rates of 7 and 10 μ A/cm², respectively, which is close to the moderate range. Additionally, it is worth mentioning that ELP–RC–03 exhibited a high corrosion rate only in a limited area, while all other locations exhibited low to no corrosion rates.

(c) ELP-RC-05, G2 Figure 3.25. Corrosion Rate Mapping Results of Bridges in Region 3, Corrosion Current Density (μA/cm²).

(g) ELP–RC–08, G2 Figure 3.25. Corrosion Rate Mapping Results of Bridges in Region 3, Corrosion Current Density (μA/cm²) (Cont.).

The results from corrosion rate mapping in Figure 3.25(a) indicate that the maximum corrosion current density (i_{corr}) for the concrete deck of ELP–RC–03, examined during the field inspection, was estimated to be 25 μ /cm². This value is equivalent to a corrosion rate of 11.4 mpy. The logarithmic polarization resistance of the core specimen taken from ELP–RC–03 measured slightly higher than 6 Ω cm². The ECR received a ranking of 8 during the knife test, indicating that the coating has degraded to some extent. Although chloride concentration at the rebar level was found to be low, the average initial sorptivity of the core from this concrete deck was recorded as 10×10^{-3} mm/s^{1/2}, and the average bulk resistivity measured from the core specimens taken from ELP–RC–03 was documented as 6.3 k Ω cm. These results indicate that the quality of the concrete deck is not in good condition because of relatively high initial sorptivity and low electrical resistivity.

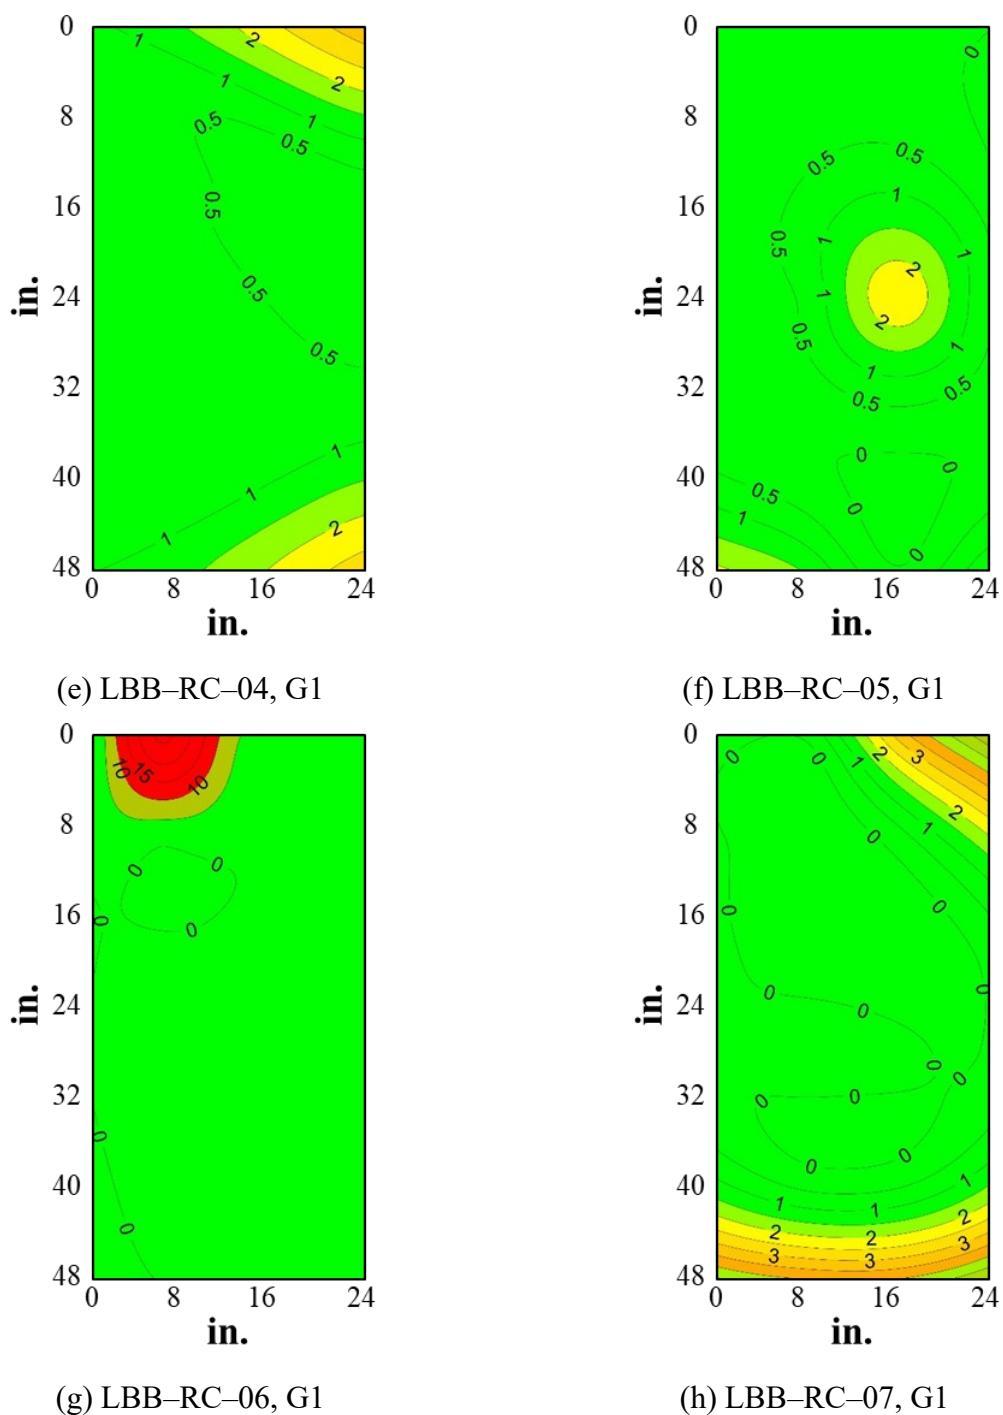
Figure 3.26 illustrates the corrosion rate mapping developed for concrete decks in Region 6, including AMA–RC–10, LBB–RC–01, LBB–RC–02, LBB–RC–03, LBB–RC–04, LBB–RC–06, and LBB–RC–07. Among these bridges, LBB–RC–01, LBB–RC–02, LBB–RC–04, LBB–RC–05, and LBB–RC–07 were determined to be in a moderate condition in terms of corrosion rate. These concrete structures exhibited corrosion damage within the range of 10 to 15 years. On the other hand, AMA–RC–10, LBB–RC–03, and LBB–RC–06 had high corrosion rates and were expected to have corrosion damage within the range of 2 to 10 years. Only limited areas of LBB–RC–03 and LBB–RC–06 showed corrosion rates of 18 and 15 μ A/cm², respectively. AMA–RC–10 G1 exhibited a corrosion rate of 30 μ A/cm² in a very limited area.

The maximum corrosion current density measured for the concrete deck of AMA–RC–10 was 30 μ /cm², which is equivalent to 13.7 mpy (Figure 3.26[a]). Although the quality of concrete used in AMA–RC–10 was determined to be of good quality based on the average bulk resistivity of the specimens extracted from this deck (measured at 20 k Ω cm), the chloride concentration at the rebar level was relatively high (0.27 wt.% concrete), indicating potential corrosion risk. Corroded rebar with damage to the epoxy coating were found in the cores tested during laboratory examinations. The quality of this epoxy coating was ranked 2 during the knife test, yet the quality of the epoxy coating in other areas of the concrete deck was found to be good. For the specimens taken from a different location and subjected to EIS examination, the logarithmic polarization resistance was measured at 6.7 Ω cm², indicating a high-quality epoxy coating. Surface cracking was also observed on the deck during the field inspection. It was concluded that aggressive ions from deicing salt can penetrate the concrete and reach the rebar level, leading to the deterioration of ECR over time. In locations where cracking is not present, significant damage and corrosion products are less likely to occur.

The results of corrosion rate mapping for LBB–RC–03, as shown in Figure 3.26(d), revealed a maximum corrosion current density of 18 μ /cm², which is equivalent to 8.23 mpy. For the core obtained from this concrete deck, the average initial sorptivity was greater than 12×10^{-3} mm/s^{1/2} and the bulk resistivity was 6 k Ω cm, which indicated a porous and poor-quality concrete. However, the quality of the epoxy coating was in good condition, as evidenced by the results from EIS, where a logarithmic polarization value exceeded 7 Ω cm², and the outcome of the knife test was a 10.

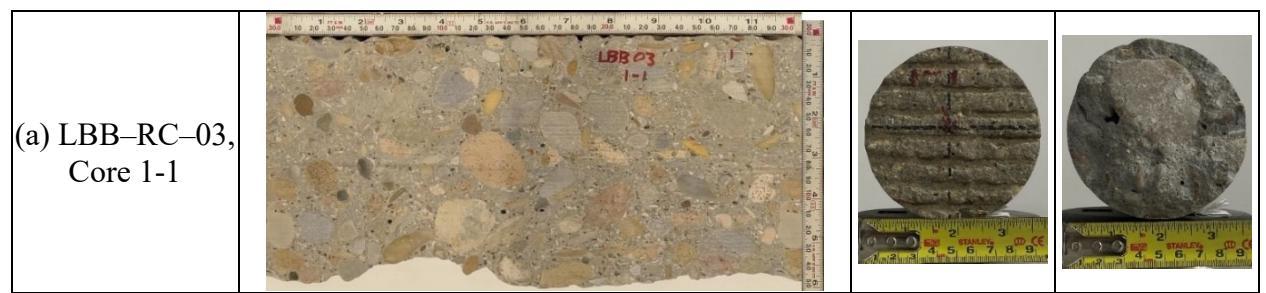
Figure 3.27. Pictures of Core 1-1 of LBB-RC-03 in Good Condition.

Overall, the rebar and cores were found to be in good condition and showed no sign of corrosion. However, laboratory examinations were also conducted to determine the corrosion condition of core specimens, and the results will be reported in Chapter 4. Figure 3.27 shows a core from its side, top, and bottom. The core, labeled 1-1, is a core from Grid 1 of LBB–RC–03, and it represents an example of a core in good condition. Upon examination, there were no visible cracks on its top surface, no delamination on the bottom surface, and no visible voids or cracks on the side surface.

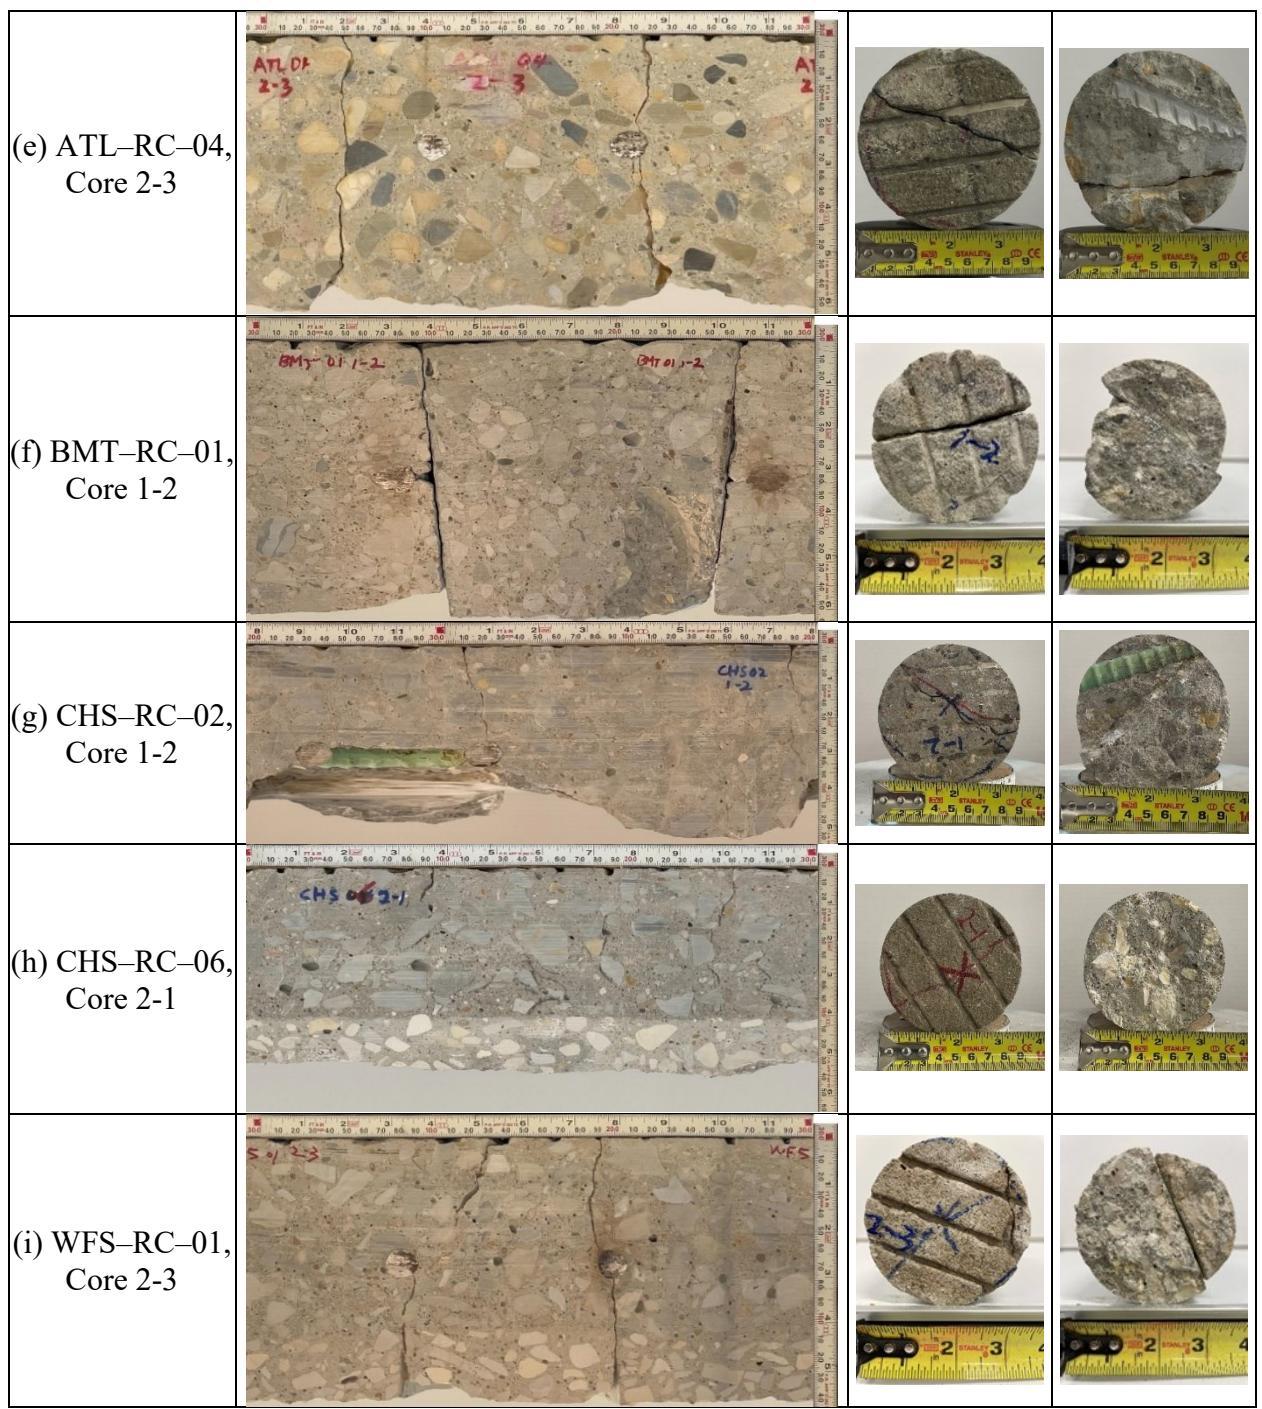
Figure 3.28. Pictures of Cores with Deterioration (Cont.).

Figure 3.28 illustrates cores with visible deterioration, each showing different forms of damage and degradation. The core labeled 2-3 from AMA-RC-03 (Figure 3.28[a]) exhibited a crack along the intersection of aggregates, which can be attributed to plastic shrinkage. This process is a form of drying shrinkage that occurs while the cement is unhardened. This type of cracking, known as settlement or subsidence cracking, is influenced by drying atmospheric conditions and can lead to segregation of coarse aggregate from the paste (ACI 224 R). Figure 3.28(b) shows a small void 1.5 in. from the top surface of a core taken from the concrete deck of AMA-RC-04. As shown in Figure 3.28(c), a core extracted from AMA-RC-05 exhibited traces of corrosion on the bottom surface and a crack propagating from or to the reinforcing bar. This occurrence suggests that the crack may have facilitated the corrosion process on steel reinforcements. Although corrosion from the rebar could potentially lead to delamination of the concrete, it is challenging to draw a definitive conclusion because concrete typically breaks during coring rather than from delamination. Figure 3.28(d) shows a similar deterioration, but the steel bar at the end of the crack remained uncorroded, indicating that the epoxy coating effectively prevented corrosion. Figure 3.28(e) illustrates a core from ATL-RC-04 split due to a plastic crack. No corrosion was observed in this specimen despite the crack passing through the reinforcing bar. The core in Figure 3.28(f) was collected from a construction joint in BMT-RC-01; it showed no signs of corrosion on the reinforcement. Figure 3.28(g) displays a core from CHS-RC-02 with a crack propagating from or to steel, accompanied by corrosion on the reinforcement. In Figure 3.28(h), a core from CHS-RC-06 exhibited several plastic cracks on the side surface; however, the top surface displayed no cracks. Figure 3.28(i) depicts a core from WFS-RC-01 that reveals a crack propagating from a joint of PCPs through a steel bar. However, no corrosion was observed on the steel.
