Evaluation of Corrosion Prevention and Mitigation Approaches Used on Texas Bridges—Volume 2: Reinforced Concrete Bridges

Technical Report 0-7040-R1-Vol2

TEXAS A&M TRANSPORTATION INSTITUTE COLLEGE STATION, TEXAS

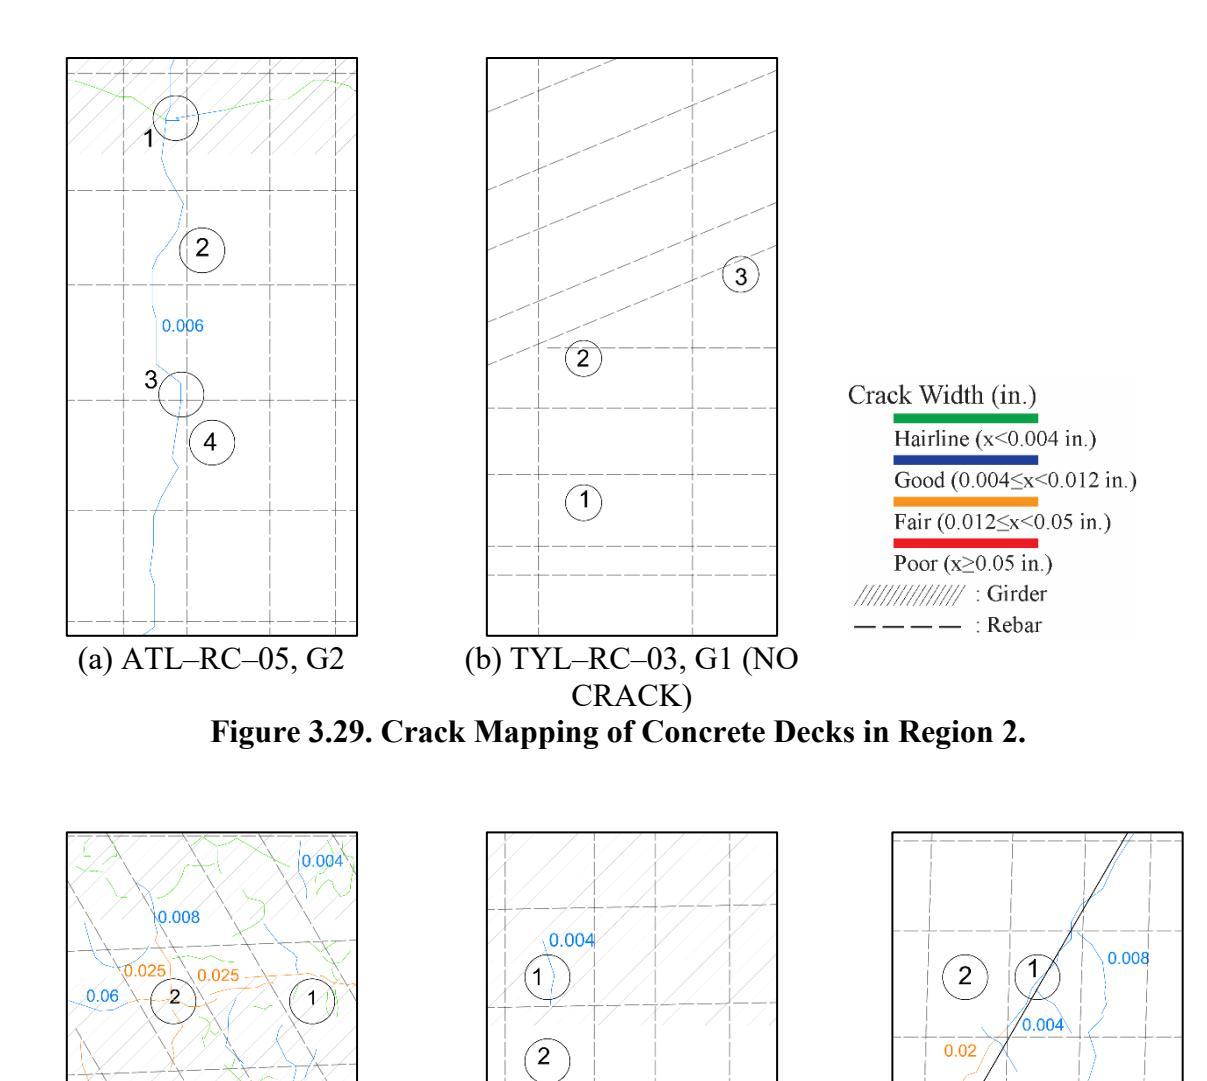
Figure 3.29 to Figure 3.33 show crack maps of inspected bridges in Region 2 to Region 6, respectively. Crack widths were categorized in different color codes to indicate their severity. A crack width larger than 0.05 in. is considered poor and marked with red. Cracks with widths ranging from 0.012 to 0.05 in. are categorized as orange. A blue color indicates cracks with widths between 0.004 in. and 0.012 in. Cracks narrower than 0.004 in. are classified as hairline cracks and marked green. The color codes provide a visual representation of the severity of cracks on the bridge decks.

Figure 3.29 provides surface crack mapping of the concrete decks in Region 3, highlighting the variations in crack conditions. As shown in this figure, the crack mapping of Grid 2 in ATL– RC–05 illustrates a 0.006-in.-wide transverse crack as well as a hairline crack. Although surface cracking was detected in Grid 2, the crack mapping represented in Figure 3.29 shows the absence of any kind of surface cracking developed in Grid 1 of TYL–RC–03. The transverse cracking observed in ATL–RC–05 is a common type of crack that can develop at the joint of PCPs. This variation in crack conditions among bridges in the same region suggests the influence of different factors such as construction methods or environmental conditions, which may contribute to the varying levels of cracking observed on the bridge decks. Cracking can occur either during construction or as a result of stress concentration after installation. If the interior diagram of

concrete panels is not properly positioned to support the concrete deck, it can result in increased rates of transverse crack development due to the production of negative longitudinal bending moments. Additionally, factors like thermal and shrinkage effects can also contribute to development of transverse cracking (Buth et al., 1972).

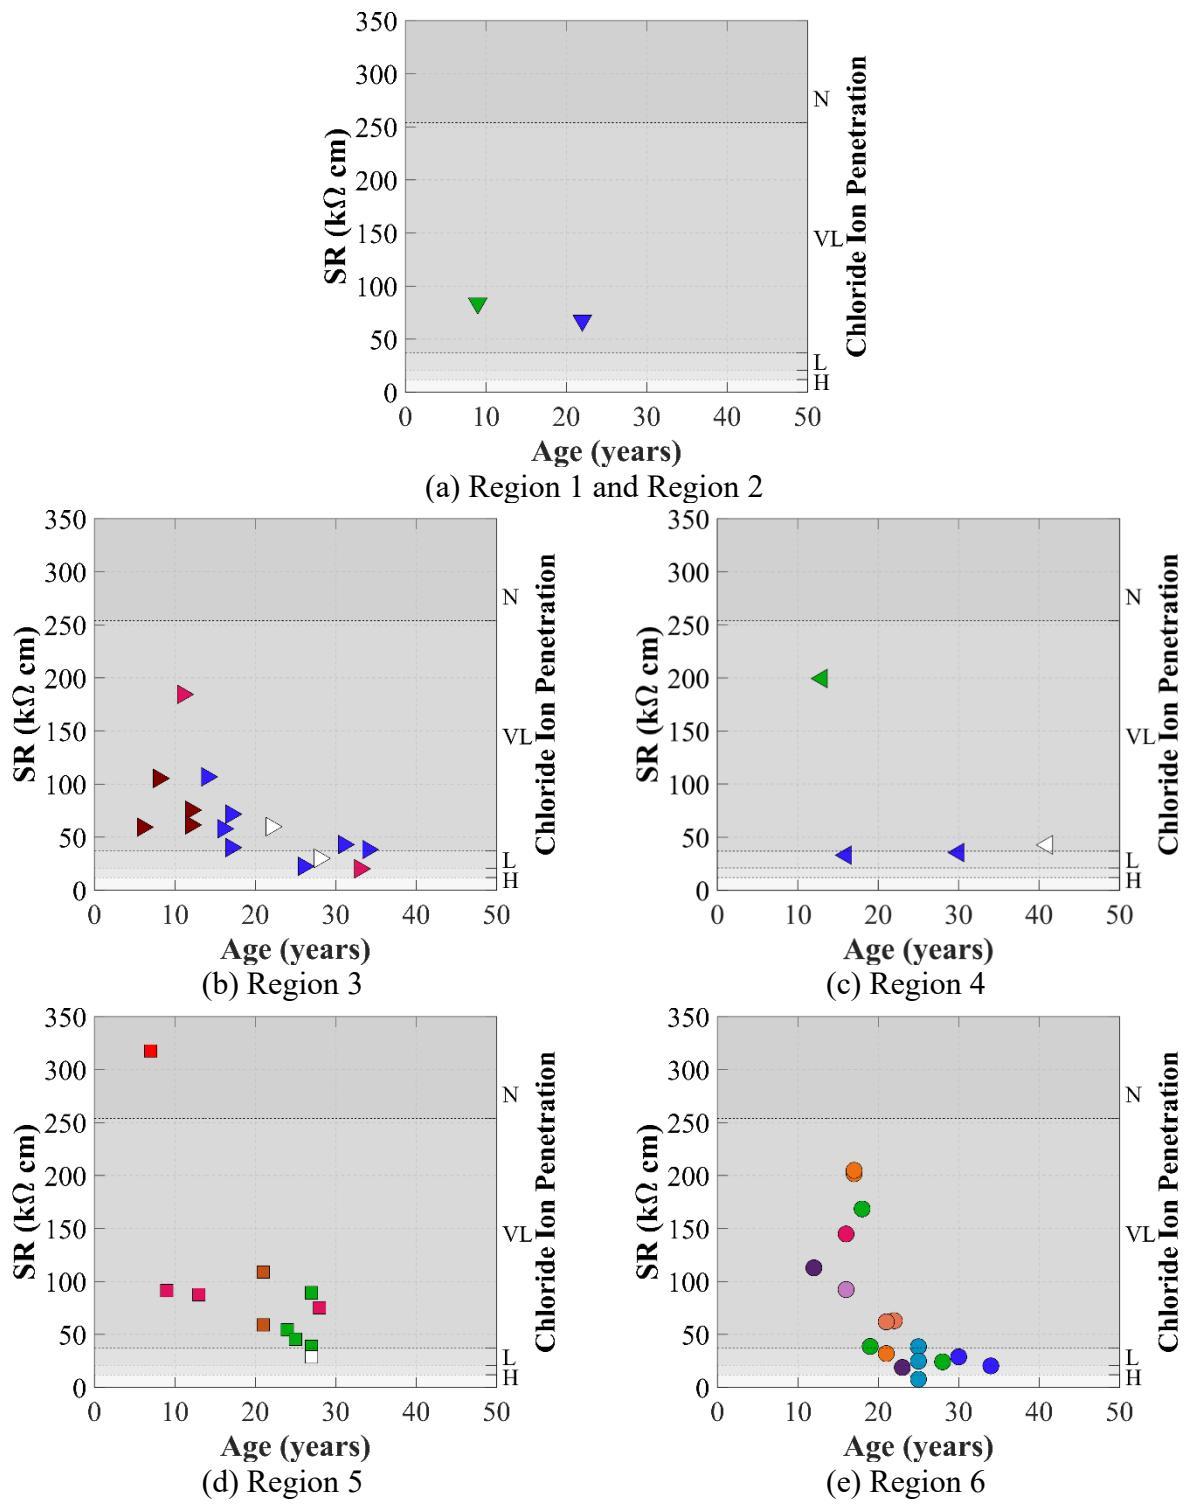
Figure 4.5. Surface Resistivity Measured for Aged Concrete Specimens Based on Different Corrosion Risk Environments.

Figure 4.5 illustrates the surface resistivity of concrete core specimens extracted from TxDOT concrete decks with varying ages of construction. In low corrosion risk environments such as Region 1 and Region 2, the surface resistivity of the concrete samples (ATL–RC–05 and TYL-EC-03) was greater than 50 k Ω cm, indicating a low concentration of chloride ions in the specimens. However, as the environment became more corrosive, the surface resistivity gradually decreased below 37 k Ω cm over time, which suggests that the volume of moisture absorbed in concrete decks was higher for older bridges.

In Region 6, which represents a severe corrosion risk environment, the surface resistivity of samples aged over 25 years fell into the moderate and high categories of chloride ion penetration. This finding indicates that corrosion issues might have emerged in the bridge decks located in this region (AMA–RC–05, LBB–RC–04 and LBB–RC–06), and further investigation is needed to assess the extent of corrosion and its impact on the concrete structures.

The moisture and chloride content of the specimens taken from bridges aged less than 25 years for concrete decks located in Region 3, Region 4, and Region 5 and aged less than 20 years for concrete decks located in Region 6 were estimated to be low; surface resistivity was recorded above 37 k Ω cm for most of these specimens except for FWT–RC–07 in Region 4, which had a lower surface resistivity reading.

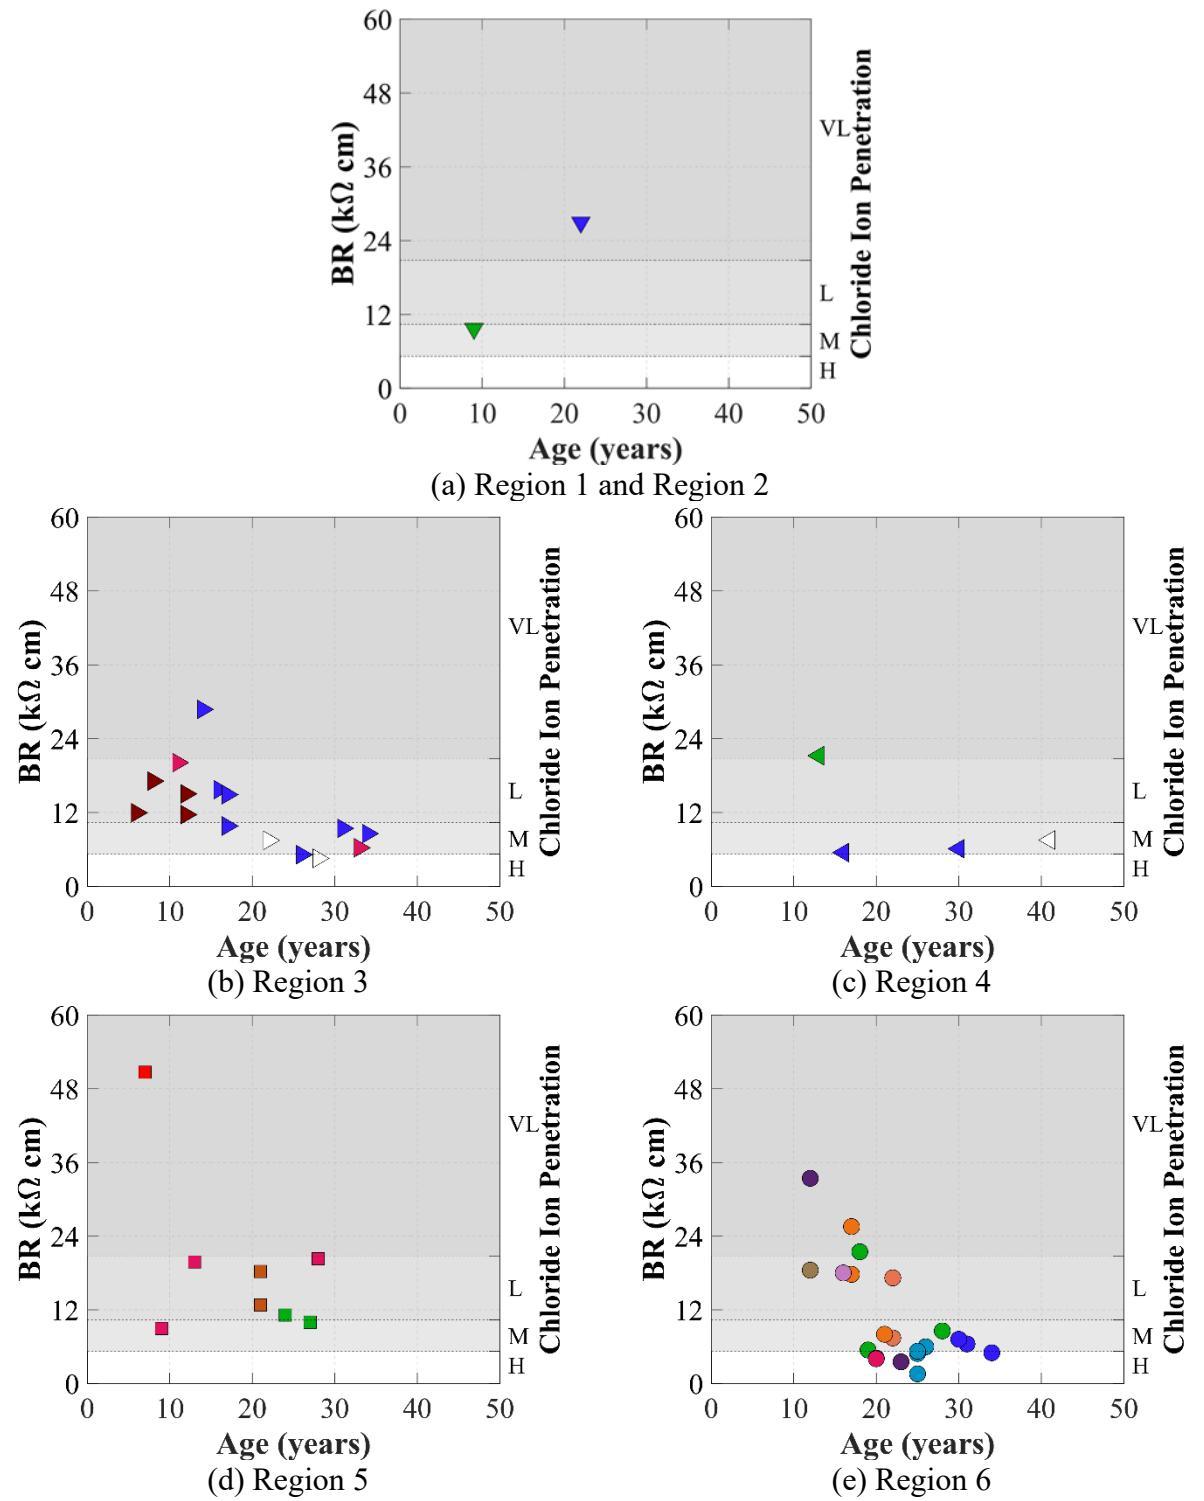
Figure 4.9. Bulk Resistivity Measured for Aged Concrete Specimens Based on Different Corrosion Risk Environments.

Figure 4.9 illustrates the recorded bulk resistivity with respect to different corrosive risk environments. Generally, a declining trend of bulk resistivity over time was observed for the samples used in this study. In a low corrosion risk environment, such as Region 1 and Region 2, a sample taken from a relatively new concrete deck in the Atlanta District exhibited a low bulk resistivity, with an average resistivity level measured below 10 k Ω cm. However, other specimens extracted from concrete decks in the Tyler District that were in service for over 30 years displayed a relatively high bulk resistivity, exceeding 20 k Ω cm.

New concrete decks constructed in Region 3 within the last 2 decades exhibited a bulk resistivity higher than 10 k Ω cm, indicating the use of higher-quality concrete during bridge construction. However, decks constructed prior to that period displayed resistivity levels lower than 10 k Ω cm. It was concluded that the application of surface treatments on the top surface of the concrete deck did not show any improvement in bulk resistivity, indicating that the resistivity is primarily influenced by factors such as the concrete mix design and W/C used during construction. With the exception of ATL–RC–03, the average bulk resistivity of concrete specimens taken from structures in Region 4 was generally less than 10 k Ω cm.

A declining trend in bulk resistivity was observed for samples extracted from concrete decks in both Region 5 and Region 6. The bulk resistivity dropped to 5 k Ω cm regardless of the mitigation method employed for bridges in Region 6 for structures over 20 years old. However, as previously discussed, this result can be attributed to factors such as the concrete admixture and mixed design. The concrete used in TxDOT bridge decks has become denser in the past 2 decades, resulting in higher resistivity values.

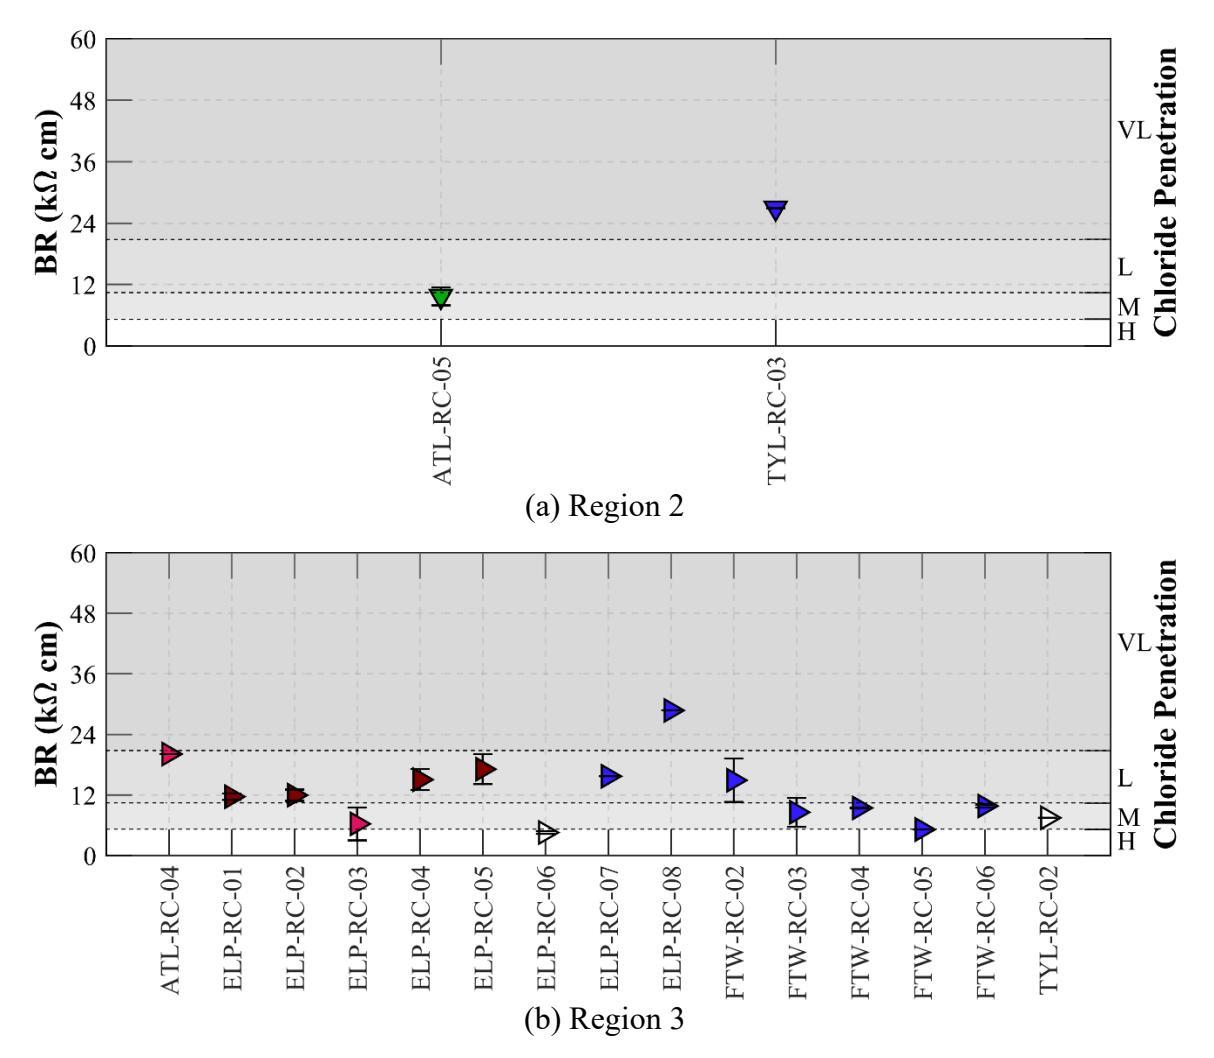
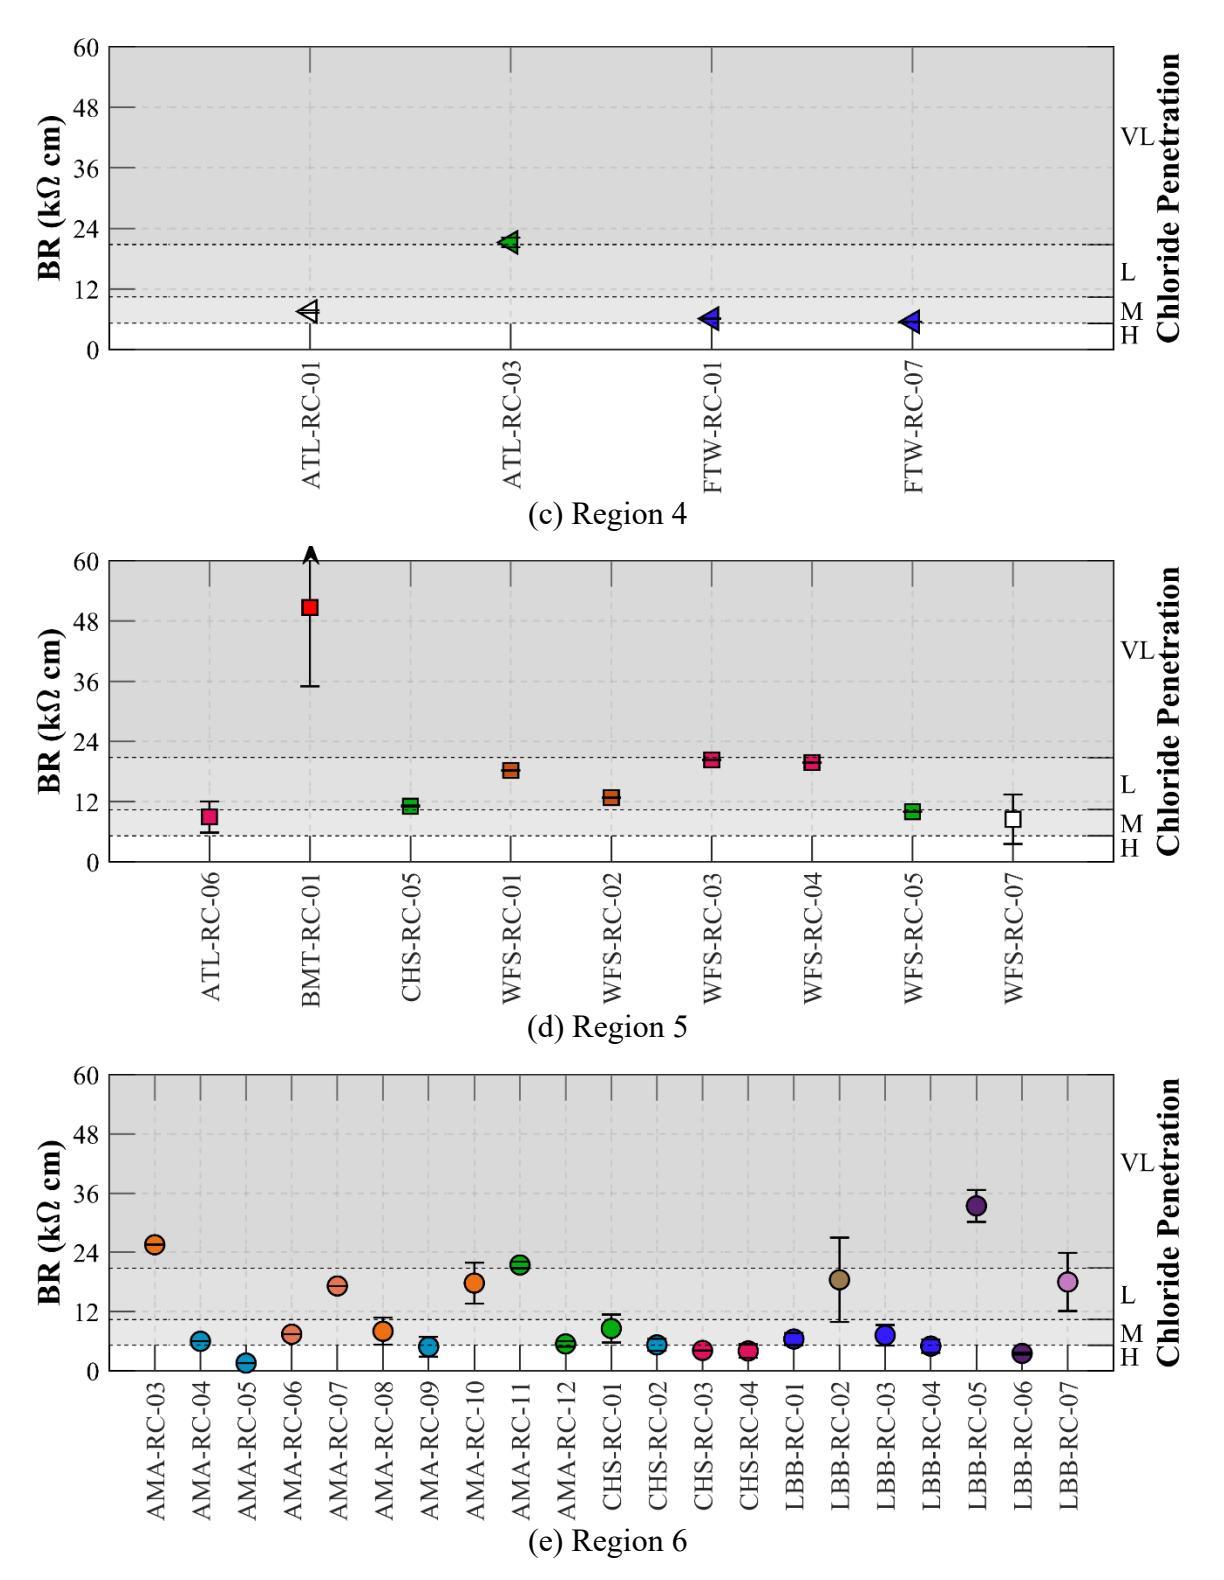
Figure 4.10. Bulk Resistivity Measured for Concrete Bridges.

Figure 4.10 depicts the bulk resistivity recorded for each core specimen. ELP–RC–03, ELP–RC–06, and FTW–RC–05 exhibited low bulk resistivity, even lower than 5 k Ω cm, indicating poor concrete quality. These bridges are located in Region 3, which is classified as a moderate corrosion environment. Thus, further investigation is recommended into the concrete decks of these bridges. The recorded bulk resistivity of FTW–RC–03, FTW–RC–04, and FTW–RC–06 was higher than 5 k Ω cm but lower than 10 k Ω cm, suggesting a poor-quality concrete used in the decks. The estimated chloride content in those concrete decks is considered moderate. In Region 4, the average bulk resistivity of ATL–RC–05 was higher than 20 k Ω cm, indicating good concrete quality. However, the average bulk resistivity was relatively low for ATL–RC–01, FTW–RC–01, and FTW–RC–07, measuring around 5 k Ω cm.

In highly corrosive environments such as Region 5 and Region 6, the bulk resistivity generally appeared to be low due to factors such as the extensive use of deicing salt during winter or airborne chloride deposition. In Region 5, the resistivity of the newly constructed bridge structure (BMT–RC–01) was found to be relatively high, indicating the use of concrete with a low W/C. In contrast, the average bulk resistivity of the newly built bridge (ATL–RC–06) was less than 10 k Ω cm. Additionally, WFS–RC–05 and WFS–RC–07, also located in Region 5, showed resistivity lower than 10 k Ω cm. Most specimens extracted from the concrete decks of bridges in the Amarillo District exhibited a low bulk resistivity except for AMA–RC–03, AMA–RC–07, AMA–RC–10, and AMA–RC–11. The electrical resistivity of all concrete specimens obtained from concrete decks in Childress was lower than 10 k Ω cm, and the same was observed for samples taken from structures in Lubbock except for LBB–RC–02, LBB–RC–05, and LBB–RC–07. Among all the specimens examined in this study, the bulk resistivity of AMA–RC–05 was particularly low, indicating a very poor condition of the concrete deck.

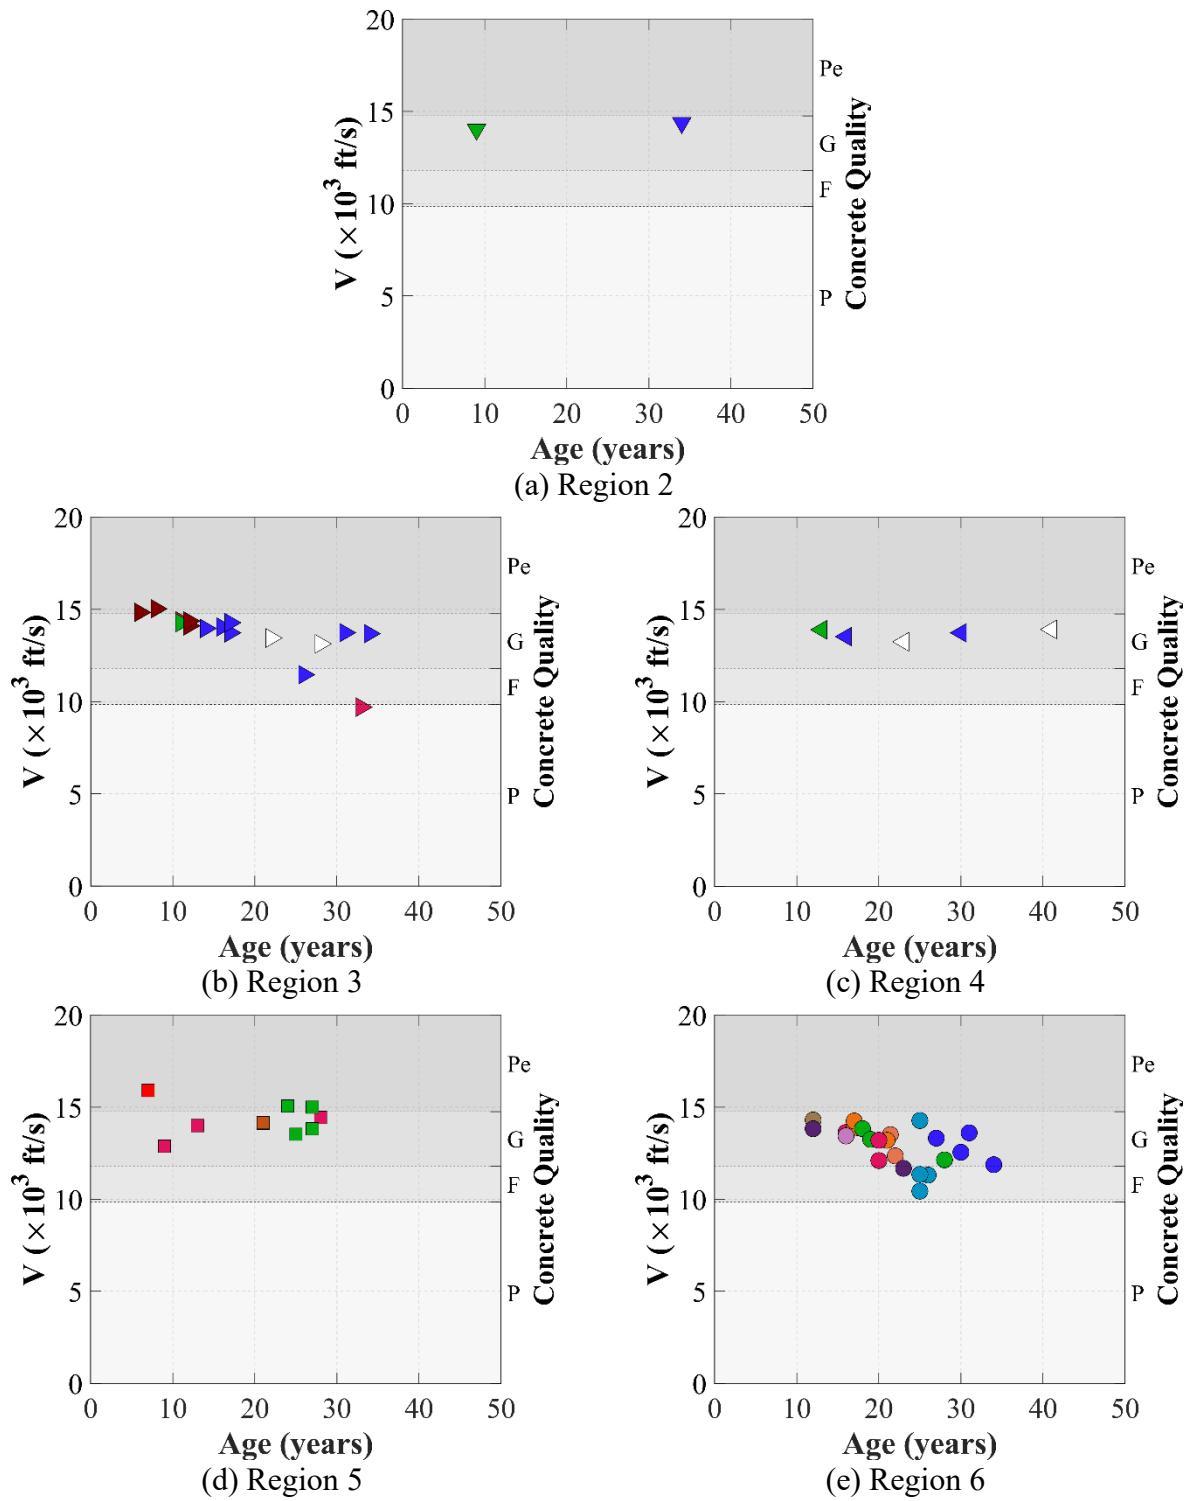
Figure 4.14. Recorded Sound Wave Velocity in Aged Concrete Specimens Based on Different Corrosion Risk Environments.

Figure 4.14 and Figure 4.15 show speed of sound waves measured in concrete specimens per region. Two bridges in Region 3 were identified as having poor-quality concrete. ELP–RC–03, which utilized HPC in its mixed design, was found to be in poor condition. This result highlights the need for additional investigation of the concrete deck, particularly considering that the bridge was constructed over 30 years ago. Similarly, FTW–RC–05, despite being relatively new compared to the El Paso bridge, was classified as being in fair condition.

In a low corrosive environment, UPV examination was carried out only on one core sample from the Atlanta area (ATL–RC–05). The lack of additional cores for testing in this environment was due to the limitations mentioned earlier, such as the presence of embedded steel bars in core specimens or the allocation of samples for other test measurements. ATL–RC–05 was constructed recently and made of regular reinforced concrete with embedded ECR. The quality of the concrete was estimated to be in good condition based on the velocity of the sound wave, which was measured to be approximately 14×10^3 ft/s.

In Region 3, except for ELP–RC–03 and FTW–RC–05, the quality of concrete in other samples was generally estimated to be in good or perfect condition. Particularly, the newly constructed HPC bridges exhibited perfect concrete quality. However, an older bridge constructed with HPC with embedded epoxy rebar showed poor concrete condition (ELP–RC–03). For bridges older than 15 years, bridge structures were mostly made of ordinary reinforced concrete with CST(LO/SI) applied on top of the bridge deck. Overall, most of these bridges were in good condition, with the exception of FTW–RC–05. In addition, all concrete decks located in Region 4 were found to be in relatively good condition. These structures were constructed with ordinary concrete reinforcement, and in some cases, CST(LO/SI) was applied to the deck of these bridges.

The quality of the concrete was estimated to be in good condition for the majority of concrete decks located in the highly corrosive environments of Region 5 and Region 6. In Region 5, most bridges were constructed using regular concrete, while some of them utilized embedded ECR. ATL–RC–06, a newly constructed concrete deck, was made of HPC with embedded epoxy. However, the UPV measurements for ATL–RC–06 showed that although the quality of the concrete was good, the velocity of the sound wave was slightly lower than other specimens obtained from different concrete decks in the region, which suggests that there may be some moisture diffusion in Atlanta's bridge structure.

The quality of concrete decks was generally identified to be in good condition in Region 6. However, there were a few exceptions. One of the concrete decks, LBB–RC–06, located in Lubbock, was classified as in fair condition. Another concrete deck, CHS–RC–04, located in Childress, was also classified as fair condition. The deck was constructed using HPC. Both structures have embedded ECR in their concrete decks. In Amarillo, three concrete decks were found to be in fair to poor condition—AMA–RC–07, AMA–RC–09, and AMA–RC–05—that were constructed using regular concrete with the addition of CNI in the concrete admixture. However, it was observed that the application of HPC and CST(LO/SI) in addition to the CNI resulted in increased resistance to moisture penetration in bridge structures located in the Amarillo District. Examples of such bridges are AMA–RC–03 and AMA–RC–07.

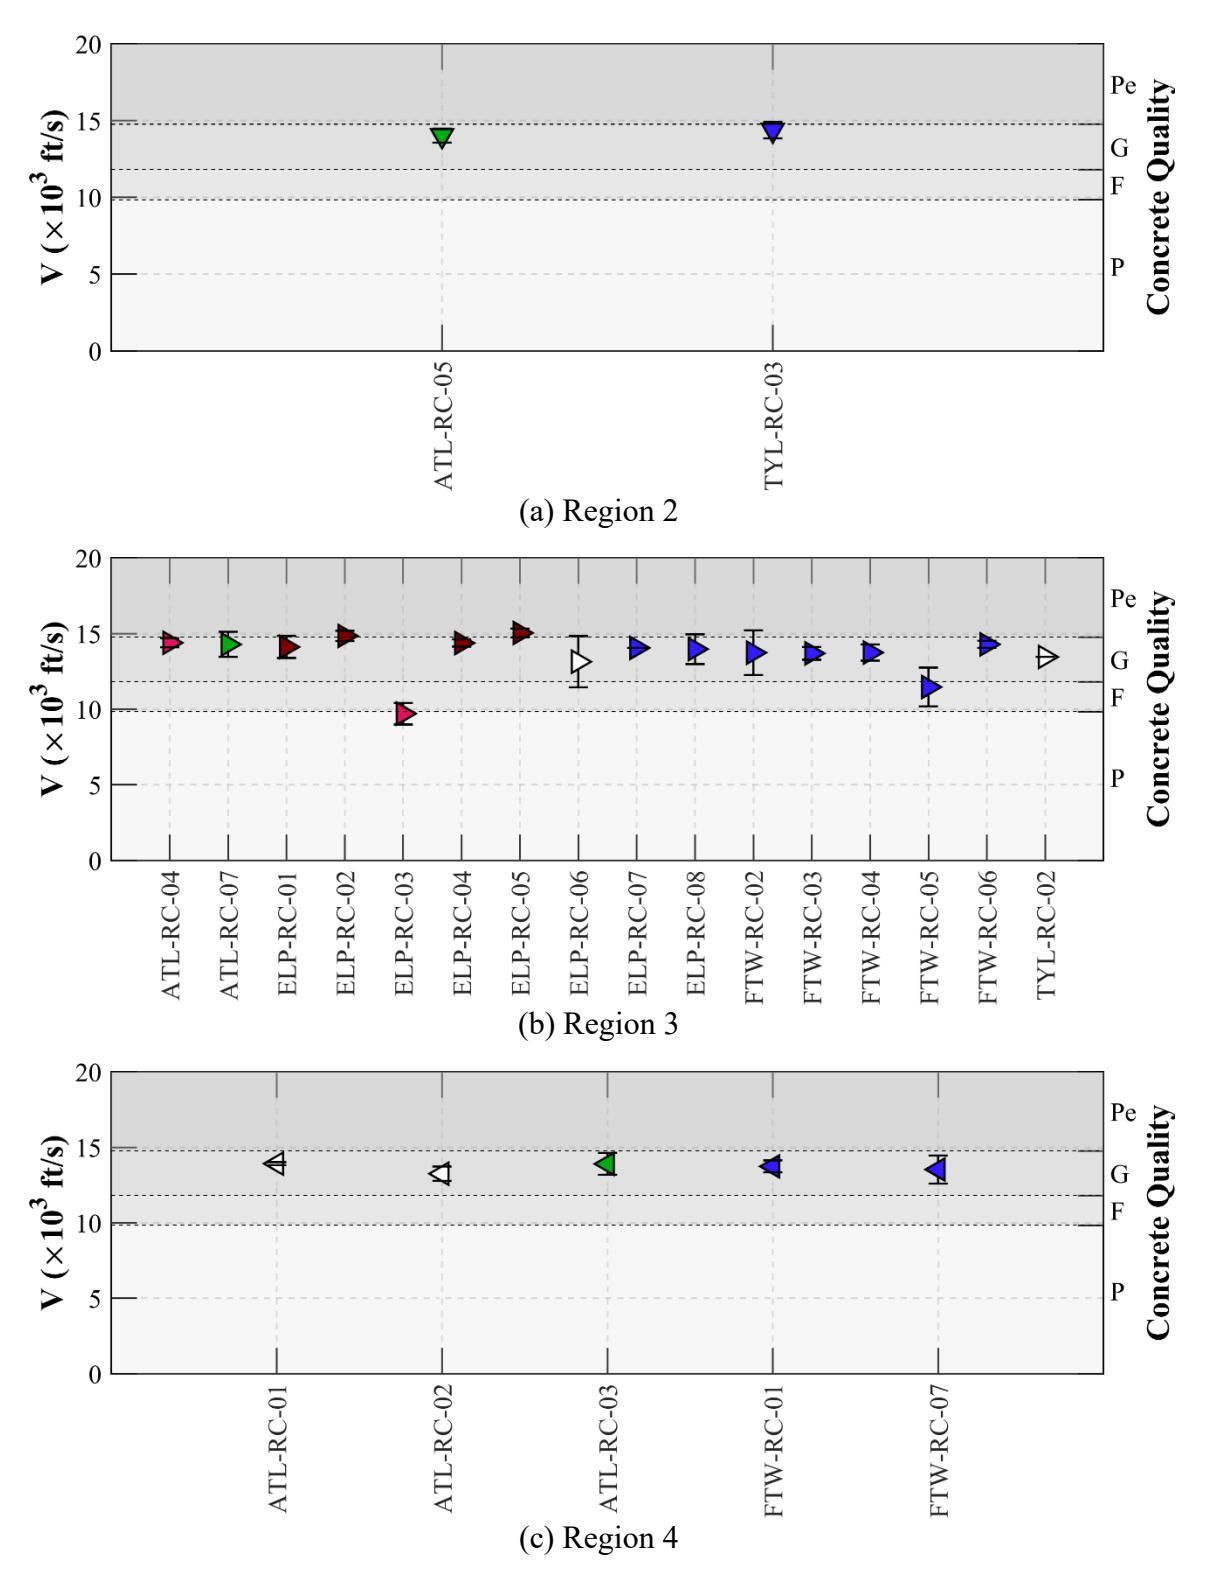
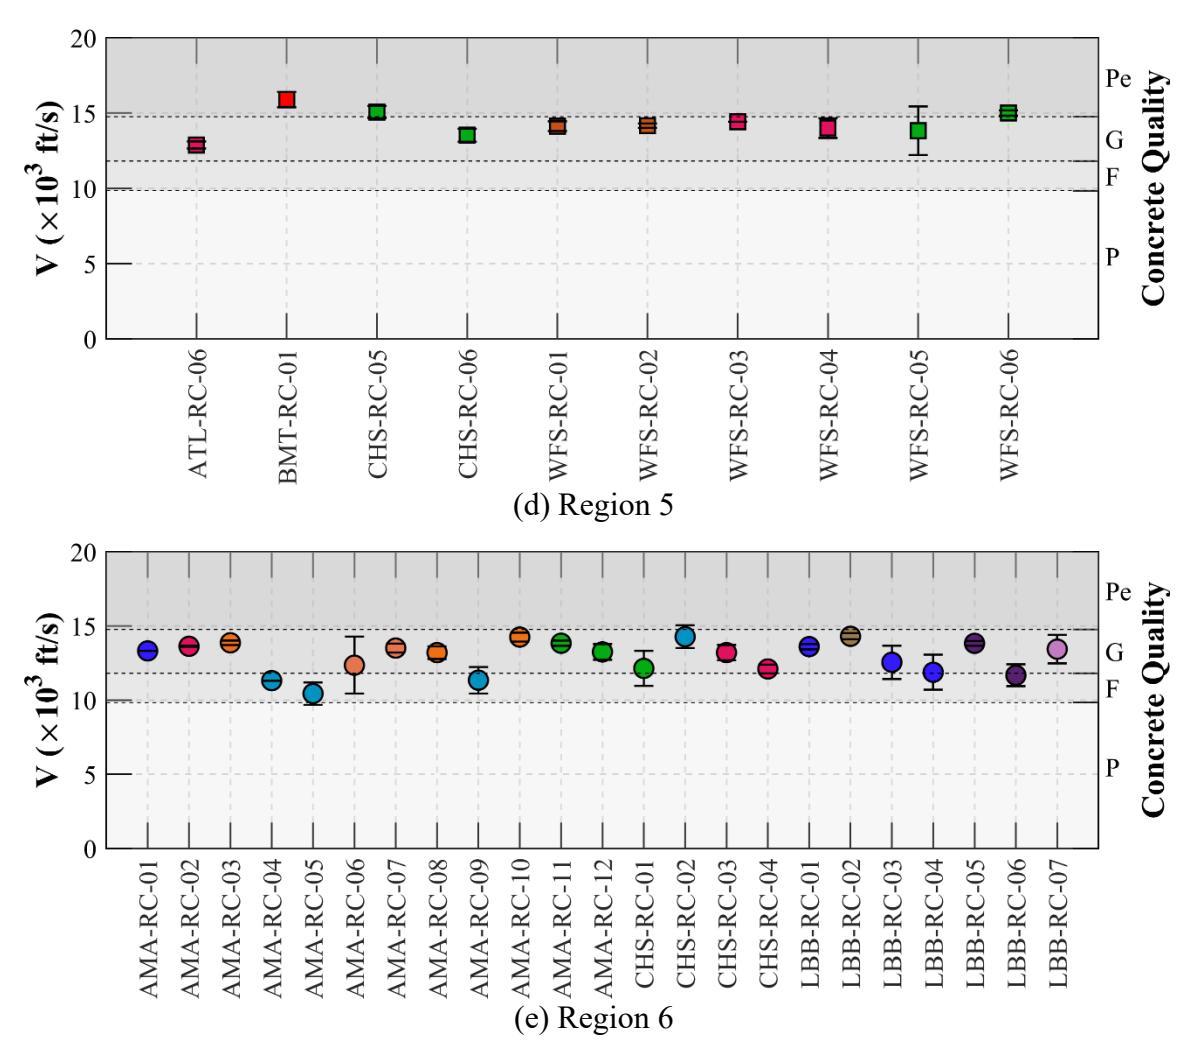
Figure 4.15. Recorded Sound Wave Velocity for Concrete Bridges.

A comparison between resistivity testing results and UPV measurements reveals some similarity of findings between to tests (Figure 4.15). For example, if the velocity of the sound wave in the specimen extracted from the concrete deck was recorded as approximately lower than 10×10^3 ft/s, then the bulk resistivity was also recorded to be less than 10 k Ω cm on average, indicating poor quality of the concrete. In a medium corrosive environment, the bulk resistivity values of ELP–RC–03, ELP–RC–06, and FTW–RC–05 were very low, which aligns with the poor quality of the concrete, as indicated by UPV testing. Particularly, ELP–RC–03 failed both resistivity and UPV tests, confirming its poor quality.

In highly corrosive environments, the bulk resistivity of core specimens extracted from ATL–RC–06 and WFS–RC–05 was relatively low. These specimens were classified as being in fair and good condition based on the UPV measurements. For BMT–RC–01, both the bulk resistivity and UPV results indicate a very high-quality concrete. The relatively high value of bulk resistivity suggests excellent corrosion resistance, which is supported by the UPV measurements classifying the concrete as perfect. In Region 6, bridges such as AMA–RC–04, AMA–RC–05, and AMA–RC–09 showed low bulk resistivity values, which raises concerns regarding the quality of the concrete. The UPV measurements also indicated low velocities for sound waves in the concrete, confirming the lower quality of the concrete. Similarly, CSH–RC–01 and CHS–RC–04 exhibited low bulk resistivity values and low UPV measurements, indicating potential issues with the quality of the concrete in these bridges, as well.

In Region 4, the recorded bulk resistivity from ATL–RC–01, FTW–RC–01, and FTW– RC–05 were very low. However, the UPV measurements showed good concrete quality for all samples taken from the deck of these bridges. Similar observations were made for the specimens from FTW–RC–03, FTW–RC–04, and TYL–RC–02 in Region 3, as well as the samples tested from CHS–RC–02, CHS–RC–03, and LBB–RC–01 in Region 6. Overall, the analysis led to the conclusion that when the UPV results indicated a low value and poor concrete quality, the bulk resistivity measurements also showed a low electrical resistivity. However, the opposite is not valid since there were cases where the bulk resistivity was relatively low but the UPV measurements indicated good concrete quality.

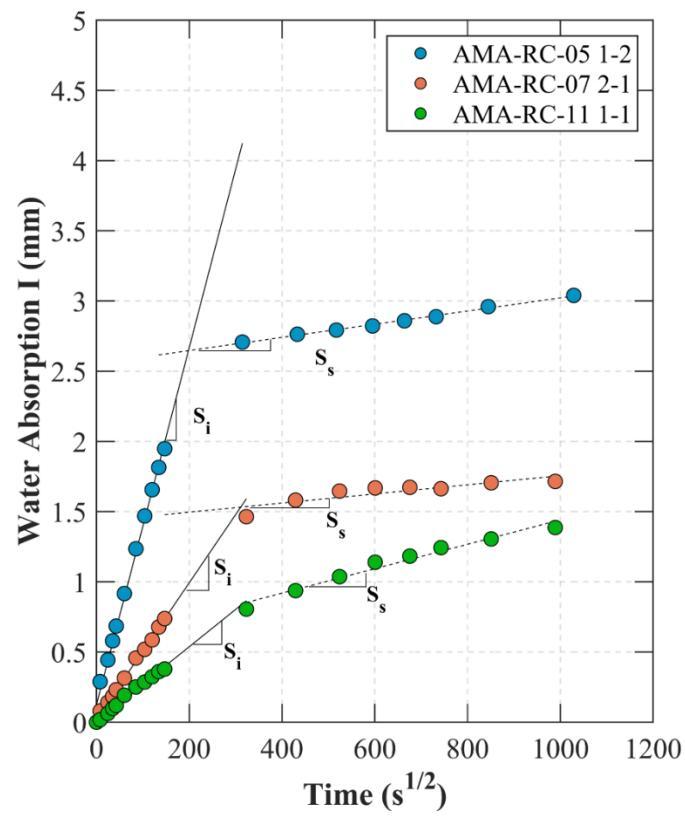
Figure 4.19. Water Absorption over 9-Day Period of Measurements.

Figure 4.19 shows the recorded data of capillary water absorption for a period of 9 days for the specimens extracted from AMA–RC–05, AMA–RC–07, and AMA–RC–11. Using this figure, the initial sorptivity (S_i) and secondary sorptivity (S_s) were determined by analyzing the slope of the line fitted to the water absorption data plotted against the square root of time. Note that a comprehensive report of water absorption recordings for the concrete core specimens from TxDOT bridge decks is provided in the appendix.

Figure 4.19 also depicts a comparison of water absorption for three specimens taken from different concrete decks located in the Amarillo District. The results indicate that the initial absorption rate of AMA–RC–05, which has been in service for 26 years, was significantly higher

than the other two specimens. CNI was used in the mixed design of AMA–RC–05 and AMA–RC– 07, but the results of the absorption test indicate a significantly lower initial sorptivity for AMA– RC–07 than for AMA–RC–05. AMA–RC–11, constructed with ordinary reinforced concrete and in service for 19 years, exhibited a lower initial absorption rate than the other specimens, suggesting a higher quality of concrete in terms of resistance to water penetration.

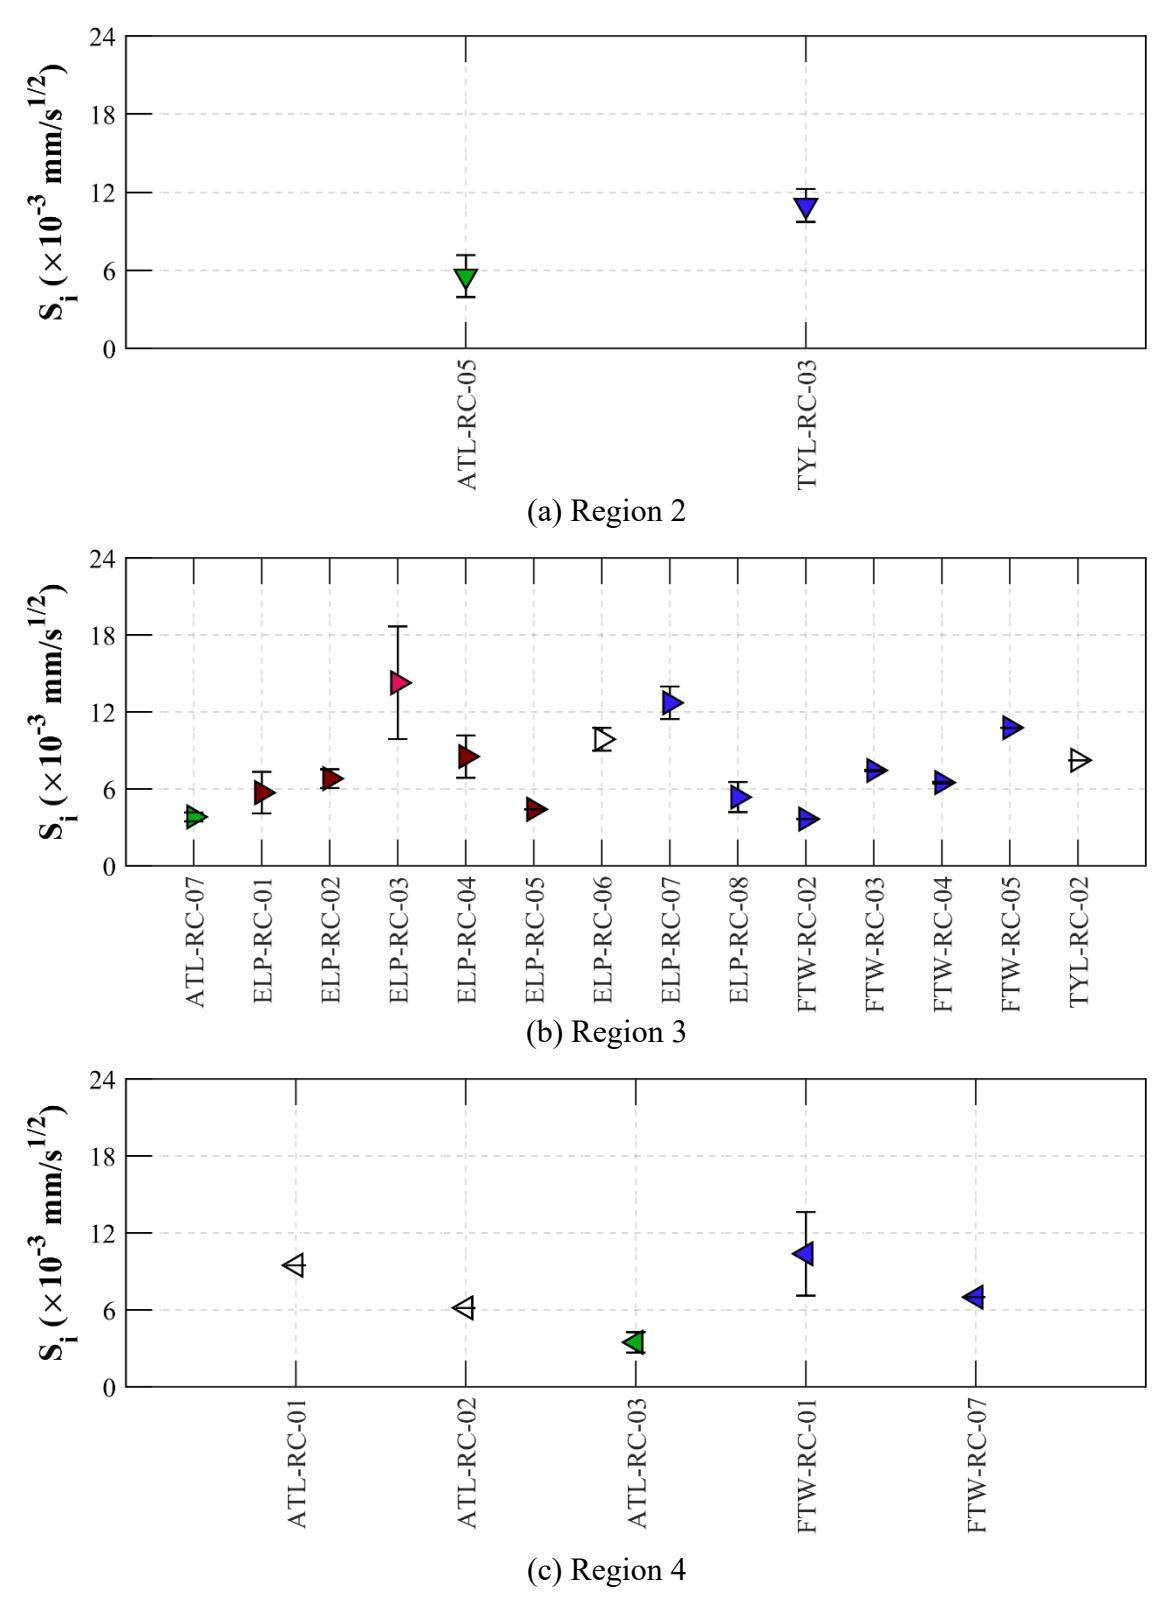
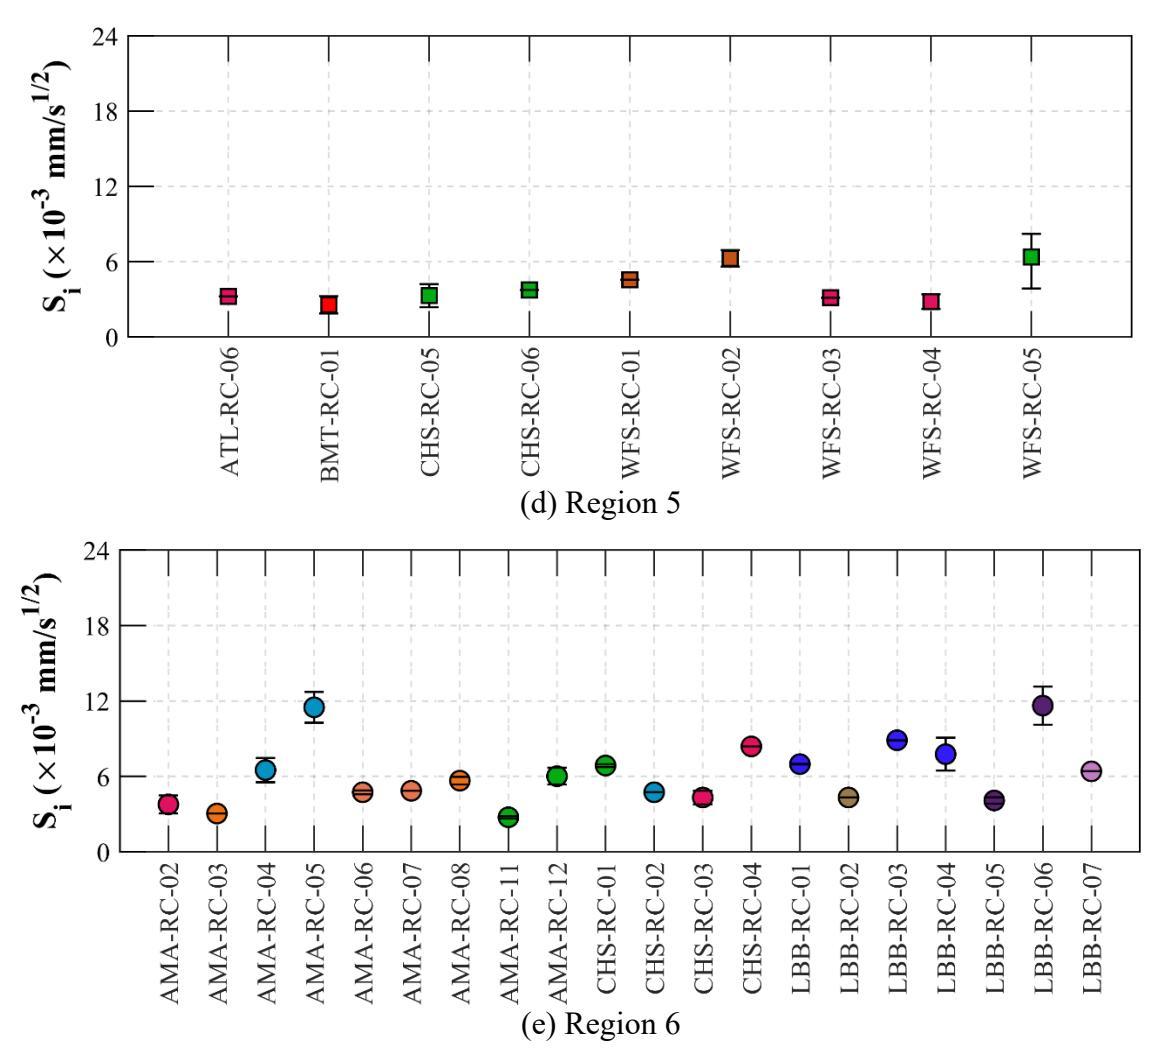
Figure 4.22. Initial Sorptivity Calculated for Concrete Bridges.

As discussed previously, the initial water absorption rate increases with concrete age, while the secondary absorption rate of concrete decreases. Studying the results presented in Figure 4.22 and Figure 4.23 provide further insight into this observation. If the secondary sorptivity is lower than 1×10^{-3} mm/s^{1/2} and the initial sorptivity is lower than 6×10^{-3} mm/s^{1/2}, then the concrete can be considered dense. However, if the initial sorptivity is higher than 6×10^{-3} mm/s^{1/2}, it indicates a higher fraction of pores in the concrete. For example, specimens taken from ELP-RC-03, AMA-RC-05 and LBB-RC-06 showed low electrical resistivity, with an average initial sorptivity of about or greater than 12×10^{-3} mm/s^{1/2} and a secondary sorptivity lower than 1×10^{-3} mm/s^{1/2}, which indicates poor-quality concrete. On the other hand, concrete cores extracted from BMT-RC-01, AMA-RC-03, and AMA-RC-11 exhibited a high electrical resistivity, averaging about or higher than 24 k Ω cm. The initial sorptivity of these samples was lower than 6×10^{-3} mm/s^{1/2}, and the secondary sorptivity was also less than 1×10^{-3} mm/s^{1/2}, indicating a dense concrete. For moderate quality concrete, the secondary absorption rate is approximately or slightly greater 1×10^{-3} mm/s^{1/2}. Improving the microstructure of the concrete, such as by improving the capillary pore size distribution and reducing void interconnection, can increase the electrical resistivity of the concrete. A finer pore structure with less connectivity results in lower permeability, higher electrical resistivity, and a slower absorption rate.
