Evaluation of Corrosion Prevention and Mitigation Approaches Used on Texas Bridges—Volume 2: Reinforced Concrete Bridges

Technical Report 0-7040-R1-Vol2

TEXAS A&M TRANSPORTATION INSTITUTE COLLEGE STATION, TEXAS

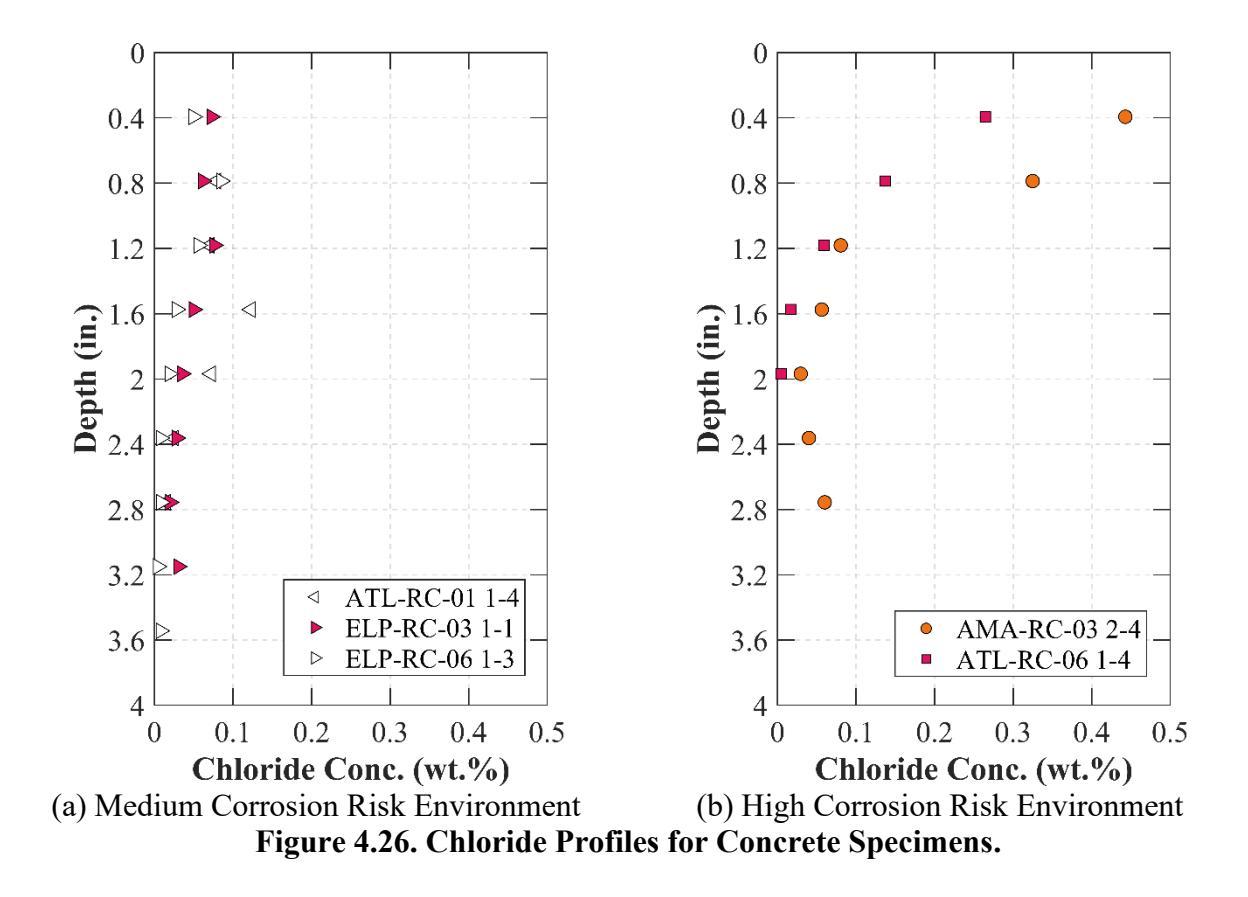
Figure 4.26(a) shows chloride profiles generated for some concrete specimens examined in this work. As illustrated in this figure, the concentration of chloride generally decreased for the samples extracted from deeper concrete layers, and it was negligible at the rebar level. The diffusion of chloride was low (lower than 0.1 % wt. concrete) for different depths of the specimens taken from ELP–RC–03, while the bulk resistivity for this bridge was recorded on average lower than 5.2 k Ω cm, and the initial sorptivity was calculated on average higher than 12×10^{-3} mm/s1/2. The results obtained from resistivity and water absorption examinations indicate that the concrete used in ELP–RC–03 and ELP–RC–06 is not in good condition. However, it can be concluded that the amount of salt applied on the bridge deck over the years was not significant; otherwise, the concentration of chloride should be higher than the measured values. Similarly, samples taken from ATL–RC–01 exhibited the same chloride diffusion pattern, even though the resistivity of the concrete was relatively low and the initial sorptivity was calculated relatively high.

Figure 4.26(b) also shows results obtained for ATL-RC-06 and AMA-RC-03, both constructed with good quality concrete. These structures can resist the diffusion of chloride ions

as long as cracks do not appear on the concrete surface. For example, the chloride concentrations in specimens extracted from the concrete decks were relatively high near the surface but significantly reduced as the depth of the concrete increased. The bulk resistivity measured for ATL–RC–06 was on average 10 k Ω cm and for AMA–RC–03 was 24 k Ω cm. The initial sorptivity calculated for these structures was lower than 6 × 10⁻³ mm/s^{1/2}, indicating the presence of dense concrete. A comprehensive report containing the chloride profiles tested in this study is included in the appendix.

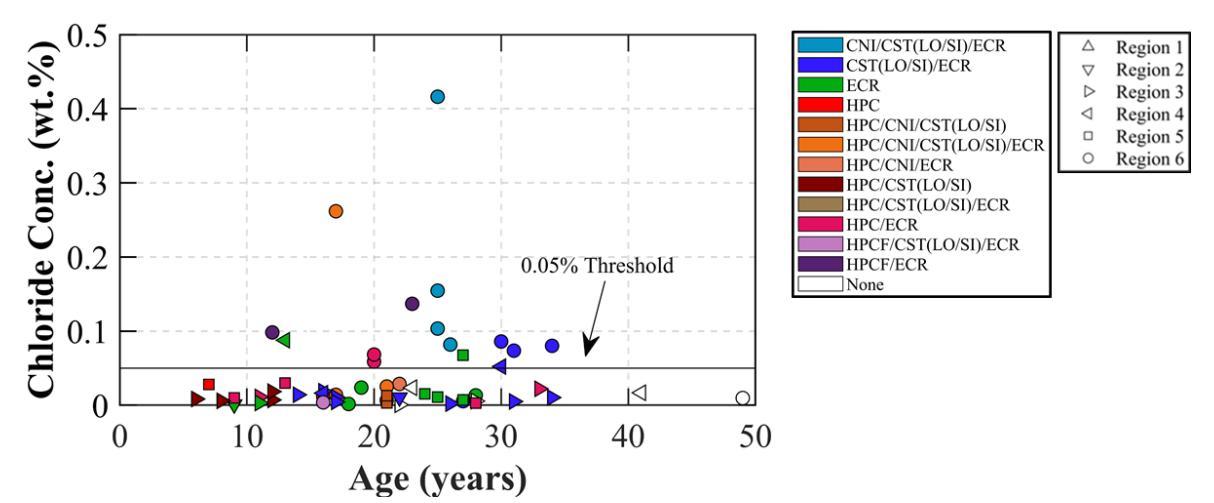
Figure 4.27. Chloride Concentration at the Concrete and Steel Reinforcement Interface.

Figure 4.27 shows the concentration of chloride ions at the concrete and steel reinforcement interface. The chloride threshold was lower than 0.05 % wt. conc. for most of the specimens examined in this study. However, in a highly corrosive environment such as Region 6, chloride ions diffused deep into the concrete, regardless of the employed mitigation method. Chloride concentration at the rebar level was determined to be on average greater than 0.05 % wt. conc. for most concrete decks in Region 6, two bridge decks in Region 4 (ATL–RC–03 and FTW–RC–01), and one deck located in Region 5 (WFS–RC–06). However, the concentration was still less than 0.1 % wt. conc. for the structures in Region 4 and Region 5.

The distribution of chloride ions in concrete can be heavily affected by several parameters such as environment, concrete composition, and the presence of cracks on the surface. In areas with high deicing salt exposure, such as Amarillo and Childress, concrete samples can have higher surface chloride concentration due to the heavy application of deicing salt. In addition, the chloride concentration on a bridge deck can vary in different areas of the structure. Chloride-laden water can flow down and accumulate on the shoulder lane due to the slope of the concrete deck. Thus, the surface chloride concentration in the shoulder lane of some bridges can be larger than that of the driving lane, leading to a higher risk of corrosion of the steel reinforcement within the concrete, particularly if the shoulder lane is not properly sloped or drained.

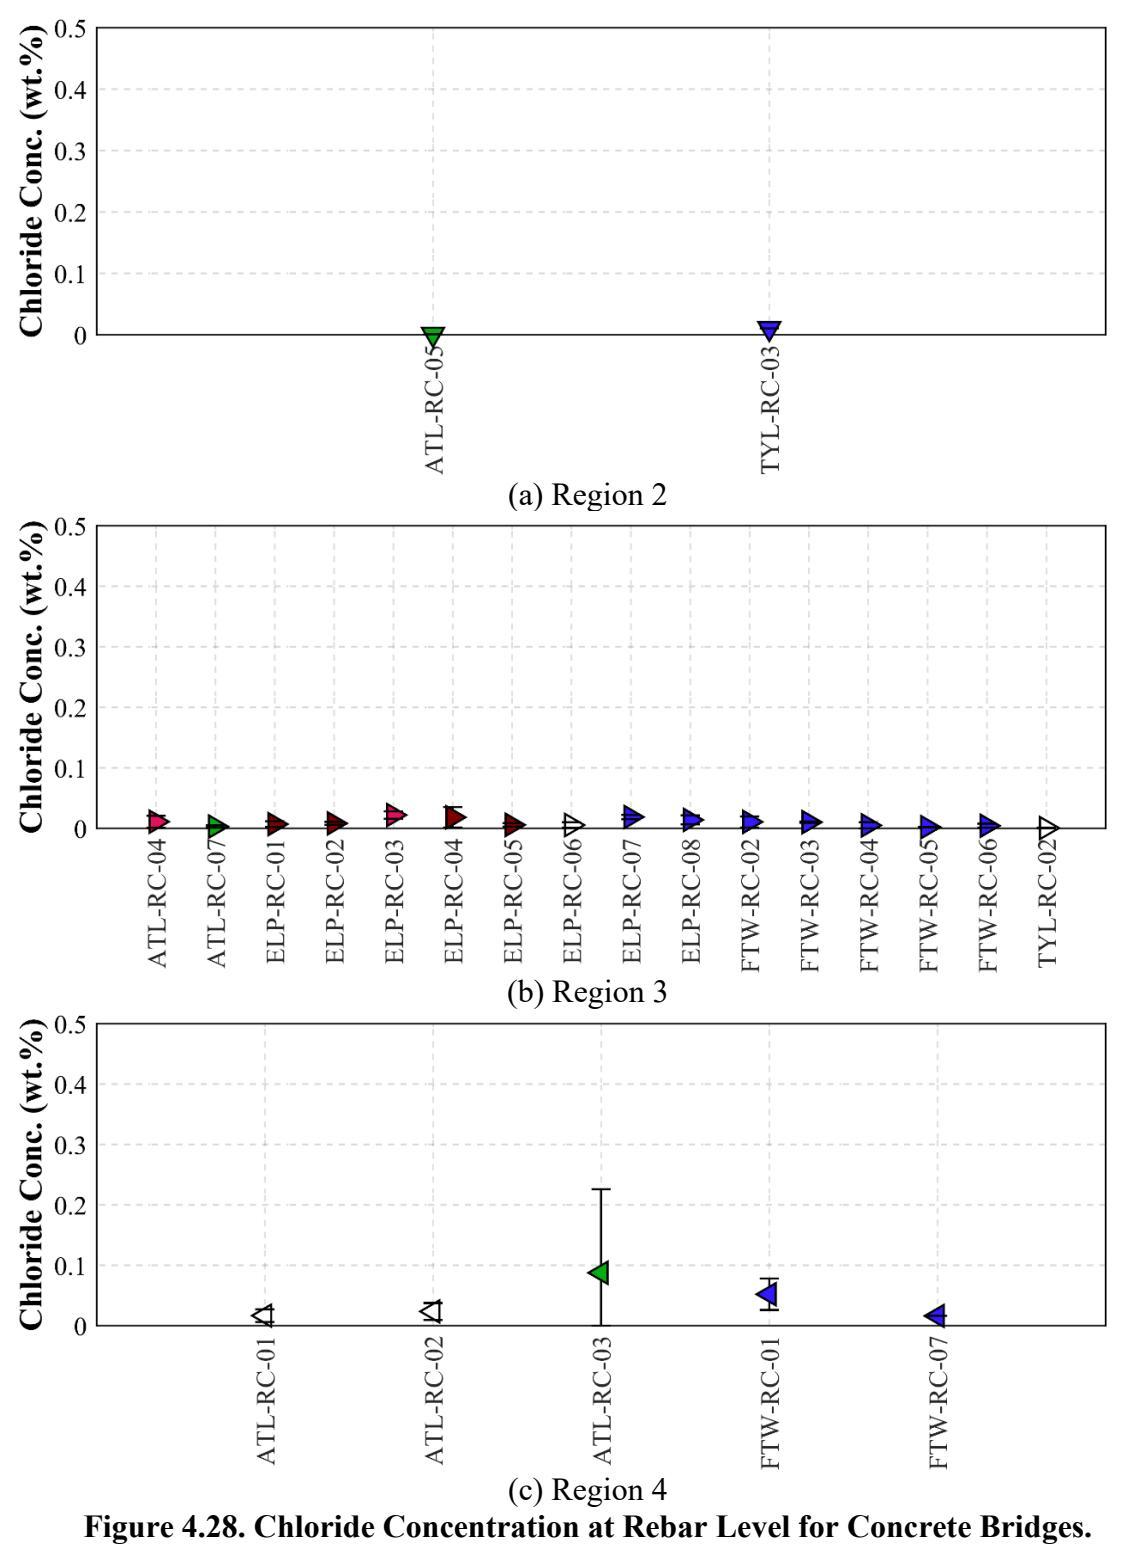
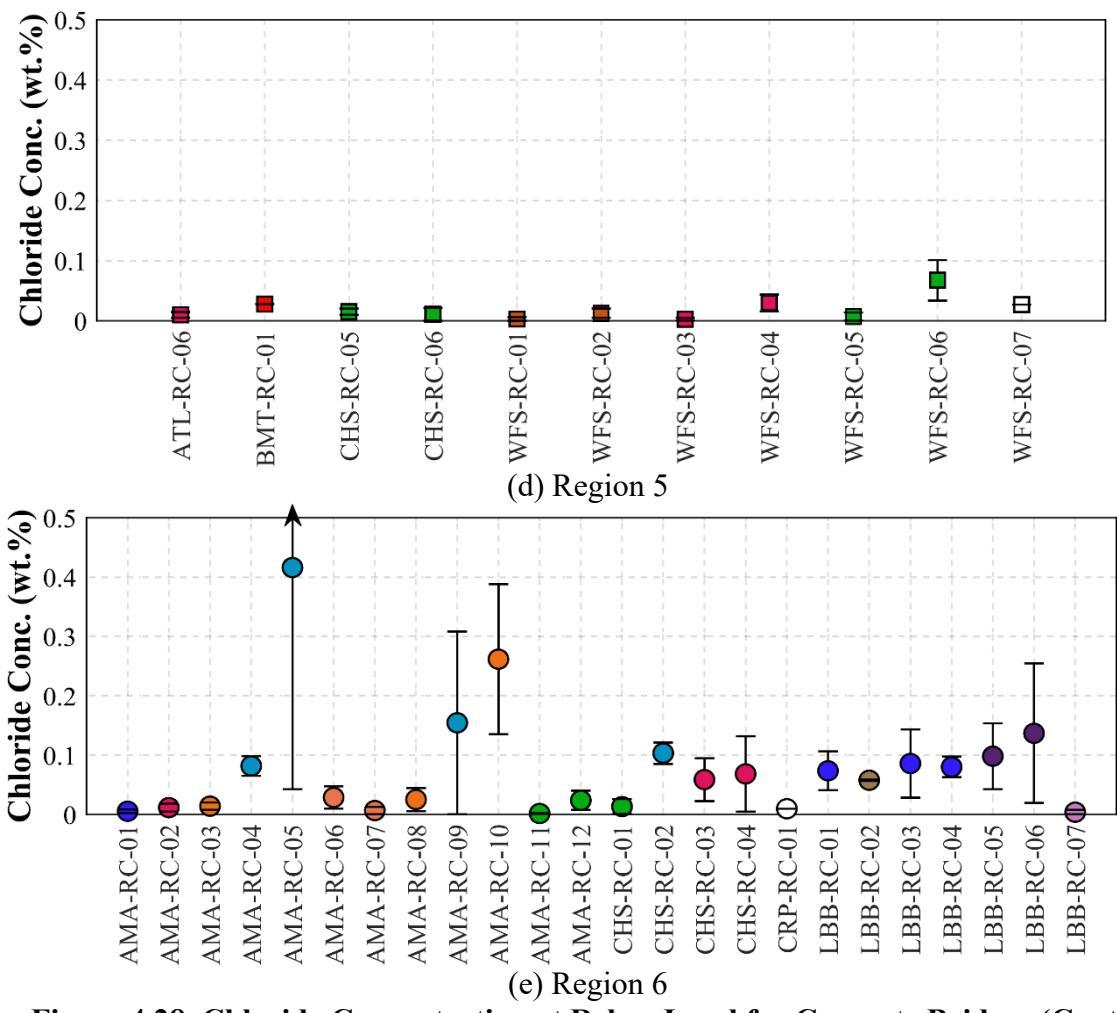
Figure 4.28. Chloride Concentration at Rebar Level for Concrete Bridges (Cont.).

Figure 4.28 shows the range of chloride concentration at the rebar level of every individual bridge. The diffusion of chloride ions in concrete was negligible at the interface of steel and concrete for most of the concrete decks across Texas, except those located in Region 6 (as discussed). The concentration of chloride in concrete cores extracted from AMA–RC–05 and LBB–RC–04 measured significantly high, particularly for specimens taken from the concrete shoulders (as referred to in the appendix). The recorded bulk resistivity for these specimens was remarkably low, whereas the calculated initial sorptivity was high. A similar pattern was observed for AMA–RC–09; the level of chloride ions was considerably high for the specimen extracted from the concrete shoulders. Bulk resistivity measured for this concrete deck was also low, but the initial sorptivity of this structure is not known because no specimen from this structure was examined during the water absorption test.

Although the chloride level increased to 0.4 % wt. conc. at the surface, the chloride concentration at the HPCF concrete and steel rebar interface was negligible for core specimens obtained from LBB–RC–07, which implies resistance of the concrete deck to chloride diffusion, even though salt accumulates at the top layers of the concrete cover. The average of bulk resistivity measured for specimens taken from LBB–RC–07 was about 20 k Ω cm, and the initial sorptivity was measured at 6 × 10⁻³ mm/s^{1/2}. It was concluded that the concrete deck of LBB–RC–07 is in good condition. A similar pattern was observed for LBB–RC–02. The average of chloride concentration at the rebar level for other specimens extracted from concrete decks in the Lubbock District exceeded the chloride threshold of 0.05 % wt. conc. recommended by Angst et al. (Angst et al., 2009).

Chloride content at the rebar level measured higher than the chloride threshold for specimens taken from concrete decks in the Childress District, with the exception of CHS–RC–01. Note that the results obtained from potentiometric titration for specimens examined in this district agree with the measurements obtained from the resistivity, UPV, and water absorption examinations.

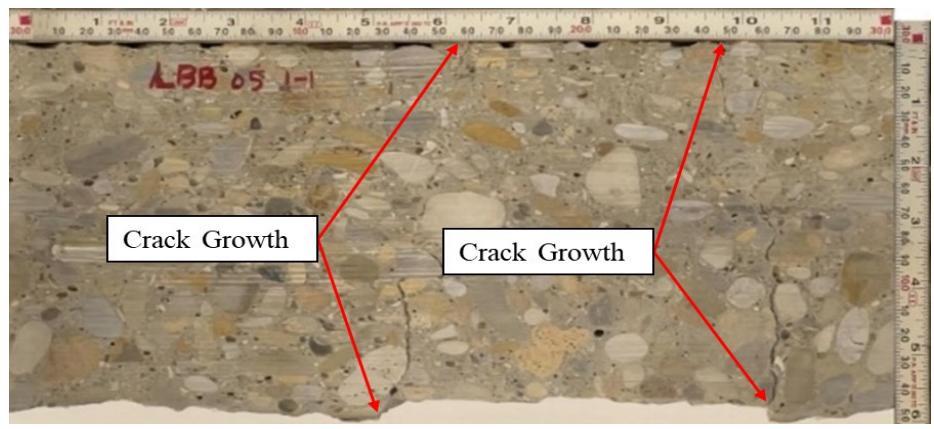
(a) Core Specimen Obtained from LBB-RC-05

The accumulation of chloride ions at the concrete and steel interface (at least for the three concrete decks shown in Figure 4.29) was due to crack formation on the top surface of the concrete. These cracks propagated within the concrete, reaching the level of the rebar. Chloride ions can transport through these cracks and subsequently aggregate near the steel reinforcement. Particularly in the Amarillo and Lubbock Districts, where the application of deicing salt on bridge roads is substantial, the average chloride content at the steel rebar was high. In fact, corrosion rust and peeling of the epoxy coating were detected for core specimens taken in Region 6.

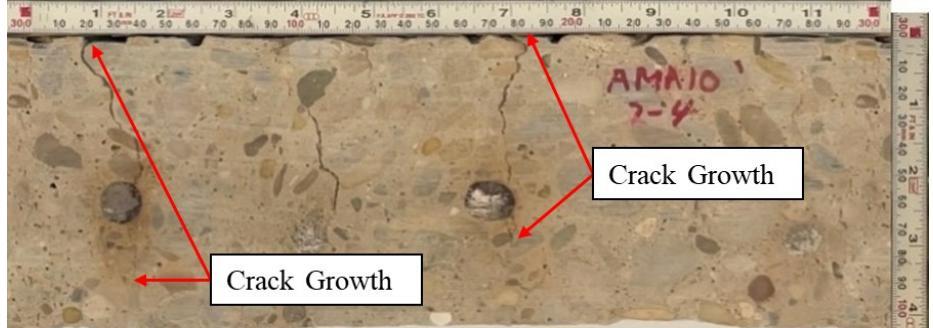
(b) Core Specimen Obtained from AMA-RC-10

The coating of the sample taken from AMA–RC–10 deteriorated and was ranked 2. As discussed previously, the concentration of chloride at the concrete and rebar interface was recorded as being high for the specimen obtained from this concrete deck—on average 0.14 % wt. conc.

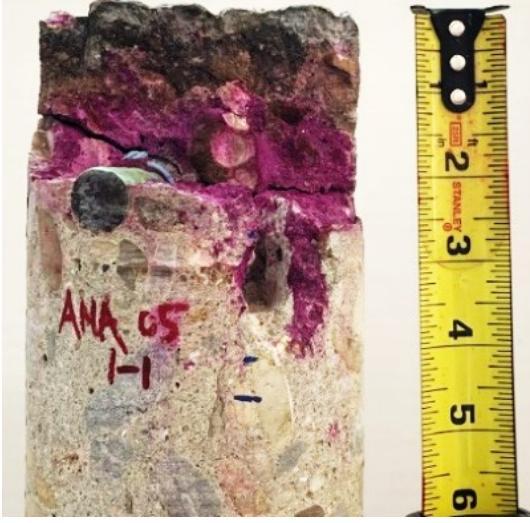
Figure 4.31. Measurement of Carbonation Depth for Concrete Specimens.

example, Figure 4.31 illustrates the procedure taken for measuring the carbonation depth of a concrete specimen extracted from AMA–RC–05. As shown in this figure, the top layers of the core sample remained colorless after applying the phenolphthalein solution, but the rest turned pink, indicating an alkaline environment. After a day, researchers measured the length of the colorless sections at four different locations to the nearest 0.04 in., and the average of the measurements was recorded as the crack depth or carbonation depth. In this example, the colorless surface turned into a blackish color after a while because the location was a crack face exposed to air for long time. Therefore, the testing area was documented as crack depth rather than carbonation depth.

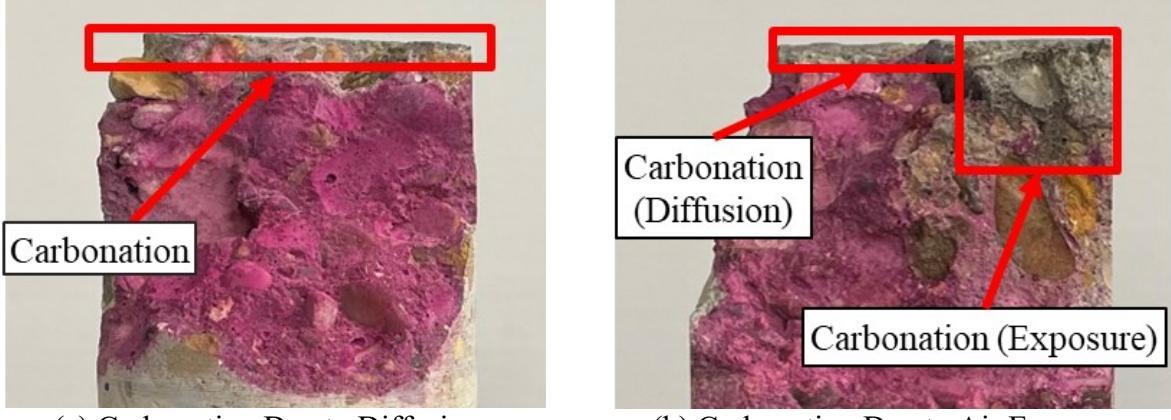
(a) Carbonation Due to Diffusion (b) Carbonation Due to Air Exposure **Figure 4.32. Carbonation Depth Measurement—AMA–RC–03; Core Sample 1–4.**

Figure 4.32 depicts the carbonation of concrete specimens obtained from AMA–RC–03 after applying the phenolphthalein solution on the fresh broken face. If the tested surface was colorless after applying the solution, as shown in Figure 4.32(a), the depth of the colorless area was considered as carbonation due to diffusion of carbon dioxide in concrete. When the concrete surface was exposed to air for a long period, carbonation might already have happened, and the tested area turned to a dullish color, as shown in Figure 4.32(b). Therefore, it was concluded that the area with the dullish color had been exposed to air because of cracks on the top surface and had been carbonated over a period of time. The carbonation depth was then only measured from the locations without any cracks to only consider carbonation depth due to diffusion of carbon dioxide in concrete.

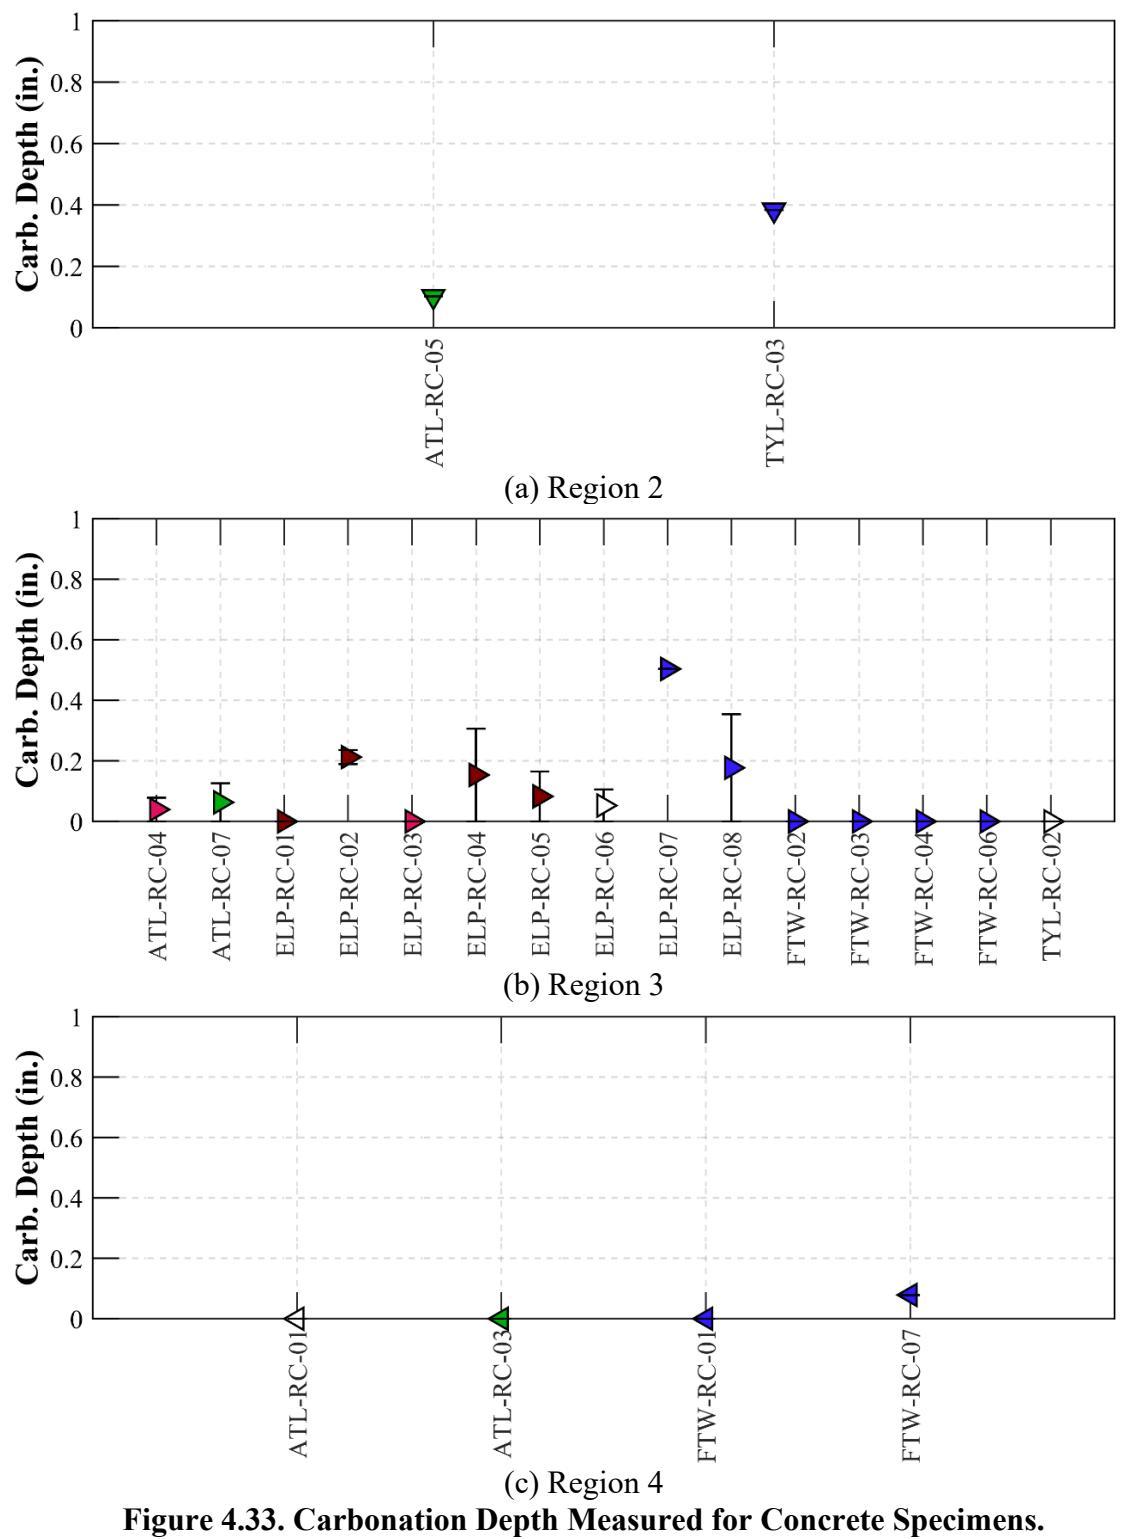
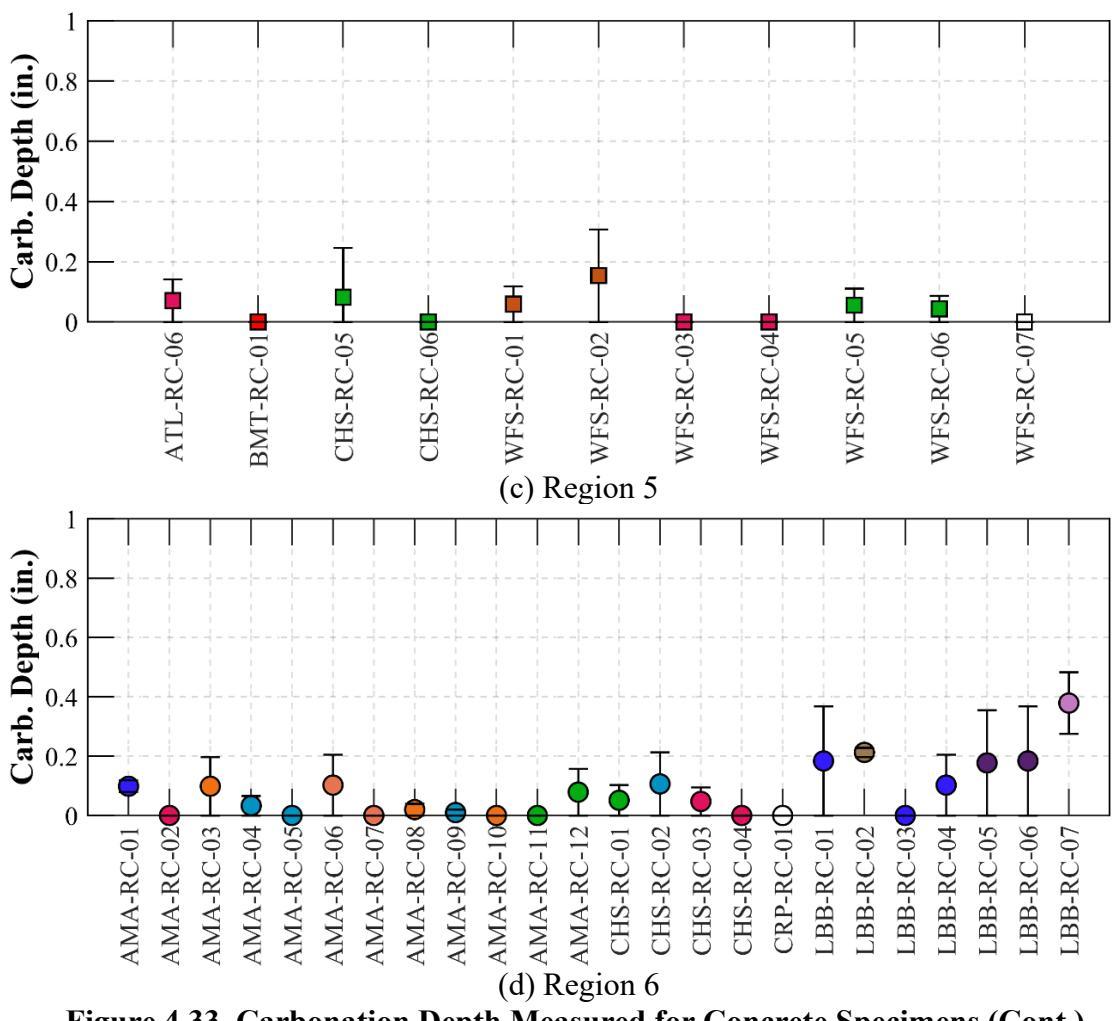
Figure 4.33. Carbonation Depth Measured for Concrete Specimens (Cont.).

Figure 4.33 represents the carbonation depths measured for core specimens taken from concrete decks across Texas. Although carbonation was generally expected to be low in low-risk environments—Region 1 and Region 2—the depth of carbonation was on average approximately 1 in. for the specimens extracted from ATL–RC–05 and TYL–RC–03. The Tyler bridge is located 15 miles away from Martin Lake Coal Plant and 16 miles away from Tenaska Gateway Generating Station Gas Plant. Similarly, the Atlanta bridge is also located 20 miles away from Martin Lake Coal Plant and 15 miles away from Tenaska Gateway Generating Station Gas Plant. Similarly, the Atlanta bridge is also located 20 miles away from Martin Lake Coal Plant and 15 miles away from Tenaska Gateway Generating Station Gas Plant. The fact that the bridges are located in industrial environments can explain the higher depth of carbonation measured for the core specimens. The initial sorptivity was calculated on average as 12×10^{-3} mm/s^{1/2} for TYL–RC–03, while it was on average lower than 6×10^{-3} mm/s^{1/2} for ATL–RC–05.

In Region 3, carbonation was detected for specimens taken from structures located in the El Paso District, a medium corrosive environment. The level of carbon monoxide released into the air was reported to be as high as 10.9 ppmv (parts per million by volume), with an average of 2.9 ppmv, for the El Paso area from 2006 to 2022 (TCEQ, 2023). That fact may explain the development of carbonation in concrete decks located in this district. For example, carbonation depth was measured on average as approximately 0.2 in. for specimens taken from ELP–RC–04 and 0.5 in. for the samples taken from ELP–RC–07. Both bridges are located in industrial environments. ELP–RC–08 is also located in the industrial environment, and the depth of carbonation was measured on average as approximately 0.2 in. The initial sorptivity calculated for

In Region 5, the average carbonation depth measured for the core sample extracted from WFS–RC–02 was approximately 0.2 in. The recorded bulk resistivity was on average 10 k Ω cm, and the initial sorptivity was calculated to be on average 6×10^{-3} mm/s^{1/2}, indicating a good quality concrete. However, the bridge was located 6 miles away from a natural gas plant at Allendale, Texas. In Region 6, carbonation was observed for core samples obtained from the Lubbock District. Of the concrete decks inspected in this district, LBB–RC–01, LBB–RC–02, LBB–RC–03, LBB–RC–04 exhibited high resistivity and low initial sorptivity. The depth of carbonation for those older concrete decks is acceptable (all constructed before 2000). The carbonation depth was on average 0.2 in. for newly built structures LBB–RC–05 and LBB–RC–06. This reading was even higher (approximately 0.4 in.) for the specimen extracted from LBB–RC–07.

The bulk resistivity recorded for LBB–RC–05 and LBB–RC–07 was over 10 k Ω cm, and the initial sorptivity was measured lower or close to 6×10^{-3} mm/s^{1/2}. However, both bridges are constructed in the industrial zone, and both are located 3 miles away from Lubbock Central Heating and Cooling plant and 12 miles away from Jones Station gas plant at Ransom Canyon, Texas. The bulk resistivity recorded for the core specimen obtained from LBB–RC–06, located 8 miles away from Lubbock Central Heating and Cooling plant and 15 miles away from Jones Station gas plant, was lower than 5.2 k Ω cm. The initial sorptivity was also found to be on average 12×10^{-3} mm/s^{1/2}. Hence, the quality of the inspected concrete deck is reported to be poor.

In general, it was concluded that carbonation is not a major cause of corrosion initiation in TxDOT concrete decks if an adequate concrete cover is provided over the steel reinforcement. A depth of 0.5 in. was measured for carbon dioxide penetration within concrete specimens taken from concrete decks across Texas. Note that in the event that cracks appear in the concrete, carbonation aligns with other pollutant such as chloride and sulfur ingress can be expected to cause deterioration of steel rebar. However, the carbonation of concrete surface should not be considered as a result of carbon dioxide diffusion within concrete.

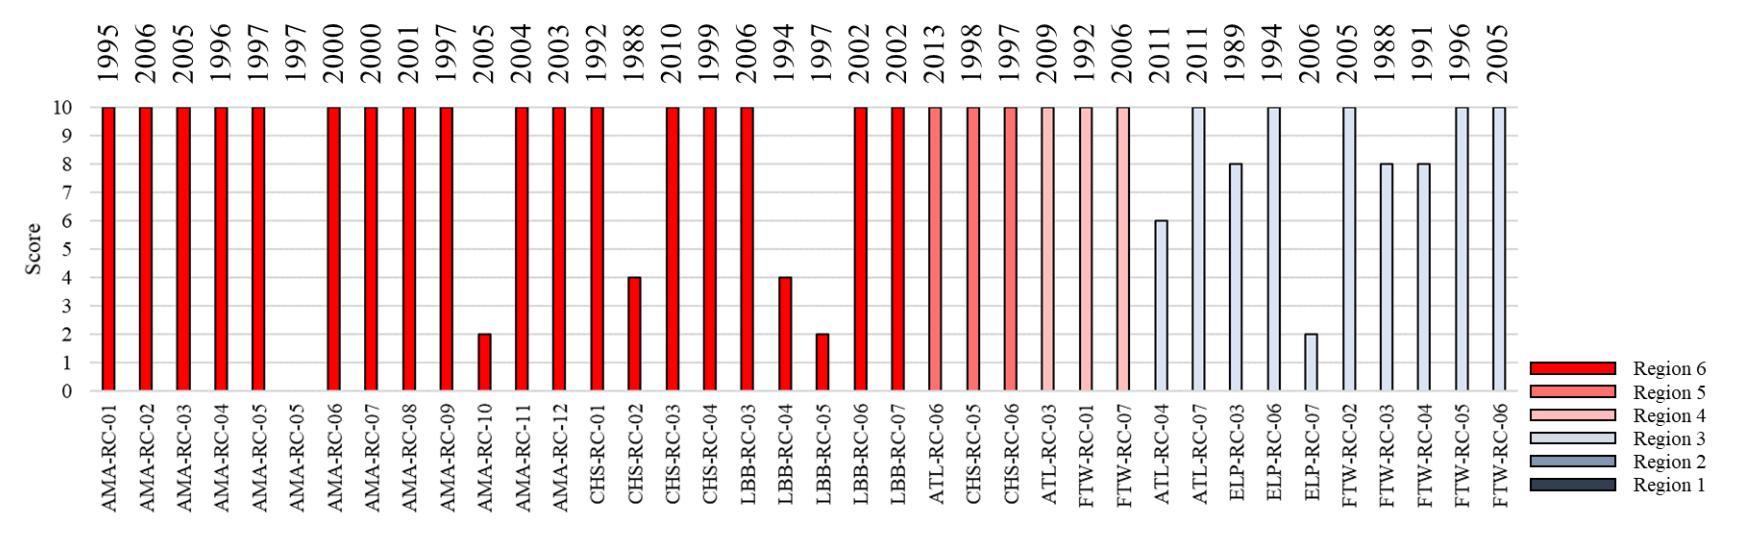
Figure 4.34. Adhesion Rating of Bridges and Built Year of Bridges.

As shown in Figure 4.34, the adhesion rating of some of the ECR extracted from core specimens from Region 6 was low, and pitting corrosion was also detected on those specimens. A low adhesion rating was also documented for some specimens taken from concrete decks in Region 3. However, no trace of corrosion was observed for these particular samples.

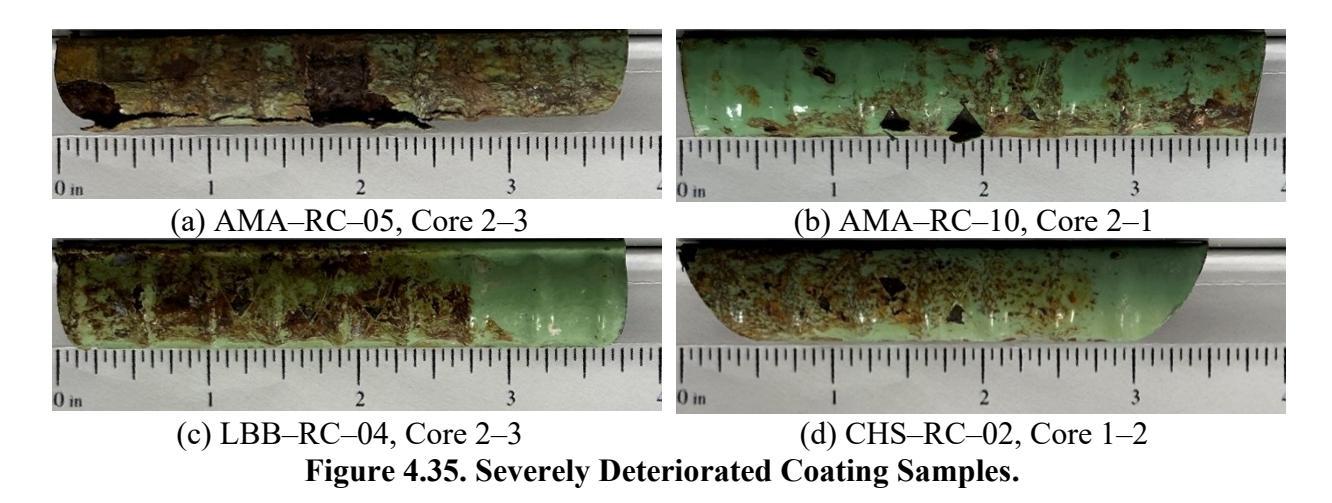
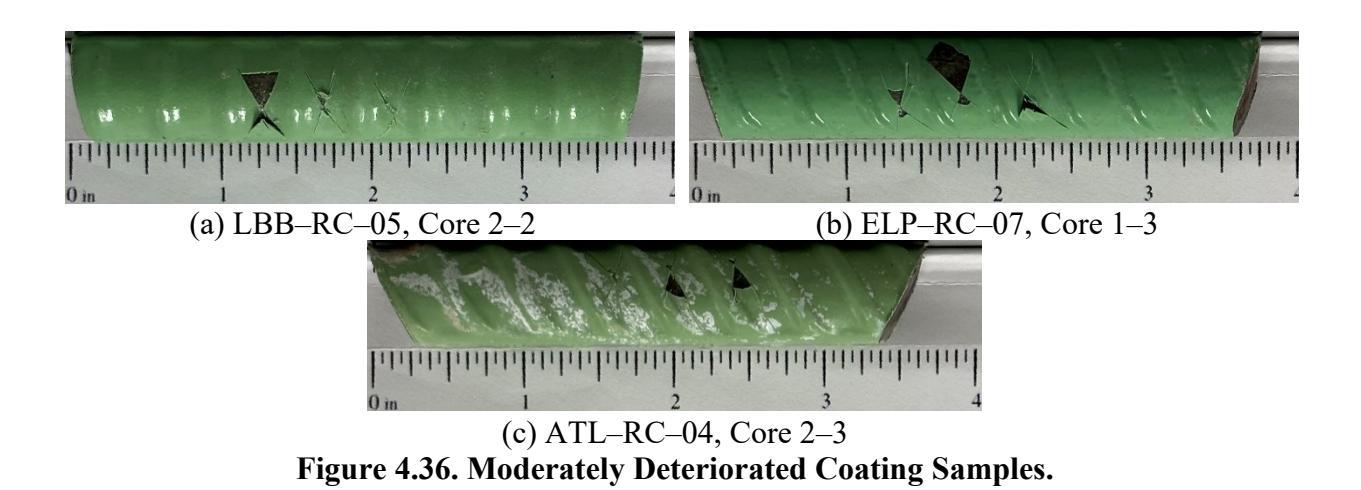
Figure 4.35 depicts rebars with severe corrosion extracted from concrete decks located in highly corrosive environments such as Amarillo, Lubbock, and Childress. Figure 4.36 shows some moderately deteriorated coatings that were ranked between 2 and 6, depending on the quality of coating adhesion. These coatings that were susceptible to chipping when subjected to light pressure were identified as "ease of removal." Among these coatings, traces of corrosion were sometimes observed on steel substrate. For example, light corrosion was detected for the samples taken from ELP–RC–07 and LBB–RC–05 as the coat was peeled off.

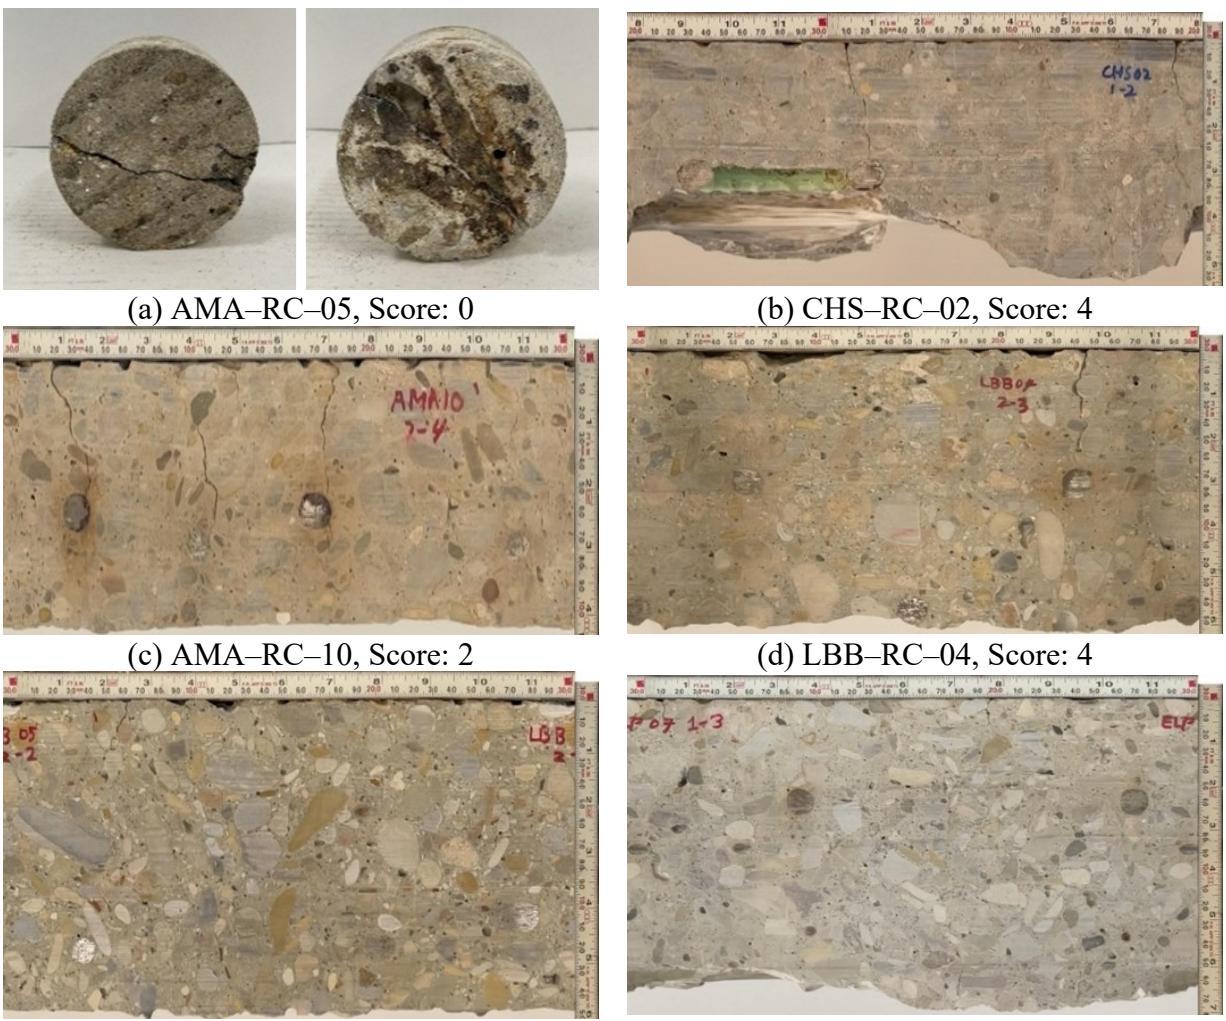
The crack condition of the cores sampled with moderately and severely deteriorated coatings are shown in Figure 4.37. Core samples from AMA–RC–05, AMA–RC–10, LBB–RC–04, and CHS–RC–02 show deep cracks, suggesting that these cracks could have led to corrosion on the coating and a loss of adhesion between the coating and the steel. In contrast, no cracks were found on the core samples from LBB–RC–05 and ELP–RC–07, indicating that other factors such

as poor quality control of the coating or handling of the ECR could have contributed to a loss of bond between the coating and the steel.

(e) LBB–RC–05, Score: 2 (f) ELP–RC–07, Score: 2 Figure 4.37. Condition of Cores of Low Adhesion Rating Bridges.

The epoxy-coated layer was not sufficiently adhering to the steel substrate for the specimen obtained from LBB–RC–05, suggesting poor surface preparation during the manufacturing of the epoxy-coated reinforcement. This issue can result in the loss of the adhesion bond and the initiation of corrosion in the future. Particularly, the chloride content at the rebar level was measured on average 0.1 % wt. conc. for the specimens extracted from LBB–RC–05 despite the good quality concrete evidenced by the result obtained during resistivity and water absorption tests.

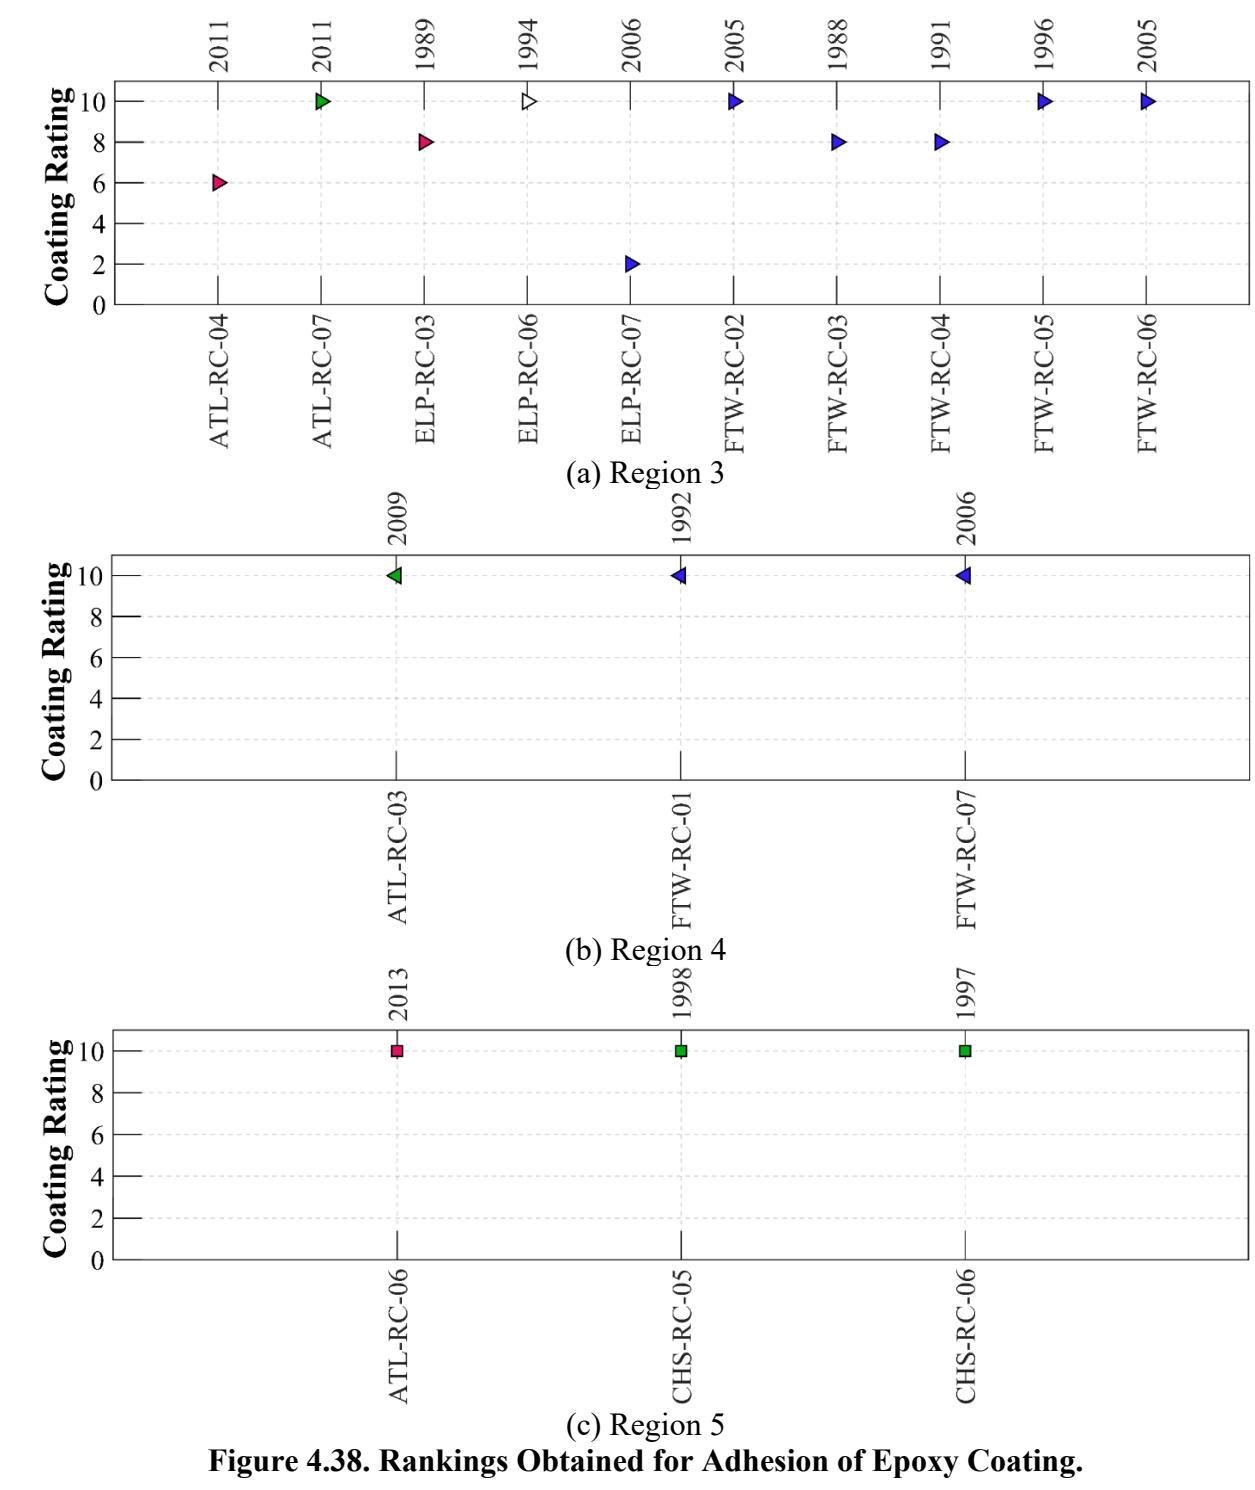
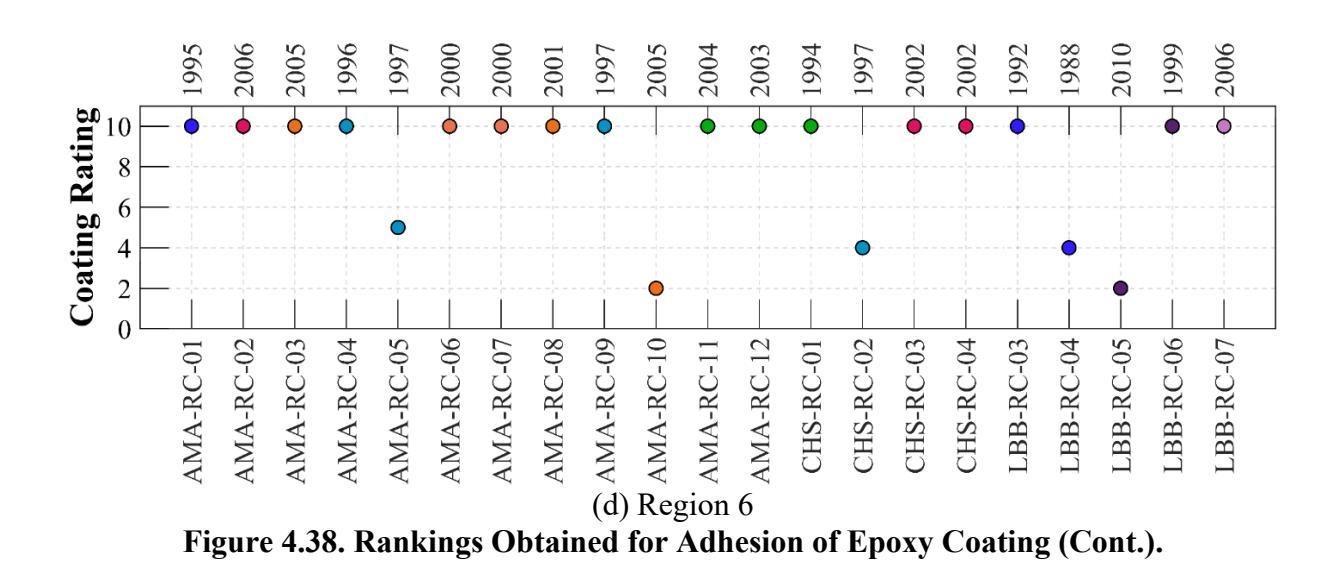
In general, researchers concluded that the bond between the steel reinforcement and epoxy coating was in good condition. However, some samples exhibited weak bonding to the steel substrate because of corrosion initiation (Figure 4.38). As shown in Figure 4.38, age of the rebar did not correlate with the condition of the coating and adhesion rating.

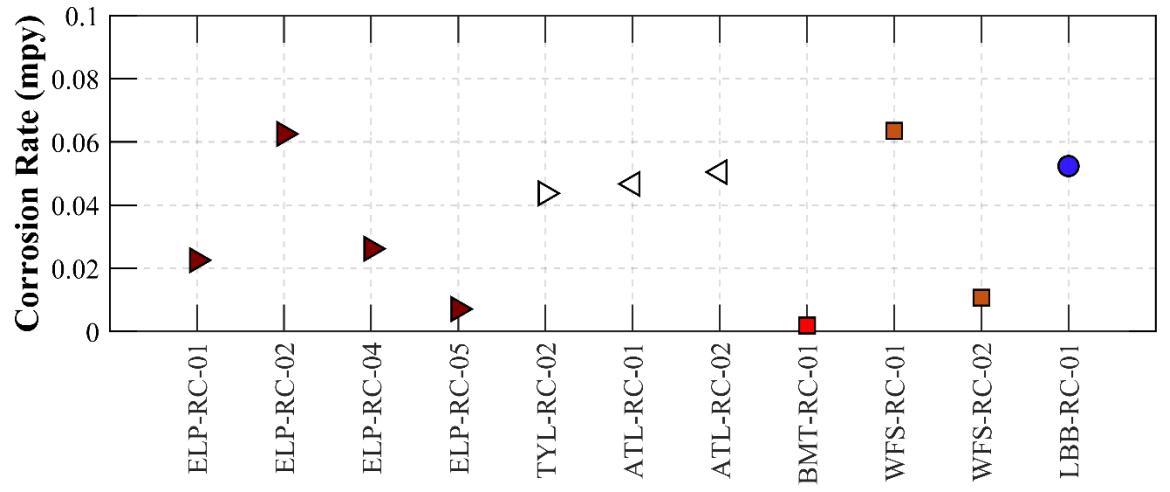
Figure 4.42. Corrosion Rate Calculated for Black Rebars Obtained from Core Specimens.

When the exchange current density of steel is below 0.05 mpy, it implies that electrochemical reactions are not taking place, or if they are, they proceed at a negligible rate, resulting in a so-called passive state. When exchange current density is between 0.05 and 0.25 mpy, it indicates low to moderate corrosion rate. As exchange current density increases within the range of 0.25 and 0.5 mpy, it suggests a moderate to high corrosion rate. When the exchange current density exceeds 0.5 mpy, then corrosion rate of the steel section should be expected to be high (Figure 4.42).

density of black rebars, are also provided in Table 4-8. The state of corrosion was obtained to be negligible or low to moderate for all the specimens. However, it is worth noting that corrosion is a localized problem, and the results shown in Figure 4.42 represent the general condition of the reinforced concrete structure.

In Region 3, the corrosion rate of the specimens was generally low since HPC was used in the construction of concrete decks. However, the specimen extracted from ELP–RC–02 exhibited a corrosion rate over 0.05 mpy, indicating a moderate rate of corrosion. The chloride concentration at the rebar level was negligible for concrete decks located in Region 3, while the initial sorptivity was calculated as being high for ELP–RC–02 and ELP–RC–04. The bulk resistivity of the specimens extracted from ELP–RC–04 was higher than ELP–RC–02, and the corrosion rate was lower. ELP–RC–01 had an average bulk resistivity of 10 k Ω cm, which is within the ELP–RC–02 range, but despite the initial sorptivity recorded for ELP–RC–02, it was lower than 6×10^{-3} mm/s^{1/2} for the specimens taken from ELP–RC–01. This conclusion is also valid for TYL–RC–02; the corrosion rate was higher than 6×10^{-3} mm/s^{1/2} (within the ELP–RC–04, while the initial sorptivity computed for this specimen was higher than 6×10^{-3} mm/s^{1/2} (within the ELP–RC–04, while the initial sorptivity computed for this specimen was higher than 6×10^{-3} mm/s^{1/2} (within the ELP–RC–04, while the initial sorptivity computed for this specimen was higher than 6×10^{-3} mm/s^{1/2} (within the ELP–RC–04, while the initial sorptivity computed for this specimen was higher than 6×10^{-3} mm/s^{1/2} (within the ELP–RC–04, while the initial sorptivity computed for this specimen was higher than 6×10^{-3} mm/s^{1/2} (within the ELP–RC–04, while the initial sorptivity computed for this specimen was higher than 6×10^{-3} mm/s^{1/2} (within the ELP–RC–04, while the initial sorptivity computed for this specimen was higher than 6×10^{-3} mm/s^{1/2} (within the ELP–RC–04), while the initial sorptivity computed for this specimen was higher than 6×10^{-3} mm/s^{1/2} (within the ELP–

In Region 4, the corrosion rate of ATL–RC–01 was almost 0.05 mpy, indicating a moderate rate of corrosion. The initial sorptivity calculated for this specimen was generally greater than 6×10^{-3} mm/s^{1/2}, and the bulk resistivity was lower than 10 k Ω cm. The corrosion rate of the black rebar in the core sample extracted from ATL–RC–02 was 0.05 mpy. The average initial sorptivity of the specimen was 6×10^{-3} mm/s^{1/2}, but the bulk resistivity is not known for this specimen. The average velocity of the sound wave in the specimens taken from ATL–RC–02 was measured at 13×10^3 ft/s, which was lower than what was measured for ATL–RC–01.

In Region 5, the average bulk resistivity of the specimens taken from BMT-RC-01 was 48 k Ω cm, and the initial sorptivity was lower than 6 × 10⁻³ mm/s^{1/2}. As shown in Figure 4.42, the rate of electrochemical reactions happening on the steel surface was found to be negligible. Note that other factors can contribute to increasing the corrosion rate on steel reinforcements. For example, similar to the concrete deck in Beaumont area, HPC was utilized in the construction of the structures in Wichita Falls District. The bulk resistivity recorded for the specimen extracted from WFS-RC-01 and WFS-RC-02 was over 10 kΩ cm, and the initial sorptivity of these specimens was at or lower than 6×10^{-3} mm/s^{1/2}. The corrosion rate calculated for the steel rebar in the core specimen extracted from WFS-RC-01 was low, yet the rate was significantly greater for the black rebar in the core taken from WFS-RC-01. After reviewing the documentation provided in the appendix, it was concluded that a deep crack originating on the concrete surface and developing over the steel reinforcing bar caused the initiation of corrosion on one side of the steel member. In Region 6, the corrosion rate of steel in LBB-RC-01 was also calculated over 0.05 mpy. The initial sorptivity obtained for the core specimen was higher than 6×10^{-3} mm/s^{1/2}, and the average bulk resistivity was lower than $10 \text{ k}\Omega$ cm. In addition, the average chloride concentration at the rebar level was measured at 0.08 % wt. conc. for the core samples obtained from this bridge deck. In fact, the chloride content at the rebar level was over 0.05 % wt. conc. of the threshold recommended by ACI 365.1R-17 (2017). Figure 4.43 shows the logarithmic polarization resistance calculated for core specimens with embedded ECR. The results shown in this figure were ordered with respect to the age of the concrete decks from which the core specimens were extracted. As shown in this figure, the logarithmic polarization resistance of ECR samples varies and is not correlated with the age of the specimens.
