Evaluation of Corrosion Prevention and Mitigation Approaches Used on Texas Bridges—Volume 2: Reinforced Concrete Bridges

Technical Report 0-7040-R1-Vol2

TEXAS A&M TRANSPORTATION INSTITUTE COLLEGE STATION, TEXAS

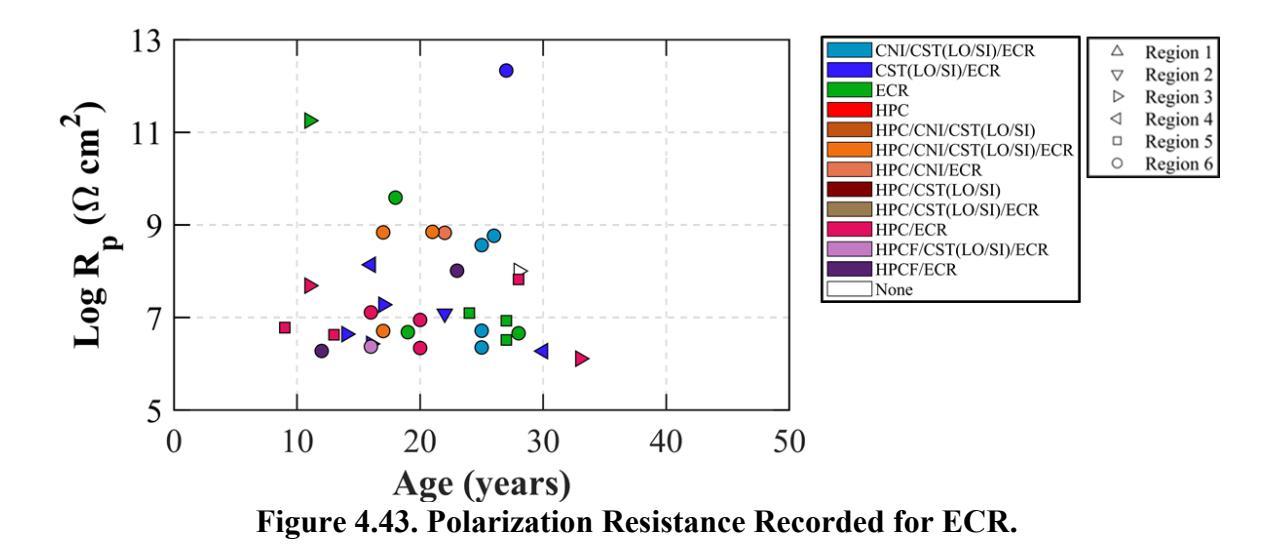
Figure 4.44 shows the electrical resistance or redox reactions occurring at the steel-coating interface in logarithmic order. The corrosion rate of the specimens embedded in concrete cores was determined to be negligible because the polarization resistance of the samples was relatively high at the metal-coating interface. For epoxy-coated steel, smaller polarization resistance indicates a higher possibility of corrosion. As the coating resistance decreases, it is indicative of an increase in corrosive agents within the concrete and the formation of corrosion products (Lau & Sabbir, 2015). Kamde and Pillai (2021) suggested that the coating resistance of an intact fusionbonded epoxy is greater than $1 \times 10^3 \text{ k}\Omega \text{ cm}^2$, which agrees with our findings from the EIS measurements conducted on the core samples taken from concrete decks. In general, the logarithmic R_p values of all the specimens was measured at or over 6 Ω cm², except AMA-RC-10 and FTW-RC-04, whose resistances were measured at 5.75 Ω cm² and 5.88 Ω cm², respectively. No sign or trace of corrosion was detected during the visual inspection of all the ECR after removing them from concrete. It was found from the EIS results documented for black rebar that electrochemical reactions proceed steadily when the logarithmic R_p value is less than 5.4 Ω cm². This feature is equivalent to a polarization resistance of 240 k Ω cm² and a corrosion rate of 0.05 mpy.

The color of the epoxy coating of specimens extracted from ELP–RC–03, FTW–RC–04, and CHS–RC–01 was found to be dark green; in comparison, other samples were bright green. The logarithmic resistance of these specimens measured low—6 Ω cm² or lower. The average initial sorptivity of cores obtained from ELP–RC–03 was calculated as 12×10^{-3} mm/s^{1/2}, and the bulk resistivity was lower than 5.2 k Ω cm, both findings indicating a poor-quality concrete.

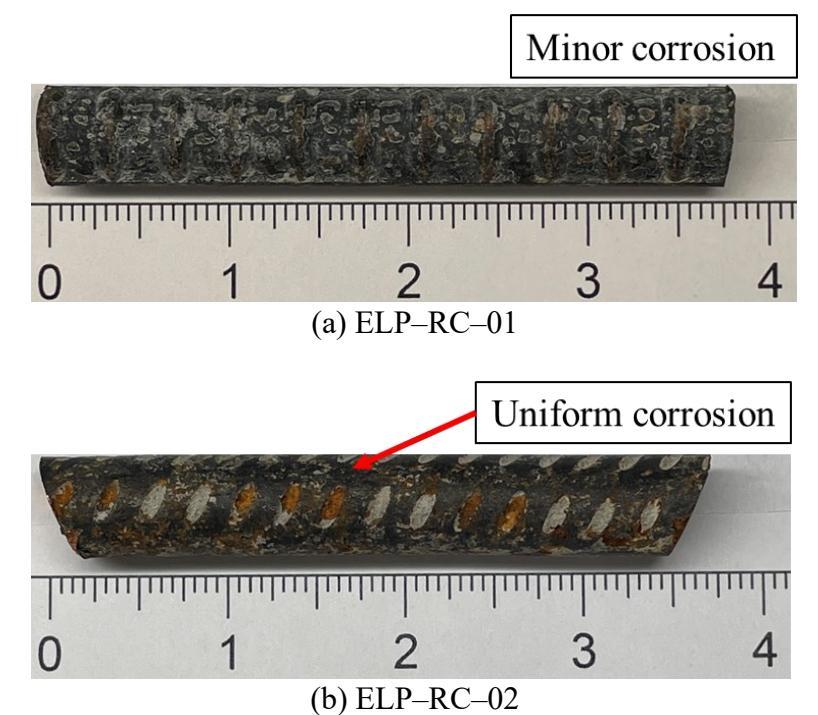
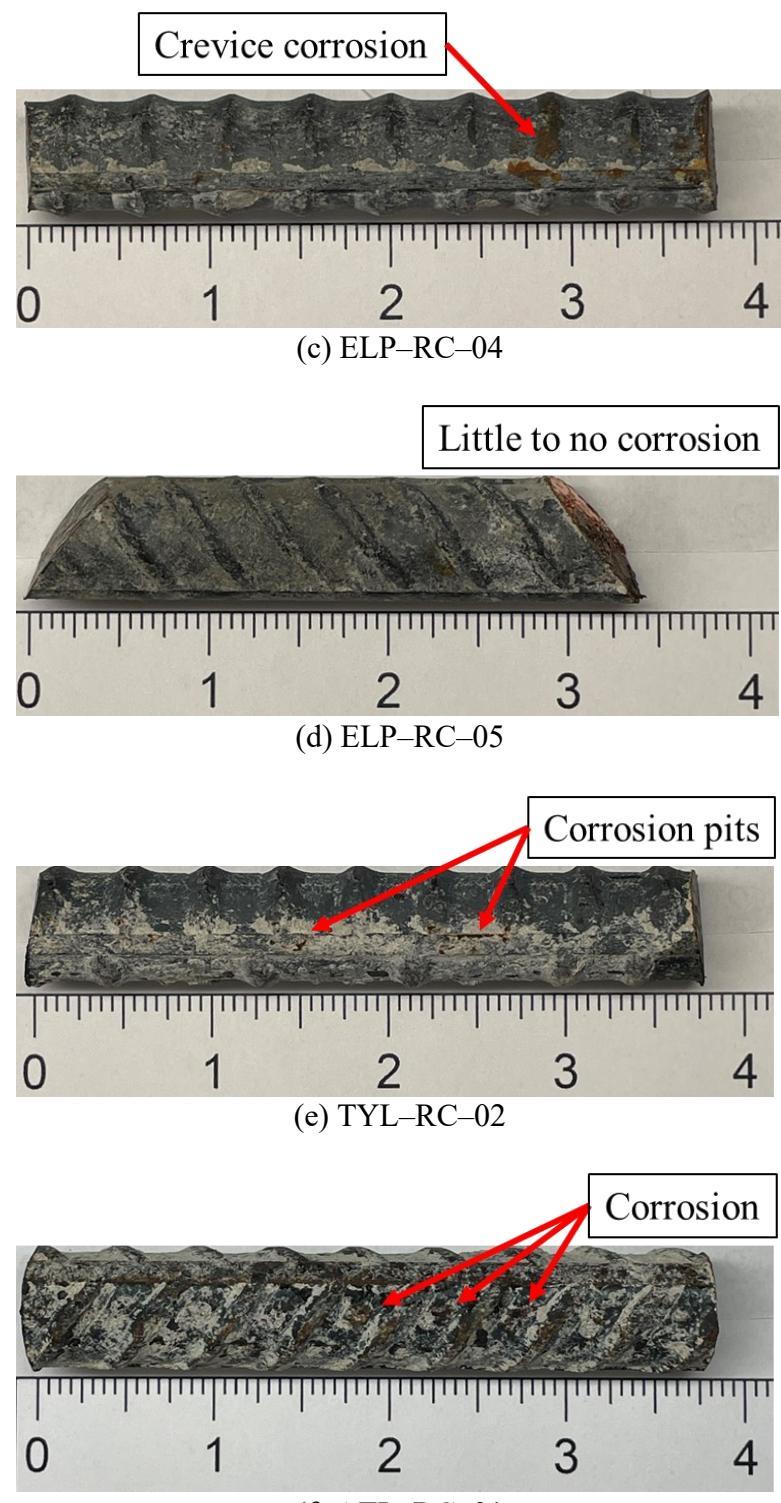
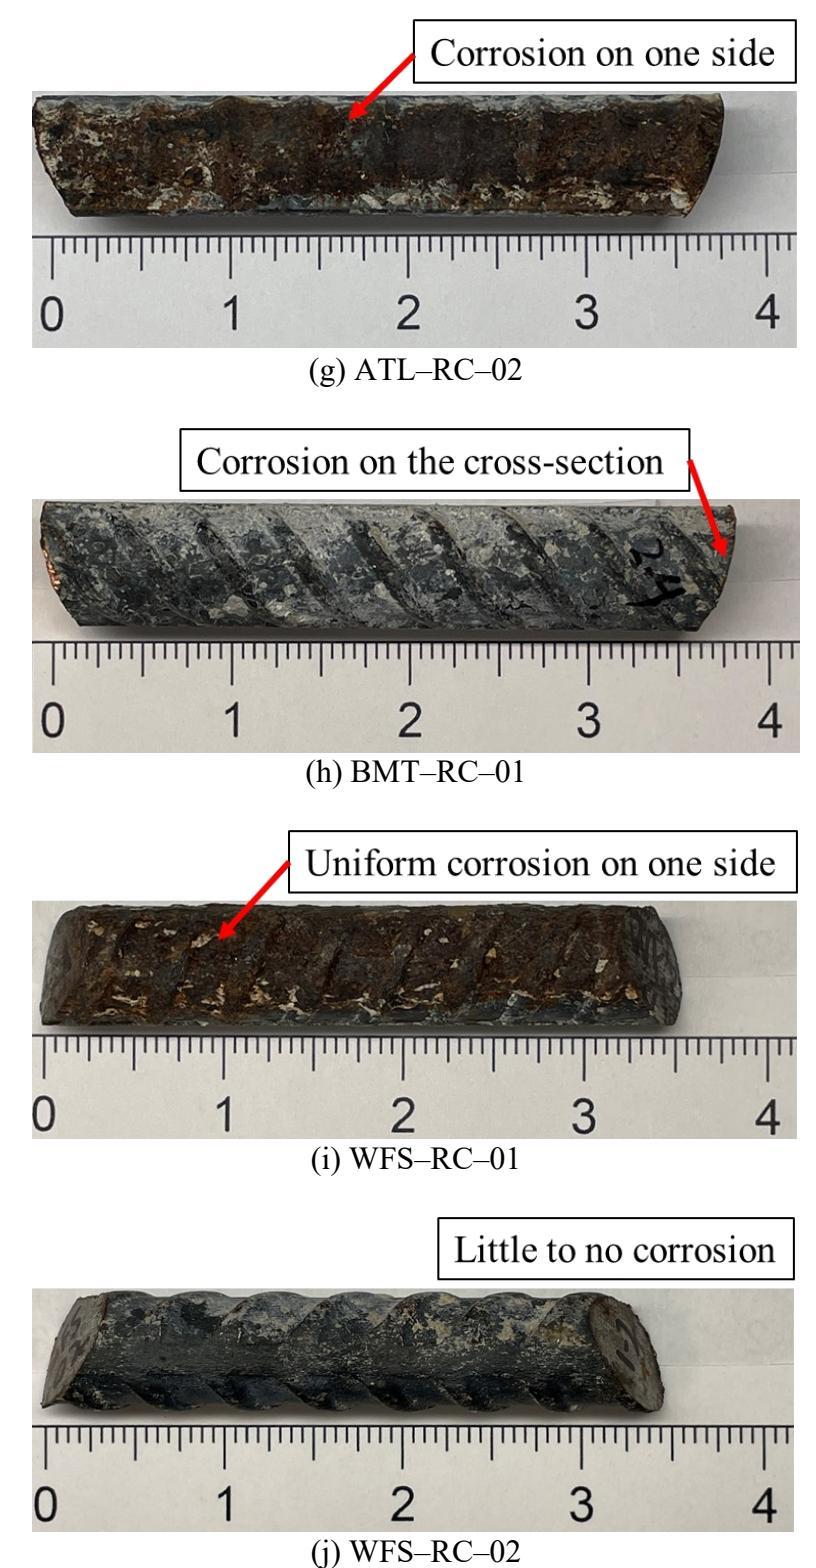
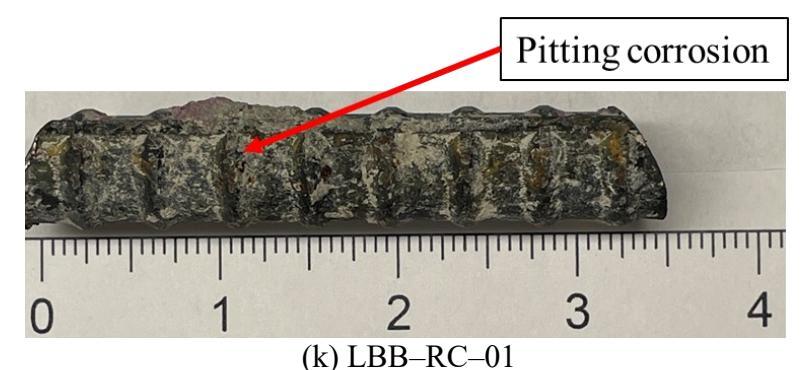
Figure 4.45. Extracted Black Rebar from Concrete Core Specimens.

Figure 4.45 shows the extent of corrosion on the black rebar extracted from core specimens.

The polarization resistance and corrosion rate of these steel bars are given in Table 4-8. For the specimen obtained from ELP-RC-02, uniform corrosion was observed where the corrosion

propagated around the surface surrounding the rebar. Severe corrosion was also detected on the top of the rebar taken from WFS–RC–01, and pitting corrosion was detected in several locations on the specimen obtained from LBB–RC–01. This pitting corrosion was more evident at crevices near the transverse and longitudinal ribs. Uniform corrosion happened on transverse and longitudinal ribs of the specimen extracted from ATL–RC–01, and uniform corrosion was detected on one side of the steel taken from ATL–RC–02. This flaw was also apparent at the crevices of the longitudinal ribs of TYL–RC–02 and ELP–RC–04. No sign of corrosion was seen on samples extracted from ELP–RC–01 and ELP–RC–05. Similarly, a minor trace of corrosion was observed on samples taken from WFS–RC–02 and BMT–RC–01 (just over the cross-sectional area). It is speculated that minor volume rust occurred on these samples after the cores were obtained.

average initial sorptivity recorded for the specimen taken from this concrete deck was lower than 6×10^{-3} mm/s^{1/2}, and the average bulk resistivity was 17 k Ω cm, indicating the concrete deck was of decent quality. However, surface cracking was detected in areas displaying high corrosion current density, with a crack width of 0.025 in. During the EIS examination, the corrosion rate of the rebar embedded in the core specimen measured very low, 0.01 mpy, thus suggesting no significant signs or traces of corrosion. The visual inspection of the rebar specimen extracted from the core further confirmed the findings of EIS (Figure 4.45[d]).

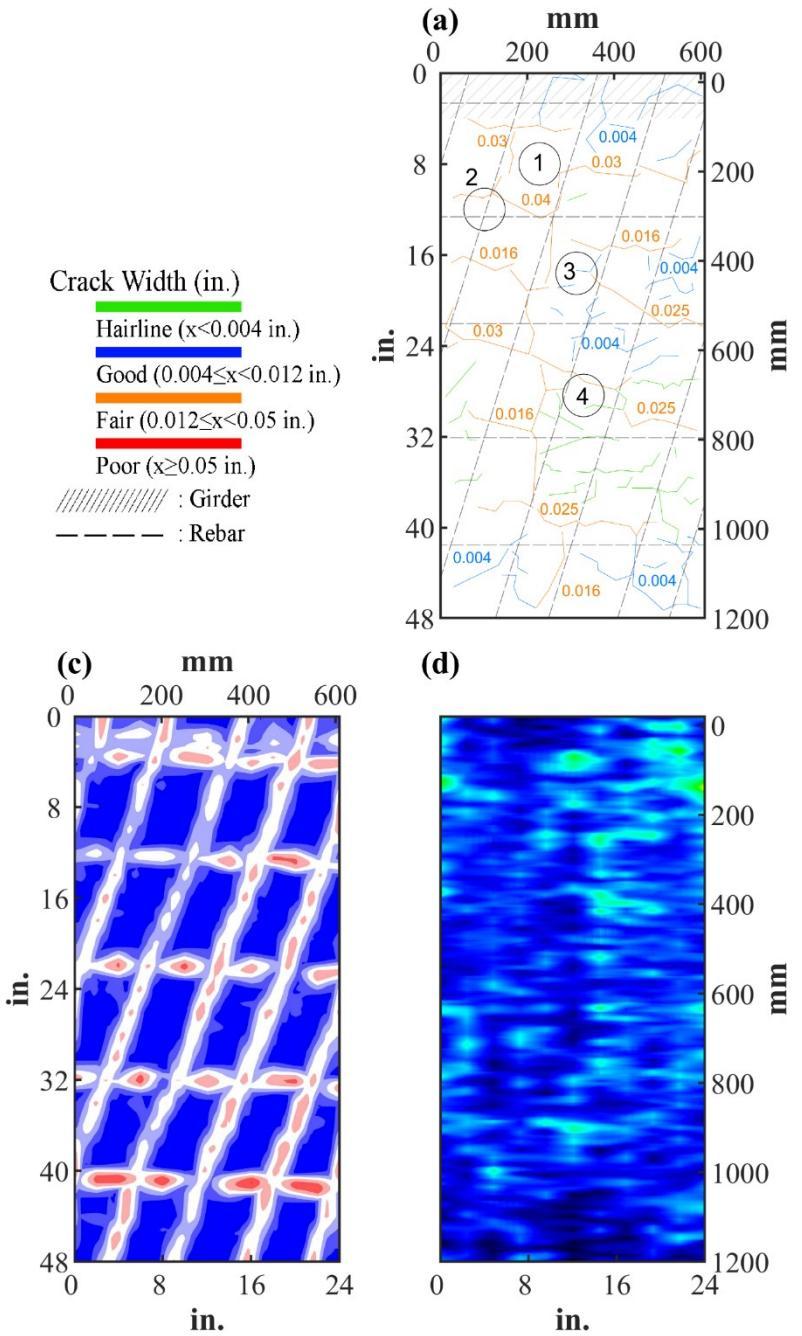
Figure B.11. Crack Map and NDE Results of Grid 1: (a) Crack Map and Location of Cores; (c) GPR C-scan at 1.2 in. to 2.25 in. Depth; (d) UST C-scan at 2.56 in. Depth

As shown in Figure B.11 (a), grid 1 had various range of cracks from a hairline crack to 0.025 in. crack. As shown in Figure A.1.5 (a), grid 2 had hairline cracks mostly, with one 0.008 in. transverse crack possibly caused by joint of two PCPs.

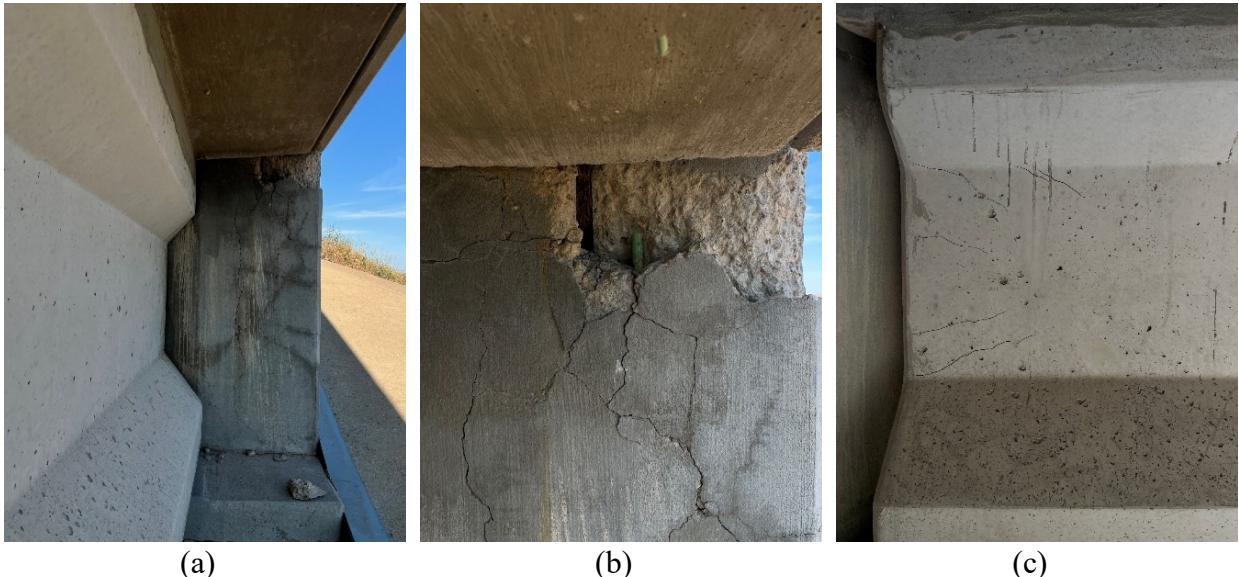
Figure B.15. Deteriorations on the Bridge: (a) Severe Cracks and Corroded Rebar On the abutment; (b) Spalling at abutment and Exposed, Corroded Rebar; (c) Hairline Diagonal Cracking on the Web of Girder

Spalling occurred on the abutment backwall possible due to the settlement of the bridge approach, and the exposed and corroded rebar is found inside as shown in Figure B.15 (a) and (b). There is hairline diagonal cracking on the web of prestressed beam at the end of support as shown in Figure B.15 (c).

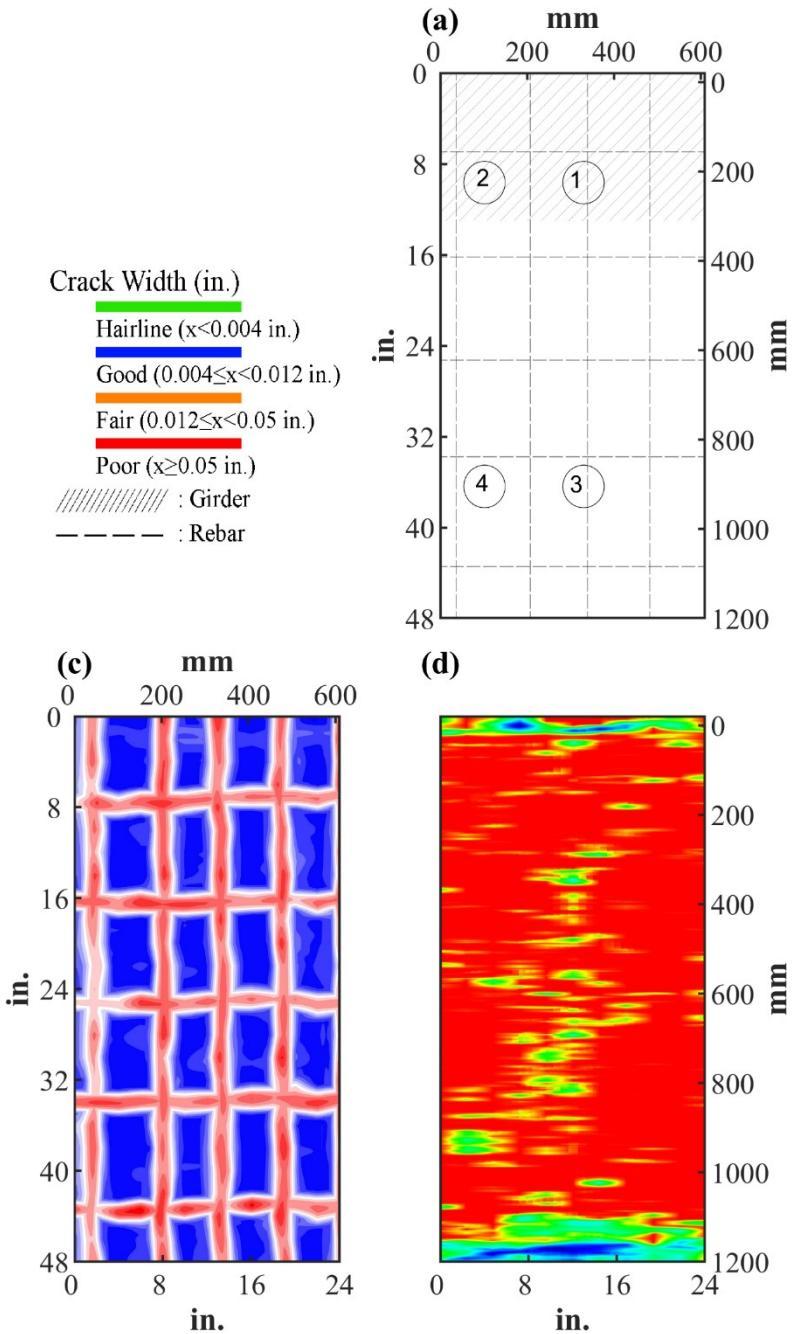
Figure B.17. Crack Map and NDE Results of Grid 1: (a) Crack Map and Location of Cores; (c) GPR C-scan at 1.85 in. to 2.85 in. Depth; (d) UST C-scan at 2.7 in. Depth

As there was MLPO on the bridge, both grids did not have any cracks.

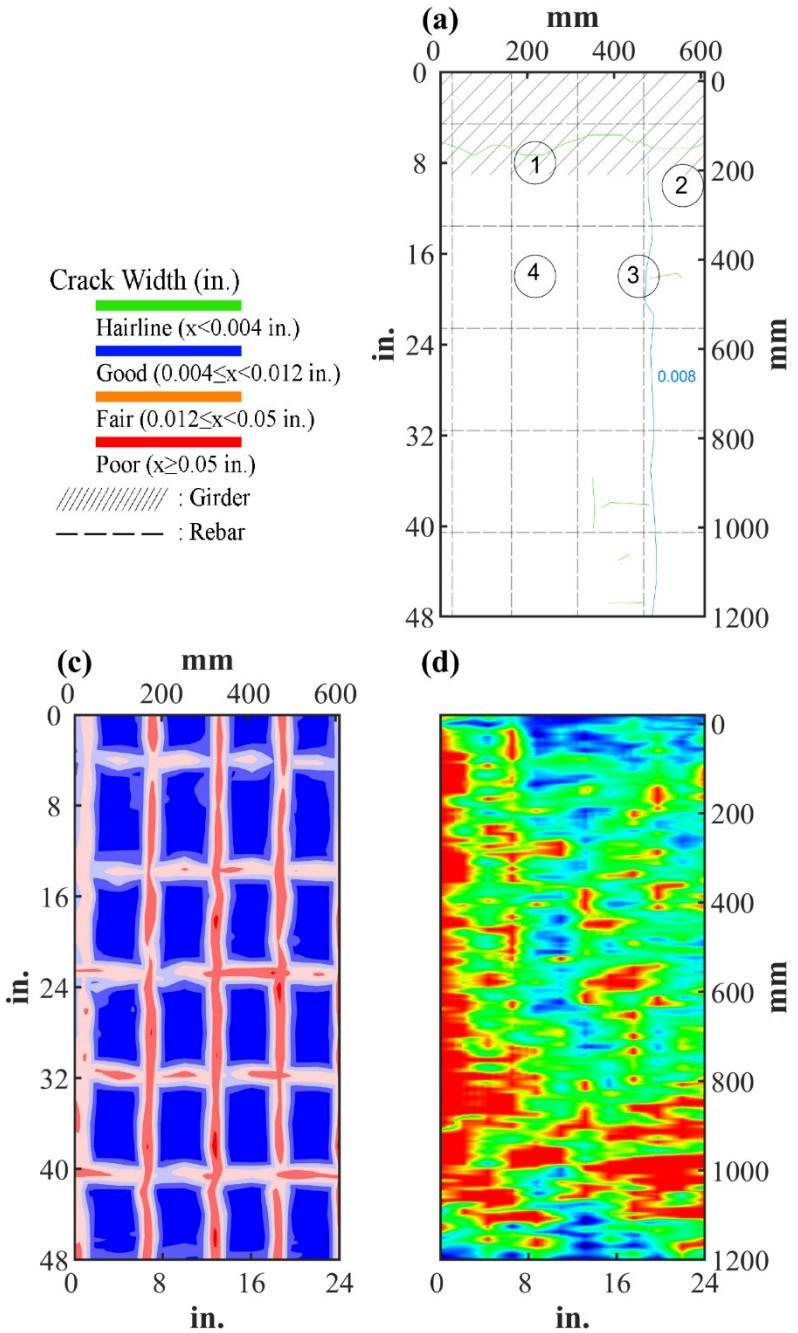
Figure B.23. Crack Map and NDE Results of Grid 1: (a) Crack Map and Location of Cores; (c) GPR C-scan at 1.45 in. to 2.45 in. Depth; (d) UST C-scan at 2.37 in. Depth

Figure B.23 and Figure B.24 show detailed information of the grids. As shown in Figure A.3.3 (a), grid 1 had little to no hairline cracks with one 0.008 in. transverse crack possibly caused by a joint of precast concrete panels. As shown in Figure A.3.4 (a), grid 2 had few hairline cracks with one 0.008 in. longitudinal crack.

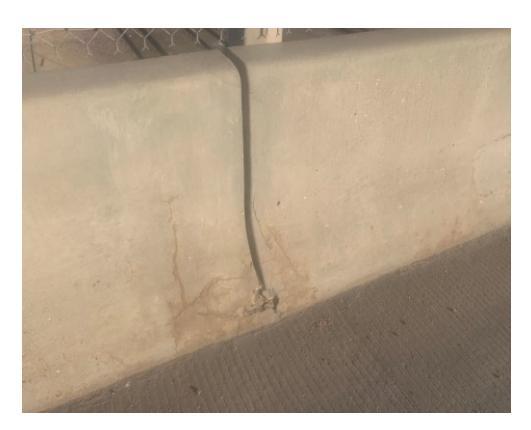
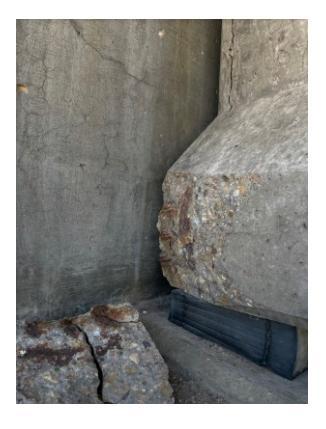
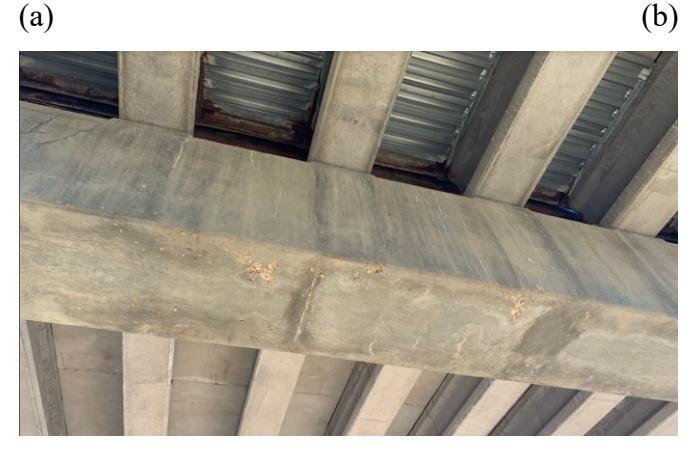
Figure B.28. Deterioration on the Bridge: (a) Spalling at Railing Bottom; (b) Spalling and Exposed Rebar and Strands on Bottom of a Beam; (c) Corrosion on the Metal Deck Form

Hairline map cracking is found on the top surface of the deck. There is minor delamination and spalling along the railing bottom as shown in Figure B.28 (a). There is spalling at the end of girders and shows sign of corrosion as shown in Figure B.28 (b). And severe rust on the permanent metal deck from under expansion joint is present as shown in Figure B.28 (c).

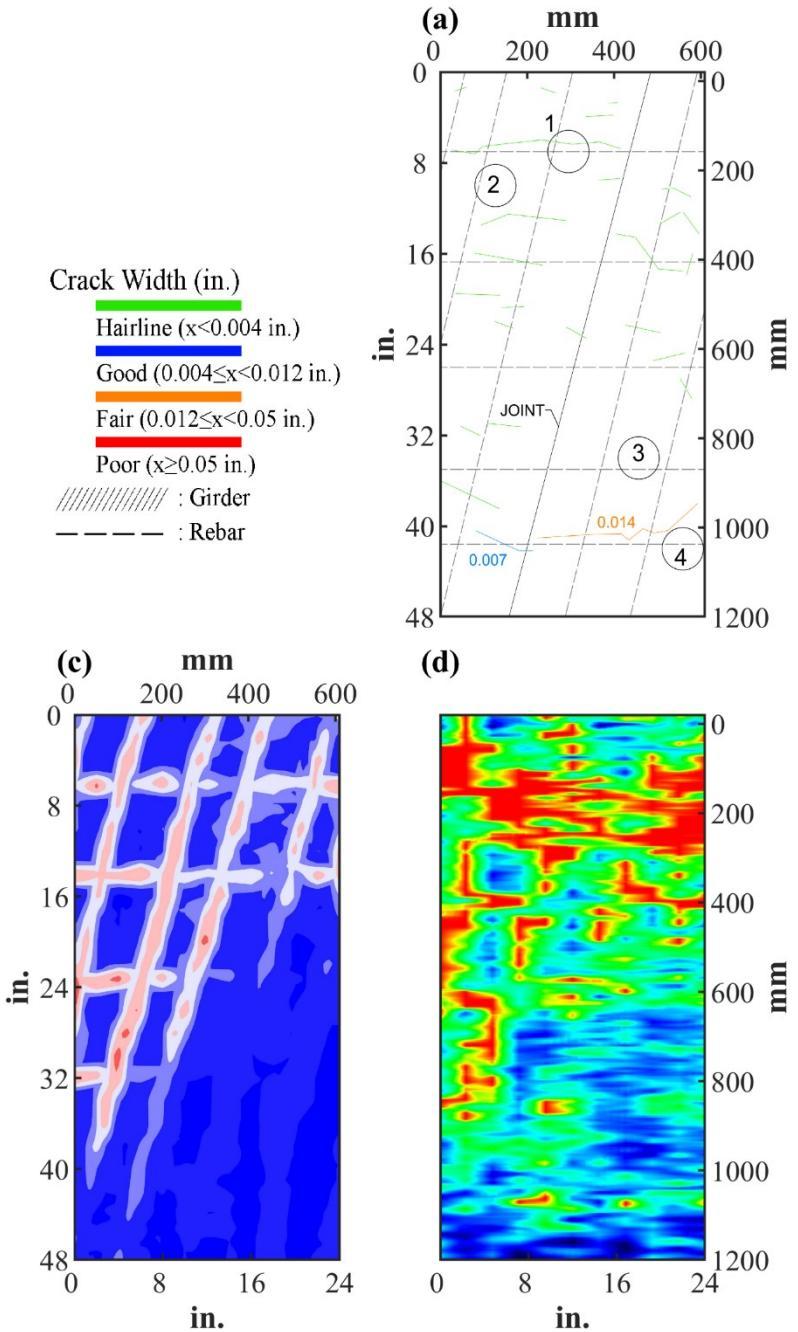
Figure 0.37. Crack Map and NDE Results of Grid 1: (a) Crack Map and Location of Cores; (c) GPR C-scan at 1.85 in. to 2.85 in. Depth; (d) UST C-scan at 2.97 in. Depth

As shown in Figure 0.37 (a), grid 1 was drawn on top of the joint and 0.007 in. wide crack and 0.014 crack were spreading from the joint. Other than the two cracks, it only showed hairline cracks. As shown in Figure 0.38 (a), the widest crack on grid 2 was 0.02 in. wide, but hairline cracks were dominant.

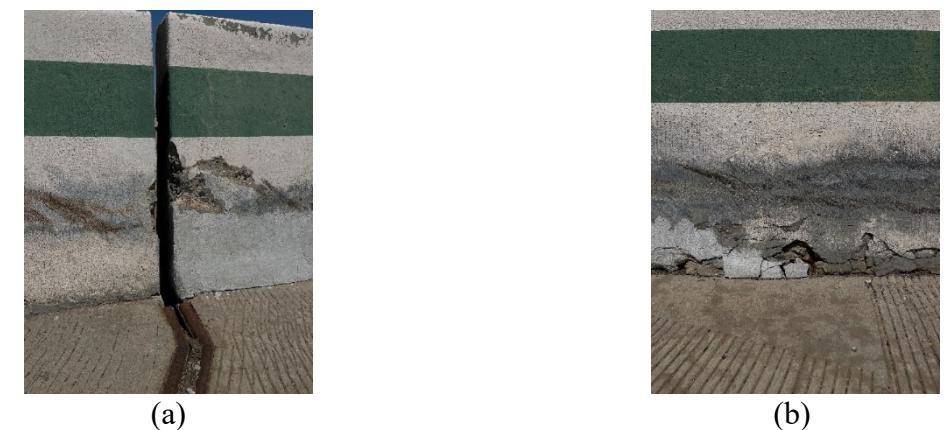
Figure 0.43. Deterioration on the Bridge: (a) Impact Damage on the East Rail of the Bridge; (b) Exposed and Corroded Rebar

The east bridge rail is damaged due to an impact, and exposed rebar is corroded as shown in Figure 0.43 (a) and (b).

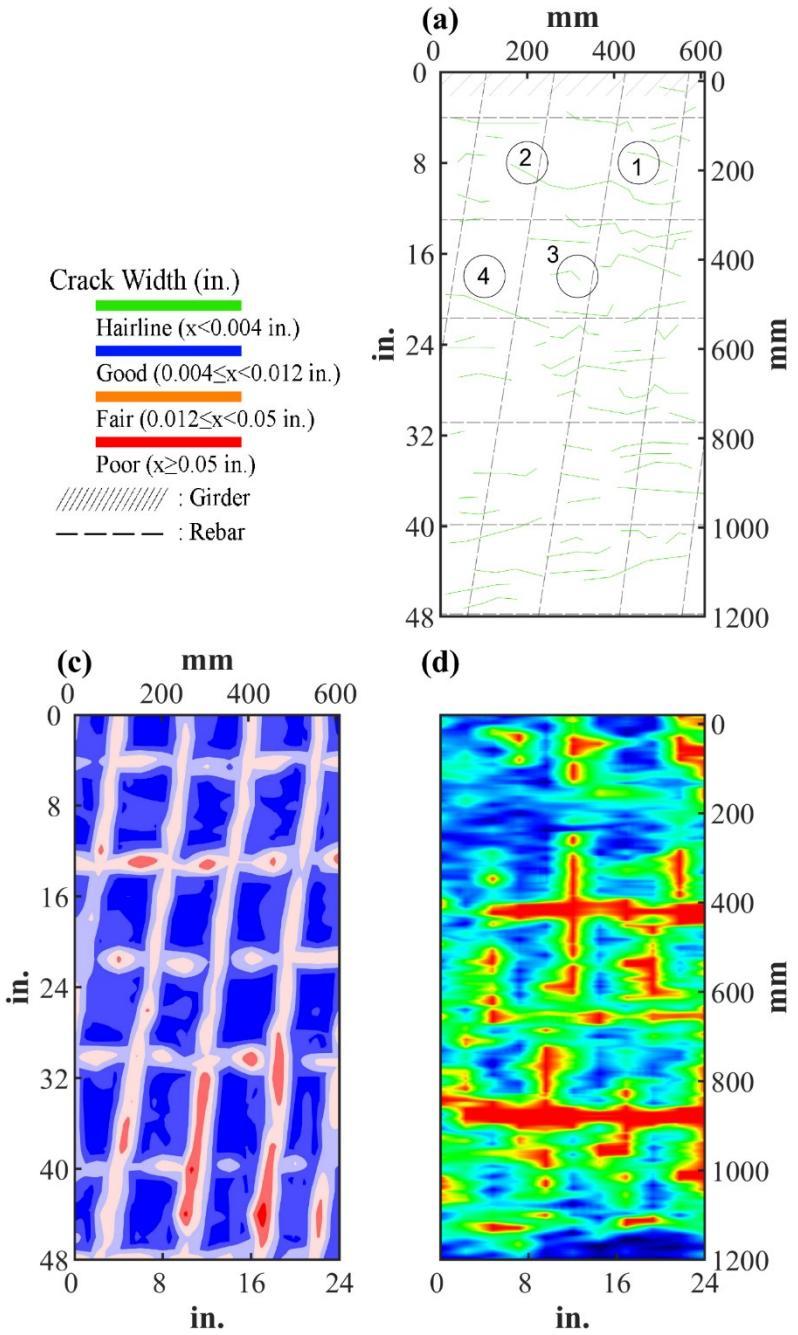
Figure 0.45. Crack Map and NDE Results of Grid 1: (a) Crack Map and Location of Cores; (c) GPR C-scan at 2.1 in. to 3.4 in. Depth; (d) UST C-scan at 3.93 in. Depth

As shown in Figure 0.45 (a), there was hairline cracks throughout the grid. On the other hand, as shown in Figure 0.46 (a), grid 2 did not have any cracks on its surface.

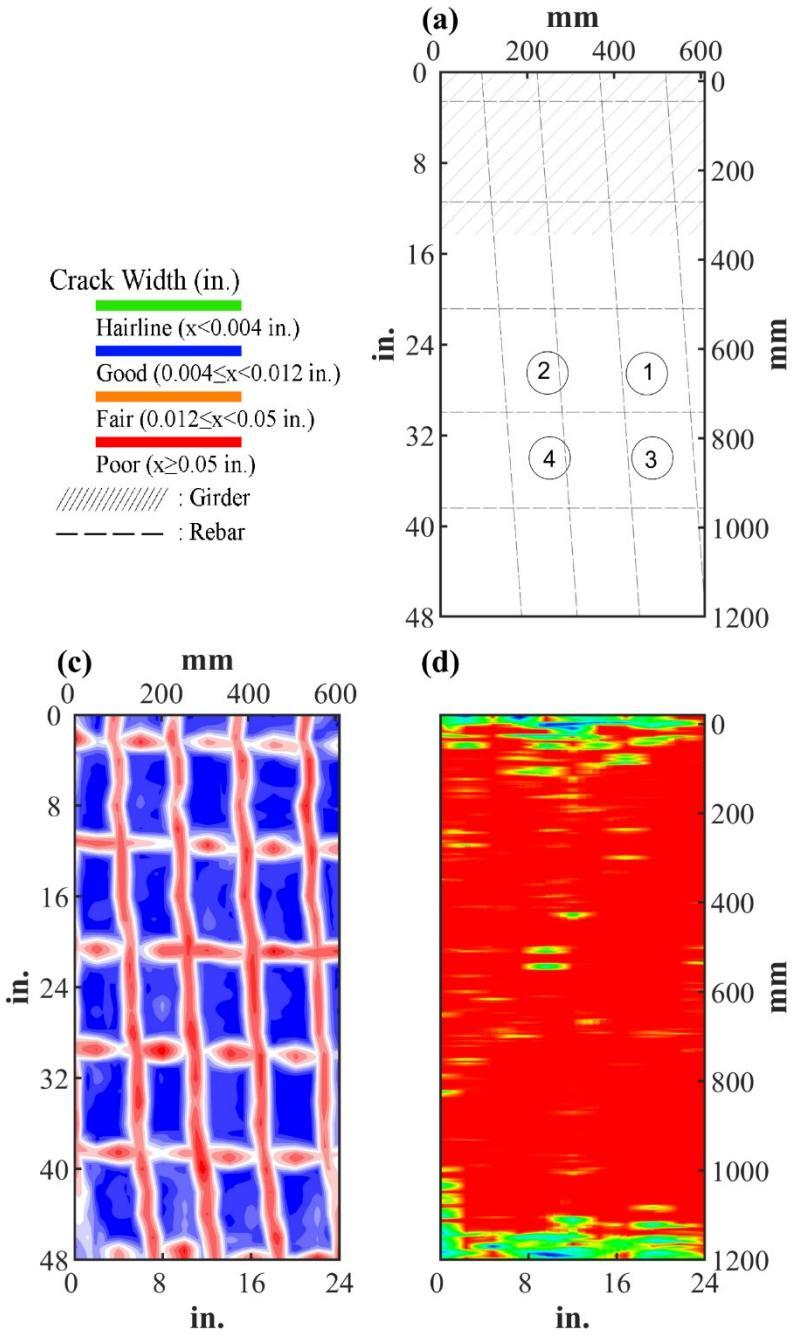
Figure 0.52. Crack Map and NDE Results of Grid 1: (a) Crack Map and Location of Cores; (c) GPR C-scan at 1.85 in. to 2.85 in. Depth; (d) UST C-scan at 1.97 in. Depth

Epoxy overlay was applied to the bridge deck surface. As a result, no cracks were visible as shown in Figure 0.52 (a) and Figure 0.53 (a)

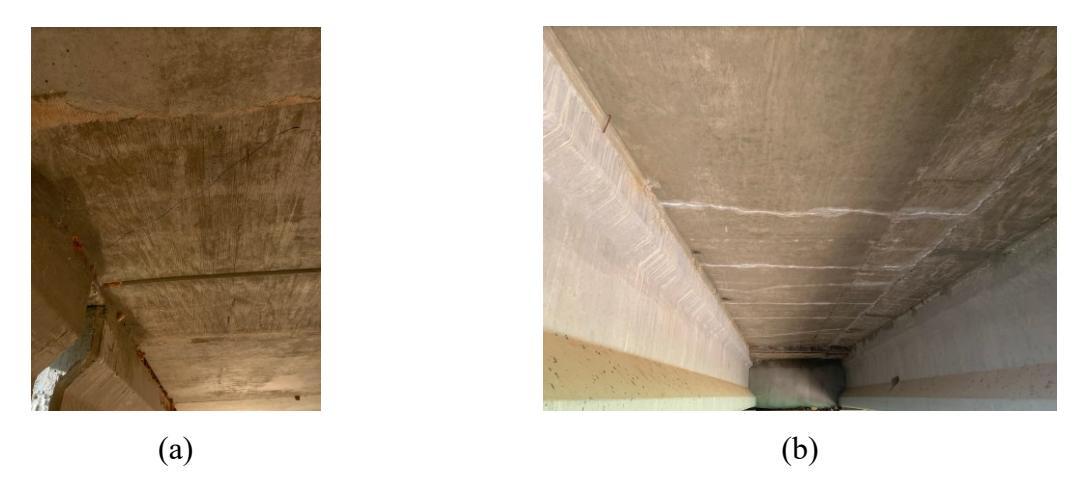
Figure 0.57. Deterioration on the Bridge: (a) Diagonal Crack at the deck bottom surface; (b) Leakage and stains on bottom surface of deck

There are hairline longitudinal and transverse cracks on the top surface of deck. The bottom surface of deck around joint has diagonal cracks as shown in Figure 0.57 (a). The undersurface of one span is with seepage in progress and obvious stains as shown in Figure 0.57 (b). There is moderate map crack at the epoxy surface of south approach pavement.

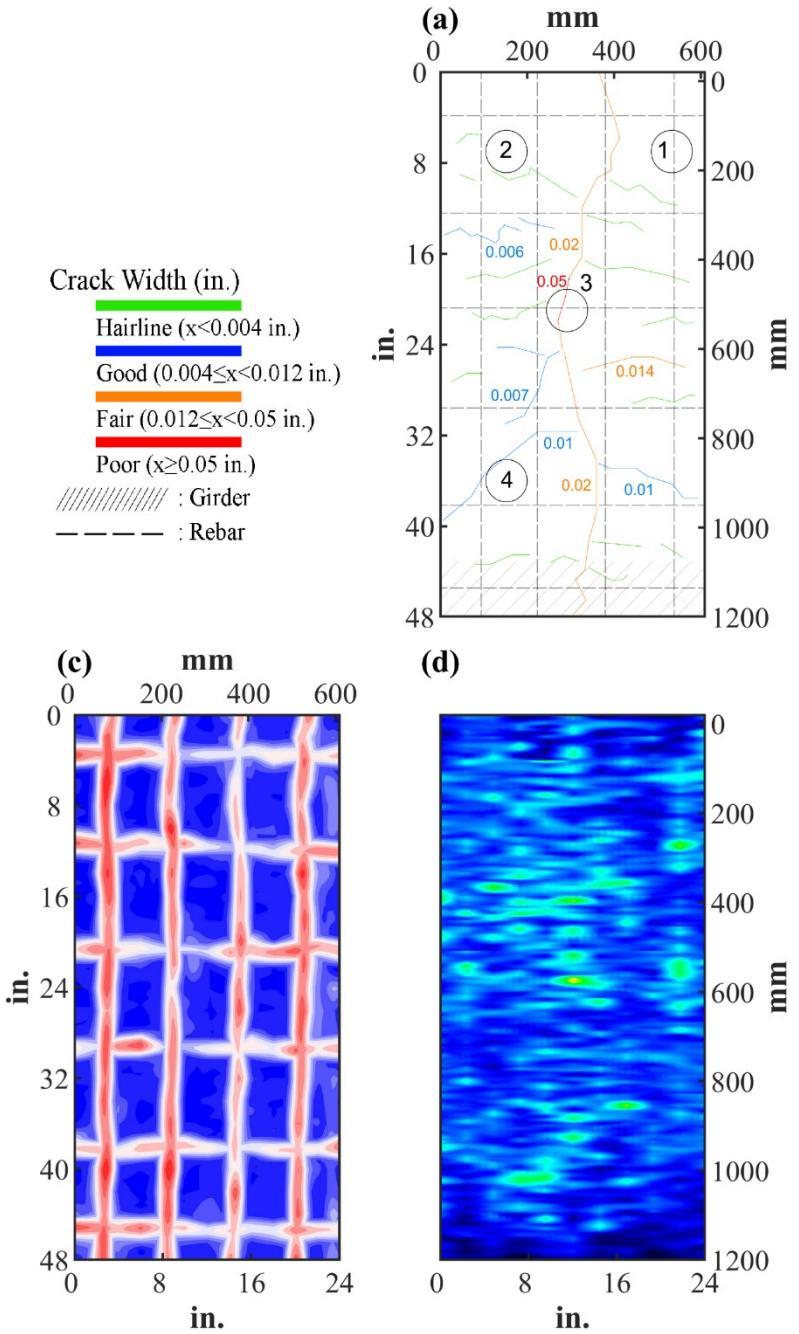
Figure 0.59. Crack Map and NDE Results of Grid 1: (a) Crack Map and Location of Cores; (c) GPR C-scan at 2.8 in. to 3.9 in. Depth; (d) UST C-scan at 2.0 in. Depth

As shown in Figure 0.58 (a), 0.05 in. crack was present in Grid 1, and 0.02 in. transverse crack possibly caused by PCP. As shown in Figure 0.59 (a), 0.007 in. transverse crack was visible in Grid 2 which was possibly caused by PCP as well.

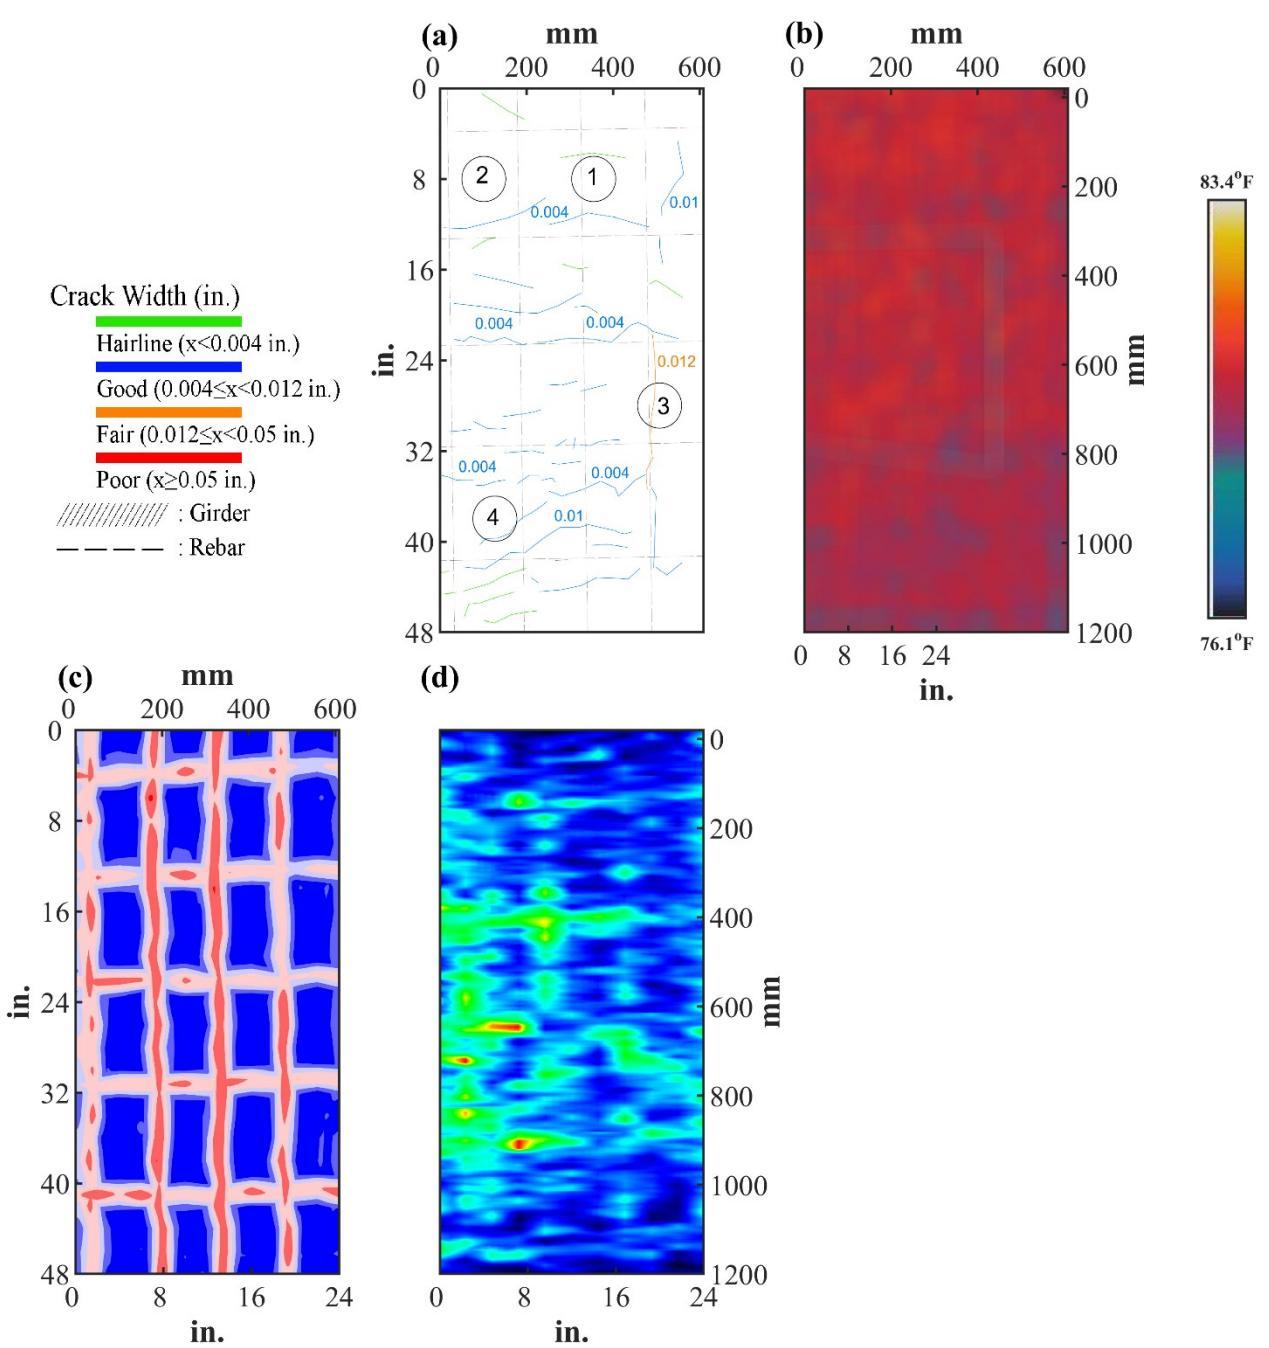
Figure 0.67 (a) shows that there was widespread of 0.004 in. wide cracks with one 0.012 wide transverse crack. The Grid 2 had one crack that was 0.004 in. wide as shown in Figure 0.68 (a).

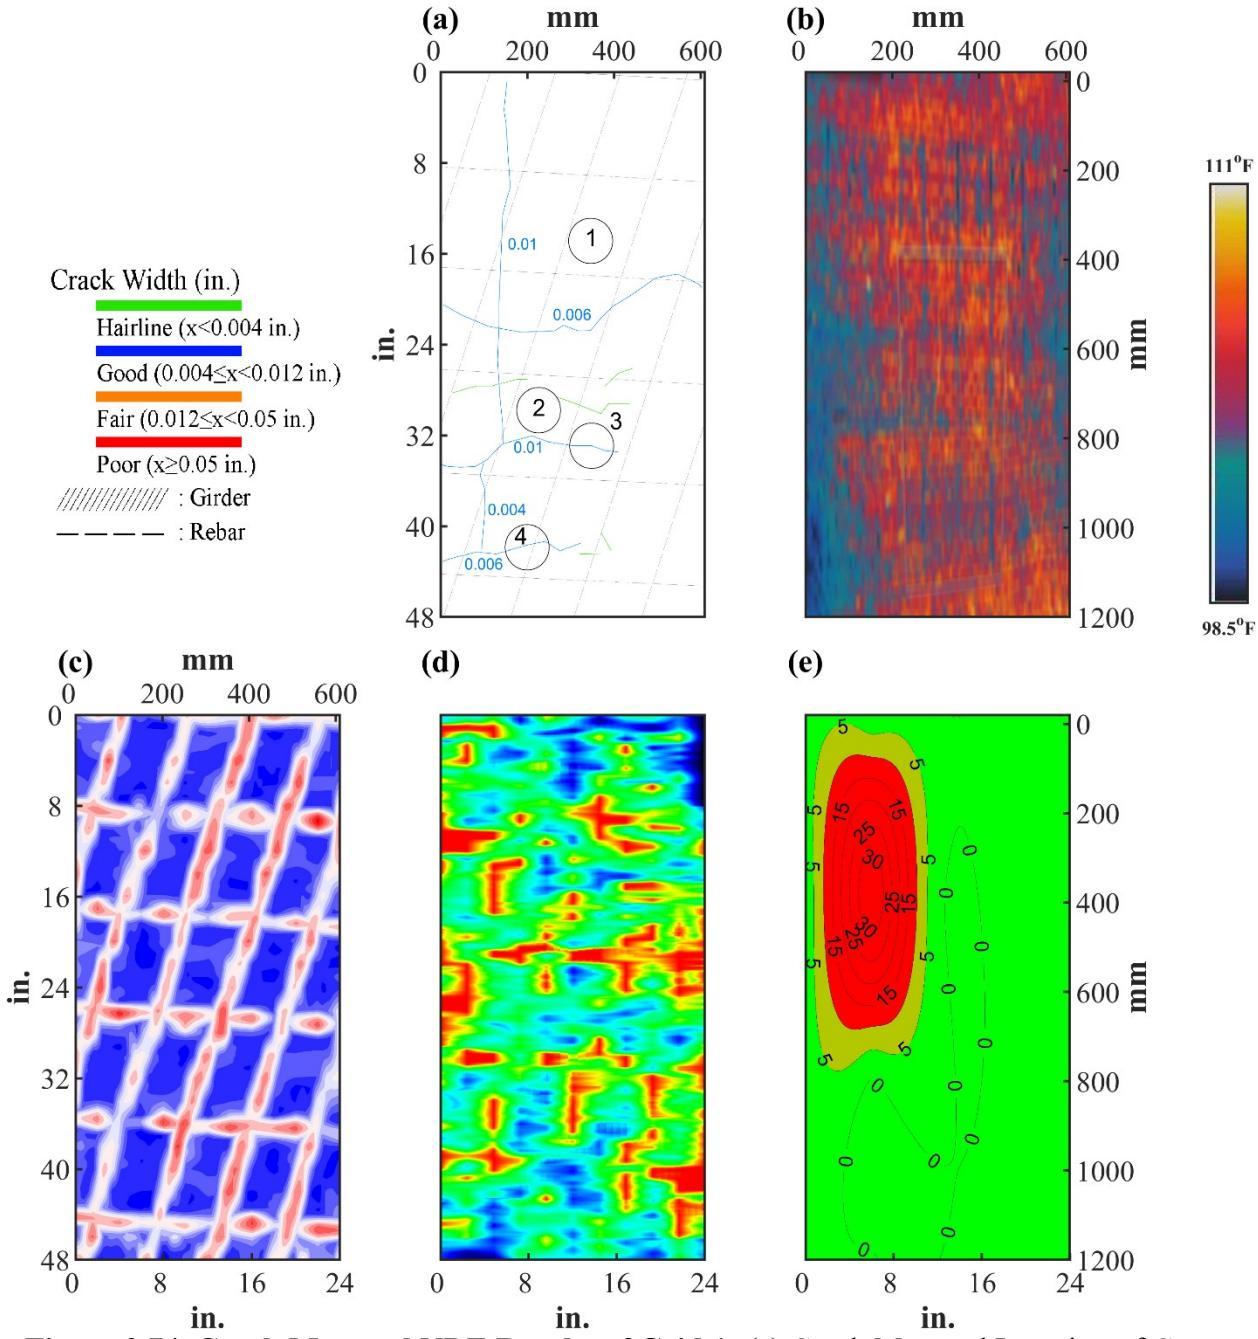
Figure 0.74. Crack Map and NDE Results of Grid 1: (a) Crack Map and Location of Cores; (b) Infrared Picture; (c) GPR C-scan at 1.8 in. to 2.9 in. Depth; (d) UST C-scan at 3.97 in. Depth; (e) Corrosion Rate Map

As shown in Figure 0.74 (a), there were cracks with width ranging from 0.006 in. to 0.01 in. 0.01 in. transverse crack could have been caused by panel joints. Based on the Figure A. 10.3 (e), there is a possibility of corrosion on upper left corner of the Grid 1. Grid 2 has cracks ranging from 0.004 in. to 0.006 in. as shown in Figure 0.75 (a). The cracks could have been caused by panel joints.

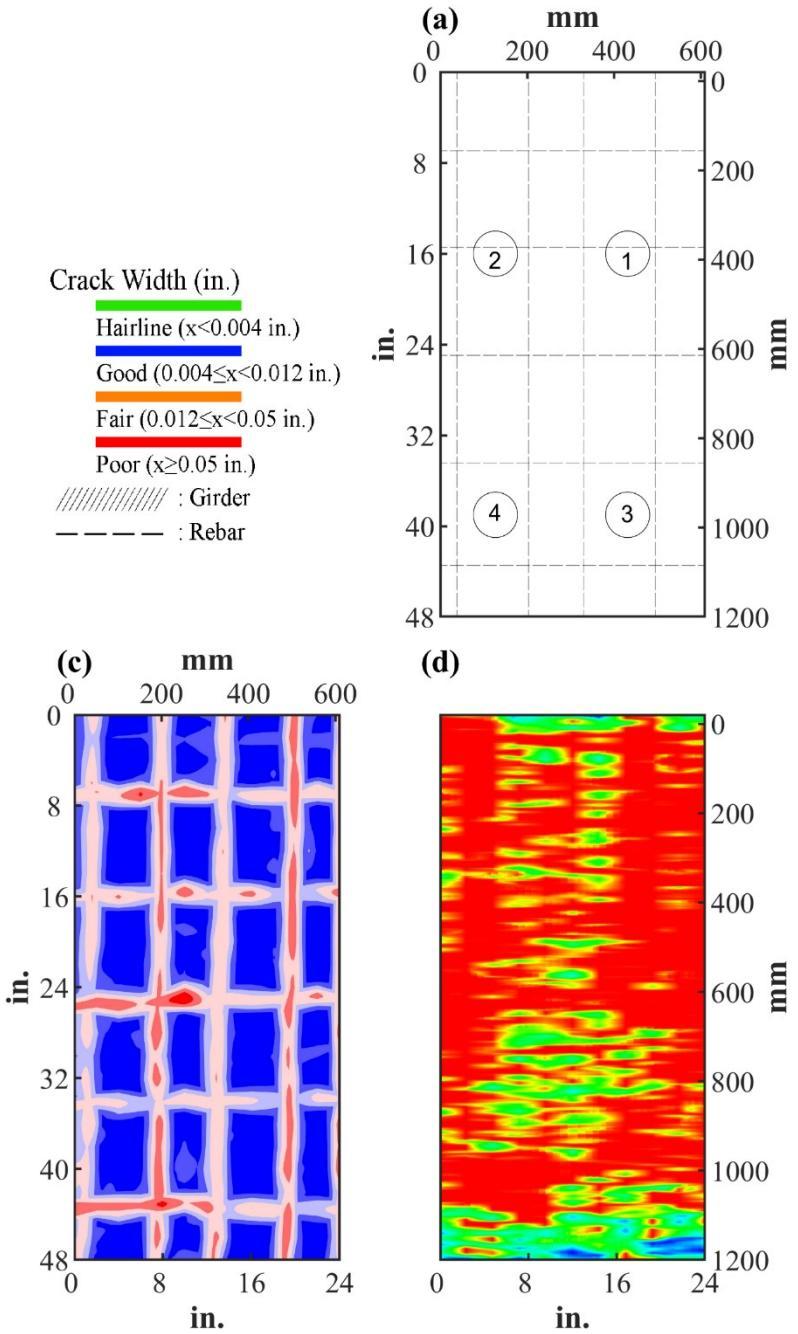
Figure 0.80. Crack Map and NDE Results of Grid 1: (a) Crack Map and Location of Cores; (c) GPR C-scan at 1.8 in. to 2.9 in. Depth; (d) UST C-scan at 1.96 in. Depth

Asphalt overlay was applied on the bridge, and as a result, no cracks were visible on the deck as shown in Figure 0.80 (a) and Figure 0.81 Figure 0.81 (a).

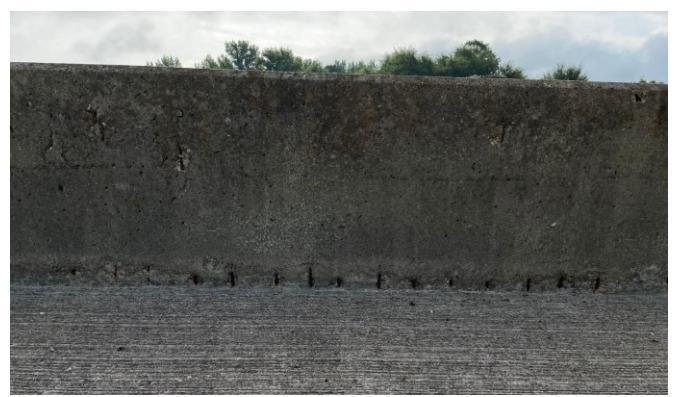
Figure 0.93. Exposed and Corroded Rebar at the Bottom of Railing

The top surface of deck has hairline and some transverse, longitudinal cracks. The west rails have minor spalling and exposed rebar along its bottom is corroded as shown in Figure 0.93. Spalling at the both west and east end of the backwall of Abutment 1. Water staining was visible at the bottom of the overhang, but no cracks were apparent. The girders bottom flanges exhibited honeycombing. Water leakage through the west overhangs at the bents was apparent.

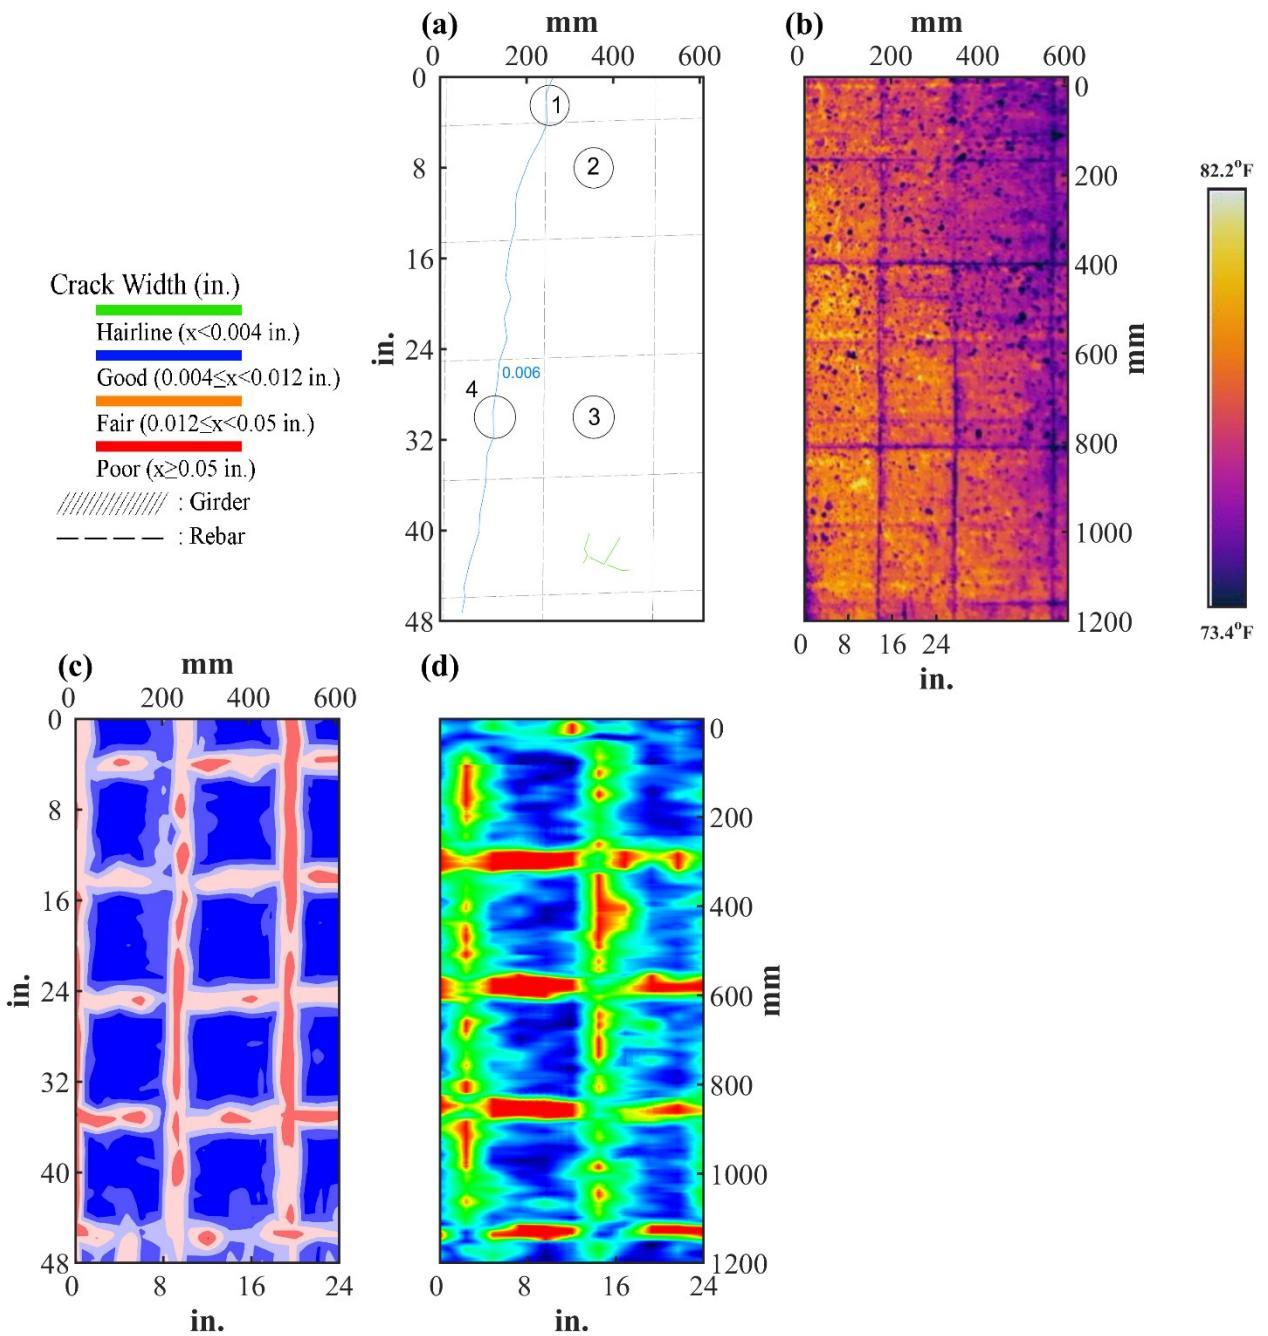
Figure 0.95. Crack Map and NDE Results of Grid 1: (a) Crack Map and Location of Cores; (b) Infrared Picture; (c) GPR C-scan at 2.2 in. to 3.3 in. Depth; (d) UST C-scan at 4.3 in. Depth

As shown in Figure 0.95 (a), one 0.006 in. wide crack in transverse direction was visible, possibly caused by panel joints. The Grid 2 had transverse cracks that are 0.007 in. and 0.008 in. wide as shown in Figure 0.96. It is possible that the cracks were caused by panel joints.
