Evaluation of Corrosion Prevention and Mitigation Approaches Used on Texas Bridges—Volume 2: Reinforced Concrete Bridges

Technical Report 0-7040-R1-Vol2

TEXAS A&M TRANSPORTATION INSTITUTE COLLEGE STATION, TEXAS

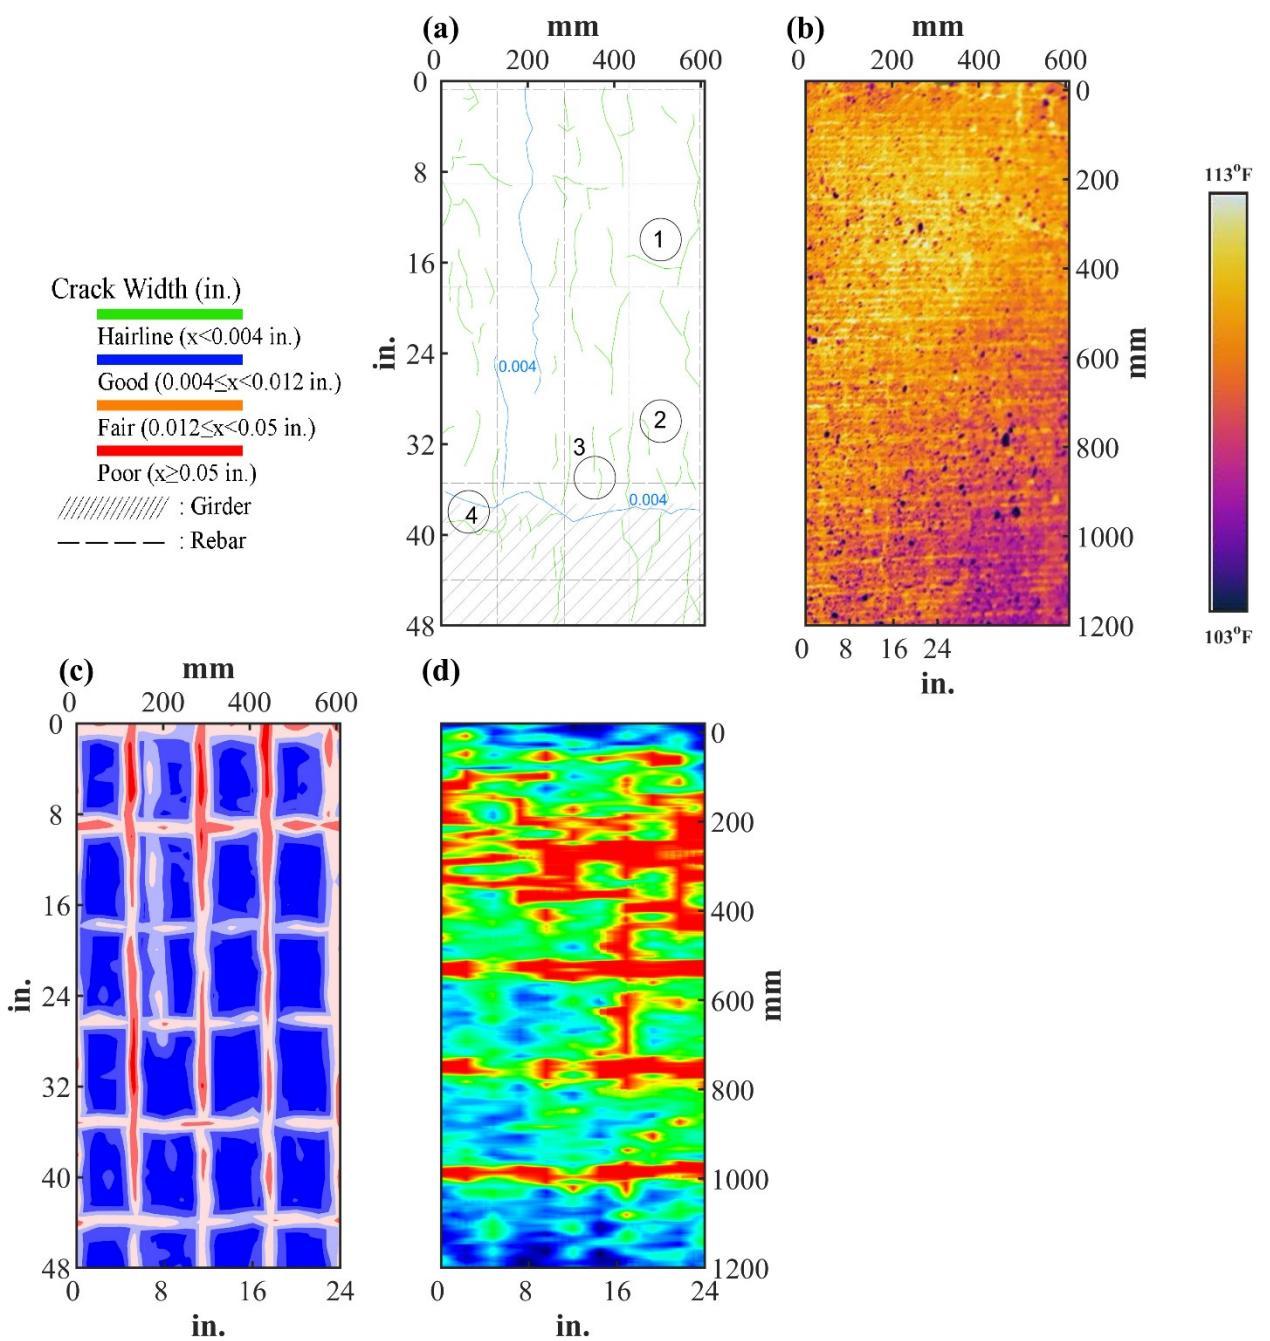
Figure 0.101. Crack Map and NDE Results of Grid 1: (a) Crack Map and Location of Cores; (b) Infrared Picture; (c) GPR C-scan at 1.2 in. to 2.3 in. Depth; (d) UST C-scan at 3.1 in. Depth

As shown in Figure 0.101 (a), G1 had widespread of hairline cracks with one 0.004 in. wide transverse crack and one 0.004 in. wide longitudinal cracks. It is possible that the longitudinal crack was caused by a girder and transverse crack was caused by panel joints. As shown in Figure 0.102 (a), hairline cracks were wide spread, and there were two 0.004 in. wide transverse cracks.

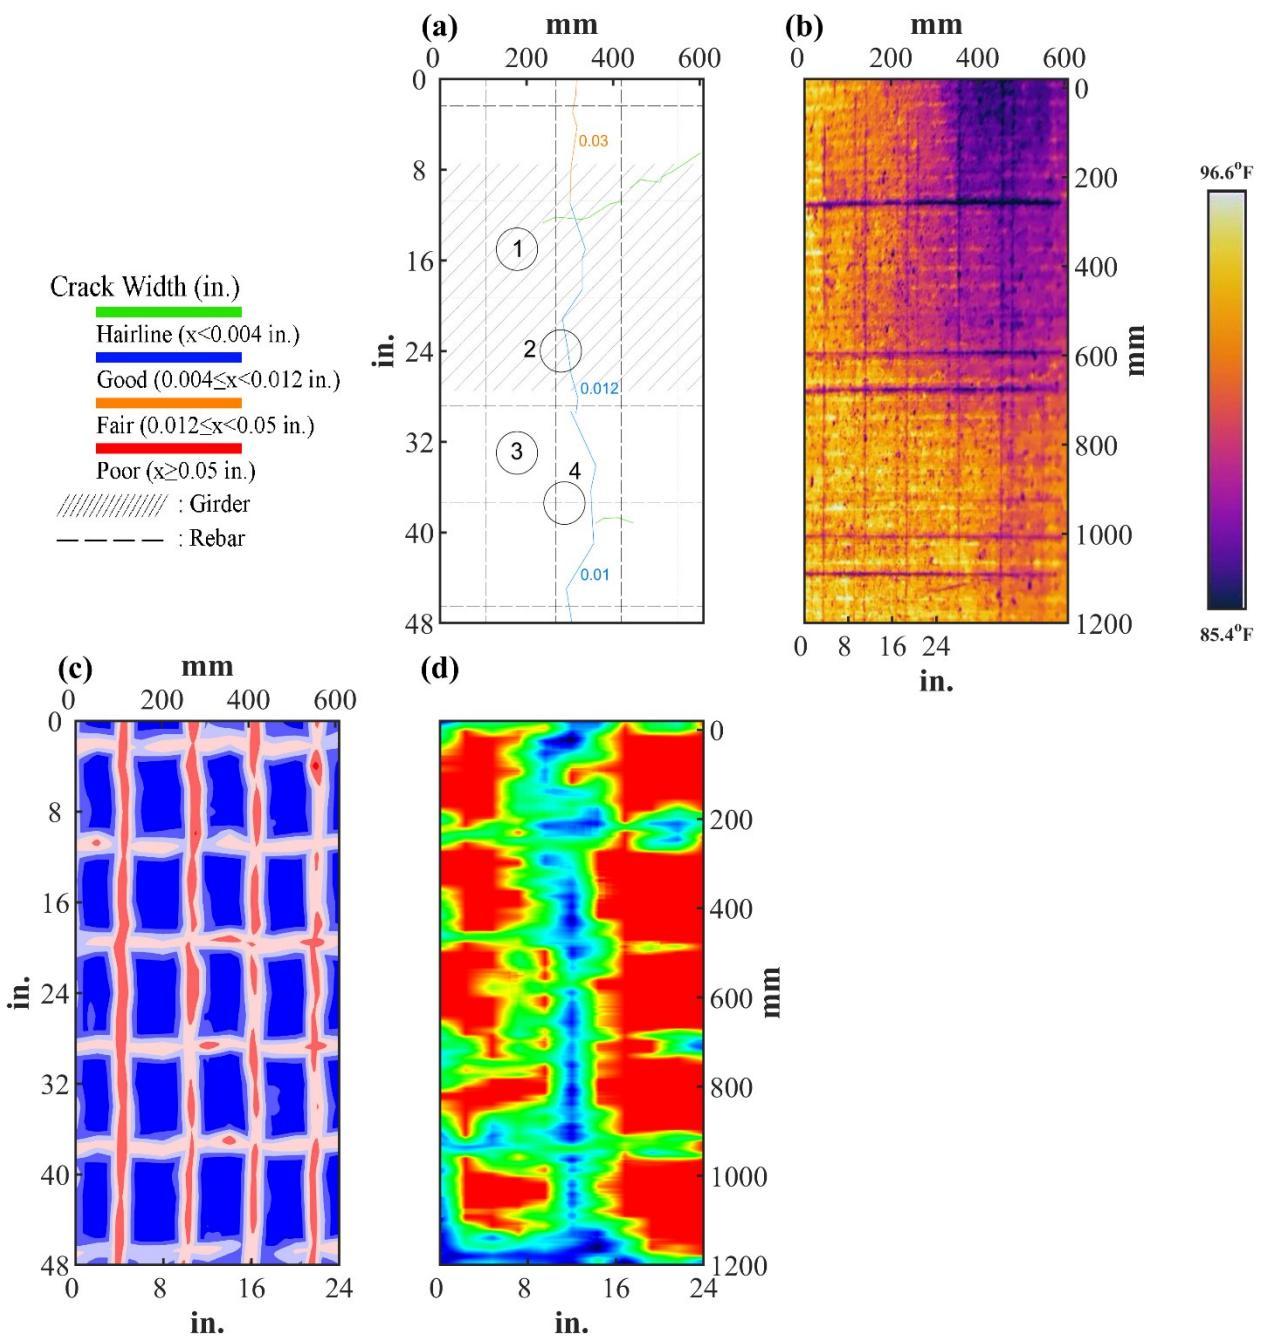
Figure 0.108. Crack Map and NDE Results of Grid 1: (a) Crack Map and Location of Cores; (b) Infrared Picture; (c) GPR C-scan at 1.7 in. to 2.8 in. Depth; (d) UST C-scan at 4.6 in. Depth

As shown in Figure 0.108 (a), the width of a transverse crack ranged from 0.01 in. to 0.03 in. It is possible that panel joints caused the crack. The Grid 2 had 0.004 in wide diagonal cracks and some hairline cracks as shown in Figure 0.109 (a). The Grid 3 had sealant applied on the crack as shown in Figure 0.110 (a).

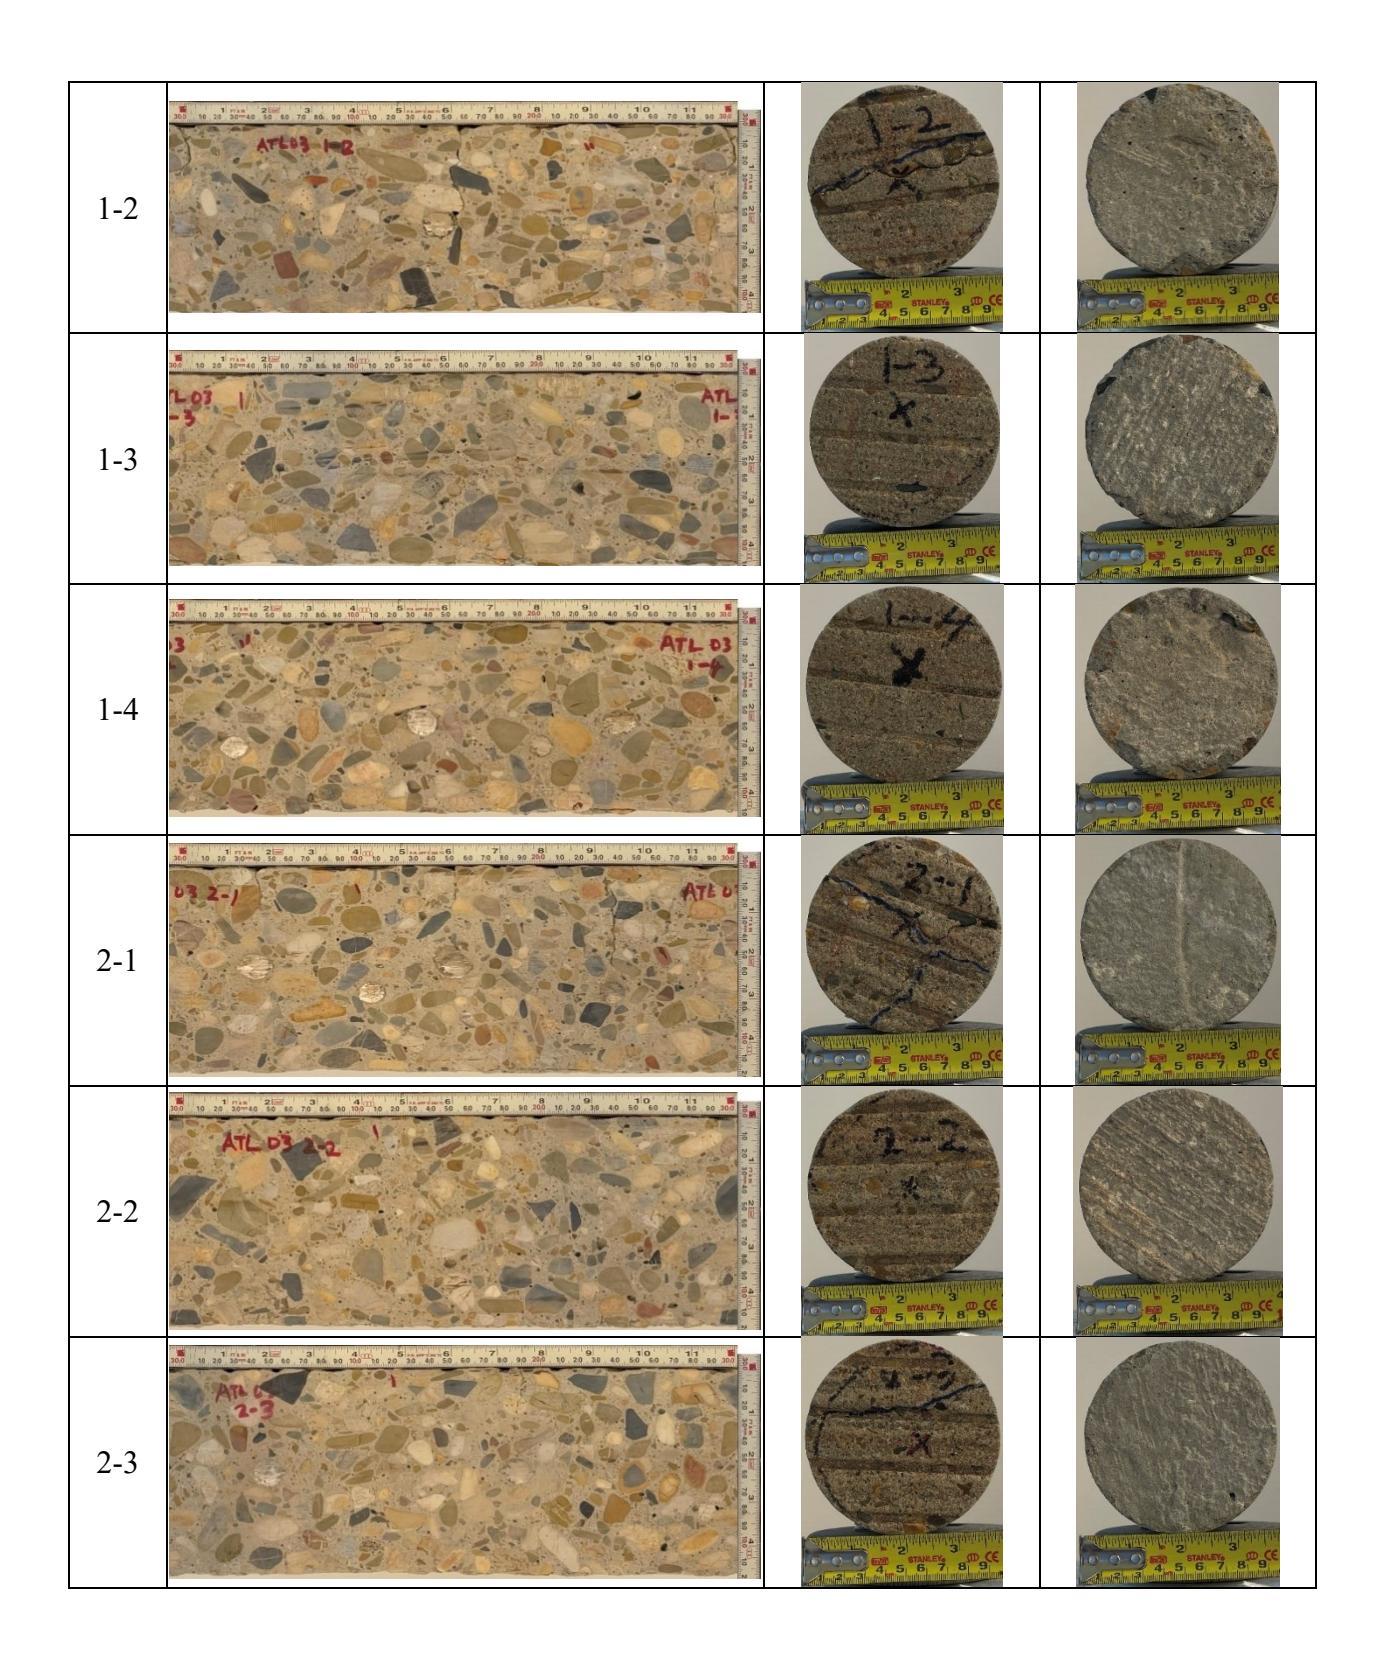
Table B-68. Core Pictures

Core	dia. x height (in.)	Rebar depth (in.)	Rebar size (#)	Epoxy (Y/N)	Crack type	Crack width (in)	Notes
1-1	3.75 x 4.3	-	-	-	-	-	Delamination between CIP and PCP
1-2	3.75 x 4.3	2.2	5	Y	transverse	0.012	Delamination between CIP and PCP; A crack propagates from a rebar
1-3	3.75 x 4.5	-	-	Y, Y	-	-	Delamination between CIP and PCP
1-4	3.75 x 4.6	2.2, 2.3	5, 4	Υ, Υ	-	-	Delamination between CIP and PCP
2-1	3.75 x 4.8	2.2, 2.3	5, 4	Y, Y	diagonal	HL	Delamination between CIP and PCP; A crack propagates along intersection of aggregates
2-2	3.75 x 4.8	-	-	-	-	-	Delamination between CIP and PCP
2-3	3.75 x 4.8	2.2	5	Y	transverse	0.004	Delamination between CIP and PCP
2-4	3.75 x 4.8	-	-	-	longitudinal	0.004	Delamination between CIP and PCP; A crack propagates along intersection of aggregates
3-1	3.75 x 4.3	2.0	5	Y	-	-	Delamination between CIP and PCP
3-2	3.75 x 4.3	-	-	-	-	-	Delamination between CIP and PCP

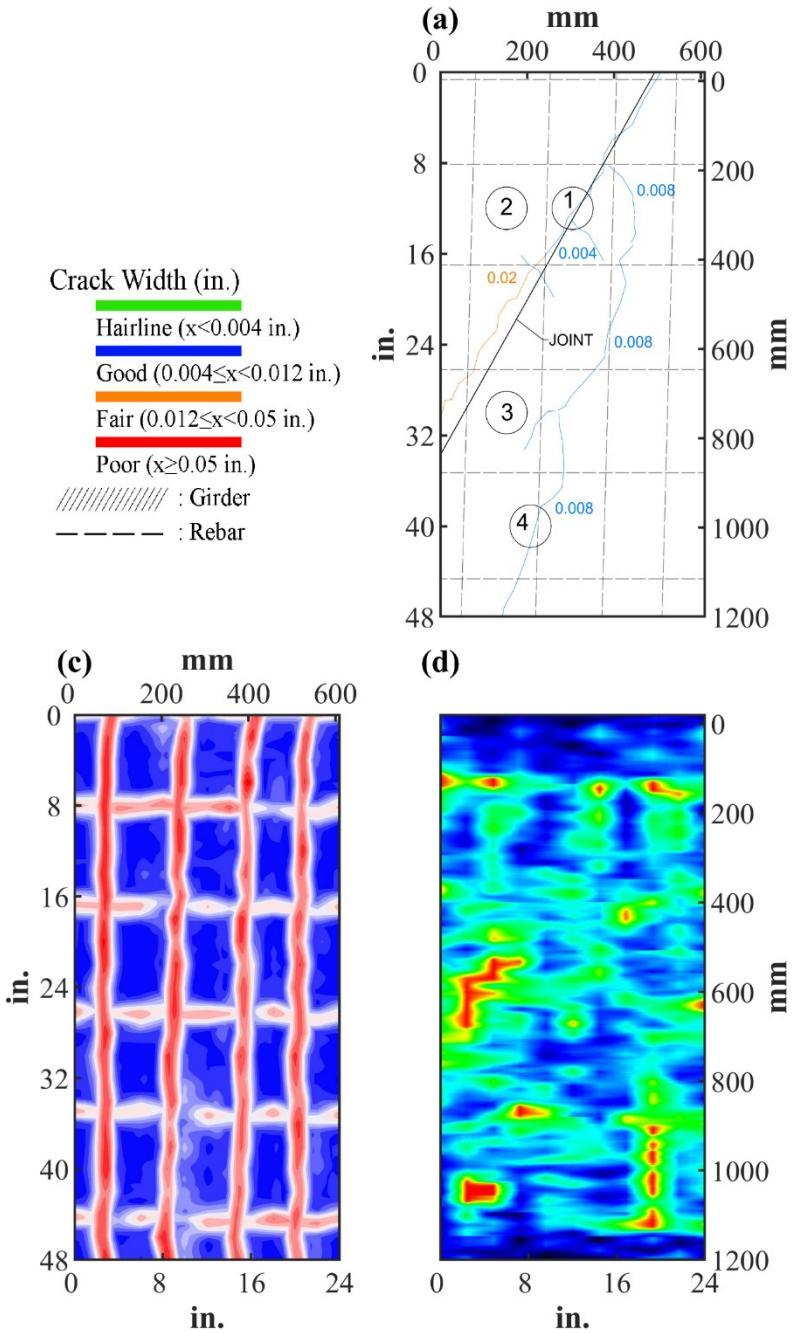
Figure 0.116. Crack Map and NDE Results of Grid 1: (a) Crack Map and Location of Cores; (c) GPR C-scan at 1.7 in. to 2.8 in. Depth; (d) UST C-scan at 6.2 in. Depth

As shown in Figure 0.116 (a), the Grid 1 had cracks with their widths ranging from 0.004 in. to 0.02 in. wide. The grid 1 was located on the joint and cracks propagate from the joint. The grid 2 was also located on the joint, and a crack ranging from 0.02 in. wide to 0.03 in. wide was propagating from the joint as shown in Figure 0.117 (a).

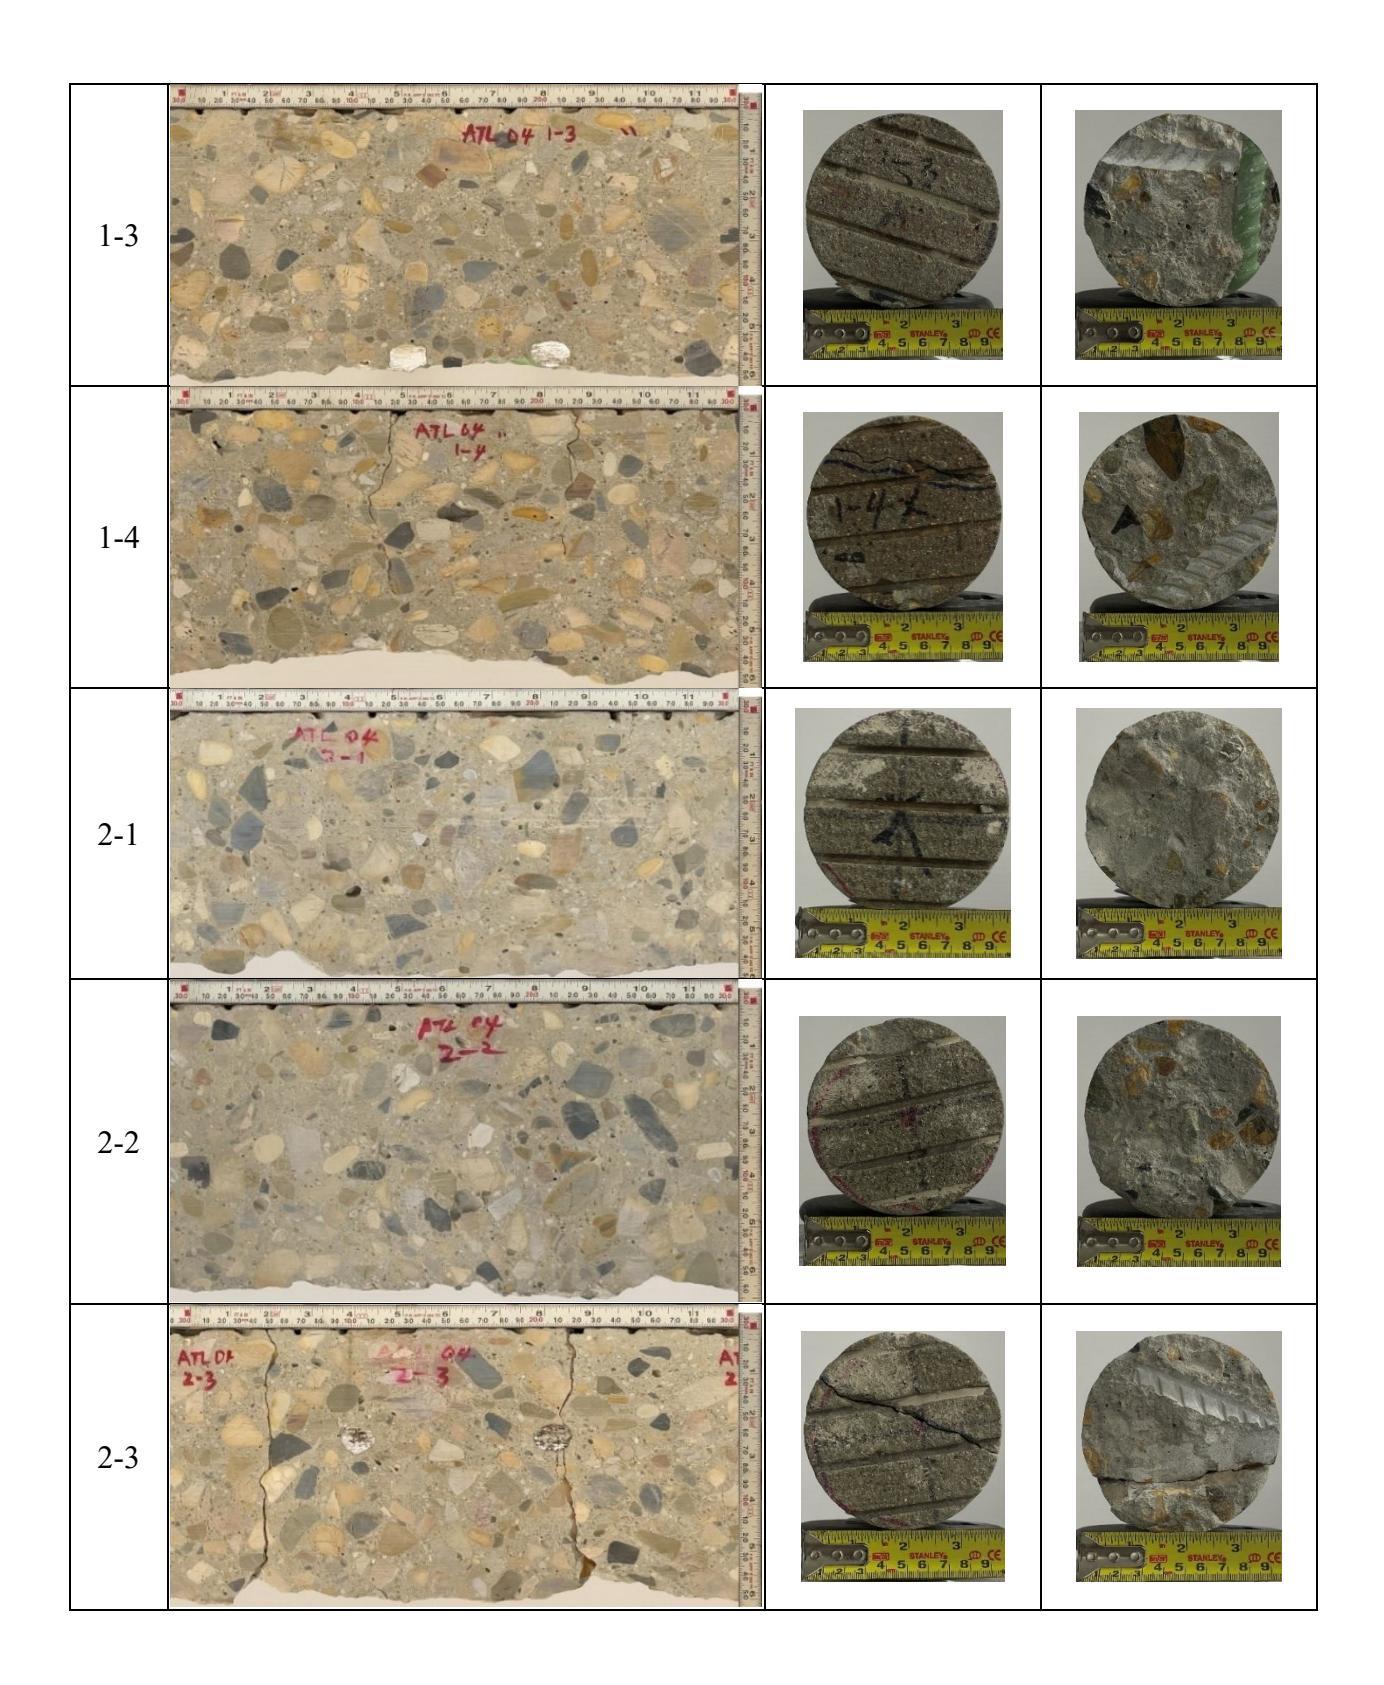
Table B-71. Core Pictures

Core	dia. x height (in.)	Rebar depth (in.)	Rebar size (#)	Epoxy (Y/N)	Crack type	Crack width (in)	Notes
1-1	3.75 x 4.7	-	-	-	diagonal	0.004	A crack propagates along intersection of aggregates
1-2	3.75 x 5.5	5.3	5	Y	-	-	Void at 1 in. depth
1-3	3.75 x 6.1	5.1	5	Y	-	-	-
1-4	3.75 x 5.3	2.0	5	Y	transverse	0.008	A crack propagates along intersection of aggregates
2-1	3.75 x 5.5	-	-	-	-	-	-
2-2	3.75 x 6.5	-	-	-	-	-	=-
2-3	3.75 x 6.3	2.3	5	Y	diagonal	0.03	Spilt due to a crack
2-4	3.75 x 2.9	_	_	-	diagonal	0.03	Spilt due to a crack

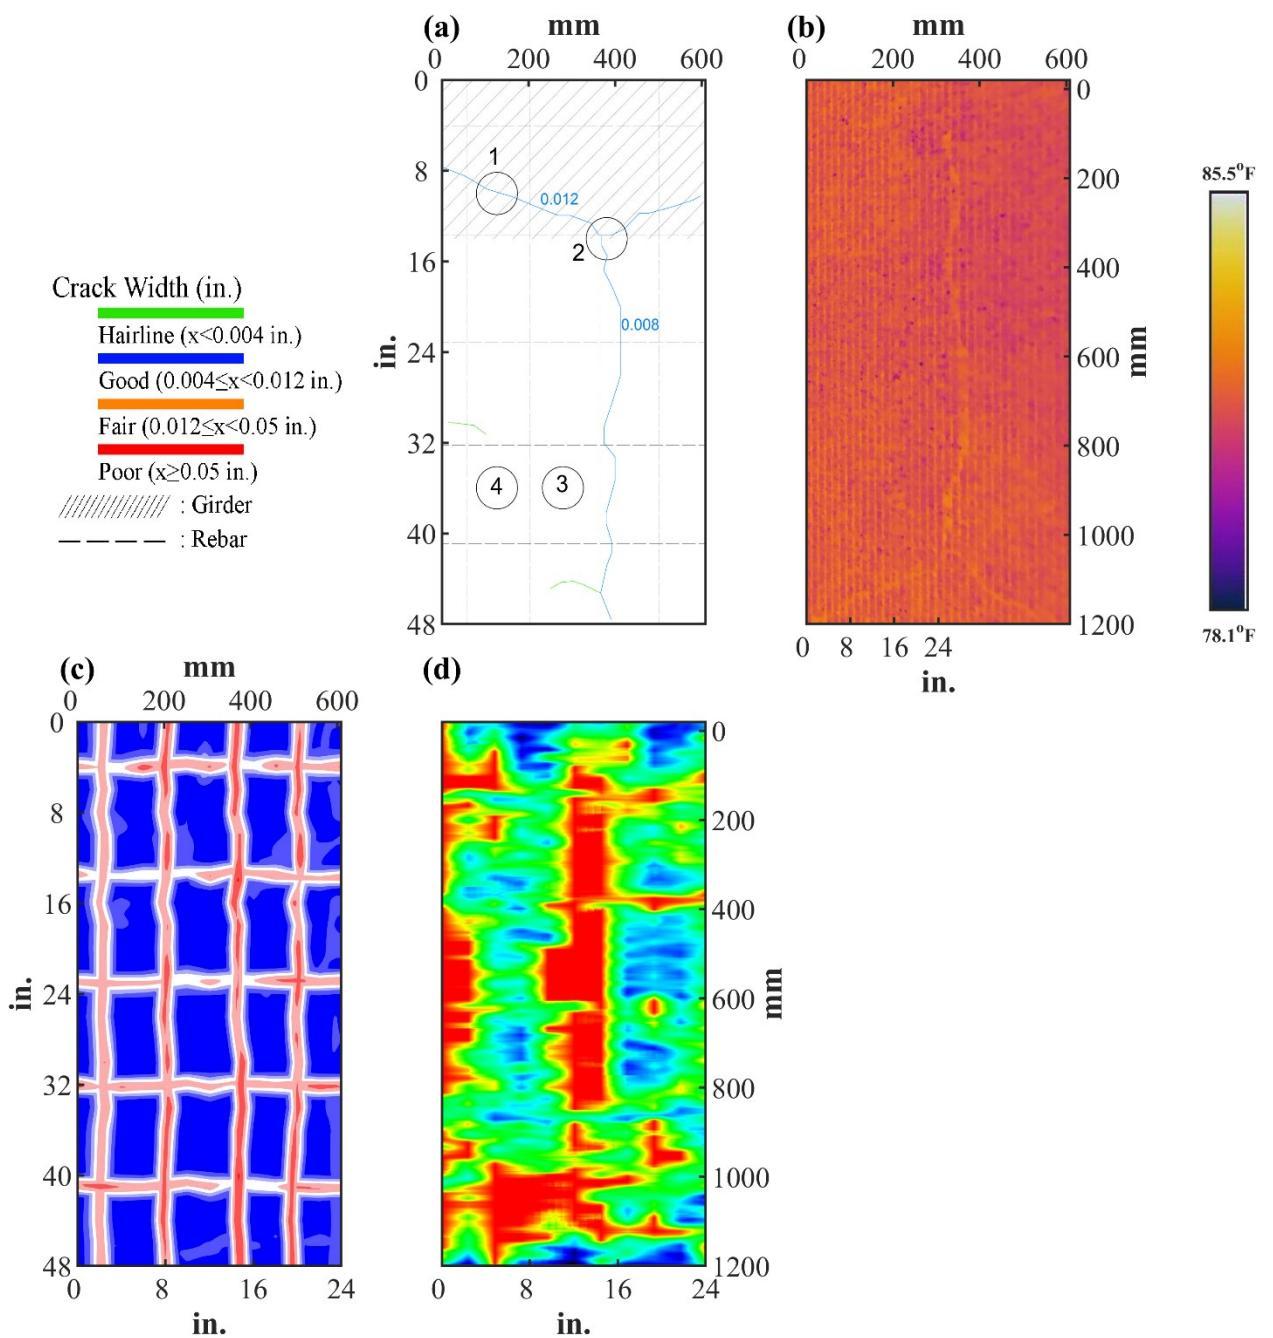
Figure 0.122. Crack Map and NDE Results of Grid 1: (a) Crack Map and Location of Cores; (b) Infrared Picture; (c) GPR C-scan at 2.7 in. to 3.8 in. Depth; (d) UST C-scan at 4.6 in. Depth

As shown in Figure 0.122 (a), it is possible that longitudinal and transverse cracks are cause by panel joints and they were 0.008 and 0.012 wide, respectively. The Grid 2 had 0.006 in. wide transverse crack, possibly cause by panel joints as shown in Figure 0.123 (a).

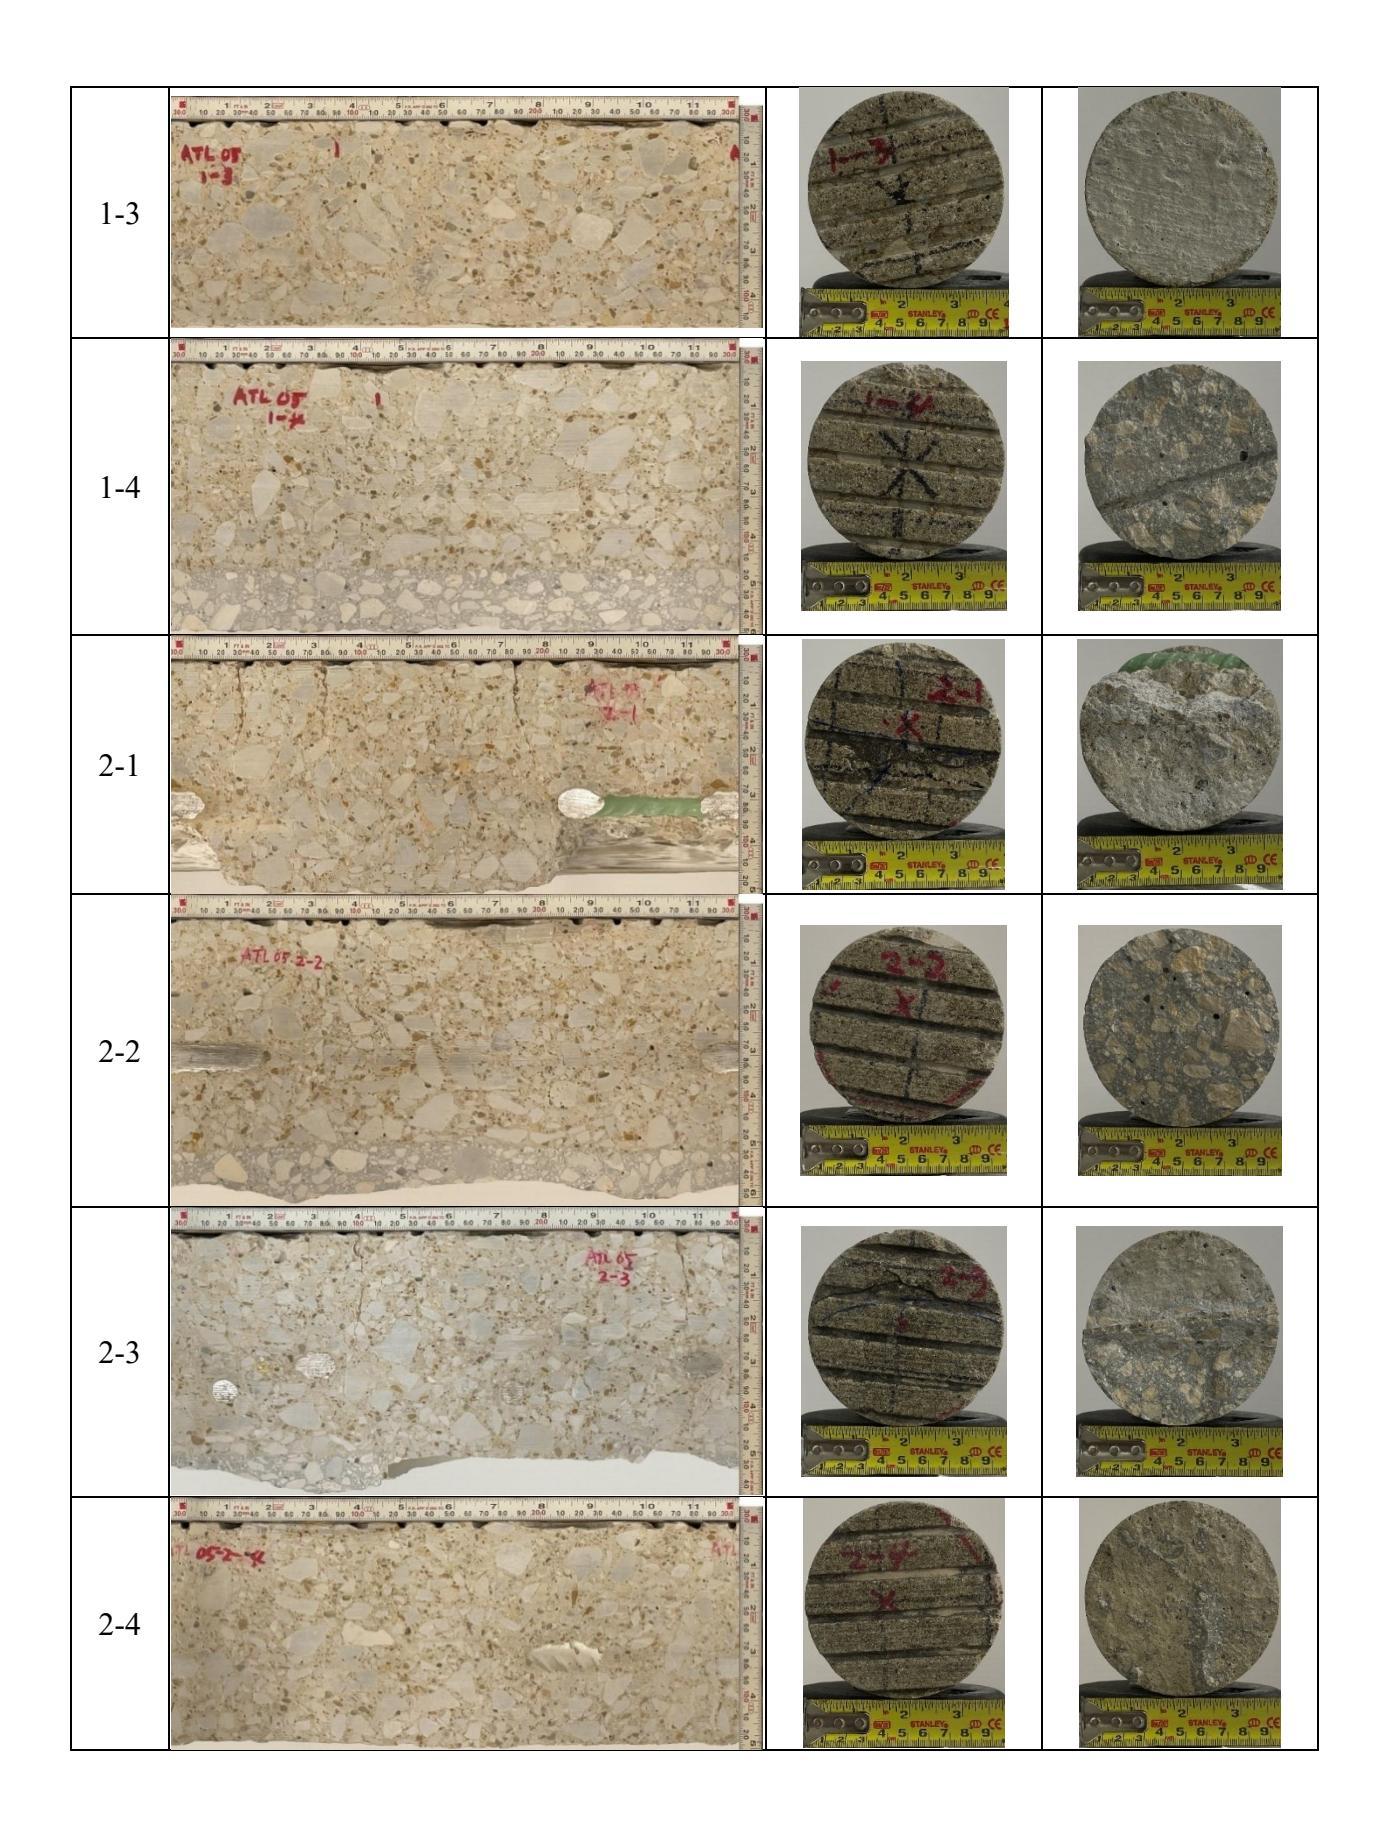
Table B-73. Core Pictures

Core	dia. x height (in.)	Rebar depth (in.)	Rebar size (#)	Epoxy (Y/N)	Crack type	Crack width (in)	Notes
1-1	3.75 x 4.9	-	-	-	diagonal	0.012	Delamination between CIP and PCP; A crack propagates along intersection of aggregates
1-2	3.75 x 4.7	2.8, 3.4	5, 4	Y, Y	transverse; diagonal	0.008; 0.012	Delamination between CIP and PCP; A crack propagates along intersection of aggregates
1-3	3.75 x 4.6	-	-	-	-	-	Delamination between CIP and PCP
1-4	3.75 x 6.1	-	-	-	-	-	-
2-1	3.75 x 2.9	2.8	5	Y	transverse	0.004	A crack propagates along intersection of aggregates
2-2	3.75 x 5.9	2.8	5	Y	-	-	-
2-3	3.75 x 5.1	2.8, 3.4	5,4	Υ, Υ	transverse	0.006	A crack propagates along intersection of aggregates
2-4	3.75 x 5.1	-	-	-			Delamination between CIP and PCP

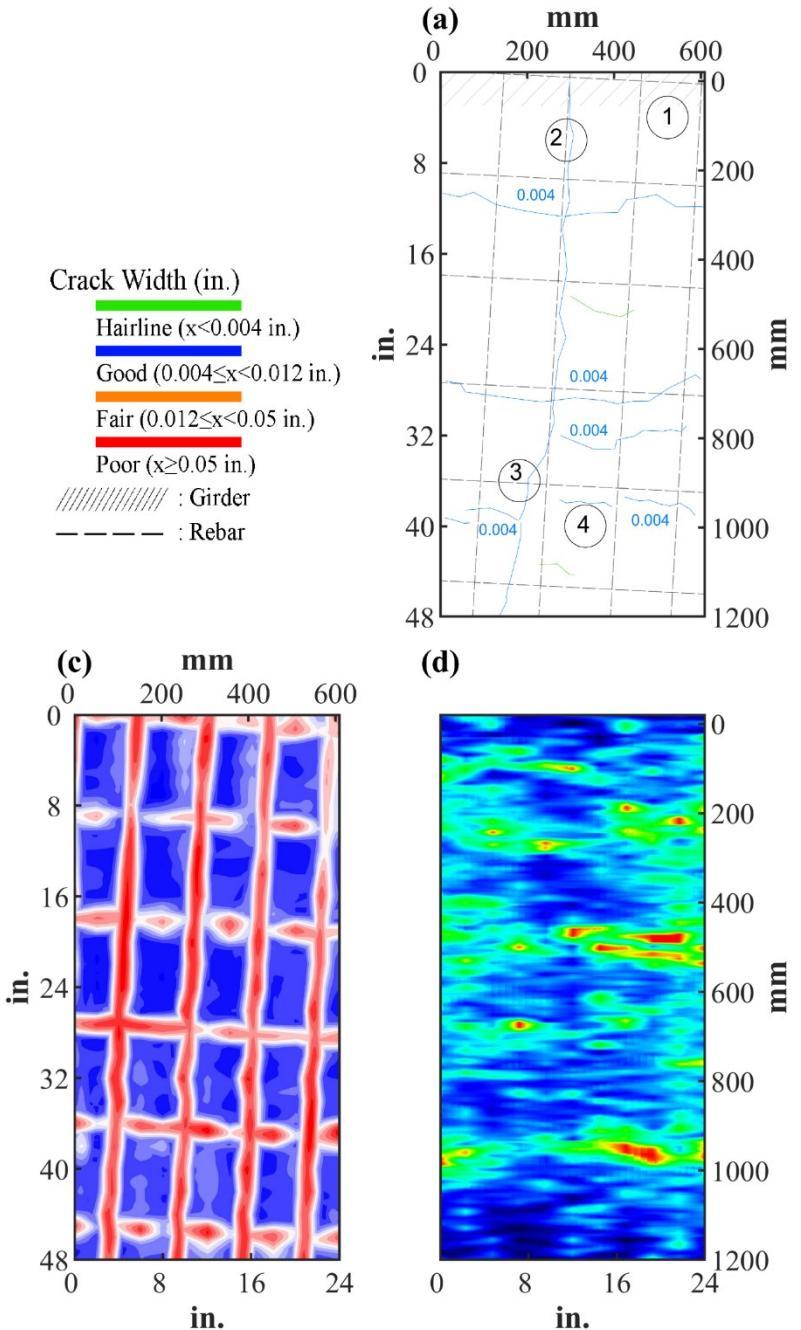
Figure 0.129. Crack Map and NDE Results of Grid 1: (a) Crack Map and Location of Cores; (c) GPR C-scan at 1.7 in. to 2.8 in. Depth; (d) UST C-scan at 1.6 in. Depth

As shown in Figure 0.129 (a), the Grid 1 had cracks that are 0.004 in. wide in both transverse and longitudinal directions. The Grid 2 had short cracks that were 0.006 in wide and 0.012 in. wide as shown in Figure 0.130 (a).

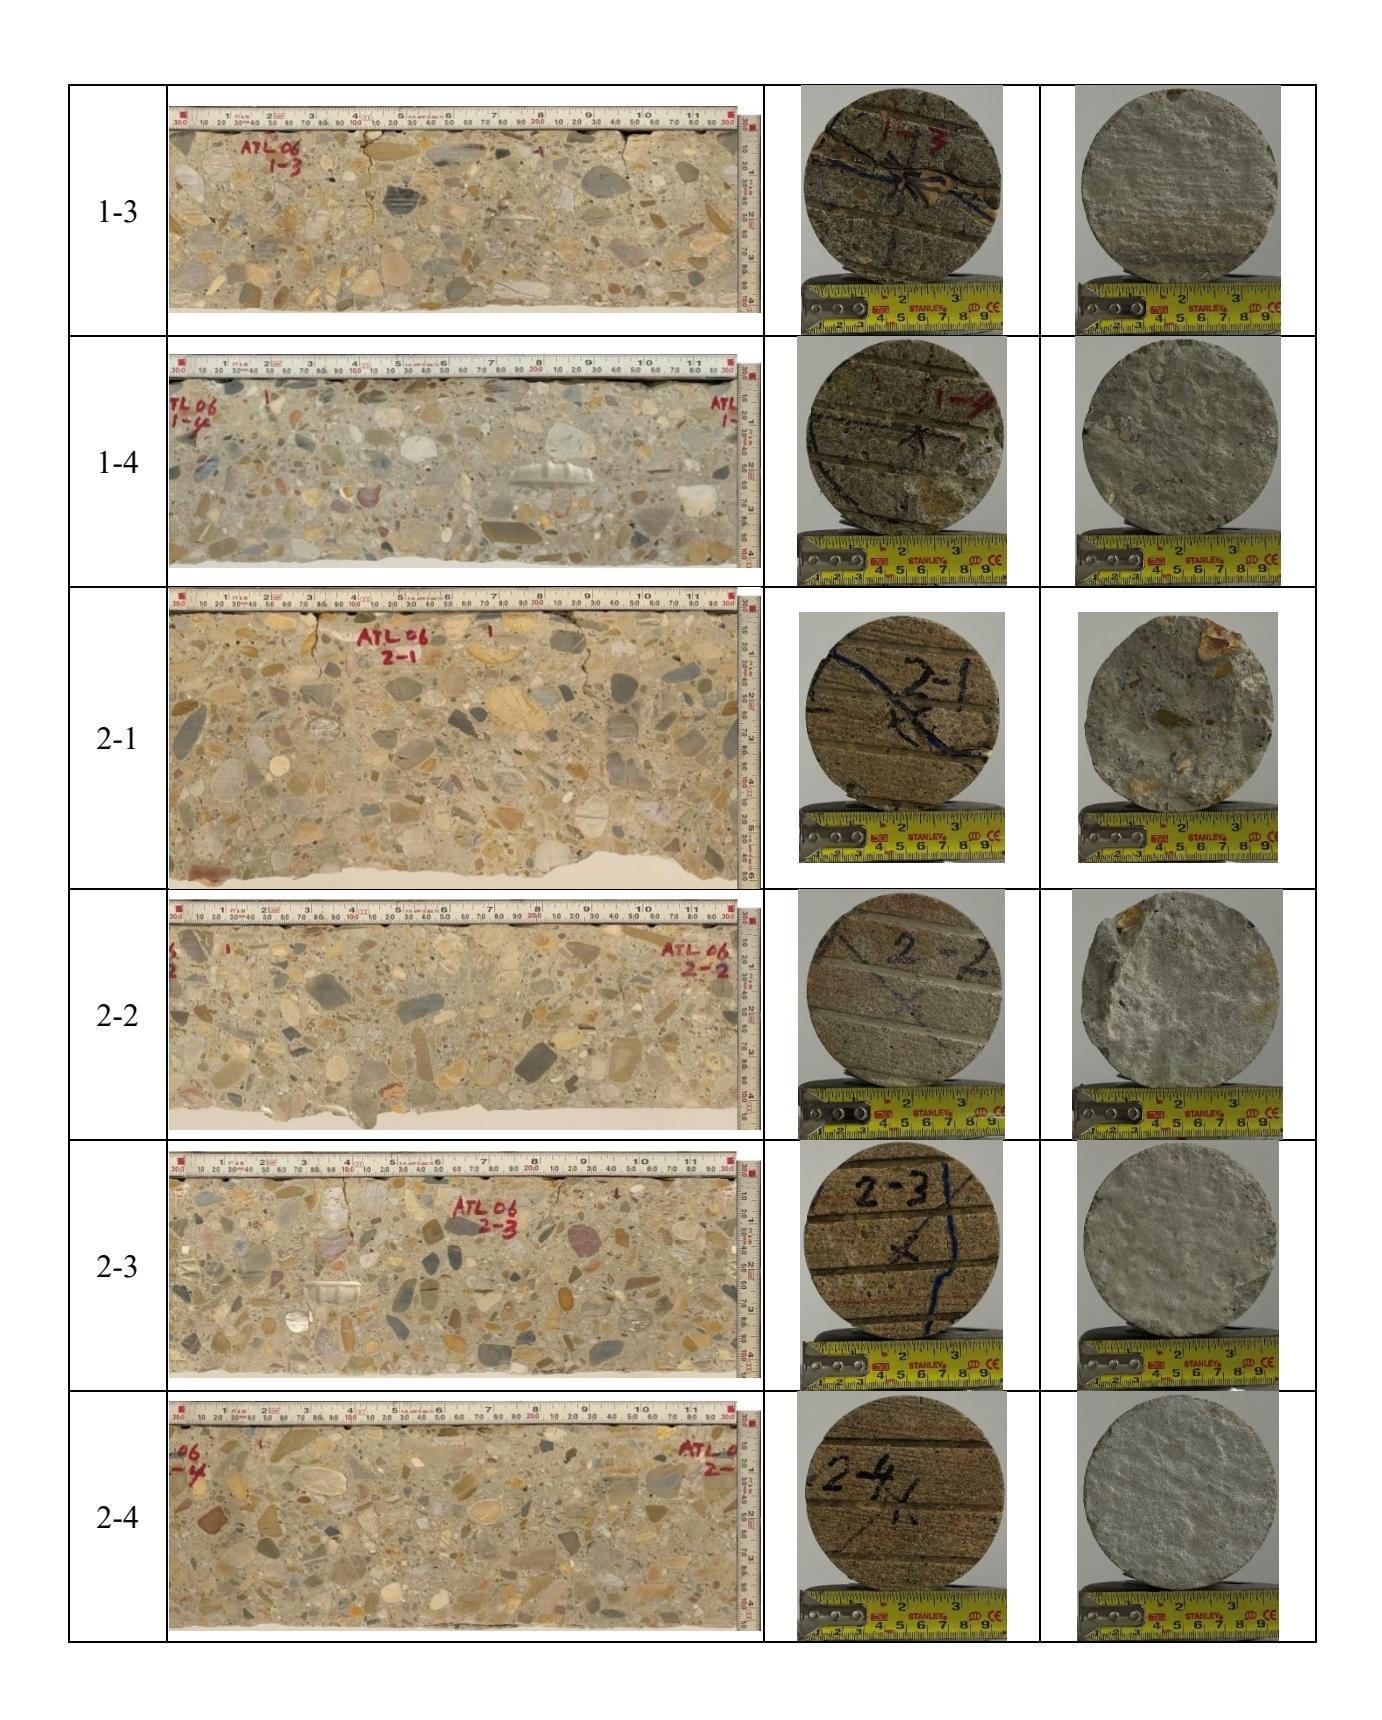
Table B-76. Core Pictures

Core	dia. x height (in.)	Rebar depth (in.)	Rebar size (#)	Epoxy (Y/N)	Crack type	Crack width (in)	Notes
1-1	3.75 x 5.5	-	-	-	-	-	-
1-2	3.75 x 5.9	2.0	5	Y	transverse	0.004	-
1-3	3.75 x 4.1	2.6	4	Y	transverse	0.004	A crack propagates along intersection of aggregates
1-4	3.75 x 4.0	-	-	-	map	HL	-
2-1	3.75 x 5.6	2.4	5	Y	diagonal	HL	A crack propagates along intersection of aggregates
2-2	3.75 x 4.3	-	-	-	-	-	-
2-3	3.75 x 4.4	3.0	4	Y	longitudinal	0.006	A crack propagates along intersection of aggregates
2-4	3.75 x 4.6	-	-	-	-	-	-

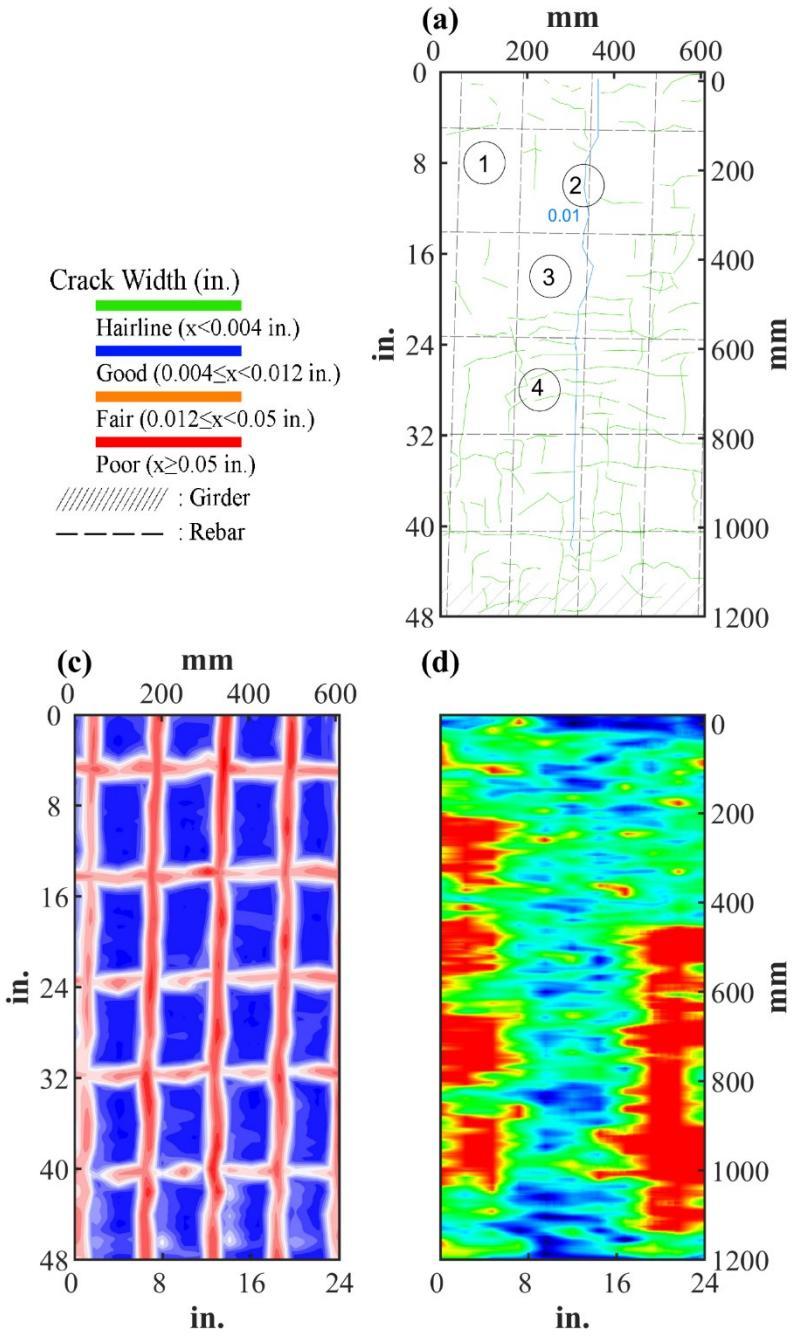
Figure 0.136. Crack Map and NDE Results of Grid 1: (a) Crack Map and Location of Cores; (c) GPR C-scan at 1.7 in. to 2.8 in. Depth; (d) UST C-scan at 6.7 in. Depth

As shown in Figure 0.136 (a), there were widespread of hairline cracks and 0.01 in. wide transverse crack which was possibly caused by panel joints. On Grid 2, 0.004 in. wide transverse crack was observed which was possibly cause by panel joints as well as shown in Figure 0.137 (a).

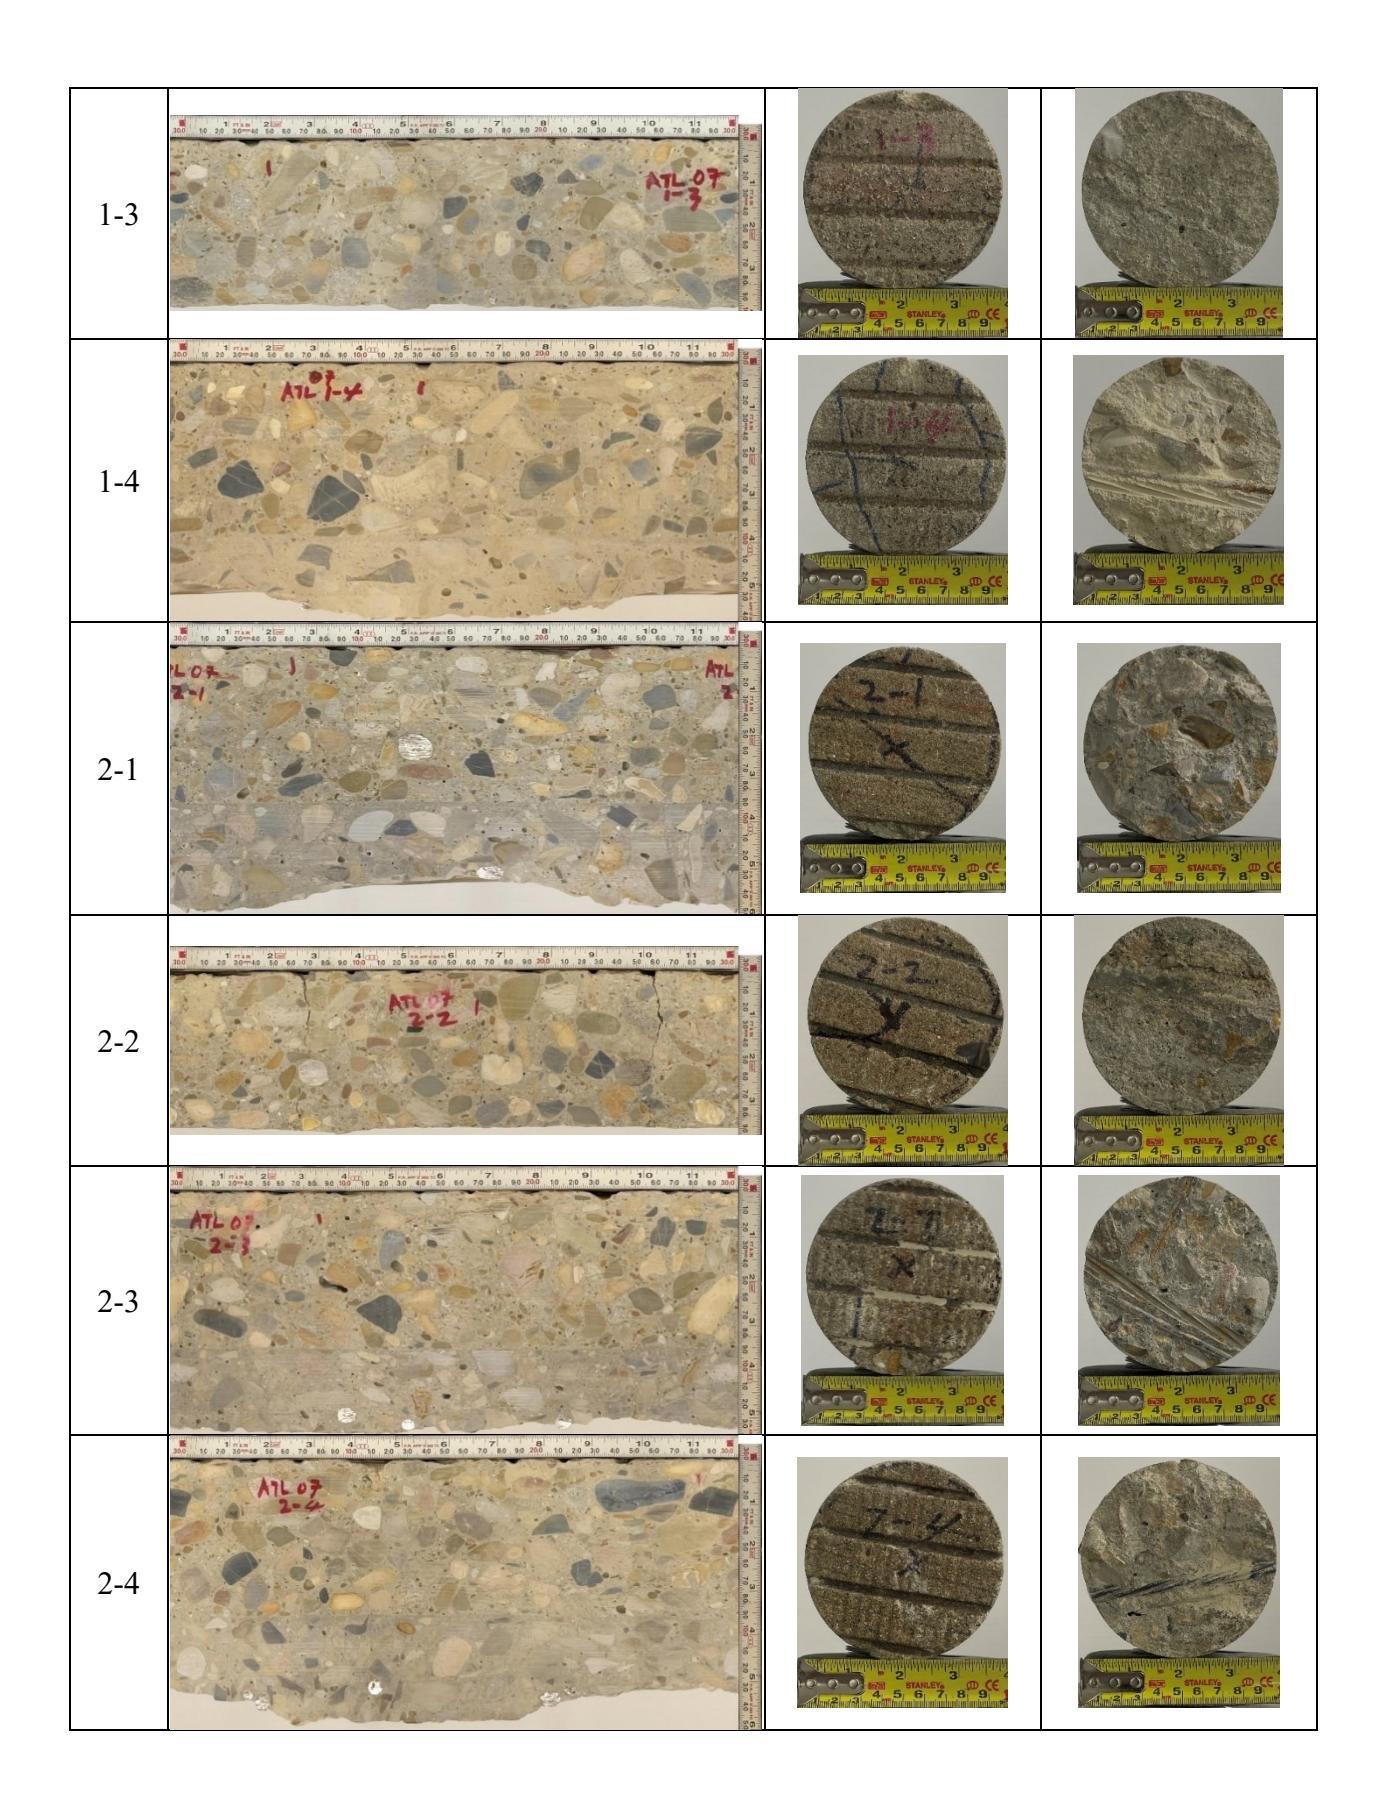
Table B-79. Core Pictures

Core	dia. x height (in.)	Rebar depth (in.)	Rebar size (#)	Epoxy (Y/N)	Crack type	Crack width (in)	Notes
1-1	3.75 x 5.5	-	-	-	-	-	-
1-2	3.75 x 6.4	2.1	5	Y	transverse	0.01	A crack propagates from panel joint
1-3	3.75 x 3.9	-	-	-	-	-	Delamination between CIP and PCP
1-4	3.75 x 5.0	-	-	-	map	HL	-
2-1	3.75 x 5.5	2.0	5	Y	-	-	-
2-2	3.75 x 3.6	2.1	5	Y	transverse	0.004	A crack propagates along intersection of aggregates
2-3	3.75 x 5.5	-	-	-	-	-	-
2-4	3.75 x 5.2	_	_	_	-	_	-

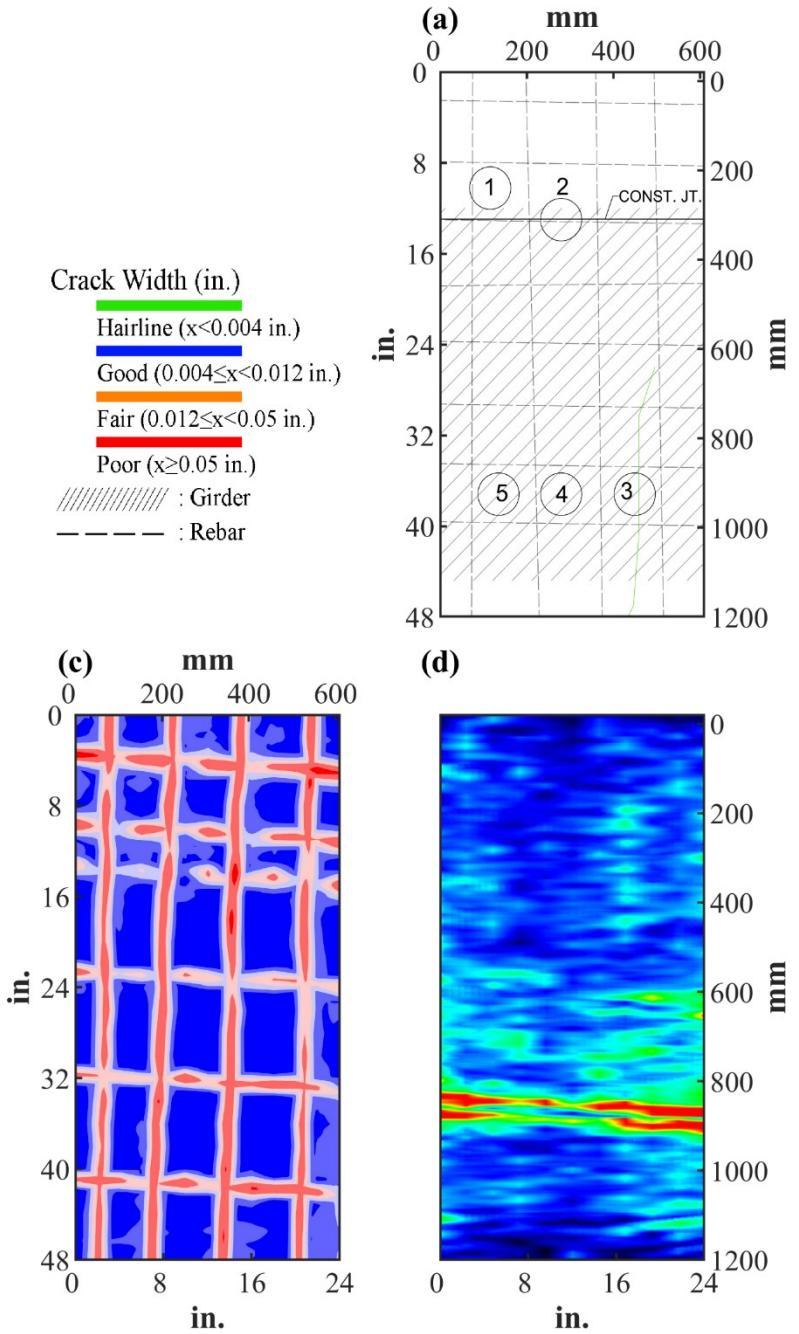
Figure 0.143. Crack Map and NDE Results of Grid 1: (a) Crack Map and Location of Cores; (c) GPR C-scan at 1.7 in. to 2.8 in. Depth; (d) UST C-scan at 6.7 in. Depth

As shown in Figure 0.143 (a), Grid 1 was located on the longitudinal construction joint. On Grid 2, there was a 0.004 in. wide diagonal crack as shown in Figure 0.144 (a). The deck was in very good condition with almost no cracks.
