Evaluation of Corrosion Prevention and Mitigation Approaches Used on Texas Bridges—Volume 2: Reinforced Concrete Bridges

Technical Report 0-7040-R1-Vol2

TEXAS A&M TRANSPORTATION INSTITUTE COLLEGE STATION, TEXAS

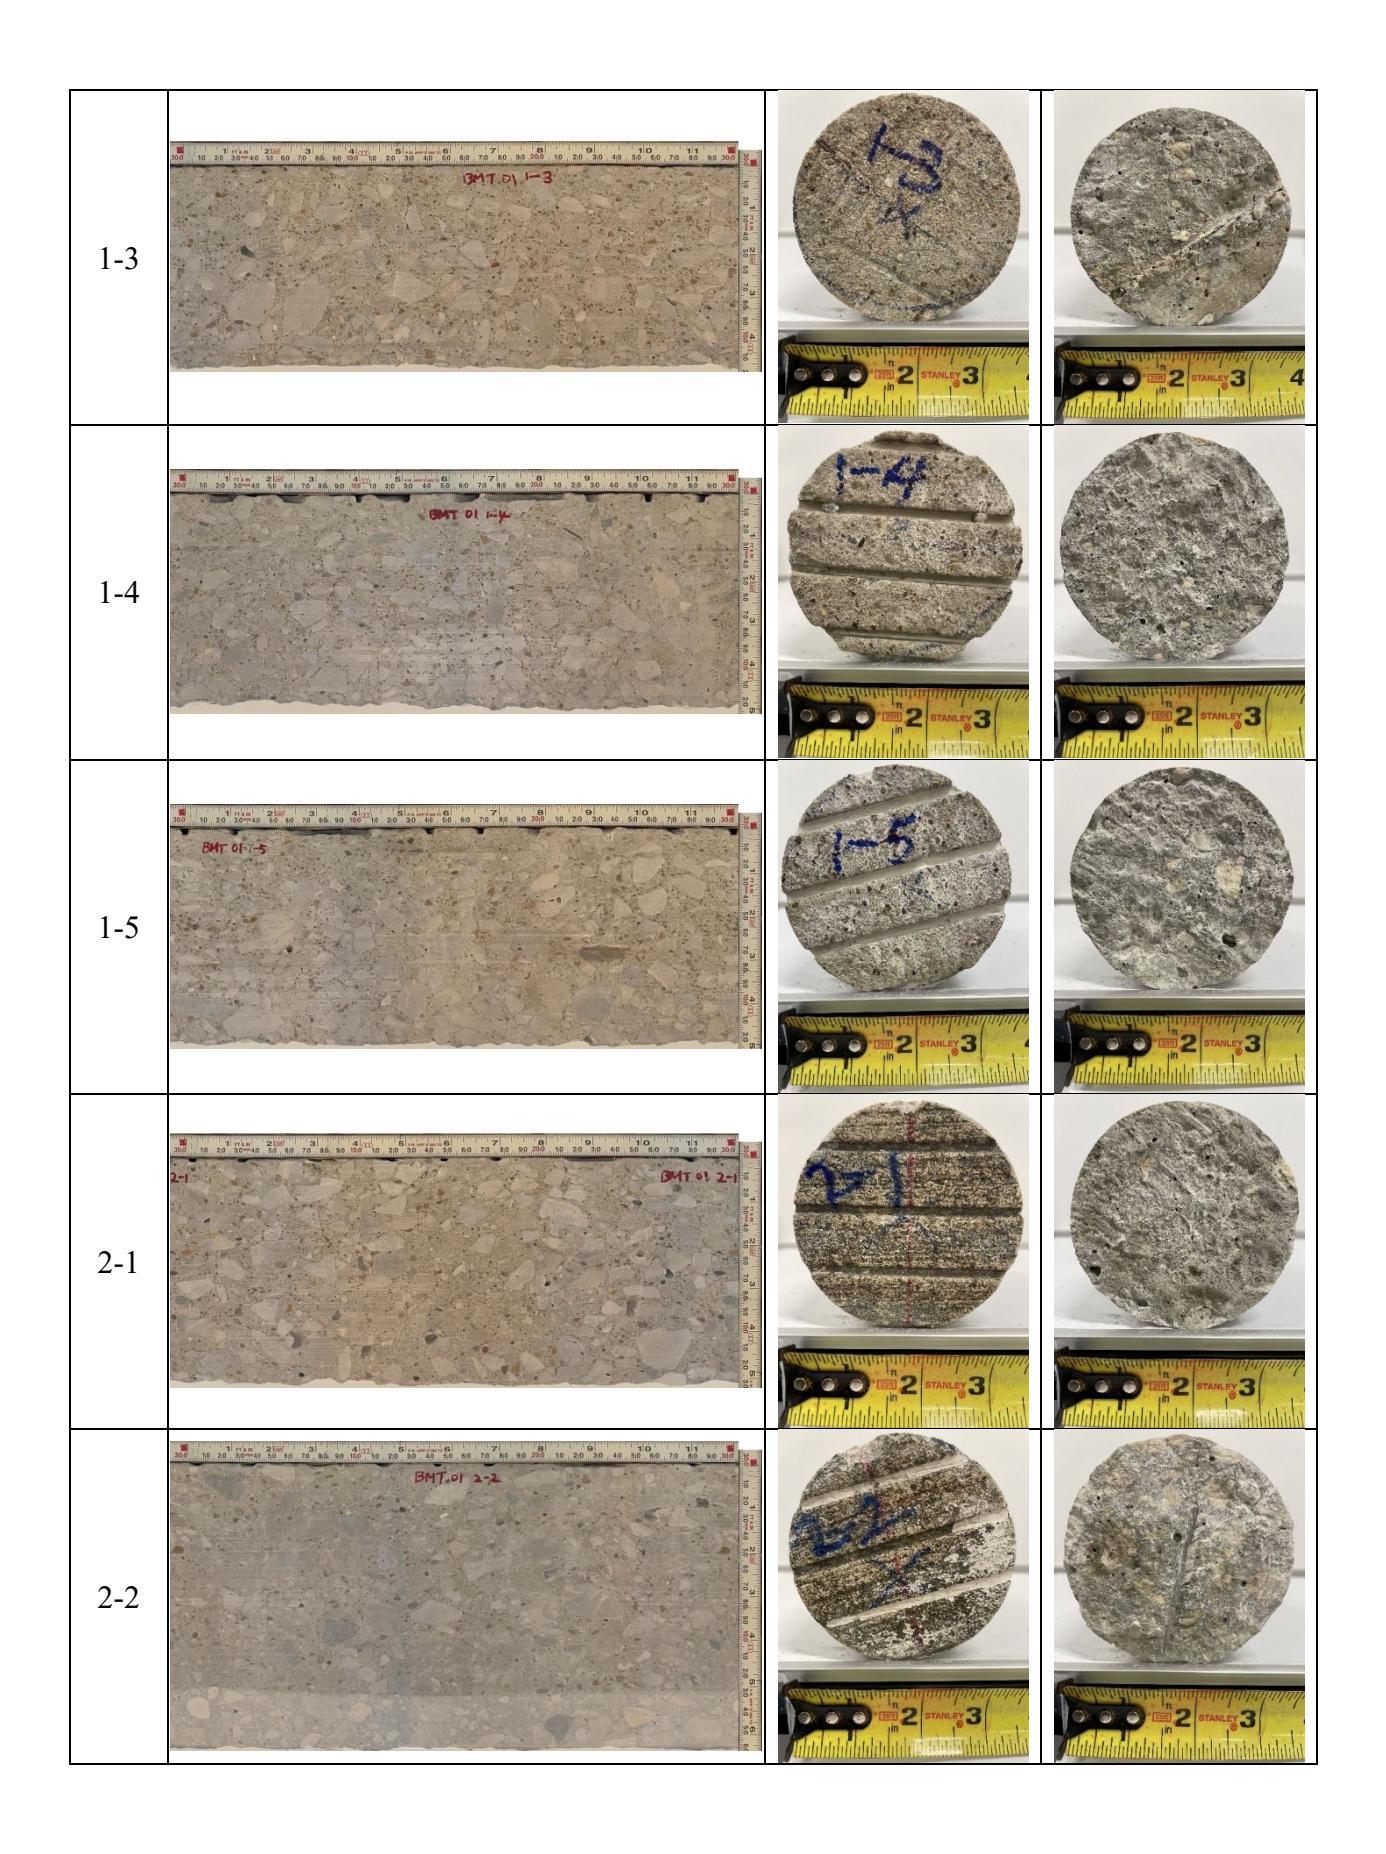
Table B-82. Core Pictures

Core	dia. x height (in.)	Rebar depth (in.)	Rebar size (#)	Epoxy (Y/N)	Crack type	Crack width (in)	Notes
1-1	3.75 x 6.3	2.7	5	Ν	-	-	-
1-2	3.75 x 6.4	3.1	5	Ν	-	-	Core split due to construction joint
1-3	3.75 x 4.7	-	-	-	transverse	HL	-
1-4	3.75 x 4.8	-	-	-	-	-	-
1-5	3.75 x 4.8	-	-	-	-	-	-
2-1	3.75 x 4.9	-	-	-	-	-	-
2-2	3.75 x 6.7	-	-	-	-	-	-
2-3	3.75 x 6.6	-	-	-	-	-	-
2-4	3.75 x 5.2	2.4	5	Ν	diagonal	HL	-

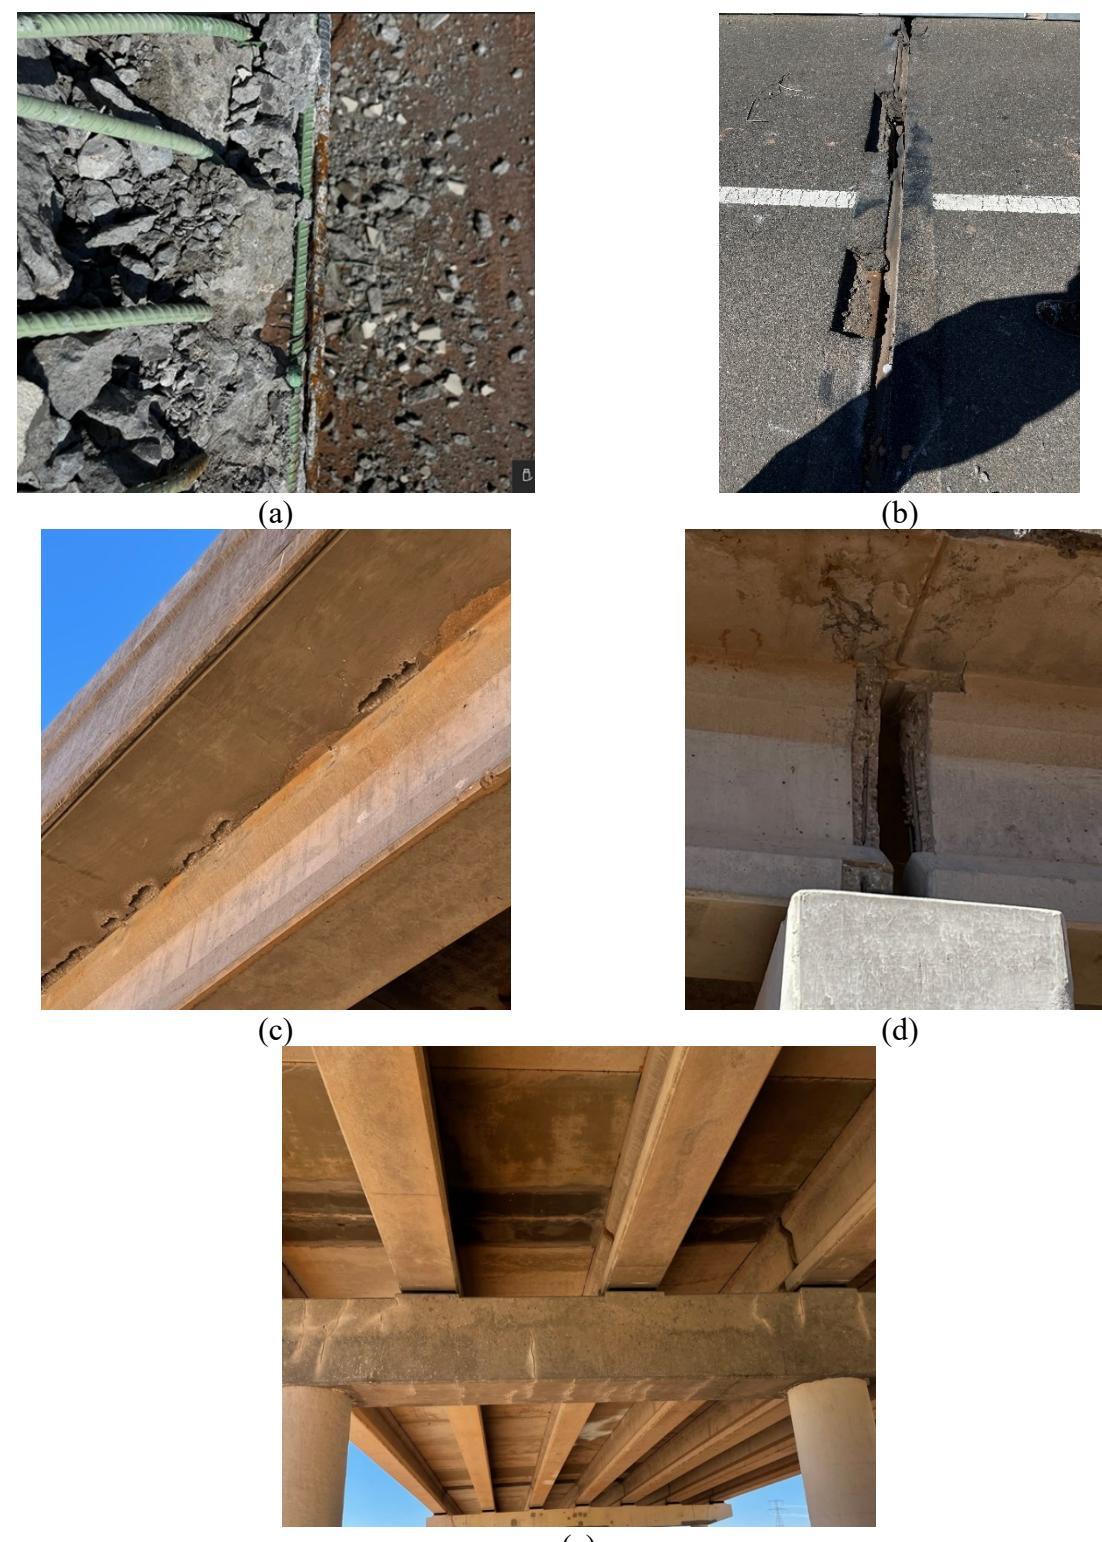
The concrete railing had been demolished, and some corroded rebar was found on the edge of railing as shown in Figure 0.148 (a). It was noted that the epoxy-coated rebar was used for top rebar whereas the bottom rebars were black rebars without any coating. As can be seen from Figure A.1.2 (a), bottom black rebar displayed severe corrosion. Expansion joint is partially failed and full of dirt and debris as shown in Figure A.1.2 (b). In the superstructure, extensive delamination was found along the deck overhang as shown in Figure A.1.2 (c). Spalling and exposed rebar were found on the end of beam at bent 25 as shown in Figure 0.148 (d). Severe vertical cracking was found the bent 29 as shown in Figure 0.148 (e).

Figure 0.148. Deteriorations on the Bridge Deck: (a) Corroded black rebar at the railing edge; (b) Spalling of overlay at Joint; (c) Delamination along the west overhang of Span 26; (d) Spalling and exposed rebar of girders at bent 25; (e) Sealed cracks at bent 29

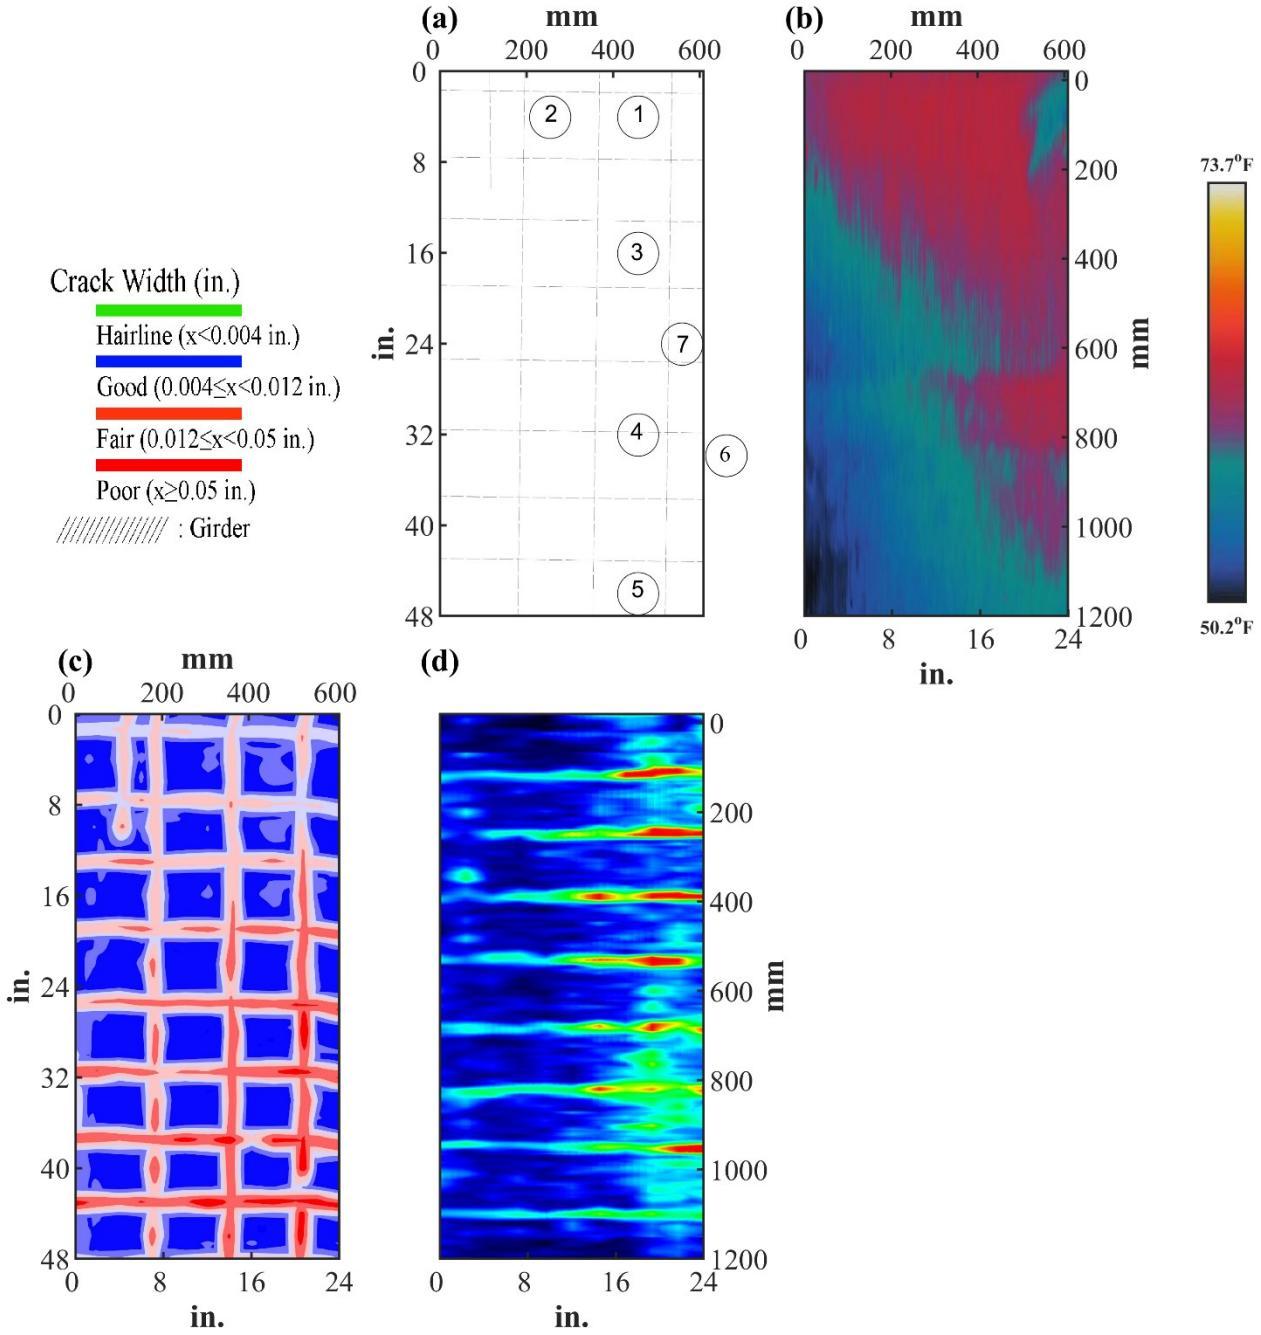
Figure 0.149. Crack Map and NDE Results of Grid 1: (a) Crack Map and Location of Cores; (b) Infrared Picture; (c) GPR C-scan at 1.5 in. to 3.4 in. Depth; (d) UST C-scan at 2.0 in. Depth

Grid 1 was located on SB shoulder lane. Because bridge was under construction and had asphalt overlay, an arbitrary location on the shoulder of span 29 where the asphalt overlay could be taken out was decided. As shown in Figure 0.149 (a), grid 1 did not have any cracks partly because the deck was originally covered by asphalt overlay.

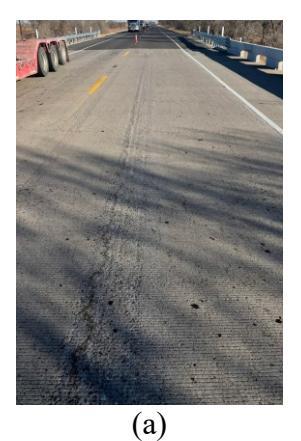
Deck surface has transverse and longitudinal cracks as shown in Figure 0.154 (a), and there were hairline cracks on the abutment.

Figure 0.154. Deteriorations on the Bridge Deck: (a) Transverse and Longitudinal Cracks on the Deck Surface; (b) Hairline cracks at Abutment

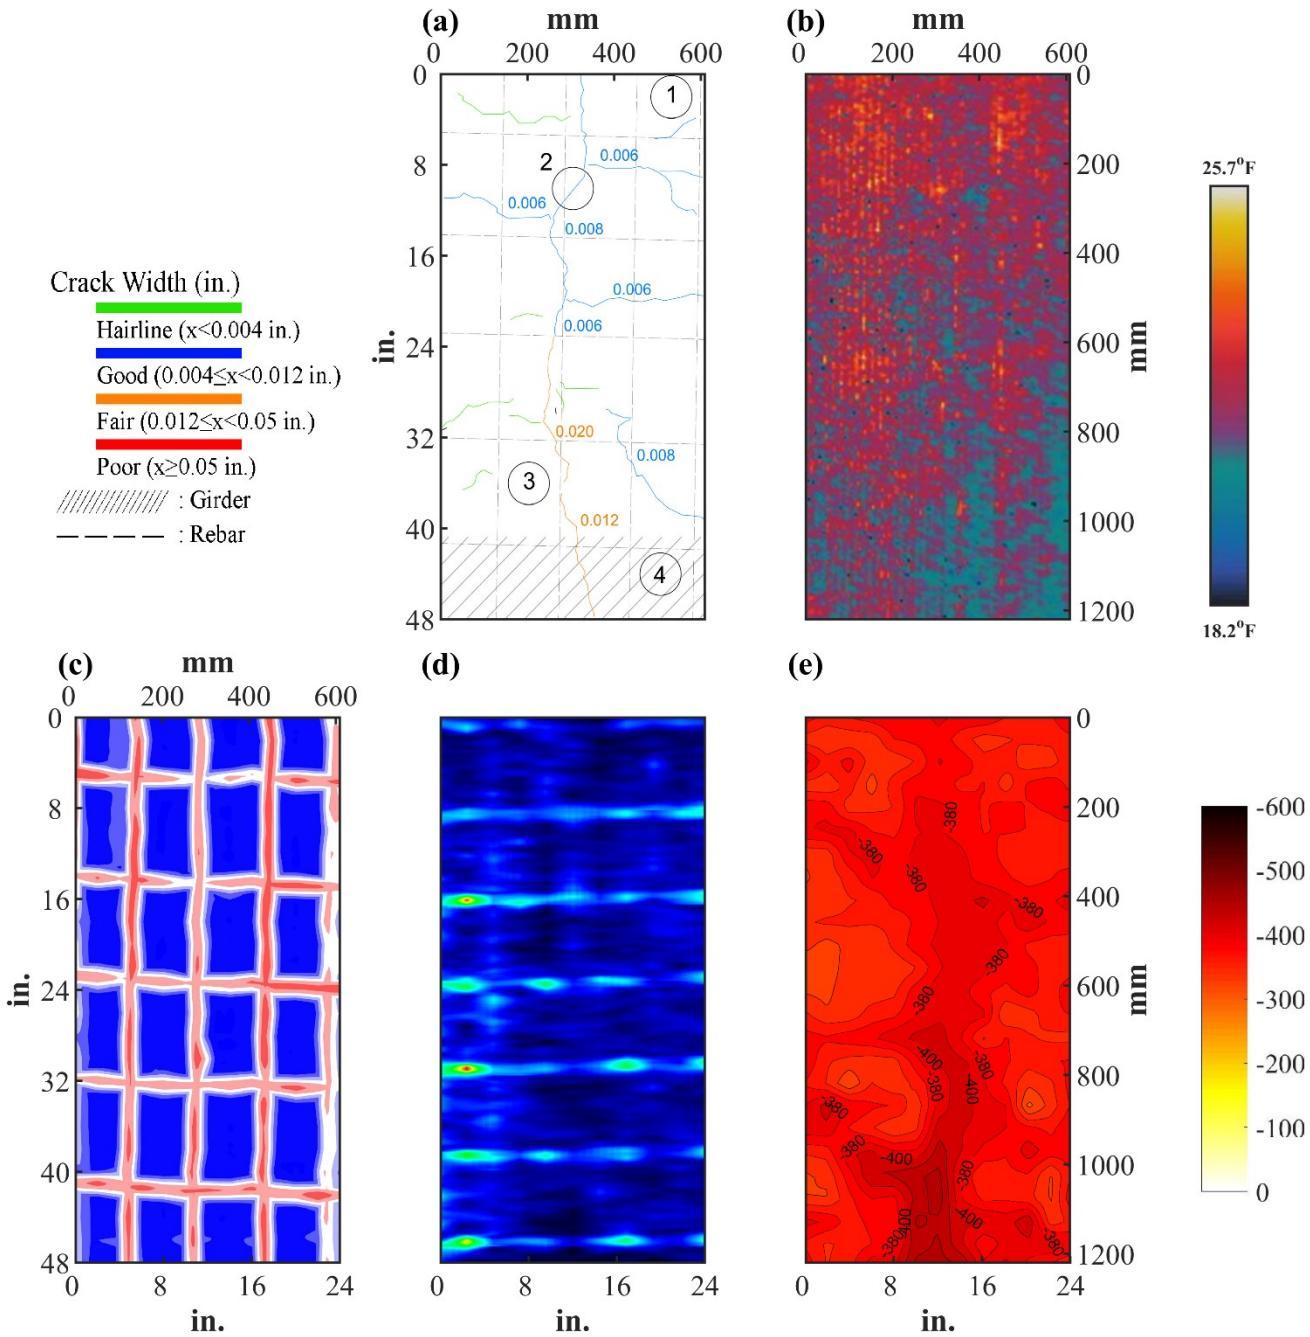
Figure 0.156. NDE Results of Grid 1: (a) Crack Map and Location of Cores; (b) Infrared Picture; (c) GPR C-scan at 1.75 in. to 3.15 in. Depth; (d) UST C-scan at 2.9 in. Depth; (e) Corrosion Rate Map

As shown in Figure 0.156 (a), there are widespread of cracks that range from 0.006 in. and 0.008 in. wide. The widest crack width was 0.02 in. transverse crack. It is possible that transverse crack was caused by panel joints. The Grid 2 had one 0.004 in. wide transverse crack as shown in Figure 0.157 (a).

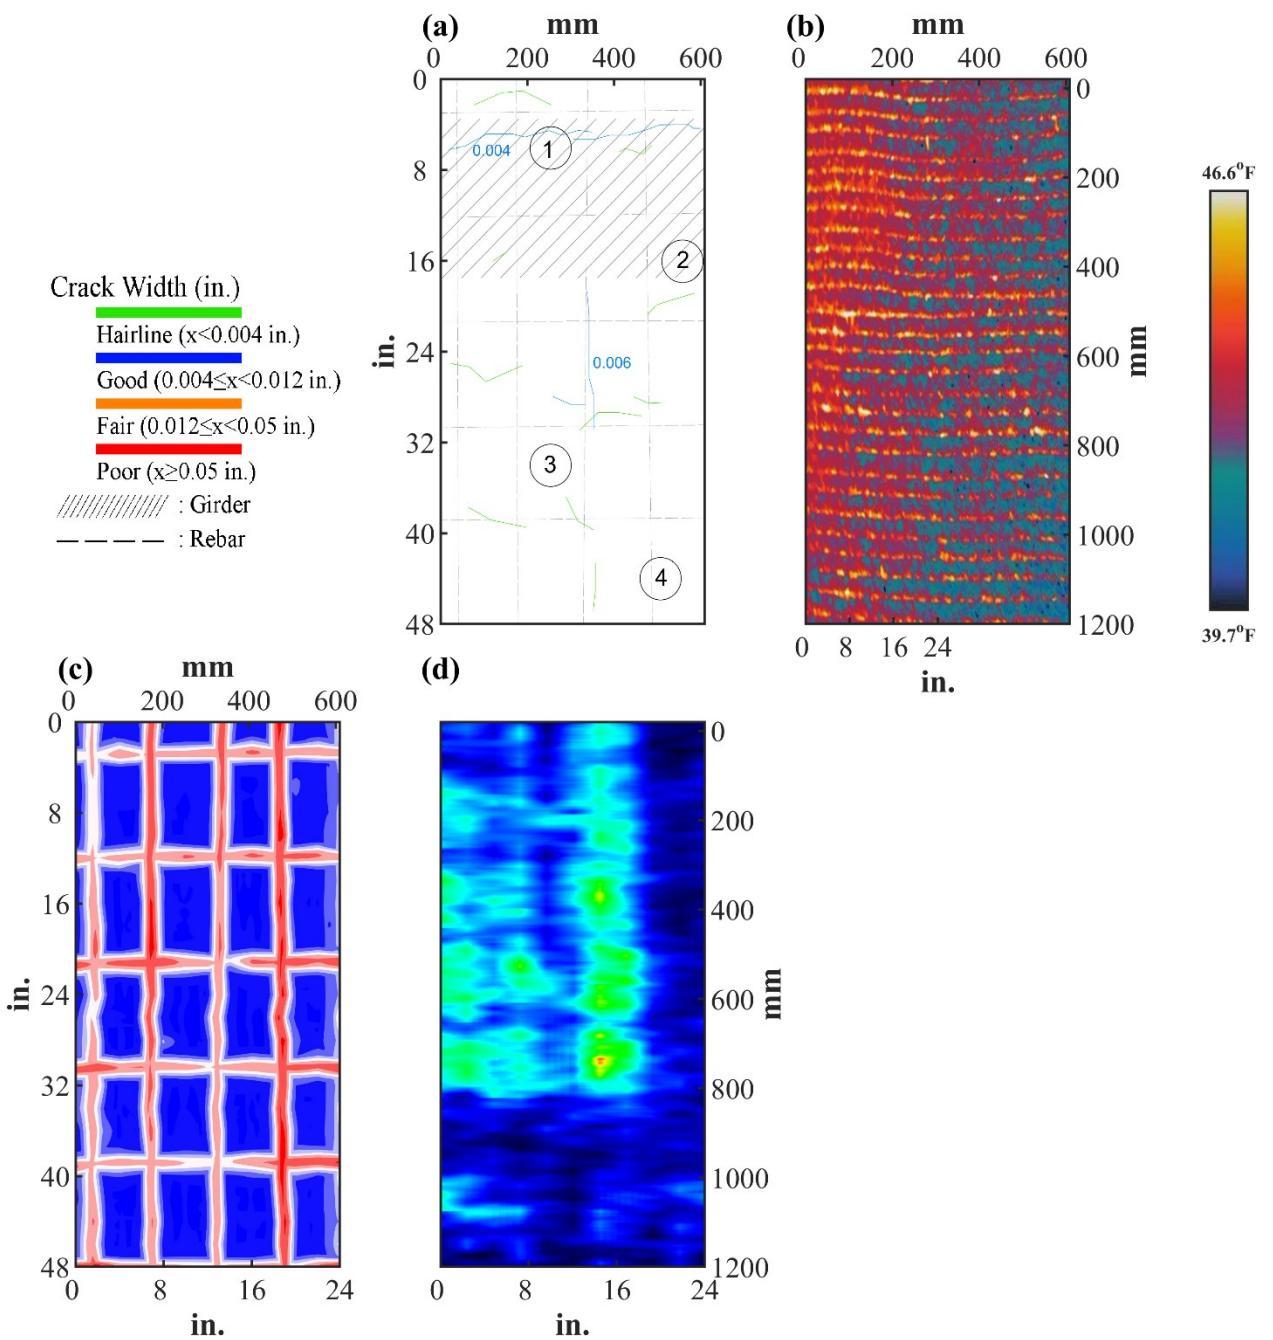
As shown in Figure 0.163 (a), there was a 0.004 in. wide longitudinal crack on top of girder and 0.006 in. wide transverse crack on grid 1. On grid 2, there was two short cracks that are 0.004 in. wide as shown in Figure 0.164 (a).

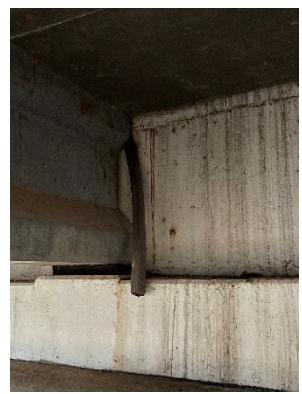
There were hairline cracks on abutment backwall as shown in Figure 0.169.

Figure 0.169. Deteriorations on the Bridge: Hairline Cracks on Abutment

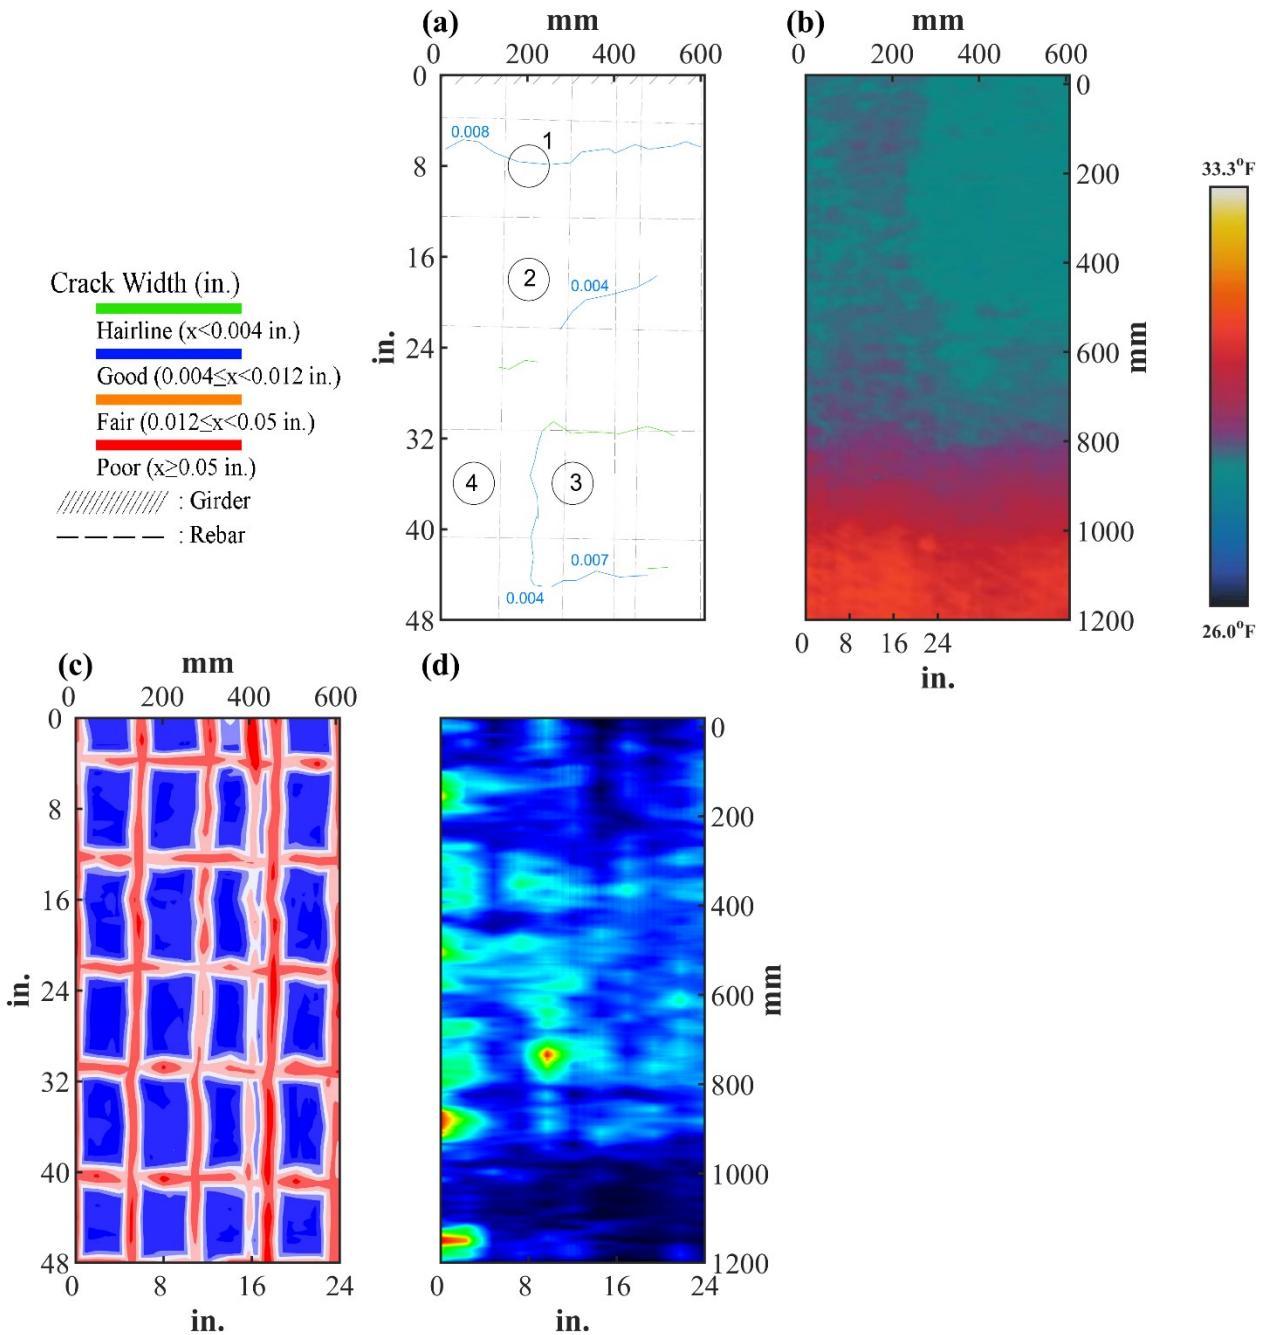
As shown in Figure 0.171 (a), grid 1 had a 0.008 in. wide longitudinal crack, maybe caused by panel joints, and some cracks that are 0.004 in. and 0.007 in. wide. On grid 2, there wasn't any cracks as shown in Figure 0.172 (a).

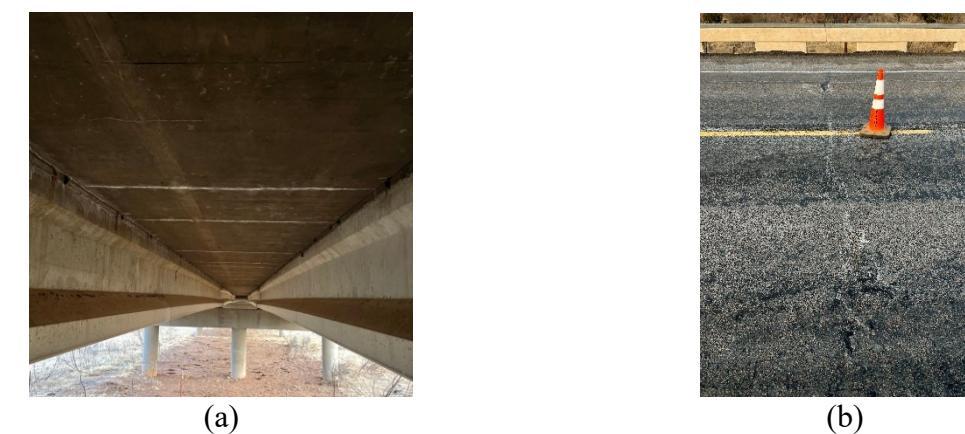
Moderate shrinkage cracks are found on the bottom of deck as shown in the Figure 0.177 (a). There were some cracks and delamination of asphalt overlay on the deck as shown in Figure 0.177 (b).

Figure 0.177. Deteriorations on the Bridge: (a) Moderate Cracks on Bottom Surface of Deck; (b) Cracks and Delamination of Asphalt Overlay

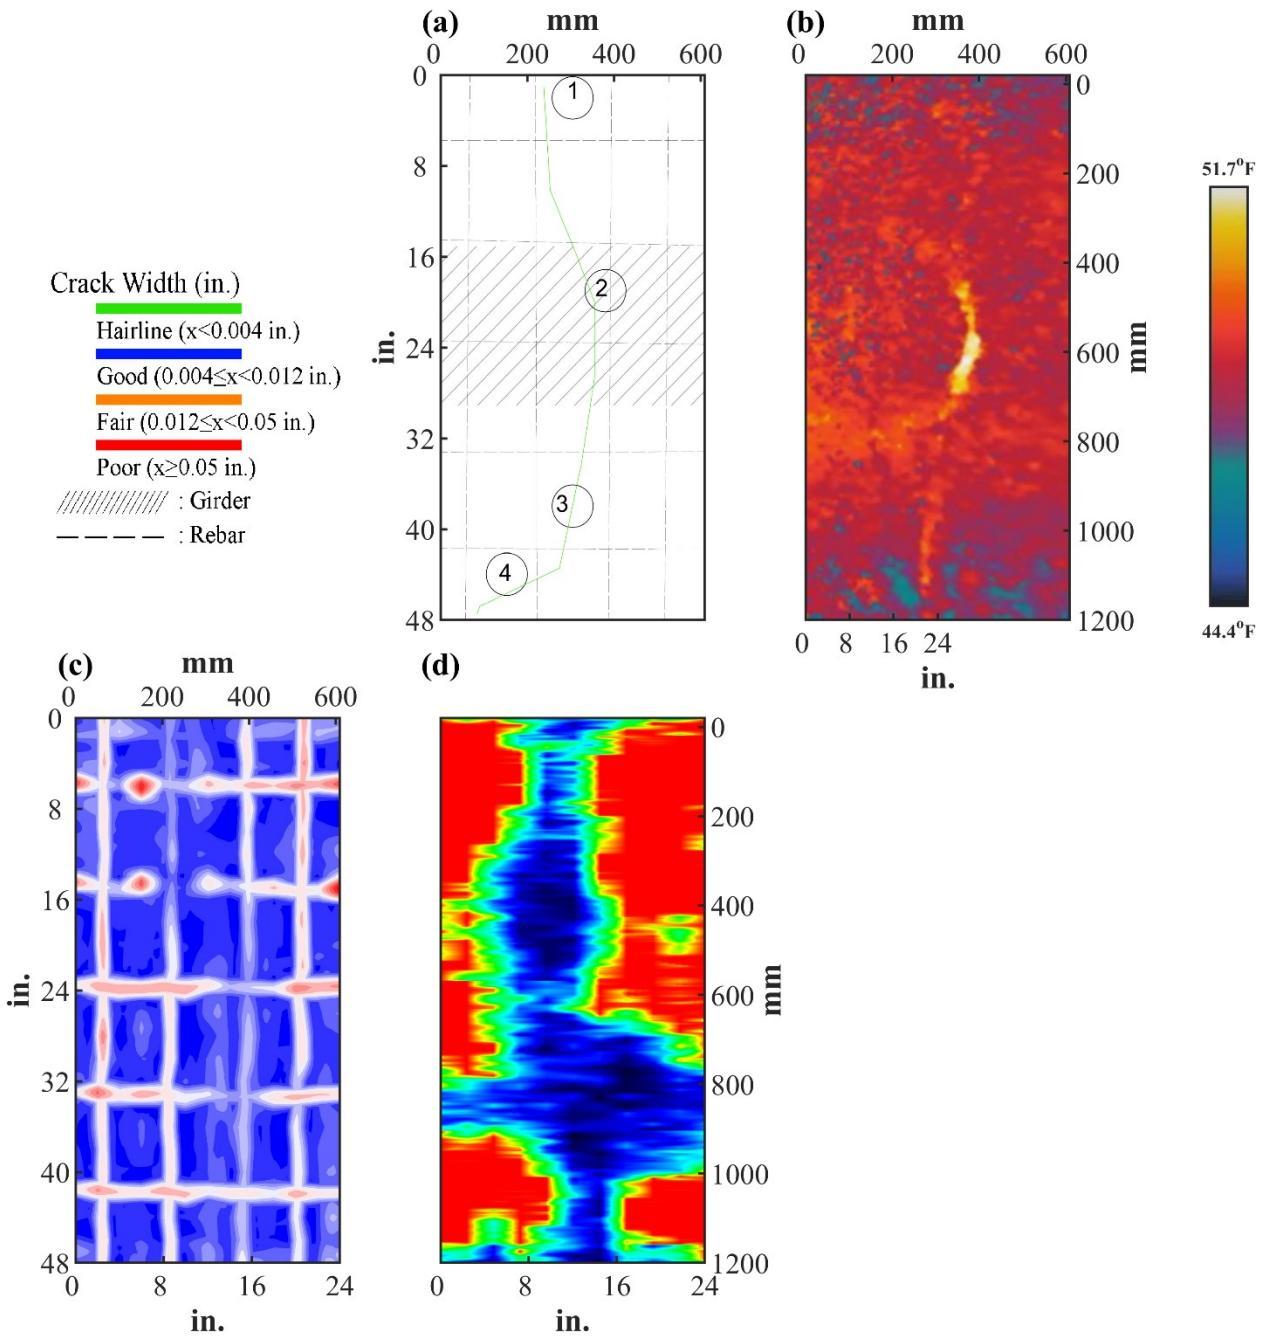
As shown in Figure 0.179 (a) and Figure 0.180 (a), both grid 1 and 2 had only one hairline crack.

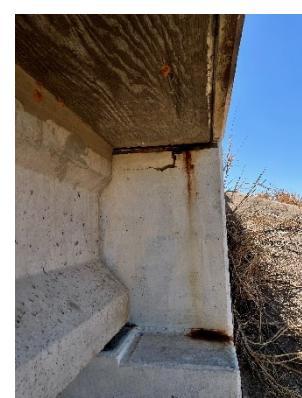
Deck surface has moderate transverse and longitudinal cracks. There are moderate cracks on the abutment backwalls as shown in

Figure 0.185. Deteriorations on the Bridge: (a) Cracks at Abutment Backwall

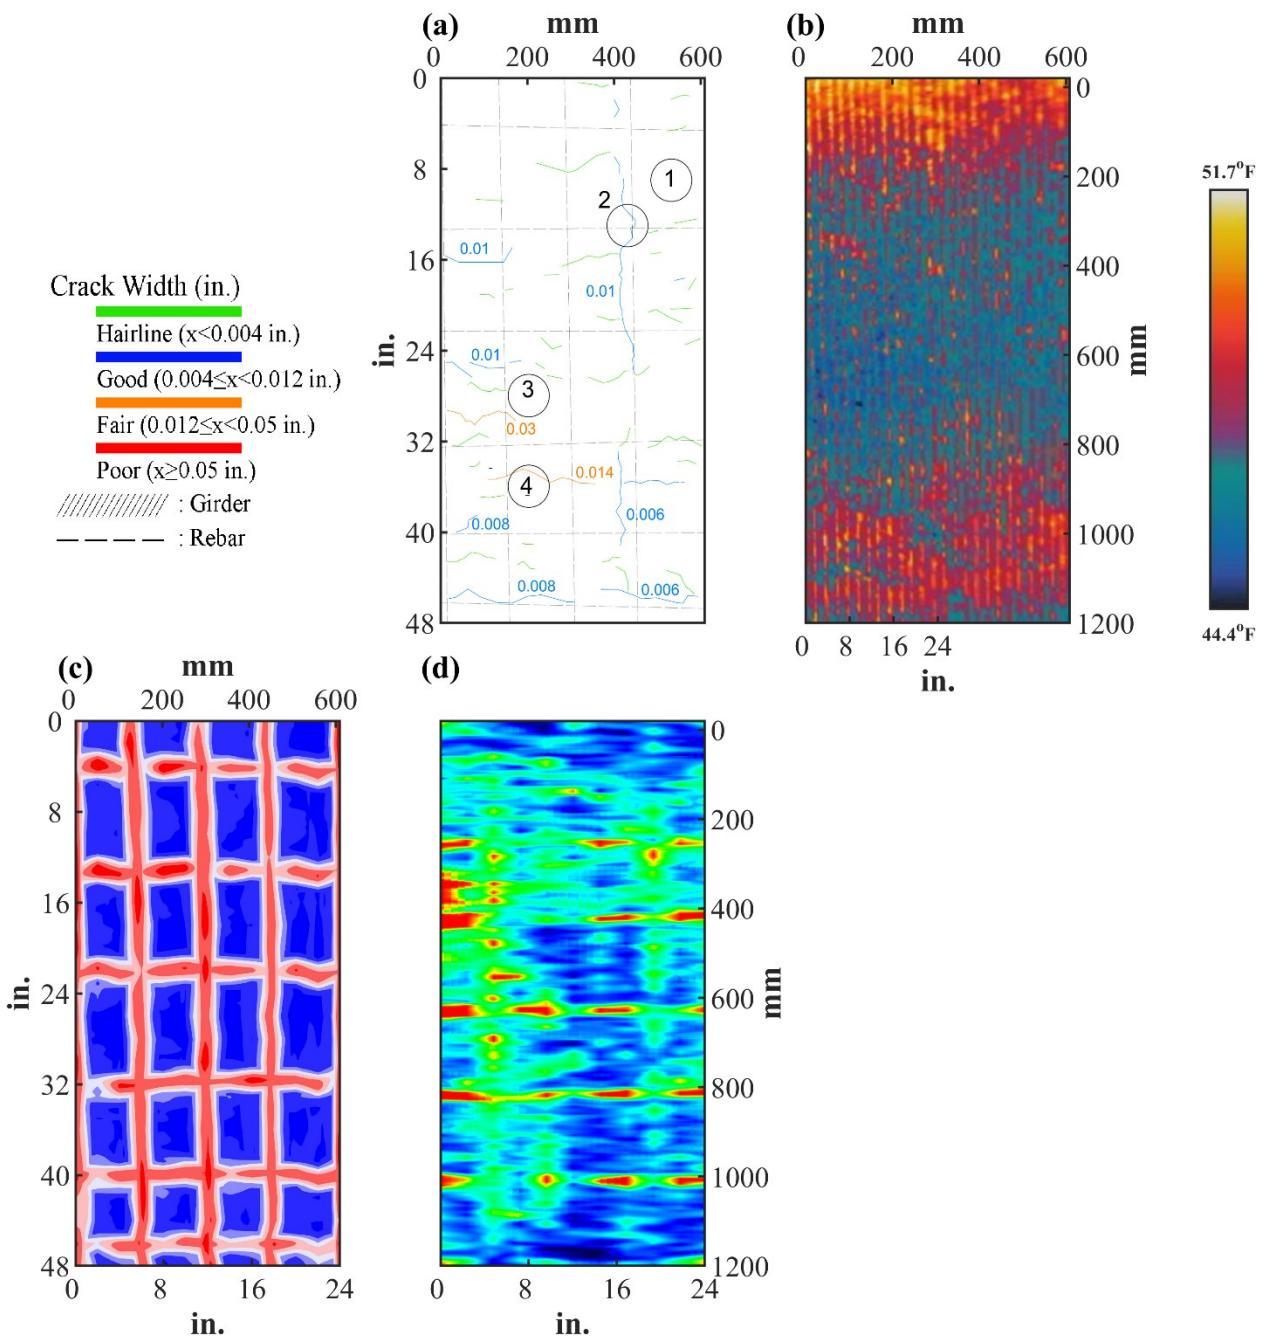
As shown in Figure 0.187 (a), there are widespread of transverse and longitudinal cracks with them width ranging from 0.006 in. to 0.03 in. wide on grid 1. On grid 2, there are longitudinal and diagonal cracks, and they are 0.01 in. and 0.012 in., and 0.01 in. wide, respectively, as shown in Figure 0.188 (a).

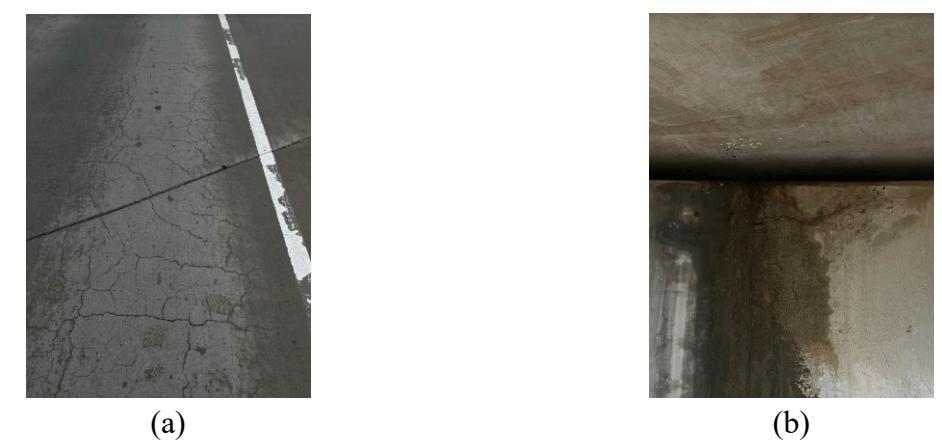
There are isolated transverse and longitudinal hairline cracks that are propagating from a joint as shown in Figure 0.193 (a). The leakage and cracks are found on the abutment as shown in Figure 0.193 (b).

Figure 0.193. Deterioration on the Bridge: (a) Map Cracks Propagating from a Joint; (b) Cracks and Leakage at Abutment

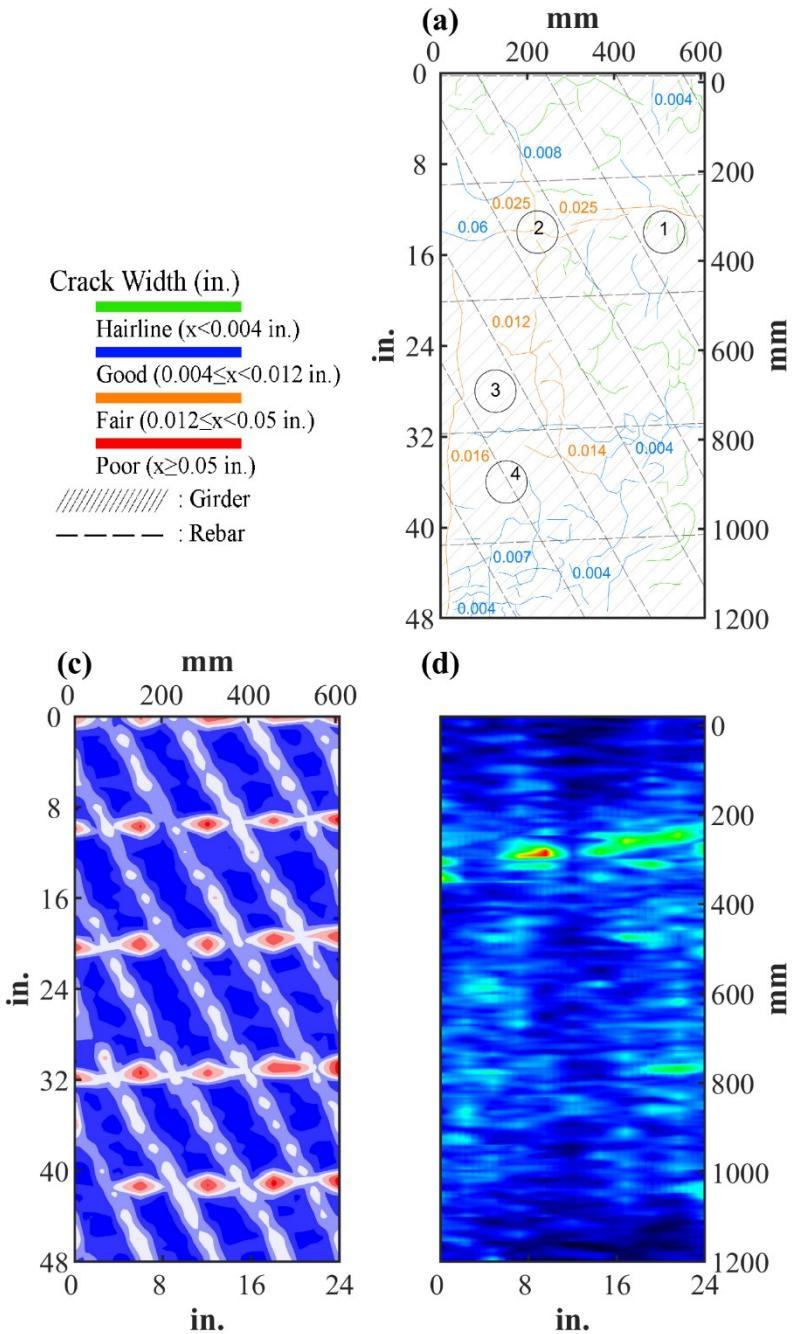
As shown in Figure 0.195 (a), there are widespread of hairline cracks and cracks that are 0.004 in. to 0.025 in. wide on grid 1. Map, transverse, and longitudinal cracks exist on grid 1. On grid 2, there are widespread of hairline cracks, and transverse cracks that are 0.004 in. to 0.012 in. wide as shown in Figure 0.196.

Figure 0.195. Crack Map and NDE Results of Grid 1: (a) Crack map and Location of Cores; (c) GPR C-scan at 1.5 in. to 3.2 in. Depth; (d) UST C-scan at 2.0 in. Depth

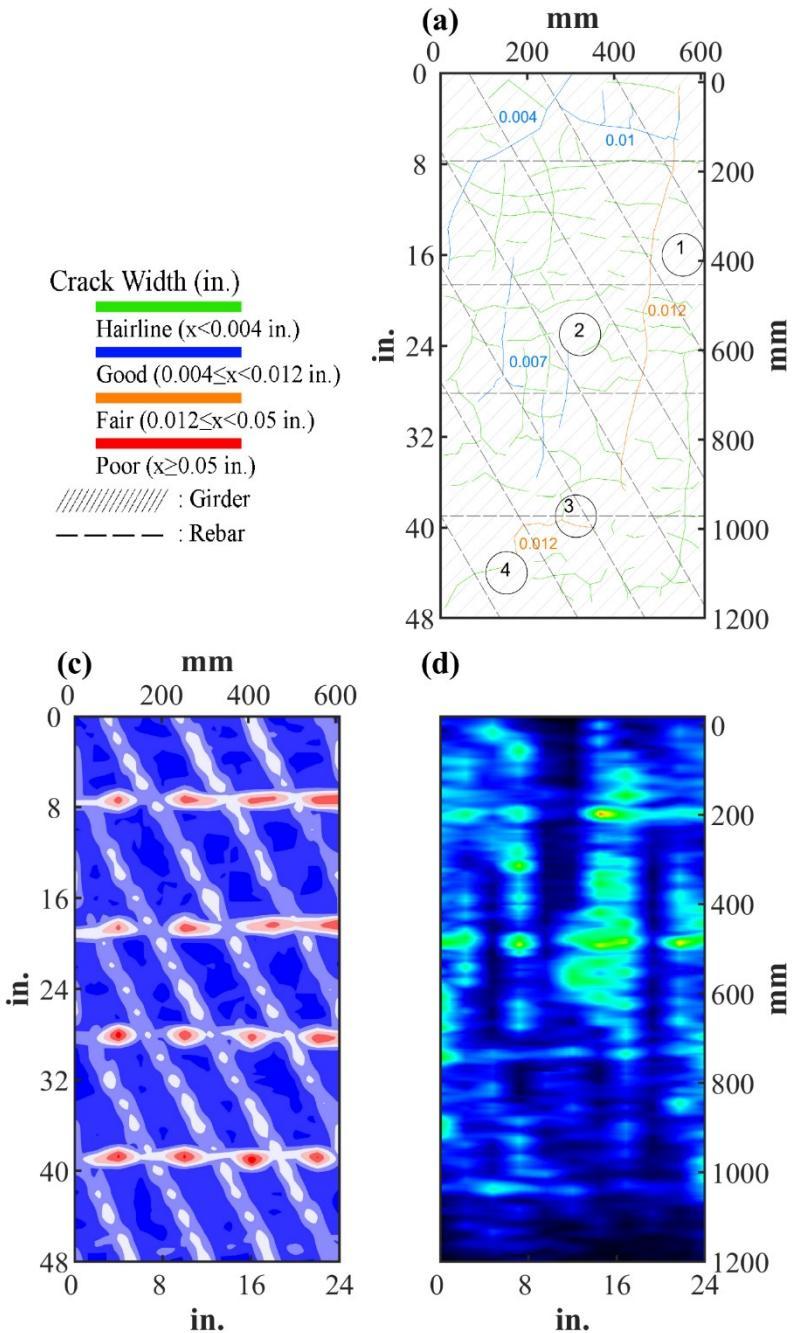
Figure 0.196. Crack Map and NDE Results of Grid 2: (a) Crack map and Location of Cores; (c) GPR C-scan at 2.55 in. to 4.0 in. Depth; (d) UST C-scan at 3.3 in. Depth

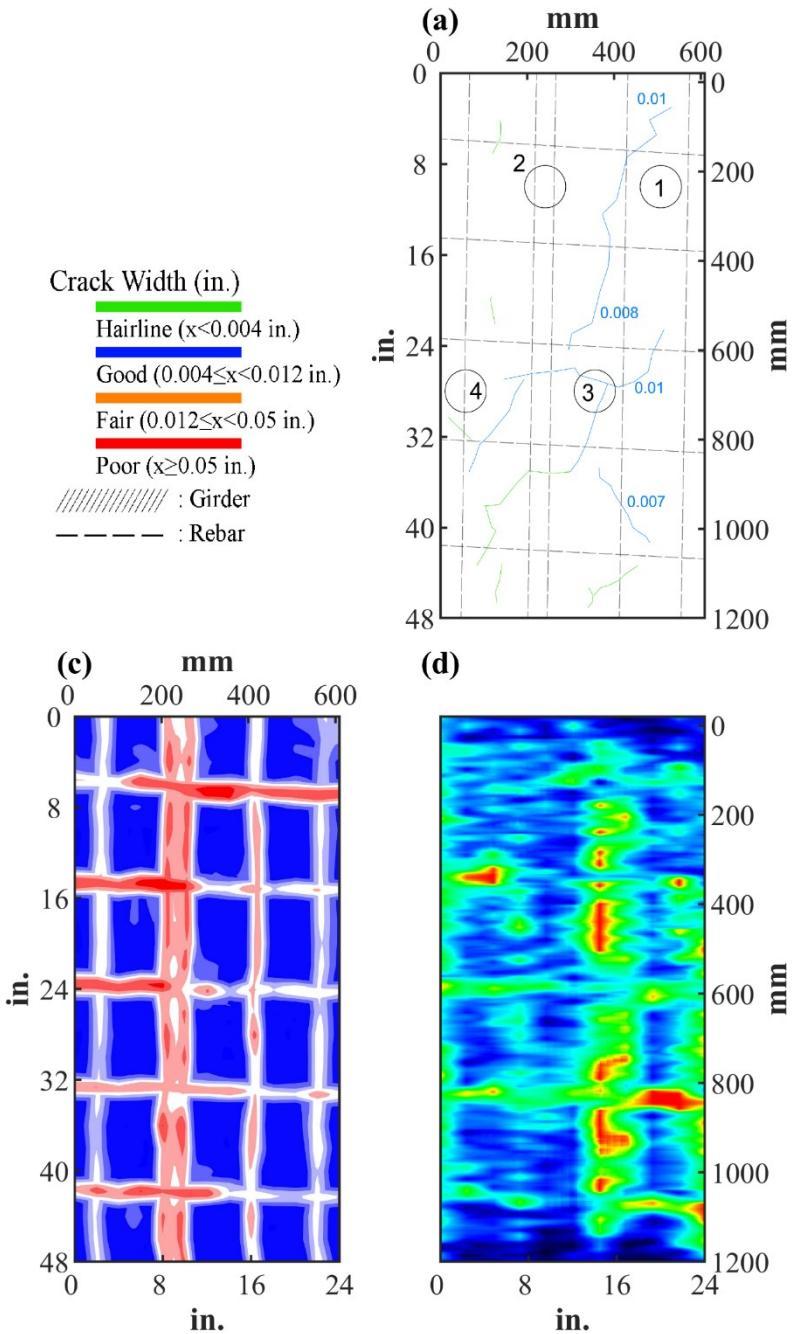
As shown in Figure 0.202 (a), there are transverse and diagonal cracks that are 0.007 in. to 0.01 in. wide on grid 1. On grid 2, there were only hairline cracks and 0.004 in. wide cracks as shown in Figure 0.203 (a).

Figure 0.202. Crack Map and NDE Results of Grid 1: (a) Crack map and Location of Cores; (b) Infrared Picture; (c) GPR C-scan at 3.8 in. to 5.2 in. Depth; (d) UST C-scan at 4.3 in. Depth

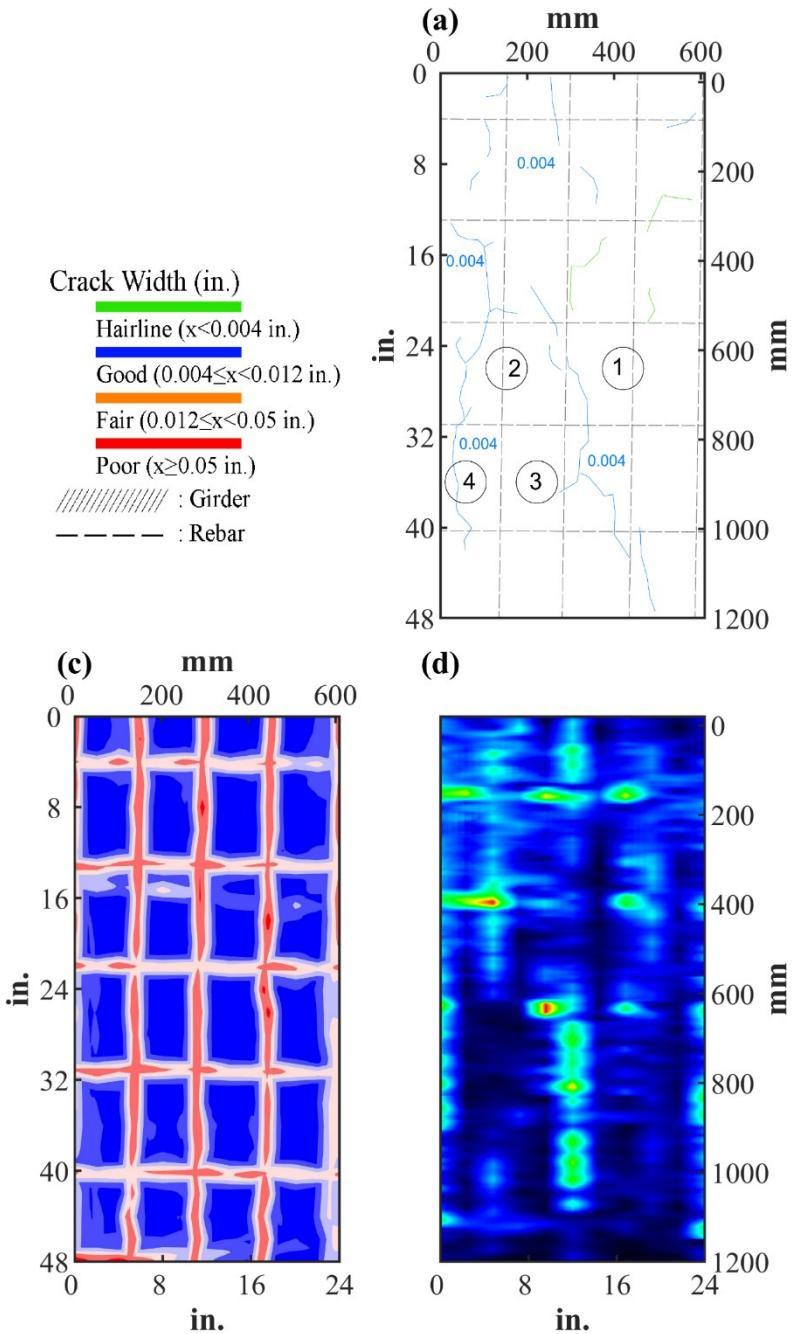
Figure 0.203. Crack Map and NDE Results of Grid 2: (a) Crack map and Location of Cores; (b) Infrared Picture; (c) GPR C-scan at 3.25 in. to 4.6 in. Depth; (d) UST C-scan at 4.3 in. Depth
