Evaluation of Corrosion Prevention and Mitigation Approaches Used on Texas Bridges—Volume 2: Reinforced Concrete Bridges

Technical Report 0-7040-R1-Vol2

TEXAS A&M TRANSPORTATION INSTITUTE COLLEGE STATION, TEXAS

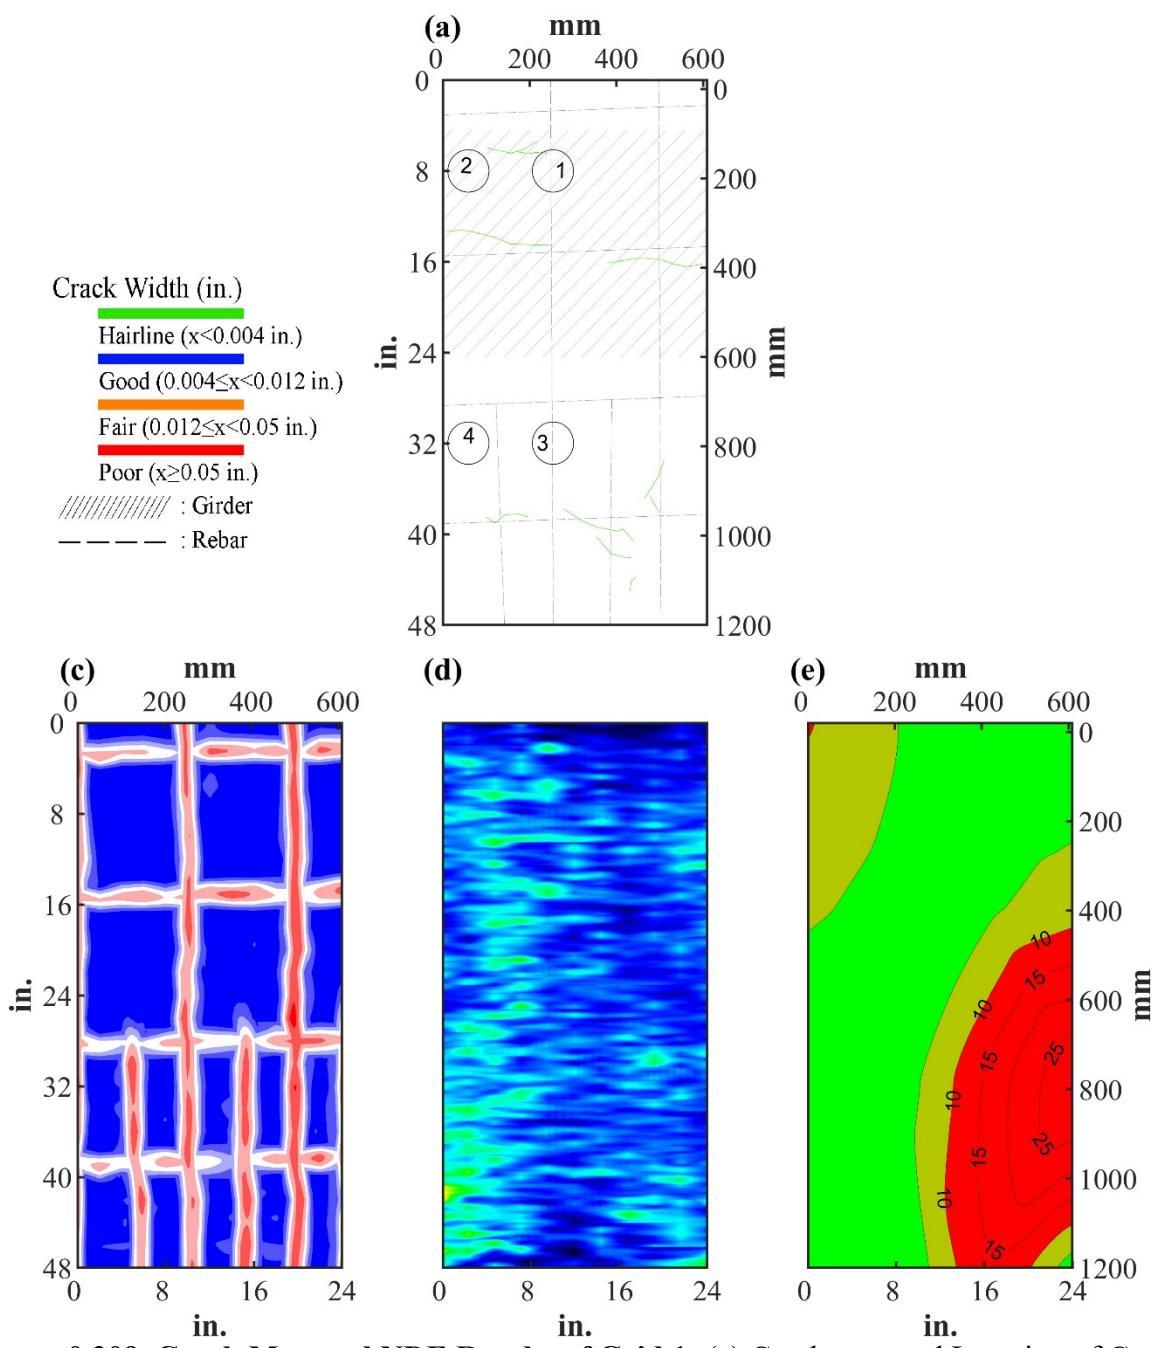
As shown in Figure 0.209 (a), only hairline cracks were visible on grid 1. On grid 2, 0.004 in. wide transverse cracks were visible as shown in Figure 0.210 (a).

Figure 0.209. Crack Map and NDE Results of Grid 1: (a) Crack map and Location of Cores; (b) Infrared Picture; (c) GPR C-scan at 1.0 in. to 2.4 in. Depth; (d) UST C-scan at 2.0 in. Depth; (e) Corrosion Rate Map

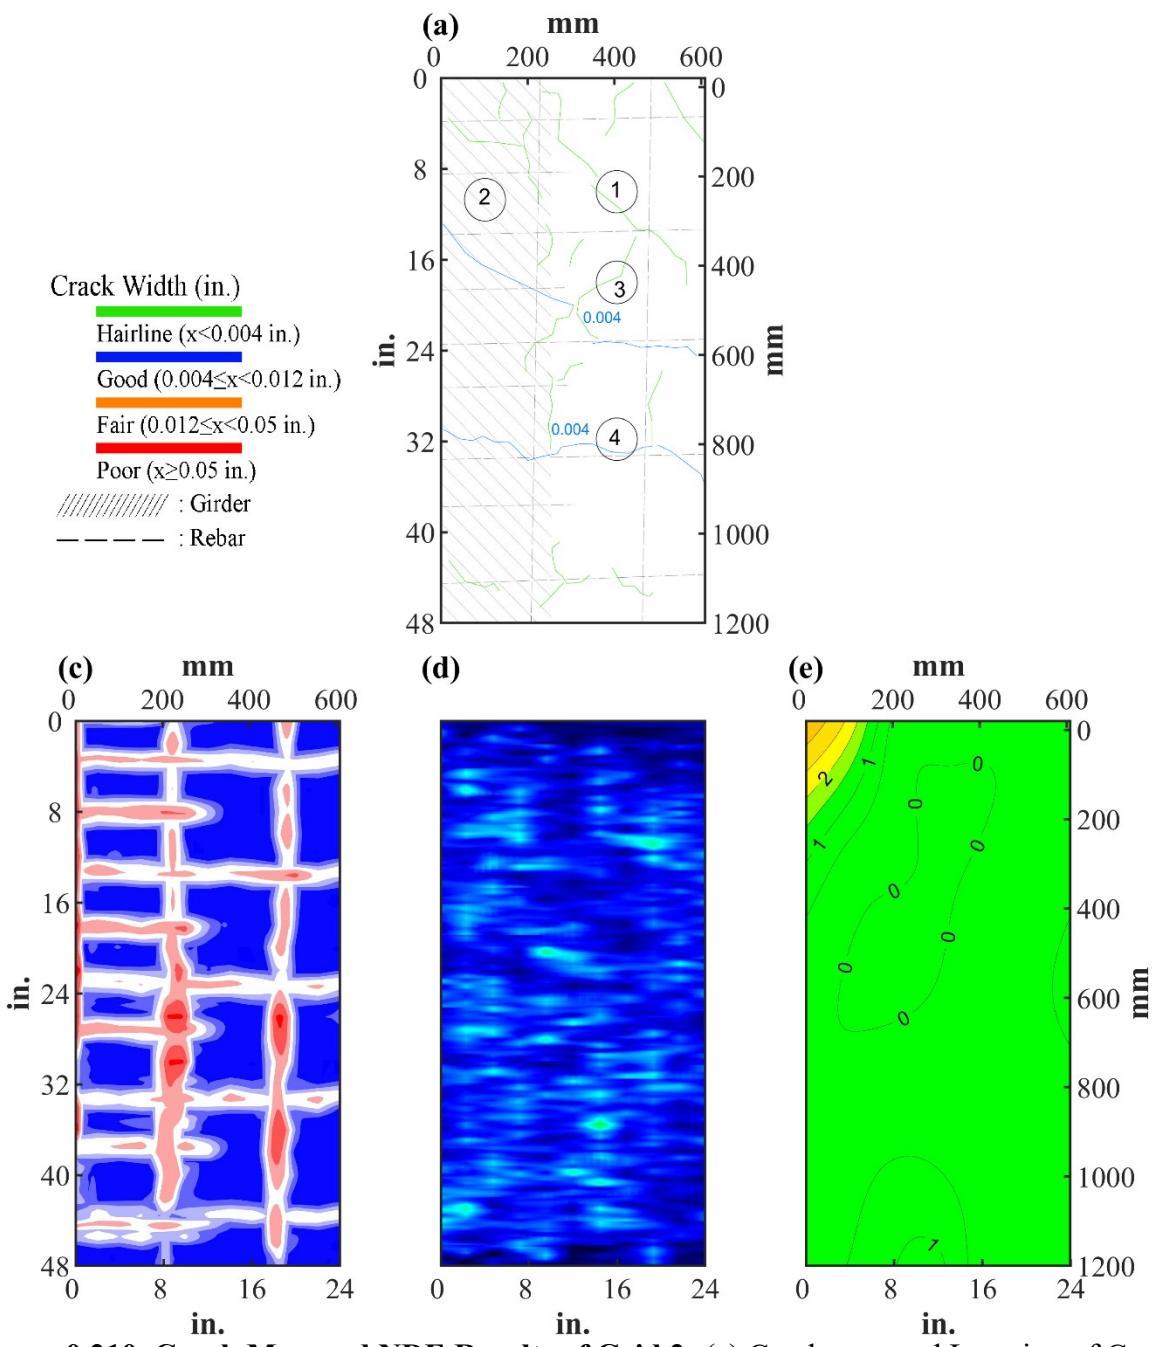
Figure 0.210. Crack Map and NDE Results of Grid 2: (a) Crack map and Location of Cores; (b) Infrared Picture; (c) GPR C-scan at 1.9 in. to 3.3 in. Depth; (d) UST C-scan at 2.2 in. Depth; (e) Corrosion Rate Map

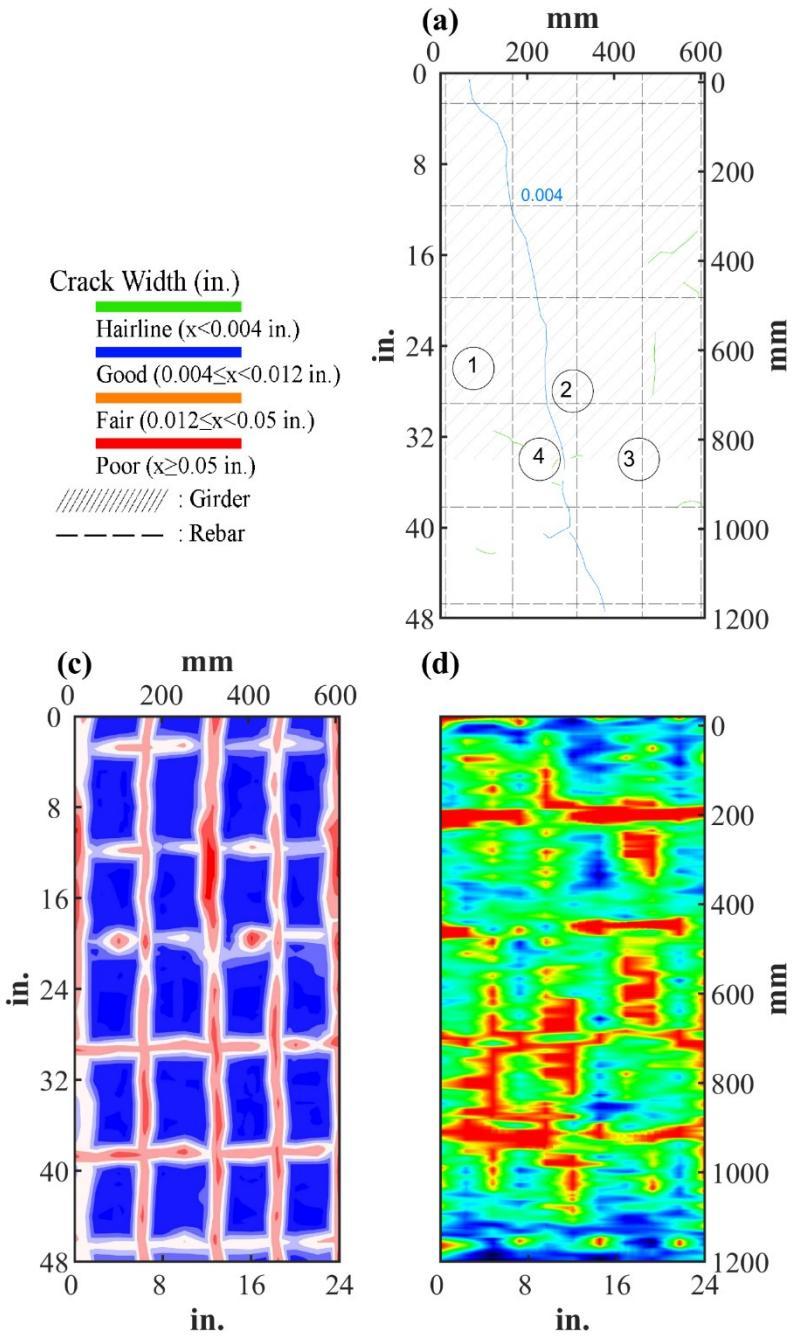
Figure 0.216. Crack Map and NDE Results of Grid 1: (a) Crack map and Location of Cores; (c) GPR C-scan at 2.6 in. to 4.0 in. Depth; (d) UST C-scan at 3.4 in. Depth

As shown in Figure 0.216 (a), one 0.004 in. wide transverse crack was visible on grid 1. On grid 2, there were two short transverse crack that are 0.004 in. wide as shown in Figure 0.217 (a).

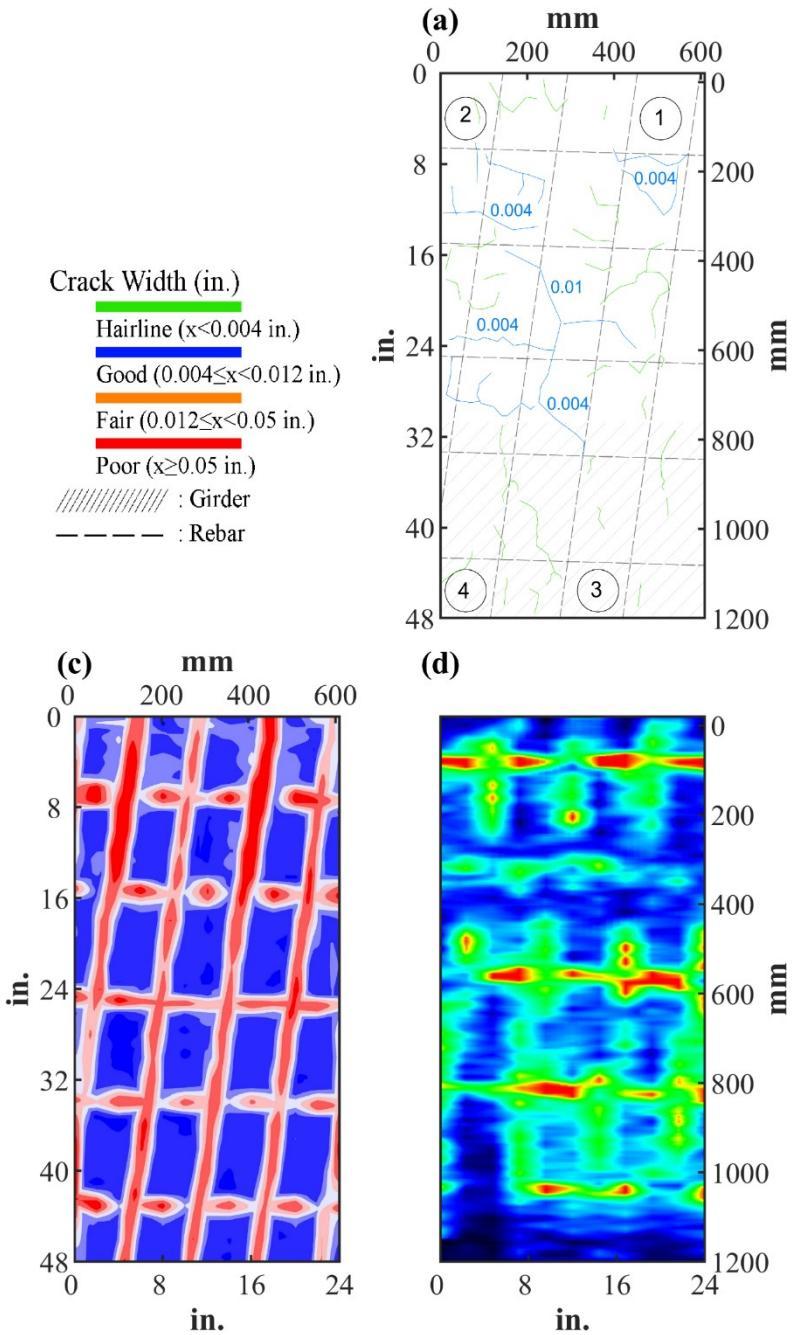
Figure 0.223. Crack Map and NDE Results of Grid 1: (a) Crack map and Location of Cores; (c) GPR C-scan at 2.3 in. to 3.5 in. Depth; (d) UST C-scan at 3.7 in. Depth

As shown in Figure 0.223 (a), there are widespread of hairline cracks and cracks ranging from 0.004 in. to 0.01 in. wide. 0.01 in wide crack was in transverse direction and 0.004 in. cracks were mostly in longitudinal direction on grid 1. On grid 2, most of the cracks were in longitudinal direction and their width ranged from 0.004 in. to 0.025 in. wide as shown in Figure 0.224 (a).

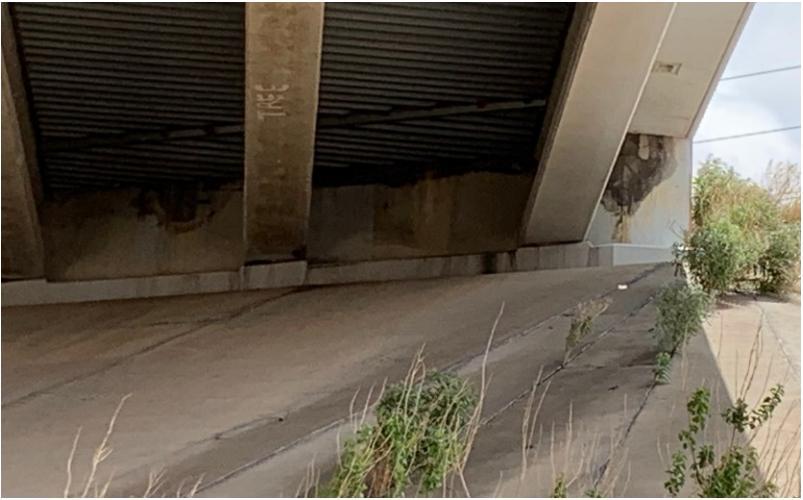
Figure 0.229. Corrosion at metal deck form and abutment

There are transverse and longitudinal hairline to minor cracks on the top surface of deck. The joint is partially failed and full of debris. The concrete railing has minor vertical cracks. Obvious soot stains are found on the beams over the railroad tracks. The metal deck form at the end of abutment has serious corrosion. The abutment has deep spalling and exposed rebar as shown in Figure 0.229

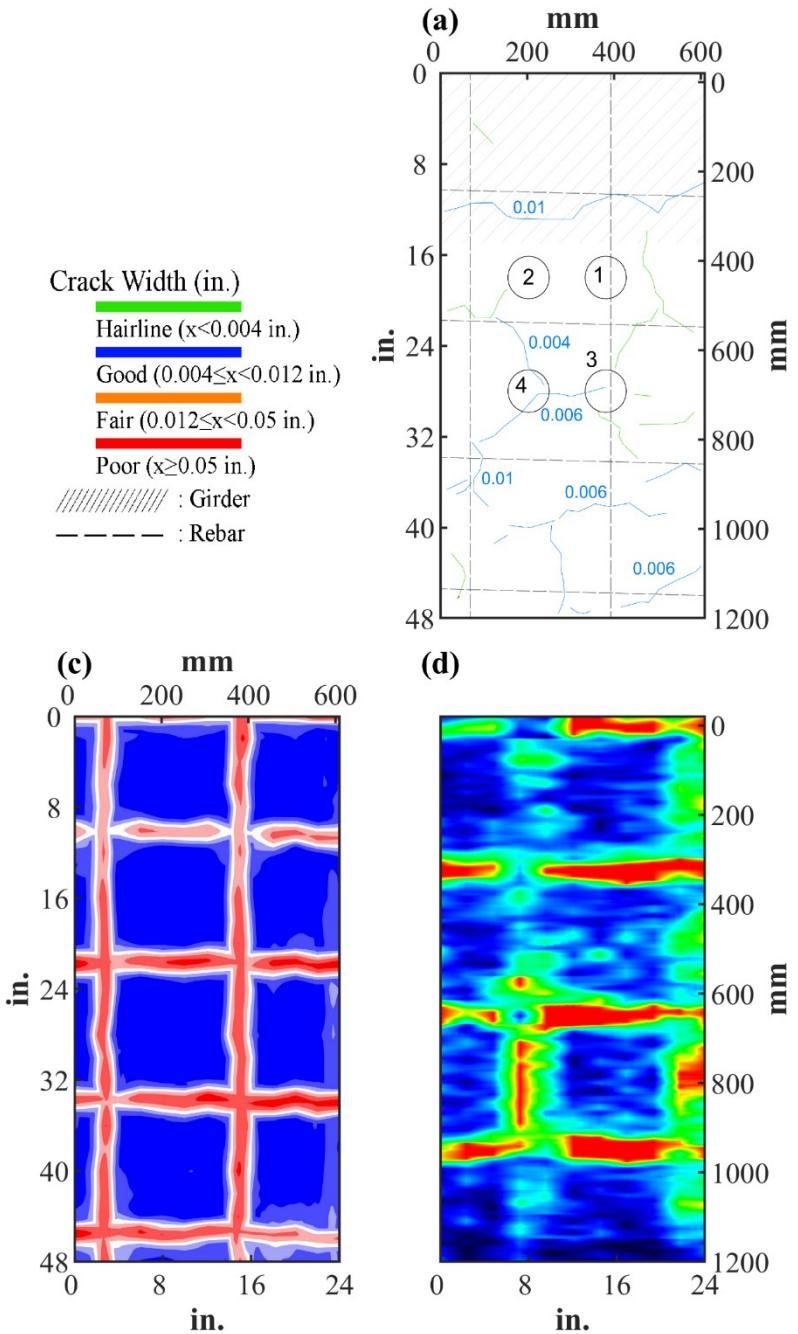
Figure 0.231. Crack Map and NDE Results of Grid 1: (a) Crack map and Location of Cores; (c) GPR C-scan at 2.2 in. to 3.6 in. Depth; (d) UST C-scan at 4.2 in. Depth

As shown in Figure 0.231 (a), there were widespread of cracks range from 0.004 in. to 0.01 in. wide on grid 1. There was one 0.01 in. wide crack that was caused by girder. On grid 2, there were cracks ranging from 0.004 in. to 0.008 in. wide. The direction of cracks was transverse, longitudinal, and diagonal as shown in Figure 0.232 (a).

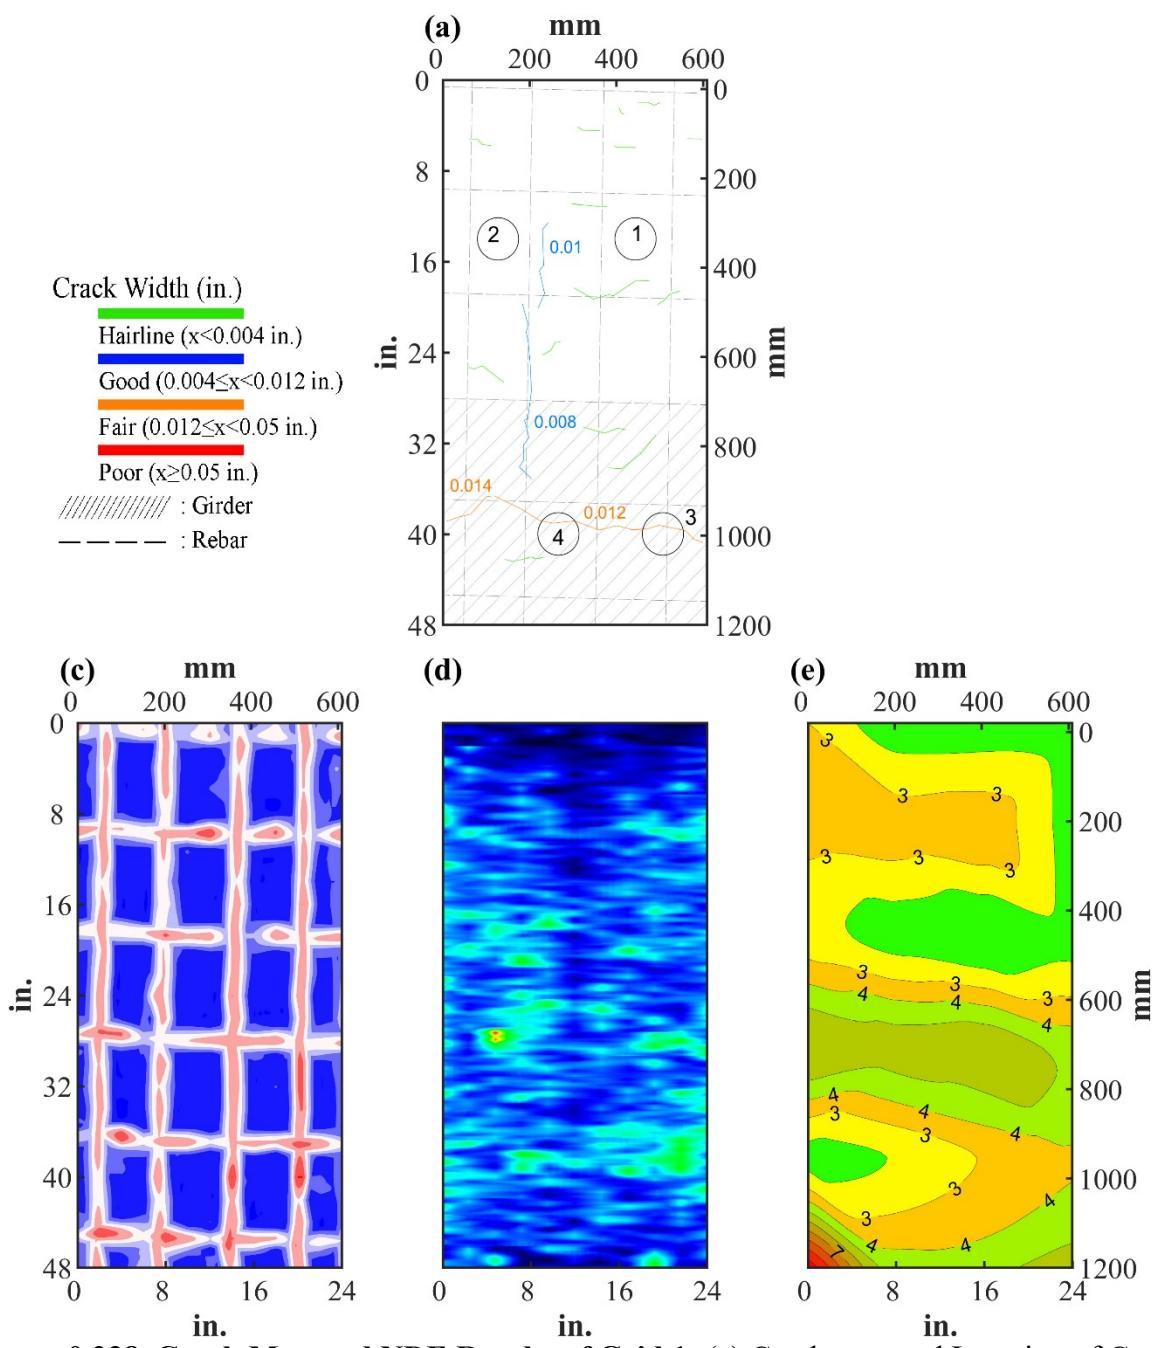
Figure 0.238. Crack Map and NDE Results of Grid 1: (a) Crack map and Location of Cores; (b) Infrared Picture; (c) GPR C-scan at 1.9 in. to 3.3 in. Depth; (d) UST C-scan at 3.9 in. Depth; (e) Corrosion Rate Map

As shown in Figure 0.238 (a), there was one 0.012 in. to 0.014 in wide longitudinal crack on top of a girder and transverse cracks that were 0.008 in and 0.01 in. wide on grid 1. On grid 2, there were no cracks as shown in Figure 0.239 (a).

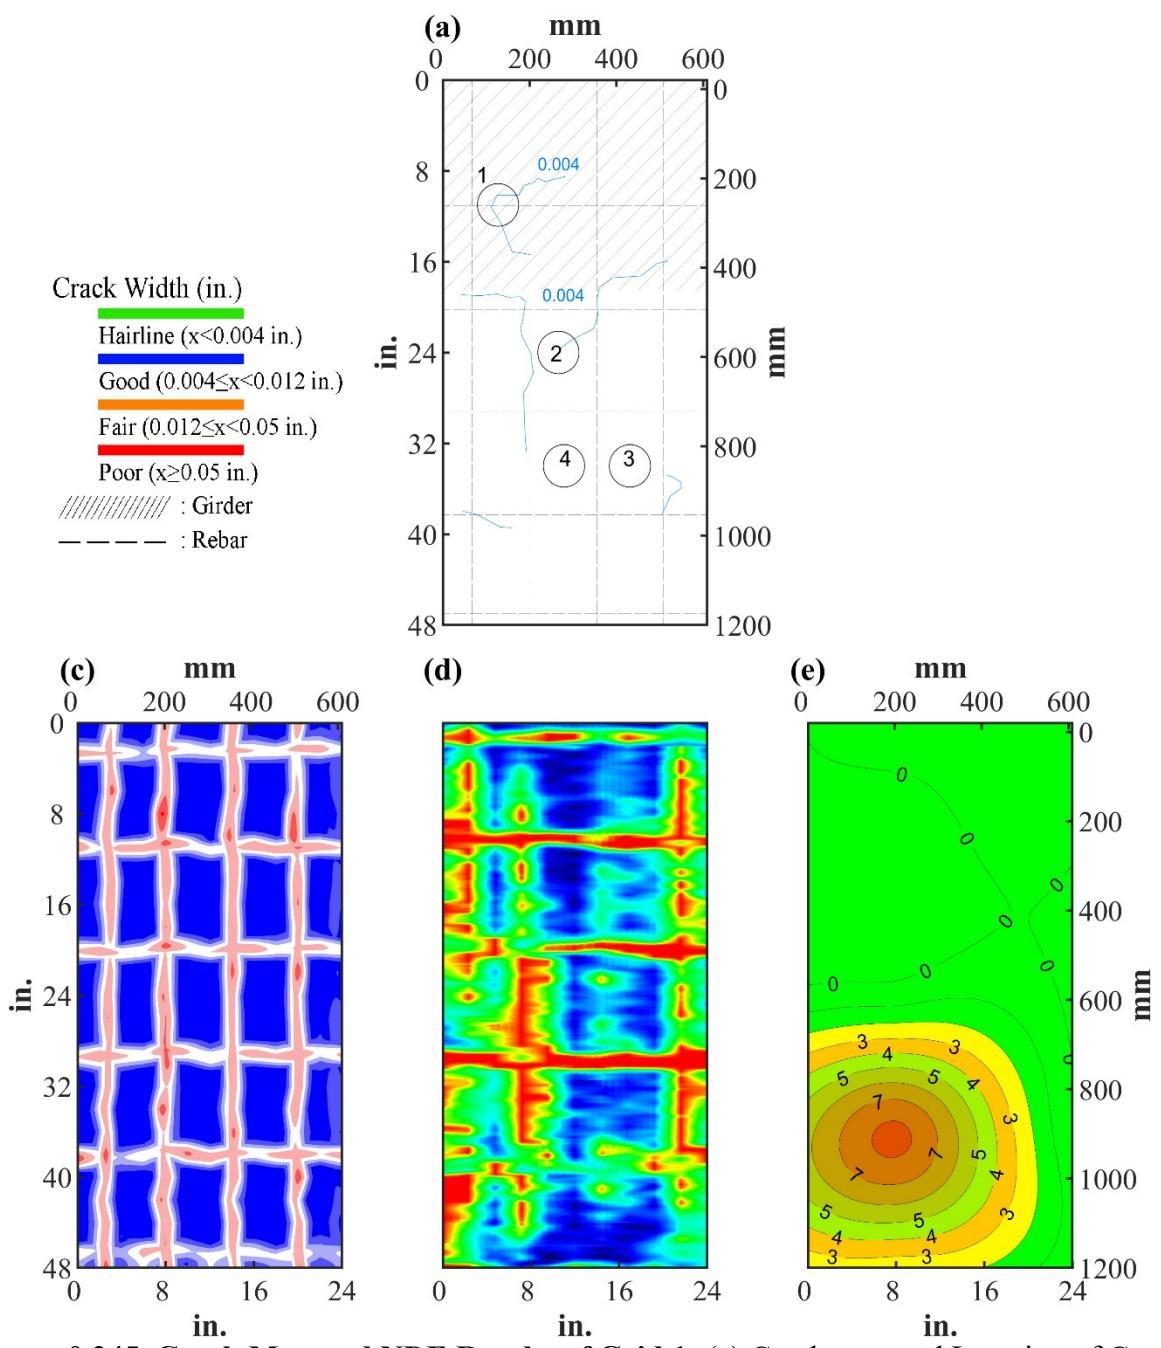
Figure 0.245. Crack Map and NDE Results of Grid 1: (a) Crack map and Location of Cores; (b) Infrared Picture; (c) GPR C-scan at 1.9 in. to 3.3 in. Depth; (d) UST C-scan at 3.5 in. Depth; (e) Corrosion Rate Map

As shown in Figure 0.245 (a), 0.004 in. wide cracks were visible on grid 1. Grid 2 was located on the joint, and 0.004 in. and 0.006 in wide cracks were propagating from the joint. In addition, there was a short diagonal crack that was 0.012 wide as shown in Figure 0.246 (a).

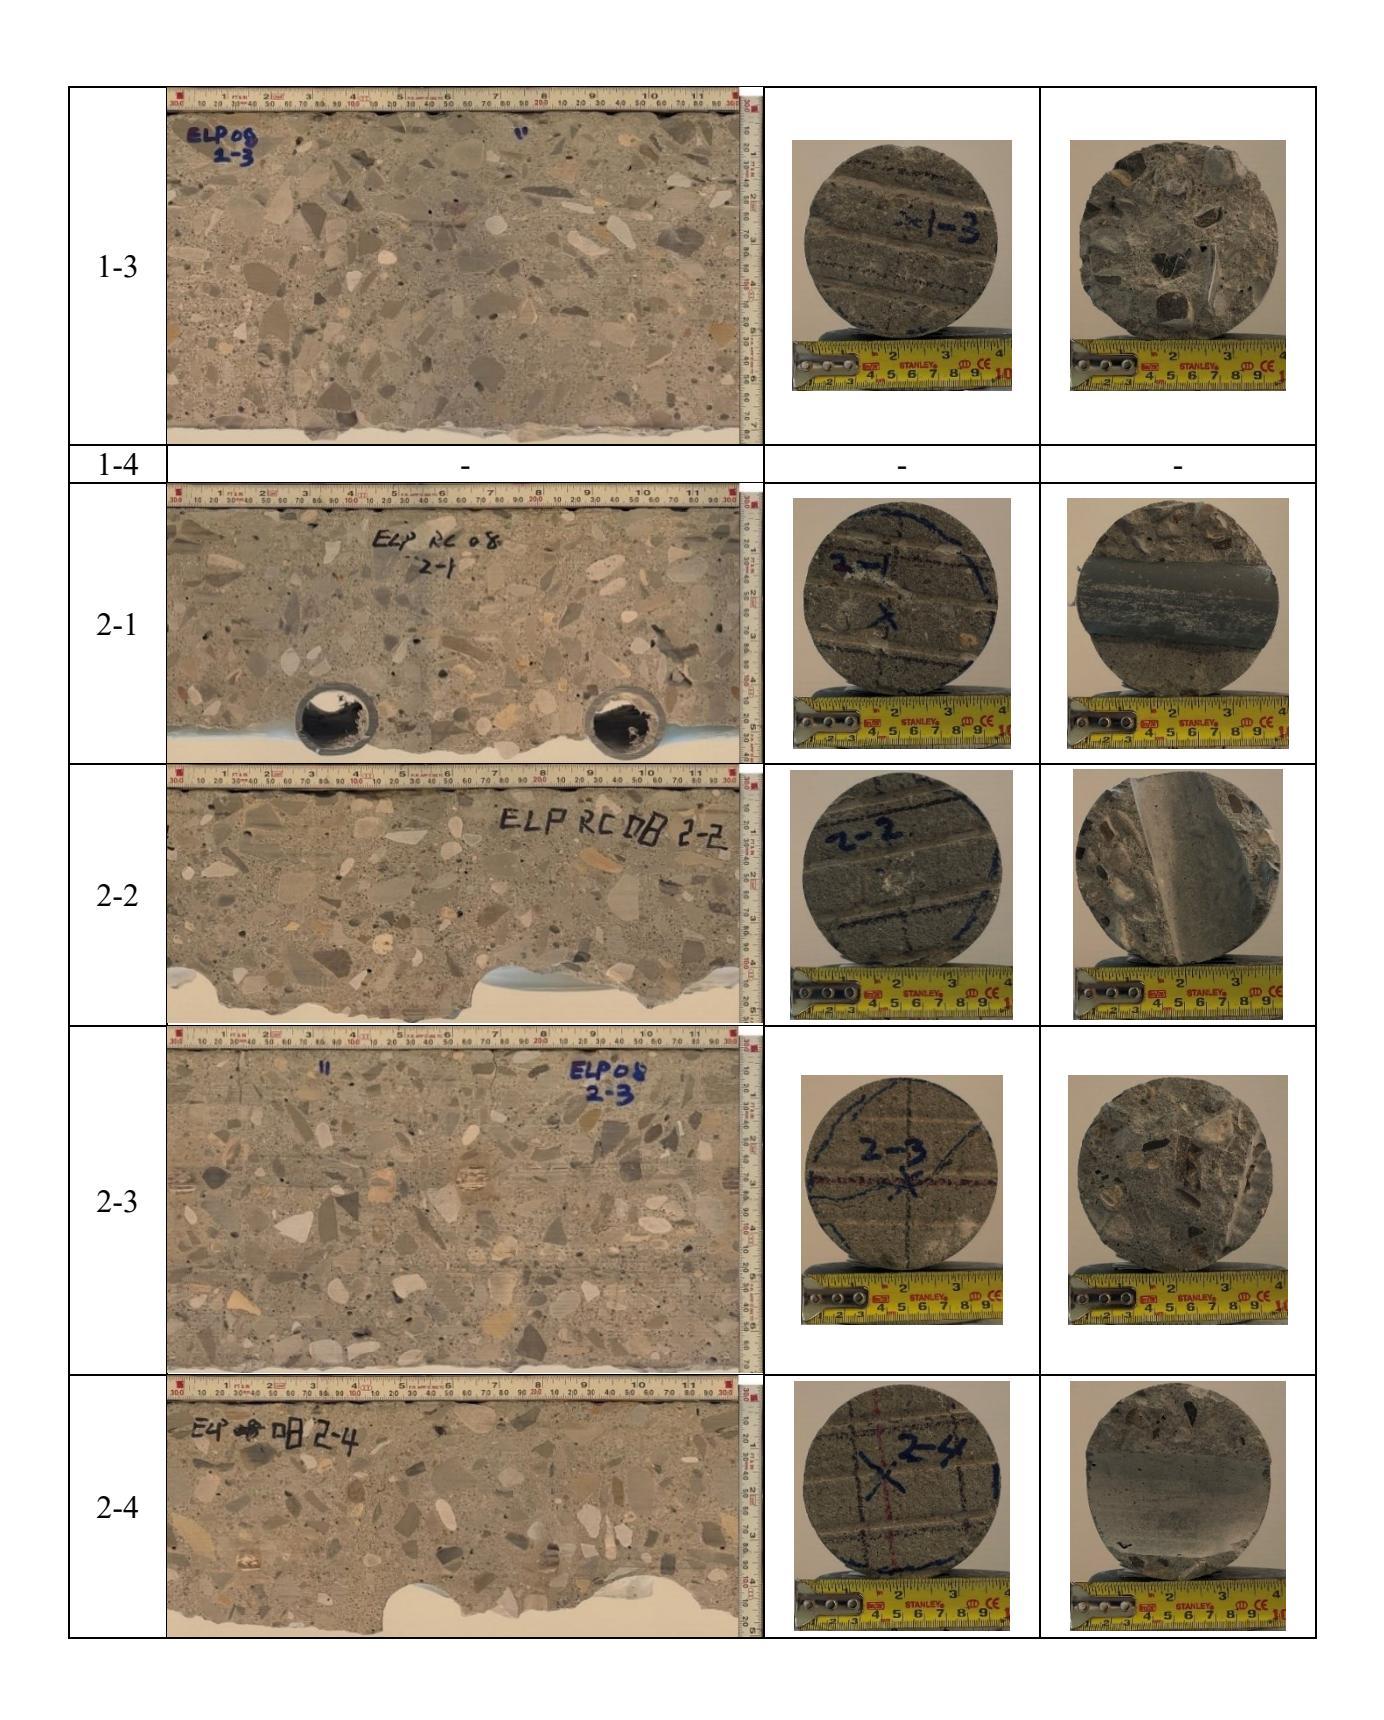
Table B-124. Core Pictures

Core	dia. x height (in.)	Rebar depth (in.)	Rebar size (#)	Epoxy (Y/N)	Crack type	Crack width (in)	Notes
1-1	3.75 x 6.9	3.1	4	Y	transverse	0.004	-
1-2	3.75 x 6.3	-	-	-	map	0.004	0.08 in. diagonal void at 8.5 in. depth
1-3	3.75 x 7.1	-	-	-	-	-	-
1-4	3.75 x 7.6	-	-	-	-	-	-
2-1	3.75 x 3.9	-	-	-	-	-	0.4 in. void at 4.7 in. depth
2-2	3.75 x 3.9	-	-	-			-
2-3	3.75 x 7.0	2.6	5	Y	diagonal	0.012	-
2-4	3.75 x 3.9	3.3	4	Y	-	-	-

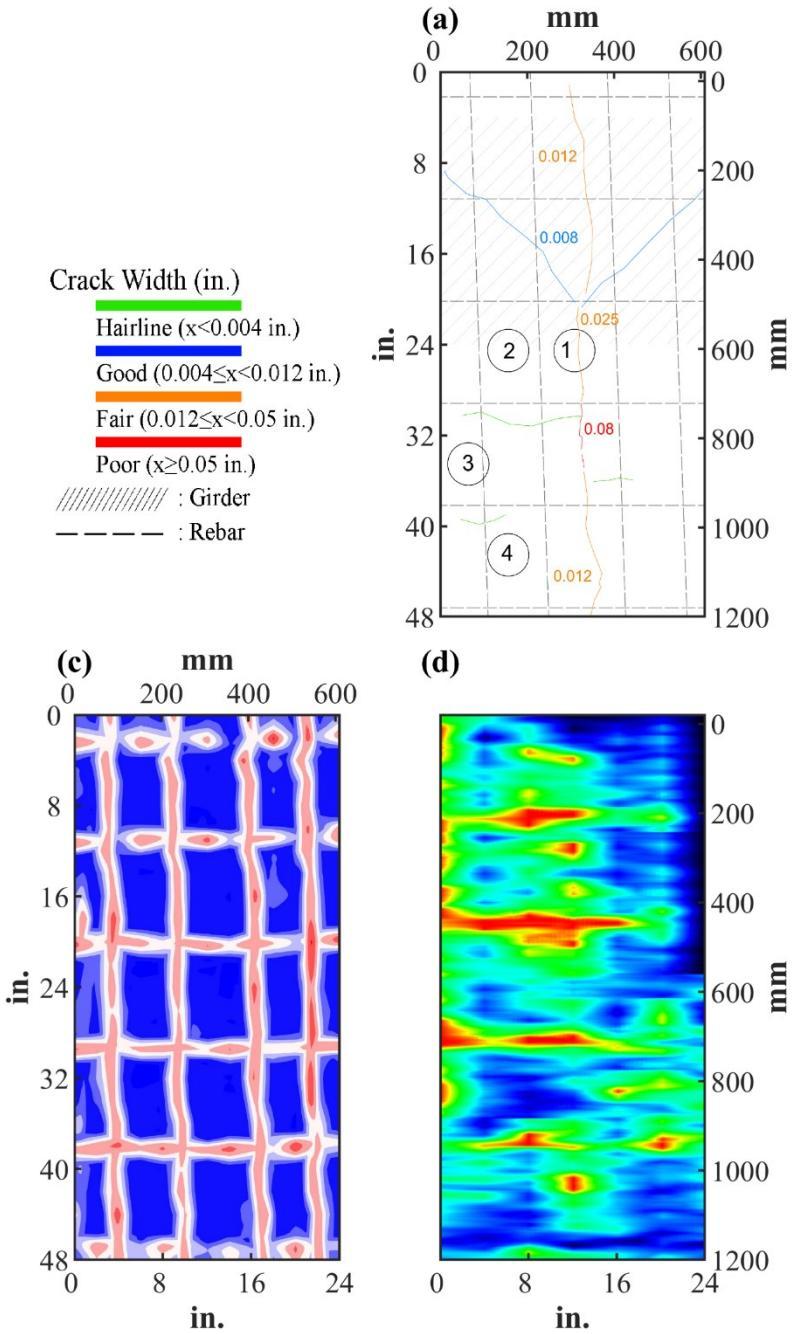
Figure 0.252. Crack Map and NDE Results of Grid 1: (a) Crack Map and Location of Cores; (c) GPR C-scan at 2.0 in. to 3.2 in. Depth; (d) UST C-scan at 4.1 in. Depth

As shown in Figure 0.252 (a), there were two diagonal cracks that were 0.008 in. wide and one transverse crack that ranged from 0.012 in. to 0.08 in. wide on grid 1. On grid 2, one 0.004 in. wide longitudinal crack and 0.012 in. wide transverse crack were visible as shown in Figure 0.253 (a).

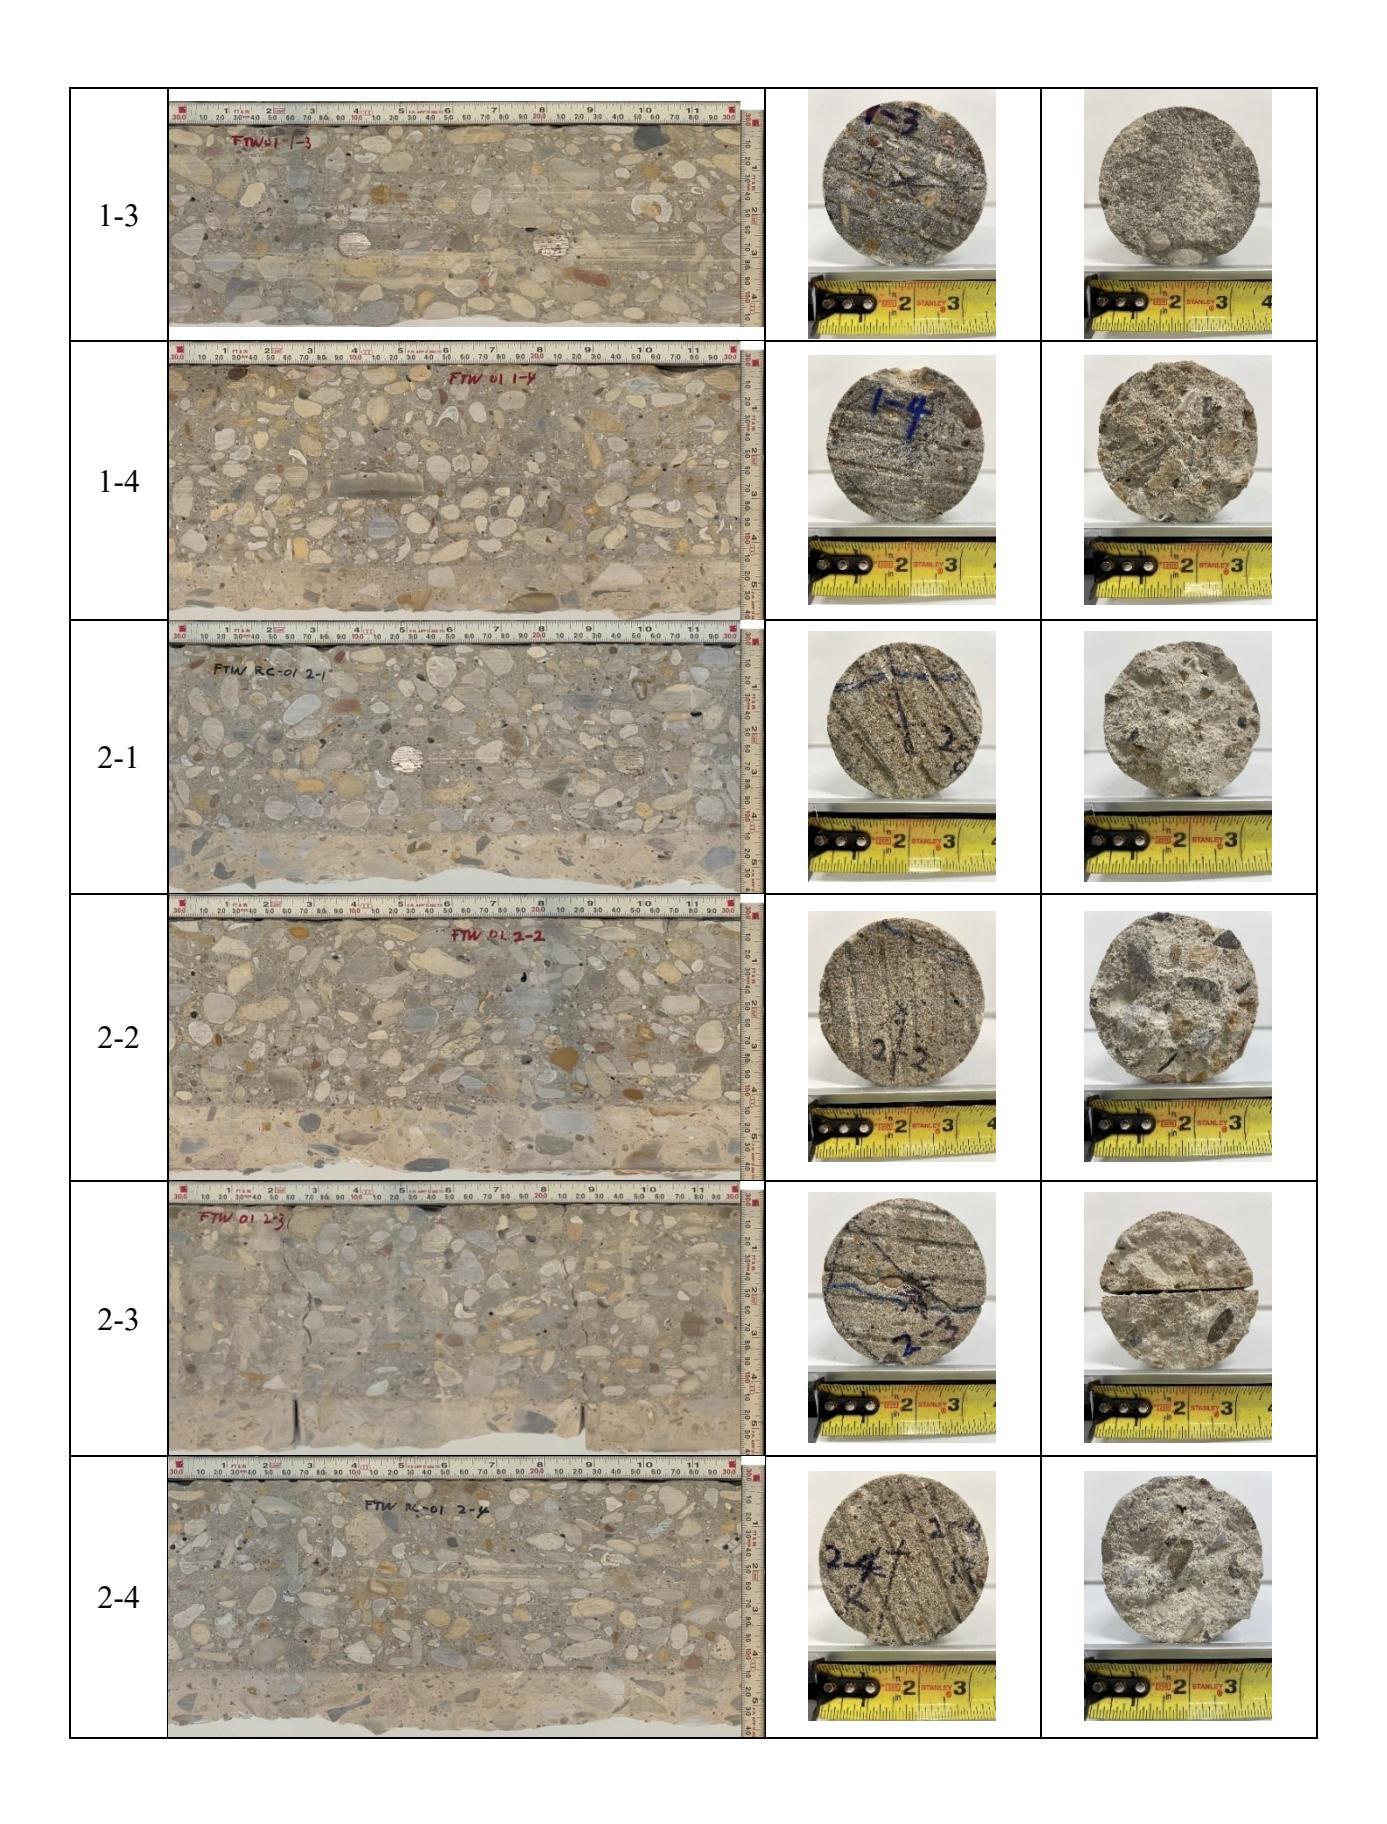
Table B-127. Core Pictures

Core	dia. x height (in.)	Rebar depth (in.)	Rebar size (#)	Epoxy (Y/N)	Crack type	Crack width (in)	Notes
1-1	3.75 x 4.5	-	-	-	transverse	0.025	Split core due to crack at intersection between column and PCP
1-2	3.75 x 5.5	-	-	-	-	-	-
1-3	3.75 x 4.7	2.6	1.7	Y	-	-	Delamination between CIP and PCP
1-4	3.75 x 5.9	-	-	-	-	-	-
2-1	3.75 x 5.3	2.6	1.7	Y	-	-	-
2-2	3.75 x 5.7	-	-	-	longitudinal	0.01	-
2-3	3.75 x 5.5	-	-	-	transverse	0.012	A crack propagates from panel joint
2-4	3.75 x 5.6	-	-	-	-	-	-

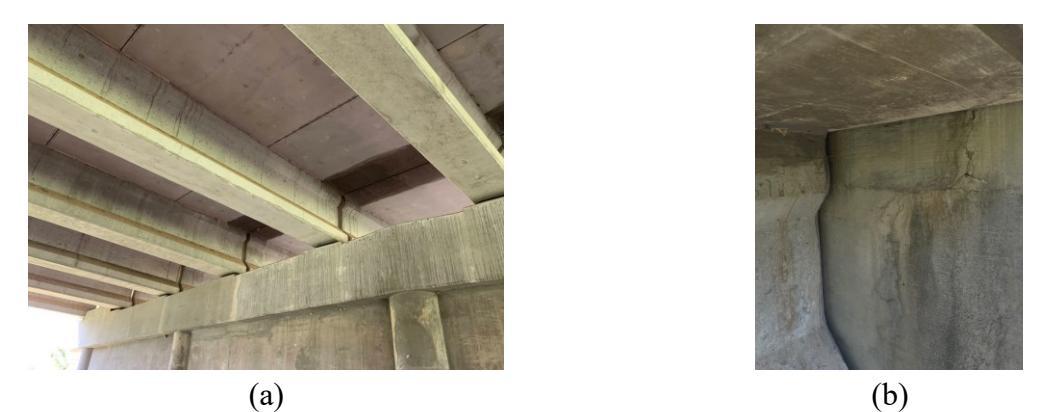
There are cracks on the top surface of deck. The deck overhang has minor cracks with efflorescence. Damage to the edge of joints results in leakage as shown in Figure 0.258 (a). The concrete railing is in good condition. There is 0.08 in. crack at the back wall of abutment as shown in Figure 0.258 (b).

Figure 0.258. Deteriorations on the Bridge: (a) Leakage at Joint; (b) Moderate Crack at Abutment

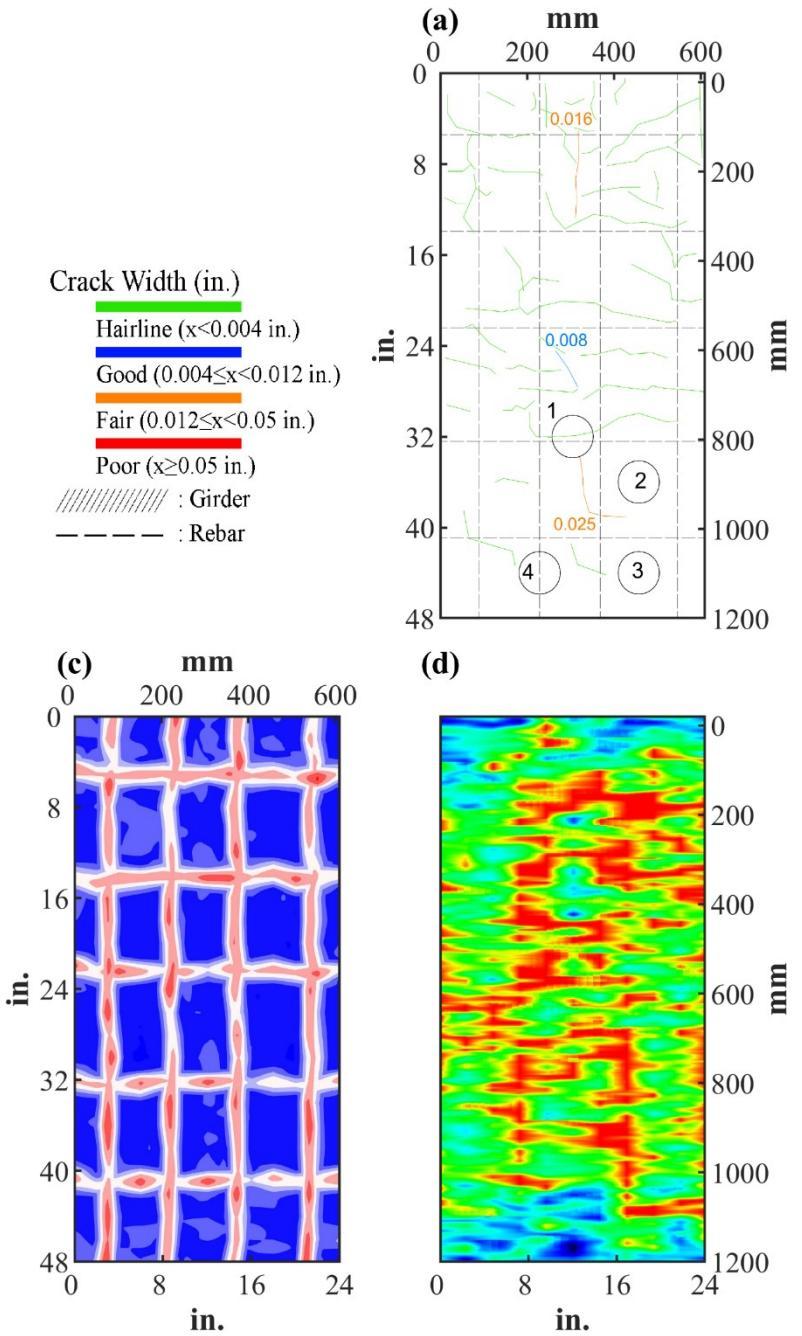
Figure 0.260. Crack Map and NDE Results of Grid 1: (a) Crack Map and Location of Cores; (c) GPR C-scan at 3.1 in. to 4.7 in. Depth; (d) UST C-scan at 3.1 in. Depth

As shown in Figure 0.260 (a), there were cracks ranging from 0.008 in to 0.025 in. wide on grid 1. On grid 2, there were transverse cracks that were 0.004 in. and .008 in. wide as shown in Figure 0.261 (a).

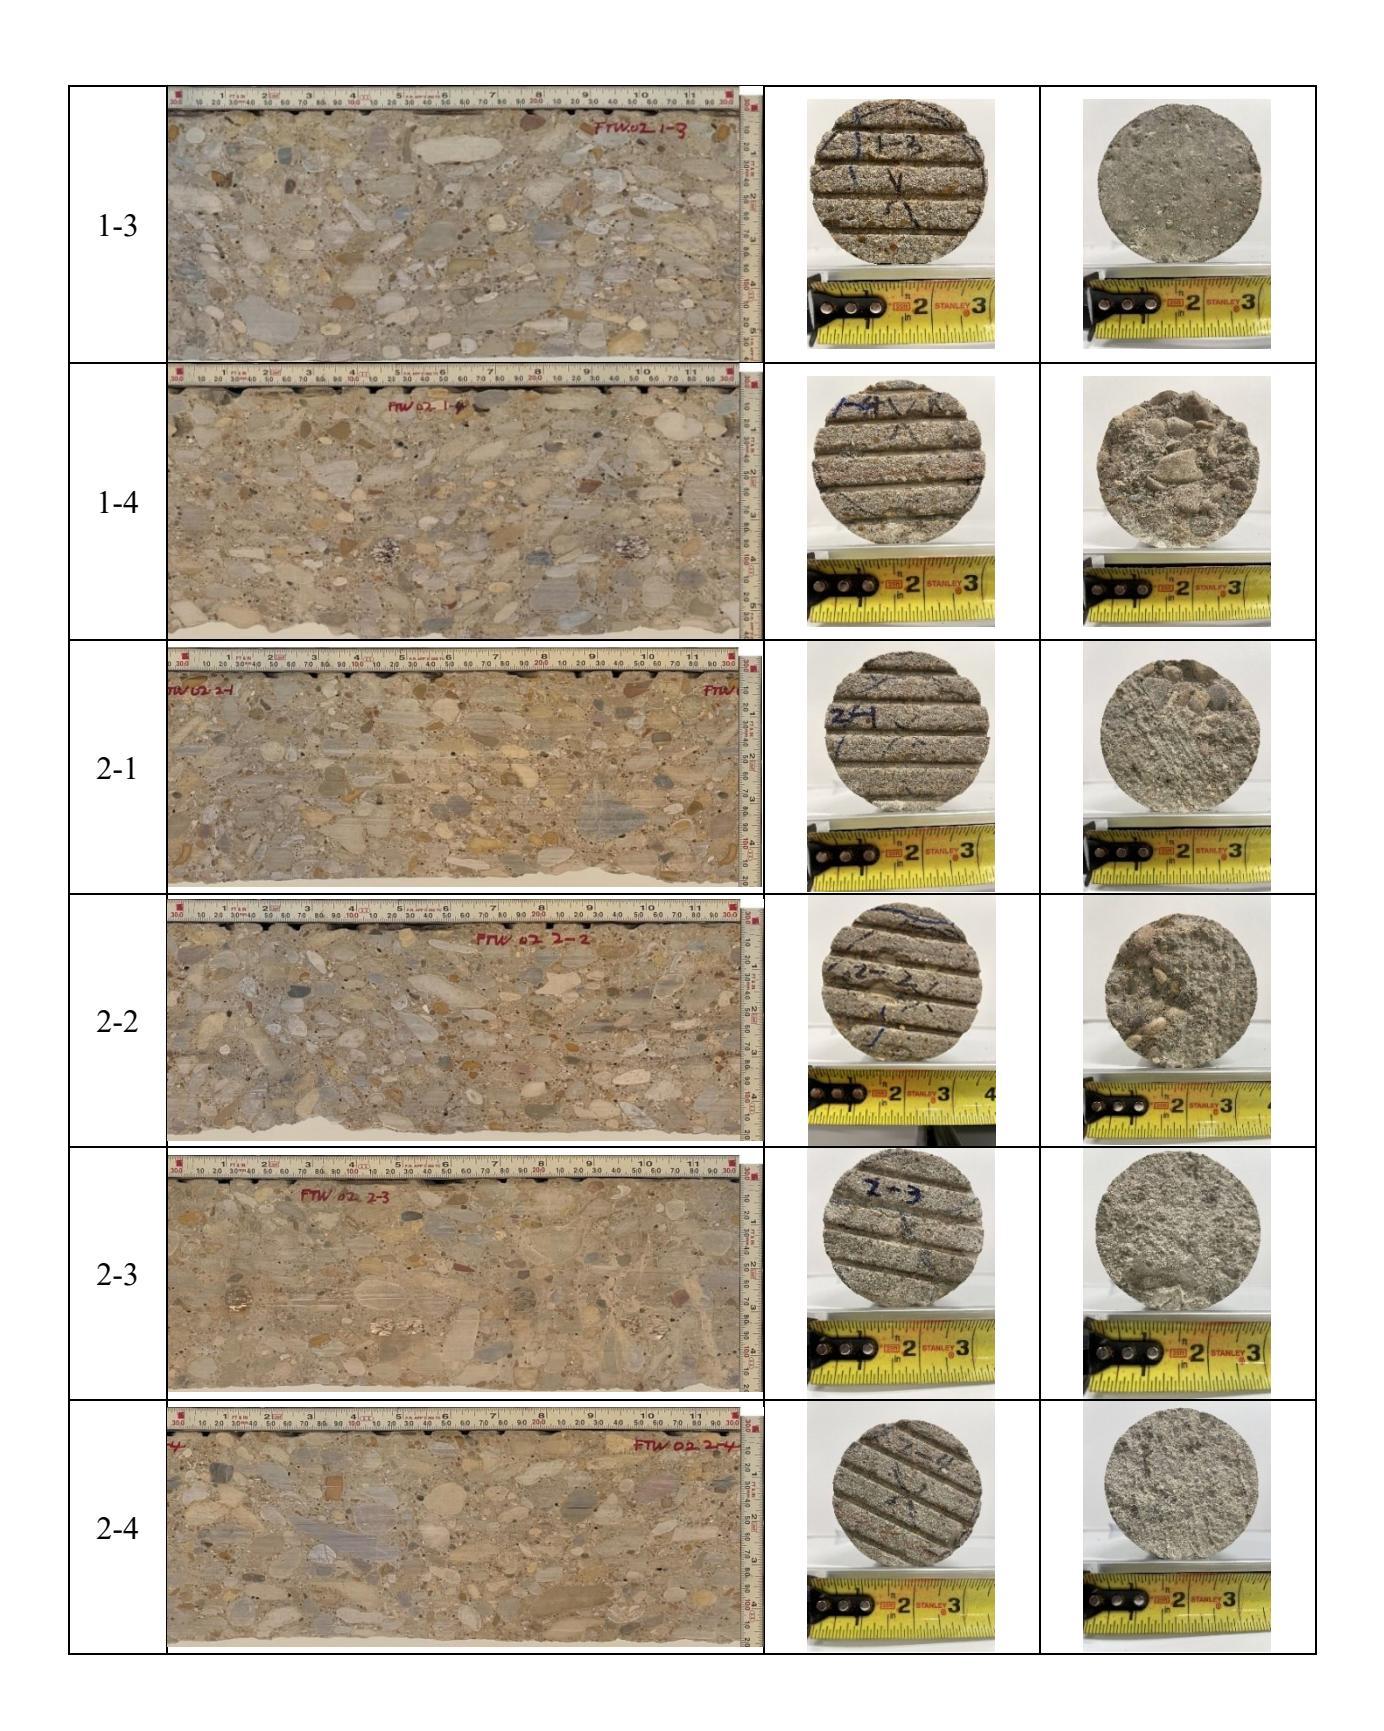
Table B-130. Core Pictures

Core	dia. x height (in.)	Rebar depth (in.)	Rebar size (#)	Epoxy (Y/N)	Crack type	Crack width (in)	Notes
1-1	3.75 x 5.5	4.1	4	Y	transverse	0.025	Delamination between CIP and PCP
1-2	3.75 x 5.5	-	-	-	-	-	Delamination between CIP and PCP
1-3	3.75 x 5.5	-	-	-	-	-	Delamination between CIP and PCP
1-4	3.75 x 5.2	3.6	5	Y	-	-	Delamination between CIP and PCP
2-1	3.75 x 4.7	-	-	-	-	-	Delamination between CIP and PCP
2-2	3.75 x 4.5	-	-	-	longitudinal	HL	Delamination between CIP and PCP
2-3	3.75 x 5.0	2.6; 3.3	5; 4	Y; Y	transverse	0.008	Delamination between CIP and PCP
2-4	3.75 x 5.0	-	-	-	-	-	Delamination between CIP and PCP

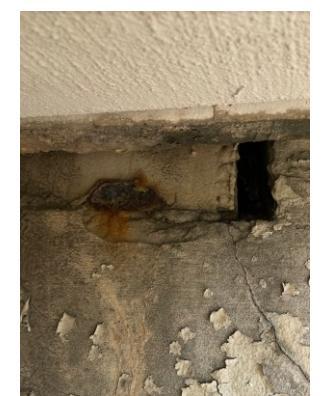
There are spalling on the top surface of deck. The concrete railing near southwest corner has severe cracking and minor spalling. Abutment back wall has serious corrosion and 0.15 in. crack as shown in Figure 0.266.

Figure 0.266. Corrosion near Bearing Pad

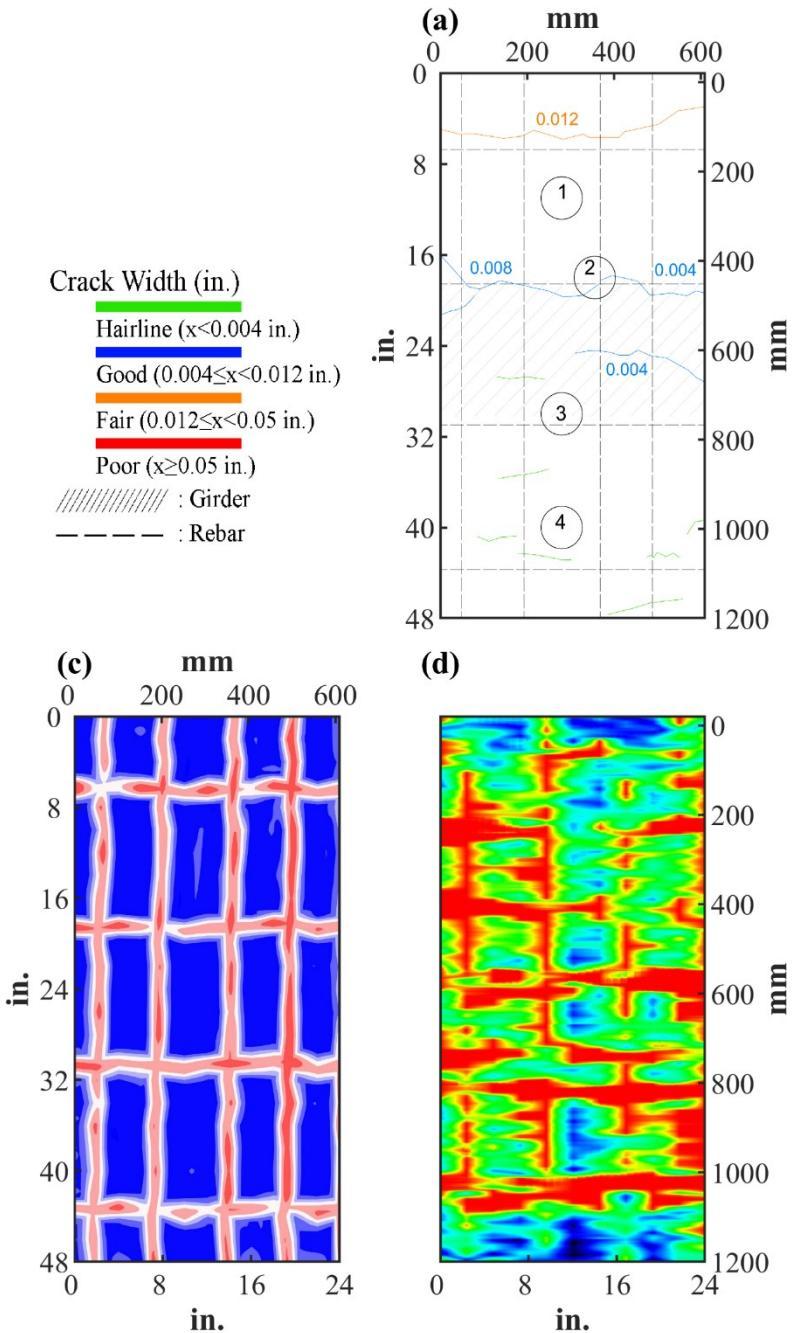
Figure 0.268. Crack Map and NDE Results of Grid 1: (a) Crack Map and Location of Cores; (c) GPR C-scan at 1.9 in. to 3.3 in. Depth; (d) UST C-scan at 4.0 in. Depth

As shown in Figure 0.268 (a), longitudinal racks ranging from 0.004 in. to 0.008 in. were located on top of a girder and 0.012 in. wide longitudinal crack was about 8 in. away from a girder on grid 1. On grid 2, there were no cracks as shown in Figure 0.269 (a).
