Evaluation of Corrosion Prevention and Mitigation Approaches Used on Texas Bridges—Volume 2: Reinforced Concrete Bridges

Technical Report 0-7040-R1-Vol2

TEXAS A&M TRANSPORTATION INSTITUTE COLLEGE STATION, TEXAS

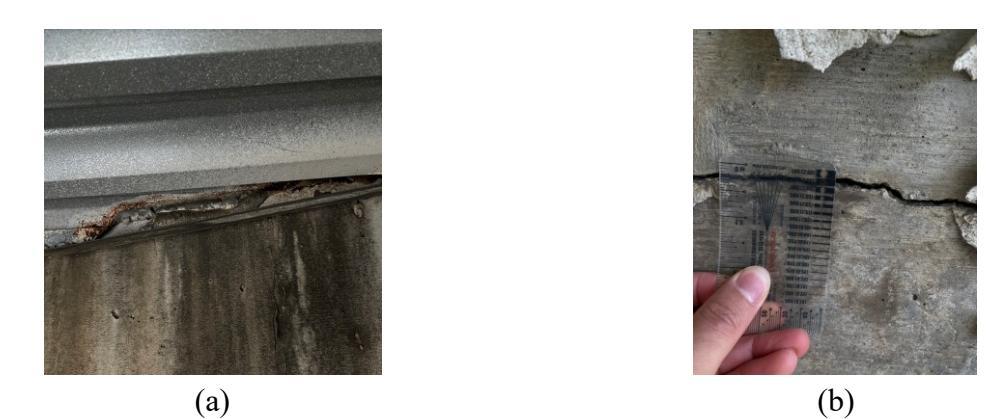
The main superstructure members are in good condition; however, there is corrosion at the metal deck form as shown in Figure 0.273 (a). A horizontal crack is found at the abutment as shown in Figure 0.273 (b).

Figure 0.273. Deteriorations on the Bridge: (a) Corrosion at Metal Deck Form; (b) Serious Crack at Abutment
B.38.2 NDE Results

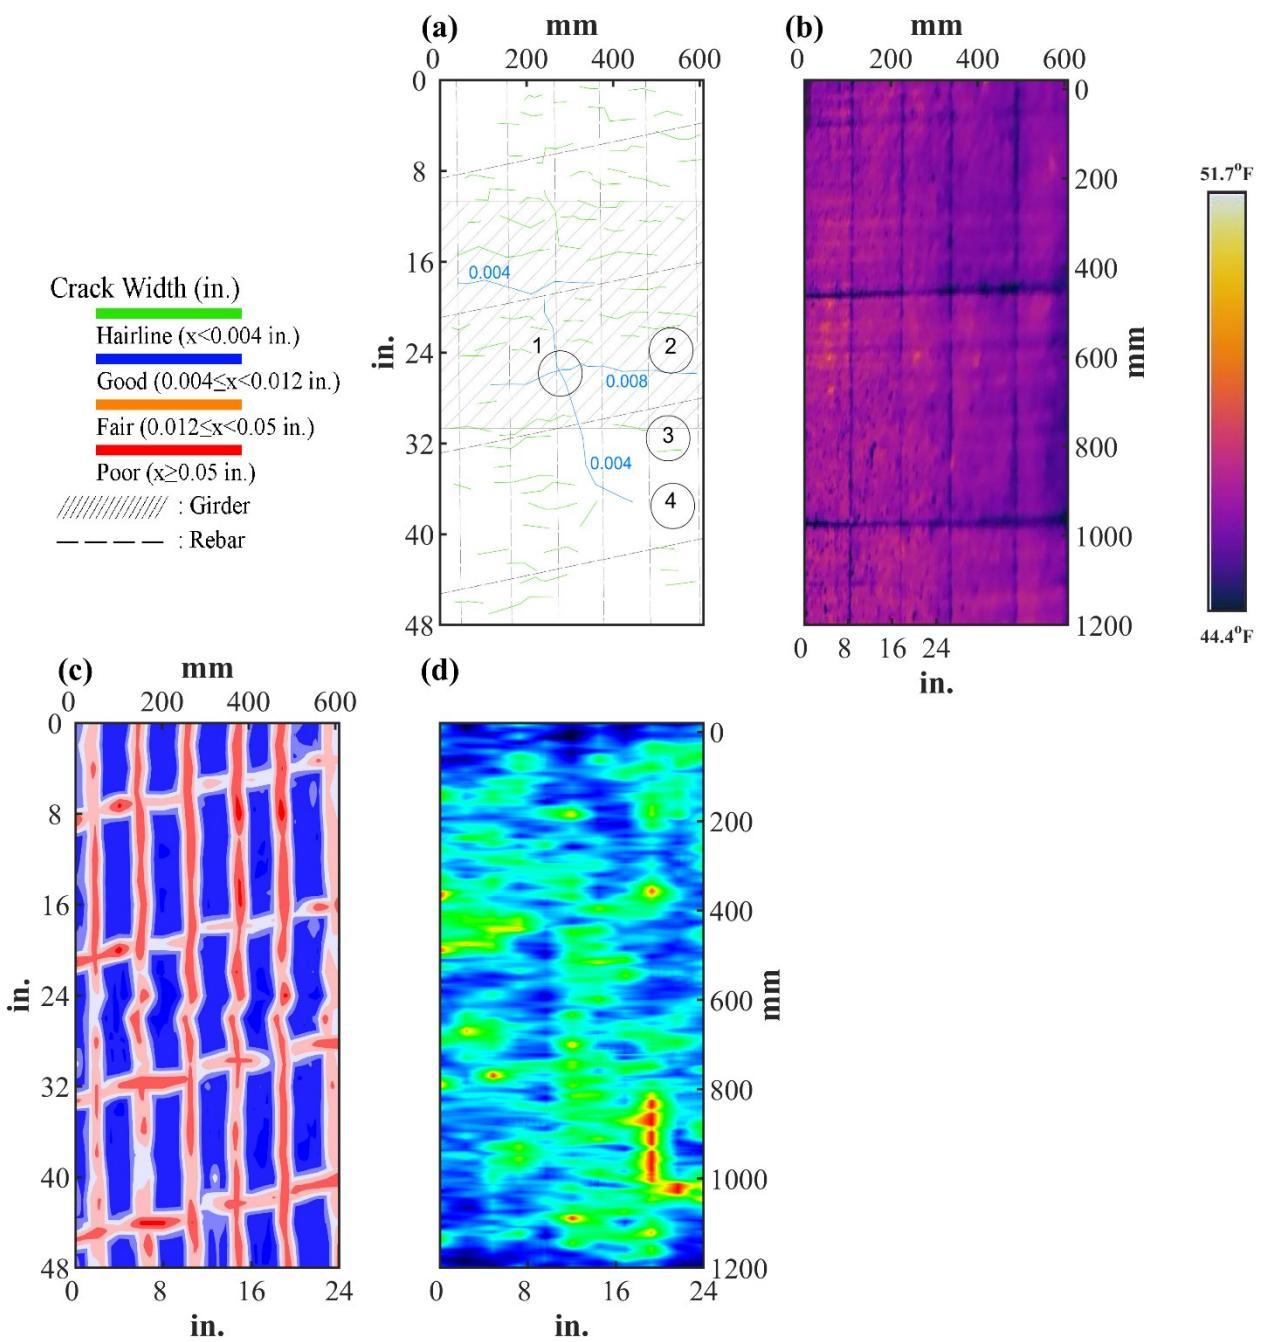
Figure 0.275. Crack Map and NDE Results of Grid 1: (a) Crack Map and Location of Cores; (b) Infrared Picture; (c) GPR C-scan at 2.0 in. to 3.2 in. Depth; (d) UST C-scan at 4.0 in. Depth

As shown in Figure 0.275 (a), there were widespread of hairline cracks and some cracks ranging from 0.004 in. to 0.008 in. wide were located on top of a girder on grid 1. On grid 2, some hairline cracks and 0.004 in. wide longitudinal cracks were visible as shown in Figure 0.276 (a).

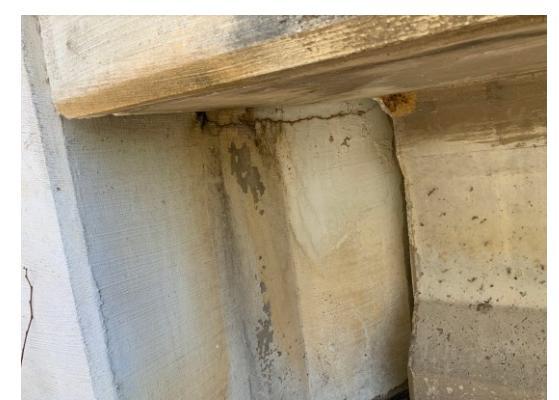
Figure 0.281. Crack and Efflorescence at the Abutment Wall

Deck surface has transverse cracks. The main superstructure members are in good condition; however, abutment backwall has minor cracks and efflorescence as shown in Figure 0.281.

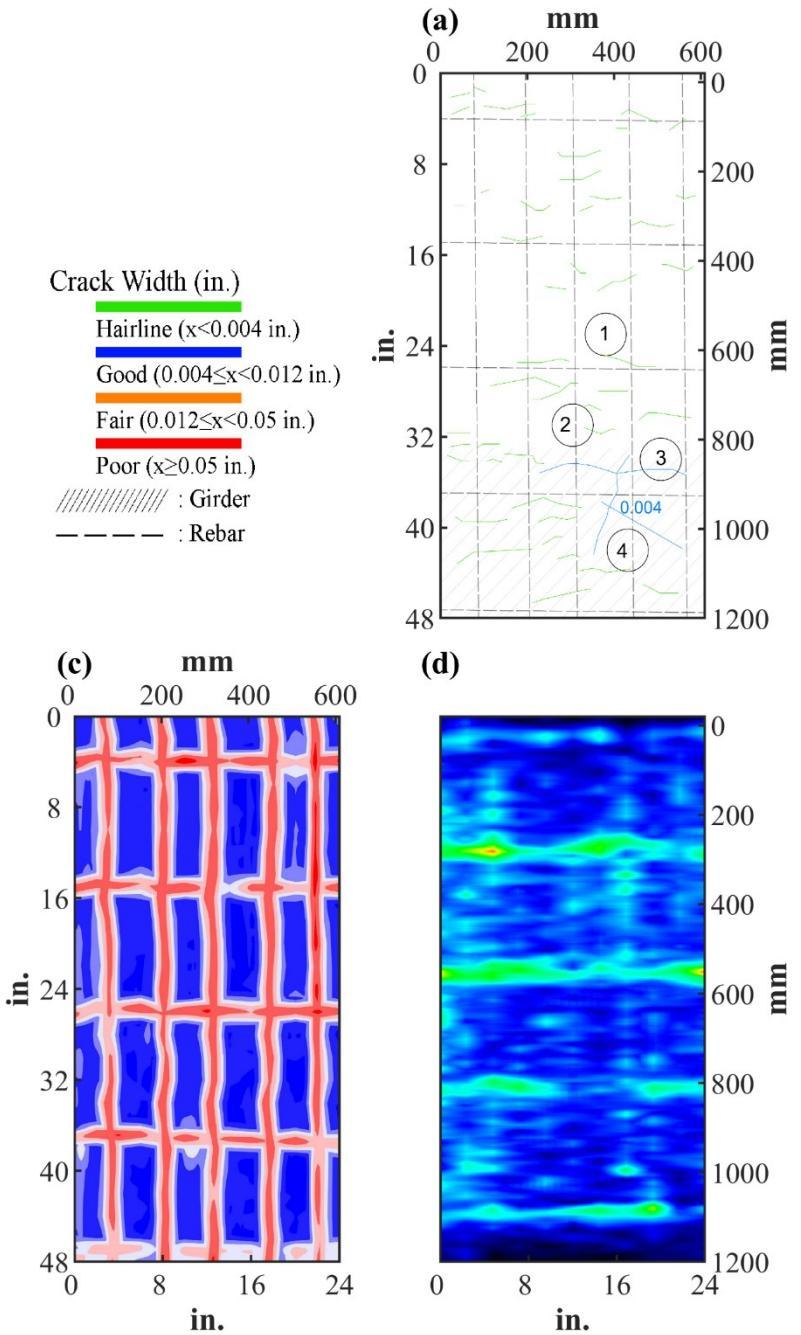
Figure 0.283. Crack Map and NDE Results of Grid 1: (a) Crack Map and Location of Cores; (c) GPR C-scan at 1.9 in. to 3.3 in. Depth; (d) UST C-scan at 4.0 in. Depth

As shown in Figure 0.283 (a), there were widespread of hairline cracks and 0.004 in. wide cracks on top of a girder on grid 1. On grid 2, there were no cracks as shown in Figure 0.284 (a).

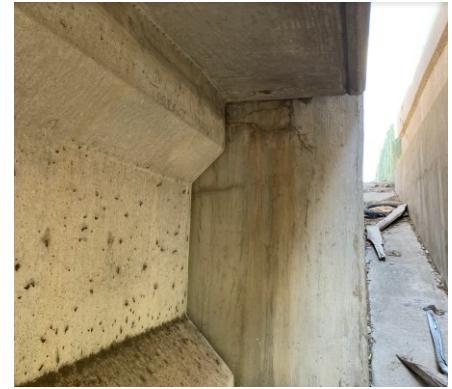
Figure 0.289. Cracks at Abutment Wall

Deck surface has transverse cracks. The main superstructure members are in good condition; however, a vertical crack is found at the abutment wall as shown in Figure 0.289

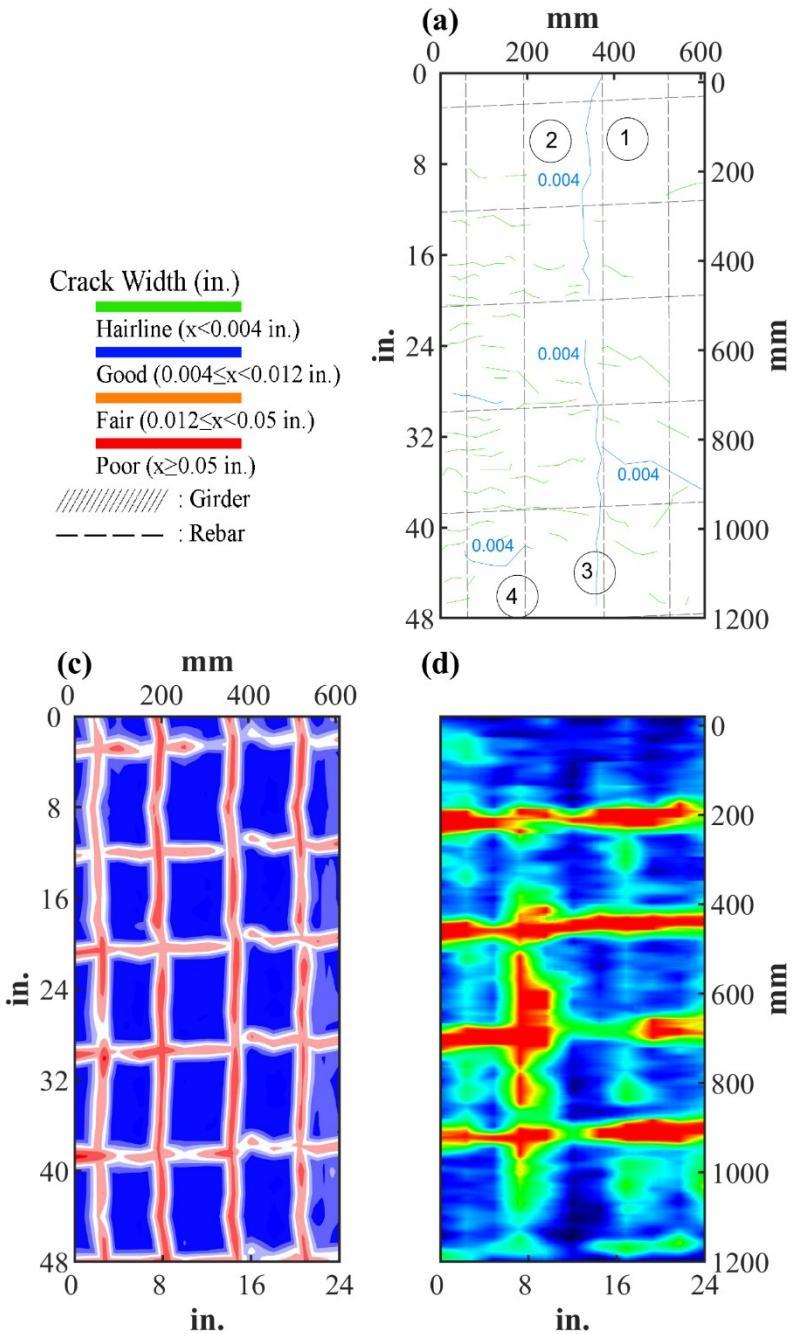
Figure 0.291. Crack Map and NDE Results of Grid 1: (a) Crack Map and Location of Cores; (c) GPR C-scan at 2.6 in. to 4.0 in. Depth; (d) UST C-scan at 4.9 in. Depth

As shown in Figure 0.291 (a), there were widespread of hairline cracks and 0.004 in. wide transverse and longitudinal cracks on grid 1. On grid 2, there were only hairline cracks as shown in Figure 0.292 (a).

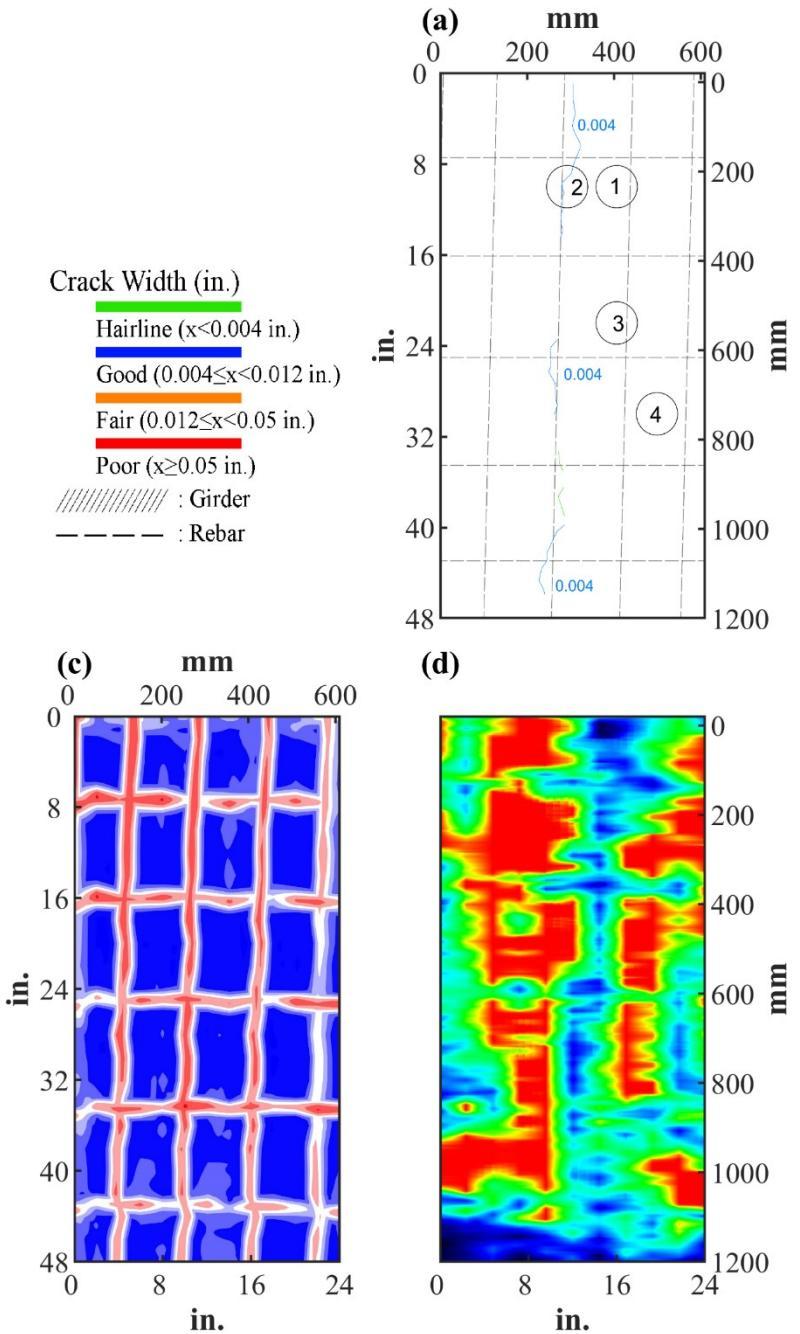
Figure 0.297. Crack Map and NDE Results of Grid 1: (a) Crack Map and Location of Cores; (c) GPR C-scan at 2.5 in. to 4.0 in. Depth; (d) UST C-scan at 4.0 in. Depth

As shown in Figure 0.297 (a), 0.004 in. wide transverse cracks were propagating from a girder on grid 1. On grid 2, 0.004 in. wide longitudinal crack was on top of a girder and 0.004 in. wide transverse crack was propagating from a girder as shown in Figure 0.298 (a).

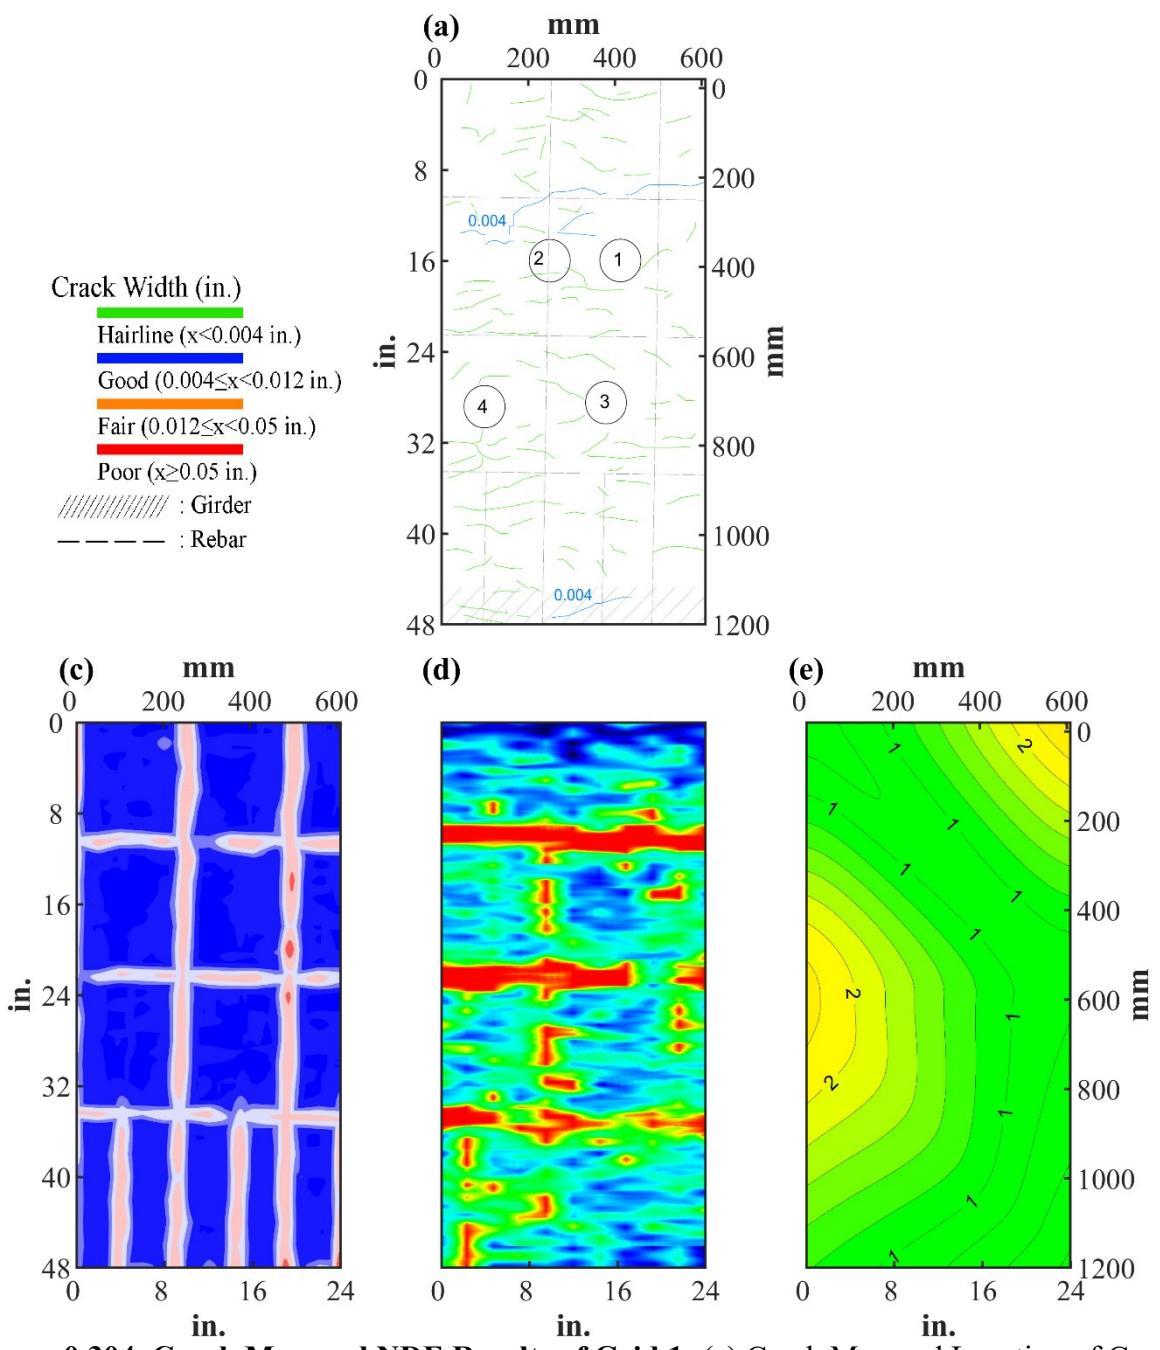
As shown in Figure 0.304 (a), widespread of hairline cracks and 0.004 in. wide cracks were observed on grid 1. Based on Figure A.1.3 (e), corrosion rate map shows low possibility of corrosion on grid 1. On grid 2, there were widespread of hairline cracks with a couple of cracks that were 0.004 in. wide in longitudinal and diagonal direction as shown in Figure 0.305 (a).

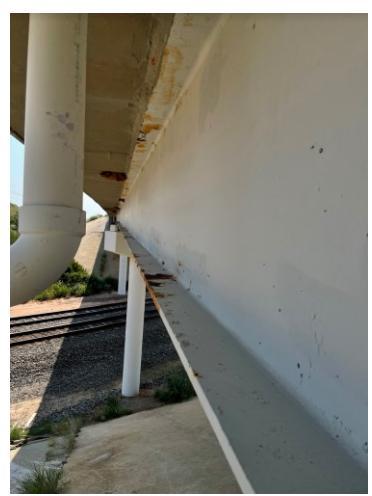
Figure 0.310. Pitting Corrosion on the Web and Bottom Flange

The deck and rails were replaced at 2010. The steel beam 1 at span 1 has isolated moderate pitting corrosion in its web and bottom flange as shown in Figure 0.310. Transverse cracks were observed on the deck of the bridge, with a diagonal crack near the Abutment 1. Diagonal cracks were observed at the transition from a skew to a straight section on the overhang. The north side backwall of Abutment 1 has some water leaking through. In addition, some cracks (0.012 in.) were observed between girders.

Painted steel girders had dirt piled up in some areas on the bottom flanges at the ends (both interior and exterior), with small bits of rust showing about 3-4 feet from the end. The interior girders exhibited some rusting at the top flanges. The north column of the west bent had paint flaked off.

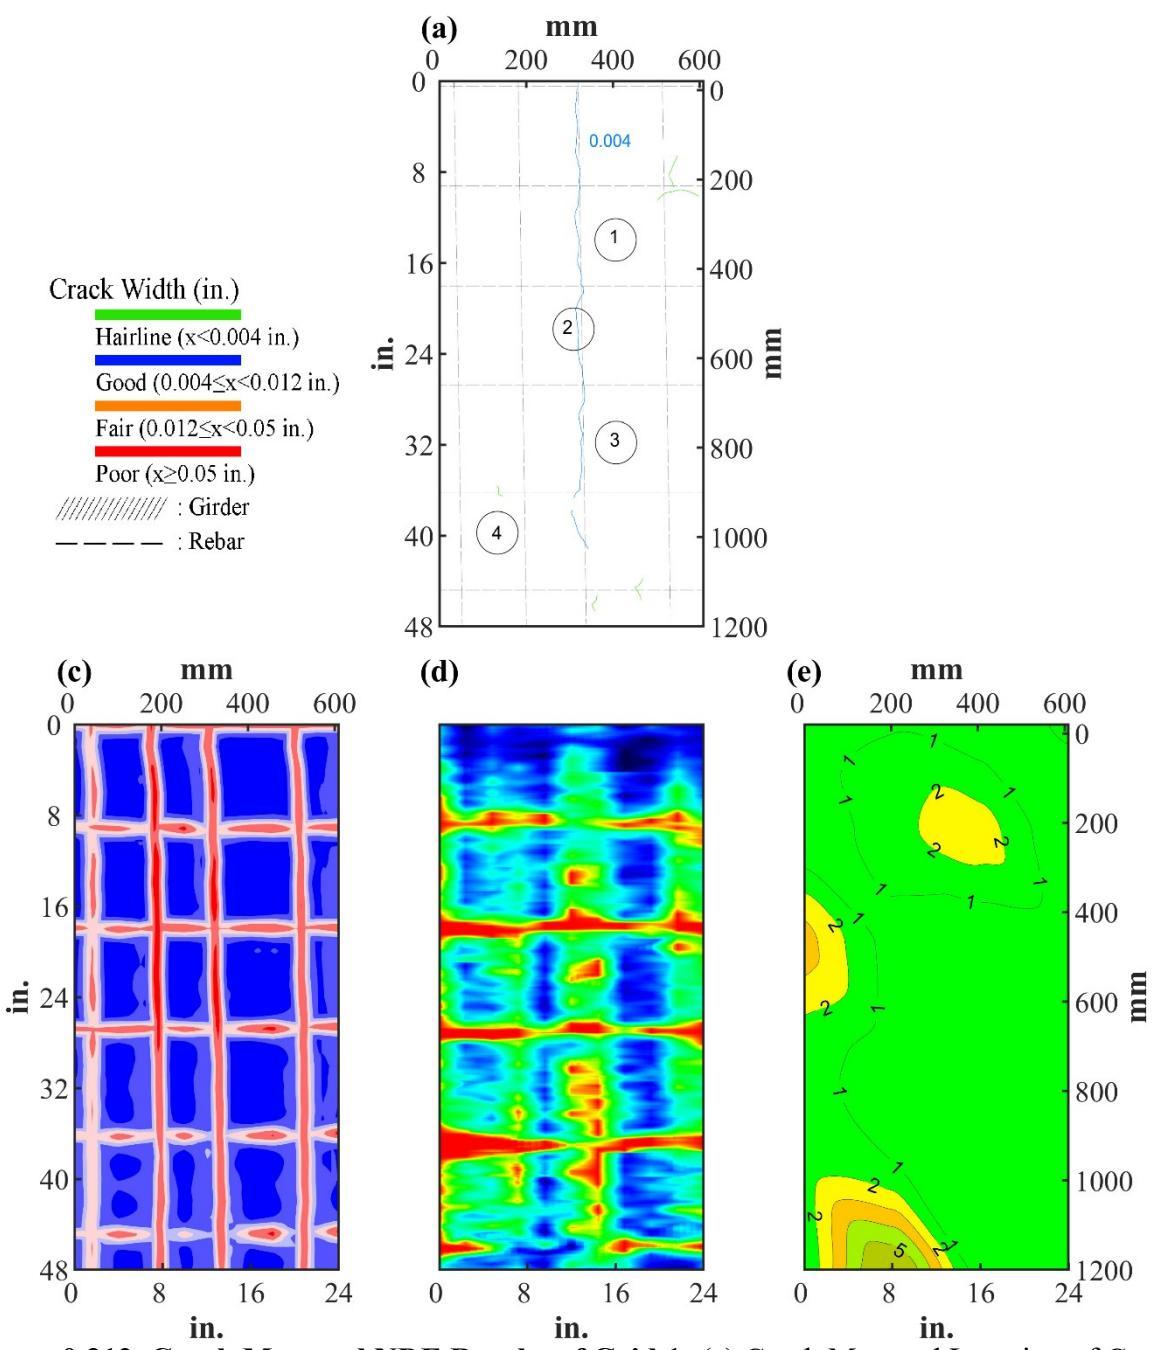
As shown in Figure 0.312 (a), there was 0.004 in. wide transverse crack which is possibly caused by panel joints on grid 1. Based on Figure A.2.4 (e), there is a small possibility of corrosion on grid 1. On grid 2, one diagonal 0.004 in. diagonal crack and 0.04 in. wide transverse crack propagating from a girder as shown in Figure 0.313 (a).

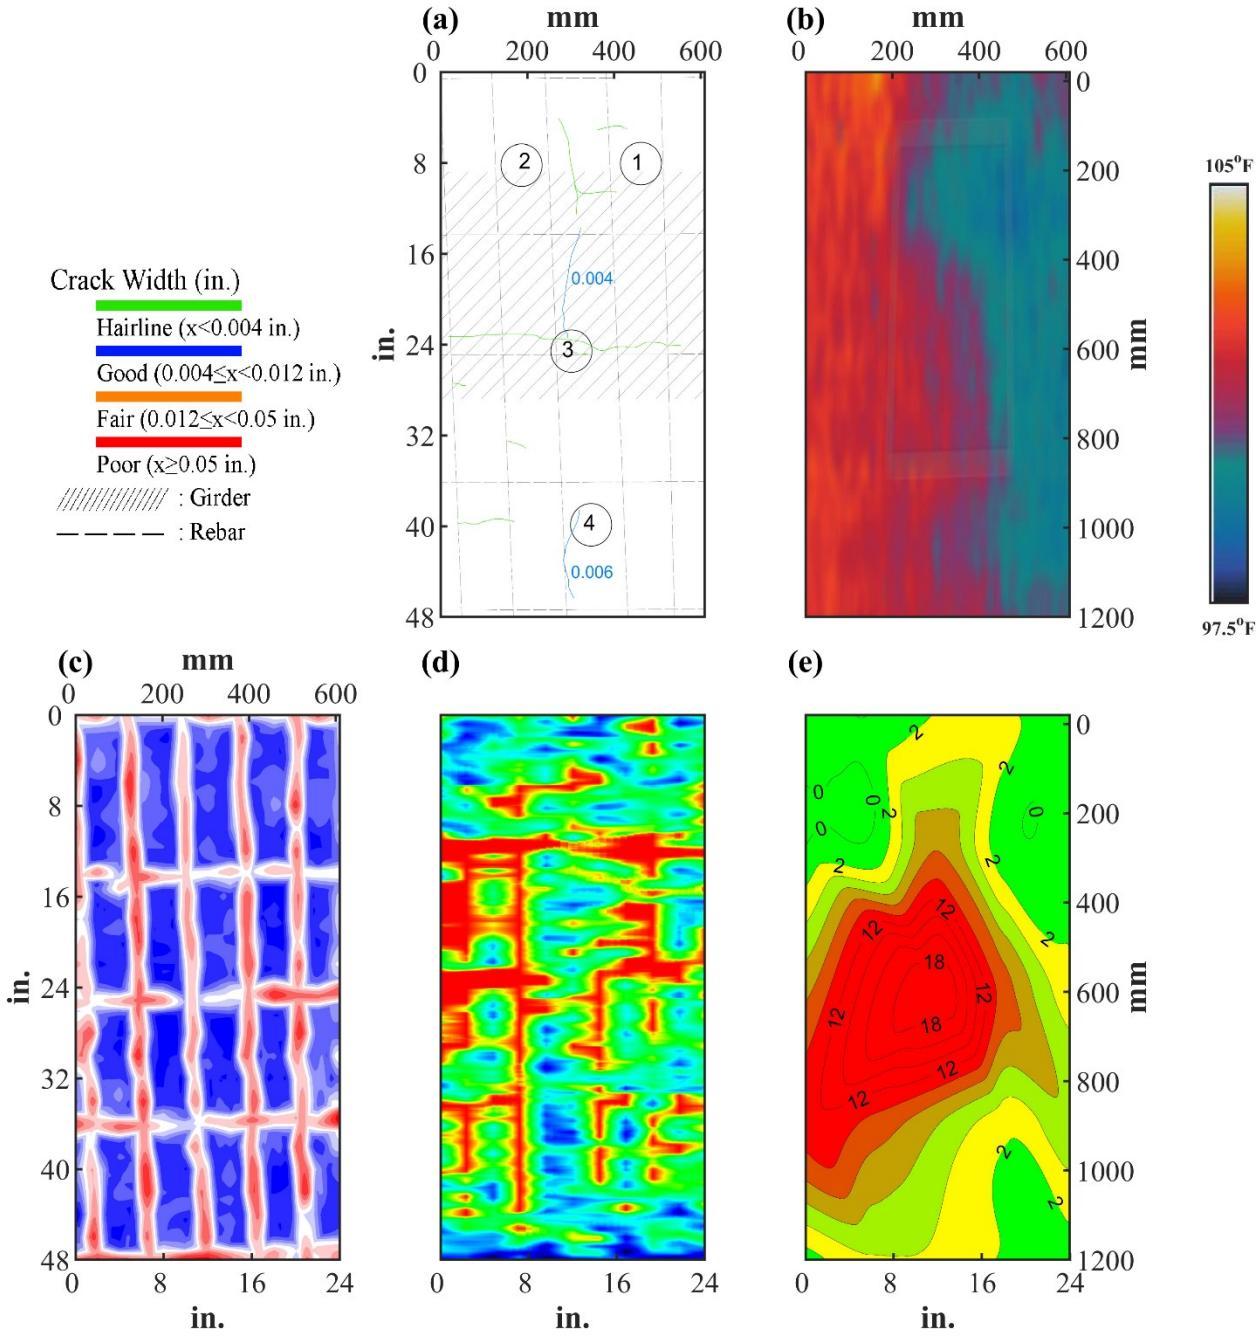
Figure 0.319. Crack Map and NDE Results of Grid 1: (a) Crack Map and Location of Cores; (b) Infrared Picture; (c) GPR C-scan at 3.0 in. to 4.1 in. Depth; (d) UST C-scan; (e) Corrosion Rate Map

As shown in Figure 0.319 (a), a 0.004 in. wide transverse crack was observed on top of a girder on grid 1. Based on Figure A.3.3 (e), there is a high possibility of corrosion on grid 1 where the color is red. On grid 2, there were 0.006 in longitudinal crack and 0.008 in. wide transverse crack on top of a girder and propagating from a girder, respectively, as shown in Figure 0.320 (a).

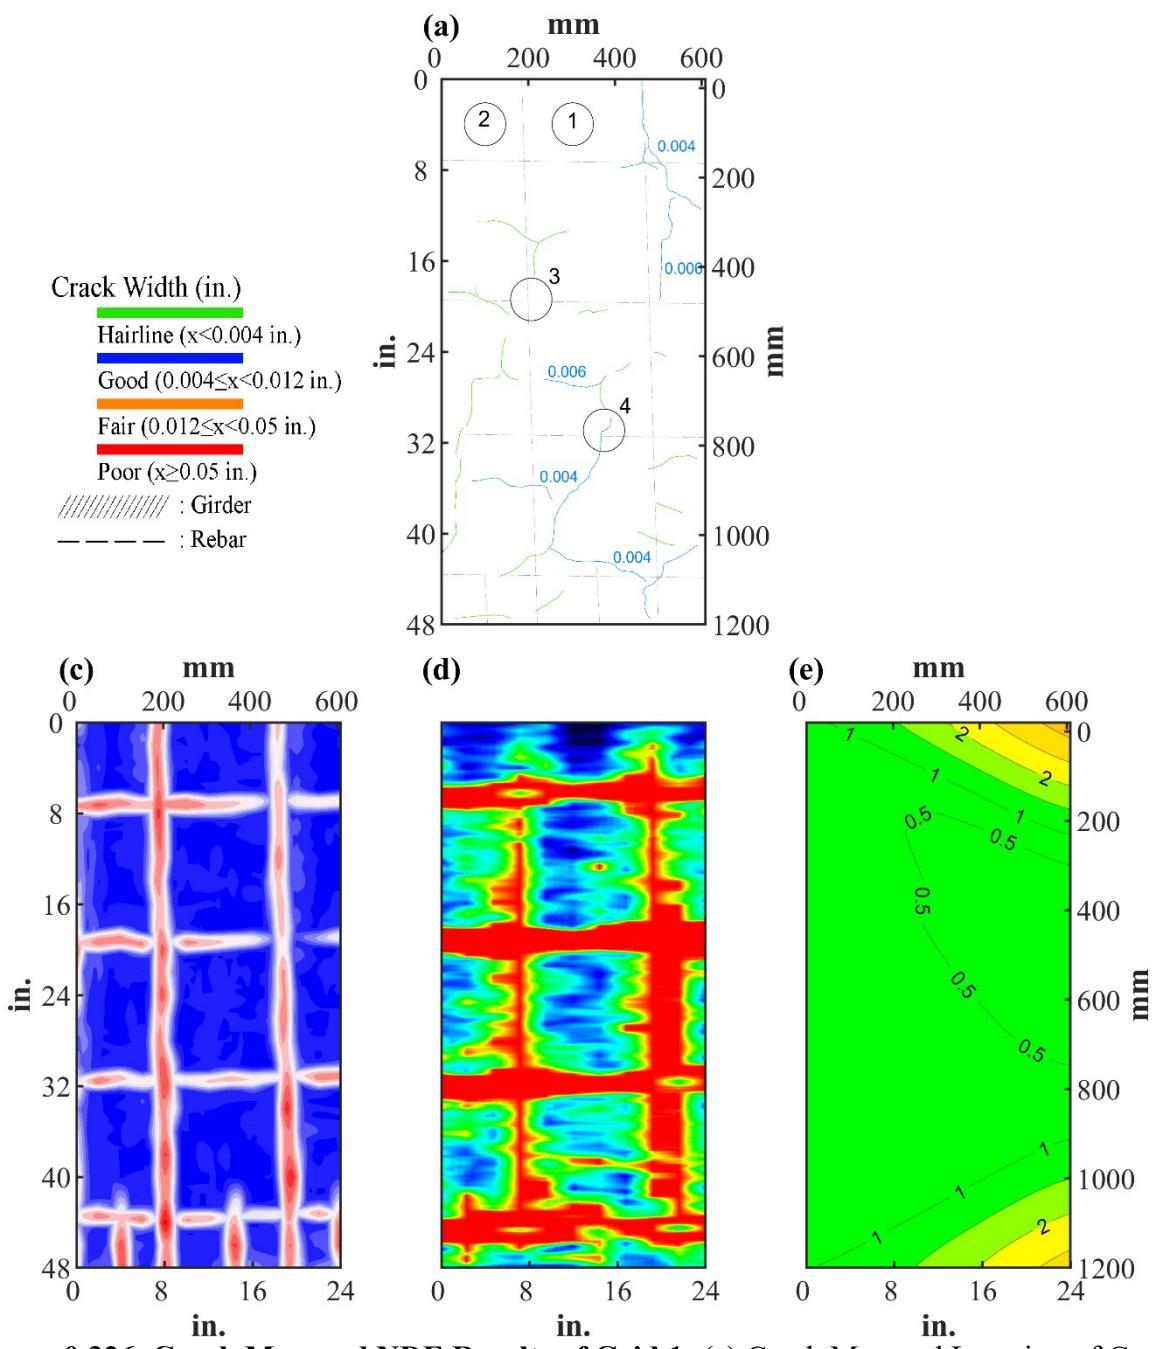
As shown in Figure 0.326 (a), 0.004 in. and 0.006 in. wide cracks were observed in grid 1 in longitudinal, transverse, and diagonal directions. Based on Figure A.4.3 (e), there is a low possibility of corrosion on grid 1. On grid 2, there was one 0.006 in. wide crack as shown in Figure 0.327 (a). It is possible that the crack is caused by panel joints.

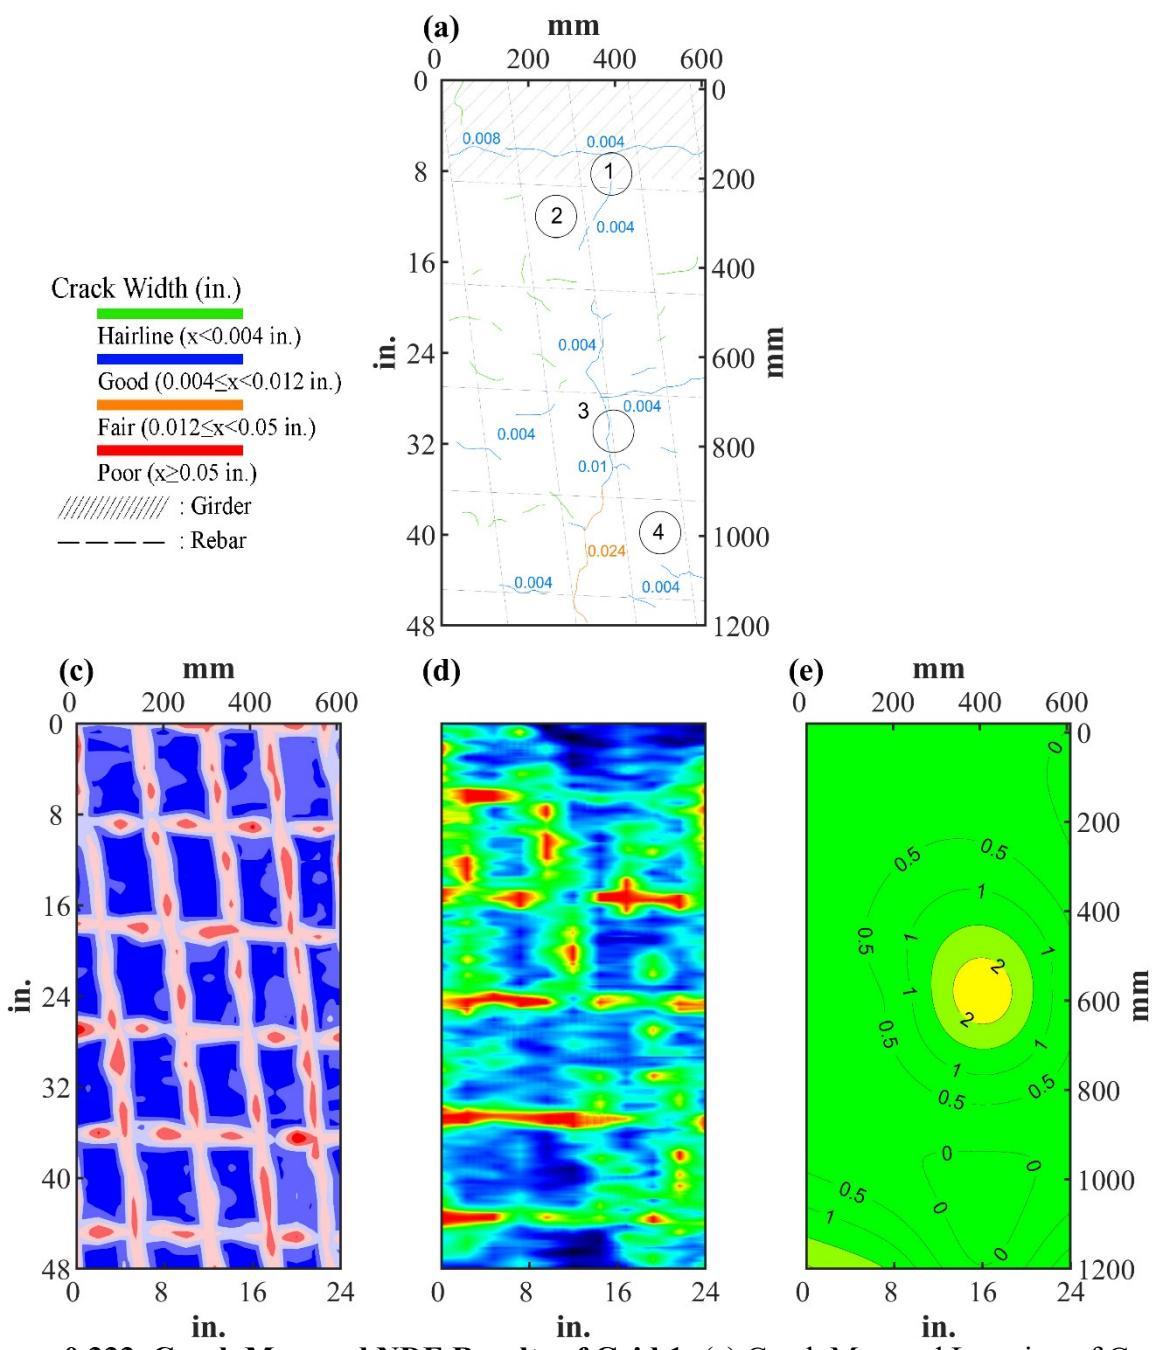
As shown in Figure 0.333 (a), a 0.008 in. wide longitudinal crack was located on top of a girder and 0.004 in., 0.01 in., and 0.024 in. cracks were propagating from a girder. Based on Figure A.5.3 (e), there is a low possibility of corrosion on grid 1. On grid 2, 0.004 in. wide cracks were in longitudinal and transverse direction, and 0.006 in. wide crack was in diagonal direction as shown in Figure 0.334 (a).

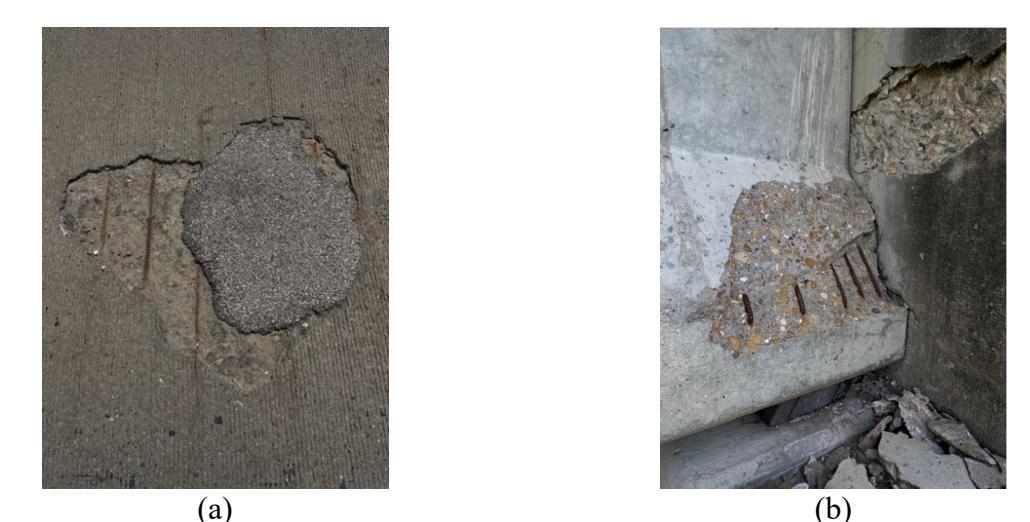
The top surface of deck has transverse, longitudinal, and diagonal cracks. There are minor hairline vertical, horizontal cracks, and impact scrapes at concrete railings. As shown in Figure 0.339 (a), spalling on the deck and corroded rebar was observed, and spalling on the girder end was also observed as shown in Figure 0.339 (b).

Figure 0.339. Deteriorations on the Bridge: (a) spalling on deck; (b) Exposed rebar on the girder end

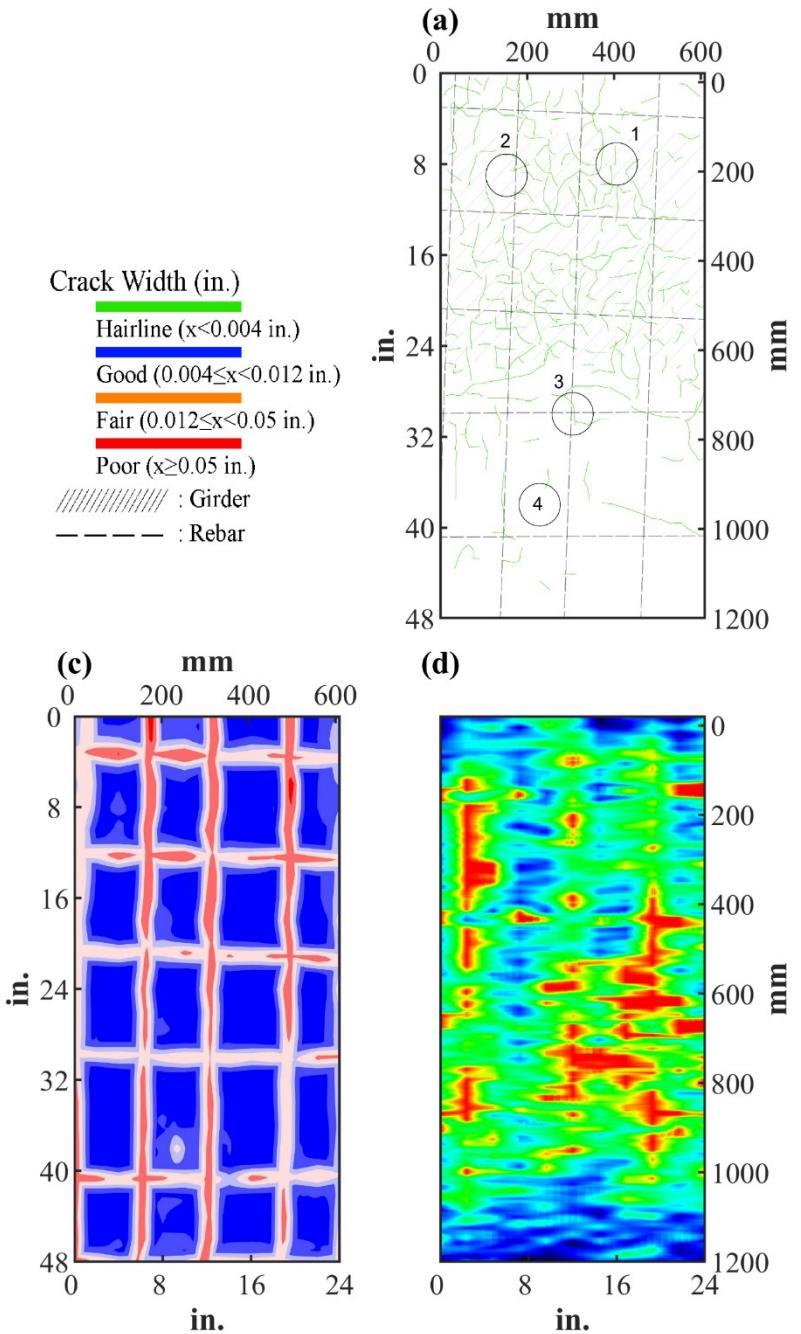
As shown in Figure 0.341 (a), there was a widespread of hairline cracks and narrow cracks ranging from 0.004 in. to 0.008 in. wide. Based on Figure A.6.3 (e), there was a high possibility of corrosion at the upper left corner of grid 1, but all other area had almost zero to no risk of corrosion. On grid 2, only hairline cracks were observed as shown in Figure 0.342 (a).

Figure 0.342. Crack Map and NDE Results of Grid 2: (a) Crack Map and Location of Cores; (c) GPR C-scan at 2.85 in. to 3.95 in. Depth; (d) UST C-scan

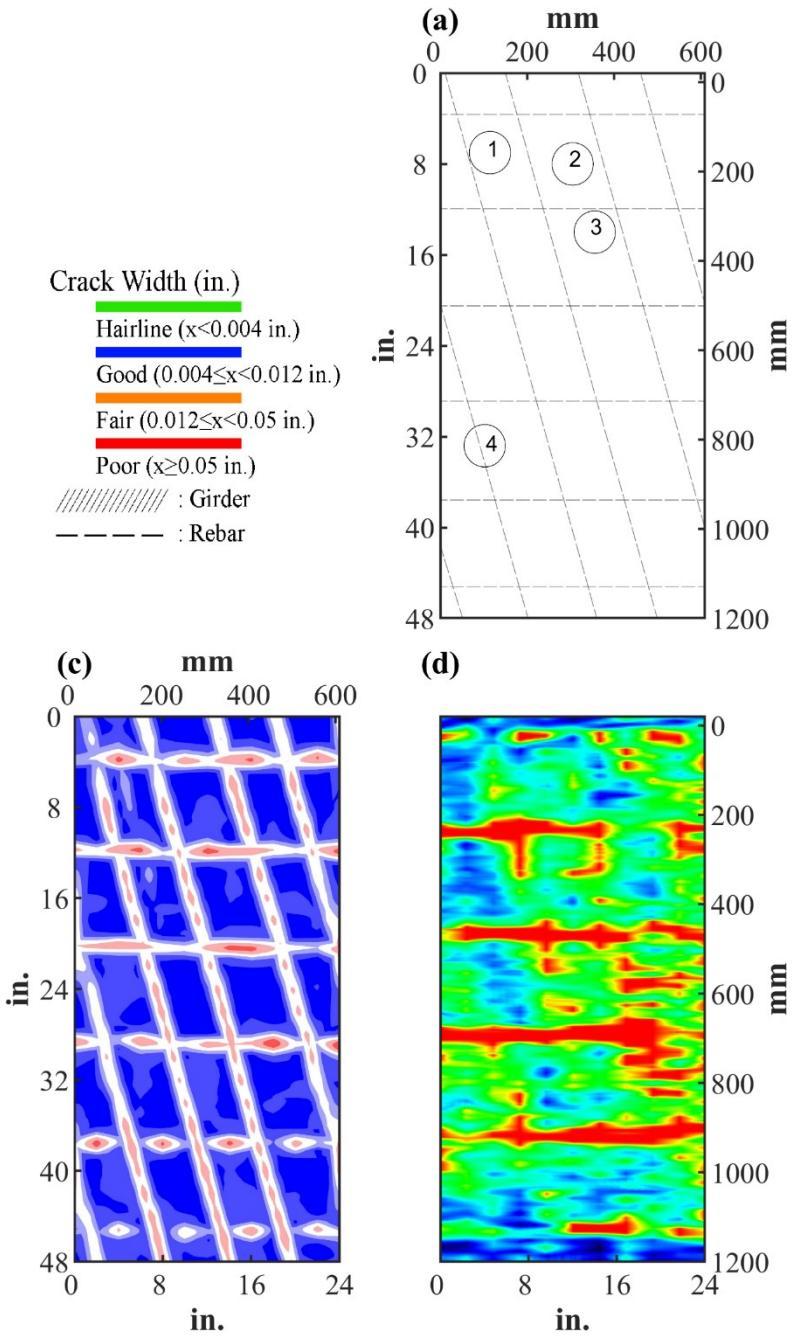
As shown in Figure 0.348 (a), hairline cracks were mostly observed from grid 1 with one 0.004 in. wide longitudinal crack along a girder. Based on Figure A.7.3 (e), there was low possibility of corrosion on grid 1. On grid 2, no cracks were observed as shown in Figure 0.349 (a).

Figure 0.349. Crack Map and NDE Results of Grid 2: (a) Crack Map and Location of Cores; (c) GPR C-scan at 2.45 in. to 3.55 in. Depth; (d) UST C-scan

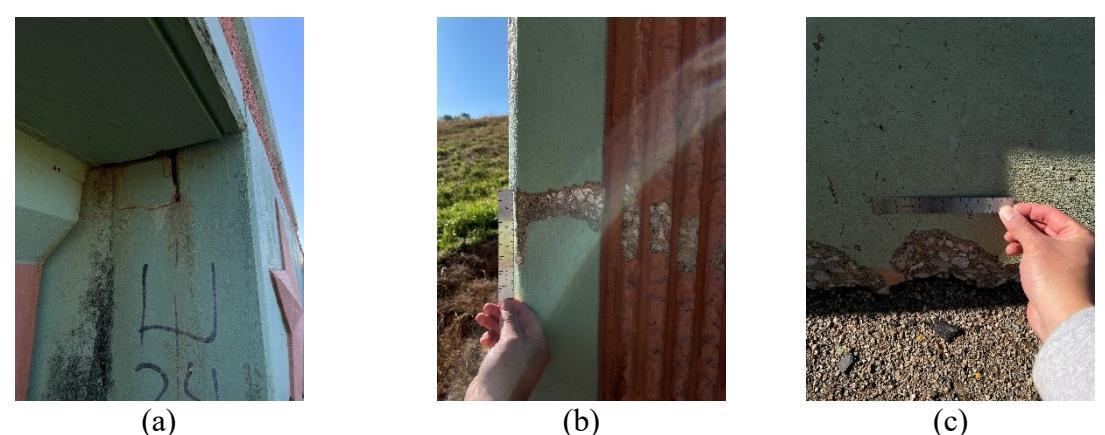
There is a crack at the exterior abutment wall and a sign of corrosion is visible as shown in Figure 0.366 (a). In addition, As shown in Figure A.3.2 (b) and (c), there were spalling at abutment wall and concrete rail, respectively.

Figure 0.366. Deteriorations on the Bridge: (a) Crack at Abutment Wall; (b) Spalling at Abutment Wall; (c) Spalling at Concrete Rail

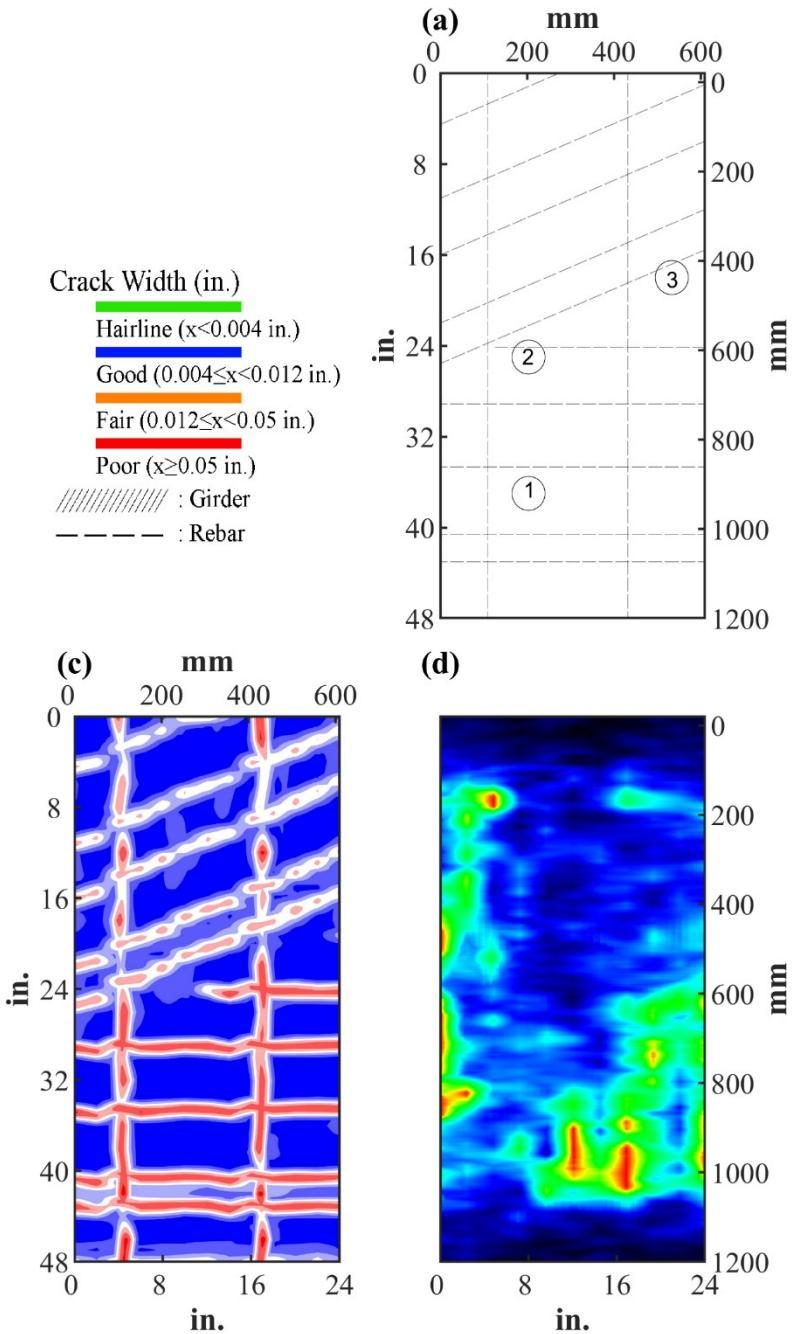
As shown in Figure 0.368 (a), there were no cracks on grid 1. On the other hand, grid 2 had a transverse crack that ranged from 0.004 in. to 0.007 in. wide. Based on its pattern, it is possible that the crack is due to panel joint.

Figure 0.368. Crack Map and NDE Results of Grid 1: (a) Crack Map and Location of Cores; (c) GPR C-scan at 1.8 in. to 2.9 in. Depth; (d) UST C-scan

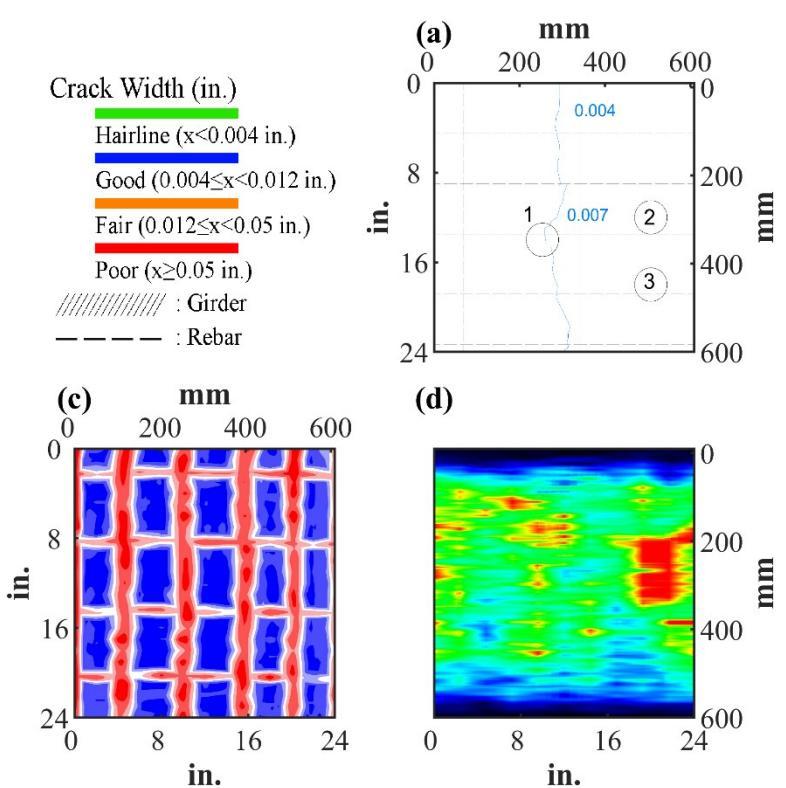
Figure 0.369. Crack Map and NDE Results of Grid 2: (a) Crack Map and Location of Cores; (c) GPR C-scan at 1.7 in. to 2.8 in. Depth; (d) UST C-scan

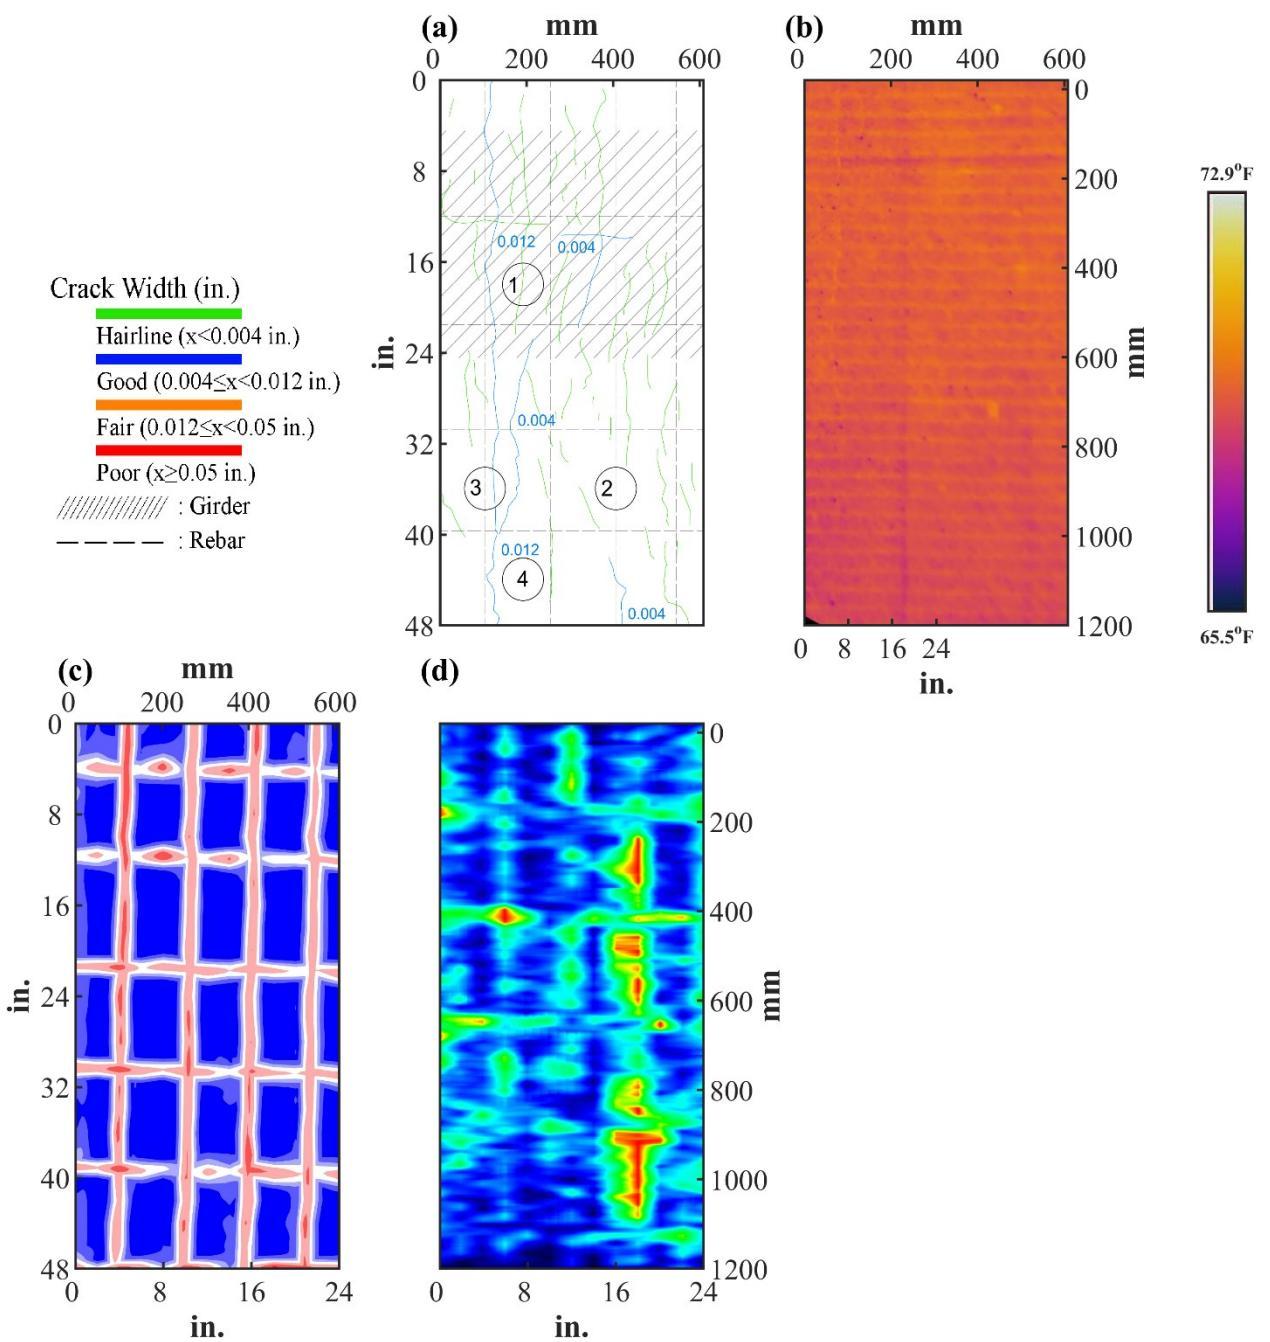
As shown in Figure 0.149 (a), there are widespread of hairline cracks and transverse cracks that range from 0.004 in. to 0.012 in. wide on grid 1. Transverse cracks were on top of a girder and propagated from it. On grid 2, hariline cracks and a 0.018 in. wide transverse crack were observed that was possibly caused by panel joints as shown in Figure 0.376 (a).

Figure 0.375. Crack Map and NDE Results of Grid 1: (a) Crack Map and Location of Cores; (b) Infrared Picture; (c) GPR C-scan at 1.9 in. to 3.3 in. Depth; (d) UST C-scan at 3.1 in. Depth
