Evaluation of Corrosion Prevention and Mitigation Approaches Used on Texas Bridges—Volume 2: Reinforced Concrete Bridges

Technical Report 0-7040-R1-Vol2

TEXAS A&M TRANSPORTATION INSTITUTE COLLEGE STATION, TEXAS

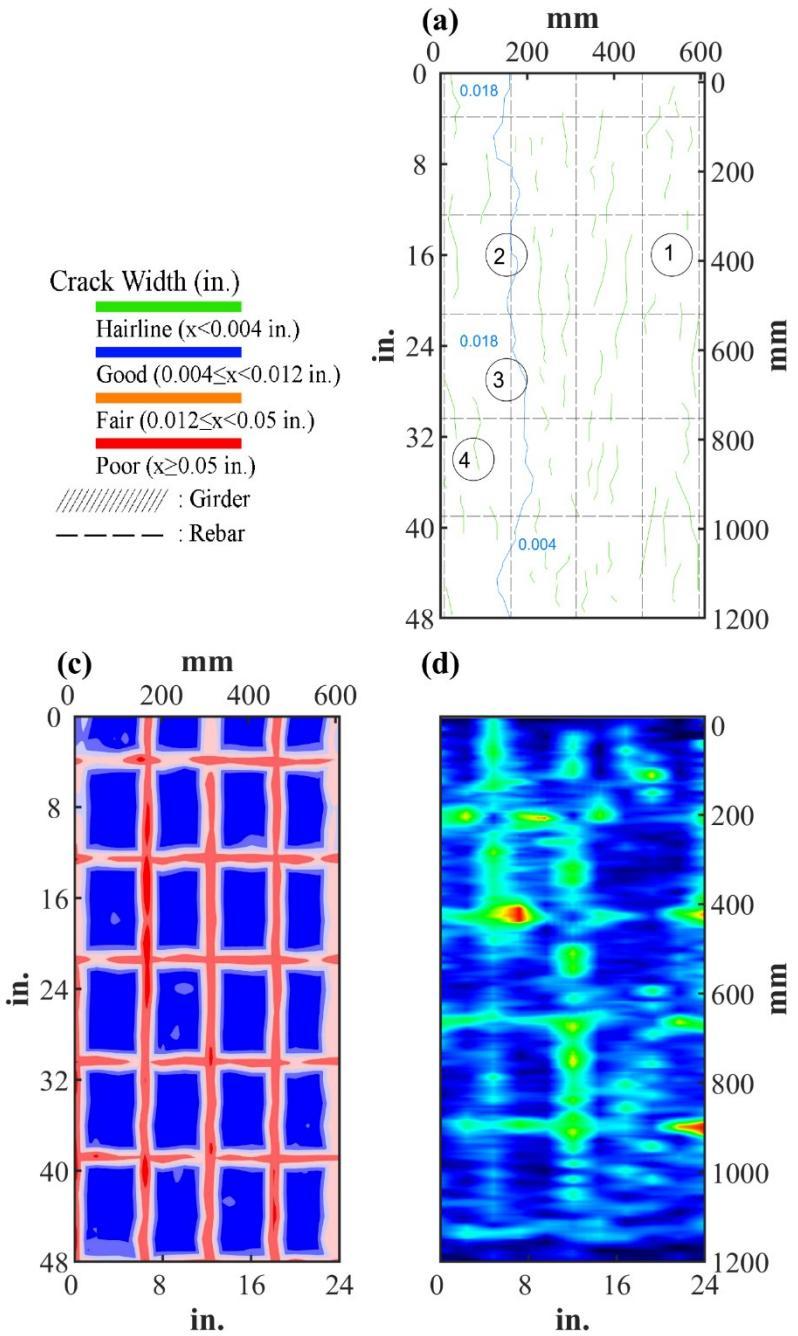
As shown in Figure 0.149 (a), there are widespread of hairline cracks and transverse cracks that range from 0.004 in. to 0.012 in. wide on grid 1. Transverse cracks were on top of a girder and propagated from it. On grid 2, hariline cracks and a 0.018 in. wide transverse crack were observed that was possibly caused by panel joints as shown in Figure 0.376 (a).

Figure 0.376. Crack Map and NDE Results of Grid 2: (a) Crack Map and Location of Cores; (c) GPR C-scan at 2.6 in. to 3.95 in. Depth; (d) UST C-scan at 3.5 in. Depth

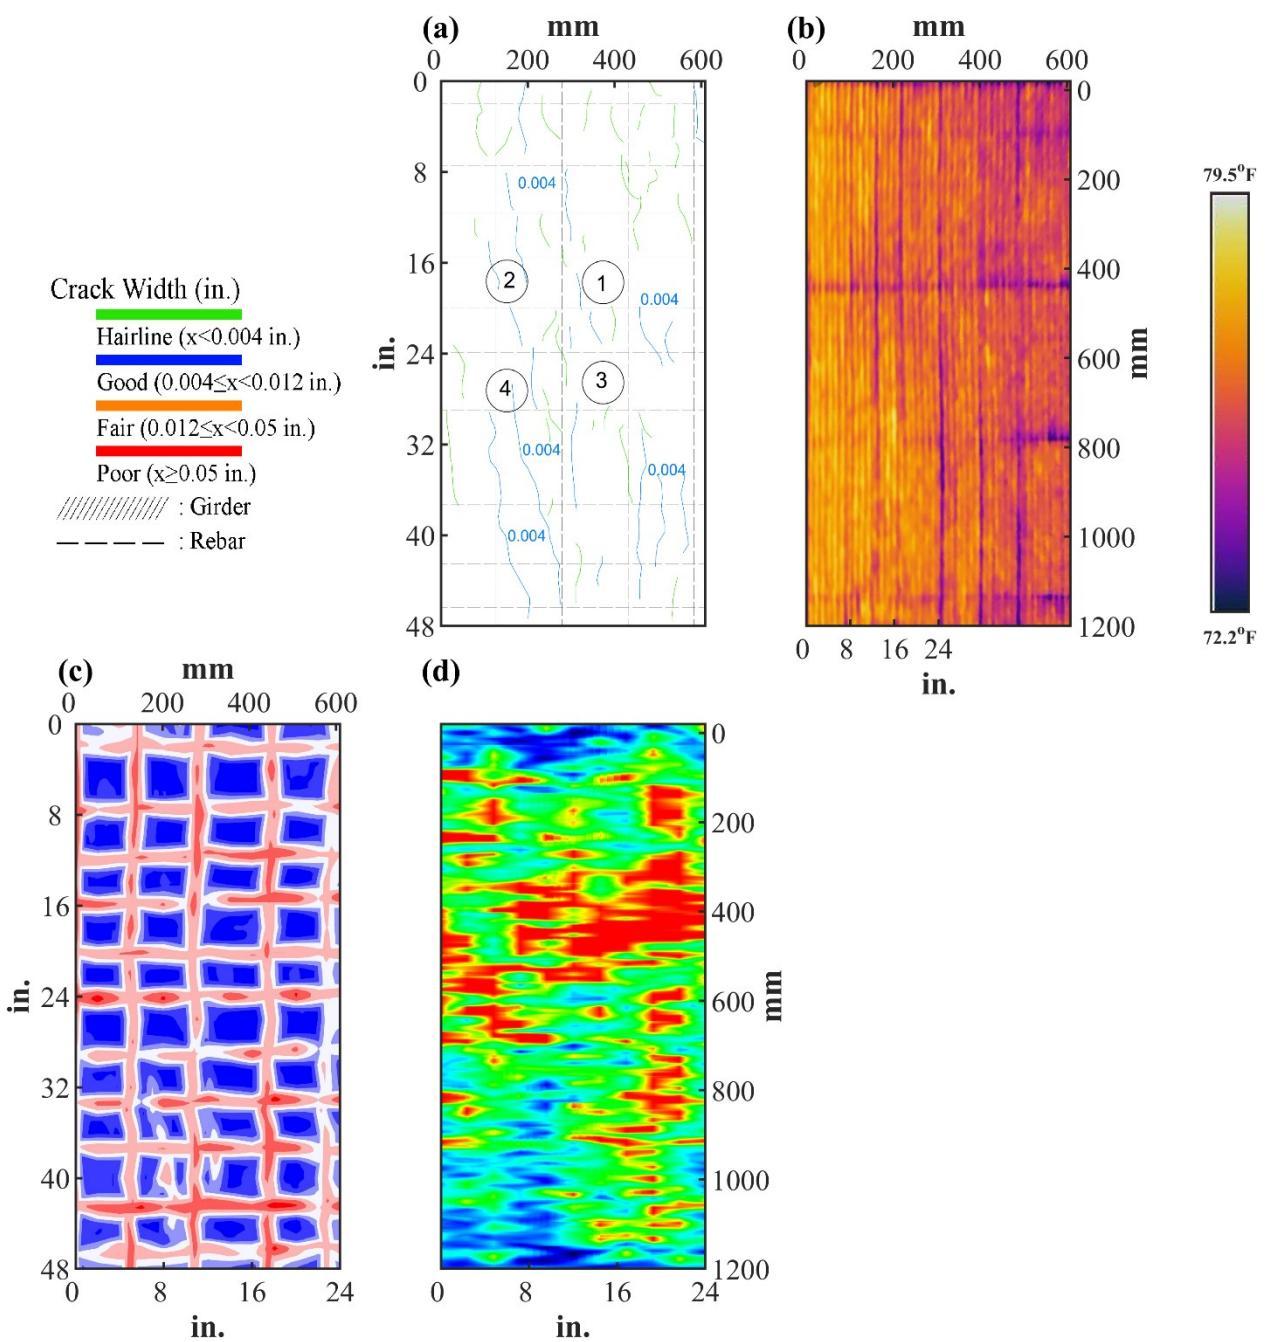
As shown in Figure 0.156 (a), there were widespread of transverse hairline cracks and 0.004 in. wide transverse cracks throughout grid 1. On grid 2, there was one 0.004 in. wide transverse crack that is possibly caused by panel joints as shown in Figure 0.157 (a).

Figure 0.382. Crack Map and NDE Results of Grid 1: (a) Crack Map and Location of Cores; (b) Infrared Picture; (c) GPR C-scan at 1.9 in. to 3.3 in. Depth; (d) UST C-scan at 2.6 in. Depth

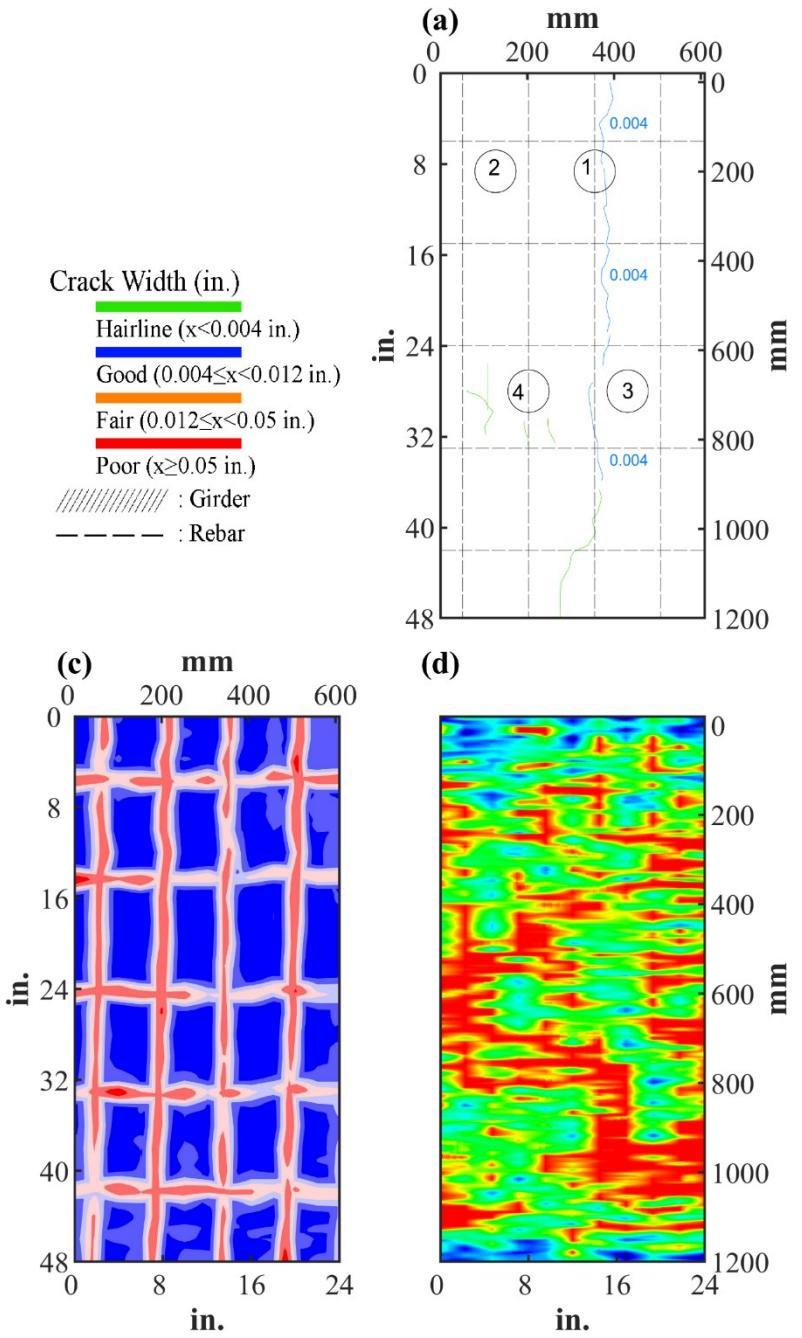
Figure 0.383. Crack Map and NDE Results of Grid 2: (a) Crack Map and Location of Cores; (c) GPR C-scan at 1.9 in. to 3.3 in. Depth; (d) UST C-scan at 2.4 in. Depth

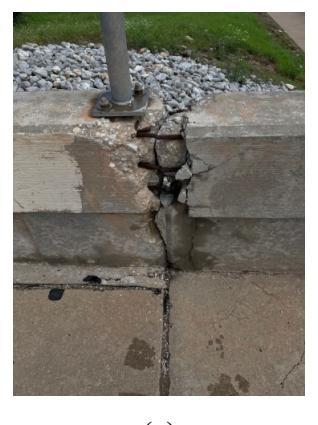
Deck surface has transverse and longitudinal cracks. Concrete rail at north has spalling and exposed rebar at its west end as shown in Figure 0.388 (a). The abutment caps have vertical cracks with efflorescence as shown in Figure 0.388 (b).

Figure 0.388. Deteriorations on the Bridge: (a) Exposed and Corroded Rebar at Concrete Railing; (b) Crack on the Abutment Wall

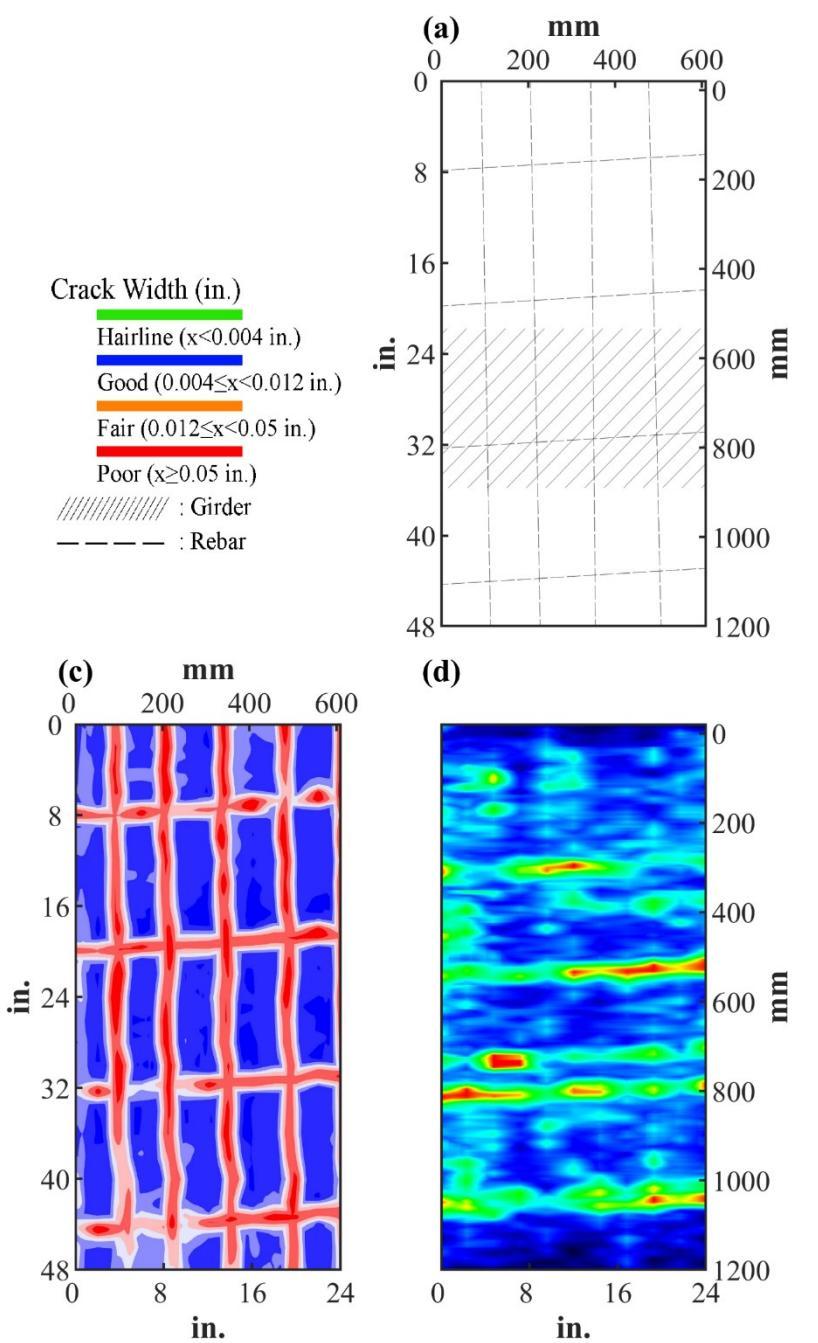
Due to a weather condition, crack map was not drawn for both grid 1 and grid 2, and GPR and UST of grid 2 was not measured.

in.in.Figure 0.390. Crack Map and NDE Results of Grid 1: (c) GPR C-scan 2.5 in. to 3.8 in. Depth;
(d) UST C-scan at 4.4 in. Depth

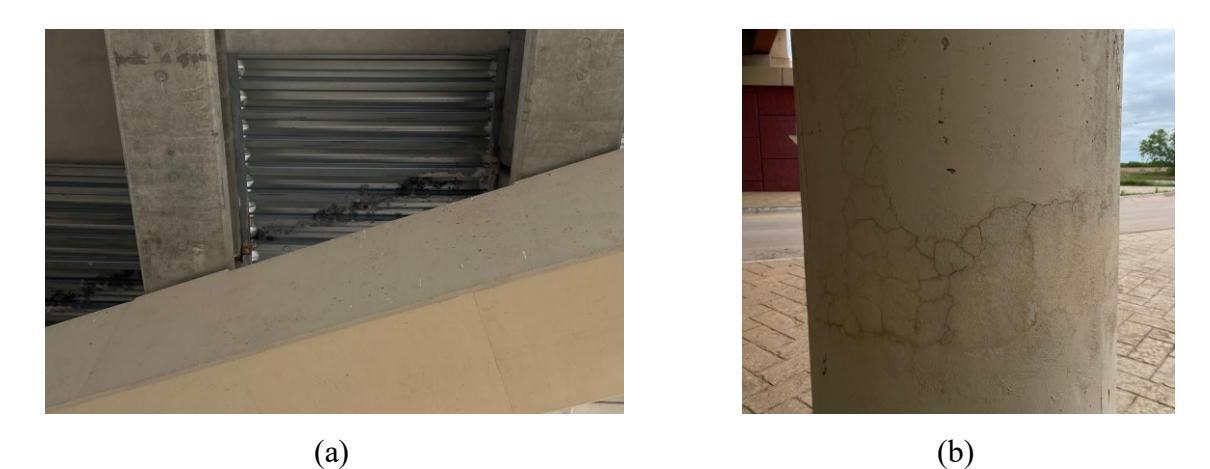
Deck surface has hairline diagonal, transverse, and longitudinal cracks. Deck joints are partially filled with debris and dirt. Its metal arms has minor corrosion. The metal deck form at its end has corrosion rust as shown in Figure 0.395 (a). The columns have hairline cracks as shown in Figure 0.395 (b).

Figure 0.395. Deteriorations on the Bridge: (a) Rust at Metal Deck Form; (b) Cracks on Column

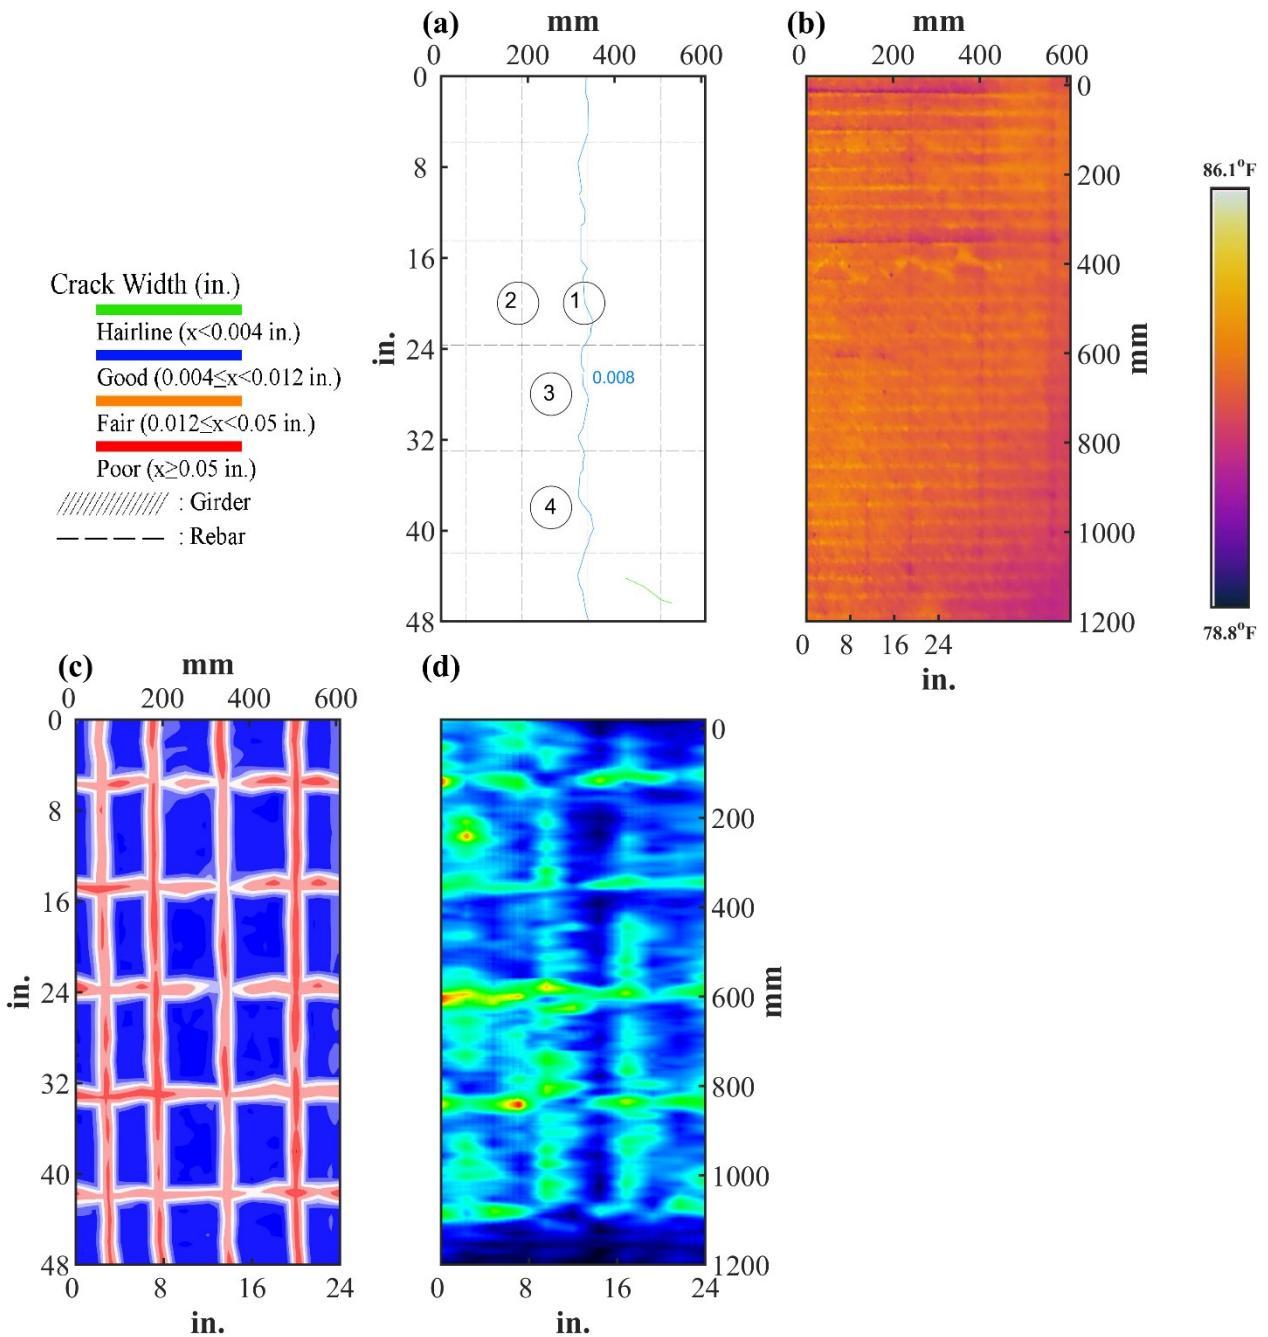
As shown in Figure 0.171 (a), there was one 0.008 in. wide transverse crack that might have been caused by panel joints on grid 1. Grid 2 was located on a joint and a 0.004 in. crack was propagating from the joint as shown in Figure 0.172 (a).

Figure 0.397. Crack Map and NDE Results of Grid 1: (a) Crack Map and Location of Cores; (b) Infrared Picture; (c) GPR C-scan at 1.9 in. to 3.3 in. Depth; (d) UST C-scan at 3.3 in. Depth

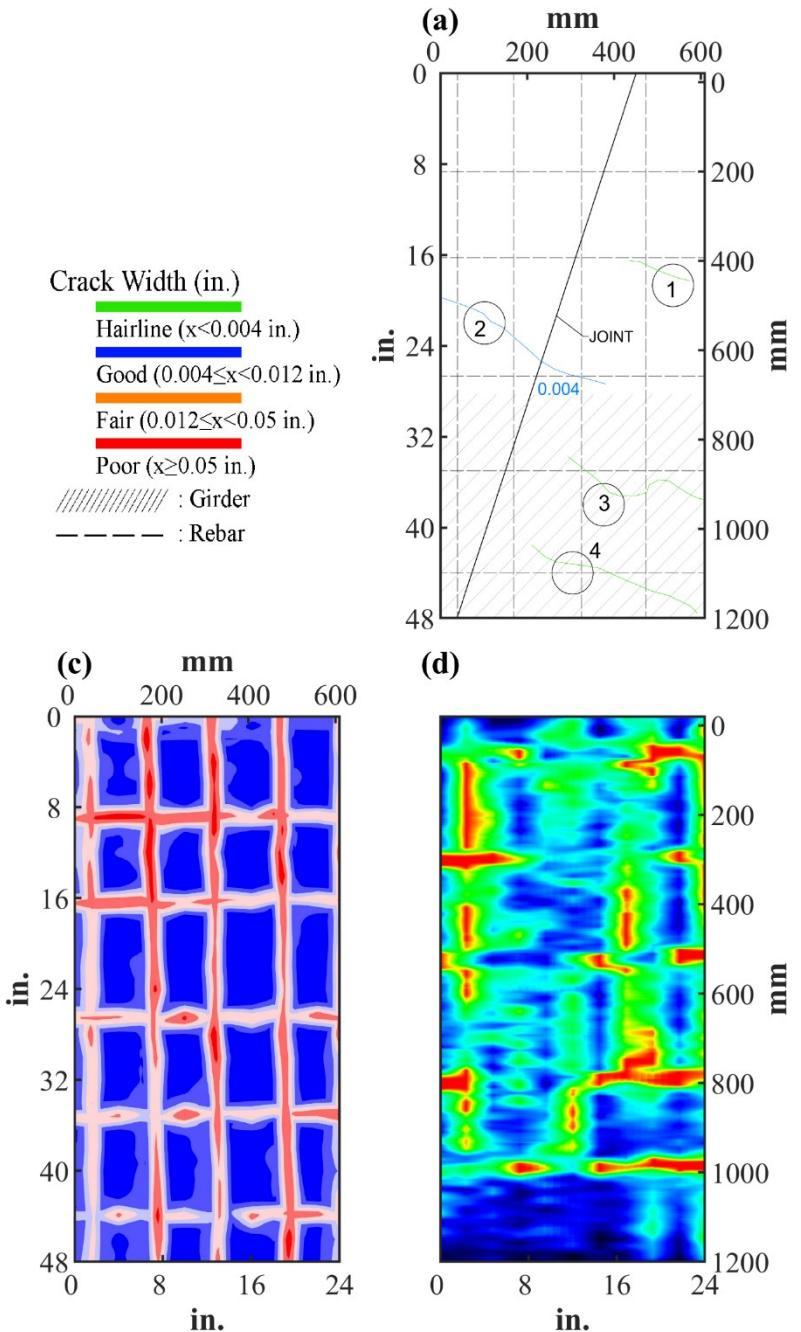
Figure 0.398. Crack Map and NDE Results of Grid 2: (a) Crack Map and Location of Cores; (c) GPR C-scan at 2.6 in. to 3.95 in. Depth; (d) UST C-scan at 3.5 in. Depth

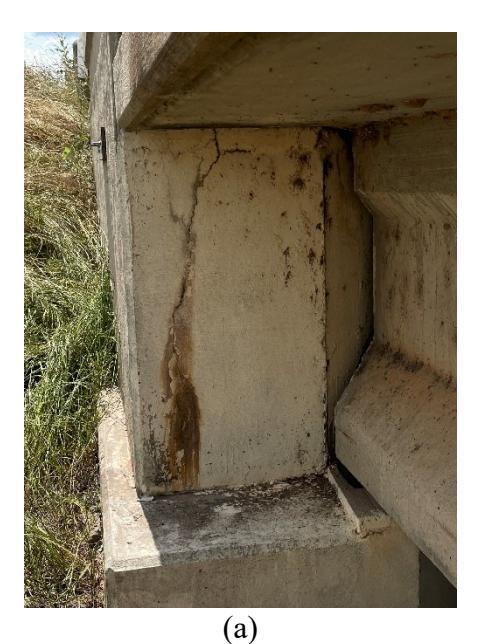
Deck surface has hairline transverse cracks. Abutment back wall has vertical and horizontal crack with efflorescence as shown in Figure 0.403 (a) and (b).

Figure 0.403. Deteriorations on the Bridge: (a) Vertical Crack and Efflorescence at Abutment Wall; (b) Horizontal Crack and Efflorescence at Abutment Wall

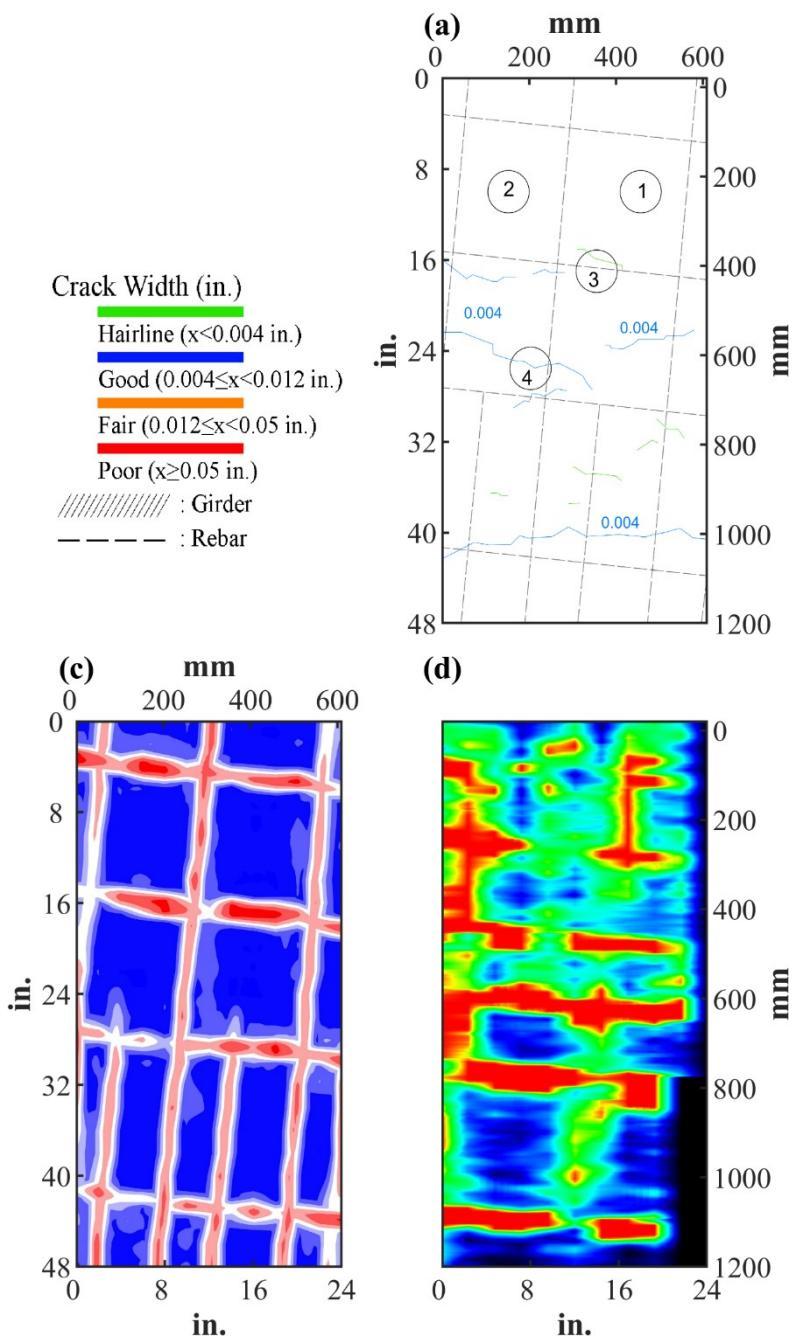
As shown in Figure 0.405 (a), there were 0.004 in. wide longitudinal cracks on grid 1. On grid 2, there were 0.004 in. longitudinal and diagonal cracks as shown in Figure 0.406 (a). Due to a weather condition, UST was not conducted on grid 2.

Figure 0.405. Crack Map and NDE Results of Grid 1: (a) Crack Map and Location of Cores; (c) GPR C-scan at 2.7 in. to 4.1 in. Depth; (d) UST C-scan at 4.4 in. Depth

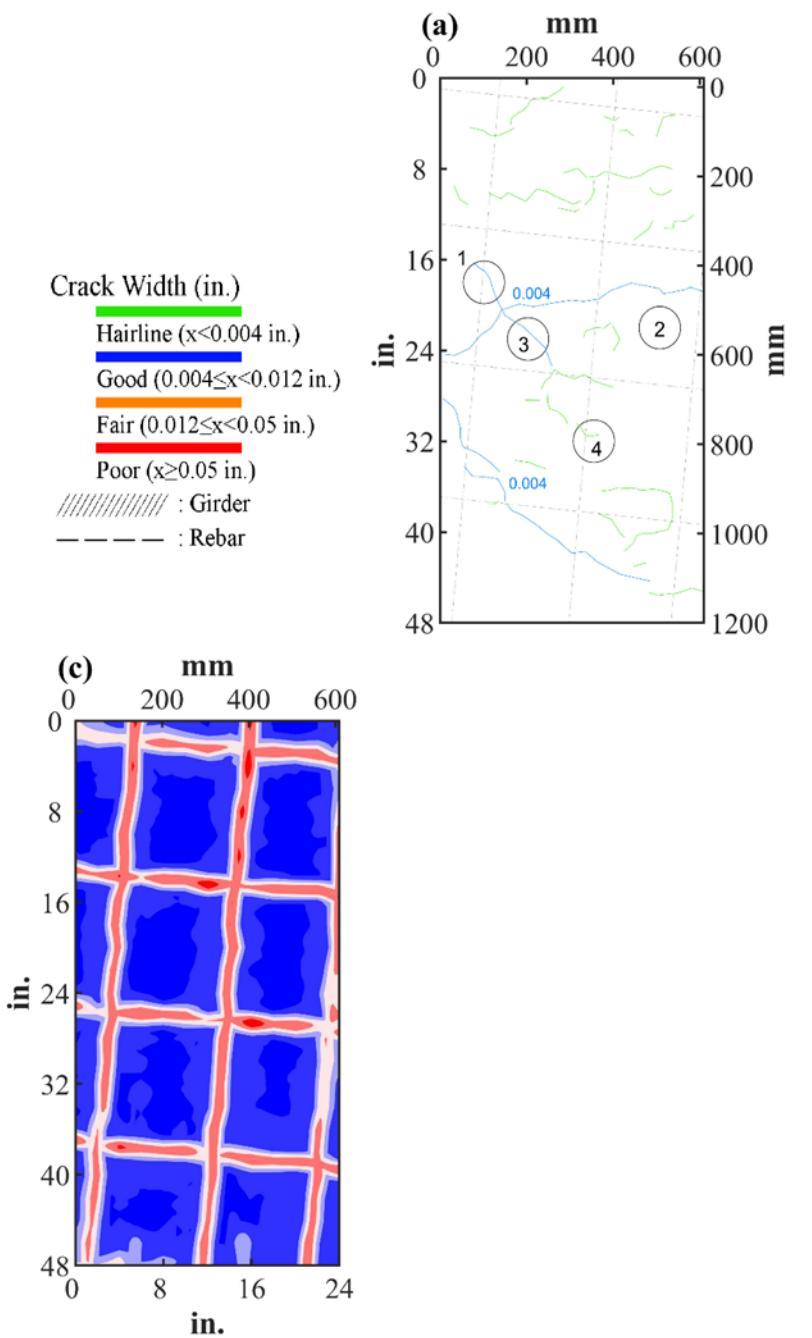
Figure 0.406. Crack Map and NDE Results of Grid 2: (a) Crack Map and Location of Cores; (c) GPR C-scan at 2.1 in. to 3.4 in. Depth

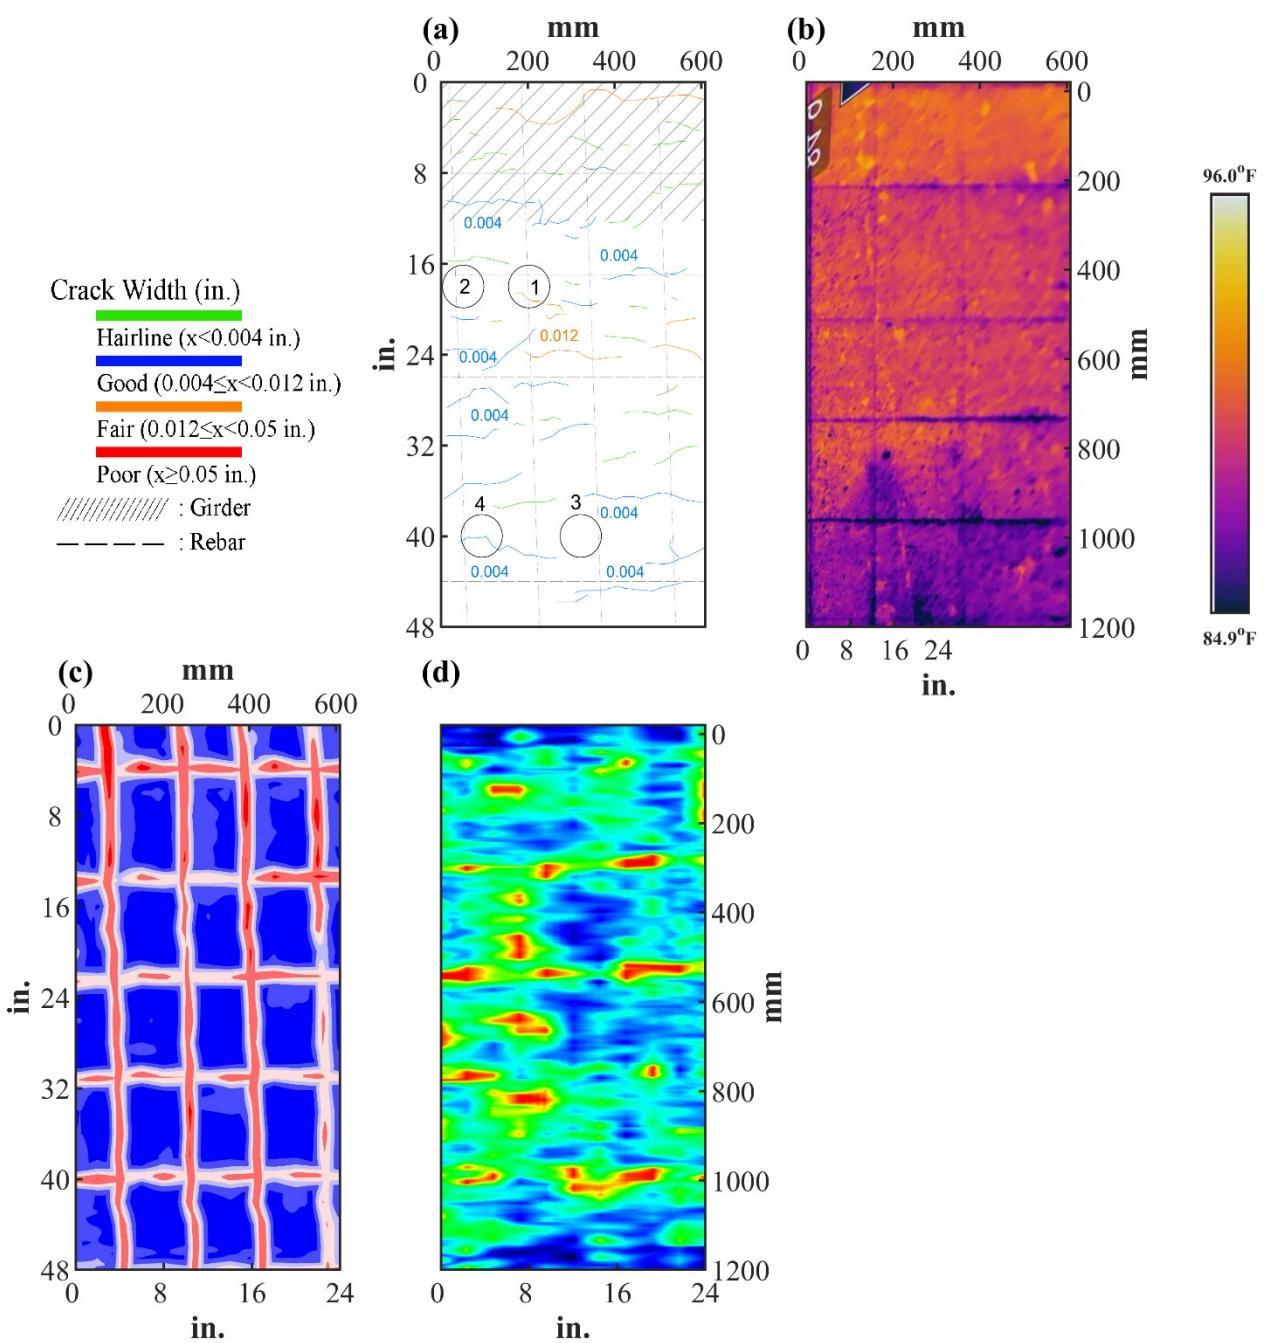
As shown in Figure 0.187 (a), there were longitudinal cracks that were 0.004 in. and 0.012 in. wide throughout the grid and along a girder on grid 1. On grid 2, there were two 0.004 in. wide longitudinal cracks and one of them were on top of a girder as shown in Figure 0.188 (a).

Figure 0.412. Crack Map and NDE Results of Grid 1: (a) Crack Map and Location of Cores; (b) Infrared Picture; (c) GPR C-scan at 1.55 in. to 2.9 in. Depth; (d) UST C-scan at 2.5 in. Depth

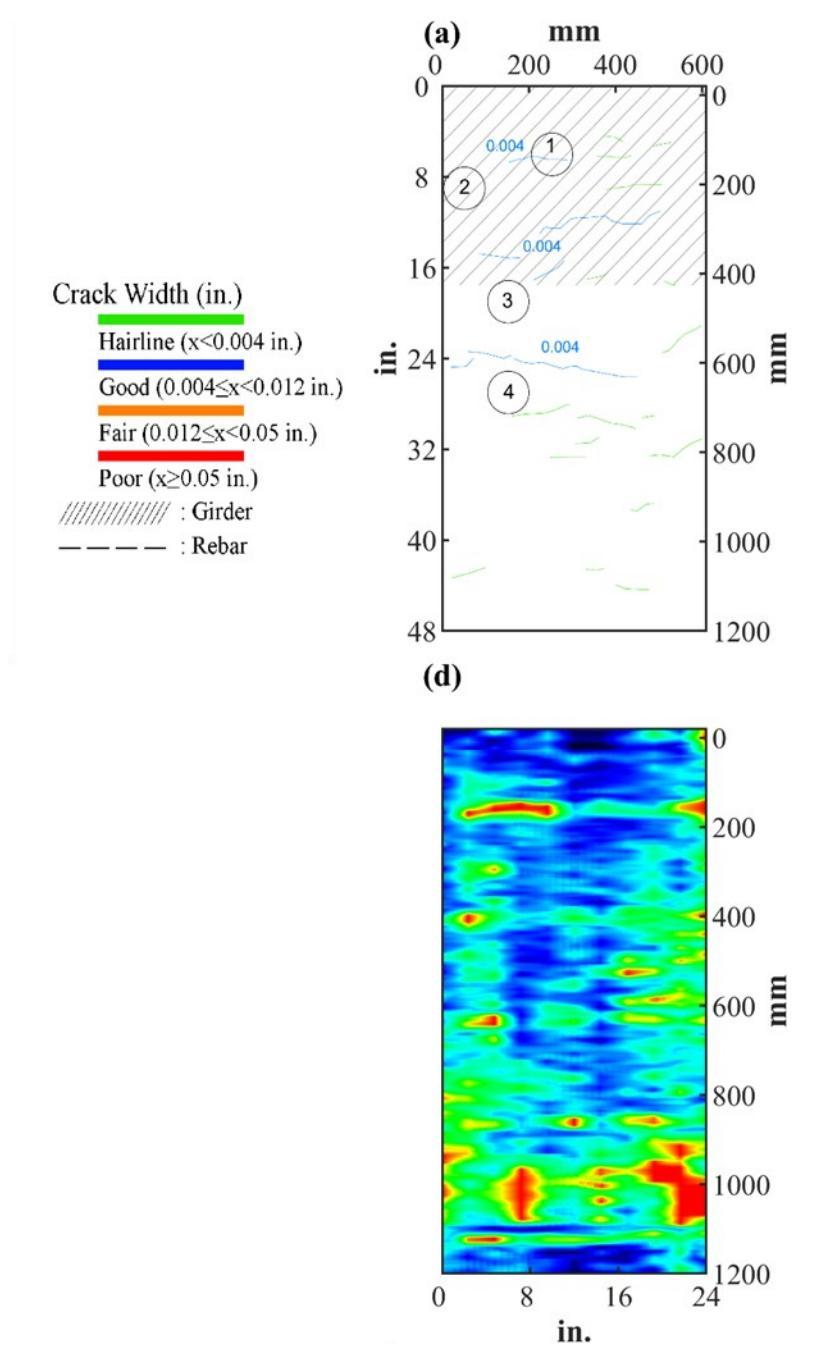
Figure 0.413. Crack Map and NDE Results of Grid 2: (a) Crack Map and Location of Cores; (d) UST C-scan at 3.0 in. Depth

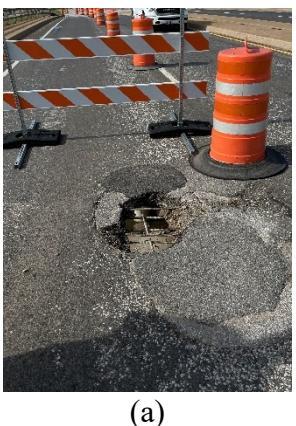
There are cracks on the top surface of deck. Crack is more widespread on span 2. There is a hole on a deck between beam 2 and 3 as shown in Figure 0.417 (a). Rebar had pitting corrosion as shown in Figure 0.417 (b). The joint is paved over by asphalt.

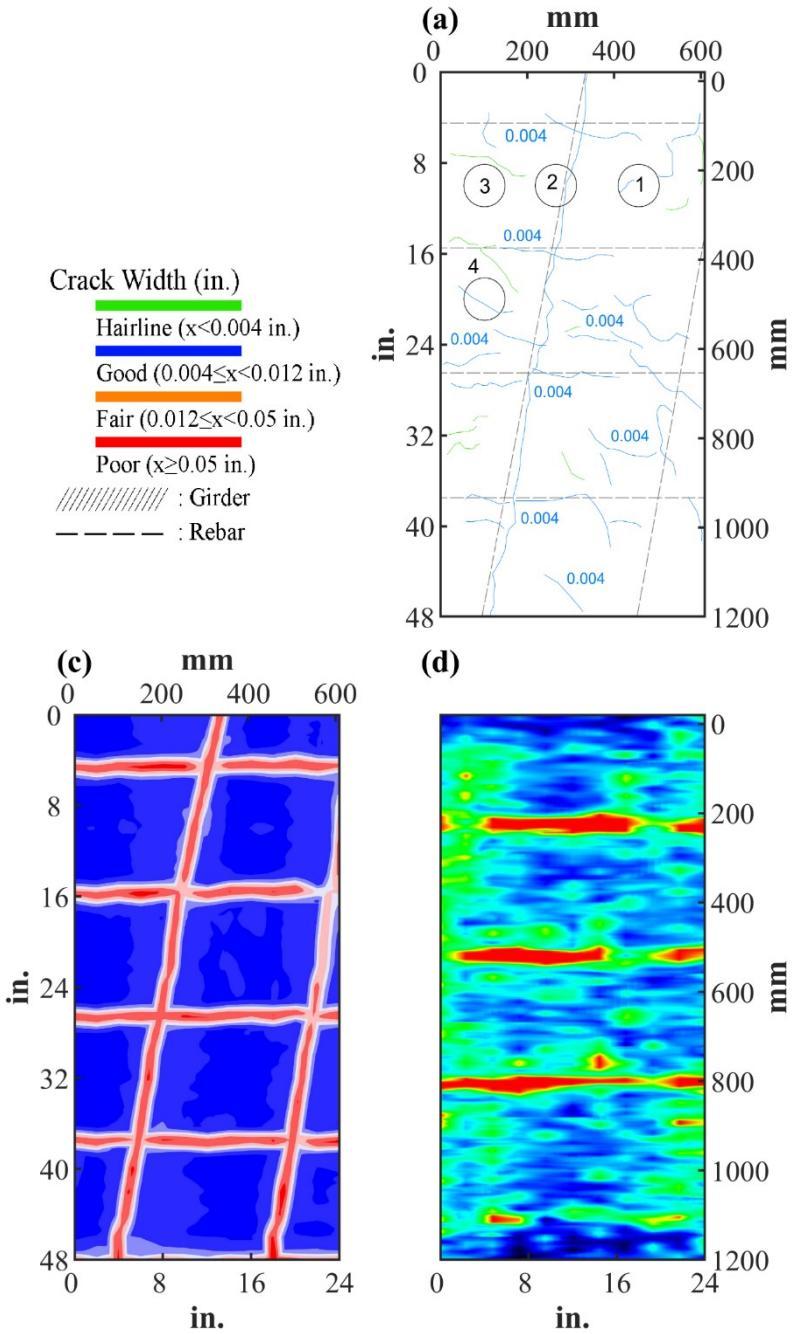
Figure 0.418. Crack Map and NDE Results of Grid 1: (a) Crack Map and Location of Cores; (c) GPR C-scan at 1.3 in. to 2.6 in. Depth; (d) UST C-scan at 2.4 in. Depth

As shown in Figure 0.418 (a), there was widespread of 0.004 in. wide cracks on grid 1, and a diagonal crack propagated along a rebar. It is possible that this crack might have been caused by panel joints.
