# Design and Rehabilitation Strategies for Permeable Friction Course Pavements

Technical Report 0-7110-R1

TEXAS A&M TRANSPORTATION INSTITUTE  
COLLEGE STATION, TEXAS

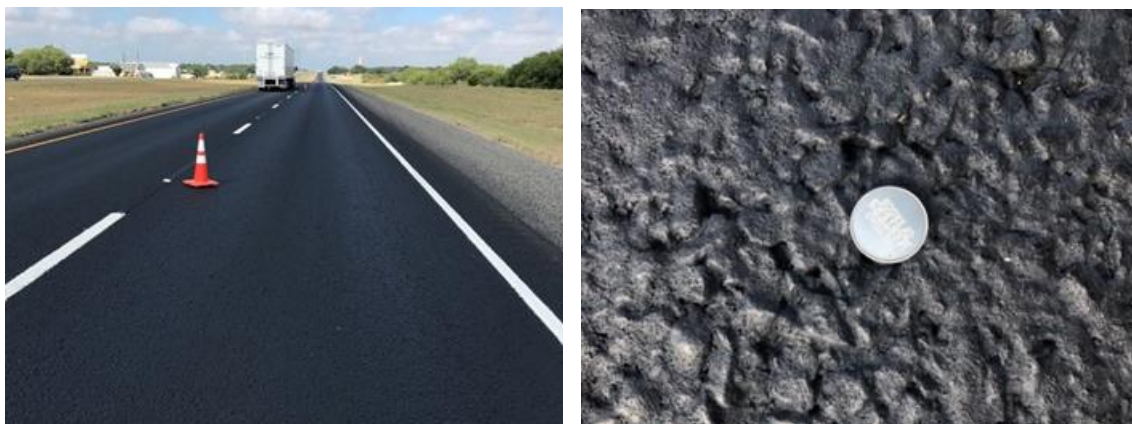
The San Antonio District constructed a 1-mi test section in the southbound lanes of IH 35 in June of 2017. This portion of IH 35 was surfaced with an older PFC that was about at the end of its life and beginning to exhibit significant raveling, and the district wanted to see if Onyx could retard the raveling and extend the life of the PFC. Figure 26 shows the treatment soon after application.

**Figure 26. IH 35 PFC surfaced with Onyx.**

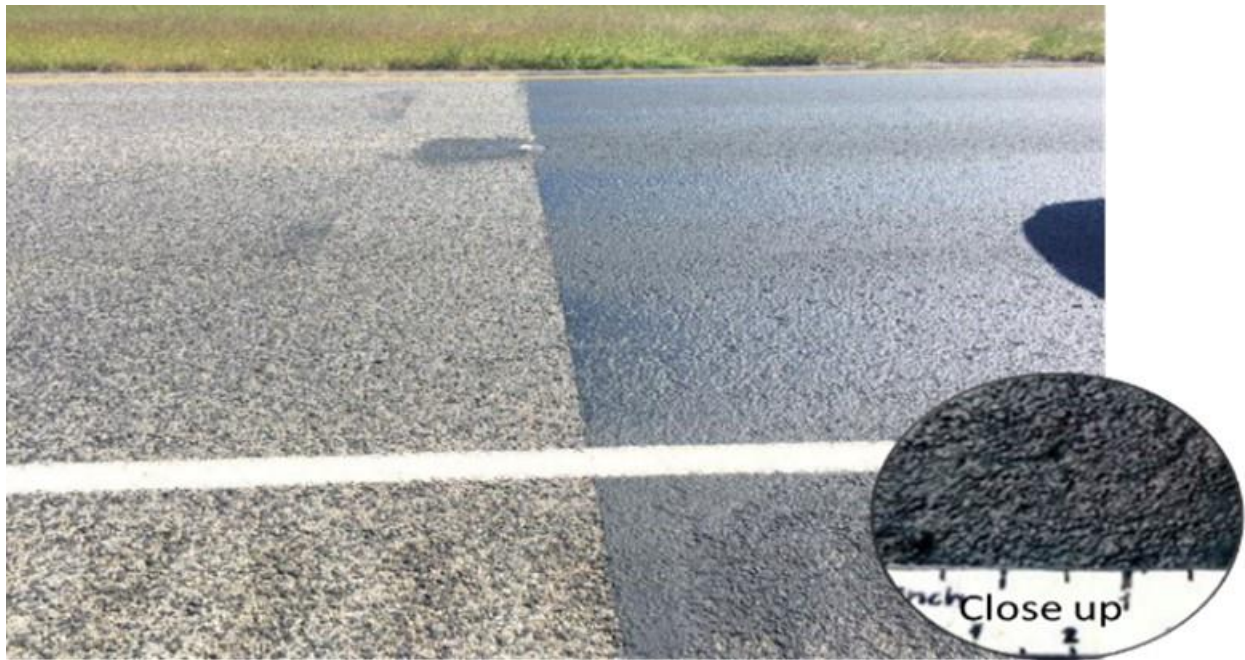
The old PFC surface along with the beginning of the Onyx application can be seen in Figure 27. Skid measurements taken on the Onyx surface and on the existing PFC at either end of the Onyx section are shown in Figure 28. These data are concerning because the skid numbers seem to have dropped by about 10 points. Some improvements in skid were noted in the last set of measurements from April 2019, but all measurements were observed to increase, and it was concluded that this increase was attributed to either (a) the slurry wearing off (Figure 29); or (b) the continuation of the raveling (Figure 30), which was visually apparent. Figure 29 and Figure 30 show the pavement surface condition 3 years after placement of the Onyx.

**Figure 27. IH 35 existing PFC and beginning of Onyx application.**

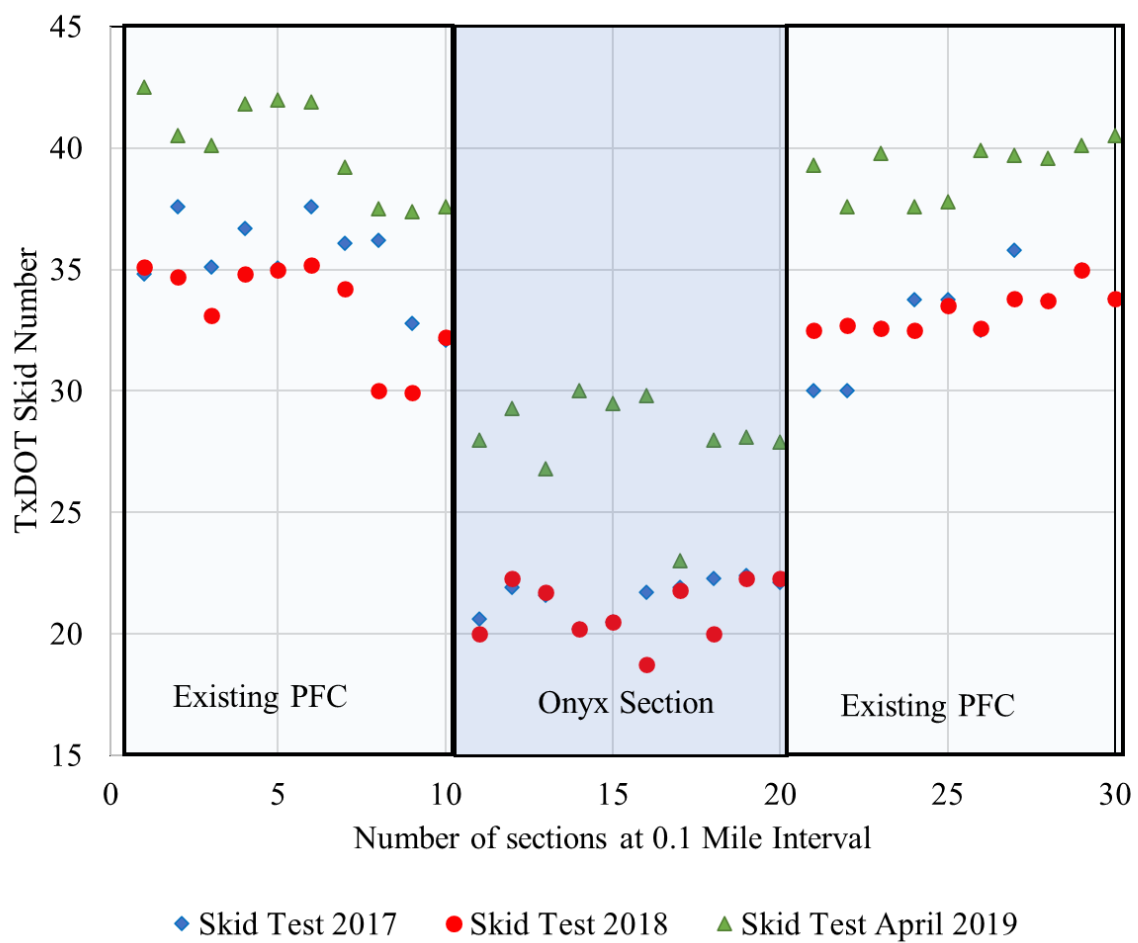
**Figure 28. Skid data on IH 35 existing PFC and Onyx test section.**

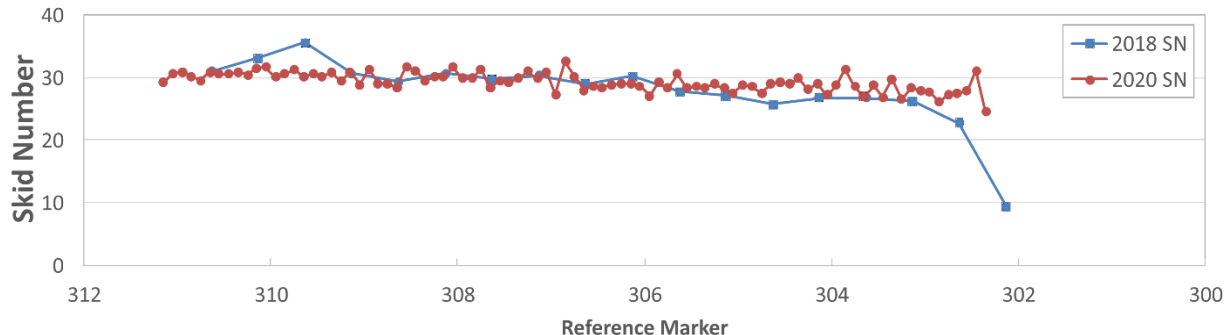
In 2020, the Brownwood District applied a frictional asphalt surface preservation treatment (Onyx, SS 3028) to a PFC on US 183 south of Breckenridge. Project information is shown in Table 11. It would have been difficult to mill this PFC off since it was originally placed on a flexible base covered with a surface treatment. The results were good in terms of friction, as shown in Figure 31. No noticeable loss in friction was observed.

**Figure 31. Skid before Onyx application (2018) compared to skid after Onyx application (2020).**

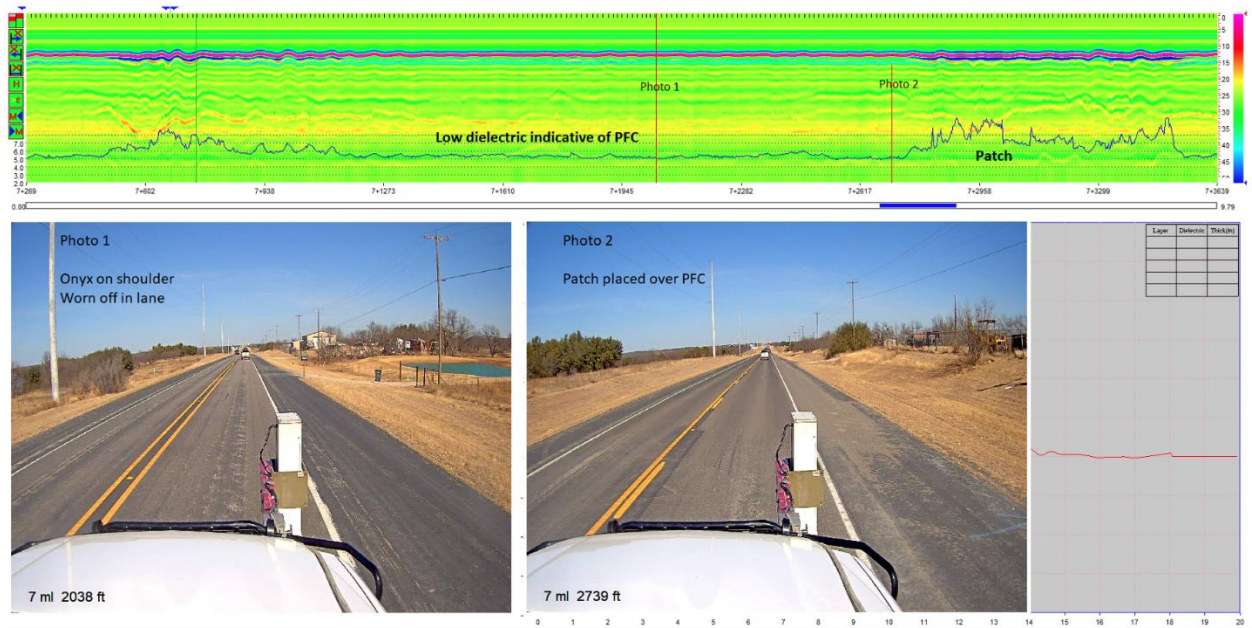
**Figure 34. GPR evaluation of US 183 in Brownwood District.**

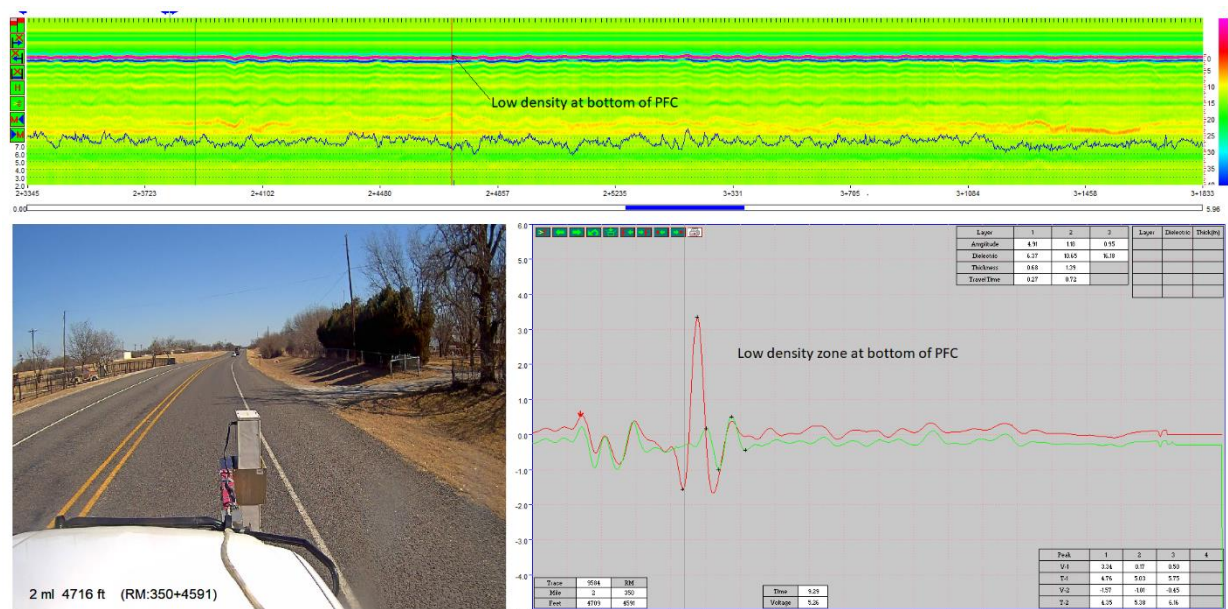
A GPR survey was conducted in February of 2022, and examples of the GPR survey are shown in Figure 36 and Figure 37. Based on the GPR, most of the project seems to be clogged (not draining) since there is no variation in density with depth, as shown in Figure 36 and schematically depicted in Figure 38. This finding indicates that the pavement was no longer functioning as a PFC at the time of seal coating. However, in some areas (as shown in Figure 37), there appears to be a portion of low density at the bottom of the PFC, meaning that the PFC is clogged in the top portion but open in the bottom portion (as illustrated in the schematic of Figure 39). While this could be an area to potentially hold water, there do not appear to be any surface distresses causing concern.

**Figure 37. GPR evaluation of SH 36 showing isolated areas of low density at the bottom of the PFC layer.**

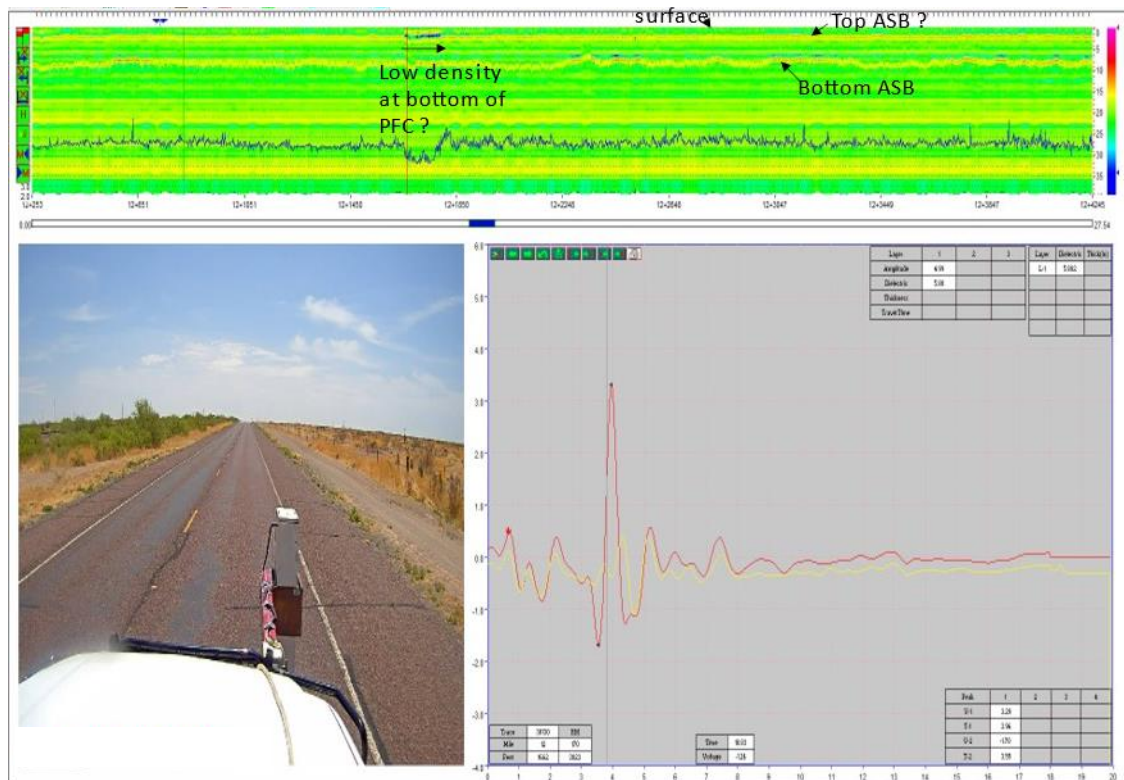
GPR imagery is shown in Figure 43. Most of the PFC appears to be clogged since there is no variation in density with depth. However, as on SH 36, there are some isolated areas where the PFC exhibits low density at the bottom of the layer, but there do not appear to be any performance problems associated with the low-density areas.

**Figure 43. GPR evaluation of US 90 in El Paso District.**

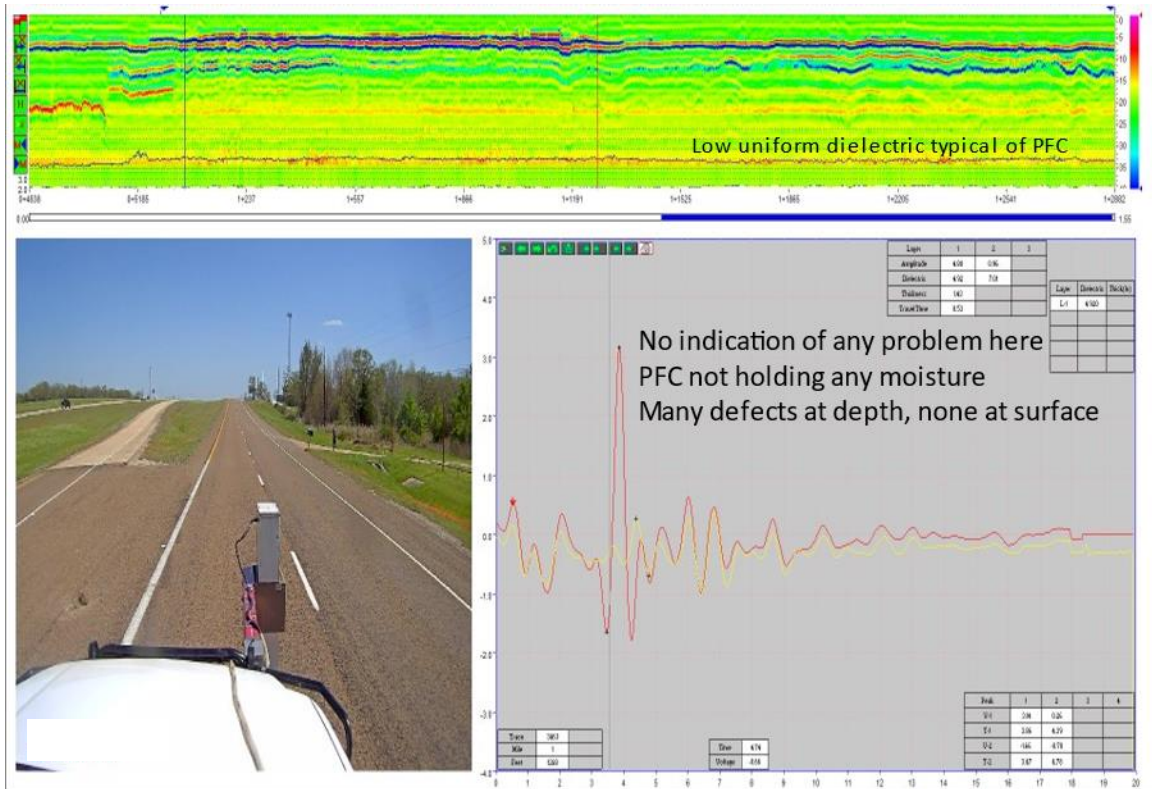
The current condition of the roadway is particularly good and can be seen in Figure 44. The GPR indicates there are quite a few defects deeper into the pavement but none near the surface. There are no indications of any problems or that the PFC may be holding moisture (Figure 45) except in an area at the bottom of a hill (Figure 46), as indicated by the elevated surface dielectric. However, there are no visual surface indicators that this area has caused any performance problems.

Figure 45. GPR evaluation of SH 6 FR indicating no problem areas.

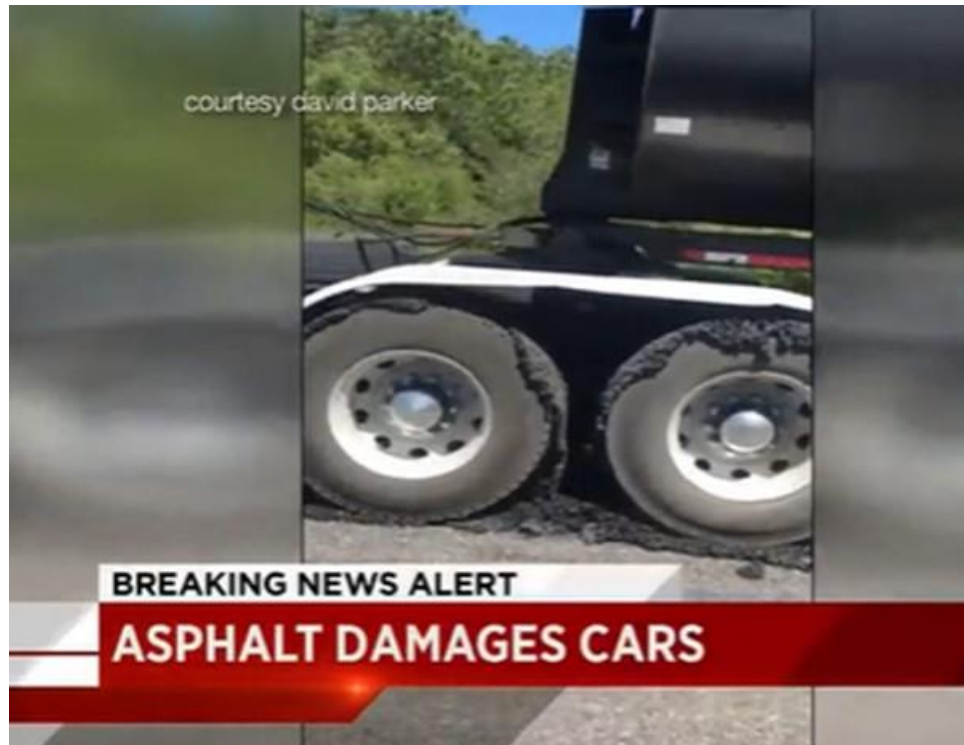
In March of 2017, Texas A&M Transportation Institute (TTI) researchers became aware of the Houston District placing an AR seal coat (intended to be an interlayer) over a PFC on SH 146. Project information is shown in Table 15. This seal coat failed dramatically by not sticking to the surface and peeling up on vehicle tires on the day of placement, as shown in Figure 47 through Figure 49.

Figure 48. Seal coat stuck to truck tires (from TV news report).

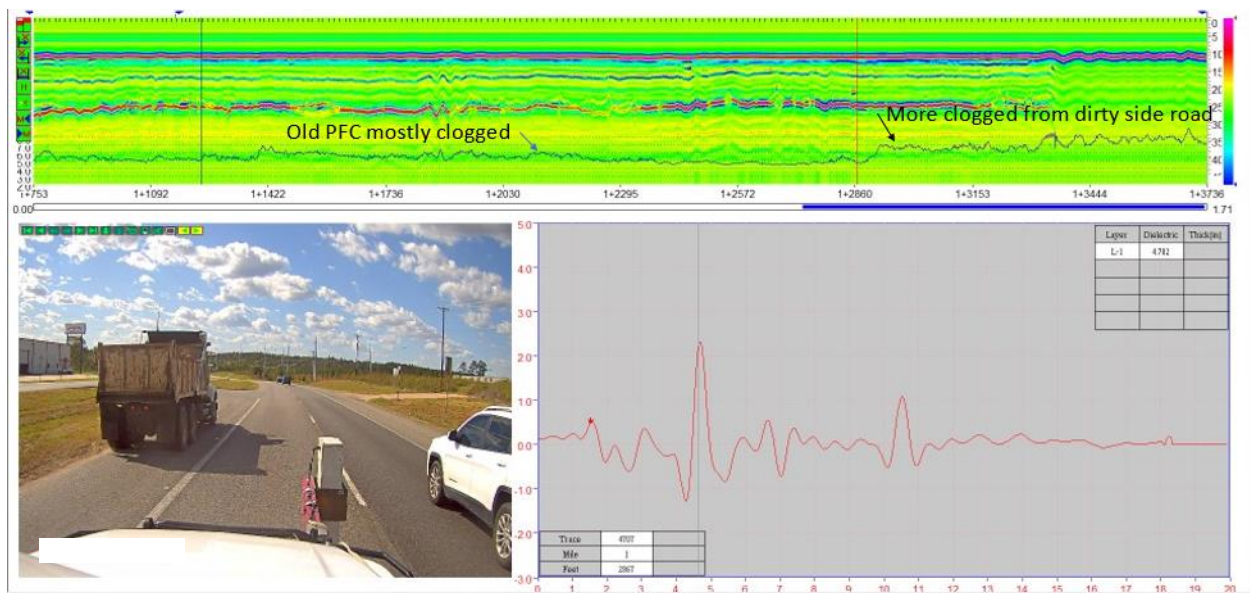
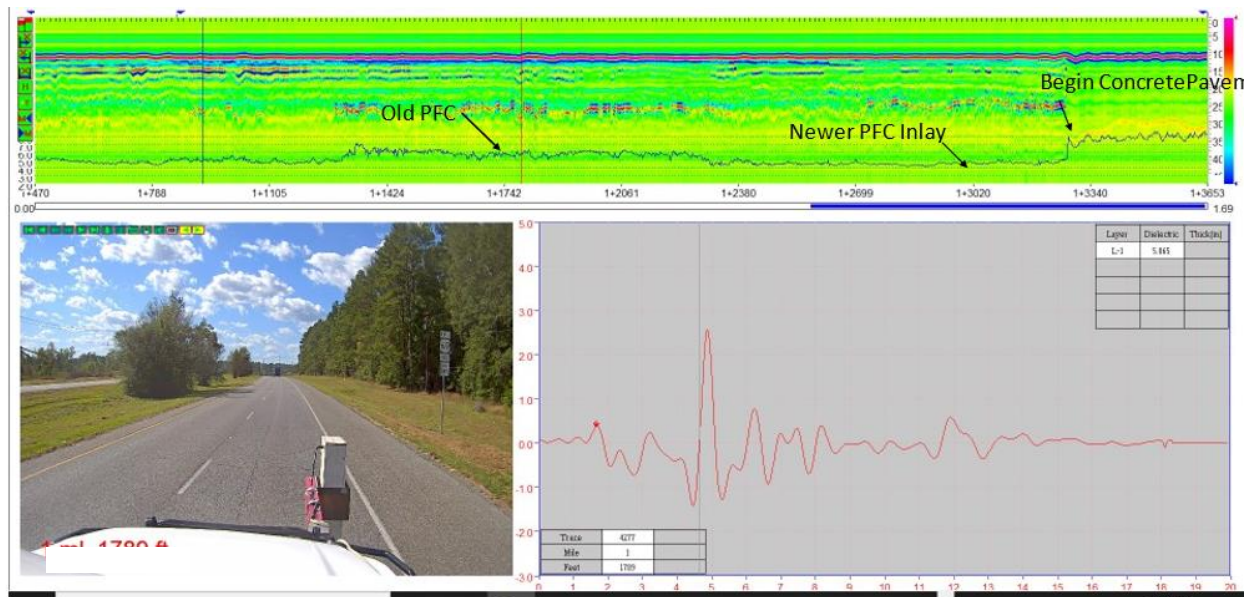
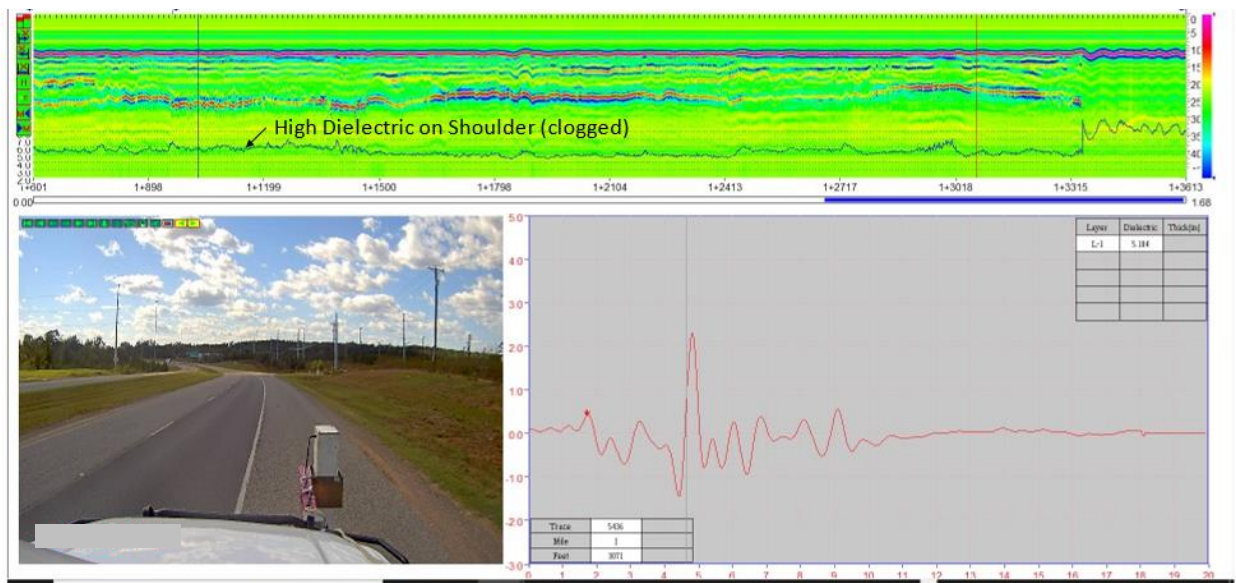
The Superpave mix was placed across the full width of the test section. GPR data for the left lane, right lane, and shoulder are shown in Figure 53 through Figure 55. When a PFC becomes clogged and is no longer draining, the GPR dielectric is higher and is more like a dense-graded HMA. Most of this older PFC tended to have a higher dielectric, indicating that it was clogged. The newer PFC inlaid patch (Figure 54) was draining a little better, but because the shoulder was also clogged, there was nowhere for the water to drain off, which created a bathtub effect within the patched area.

**Figure 53. GPR data for left lane of US 69.**

**Figure 54. GPR data for right lane of US 69.**

**Figure 55. GPR data for shoulder of US 69.**

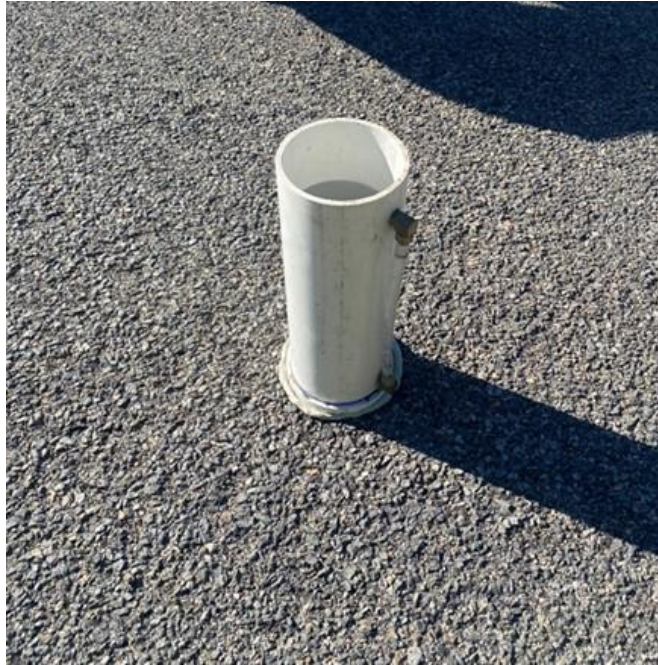
To verify these findings, the Lufkin District provided traffic control for the researchers to conduct field water flow tests and to take cores of the PFC pavement. The older PFC was not draining. At 180 seconds, as shown in the photo in Figure 56, if there was still no water flowing, the test was discontinued. The newer inlaid PFC patch performed better in terms of drainability, and these field tests confirmed the GPR data. A schematic of the test section layout and locations of field water flow tests along with results is shown in Figure 57.

**Figure 56. No water flowing in old PFC.**

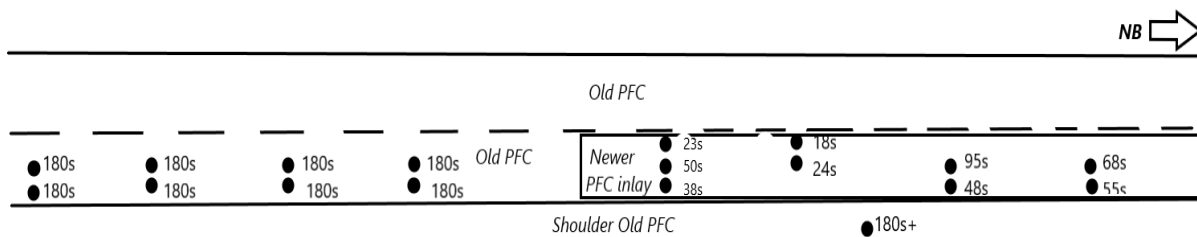
**Figure 57. US 69 test section location with field water flow test results.**

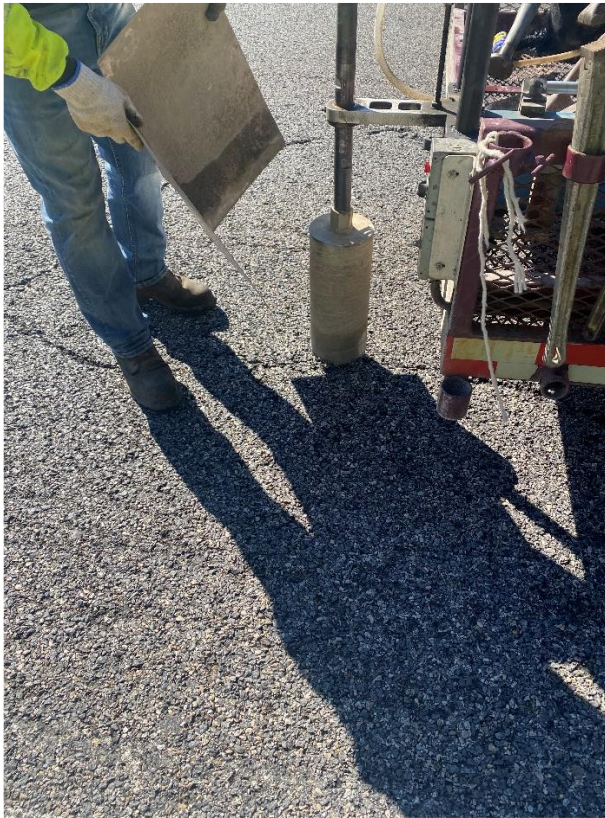
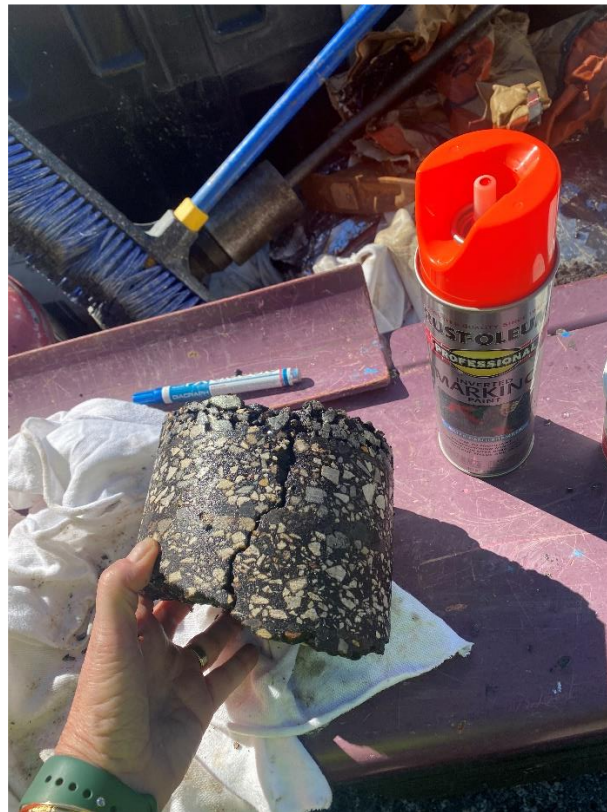
A core was also taken over one of the cracked areas of the PFC to determine if the crack was coming from underneath or if it originated in the PFC. Figure 59 shows that the crack originated in a lower layer; however, when it reflected through to the PFC, there tended to be raveling around the crack edges, making the crack more open.

**Figure 59. Coring on US 69: (a) coring rig, and (b) core acquired over cracked area of the pavement.**

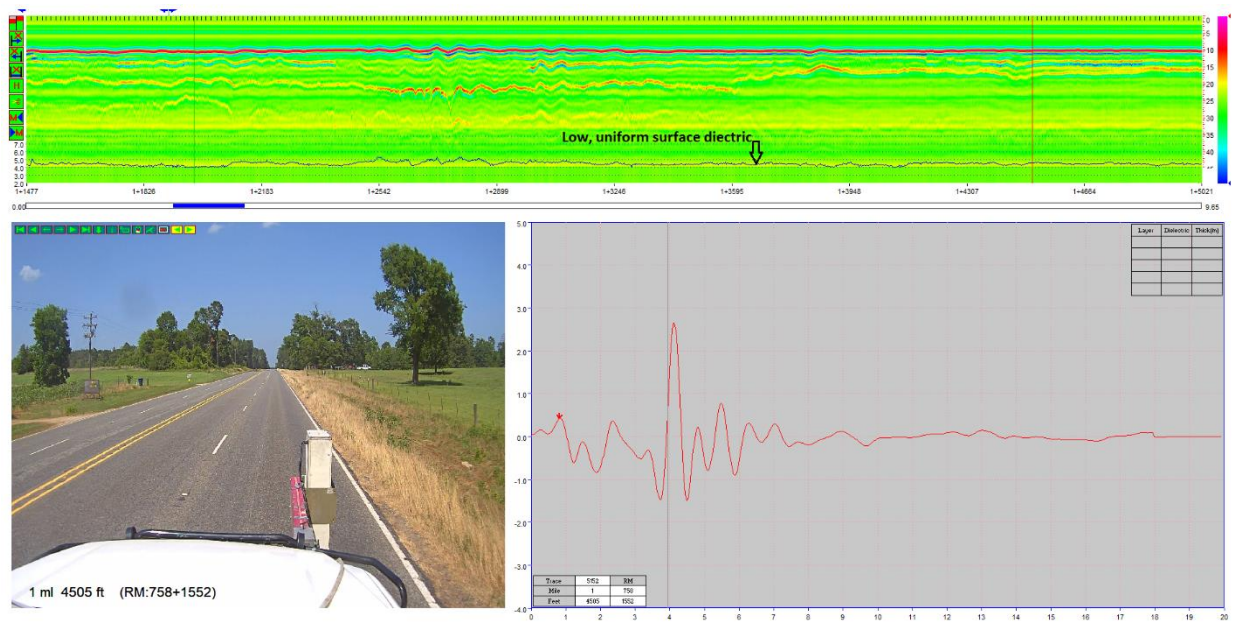
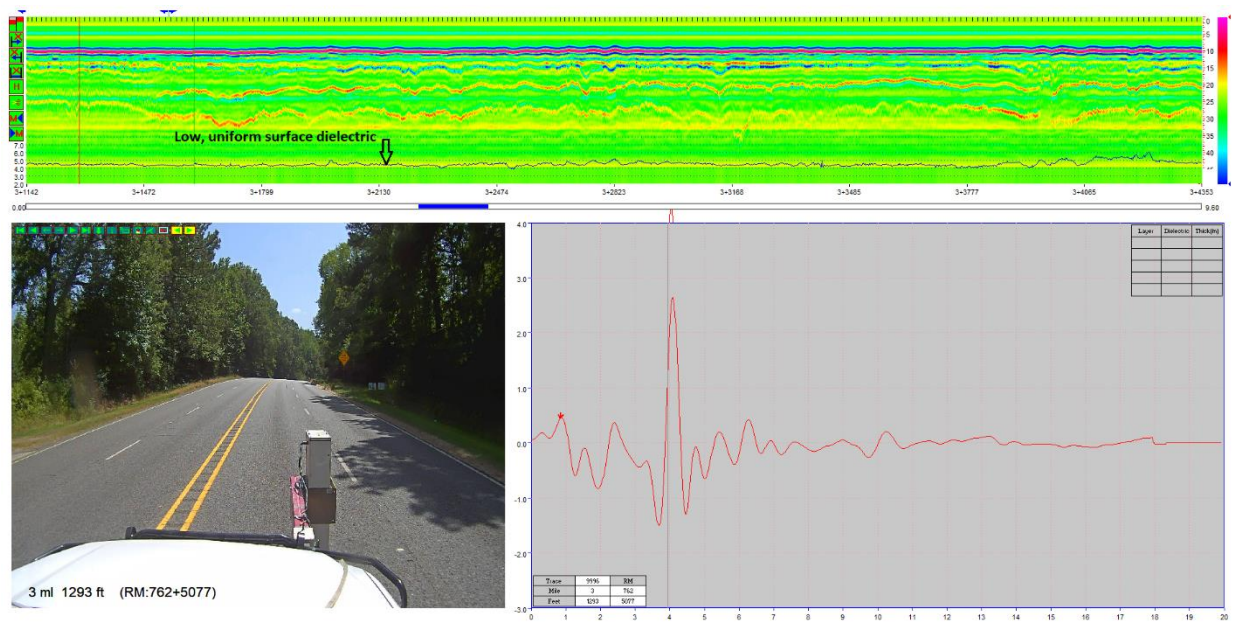
The location of this PFC was on SH 7 from SH 96 to Mt. Herman. This PFC was performing well but was exhibiting some minor transverse and longitudinal cracking. There was no indication of significant raveling. GPR data are presented in Figure 60 and Figure 61. Based on the low and uniform dielectric shown in these figures, the PFC appeared to be draining.

**Figure 60. SH 7 PFC eastbound outside lane.**

**Figure 61. SH 7 PFC westbound outside lane.**

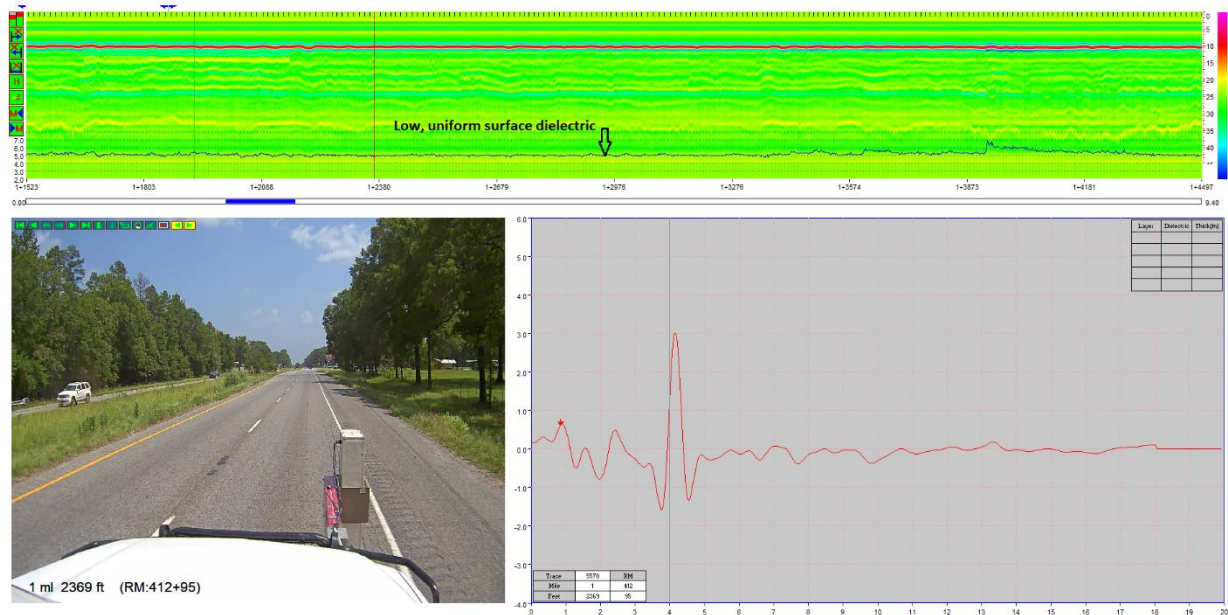
This PFC was located on US 59, from the Angelina County Line to Corrigan. According to the GPR data in Figure 62, the surface dielectric was around 5 and was uniform, indicating it was still functioning as a PFC (i.e., draining). The overall condition of the PFC was relatively good.

**Figure 62. GPR data on US 59 near Corrigan (northbound outside lane).**

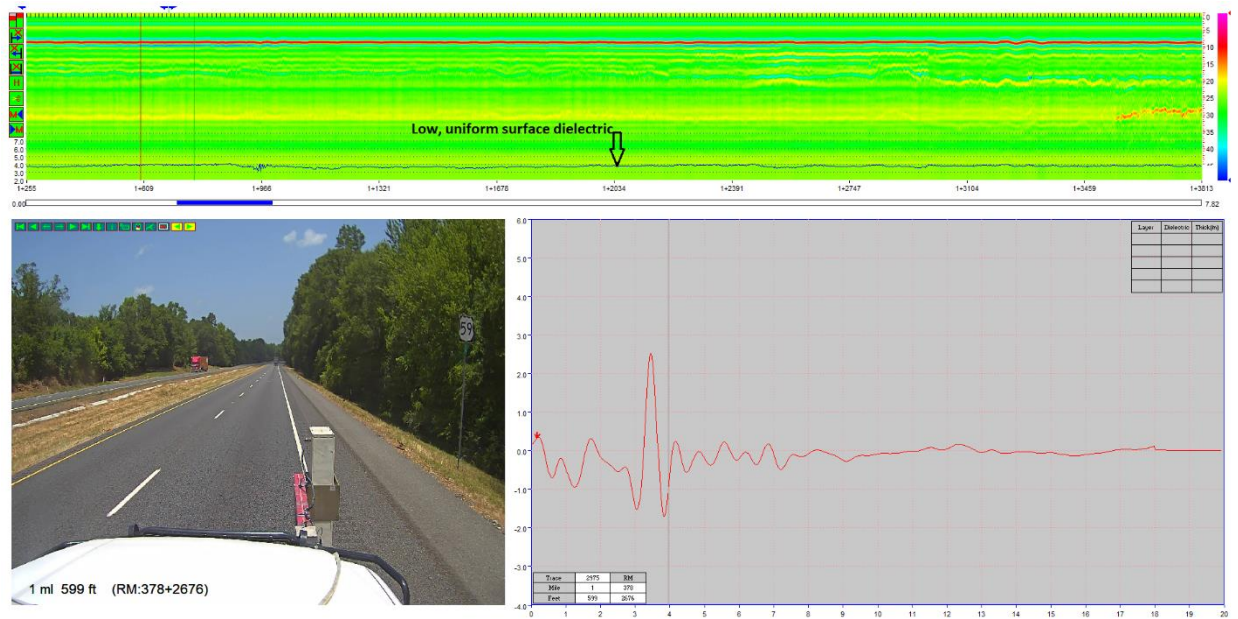
This PFC was located on US 59 from the Angelina River to the Nacogdoches city limits. GPR data shown in Figure 63 indicate that the surface dielectric was less than 5 and was functioning as a PFC (i.e., draining). The surface layer was a relatively thin PFC and appeared to have some isolated areas of delamination.

**Figure 63. GPR data on US 59 near Nacogdoches (northbound outside lane).**

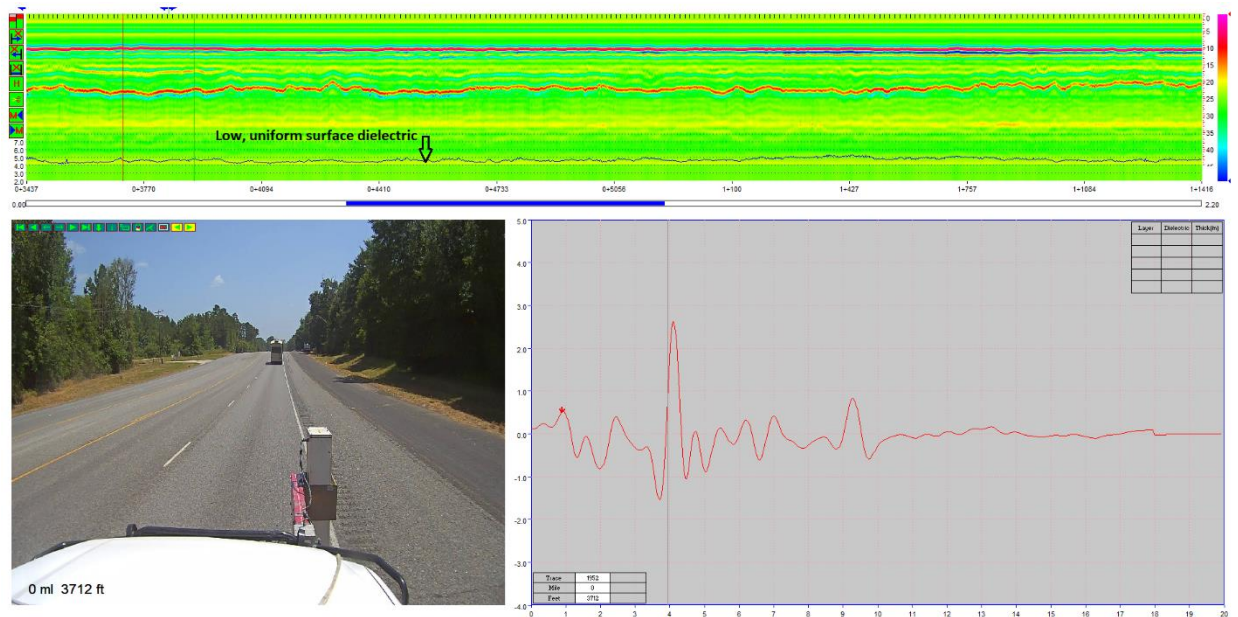
This PFC was located on US 59 north, beginning at the cloverleaf intersection of SH 84 and US 59 and going north to the county line about 4 mi. This PFC also had a low, consistent dielectric around 5, indicating that it was still draining, as shown in Figure 64.

**Figure 64. GPR data on US 59 near Tenaha (northbound outside lane).**

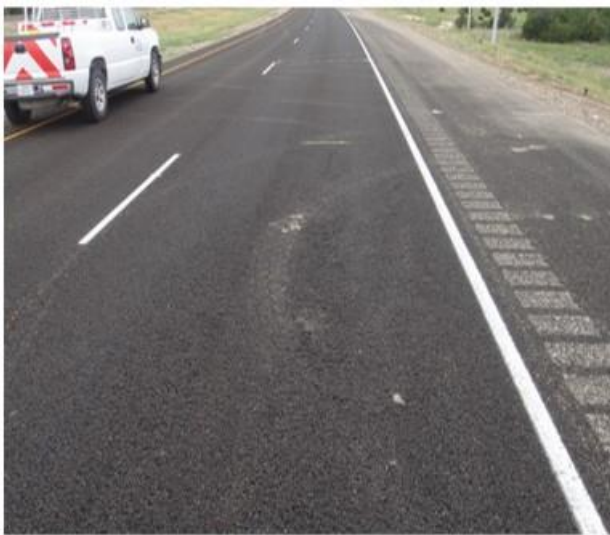
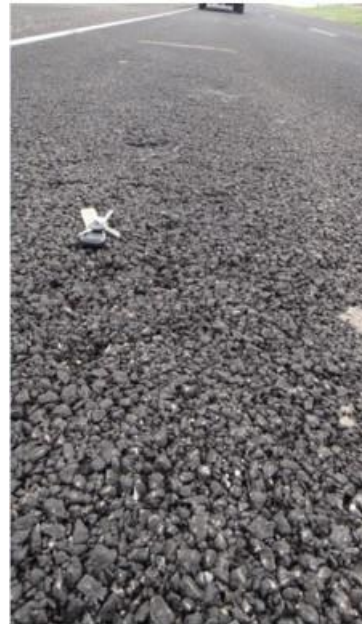
In 2014, the Austin District constructed a PFC on SH 195 (new construction) near Florence. Prior to opening to traffic, the PFC started to exhibit potential signs of raveling. Even turning a pickup truck tire on the mix caused raveling. Also, the mix looked very aged and oxidized (see Figure 65 and Figure 66). The exact cause of the excess wear was not determined, but this construction occurred when recycled oil engine bottoms were first being identified in asphalt, along with their negative effects on HMA.

**Figure 65. SH 195 PFC in 2014: (a) overview of the signs of pavement distress before opening to traffic, and (b) closeup view of the oxidation and raveling distress.**

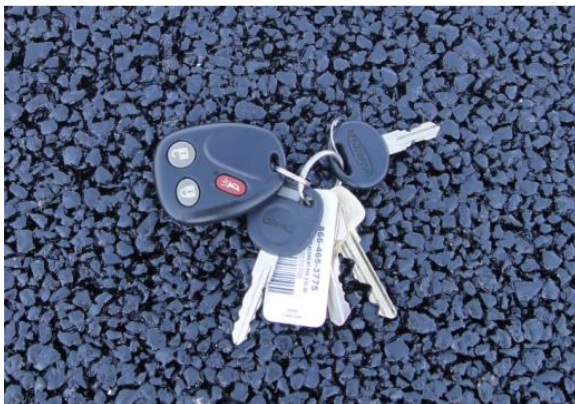
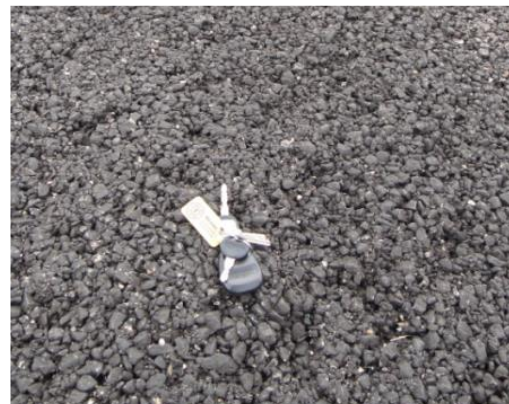
**Figure 66. Comparison of typical new PFC to the SH 195 PFC mix: (a) typical new PFC; (b) SH 195 new PFC.**

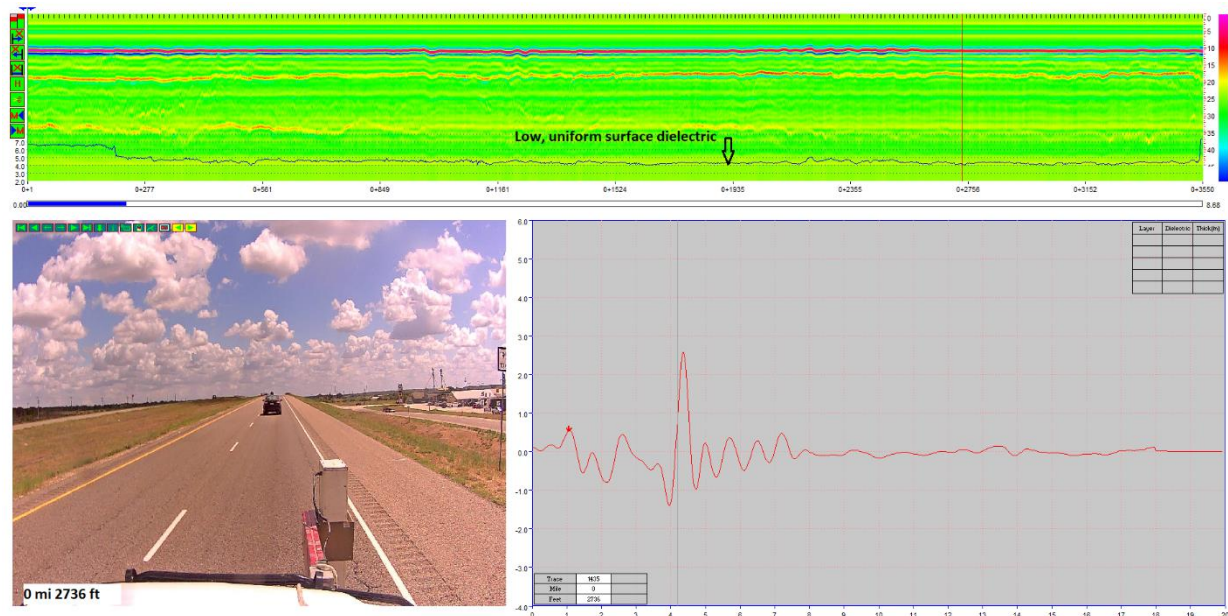
**Figure 67. GPR data for SH 195 collected in August 2022.**

TTI collected GPR and HD video in August 2022 (8 years later), as shown in Figure 67. While the PFC is showing some signs of raveling and some cracking, it has performed remarkably well given initial concerns.

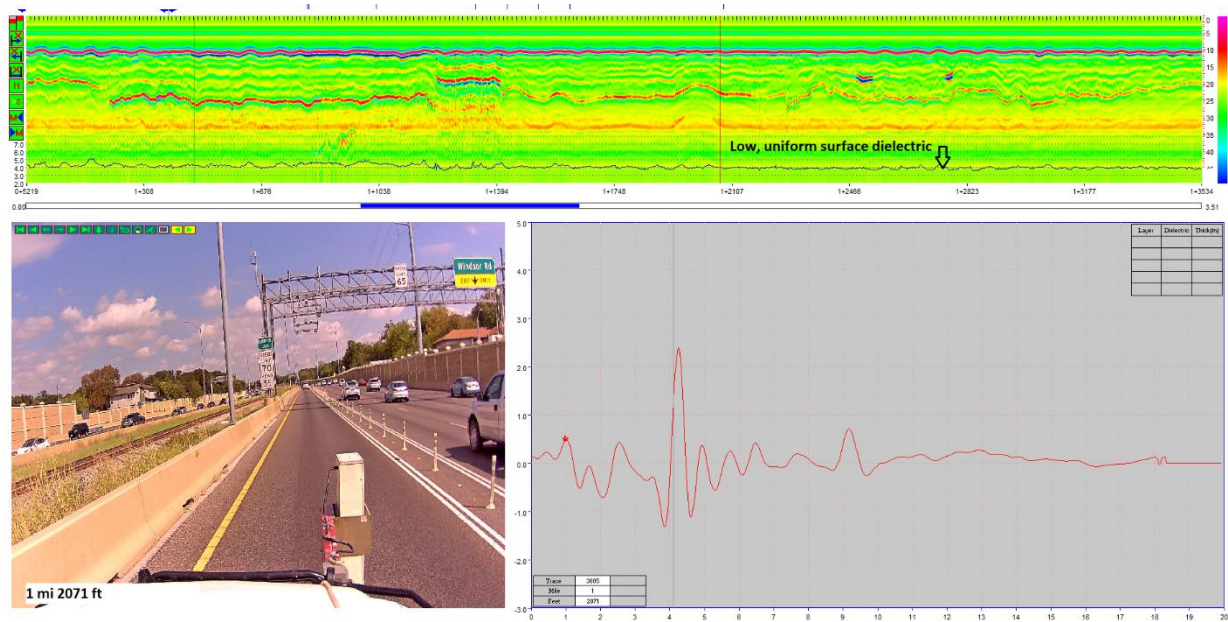
**Figure 68. GPR data on MoPac.**

Testing before and after fog seal included skid, GPR, and water flow. The research team also collected GPR data on the test section in October 2022 prior to placement of the fog seal. Some of these data are shown in Figure 68. The video shows the surface to be in good condition, and the surface dielectric is low and consistent, indicating good drainability.

As discussed in Chapter 5, TTI collected GPR data on the test section in October 2022 prior to placement of the fog seal. As shown in Figure 68, the surface at that time was in good condition, and the surface dielectric was low and consistent, indicating good drainability.

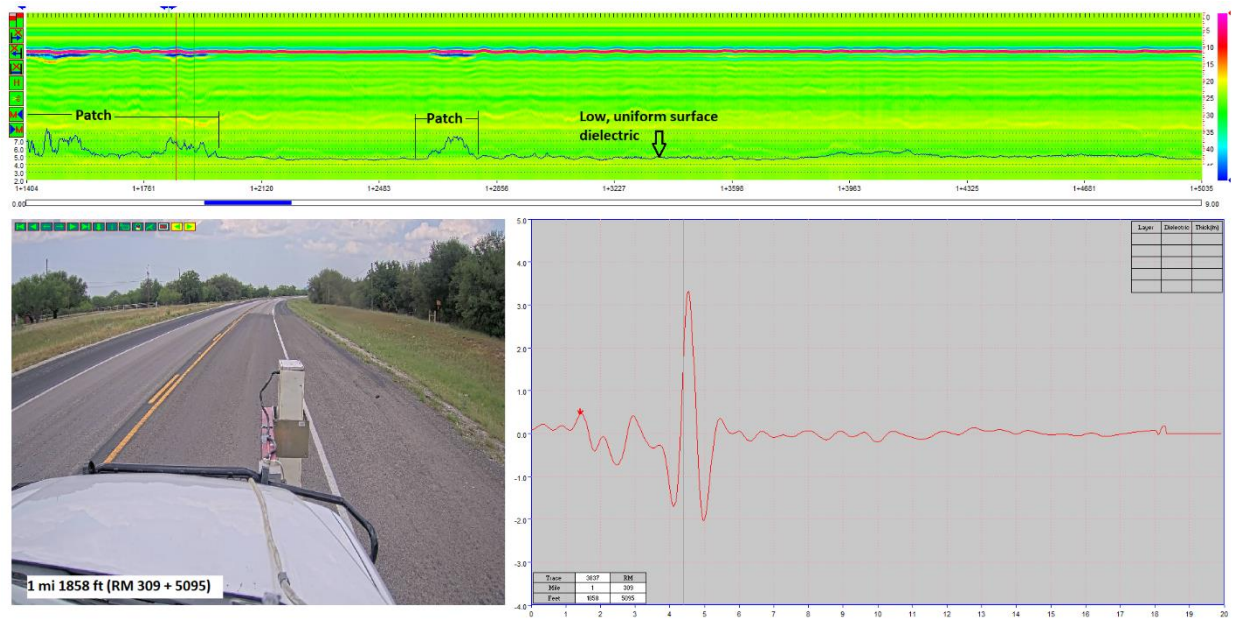
**Figure 69. GPR data on US 183 south of Breckenridge.**

In 2012, the Brownwood District placed a fine PFC on US 183 south of Breckenridge. This section of roadway had a surface treatment exhibiting some flushing, which is why a PFC was selected as the overlay. In 2020, the district applied a frictional asphalt surface preservation treatment (Onyx, SS 3028) to this PFC to extend its life (Figure 69 and Figure 70). After a couple of years in service, the Onyx surface was almost completely worn off.

Since the Onyx surface has worn off, the district is planning to place a seal coat. This PFC cannot be milled off since any milling would probably damage the flex base underneath because it is very thin.

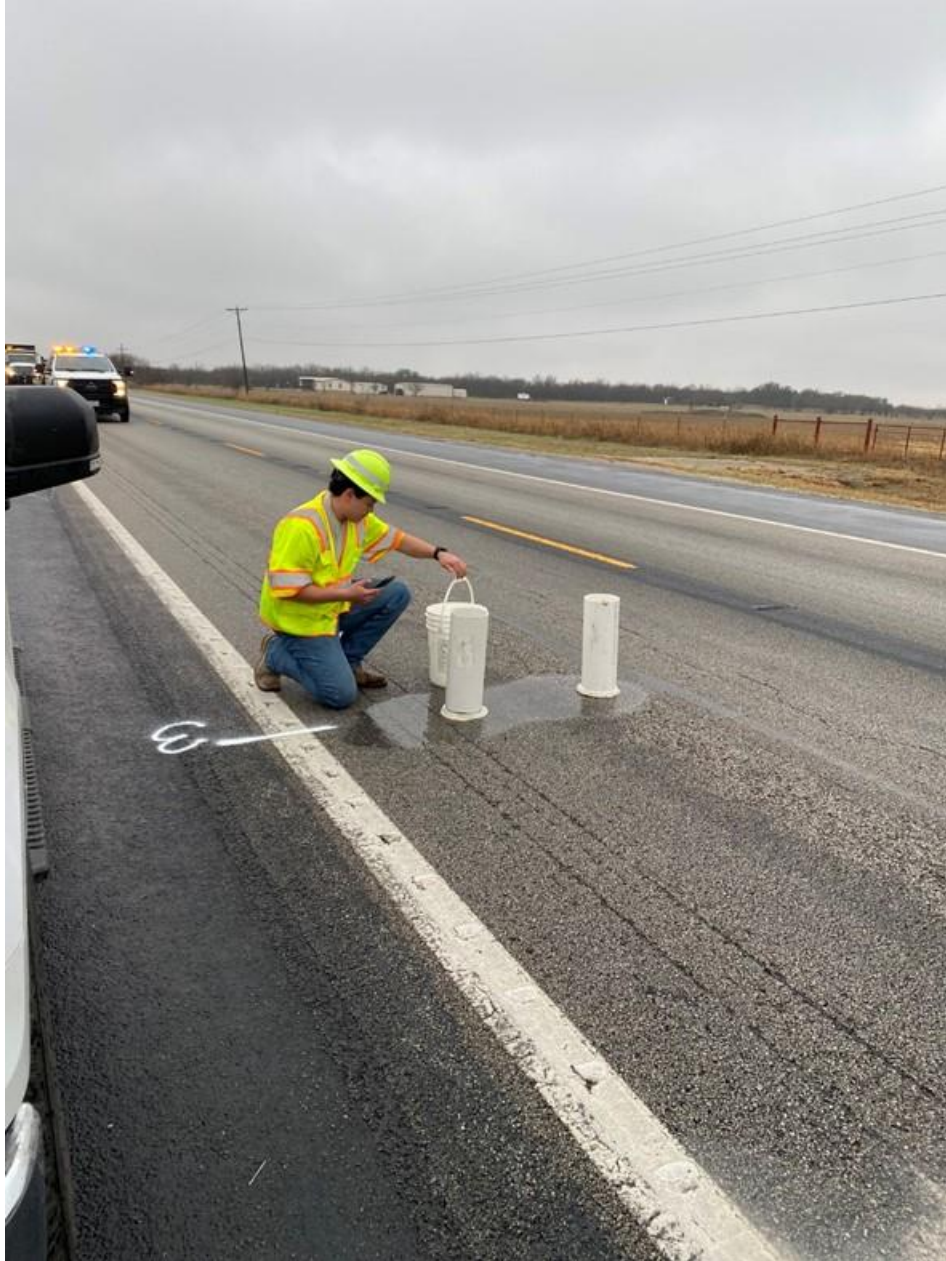
**Figure 71. Water flow testing.**

In March of 2023, TTI researchers conducted field testing on this section of roadway. Five locations were selected for water flow testing and for coring. Water flow tests were conducted in the outside wheel path and between the wheel paths, as shown in Figure 71. For the most part, the PFC was clogged, but there were a few locations where the PFC could be taking in water. The results of the water flow tests are shown in Figure 72.
